*Hawaii Department of Transportation
Research Project Number 67167*

HAWAII DOT FLARED BURIED-IN-BACKSLOPE GUARDRAIL END TERMINAL PART 2 – REVERSE DIRECTION TESTS

MwRSF Research Report No. TRP-03-496b-25

December 16, 2025

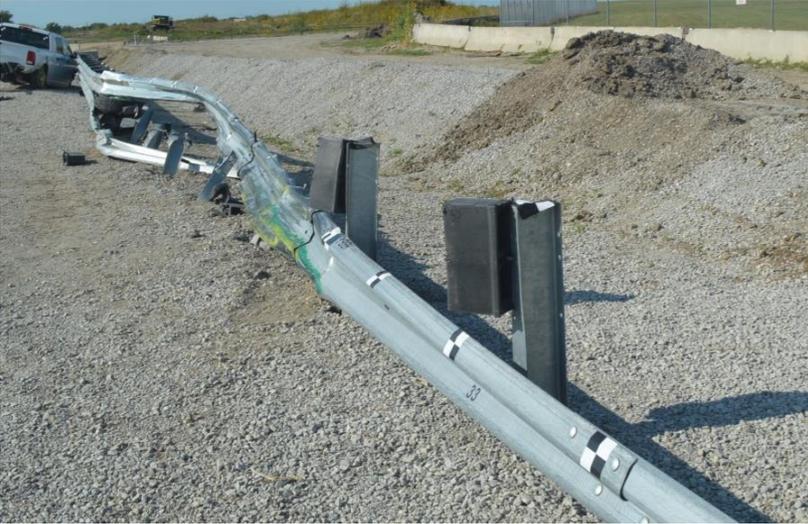
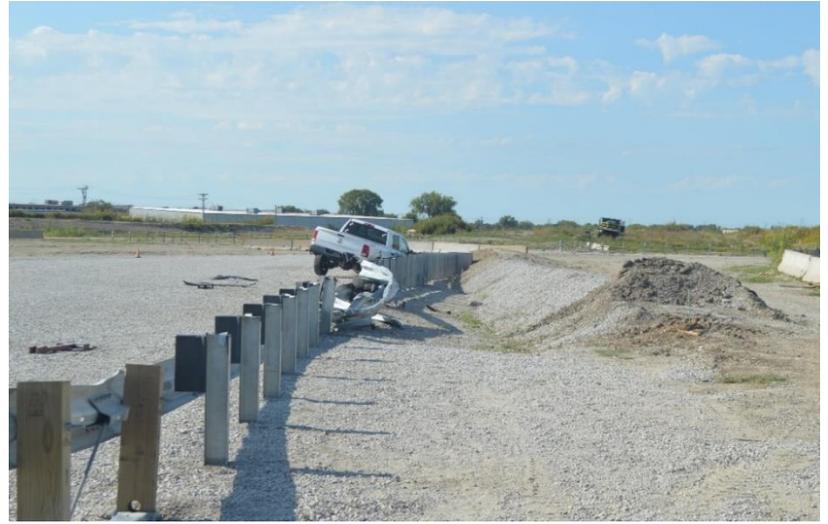
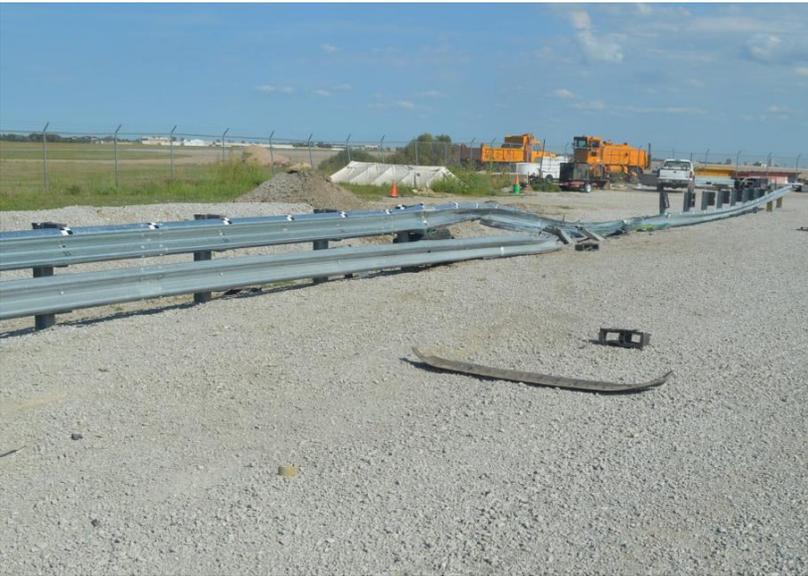
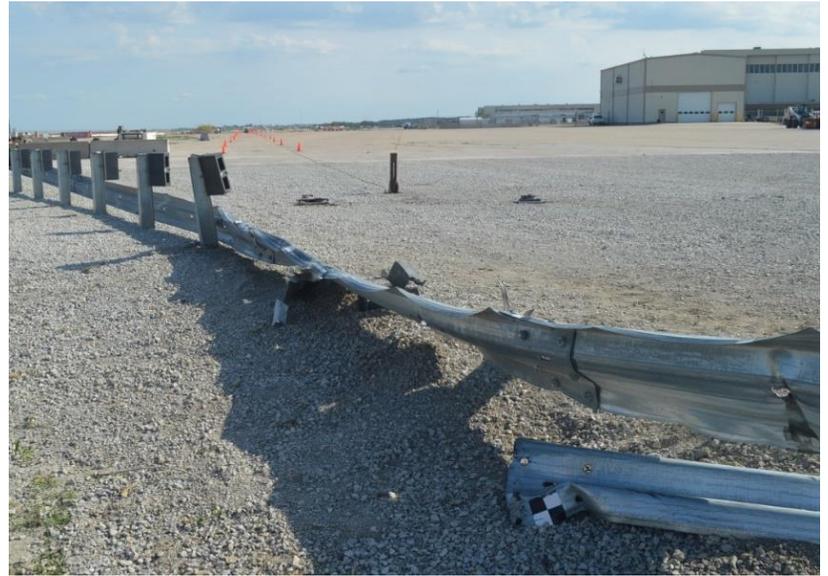
Figure 82. System Damage, Test No. HBIB-6

Damage to the barrier was severe, as shown in Figures 81 through 86. Barrier damage consisted of kinks, rail flattening, bending, gouging, and bolt hole tearing. The length of vehicle contact along the barrier was approximately 31 ft which spanned from the centerline of post no. 32 to the vehicle's final position near post no. 27. Secondary contact occurred 23 in. upstream from the centerline of post no. 17 and extended 65 in. downstream.

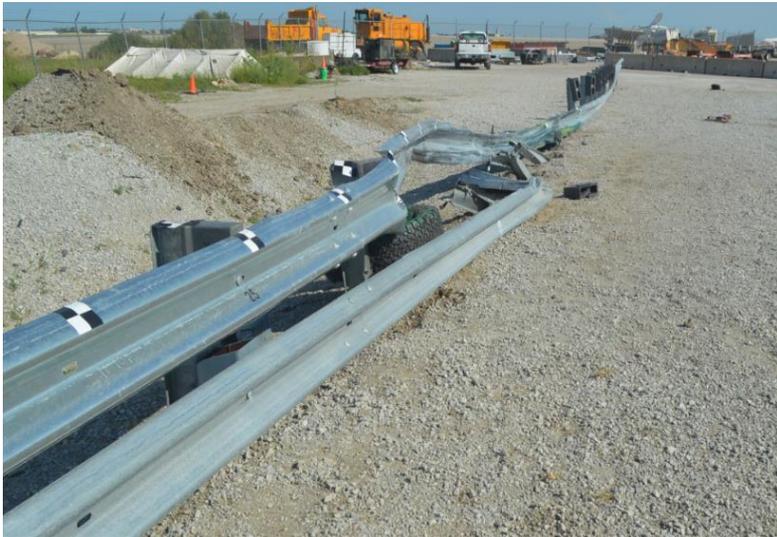
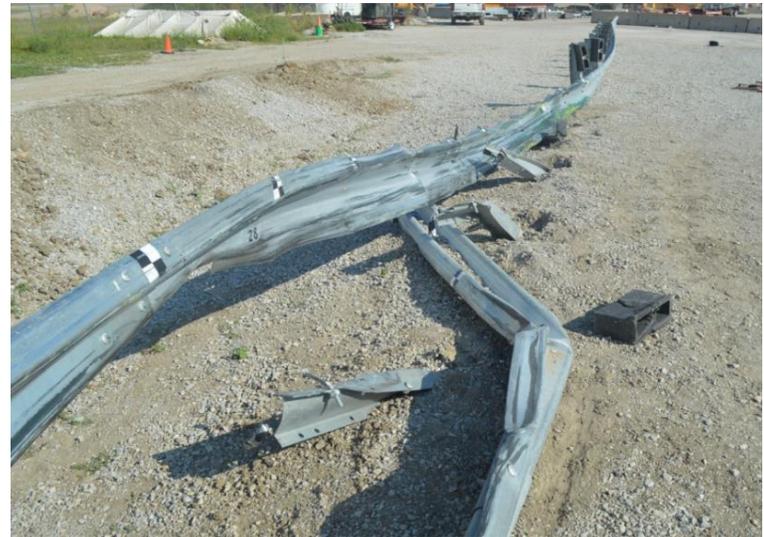
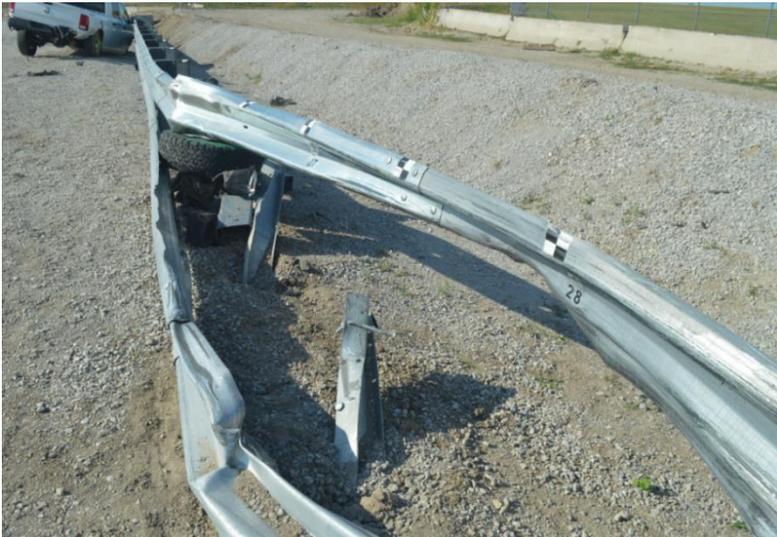
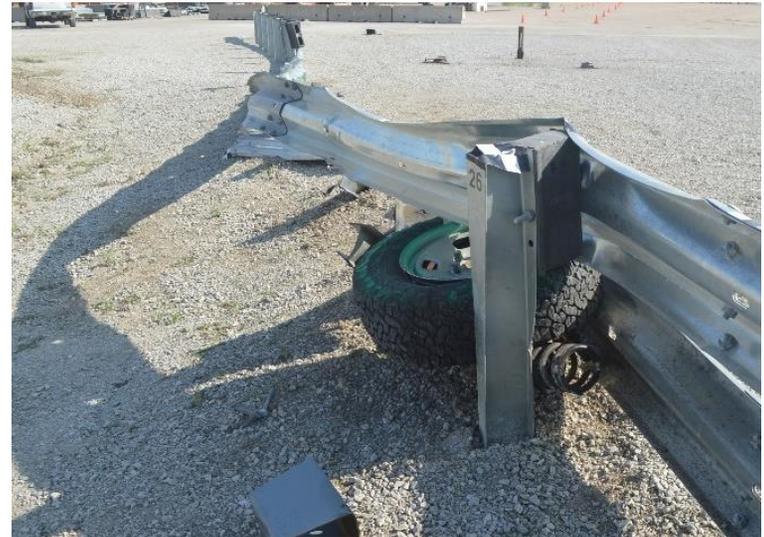
Figure 83. Upper Rail and Rubrail Damage Test No. HBIB-6

Damage to the rail was primarily located along both the top and bottom rails. The top rail showed significant contact marks, with the primary mark located at the centerline of post no. 32, extending 31 in. downstream along the top rail. Another contact mark appeared 23 in. upstream from the centerline of post no. 17 and extended 65 in. downstream. On the bottom rail, a contact mark began at the downstream centerline of post no. 28 and extended for 104 in. with a consistent width of 3 in. Flattening of the top rail was observed 51 in. downstream from post no. 32, continuing 22 in. along the entire vertical face of the rail. Additional damage included a bend in the rail beginning at the centerline of post no. 32 measuring 30 in. long, 16 in. wide, and 4½ in. deep. Kinks were noted along the top rail, specifically at the centerline of post no. 32, extending 15 in. Bolt hole pullouts occurred along the top rail between post nos. 27 and 38. The bottom rail also exhibited bolt hole pullouts between post nos. 27 and 29. Additional damage to the top rail included tearing near bolt holes at post nos. 26, 27, 24, and 31. Tears were observed on the top rail 5 in. downstream from post no. 30 and 10 in. downstream from post no. 28, both measuring 5 in. wide.

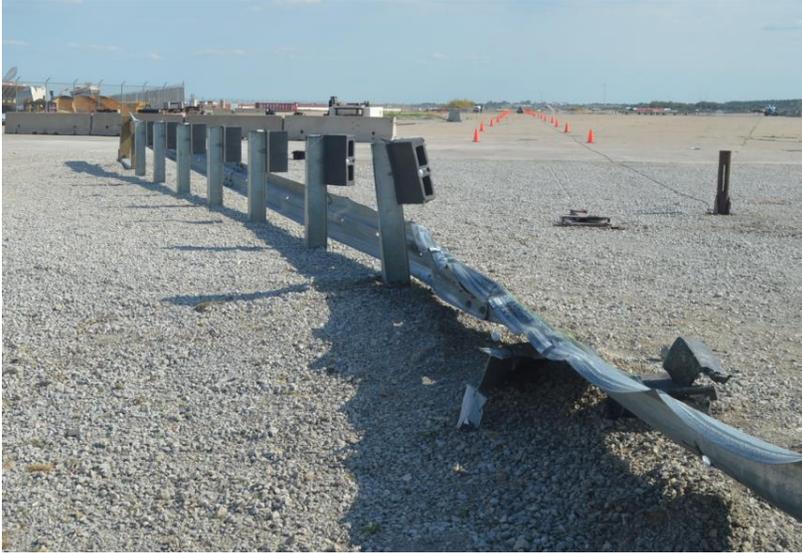
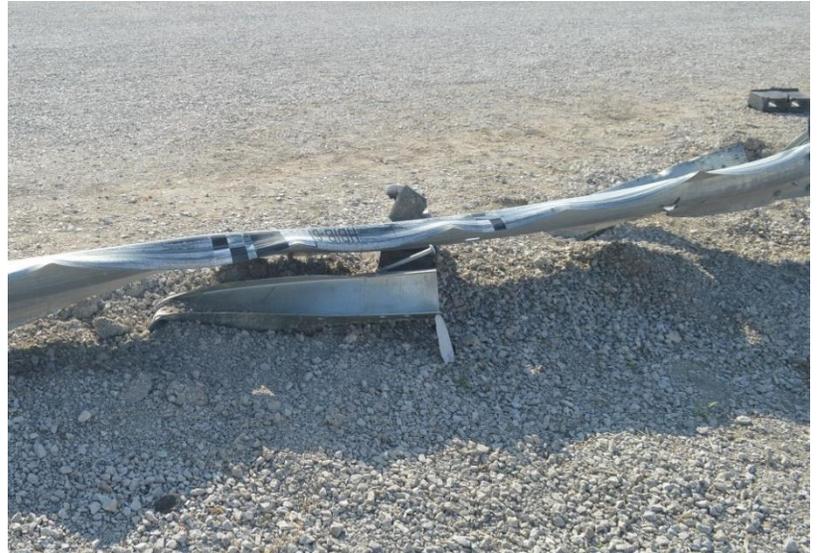
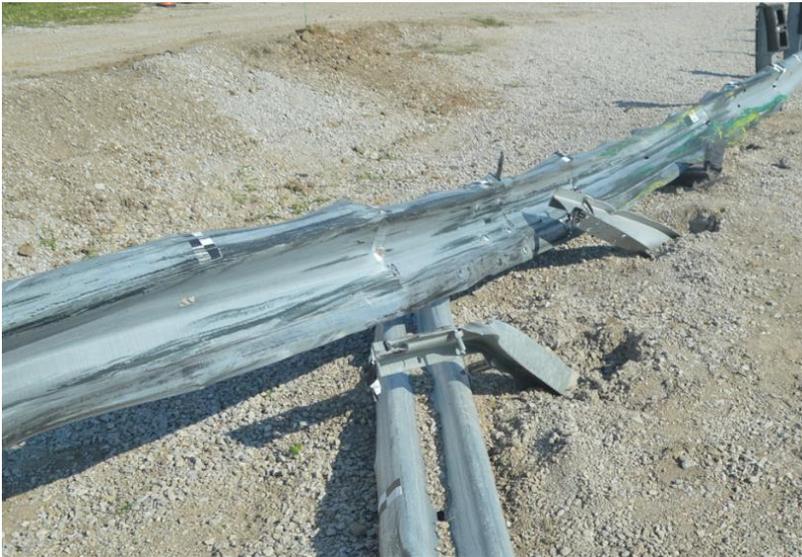
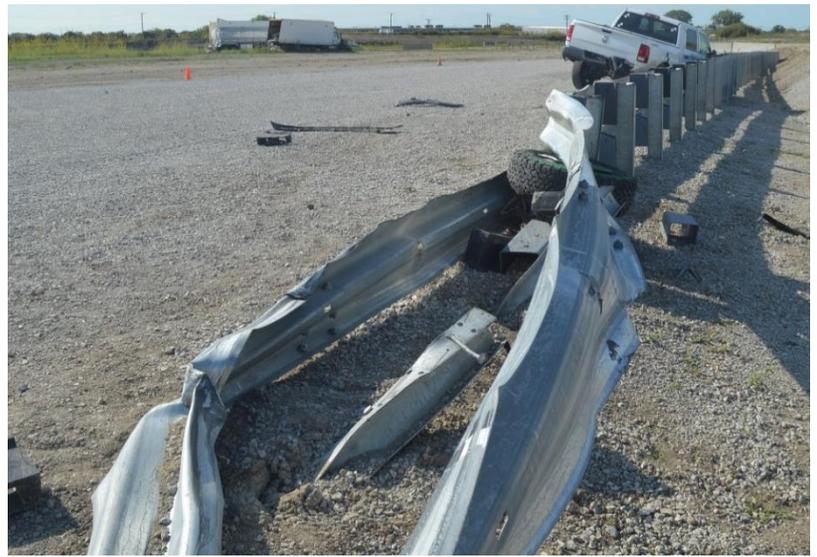
Figure 84. Post Damage Test No. HBIB-6

Several posts showed substantial deformation. Post no. 26 exhibited a kink on the front flange starting 22½ in. from the ground and measuring 1½ in. in both length and width. This post also experienced lower rail pullout, and the blockout disengaged. The front flange of post no. 27 was bent beginning 37 in. from the ground and extending 10 in. Both upper and lower rail pullouts were observed here, with the top blockout disengaged. Additionally, a 4-in. long by 1-in. wide kink was found on the upstream side of the flange of post no. 27 beginning 20 in. from the ground. Post no. 28 had a 4-in. long by 1-in. wide kink on the downstream side of the front flange. Both the upper and lower rails pulled out, and the blockout disengaged. Further deformation was recorded on post no. 29, including flange flattening, upper and lower rail pullouts, bolt hole tearout, and blockout disengagement. The lower bolt of post no. 29 remained intact, but the post was visibly bent. At post no. 30, a kink was observed on the downstream side of the front flange, starting 7½ in. from the ground and extending 8 in. with a width of 1½ in. This post also had upper rail pullout and bottom rail bolt hole tearout, with the top blockout disengaged. Post no. 31 experienced bending in both the front and rear flanges as well as the web, with the blockout disengaged. Post nos. 27 and 28 deflected 15 degrees backward and rotated 30 degrees counterclockwise, while post no. 29 deflected 20 degrees backward with a slight counterclockwise rotation.

The impact resulted in bolt deformation across various posts. At post no. 27, the upper and lower bolts exhibited bending, with the top bolt showing a pronounced bend while the bottom bolt had only minor bending. At post no. 28, the lower bolt fractured, and the upper bolt bent. Additionally, bending of the upper bolts was observed on post nos. 29 through 33. Blockouts at post nos. 32 and 33 rotated downstream, which caused the bolts at these posts to bend in the same direction. Between post nos. 34 and 38, the guardrail elongated and disengaged from the bolts, resulting in rail disengagement.

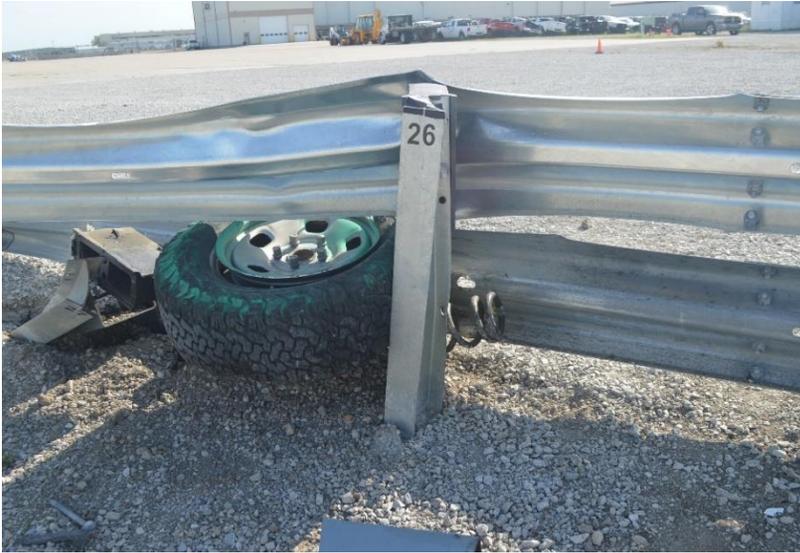
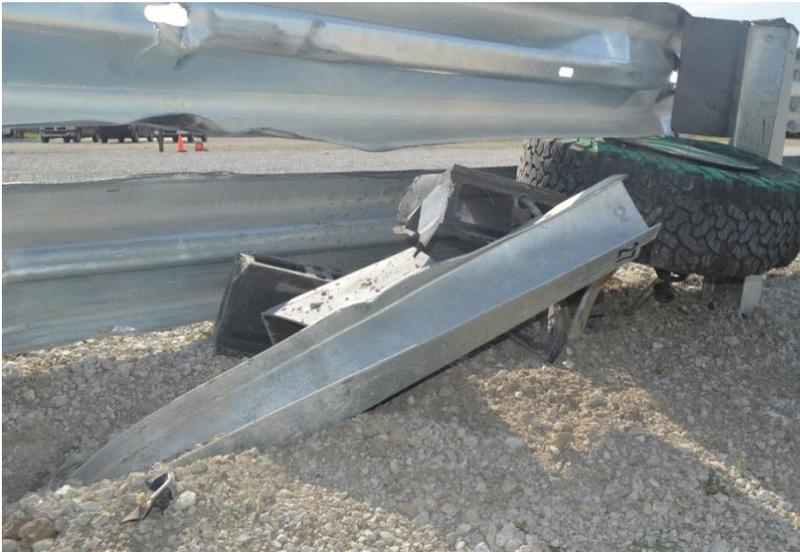
Figure 85. Post Damage, Post Nos. 26 (top left), 27 (bottom left), 28 (top right), and 29 (bottom right), Test No. HBIB-6

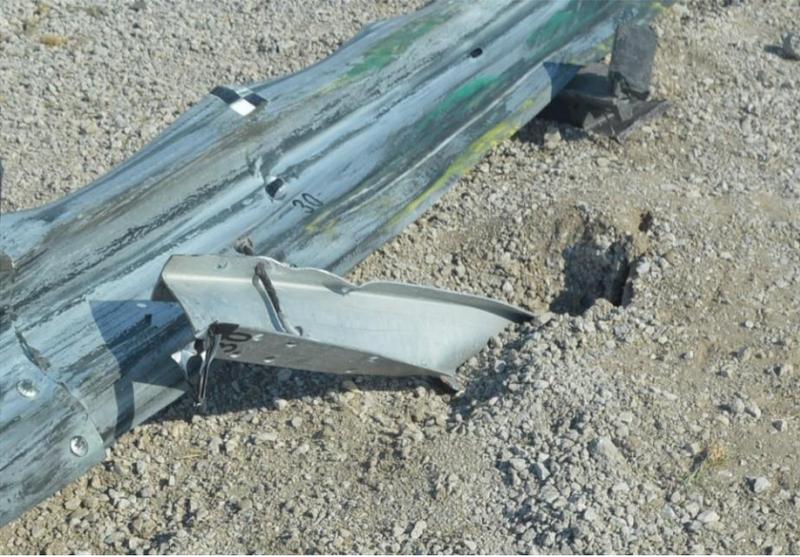
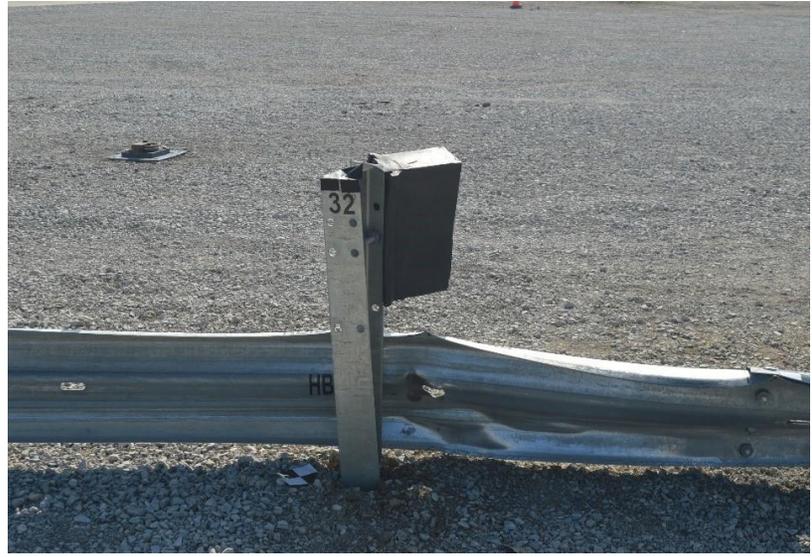
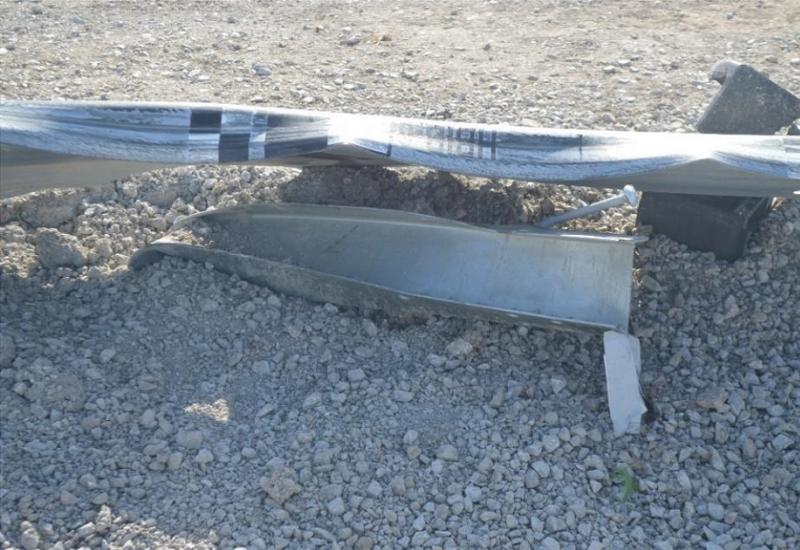
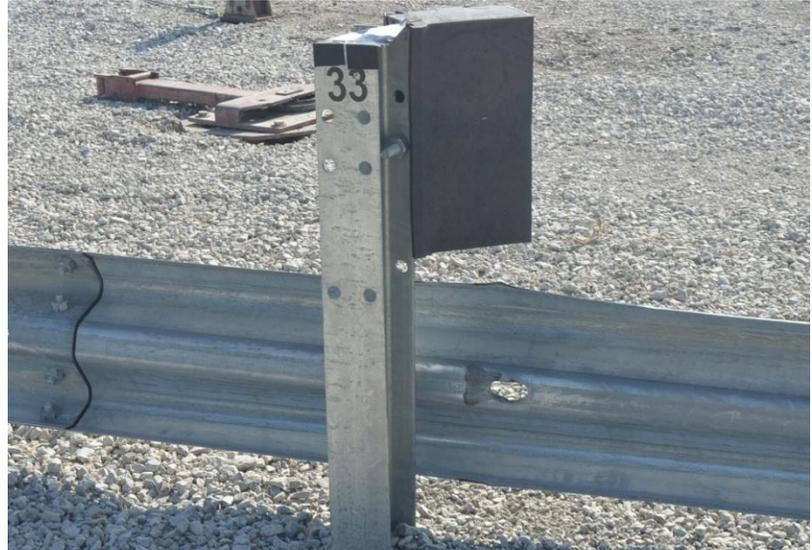
Figure 86. Post Damage, Post Nos. 30 through 33, Test No. HBIB-6

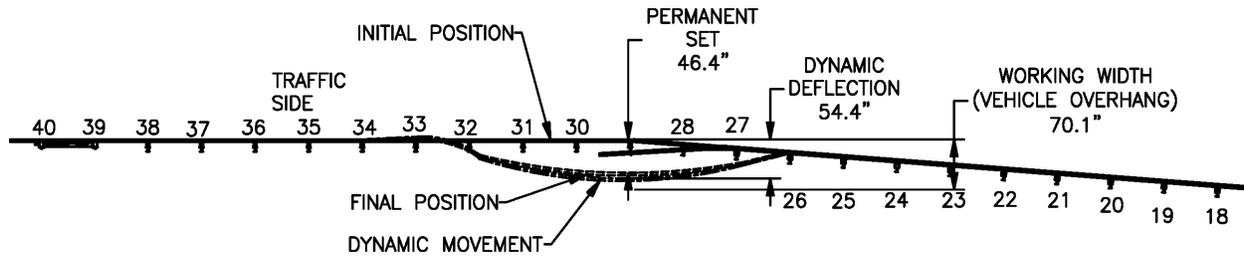
The maximum lateral permanent set of the barrier system was 46.4 in. at the rail near post no. 29, as measured in the field. The maximum lateral dynamic deflection of the rail was 54.4 in. at the rail at post no. 29. The maximum lateral dynamic deflection of the post was 29.7 in. at post no. 31, as determined from high-speed digital video analysis. The working width of the system was found to be 70.1 in., including vehicle overhang at the vehicle's rear bumper, also determined from high-speed digital video analysis. A schematic of the permanent set deflection, dynamic deflection, and working width is shown in Figure 87.

Figure 87. Permanent Set, Dynamic Deflection, and Working Width, Test No. HBIB-6

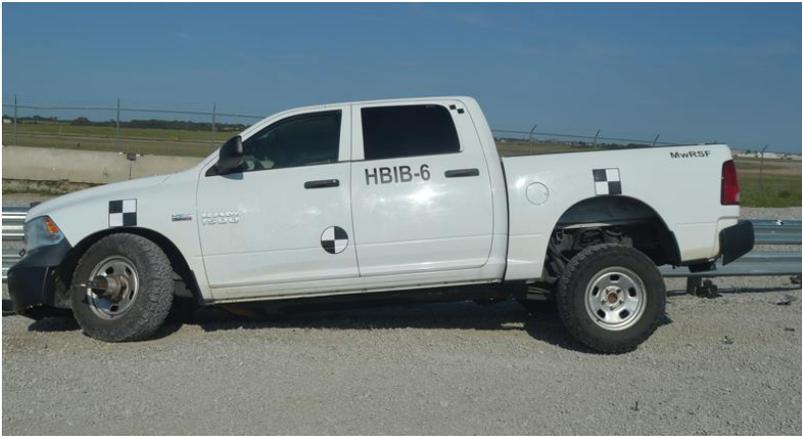
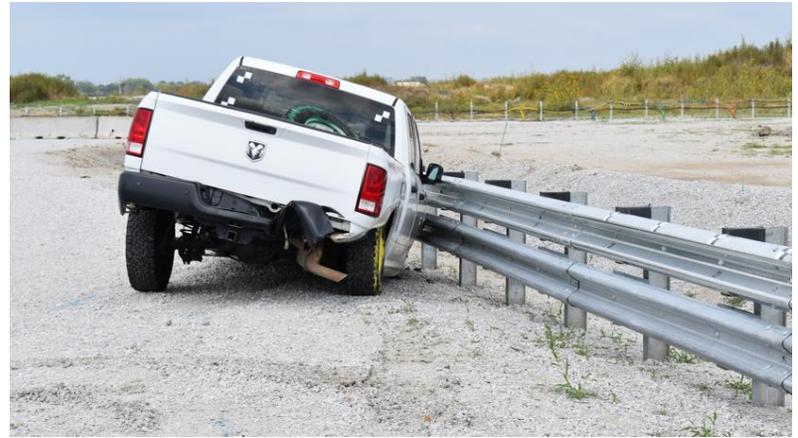
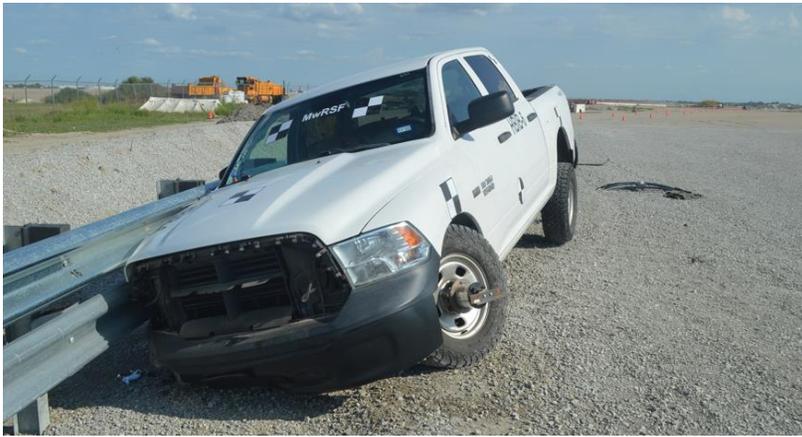
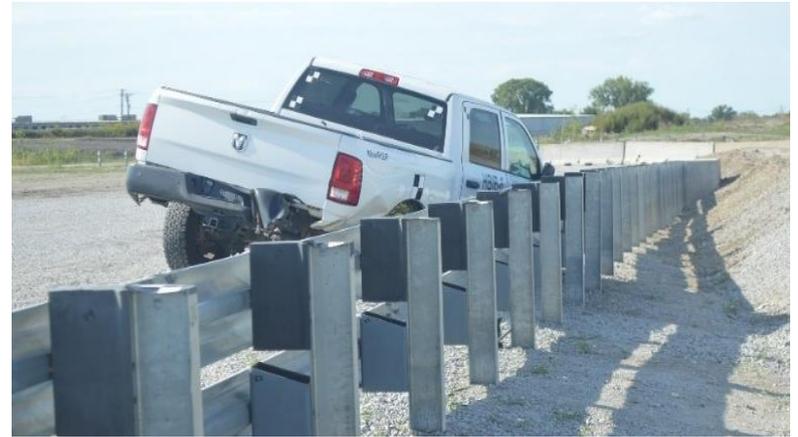
Figure 88. Vehicle Damage, Test No. HBIB-6

Majority of the damage was concentrated on the right-front corner and right side of the vehicle, where the impact occurred. The front end of the vehicle showed considerable deformation. The front bumper was crushed inward and twisted along the right side, with buckling in the center. The right-front fender was also damaged and it was pushed rearward and inward along its length. The grille and right headlight were detached, with the headlight itself broken. The hood was crushed inward and deformed along its right edge and the windshield displayed a crack on the right side. The damage continued along the right side of the vehicle. The right-front door had multiple dents, especially along the leading edge, with a tear measuring approximately 4 in. by 1½ in. The right rear door showed light scraping but no structural damage. The right side of the truck bed exhibited large dents from the wheel well to the rear bumper, causing the bed to fold inward. Although still attached, the right taillight was crushed. At the rear, the right side of the bumper buckled outward. The side windows remained intact.

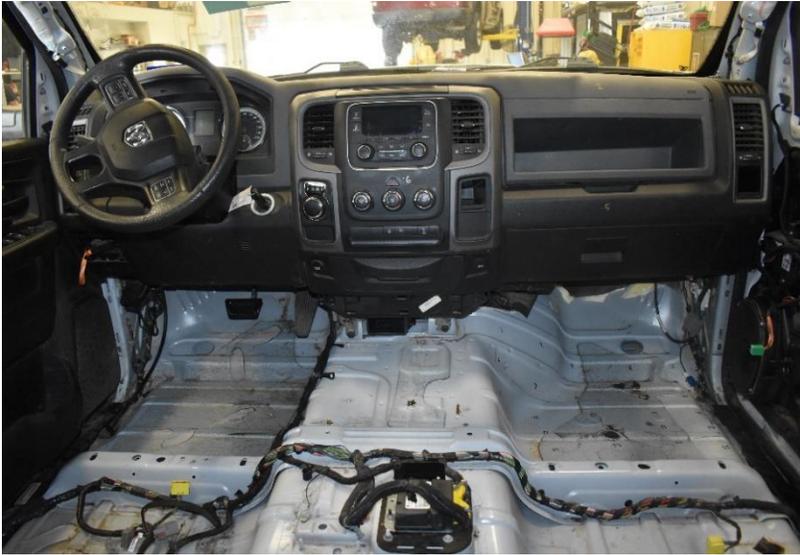
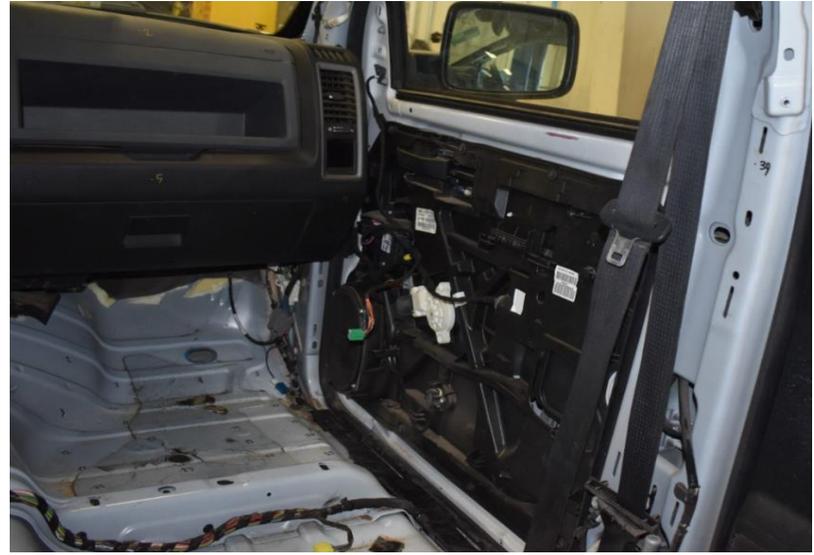
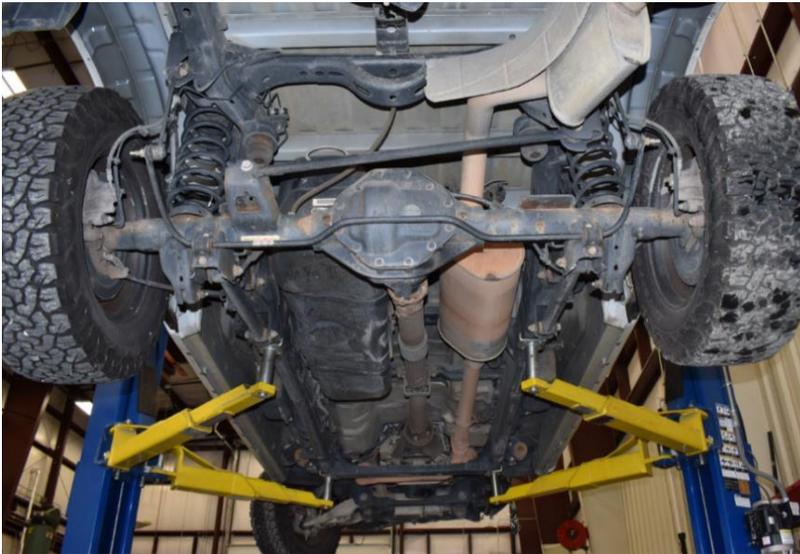
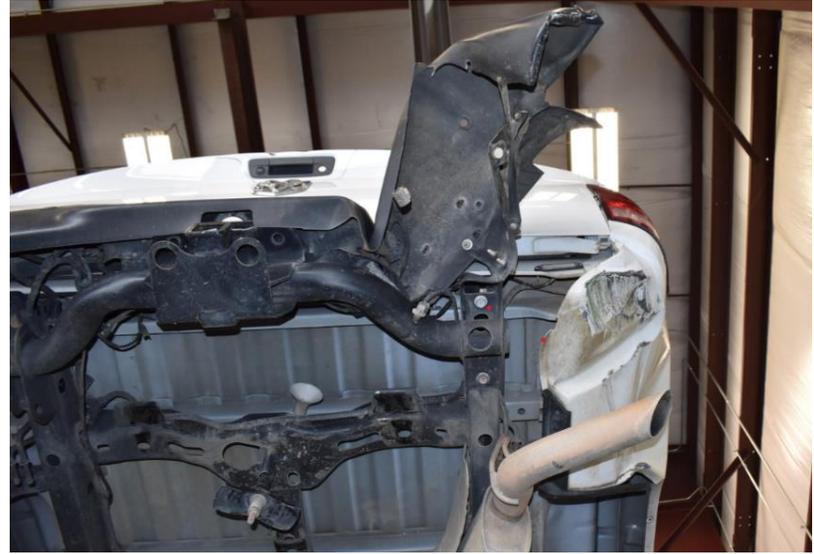
The undercarriage and suspension components were also affected. The right-front suspension had damage, with the lower control arm and spring detached and the tie rod bent. The frame horn on the right side was bent inward, and the right front body mount was twisted.

Figure 90. Test Vehicle's Interior Floorboards and Undercarriage Damage, Test No. HBIB-6

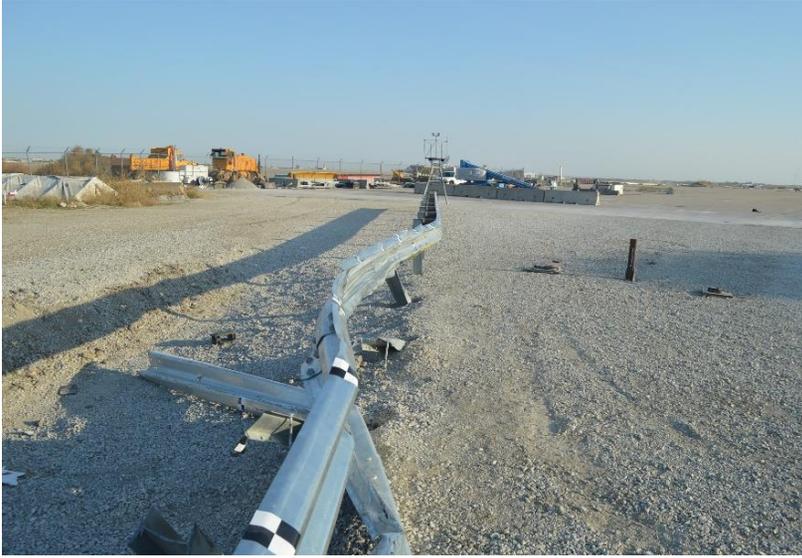
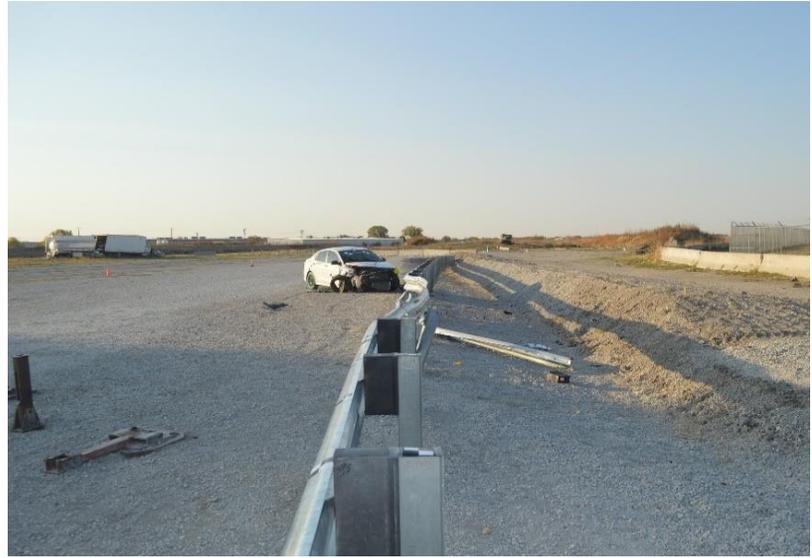
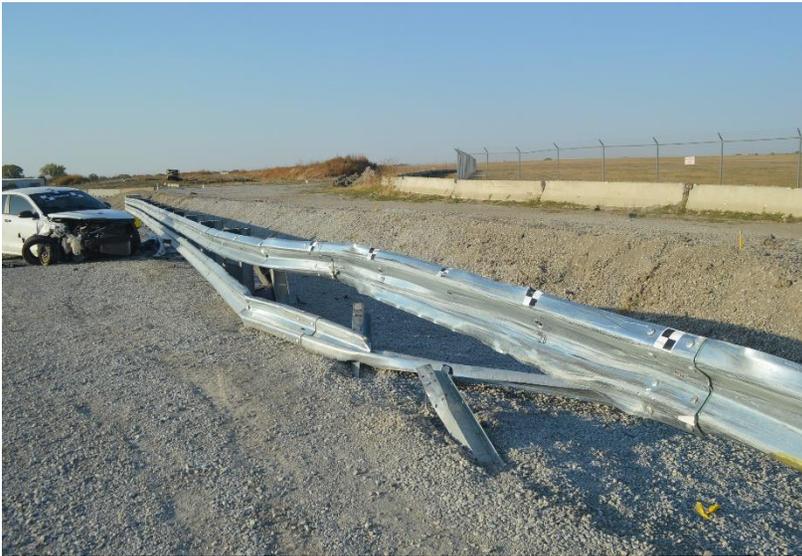
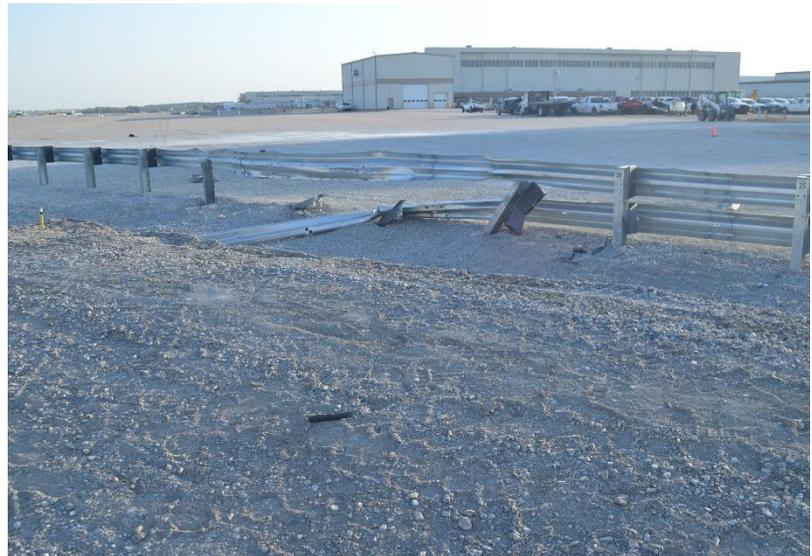
Figure 98. System Damage Test No. HBIB-7

The damage to the barrier was moderate, as shown in Figures 97 through 100. Barrier damage consisted of kinks, rail flattening, bending, gouging, and bolt hole tearing. The length of vehicle contact along the barrier was approximately 24 ft – 11 in., which spanned 21 in. downstream from the centerline of post no. 31 to 20.4 in. downstream from post no. 27. Secondary contact occurred 196 in. upstream from the centerline of post no. 29 and ended between posts no. 26 and 27.

Damage to the rail was primarily located along both the top and bottom rails. The top rail showed significant contact marks, with the primary mark beginning at the centerline of post no. 31 and extending 21 in., with a consistent width of 15 in. downstream along the top rail. Additional damage included bends on the bottom rail located at the centerline of post no. 27, measuring 9 in. long by 3 in. wide by 5 in. deep at a height of 11 in. above ground, and at the centerline of post no. 28, measuring 5 in. long by 5 in. wide by 7 in. deep. Kinks were noted along the top rail from posts nos. 27 through 31, specifically 78 in. downstream from the centerline of post no. 31, and at the bottom rail 33 in. upstream from post no. 26. Additional damage included flattening 42¼ in. upstream from the centerline of post no. 29 measuring 151 in. long and 8 in. wide. Furthermore, a bolt hole tear occurred at the top rail at post no. 30 and at the bottom rail at post no. 28. The top rail bolt hole elongated between posts nos. 26 through 29 and at the bottom rail at posts nos. 26 and 27.

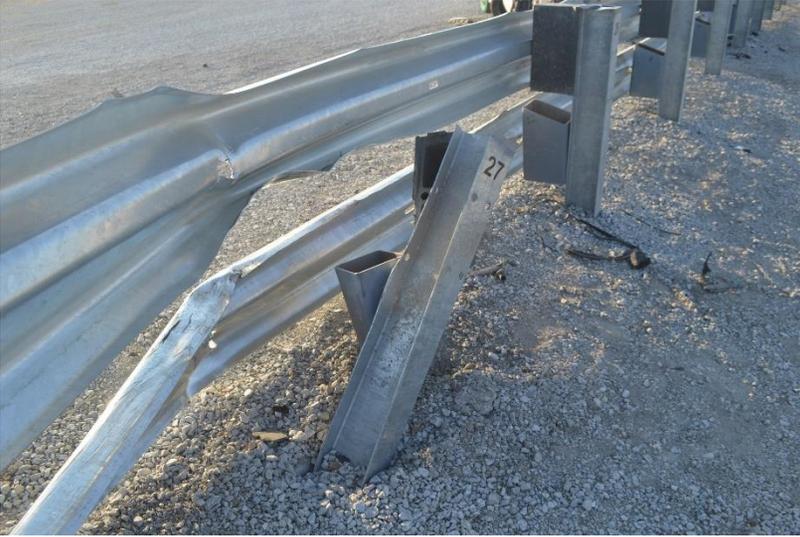
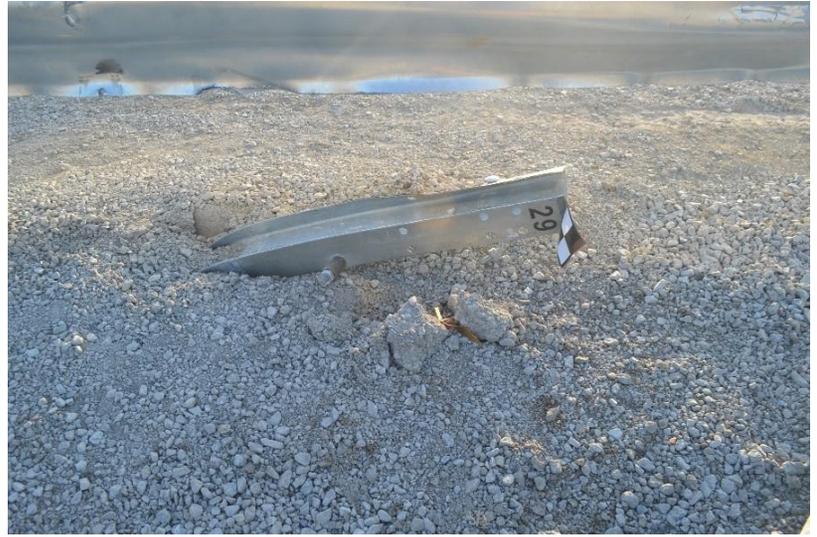
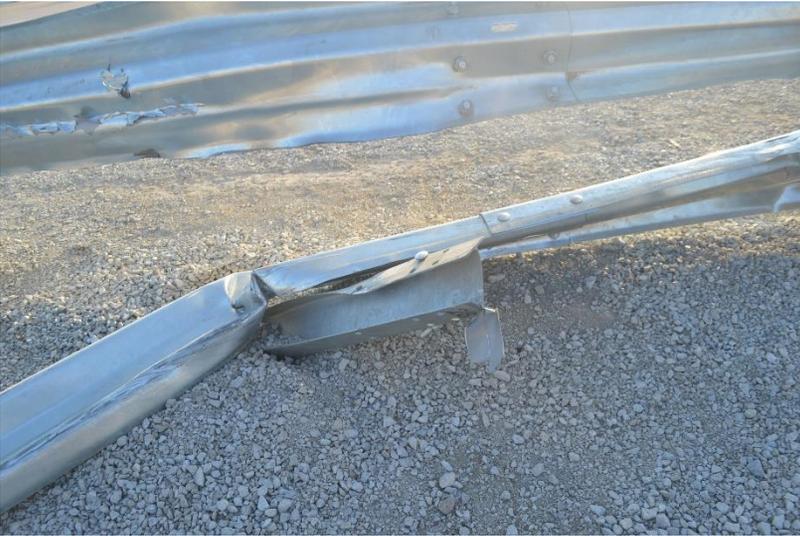
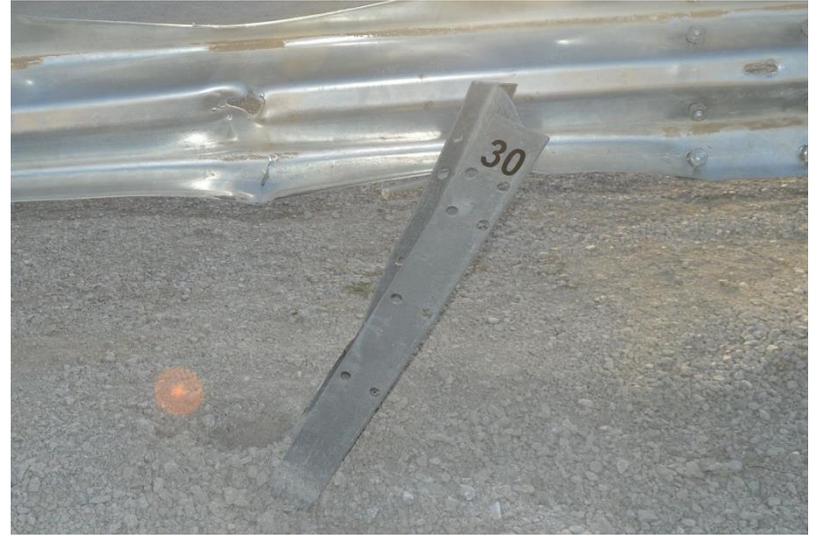
Figure 100. Post Damage, Post Nos. 27 through 30, Test No. HBIB-7

0.054	Post no. 29 rotated backward. Post no. 30 bent downstream, twisted clockwise, and its blockout fractured and disengaged.
0.068	Vehicle rolled away from barrier.

0.092	Post no. 29 bent downstream and twisted clockwise and its blockout fractured and disengaged.
0.108	Post no. 28 rotated backward.
0.120	Post no. 27 rotated backward. Occupant head contacted right-front window.

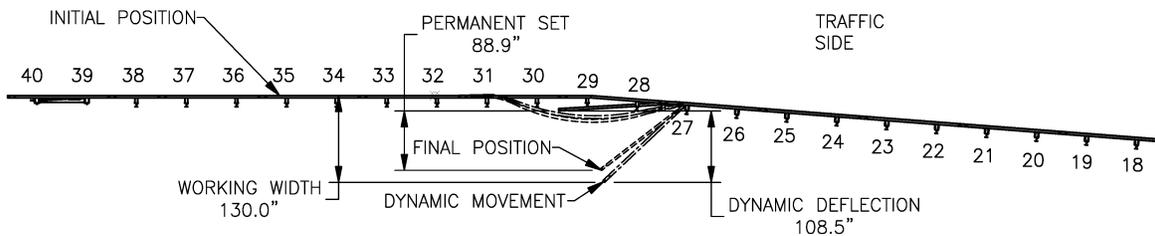
Figure 101. Permanent Set, Dynamic Deflection, and Working Width, Test No. HBIB-7

The maximum lateral permanent set of the barrier system was 88.9 in. at the rail in post no. 29, as measured in the field. The maximum lateral dynamic deflection of the upper rail was 30.0 in. at post no. 29. The maximum lateral dynamic deflection of the lower rail was 108.5 in. at post no. 29. The maximum lateral dynamic deflection of the post was 21.3 in. at post no. 28. All dynamic deflections were determined from high-speed digital video analysis. The working width of the system was found to be 130.0 in. at the free end of the rub rail, also determined from high-speed digital video analysis. A schematic of the permanent set deflection, dynamic deflection, and working width is shown in Figure 101.

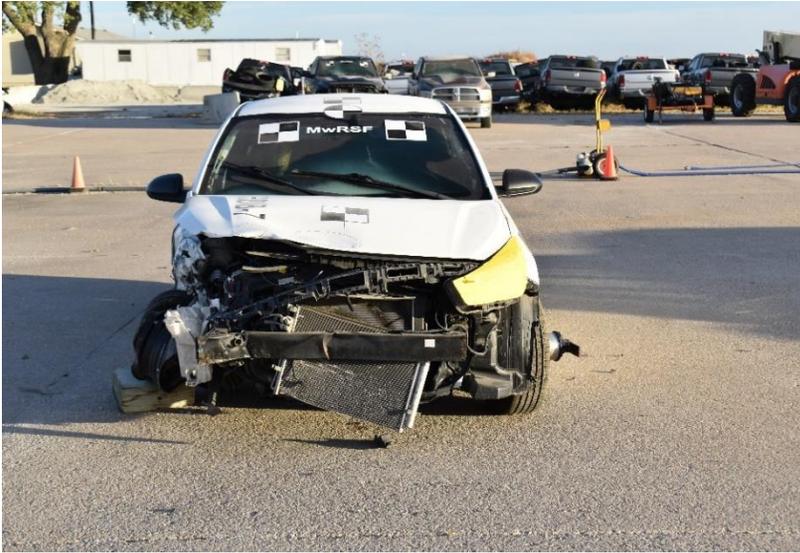
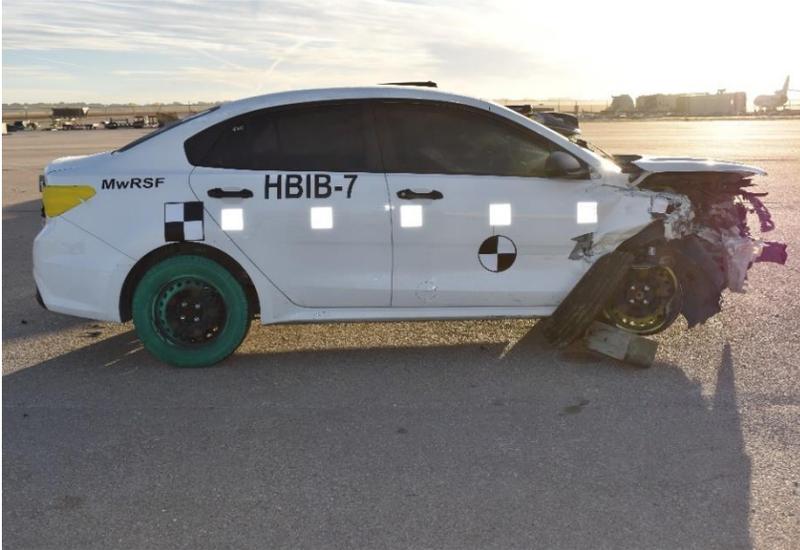
Figure 102. Vehicle Damage, Test No. HBIB-7

The damage to the vehicle was moderate, as shown in Figures 102 and 103. The majority of the damage was concentrated on the right-front corner and right side of the vehicle where the impact occurred. The front bumper cover was disengaged from the vehicle. The bumper bar was dented and crushed slightly rearward. The right headlight disengaged. The hood was bent in and upward at the right leading end. The fender was crushed, dented, and scraped throughout, with the majority of the damage located just above the wheel opening and behind the headlight area. Damage from the fender extended to the door panel, which had a 5-in. high and 5-in. long tear with some of the sheet metal folded back. The door panel was dented and had a 13-in. long scrape just behind the tear. The right-front wheel was dented and scraped in several places around the outer perimeter with the tire detached but still present. The tire was pinched between the wheel and the firewall. The side windows and windshield remained undamaged.

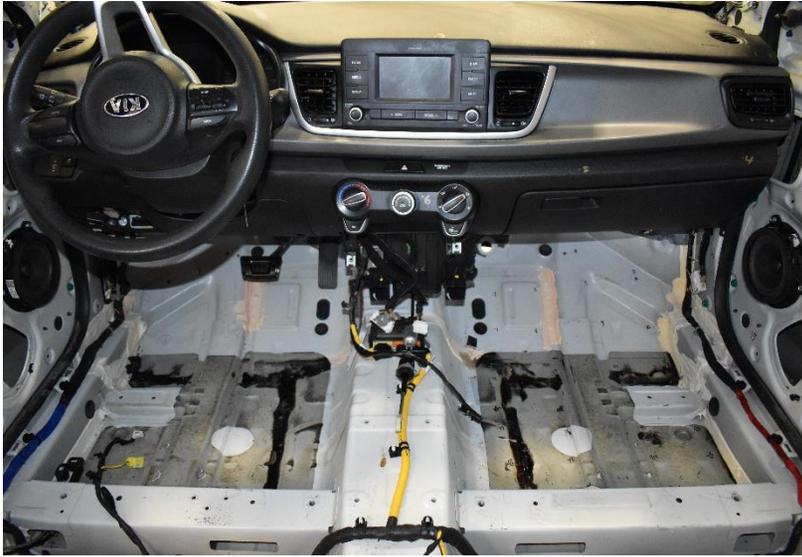
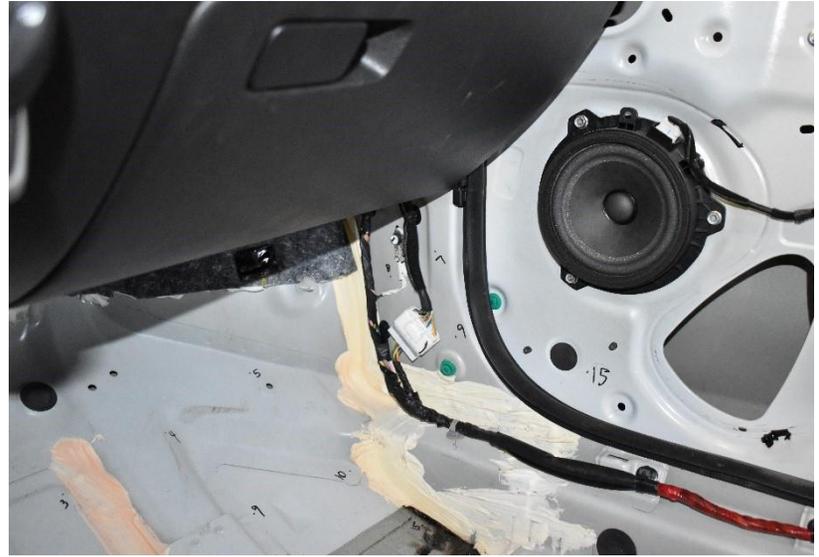
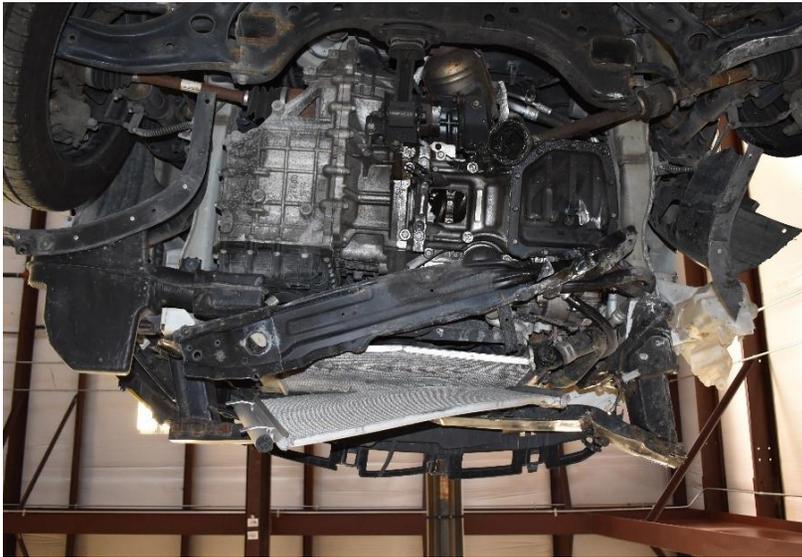
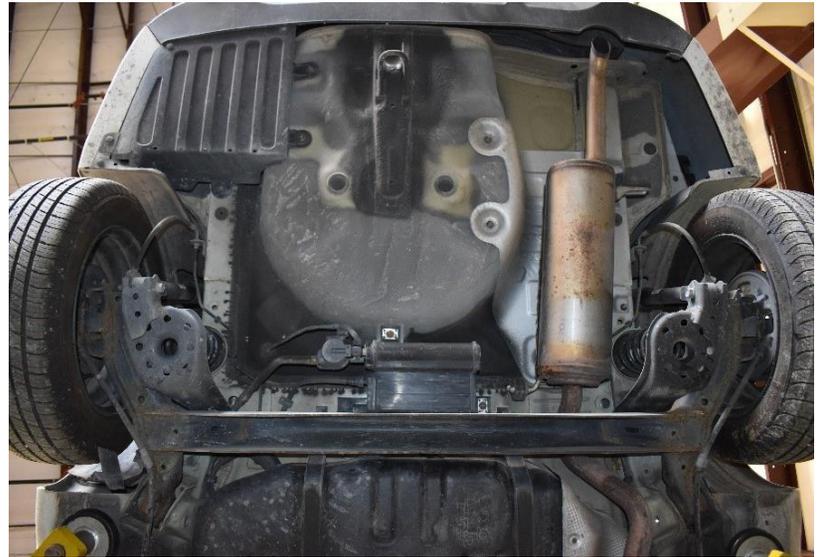
Figure 103. Test Vehicle's Interior Floorboards and Undercarriage Damage, Test No. HBIB-7

The undercarriage and suspension components were also affected. The right front strut was bent at both the lower mount and at the upper spring location. The front sway bar shifted toward the right side of the vehicle, with the right end of the sway bar—near its connection to the tie-rod end link—bent inward toward the motor. The right-front lower control arm was bent downward in the center and bent upward from its attachment point on the front subframe, forming a peak at the midpoint. The arm was torn from the front pivot. The left-front side lower control arm was tilted upward slightly from its attachment points on the front subframe. The right inner tie rod was bent slightly.
