*Hawaii Department of Transportation
Research Project Number 67167*

HAWAII DOT FLARED BURIED-IN-BACKSLOPE GUARDRAIL END TERMINAL PART 2 – REVERSE DIRECTION TESTS

MwRSF Research Report No. TRP-03-496b-25

December 16, 2025

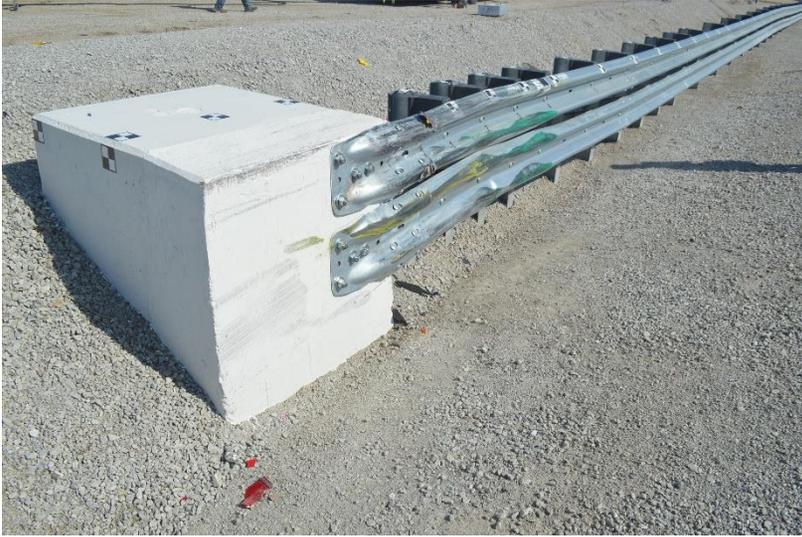
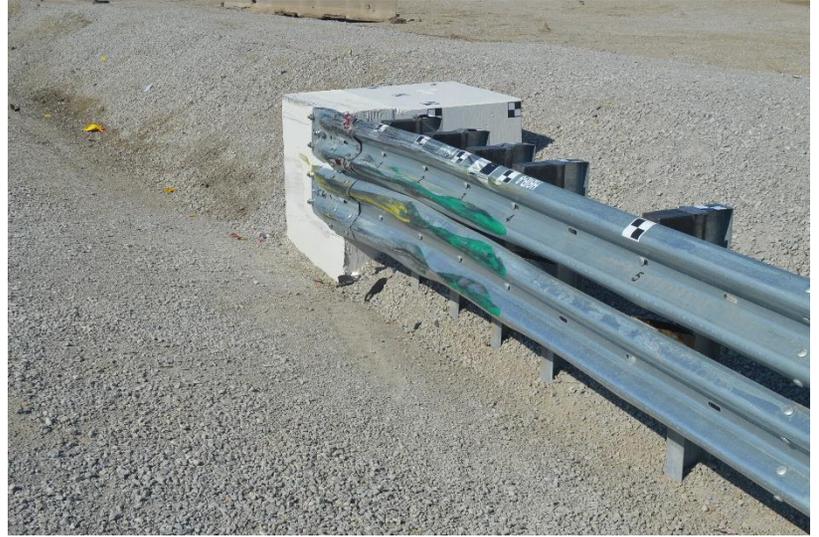
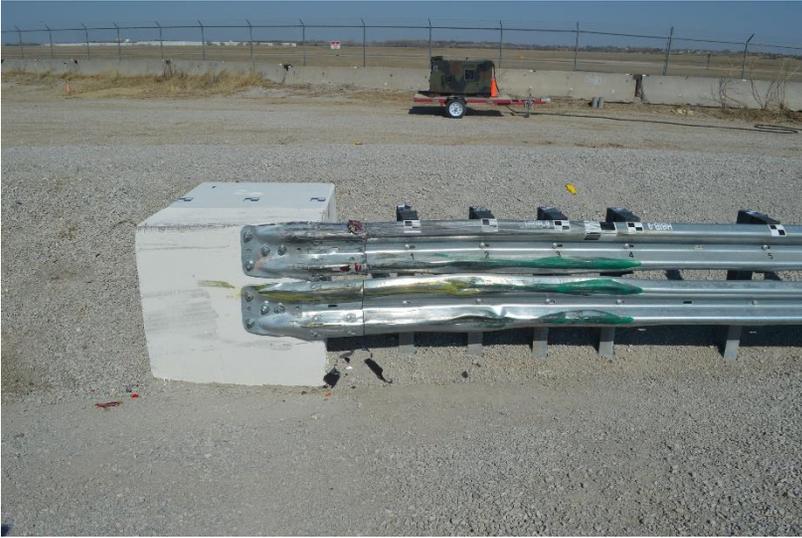
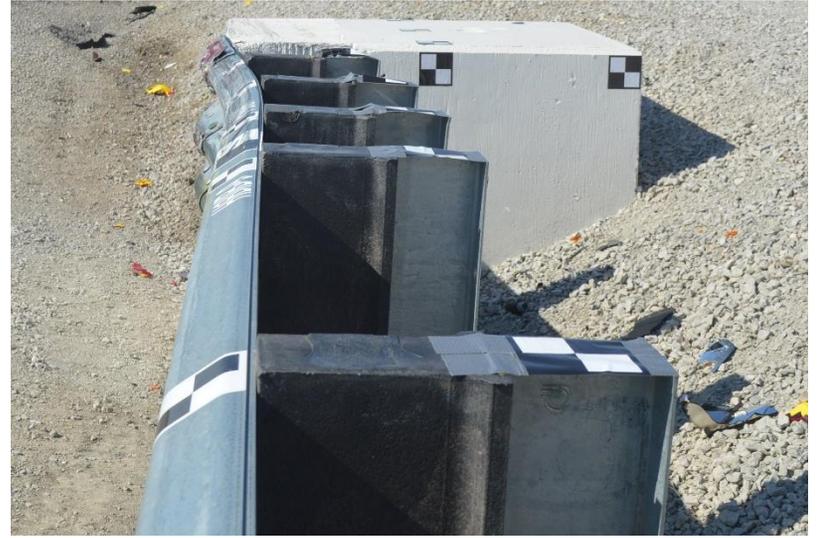
Figure 110. System Damage, Test No. HBIB-8

The damage to the barrier was minimal, as shown in Figures 110 and 111. Barrier damage consisted of kinks and rail flattening. The length of vehicle contact along the barrier was approximately 108½ in. which spanned from 6¼ in. upstream from the centerline of post no. 3 through to the end of the concrete anchor. The primary contact mark spanned the bottom corrugation of the top rail and both corrugations of the bottom rail, beginning at the centerline of post no. 3 and extending downstream to the end of the concrete anchor.

A series of kinks on the top rail was observed 25 in. downstream from post no. 1 measuring 19½ in. long, 2 in. wide, ½ in. deep, and 24 in. downstream from post no. 1 measuring 17 in. long, 2 in. wide, ½ in. deep. The bottom flange of the top rail and the top flange of the bottom rail had a series of kinks 24 in. downstream from post no. 1 measuring 17 in. long, 2 in. wide, ½ in. deep. The bottom rail had a series of kinks 24 in. downstream from post no. 1 measuring 20 in. long, 2 in. wide, ½ in. deep.

Additional damage included flattening of the bottom rail 5 in. upstream from the centerline of post no. 1 measuring 17 in. long, 2 in. wide, and 1 in. deep. A kink was found on the top flange of the top rail 6 in. downstream from the centerline of post no. 3 measuring 18 in. long and 2 in. wide. The blockout at post no. 1 had two tears: a 5-in. long vertical tear at the top on the upstream side, and a 6-in. long vertical tear at the bottom on the downstream side.

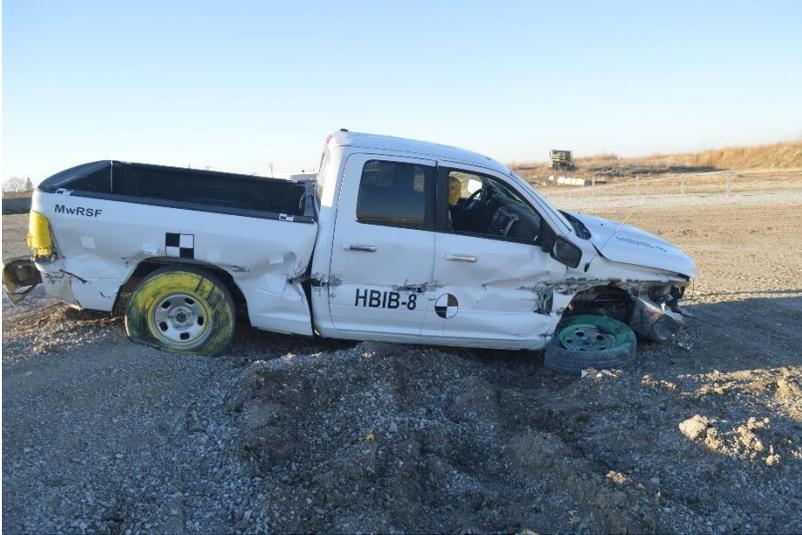
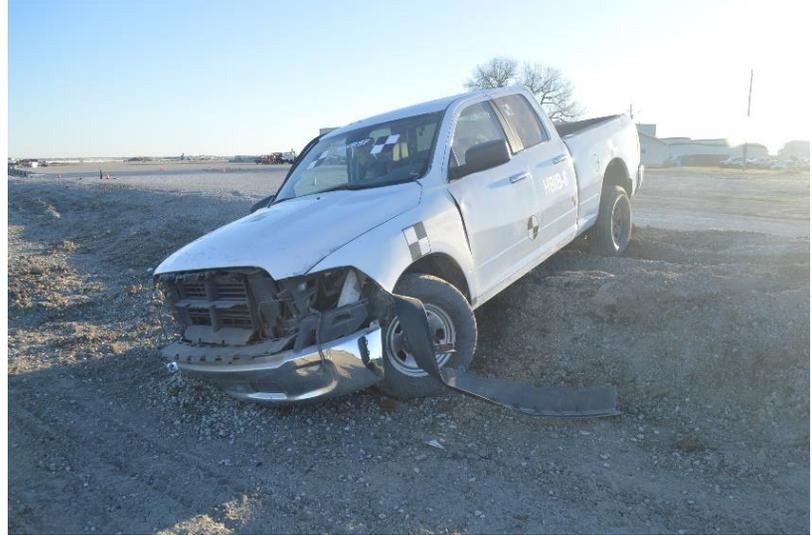
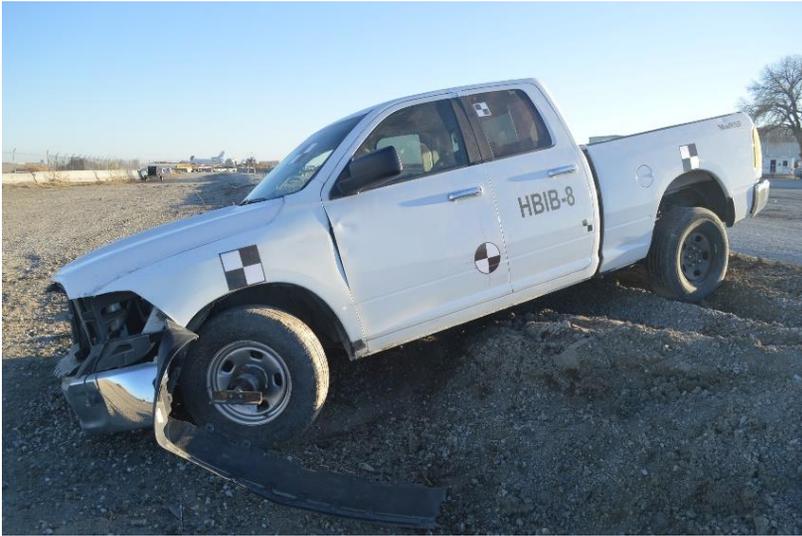
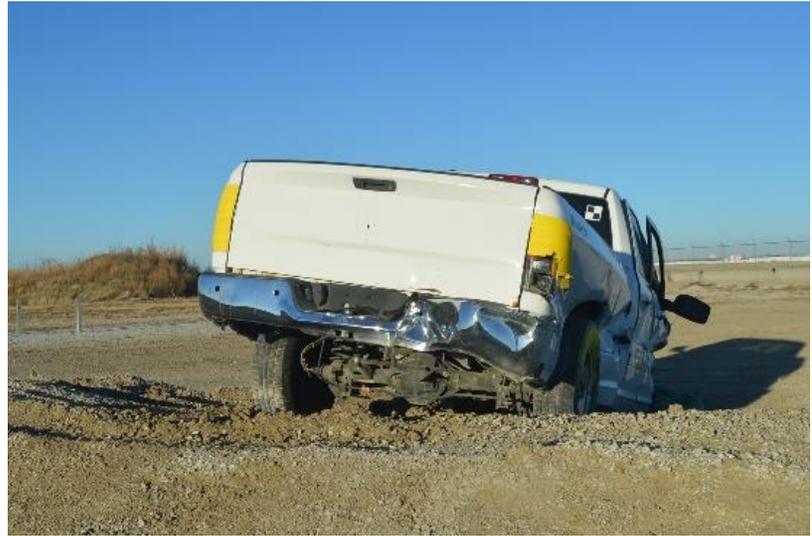
Figure 113. Vehicle Damage, Test No. HBIB-8

The damage to the vehicle was severe, as shown in the Figures 113 through 116. The majority of the damage was concentrated on the right-front corner and right side of the vehicle where the impact had occurred. A large dent was found on the right-front corner of the front bumper. Both headlights and the grille were disengaged from the vehicle. The right one-third of the rear bumper was bent backward at roughly a 45-degree angle, leading to protrusion of the bumper's corner and an inward buckle at the point of bending. Denting and buckling were found along the entire length of the right side of the truck bed with a width of approximately 10 to 16 in. midway up the bed and along the top of the wheel opening. A gouge approximately 3 in. in length was found on the leading edge of the box.

The middle section of the right-rear door was dented and buckled. A 2-in. gouge was found on the trailing edge of the right-rear door, and a 10-in. gouge was found on the door's leading edge. The right-front door panel buckled along the middle of the door. There was a gap at the top of the right-front door where it no longer sat flush with the vehicle's frame. The leading edge of the door panel was buckled and torn approximately 4 in. rearward. Severe crushing and denting were located at the top of the wheel opening with scrapes and gouges throughout the right-front side of the vehicle.

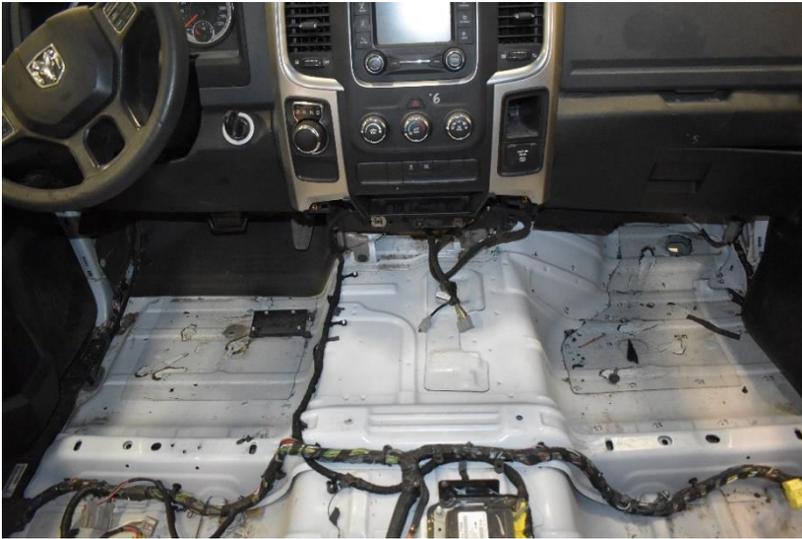
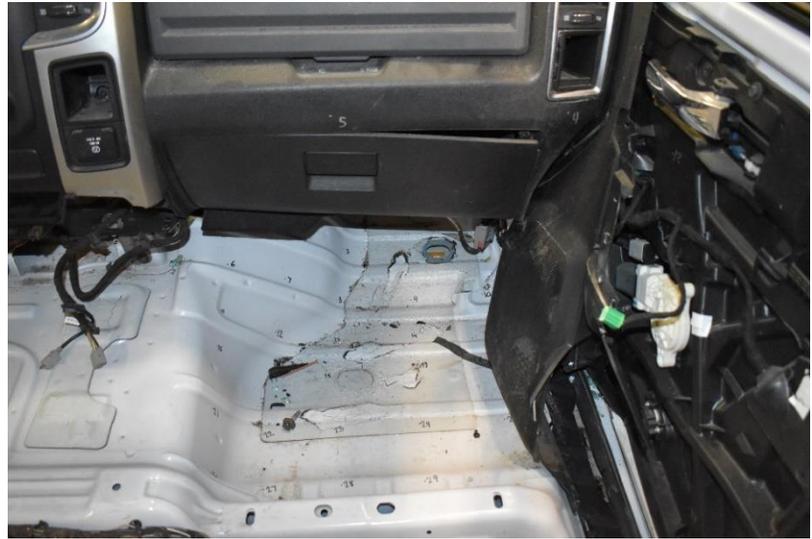
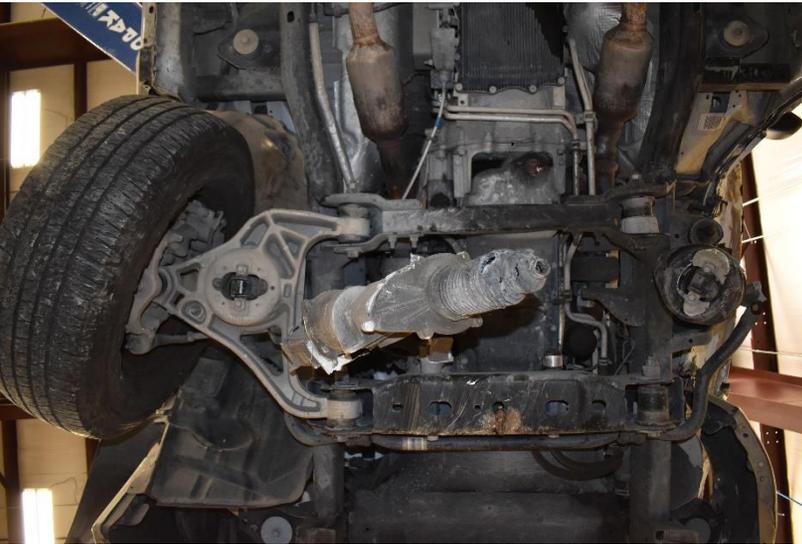
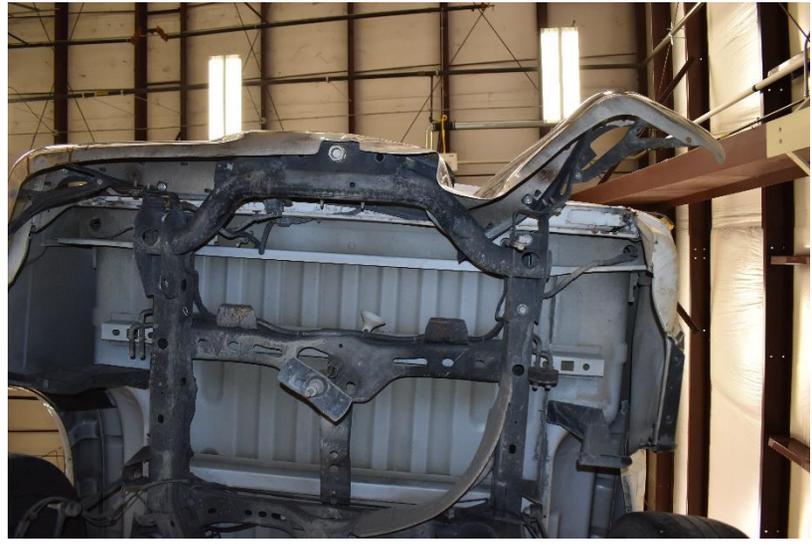
Figure 116. Test Vehicle's Interior Floorboards and Undercarriage Damage, Test No. HBIB-8

The undercarriage and suspension components were also affected, as shown in the Figure 116. The right-front shock and spring were bent rearward and inward toward the vehicle. The left shock remained intact. The end link was disengaged from the sway bar and the vehicle on the right side. The right steering knuckle was also disengaged from the vehicle. The left-side steering knuckle sustained two minor scrapes where it contacted the lower control arm. The front right lower control arm was detached from the vehicle, and the front right upper control arm was slightly twisted at the point where the rubber bushing met the frame. No damage was observed on the front left upper control arm, though small scrapes were present on the leading and trailing edges of the front left lower control arm.

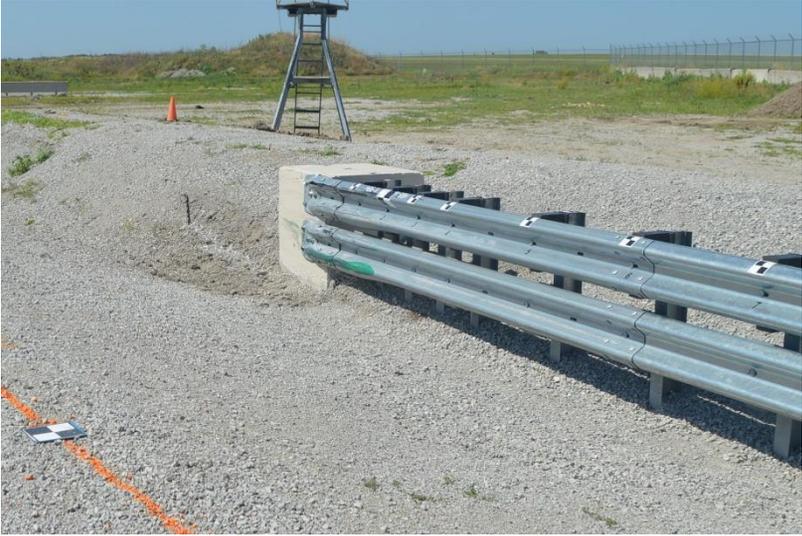
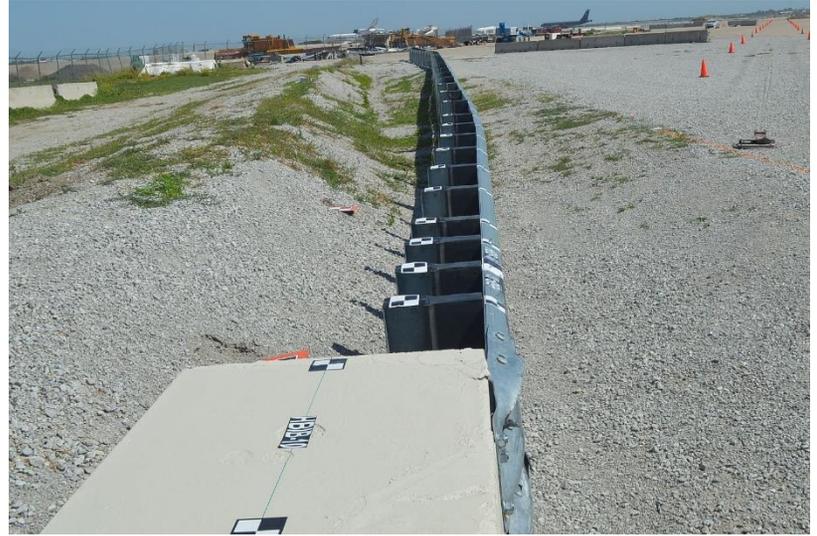
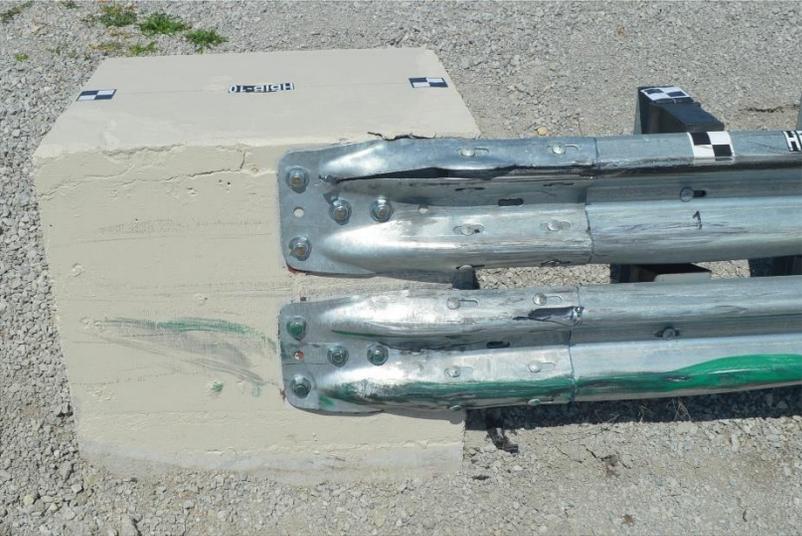
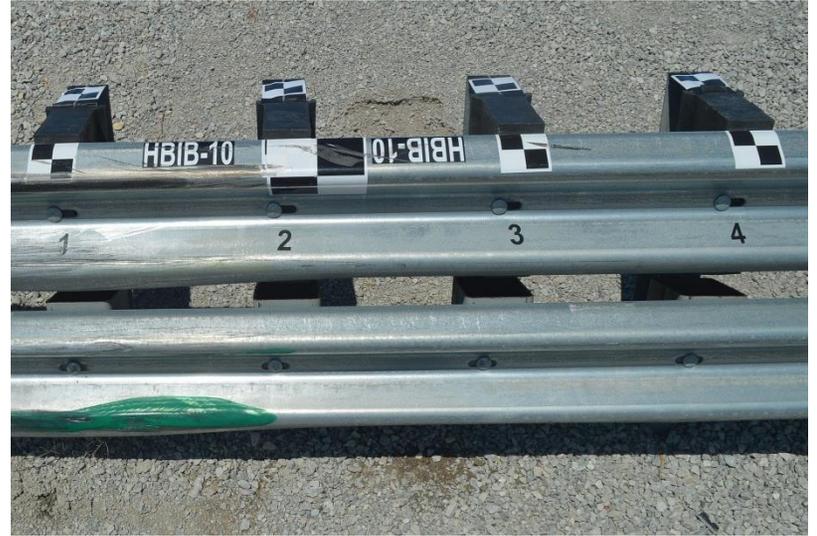
Figure 125. System Damage, Test No. HBIB-10

Damage to the barrier was minimal, as shown in Figures 125 and 126. Barrier damage consisted of contact marks, tears, flattening, kinks, translation of the rails at splices, post deformation, and concrete cracking. The length of vehicle contact along the barrier was approximately 7 ft – 4 in. which spanned from 8 in. downstream from post no. 3 to the downstream end of the concrete fascia.

An $\frac{1}{8}$ -in. splice slip occurred at the splice located downstream from post no. 1 and between post nos. 13 and 14. A $\frac{1}{4}$ in. splice slip occurred at the splice located between post nos. 17 and 18. Two posts had slight deformation after the crash. Post nos. 2 and 3 both deflected backward $\frac{1}{4}$ in.

Several cracks were observed on the concrete anchor. The first crack was found on the upstream front corner of the concrete block measuring 11 in. long, along with spalling that measured 11 in. long and $3\frac{1}{2}$ in. wide. A 6-in. long crack was located 10 in. upstream from the front downstream corner of the concrete block. A crack was located 14 in. upstream from the front, downstream corner of the concrete that measured 4 in. long. Finally, a 4-in. long crack was located 11 in. upstream from the front, downstream corner of the concrete block.

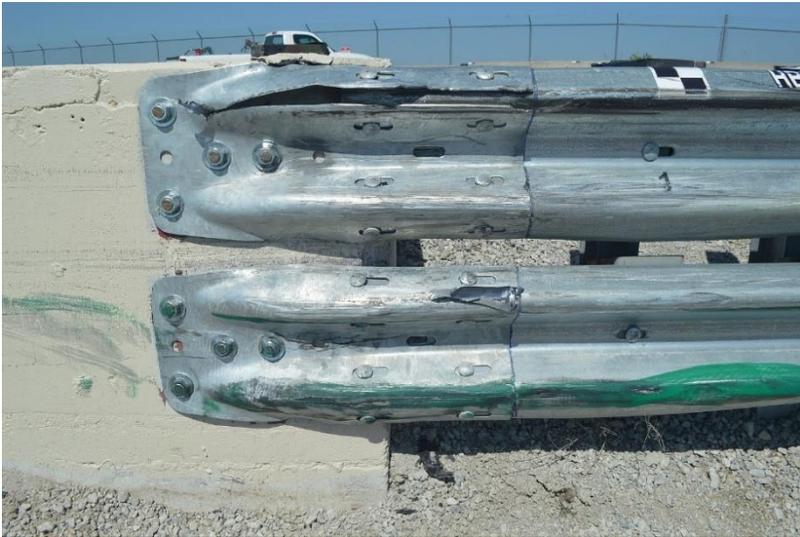
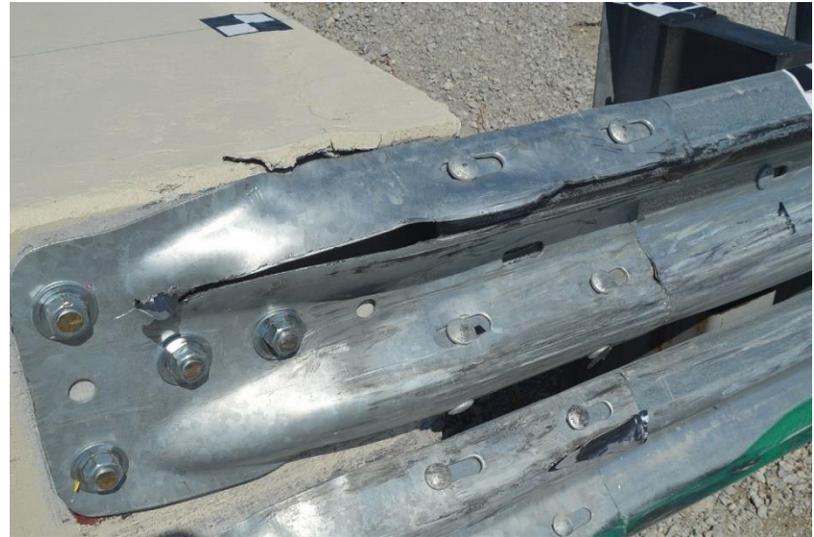
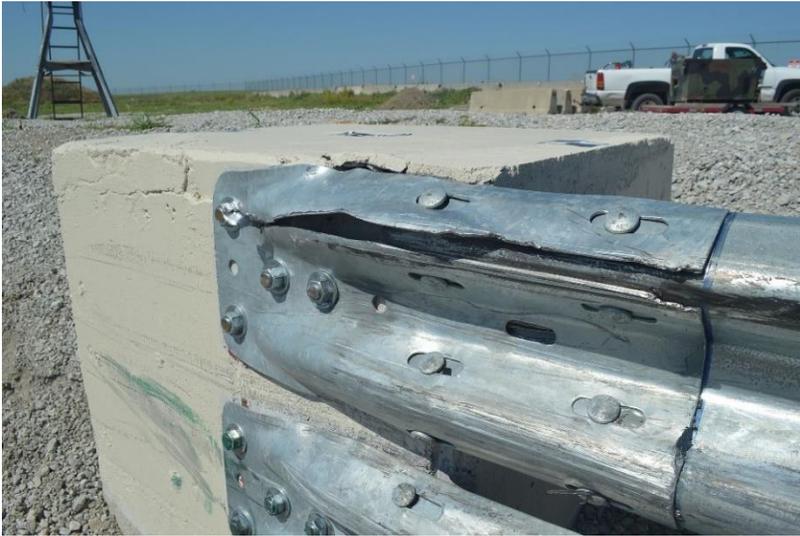
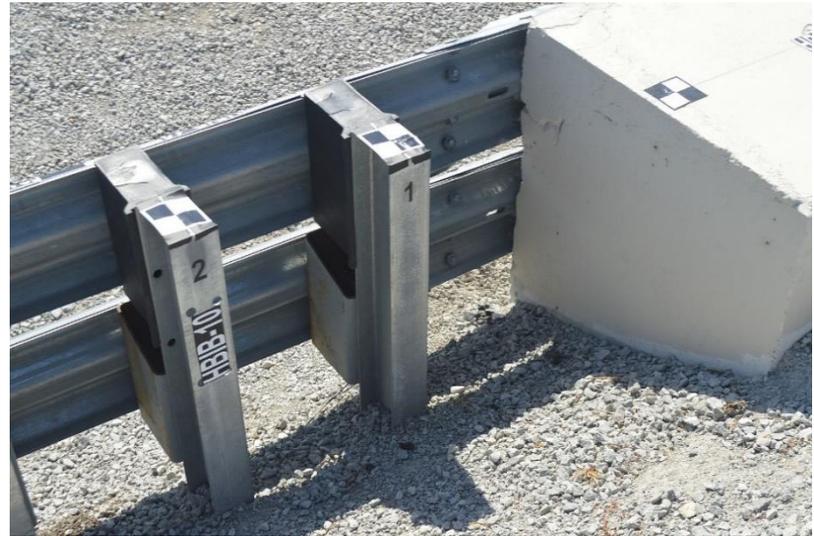
Figure 126. Upper Rail and Rub Rail Damage, Test No. HBIB-10

Rail damage consisted of contact marks, tears, flattening, kinks, and splice slipping. There was a total of four major contact marks. The first contact mark was located on the top rail on the top flange, beginning 8 in. downstream from post no. 3 and was 66 in. in length and 5 in. in width. The second contact mark was located on the top rail on the top flange, $\frac{1}{2}$ in. upstream from post no. 3, and was 5 in. long and $\frac{1}{4}$ in. wide. The third contact mark, located on the top rail on the bottom flange $9\frac{1}{2}$ in. downstream from post no. 3, was 65 in. long and 5 in. wide. The fourth contact mark, located on the bottom rail and continuing onto the concrete, began 18 in. downstream from post no. 3 and was 81 in. long and 12 in. wide.

A 25-in. long and $1\frac{1}{2}$ -in. wide tear was found on the rail $11\frac{1}{2}$ in. downstream from post no. 1 and $37\frac{1}{2}$ in. from the ground. The bottom rail was flattened on its bottom flange 14 in. downstream from post no. 2 and 14 in. from the ground, measured 4 in. long and 2 in. wide. A series of kinks was observed on the top flange of the top rail located 22 in. downstream from post no. 1, measuring 15 in. long and $\frac{1}{2}$ in. wide. A 17-in. long and $\frac{1}{2}$ -in. deep series of kinks was also present on the top flange of the bottom rail located 22 in. downstream from post no. 1. A 20-in. in long and $\frac{1}{2}$ -in. deep kink was found on the bottom flange of the top rail located 22 in. downstream from post no. 1. Finally, a series of kinks was found on the bottom flange of the bottom rail located 19 in. downstream from post no. 1 and measured 20 in. in length and $\frac{1}{2}$ in. in depth.

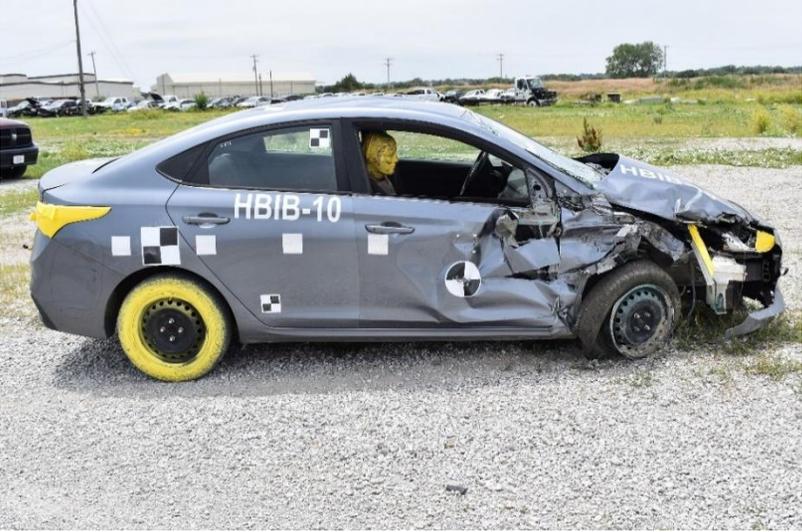
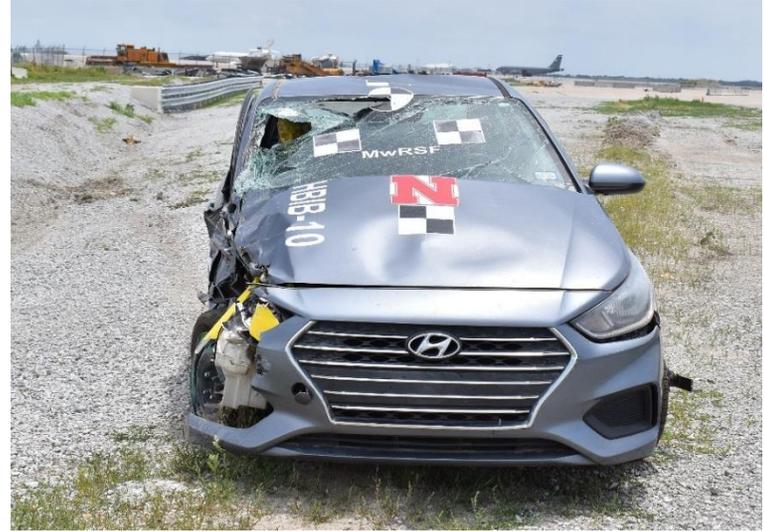
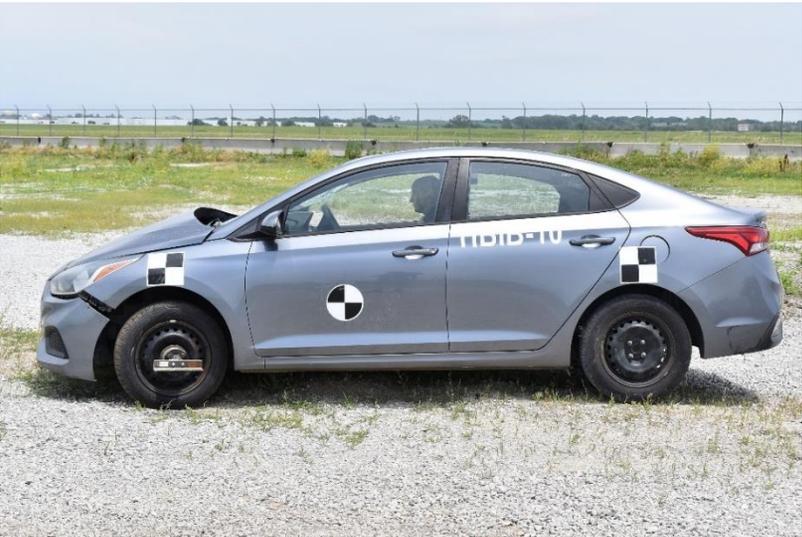
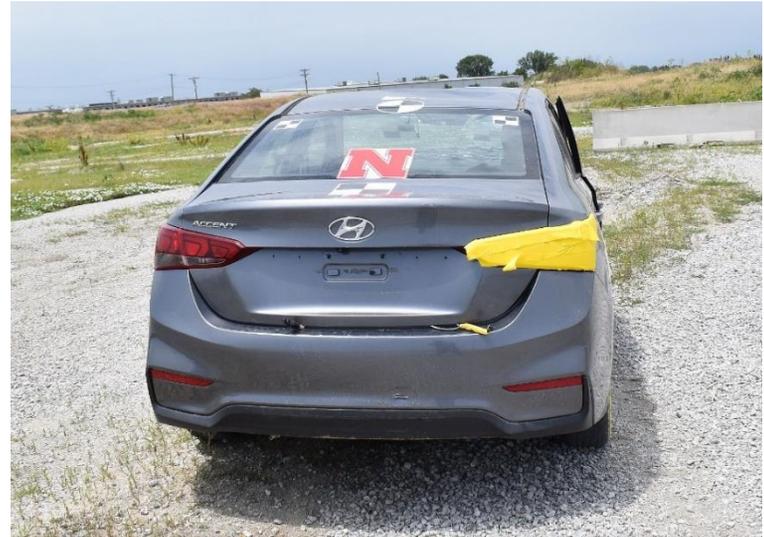
Figure 128. Vehicle Damage, Test No. HBIB-10

The damage to the vehicle was moderate, as shown in Figures 128 through 130. The majority of the damage was concentrated on the right-front corner and right side of the vehicle where the impact occurred. The right side of the front bumper was detached and the right headlight was damaged, but remained attached. The right-front fender panel was crashed rearward and inward throughout its length, and the leading edge of the panel was detached and bent rearward. The right side of the hood was dented and scraped and the hood panel buckled and deformed, causing the center of the hood to heave upward. The right-front door panel was dented, deformed, with scrapes extending from the fender panel. The leading edge of the right-front door panel was torn rearward at the area just under the side mirror. The upper tear was 8 in. long and 6 in. high, while the lower tear was 12 in. long. The tears in the right-side doors did not penetrate into the interior of the occupant compartment. The window on the passenger door was shattered. The right side of the front windshield was crushed inward and the glass liner was torn due to deformation of the right-side door frame and the roof panel. The roof panel was deformed across the entire panel but showed no evidence of damage from direct contact.

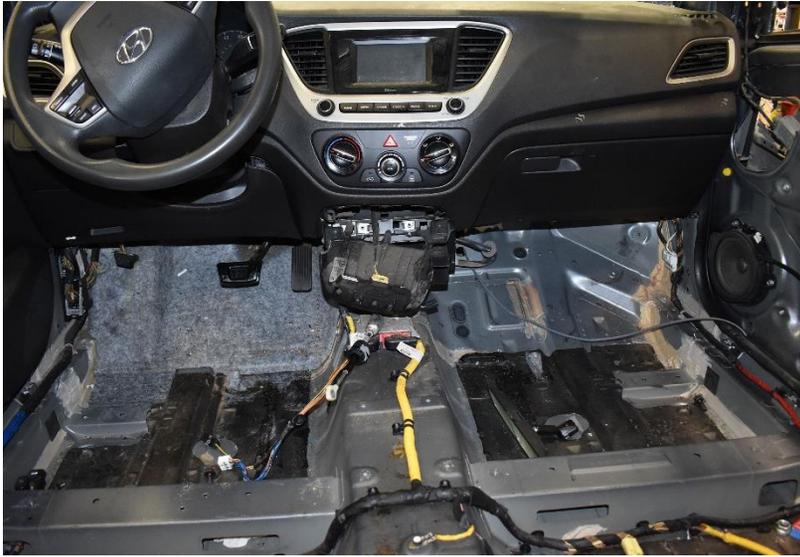
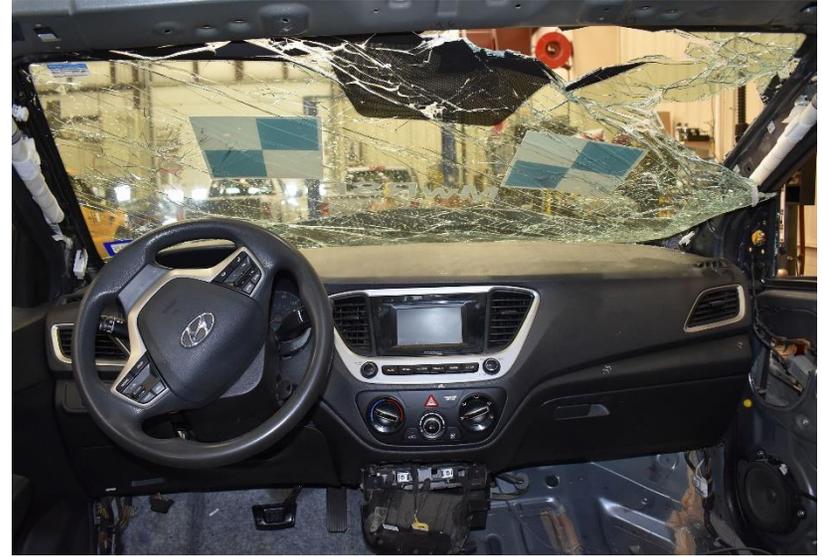
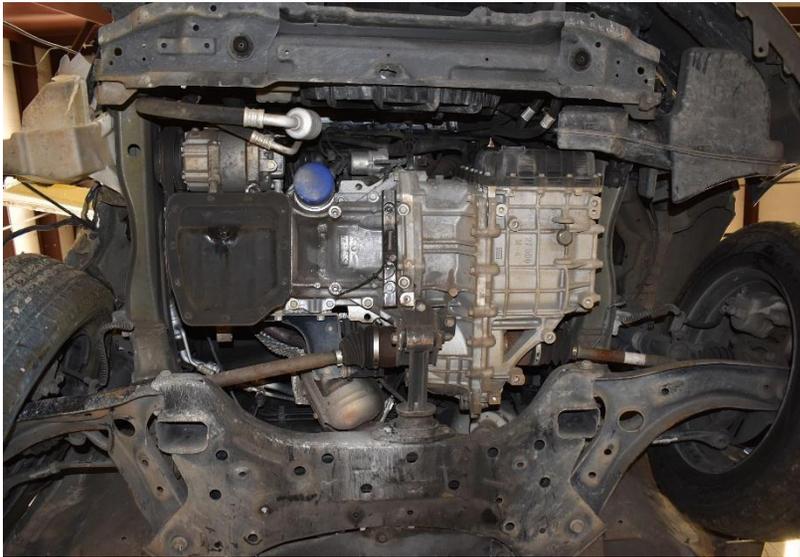
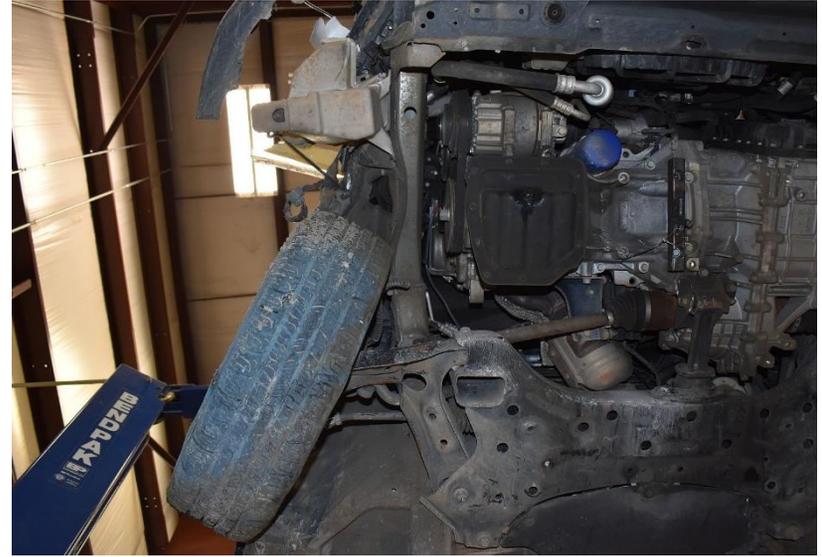
Figure 130. Test Vehicle's Interior Floorboards and Undercarriage Damage, Test No. HBIB-10

Damage to the vehicle's undercarriage was minimal. The right-front shock, end of the sway bar, and right-side outer tie rod were bent. The right-side lower control arm was bent downward and inward.

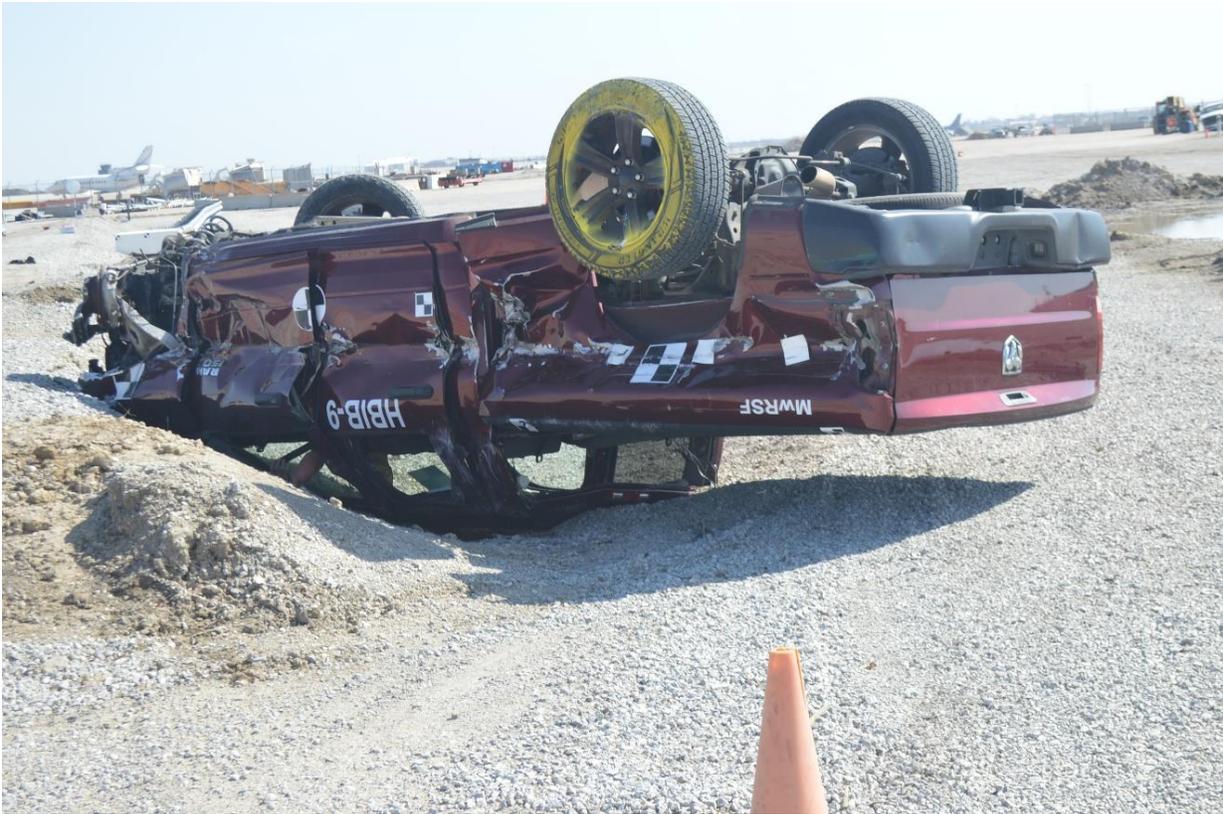
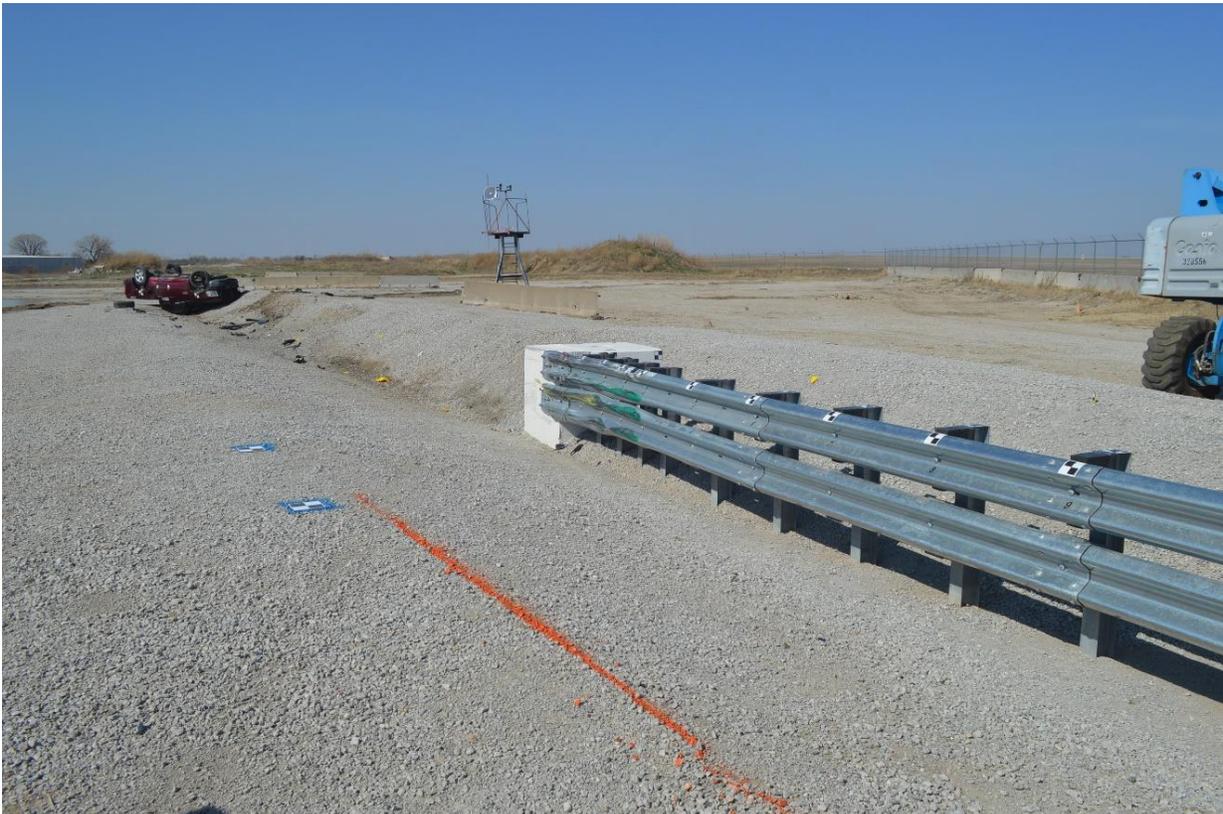
Figure 176. Vehicle Final Position and Trajectory Marks, Test No. HBIB-9

The targeted vehicle impact was to occur 69¼ in. upstream from the upstream end of the concrete anchor block, as shown in Figure 170. The CIP for test no. HBIB-9 was selected using the recommended TL-3 test matrix Table 2-3 of MASH. The CIP plots found in MASH Section 2.3 were implemented to maximize the probability of pocketing and vehicle snagging on the concrete parapet. The 5,000-lb quad cab pickup truck impacted the slope break point of the system in the reverse direction at a speed of 62.0 mph and at an angle of 25.4 degrees and impacted the barrier at a speed of 62.1 mph and at an angle of 28.8 degrees. The actual point of impact was 68.5 in. upstream from the upstream end of the concrete anchor. At 0.330 sec, the vehicle exited the system and at 0.508 sec the vehicle began to roll away from the system, subsequently rolling over. At 6.838 sec, the vehicle came to rest on its roof.

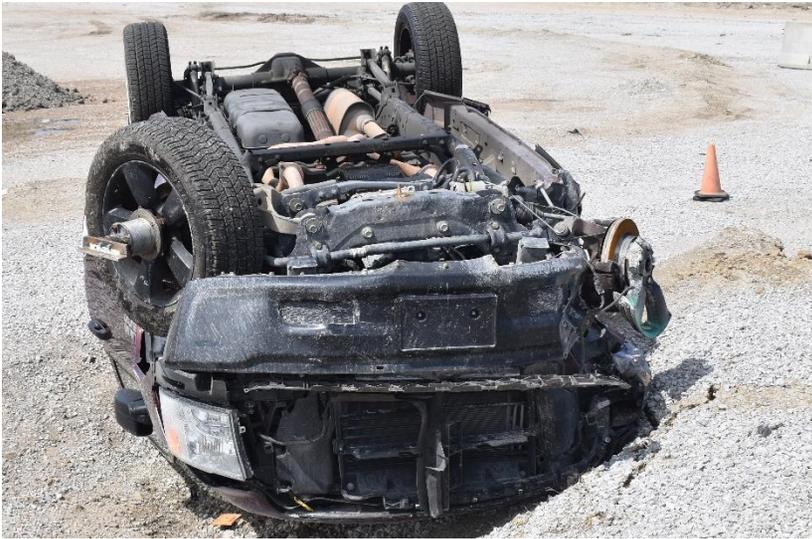
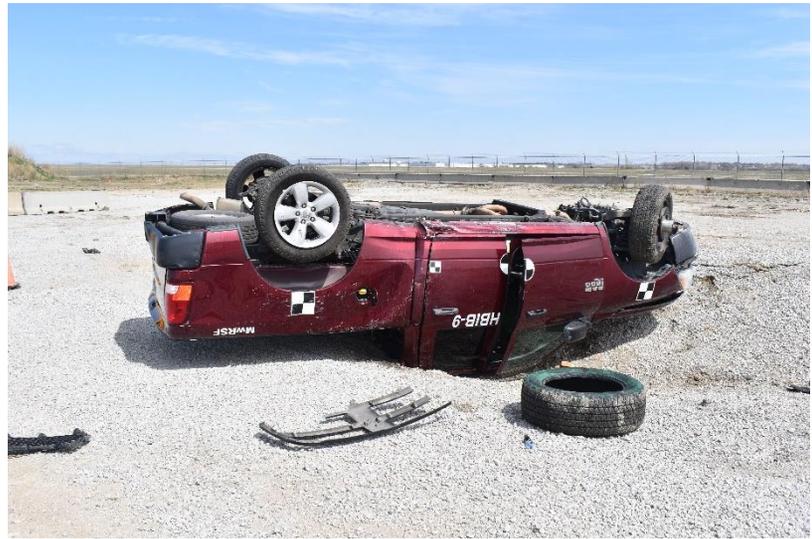
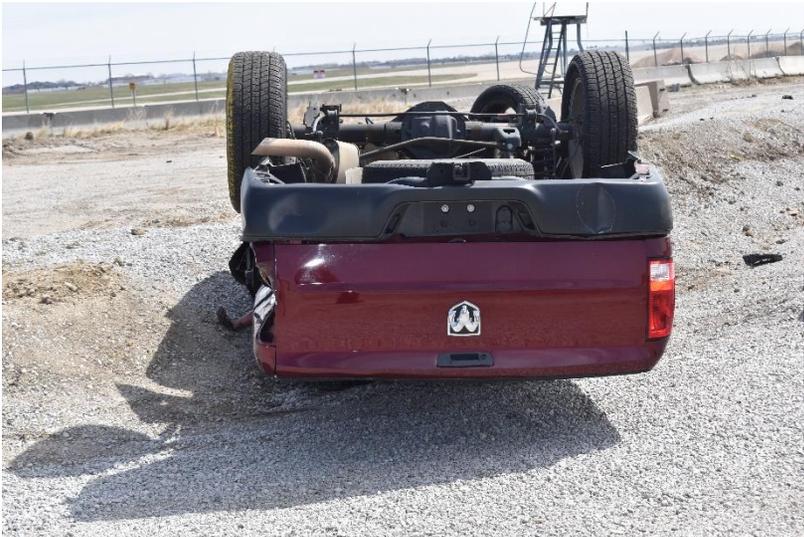
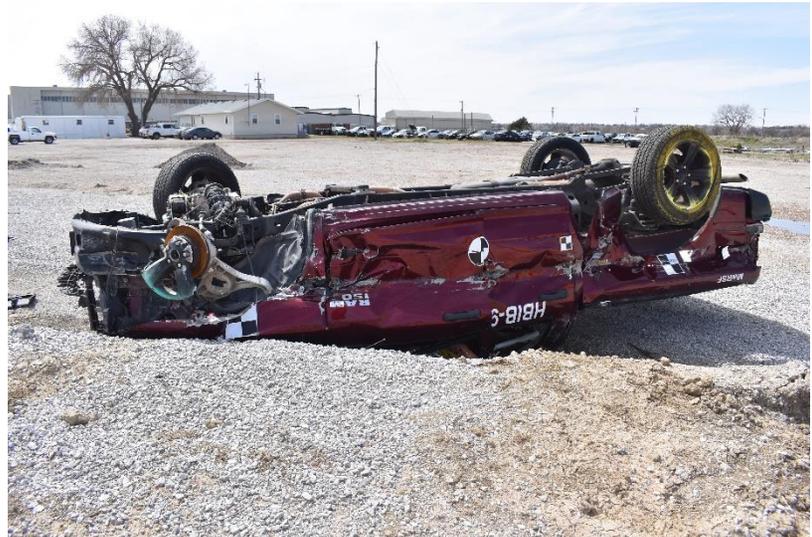
Figure 180. Vehicle Damage, Test No. HBIB-9

The damage to the vehicle was severe, as shown in Figures 180 through 182. Majority of the damage was concentrated on the right-front corner and right side of the vehicle where the impact had occurred. The grille and right headlight were disengaged from the vehicle. The bumper was crushed rearward at its rightmost end. The hood was dented and scraped along both the right and left leading edges of the panel, and two dents appeared just behind the scraped areas. The right fender was severely crushed inward immediately above and behind the wheel opening. This damage extended into the right-front door panel, which was crushed inward and scraped at its vertical center, and the deformation continued onto the rear door. The upper portion of the door's window frame was bent and buckled and the side window shattered; the upper half of the panel protruded noticeably from the vehicle and a 2-in. tear appeared at the rear of the crushed section.

On the left side, the box was dented and scraped along its entire length, and the fuel door folded forward from its rear to its front edge. The left-rear door was dented and scraped along its trailing edge and around the window opening, while the left-front door bore a slight dent at its upper center. The left front fender was dented inward and downward at the leading edge just behind the headlight. The roof was dented and scraped downward at the rear of its panel, with additional damage at the roof-to-door transition. Finally, the windshield cracked throughout, with the most extensive fracture concentrated in the upper right section of the pane.

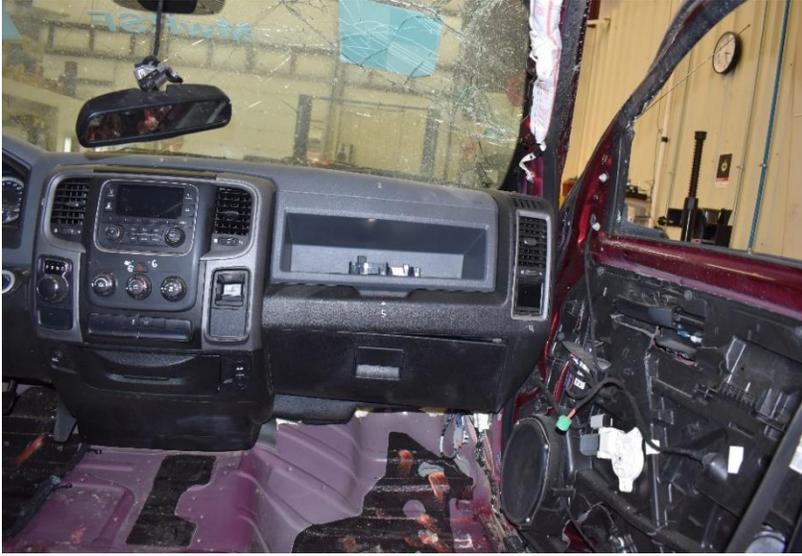
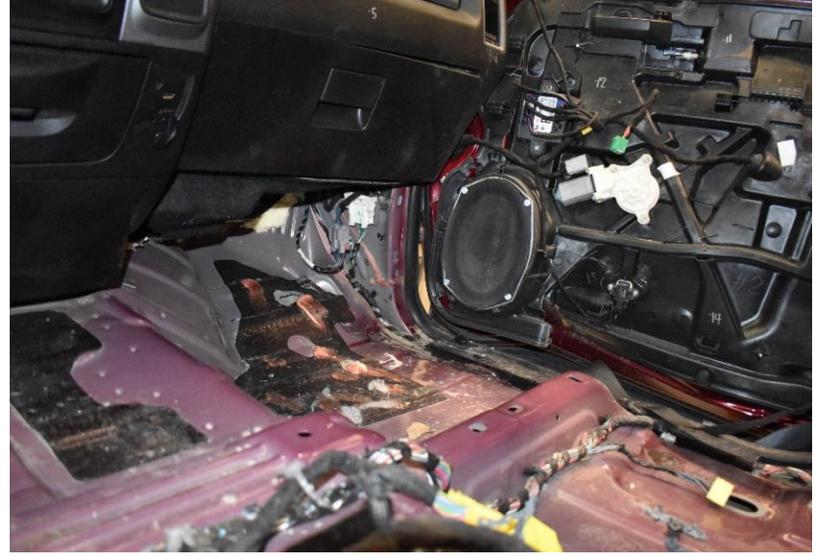
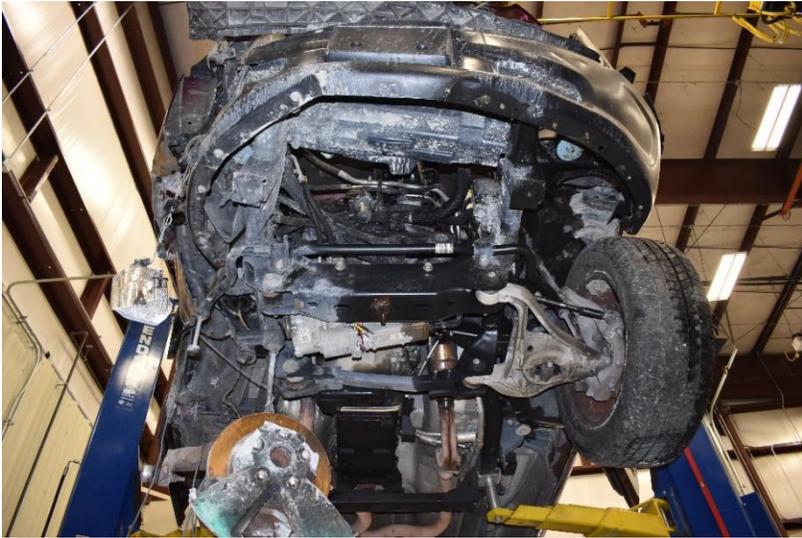
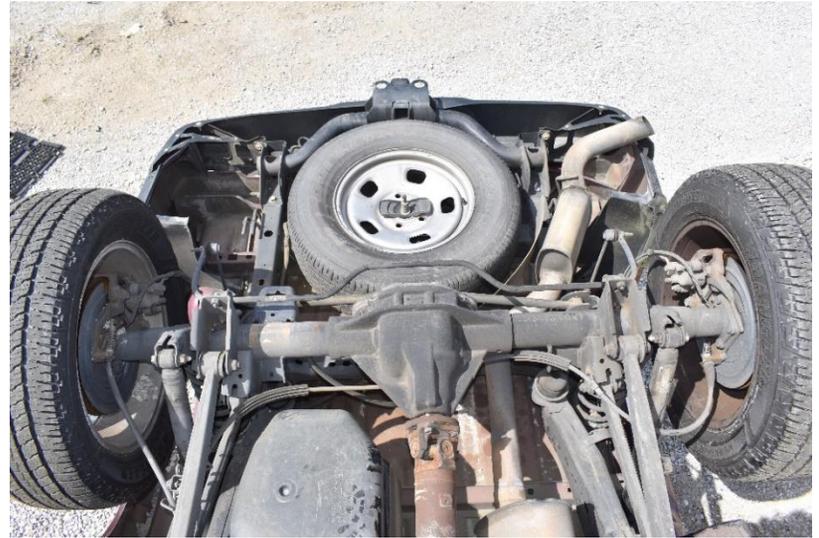
Figure 182. Test Vehicle's Interior Floorboards and Undercarriage Damage, Test No. HBIB-9

The undercarriage and suspension components were also affected. The end link on the right side detached at its lower mounting. The right lower control arm separated from the cross members, and the upper control arm was bent rearward. The inner tie rod was bent, and the steering rack and gearbox were split in half. The middle cross member exhibited a slight twist, and the right frame horn buckled slightly. The right-front tire disengaged, and the right-front brake line was severed at the steering knuckle.

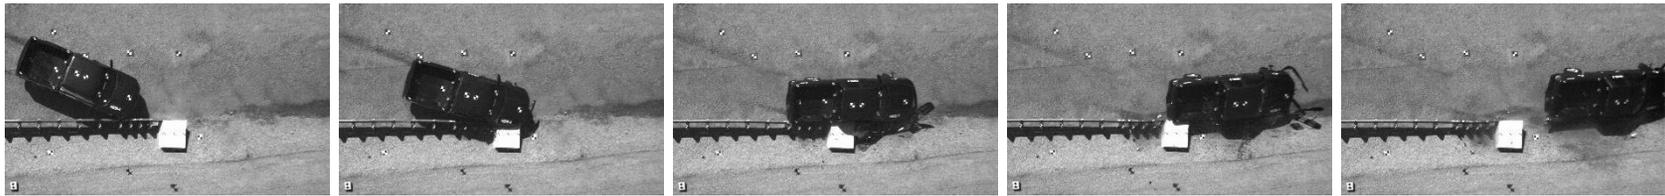
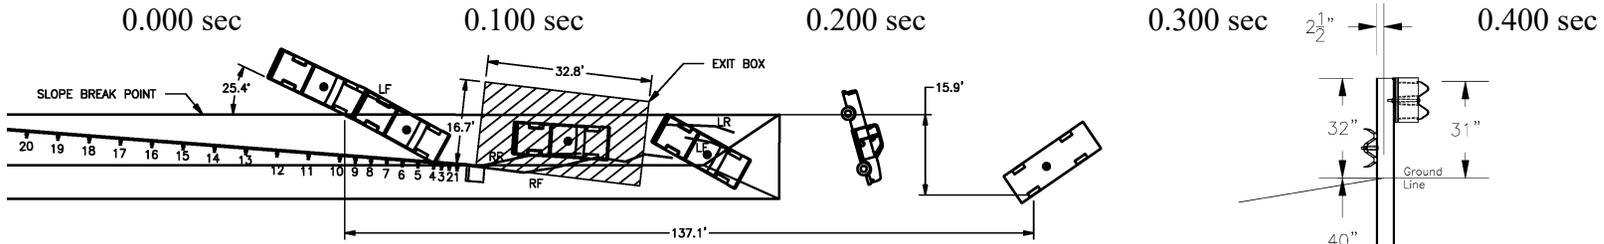
Figure 183. Summary of Test Results and Sequential Photographs, Test No. HBIB-9

Analysis of the test results for test no. HBIB-9 showed that the 2270P vehicle impact with the system resulted in test failure. A summary of the test results and sequential photographs are shown in Figure 183. The barrier system effectively contained and redirected the 1100C vehicle with controlled lateral displacements of the barrier. Detached elements, fragments, or other debris from the test article did not penetrate or show potential for penetrating the occupant compartment, or present an undue hazard to other traffic, pedestrians, or work-zone personnel. However, due to the severity of the impact to the top rail, the deformation of the vehicle's A-pillar measured 6.4 in., exceeding the MASH safety limits of 5 in.; the deformation of the B-pillar measured 17.5 in., exceeding the MASH safety limits of 5 in.; and the lateral deformation of the A-pillar measured 6.2 in., exceeding the MASH safety limits of 3 in. The test vehicle did not penetrate or override the barrier. Pitch and yaw angular displacements, shown in Appendix K, were deemed acceptable, however, the vehicle's maximum roll of -543.9 degrees exceeded the MASH safety limit of 75 degrees and the vehicle rolled over. Deformation of the roof measured 7.6 in., exceeding the MASH safety limit of 4 in. After impact, the vehicle exited the barrier at an angle of -3.7 degrees with respect to the barrier, and its trajectory did not violate the bounds of the exit box. Therefore, test no. HBIB-9 was determined to be unsuccessful according to MASH safety performance criteria for test designation no. 3-37a.

- Exit Box Criterion..... Pass
- Vehicle Stability Fail
- Vehicle Stopping Distance 137.1 ft downstream, 15.9 ft laterally behind slope break
- Vehicle Damage..... Severe
 - VDS [15] 1-RFQ-7
 - CDC [16]..... 01-RFEE-9
 - Maximum Interior Deformation 17.5 in. at B-Pillar ≥ 5-in. MASH limit
- Test Article Damage Moderate
- Maximum Test Article Deflections
 - Permanent Set 3.2 in.
 - Dynamic 5.5 in.
 - Working Width 22.3 in.
- Transducer Data
