*Hawaii Department of Transportation
Research Contract No. 69876
Research Project No. STP-1500(115) – Phase III*

EVALUATION OF THE HAWAII MODIFIED NATCHEZ TRACE BRIDGE RAIL: MASH TEST DESIGNATION NO. 3-11

MwRSF Research Report No. TRP-03-478a-25

May 16, 2025

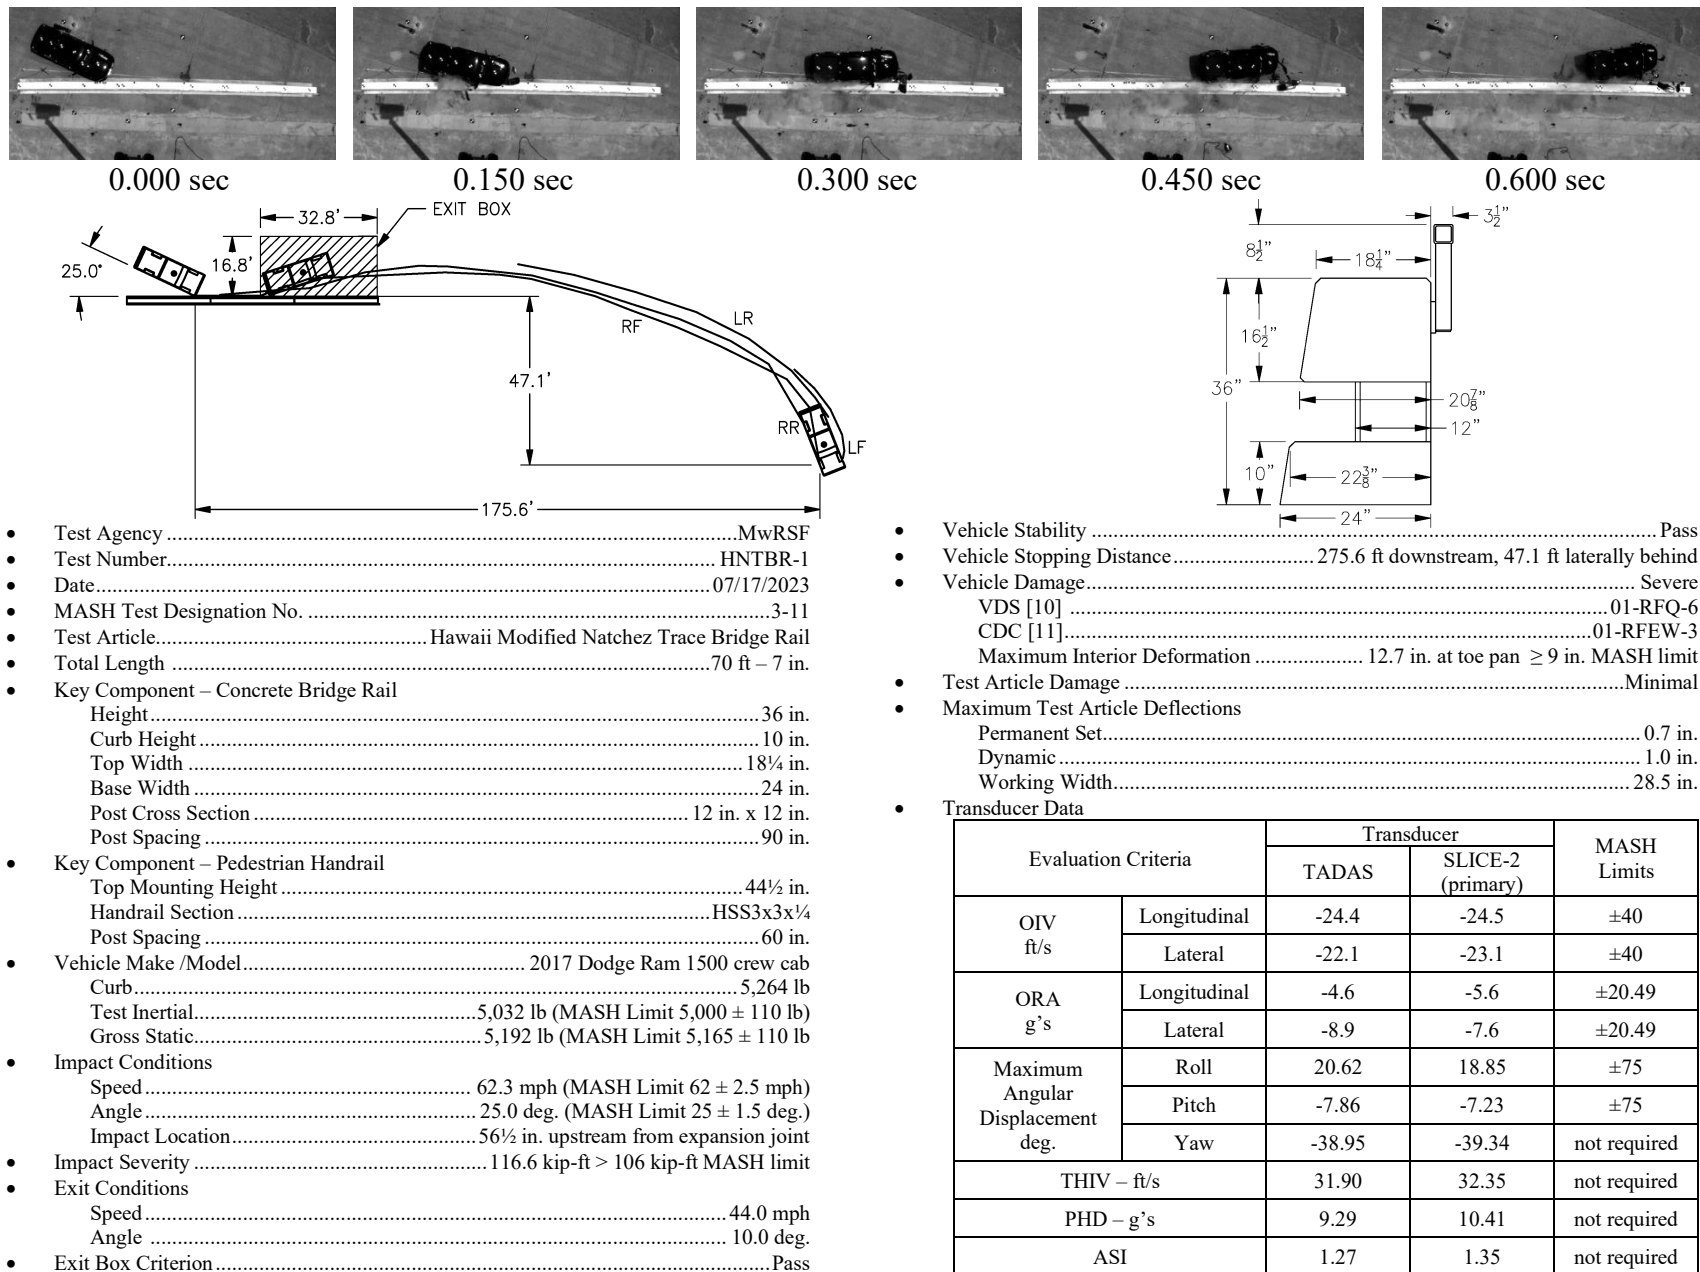
Figure 35. Summary of Test Results and Sequential Photographs, Test No. HNTBR-1

The analysis of the test results for test no. HNTBR-1 showed that the system contained and redirected the 2270P vehicle with minimal lateral displacements of the barrier. Vehicle roll, pitch, and yaw angular displacements, as shown in Appendix E, were deemed acceptable because they did not adversely influence occupant risk nor cause rollover. After impact, the vehicle exited the barrier at an angle of 10.0 degrees, and its trajectory did not violate the bounds of the exit box. However, deformations of, or intrusions into, the occupant compartment could have caused serious injury. The floor pan deformation of 12.7 in. exceeded the MASH limit of 9 in. Therefore, test no. HNTBR-1 was determined to be unsatisfactory according to the safety performance criteria for MASH test designation no. 3-11. A summary of the test results and sequential photographs are shown in Figure 35.

The Hawaii Modified Natchez Trace Bridge Rail was subjected to one full-scale crash test in accordance with MASH test designation no. 3-11. The test evaluation is summarized in Table 7. In test no. HNTBR-1, a 5,032-lb crew cab pickup truck impacted the Hawaii Modified Natchez Trace Bridge Rail at a speed of 62.3 mph and an angle of 25.0 degrees. The impact occurred 56½ in. upstream from the expansion joint between post nos. 4 and 5 with an impact severity of 116.6 kip-ft. The vehicle was contained and redirected and exited the system at a speed of 44.0 mph and an angle of 10 degrees. Damage to the barrier was minimal, while damage to the vehicle was extensive. Intrusion to the occupant compartment at the toe pan was 12.7 in., which exceeded the MASH limit of 9 in. Therefore, test no. HNTBR-1 was unsatisfactory according to the safety performance criteria of MASH test designation no. 3-11.

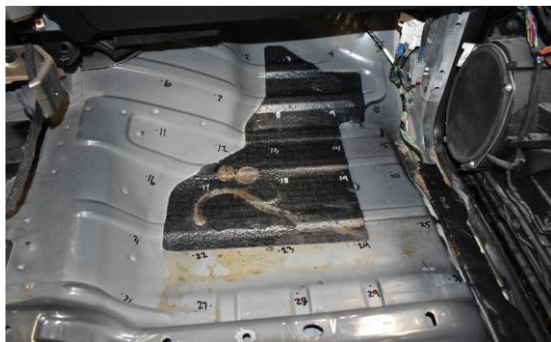
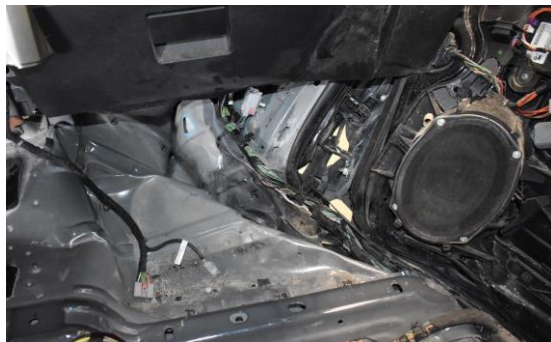
Figure D-1. Passenger Side Floor Pan Deformation Data – Set 1, Test No. HNTBR-1

Appendix D. MASH defines intrusion or deformation as the occupant compartment being deformed and reduced in size with no observed penetration. The vehicle's toe pan was deformed 12.7 in., which exceeded the 9-in. MASH intrusion limit. Outward deformations, which are denoted as negative numbers in Appendix D, are not considered crush toward the occupant, and are not evaluated by MASH criteria.

| Due to damage points 2-3, 8-9, 12-14, 17-19, 25, & 30 are unusable | |
