Hawaii Department of Transportation Research Contract No. 69876 Research Project No. STP-1500(115) – Phase III

DEVELOPMENT AND CRASH TESTING OF THE HAWAII CONCRETE POST AND BEAM BRIDGE RAIL

MwRSF Research Report No. TRP-03-478b-25-R1

September 25, 2025

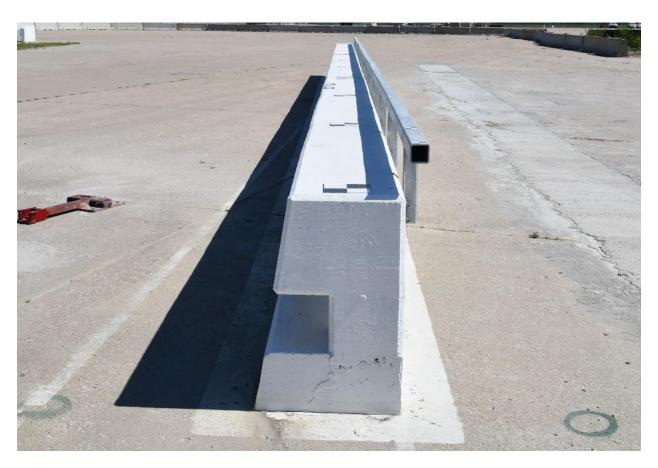
Figure 4. Hawaii Modified Natchez Trace Bridge Rail – Test No. HNTBR-1

MASH evaluation of the Hawaii Modified Natchez Trace Bridge Rail began with a pickup truck impact in accordance with MASH test designation no. 3-11. In test no. HNTBR-1, a 5,032-lb crew cab pickup truck impacted the Hawaii Modified Natchez Trace Bridge Rail, as shown in Figure 4, at a speed of 62.3 mph and an angle of 25.0 degrees. The vehicle was contained and redirected with minimal damage to the bridge railing. However, there was extensive damage to the vehicle, as shown in Figure 5. The vehicle's wheel well and toe pan had intrusion deformations of 12.7 in., which exceeded the MASH limit of 9 in. Therefore, test no. HNTBR-1 failed the safety criteria of MASH test designation no. 3-11. Test no. HNTBR-1 was previously documented in a separate test report [6].

Upon the failure of test no. HNTBR-1, an investigation into the potential causes of the excessive toe pan deformations was conducted. Vehicle deformations were caused by the impact-side wheel snagging on the bridge railing and being shoved back toward the occupant compartment as the vehicle traveled downstream. Through a review and comparison of the previous crash tests on the original Natchez Trace Bridge Railing and the Hawaii Modified Natchez Trace Bridge Rail [2, 4, and 6], three factors were identified as contributors to the MASH test failure: (1) increased impact severity of the MASH test compared to the previous crash testing standards, (2) the limited curb-to-rail offset of the Hawaii Modified Natchez Trace Bridge Rail, and (3) the angled bottom edge of the upper railing.

The original Natchez Trace Bridge Rail had a 4.5 in. lateral offset between the top of the curb and the lower edge of the upper rail. This allowed the impacting wheel to traverse up and over the curb prior to impacting the upper rail. The Hawaii Modified Natchez Trace Bridge Rail reduced this lateral offset to only 1.5 in., which gave the railing more of a "single slope" front face, as shown previously in Figure 3. The limited offset resulted in the wheel impacting and being loaded against the upper rail while trying to traverse over the curb at the same time. The combined lateral loading and vertical motion of the wheel caused the rim to gouge into and snag on the lower edge of the railing. As the vehicle continued to move downstream and against the bridge rail, the wheel was pushed back toward the occupant compartment and deformed the vehicle toe pan.

Following the failure analysis of test no. HNTBR-1, the research team identified various options to alter the bridge railing to alleviate the rim gouging and snag issues. These options are explored in the following sections.

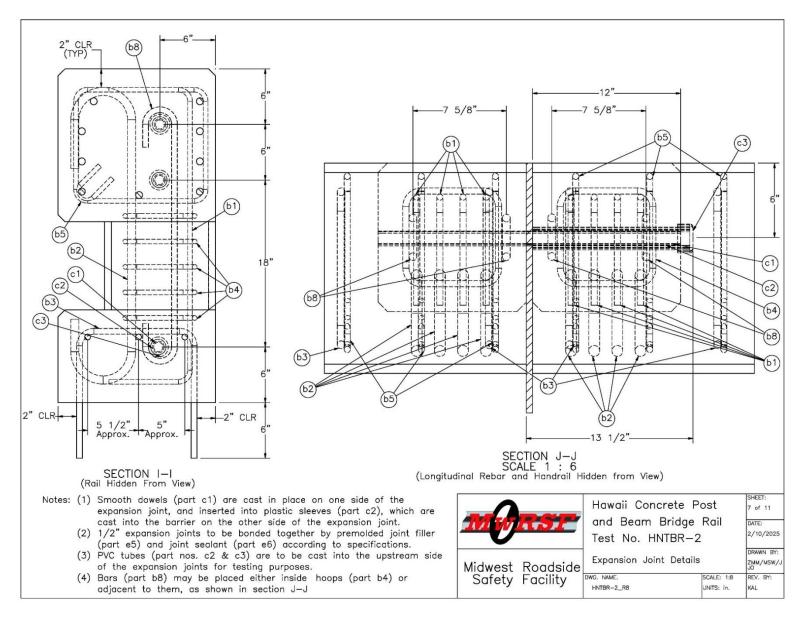
Figure 19. Post-Rail Rebar Arrangement, Test Nos. HNTBR-2 and HNTBR-3

Within Figure 19, in note 4, the b4 hoops were incorrectly referred to as "stoops." This typo was corrected.

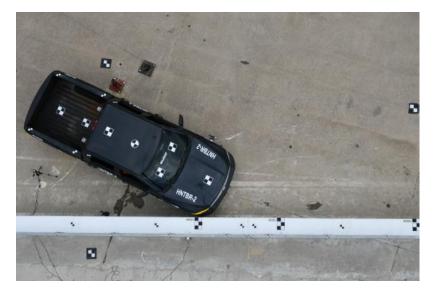
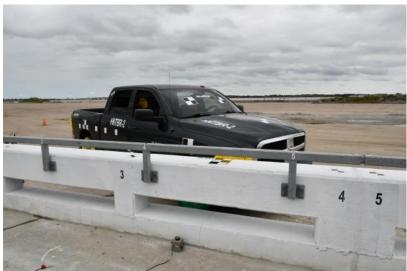
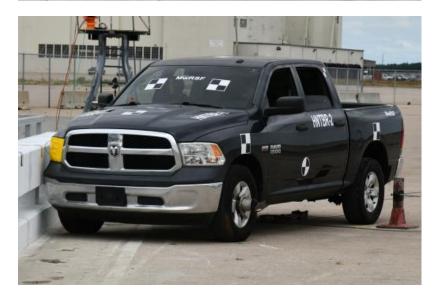
Figure 36. Target Impact Location, Test No. HNTBR-2

Initial vehicle impact was to occur 51½ in. upstream from the centerline of expansion joint no. 1, as shown in Figure 36, which was selected using the CIP plots found in Section 2.3 of MASH to maximize loading to the bridge rail adjacent to the expansion joint. The 4,995-lb crew cab pickup truck impacted the concrete bridge rail at a speed of 62.7 mph and an angle of 25.2 degrees. The actual point of impact was 8 in. upstream from the targeted CIP. The vehicle was contained and redirected and remained stable throughout the impact event. After exiting the bridge rail, the brakes were applied remotely, and the vehicle came to rest 273.1 ft downstream from impact after impacting a row of concrete containment barriers.

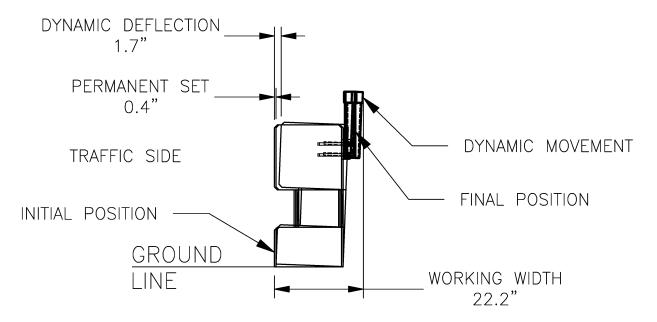
Figure 44. Permanent Set, Dynamic Deflection, and Working Width, Test No. HNTBR-2

The maximum lateral permanent set of the barrier system was 0.4 in. located on the downstream side of expansion joint no. 1, as measured in the field. The maximum lateral dynamic barrier deflection was 1.7 in. located on the downstream side of expansion joint no. 1, as determined from high-speed digital video analysis. The working width of the system was found to be 22.2 in., also determined from high-speed digital video analysis. A schematic of the permanent set deflection, dynamic deflection, and working width is shown in Figure 44.

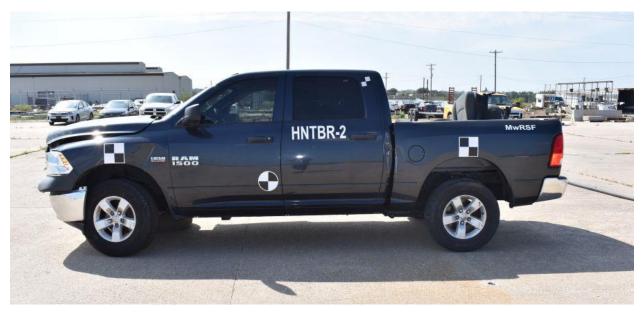
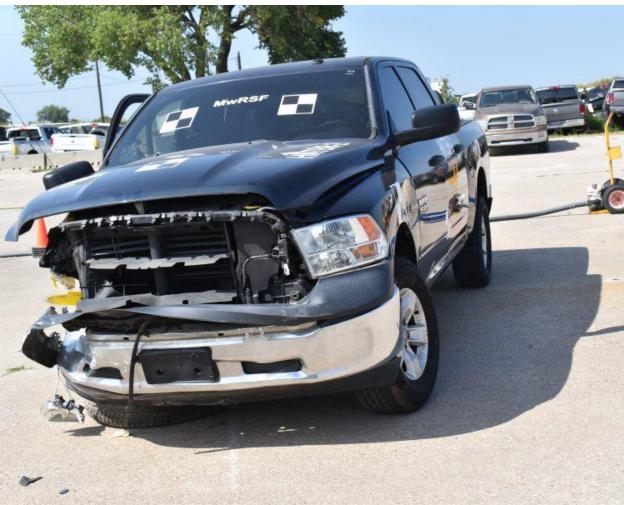
Figure 46. Vehicle Damage, Test No. HNTBR-2

The damage to the vehicle was severe, as shown in Figures 45 through 49. Note that there was a secondary impact with a row of containment barriers downstream from the test article which contributed to the damage on the front of the vehicle. Vehicle damage prior to the secondary impact is shown in Figure 45. The impact side of the vehicle, or the passenger's side, is referred to as the vehicle's right side throughout this report. The non-impact side, or driver's side, is referred to as the vehicle's left side. The majority of the damage was concentrated on the right-front corner and right side of the vehicle where the impact occurred. The right side of the front bumper was bent rearward and scraped. The right-front headlight and grille were disengaged from the vehicle. Scrapes and dents were observed throughout the right-side of the vehicle including the fender, doors, rear quarter panel, and rear bumper. Cracks were observed on the right side of the windshield, and the right-front side window was disengaged from the vehicle due to a combination of door flexure and contact with the dummy. Note, neither the side window nor the dummy contacted the bridge railing.

On the undercarriage, the right-front side spring was disengaged and the right-front shocks were bent rearward. The left-side end link was bent rearward, and the left steering knuckle was disengaged. The right lower control arm disengaged from the vehicle, and the right upper control arm was bent backward. The right tie rod disengaged and the steering rack case was fractured. The right end of the front engine cross member was scraped and twisted slightly, and the rear cross member was bent and slightly scraped. The right frame horn was bent and twisted inward, and the left frame horn was bent outward. The right-front wheel detached from the vehicle and the right rear wheel was scraped.

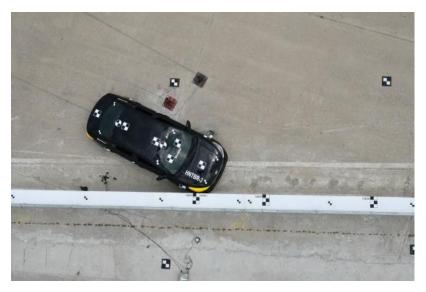
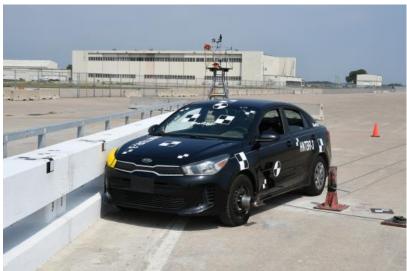
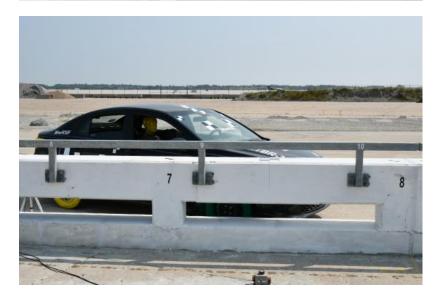
Figure 51. Target Impact Location, Test No. HNTBR-3

Initial vehicle impact was to occur 43½ in. upstream from a post, which was selected using MASH Table 2-7 to maximize the potential for vehicle snag. Post no. 8, which was just upstream from expansion joint no. 2, was selected as the targeted snag post to simultaneously apply impact loads near a joint. Thus, the targeted impact point was also 55½ in. upstream from the centerline of expansion joint no. 2, as shown in Figure 51. The 2,400-lb Kia Rio impacted the concrete bridge rail at a speed of 63.6 mph and at an angle of 24.9 degrees. The actual point of impact was 4.8 in. downstream of the targeted impact location. The vehicle was contained and redirected and remained stable throughout the impact event. After exiting the bridge rail, the brakes were applied remotely, and the vehicle came to rest 254 ft downstream from impact after impacting a row of concrete containment barriers.

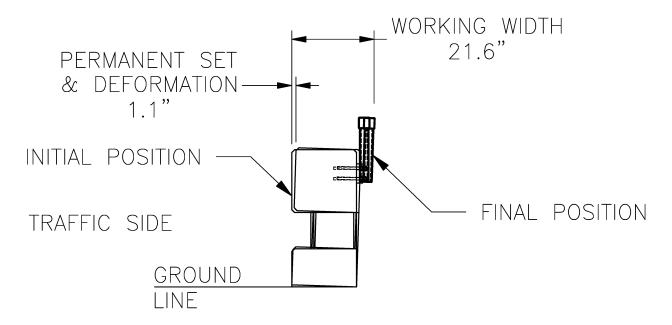
Figure 59. Permanent Set, Dynamic Deflection, and Working Width, Test No. HNTBR-3

The maximum lateral permanent set of the barrier system was 1.1 in. at the upstream end of the third bridge rail segment, as measured in the field. The maximum lateral dynamic barrier deflection was 1.1 in. at the upstream end of the third bridge rail segment, as determined from high-speed digital video analysis. The working width of the system was found to be 21.6 in., also determined from high-speed digital video analysis. A schematic of the permanent set deflection, dynamic deflection, and working width is shown in Figure 59.

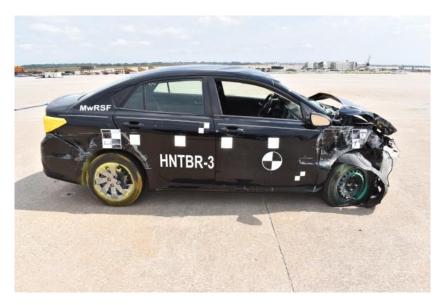
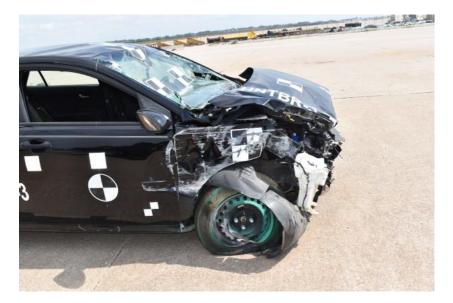
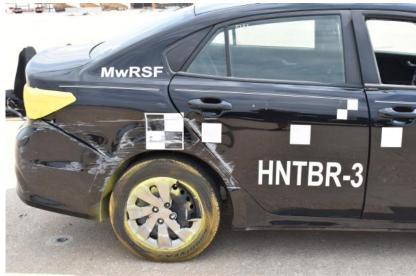
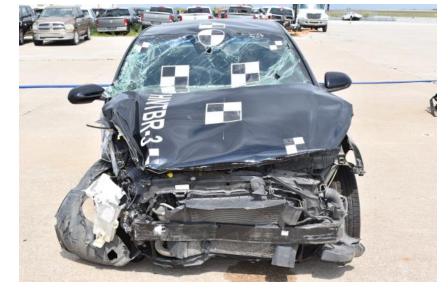
Figure 61. Vehicle Damage, Test No. HNTBR-3

The damage to the vehicle was severe, as shown in Figures 60 through 63. Note that there was a secondary impact with a row of containment barriers downstream from the test article. Vehicle damage prior to the secondary impact is shown Figure 60. The impact side of the vehicle, or the passenger's side, is referred to as the vehicle's right side throughout this report. The nonimpact side, or driver's side, is referred to as the vehicle's left side. The majority of the damage was concentrated on the right-front corner and right side of the vehicle where the impact had occurred. The front bumper cover detached, and the front bumper was pushed back into the radiator. Both front headlights were disengaged from the vehicle, and the hood was deformed. The front fender was dented and crushed. The base of the A-pillar was deformed and crushed inward. The right-front door's leading edge was dented and scraped, and the right-front window was detached from the vehicle. The right-rear door was dented along its length, and the right quarter panel was dented inward. The entire right side of the vehicle was scraped from the front fender to the rear bumper. The front half of the roof was kinked and buckled.

The windshield shattered and tore, with a maximum deformation of 4.2 in. However, this damage was caused by loading and deformations at the base of the A-pillar rather than direct contact between the bridge rail and windshield. Furthermore, a secondary impact with a row of containment barriers downstream of the test article contributed to additional damage and deformations to the windshield. Thus, the windshield damage was not in violation of MASH safety criteria. Note, similar 1100C windshield and front window damage has been observed in previous evaluations of MASH-crashworthy concrete barriers [13, 14].
