*Hawaii Department of Transportation  
Research Contract No. 69876  
Research Project No. STP-1500(115) – Phase III*

## **DEVELOPMENT AND CRASH TESTING OF THE HAWAII CONCRETE POST AND BEAM BRIDGE RAIL**

MwRSF Research Report No. TRP-03-478b-25

July 15, 2025

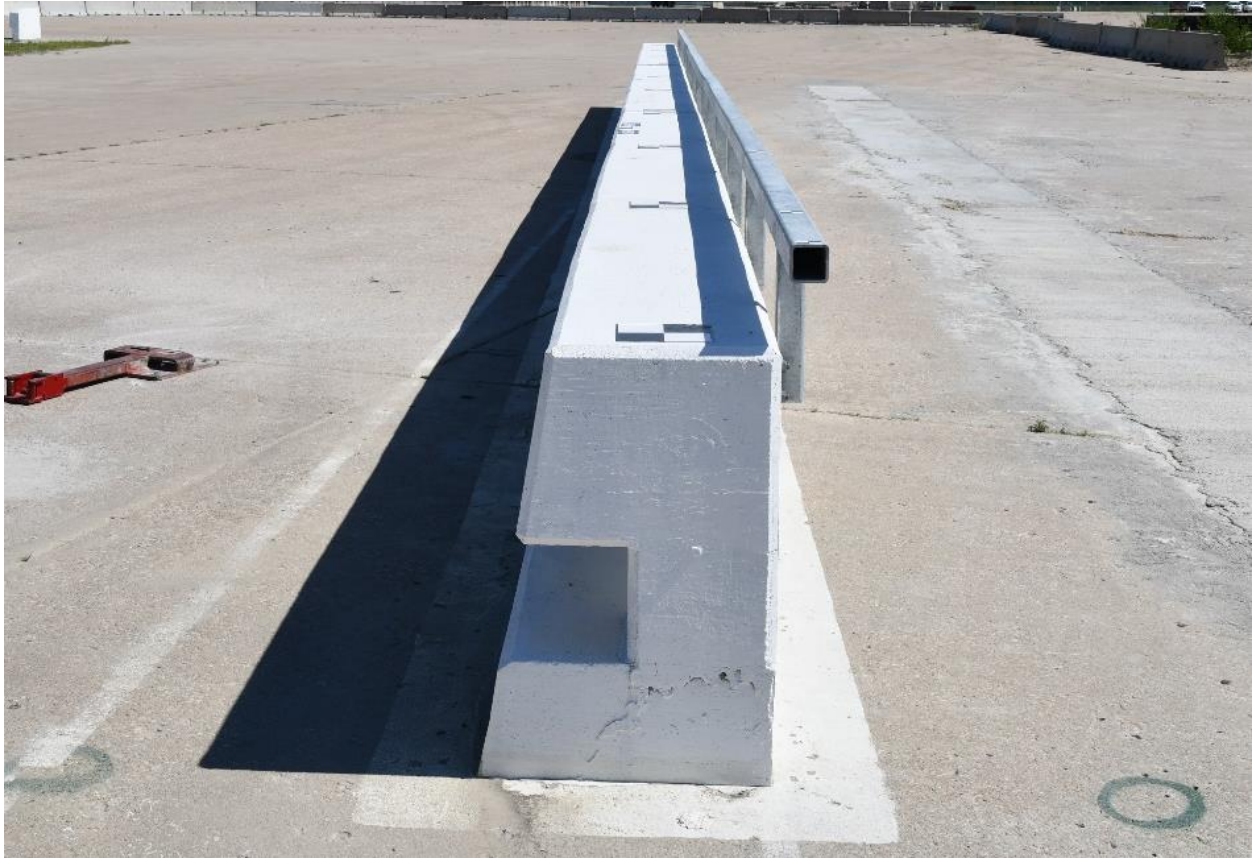
Figure 4. Hawaii Modified Natchez Trace Bridge Rail – Test No. HNTBR-1

MASH evaluation of the Hawaii Modified Natchez Trace Bridge Rail began with a pickup truck impact in accordance with MASH test designation no. 3-11. In test no. HNTBR-1, a 5,032-lb crew cab pickup truck impacted the Hawaii Modified Natchez Trace Bridge Rail, as shown in Figure 4, at a speed of 62.3 mph and an angle of 25.0 degrees. The vehicle was contained and redirected with minimal damage to the bridge railing. However, there was extensive damage to the vehicle, as shown in Figure 5. The vehicle's wheel well and toe pan had intrusion deformations of 12.7 in., which exceeded the MASH limit of 9 in. Therefore, test no. HNTBR-1 failed the safety criteria of MASH test designation no. 3-11. Test no. HNTBR-1 was previously documented in a separate test report [6].

Upon the failure of test no. HNTBR-1, an investigation into the potential causes of the excessive toe pan deformations was conducted. Vehicle deformations were caused by the impact-side wheel snagging on the bridge railing and being shoved back toward the occupant compartment as the vehicle traveled downstream. Through a review and comparison of the previous crash tests on the original Natchez Trace Bridge Railing and the Hawaii Modified Natchez Trace Bridge Rail [2, 4, and 6], three factors were identified as contributors to the MASH test failure: (1) increased impact severity of the MASH test compared to the previous crash testing standards, (2) the limited curb-to-rail offset of the Hawaii Modified Natchez Trace Bridge Rail, and (3) the angled bottom edge of the upper railing.

The original Natchez Trace Bridge Rail had a 4.5 in. lateral offset between the top of the curb and the lower edge of the upper rail. This allowed the impacting wheel to traverse up and over the curb prior to impacting the upper rail. The Hawaii Modified Natchez Trace Bridge Rail reduced this lateral offset to only 1.5 in., which gave the railing more of a “single slope” front face, as shown previously in Figure 3. The limited offset resulted in the wheel impacting and being loaded against the upper rail while trying to traverse over the curb at the same time. The combined lateral loading and vertical motion of the wheel caused the rim to gouge into and snag on the lower edge of the railing. As the vehicle continued to move downstream and against the bridge rail, the wheel was pushed back toward the occupant compartment and deformed the vehicle toe pan.

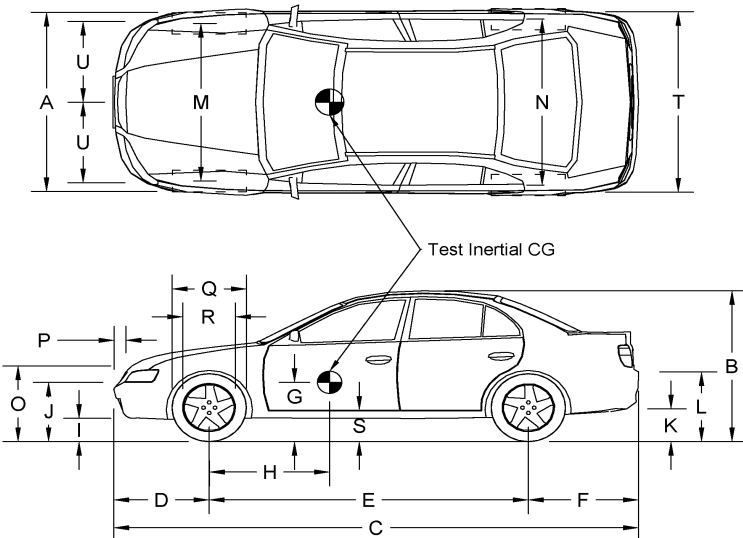
Figure 31. Vehicle Dimensions, Test No. HNTBR-3

**Note any damage prior to test:** cracked windshield, dents on right side rocker panel, small dent on left rear quarter panel, cracks on bumper flares, small dent on roof

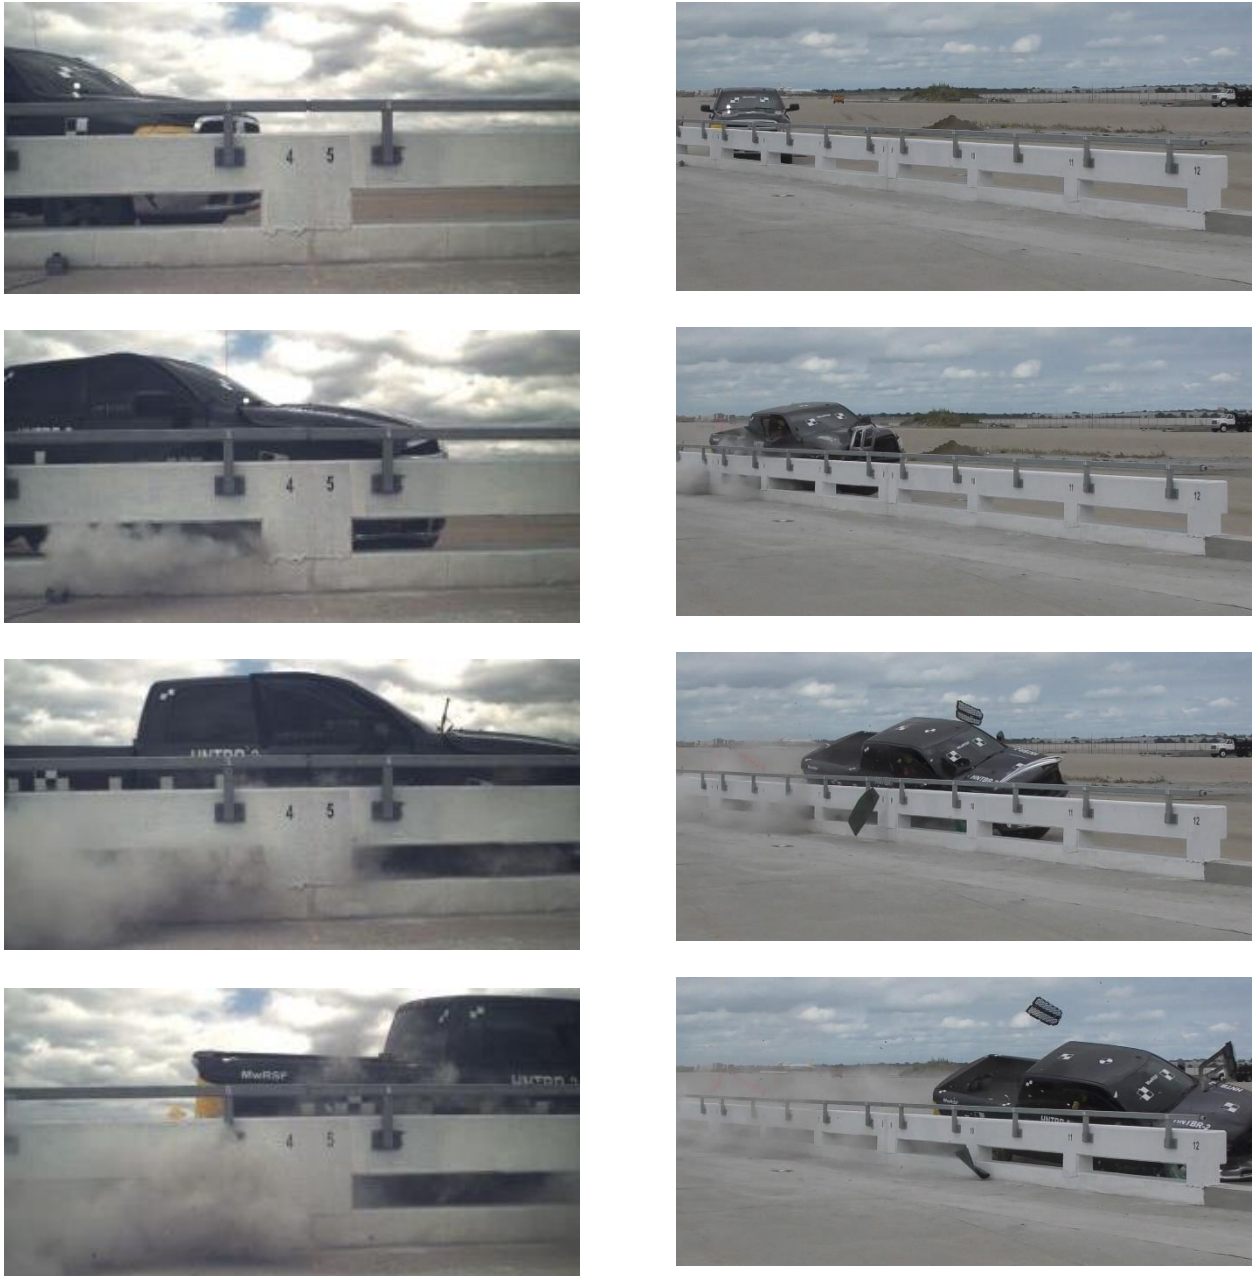
Figure 39. Documentary Photographs, Test No. HNTBR-2

A detailed description of the sequential impact events is contained in Table 4. Sequential photographs are shown in Figures 37 and 38. Documentary photographs of the crash test are shown in Figure 39. The vehicle trajectory and final position are shown in Figure 40.

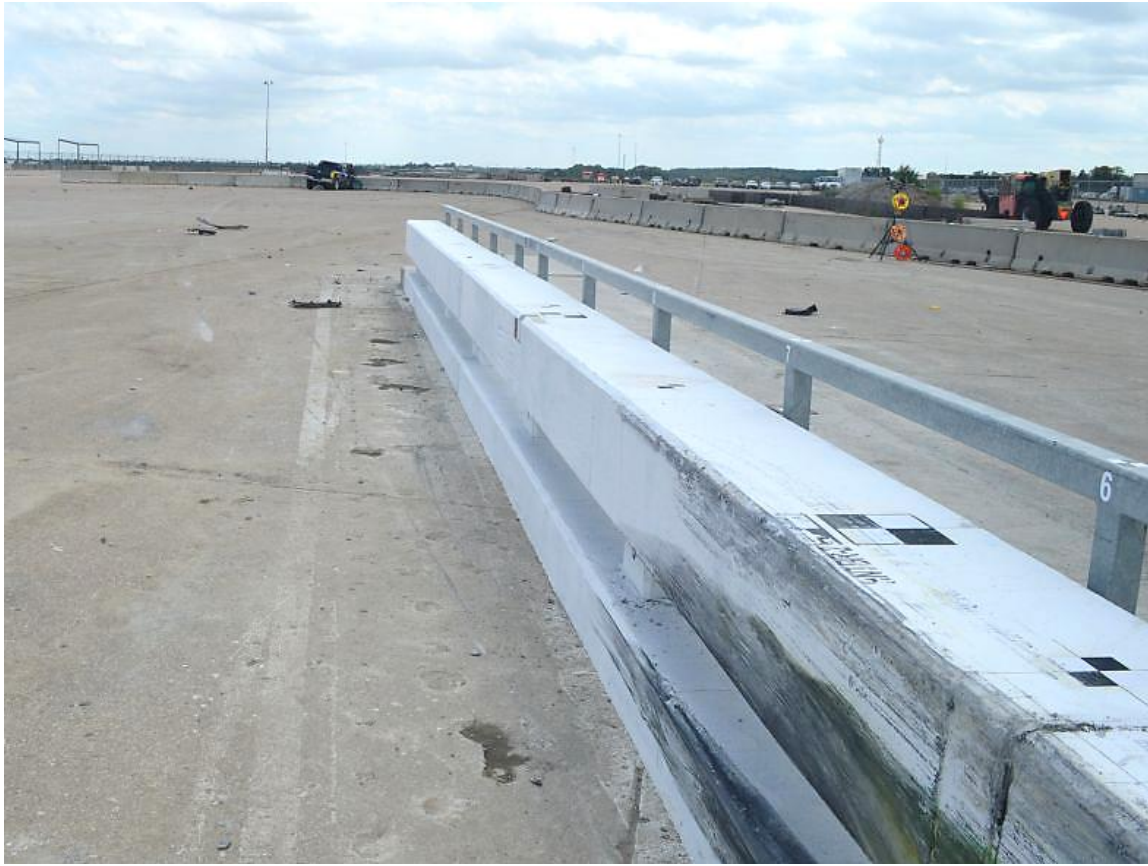
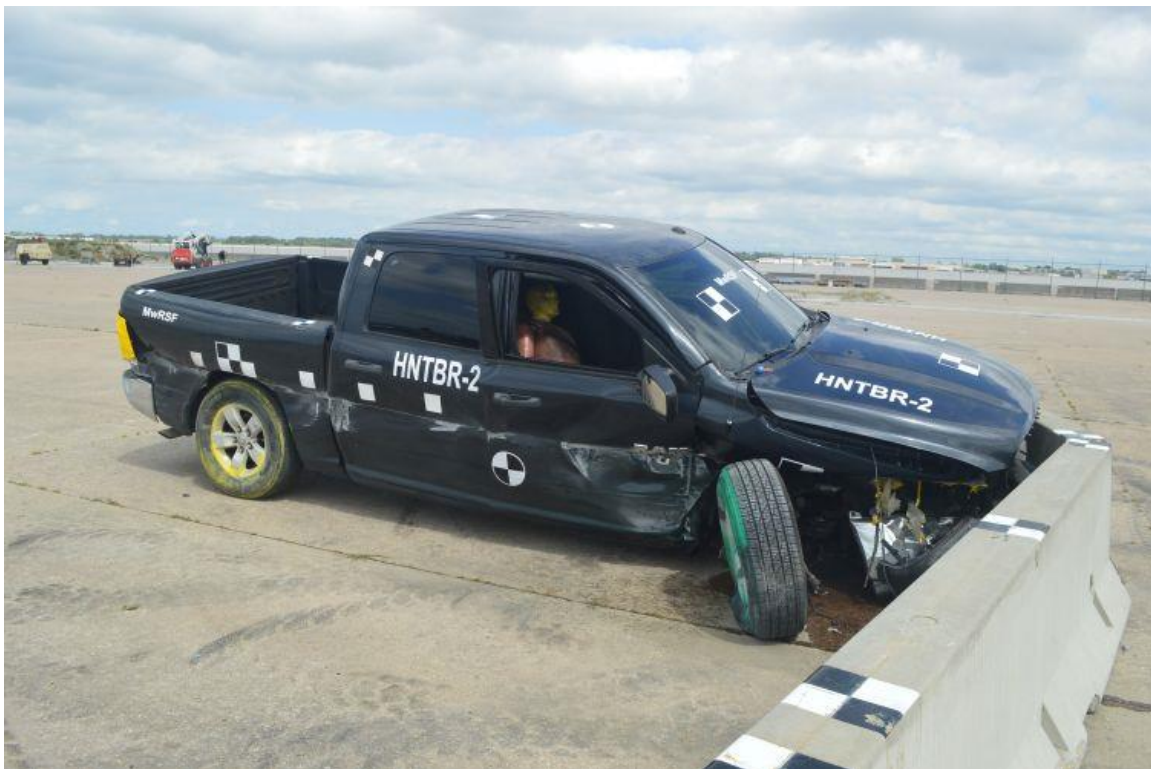
Figure 40. Vehicle Final Position and Trajectory Marks, Test No. HNTBR-2

Initial vehicle impact was to occur 51½ in. upstream from the centerline of expansion joint no. 1, as shown in Figure 36, which was selected using the CIP plots found in Section 2.3 of MASH to maximize loading to the bridge rail adjacent to the expansion joint. The 4,995-lb crew cab pickup truck impacted the concrete bridge rail at a speed of 62.7 mph and an angle of 25.2 degrees. The actual point of impact was 8 in. upstream from the targeted CIP. The vehicle was contained and redirected and remained stable throughout the impact event. After exiting the bridge rail, the brakes were applied remotely, and the vehicle came to rest 273.1 ft downstream from impact after impacting a row of concrete containment barriers.

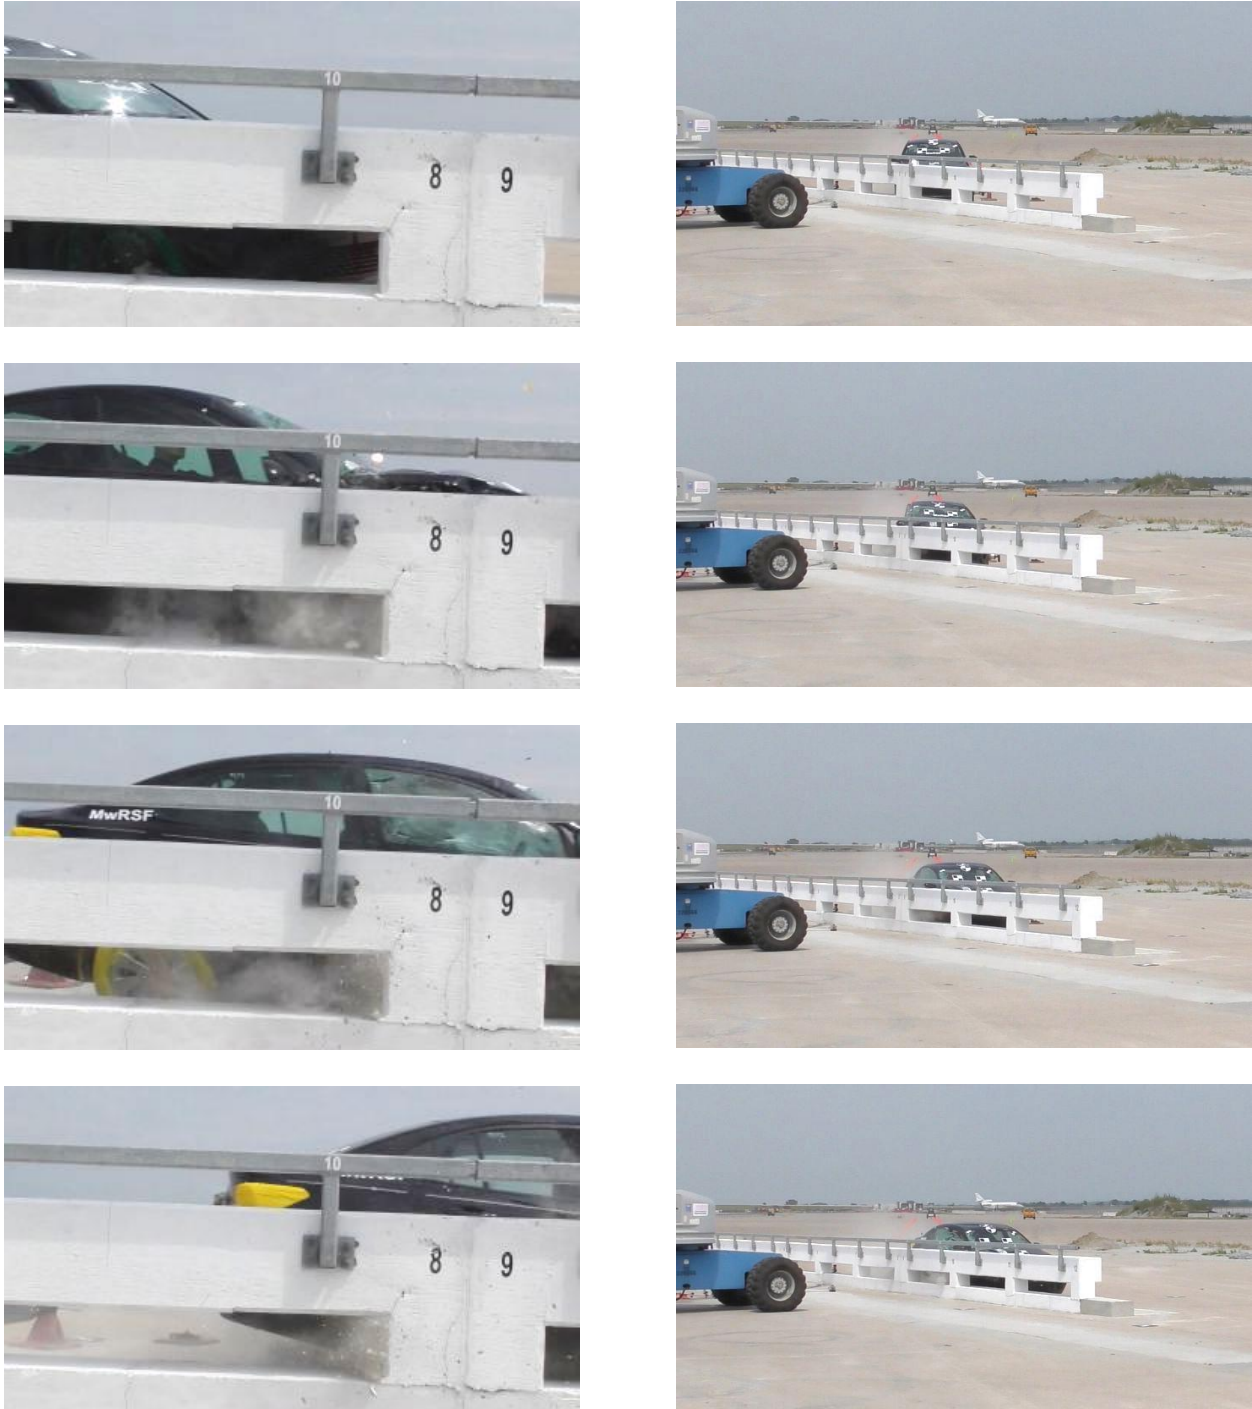
Figure 54. Documentary Photographs, Test No. HNTBR-3

A detailed description of the sequential impact events is contained in Table 8. Sequential photographs are shown in Figures 52 and 53. Documentary photographs of the crash test are shown in Figure 54. The vehicle trajectory and final position are shown in Figure 55.

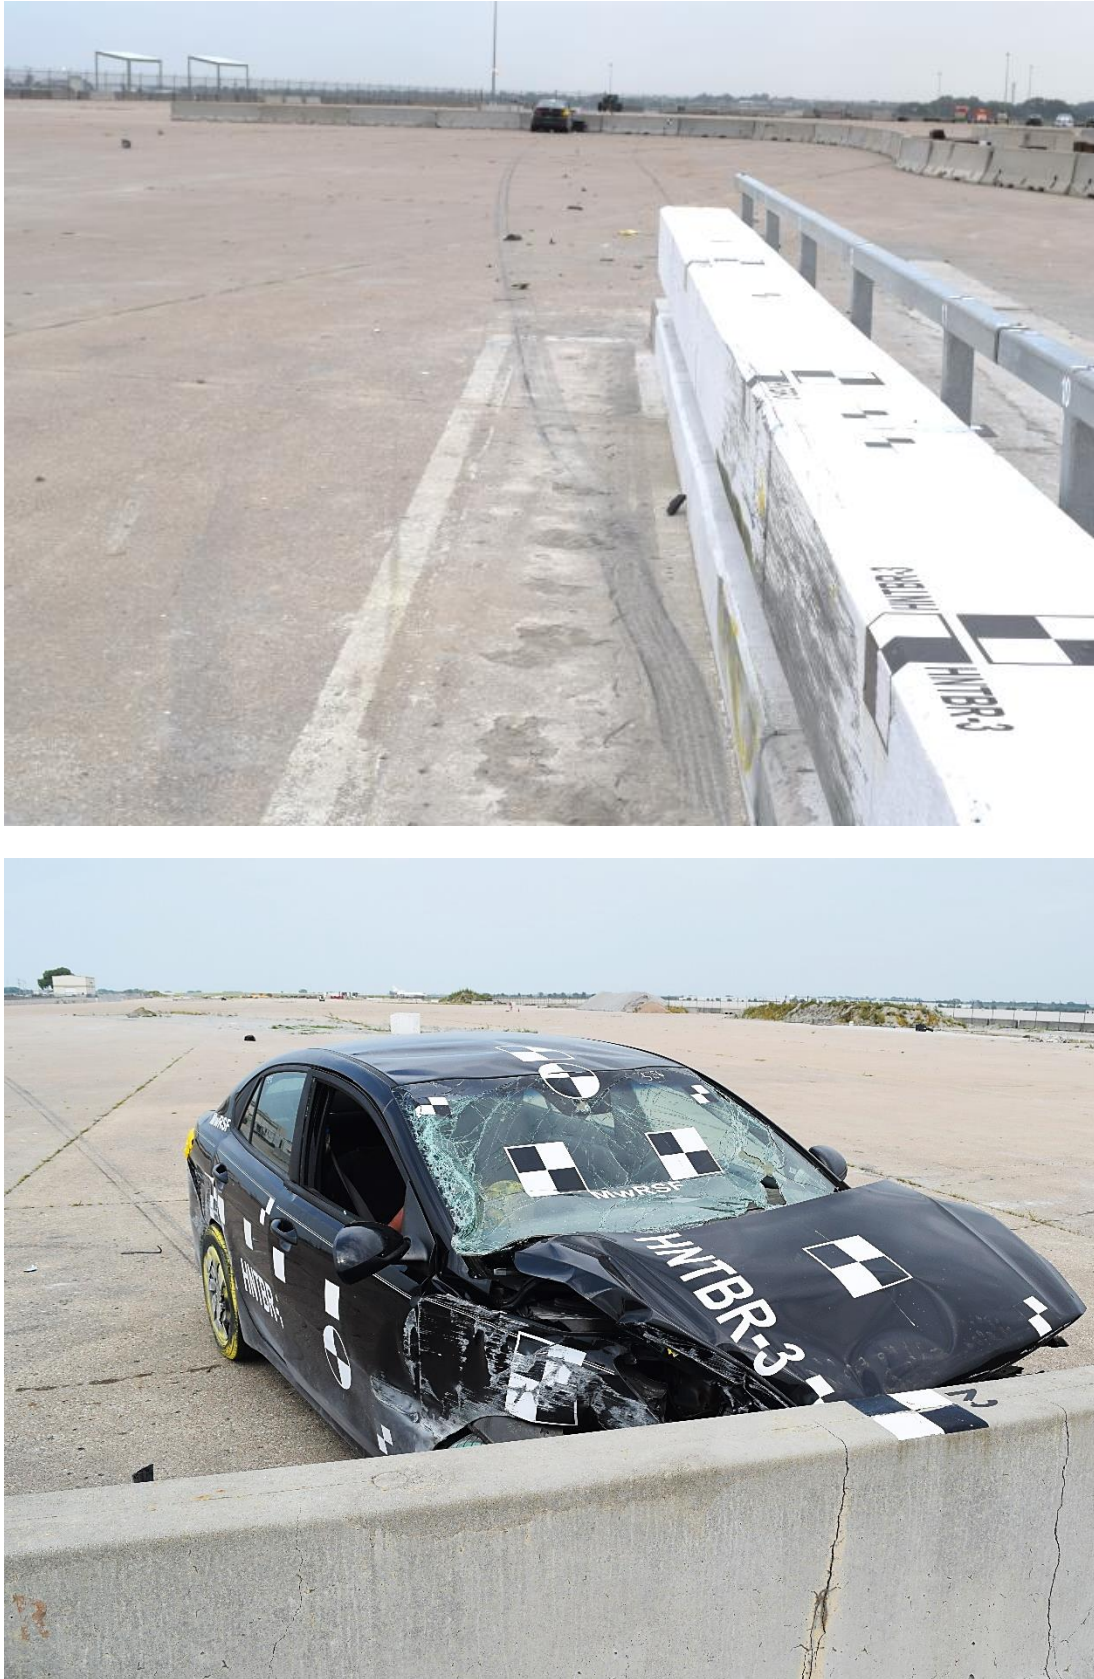
Figure 55. Vehicle Final Position and Trajectory Marks, Test No. HNTBR-3

Initial vehicle impact was to occur 43¼ in. upstream from a post, which was selected using MASH Table 2-7 to maximize the potential for vehicle snag. Post no. 8, which was just upstream from expansion joint no. 2, was selected as the targeted snag post to simultaneously apply impact loads near a joint. Thus, the targeted impact point was also 55½ in. upstream from the centerline of expansion joint no. 2, as shown in Figure 51. The 2,400-lb Kia Rio impacted the concrete bridge rail at a speed of 63.6 mph and at an angle of 24.9 degrees. The actual point of impact was 4.8 in. downstream of the targeted impact location. The vehicle was contained and redirected and remained stable throughout the impact event. After exiting the bridge rail, the brakes were applied remotely, and the vehicle came to rest 254 ft downstream from impact after impacting a row of concrete containment barriers.

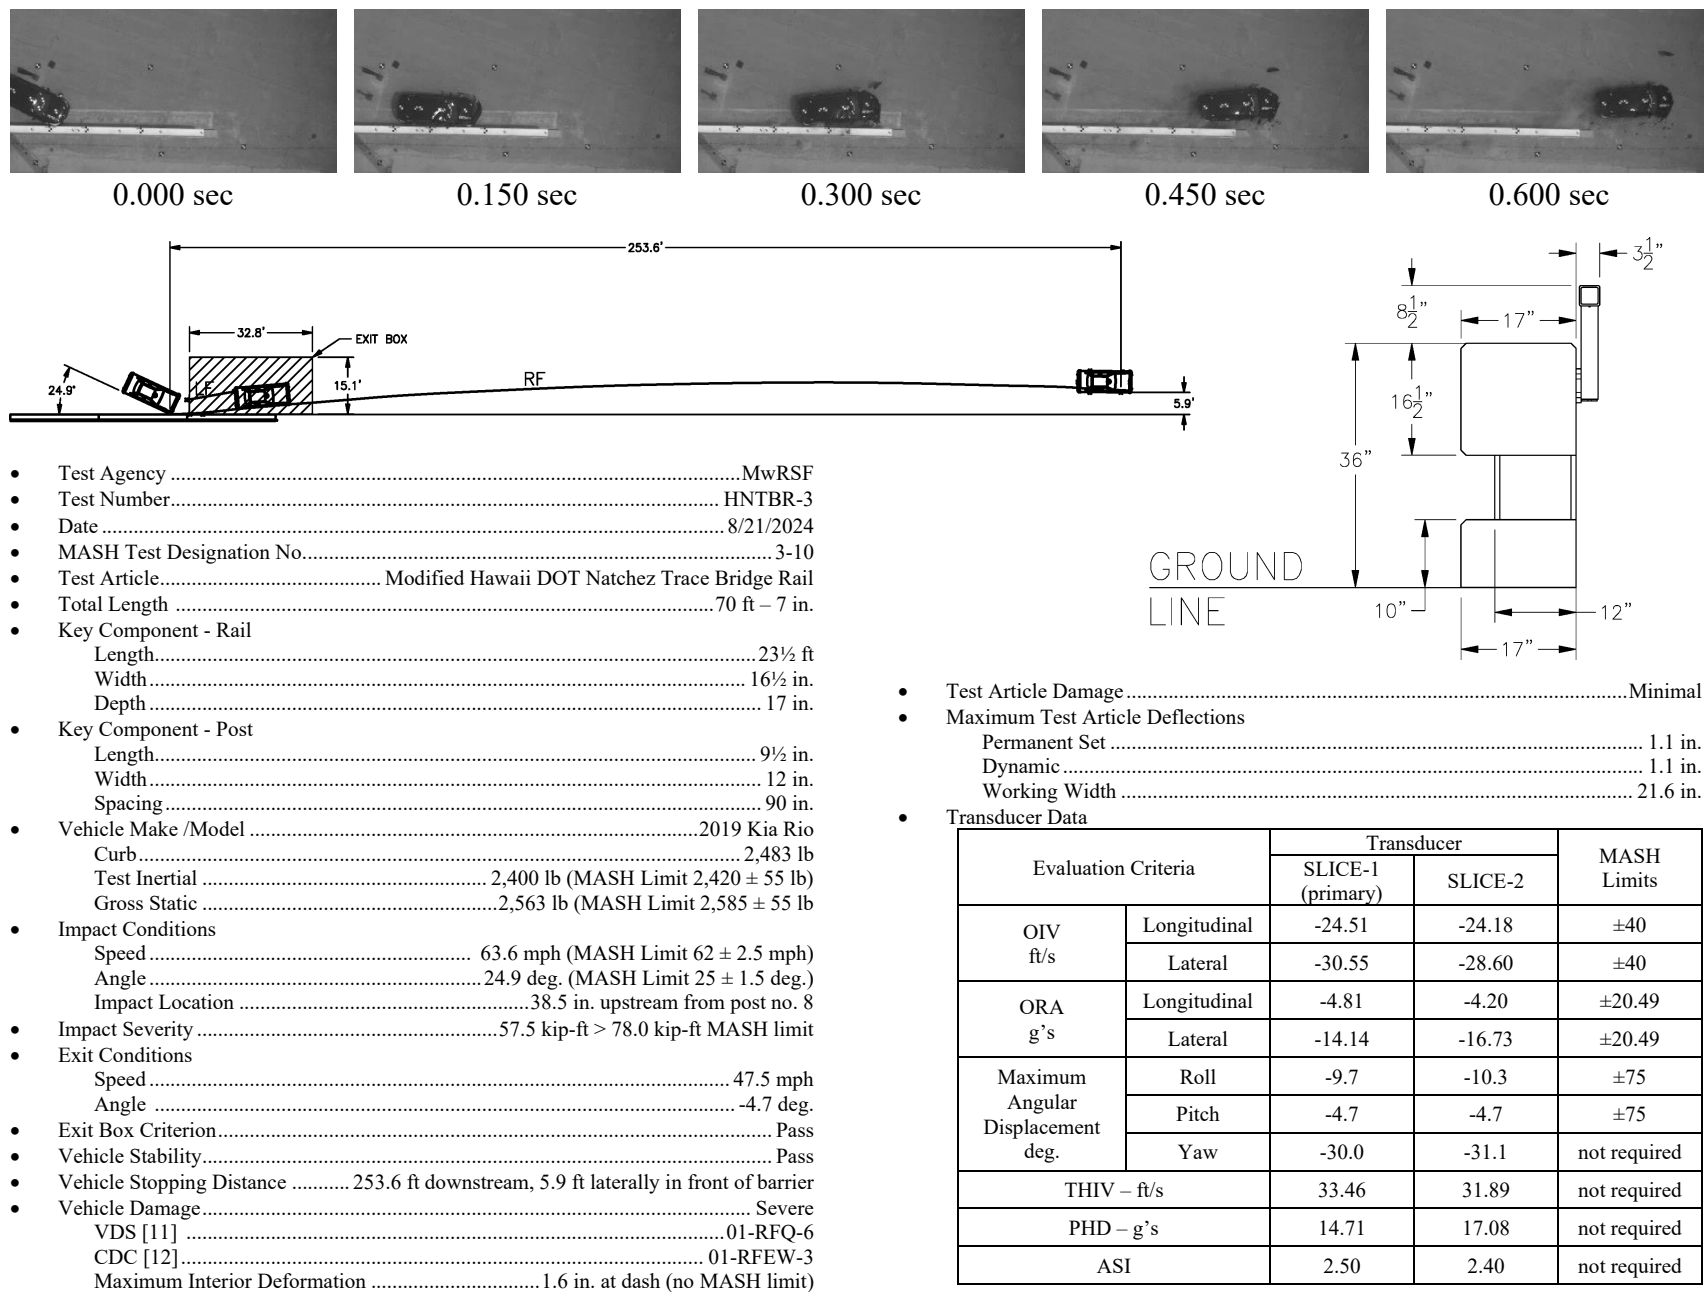
Figure 64. Summary of Test Results and Sequential Photographs, Test No. HNTBR-3

The analysis of the test results for test no. HNTBR-3 showed that the system adequately contained and redirected the 1100C vehicle with controlled lateral displacements of the barrier. The test vehicle did not penetrate nor ride over the barrier and remained upright during and after the collision. Vehicle roll, pitch, and yaw angular displacements, as shown in Appendix F, were deemed acceptable because they did not adversely influence occupant risk nor cause rollover. After impact, the vehicle exited the barrier at an angle of -4.7 degrees, and its trajectory did not violate the bounds of the exit box. Deformations of, or intrusions into, the occupant compartment that could have caused serious injury did not occur. The windshield had a maximum deformation of 4.2 in.; however, this damage was caused by loading and deformations at the base of the A-pillar rather than direct contact between the bridge rail and windshield. Furthermore, the secondary impact with a row of containment barriers downstream of the test article contributed to additional damage and deformation to the windshield. Thus, the windshield damage did not constitute grounds for violating MASH safety criteria. Therefore, test no. HNTBR-3 satisfied the safety performance criteria for MASH test designation no. 3-10. A summary of the test results and sequential photographs are shown in Figure 64.

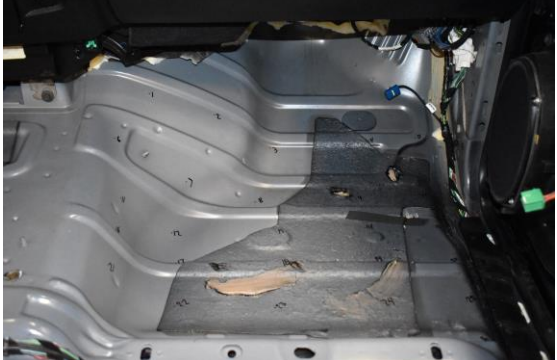
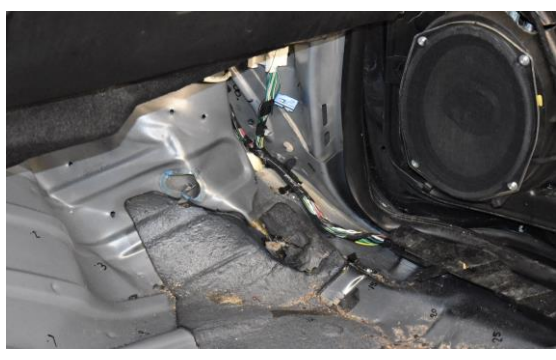
Figure D-1. Floor Pan Deformation Data – Set 1, Test No. HNTBR-2

Complete occupant compartment and vehicle deformations and the corresponding locations are provided in Appendix D. MASH defines intrusion or deformation as the occupant compartment being deformed and reduced in size with no observed penetration. There was no penetration into the occupant compartment, and no established MASH deformation limits were violated. Outward deformations, which are denoted as negative numbers in Appendix D, are not considered crush toward the occupant, and are not evaluated by MASH criteria.
