# Midwest Pooled Fund Program

# EVALUATION OF FLARED APPROACH GUARDRAIL TRANSITIONS: TEST NO. FLAGT-2

MwRSF Research Report No. TRP-03-439c-25

December 12, 2025

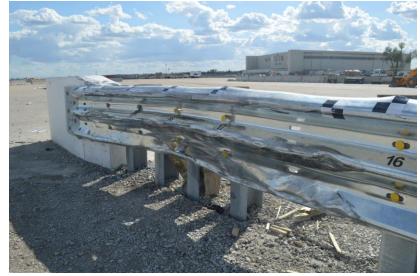
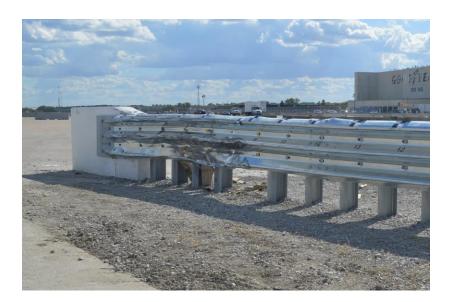
Figure 46. Concrete and Thrie-Beam Damage, Test No. FLAGT-2

Damage to the barrier was moderate, as shown in Figures 45 through 49. Barrier damage consisted of contacts marks, deformation to the thrie-beam rail, post rotations, and blockout fracture. The length of vehicle contact along the barrier was 12 ft - 4 in., beginning 4 in. downstream from post no. 16 and extending downstream. Contact marks were observed on the top surface of the concrete buttress beginning at the upstream end and continuing downstream for 47 in., as shown in Figure 46. No contact marks were observed on the lower chamfer of the buttress below the guardrail.

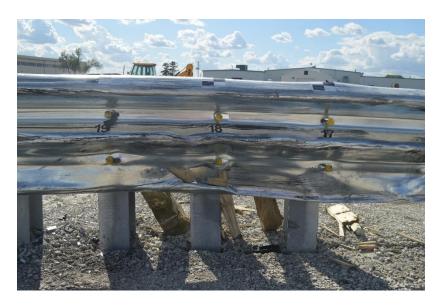
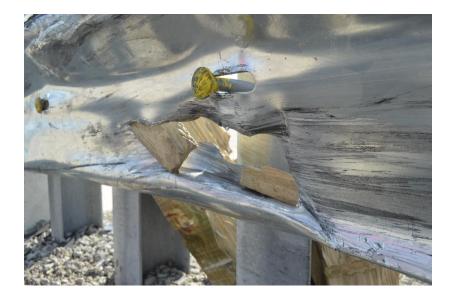
Figure 47. Thrie-Beam Damage, Test No. FLAGT-2

The thrie beam was displaced laterally between post no. 16 and the buttress, and localized kinking, bending, denting, and flattening of the thrie beam were present throughout this region, as show in Figure 47. The bottom corrugation of the rail was flattened and bent backward between post nos. 16 and 19. The middle corrugation of the guardrail was gouged and sharply dented at various locations between post nos. 16 and 20 due to contact with the front wheel rim. An 11-in. long tear through both thrie beam segments was present on the bottom corrugations near post no. 18. It was believed that this tear was caused by the vehicle's upper control arm punching through the guardrail after the front wheel disengaged.

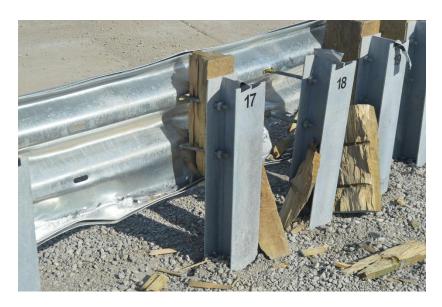
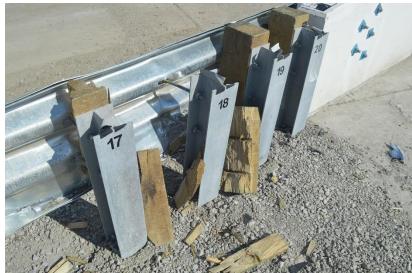
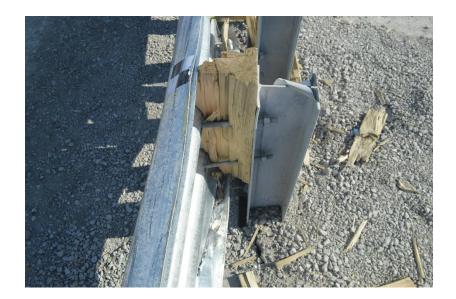
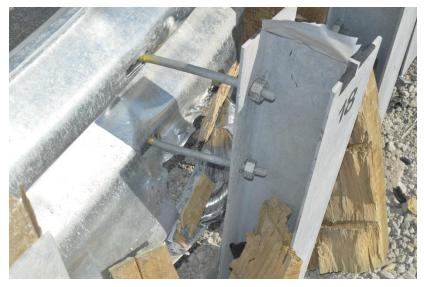
Post nos. 15 through 20 were displaced backward and a small crack in the soil formed along the front flanges of these posts. A soil heave formed behind the posts. Post nos. 18 and 19 were also twisted and deflected downstream. The wooden blockouts at post nos. 17 and 18 were fractured and the attachment bolts at these posts were bent. Contact marks were found on the upstream front flanges of post nos. 17 and 19 and the upstream face of the blockout at post no. 19 above the guardrail.

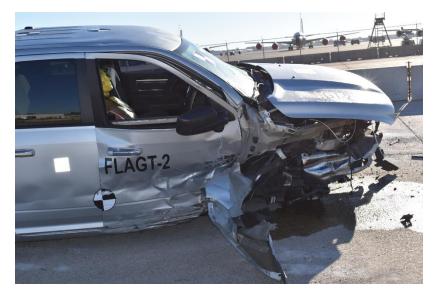
Figure 51. Vehicle Damage, Test No. FLAGT-2

The majority of the damage was concentrated on the right-front corner and right side of the vehicle where the impact had occurred. The bumper cover was disengaged on the right end and the radiator was crushed inward on the right side. The right fender was barely attached to the vehicle after impact, and the frame was completely crushed inward approximately 1 ft at the front

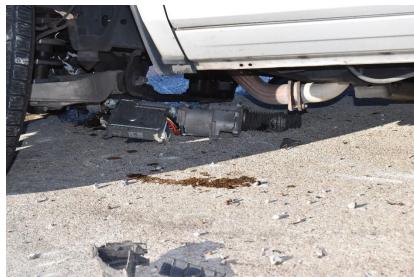
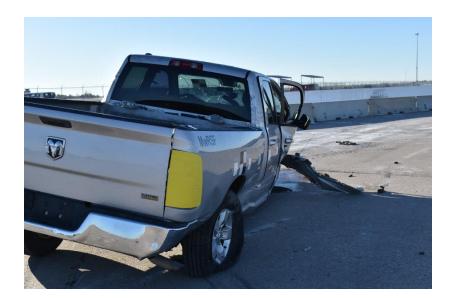
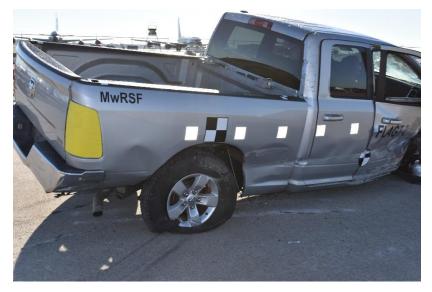
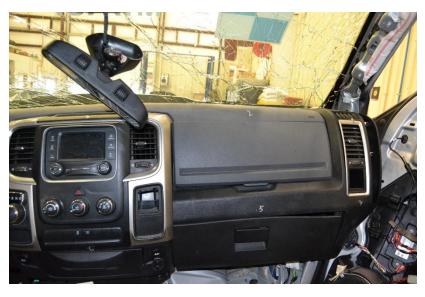
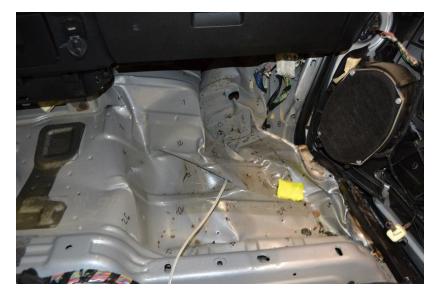
Figure 53. Vehicle Interior and Undercarriage Damage, Test No. FLAGT-2

The undercarriage was damaged as well. The right-front shock and spring were disengaged, and the rear shock was dented slightly. The sway bar was shifted to the right side, and there was a scrape on the outside of the right sway bar. The right passenger control arm was fractured and disengaged from the vehicle. The right passenger steering knuckle was disengaged at the ball joint, while the left side steering knuckle was scraped. The right tie rod was disengaged from the vehicle. The gear box was detached from the frame and steering shaft, and the gear box was cracked in several places. The rear axle was bent, and there was a puncture in the oil pan. There were several bends and kinks in the right side of the frame, and the entire frame appeared twisted. There was scraping on the bottom of every cross member on the right side, and the middle cross member appeared to be buckled in the middle. The right-front cab mount was crushed and disengaged. The toe pan was visibly damaged, and there was a small gouge on the right side of the gas tank from contact with the drive shaft.

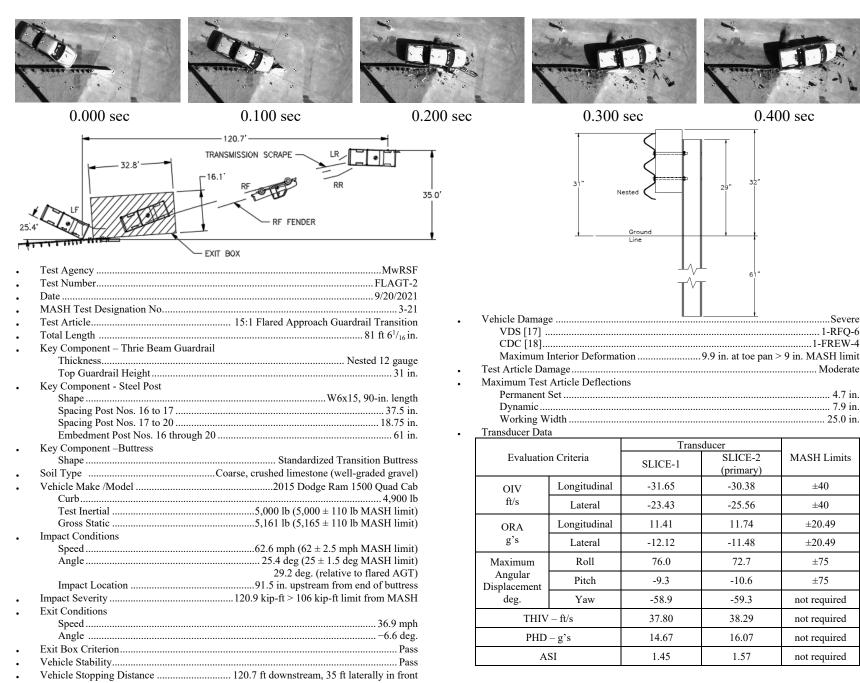
Figure 54. Summary of Test Results and Sequential Photographs, Test No. FLAGT-2

Analysis of the results from test no. FLAGT-2 showed that the system adequately contained and redirected the 2270P vehicle with controlled lateral displacements of the barrier. The test vehicle did not penetrate nor ride over the barrier. Vehicle roll, pitch, and yaw angular displacements, as shown in Appendix F, were deemed acceptable because they did not adversely influence occupant risk nor cause rollover. The vehicle rolled significantly after exiting the system with a maximum roll angle of 73 degrees recorded by the primary data recorder, but the vehicle remained upright and within the 75-degree maximum roll angle allowed by MASH. After impact, the vehicle exited the barrier at an angle of –6.6 degrees, and its trajectory did not violate the bounds of the exit box. Detached elements, fragments, or other debris from the test article did not penetrate or show potential for penetrating the occupant compartment, or present an undue hazard to other traffic, pedestrians, or work-zone personnel. However, deformations of the wheel well and toe pan area of 9.9 in. exceeded the MASH deformation limit of 9 in. Therefore, test no. FLAGT-2 failed to satisfy the safety performance criteria for MASH test designation no. 3-21. A summary of the test results and sequential photographs are shown in Figure 54.
