PERFORMANCE LIMITS FOR 6-IN. (152-MM) HIGH CURBS PLACED IN ADVANCE OF THE MGS USING MASH VEHICLES PART II: FULL-SCALE CRASH TESTING

MwRSF Research Report No. TRP-03-221-09

October 30, 2009

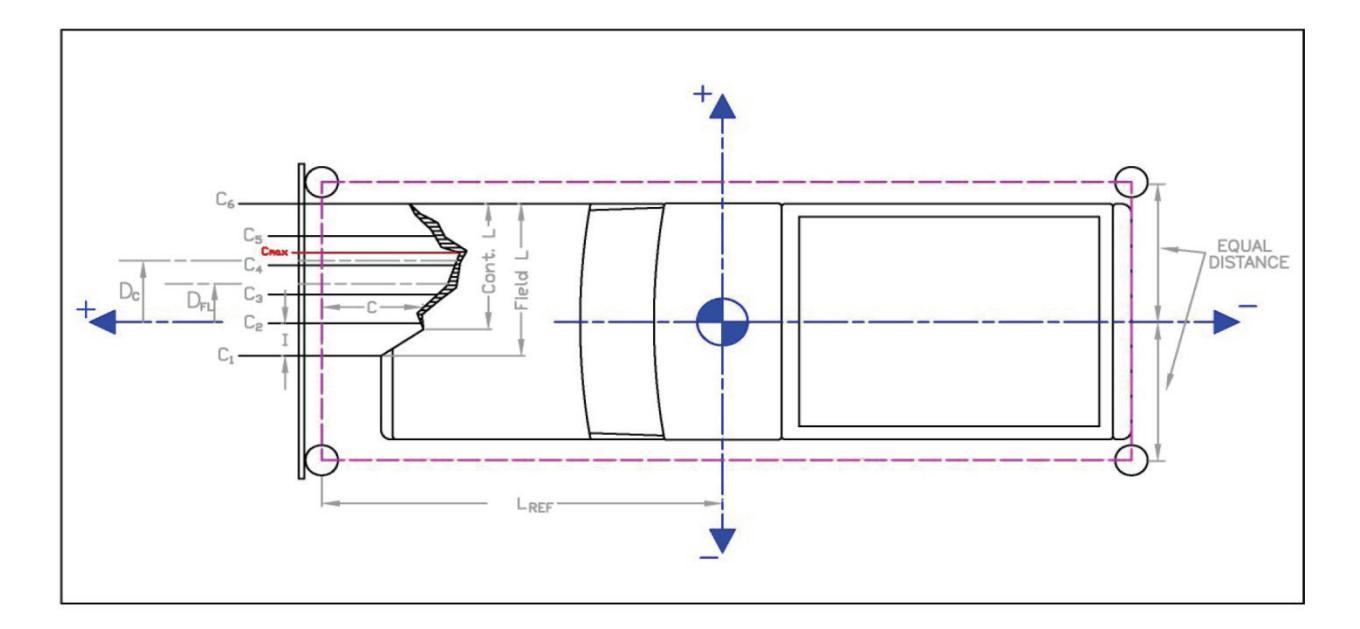
Figure D-4. Exterior Vehicle Crush (NASS) - Front, Test No. MGSC-5

Crush Measurement		Lateral	Location	Original Measur	Profile ement	Dist. Be Ref. I	etween Lines	Actual	Crush
	in.	(mm)	in.	(mm)	in.	(mm)	in.	(mm)	in.	(mm)
C ₁	3.75	(95)	12	(305)	11	(279)	-7.0818	-(180)	-0.1682	-(4)
C_2	6.25	(159)	17.45	(443)	11.9844	(304)			1.34742	(34)
C ₃	12.5	(318)	22.9	(582)	13.2344	(336)			6.34742	(161)
C4	na	#######	28.35	(720)	15.3594	(390)			#######	#######
C ₅	na	#######	33.8	(859)	19.0313	(483)			#######	#######
C ₆	na	#######	39.25	(997)	29	(737)			#######	#######
C _{MAX}	24.5	(622)	29	(737)	15.6875	(398)			15.8943	(404)

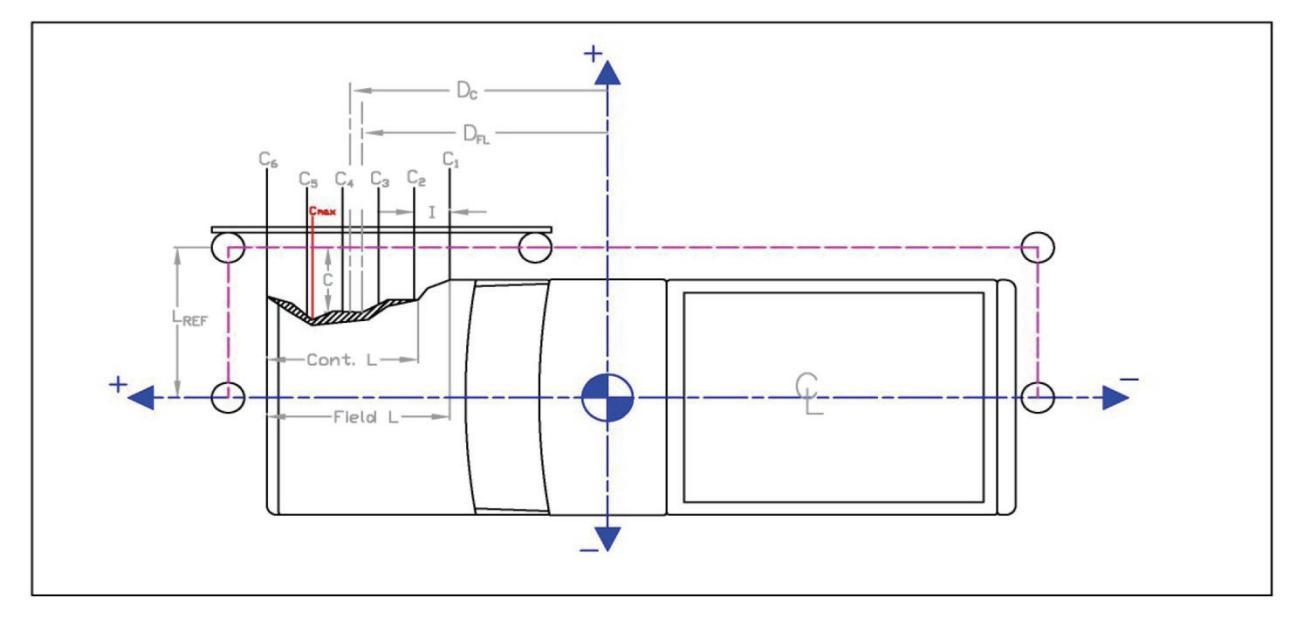
Figure D-5. Exterior Vehicle Crush (NASS) - Side, Test No. MGSC-5

Distance from vehicle c.g. to center of contect damage - D c:
 171.375
 (4353)
