DEVELOPMENT AND EVALUATION OF THE MIDWEST GUARDRAIL SYSTEM (MGS) PLACED ADJACENT TO A 2:1 FILL SLOPE

MwRSF Research Report No. TRP-03-185-10

February 24, 2010

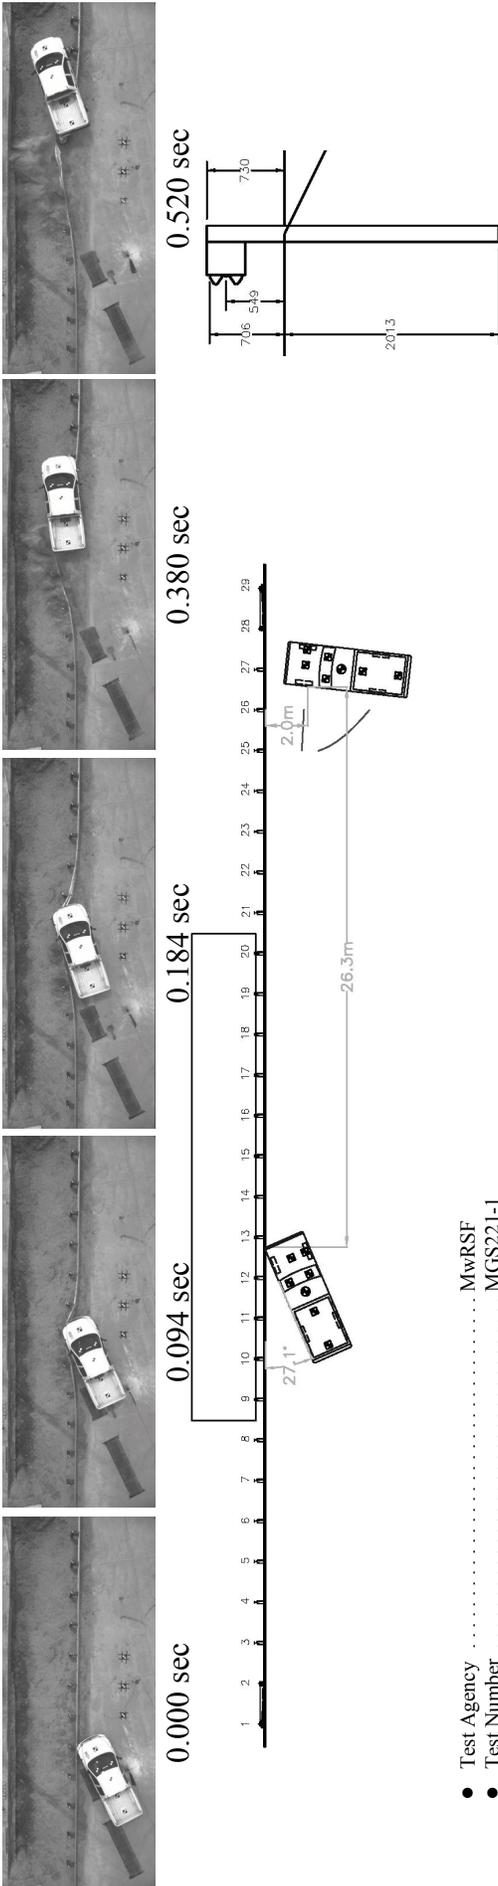
Figure 24. Summary of Test Results and Sequential Photographs, Test No. MGS221-1

The analysis of the test results for test no. MGS221-1 showed that the MGS, with a 706-mm (27¾-in.) top mounting height and installed adjacent to a 2:1 fill slope, did not adequately contain nor redirect the 2270P vehicle as the vehicle overrode the top of the system and subsequently landed behind the system. There were no detached elements nor fragments which showed potential for penetrating the occupant compartment nor presented undue hazard to other traffic. Deformations of, or intrusion into, the occupant compartment that could have caused serious injury did not occur. The test vehicle overrode and penetrated the guardrail system. It did remain upright during and after the collision. Vehicle roll, pitch, and yaw angular displacements were noted, but they were deemed acceptable because they did not adversely influence occupant risk safety criteria nor cause rollover. Therefore, test no. MGS221-1 conducted on the MGS installed adjacent to a 2:1 fill slope was determined to be unacceptable according to the TL-3 safety performance criteria found in MASH.

The vehicle override was attributed to the slow release of post no. 15 from the guardrail, thus causing the W-beam to be pulled downward. In addition, the vehicle override was also attributed to the failure of the vehicle's front suspension shortly after impact, thus preventing the guardrail from capturing the pickup truck's left-front tire.

- CDC²⁷ 11-LFQ-3
 - 11-LYENS
 - Maximum Deformation 13 mm left-side floor pan
 - Angular Displacement
 - Roll -32.2 degrees
 - Pitch -23.7 degrees
 - Yaw -34.3 degrees

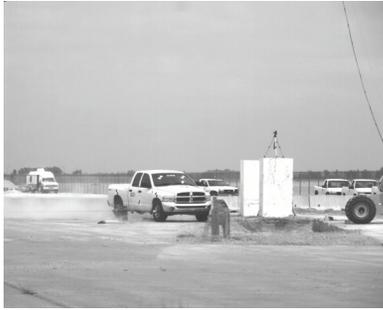
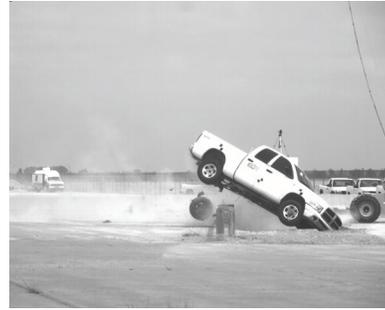
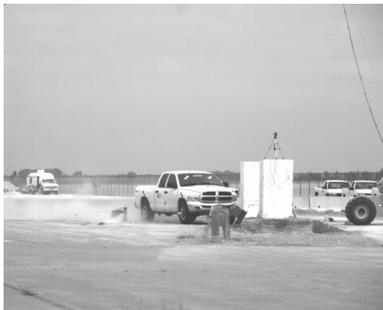
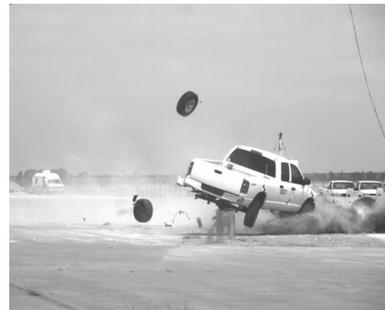
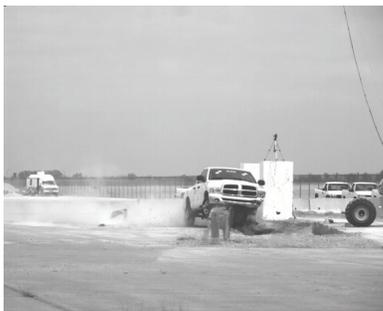
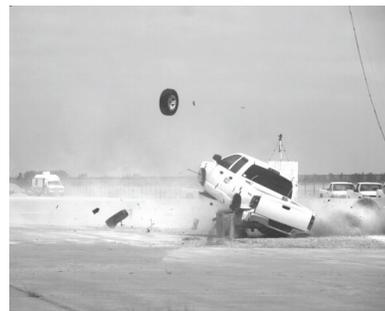
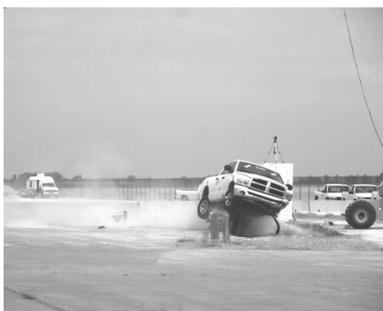
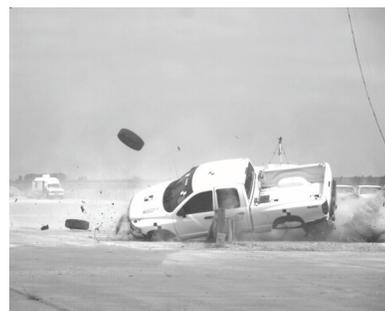
Figure 25. Additional Sequential Photographs, Test No. MGS221-1

sec, the left-rear tire disengaged from the vehicle. At 0.412 sec, the front of the vehicle began to yaw away from the back of the system. At 0.450 sec, the vehicle was completely airborne. At 0.474 sec, the vehicle continued to yaw the same direction. At 0.592 sec, the vehicle began to descend toward the ground. At 0.790 sec, the front of the vehicle contacted the ground behind the system. At 0.838 sec, the vehicle continued to yaw the same direction. At 0.938 sec, the vehicle, positioned over the top of the barrier, appeared to be perpendicular to the system with the rear positioned toward the traffic side of the system. At 1.252 sec, the rear axle contacted the top of the system. At 1.462 sec, the vehicle continued to yaw and descended toward the ground. At 1.618 sec, the right-rear tire disengaged from the vehicle. At 1.856 sec, the front of the vehicle contacted the ground. The vehicle came to rest 26.3 m (86 ft - 4½ in.) downstream from impact and 2.0 m (6 ft - 7 in.) laterally away from the traffic-side face of the barrier. The trajectory and final position of the pickup truck are shown in Figures 24 and 32.

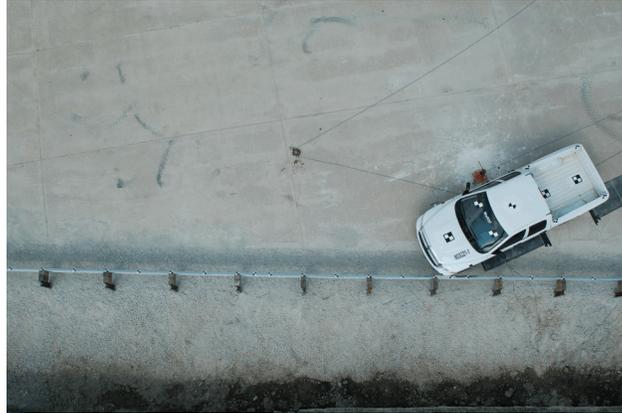
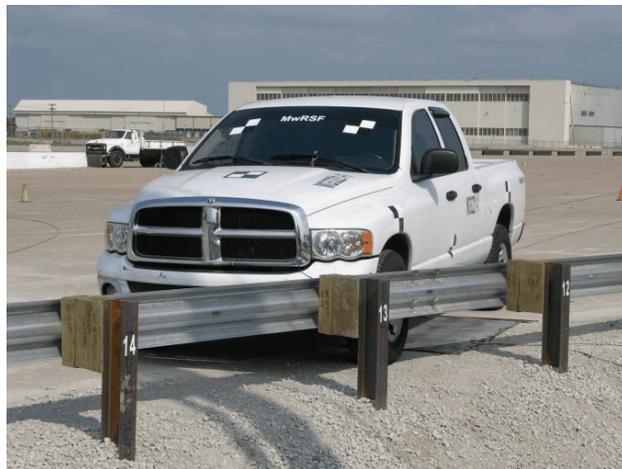
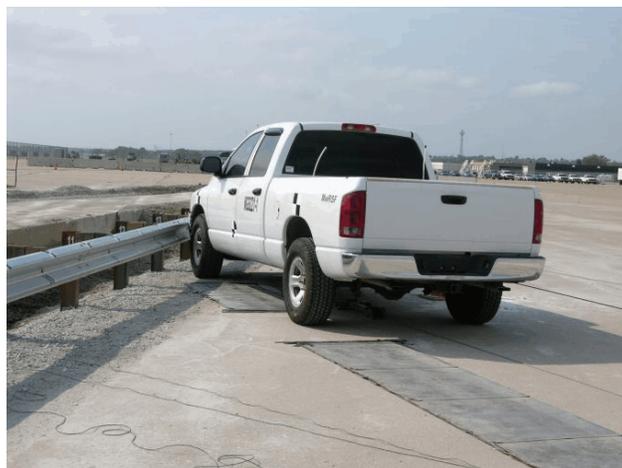
Figure 31. Impact Location, Test No. MGS221-1

Initial vehicle impact was to occur 476 mm (18¾ in.) upstream from the centerline of post no. 13, as shown in Figure 31. Actual vehicle impact occurred 432 mm (17 in.) upstream from the centerline of post no. 13. At 0.010 sec after impact, the left corner of the bumper crushed inward, and post no. 13 deflected. At 0.018 sec, post no. 14 deflected, and the impacted rail flattened. At 0.024 sec, post no. 12 deflected. At 0.036 sec, the rail deformed around post no. 14. At 0.064 sec, post no. 15 deflected, and a buckle point formed at the midspan between post nos. 14 and 15. At 0.074 sec, the left corner of the front bumper was located at post no. 14 which was deflecting. At 0.096 sec, the guardrail released from post no. 14, and post no. 16 deflected. At 0.112 sec, the front of the vehicle was located at the midspan between post nos. 14 and 15. At 0.120 sec, the left-front tire disengaged from the vehicle. At 0.128 sec, buckling occurred at the midspan between post nos. 15 and 16. At this same time, the rail was located under the left corner of the front bumper. At 0.138 sec, the rail deformed around post no. 16, and post no. 17 deflected. At 0.146 sec, the guardrail released from post no. 15, and the right-front tire became airborne. At 0.154 sec, the left corner of the front bumper was located at post no. 15, which was deflecting. At 0.182 sec, the left corner of the bumper protruded over the top of the rail. At 0.206 sec, the front of the vehicle pitched upward. At 0.226 sec, the guardrail released from post no. 15. At this same time, the entire left side of the vehicle was in contact with the rail. At 0.250 sec, the front of the vehicle was located between post nos. 16 and 17. At 0.308 sec, the front of the vehicle was located on top of post no. 17. At 0.324 sec, the right-front tire overrode the rail, the truck stopped redirecting, and the right-rear tire became airborne. At 0.342 sec, the rail began to tear. At this same time, the left-rear tire contacted the rail. At 0.376 sec, the front of the vehicle overrode post no. 18, and the rail at post no. 15 tore. At 0.400

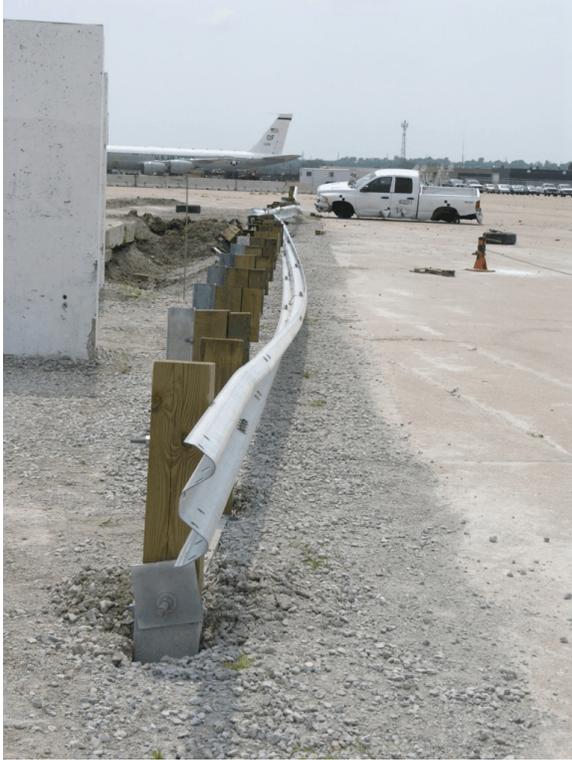
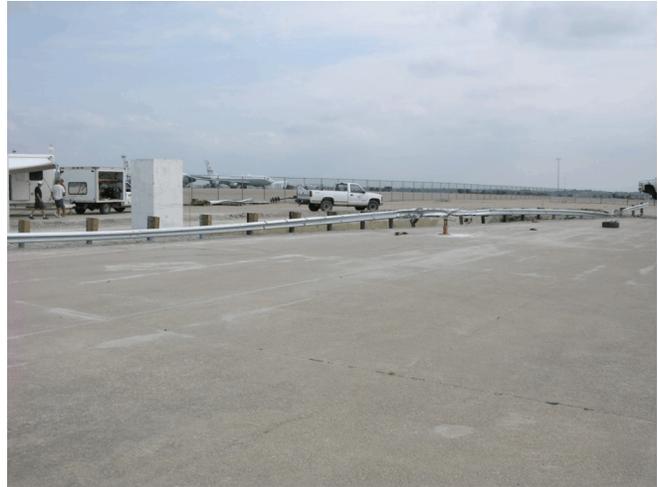
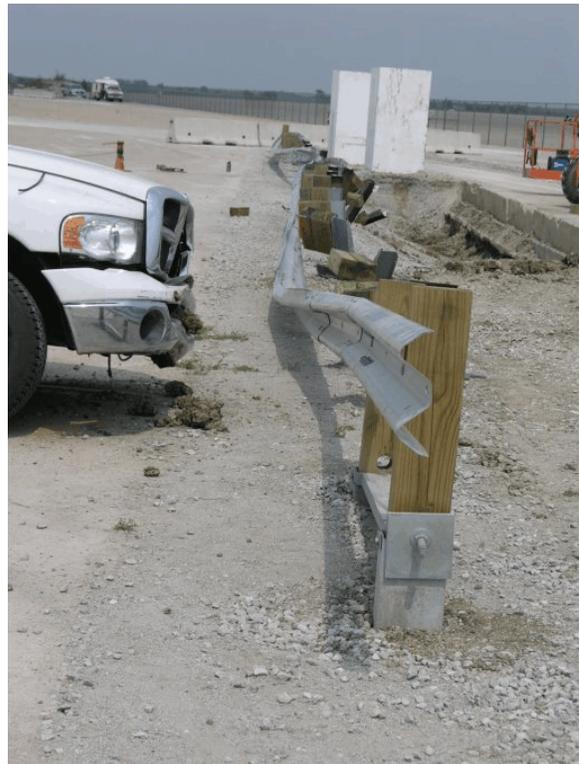
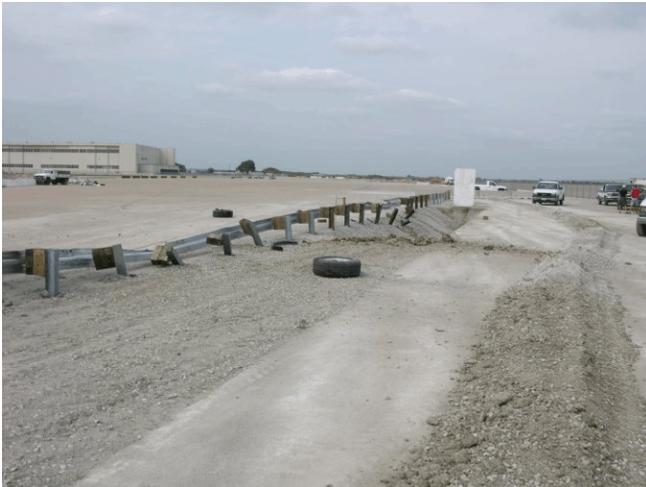
Figure 33. System Damage, Test No. MGS221-1

Damage to the barrier was moderate, as shown in Figures 33 through 41. Barrier damage consisted of deformed guardrail posts, disengaged wooden blockouts, contact marks on a guardrail section and posts, and deformed and fractured W-beam rail. The length of the vehicle contact along the MGS system was approximately 8.8 m (29 ft - 1½ in.), which spanned from 305 mm (12 in.) upstream from the centerline of post no. 13 through the midspan between post nos. 17 and 18.

The permanent set of the barrier system is shown in Figure 33. The maximum lateral permanent set rail and post deflections were 810 mm (31⁷/₈ in.) at the centerline of post no. 16 and 1,086 mm (42³/₄ in.) at post no. 15, respectively, as measured in the field. The maximum lateral dynamic rail and post deflections were 955 mm (37.6 in.) at the centerline of post no. 15 and 1,126 mm (44.3 in.) at post no. 15, respectively, as determined from high-speed digital video analysis.

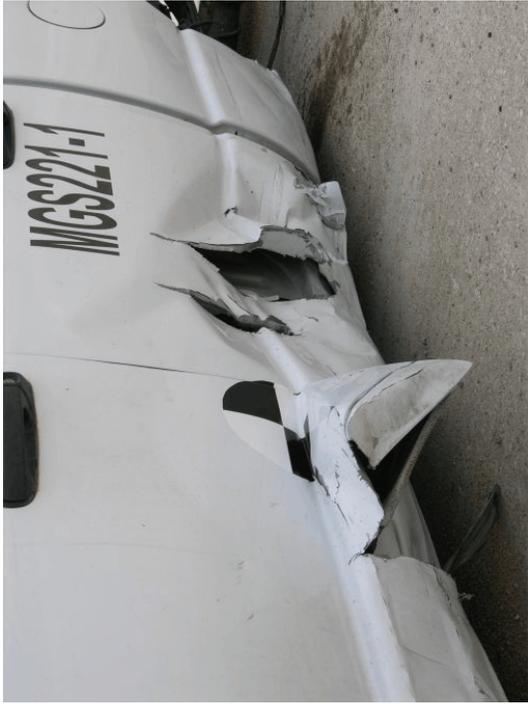
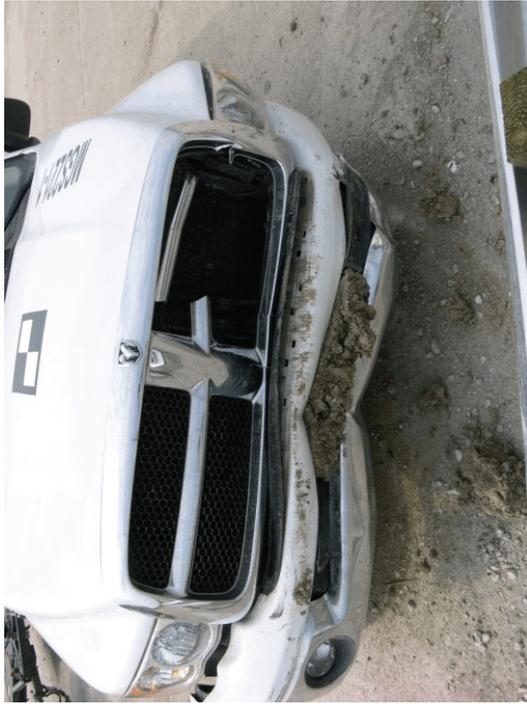
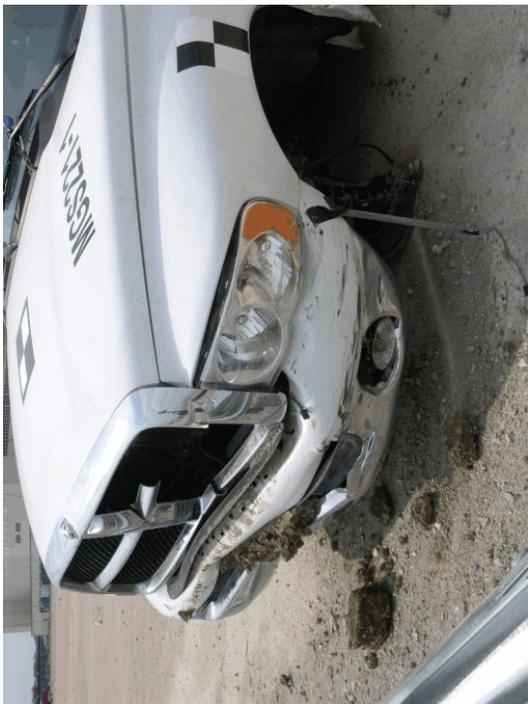
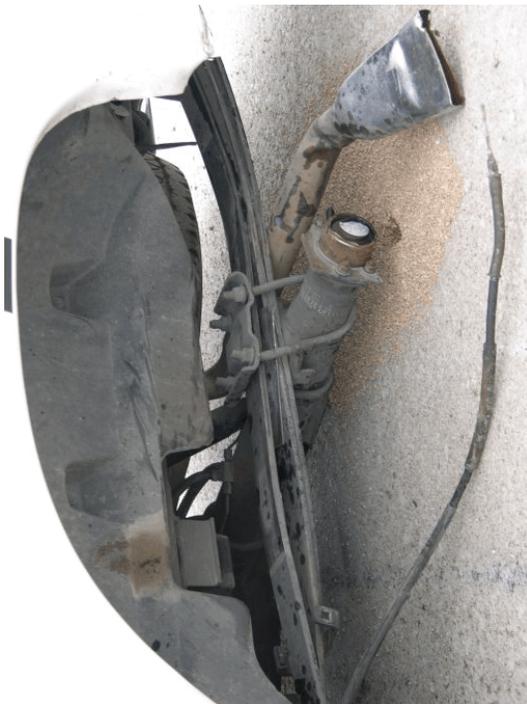
Figure 42. Vehicle Damage, Test No. MGS221-1

Exterior vehicle damage was moderate, as shown in Figures 42 through 44. Occupant compartment deformations to the left side and center of the floor pan were judged insufficient to cause serious injury to the vehicle occupants, as shown in Figure 45. Maximum longitudinal deflections of 6 mm (¹/₄ in.) were located throughout the left-side floor pan. Maximum lateral deflections of 13 mm (¹/₂ in.) were located at the rear-center of the left-side floor pan. Maximum vertical deflections of 13 mm (¹/₂ in.) were located on the floor pan near the left-side door. Complete occupant compartment deformations and the corresponding locations are provided in Appendix E.

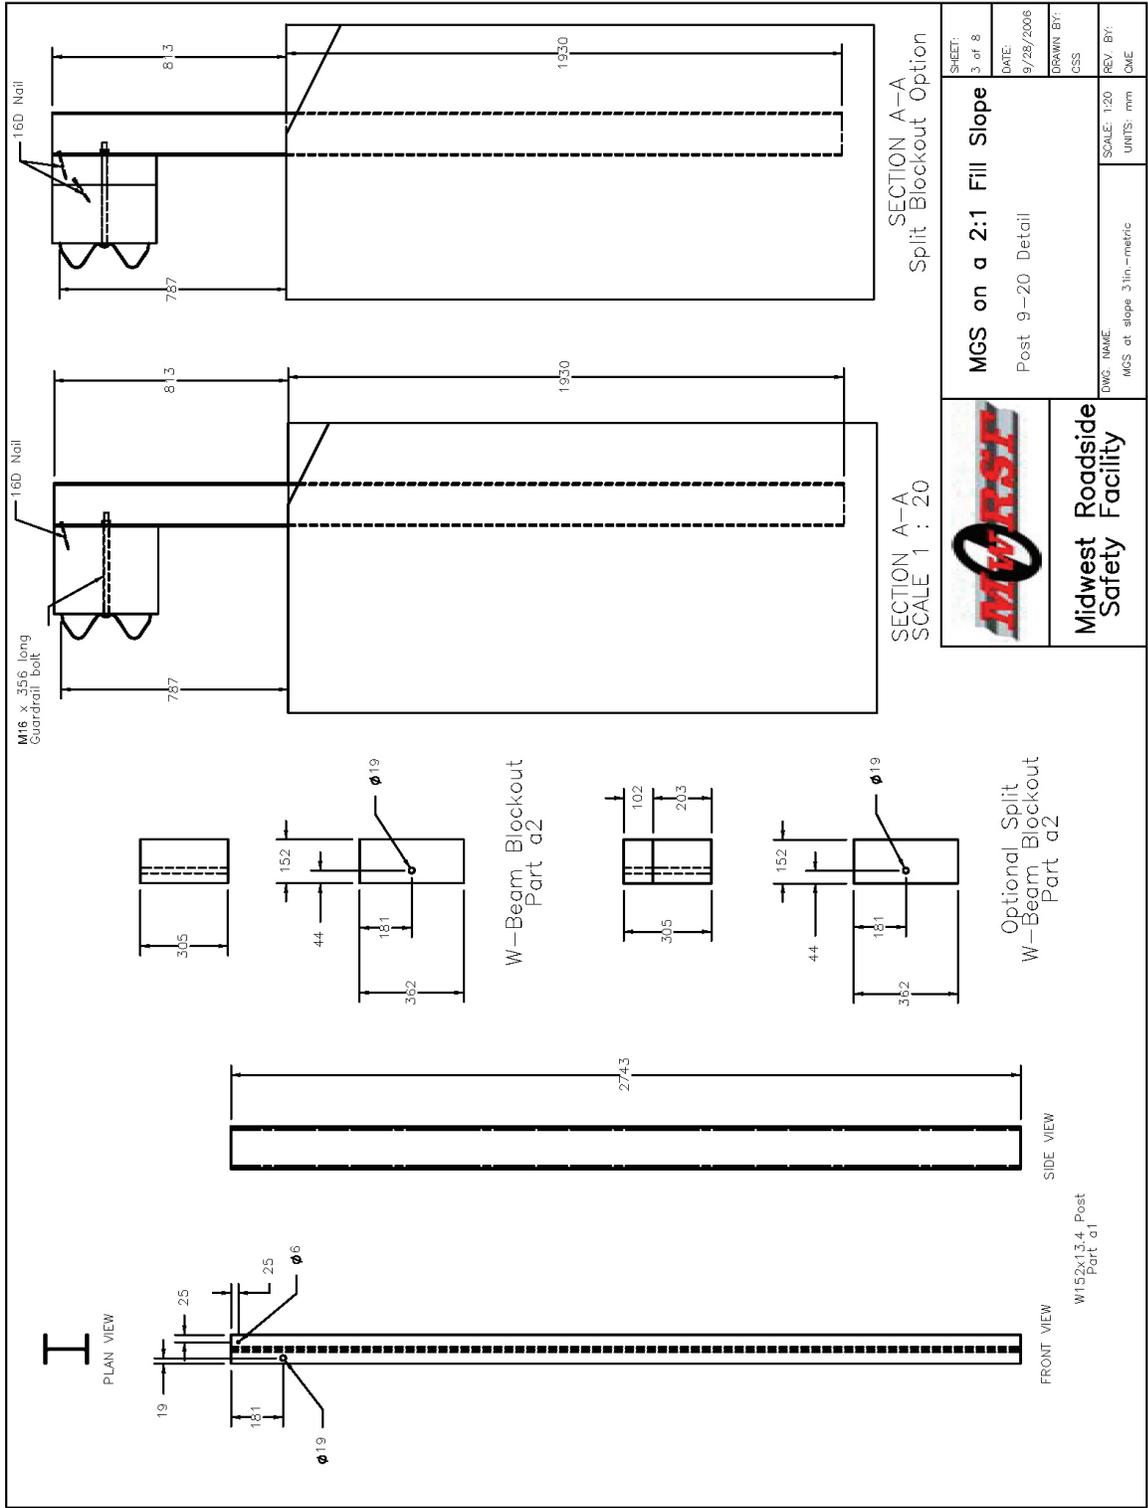
Figure 46. MGS Installed Adjacent to a 2:1 Fill Slope System Modifications, Test No. MGS221-2

Following the unsuccessful performance of the 706-mm (27³/₄ in.) high, MGS installed adjacent to a steep slope, it was believed that raising the rail height to 787 mm (31 in.) would allow for improved engagement between the barrier system and the vehicle. Therefore, the second design of the MGS installed adjacent to a 2:1 fill slope system was identical to the system in test no. MGS221-1 except for the guardrail's top mounting height. The first installation's height was set at the design's anticipated minimum height tolerance of 706 mm (27³/₄ in.). For the second installation, the top W-beam guardrail height was raised to 787 mm (31 in.) with a 632-mm (24⁷/₈-in.) center mounting height. Additionally, post nos. 1 through 29 were still spaced 1,905 mm (75 in.) on center but were embedded to a depth of 1,930 mm (76 in.), as shown in Figures 46 and 47.

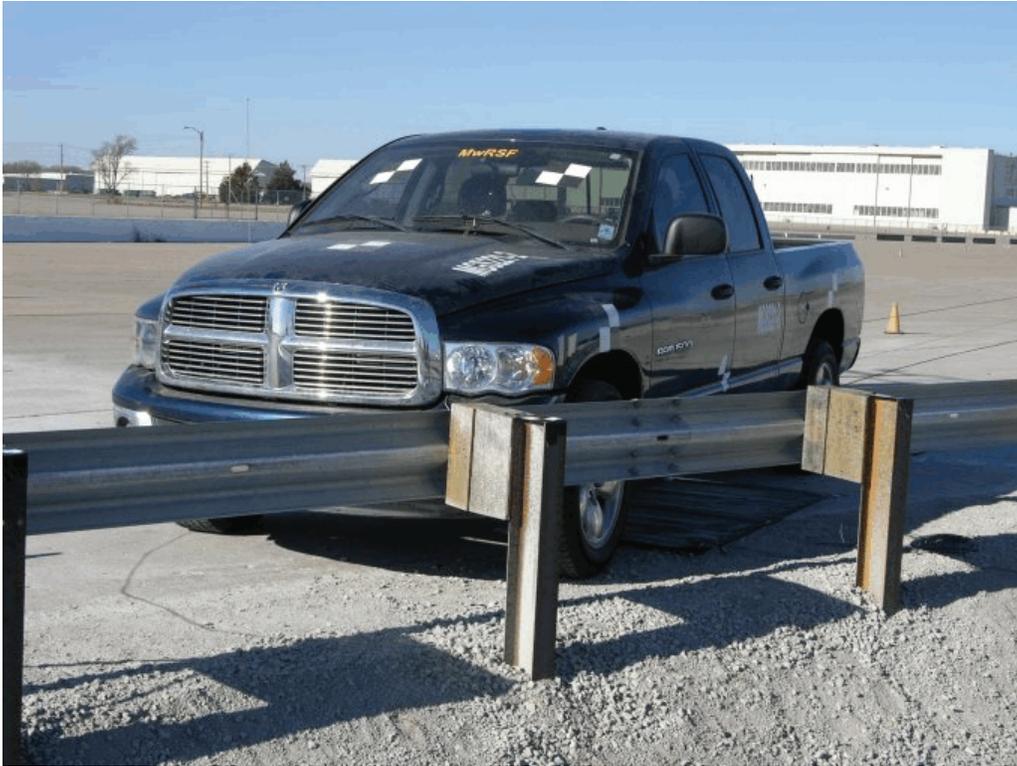
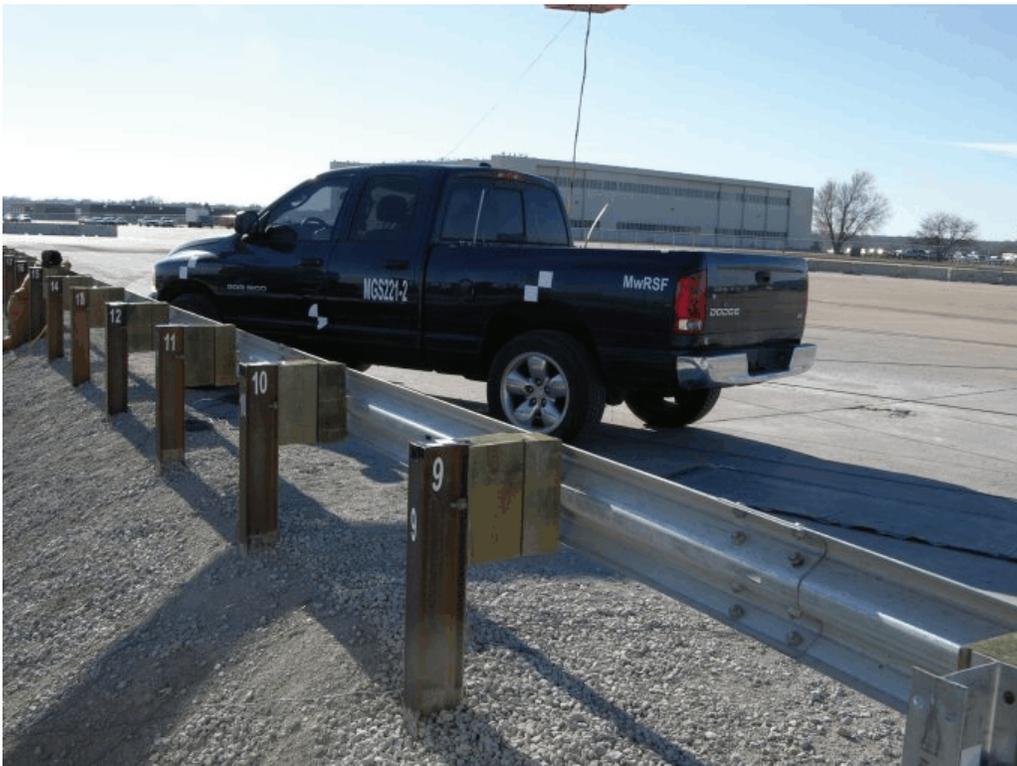
Figure 56. Impact Location, Test No. MGS221-2

Initial vehicle impact was to occur 476 mm (18¾ in.) upstream from the centerline of post no. 13, as shown in Figure 56. Actual vehicle impact occurred 394 mm (15½ in.) upstream from the centerline of post no. 13. At 0.014 sec after impact, post no. 13 deflected. At 0.022 sec, post no. 12 twisted downstream, and the left-front corner of the vehicle crushed inward toward the engine compartment. At this same time, post no. 14 deflected. At 0.030 sec, the soil heaved behind post no. 13. At 0.044 sec, post nos. 14 through 19 twisted downstream. At 0.050 sec, the rail buckled upstream of post no. 5, and the soil heaved behind post no. 14. At 0.076 sec, the left-front tire protruded past the slope break point, and post no. 15 deflected. At this same time, the rail buckled downstream of post no. 15. At 0.084 sec, the left corner of the front bumper was located at post no. 14. At this same time, the left-front corner of the vehicle crushed inward, and the left-side headlight fractured. At 0.090 sec, the rail released from post no. 14 as the post deflected. At this same time, the soil heaved behind post no. 15. At 0.112 sec, the rail buckled at post no. 16. At 0.126 sec, the vehicle began to redirect. At 0.150 sec, the rail released from post no. 15 as the vehicle traversed over it. At this same time, the left-front wheel deformed due to contact with post no. 14. At 0.166 sec, the rail released from post nos. 10 and 11. At 0.208 sec, the deformed left-front wheel contacted post no. 15. At 0.220 sec, the entire left side of the vehicle was in contact with the rail, and both left-side tires protruded past the slope break point. At 0.236 sec, the rail released from post no. 16. At 0.266 sec, post no. 17 deflected. At 0.298 sec, the left-front tire contacted post no. 16. At 0.306 sec, the vehicle became parallel to the system with a resultant velocity of 68.1 km/h (42.3 mph). At 0.322 sec, the left-front corner of the vehicle contacted post no. 17 as the vehicle redirected away from the system. At this same time, the left-rear tire was airborne above the slope. At 0.330 sec, the left-front

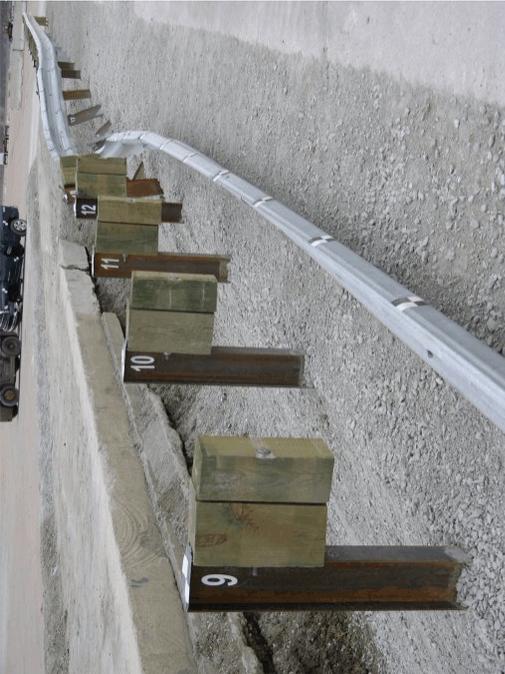
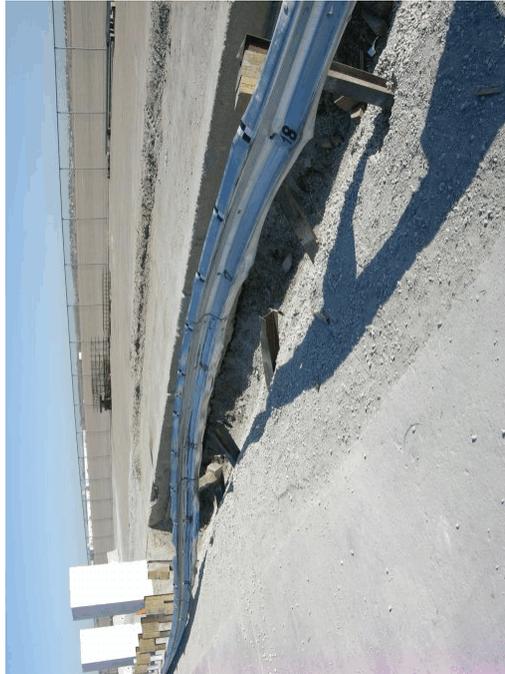
Figure 58. System Damage, Test No. MGS221-2

Damage to the barrier was moderate, as shown in Figures 58 through 64. Barrier damage consisted of deformed W-beam and guardrail posts, disengaged wooden blockouts, and contact marks on a guardrail section and posts. The length of the vehicle contact along the MGS system was approximately 12.42 m (40 ft - 9 in.), which spanned from 394 mm (15½ in.) upstream of the centerline of post no. 13 through 597 mm (23½ in.) downstream from the centerline of post no. 19.

The permanent set of the barrier system is shown in Figure 58. The maximum lateral permanent set rail and post deflections were 1,067 mm (42 in.) at the midspan between post nos. 15 and 16 and 864 mm (34 in.) at post no. 14, respectively, as measured in the field. The maximum lateral dynamic rail and post deflections were 1,463 mm (57.6 in.) at the centerline of post no. 15 and 805 mm (31.7 in.) at post no. 14, respectively, as determined from high-speed digital video analysis. The working width of the system was found to be 1,631 mm (64.2 in.).

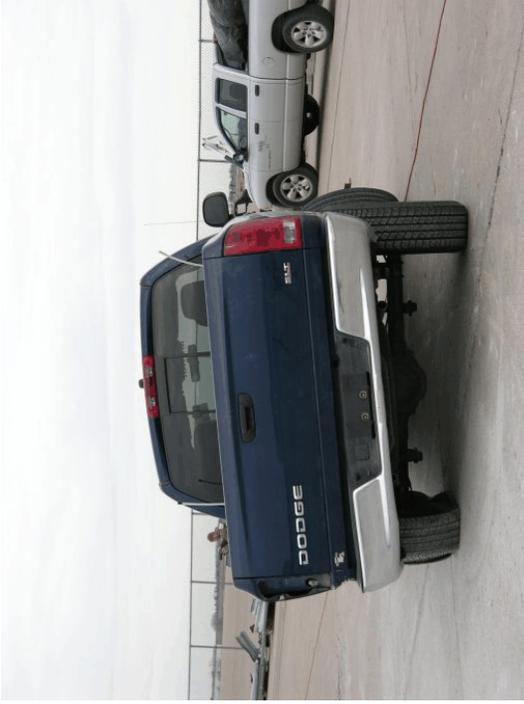
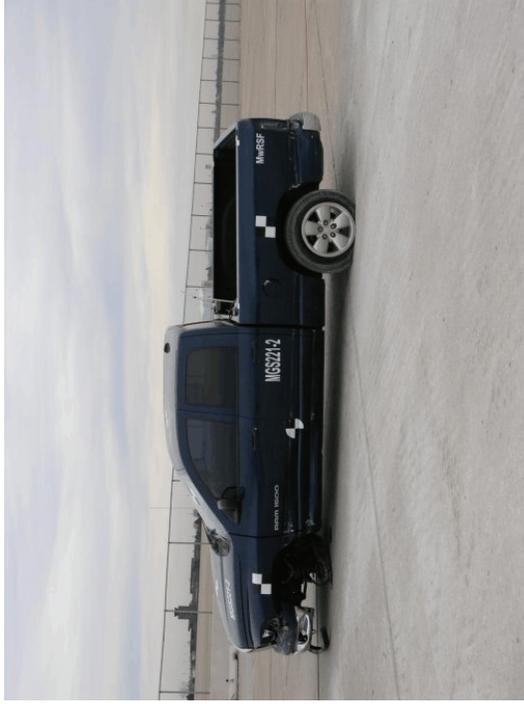
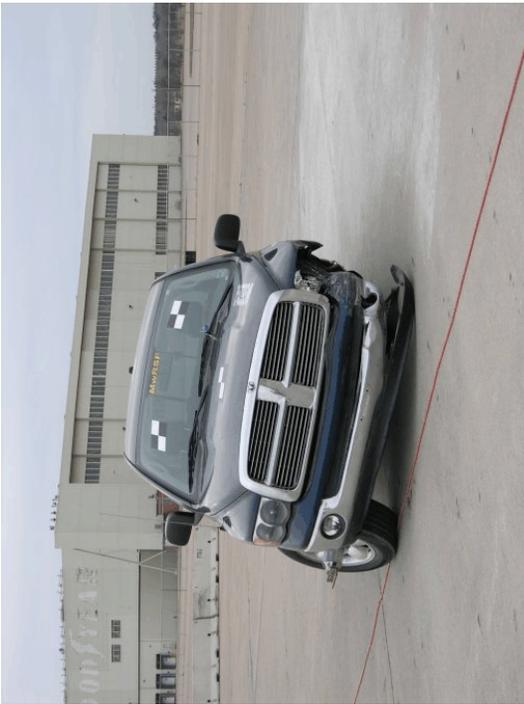
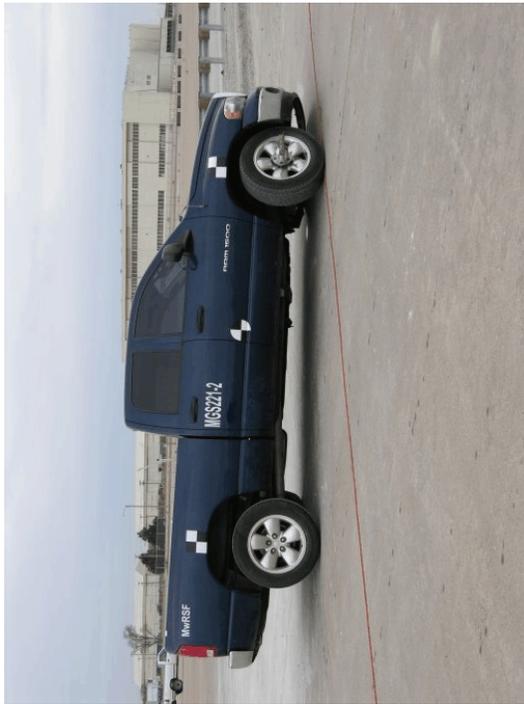
Figure 65. Vehicle Damage, Test No. MGS221-2

Exterior vehicle damage was moderate, as shown in Figures 65 and 66. Occupant compartment deformations to the left side and center of the floor pan were judged insufficient to cause serious injury to the vehicle occupants. Maximum longitudinal deflections of 6 mm (¼ in.) were located throughout the left-side floor pan. Maximum lateral deflections of 13 mm (½ in.) were

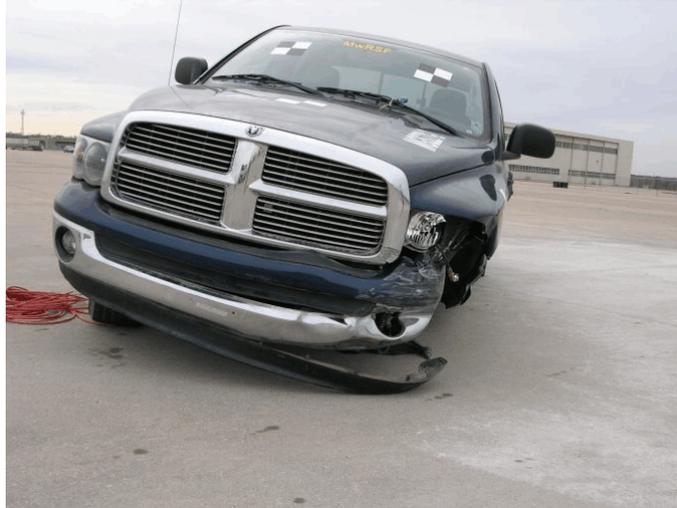
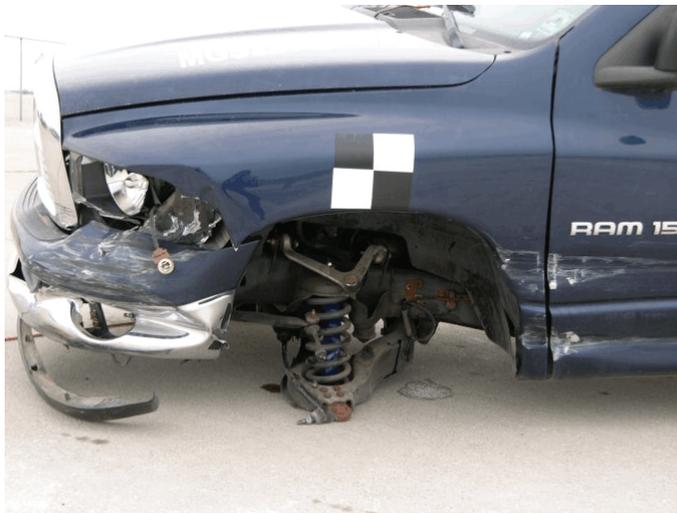
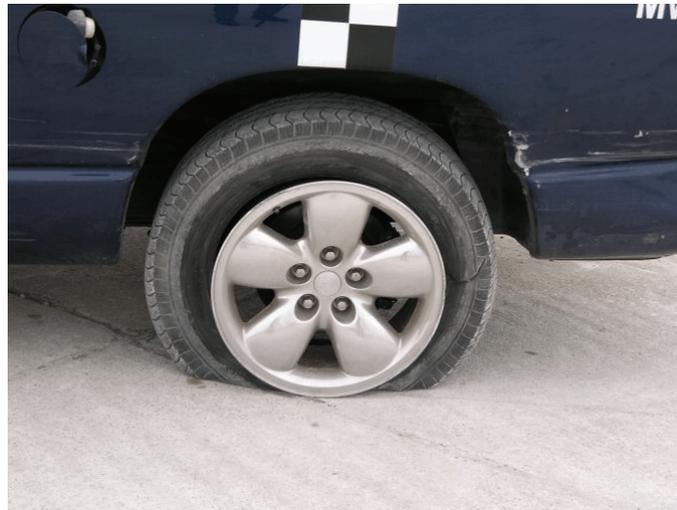
Figure 66. Vehicle Damage, Test No. MGS221-2

Damage was concentrated on the left-front corner of the vehicle. The left-front corner was deformed inward toward the engine compartment. The left-front tire disengaged from the vehicle. The left-rear tire was deflated. Sheet metal tearing and major deformations were found along the lower portion of the left-side doors and the left-rear fender. The left-side taillight was fractured, while the right-side taillight was slightly dislodged. The roof, hood, and right side of the vehicle and all window glass remained undamaged.
