# MID-AMERICA TRANSPORTATION CENTER

Report # MATC-UNL: 100

## **Safety Investigation and Guidance for Work-Zone Devices in Freight Transportation Systems Subjected to Passenger Car and Truck Impacts with New Crash Standards**

### **Midwest Roadside Safety Facility**

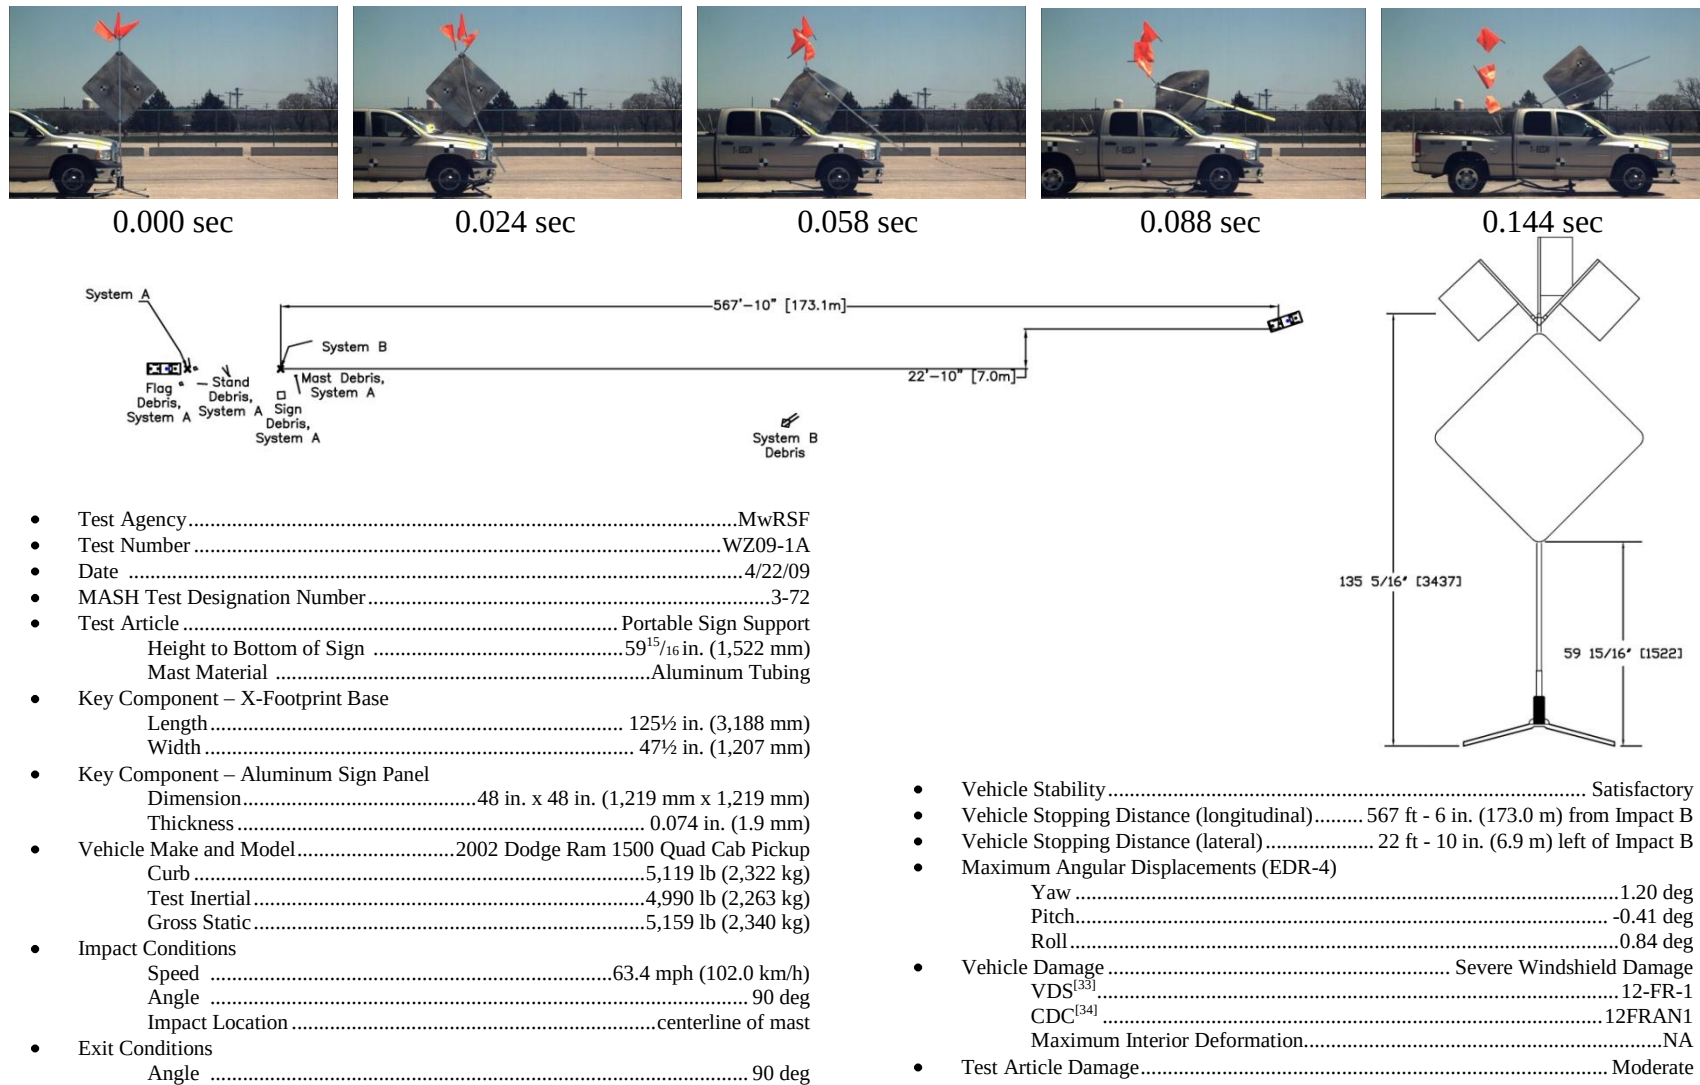
Figure 45. Summary of Test Results and Sequential Photographs, Test No. WZ09-1A

The 5,159-lb (2,340-kg) pickup truck with a simulated occupant seated in the right-front seat impacted System No. 1A, a work-zone sign support oriented end-on to the vehicle, at a speed of 63.4 mph (102.1 km/h) and at an angle of 90 degrees. The pickup truck then impacted System No. 1B, a work-zone sign support oriented end-on to the vehicle, at a speed of 62.0 mph (99.8 km/h) and at an angle of 90 degrees. A summary of the test results and sequential photographs are shown in Figures 45 and 46. Additional sequential photographs are shown in Figures 47 and 48. Documentary photographs of the crash test are shown in Figure 49.

Following test no. WZ09-1, a safety performance evaluation was conducted, and the performance of System No. 1A was determined to be unacceptable according to the MASH criteria. It was deemed unacceptable due to the flag holder penetrating the roof, the sign panel penetrating the windshield, windshield indentation greater than 3 in. (76 mm), and significant windshield cracking. Deformations of, and intrusion into, the occupant compartment did occur as System No. 1A penetrated into the occupant compartment on the right side of the windshield when the corner of the sign panel sliced through the windshield and also when the metal flag holder penetrated the roof into the occupant compartment.

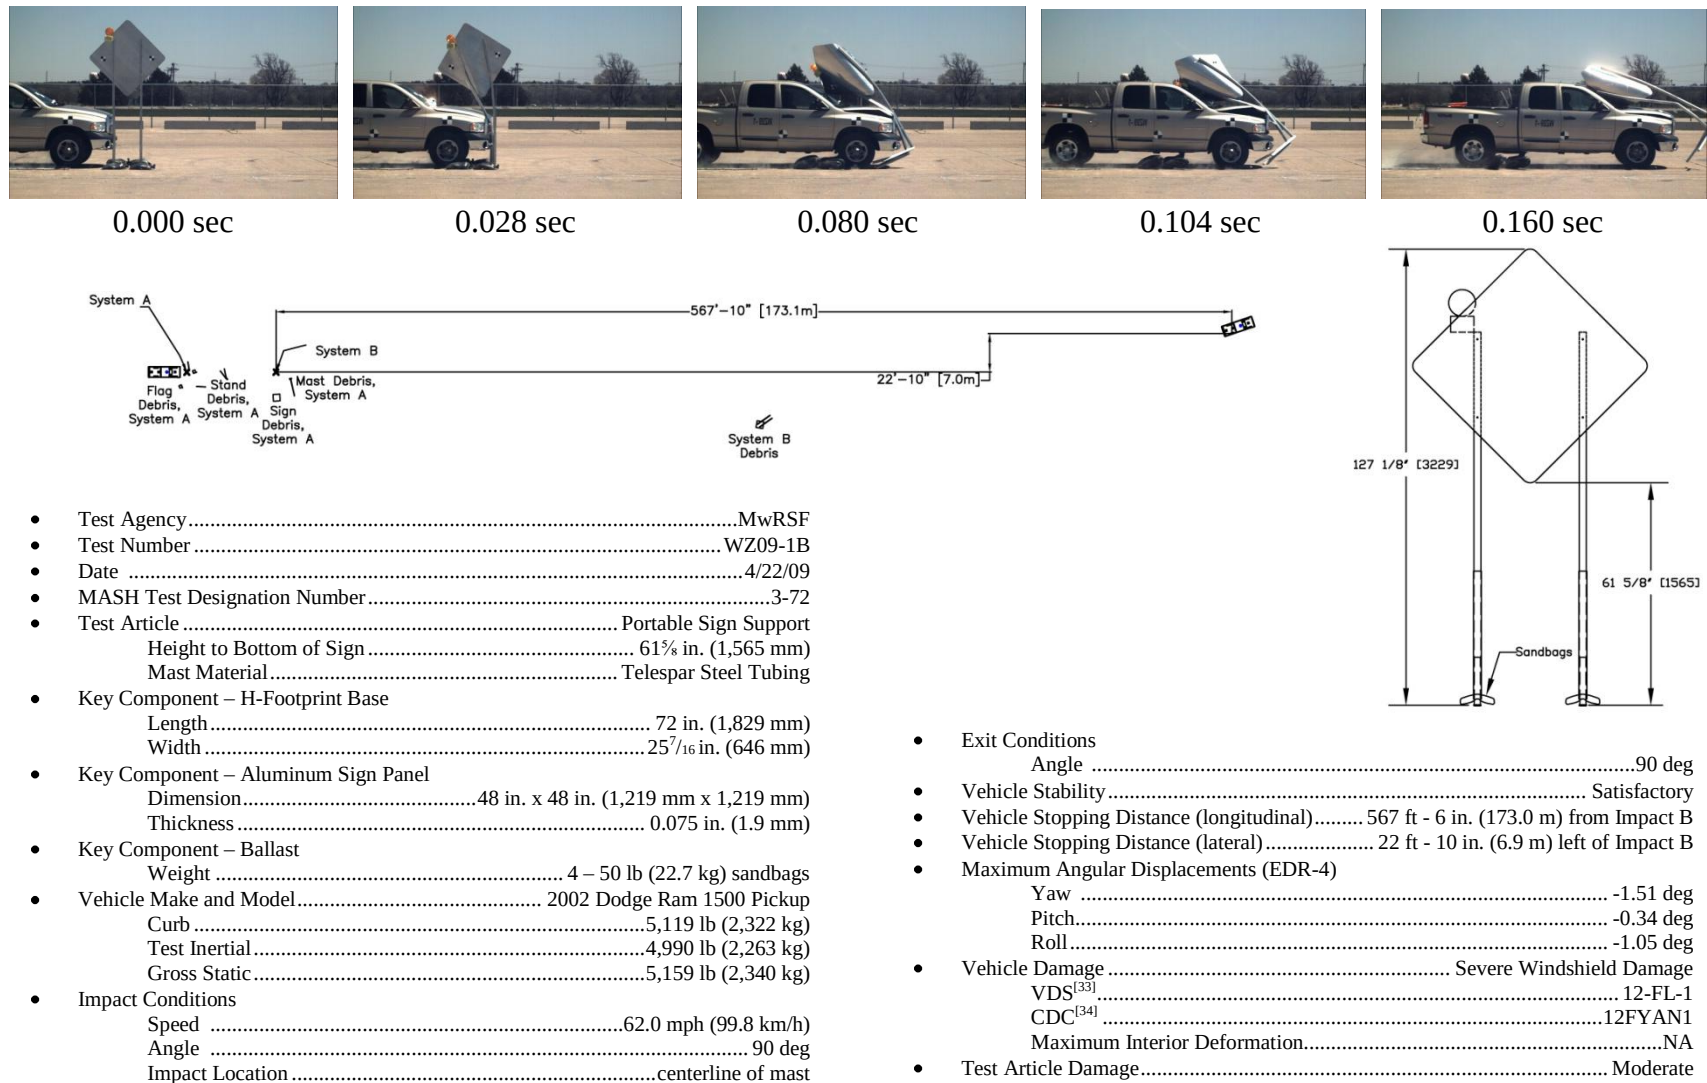
Figure 46. Summary of Test Results and Sequential Photographs, Test No. WZ09-1B

System No. 1B was also determined to be unacceptable according to the MASH criteria due to the light and mast penetrating the windshield, windshield indentation greater than 3 in. (76 mm), and significant windshield cracking, which caused the obstruction of driver visibility and the loss of structure in both glass layers in the windshield. Deformations of, and intrusion into, the occupant compartment did occur as System No. 1B penetrated into the occupant compartment near the upper-center region and upper-left corner of the windshield when the light, mast, and sign panel contacted the windshield. The vehicle's trajectory did not intrude into adjacent traffic lanes.

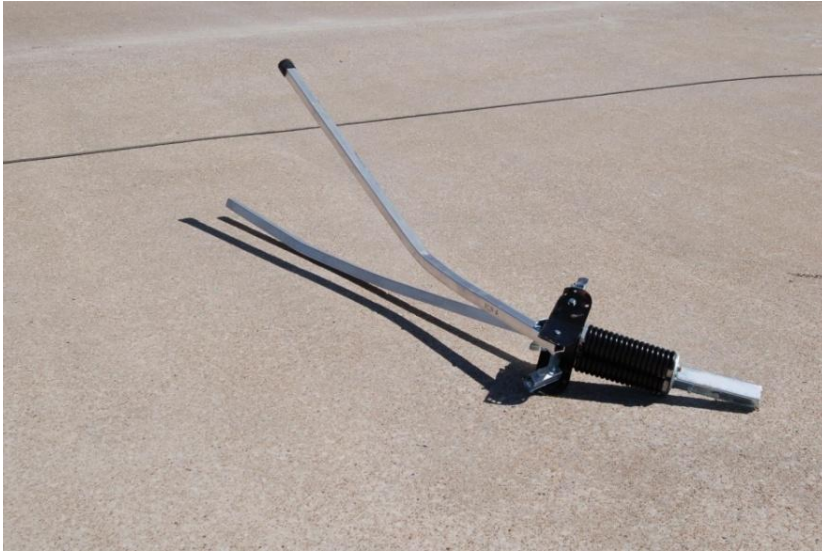
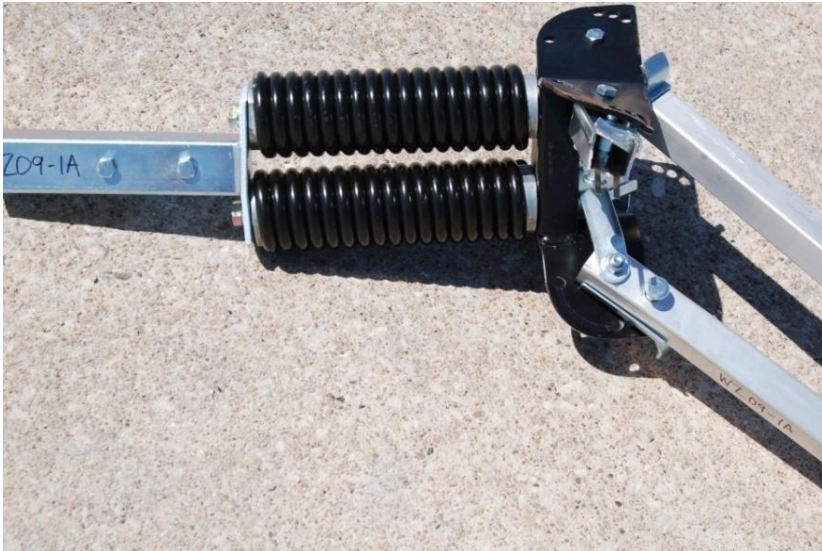
Figure 53. System Damage, Test No. WZ09-1A

Damage to System Nos. 1A and 1B is shown in Figures 53 through 56. System No. 1A encountered severe damage to the sign support stand. Two of the four legs were still attached to the base but were not in their original positions. One of the attached legs was bent moderately, and the other was bent slightly. The other two legs were fractured completely at the leg release/lock mechanism and were slightly bent. The angled base plates attaching the legs were bent, and the plate above the springs was slightly bent. The lower mast was fractured at the breakaway holes. The upper mast was slightly bent. The upper rigid bracket was significantly deformed outwards. All corners of the sign panel were dented and scratched. All three flags were undamaged, and one was located in the bed of the pickup truck.

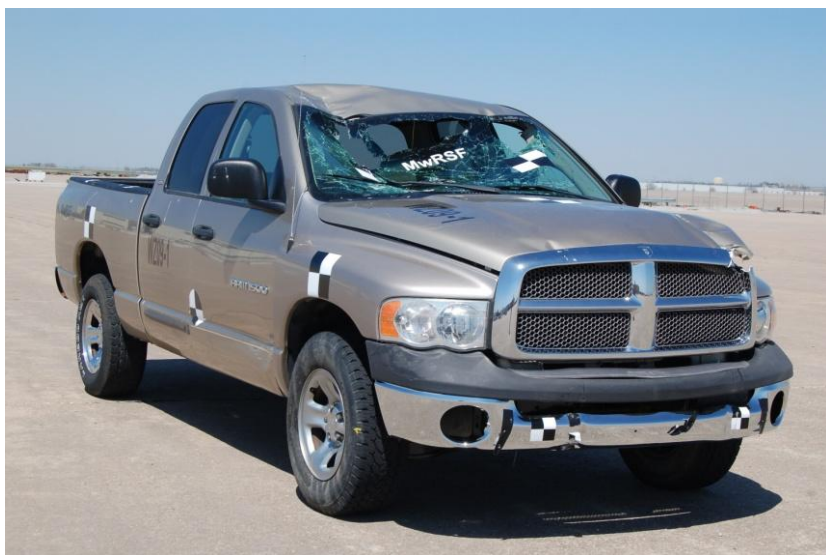
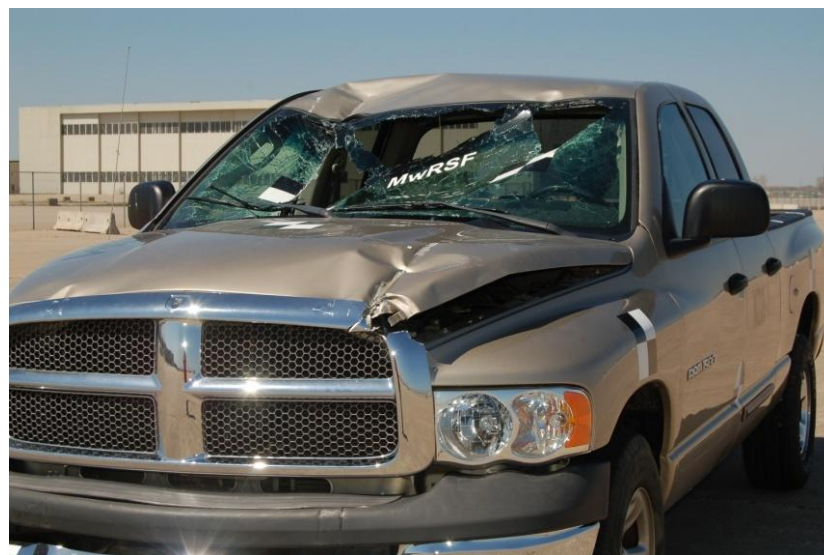
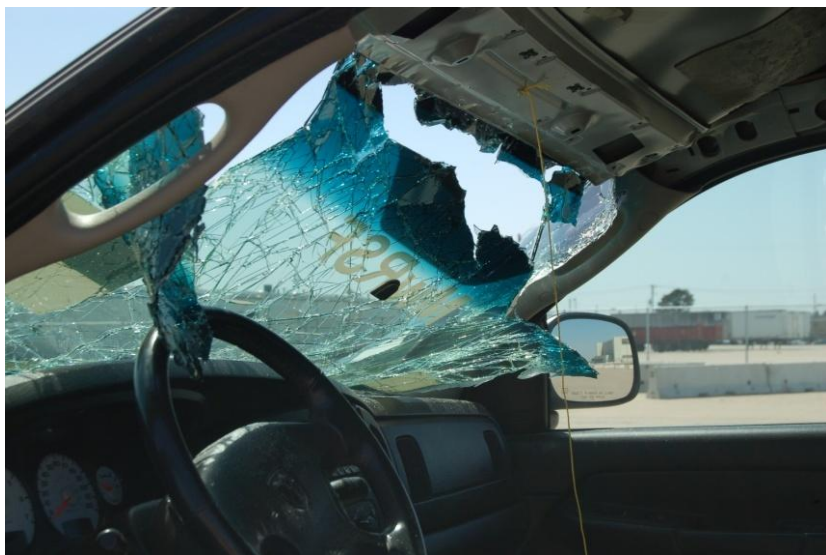
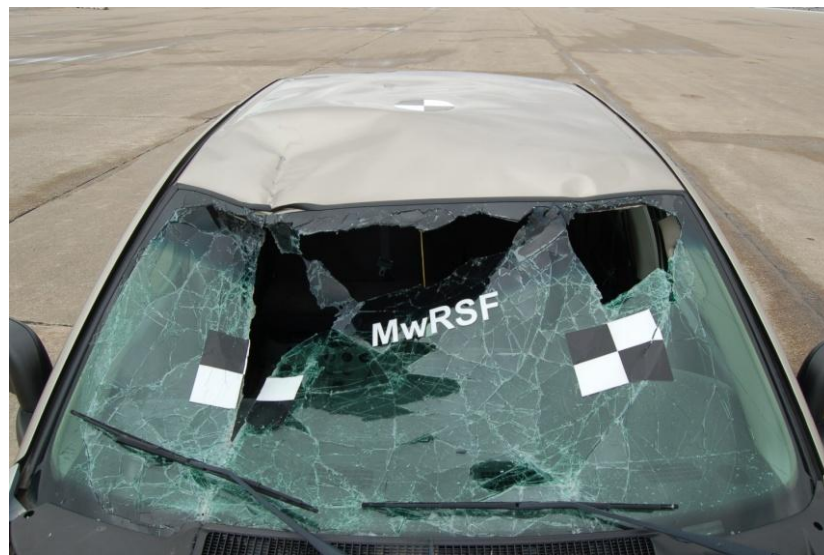
Figure 57. Vehicle Damage, Test No. WZ09-1

Vehicle damage is shown in Figures 57 and 58. The bumper was dented inward where it contacted System Nos. 1A and No. 1B. Small scuffs were found on the plastic bumper on the right side and at both impact locations. The upper-right side of the grill was scratched. The left corner of the grill was broken, and the engine hood sustained a cut at the left-side impact location. The hood was pushed backward and upward at the left-front corner, and the left-front half of the hood was scratched. The windshield was sliced through at the center of the right target where it was contacted by the sign panel from System No. 1A. The upper-center windshield contained a large hole along the roofline where the sign panel of System No. 1B impacted. Another large hole occurred in the upper-left corner of the windshield where the light and mast of System No. 1B impacted. Significant windshield indentation and cracking occurred. The roof was dented and encountered scratches at the right-side impact location. Small dents were found in the front of the roof at the left-side impact location. A small hole was observed in the middle of the roof and slightly off center to the right side where the flag holder of System No. 1B impacted.

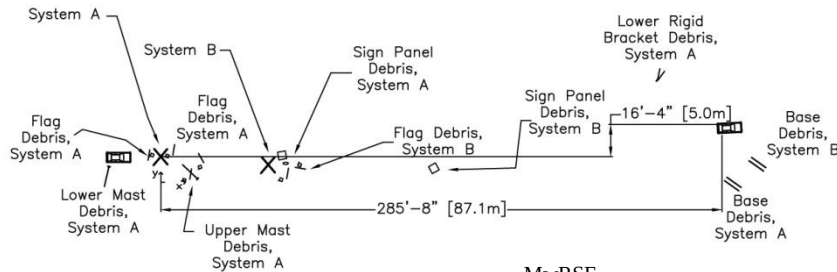
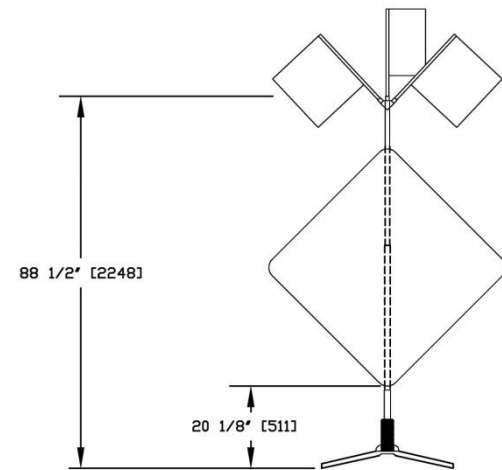
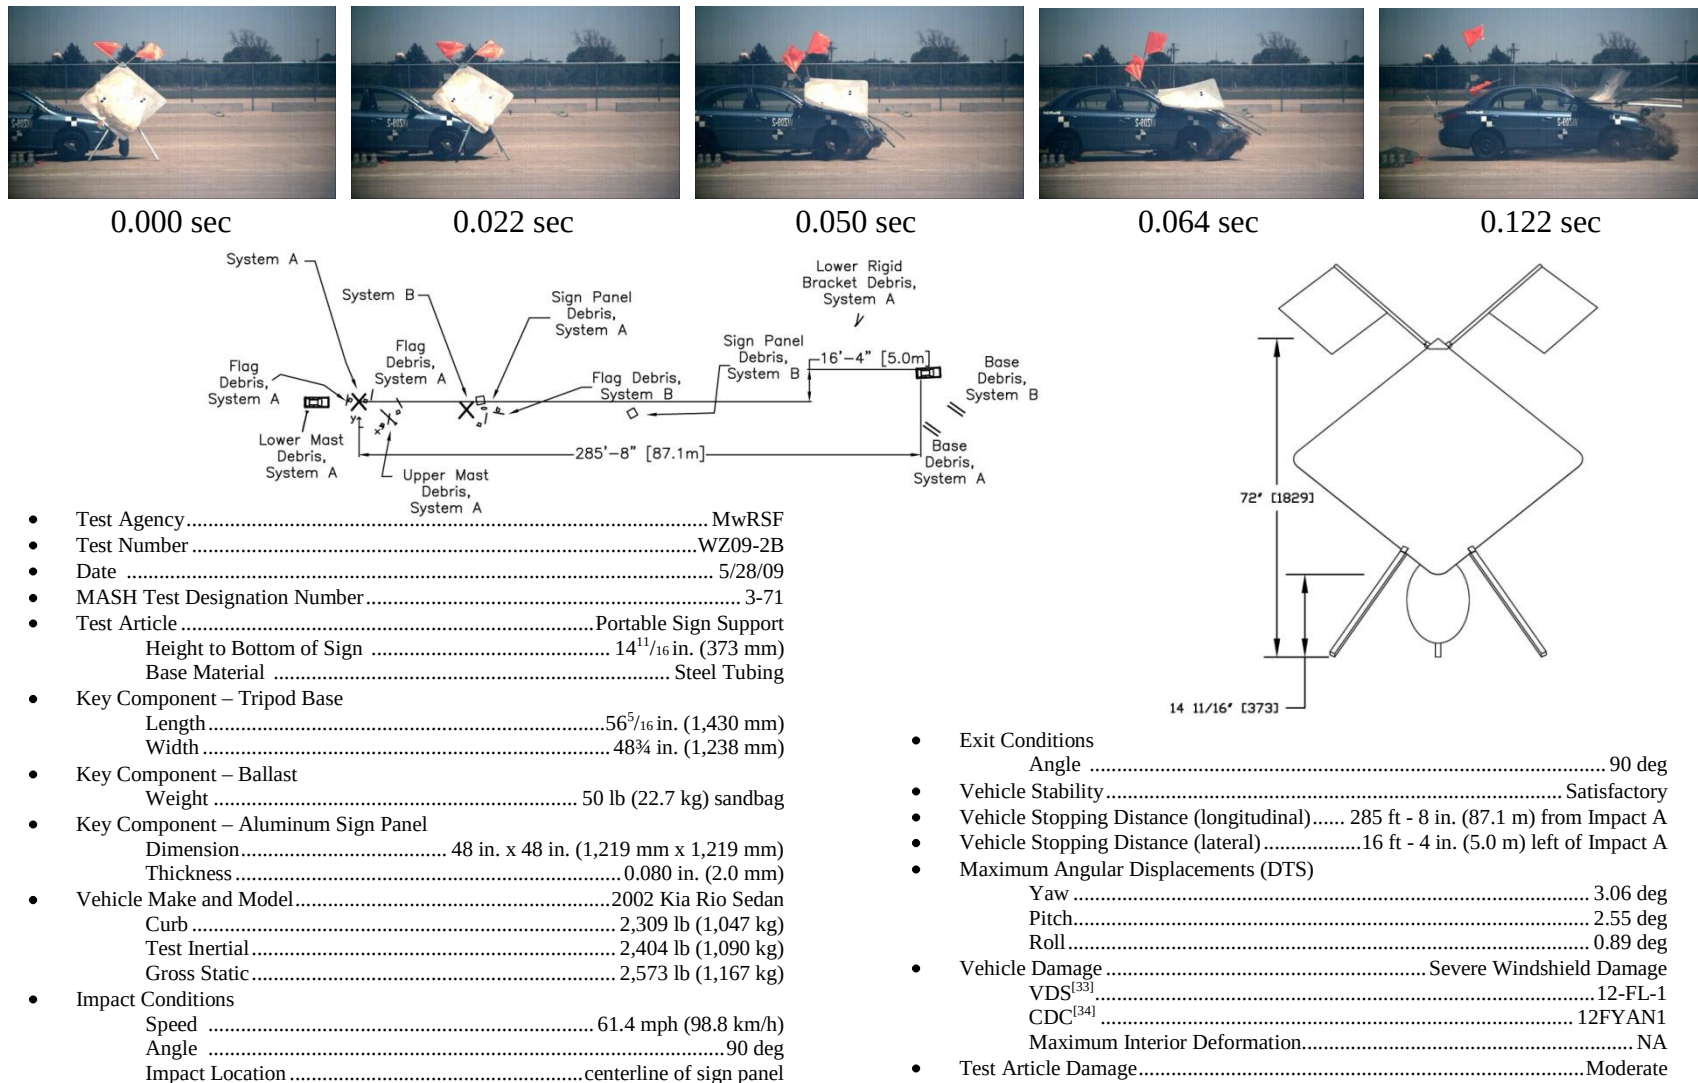
Figure 59. Summary of Test Results and Sequential Photographs, Test No. WZ09-2A

Following test no. WZ09-2, a safety performance evaluation was conducted, and the performance of System No. 2A was determined to be successful according to the MASH criteria. The windshield damage from System Nos. 2A and 2B overlapped at the middle third of the windshield, but the damage to the right third of the windshield was specifically from System No. 2A. A concentrated point of impact from the flash bulb on the lower windshield, and not the test article, occurred in the lower-right corner of the windshield. All other cracking and indentation on the right side of the windshield was from the test article. Detached elements and debris from System No. 2A contacted the windshield, and moderate cracking occurred. A maximum deformation of 2¼ in. (57 mm) occurred on the right side of the windshield, which is below the 3 in. (76 mm) maximum value defined in MASH. There was no penetration of the windshield and no tear in the plastic liner. Moderate windshield cracking also occurred along the upper-right two-thirds of the windshield when the sign panel from System No. 2A released and impacted the windshield, as determined from high-speed video analysis. The cracking appeared to be the same at the upper-middle region of the windshield as well as to the right side. The maximum deformations at the top of the windshield are unknown due to overlapping damage with System No. 2B, but the deformations were less than 3 in. (76 mm). Therefore, the system performance was determined to be acceptable.

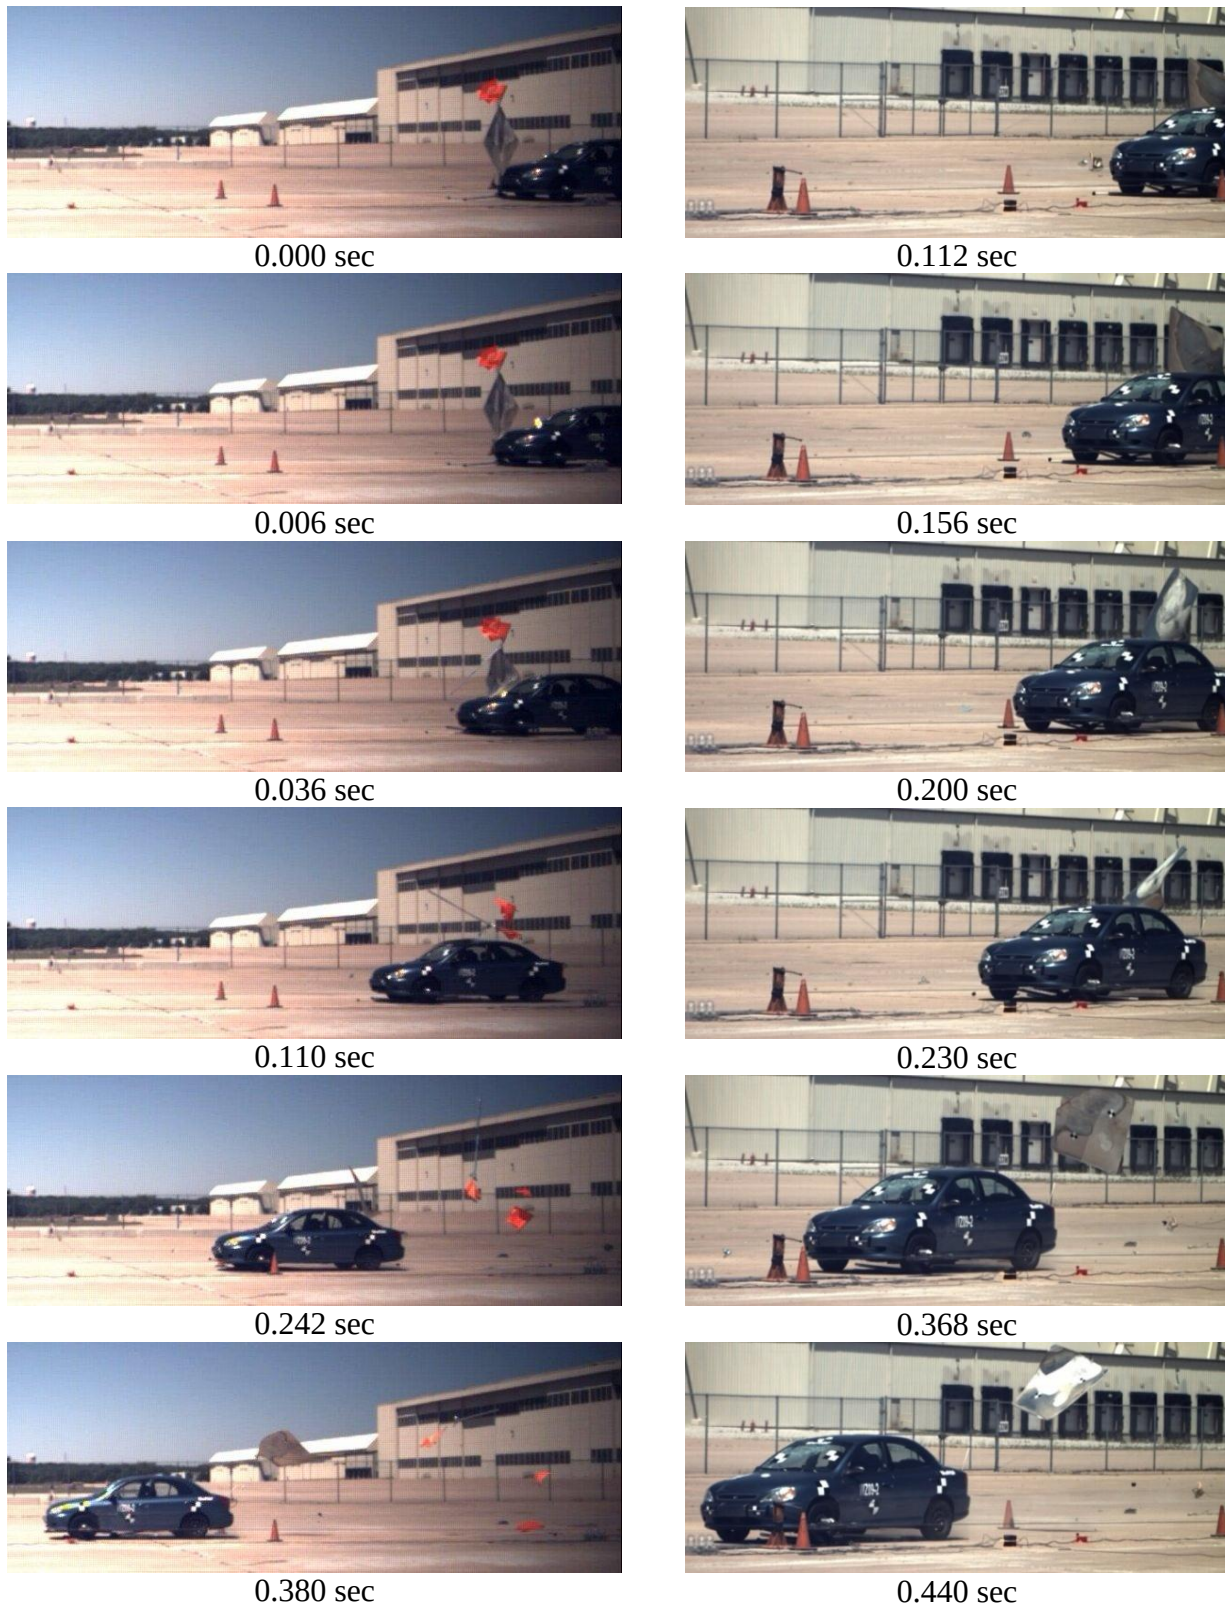
Figure 60. Summary of Test Results and Sequential Photographs, Test No. WZ09-2B

System No. 2B was determined to be unacceptable according to the MASH criteria due to significant windshield cracking, windshield indentation greater than 3 in. (76 mm), and windshield penetration. Deformations of, and intrusion into, the occupant compartment did occur as System No. 2B penetrated into the occupant compartment near the upper-center region of the windshield when the mast contacted the windshield. Even though the mast impacted the top of the windshield, which was already weakened from the impact with System No. 2A, the penetration was significant and was believed to have occurred without the prior damage. The vehicle's trajectory did not intrude into adjacent traffic lanes.

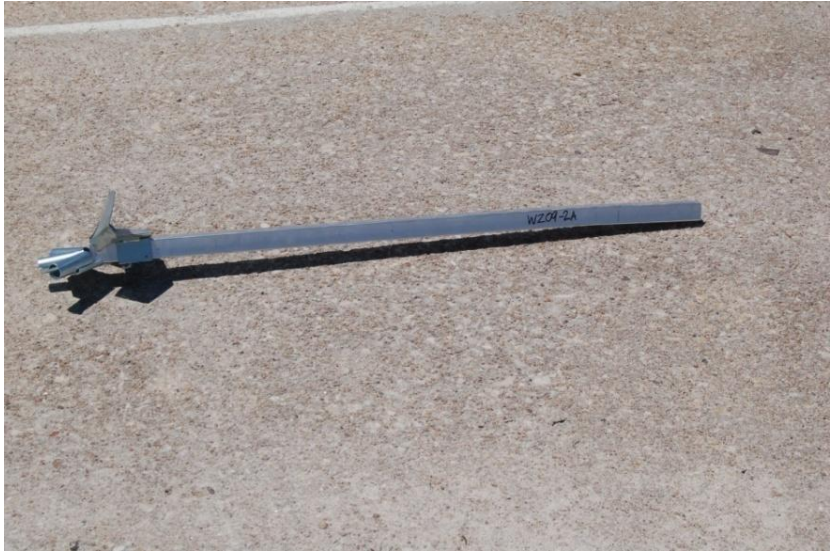
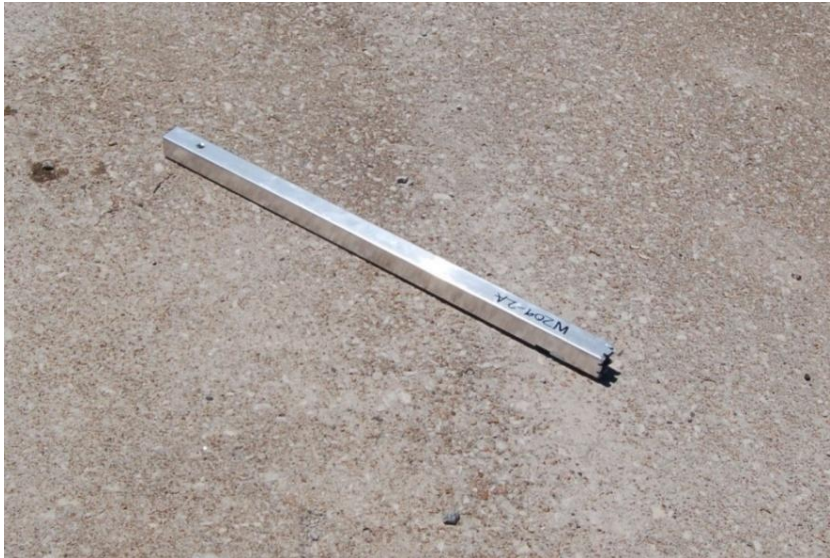
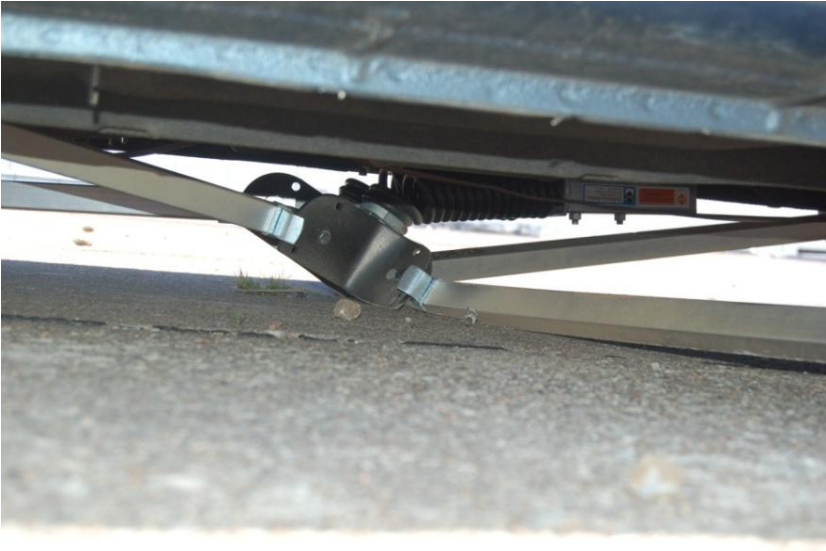
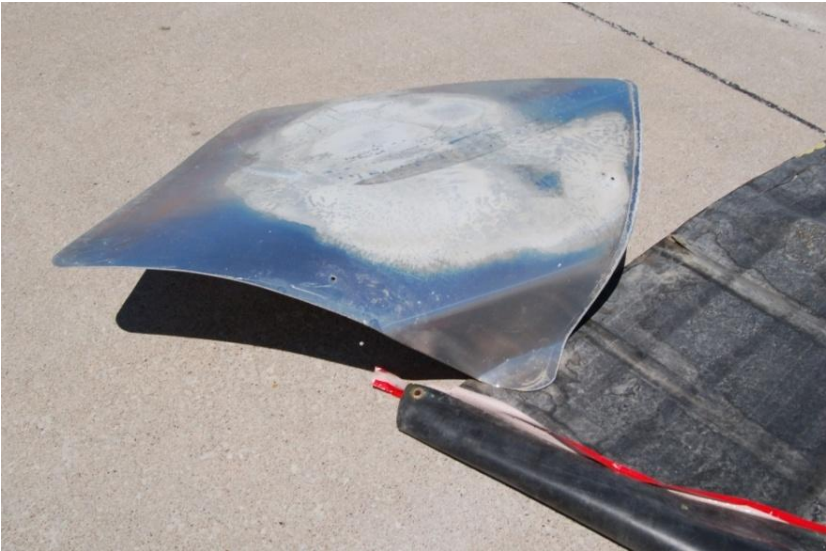
Figure 67. System Damage, Test No. WZ09-2A

Damage to System Nos. 2A and 2B is shown in Figures 67 through 70. System No. 2A encountered severe damage to the sign support stand. The lower mast fractured at the breakaway holes and landed upstream of the impact. The base, with all four legs attached, remained intact under the car. The angled plate attaching two of the legs was bent and torn at one of the bolt holes. The other angled plate's corner was deformed and crushed from dragging. Both coil springs were significantly deformed and bent over. The upper rigid bracket deformed out. The flag holders were slightly bent, and the bottoms of two flag staffs were fractured. The upper mast was bent slightly. The lower rigid bracket was slightly deformed out. The sign panel was deformed out with a crease at the top corner from the rigid panel bracket.

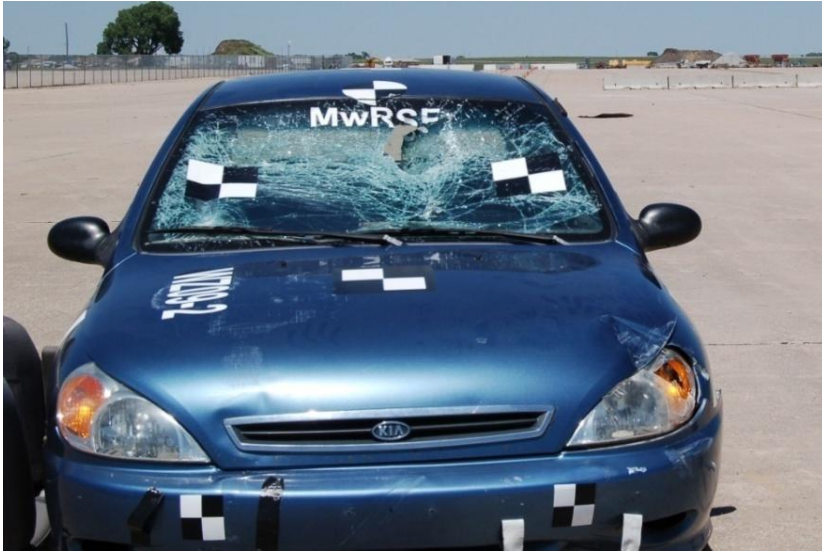
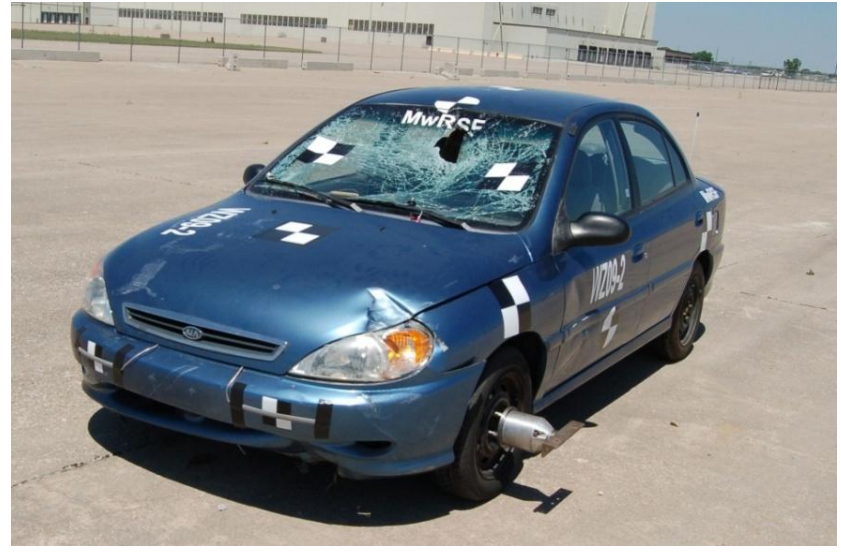
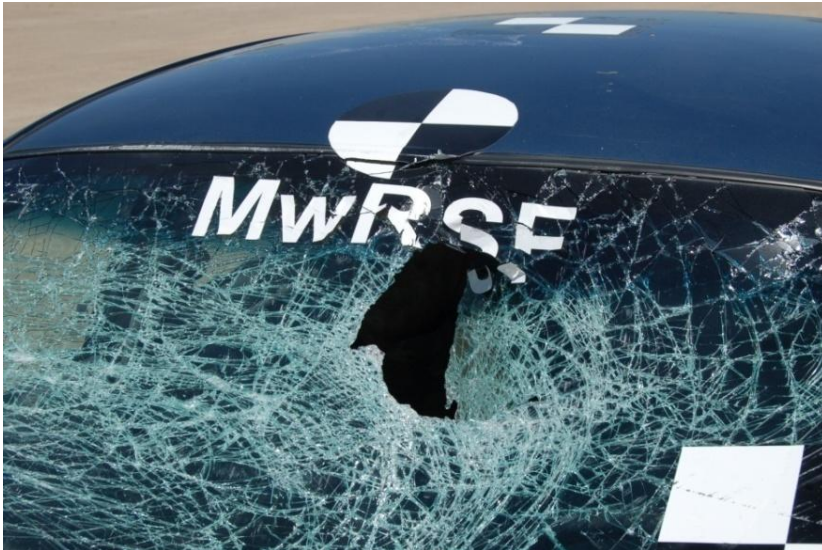
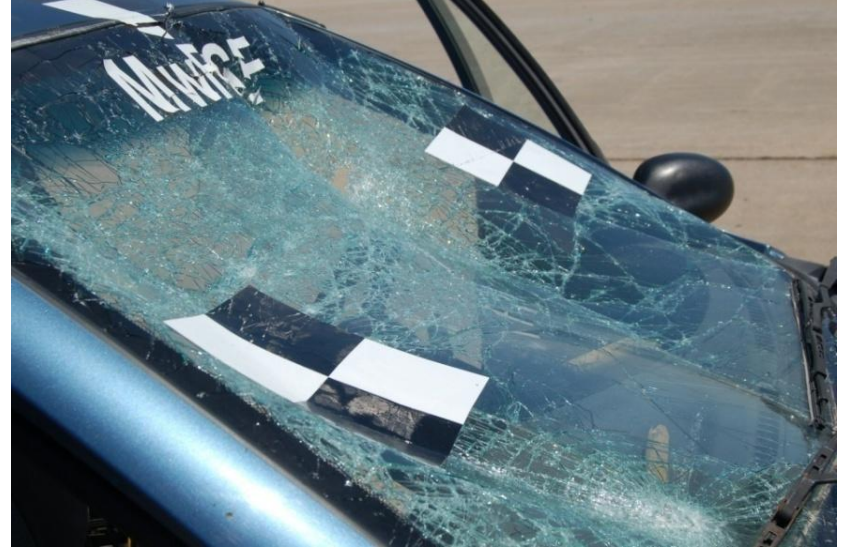
Figure 71. Vehicle Damage, Test No. WZ09-2

Vehicle damage is shown in Figures 71 and 72. The left side of the front plastic bumper was scuffed and cut where it contacted System No. 2B, and it was deformed outward from the left-front quarter panel. The lower-left side of the plastic bumper was deformed backward and torn. The left headlight was fractured. The left-front quarter panel was dented at the front. The left-front corner of the hood was deformed down. The right side of the engine hood and roof were scuffed from the sign panel of System No. 2A. A concentrated point of impact was found at the bottom-right corner of the windshield from the flash bulb deforming into the windshield. A large hole was found at the top of the windshield slightly to the left of center where the upper rigid bracket and mast of System No. 2B impacted. The entire windshield encountered cracking with severe cracking at the upper half of the windshield. The rearview mirror disengaged from the windshield, and glass was found on both the front and back seats.

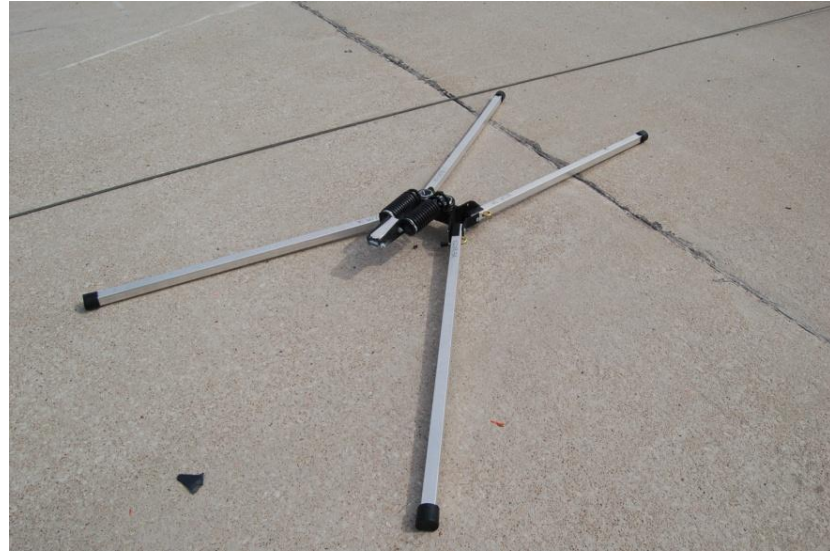
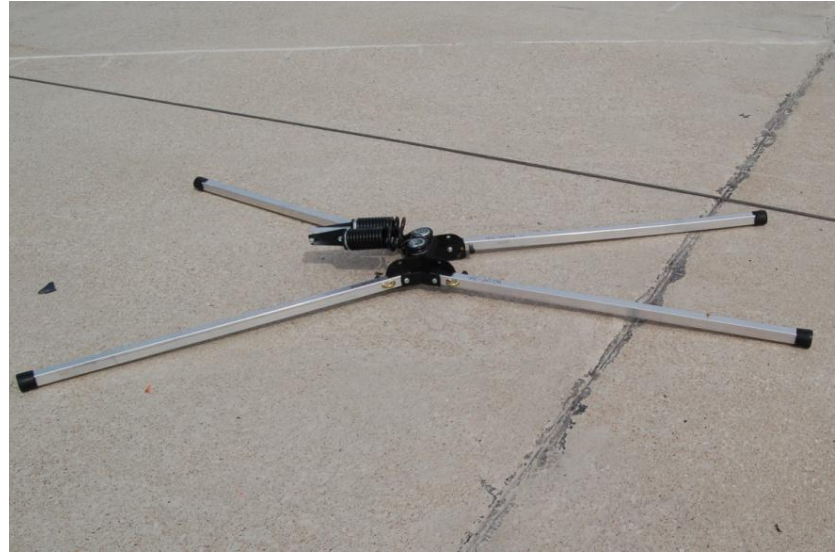
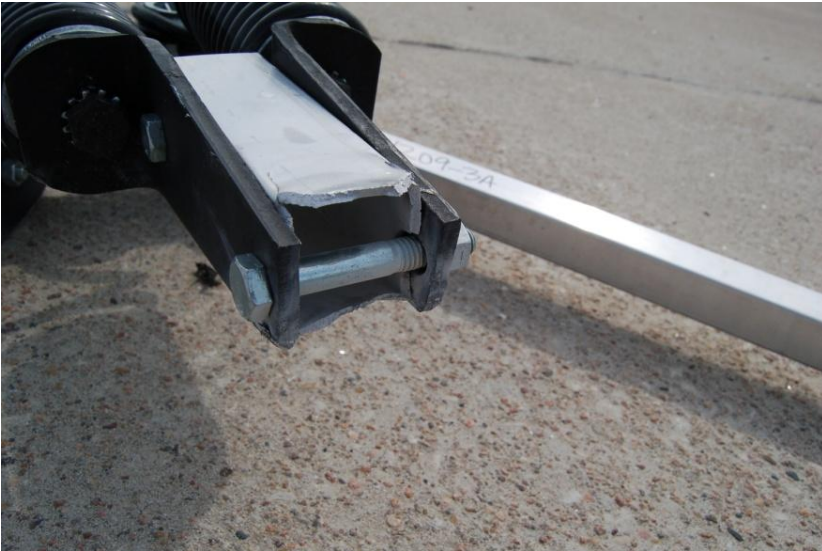
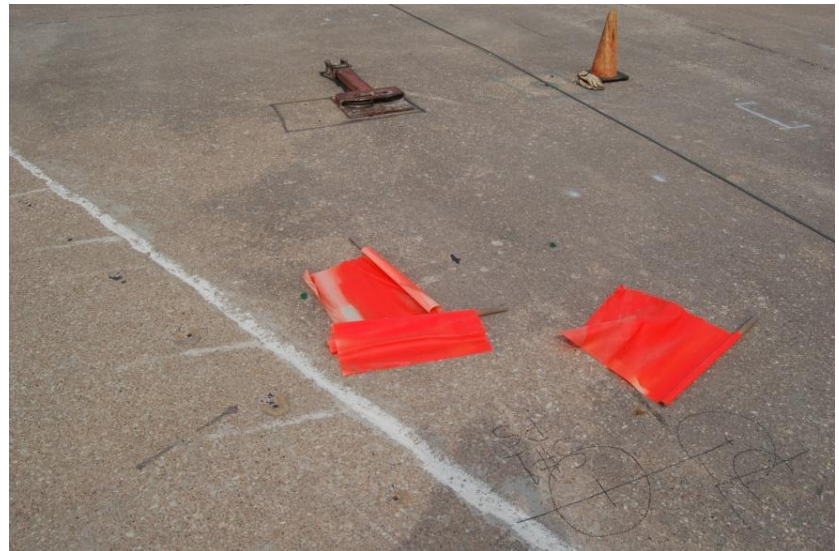
Figure 82. System Damage, Test No. WZ09-3A

Damage to System Nos. 3A and 3B is shown in Figures 82 through 85. System No. 3A encountered moderate damage. The three flags released from the flag holder. Both springs were deformed to a horizontal position. The front of base plate deformed inward, and the front legs were pushed closer together. The lower mast completely fractured at the top of bolt side plates and was crushed at the fracture point. The lower mast aluminum was torn below the fracture point at one corner. The sign panel remained intact with the car, and reflective material was scraped on the front face. The sign panel was also deformed outward with a small hole near the top. Damage to the concrete surface around the original location of System No. 3A included gouges 2½ ft (0.8 m) downstream of the impact, where the bottom part of the lower mast contacted the concrete.

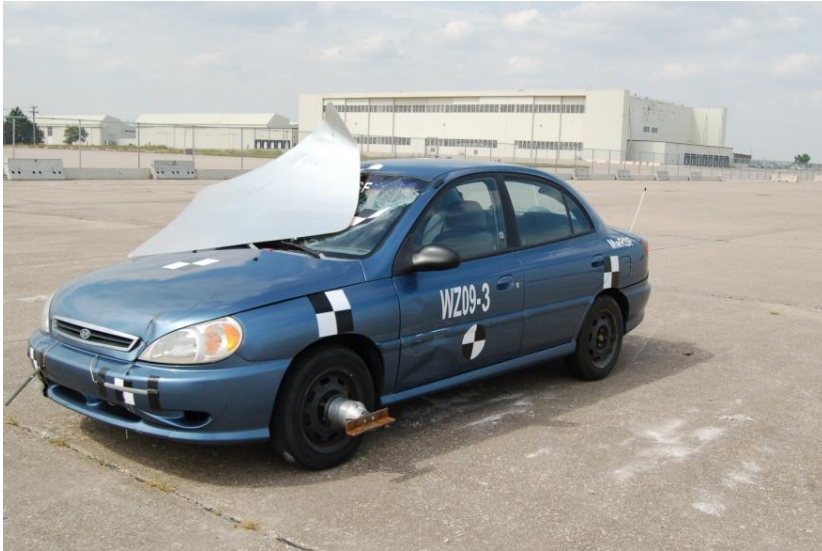
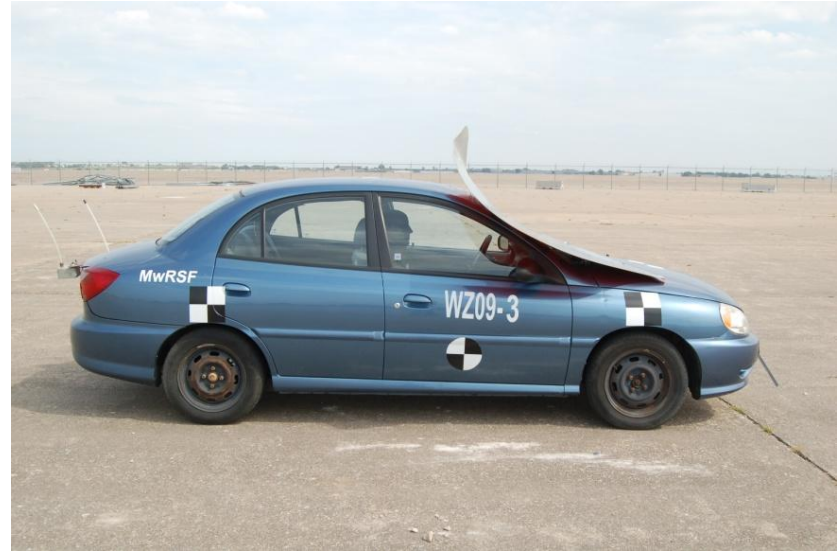
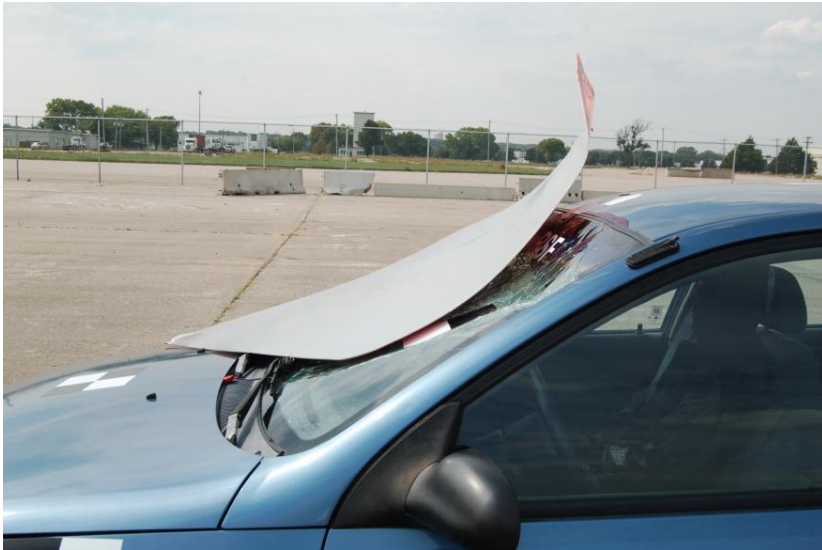
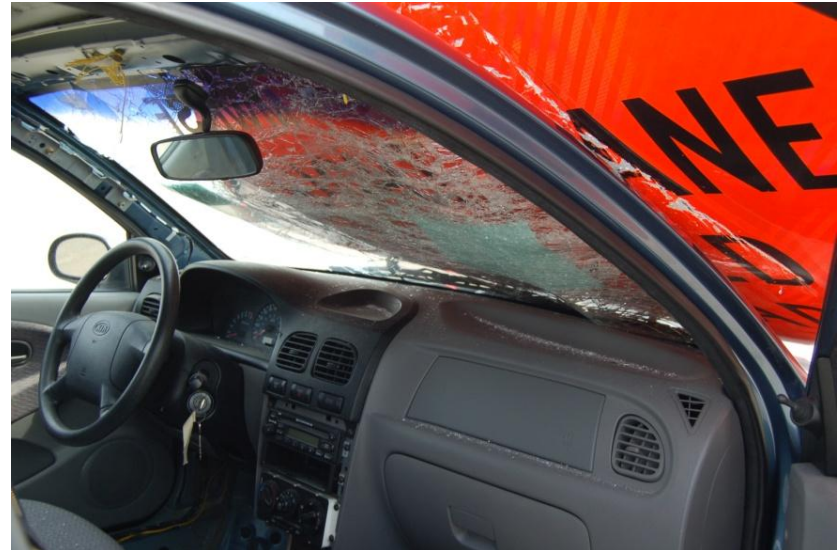
Figure 86. Vehicle Damage, Test No. WZ09-3

Vehicle damage is shown in Figures 86 and 87. The lower and upper plastic front bumpers were fractured at both the left- and right-side impact locations. The bolts underneath the car were scuffed on the left and right sides. The left front of the engine hood was dented and scraped, and black scuff marks were found on the left side of the hood. Minor scraping occurred along the right side of the hood. Significant windshield cracking occurred with a concentrated point of impact from the right-side flash bulb deforming into the windshield. Orange reflective material was embedded in the windshield cracks on the right side. A hole was found in the upper-middle region of the windshield where the rearview mirror was attached. A small scrape was found on the right-front roof, and minor scuffing occurred along the right side of the roof.

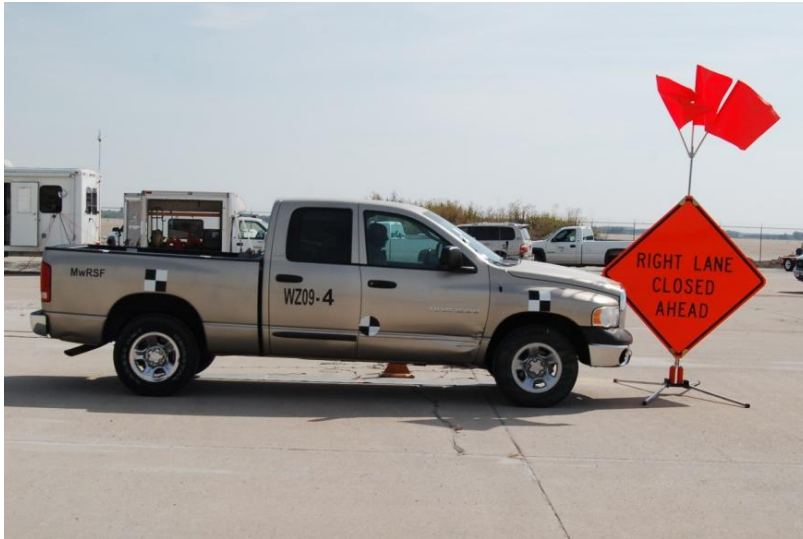
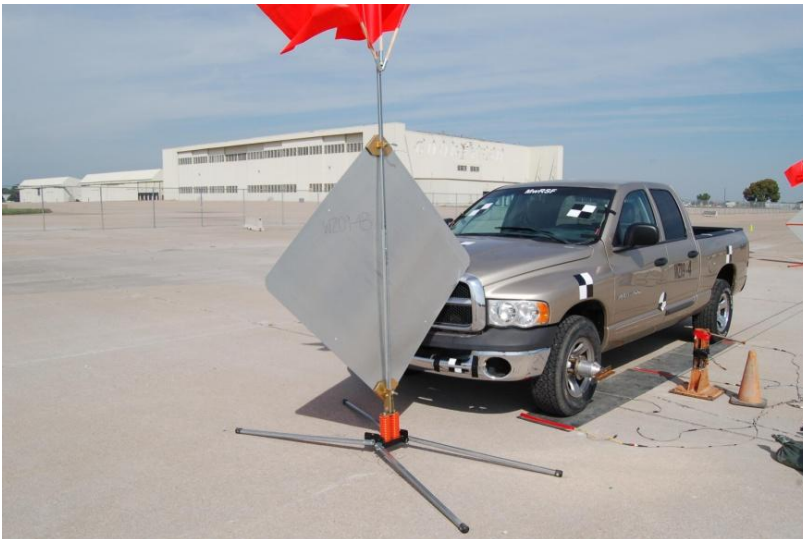
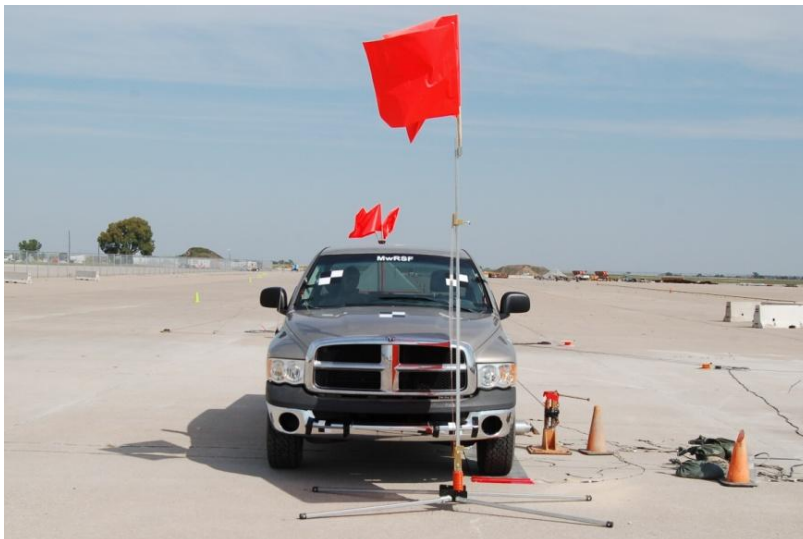
Figure 93. Impact Location, Test No. WZ09-4A

For System No. 4A, initial vehicle impact was to occur with the centerline of the mast at the right-side quarter point on the pickup truck's bumper, as shown in Figure 93. The actual point of impact was 1½ in. (38 mm) to the left of the right-side quarter point. For System No. 4B,
