# MID-AMERICA TRANSPORTATION CENTER

Report # MATC-UNL: 100

## **Safety Investigation and Guidance for Work-Zone Devices in Freight Transportation Systems Subjected to Passenger Car and Truck Impacts with New Crash Standards**

### **Midwest Roadside Safety Facility**

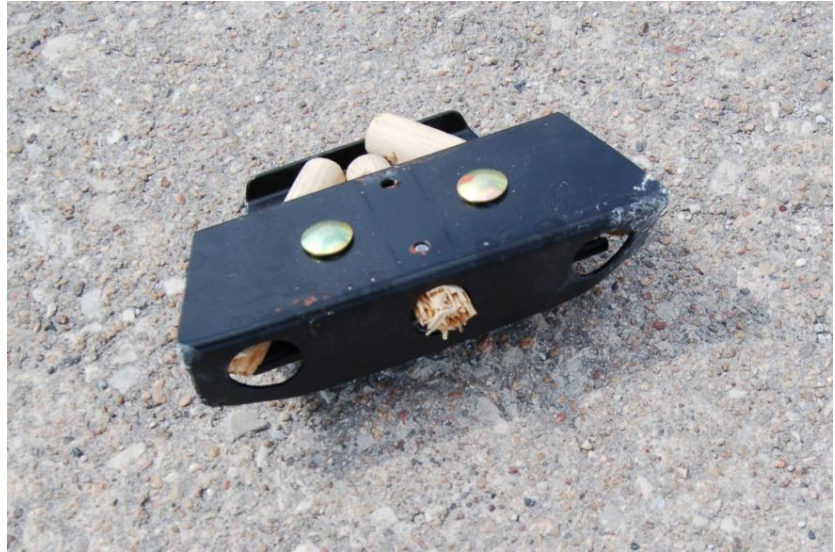
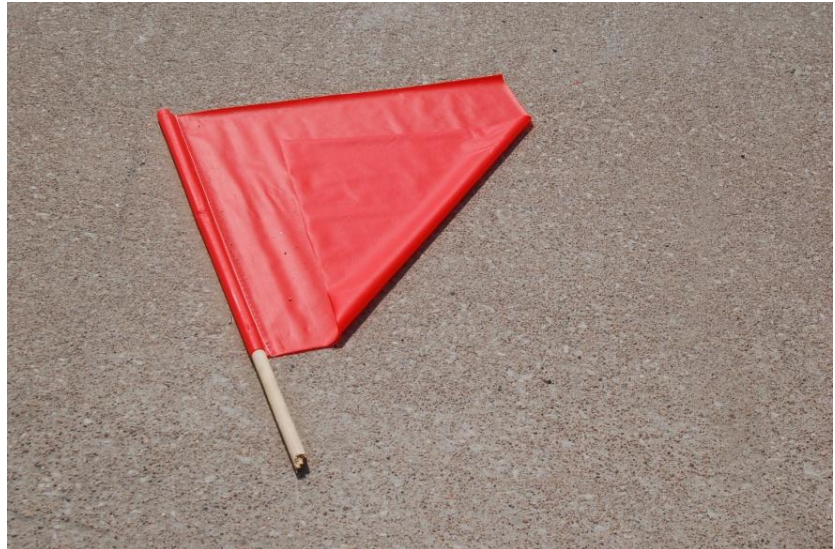
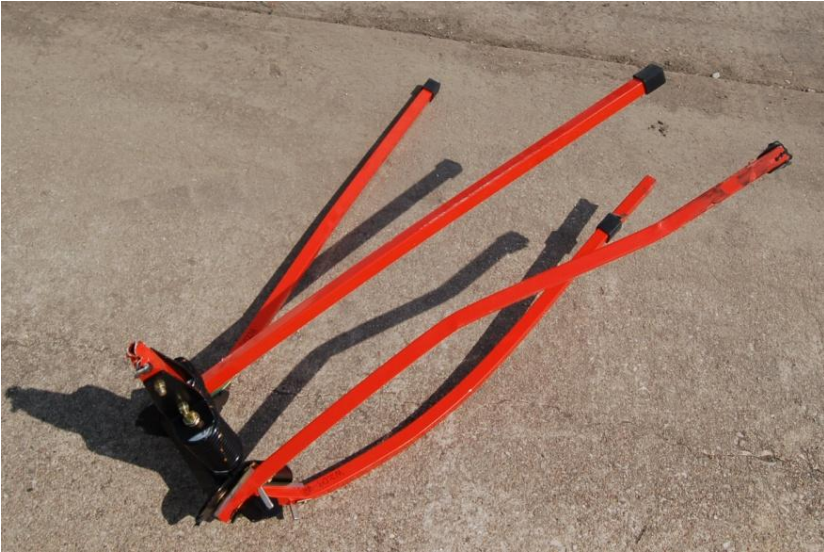
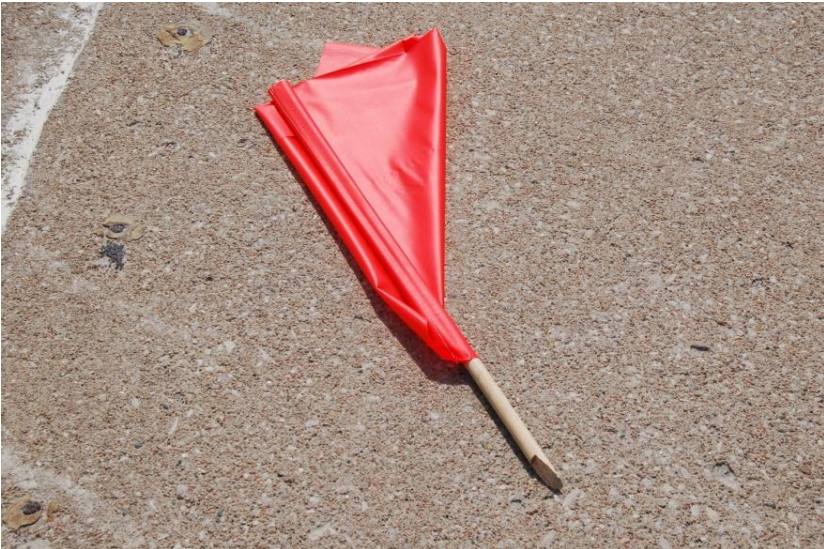
Figure 96. System Damage, Test No. WZ09-4A

Damage to System Nos. 4A and 4B is shown in Figures 96 through 99. System No. 4A encountered severe damage. All three flag staffs fractured at the top of the flag holder, and the ends remained intact with the flag holder. The vertical crossbracing tore through the top of sign panel. The upper mast was bent slightly and separated from the lower mast. The flag holder separated from the upper mast and had scratches and denting on one corner. The base was carried underneath the truck the entire time. One leg penetrated the floorboard and was bent significantly. One leg was wedged behind the right-front wheel and was bent slightly. The lower mast almost completely fractured 1½ in. (38 mm) above the top bent plates. The springs deformed to a horizontal position and were scraped on their sides. All legs released from their original lock positions.

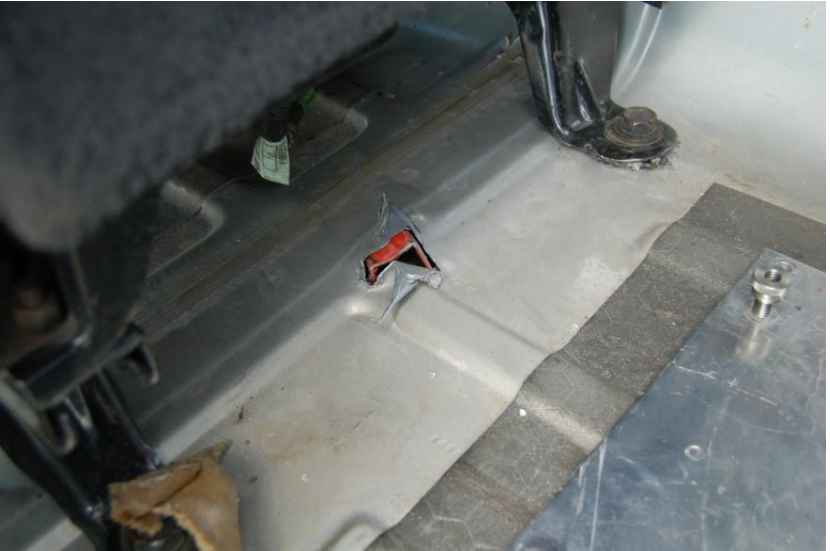
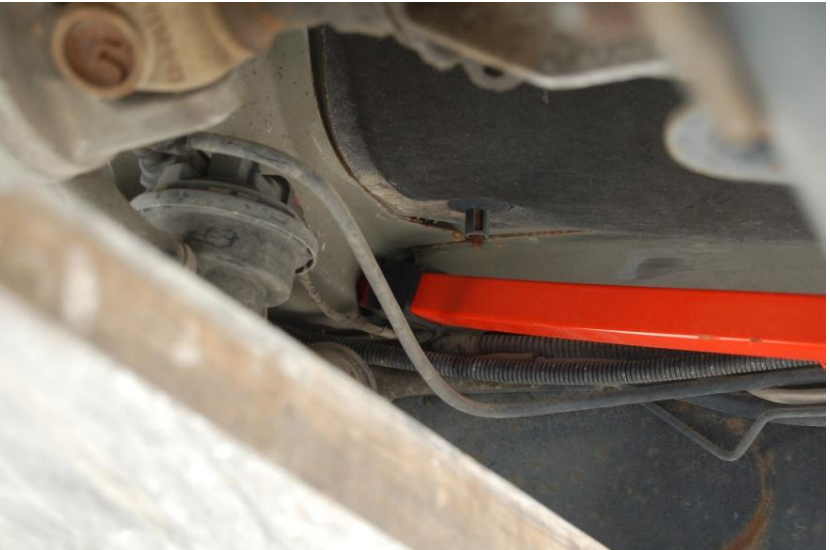
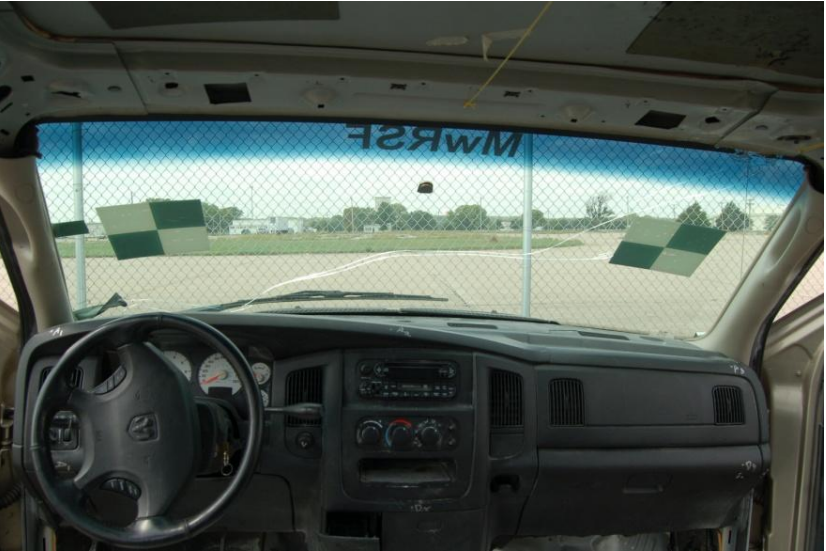
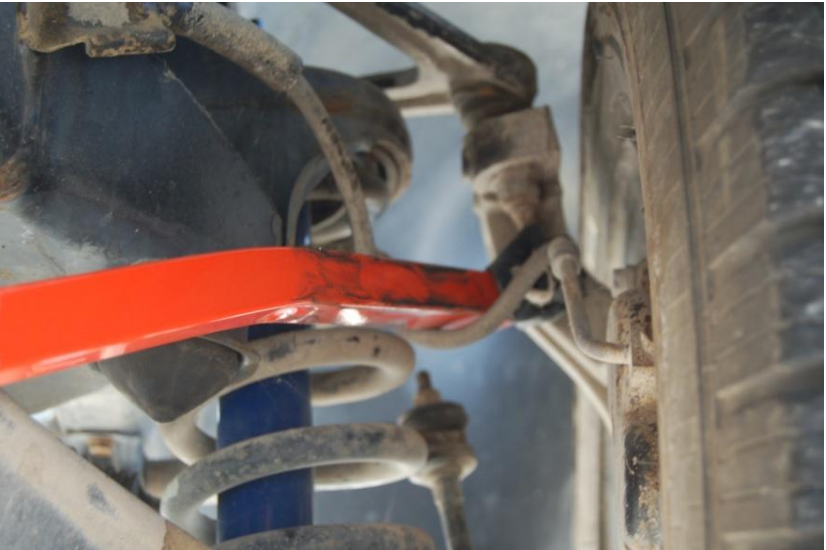
Figure 100. Vehicle Damage, Test No. WZ09-4

Vehicle damage is shown in Figures 100 and 101. The bumper was dented inward where it contacted System No. 4A and where it contacted System No. 4B. The grill was sliced at the upper-left region. The left front of the engine hood was dented inward and sliced. Scraping occurred on the right-front corner of the hood. A small dent was found in the right-front corner of the hood, and a scratch was found down the right side of the hood. A concentrated tear occurred in the upper-right corner of the windshield where it was contacted by the flag holder from System No. 4A. Two hairline cracks were found beginning at the lower-left corner of the windshield and spanning to the upper-right corner of the windshield. A dent and a scratch were found at the right-front region of the roof. A small hole was found in the floorboard on the left side with one of the legs of System No. 4A protruding through it. The right-front tire was deflated, and one leg of System No. 4A was wedged behind the right-front tire. The front bumper was pushed down and scuffed from a secondary impact with a concrete barrier prior to stopping.

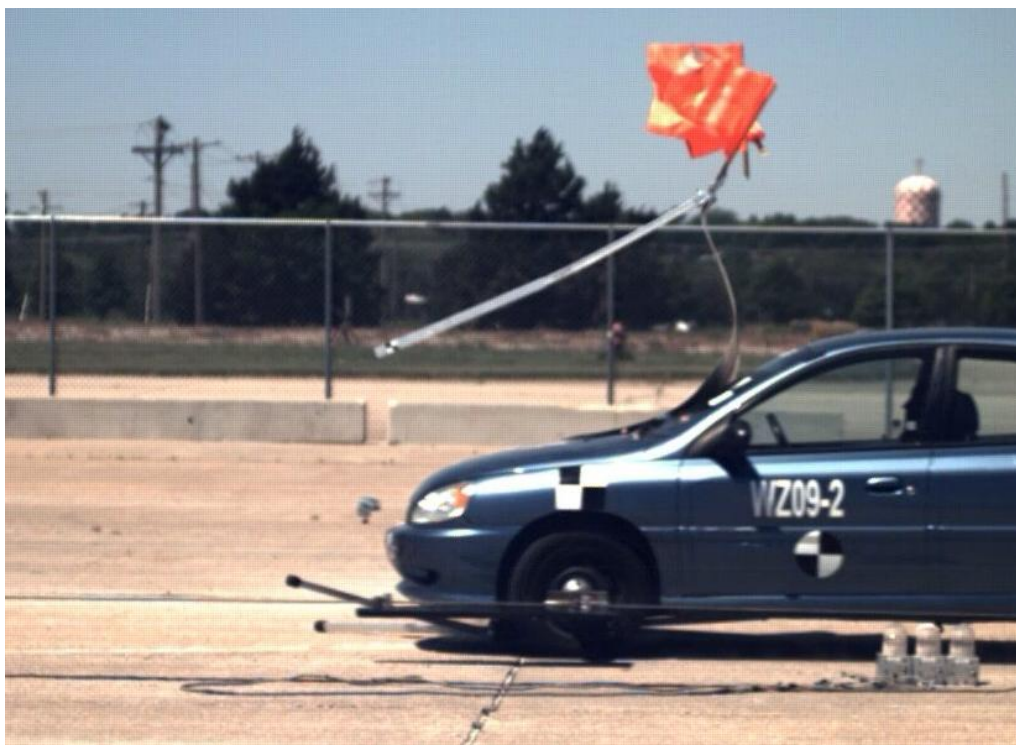
Figure 103. System No. 3A, Frangible Mast

A mast with a frangible base reduces the amount of flex that develops in the sign panel and mast (System Nos. 1A, 2A, 3A, and 4A). This relatively quick release of the mast from the stand allows the sign panel and mast to fall upon the vehicle with little additional force than what normally occurs through the impact event, as shown in Figure 103. However, this force can still be sufficient to cause indentation or penetration of the windshield. On the other hand, when base bending occurs, as shown in Figure 104, the sign panel and the top of mast are accelerated downward into the windshield (System No. 1B). When the mast was unloaded, the sign panel and mast have the tendency to "whip" downward onto the vehicle. In addition, a base-bending

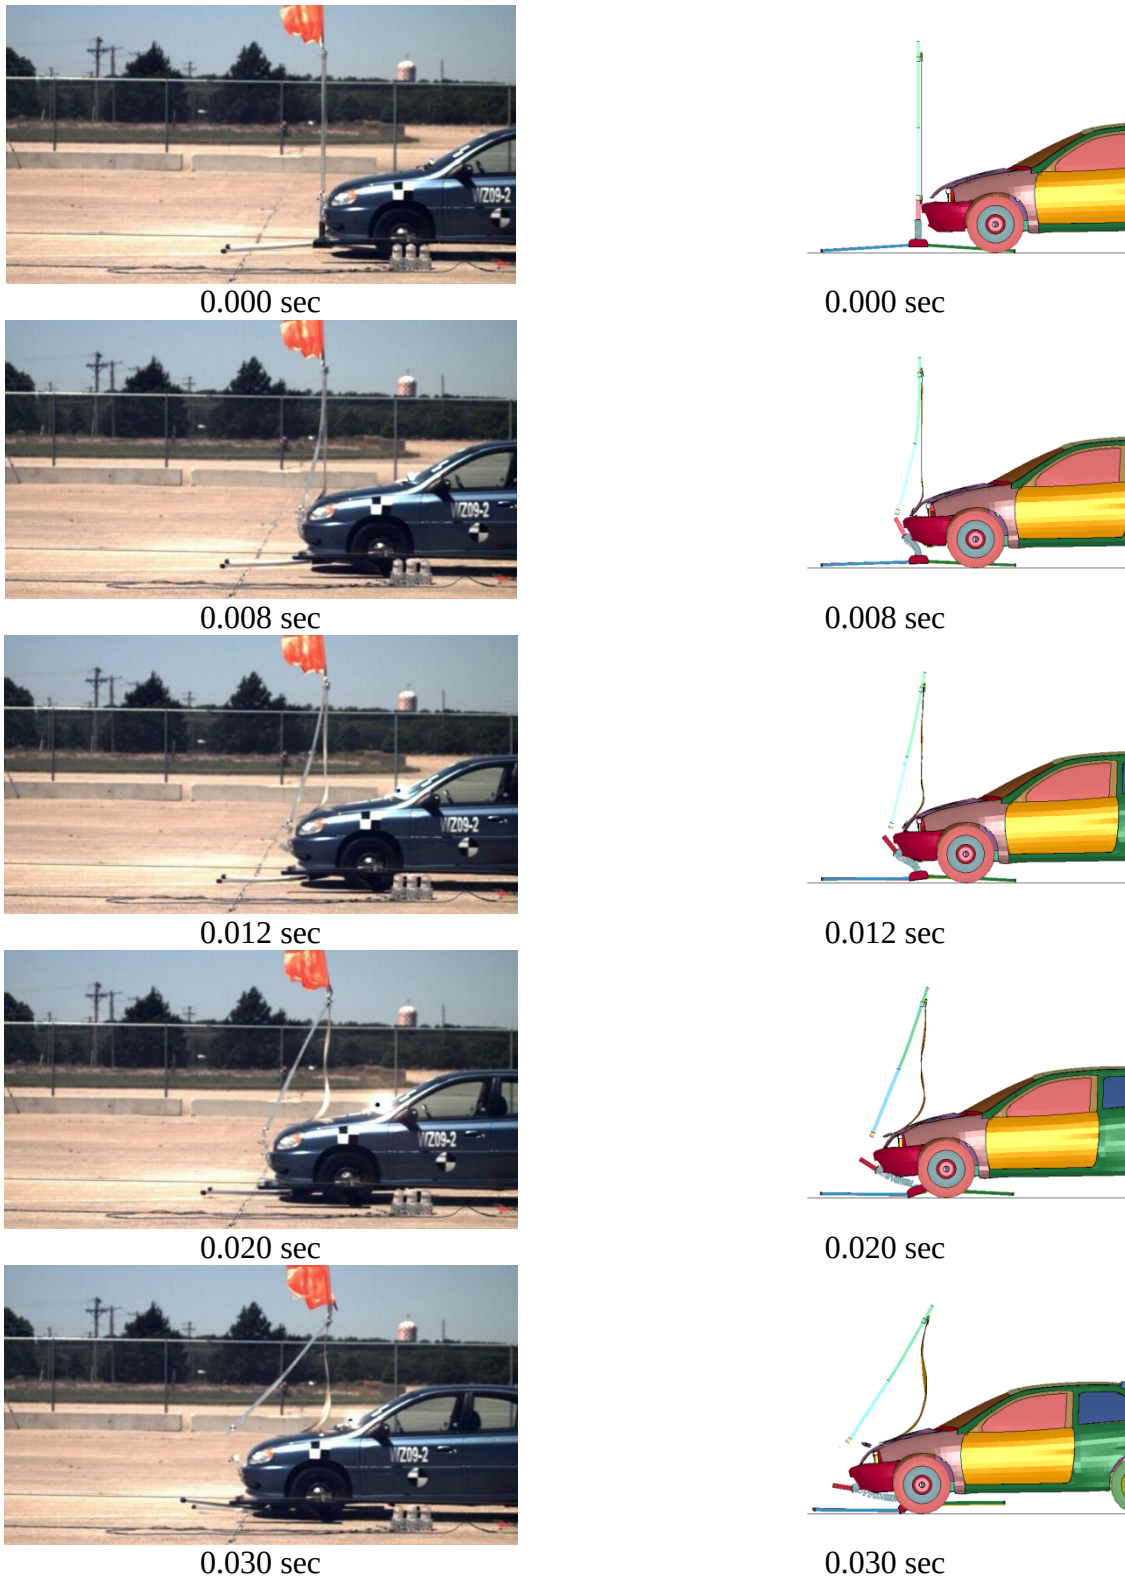
Figure 110. Comparison of Full-Scale Crash Test and Simulation Results

A comparison between the simulation and the full-scale test video is shown in Figures 110 and 111. The lower mast fractured at the breakaway holes, which was critical for the trajectory of the sign system to be accurate. The fracture appears accurate when compared to the full-scale crash test, except the lower mast in the full-scale crash test lags the simulation by 3 ms. The trajectories of all parts appear similar for the first 40 ms. Around 50 ms, the sign panel in the simulation began to slip out of the upper rigid bracket therefore the sign panel does not bend as much as was observed in the full-scale crash test. At this same time, the bottom of the mast began to rotate slower than observed in test no. WZ09-2A.

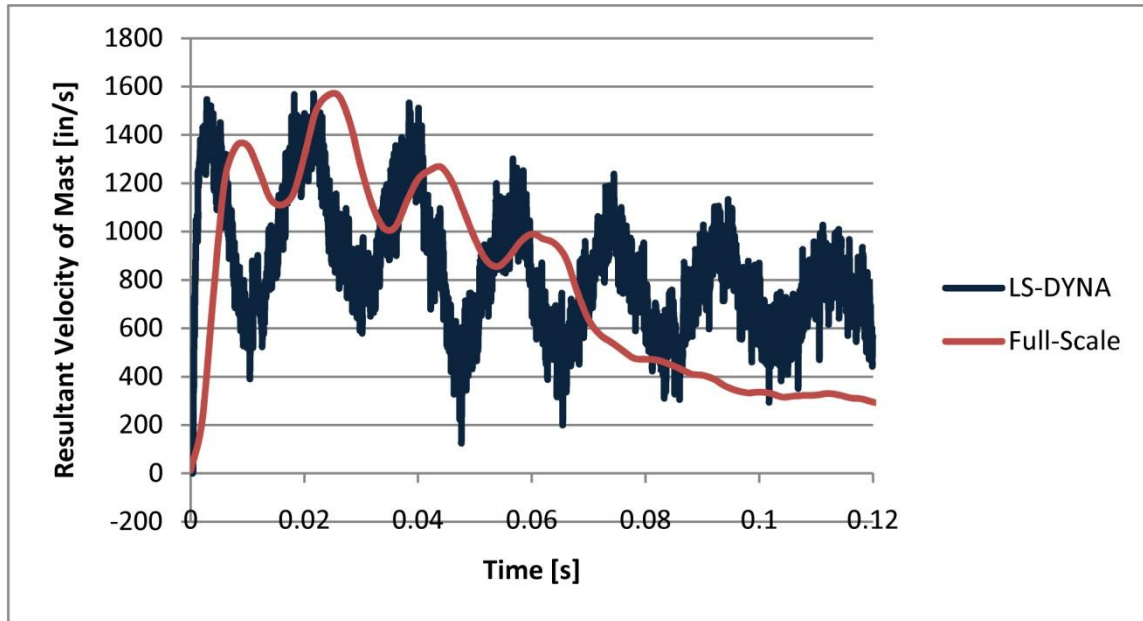
Figure 112. Velocity of Mast vs. Time

A target was placed above the fracture point on the lower mast in test no. WZ09-2A. The velocity of the target was compared to the velocity at an equivalent point on the mast in the simulation and is shown in Figure 112. The full-scale crash test and the simulation achieved the same peak values, and the curves were nearly identical except for a phase shift. The curves oscillate because the mast vibrates through the air after the impact event.

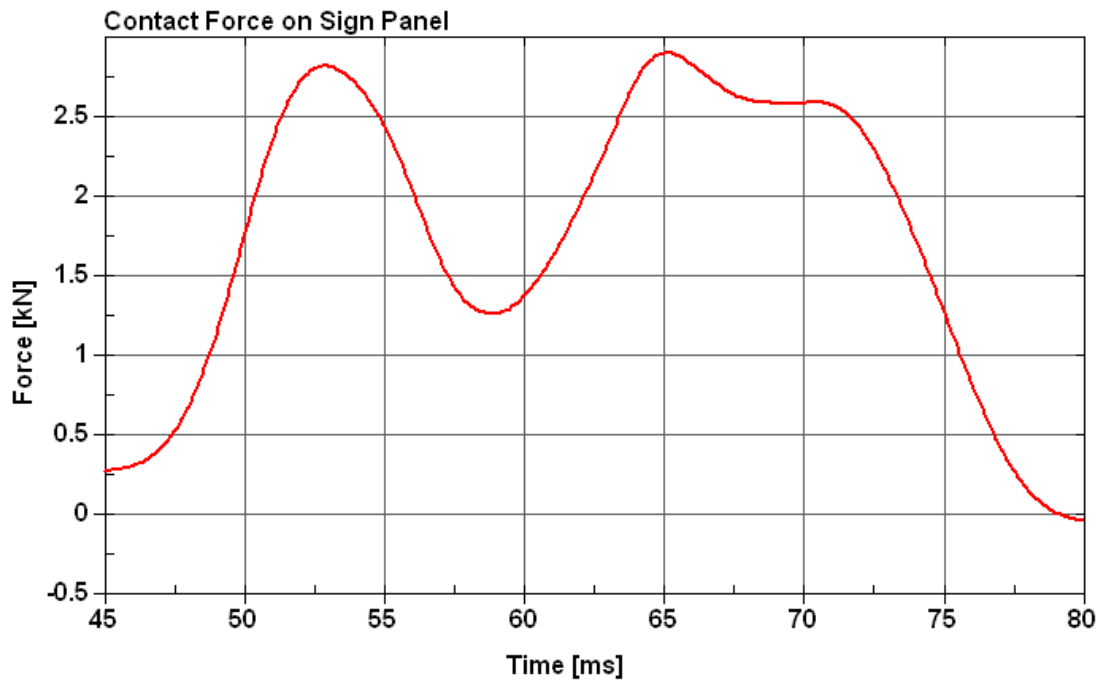
Figure 113. Contact Force between Sign Panel and Windshield

Since the mass of the sign stand is small and the actual accelerations are low, the force exerted on the sign stand should also be low. The contact force was filtered with Butterworth (BW) at 100 Hz. The contact force between the sign panel and windshield is shown in Figure 113. A maximum force of 654 lb (2.91 kN) occurred at the initial impact. There is no validation data to compare if this force is accurate, but it seems slightly high to cause 2¼ in. (57 mm) of windshield deformation.

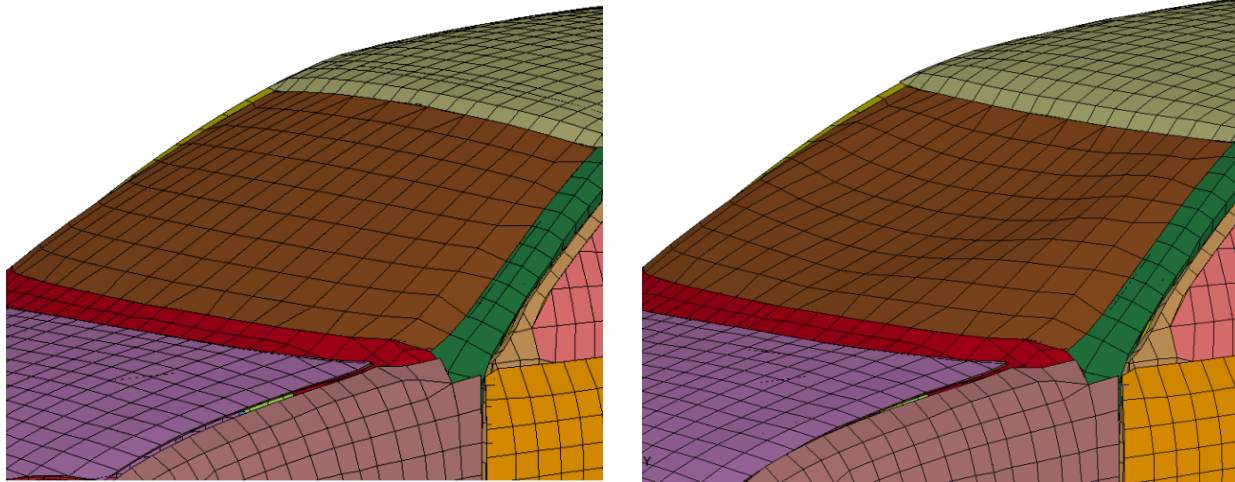
Figure 117. Windshield Deformation

Although the windshield material model was believed to be inaccurate in predicting deformations, the windshield deformed similar to what was found in test no. WZ09-2A. A comparison of the deformation in the simulation is shown in Figure 117. The vertical displacement of the windshield was compared over time, as shown in Figure 118. The maximum vertical deformation in the simulation was 2.24 in. (56.8 mm). The maximum windshield deformation in the full scale crash test was 2¼ in. (57 mm).

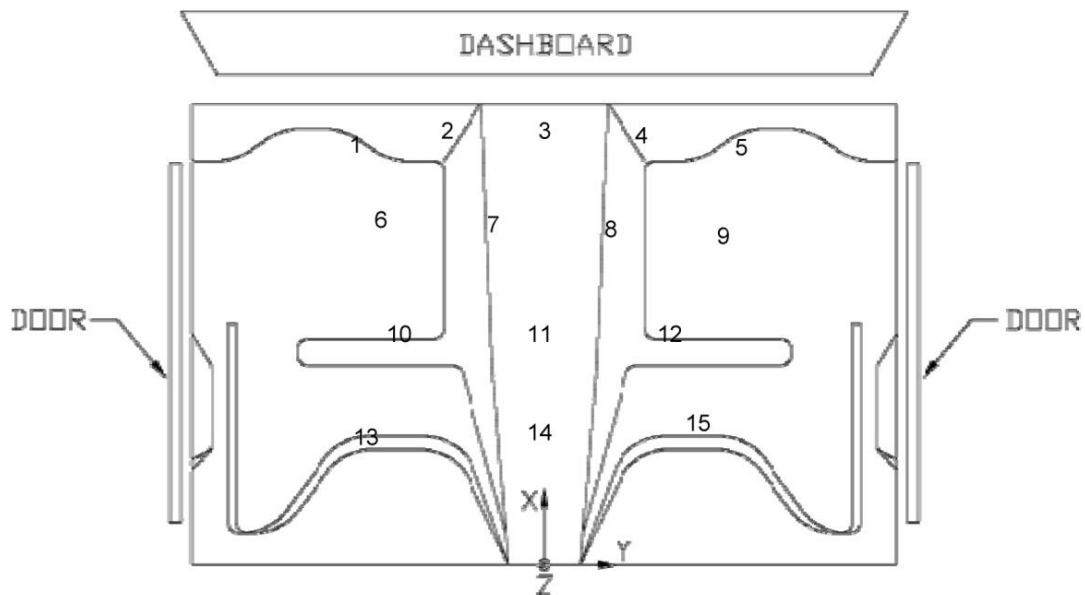
Figure E-1. Roof Deformation Data, Test No. WZ09-1

Max is at roof edge of glass, passenger side, 1.5inches in from roof seam.
