DESIGN AND EVALUATION OF A LOW-TENSION CABLE MEDIAN BARRIER SYSTEM

MwRSF Research Report No. TRP-03-195-08

December 8, 2008

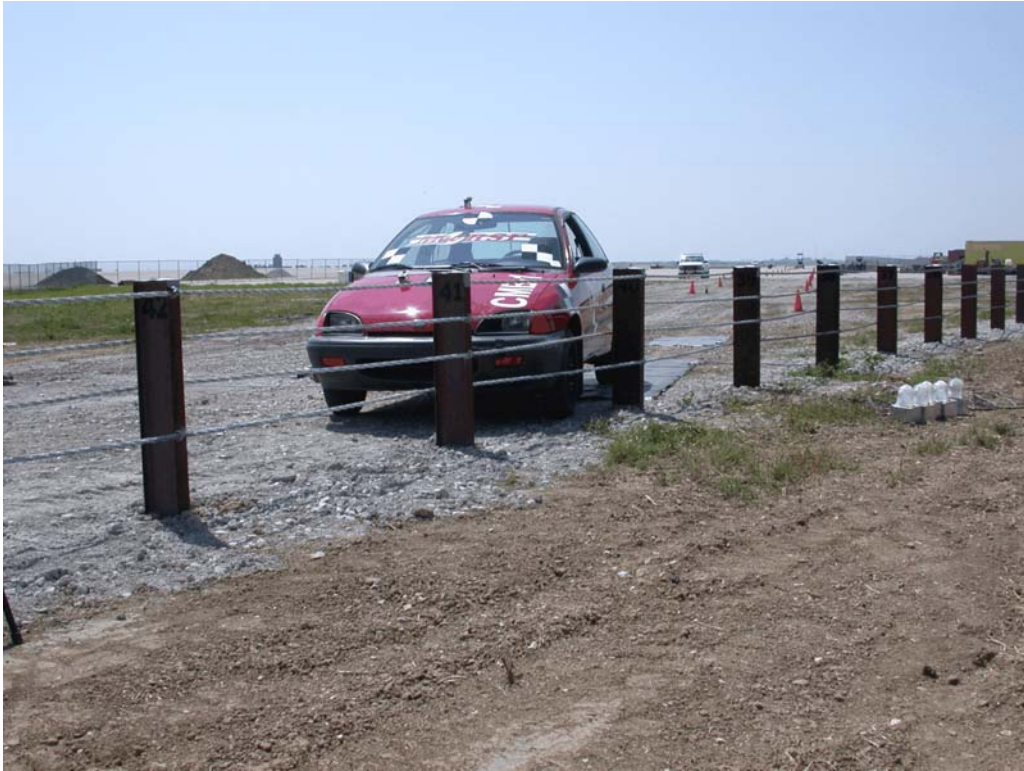
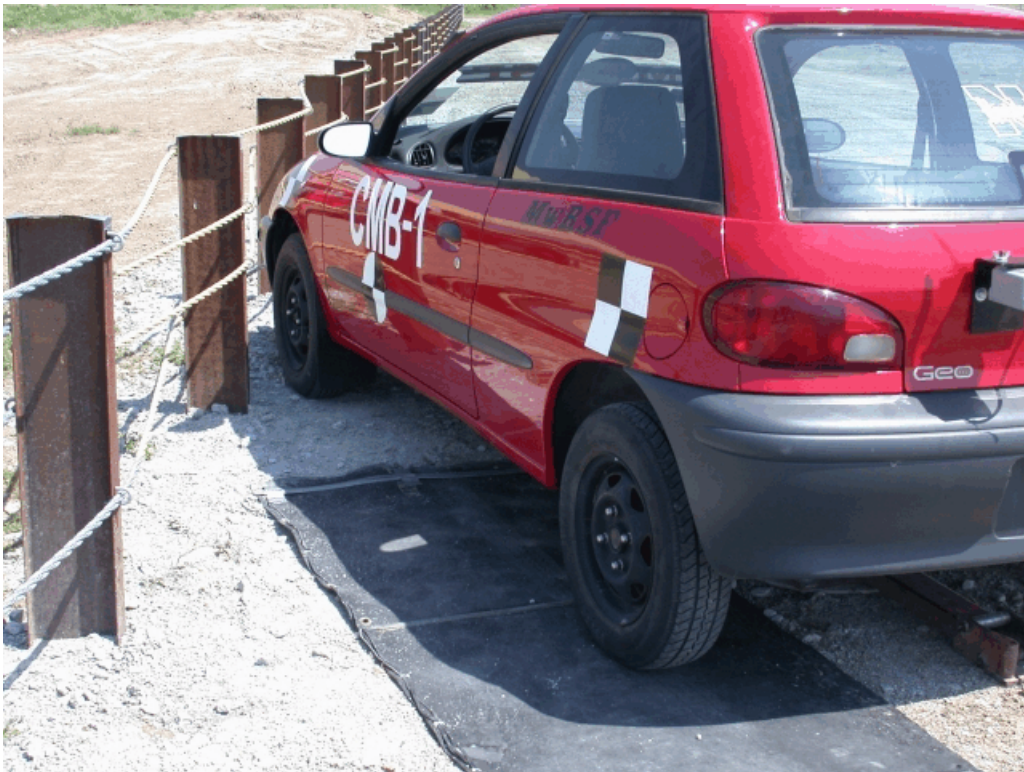
Figure 41. Impact Location, Test CMB-1

Initial vehicle impact was to occur between post nos. 40 and 41, or 846 mm (33.3 in.) upstream from post no. 41, as shown in Figure 41. At impact, the left-front corner of the bumper protruded between the cables with the top cable above the hood of the vehicle. At 0.016 sec after initial impact, post no. 41 deflected due to contact with front bumper. At 0.030 sec, the left-front tire was located on top of post no. 41, and post no. 40 was bending toward the ground. At 0.062 sec, post no. 40 deflected downstream and buckled as it rotated counter-clockwise. At 0.068 sec, the vehicle impacted post no. 42, while the upper-middle cable was deforming the sheet metal above the left-front wheel well. At 0.156 sec, the vehicle contacted post no. 43, and the left-rear tire lost contact with the ground. At this same time, the driver's-side window was shattered by the contact with the top cable. At 0.212 sec, the vehicle contacted post no. 44. At 0.306 sec, the vehicle had redirected parallel to the barrier with a speed of 78.6 km/h (48.9 mph). At 0.320 sec, the left side of the vehicle was airborne as the car contacted post no. 45. The vehicle impacted post no. 46 at 0.414 sec. At 0.561 sec, the right-rear tire was the only tire touching ground. At 1.110 sec, the car became airborne. At 1.200 sec, the vehicle exited the system at approximately 5 degrees with a velocity of

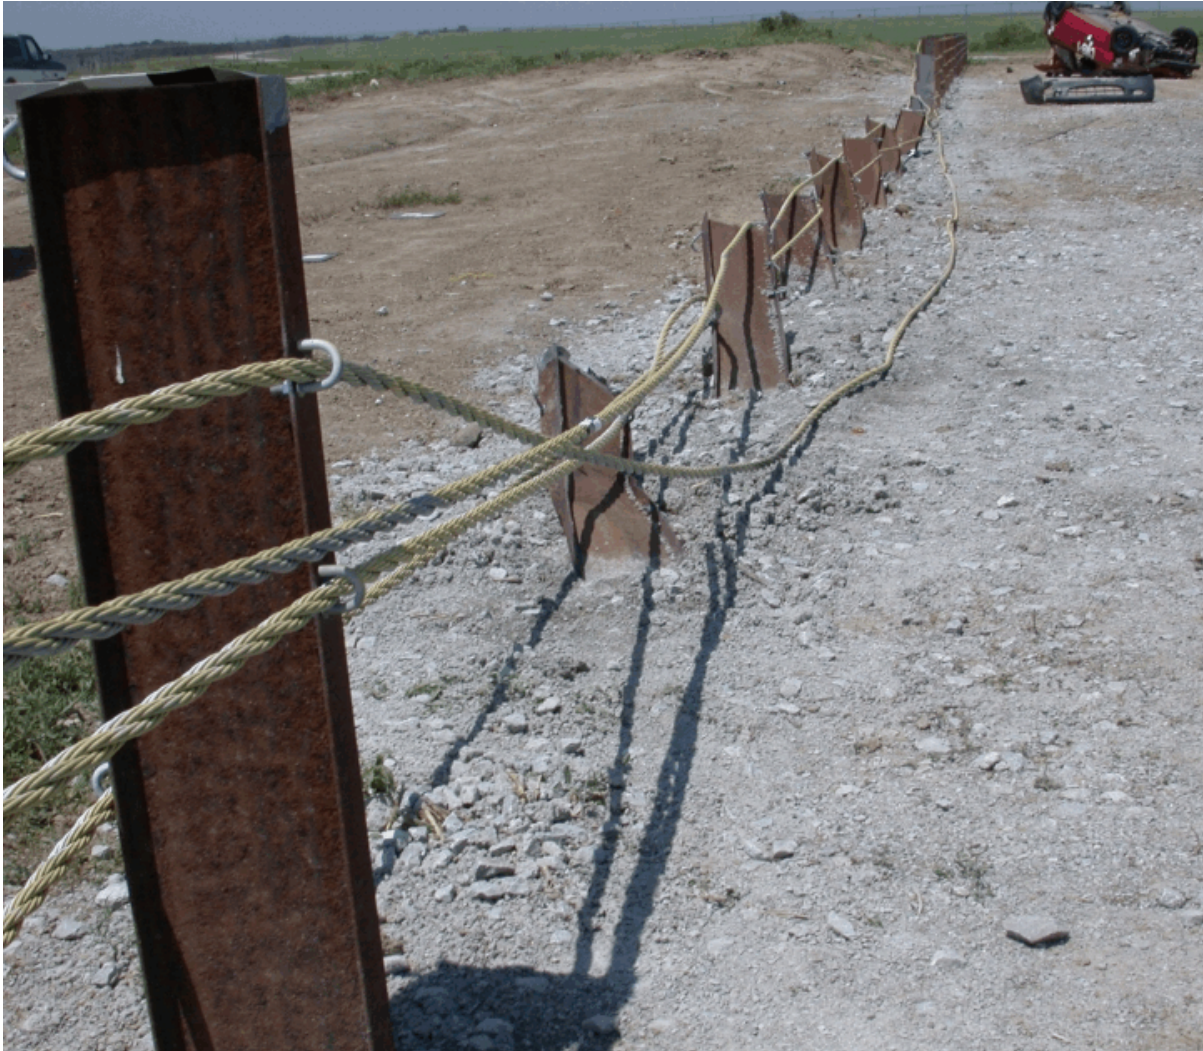
Figure 42. Vehicle Final Position and Trajectory Marks, Test CMB-1

53.6 km/h (33.3 mph). At 1.674 sec, the car had rolled such that its entire right side was in contact with the ground. At 1.936 sec, the car had rolled completely over and was sliding on its roof. At 2.180 sec, the left-front corner of the car was the only vehicle component still in contact with the ground. At 2.312 sec, the vehicle was completely airborne, and it continued to roll. The final position of the vehicle was determined to be 34.5 m (113.2 ft) downstream from impact and 4.3 m (14.1 ft) laterally from the barrier, as shown in Figure 42.

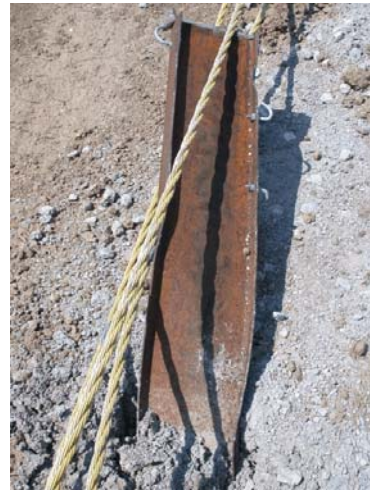
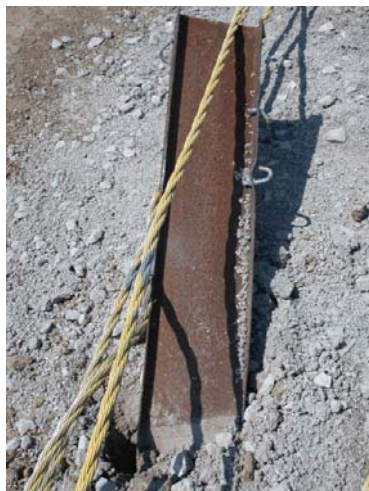
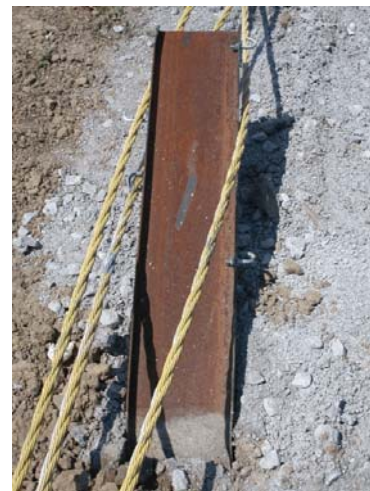
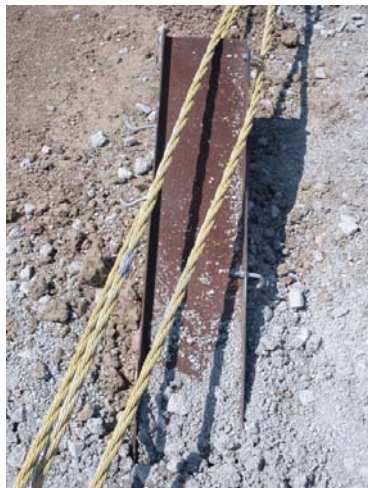
Figure 44. Post Nos. 41 through 46 Damage, Test CMB-1

The permanent set of the posts is shown in Figures 43 through 45. The anchor ends encountered slight permanent set deformations, as shown in Figure 46. The maximum lateral permanent set post deflections were not calculated for this test. The maximum lateral dynamic post

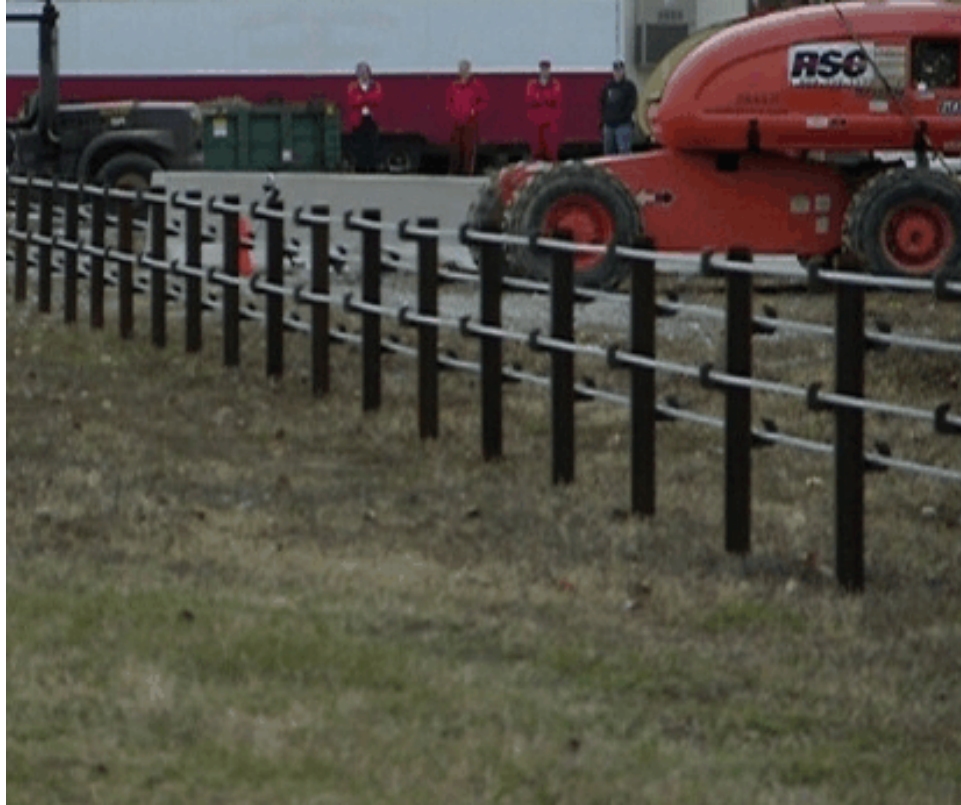
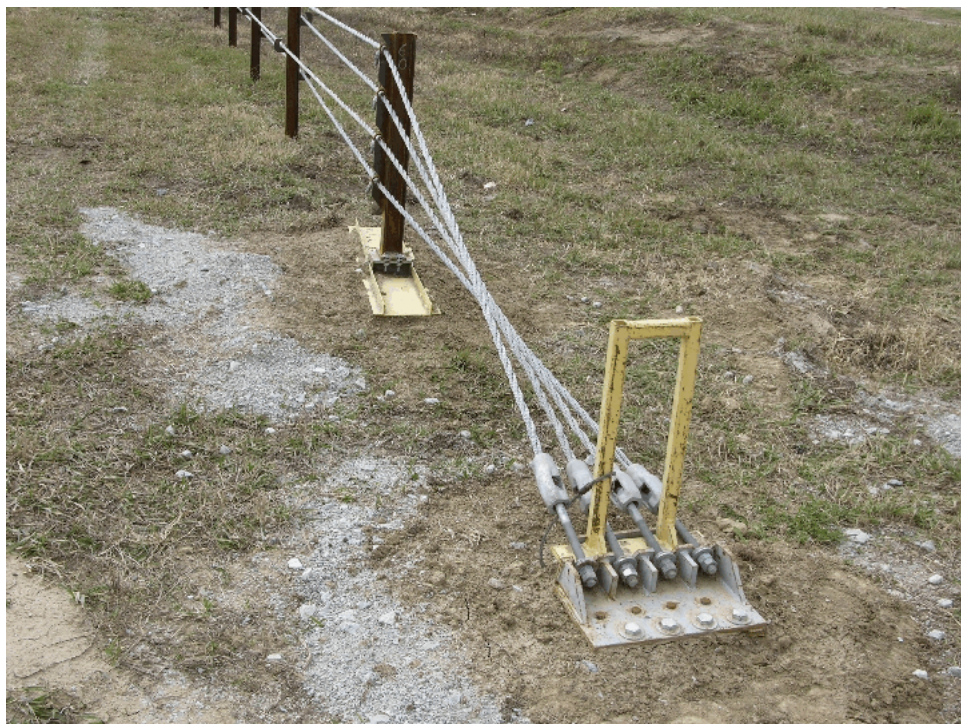
Figure 56. Low-Tension Cable Median Barrier, Design No. 2

middle two cables. Once again, four cables were supported by each post but without weaving the cables between the posts. The top and lower-middle cables were placed on one flange, while the bottom and upper-middle cables were attached to the opposite flange. Photographs of the test installation are shown in Figures 56 and 57. Complete system drawings in metric and English units are shown in Appendix D.

In order to improve barrier performance, several design modifications were implemented into the low-tension, cable guardrail system. First, the post spacing was increased from 1.83 m (6 ft) to 2.44 m (8 ft). Following this modification, the cable guardrail system was altered from an 80 post, 148-m (486-ft) long barrier system to a 61 post, 147.5-m (484-ft) long test installation, which is shown in Figure 53. Second, the M203x9.7 (M8x6.5) posts were replaced with 1,676 mm (66 in.) long, S76x8.5 (S3x5.7) sections. Each post incorporated a welded 6-mm x 203-mm x 610-mm (0.25-in. x 8-in. x 24-in.) soil plate. All cables were attached to the posts using welded 13-mm x 86-mm x 76-mm (0.5-in. x 3.375-in. x 3-in.) rigid cable brackets, as shown in Figures 54 and 55. The new hooks were designed to develop the moment capacity of the line posts. Third, the embedment depth of the post was changed from 1,067 mm (42 in.) to 787 mm (31 in.). Last, the cable mounting heights were altered from Design No. 1 due to the interaction of the vehicle with the cables. The bottom and top cable mounting heights were increased to 343 mm (13.5 in.) and decreased to 838 mm (33 in.) respectively, incorporating an incremental spacing of 165 mm (6.5 in.) between the

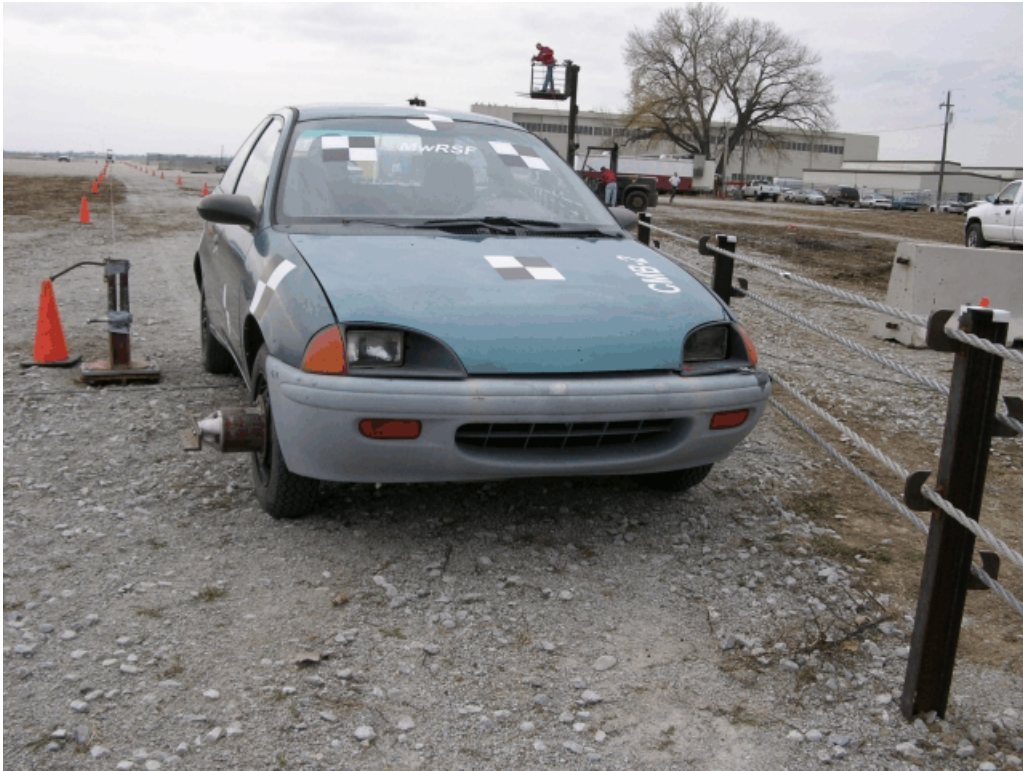
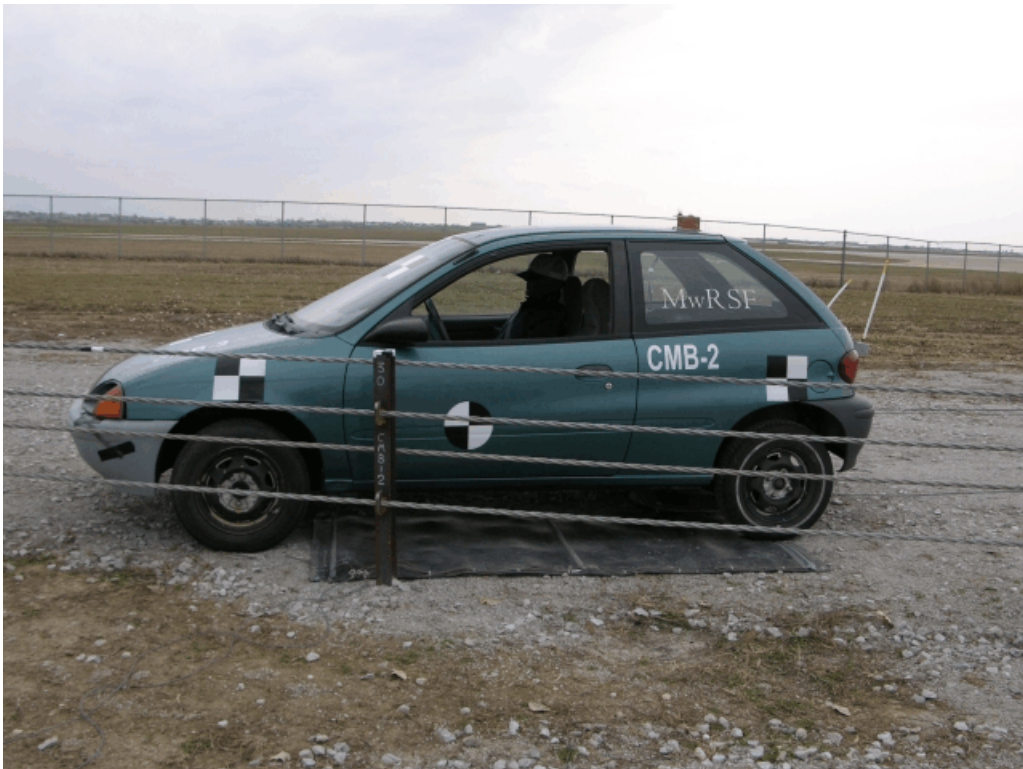
Figure 65. Impact Location, Test CMB-2

Initial vehicle impact was to occur between post nos. 30 and 31, or 1,219 mm (4 ft) upstream from the centerline of post no. 31, as shown in Figure 65. At 0.036 sec, post no. 32 was impacted and deflected backward. At 0.082 sec, the left-front corner of the vehicle was crushed inward. At 0.116 sec, the vehicle impacted post no. 33. At 0.178 sec, the top and upper-middle cables rode across the windshield and the bottom and lower-middle cables redirected the vehicle. At 0.258 sec, the vehicle rolled slightly to the passenger's side. At 0.456 sec, the vehicle was redirected parallel to the barrier system with a speed of 58.6 km/h (36.4 mph). At 0.532 sec, the vehicle impacted post no. 34. At 0.660 sec, a large separation was observed between the car and the engine hood. At 0.746 sec, vehicle snag was observed near post no. 37, thus causing the car to rapidly rotate toward the driver's side. At 0.820 sec, the back end of the car became airborne and was yawing counter-clockwise away from the barrier. At 1.004 sec, the car continued to rotate toward the system as the rear wheels dropped to the ground. At 1.356 sec, the car began to roll toward the driver's side as the counter-clockwise yawing motion of the vehicle caused the right-rear tire to slide across the ground. At 1.688 sec, the vehicle came to rest and was nearly perpendicular to the barrier system, with the

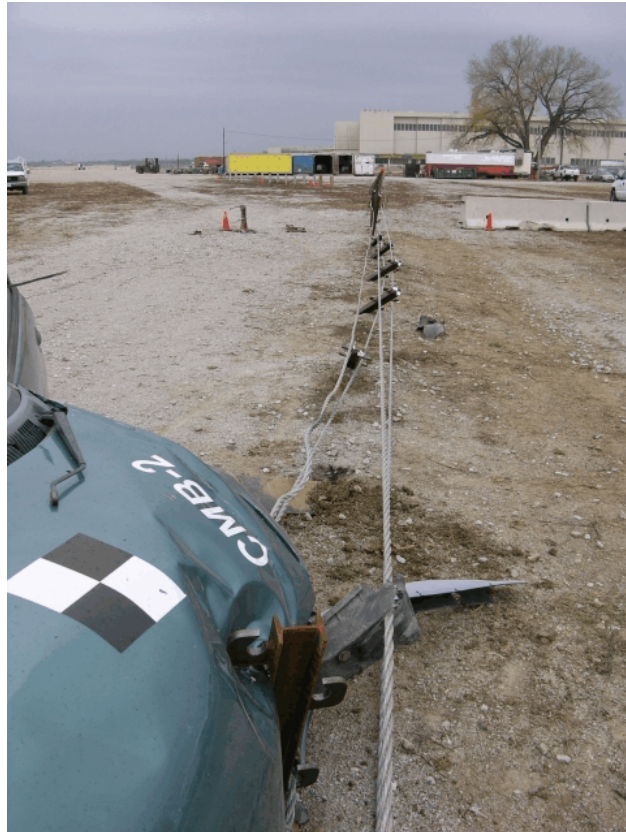
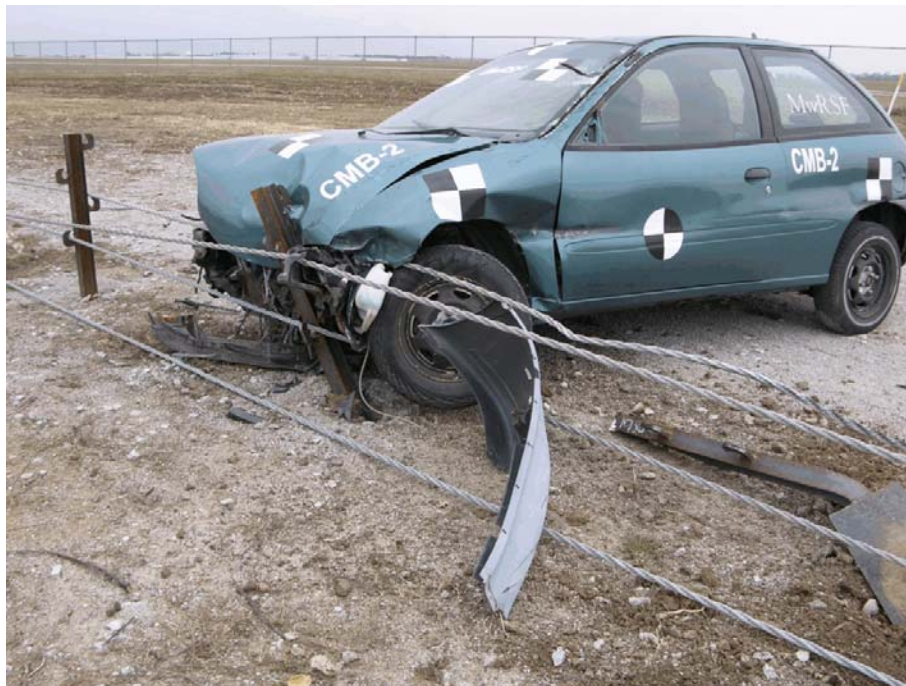
Figure 66. Vehicle Final Position and Trajectory Marks, Test CMB-2

front side of the car resting on post no. 37. The final position of the vehicle was determined to be 15.4 m (50.5 ft) downstream from impact and 0.0 m (0.0 ft) laterally from the barrier, as shown in Figure 66.

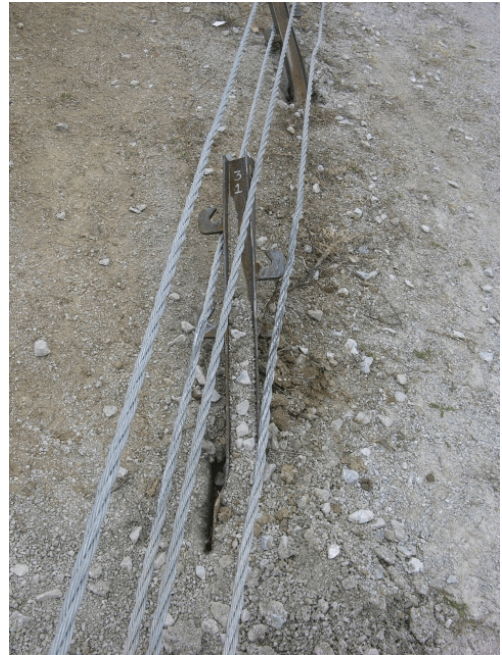
Post No. 31

The permanent set of the posts is shown in Figures 67 through 69. The anchor ends encountered slight permanent set deformations, as shown in Figure 70. The maximum lateral permanent set post deflection was 394 mm (15.5 in.) at post nos. 33 and 34. The maximum lateral dynamic post deflection was 842 mm (33.1 in.) at post no. 33, and the working width was determined to be 1,919 mm (75.6 in.), as determined from the high-speed film analysis.

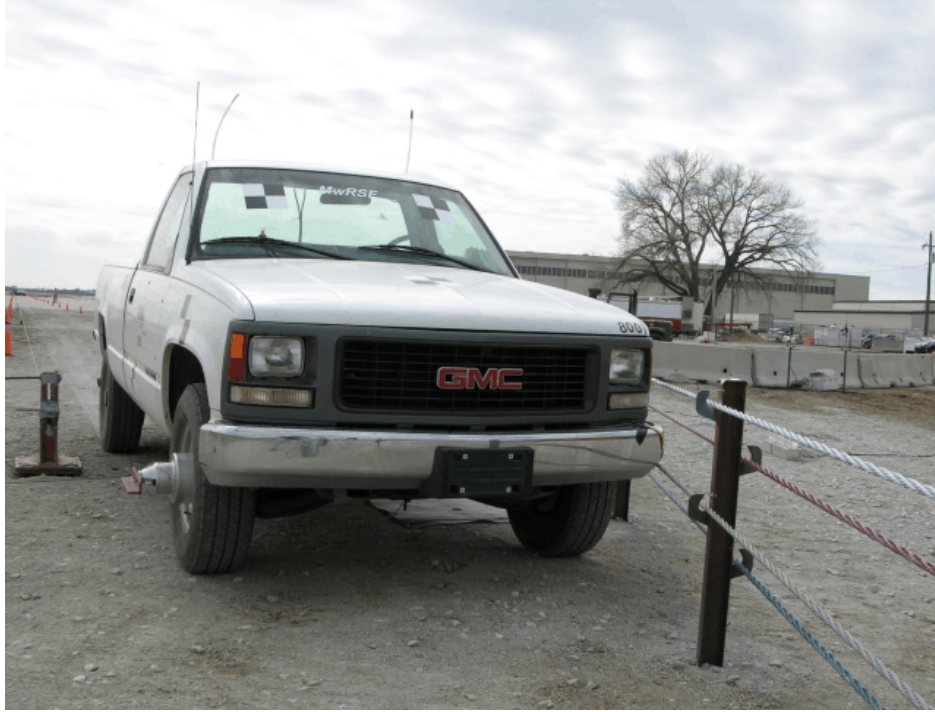
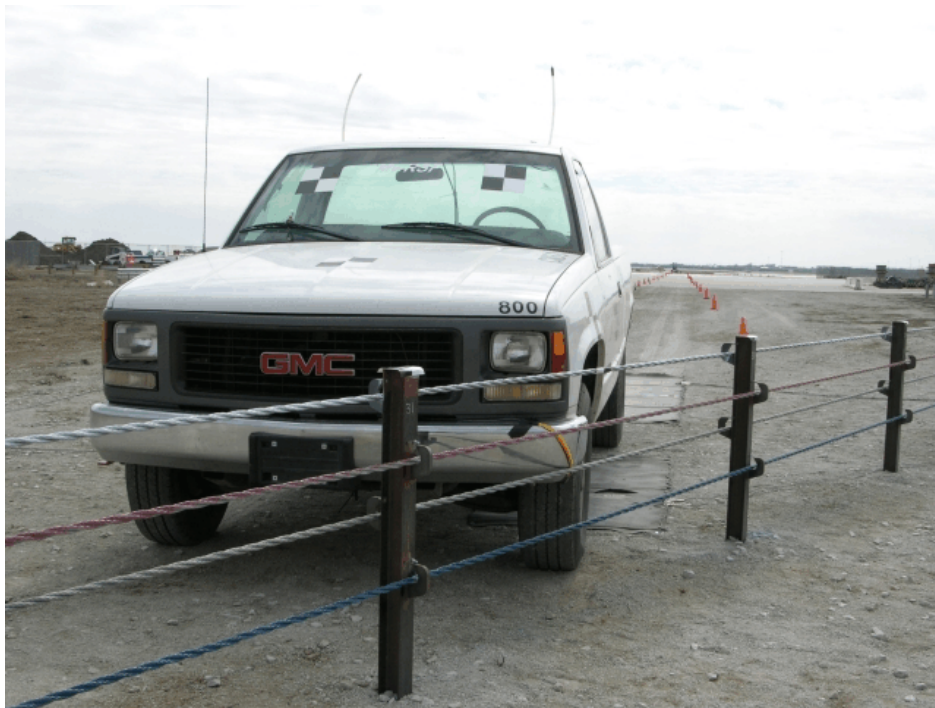
Figure 88. Vehicle Impact Location, Test CMB-3

Initial vehicle impact was to occur between post nos. 30 and 31, or 1,219 mm (4 ft) upstream from the centerline of post no. 31, as shown in Figure 88. At 0.010 sec, the left-front bumper impacted post no. 31. At 0.022 sec, the lower-middle and bottom cables were in contact with the left-front tire, and post no. 32 rotated clockwise. At 0.042 sec, the vehicle impacted post no. 32, which caused it to bend downstream. At 0.050 sec, top and upper-middle cables were released from post no. 32, and the left-front tire rolled on top of the lower-middle and bottom cables. At 0.064 sec, the front bumper crushed farther into the engine compartment. At 0.084 sec, the left-front tire was completely airborne. At 0.118 sec, post no. 32 was impacted by the pickup truck. At this time, the rear end of the truck pitched upward slightly, but the tires remained on the ground. Subsequently, the vehicle traveled behind post nos. 33 through 37. At 0.154 sec, post no. 34 deflected backward, and the pickup truck pitched and rolled toward the vehicle's right-front corner. At 0.162 sec, the top and upper-middle cables detached from post no. 34. The left-front door was positioned behind the original barrier face. At 0.208 sec, the right-front wheel passed over the lower-middle and bottom cables, thus causing a jerking motion on post nos. 34 and 35. At this same time, the top two cables continued to

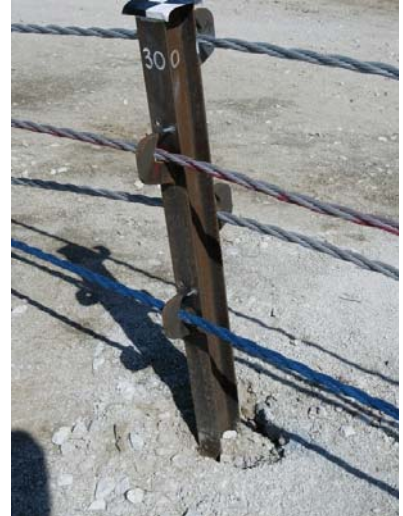
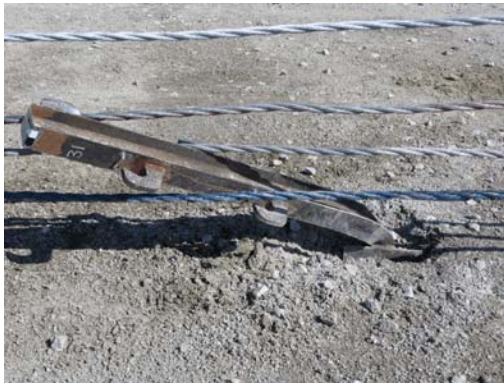
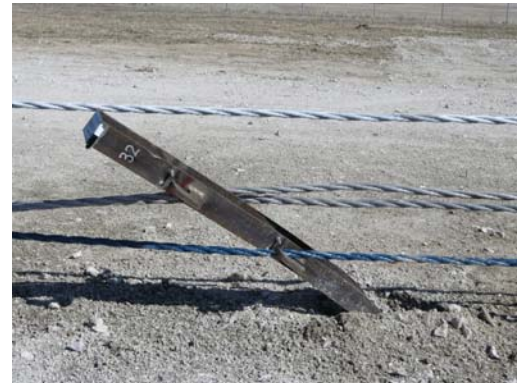
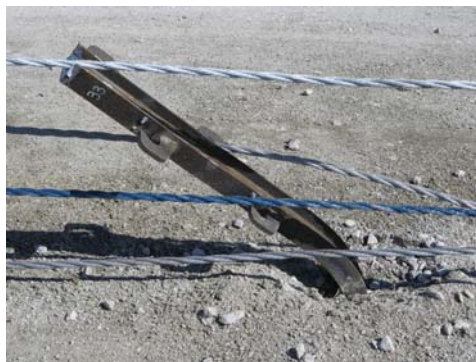
Figure 91. Post Nos. 29 through 33 and 35 Damage, Test CMB-3

The permanent set of the posts is shown in Figures 90 through 92. The anchor ends encountered slight permanent set deformations, as shown in Figures 93 and 94. The maximum lateral permanent set post deflection was not calculated for this system. The maximum lateral dynamic post deflection was 665 mm (26.2 in.) at post no. 30, and the working width was determined to be 2,878 mm (113.3 in.), as determined from the high-speed film analysis.
