DESIGN AND EVALUATION OF A LOW-TENSION CABLE GUARDRAIL END TERMINAL SYSTEM

MIDWEST ROADSIDE SAFETY FACILITY

MwRSF Research Report No. TRP-03-131-08

July 15, 2008

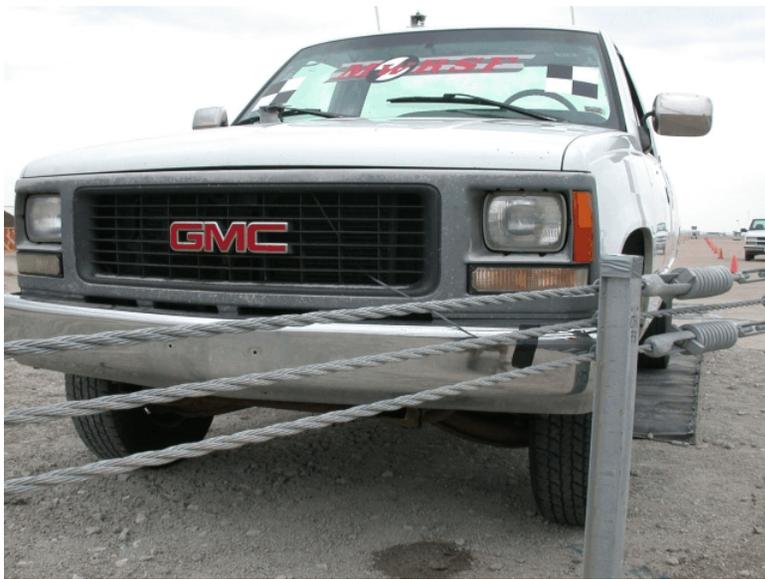
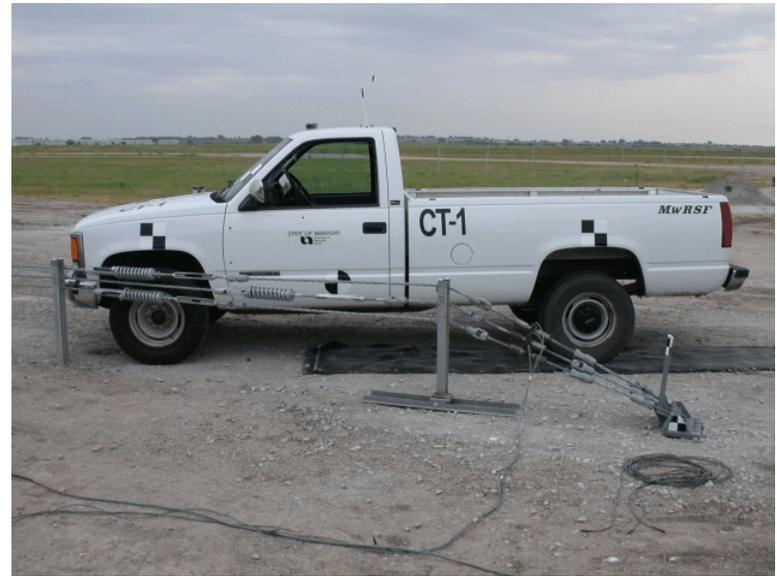
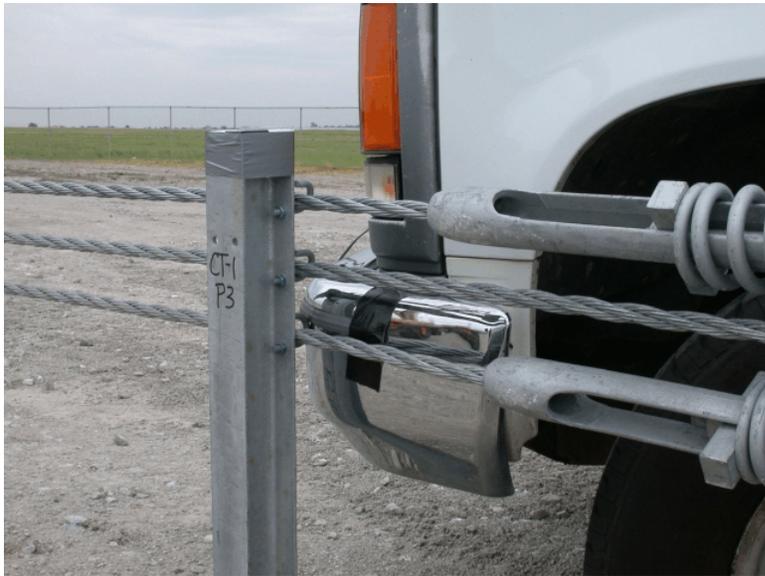
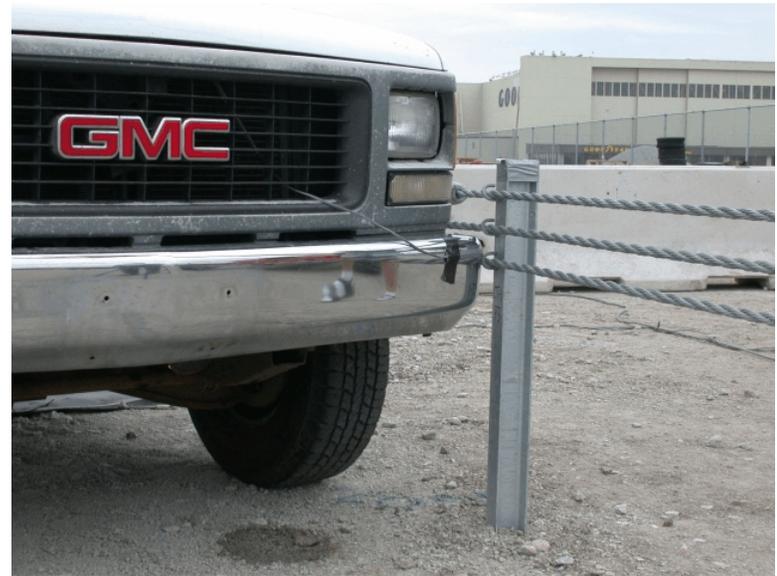
Figure 30. Impact Location, Test CT-1

Impact occurred at post no. 3, as shown in Figure 30. At 0.062 sec after impact, the top and middle cables deformed the left-front corner of the hood. At 0.084 sec, the bottom cable was positioned above the bumper. At 0.154 sec, the truck contacted post no. 4. At 0.192 sec, the truck began to redirect. At 0.270 sec, the left-front fender deformed downward from the cable tension. At 0.338 sec, the truck contacted post no. 5. At 0.378 sec, the right end of the bumper contacted post no. 6. By 0.450 sec, the entire truck was positioned behind the line of posts. At this same time, the middle and bottom cables were positioned under the rear bumper, and the right-rear tire contacted the top of post no. 4. At 0.509 sec, the truck became parallel to the system with a resultant velocity of 93.6 km/h (58.2 mph). At 0.570 sec, the truck rolled slightly towards the right side. At 0.673 sec, the right side of the bumper contacted post no. 7, and the truck exhibited roll toward the left side. At this same time, the right-rear tire traversed over the top of post no. 5, and the left-side headlight housing fractured. At 0.798 sec, the right-front tire traversed over post no. 7. At 0.989 sec, the truck contacted post no. 8. At 1.331 sec, the front of the truck exited the system. The truck exited the

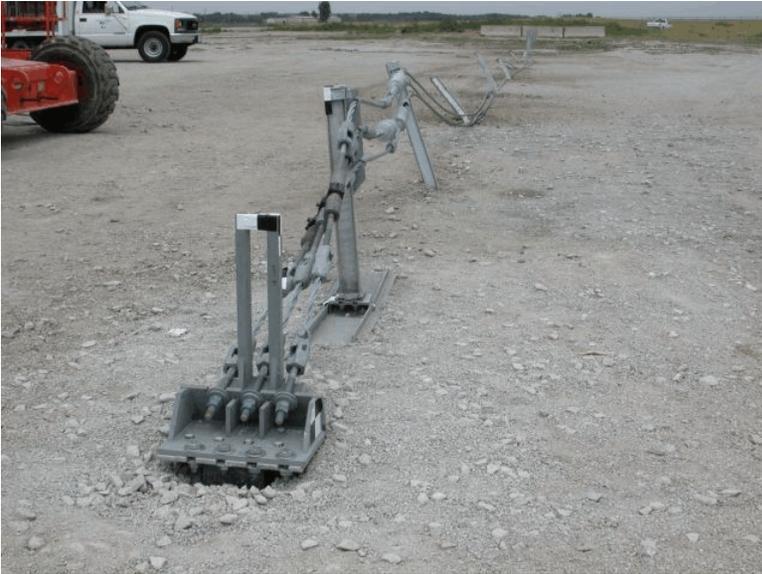
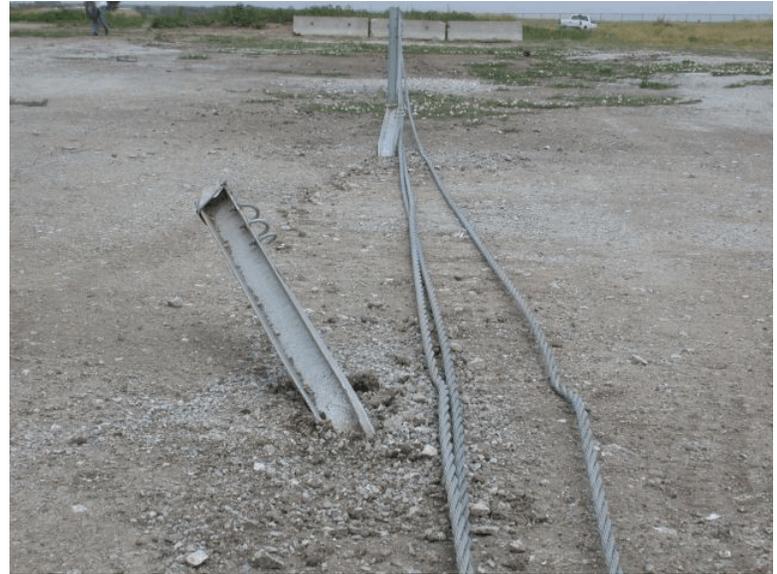
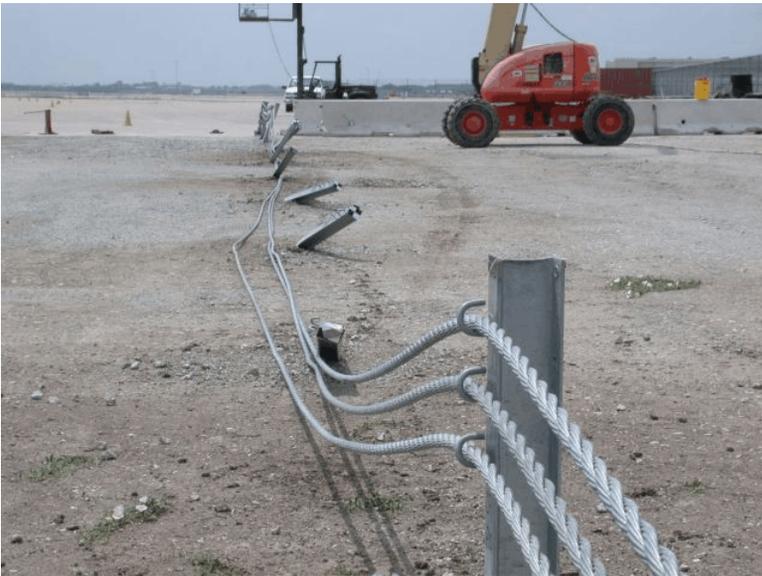
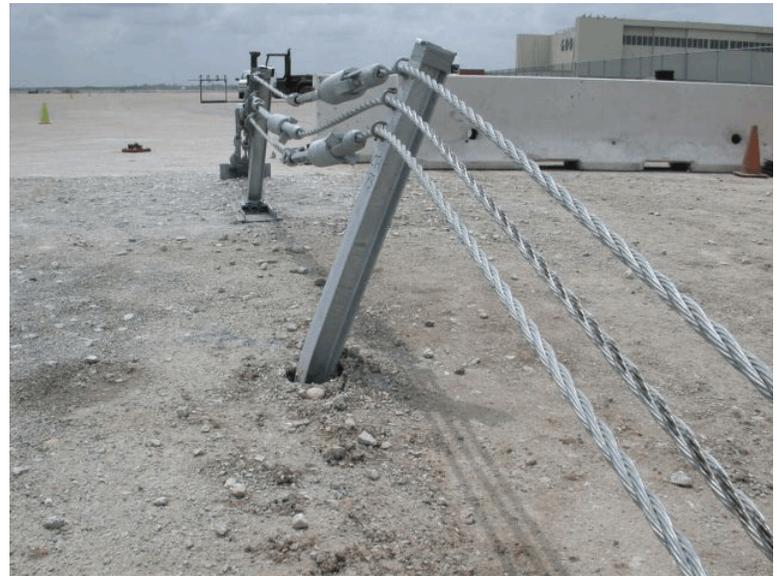
Figure 32. System Damage, Test CT-1

Damage to the cable guardrail end terminal was moderate, as shown in Figures 32 through 36. Barrier damage consisted of contact marks on posts, deformed line posts, disengaged cable, and deformed cable hooks. The length of vehicle contact along the cable system was approximately 39.3 m (128 ft - 11 in.), which spanned from post no. 3 through post no. 8.

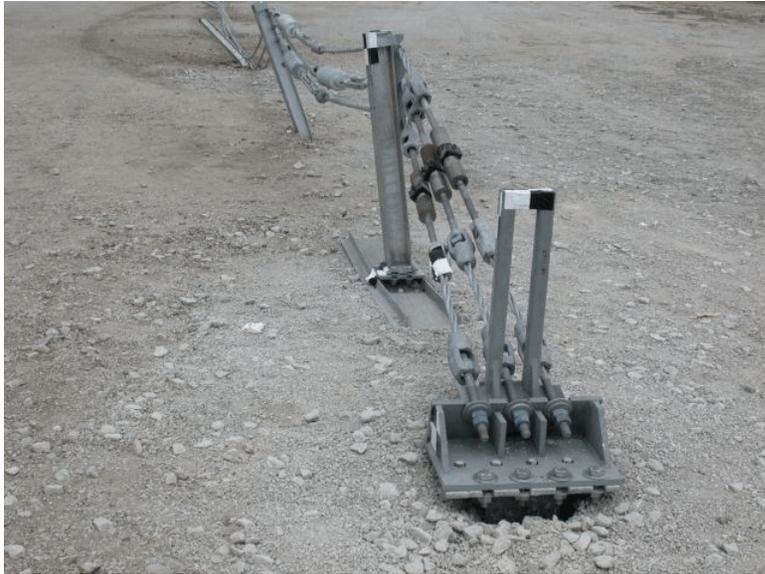
Figure 33. Upstream Anchor Post Damage, Test CT-1

Post no. 1 rotated and deflected downstream. However, the cable anchor bracket, cable release lever, and cable fittings were undamaged. The center of the soil plate on post no. 2 was bent. Post no. 2 rotated causing damage to the upstream traffic-side slip bolt and washer. The slip plate welds on the traffic and back sides of post no. 2 were torn. Post no. 3 bent downstream and twisted in the soil. Post no. 4 also bent but twisted at the ground line. Heavy contact marks were found on the upstream-back flange which were 51 mm (2 in.) long and 32 mm (1.2-in.) long. Post no. 4 had contact marks on the front flange and gouges along the top 203 mm (8 in.) of the post. Post no. 5 bent and twisted 90 degrees with contact marks on the front face. Post no. 6 twisted slightly and bent downstream with cable marks on the front face of the post. Post nos. 7 through 9 bent downstream about the weak axis. Post no. 8 encountered heavy contact marks on the upstream front flange. Minor contact marks were evident on post no. 9. Post nos. 10 through 17 remained undamaged, but rotated slightly upstream towards impact. Post no. 18 encountered slight bending at the base and damage to the soil plate, as shown in Figure 36.

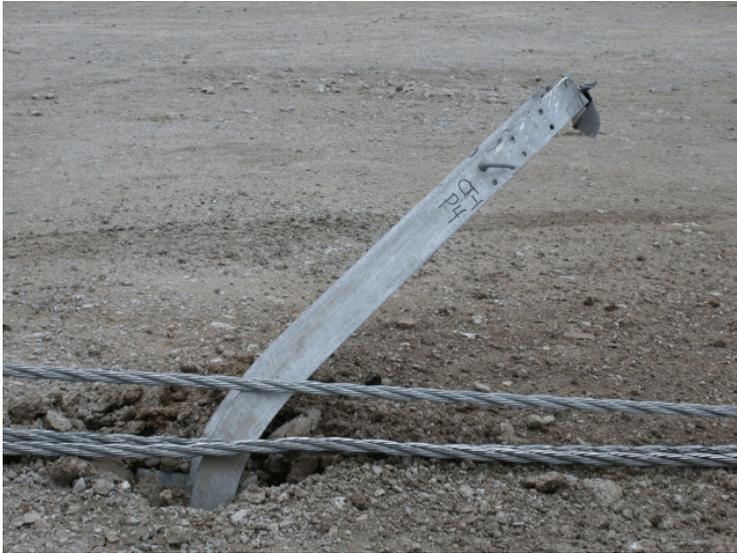
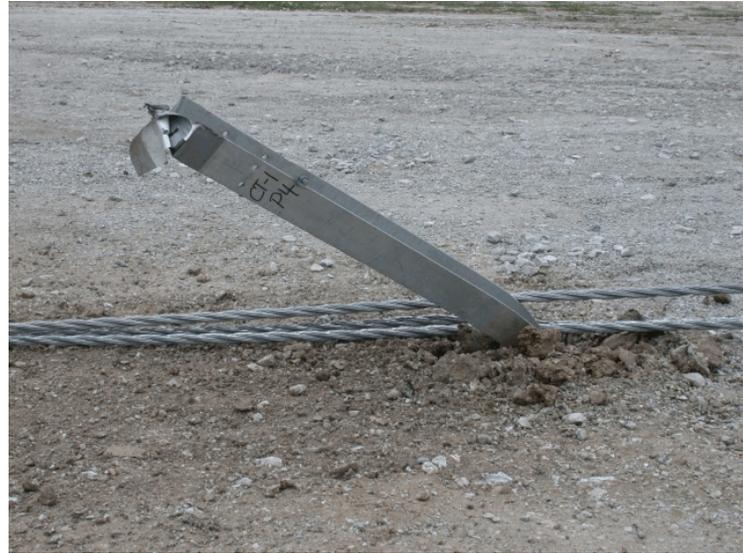
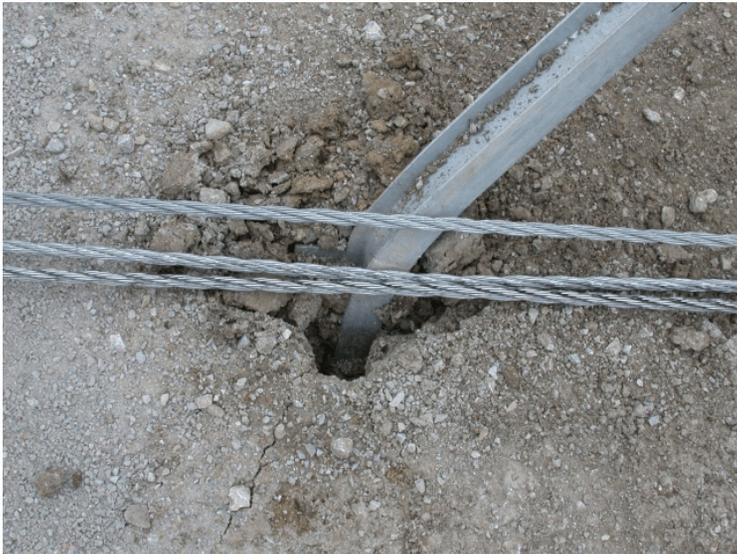
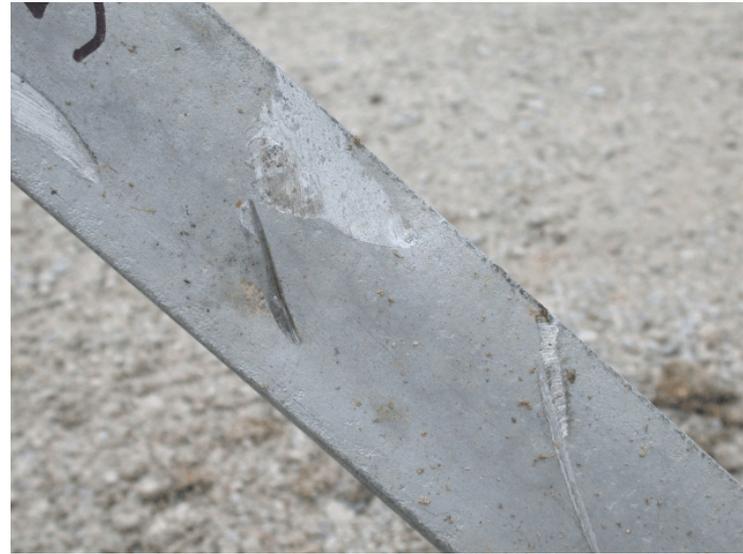
Figure 33. Post Nos. 4 and 5 Damage, Test CT-1

The top and middle hook bolts disengaged from post no. 4. All three hook bolts on post nos. 5 through 9 were deformed and damaged, but remained attached to the posts. The hook bolts on post nos. 3 and 10 through 17 remained undamaged and attached to the posts. The cables disengaged from post nos. 4 through 9.

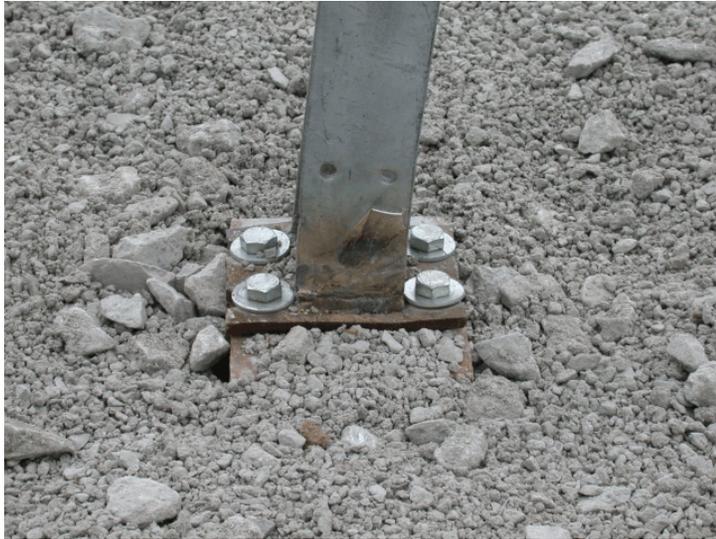
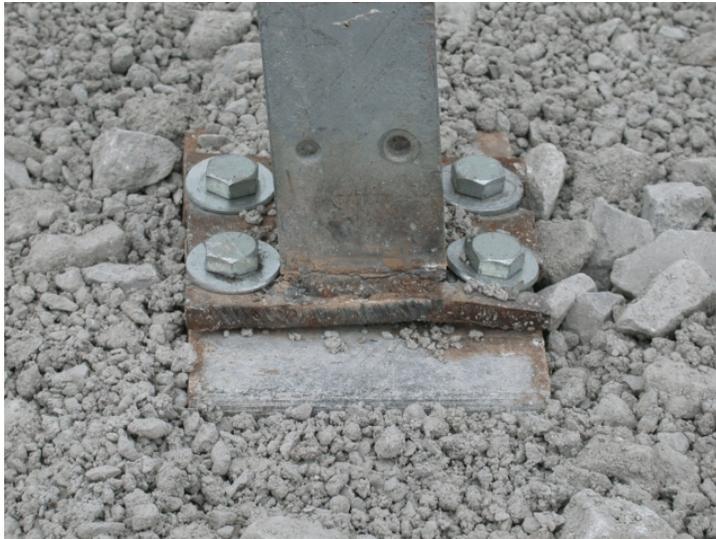
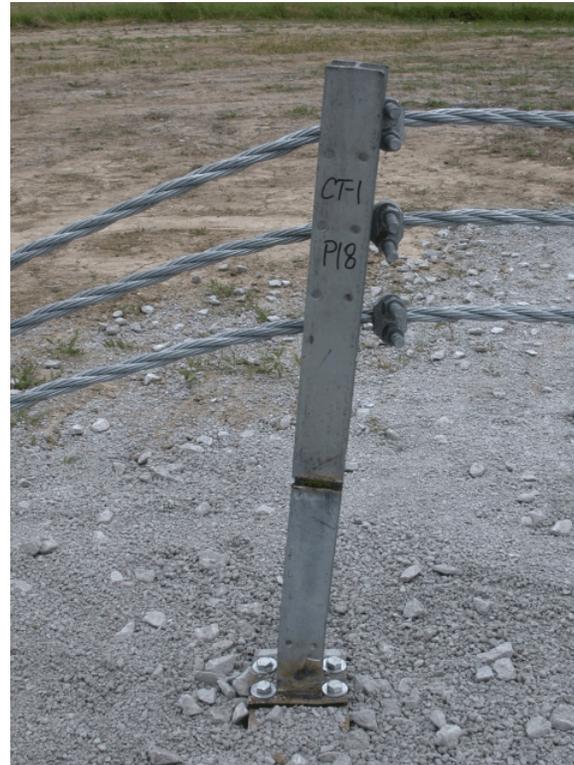
Figure 36. Post No. 18 Damage, Test CT-1

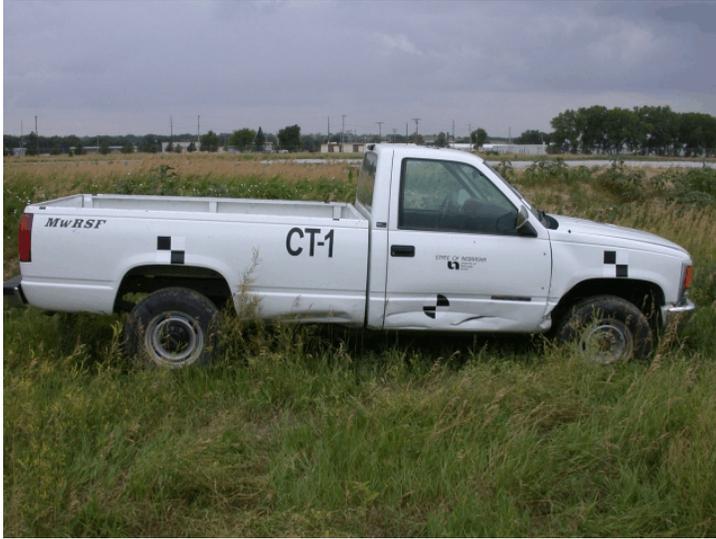
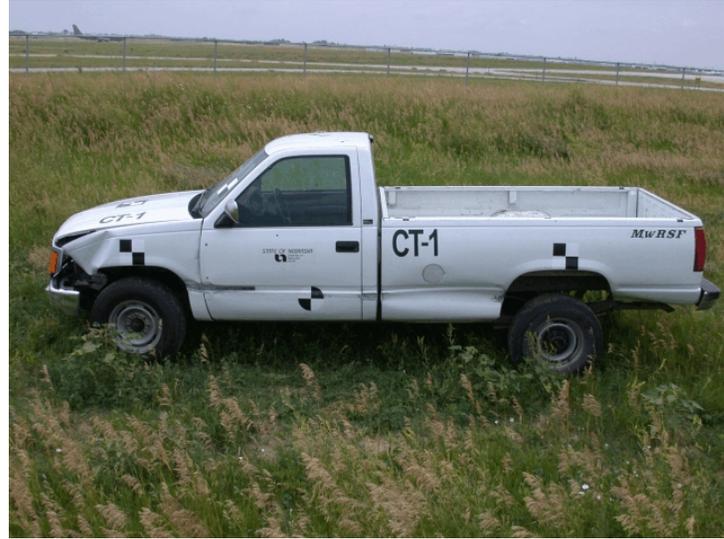
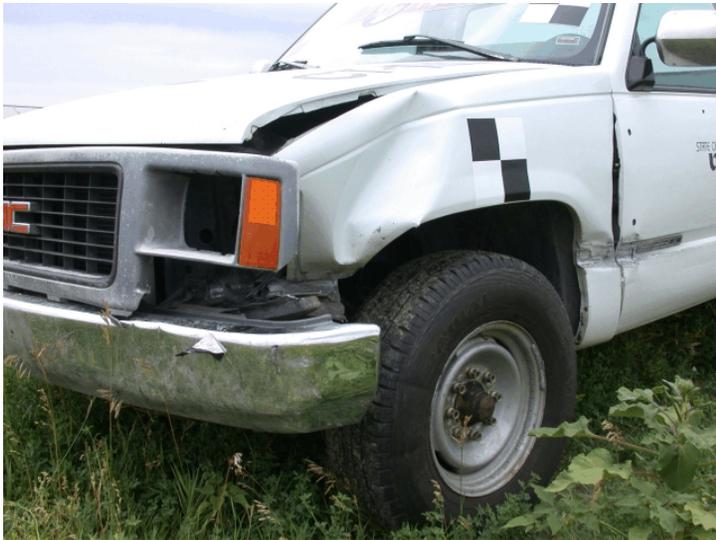
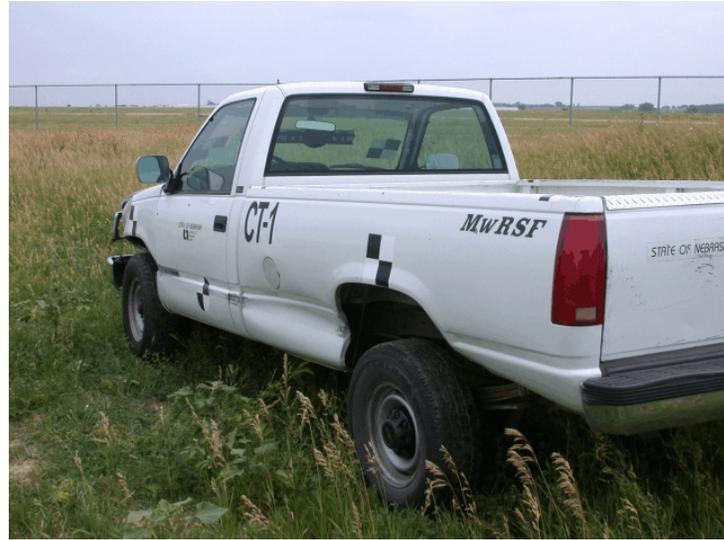
Exterior vehicle damage was minimal, as shown in Figures 37 through 40. Occupant compartment deformations to the left side and center of the floorboard were judged insufficient to cause serious injury to the vehicle occupants. The maximum lateral deformation was measured to be 13 mm (0.5 in.) at the center of the left-side dashboard. The maximum longitudinal and vertical deformations were measured to be 6 mm (0.25 in.) distributed throughout the floor pan. Complete occupant compartment deformations and the corresponding locations are provided in Appendix C.

Figure 37. Vehicle Damage, Test CT-1

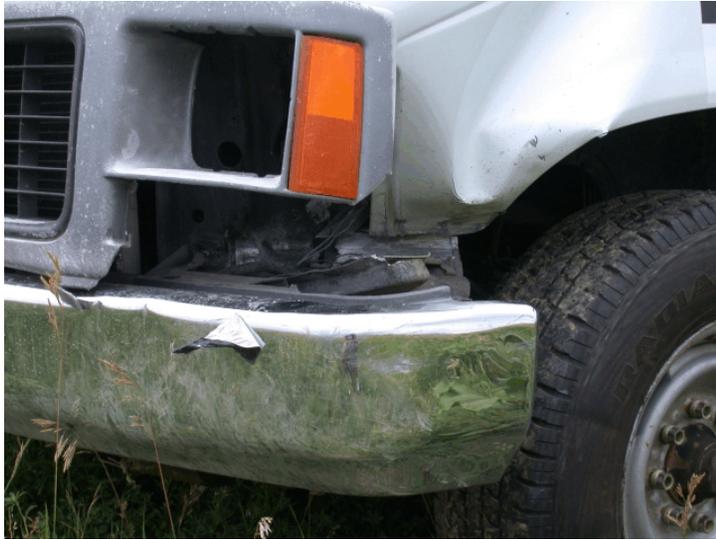
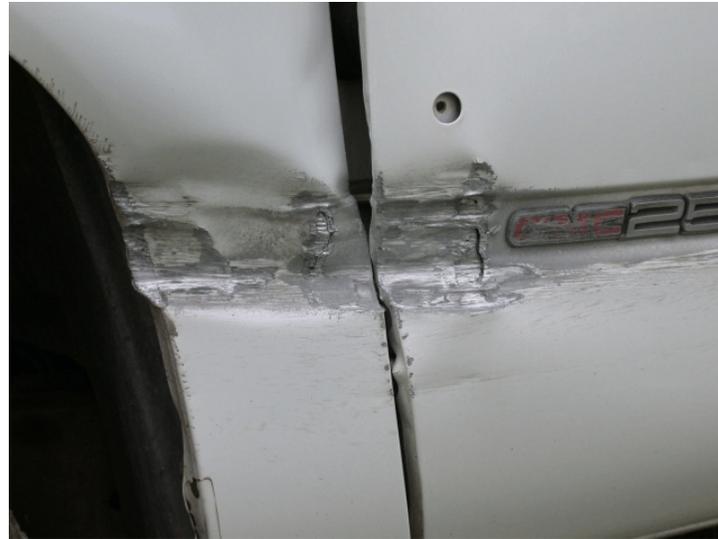
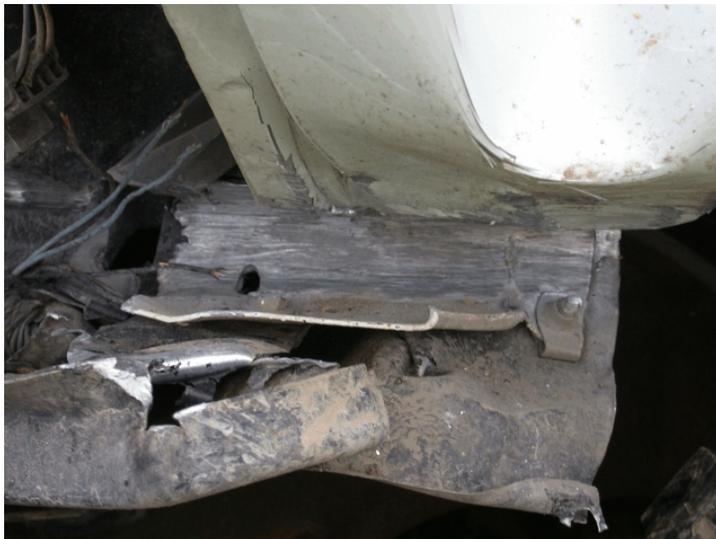
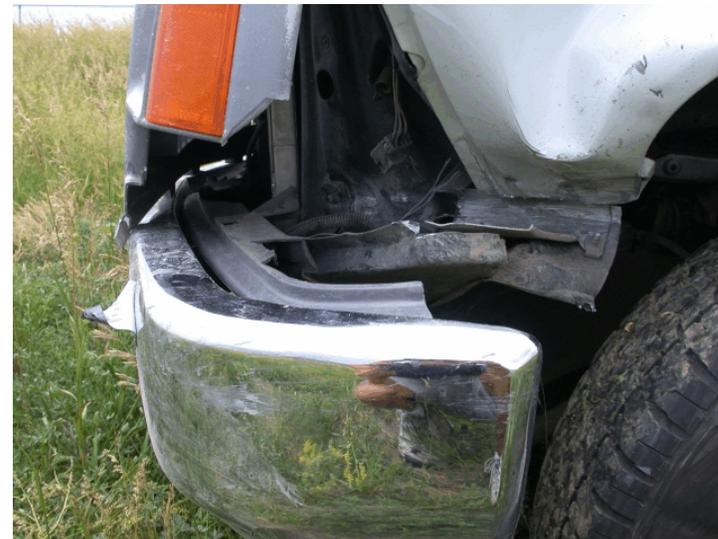
Figure 38. Vehicle Damage, Test CT-1

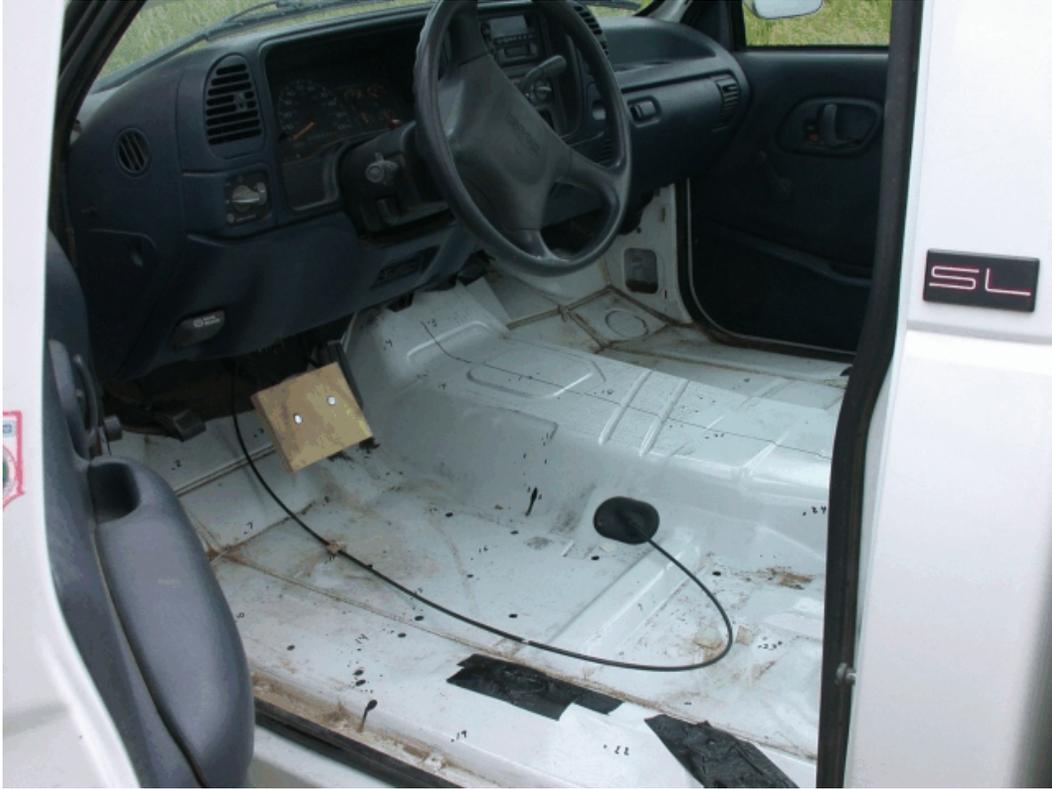
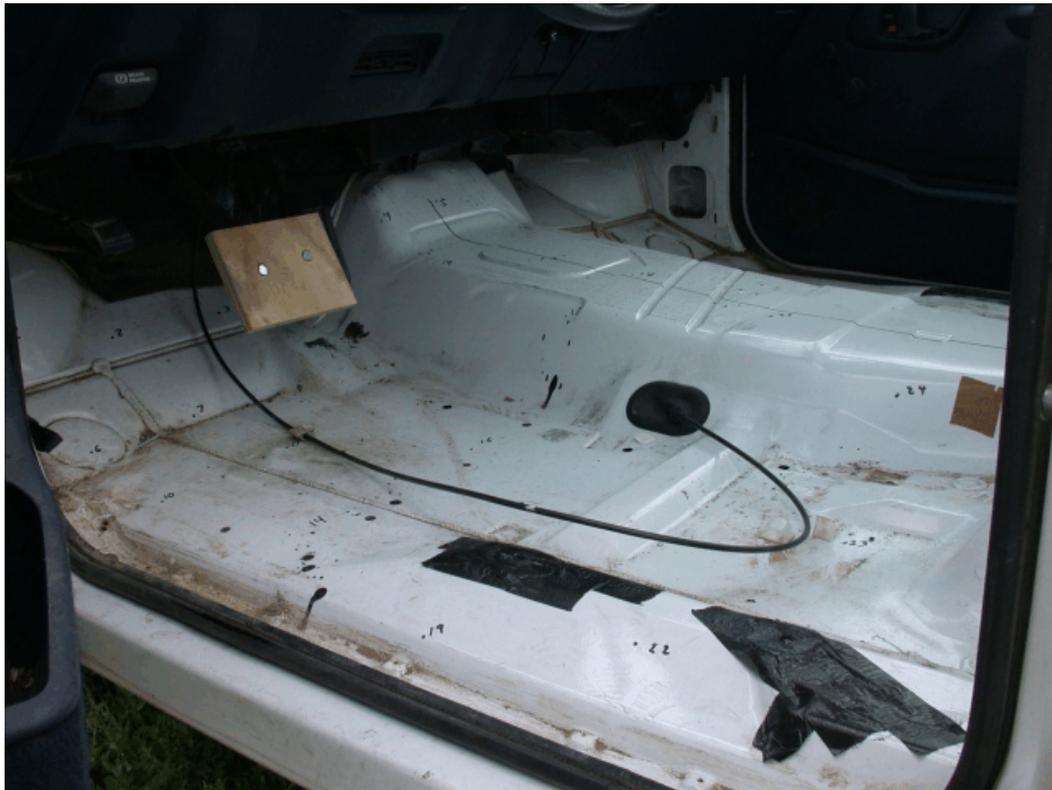
Figure 40. Occupant Compartment Damage, Test CT-1

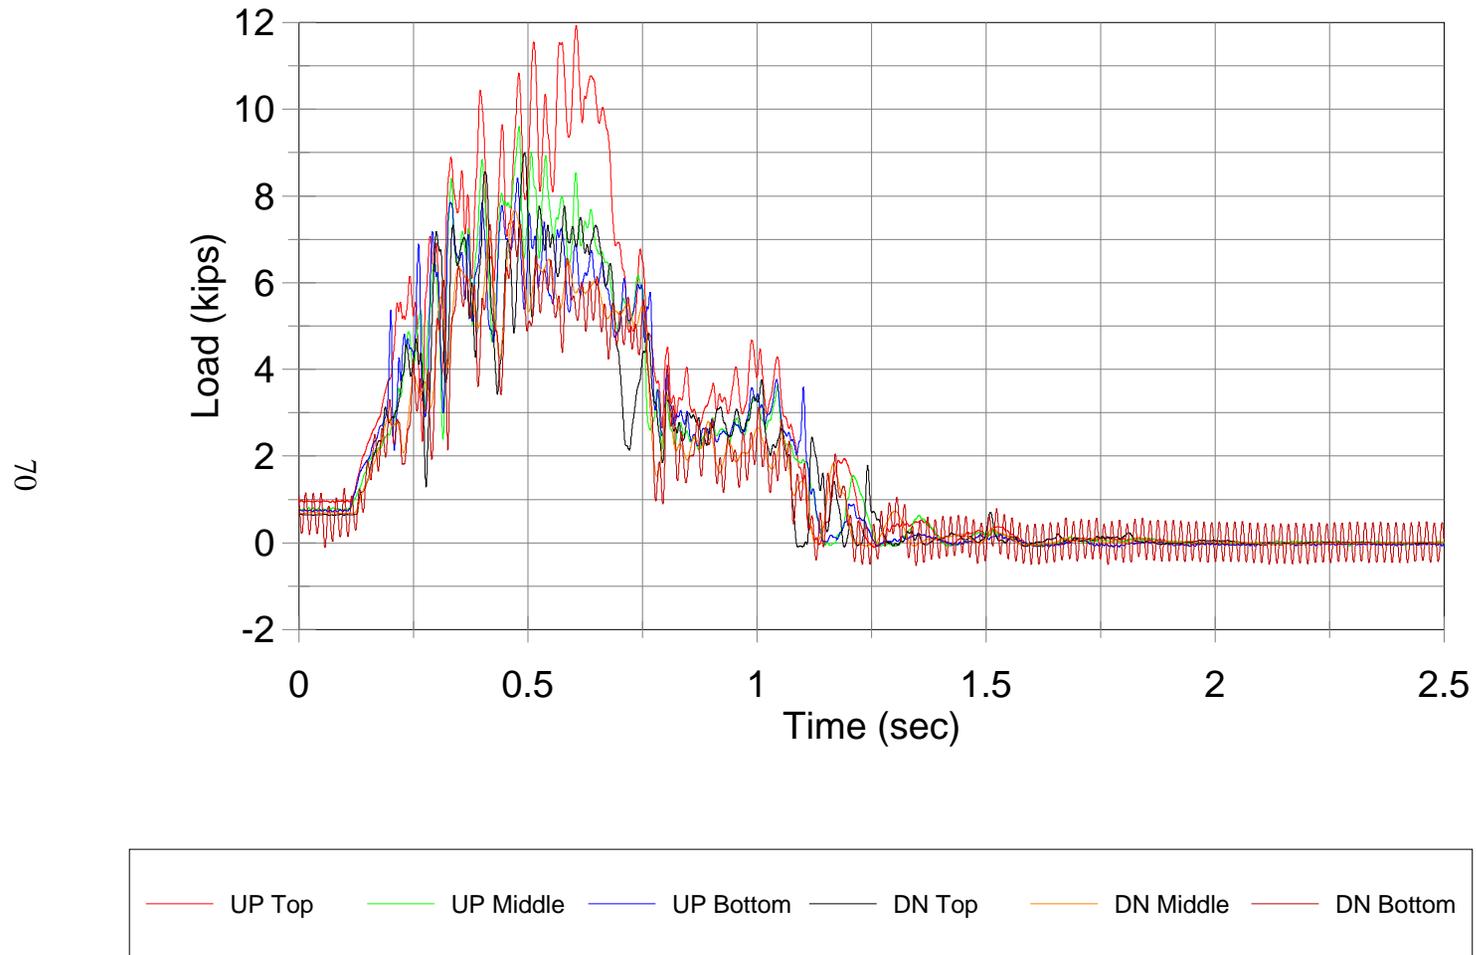
The recorded data for both sensor types is shown in Figures 41 through 45. The total cable load was summed and plotted, as shown in Figures 41 and 42. As expected, the upstream anchor experienced a larger load than the downstream anchor, due to vehicle friction with the cables during impact. The maximum forces acting on the upstream and downstream anchors were 127.2 kN (28.60 kips) and 100.3 kN (22.55 kips), respectively. The dissection of the total cable loading to the contribution of each individual cable is shown in Figures 43 through 45. The load pattern for the top cable mimics that of the total load. The upstream anchor experienced a maximum load of 53.1 kN (11.93 kips) and the downstream anchor experienced a maximum load of 40.0 kN (9.00 kips) by the top cable. The middle cable also followed the expected pattern, with the upstream anchor sustaining

Figure 41. Force - Time History for All Cables, Test CT-1

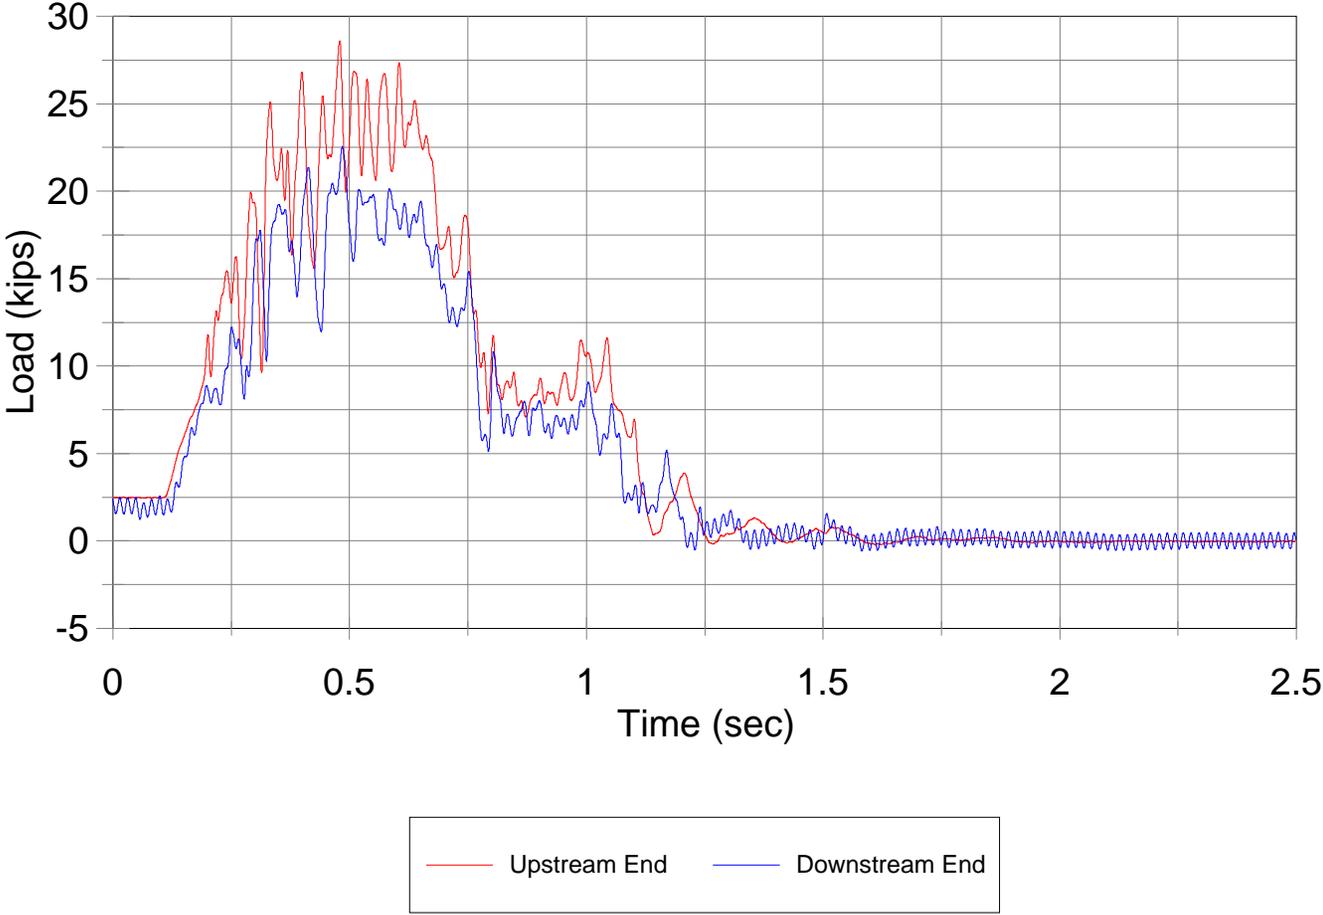
Figure 42. Force - Time History for Combined Cable Loading, Test CT-1

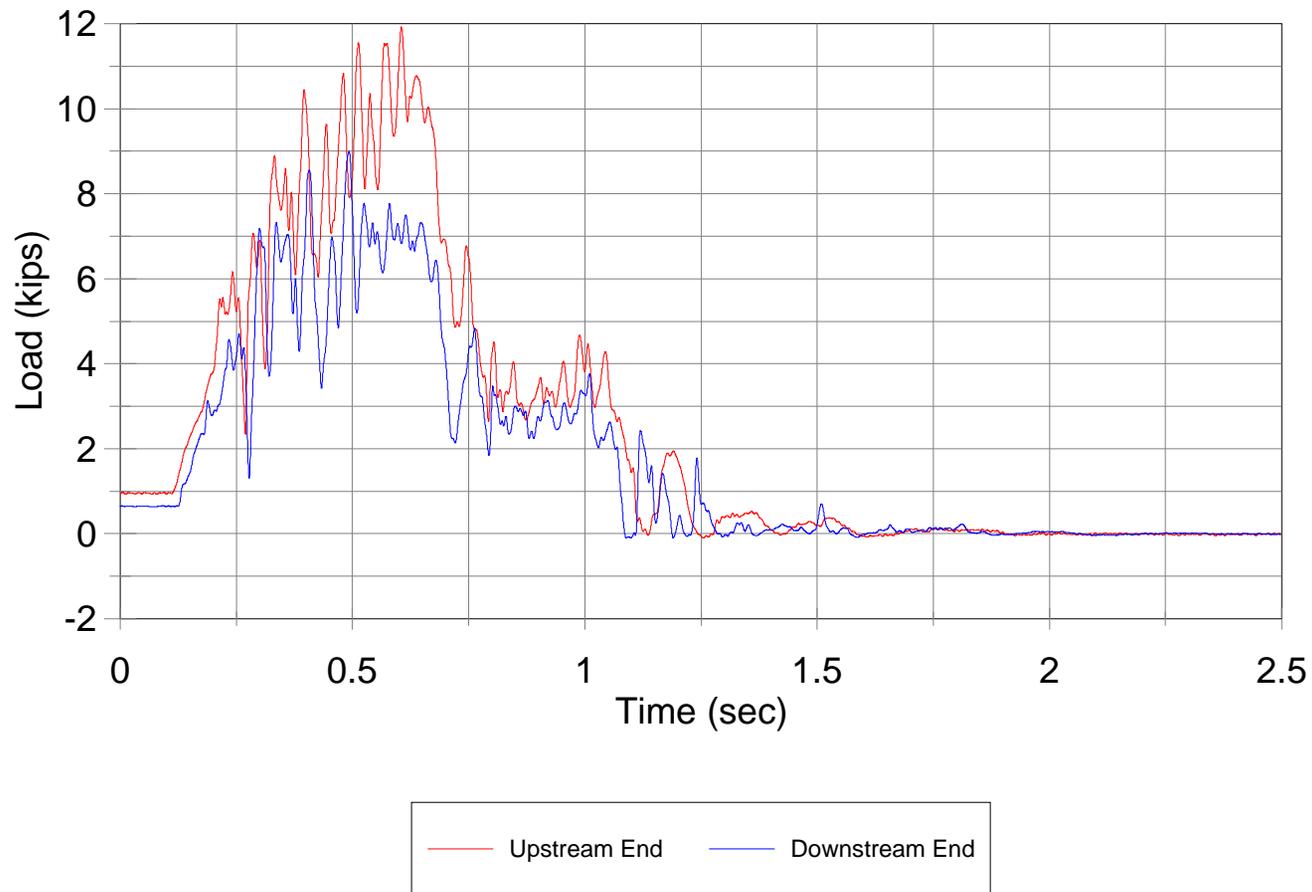
Figure 43. Force - Time History for Top Cable, Test CT-1

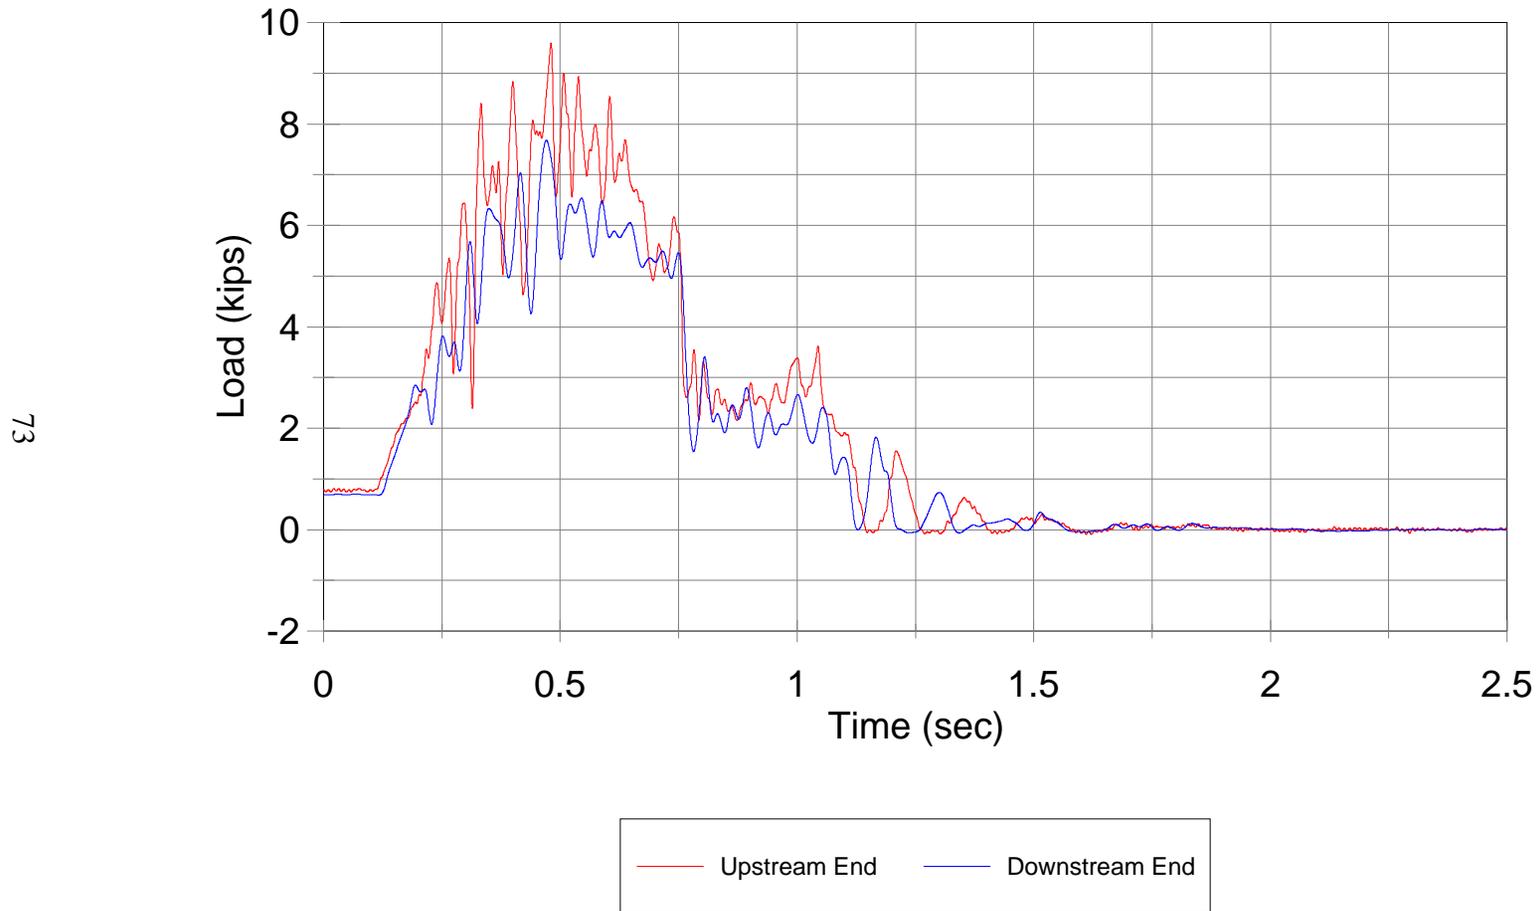
Figure 44. Force - Time History for Middle Cable, Test CT-1

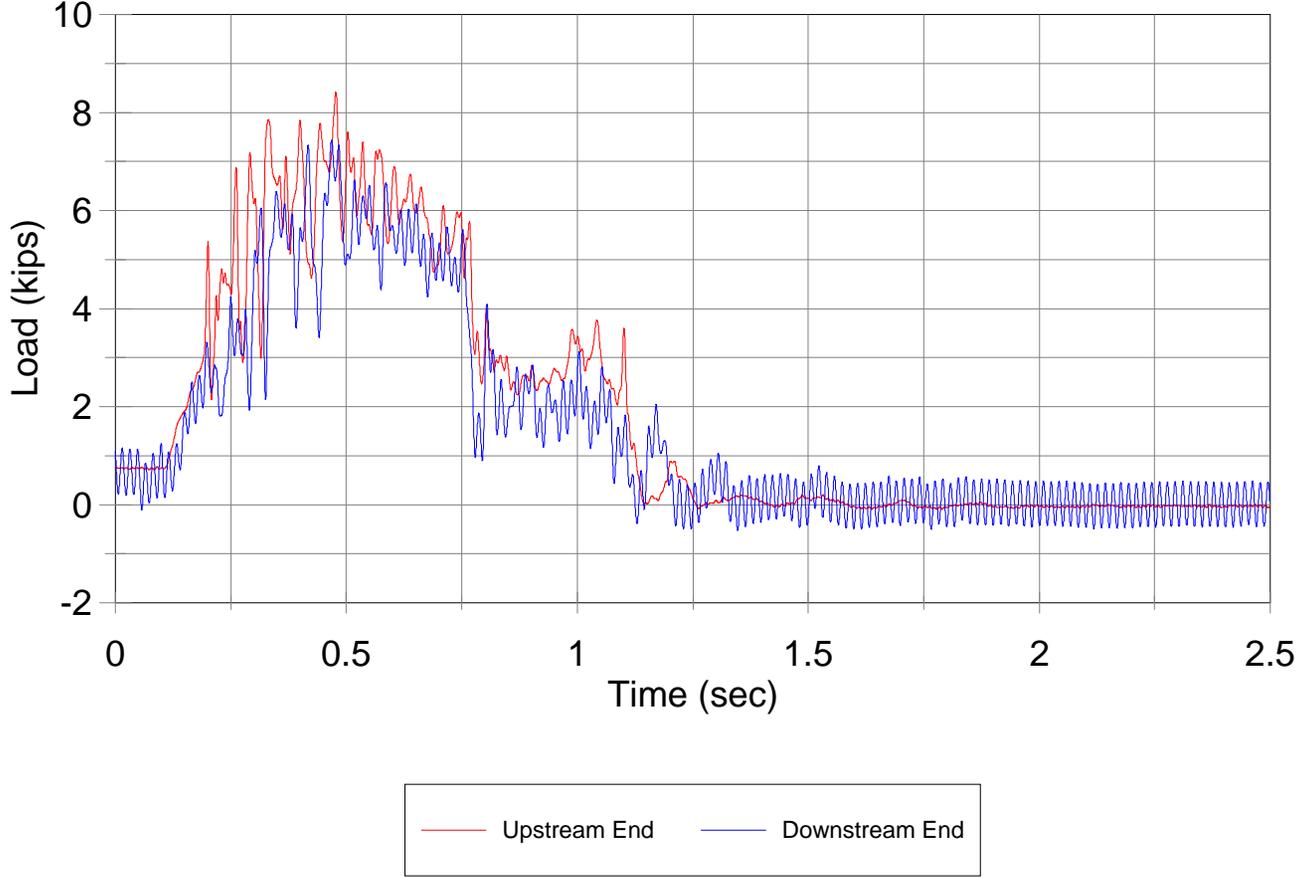
Figure 45. Force-Time History for Bottom Cable, Test CT-1

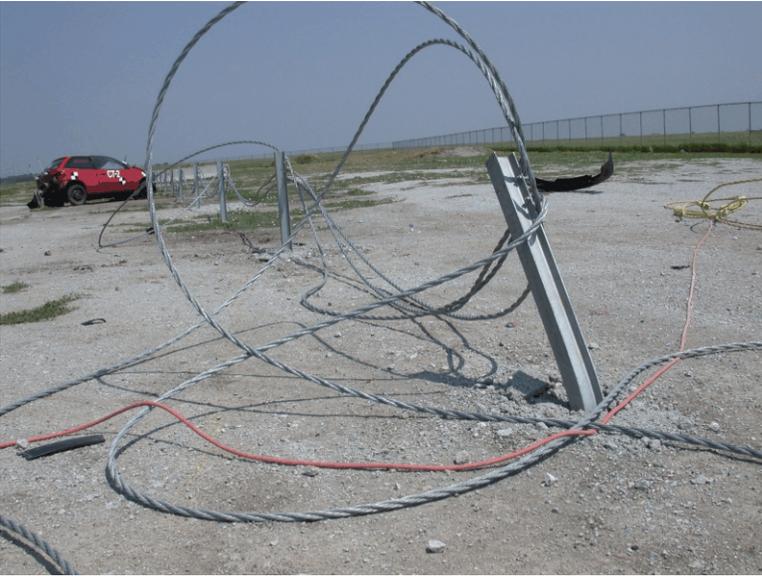
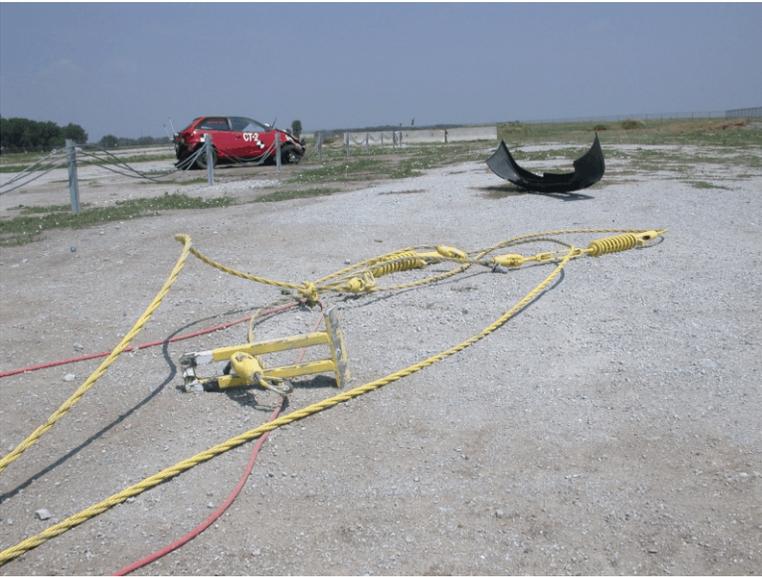
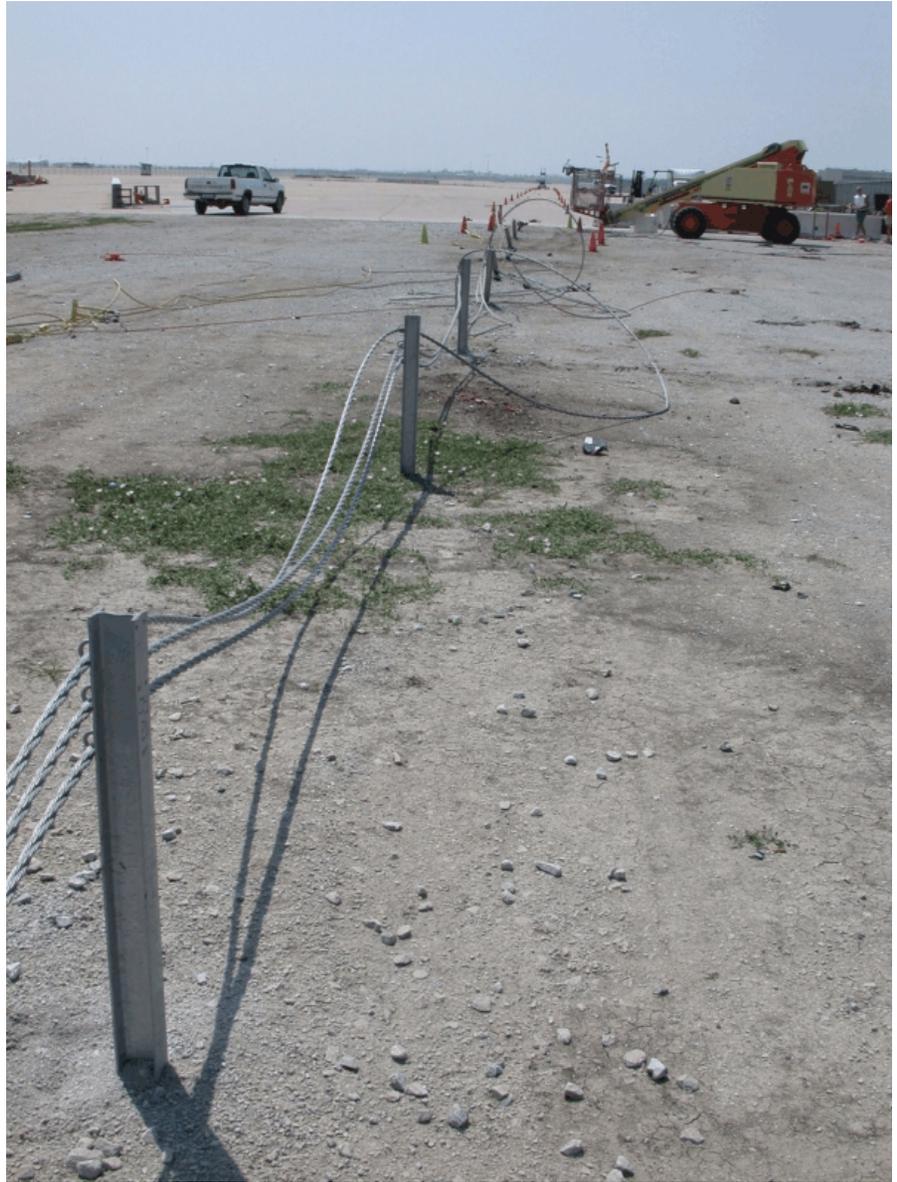
Damage to the cable guardrail end terminal was moderate, as shown in Figures 53 through 61. Barrier damage consisted of contact marks on posts, deformed line posts, disengaged cable, and deformed cable hooks. The length of vehicle contact along the cable system was approximately 28.9 m (94 ft - 10 in.) downstream, which spanned from post no. 1 through post no. 8.

Figure 53. System Damage, Test CT-2

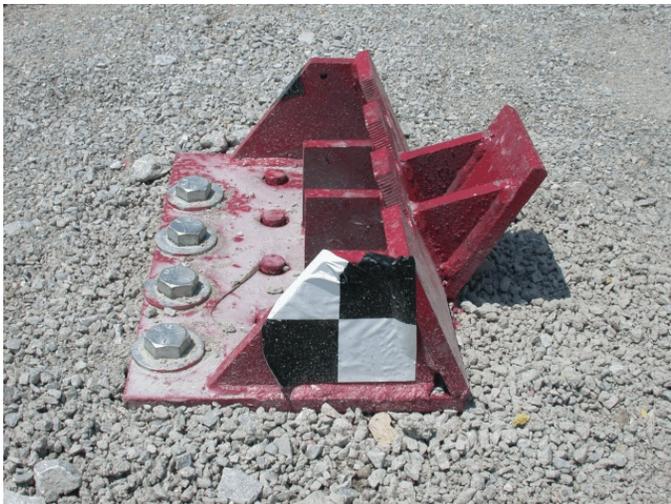
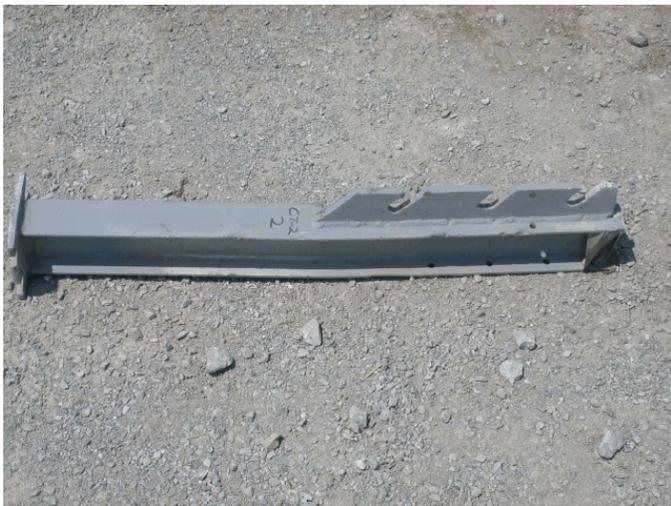
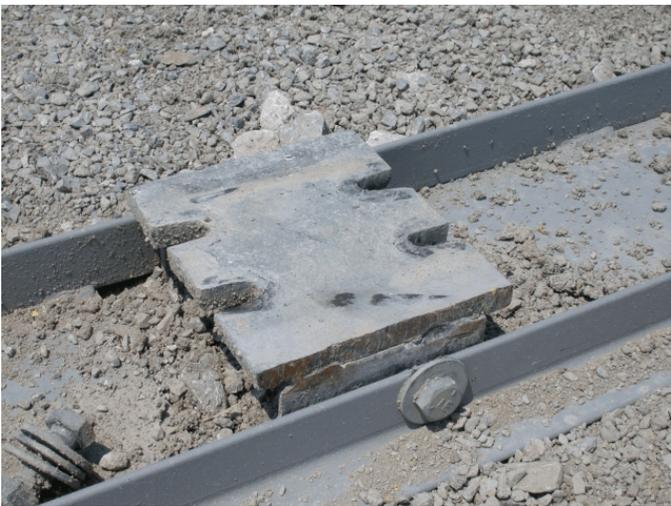
The cable release lever at post no. 1 was dented, scratched, and disengaged from the system. The cable release lever was located 3.05 m (10 ft) downstream of post no. 8 and 3.35 m (11 ft) laterally away from the traffic-side face of the system. Minor scratching and scraping around the bolt locations was found on post no. 2. Minor buckling and flange twisting was found on the top section of post no. 2. The top section of post no. 2 was located 0.91 m (3 ft) upstream from post no. 8 and 6.10 m (20 ft) laterally away from the traffic-side face of the system. Post nos. 3 through 8 rotated downstream in the soil and bent about the weak axis. However, post nos. 6 and 7 were bent nearly to the ground. Heavy contact marks were visible on the upstream flanges of post nos. 3 through 7.

Figure 54. Post Nos. 1 and 2 Damage, Test CT-2
