DESIGN AND EVALUATION OF A LOW-TENSION CABLE GUARDRAIL END TERMINAL SYSTEM

MIDWEST ROADSIDE SAFETY FACILITY

MwRSF Research Report No. TRP-03-131-08

July 15, 2008

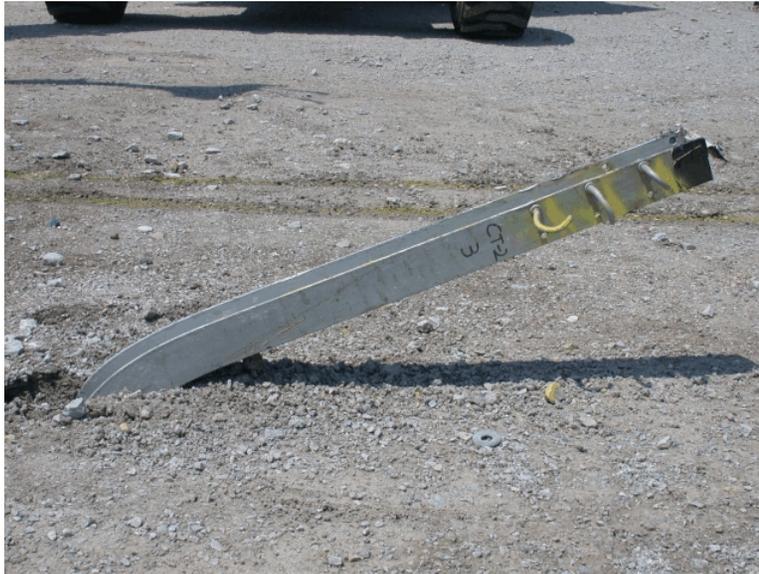
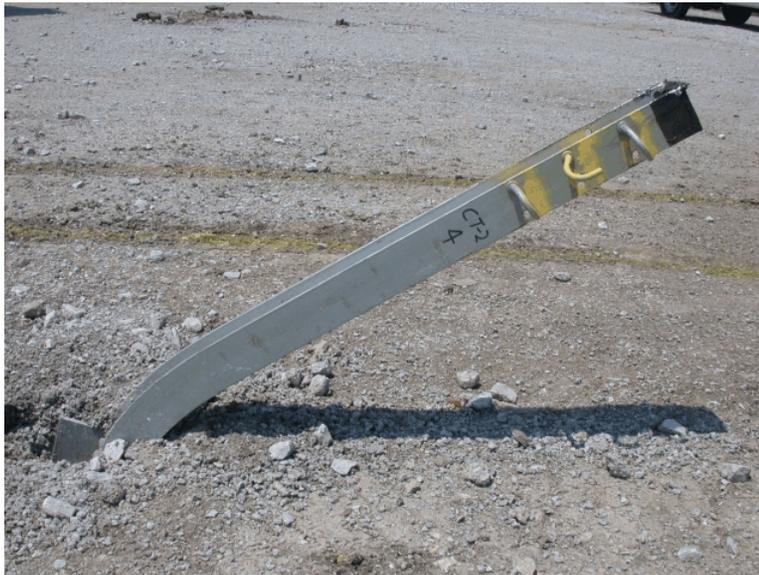
The cable release lever at post no. 1 was dented, scratched, and disengaged from the system. The cable release lever was located 3.05 m (10 ft) downstream of post no. 8 and 3.35 m (11 ft) laterally away from the traffic-side face of the system. Minor scratching and scraping around the bolt locations was found on post no. 2. Minor buckling and flange twisting was found on the top section of post no. 2. The top section of post no. 2 was located 0.91 m (3 ft) upstream from post no. 8 and 6.10 m (20 ft) laterally away from the traffic-side face of the system. Post nos. 3 through 8 rotated downstream in the soil and bent about the weak axis. However, post nos. 6 and 7 were bent nearly to the ground. Heavy contact marks were visible on the upstream flanges of post nos. 3 through 7.

All of the hook bolts on post nos. 3 through 8 were deformed, but remained attached to the posts. All three cables disengaged from post nos. 3 through 7, except the bottom cable remained attached to post no. 5. The threaded cable end fittings were fractured at the nut locations.

Figure 55. Post Nos. 3 and 4 Damage, Test CT-2

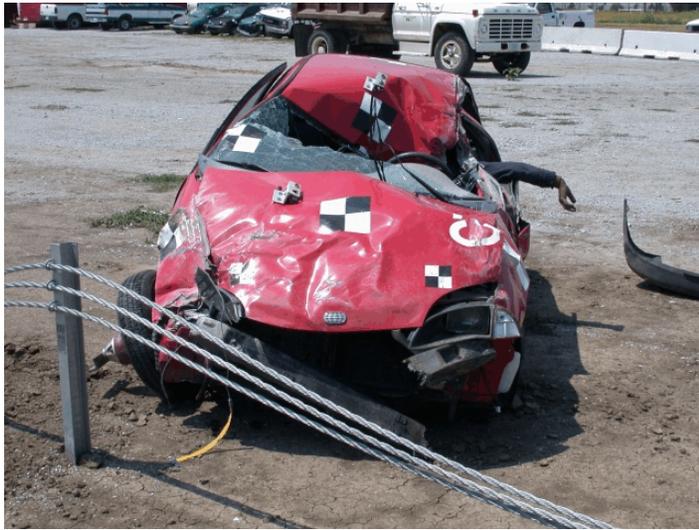
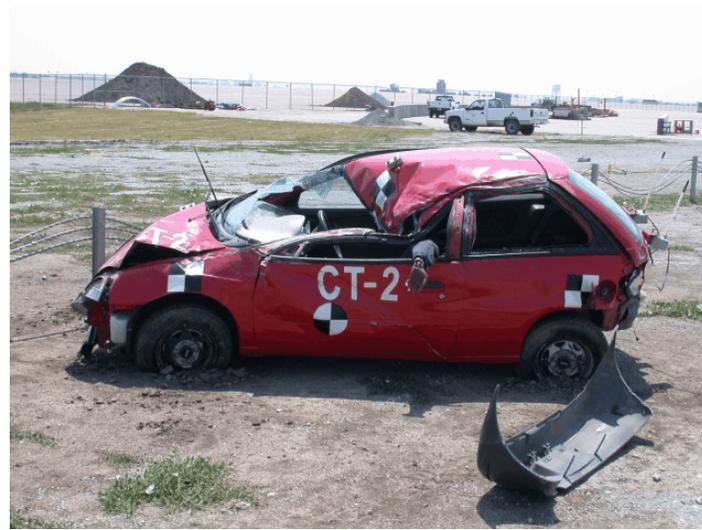
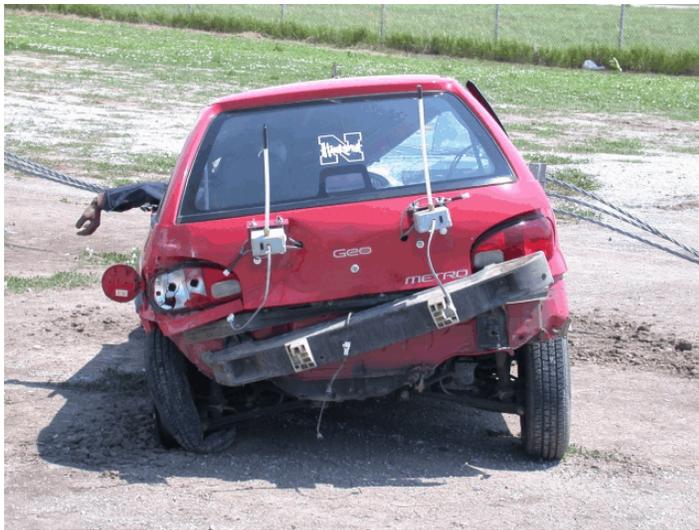
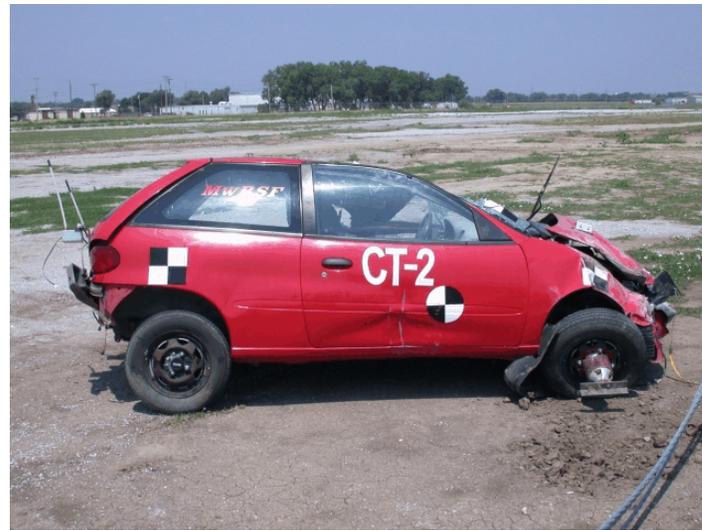
Figure 62. Vehicle Damage, Test CT-2

Exterior and interior damage was extensive, as shown in Figures 62 and 63. Most of the damage that occurred was due to the multiple rollovers of the vehicle. It should be noted that it was impossible to distinguish the damage due to the impact from that due to the rollover.

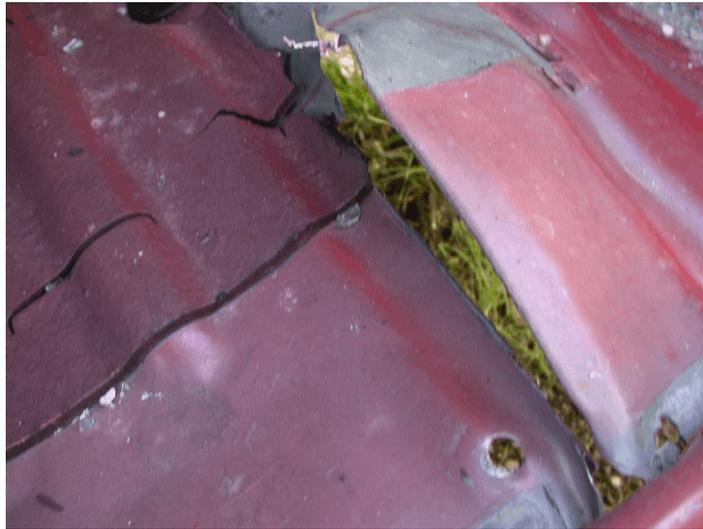
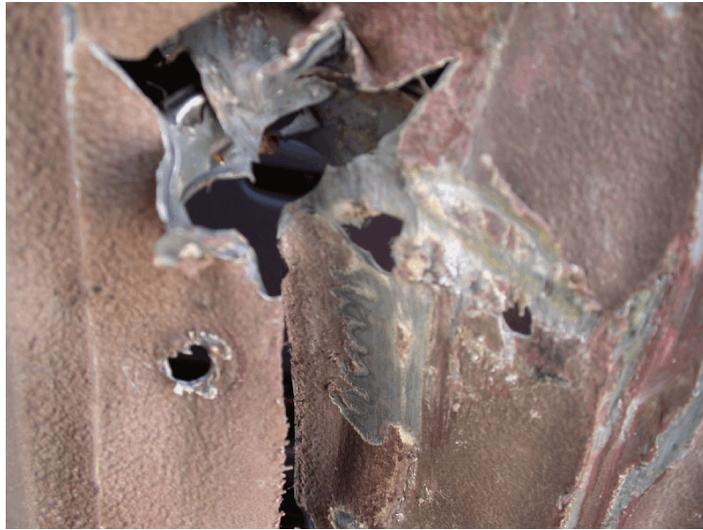
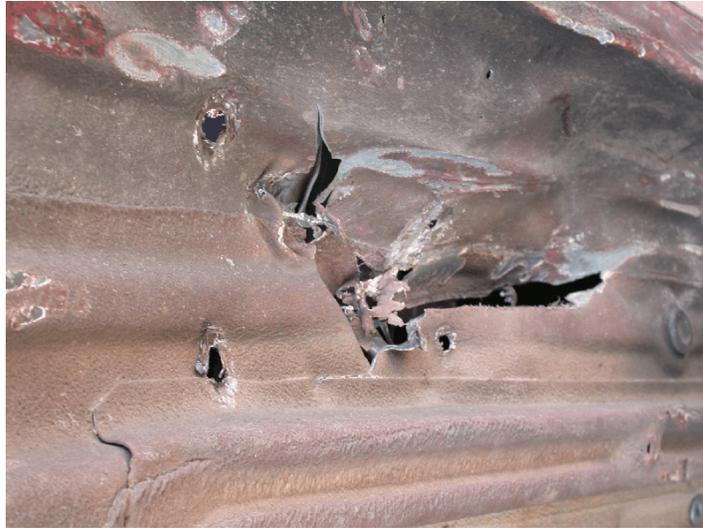
Figure 63. Occupant Compartment Deformation, Test CT-2

Following the unsuccessful performance of test no. CT-2, modifications were made to the system in an attempt to improve impact performance. After reviewing the high-speed videos and photographs, the cable release lever was determined to be responsible for the occupant compartment penetration in the floorpan and rear. As the vehicle passed over the cable release lever it became lodged between the ground and the floorpan of the vehicle, causing the vehicle to be propelled upward, and subsequently rolling over. It was then determined that retaining the cable release lever would be prudent, and therefore, in the modified system, a cable was used to retain the cable release lever attached to the anchor bracket. The 9.5-mm (0.375-in.) diameter, 7x19 galvanized aircraft cable was 813 mm (32 in.) long.

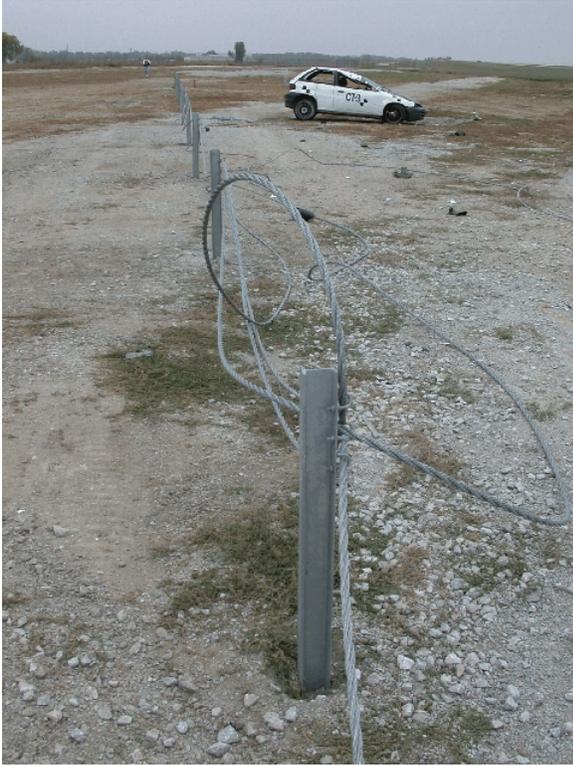
Figure 74. System Damage, Test CT-3

Damage to the cable guardrail end terminal was moderate, as shown in Figures 74 through 81. Barrier damage consisted of contact marks on posts, deformed line posts, disengaged cable and deformed cable hooks. The length of vehicle contact along the cable system was approximately 24.0 m (78 ft - 8 in.), which spanned from post no. 1 through post no. 7.

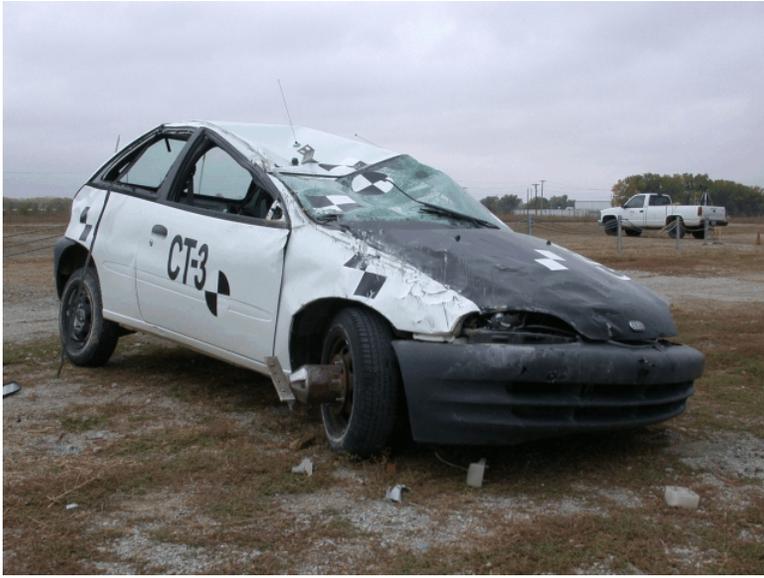
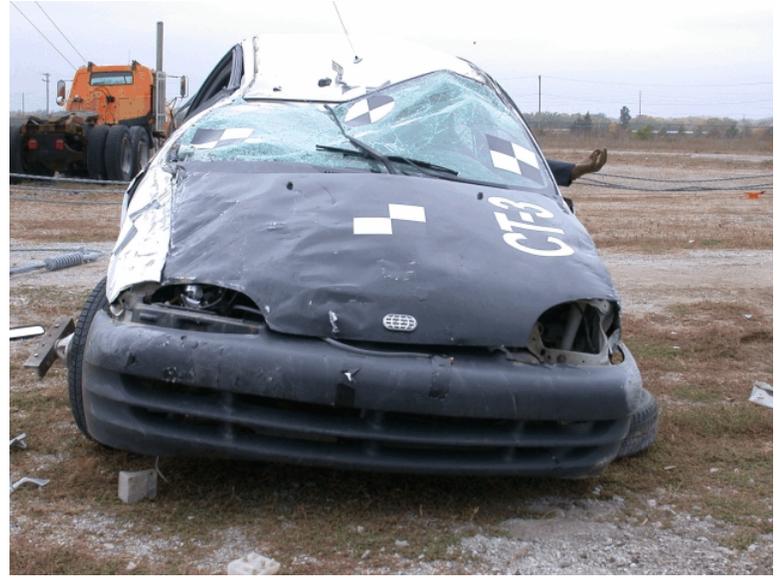
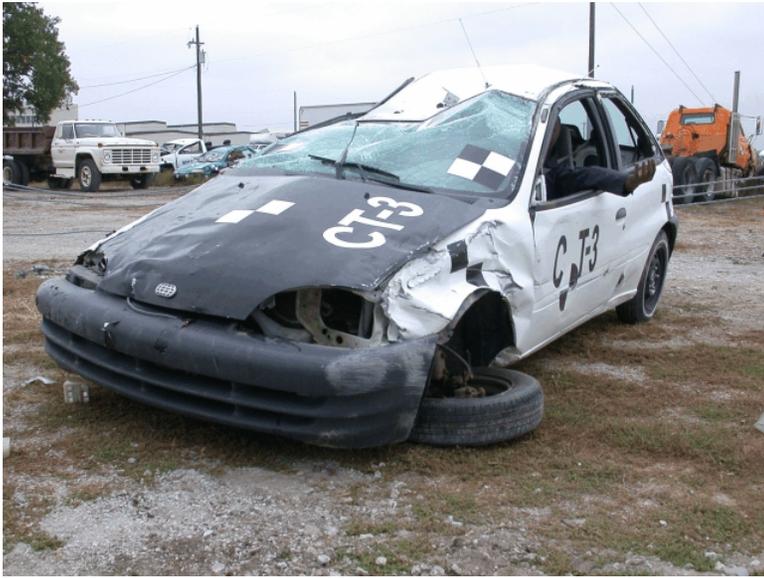
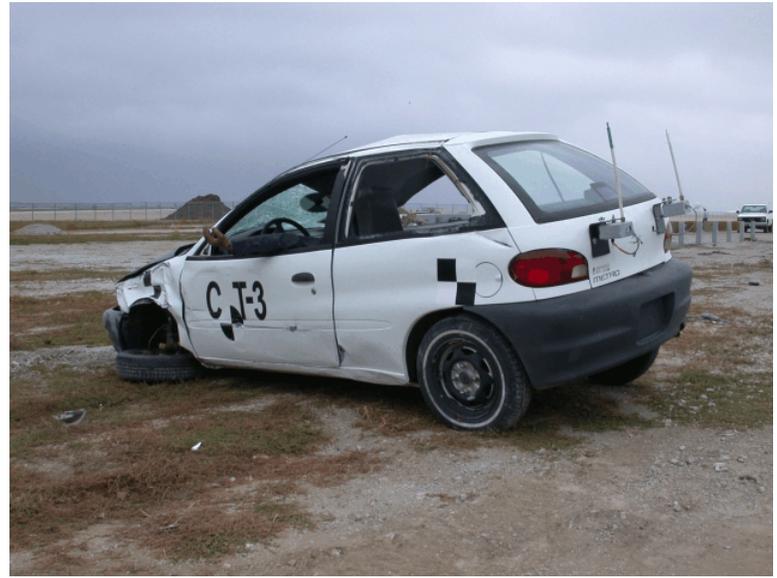
Figure 82. Vehicle Damage, Test CT-3

Exterior and interior vehicle damage was extensive, as shown in Figures 82 through 84. It should be noted that it was almost impossible to distinguish the damage due to impact from that due to the rollovers.

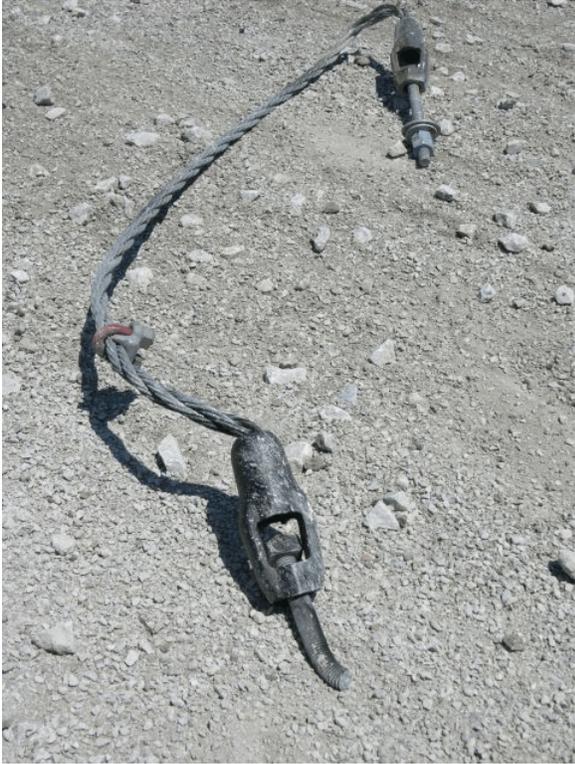
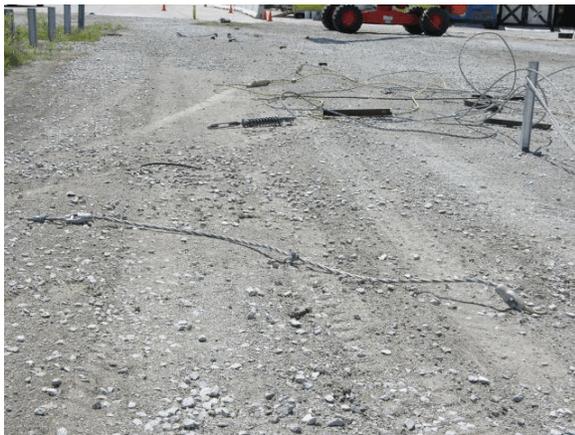
Figure 102. System Damage, Test CT-4

Damage to the cable guardrail end terminal system was moderate, as shown in Figures 102 through 106. Barrier damage consisted of contact marks on posts, deformed and disengaged line posts, disengaged cables, and deformed cable hooks. The length of vehicle contact along the cable system was approximately 24.0 m (78 ft - 8 in.), which spanned from post no. 1 through post no. 7.

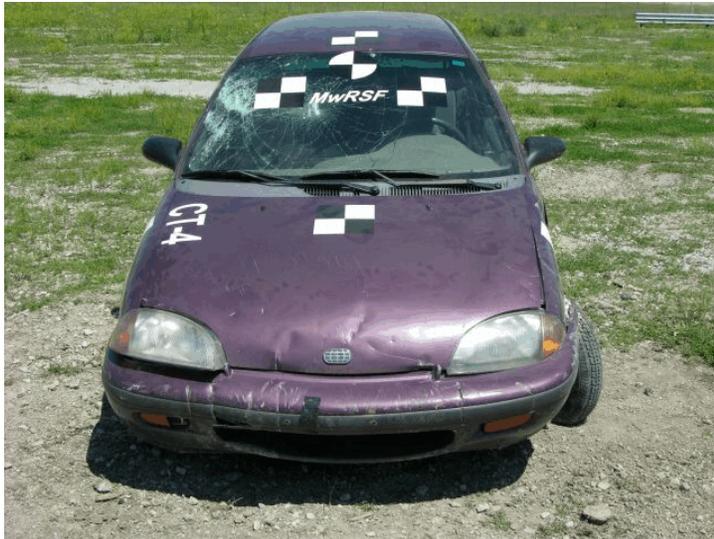
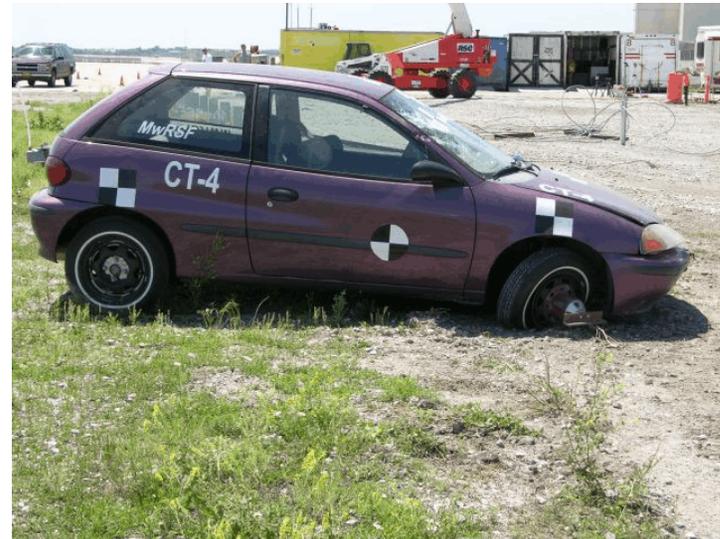
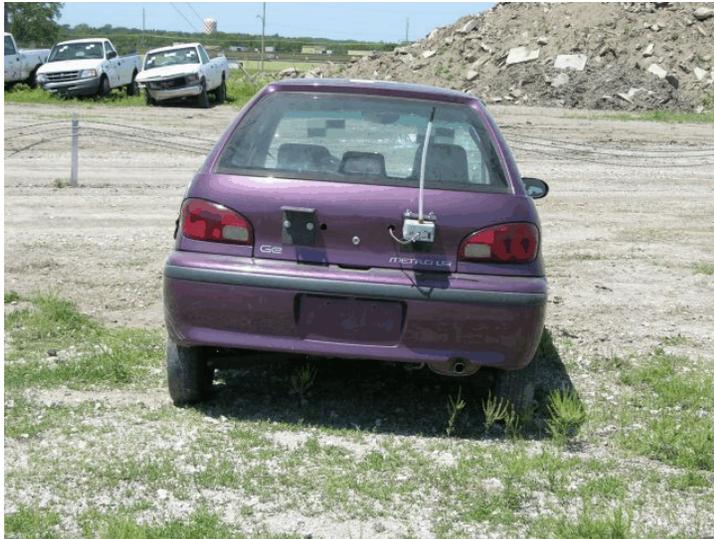
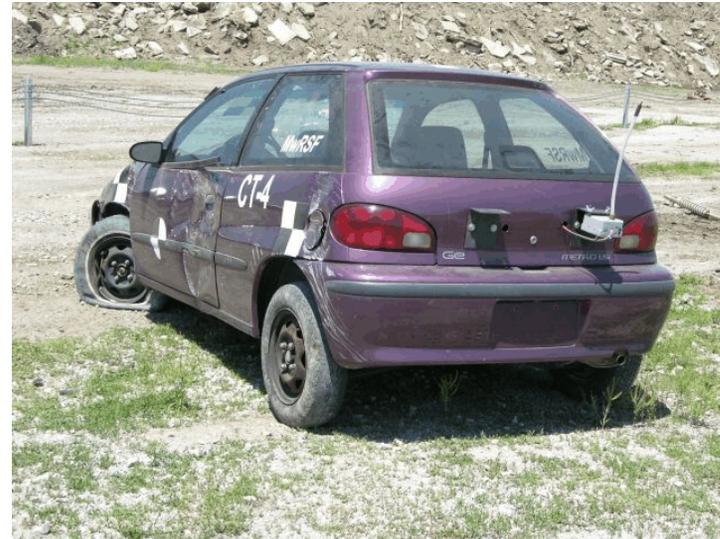
Figure 107. Vehicle Damage, Test CT-4

Exterior vehicle damage was minimal, as shown in Figures 107 through 111. Occupant compartment deformations to the right side and center of the floorboard were judged insufficient to
