# **EVALUATION OF CRITICAL FLARE RATES FOR**

# THE MIDWEST GUARDRAIL SYSTEM (MGS)

MwRSF Research Report No. TRP-03-191-08

July 15, 2008

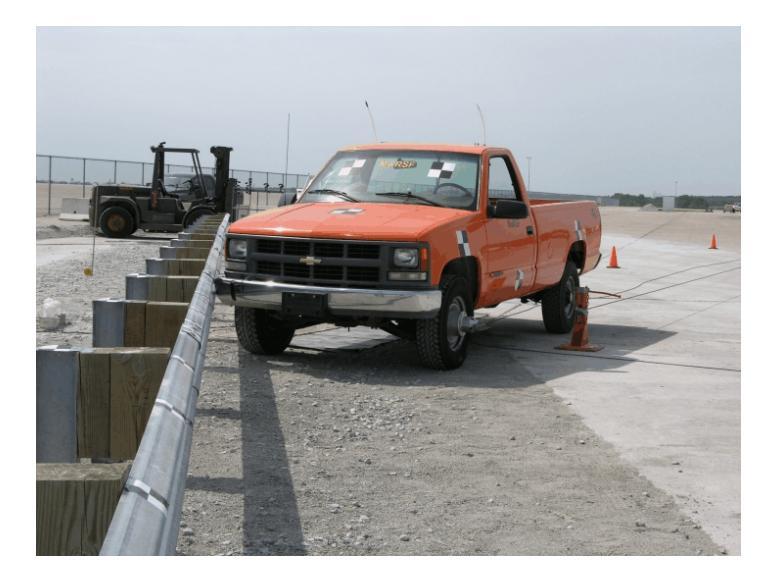
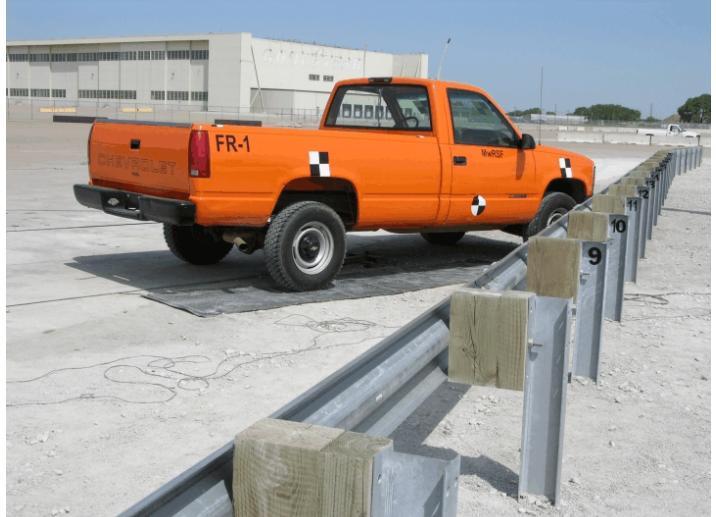
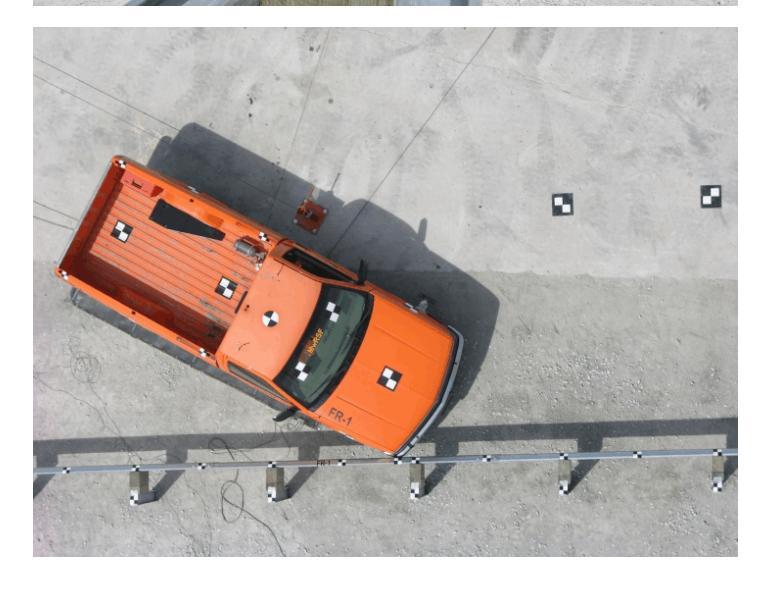
Figure 37. Impact Location, Test FR-1

Initial impact was to occur between post nos. 11 and 12, or 4.97-m (16 ft - 3.625 in.) upstream from the centerline of the splice between post nos. 14 and 15, as shown in Figure 37. Actual vehicle impact occurred at post no. 12, or 4.76 m (15 ft - 7.5 in.) upstream from the centerline of the splice between post nos. 14 and 15. At 0.014 sec after impact, post no. 12 rotated backwards, and a dent appeared in the vehicle's right-front quarter panel. At 0.020 sec, post nos. 11 and 13 deflected backwards. At 0.030 sec, the rail flattened, and the right-front headlight disengaged and protruded over the rail. At 0.042 sec, the hood protruded over the top of the system, and post no. 14 deflected backwards. At 0.064 sec, the right-front headlight contacted post no. 13, and post nos. 10 and 15 deflected. At this same time, the vehicle's right-front tire twisted. At 0.078 sec, as the right-front tire blockout at post no. 13 disengaged from the system. At 0.092 sec, the vehicle's right-front tire contacted post no. 13. At 0.100 sec, buckle points appeared in the rail at post no. 13, and the rail flattened around the vehicle. At this same time, the center of the vehicle's bumper bent upwards and

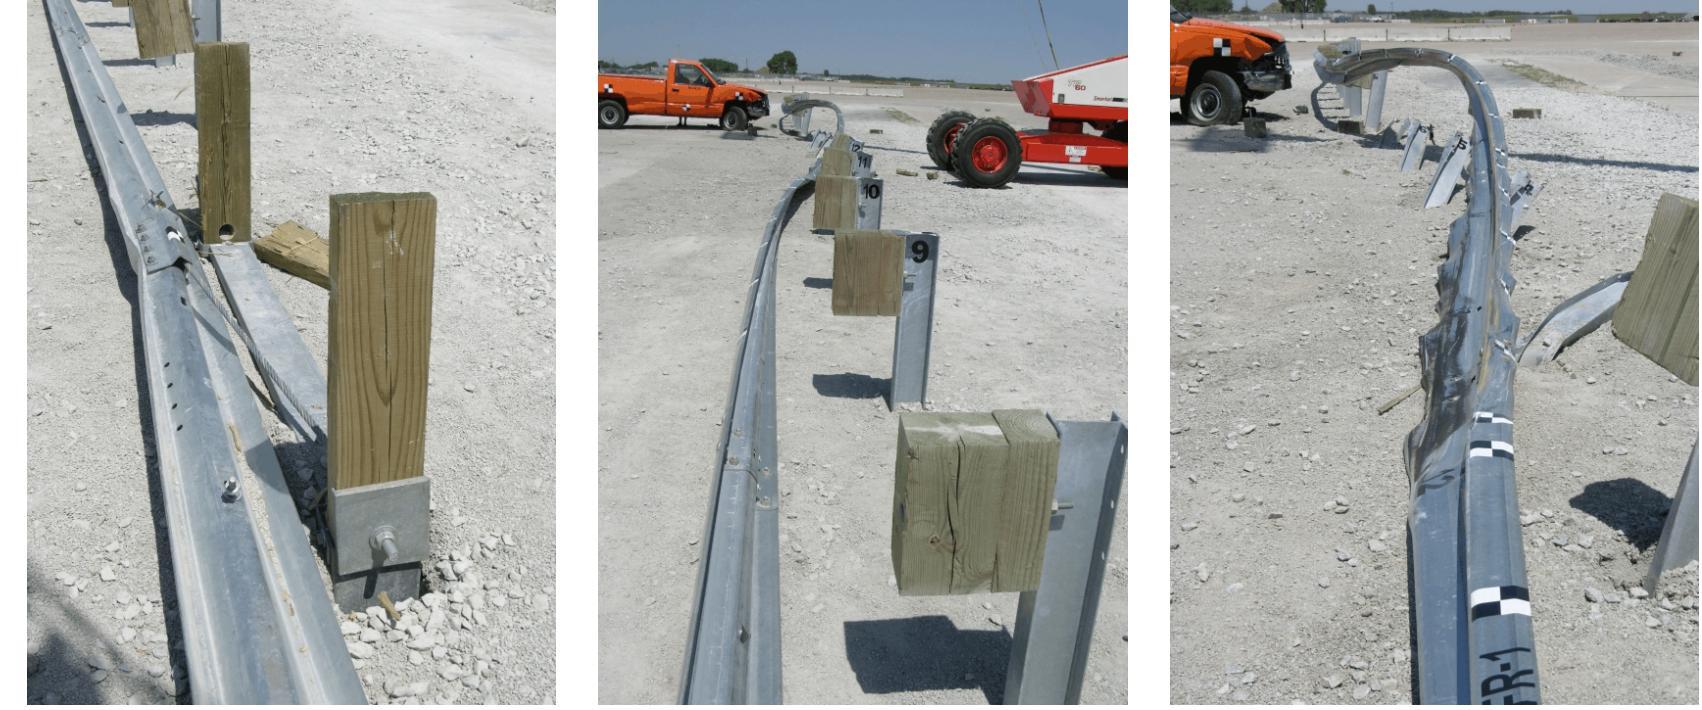
Figure 39. System Damage, Test FR-1

The permanent set of the barrier system is shown in Figure 39. The maximum lateral permanent set rail and post deflections were 1,140 mm (44.875 in.) at the midspan between post nos. 15 and 16 and 813 mm (32 in.) at the centerline of post no. 13, respectively, as measured in the field. The maximum lateral dynamic rail and post deflections were 1,684 mm (66.3 in.) at the centerline of post no. 15 and 853 mm (33.6 in.) at the centerline of post no. 13, respectively, as determined from high-speed video analysis. The working width of the system was found to be 1,794 mm (70.6 in.).

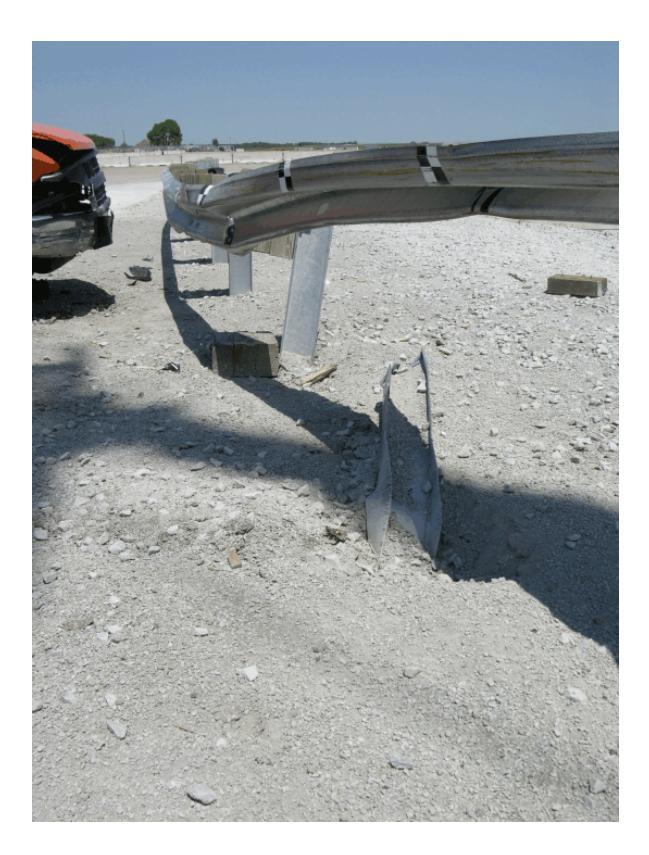
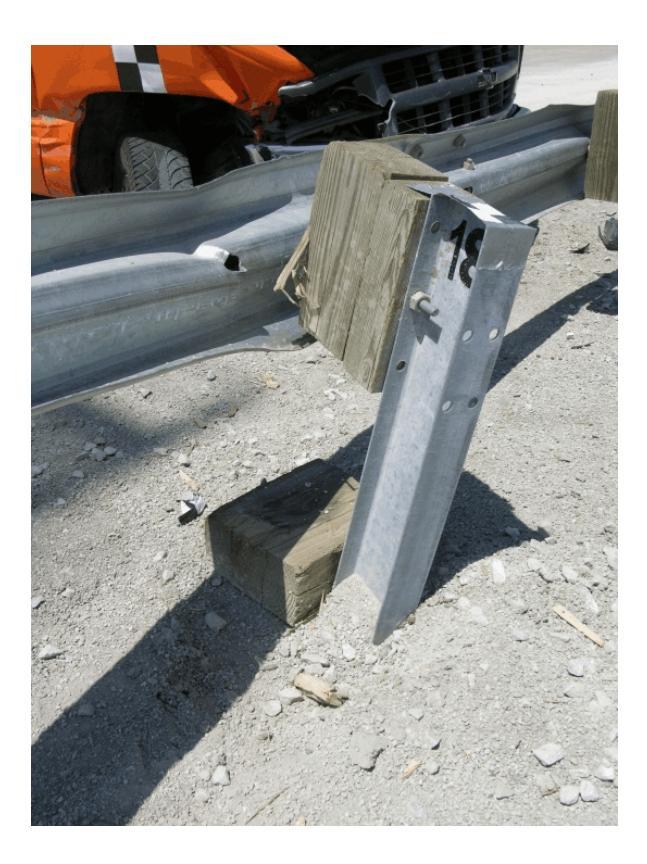
Figure 44. Post Nos. 17 and 18 Damage, Test FR-1

Moderate deformation and flattening of the impacted section of W-beam rail occurred between post nos. 12 and 18. Contact marks were found on the rail between post nos. 12 and 18. The guardrail buckled at nearly every post location between post nos. 12 and 18. Major buckling of the guardrail occurred at the upstream side of post no. 19. The W-beam was pulled off of post nos. 1 through 19. The W-beam rail sustained significant yielding around the post bolt slots at post nos. 1 through 11, 13, 14, 18, and 19. Minor tearing of the W-beam rail occurred around the post bolt slots at post nos. 12 and 15, while the tearing of the W-beam rail around the post bolt slots at post nos. 16 and 17 was very significant. No significant guardrail damage occurred downstream of post no. 20.

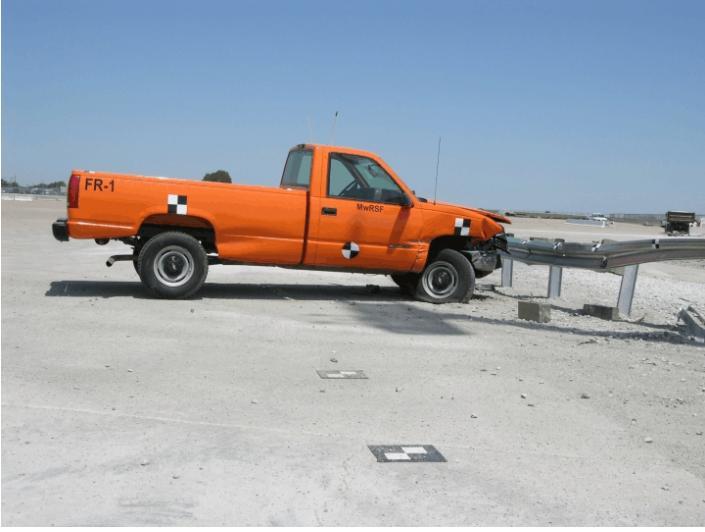
Figure 46. Vehicle Damage, Test FR-1

Exterior vehicle damage was moderate, as shown in Figures 46 through 49. Occupant compartment deformations to the right side and center of the floorboard were judged insufficient to cause serious injury to the vehicle occupants. Maximum longitudinal deflections of 6 mm (0.25 in.) were located near the front and left sides of the right-side floorpan. Maximum lateral deflections of 13 mm (0.5 in.) were located near the center of the right-side floorpan. Maximum vertical deflections of 19 mm (0.75 in.) were located near the right side of the right-side floorpan. Complete occupant compartment deformations and the corresponding locations are provided in Appendix C.

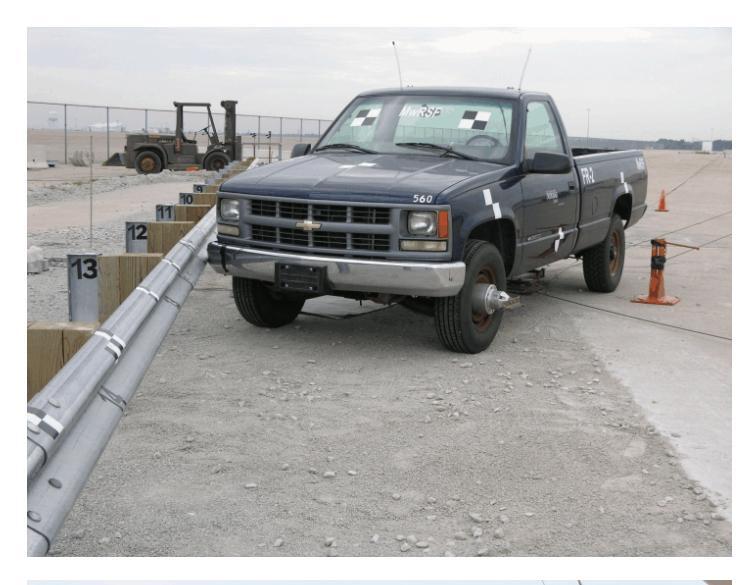
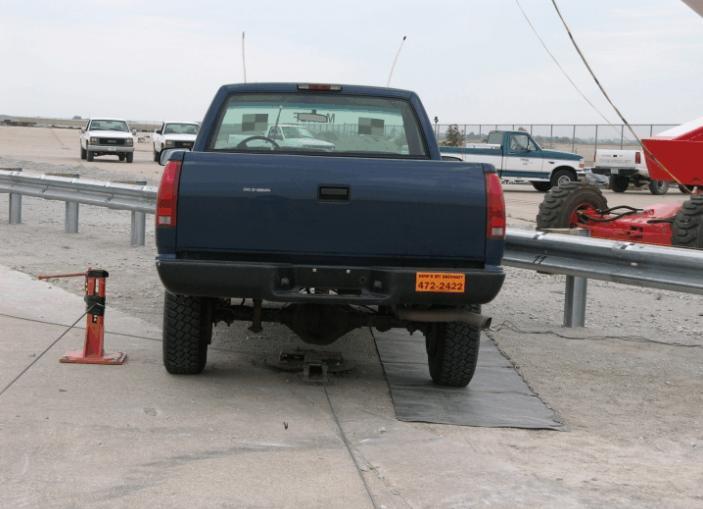
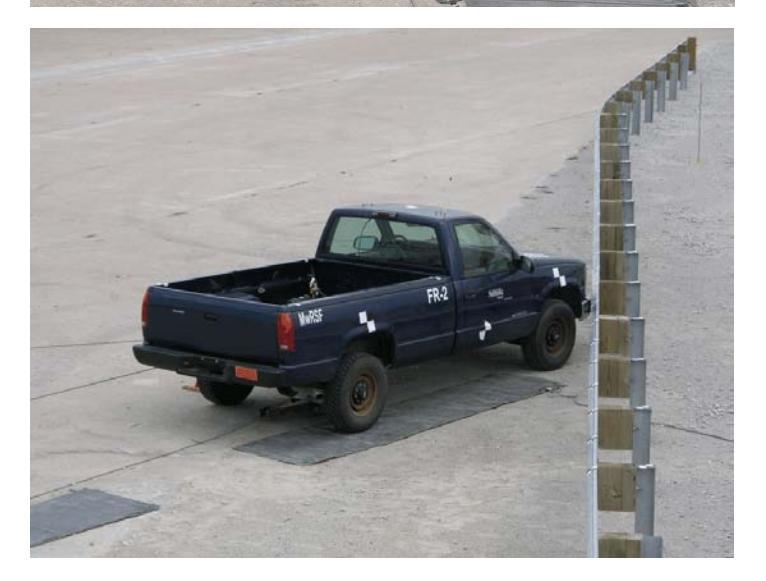
Figure 59. Impact Location, Test FR-2

Initial impact was to occur between post nos. 11 and 12, or 5.24 m (17 ft - 2.25 in.) upstream from the centerline of the splice between post nos. 14 and 15, as shown in Figure 59. Actual vehicle impact occurred 5.21 m (17 ft - 1 in.) upstream from the centerline of the splice between post nos. 14 and 15. Immediately following impact, the front bumper and the rail deformed. At 0.010 sec, post no. 12 deflected backward. At 0.018 sec, post no. 13 deflected, and a gap formed between the vehicle's hood and body. At 0.042 sec, post nos. 3 through 11 twisted clockwise towards impact, and post no. 14 deflected slightly. At 0.078 sec, the vehicle contacted the blockout and traffic-side flange of post no. 13. At 0.086 sec, cracks propagated throughout the blockout at post no. 14 twisted counter-clockwise, and post no. 13 contacted the ground. At 0.132 sec, post no. 16 deflected backwards. At 0.150 sec, the vehicle contacted the blockout on post no. 14, and the vehicle's right-front tire protruded under the rail. At 0.182 sec, post no. 17 deflected backwards, and the hood rose slightly. At 0.216 sec, the blockout at post no. 15 disengaged from the rail. At 0.242 sec, the vehicle

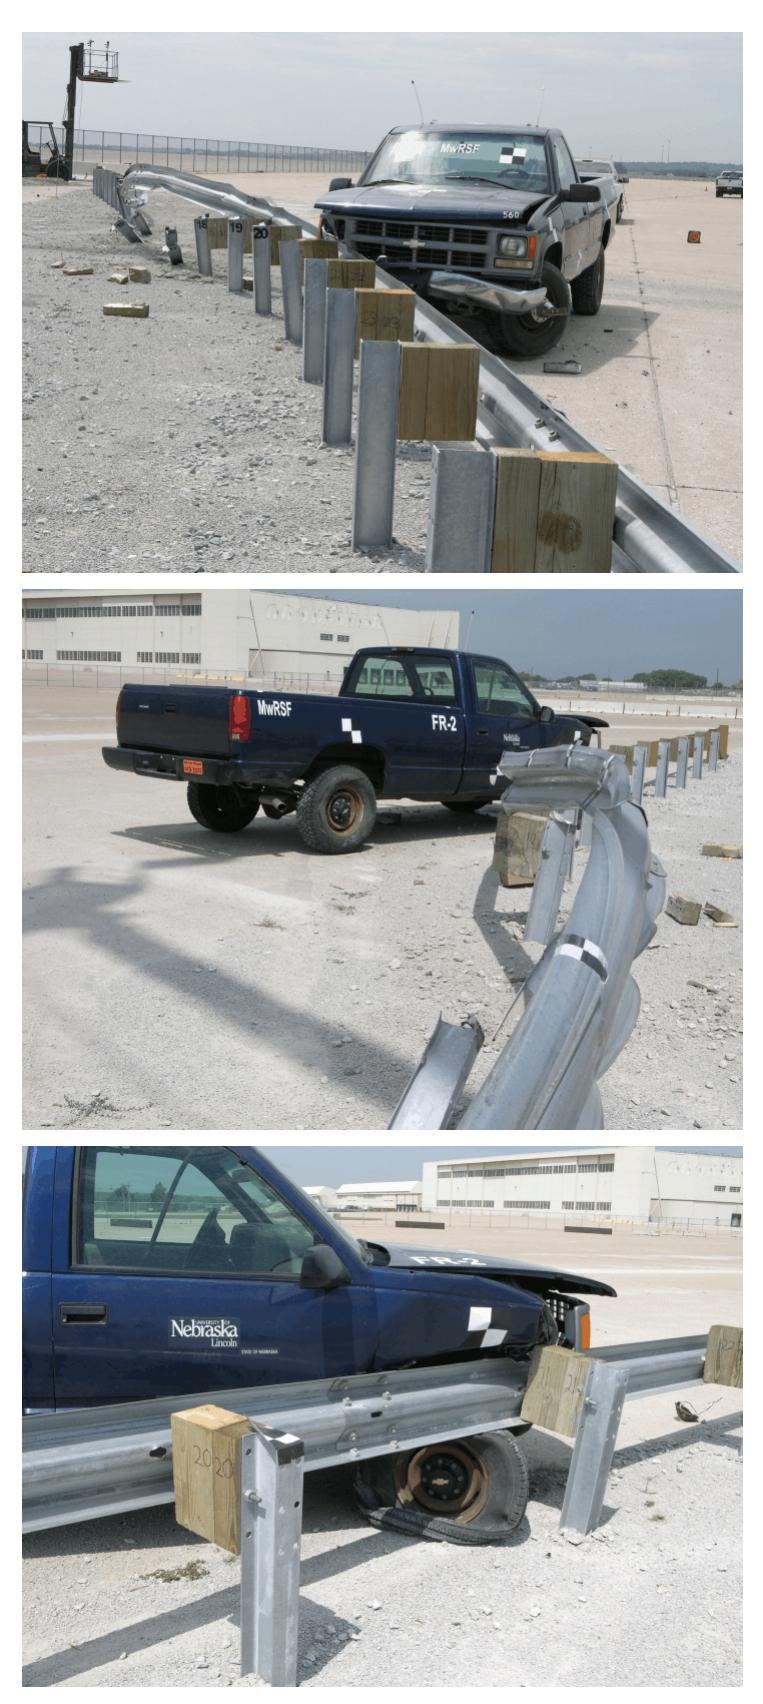
Figure 60. Vehicle Trajectory and Final Position, Test FR-2

contacted the traffic-side flange of post no. 15. At 0.262 sec, the blockout at post no. 16 disengaged from the system, and the right-rear tire became airborne. At 0.286 sec, post no. 17 twisted counterclockwise toward the vehicle as the rear of the vehicle pitched downward. At 0.302 sec, the rightrear corner of the vehicle contacted the guardrail. At 0.364 sec, the vehicle contacted the upstream edge of the traffic-side flange of post no. 16. At 0.392 sec, the rail disengaged from the blockout at post no. 17 and twisted. At 0.478 sec, the vehicle became parallel to the system with a resultant velocity of 41.4 km/h (25.7 mph). At this same time, the vehicle contacted post no. 17. At 0.490 sec, the right-rear corner of the vehicle rode on top of the guardrail section. At 0.562 sec, post nos. 8 through 10 ceased twisting as the rail rebounded. At 0.960 sec, the vehicle vawed while in contact with post no. 18. At 1.360 sec, the vehicle exited the system with a resultant velocity of 23.2 km/h (14.4 mph) and at an angle of 8.7 degrees relative to the tangent section. At 2.410 sec, the vehicle came to rest in contact with the "knee joint" between the flare and the tangent guardrail sections. The vehicle came to rest 16.9 m (55 ft - 4 in.) downstream from impact and 2.5 m (8 ft - 2 in.) laterally away from the traffic-side face of the tangent rail. The trajectory and final position of the pickup truck are shown in Figure 60.

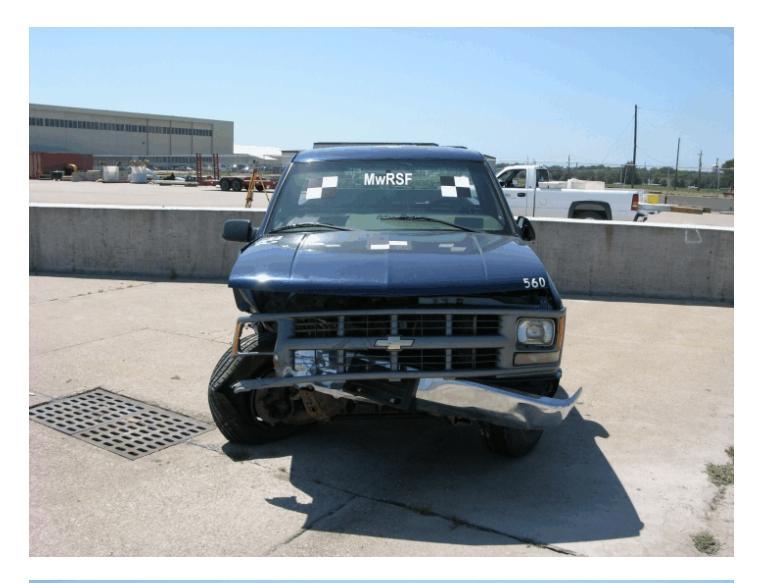
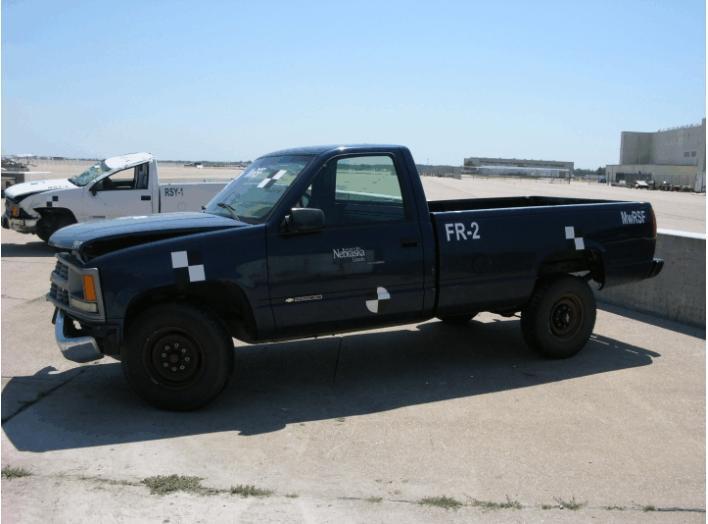
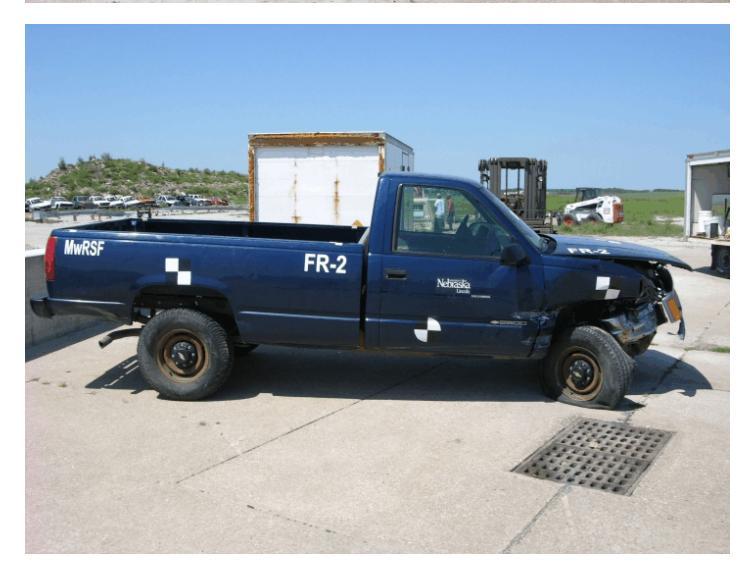
Figure 71. Vehicle Damage, Test FR-2

Exterior vehicle damage was moderate, as shown in Figures 71 through 74. Occupant compartment deformations to the right side and center of the floorboard were judged insufficient to cause serious injury to the vehicle occupants. Maximum longitudinal deflections of 6 mm (0.25 in.) were located along the left side of the right-side floorpan. Maximum lateral deflections of 13 mm (0.5 in.) were located near the left-front corner of the right-side floorpan. Maximum vertical deflections of 6 mm (0.25 in.) were located near the left-front corner of the right-side floorpan. Complete occupant compartment deformations and the corresponding locations are provided in Appendix F.

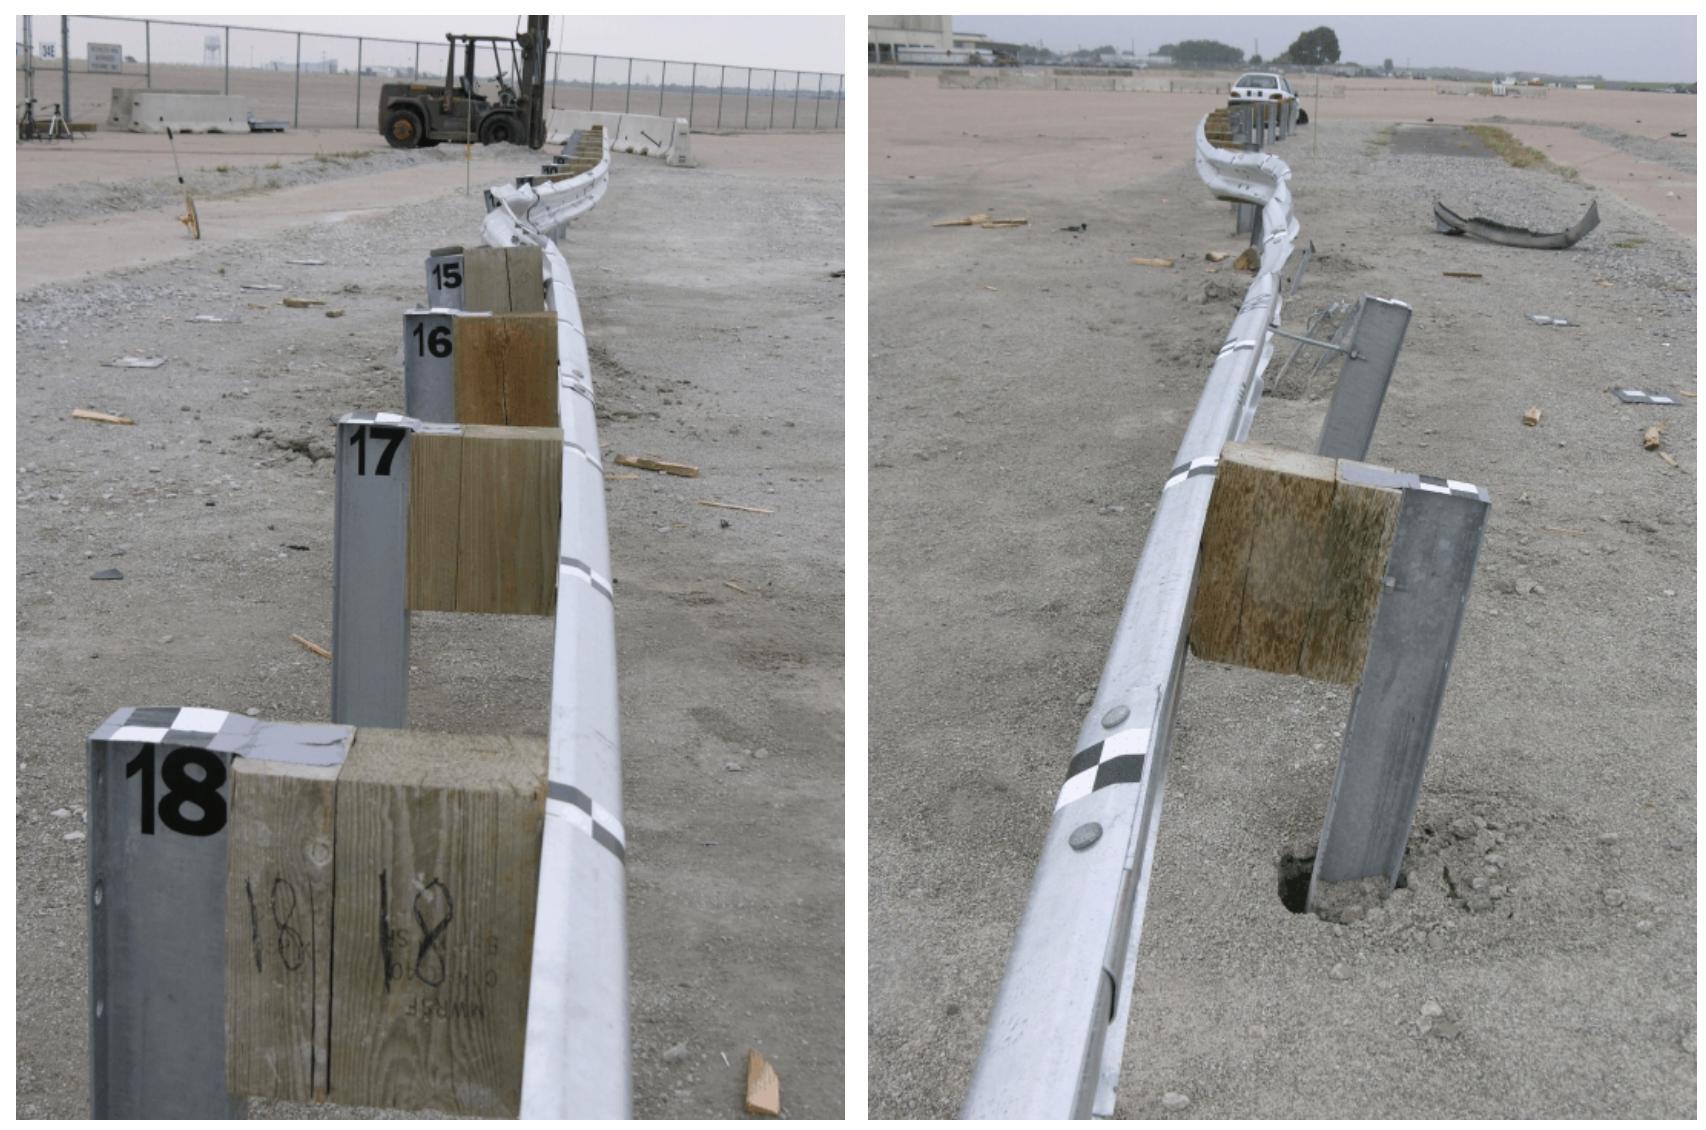
Figure 83. System Damage, Test FR-3

Barrier damage was moderate, as shown in Figure 83. Barrier damage consisted of deformed guardrail posts, deformed and disengaged blockouts, deformed W-beam guardrail, and contact marks on a guardrail section. The length of vehicle contact along the system was approximately 9.6 m (31 ft - 4.1875 in.), which spanned from 849 mm (33.4375 in.) downstream upstream from the centerline of post no. 12 through 1,086 mm (42.75 in.) downstream from the centerline of post no. 16.

The permanent set of the barrier system is shown in Figure 83. The maximum lateral permanent set rail and post deflections were 527 mm (20.75 in.) at the midspan between post nos. 13 and 14 and 483 mm (19 in.) at the centerline of post no. 13, as measured in the field. The maximum lateral dynamic rail and post deflections 925 mm (36.4 in.) at the centerline of post no. 13 and 693 mm (27.3 in.) at the centerline of post no. 13, as determined from high-speed digital video analysis. The working width of the system was found to be 1,107 mm (43.6 in.).

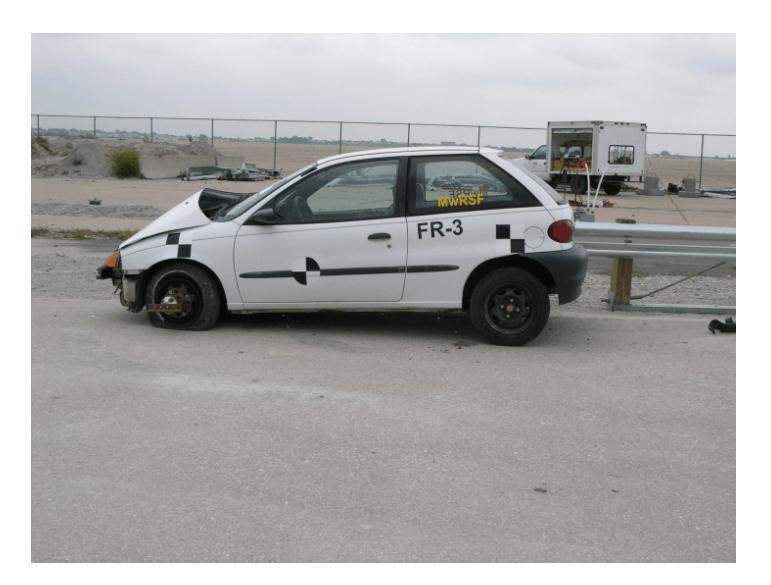
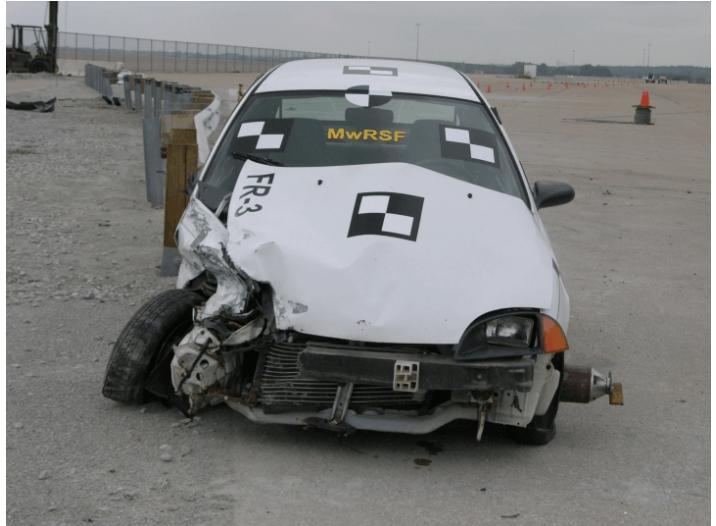
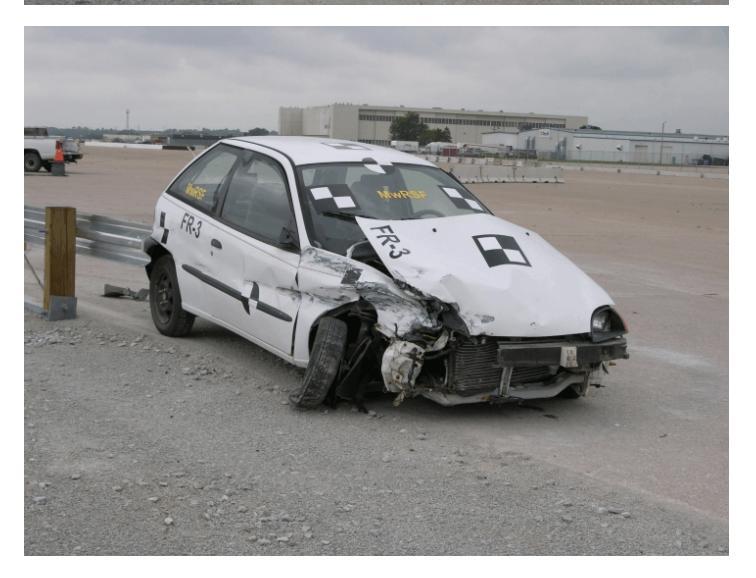
Figure 91. Vehicle Damage, Test FR-3

Exterior vehicle damage was moderate, as shown in Figures 91 through 96. Occupant compartment deformations to the right side and center of the floorboard were judged insufficient to cause serious injury to the vehicle occupants. Complete occupant compartment deformations and the corresponding locations are provided in Appendix H.

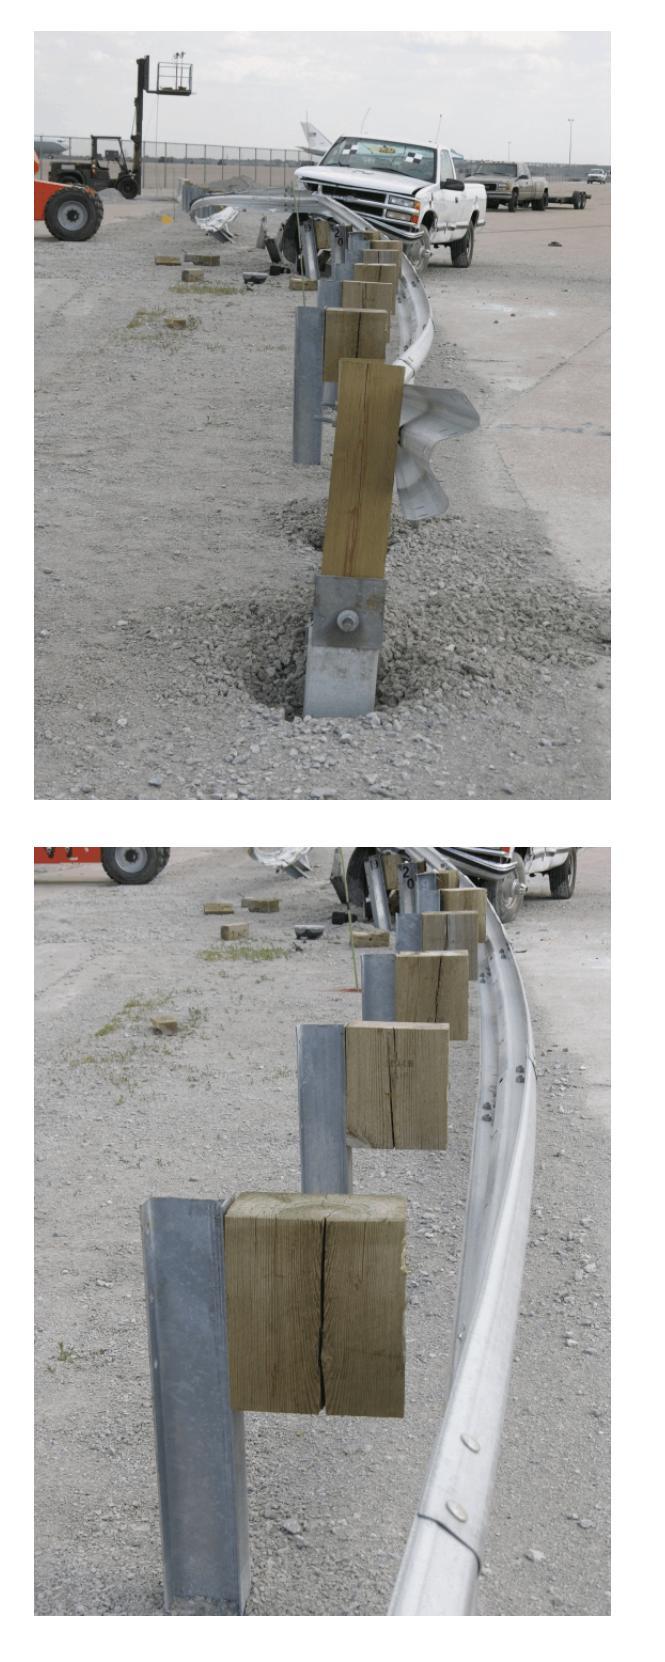
Figure 109. System Damage, Test FR-4

Barrier damage was moderate, as shown in Figures 109 through 119. Barrier damage consisted of deformed guardrail posts, deformed and disengaged blockouts, deformed W-beam guardrail, and contact marks on a guardrail section. The length of vehicle contact along the system was approximately 11.8 m (38 ft - 10 in.), which spanned from the centerline of post no. 12 through 406 mm (16 in.) downstream from the centerline of post no. 18.

The permanent set of the barrier system is shown in Figure 109. The maximum lateral permanent set rail and post deflections were 1,753 mm (69 in.) at the midspan between post nos. 16 and 17 and 737 mm (29 in.) at the centerline of post no. 14, respectively, as measured in the field. The maximum lateral dynamic rail and post deflections were 1,919 mm (75.6 in.) at the centerline of post no. 16 and 834 mm (32.8 in.) at the centerline of post no. 14, respectively, as determined from high-speed digital video analysis. The working width of the system was found to be 2,475 mm (97.4 in.).

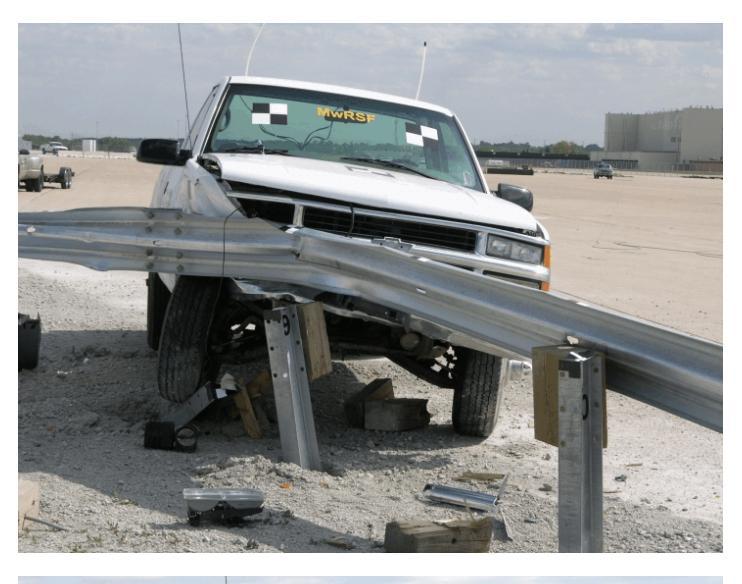
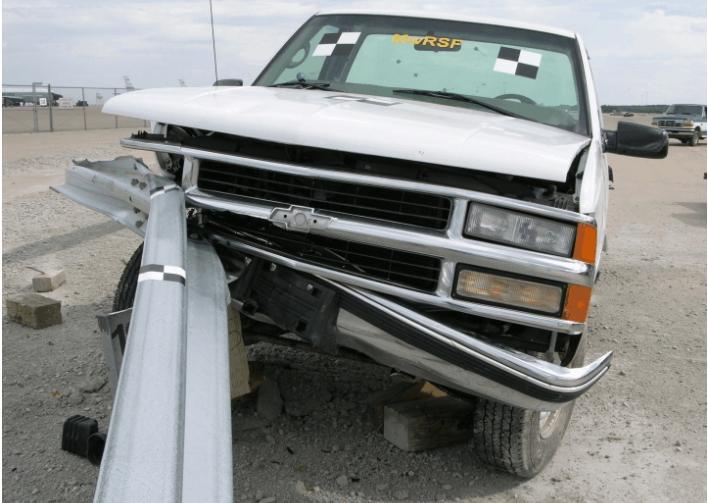
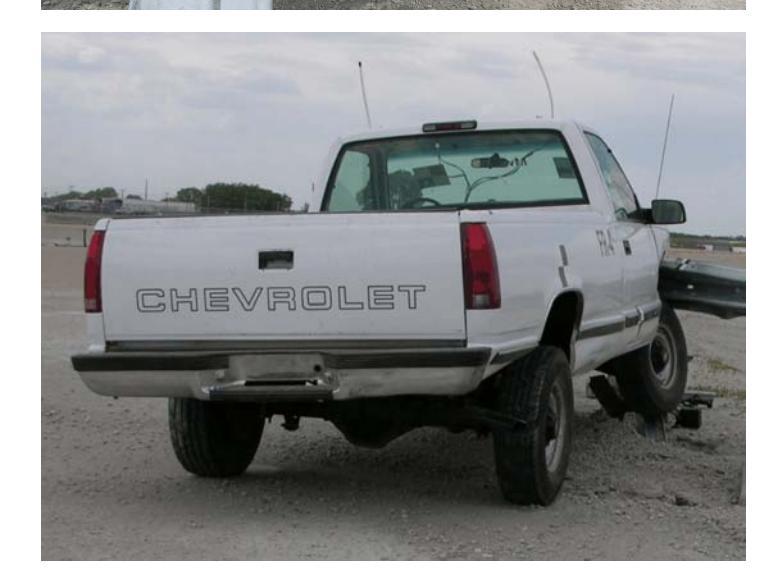
Figure 120. Vehicle Damage, Test FR-4

Exterior vehicle damage was moderate, as shown in Figures 120 through 122. Occupant compartment deformations to the right side and center of the floorboard were judged insufficient to cause serious injury to the vehicle occupants. Maximum longitudinal deflections of 6 mm (0.25 in.)

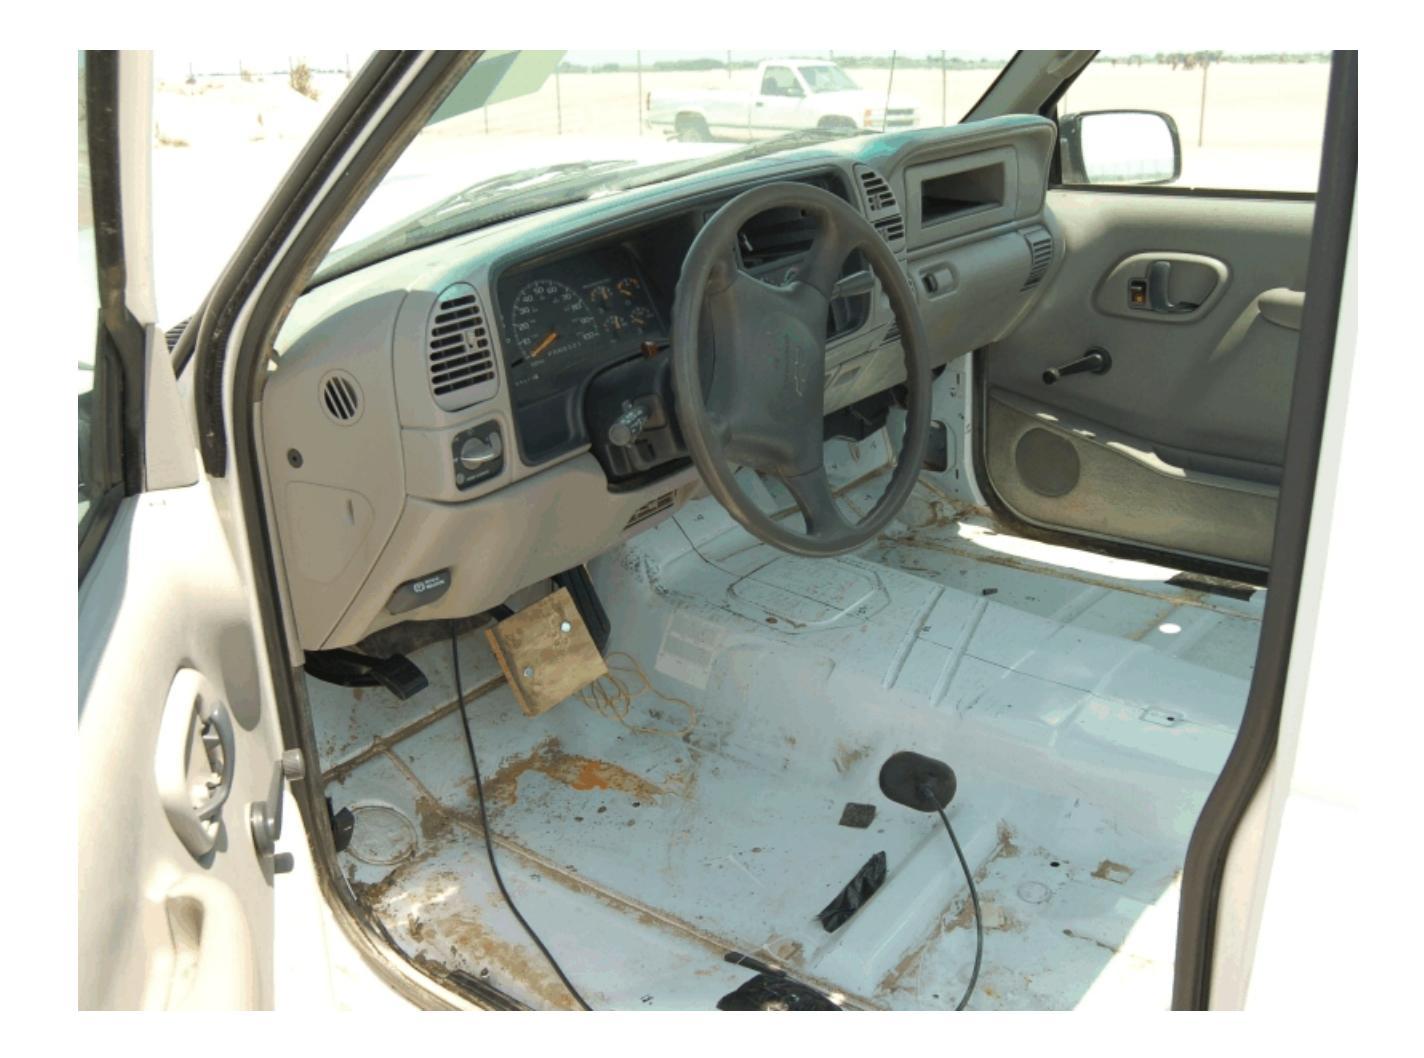
Figure 123. Occupant Compartment Deformation, Test FR-4

were located along the center and right side of the right-side floorpan. Maximum lateral deflections of 19 mm (0.75 in.) were located along the firewall and near the left center of the right-side floorpan. Maximum vertical deflections of 13 mm (0.5 in.) were located near the left-rear corner of the rightside floorpan. The occupant compartment deformation is shown in Figure 123. Complete occupant compartment deformations and the corresponding locations are provided in Appendix K.

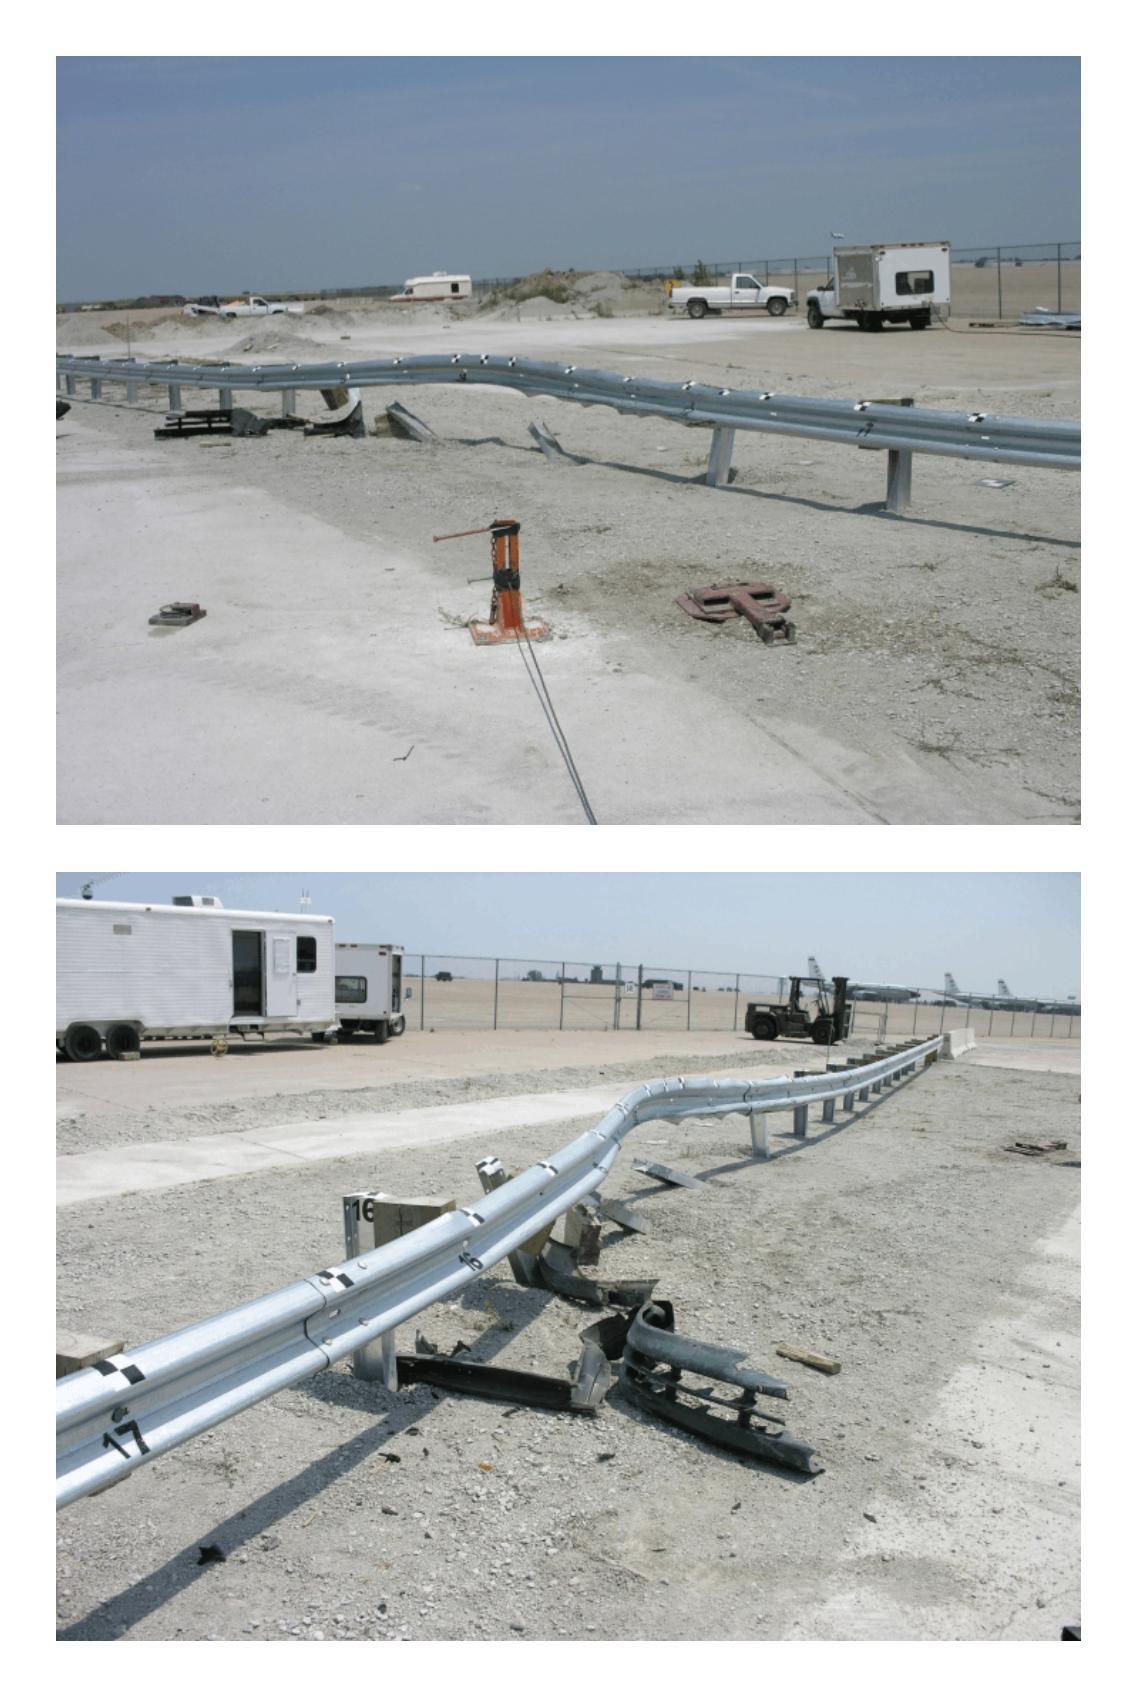
Figure 132. System Damage, Test FR-5

Damage to the barrier system was minimal, as shown in Figures 132 through 140. Barrier damage consisted of deformed guardrail posts, deformed and disengaged blockouts, deformed guardrail, and contact marks on a guardrail section. The length of vehicle contact along the system was approximately 6.14 m (20 ft - 4.75 in.), which spanned from 425 mm (16.75 in.) upstream from the centerline of post no. 12 through the centerline of post no. 15.

The permanent set of the barrier system is shown in Figure 132. The maximum lateral permanent set and post deflections were 660 mm (26 in.) at the midspan between post nos. 13 and 14 and 470 mm (18.5 in.) at the centerline of post no. 13, respectively, as measured in the field. The maximum lateral dynamic rail and post deflections were 908 mm (35.7 in.) at the midspan between post nos. 13 and 14 and 670 mm (26.4 in.) at the centerline of post no. 14, respectively, as determined from high-speed digital video analysis. The working width of the system was found to be 1,270 mm (50 in.).
#### **11.4 Vehicle Damage**

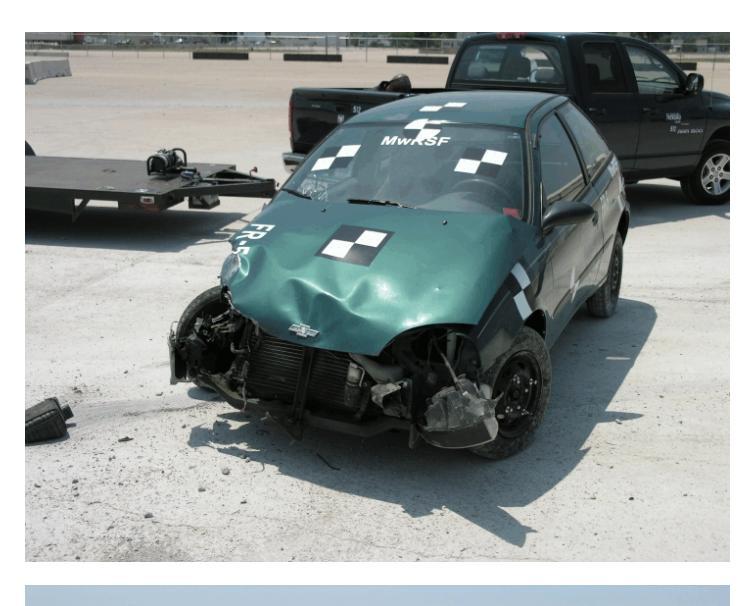
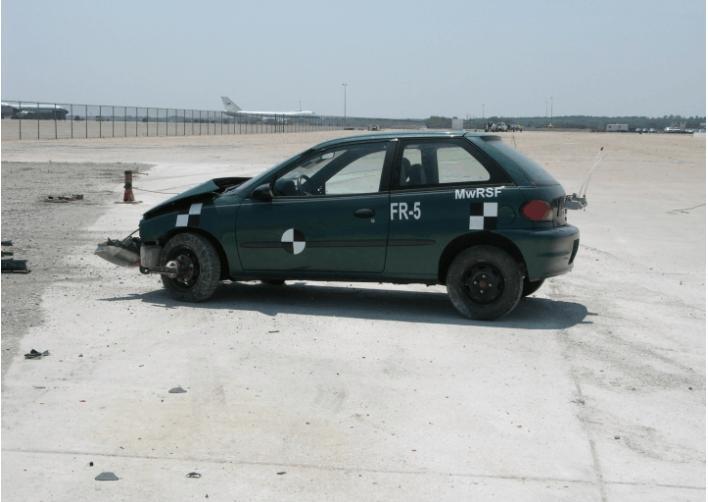
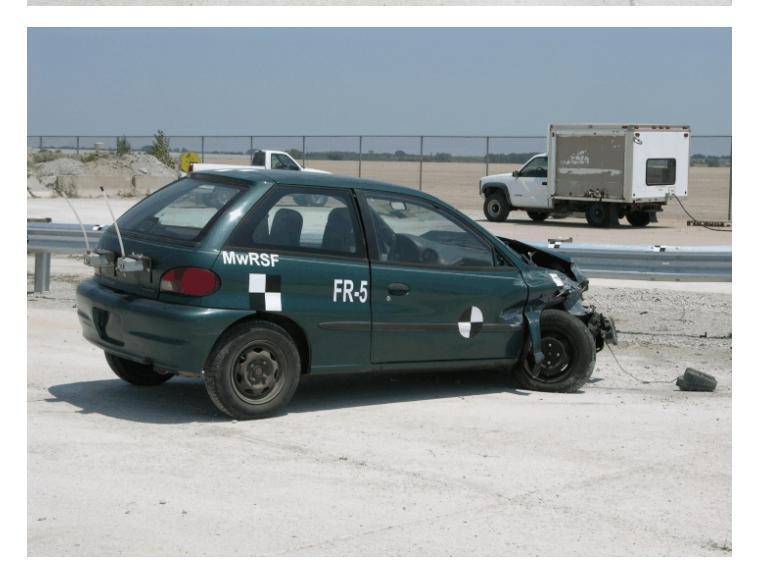
Figure 141. Vehicle Damage, Test FR-5

Exterior vehicle damage was moderate, as shown in Figures 141 through 145. Occupant compartment deformations to the right and center of the floorboard were judged insufficient to cause serious injury to the vehicle occupants. The occupant compartment deformation is shown in Figure 145. Complete occupant compartment deformations and the corresponding locations are provided in Appendix M.
