# **EVALUATION OF CRITICAL FLARE RATES FOR**

# THE MIDWEST GUARDRAIL SYSTEM (MGS)

MwRSF Research Report No. TRP-03-191-08

July 15, 2008

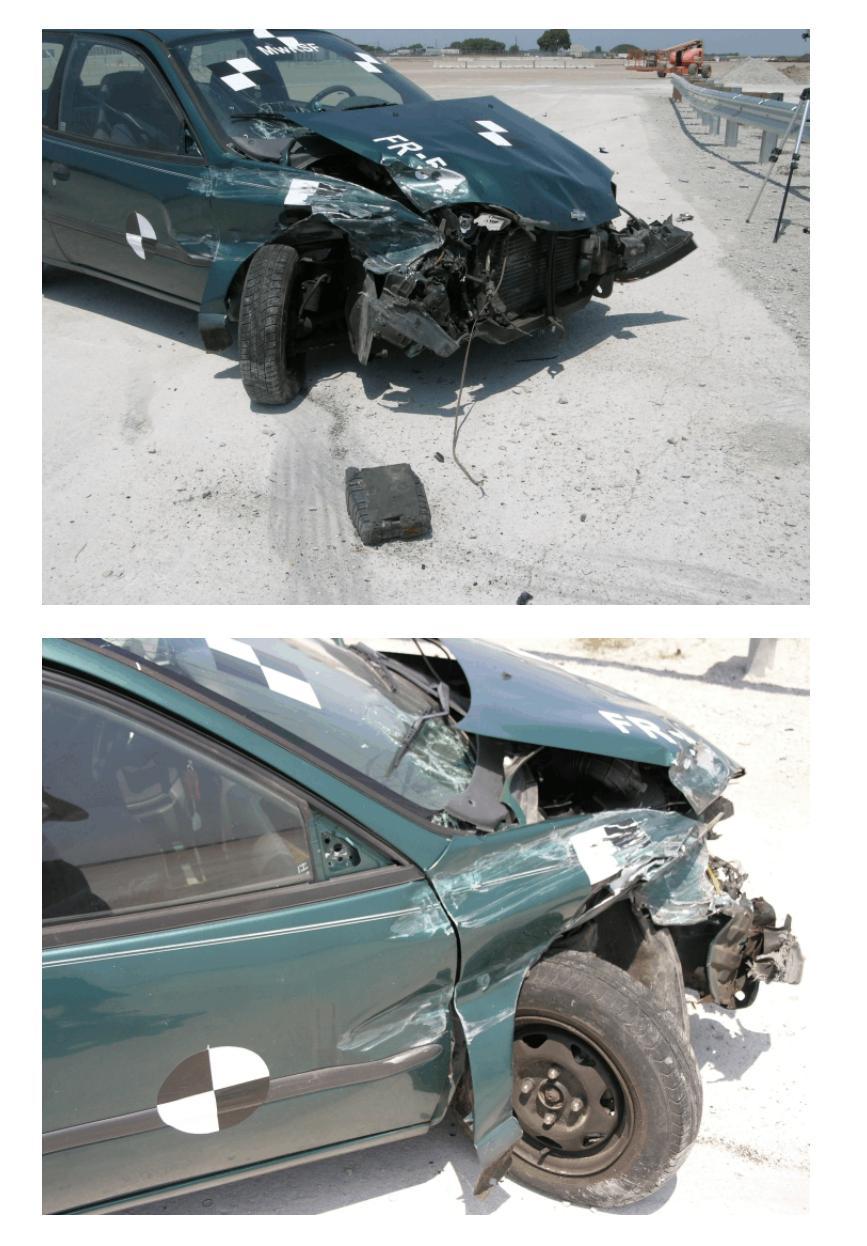
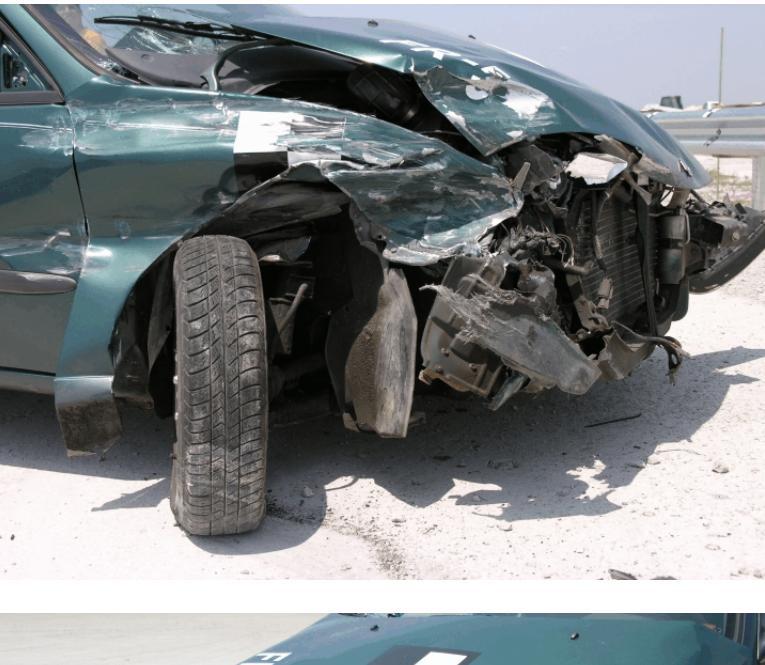
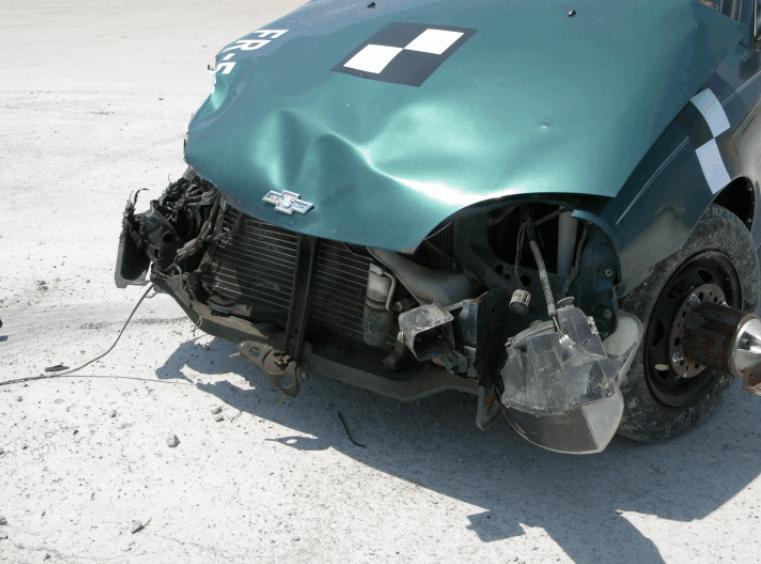
Figure 142. Vehicle Damage, Test FR-5

Exterior vehicle damage was moderate, as shown in Figures 141 through 145. Occupant compartment deformations to the right and center of the floorboard were judged insufficient to cause serious injury to the vehicle occupants. The occupant compartment deformation is shown in Figure 145. Complete occupant compartment deformations and the corresponding locations are provided in Appendix M.
