# DEVELOPMENT AND EVALUATION OF A MASH TL-3 31-INCH W-BEAM MEDIAN BARRIER

**Test Report 9-1002-12-8**

TEXAS A&M TRANSPORTATION INSTITUTE COLLEGE STATION, TEXAS

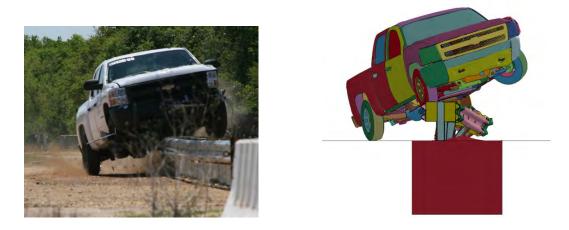
Figure 2.3. Simulation of the MASH 3-11 as the 2270P Vehicle Vaults over the 27-Inch Median Barrier.

The research team started by simulating the failed test using LS-DYNA (20) finite element code. Figure 2.3 shows the vaulting phenomena of the vehicle captured in the simulation. Hence, the model is considered corroborated with the failed *MASH* test 3-11 and can be used as a tool to investigate the system performance once modified.

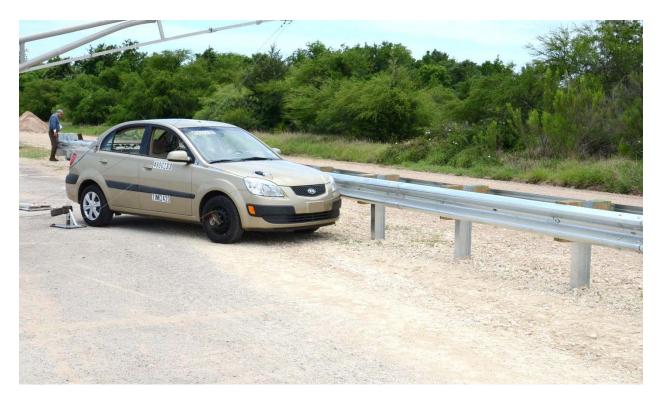
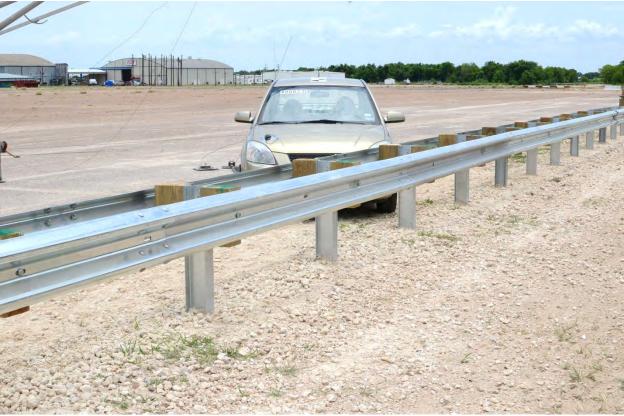
Figure 6.1. Vehicle/Installation Geometrics for Test No. 490023-3.

A 2006 Kia Rio, shown in Figures 6.1 and 6.2, was used for the crash test. Test inertia weight of the vehicle was 2444 lb, and its gross static weight was 2624 lb. The height to the lower edge of the vehicle bumper was 7.12 inches, and it was 21.00 inches to the upper edge of the bumper. Tables D1 and D2 in Appendix D give additional dimensions and information on the vehicle. The vehicle was directed into the installation using the cable reverse tow and guidance system, and was released to be free-wheeling and unrestrained just prior to impact.

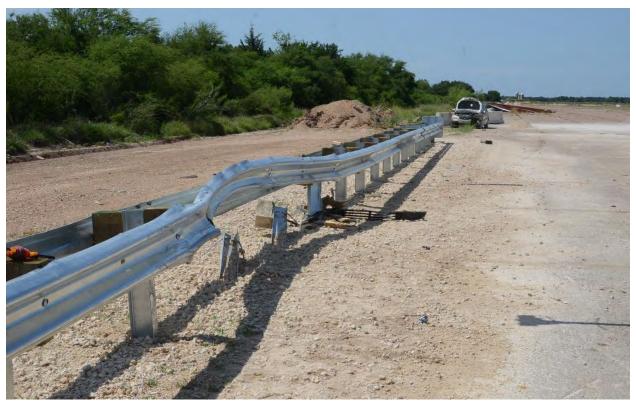
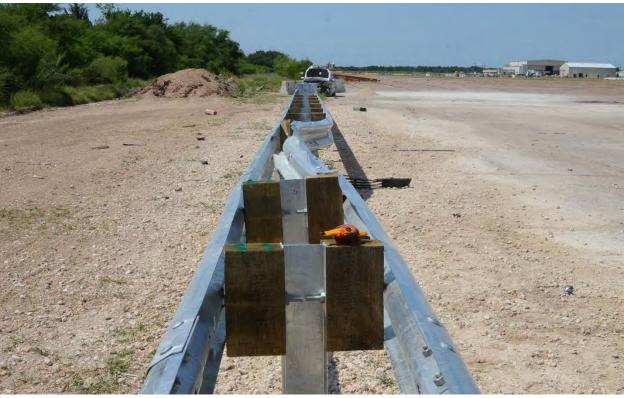
Figure 6.3. Vehicle/Installation Positions after Test No. 490023-3.

Figures 6.3 and 6.4 show damage to the TxDOT 31-inch W-Beam Median Barrier. No apparent movement was noted at post 1 or post 26 (the end posts). Post 11 and 12 were displaced through the soil toward the side opposite impact 0.25 inch and 1.75 inches, respectively. Posts 13 and 14 were leaning 70 degrees toward the side opposite impact and the rail element on the impact side separated from the posts. Both blockouts at post 13 separated from the post and the blockout on the side opposite impact separated from post 14. Post 15 rotated 45 degrees in the soil, the blockout on impact side separated from the post, and both rail elements separated from the post. The rail element on the impact side ruptured upward two-thirds of the width of the rail element at the upstream bolts on the splice between posts 12 and 13. The length of contact of the 1100C vehicle with the rail was 22.0 ft. Maximum permanent deformation of the rail was 20.25 inches between posts 13 and 14.

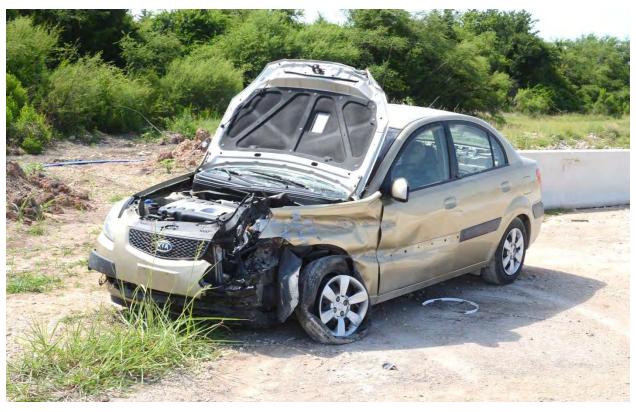
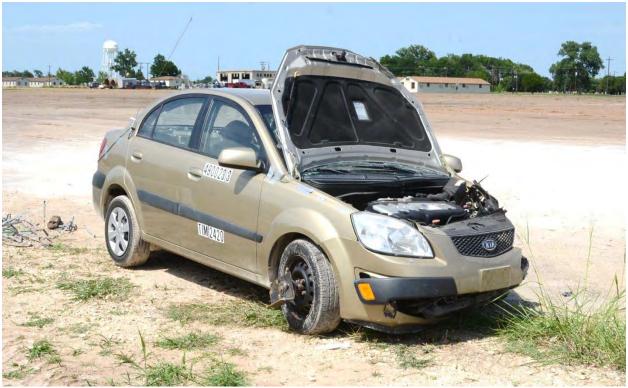
Figure 6.5. Vehicle after Test No. 490023-3.

Figure 6.5 shows damage to the 1100C vehicle. The front bumper, hood, radiator and support, left front strut and tower, left front tire and wheel rim, left front fender, and left front door were damaged. The hood was pushed into the windshield, which shattered the lower portion of the windshield. Maximum exterior crush to the 1100C vehicle was 13.0 inches in the side plane at the left front corner just above bumper height. No occupant compartment deformation was noted. Figure 6.6 provides photographs of the interior of the vehicle, and Tables D1 and D2 provide exterior and occupant compartment measurements.

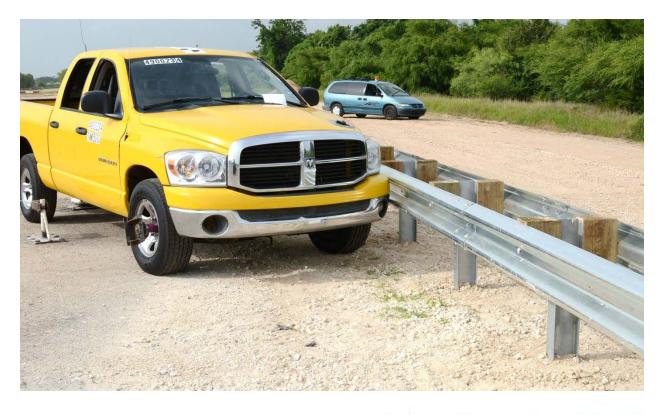
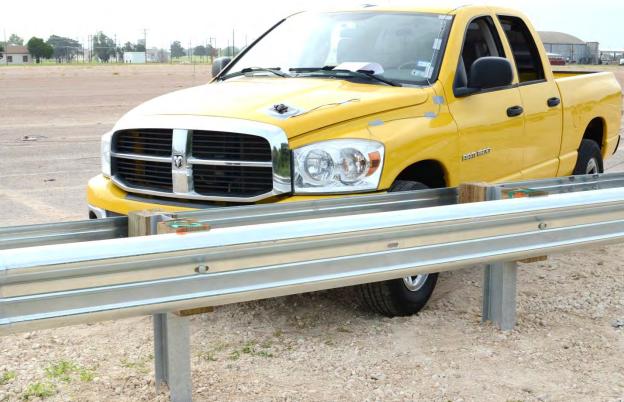
Figure 7.1. Vehicle/Installation Geometrics for Test No. 490023-4.

A 2007 Dodge Ram 1500 pickup truck, shown in Figures 7.1 and 7.2, was used for the crash test. Test inertia weight of the vehicle was 5014 lb, and its gross static weight was 5017 lb. The height to the lower edge of the vehicle bumper was 15.50 inches, and it was 28.00 inches to the upper edge of the bumper. The height to the vehicle's center of gravity was 28.50 inches. Tables E1 and E2 in Appendix E give additional dimensions and information on the vehicle. The vehicle was directed into the installation using the cable reverse tow and guidance system, and was released to be free-wheeling and unrestrained just prior to impact.

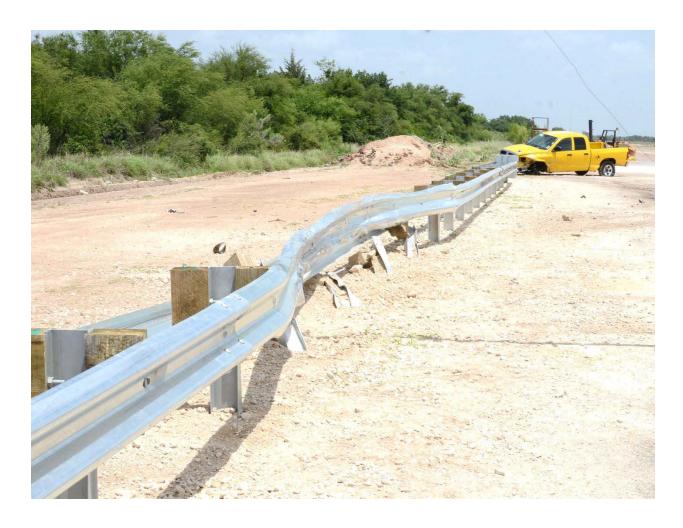
Figure 7.3. Vehicle/Installation Positions after Test No. 490023-4.

Figures 7.3 and 7.4 show damage to the TxDOT 31-inch W-Beam Median Barrier. Post 1 was displaced through the soil 0.5 inch at ground level on the upstream side, and no apparent movement was noted at post 26 (end posts). Posts 6 through 11 were slightly rotated, and post 11 was displaced through the soil 0.5 inch toward the side opposite impact. Post 12 was leaning downstream and toward the side opposite impact 45 degrees. Post 13 was leaning downstream 85 degrees and toward the side opposite impact 45 degrees. Posts 14 and 15 were leaning downstream 60 degrees. Post 16 was rotated slightly. The rail element on the impact side separated from posts 12 through 15, and the rail element on the side opposite impact released from posts 8 through 17. The blockouts on the impact side of posts 12 through 15 fractured and separated from the posts and rail element. The length of contact of the 2270P vehicle with the rail was 31.0 ft. Maximum permanent deformation of the rail was 29.5 inches between posts 13 and 14.

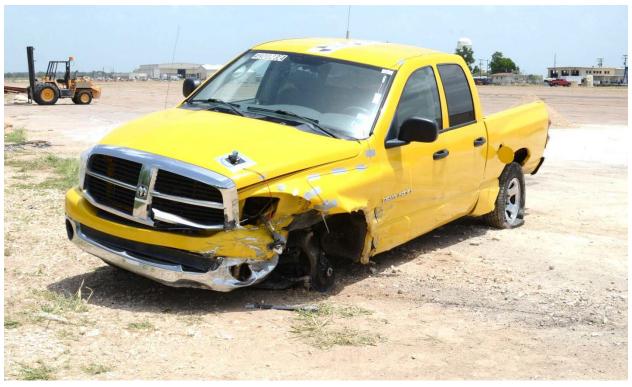
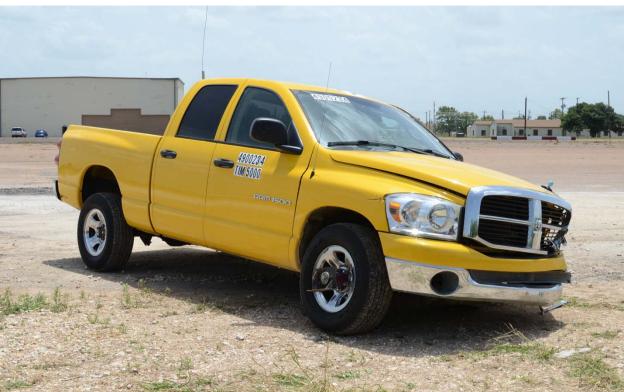
Figure 7.5. Vehicle after Test No. 490023-4.

Figure 7.5 shows damage to the 2270P vehicle. The left front tie rod, left front lower A-arm, left front frame rail, and left front hub assembly were deformed. Also damaged were the front bumper, grill, left front tire and wheel rim, left front fender, left front door, left rear door, left rear exterior bed, left rear tire, and rear bumper. Maximum exterior crush to the vehicle was 11.0 inches in the side plane at the left front corner just above bumper height. No occupant compartment deformation occurred. Figure 7.6 shows the interior of the vehicle before and after the test. Tables E3 and E4 in Appendix E present the measurements made on the vehicle.

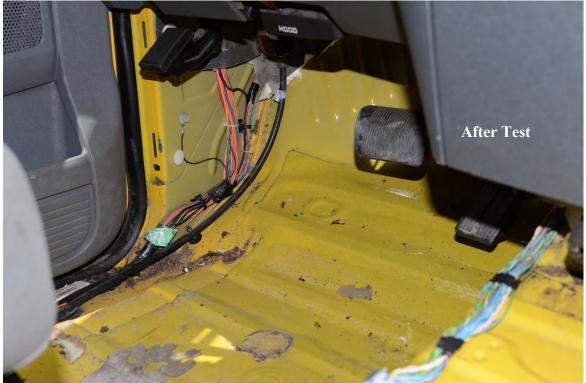
Figure 7.6. Interior of Vehicle for Test No. 490023-4.
