# CRASH TESTING OF VARIOUS TEXTURED BARRIERS

**CRASH TESTING OF VARIOUS TEXTURED BARRIERS**

1. REPORT NO. <b>FHWA/CA/TL-2002/03</b>	2. GOVERNMENT ACCESSION NO.	3. RECIPIENT'S CATALOG NO.	
4. TITLE AND SUBTITLE  <b>CRASH TESTING OF VARIOUS TEXTURED BARRIERS</b>		5. REPORT DATE September, 2002

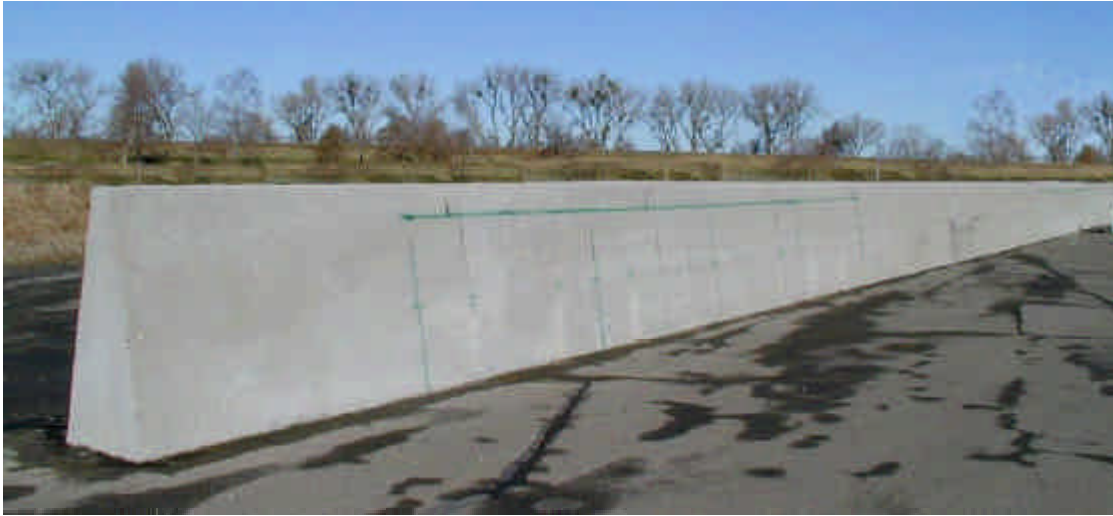
Figure 2-1 Existing Type 60G barrier

In 1997 Caltrans conducted full-scale crash tests on a slip-formed, single-slope, concrete median barrier known as the Type 60G<sup>2</sup>. This barrier is 1.42 meters high with a traffic-side face that slopes 9.1 degrees from vertical (Figure 2-1). This barrier is still in place at the Caltrans facility and was used as a “backing” for all of the tests performed in this study<sup>2</sup>. It was determined that casting relatively thin (300 mm) panels against this existing barrier would be less costly than forming and casting an entire textured barrier capable of withstanding full-scale impacts.

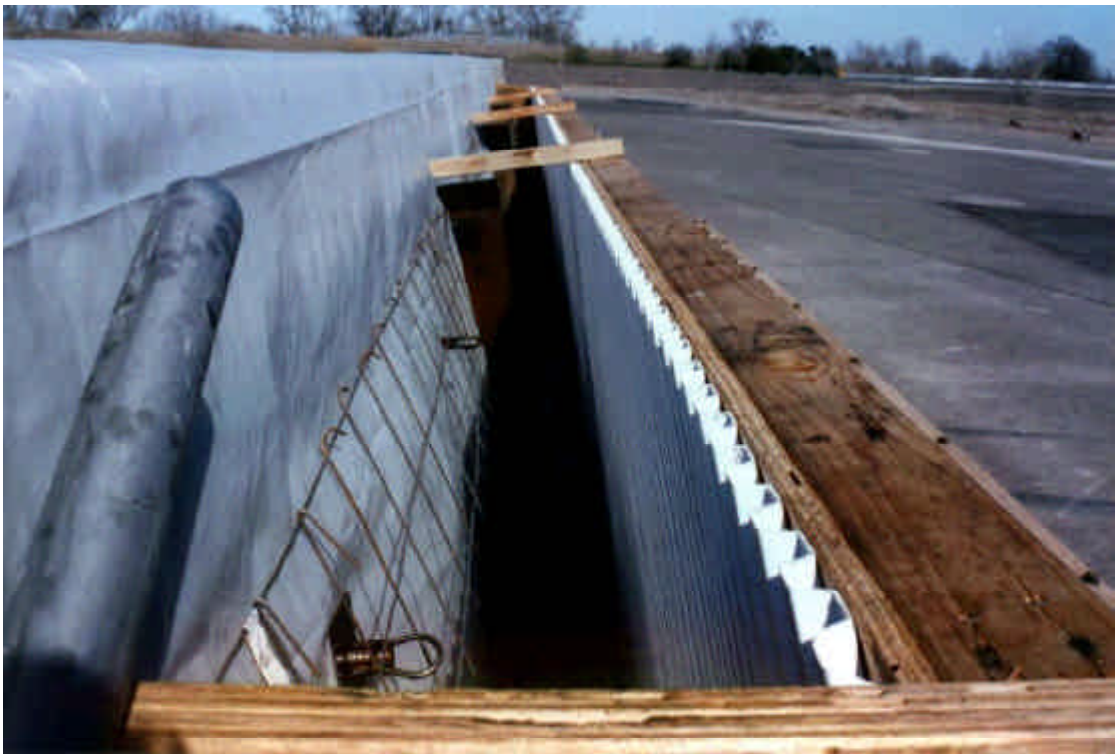
Figure 2-2. Formwork ready for concrete placement  
(note the plastic sheeting and ferrule loop inserts)

It was necessary to be able to remove each set of textured barrier panels easily after testing to make way for the next set of textured panels to be tested. A sheet of plastic was placed over the existing Type 60G barrier to prevent the textured panels from bonding to the Type 60G. Because this kept the textured concrete panel physically separate from the Type 60G concrete, a method was developed to temporarily secure the panels to the Type 60G. Cast in each panel were 19-mm ferrule loop inserts attached to threaded rods. These threaded rods passed through the plastic sheet and into 76 mm diameter holes cored through the existing Type 60G barrier. Thin sheet metal plates placed directly under the ferrule loop inserts kept the fluid concrete from flowing into the 76 mm cored holes (Figure 2-2). Steel plates and nuts were used on the backside of the Type 60G to hold the ferrule loop inserts in place during the casting process. These nuts were tightened on the day of the crash test.

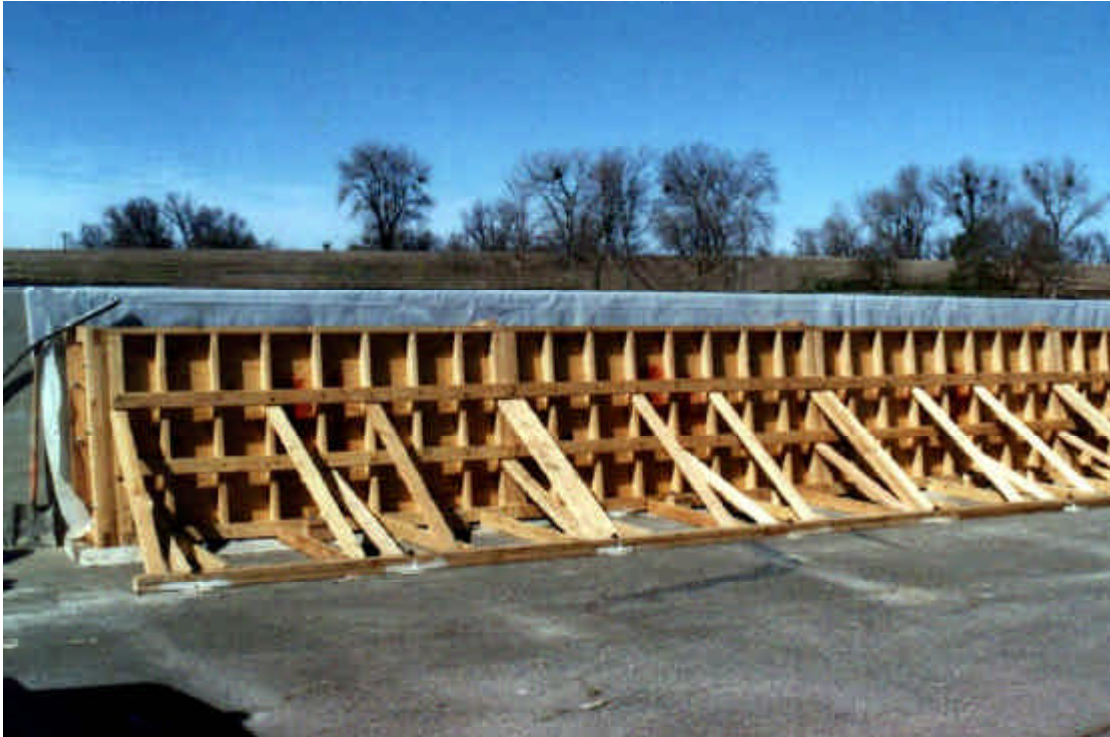
Figure 2-3. Formwork bracing for the 1220 mm high barriers

The reusable formwork for each of the textured panel designs was constructed using typical 2” x 4” wood framing to make four separate panels each 2.4-m long. The panels used for Tests 581 through 584 were 1220-mm high while the panels for all other tests were 1422-mm high. The panels were bolted to each other to form a continuous wall 9.8-m long. The panel forms at the ends of the barrier were bolted to a form end-piece, which in turn was bolted to the existing Type 60G barrier via mechanical expansion anchors. The entire formwork assembly was braced against a “kickboard” which was bolted to 19-mm ferrule loop inserts cast into concrete footings in the asphalt directly in front of the barrier (Figure 2-3).

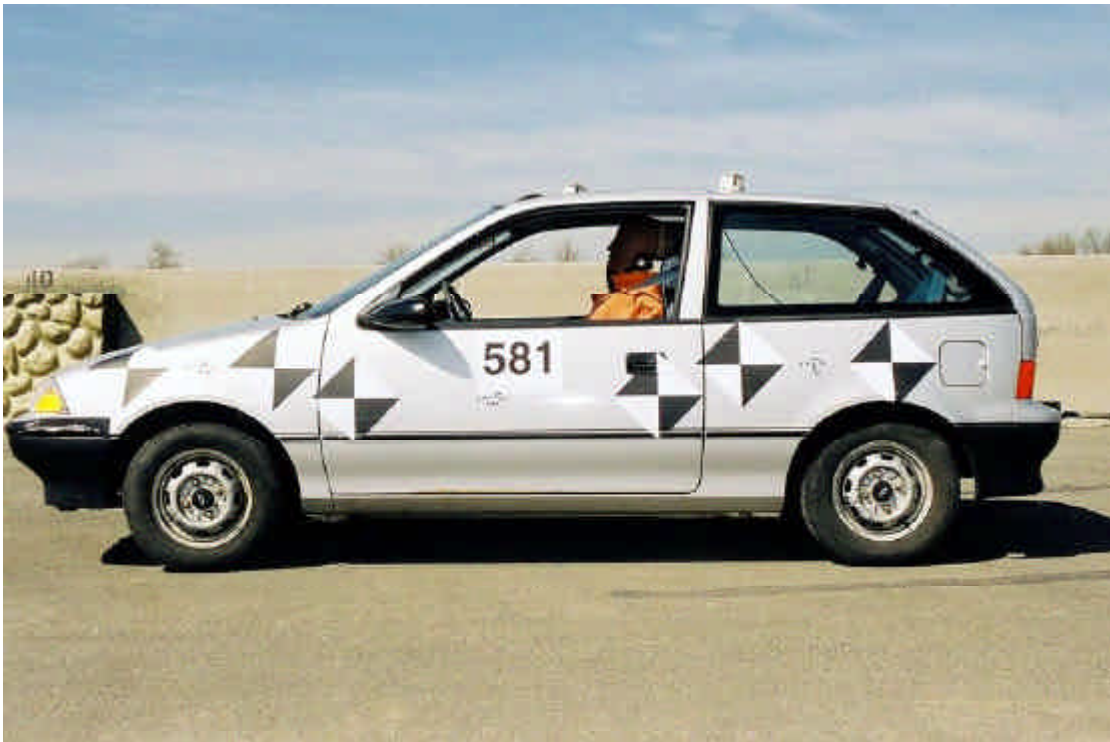
Figure 2-4 Test vehicle for Test 581

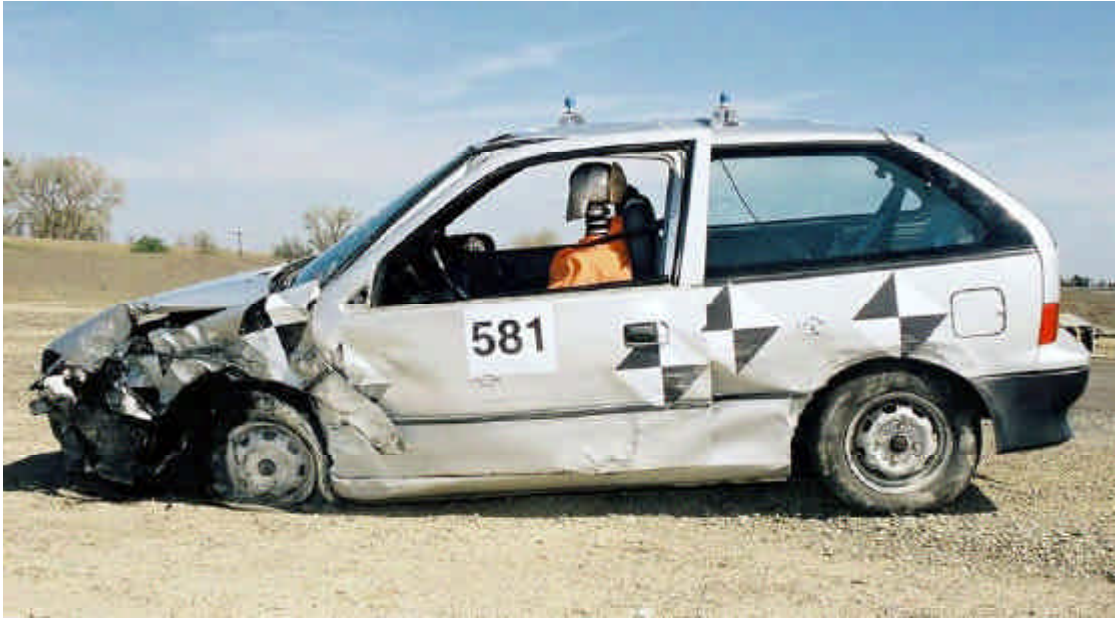
Figure 2-5 Test vehicle after Test 581

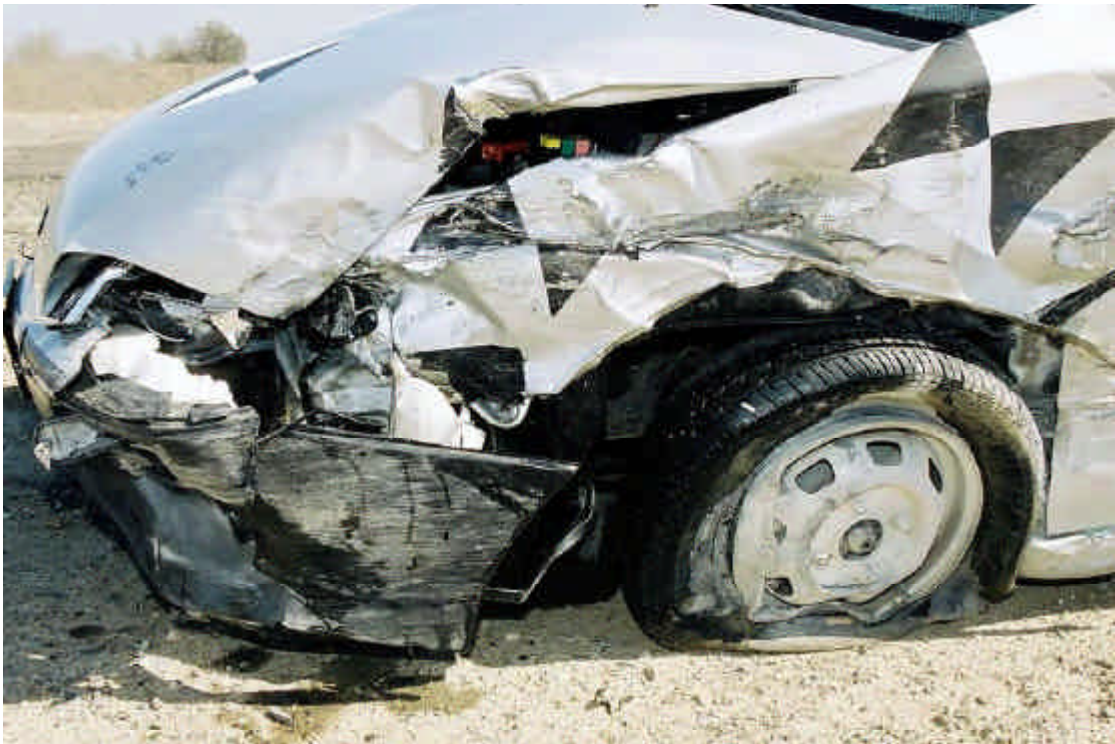
Figure 2-6. Left front corner of test vehicle after Test 581

The left front quarter section of the vehicle was moderately damaged in the initial impact with the barrier. The left front fender, hood, bumper, headlamp area, grille, and suspension components were all affected. The driver side doorframe was deformed outward but the door remained latched. The left front tire was also ruptured. Some minor damage along the left side of the vehicle and to the left rear quarter occurred as the vehicle continued to contact the barrier after the initial impact. The maximum deformation of the driver side floorboard was 105 mm, mostly in the vicinity of the wheel well. This was within the generally accepted limit of 150 mm.<sup>3</sup> Nevertheless, this deformation was of some concern because it occurred in the narrowest part of the driver footwell and was greater than what is usually seen in an 820C test. Moreover, it was the result of the left front wheel being pushed back in the wheel well, indicative of snagging. The decision to run test 3-11 on the cobble texture was based on snagging concerns.

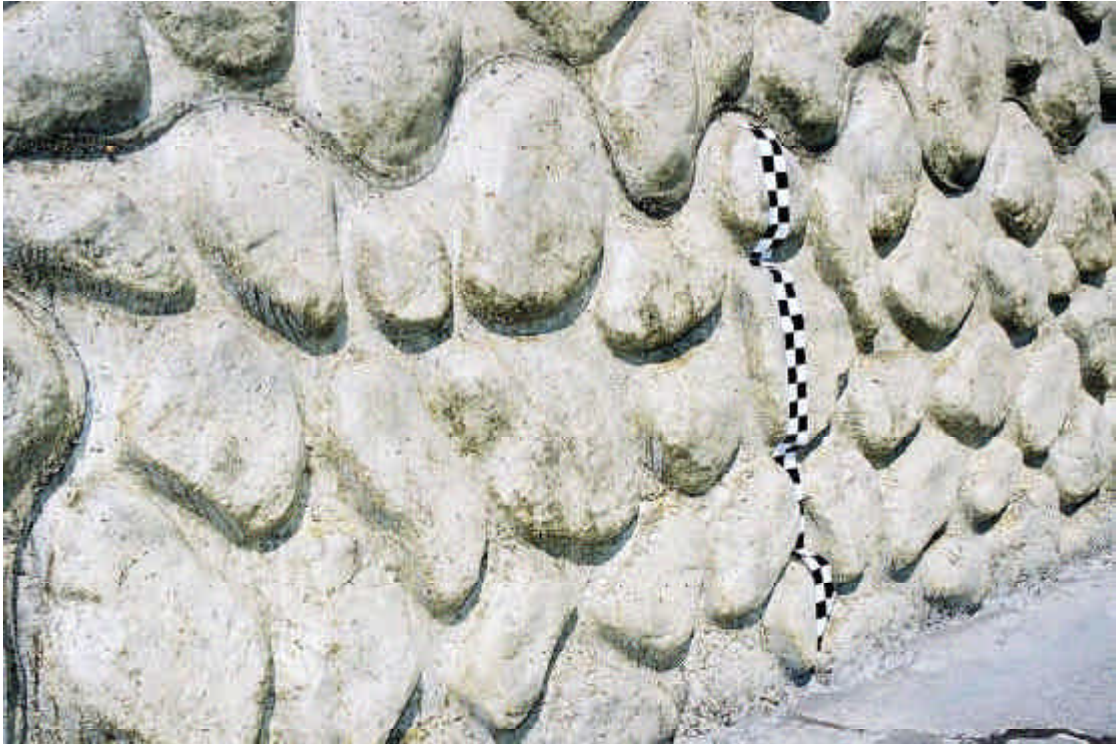
Figure 2-7 Cobble pattern test article prior to Test 581

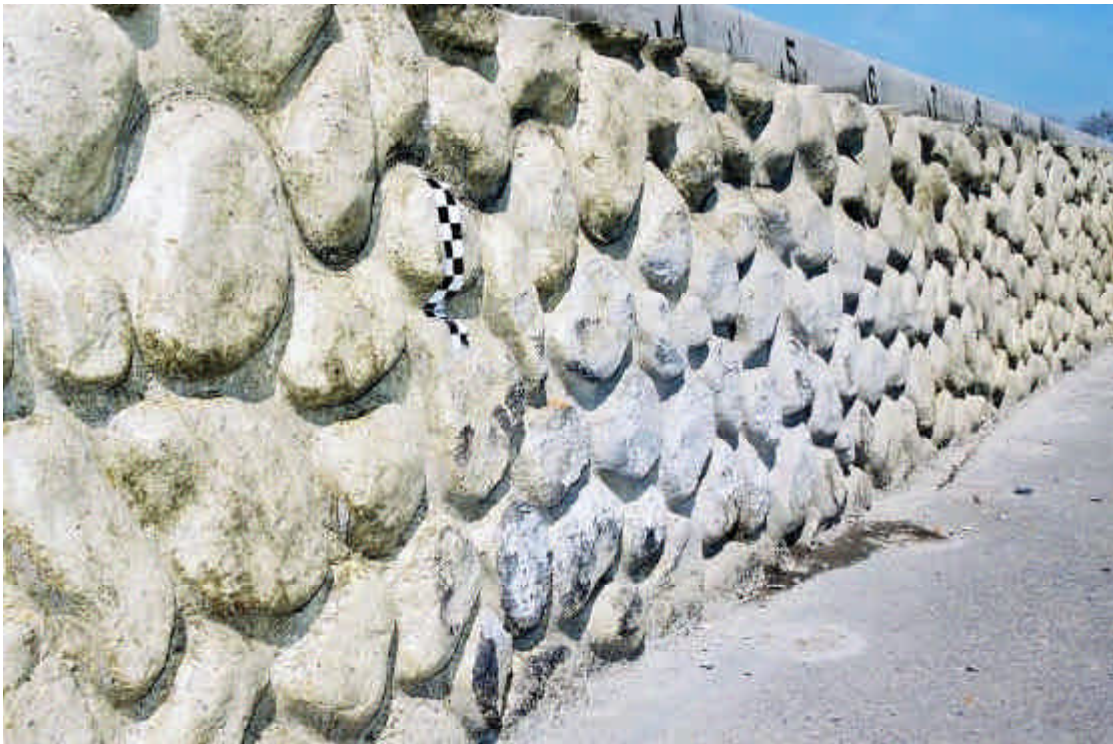
Figure 2-8 Cobble pattern test article after Test 581

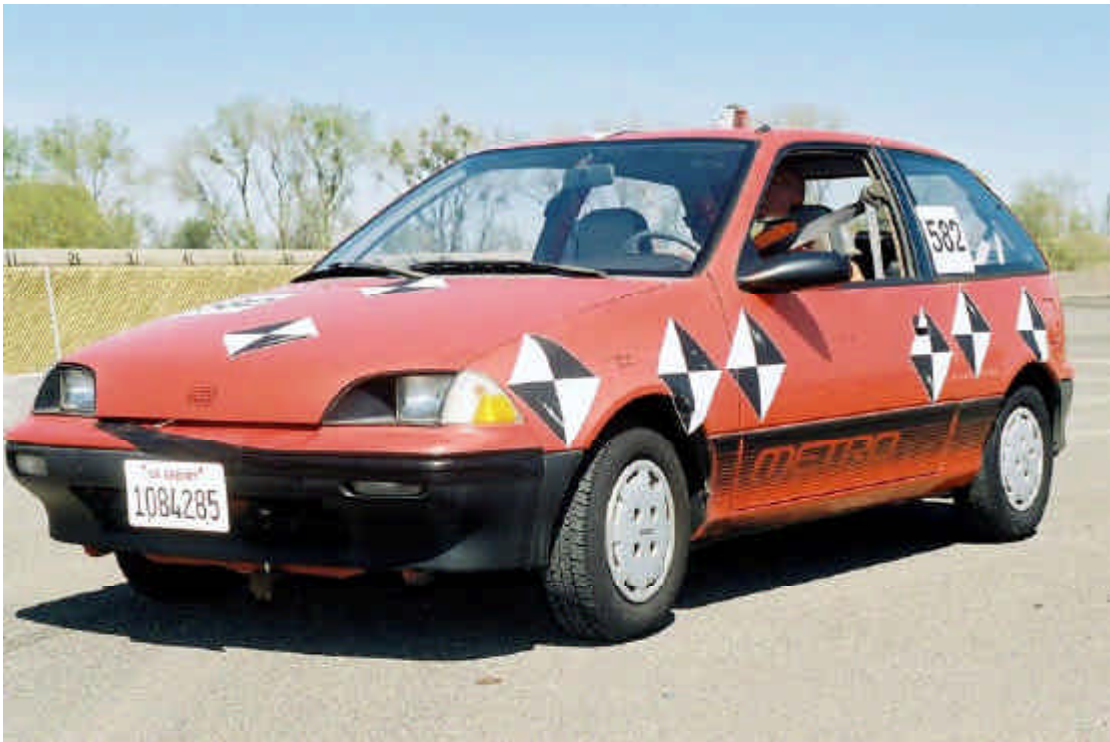
Figure 2-10 Test vehicle prior to Test 582

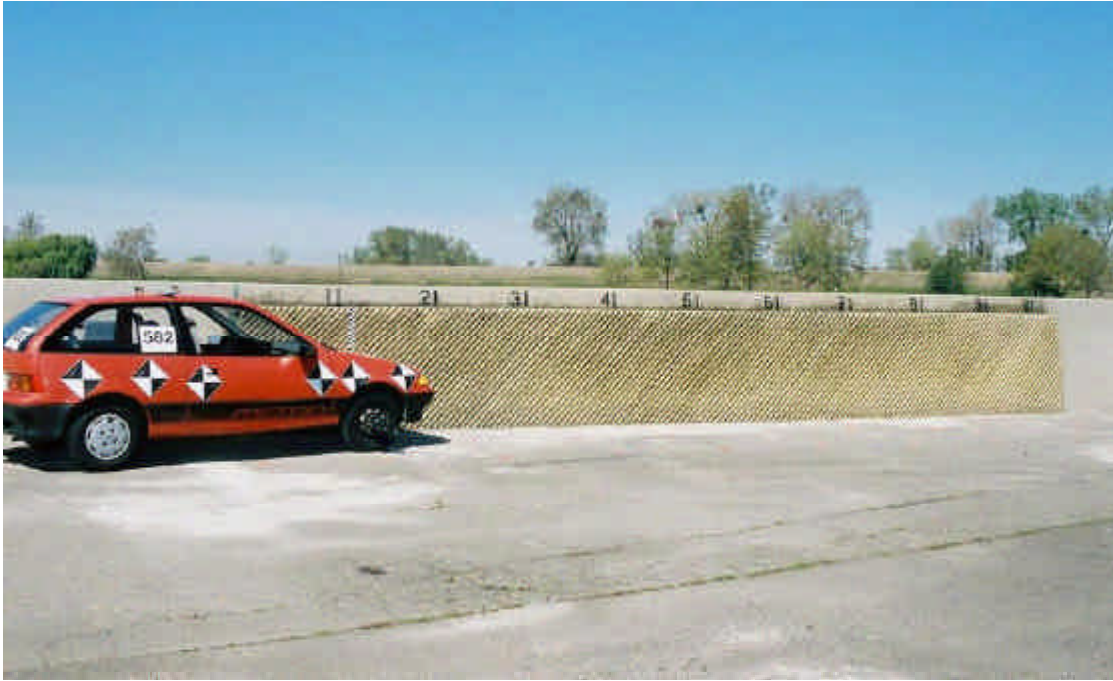
Figure 2-11 Test vehicle and test article prior to Test 582

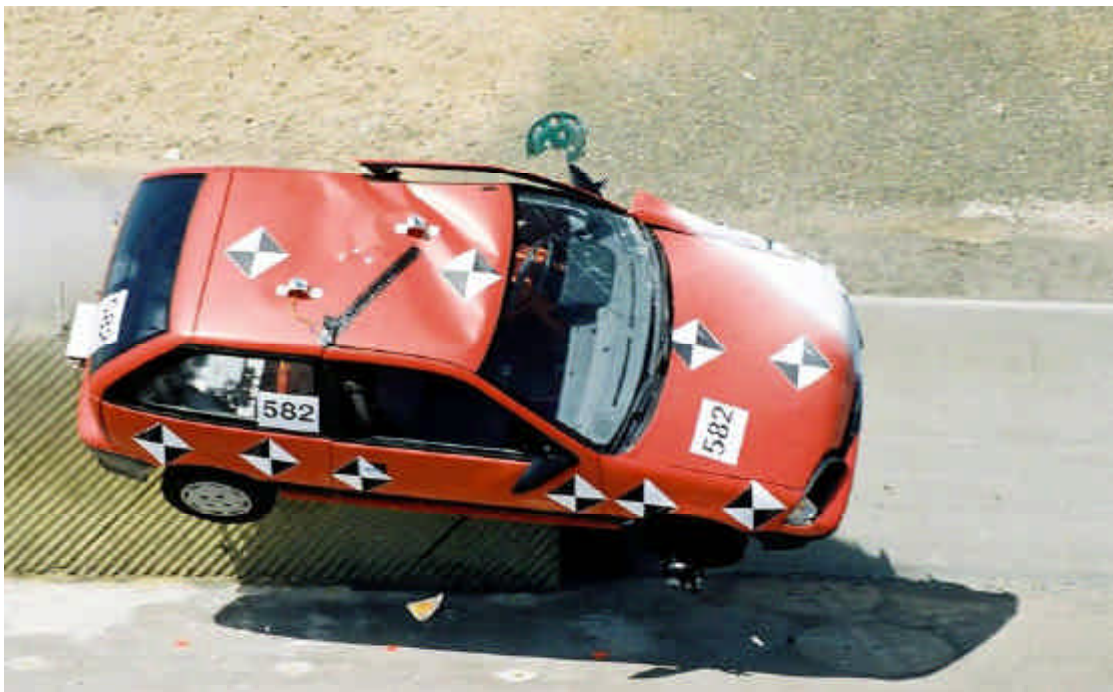
Figure 2-12 Test vehicle 582 during the Test  
(the vehicle rolled over twice to the left after landing)

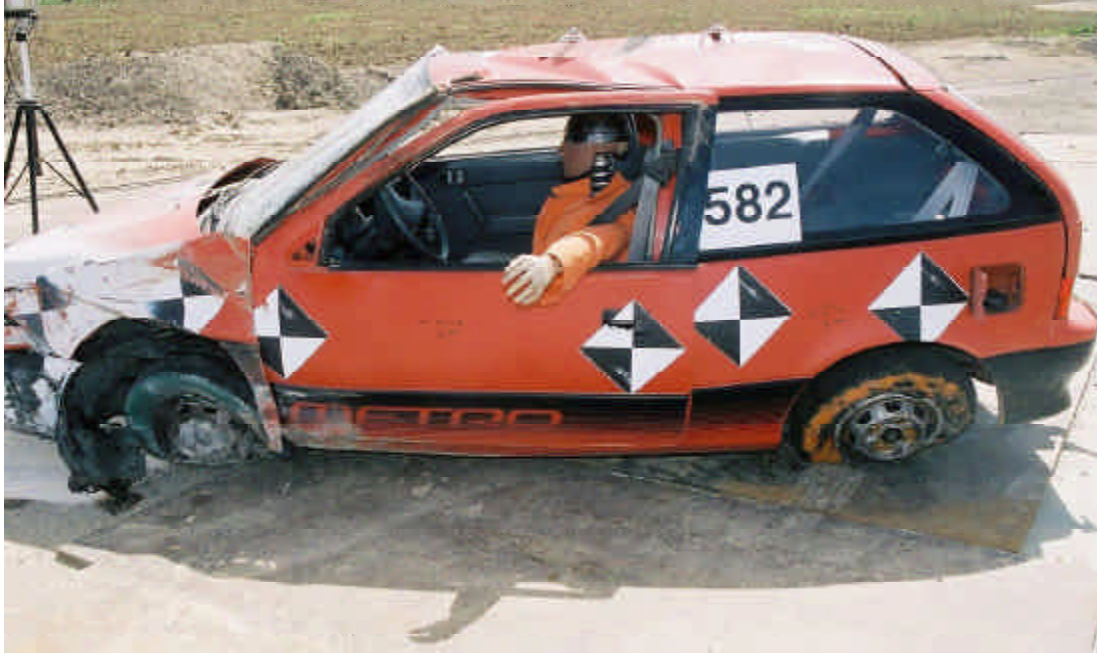
Figure 2-13 Test vehicle after Test 582

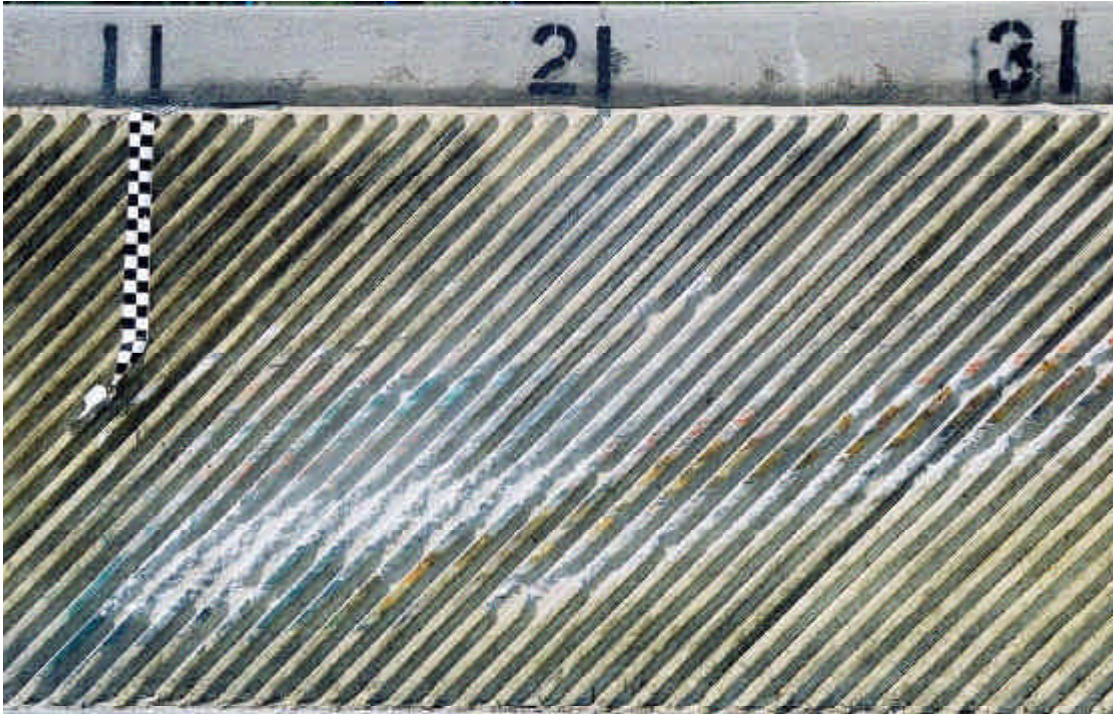
Figure 2-14 Test article after Test 582

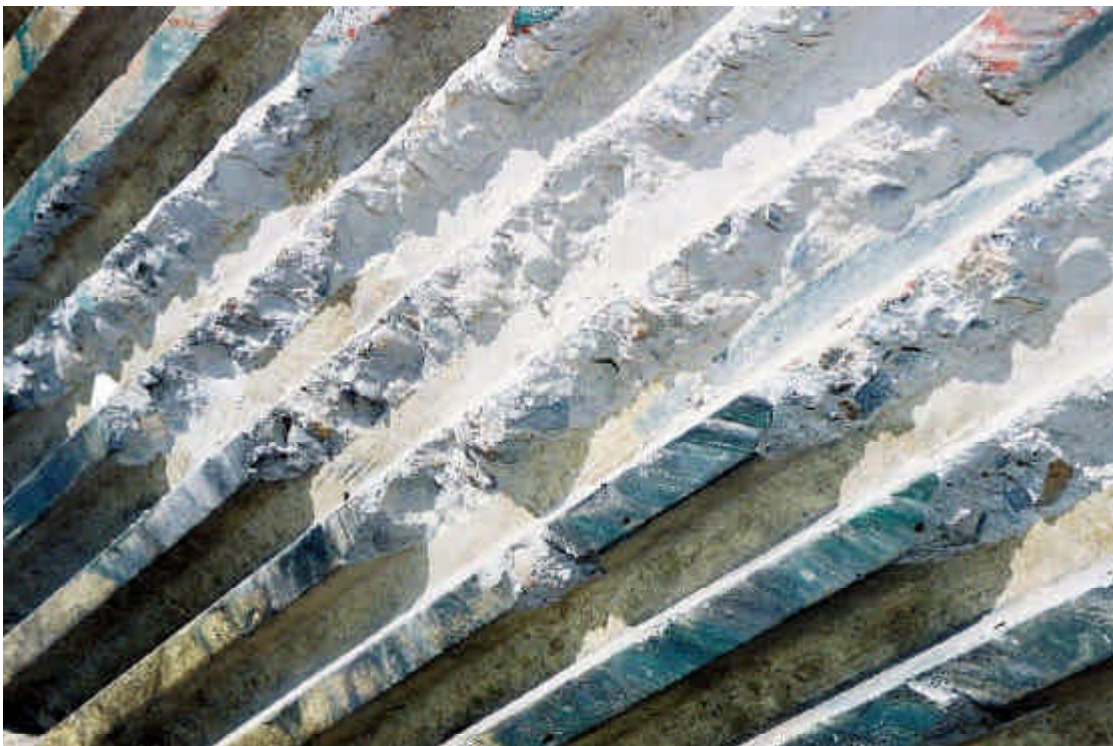
Figure 2-15 Test article after Test 582

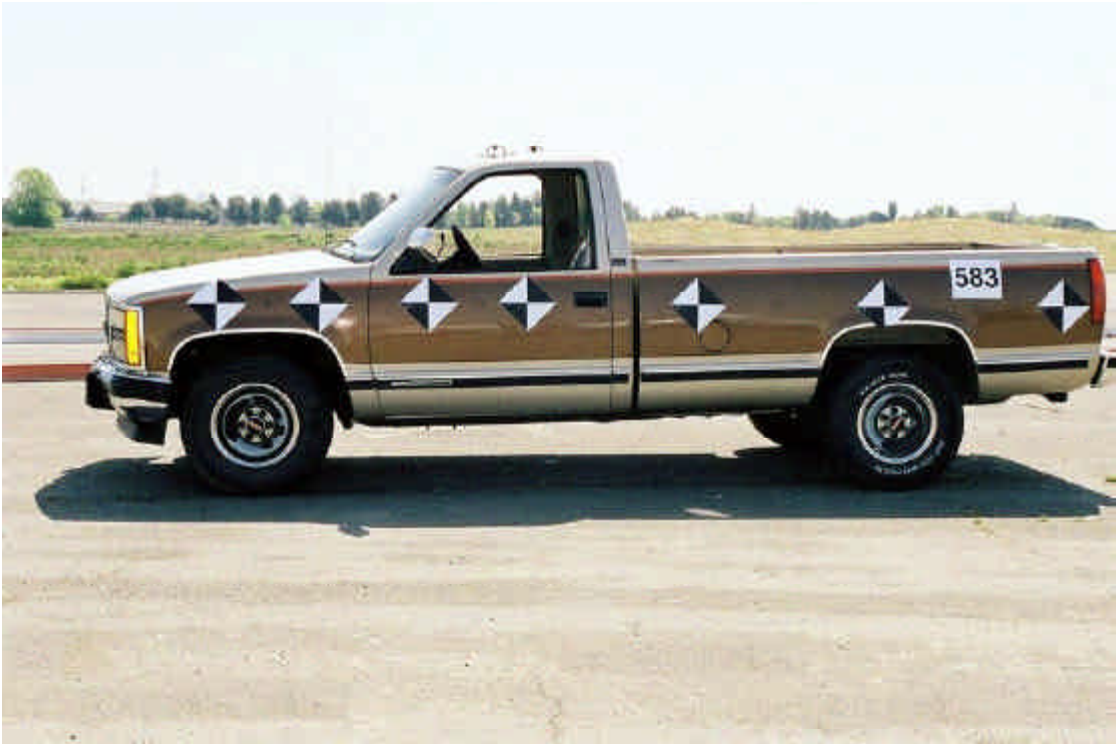
Figure 2-17 Test vehicle prior to Test 583

barrier. Figure 2-17 through Figure 2-22 show the pre-test and post-test condition of the test vehicle and test article. Sequence photographs of the impact for Test 583 are shown as Figure 2-23 on the data summary sheet on page 25.

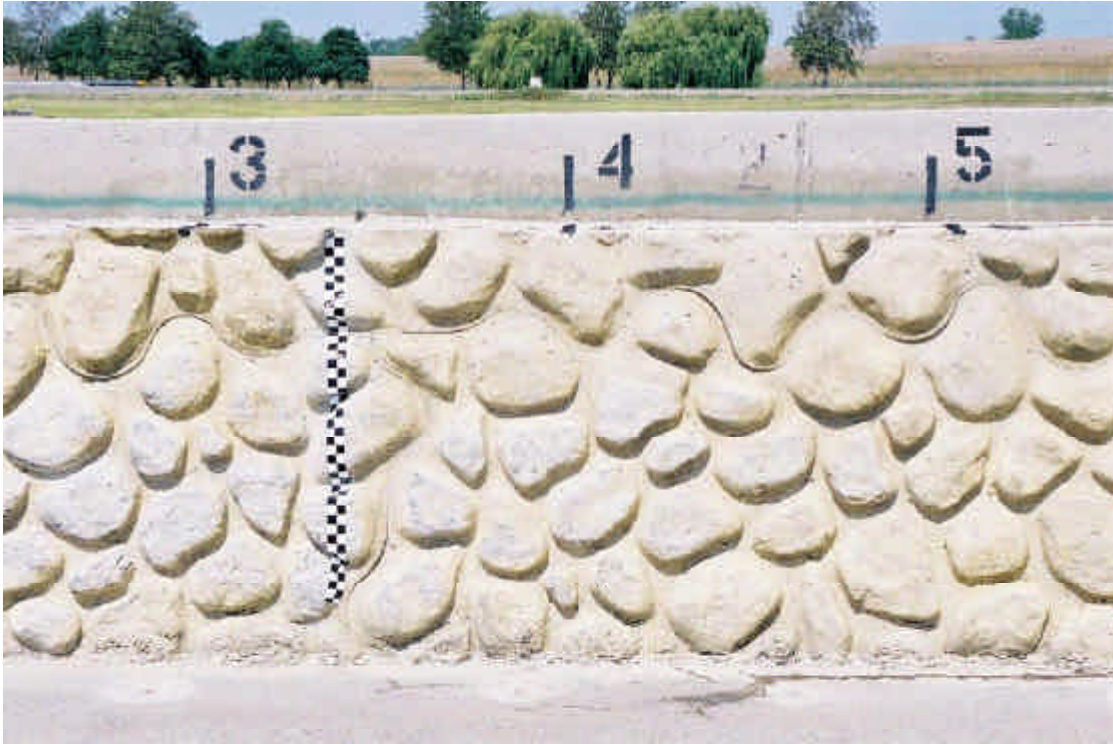
Figure 2-18 Test vehicle and test article prior to Test 583

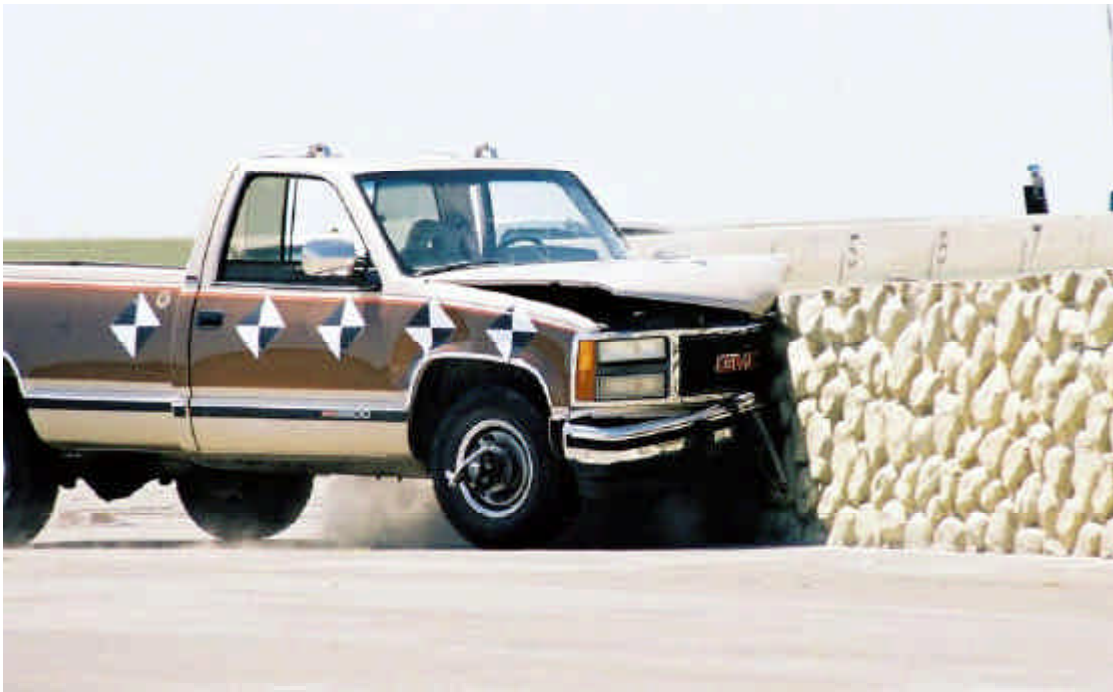
Figure 2-19 Test vehicle 583 during the Test

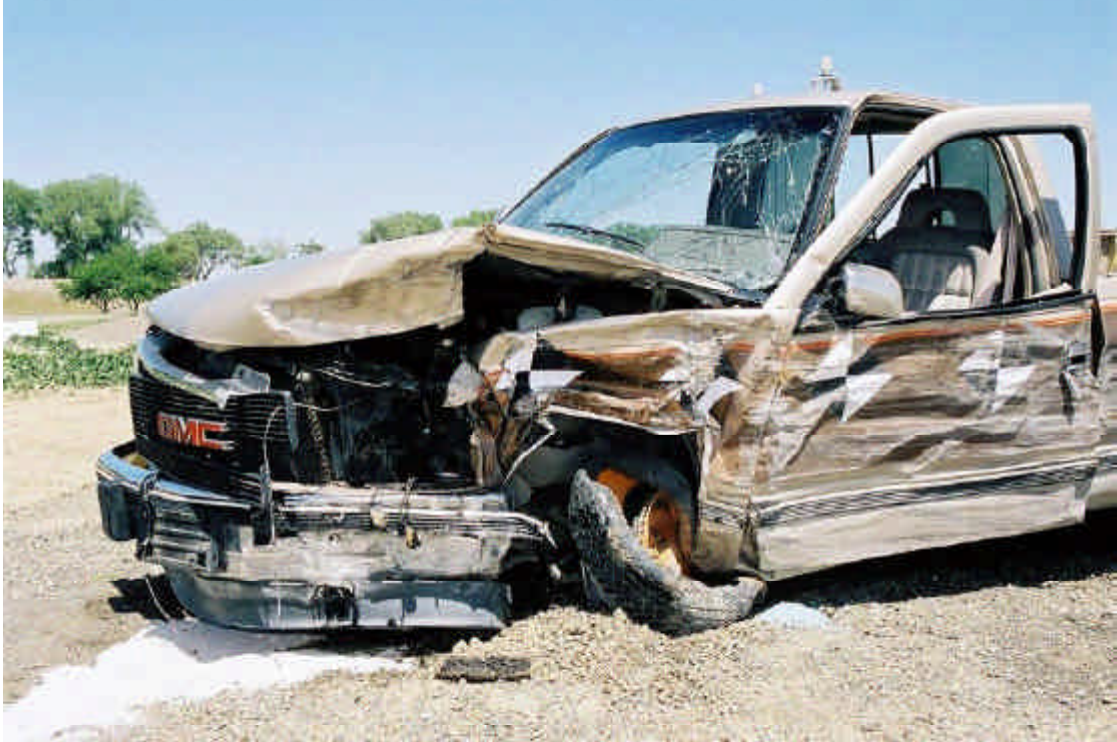
Figure 2-20 Test vehicle after Test 583

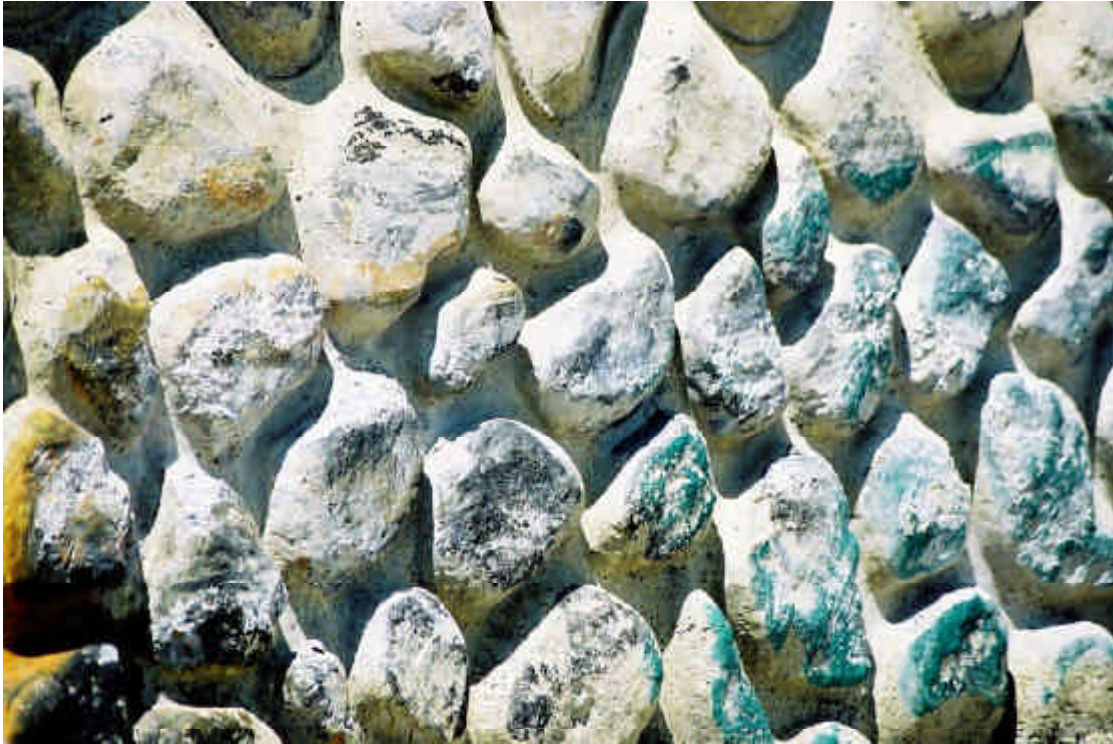
Figure 2-21 Test article after Test 583 (downstream of impact point)

Most of the damage to the barrier was superficial scraping and gouging. The vehicle impact caused some edges of individual cobbles to chip or break off (Figure 2-21 and Figure 2-22). The barrier would not require immediate repair. The gouges and scrapes could be filled on-site by maintenance crews.

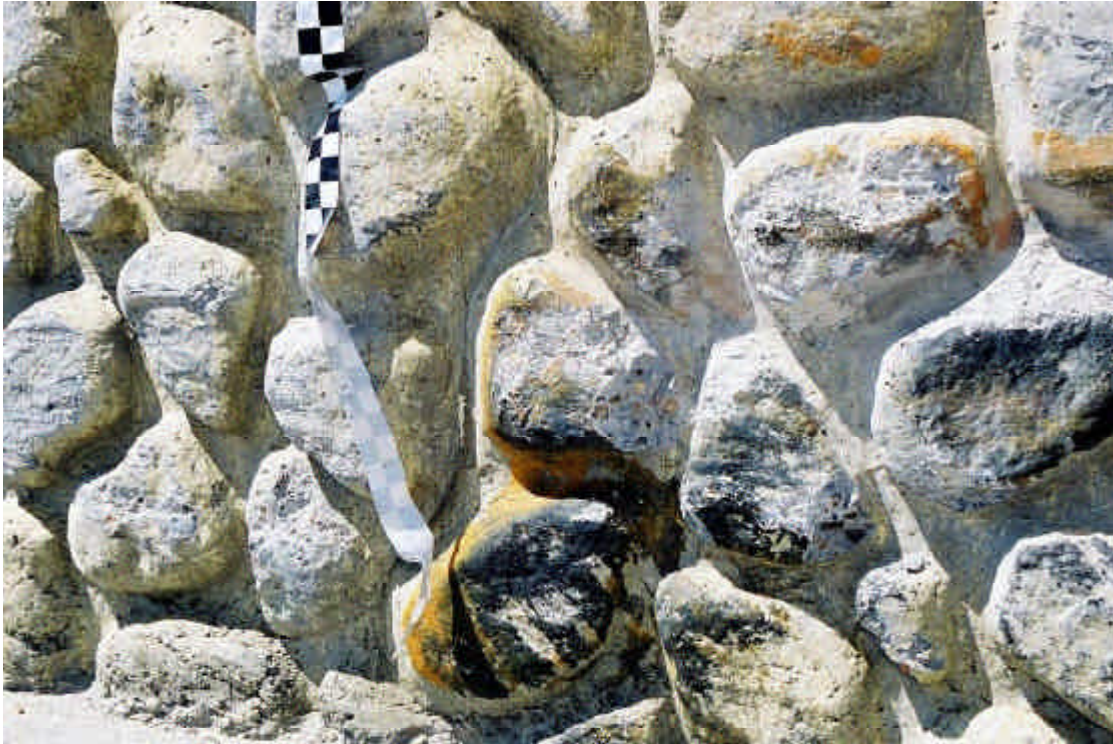
Figure 2-22 Test article after Test 583 (at impact point)

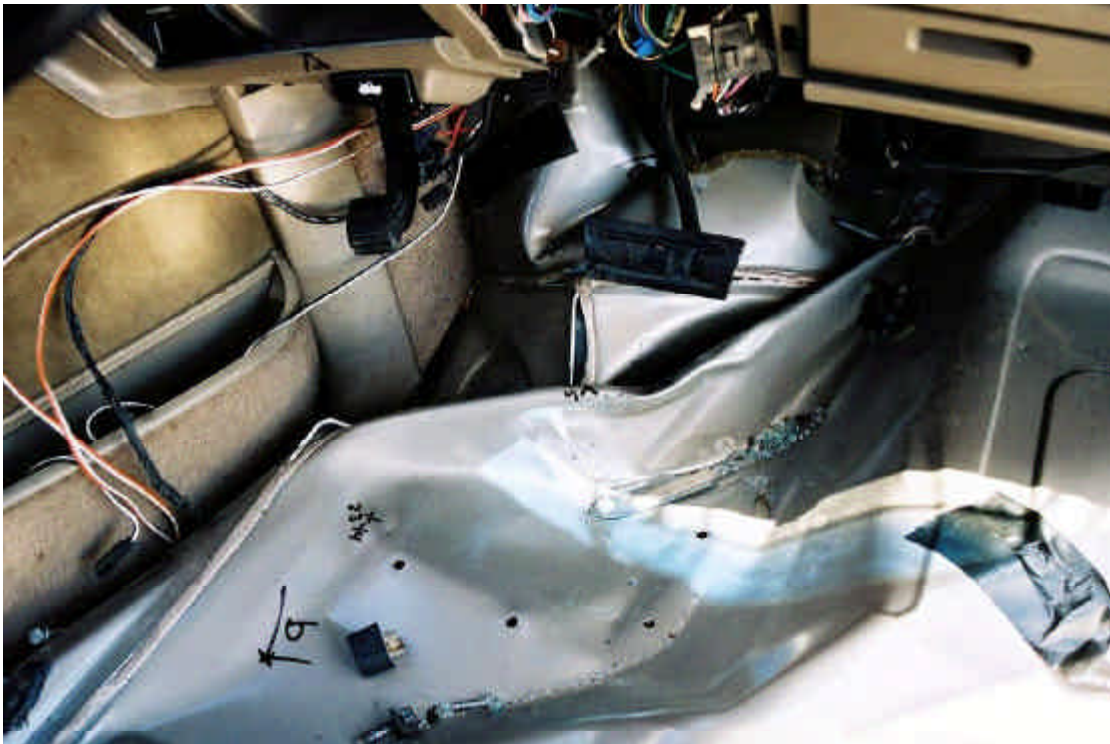
Figure 2-24 Vehicle floorboard deformation after Test 583

The left front corner of the vehicle was substantially damaged in the initial impact with the barrier. The left side of the vehicle also had significant scraping and the door was pushed rearward. The driver-side door remained latched even though the top window frame portion was buckled outward from the cab roof by 250 mm. The left front bumper and left fender were pushed rearward and inward. The left side tires were deflated but the right side tires remained inflated. The left front wheel assembly was pushed rearward enough to cause excessive deformation of the driver's side floorboard area (Figure 2-24). This amount of deformation exceeded the upper limit of 150 mm which has been informally proposed by the FHWA and is generally accepted by the roadside safety community.

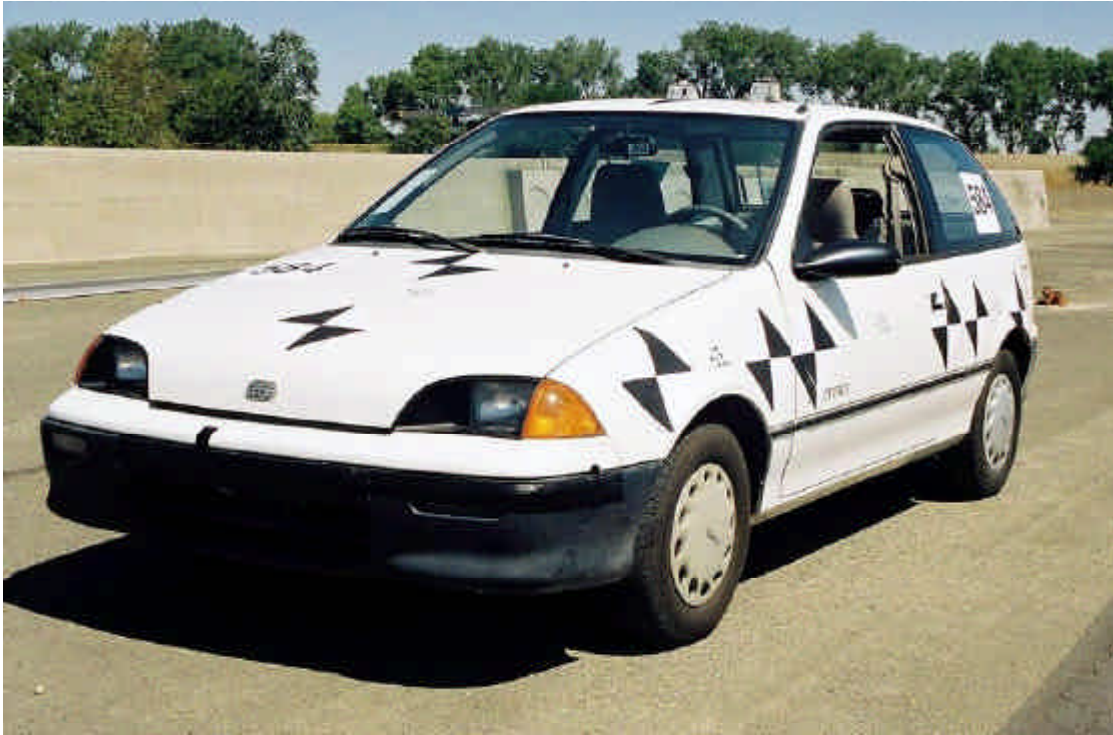
Figure 2-25 Test vehicle prior to Test 584

The impact angle was set at 20° by placement of the guide rail and film analysis indicates the impact angle was 19.3°. The impact speed of 95.8 km/h was obtained by an average of two different speed traps located just upstream from the impact point and also verified by film analysis. The test vehicle impacted the barrier 1.2 m downstream of the leading edge of the barrier as intended. As the impact progressed, the left front corner of the vehicle deformed and the vehicle began to yaw right (positive). At 0.07 seconds after impact the upper section of the driver side door frame was deformed outward to a maximum opening of about 115 mm. The left rear quarter of the vehicle contacted the barrier 0.15 seconds after the initial impact. This secondary impact by the rear of the vehicle caused slight damage to the left side of the vehicle. The vehicle remained parallel to the barrier and began a slight degree of positive pitch (nose up) to a maximum of 3.0°. From analysis of high-speed film, the maximum roll was less than 7° to the left (negative) as the right-side tires briefly lost contact with the ground approximately 0.20 seconds after impact. At 0.38 seconds after initial impact the vehicle lost contact with the barrier at which time the exit speed was determined through film analysis to be 74.4 km/h and the exit angle was less than 7°. The left-side tires remained in contact with the pavement throughout the entire test. The right front tire regained contact with the pavement at 0.56 seconds after impact and the right rear regained contact at 0.68 seconds after initial impact. The vehicle was smoothly redirected into the run-out area. The brakes were applied 1.19 seconds after the initial impact as indicated by the firing of the brake flash mounted on top of the vehicle. The vehicle came to rest in an open area approximately 35 m downstream from the end of the barrier. Figure 2-25 through Figure 2-29 show the pre-test and post-test condition of the test vehicle and test article.

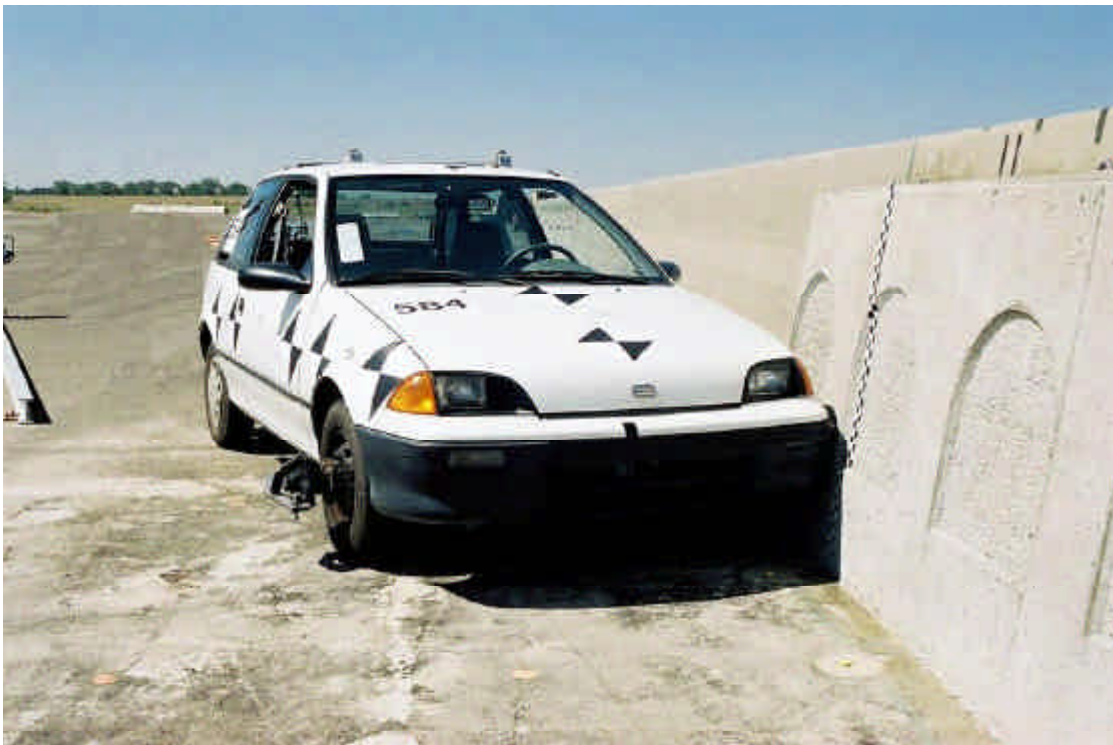
Figure 2-26 Test vehicle and test article prior to Test 584

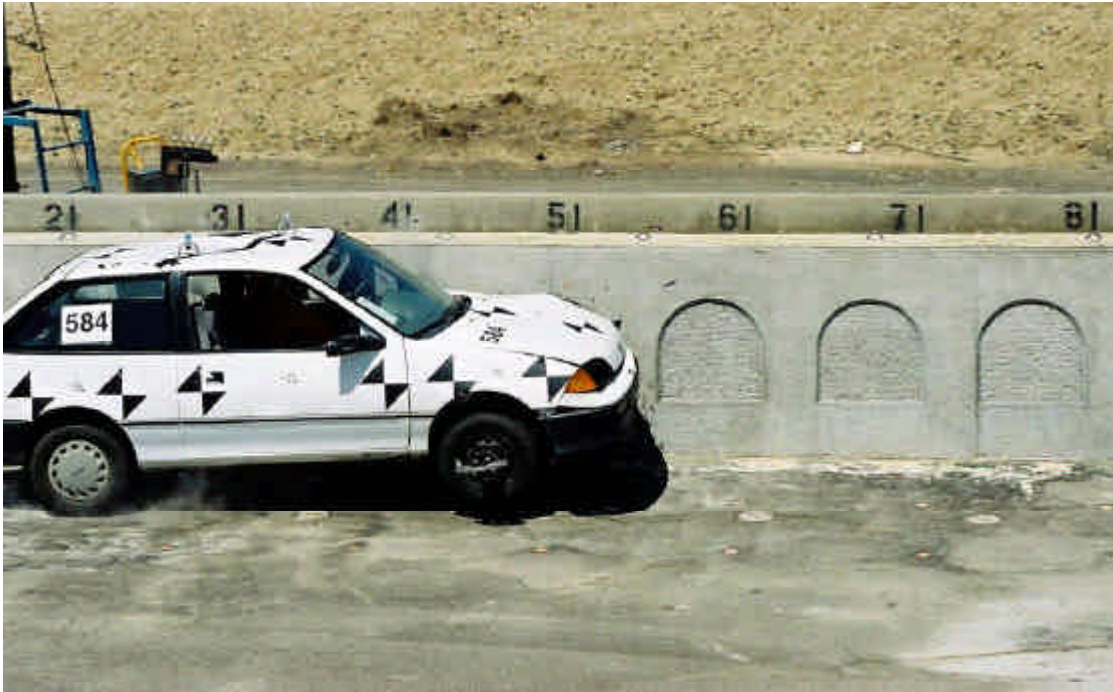
Figure 2-27 Test vehicle 584 during the Test

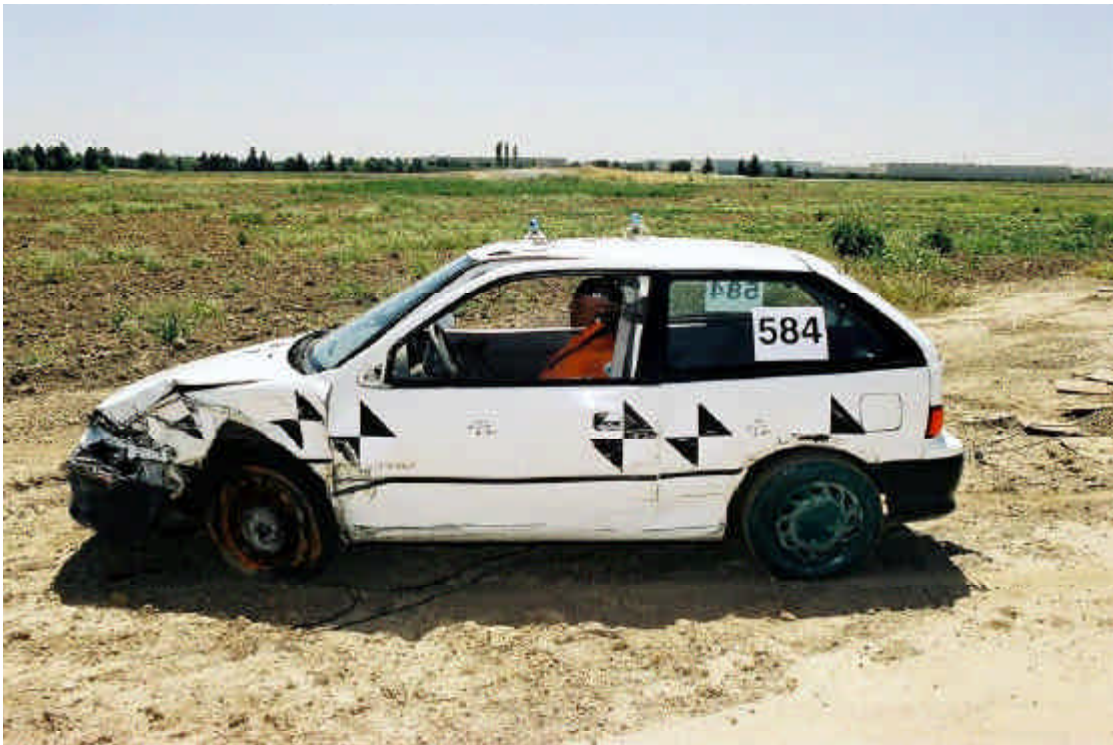
Figure 2-28 Test vehicle after Test 584
