# CRASH TESTING OF VARIOUS TEXTURED BARRIERS

**CRASH TESTING OF VARIOUS TEXTURED BARRIERS**

1. REPORT NO. <b>FHWA/CA/TL-2002/03</b>	2. GOVERNMENT ACCESSION NO.	3. RECIPIENT'S CATALOG NO.	
4. TITLE AND SUBTITLE  <b>CRASH TESTING OF VARIOUS TEXTURED BARRIERS</b>		5. REPORT DATE September, 2002

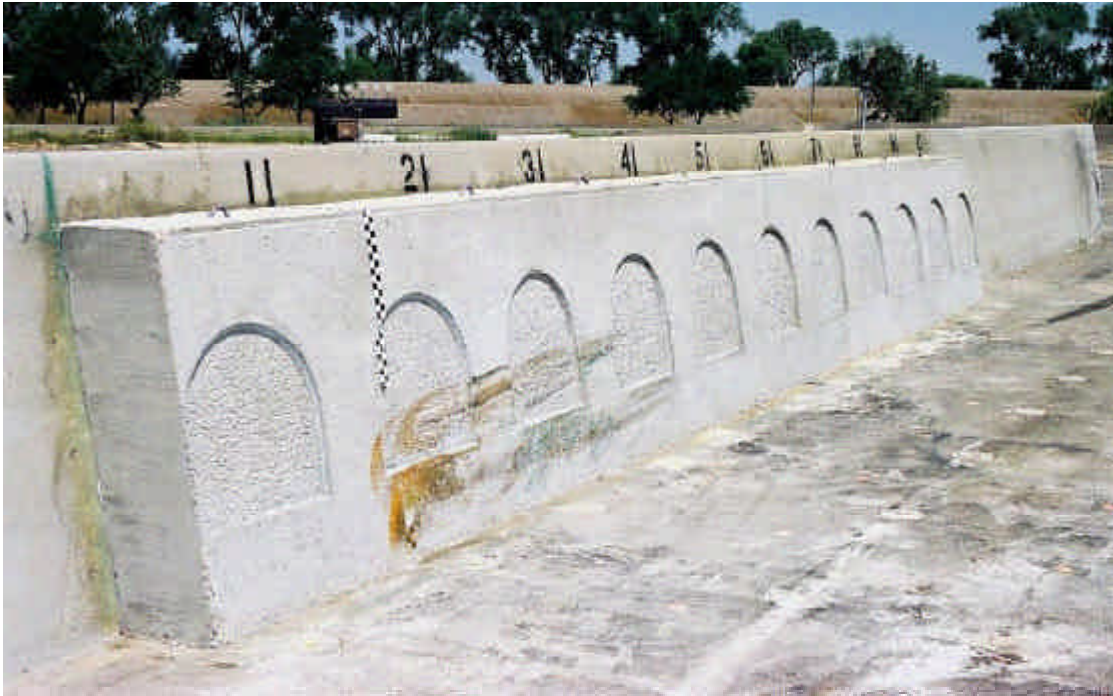
Figure 2-29 Test article after Test 584

The impact angle was set at 20° by placement of the guide rail and film analysis indicates the impact angle was 19.3°. The impact speed of 95.8 km/h was obtained by an average of two different speed traps located just upstream from the impact point and also verified by film analysis. The test vehicle impacted the barrier 1.2 m downstream of the leading edge of the barrier as intended. As the impact progressed, the left front corner of the vehicle deformed and the vehicle began to yaw right (positive). At 0.07 seconds after impact the upper section of the driver side door frame was deformed outward to a maximum opening of about 115 mm. The left rear quarter of the vehicle contacted the barrier 0.15 seconds after the initial impact. This secondary impact by the rear of the vehicle caused slight damage to the left side of the vehicle. The vehicle remained parallel to the barrier and began a slight degree of positive pitch (nose up) to a maximum of 3.0°. From analysis of high-speed film, the maximum roll was less than 7° to the left (negative) as the right-side tires briefly lost contact with the ground approximately 0.20 seconds after impact. At 0.38 seconds after initial impact the vehicle lost contact with the barrier at which time the exit speed was determined through film analysis to be 74.4 km/h and the exit angle was less than 7°. The left-side tires remained in contact with the pavement throughout the entire test. The right front tire regained contact with the pavement at 0.56 seconds after impact and the right rear regained contact at 0.68 seconds after initial impact. The vehicle was smoothly redirected into the run-out area. The brakes were applied 1.19 seconds after the initial impact as indicated by the firing of the brake flash mounted on top of the vehicle. The vehicle came to rest in an open area approximately 35 m downstream from the end of the barrier. Figure 2-25 through Figure 2-29 show the pre-test and post-test condition of the test vehicle and test article.

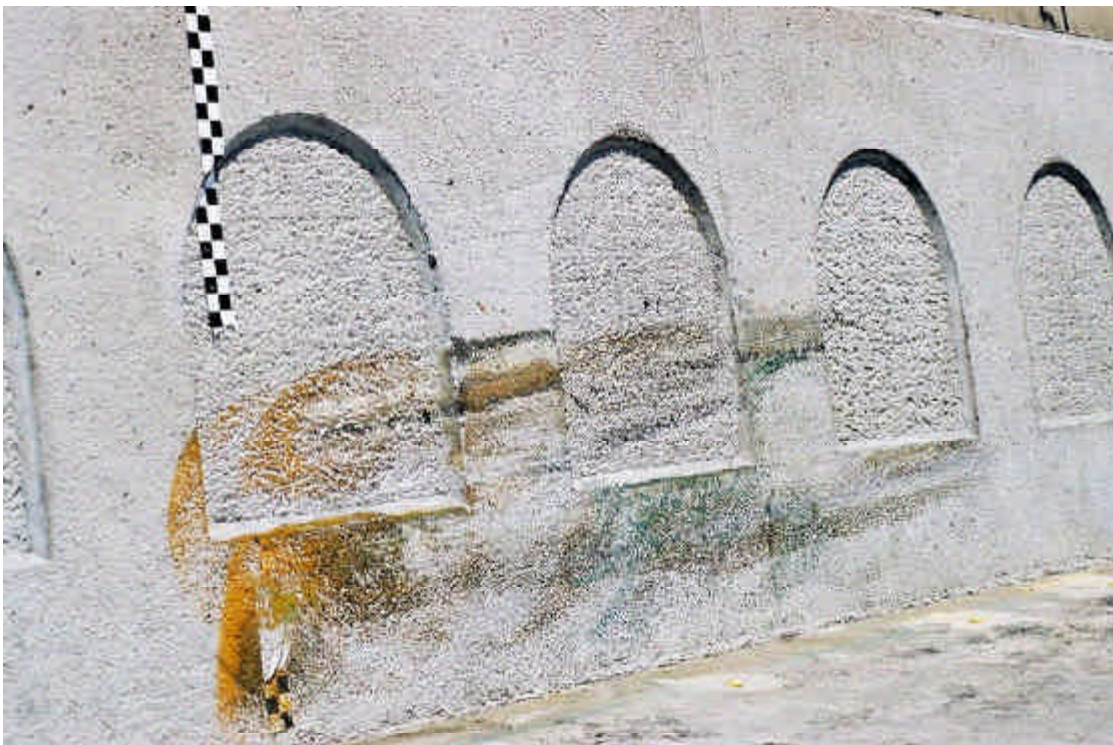
Figure 2-30 Test article after Test 584

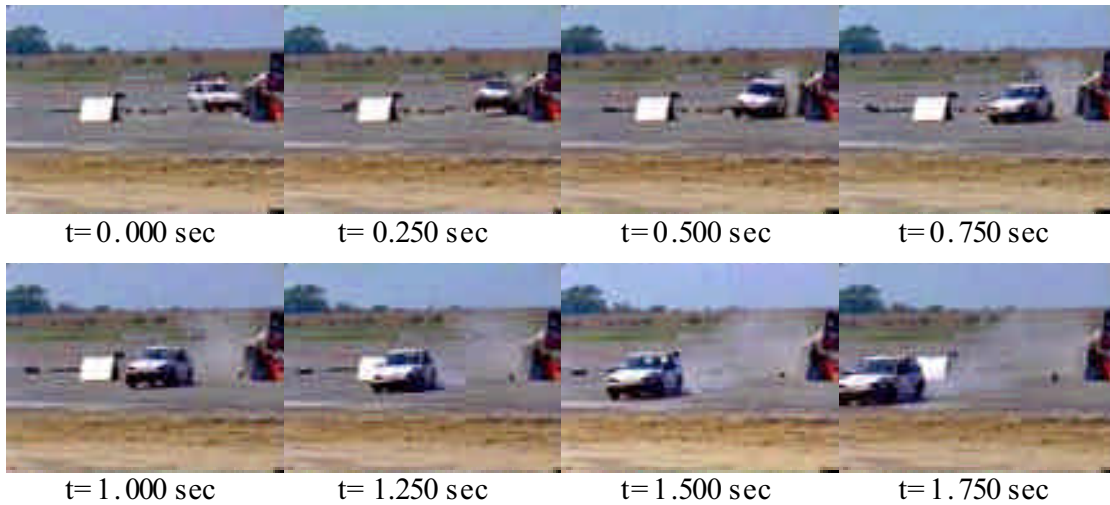
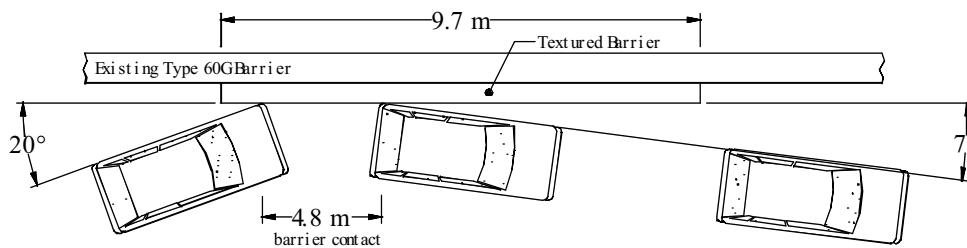
Figure 2-31 Impact sequence and diagram for Test 584

**Test Barrier:** Type: 1220-mm high, Mission Arch textured barrier with a Type 60 profile  
 Length: 9.75-m total length  
 Test Date: May 8, 2001

Sequence photographs of the impact for Test 584 are shown as Figure 2-31 on the data summary sheet on page 31.

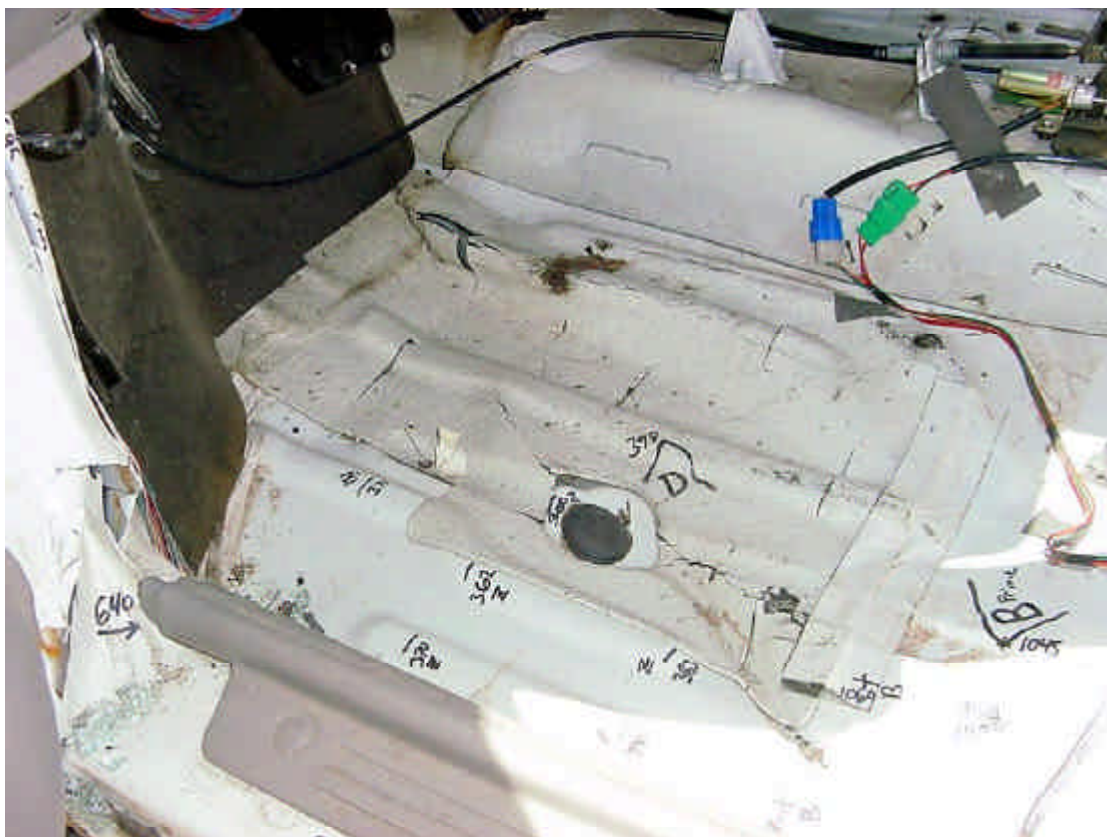
Figure 2-32 Test 584 vehicle floorboard deformation

The left front corner of the vehicle was moderately damaged in the initial impact with the barrier. The left side of the vehicle had minor scraping and the door was pushed slightly rearward. The driver-side door remained latched even though film analysis showed a 115 mm gap along the top edge of the door frame during the impact. The left front bumper and left fender were pushed slightly rearward and inward. All four tires remained inflated. The left front tire and wheel assembly were pushed rearward enough to cause minor deformation of the drivers side floorboard area. This deformation was no more than 40 mm and would not pose a serious threat to an occupant, Figure 2-32.

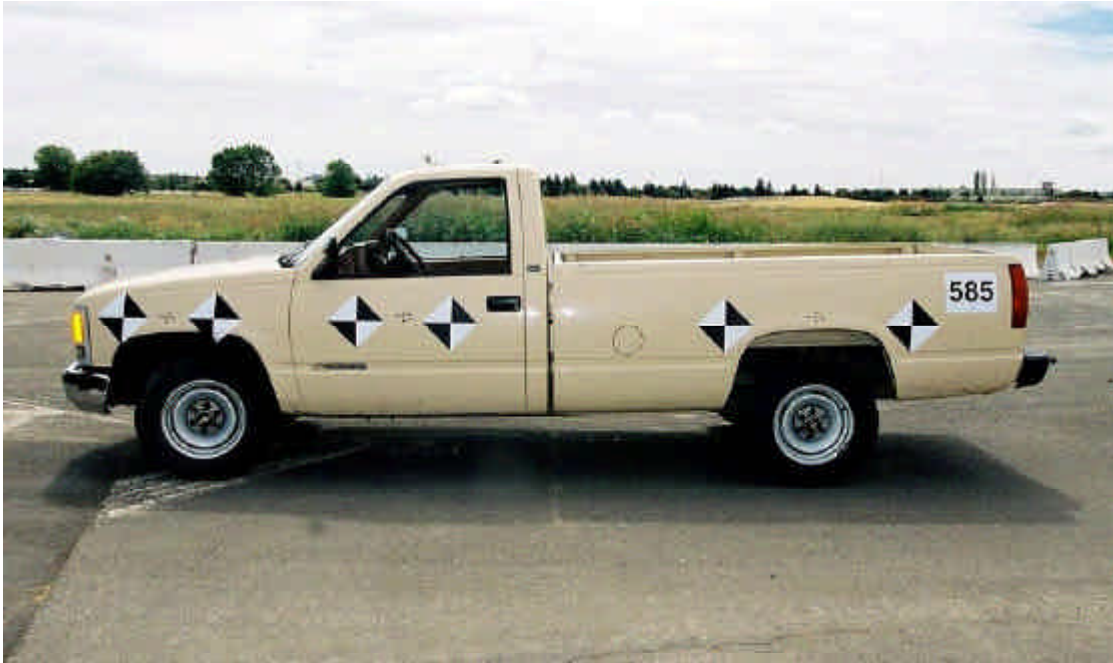
Figure 2-33 Test vehicle for Test 585

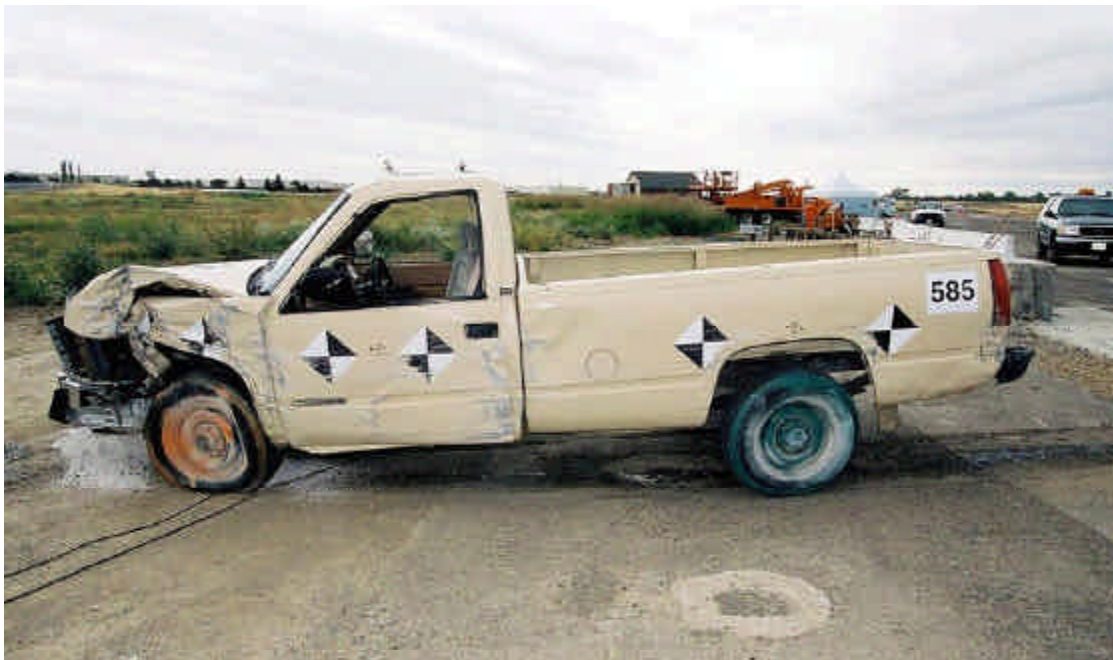
Figure 2-34 Test vehicle after Test 585

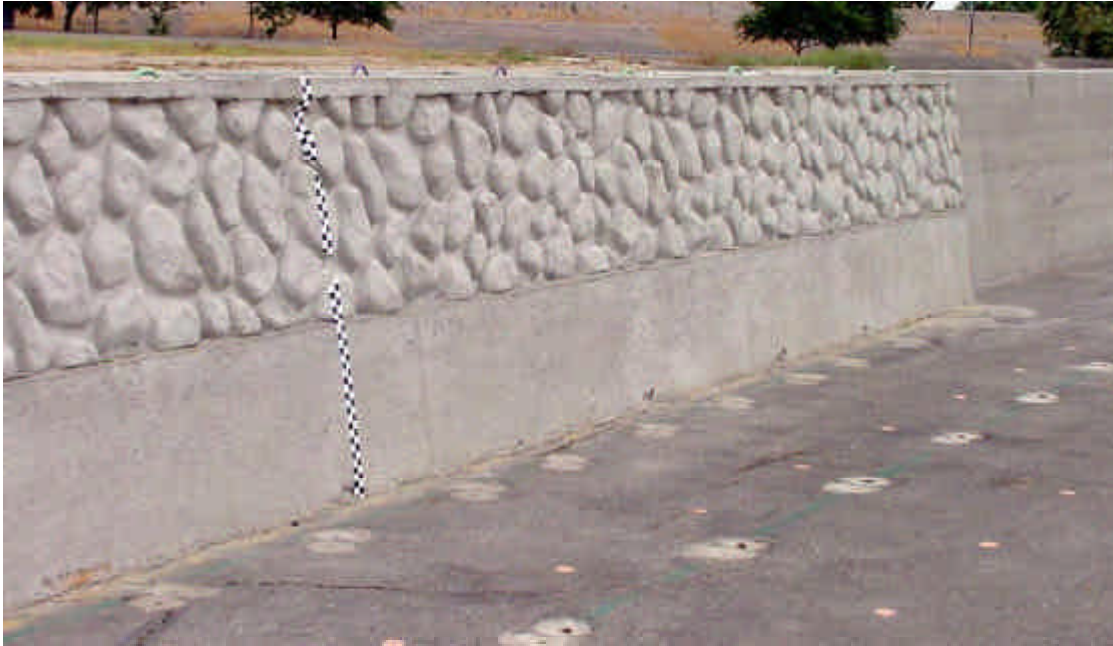
Figure 2-35 Cobble-Reveal test article prior to Test 585  
(the cobblestone section of the pattern is the same as that used in Test 581)

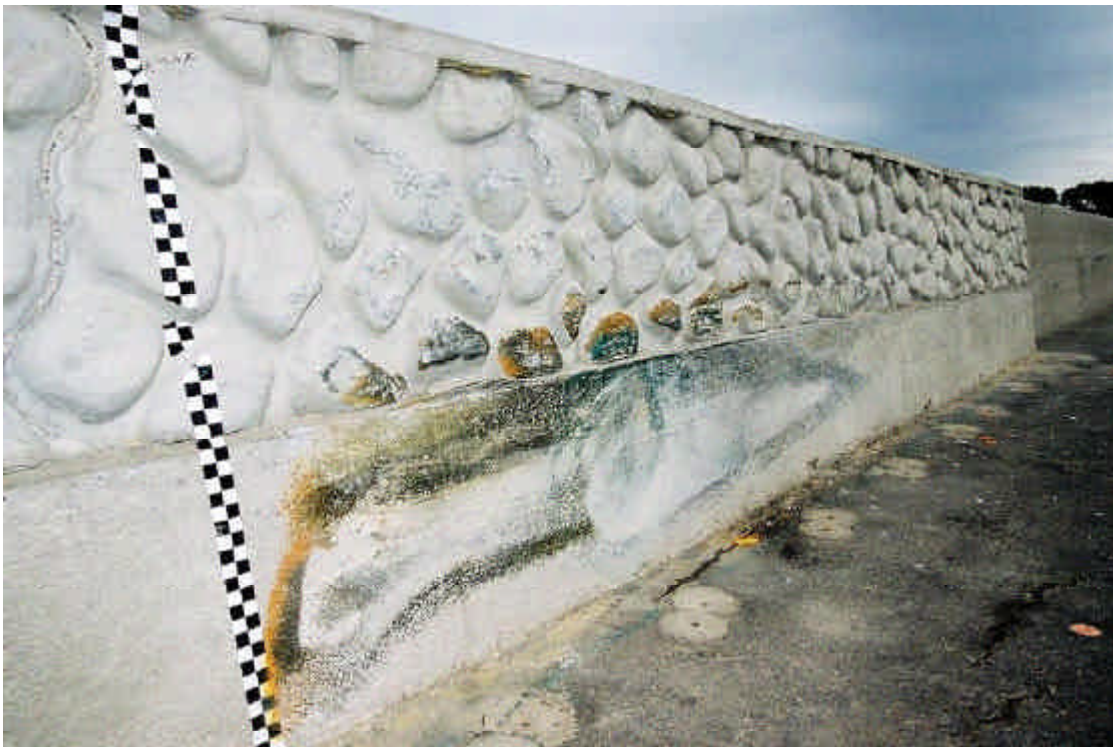
Figure 2-36 Cobble-Reveal test article after Test 585

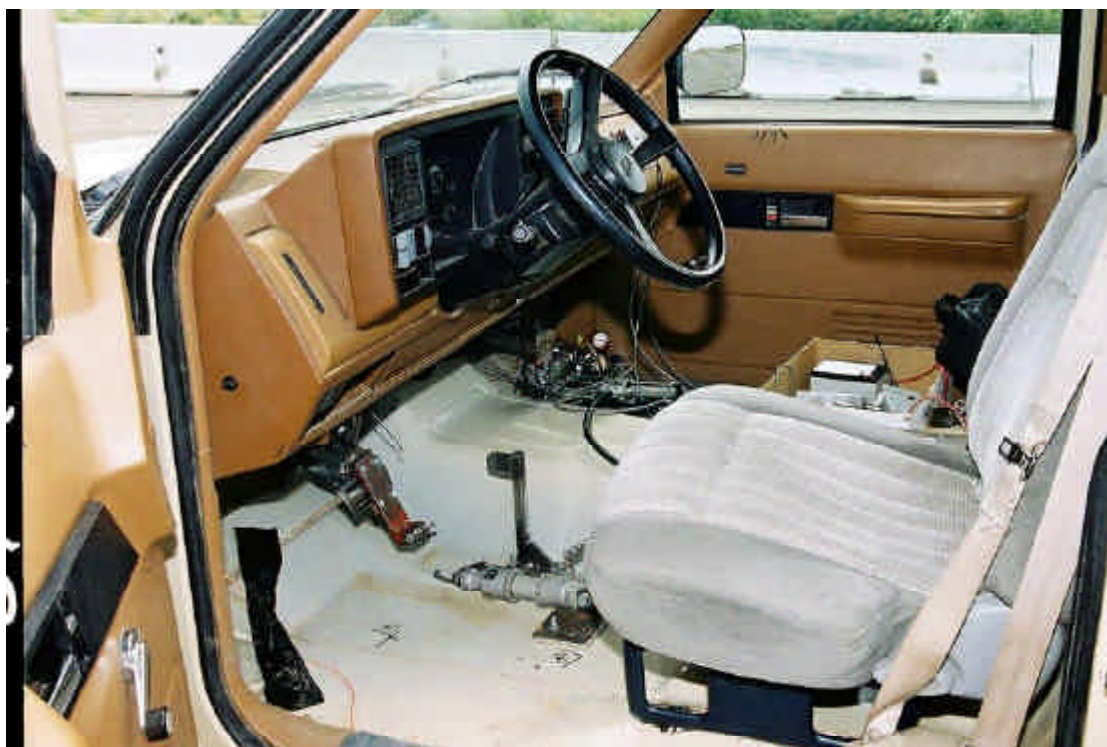
Figure 2-38 Interior and floorboard of test vehicle prior to Test 585

The left front quarter section of the vehicle was moderately damaged in the initial impact with the barrier. The left front fender, hood, bumper, headlamp area, grille, and suspension components were all affected. The driver side doorframe was deformed outward but the door remained latched. Some minor damage along the left side of the vehicle and to the left rear quarter panel occurred as the vehicle continued to engage the barrier after the initial impact. The left front rim was damaged, however the tire remained inflated. The force of the initial impact drove the left front tire and rim assembly rearward into the underside of the driver side floorboard. This caused some deformation (buckling) of the floorboard, which did not exceed 98 mm. This was within the accepted limit of 150 mm. Compare Figure 2-38 and Figure 2-39.

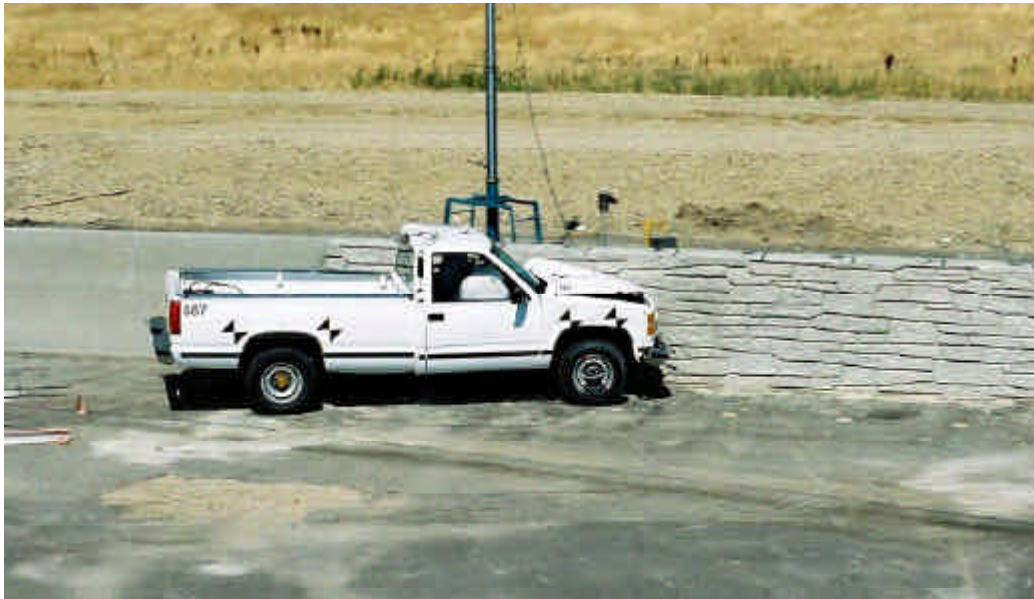
Figure 2-40 Test 587 at impact

The impact angle was set to 25° by placement of the guide rail while film analysis indicates the actual angle was 23.6°. The impact speed of 101.1 km/h was obtained by an average of two different speed traps located just upstream from the impact point. The test vehicle impacted the barrier 1.2 m downstream of the leading edge of the barrier as intended. There was moderate deformation to the left front corner of the vehicle as it impacted and began to yaw slightly right (positive). At 0.08 seconds after impact the upper section of the driver side door frame was deformed outward to a maximum opening of about 235 mm. The back left side of the vehicle contacted the barrier 0.20 seconds after the initial impact. This secondary impact by the rear of the vehicle caused slight damage to the left rear quarter section of the vehicle and halted the positive yaw of the vehicle. The vehicle had a slight degree of positive pitch (nose up) at this point, which did not exceed 2°. The maximum roll was less than 4° (to the left) as the right-side tires briefly lost contact with the ground approximately 0.27 seconds after impact. At 0.30 seconds after initial impact the vehicle lost contact with the barrier at which time the exit speed was determined through film analysis to be 75.8 km/h and the exit angle was less than 2°. As the vehicle lost contact with the barrier, the rear wheels were still off the ground which resulted in a maximum pitch (nose down) of about 5°. The brakes were applied 1.7 seconds after the initial impact as indicated by the firing of the brake flash mounted on top of the vehicle. The vehicle swerved slightly right after it lost contact with the test article and came to rest in an open area approximately 40 m downstream from the end of the barrier. Figure 2-40 through Figure 2-44 show the pre-test and post-test condition of the test vehicle and test article. Sequence photographs of the impact for Test 587 are shown as Figure 2-45 on the data summary sheet on page 42.

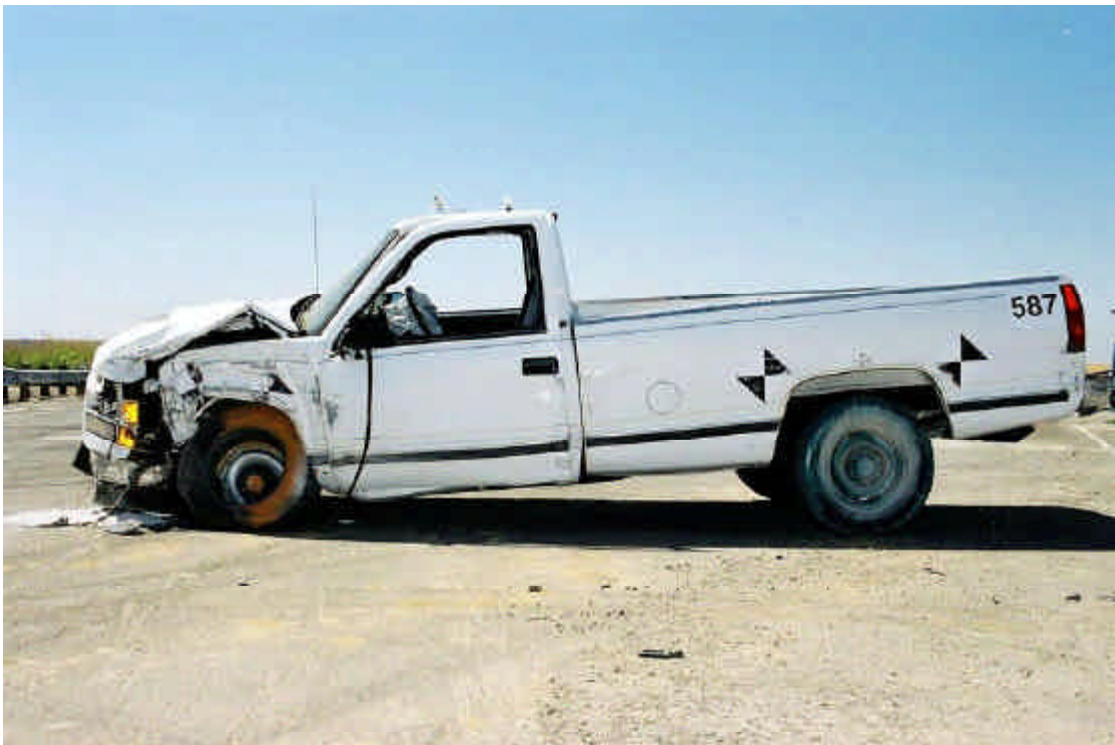
Figure 2-42 Test vehicle after Test 587

The left front corner of the vehicle was moderately damaged in the initial impact with the barrier. The left front fender, hood, bumper, headlamp area, grille, and suspension components were all affected. The driver side doorframe was deformed slightly and buckled outward. Both doors and the hood remained latched. The left front tire was ruptured. There was minor damage along the left side of the vehicle and to the left rear quarter. The left front wheel assembly was pushed rearward which resulted in moderate deformation of the floorboard. The maximum amount of passenger compartment deformation, 171 mm, occurred behind the parking brake pedal in the upper left corner of the footwell area. While this is over the accepted limit of 150 mm, it is in an area where a driver's foot is not likely to be located. The area of the floorboard where the driver's feet would more likely be located was deformed a maximum of 102 mm.

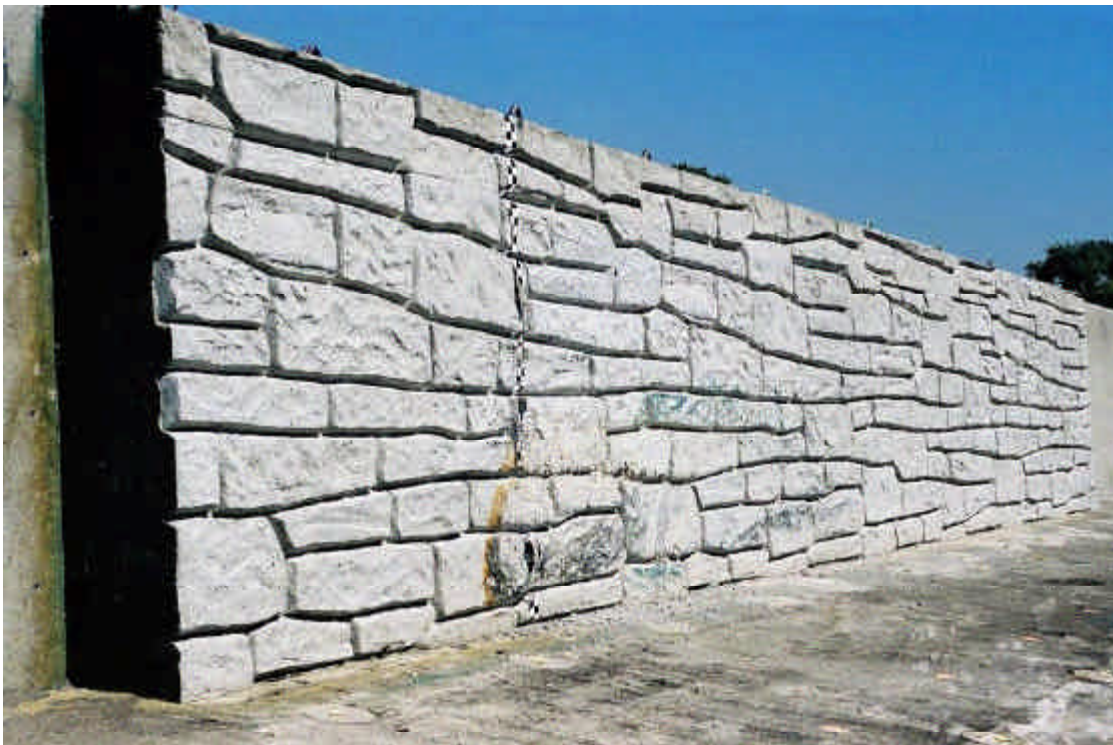
Figure 2-44 Drystack test article after Test 587

There was essentially no permanent damage to the barrier during Test 587. The vehicle did cause minor scrapes and gouges in the concrete surface of the barrier. The barrier would not require immediate repair. The gouges and scrapes could be repaired on-site by maintenance crews.

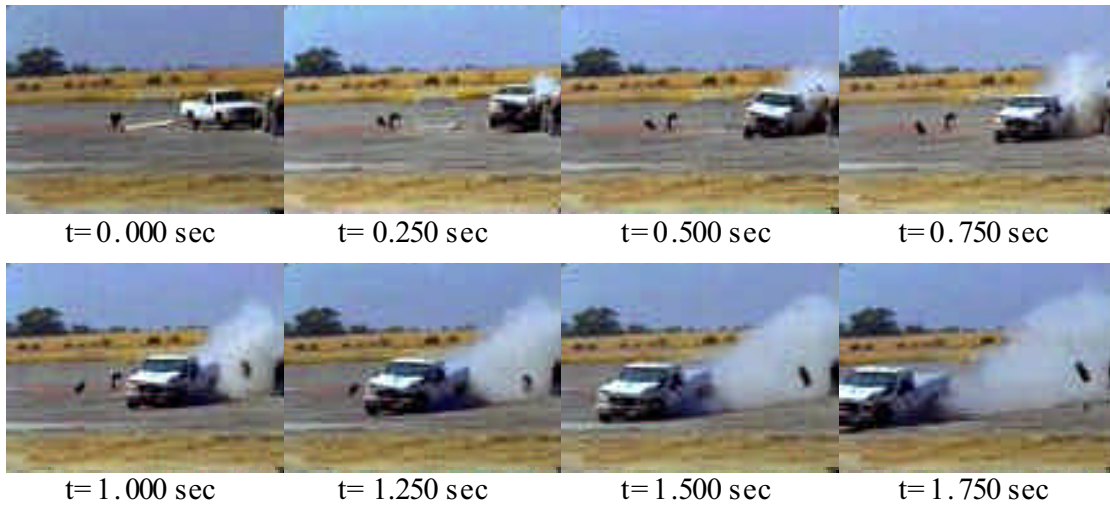
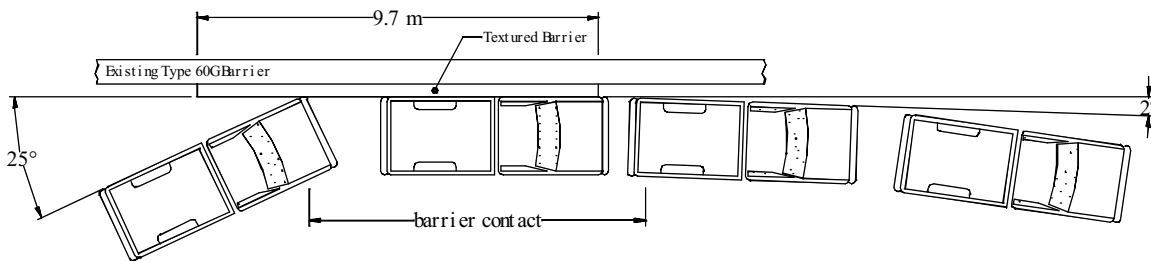
Figure 2-45 Impact sequence and diagram for Test 587

**Test Barrier:** Type: 1422-mm high, dry stack stone textured barrier with a Type 60 profile  
 Length: 9.75-m total length.

**Barrier Damage:** Very minor scraping of the “stone” surface. No chipping or gouging was observed. The barrier would not require immediate repair. The barrier would not require immediate repair.

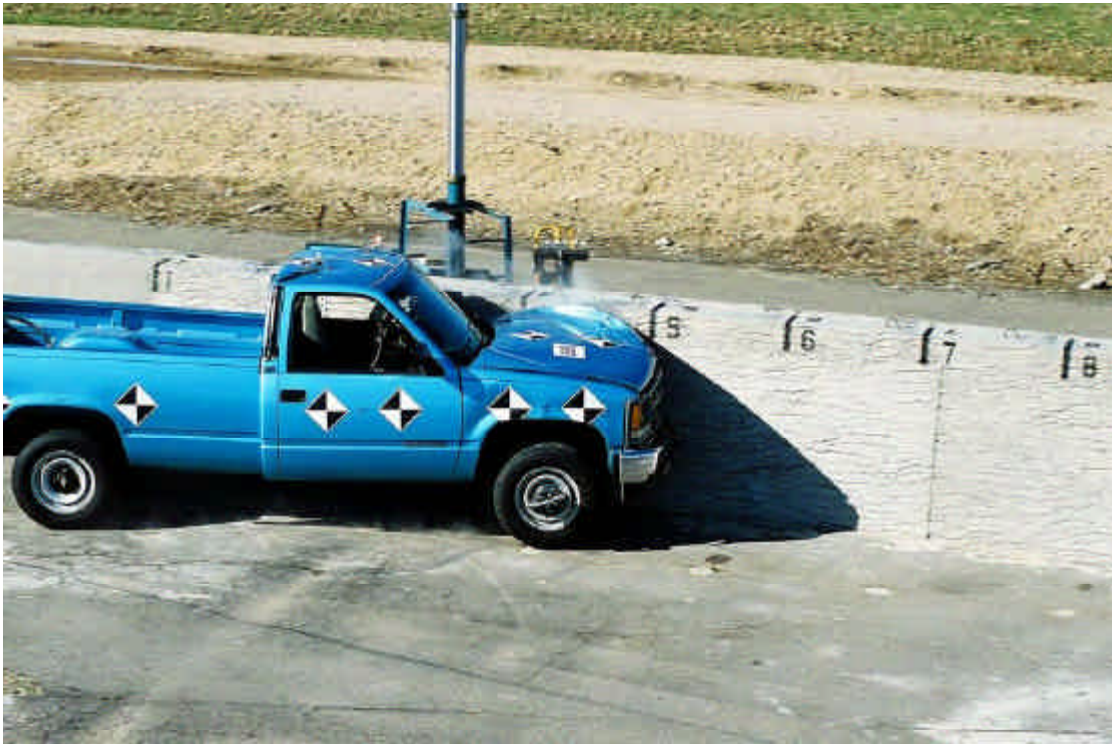
Figure 2-48 Test 588 at impact

The impact angle was set to 25° by placement of the guide rail and high-speed film analysis indicated the actual impact angle was 24°. The impact speed of 100.3 km/h was obtained by an average of two different speed traps located just upstream from the impact point. The test vehicle impacted the barrier 2.4 m downstream of the leading edge of the barrier as intended. The left front corner of the vehicle began to deform and the vehicle began to yaw slightly right (positive) as the impact progressed. At 0.08 seconds after impact the upper section of the driver side door frame was deformed outward to a maximum opening of about 209 mm.

The back left side of the vehicle contacted the barrier approximately 0.20 seconds after the initial impact. This secondary impact by the rear of the vehicle caused slight damage to the left rear quarter section of the vehicle. This slowed the positive yaw of the vehicle and also initiated a slight degree of positive pitch (nose up) to a maximum of 3.5°. The maximum roll was less than 8° as the right-side tires briefly lost contact with the ground approximately 0.26 seconds after impact. At 0.26 seconds after initial impact the vehicle lost contact with the barrier at which time the exit speed was determined through film analysis to be 79.0 km/h and the exit angle was less than 2°. The left-side tires briefly lost contact with the pavement but the duration could not be determined due to dust and debris obscuring the view on the high-speed film. The right front tire regained contact with the pavement at 0.59 seconds after impact and the right rear regained contact immediately afterward. The vehicle was smoothly redirected into the run-out area. The brakes were applied more than 2.3 seconds after the initial impact. The vehicle came to rest in an open area approximately 40 m downstream from the end of the barrier. Figure 2-48 through Figure 2-52 show the pre-test and post-test condition of the test vehicle and test article. Sequence photographs of the impact for Test 588 are shown as Figure 2-53 on the data summary sheet on page 48.

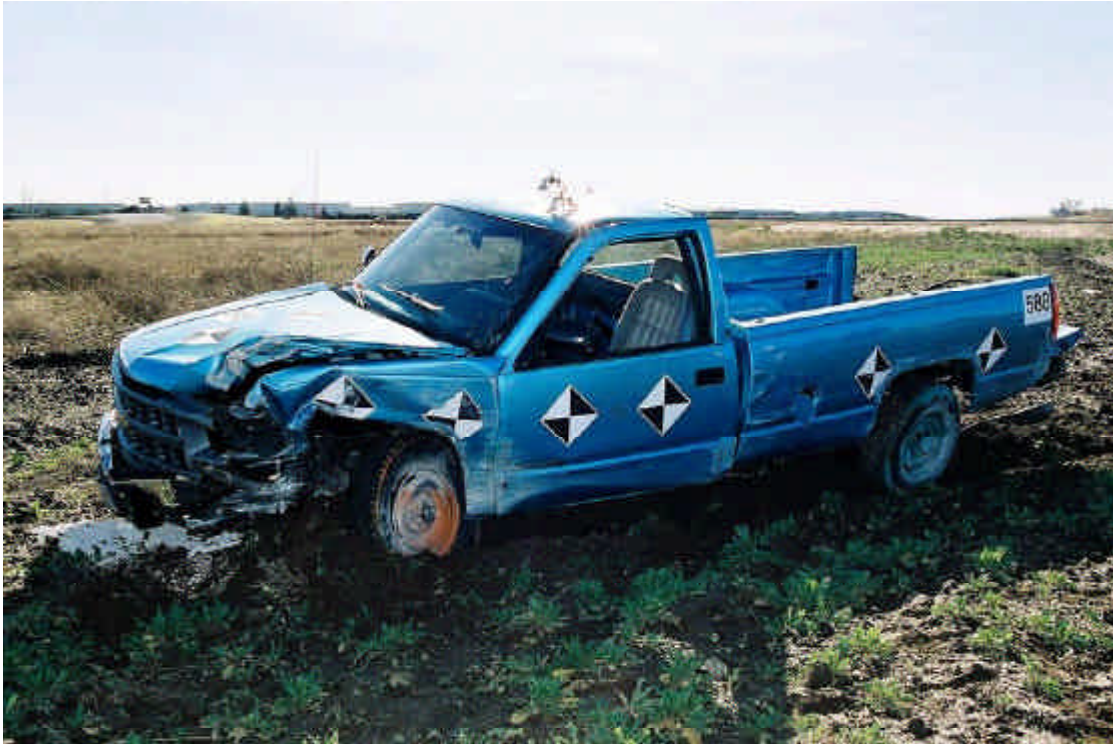
Figure 2-50 Test vehicle after Test 588

The left front corner of the vehicle was moderately damaged in the initial impact with the barrier. The left front fender, hood, bumper, headlamp area, grille, and suspension components were all affected. The driver side doorframe was deformed slightly and buckled outward. Both doors and the hood remained latched. The left front tire was ruptured. There was minor damage along the left side of the vehicle and to the left rear quarter. The force of the initial impact drove the left front tire and rim assembly rearward into the underside of the driver side floorboard. This caused some deformation (buckling) of the floorboard which did not exceed 134 mm. This was within the accepted limit of 150 mm.

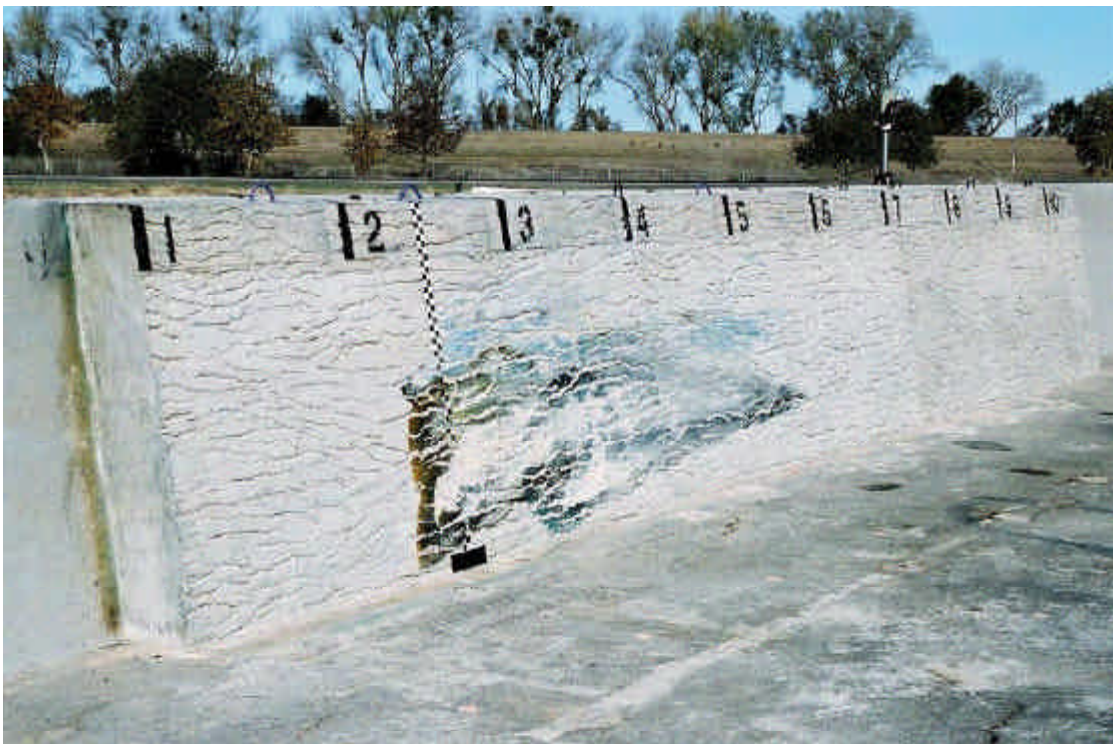
Figure 2-52 Fractured Granite test article after Test 588

There was essentially no permanent damage to the barrier during Test 588. The vehicle did cause minor scrapes and gouges in the concrete surface of the barrier. The barrier would not require immediate repair and the gouges and scrapes could be filled on-site by maintenance crews.

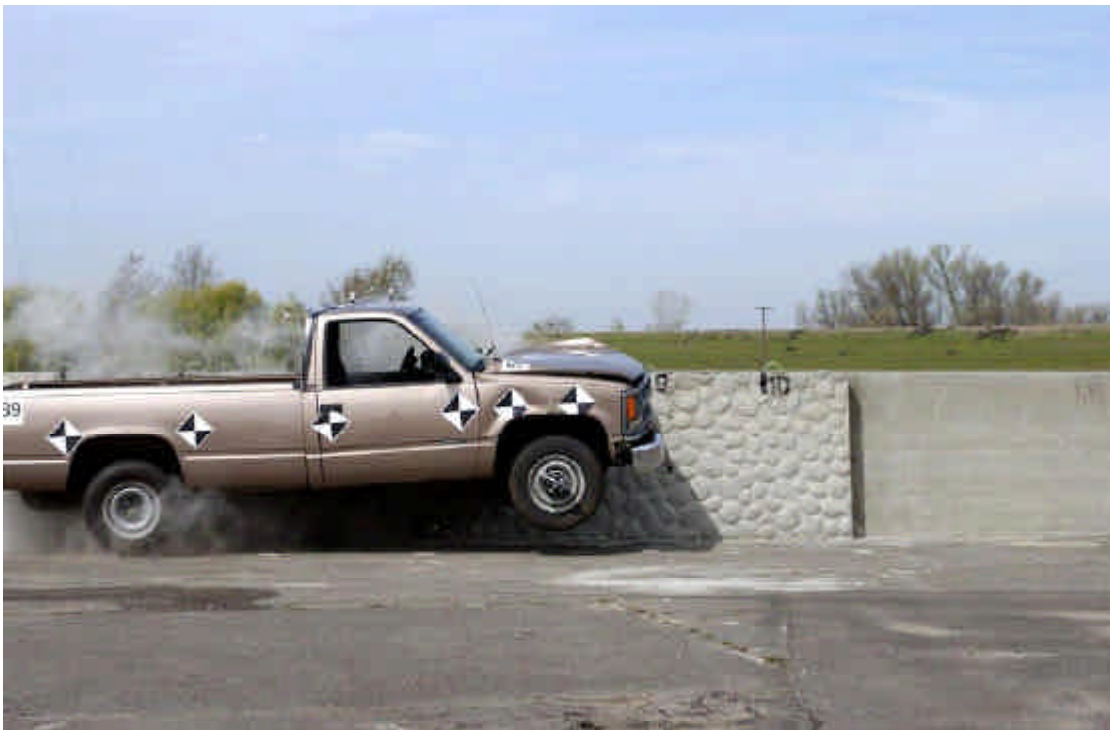
Figure 2-56 Test 589 (0.2 seconds after impact)

The impact angle was set at 25° by placement of the guide rail. Film analysis indicated that the impact angle was 23.6°. The impact speed of 100.8 km/h was obtained by an average of two different speed traps located just upstream from the impact point. The test vehicle impacted the barrier 1.2 m downstream of the leading edge of the barrier as intended. The left front corner of the vehicle began to deform and the vehicle began to yaw right (positive) as the impact progressed. At 0.1 seconds after impact the upper section of the driver side door frame was deformed outward to a maximum opening of 225 mm. The vehicle attained a slight degree of positive pitch (nose up) to a maximum of 2.6° at 0.18 seconds. The back left side of the vehicle contacted the barrier at 0.2 seconds after the initial impact. This secondary impact by the rear of

the vehicle damaged the left rear quarter section while essentially stopping the positive yaw of the vehicle. The maximum roll was less than  $5.3^\circ$  as the left side of the vehicle climbed a short distance up the face of the barrier approximately 0.22 seconds after impact. At 0.3 seconds after initial impact the vehicle lost contact with the barrier. The exit speed was determined through film analysis to be 76.7 km/h and the exit angle was less than  $3.3^\circ$ . The front tires regained contact with the pavement at 0.53 seconds after impact and the rear tires touched down about 0.2 seconds later. The vehicle was redirected and completed a  $180^\circ$  spin as it continued into the run-out area. The brakes were applied 1.1 seconds after the initial impact as indicated by the firing of the brake flash mounted on top of the vehicle. The vehicle came to rest in an open area approximately 30 m downstream from the end of the barrier. Figure 2-56 through Figure 2-60 show the pre-test and post-test condition of the test vehicle and test article. Sequence photographs of the impact for Test 589 are shown as Figure 2-61 on the data summary sheet on page 54.

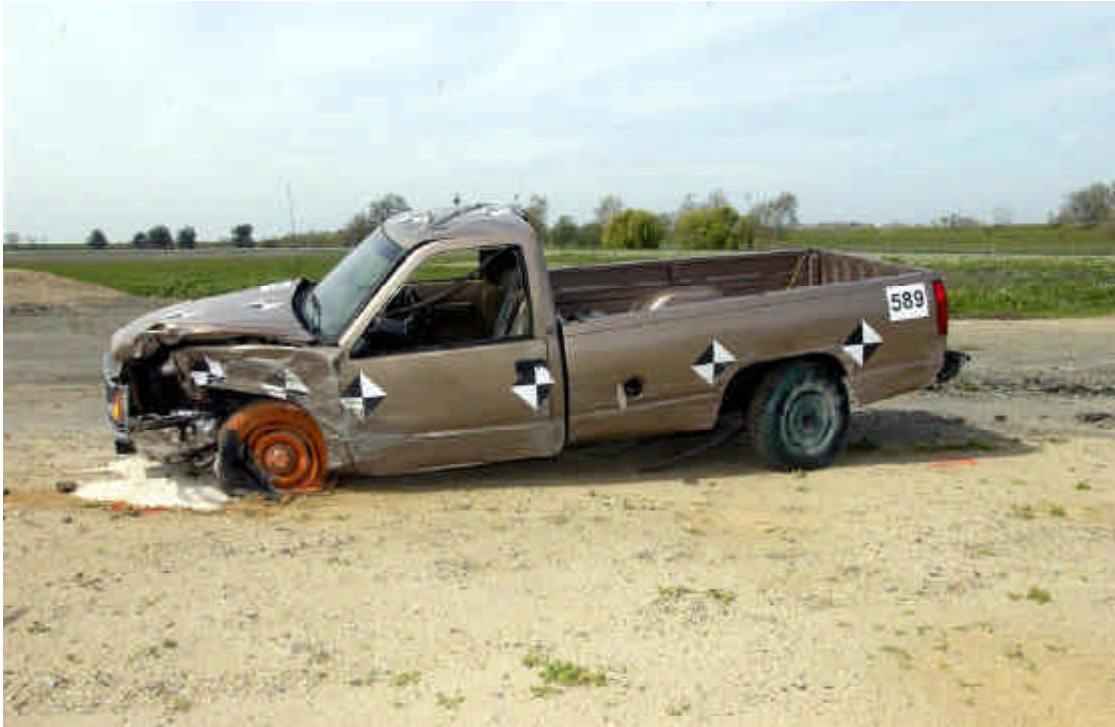
Figure 2-58 Test vehicle after Test 589

The left front corner of the vehicle was moderately damaged in the initial impact with the barrier. The left front fender, hood, bumper, headlamp area, grille, and suspension components were all affected. The driver side doorframe was deformed slightly and buckled outward. Both doors and the hood remained latched. The left front tire was ruptured. There was moderate damage along the left side of the vehicle and to the left rear quarter. The left side of the rear axle broke loose from the leaf spring mount and was pushed rearward. This allowed the drive shaft to disengage from the rear of the transmission and drag along the ground. This situation has resulted in rollover exit trajectories in other crash tests using a similar 2000P vehicle.

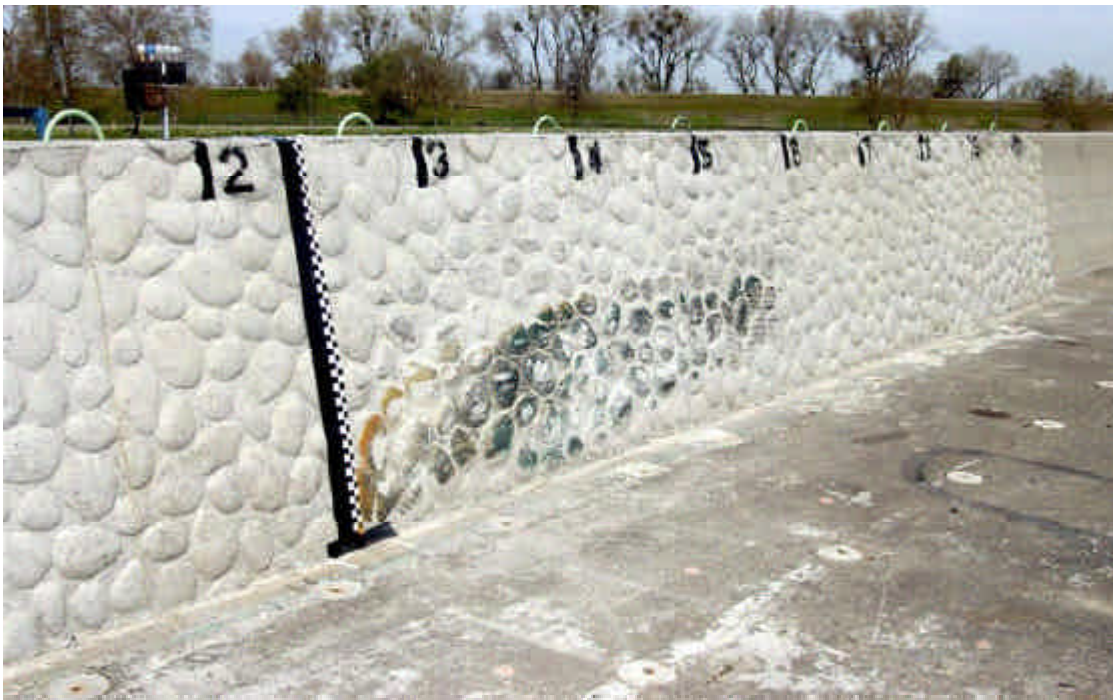
Figure 2-60 Shallow cobblestone test article after Test 589

There was essentially no permanent damage to the barrier during Test 589. The vehicle did cause minor scrapes and gouges in the concrete surface of the barrier. The barrier would not require immediate repair and the gouges and scrapes could be filled on-site by maintenance crews.

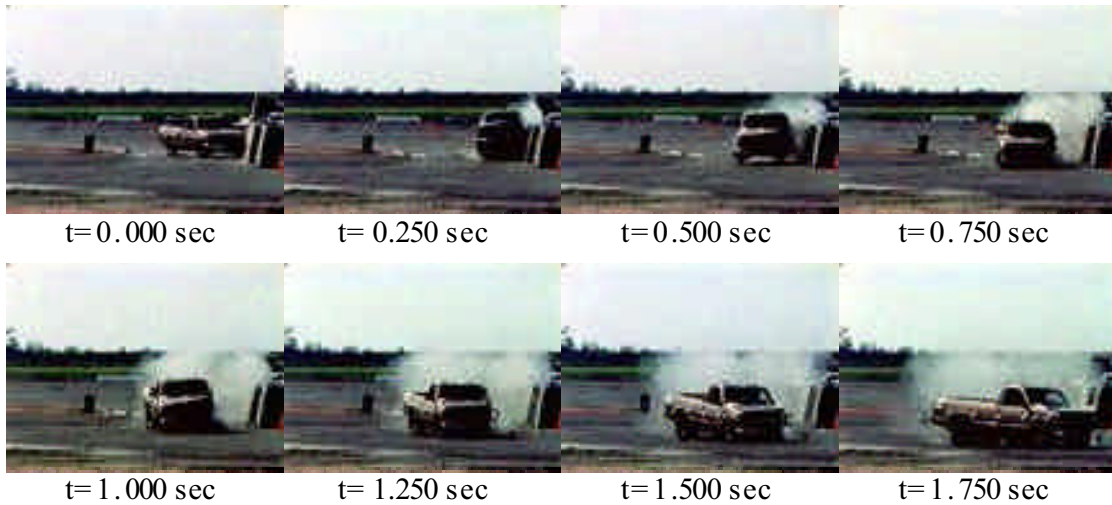
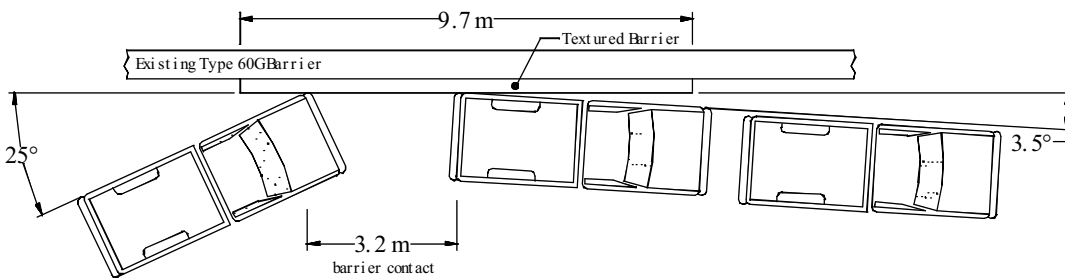
Figure 2-61 Impact sequence and diagram for Test 589

**Test Barrier:** Type: 1422-mm high, Shallow Cobble textured barrier with a Type 60 profile  
Length: 9.75-m total length

**Barrier Damage:** Minor scraping of the “stone” surface. No chipping or gouging was observed. The barrier would not require immediate repair. The barrier would not require immediate repair.

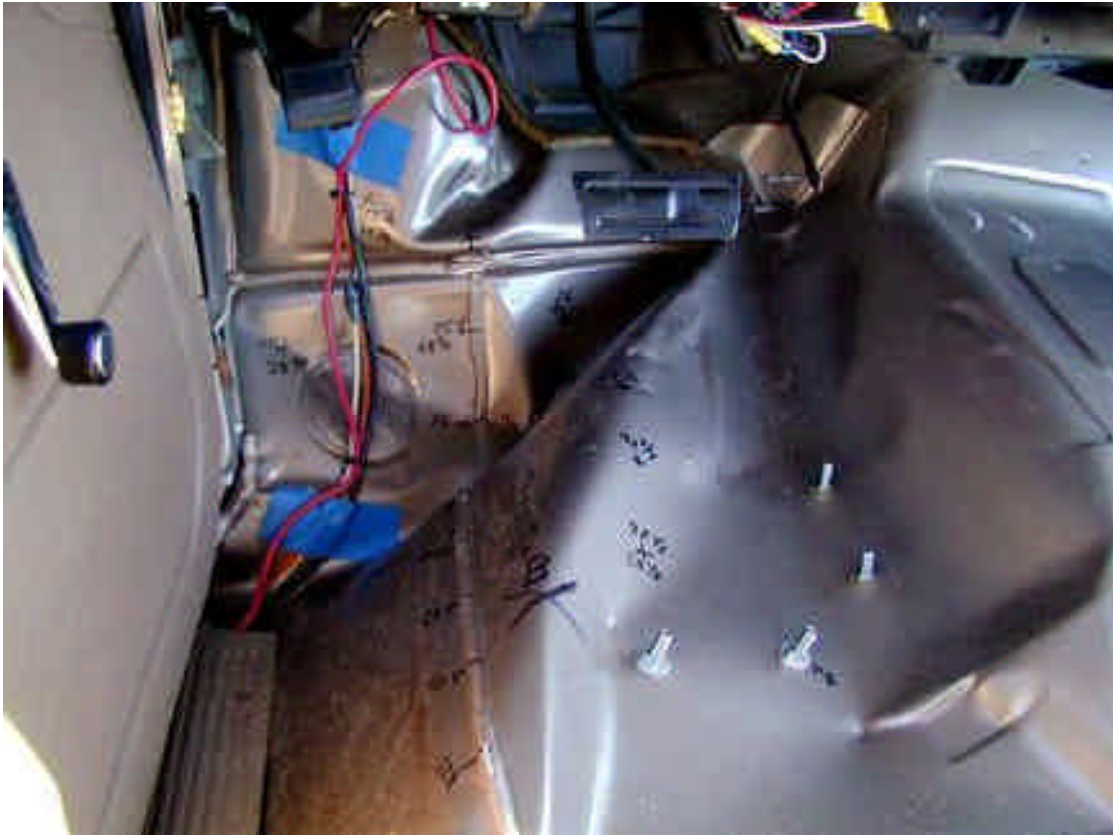
Figure 2-63 Vehicle floorboard after Test 589

The force of the initial impact drove the left front tire and rim assembly rearward into the underside of the driver side floorboard. This caused a maximum floorboard deformation (buckling) of 133 mm which is less than the accepted limit of 150 mm.

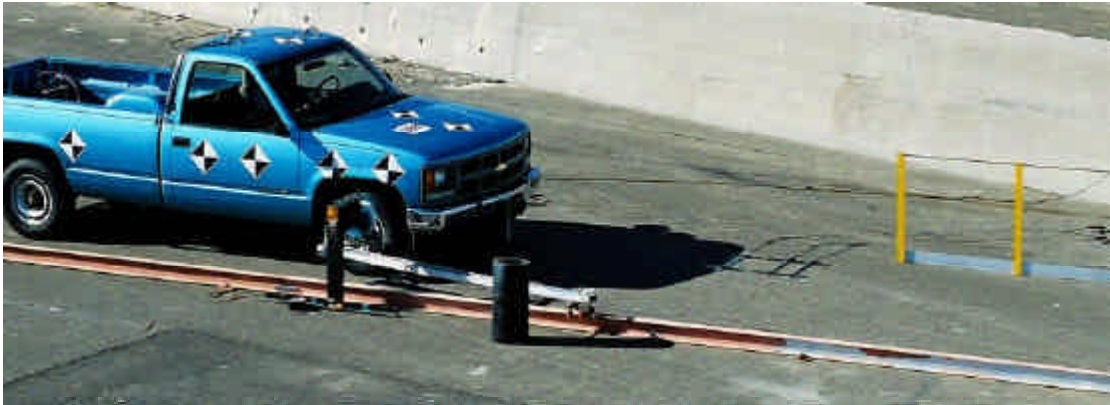
Figure 7-1 – Typical guidance arm release

A rail guidance system directed the vehicle into the barrier. The guidance rail, anchored at 3.8 m intervals along its length, was used to guide a mechanical arm that was attached to the front right wheel of each of the vehicles. A 10-mm nylon rope was used to trigger the release mechanism on the guidance arm, thereby releasing the vehicle from the guidance system before impact (Figure 7-1).
