# CRASH TESTING OF VARIOUS TEXTURED BARRIERS

**CRASH TESTING OF VARIOUS TEXTURED BARRIERS**

1. REPORT NO. <b>FHWA/CA/TL-2002/03</b>	2. GOVERNMENT ACCESSION NO.	3. RECIPIENT'S CATALOG NO.	
4. TITLE AND SUBTITLE  <b>CRASH TESTING OF VARIOUS TEXTURED BARRIERS</b>		5. REPORT DATE September, 2002

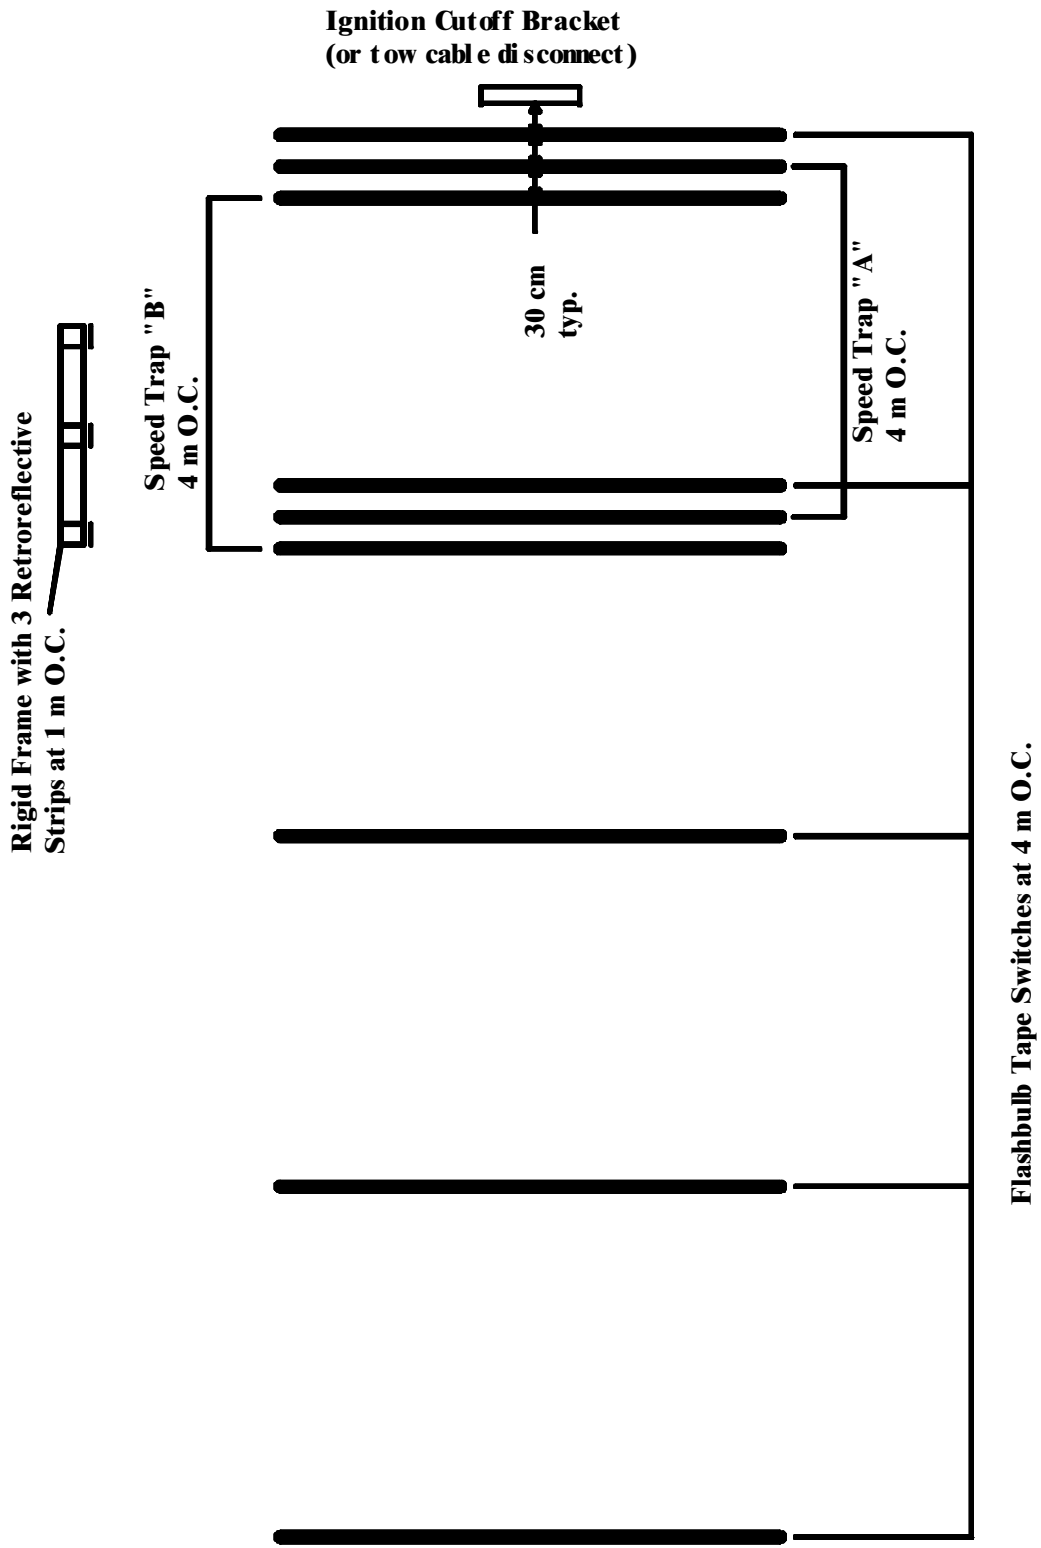
Figure 7-3 - Event Switch Layout

3) Five tape switches, placed at 4 m intervals, were attached to the ground near the barrier and were perpendicular to the path of the test vehicle. Flashbulbs were activated sequentially when the tires of the test vehicle rolled over the tape switches. The flashbulb stand was placed in view of the cameras. The flashbulbs were used to correlate the cameras with the impact events and to calculate the impact speed independent of the electronic speed trap. The tape switch layout is shown in Figure 7-3.

A rigid stand with three retroreflective 90° polarizing tape strips was placed on the ground near the test barrier and alongside the path of the test vehicle (Figure 7-3). The strips were spaced at carefully measured intervals of 1 m. The test vehicle had an onboard optical sensor which produced sequential impulses or "event blips" that were recorded concurrently with the accelerometer signals on the TDR, serving as "event markers". The impact velocity of the vehicle could be determined from these sensor impulses and timing cycles and the known distance between the tape strips. A pressure sensitive tape switch on the front bumper of the vehicle closed at the instant of impact and triggered two events: 1) an "event marker" was added to the recorded data, and 2) a flashbulb mounted on the top of the vehicle was activated. Two other pressure sensitive tape switches, connected to a speed trap, were placed 4 m apart just upstream of the test barrier specifically to establish the impact speed of the test vehicle. The layout for all of the pressure sensitive tape switches is shown in Figure 7-3.

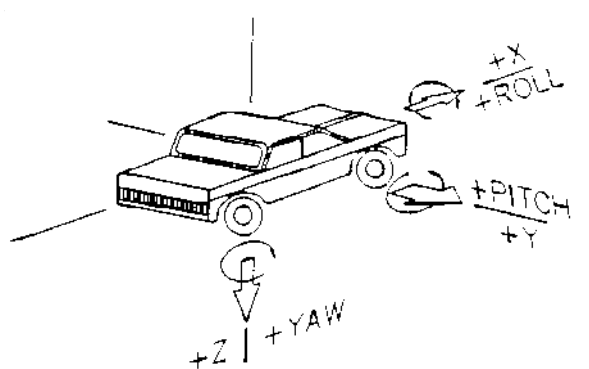
Figure 7-4 - Vehicle Accelerometer Sign Convention

Accelerometer specifications are shown in Table 7-10. The vehicle accelerometer sign convention used throughout this report is the same as that described in NCHRP Report 350 and is shown in Figure 7-4.

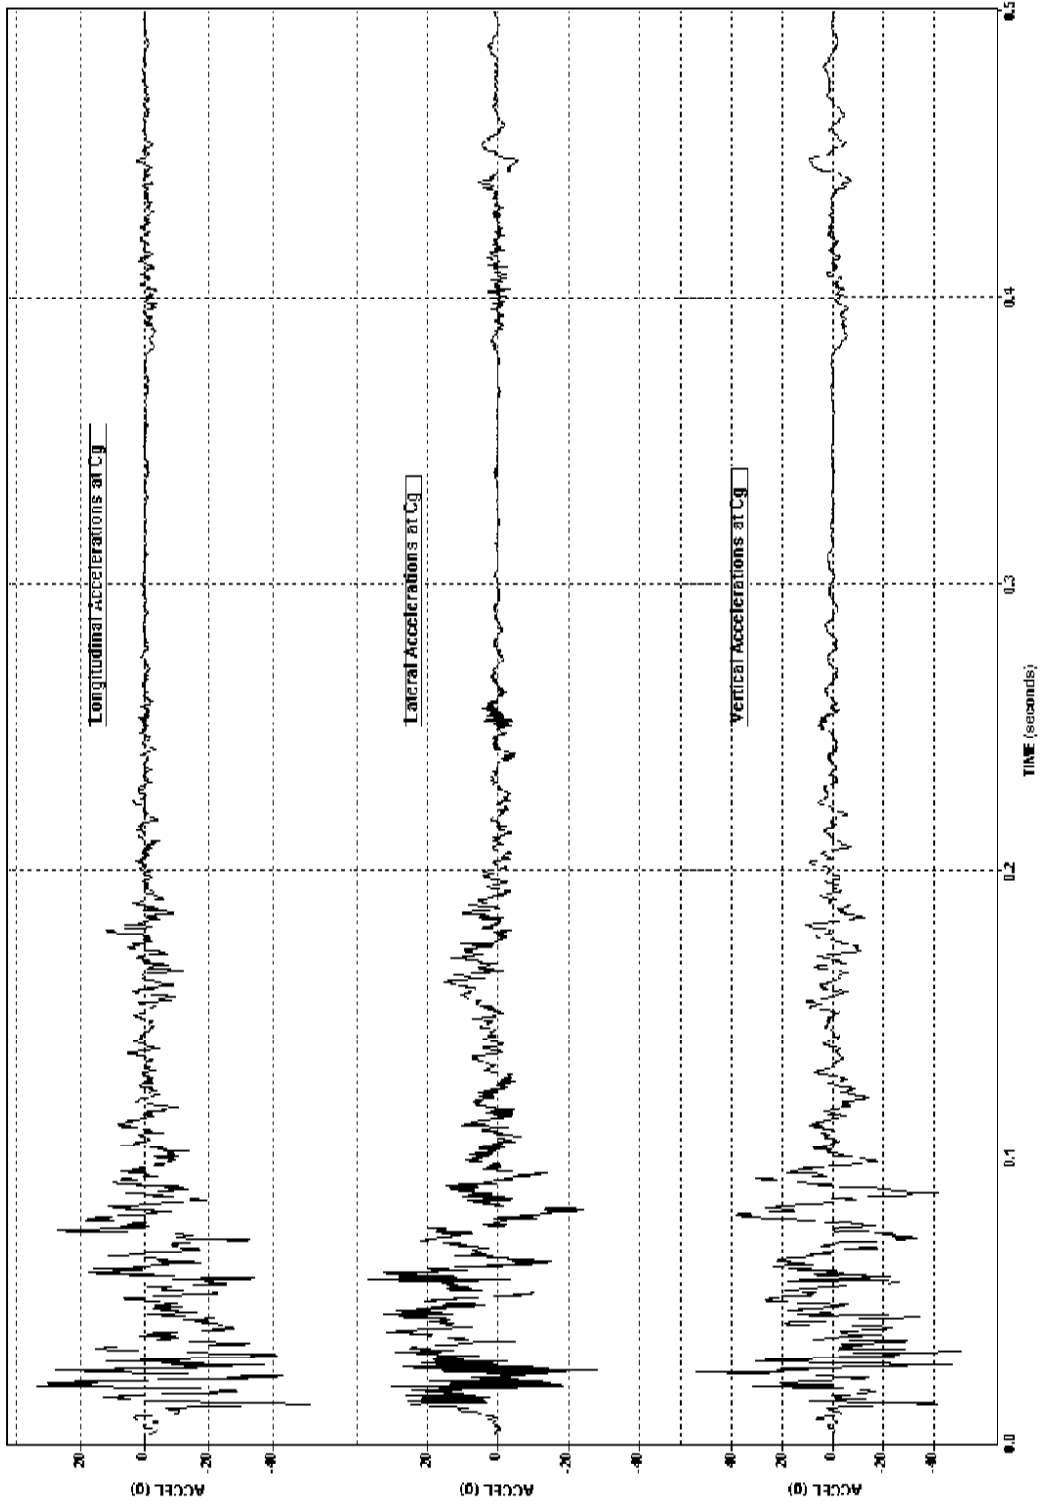
Figure 7-5 - Test 581 Vehicle Accelerations Vs Time

The data curves are shown in Figure 7-5 through Figure 7-44 and include the accelerometer and rate gyro records from the test vehicles. They also show the velocity and displacement curves for the longitudinal and lateral components. These plots were needed to calculate the occupant impact velocity defined in NCHRP Report 350. All data were analyzed using software written by DADiSP and modified by Caltrans.

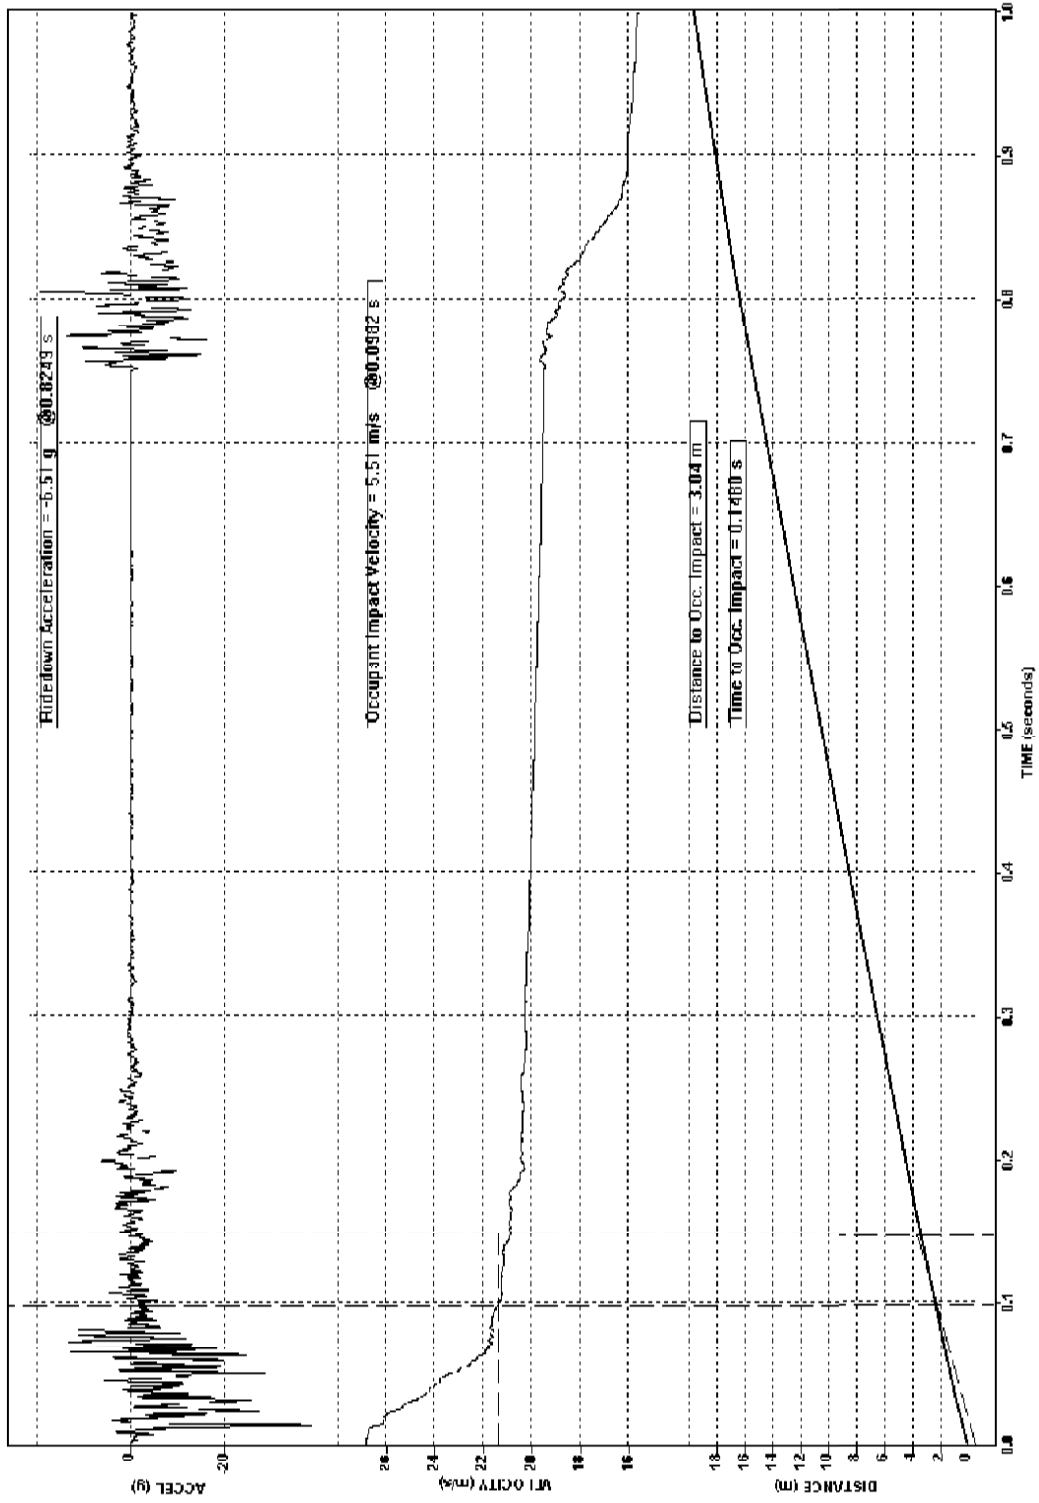
Figure 7-10 - Test 582 Vehicle Accelerations Vs Time

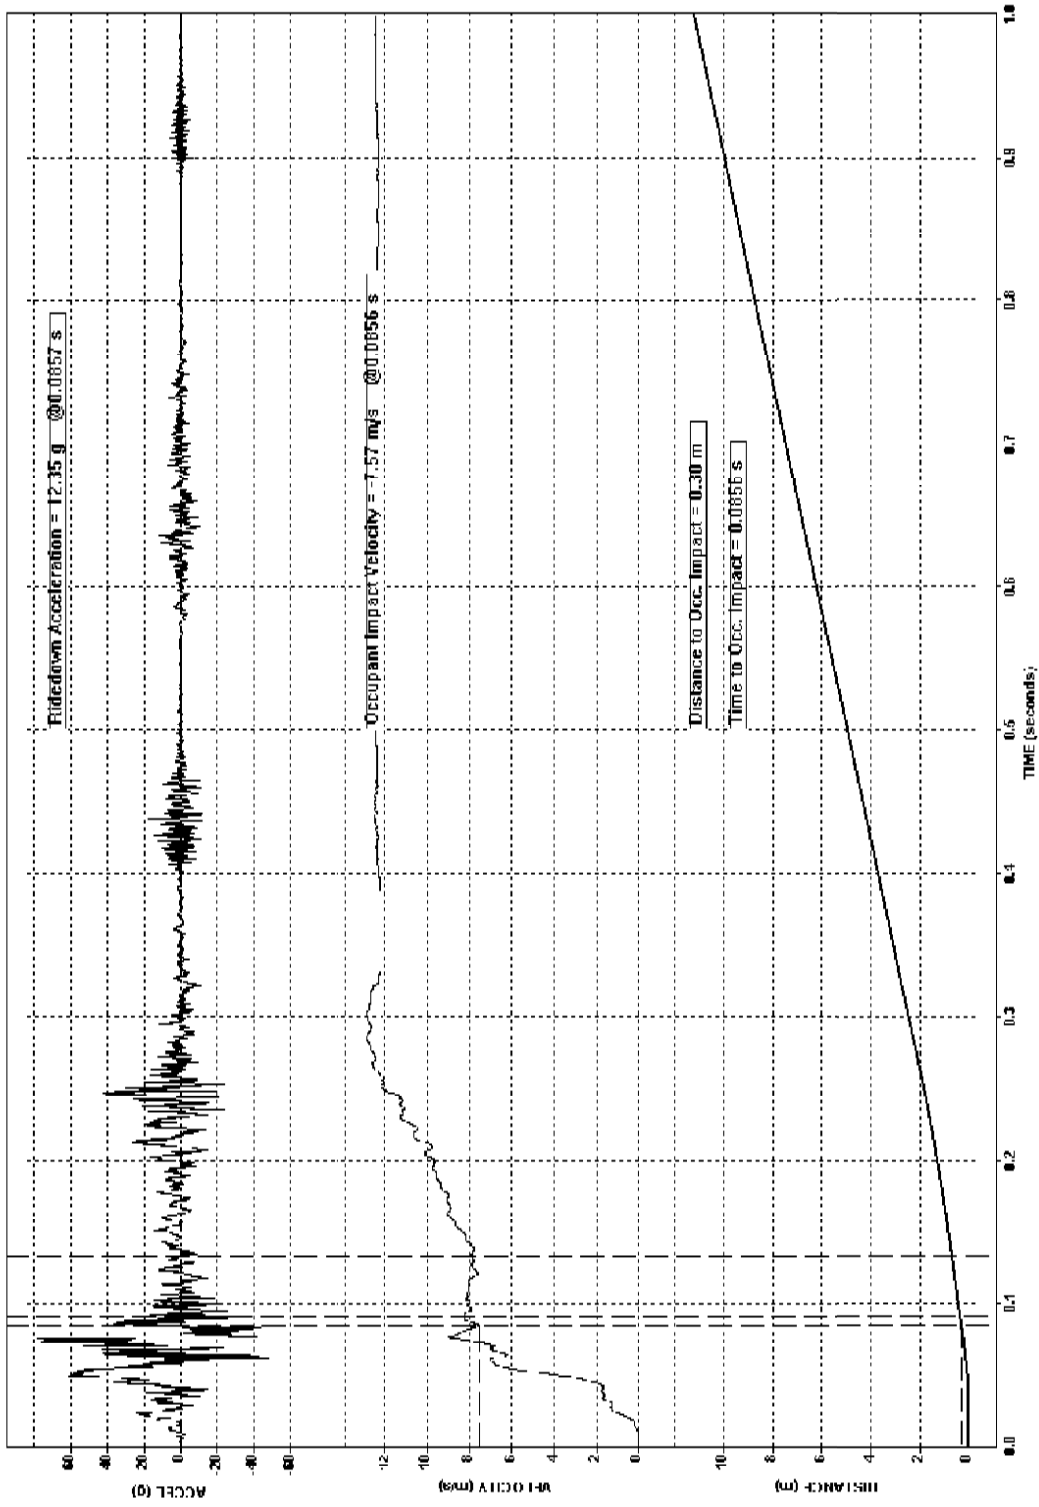
Figure 7-26 - Test 585 Vehicle Longitudinal Acceleration, Velocity, and Distance Vs Time

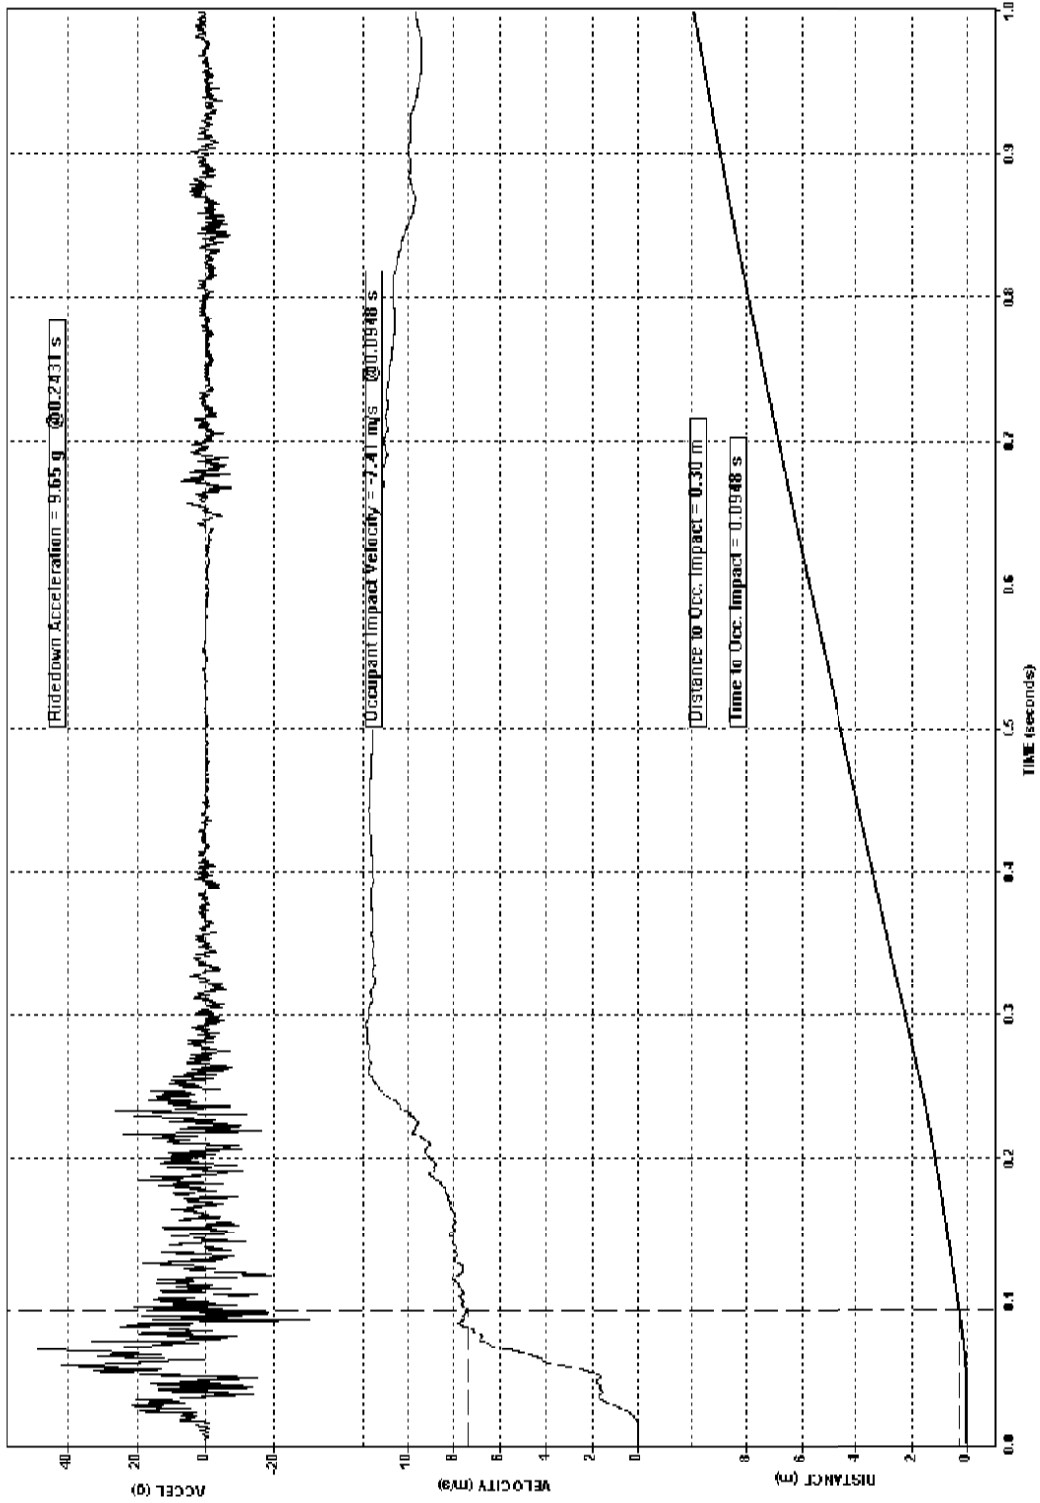
Figure 7-41 - Test 589 Vehicle Longitudinal Acceleration, Velocity, and Distance Vs Time

W32: Test 589 - Textured Barrier: Shallow, LAT CALCS Test Date: 3/20/02
