DEVELOPMENT OF A TL-1 TIMBER, CURB- TYPE, BRIDGE RAILING FOR USE ON TRANSVERSE, NAIL-LAMINATED, TIMBER BRIDGES

MIDWEST ROADSIDE SAFETY FACILITY

WEST VIRGINIA DEPARTMENT OF TRANSPORTATION

MwRSF Research Report No. TRP-03-211-09-R1

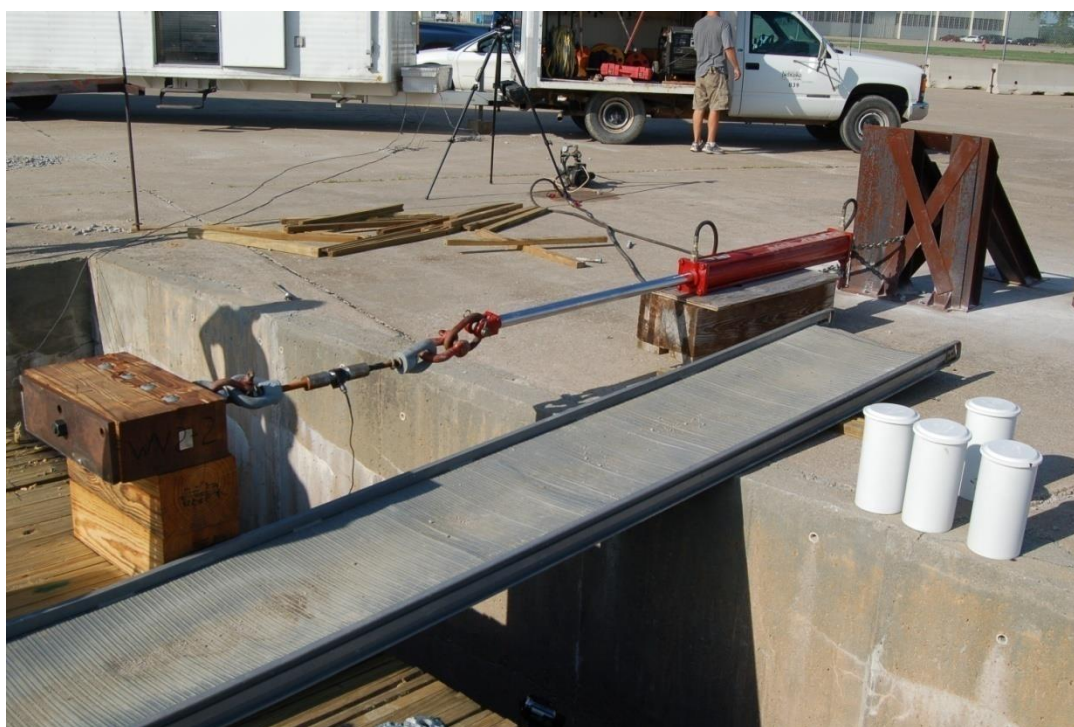
Figure 8. Modified Static Test Setup - Test Nos. WVS-1 through 5

During test no. WVS-1, the winch reached its maximum load before the test component failed. As such, the method for applying the load required modification. The winch and 2:1 cable pulley system were replaced by a 50,000-lb (222,000-N) capacity hydraulic ram. The ram was attached to a steel anchor frame which was bolted down to the tarmac. The locations for the load cell and string potentiometer remained the same. This modified static test setup, as shown in Figure 8, was utilized to finish test no. WVS-1 as well as for static test nos. 2 through 5.

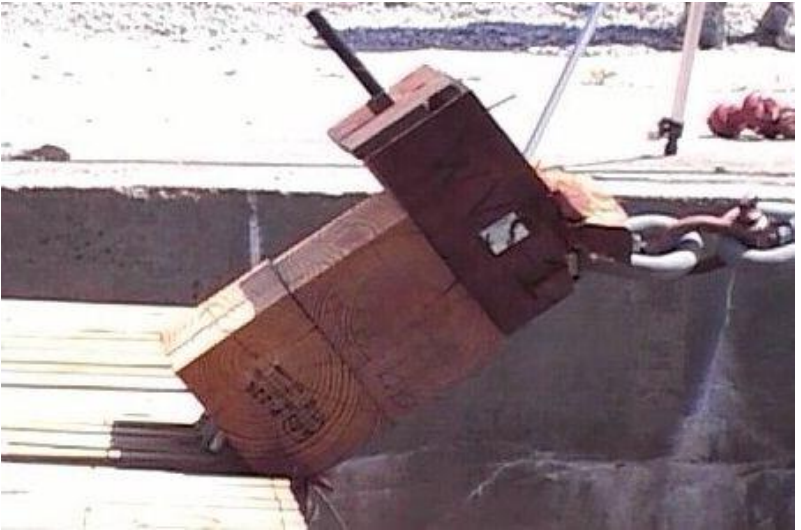
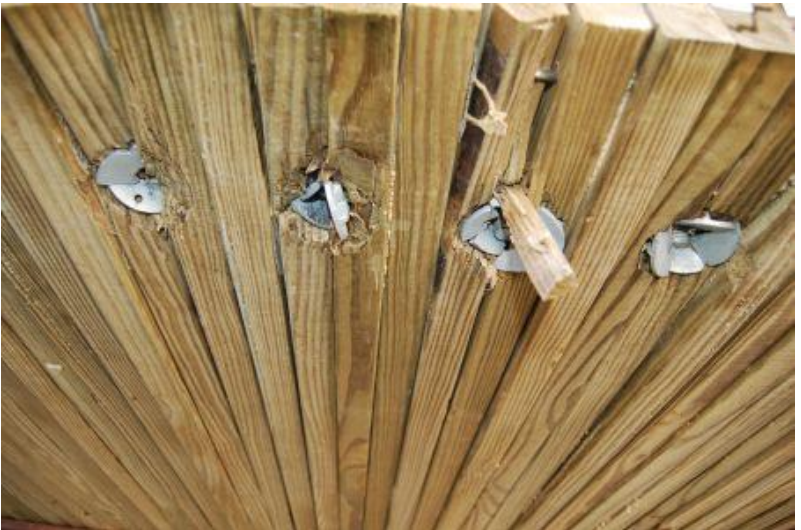
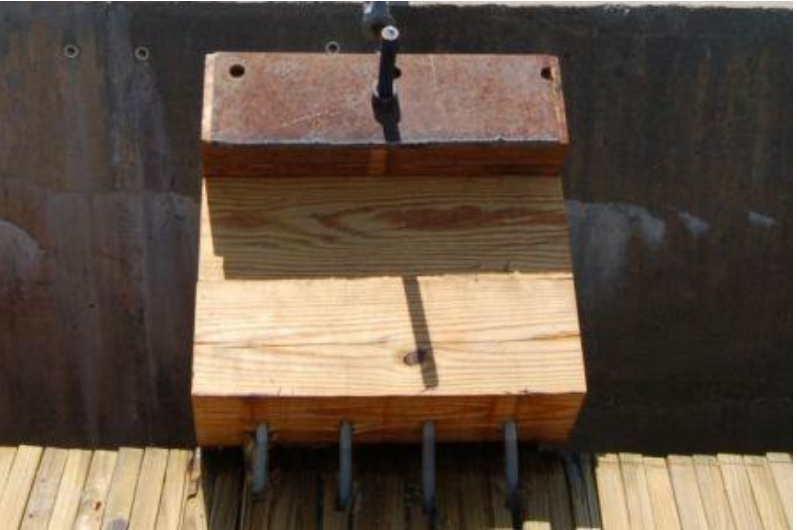
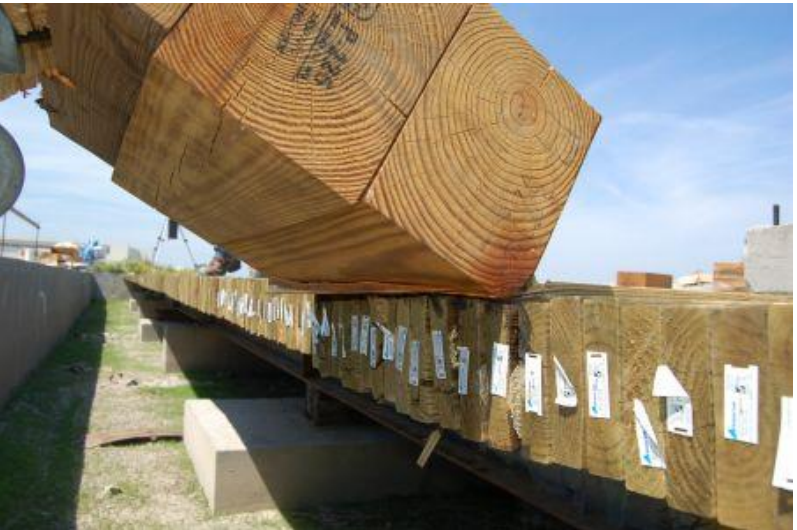
Figure 10. Component Damage and Permanent Set Deflection, Test No. WVS-1

As previously stated, test no. WVS-1 began with the use of the winch and a 2:1 cable pulley system, but it was completed using a hydraulic ram to load the test component to failure. During the test, the post assembly leaned backward, thus opening a gap between the front of the lower scupper block and the bridge deck. At the same time, the edge of the deck deflected downward. A maximum lateral force of 17.9 kips (79.7 kN) was observed at 14.9 in. (378 mm) of deflection. The force versus displacement curve for test no. WVS-1 is shown in Figure 9, while photographs for the deflected post are shown in Figure 10.

Damage to the post assembly and bridge deck was minimal, as shown in Figures 10 and 11. The back edge of the lower scupper block was compressed, thus causing some fibers to splinter off. The top-back edge of the rail segment was partially removed as a result of the loading to the steel rod near the conclusion of the test. All four of the connection bolts were bent near the scupper-deck interface, and all four of the malleable iron washers on the underside of the deck had fractured. It was later revealed that the washers were placed upside-down. The transverse boards in the deck were pulled laterally approximately 1 in. (25 mm) at the post location, and the vertical bolt holes drilled through the deck were elongated due to bearing-type failures in the timber deck. Finally, six of the transverse deck boards had longitudinal cracks near the edge of the deck. However, none of the deck boards had completely fractured.

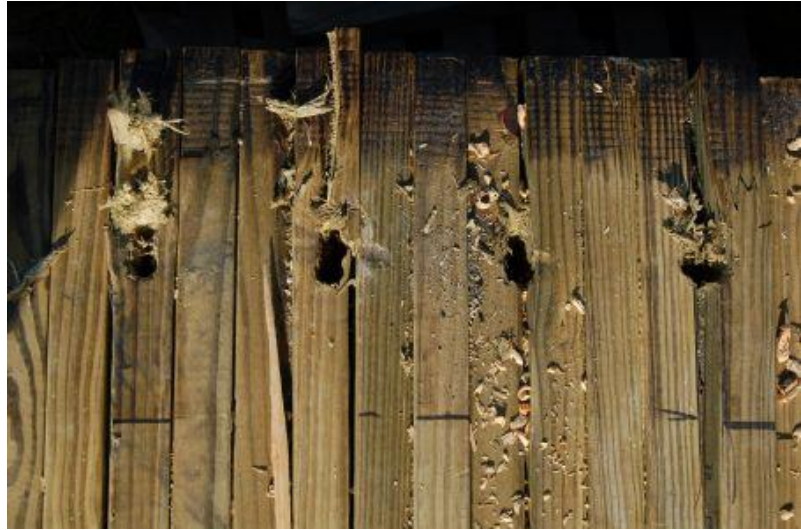
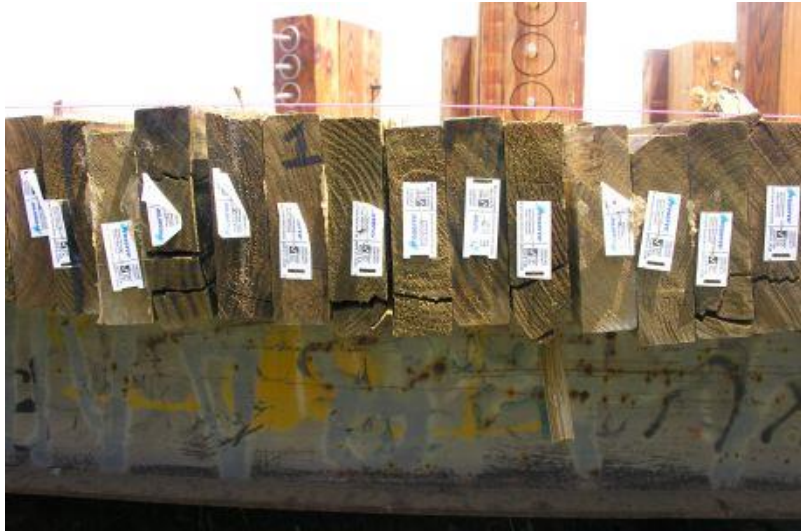
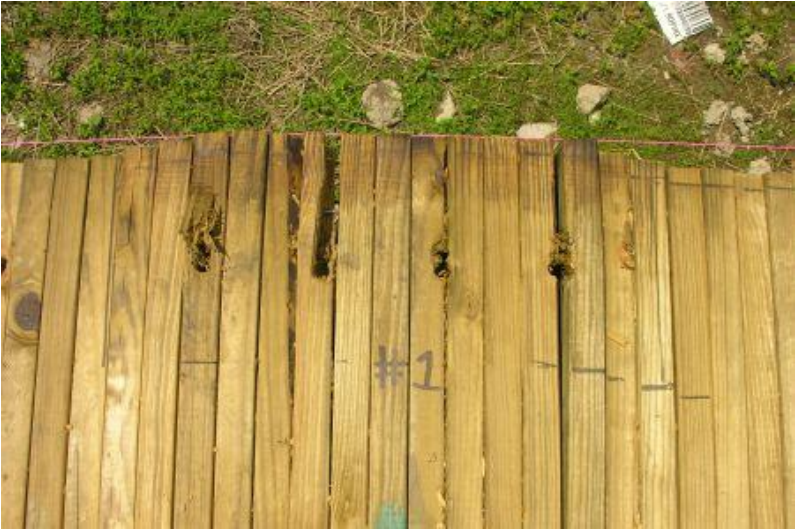
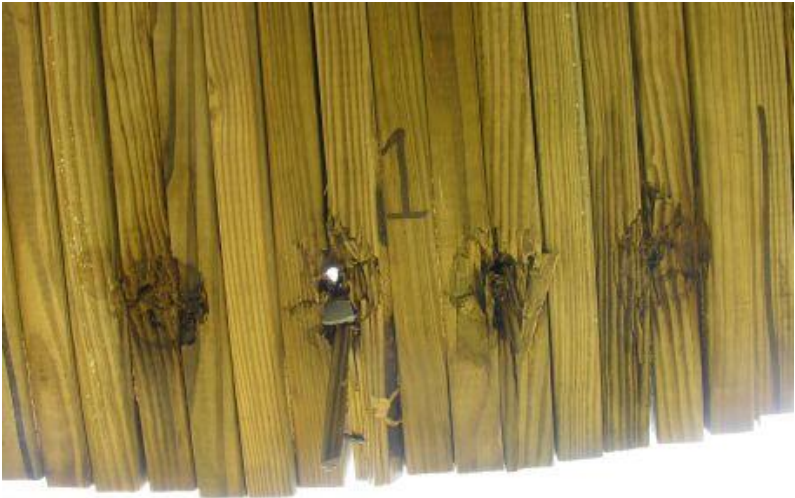
Figure 11. Bridge Deck Damage, Test No. WVS-1

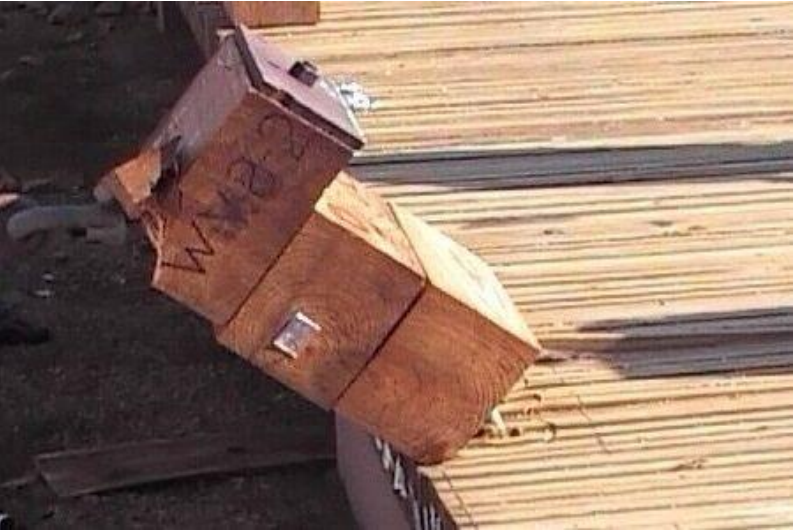
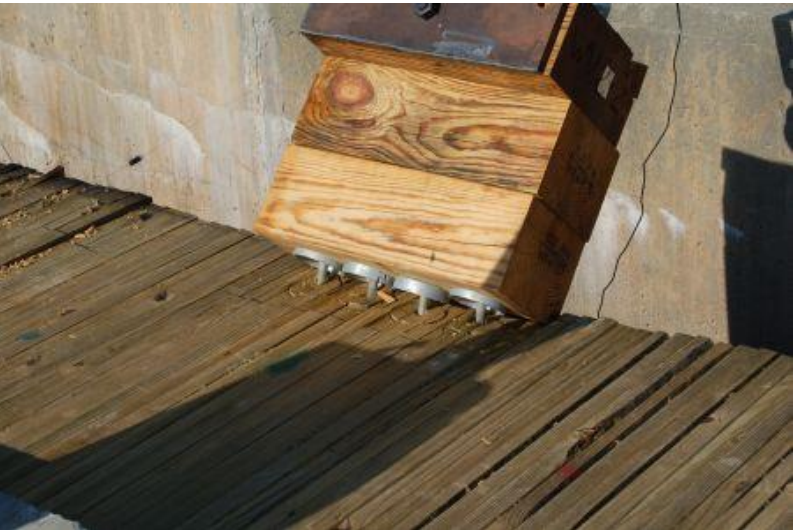
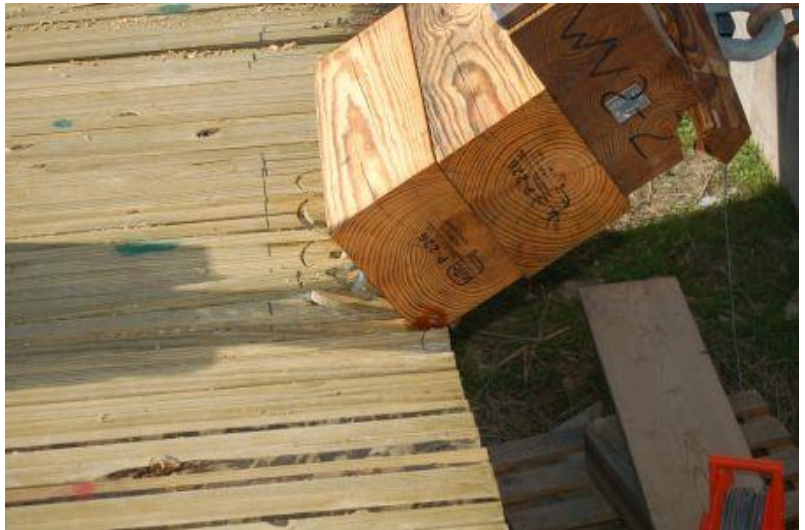
Figure 13. Component Damage and Permanent Set Deflection, Test No. WVS-2

During test no. WVS-2, the post assembly leaned backward, thus opening a gap between the front of the lower scupper block and the bridge deck. At the same time, the edge of the deck deflected downward. A maximum force of 14.7 kips (65.4 kN) was observed at 15.5 in. (394 mm) of deflection. The force versus displacement curve for test no. WVS-2 is shown in Figure 12, while photographs for the deflected post are shown in Figure 13.

Damage to the post assembly and bridge deck was minimal, as shown in Figures 13 and 14. The back edge of the lower scupper block was compressed, and the top-back edge of the glulam rail segment was partially removed as a result of the loading to the steel rod near the conclusion of the test. All four of the connection bolts were bent near the scupper-deck interface, and three malleable iron washers on the underside of the deck had fractured. The transverse boards in the deck were pulled slightly outward, and three of the deck boards had longitudinal cracks at the deck edge. Two deck boards were fractured near the bolt line. Finally, wood pieces had chipped away from the deck surface between the bolt holes and the split ring grooves.

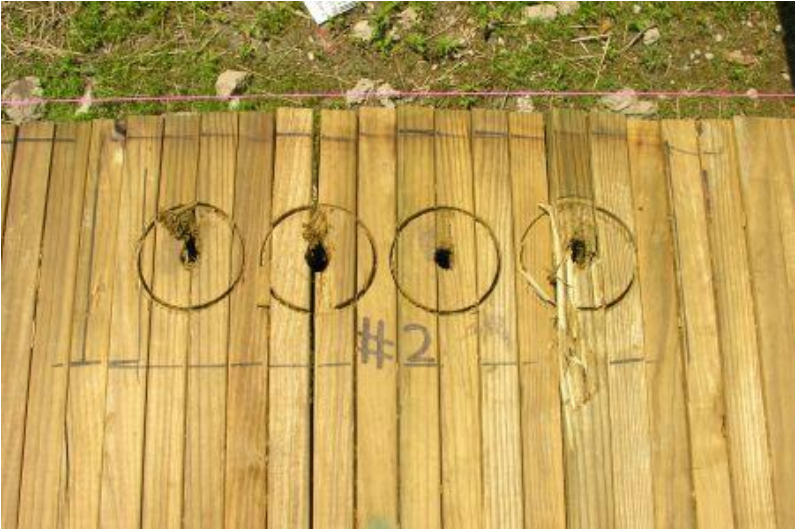
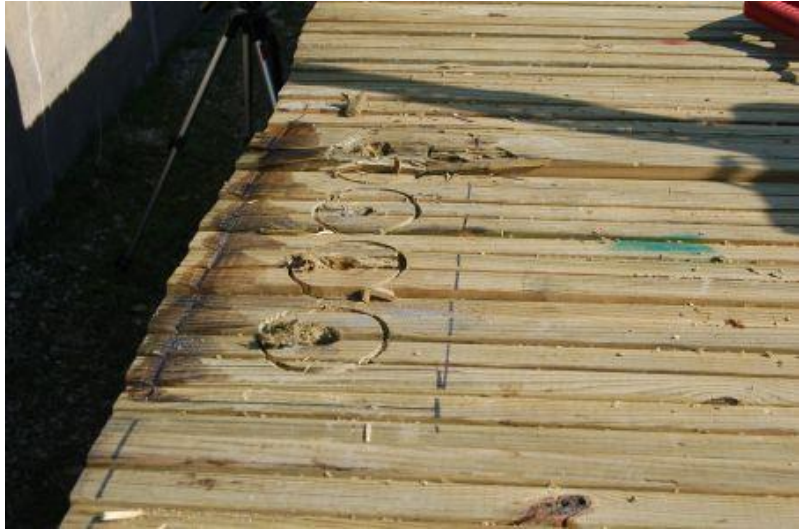
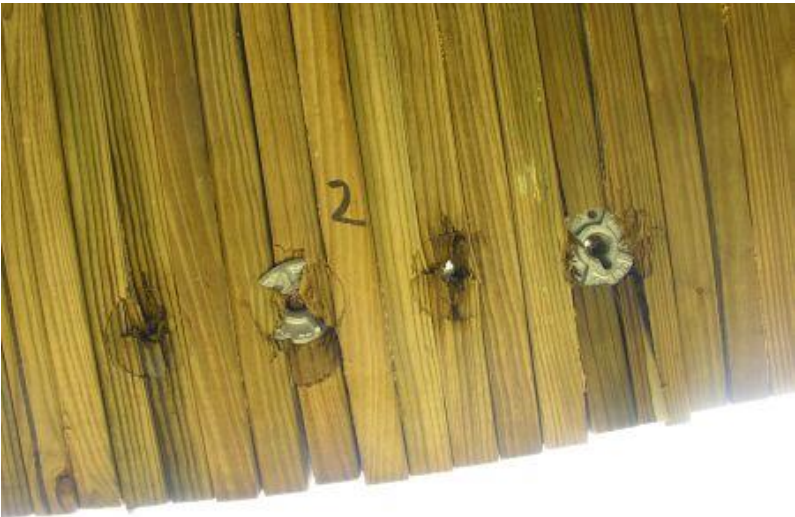
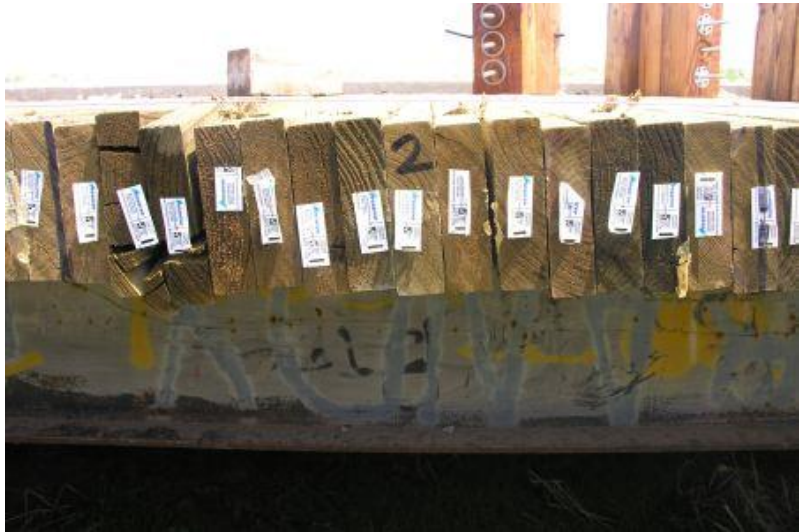
Figure 14. Bridge Deck Damage, Test No. WVS-2

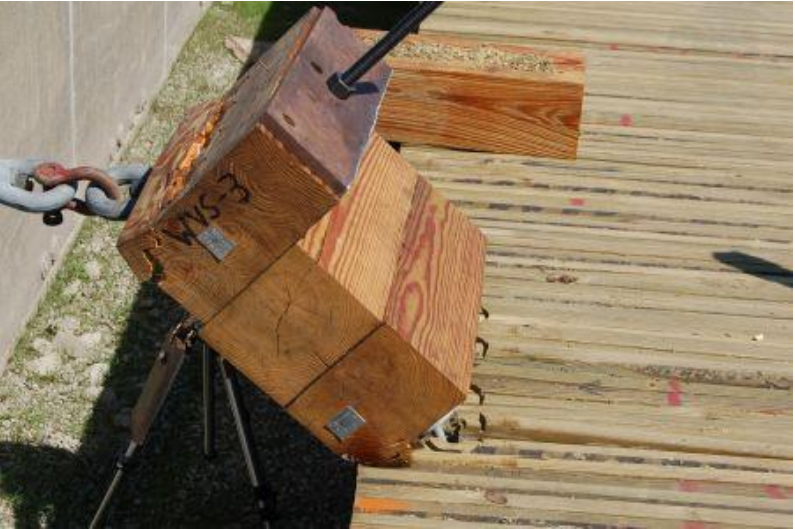
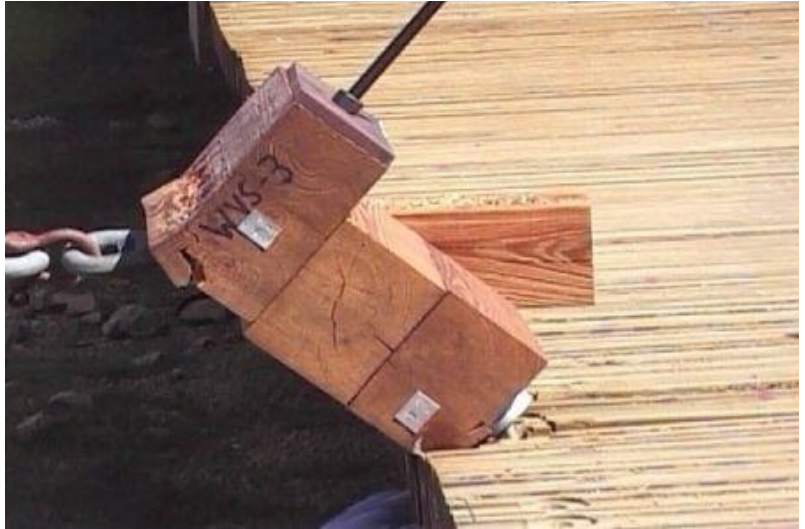
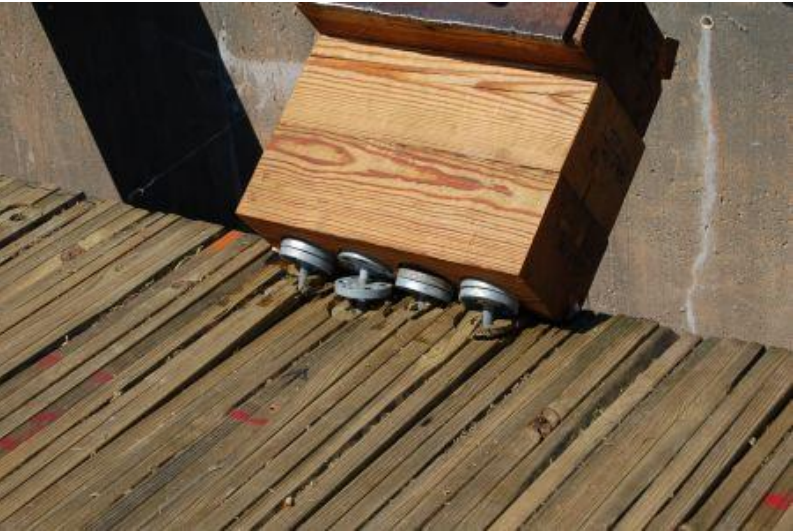
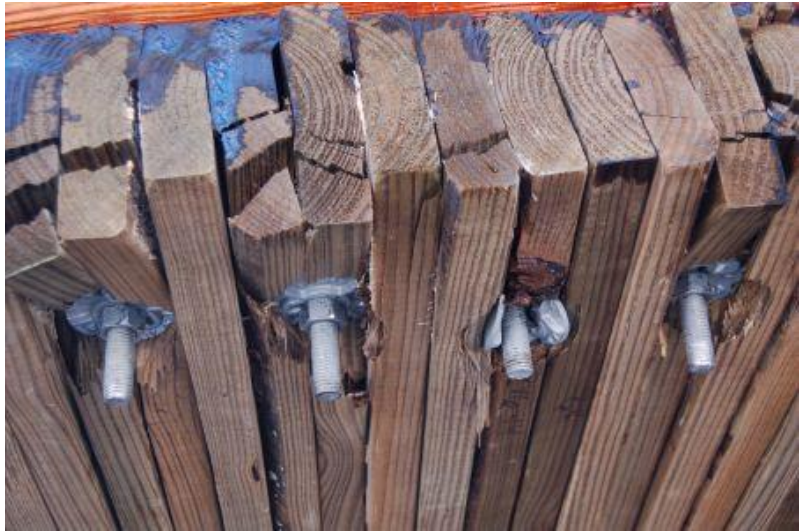
Figure 16. Component Damage and Permanent Set Deflection, Test No. WVS-3

During test no. WVS-3, the post assembly leaned backward, thus opening a gap between the front of the lower scupper block and the bridge deck. At the same time, the edge of the deck deflected downward. A maximum force of 17.1 kips (76.1 kN) was observed at 19.3 in. (490 mm) of deflection. The force versus displacement curve for test no. WVS-3 is shown in Figure 15, while photographs for the deflected post are shown in Figure 16.

Damage to the post assembly and bridge deck was minimal, as shown in Figures 16 and 17. The back edge of the lower scupper block was compressed, thus resulting in deformation and cracking of the block. The top-back edge of the rail segment was partially removed as a result of the loading to the steel rod near the conclusion of the test. All four of the connection bolts were bent near the scupper-deck interface, and one of the malleable iron washers on the underside of the deck fractured. Eight of the transverse deck boards had longitudinal cracks at the deck edge, and five of the deck boards appeared to be fractured near the bolt line. Finally, wood pieces had chipped off of the deck surface between the bolt holes and the shear plate grooves.

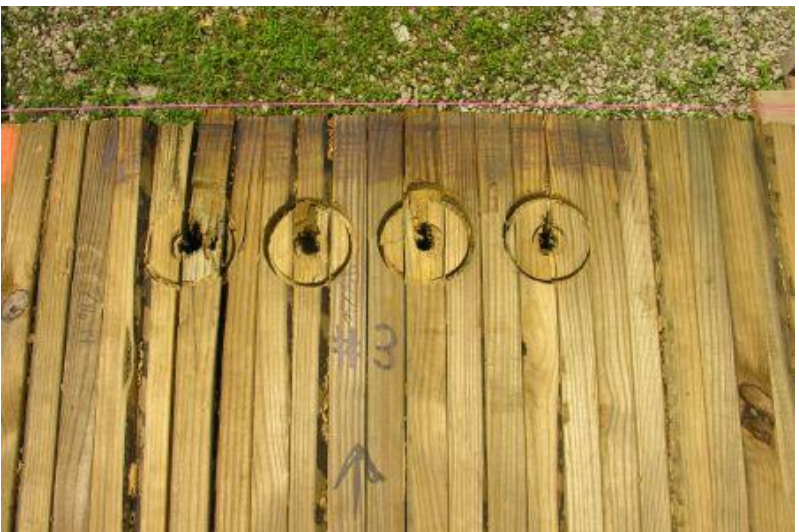
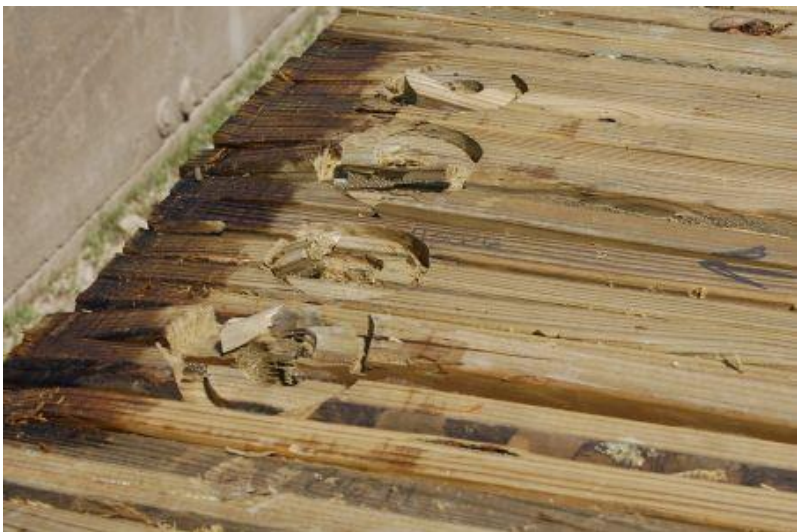
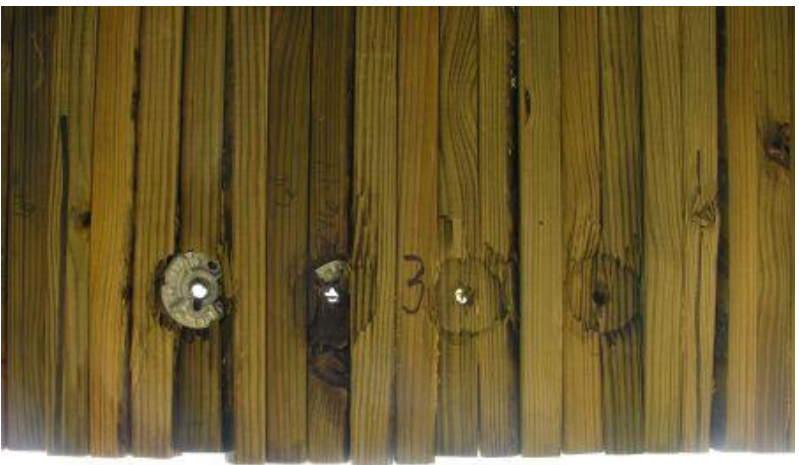
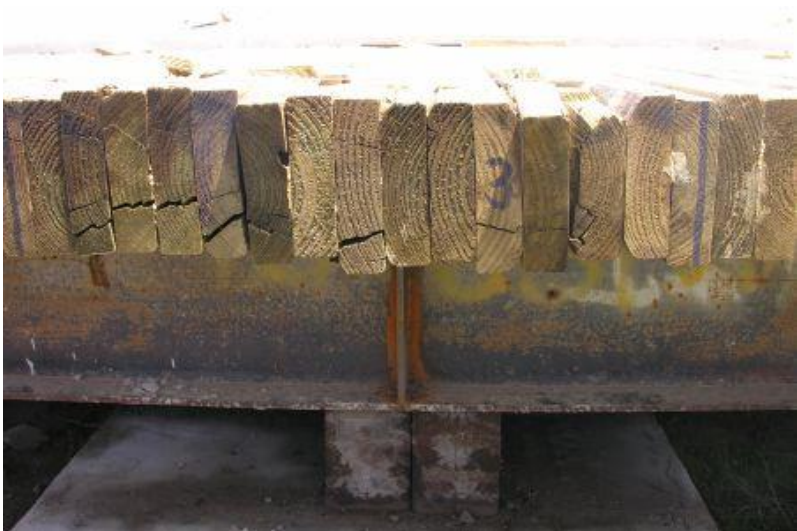
Figure 17. Bridge Deck Damage, Test No. WVS-3

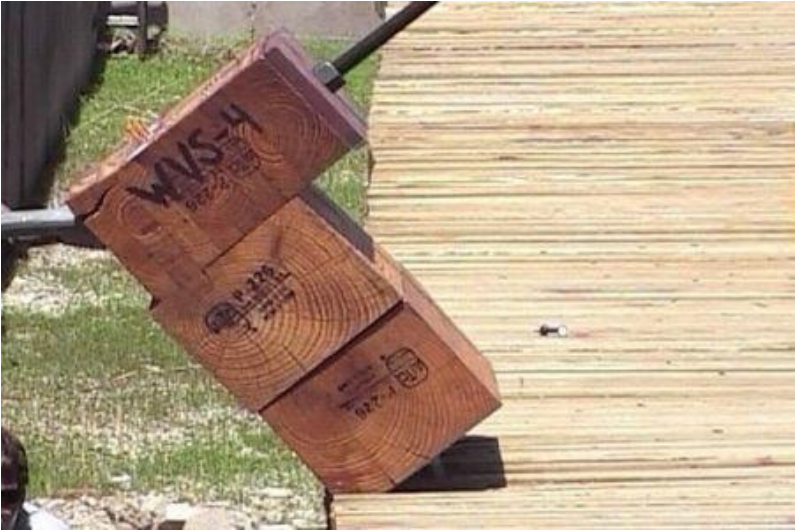
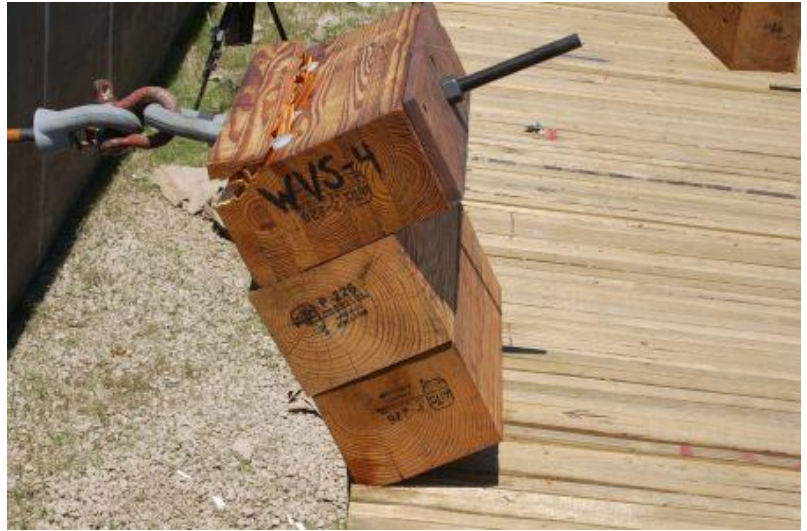
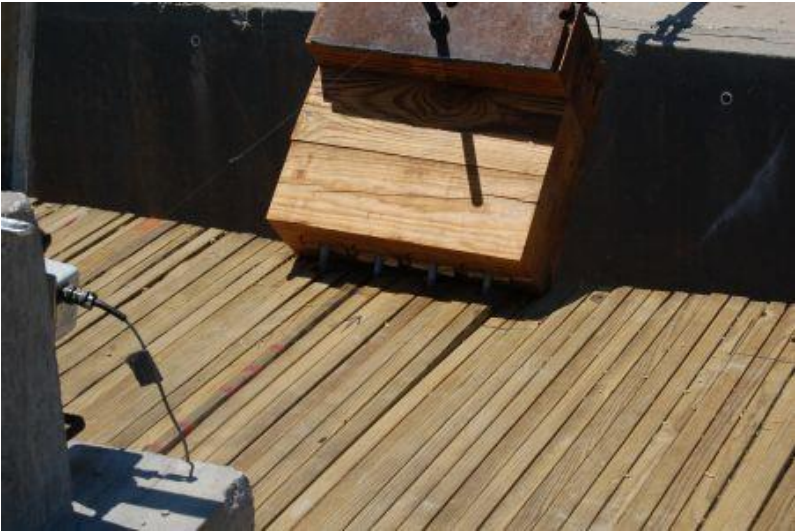
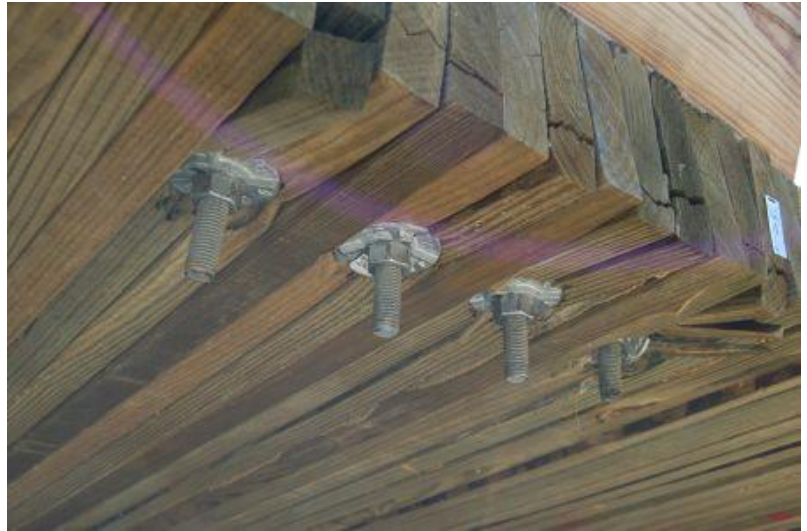
Figure 19. Component Damage and Permanent Set Deflection, Test No. WVS-4

Damage to the post assembly and bridge deck was minimal, as shown in Figures 19 and 20. The back edge of the lower scupper block was compressed, and the top-back edge of the rail segment was partially removed as a result of the loading to the steel rod near the conclusion of the test. All four of the connection bolts were bent near the scupper-deck interface, and two of the malleable iron washers on the underside of the deck fractured. The transverse boards in the deck were pulled slightly outward, and six of the boards had longitudinal cracks at the deck edge. Two of the deck boards appeared to be fractured near the bolt line.

During test no. WVS-4, the post assembly leaned backward, thus opening a gap between the front of the lower scupper block and the bridge deck. At the same time, the edge of the deck deflected downward. A maximum force of 16.8 kips (74.8 kN) was observed at 22.5 in. (572 mm) of deflection. The force versus displacement curve for test no. WVS-4 is shown in Figure 18, while photographs for the deflected post are shown in Figure 19.

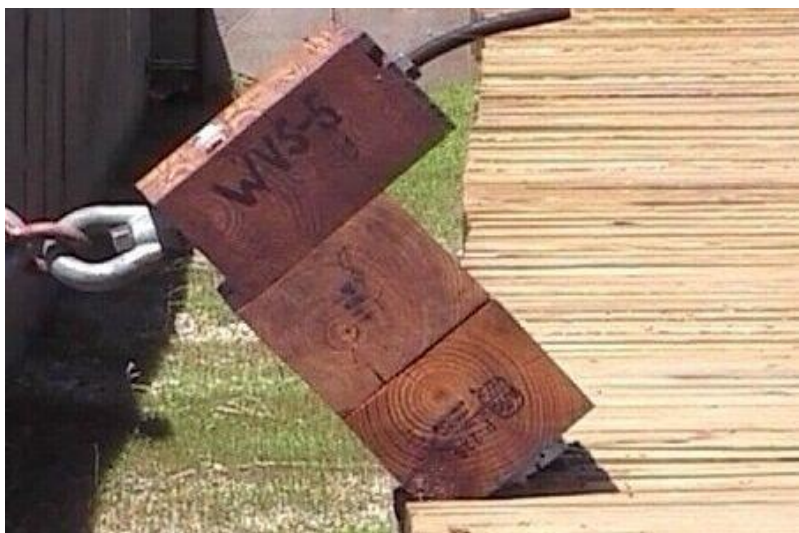
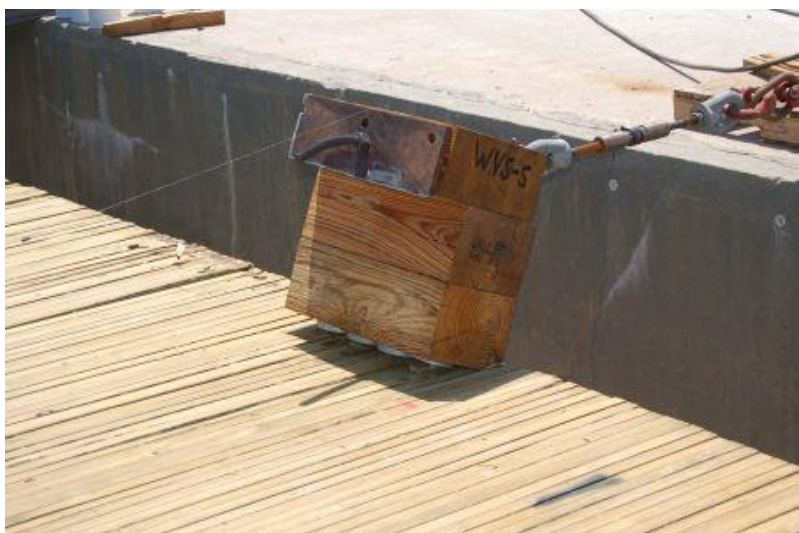
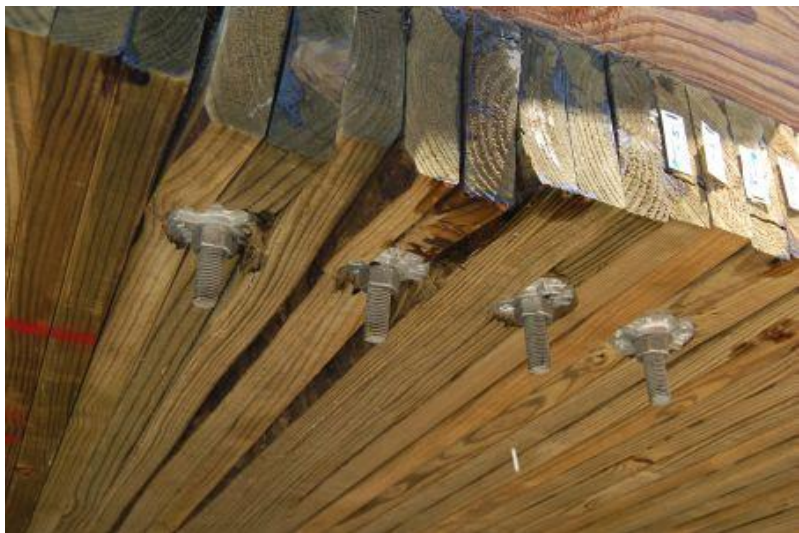
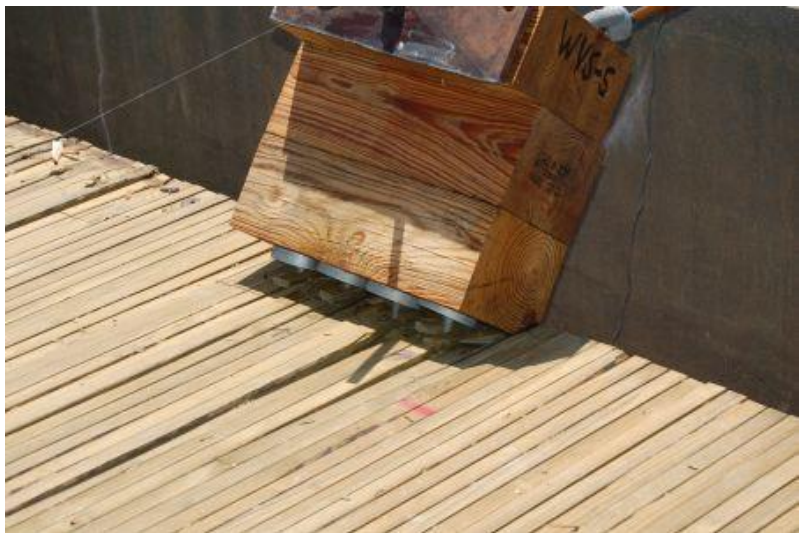
Figure 22. Component Damage and Permanent Set Deflection, Test No. WVS-5

Damage to the post assembly and bridge deck was minimal, as shown in Figures 22 and 23. The back edge of the lower scupper block was compressed, and the top-back edge of the rail segment was partially removed as a result of the loading to the steel rod near the conclusion of the test. All four of the connection bolts were bent near the scupper-deck interface. The transverse boards in the deck were pulled slightly outward at the post location, and four of the deck boards appeared to be fractured near the bolt line. Finally, wood pieces had chipped away from the deck surface between the bolt holes and the timber split ring grooves.

During test no. WVS-5, the post assembly leaned backward, thus opening a gap between the front of the lower scupper block and the bridge deck. At the same time, the edge of the deck deflected downward. A maximum force of 13.4 kips (59.6 kN) was observed at 17.0 in. (432 mm) of deflection. The force versus displacement curve for test no. WVS-5 is shown in Figure 21, while photographs of the deflected post are shown in Figure 22.

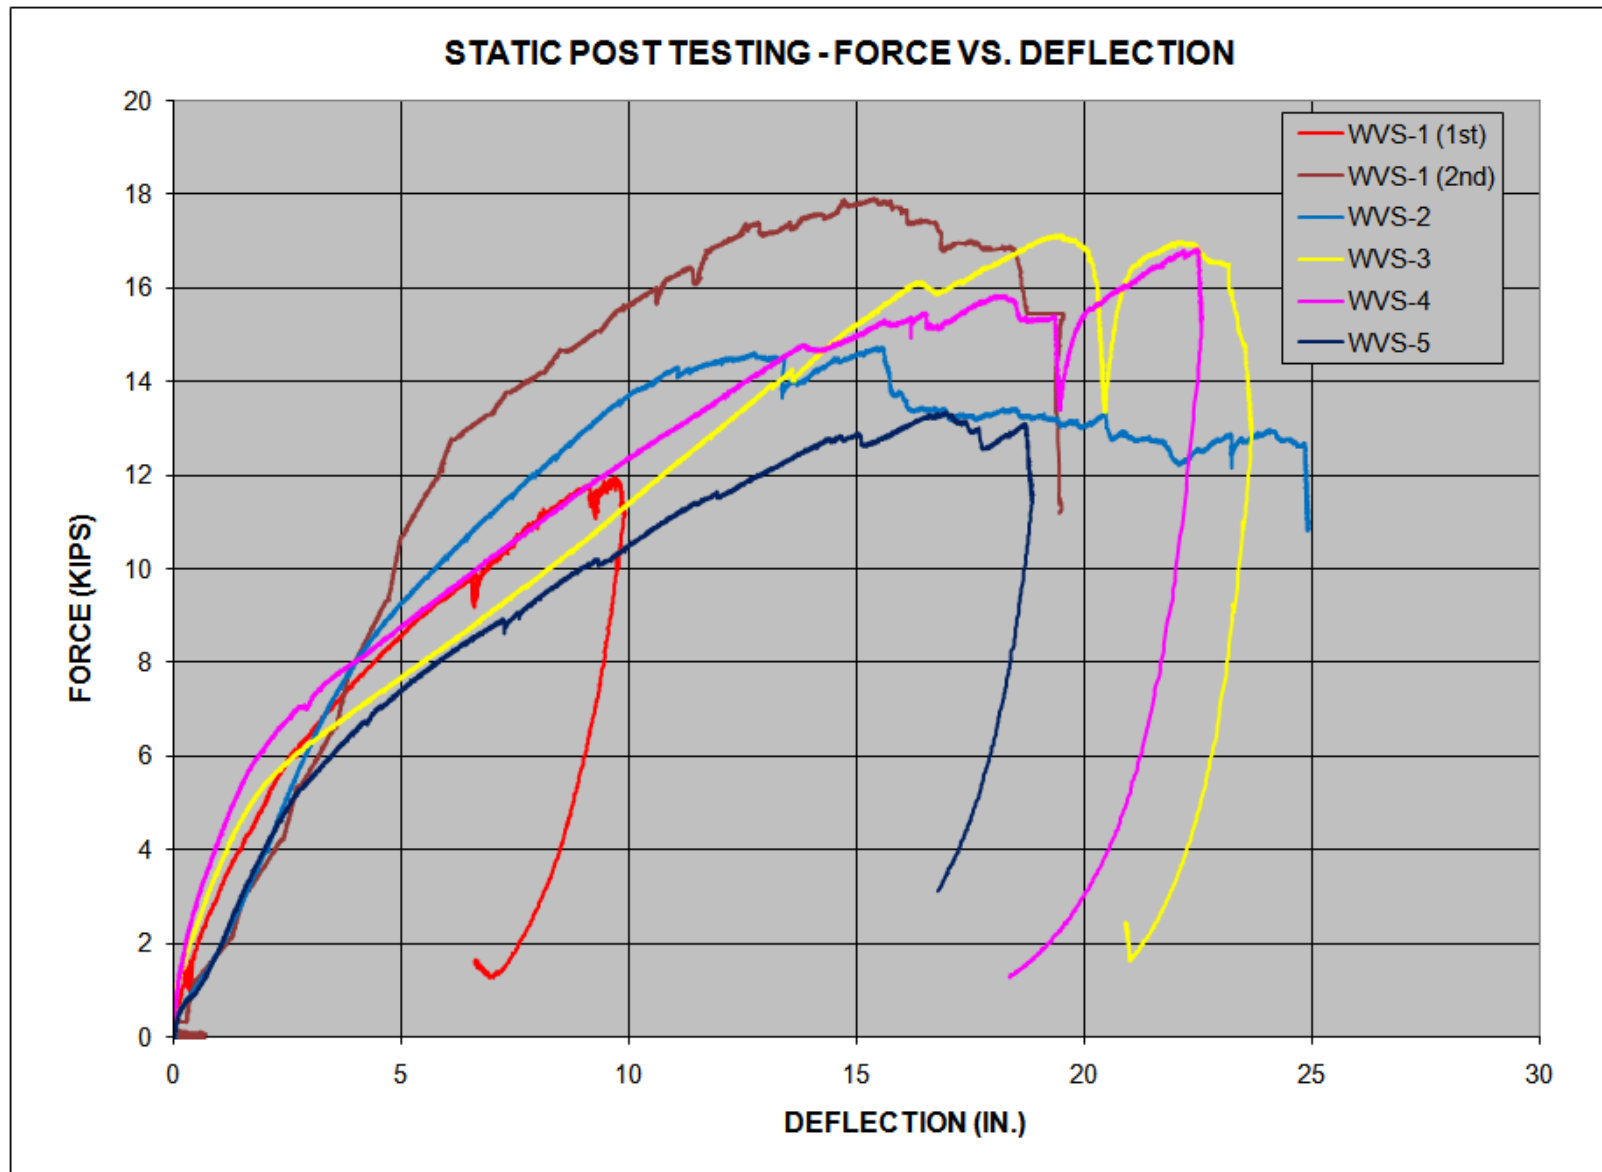
Figure 24. Force vs. Deflection Comparison for All Five Static Tests

As noted previously, it was desired that the modified bridge posts be capable of resisting a lateral static load of approximately 14 kips (62 kN) or greater. As shown in Figure 24, only one post test resulted in maximum lateral load capacity below the targeted value. In static test no. WVS-5, or the system utilizing split rings between the lower scupper block and the bridge deck, a lateral static capacity of 13.4 kips (59.6 kN) was observed, or only 0.6 kips (2.7 kN) below the targeted value. For the remaining four static tests, the maximum lateral load capacities ranged between 14.7 and 17.9 kips (65.4 to 79.6 kN).

When comparing split rings usage, a 9.7 percent increase in lateral load capacity was observed for split rings used at all interfaces as compared only placed at the lower interface. However, the increase in lateral load capacity ranged between 25.4 to 33.6 percent for the case of not using shear connectors as compared to the use of split rings at the lower interface only. The option for using shear plates at all interfaces provided an increase in lateral load capacity of approximately 27.6 percent as compared to split rings placed at only the lower interface. Finally, it was observed that the no shear connector option [16.8 to 17.9 kips (74.8 to 79.6 kN)] provided a comparable maximum lateral load capacity to that provided by the option for using shear plates at all interfaces [17.1 kips (76.1 kN)].

Further, the initial stiffness observed for each of the static tests was very similar, and the variance in the force versus deflection curves occurred only in the plastic region. Thus, the use of shear connectors had little to no effect on the strength of the post assemblies. In fact, the static testing of post assemblies configured without shear connectors, test nos. WVS-1 and 4, recorded the 1st and 3rd highest lateral capacities.

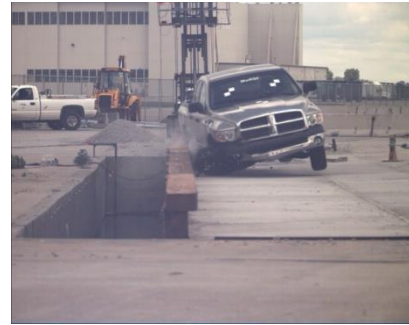
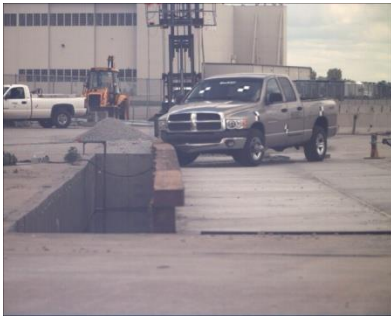
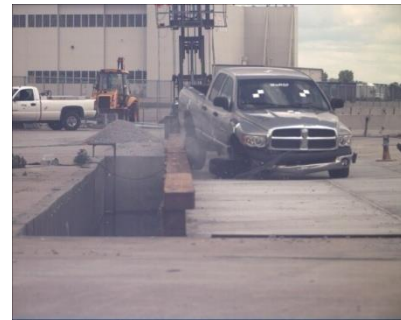
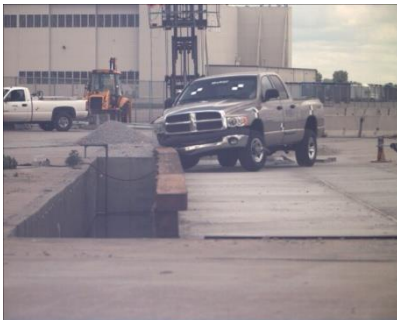
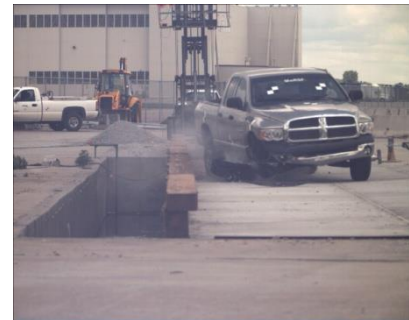
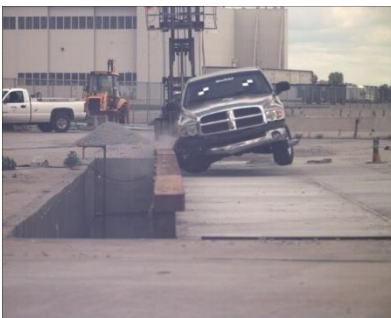
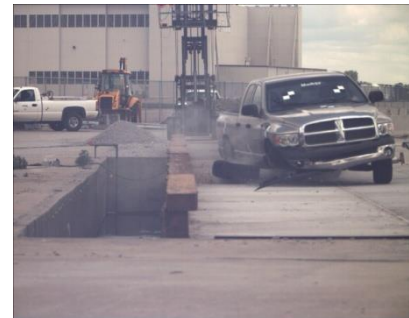
Figure 68. Additional Sequential Photographs, Test No. WVBR-1

The 5,179-lb (2349-kg) pickup truck impacted the timber bridge rail at a speed of 30.8 mph (49.6 km/h) and at an angle of 26.1 degrees. A summary of the test results and sequential photographs are shown in Figure 65. The summary of the test results in SI units are shown in APPENDIX B. Additional sequential photographs are shown in Figures 66 through 68. Documentary photographs of the crash test are shown in Figure 69.

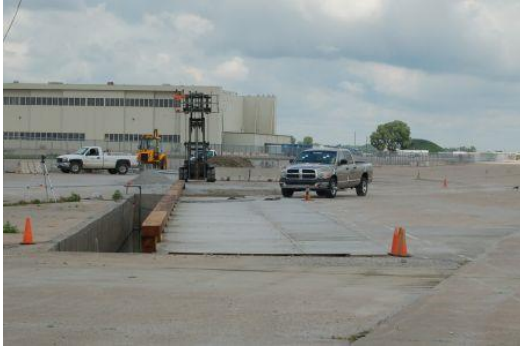
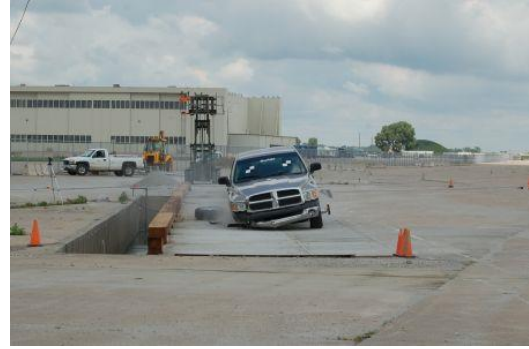
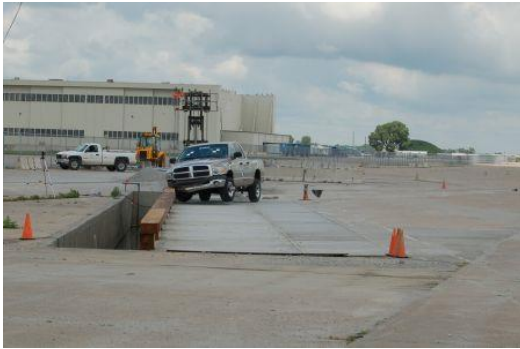
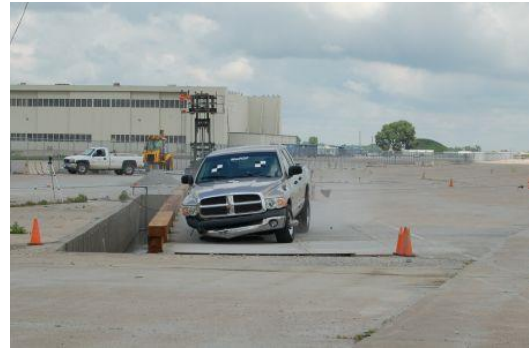
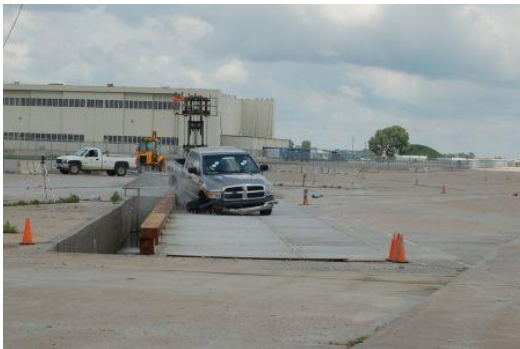
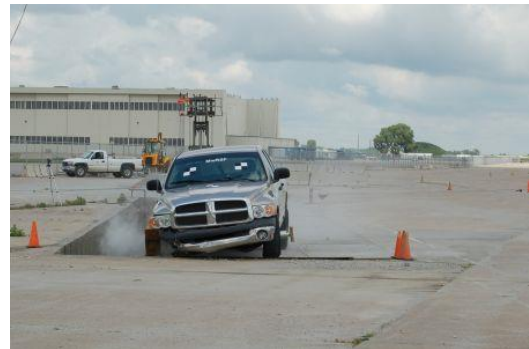
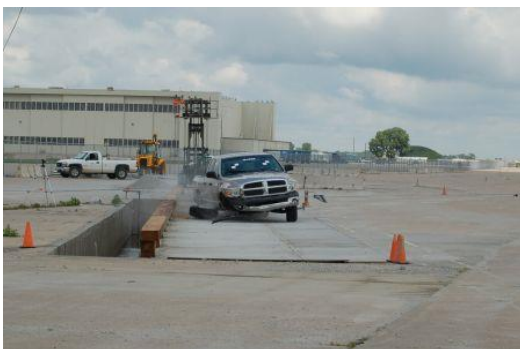
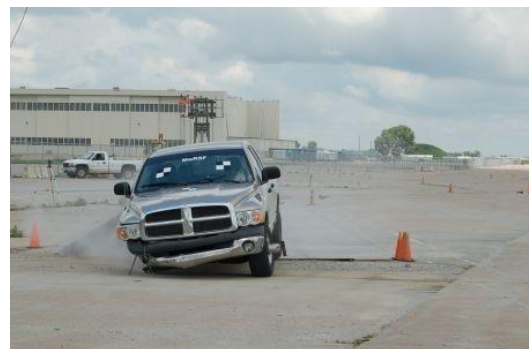
Figure 69. Documentary Photographs, Test No. WVBR-1

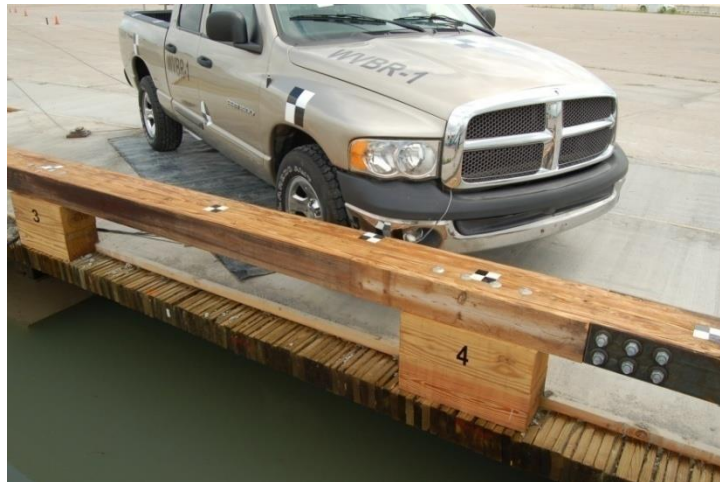
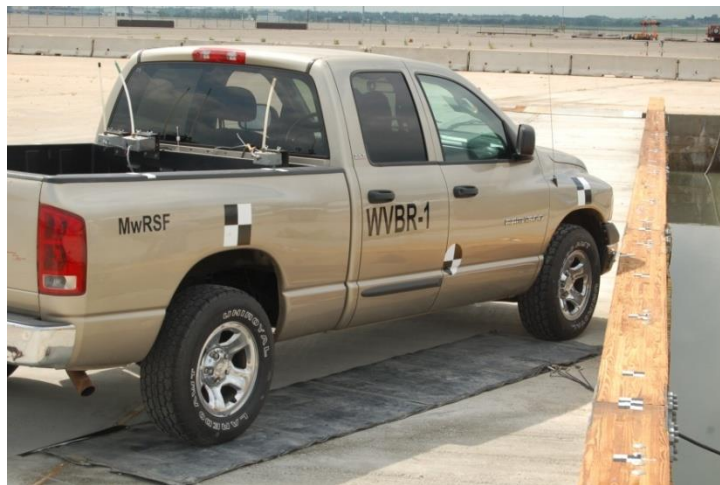
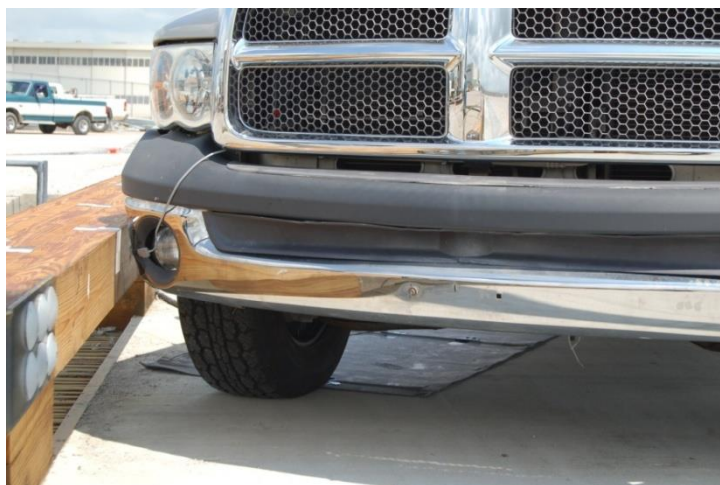
Figure 70. Target Impact Location, Test No. WVBR-1

Initial impact was to occur 60 in. (1,524 mm) upstream from the centerline of the H-splice plate located between post nos. 4 and 5, as shown in Figure 70. Actual vehicle impact occurred 66.4 in. (1,687 mm) upstream from the centerline of the H-splice plate located between post nos. 4 and 5. At 0.002 seconds after impact, the right-front bumper corner deflected inward. At 0.03 sec, the right-front wheel impacted the barrier at the impact point. At 0.034 sec, the rail began to deflect backward near the impact point. At 0.042 sec, the right-front wheel impacted the rail
