DEVELOPMENT OF A TL-1 TIMBER, CURB- TYPE, BRIDGE RAILING FOR USE ON TRANSVERSE, NAIL-LAMINATED, TIMBER BRIDGES

MIDWEST ROADSIDE SAFETY FACILITY

WEST VIRGINIA DEPARTMENT OF TRANSPORTATION

MwRSF Research Report No. TRP-03-211-09-R1

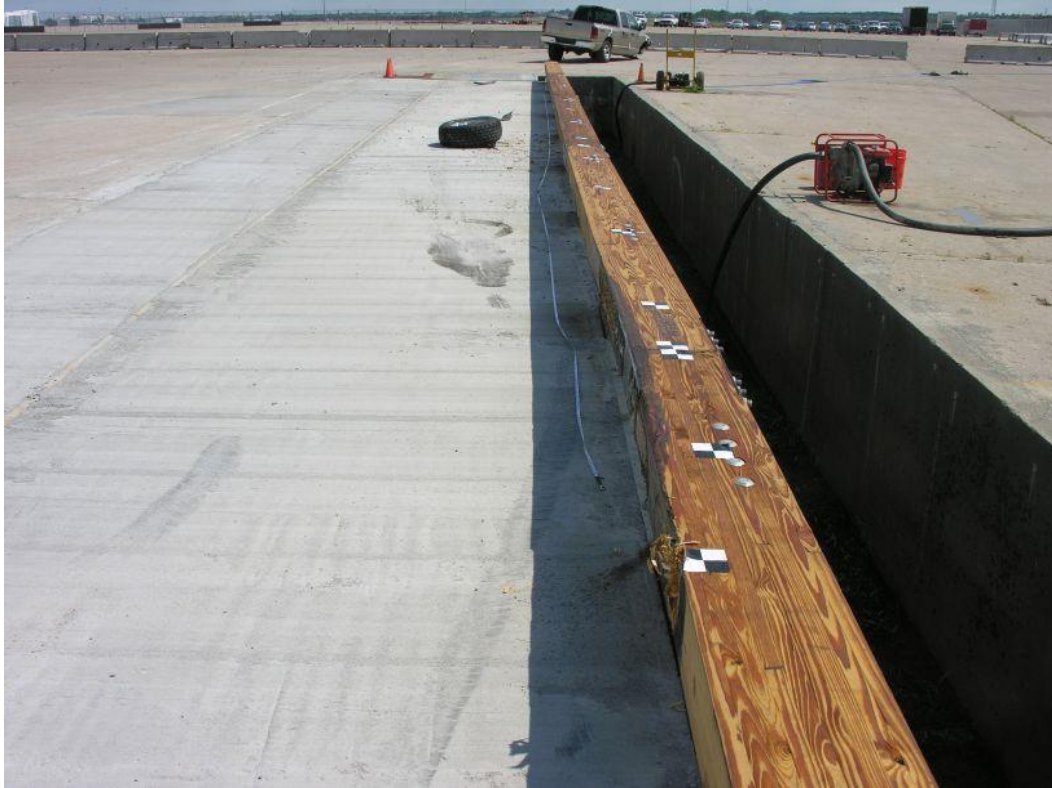
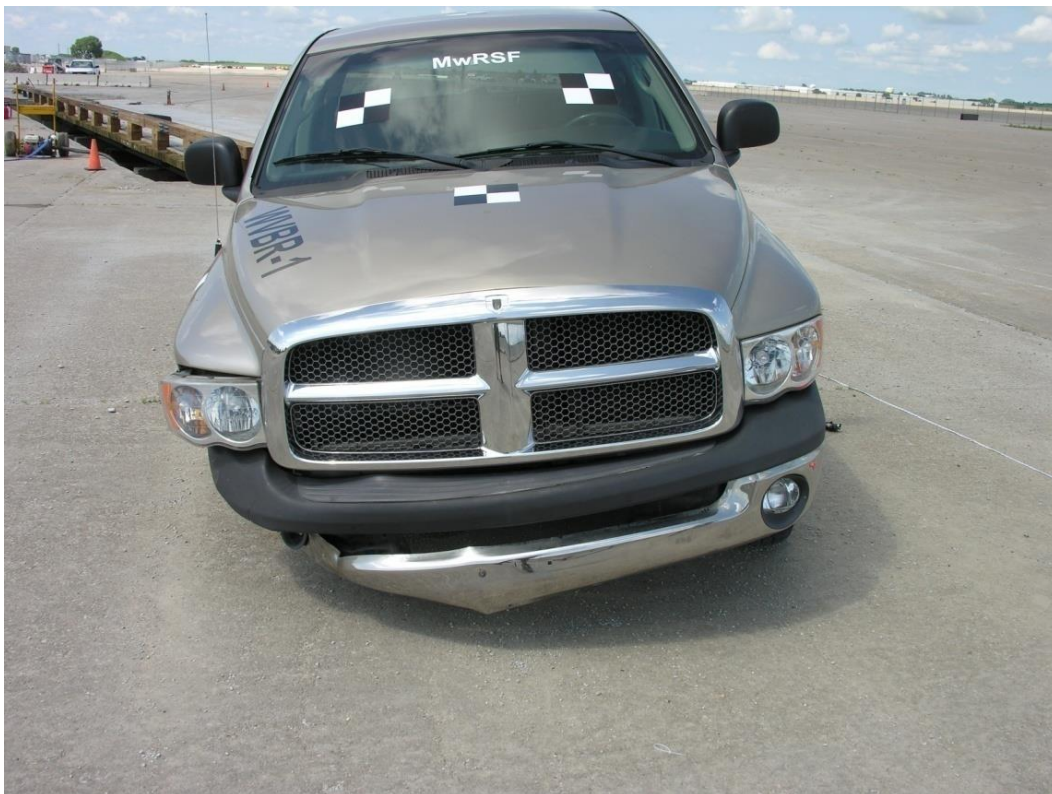
Figure 71. Vehicle Final Position and Trajectory Marks, Test No. WVBR-1

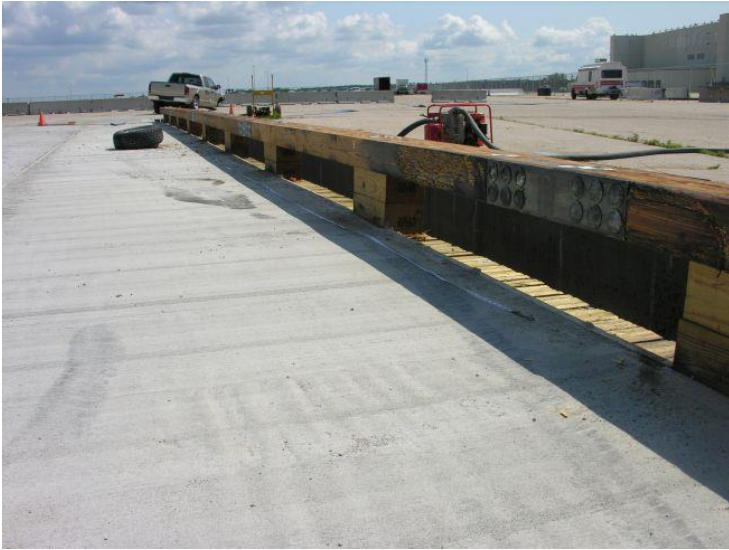
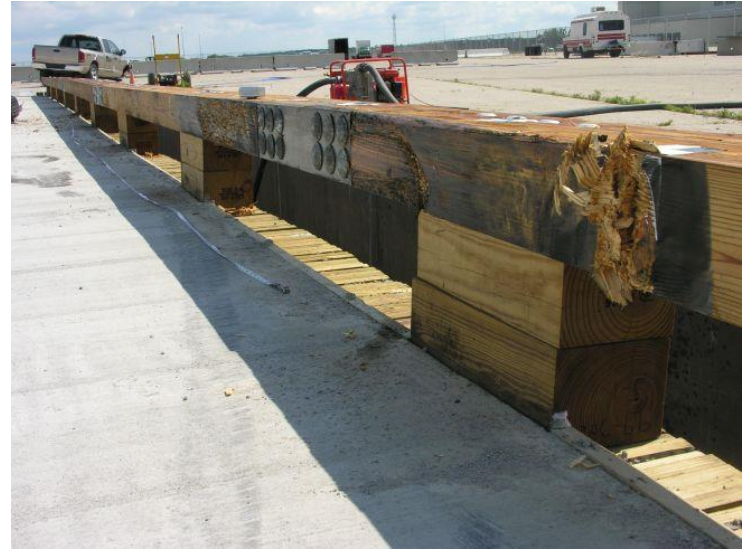
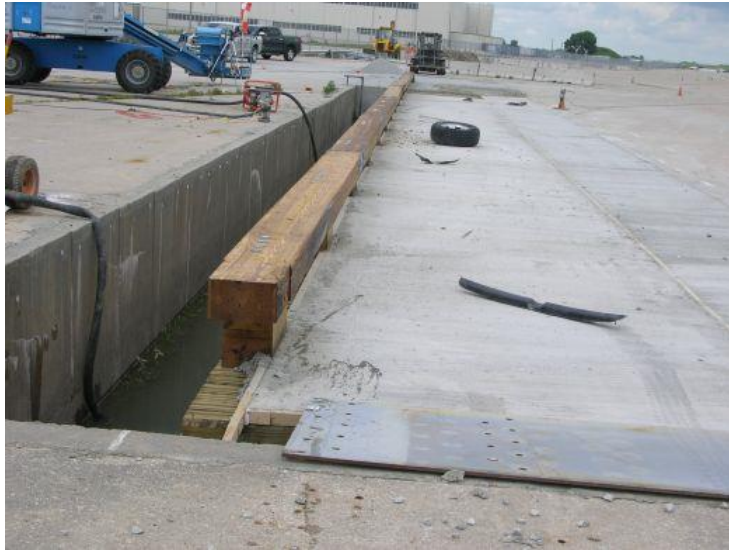
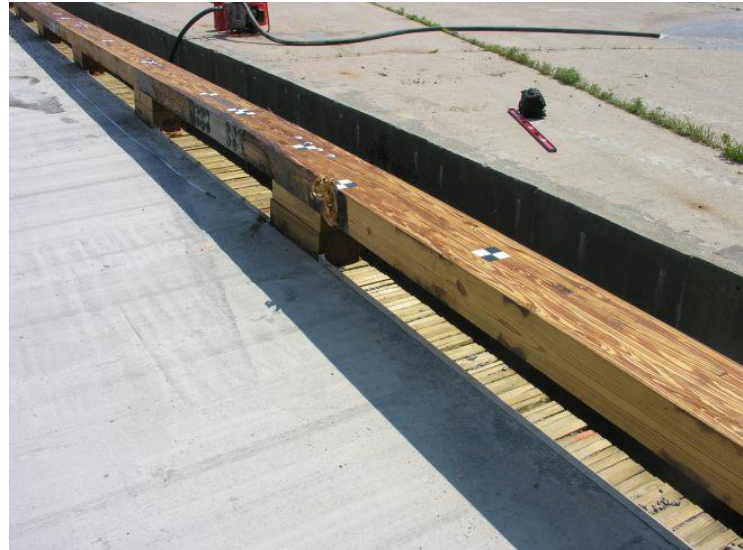
Figure 72. System Damage, Test No. WVBR-1

The bridge rail suffered minor damage, as shown in Figures 72 through 75. No visible railing damage was observed upstream of the impact location. Tire and scuff marks were found on the rail from the impact point to 1 in. (25 mm) upstream from post no. 5. A 1 ½-in. (38-mm) deep by 4-in. (102-mm) long gouge was observed on the front face of the rail just upstream of post no. 4, as shown in Figure 72. Also, scrape marks were found on the rail starting at post no. 4 and extending 7 ¾ ft (2.4 m) downstream. A ½-in. (13-mm) deep gouge was found on the face of the rail 2 in. (51 mm) downstream from the centerline of post no. 4.

The permanent set deflection of the barrier system is shown in Figures 72 and 73. Post nos. 4 and 5 were deflected laterally backward, while the other posts had no permanent set deflections. The maximum lateral permanent post deflection was 2.4 in. (61 mm) at post no. 4. A maximum dynamic deflection of 6.1 in. (155 mm) was observed at the upstream end of the splice between post nos. 4 and 5. The working width for the system was 12.4 in. (314 mm).

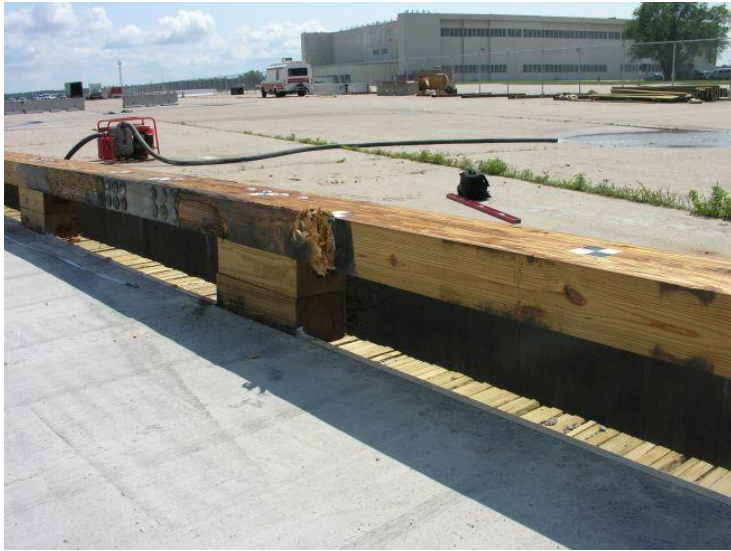
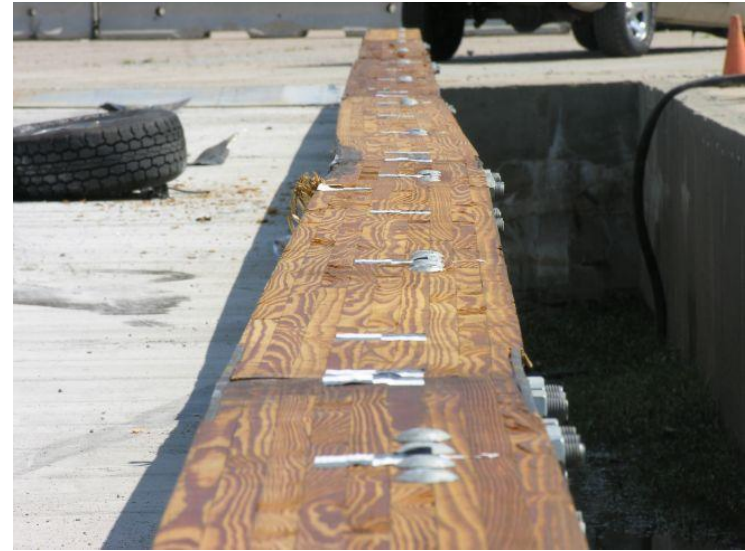
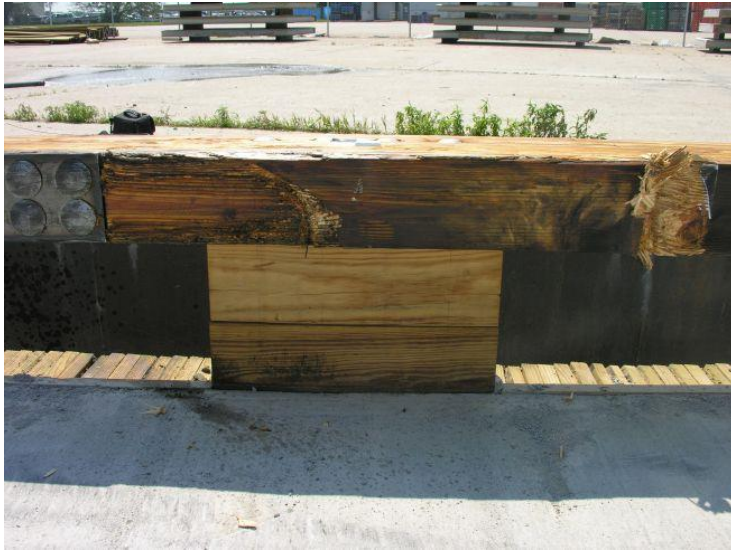
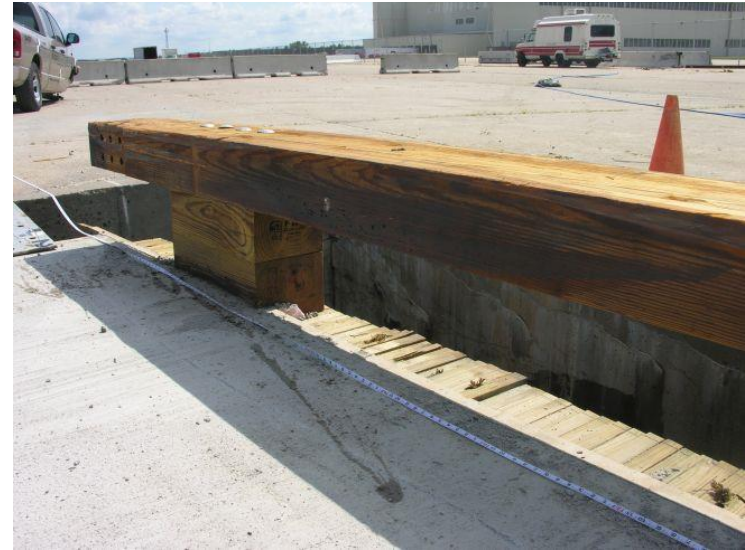
Figure 73. Rail Damage and Displacement, Test No. WVBR-1

No visible damage occurred to the railing system between post nos. 5 through 11. No top-side or under-side deck damage was observed near the vertical bolt holes. Tire and scuff marks were found on the last 8 ft - 8 in. (2.64 m) of the railing system, as shown in Figure 73.

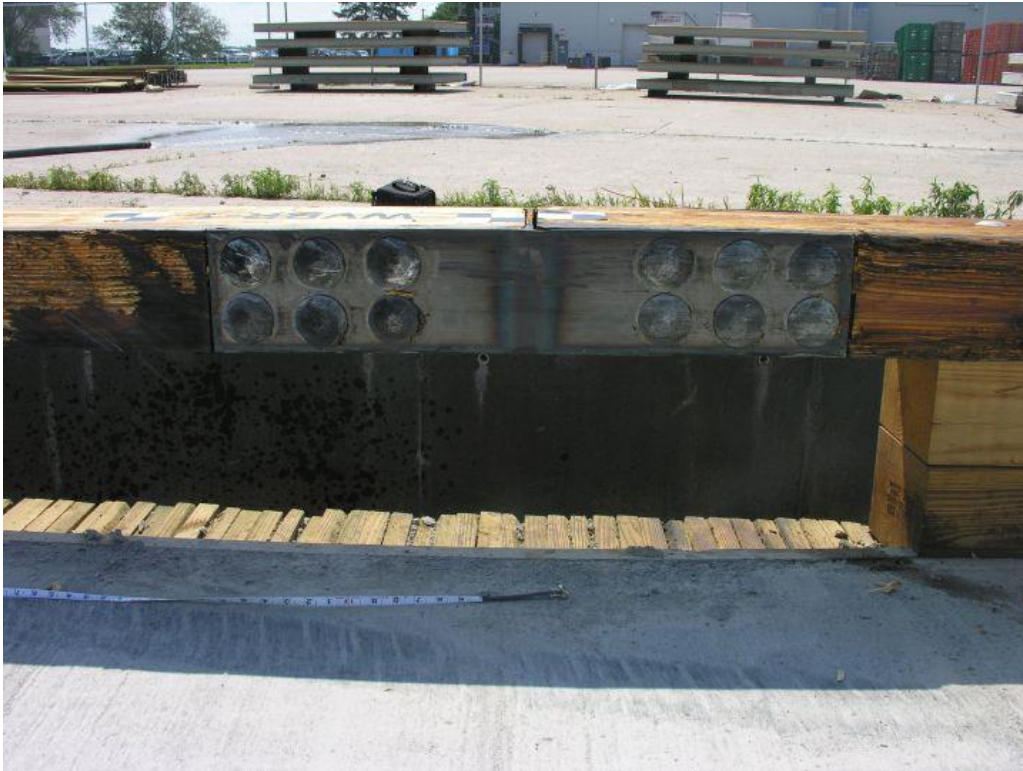
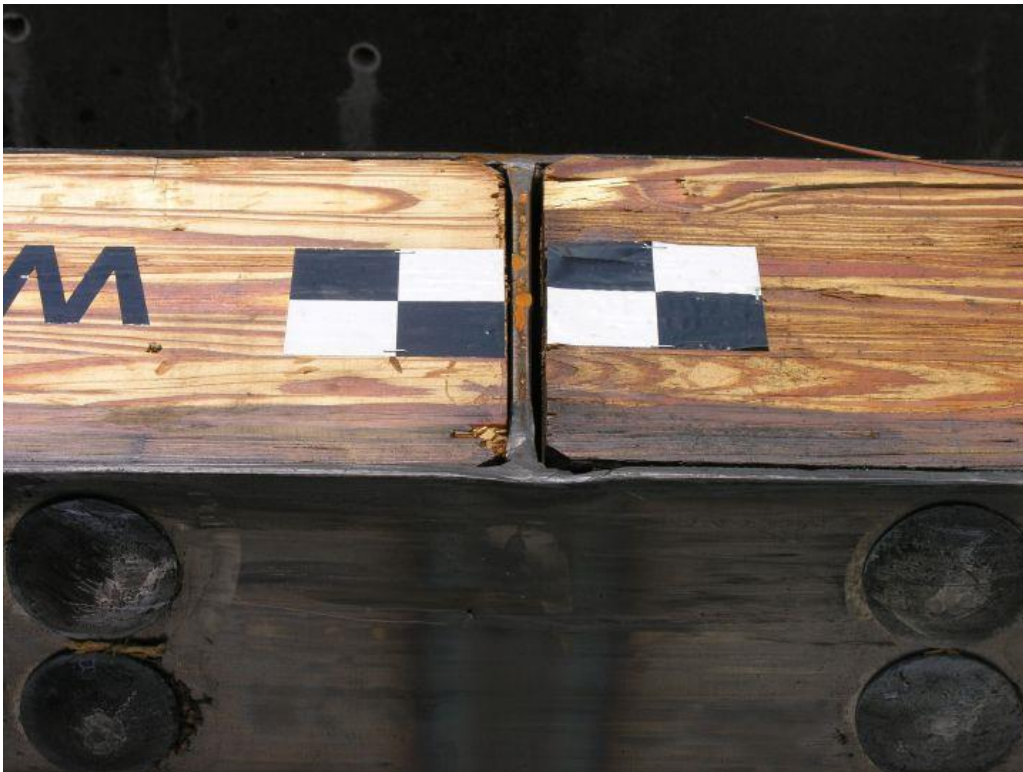
Figure 74. System Damage at Joint Between Post Nos. 4 and 5, Test No. WVBR-1

At the top of post nos. 4 and 5, several bolt heads were slightly pulled into the rail during impact. Also, a slight kink developed in the front face of the H-splice plate located between post nos. 4 and 5, as shown in Figure 74. Due to the permanent set deflection of the rail and rotation of the posts, a ⅜-in. (10-mm) gap formed between the concrete wearing surface and post no. 4 and the upstream end of post no. 5, as shown in Figure 75.

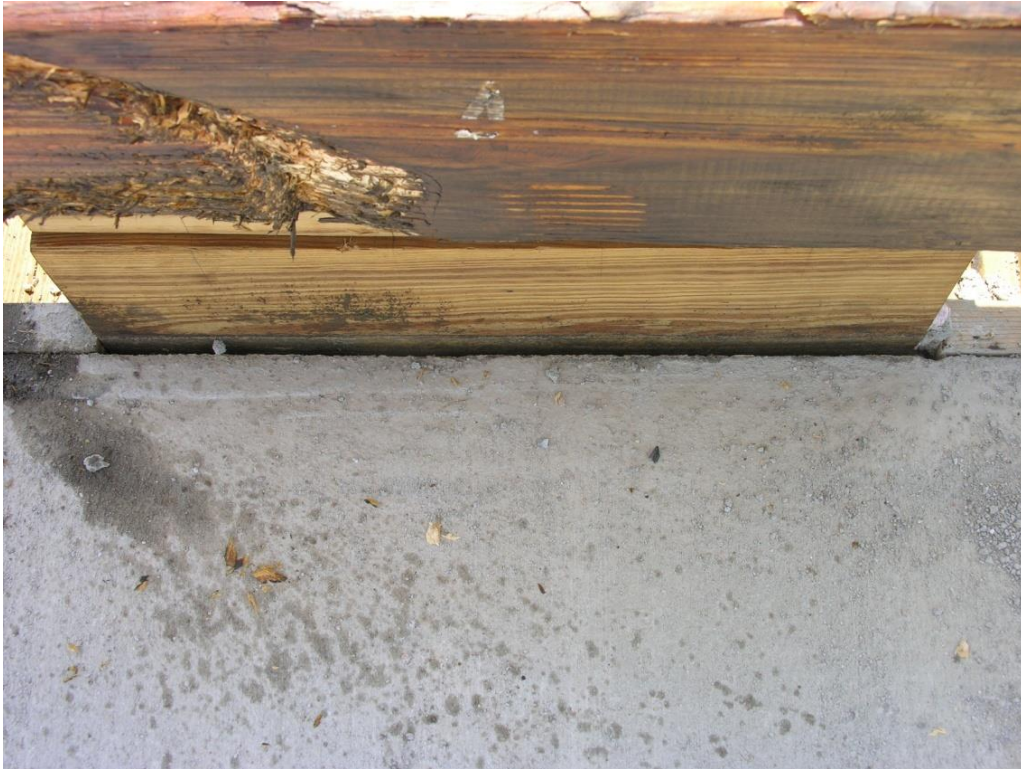
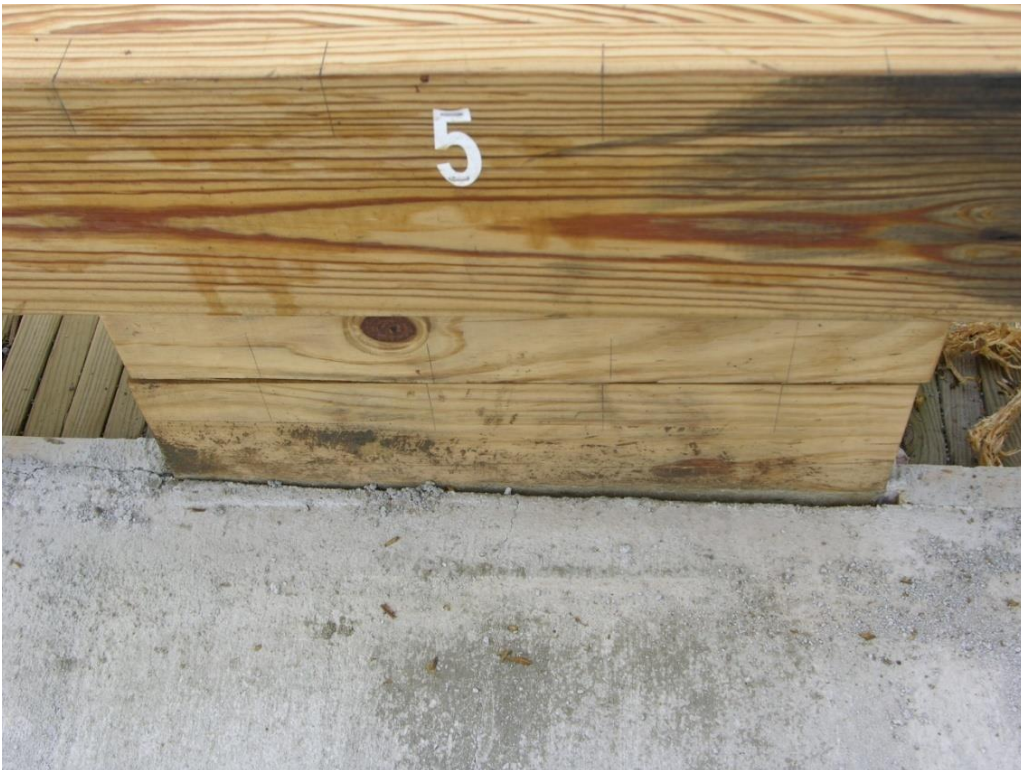
Figure 75. Concrete Gaps at Post Nos. 4 and 5, Test No. WVBR-1

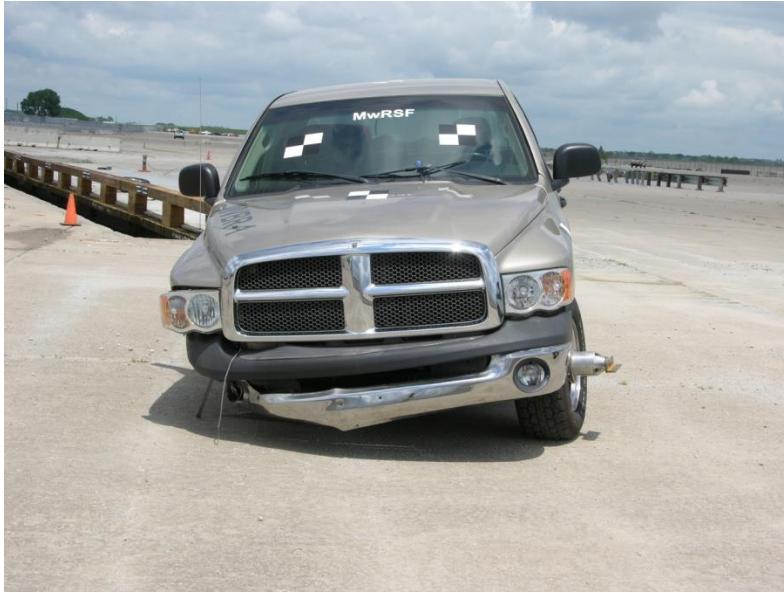
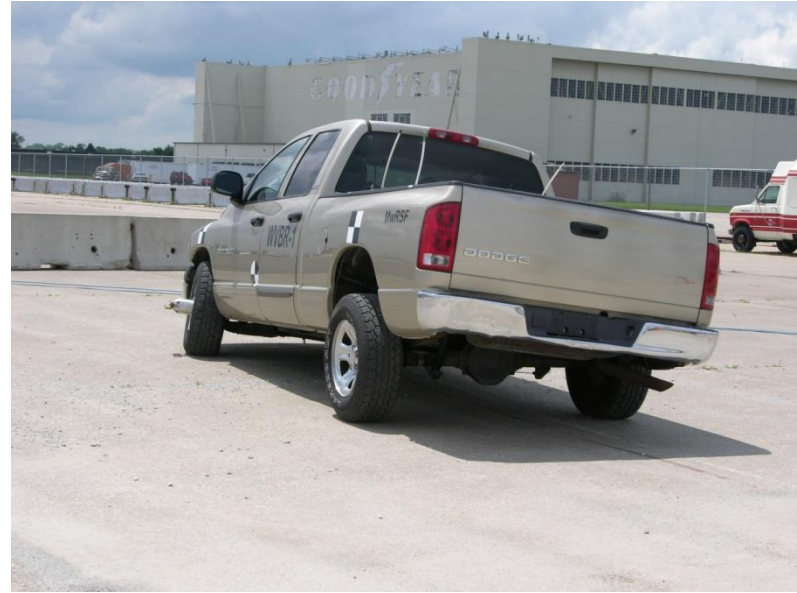
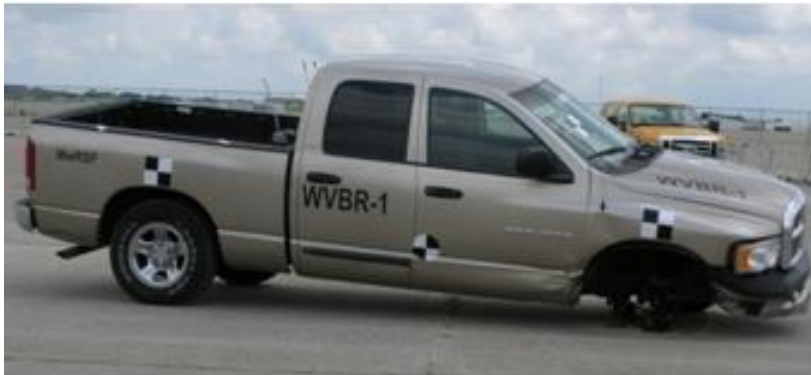
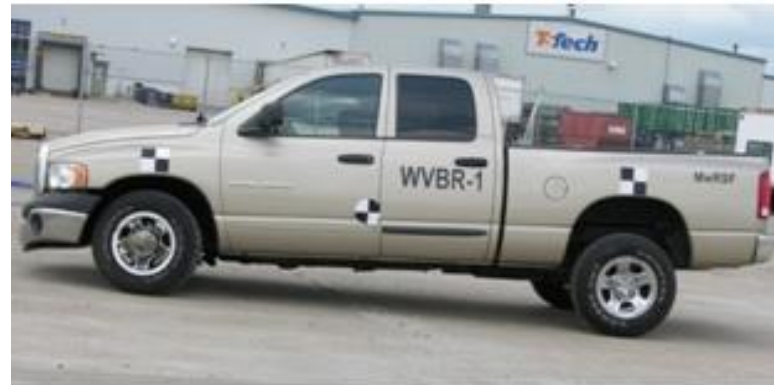
Figure 76. Vehicle Damage, Test No. WVBR-1

The damage to the vehicle was minor, as shown as shown in Figures 76 and 77. Damage was mostly concentrated to the right-front corner of the vehicle. The right-side bumper was scraped and deformed inward toward the engine compartment. The right-side headlight was loosened from its original mounting position. The right-side fog light detached and broke into several pieces. Scratches and scuffs were found on the right-rear tire and occurred due to the impact with the glulam rail, as evidenced by the wood fibers lodged between the tire and rim. Small dents were observed in the sheet metal behind the right-rear tire and the tailpipe. Scratches and denting was observed on the right-side panel, starting behind the right-front wheel and extending 18 in. (457 mm) onto the passenger-side door. The right-front tire detached from the vehicle due to the impact with the glulam rail, as evidenced by the wood fibers lodged between the tire and rim. Multiple tears were found in the sidewall of the right-front tire. The upper and lower ball joints on the right-front side of the vehicle were broken. Brake fluid was observed leaking on the right-front side of the vehicle. The plastic inner liner under the right-front wheel well moved downward 2 in. (51 mm) and broke near the lower-rear corner. The rear-view mirror was partially detached and hanging. All window glass remained undamaged.

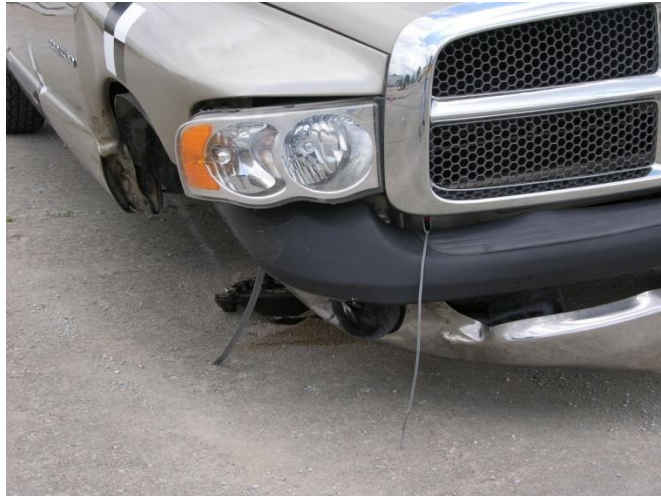
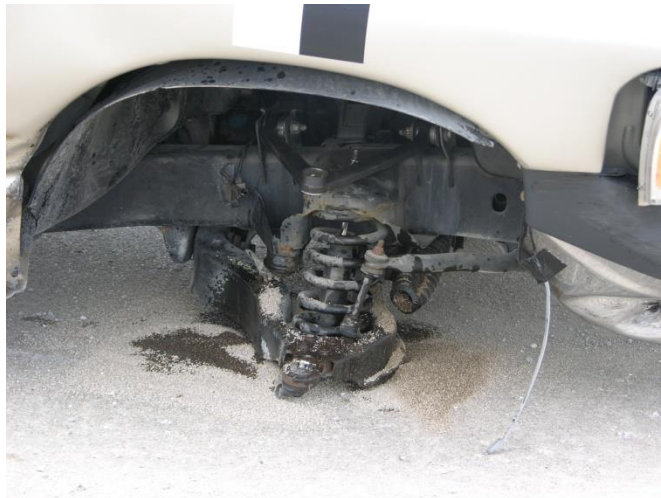
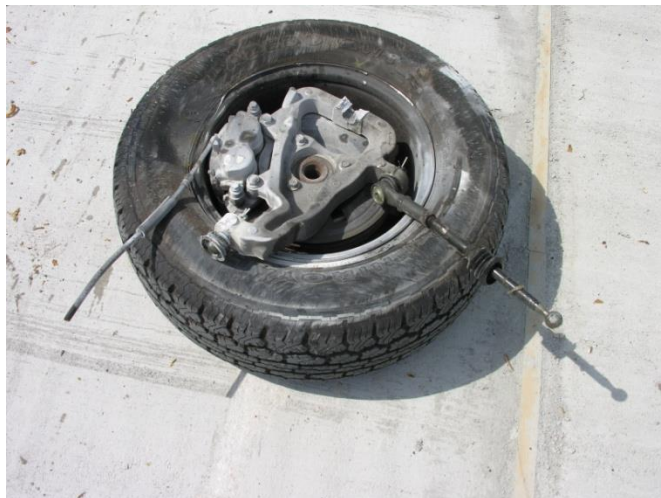
Figure 77. Vehicle Damage at Right-Front Corner, Test No. WVBR-1

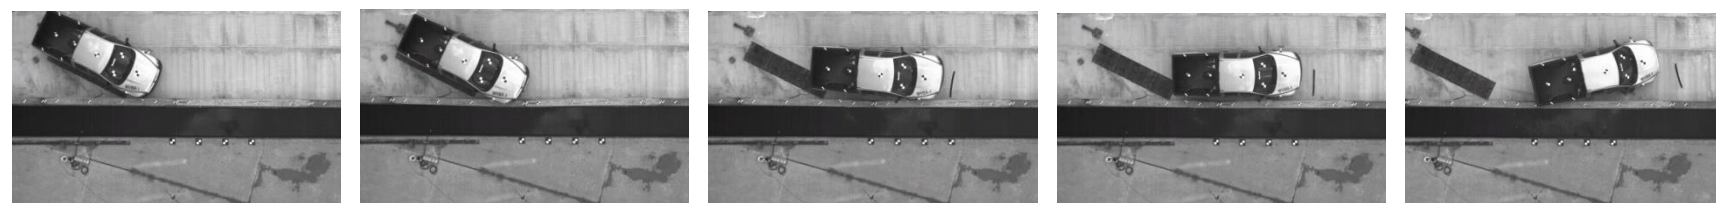
- Test Agency MwRSF
- Test Number WVBR-1
- Date 7/18/08
- MASH 08 Test Designation 1-11
- Test Article Low-Profile, Curb-Type, Timber Bridge Rail
- Total Length 47.2 m
- Scupper Post Spacing 3.05 m
- Key Component - Glulam Bridge Rail Segment
 - Length 6.1 m
 - Width 171 mm
 - Depth 314 mm
- Key Component - Scupper Block
 - Length 584 mm
 - Width 191 mm
 - Depth 241 mm
- Vehicle Model 2002 Dodge Ram 1500 Quad Cab
 - Curb 2,322 kg
 - Test Inertial 2,271 kg
 - Gross Static 2,349 kg
- Impact Conditions
 - Speed 48.6 km/h
 - Angle 26.1 deg
 - Impact Location 775 mm Upstream from Post No. 4
- Exit Conditions
 - Speed 30.7 km/h
 - Angle 12.6 deg
- Vehicle Stability Satisfactory
- Vehicle Stopping Distance 37.2 m Downstream from of Impact

- Occupant Ridedown Acceleration (DTS)
 - Longitudinal -4.74 g's < 20.49 g's
 - Lateral -3.23 g's < 20.49 g's
- Occupant Impact Velocity (DTS)
 - Longitudinal -3.34 m/s < 12.2 m/s
 - Lateral -3.96 m/s < 12.2 m/s
- Occupant Ridedown Acceleration (EDR-3)
 - Longitudinal -5.33 g's < 20.49 g's
 - Lateral -2.69 g's < 20.49 g's
- Occupant Impact Velocity (EDR-3)
 - Longitudinal -3.60 m/s < 12.2 m/s
 - Lateral -3.84 m/s < 12.2 m/s
- Maximum Roll Angle 8.7 degrees
- THIV 4.79 m/s < 12.2 m/s
- PHD 5.25 g's < 20 g's
- Vehicle Damage Minimal
 - TAD¹¹ 1-RFQ-3
 - SAE¹² 01-RFLW1
 - Maximum Deformation 32 mm Near Front Floor Pan
- Test Article Damage Minimal
- Maximum Rail Deflections
 - Permanent Set 61 mm
 - Dynamic 155 mm
- Working Width 315 mm

Figure B-1. Summary of Test Results and Sequential Photographs (SI), Test No. WVBR-1

- Test Agency MwRSF
- Test Number WVBR-1
- Date 7/18/08
- MASH-08 Test Designation..... 1-11
- Test Article Low-Profile, Curb-Type, Timber Bridge Rail
- Total Length 155 ft
- Scupper Block or Post Spacing 10 ft
- Key Component - Glulam Bridge Rail Segment
 - Length 20 ft
 - Width 6 ¾ in.
 - Depth 12 ⅜ in.
- Key Component - Scupper Block
 - Length 23 in.
 - Width 7 ½ in.
 - Depth 9 ½ in.
- Vehicle Model..... 2002 Dodge Ram 1500 Quad Cab
 - Curb..... 5,119 lbs
 - Test Inertial 5,007 lbs
 - Gross Static 5,179 lbs
- Impact Conditions
 - Speed 30.8 mph
 - Angle 26.1 deg
 - Impact Location..... 30 ½ in. Upstream from Post No. 4
- Exit Conditions
 - Speed 19.1 mph
 - Angle 12.6 deg
- Vehicle Stability..... Satisfactory
- Vehicle Stopping Distance 120 ft Downstream from Impact

- Occupant Ridedown Acceleration (DTS)
 - Longitudinal-4.74 g's < 20.49 g's
 - Lateral-3.23 g's < 20.49 g's
- Occupant Impact Velocity (DTS)
 - Longitudinal -10.95 ft/s < 40.0 ft/s
 - Lateral -13.00 ft/s < 40.0 ft/s
- Occupant Ridedown Acceleration (EDR-3)
 - Longitudinal-5.33 g's < 20.49 g's
 - Lateral-2.69 g's < 20.49 g's
- Occupant Impact Velocity (EDR-3)
 - Longitudinal -11.81 ft/s < 40.0 ft/s
 - Lateral -12.61 ft/s < 40.0 ft/s
- Maximum Roll Angle8.7 degrees
- THIV15.72 ft/s < 39.4 ft/s
- PHD 5.25 g's < 20 g's
- Vehicle Damage Minimal
 - TAD¹¹ 1-RFQ-3
 - SAE¹² 01-RFLW1
 - Maximum Deformation..... 1 ¼ in. Near Front Floor Pan
- Test Article Damage Minimal
- Maximum Rail Deflections
 - Permanent Set2.4 in.
 - Dynamic6.1 in.
- Working Width 12.4 in.
