HSA-10/ B105

In response to your e-mail request last May, please be advised that the Nebraska Bridge Approach Section described in the Texas Transportation Institute's report entitled "NCHRP Report 350 Test 3-21 of the Nebraska Thrie-Beam Transition" may be considered a test level 3 (TL-3) transition design and used on the National Highway System when such use is acceptable to the contracting agency.

#### **Test Conditions**

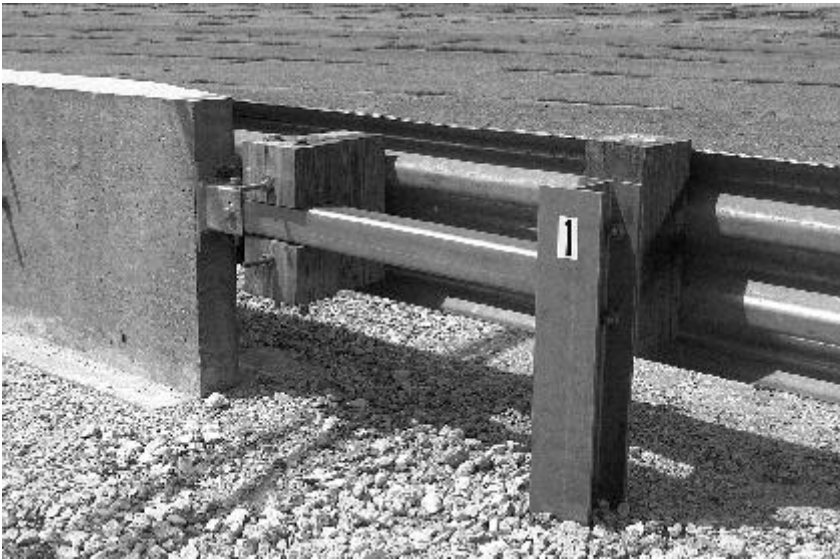
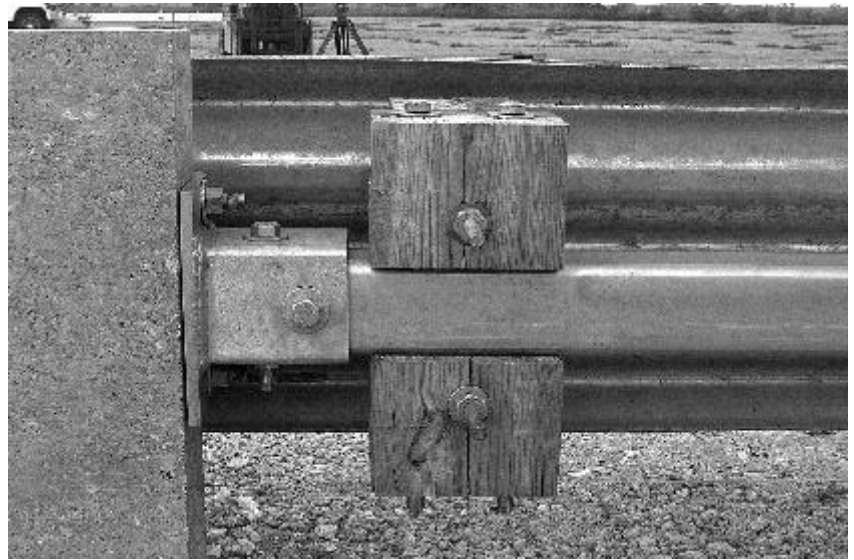
Figure 43. Nebraska thrie beam transition prior to test 404211-7.

Wood blockouts were used at posts 1 through 13. Wood blockouts were not required for posts 14 and 15. For posts 1 through 4, 150-mm × 200-mm × 457-mm long wood blocks were used between the guardrail and posts. At posts 5 and 6, 150-mm × 200-mm × 356-mm long wood blockouts were used between the guardrail and posts. For posts 7 through 9, 150-mm × 200-mm × 356-mm routed wood blockouts were used between the guardrail and posts. Posts 1–4 used two 16-mm-diameter by 255-mm-long guardrail bolts and nuts to secure the guardrail and blockout to each post. In addition, posts 5–9 used one 16-mm-diameter by 255-mm-long guardrail bolt and nut to secure the guardrail and blockout to each post. Longer 16-mm-diameter bolts (460 mm) were used for the wood posts in the LET end anchorage system. All posts were embedded in compacted *NCHRP Report 350* standard soil with the moisture content within 4% +/- of optimum moisture content of the material. Additional detail drawings are shown on pages 2 and 3 of figure 42. Photographs of the completed test installation are shown in figure 43.

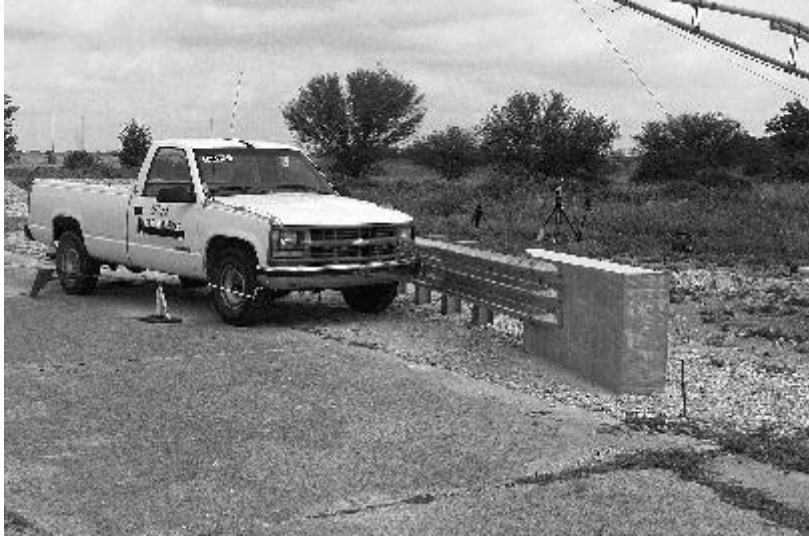
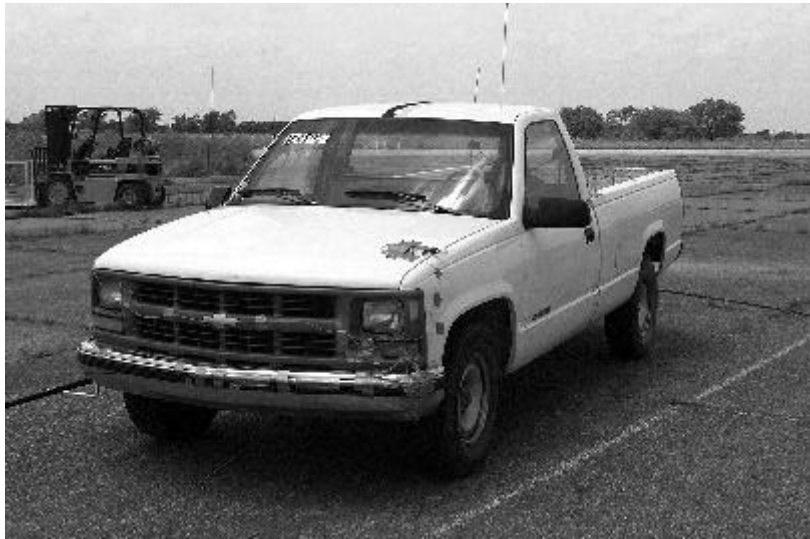
Figure 44. Vehicle before test 404211-7.

A 1995 Chevrolet 2500 pickup truck, shown in figure 44, was used for the crash test. Test inertia weight of the vehicle was 2000 kg, and its gross static weight was 2075 kg. The height to the lower edge of the vehicle front bumper was 370 mm and to the upper edge of the front bumper was 590 mm. Additional dimensions and information on the vehicle are given in appendix B, figure 86.

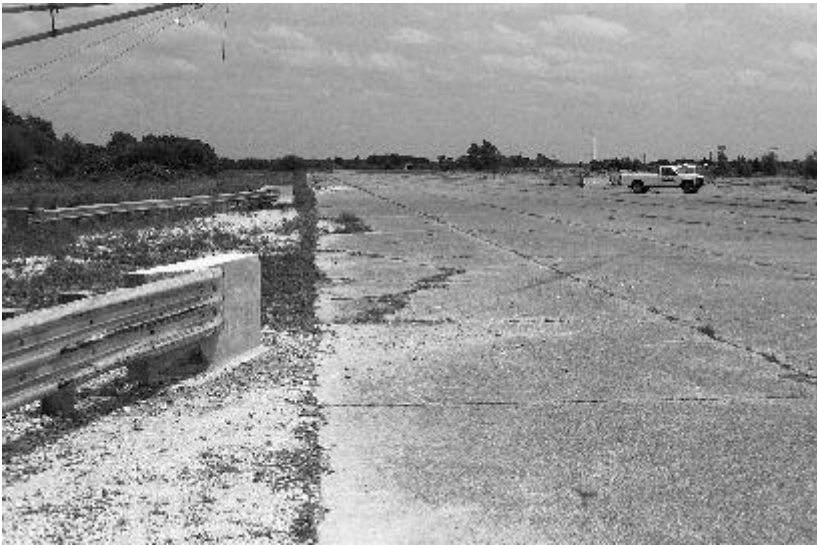
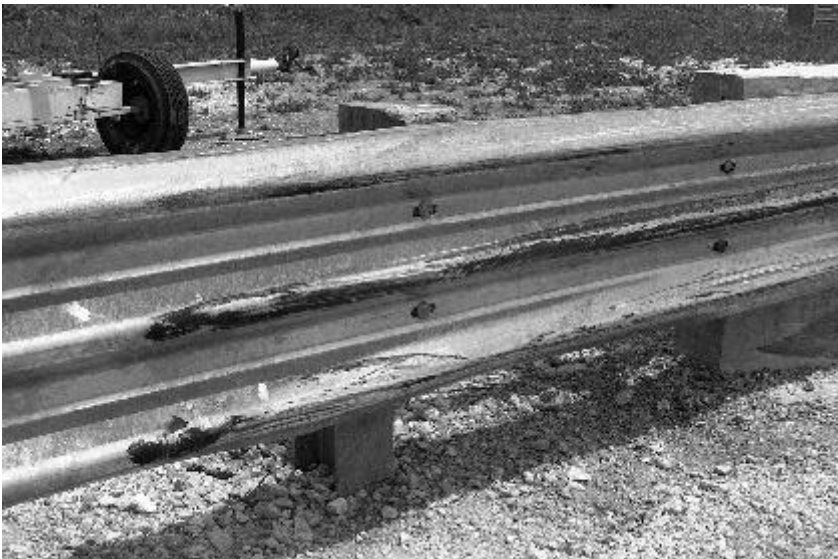
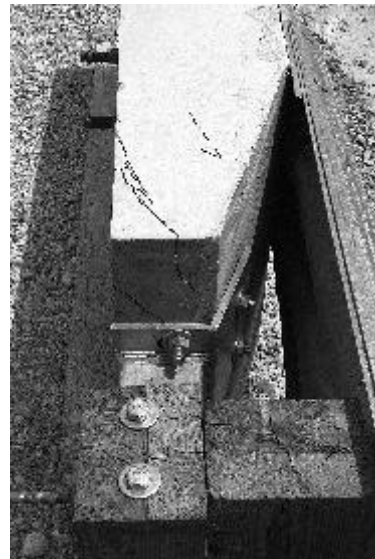
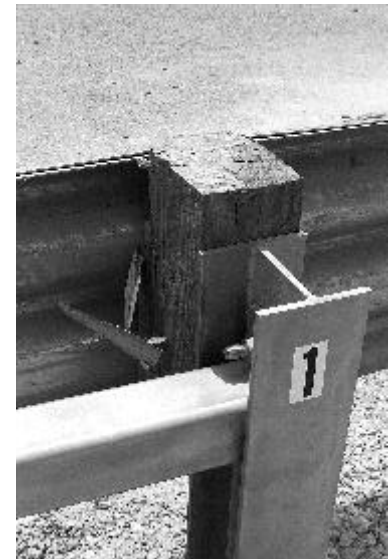
Figure 45. Installation after test 404211-7.

The Nebraska thrie beam transition sustained minimal damage as shown in figure 45. No movement was noted in the end terminal. Posts 4 and 5 were disturbed, post 3 moved rearward 4 mm, and post 2 was pushed rearward 20 mm. The corner of the blockout at post 1 was missing and the post was pushed back 15 mm. The pipe spacer between the parapet and rail element was crushed 25 mm and the parapet base was disturbed 2 mm. Tire marks were on the flare of the parapet and cracks in the end of the parapet radiated from the bolts connecting the thrie beam. Length of contact of the vehicle with the transition was 3.07 m. Maximum dynamic deflection of the rail element during the test was 82 mm and maximum permanent deformation was 24 mm, both occurring at post 2.

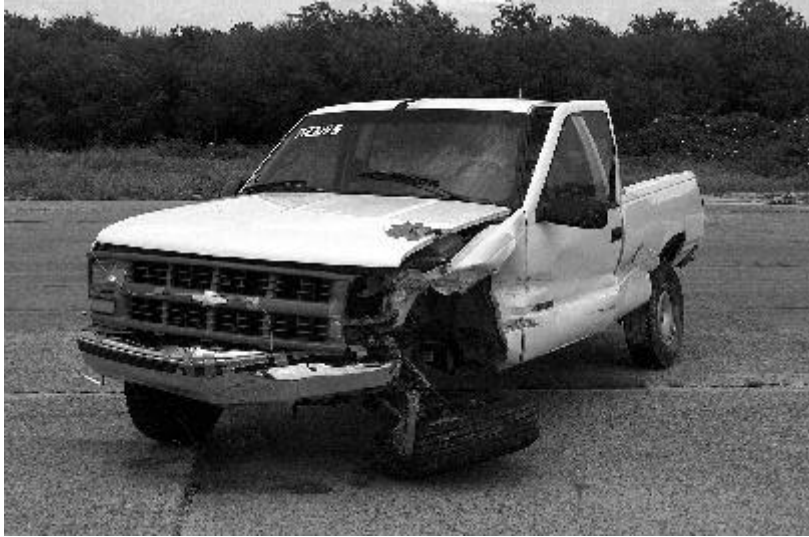
Figure 46. Vehicle after test 404211-7.

Moderate damage was imparted to the 2000P vehicle as shown in figure 46. The following vehicle components received structural damage: the frame at the left front, steering arm, stabilizer bar, left side rod ends, left upper and lower A-arms, and left front spindle, rotor and tire. Also damaged were the front bumper, fan, radiator, left front quarter-panel, left door, left side of the bed, and the left rear rim. The floor pan and firewall were deformed and the seam where the floor pan and firewall connect were separated. Maximum exterior crush to the left front corner was 400 mm. Maximum interior deformation was 129 mm at the left side floor pan area. Exterior vehicle crush and occupant compartment measurements are shown in appendix B, tables 39 and 40.
