## SKID-MOUNTED SUPPORT SYSTEM FOR TEMPORARY GUIDE SIGNS

**Test Report No. 0-6782-2**

TEXAS A&M TRANSPORTATION INSTITUTE  
COLLEGE STATION, TEXAS

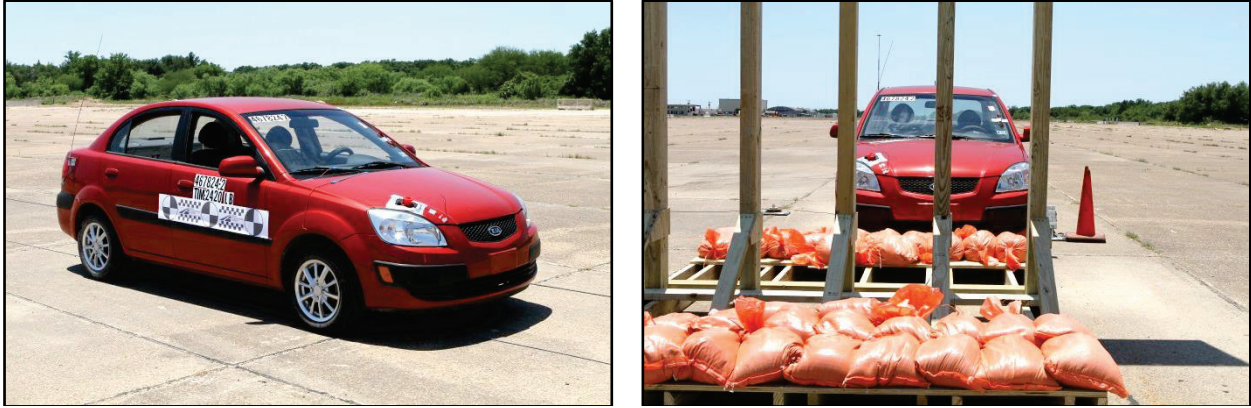
**Figure 4.7. Vehicle before Test No. 467824-2.**

A 2008 Kia Rio, shown in Figure 4.7, was used for the crash test. The test inertia weight of the vehicle was 2425 lb, and the gross static weight was 2590 lb. The height to the lower edge of the vehicle bumper was 8.75 inches, and the height to the upper edge of the bumper was 21.0 inches. Table D1 in Appendix D gives additional dimensions and information on the vehicle. The vehicle was directed into the installation using a cable reverse tow and guidance system, and was released to be freewheeling and unrestrained just prior to impact.

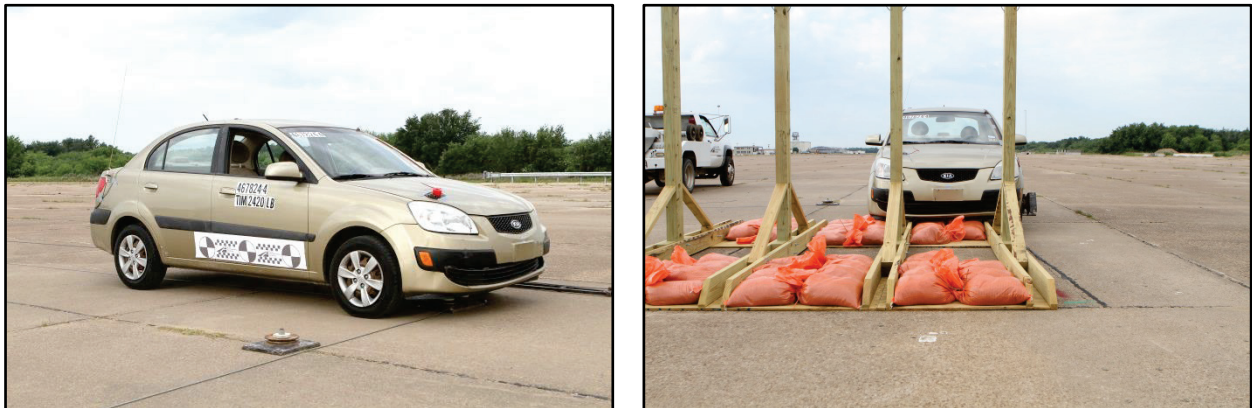
Figure 4.12. Vehicle before Test No. 467824-4.

A 2008 Kia Rio, shown in Figure 4.12, was used for the crash test. The test inertia weight of the vehicle was 2440 lb, and the gross static weight was 2605 lb. The height to the lower edge of the vehicle bumper was 8.0 inches, and the height to the upper edge of the bumper was 21.0 inches. Table G1 in Appendix G gives additional dimensions and information on the vehicle. The vehicle was directed into the installation using a cable reverse tow and guidance system, and was released to be freewheeling and unrestrained just prior to impact.

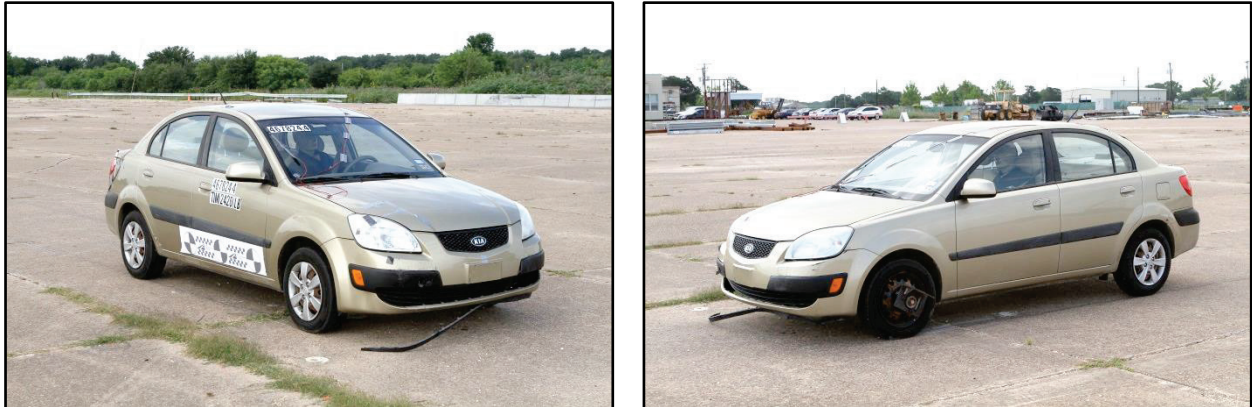
Figure 4.14. Vehicle after Test No. 467824-4.

Figure 4.14 shows the damage that the vehicle sustained during the test, which included only cosmetic damage in the form of scratches to the front bumper. No measureable exterior crush to the vehicle was noted. No occupant compartment deformation occurred. Tables G2 and G3 in Appendix G give exterior crush and occupant compartment measurements.

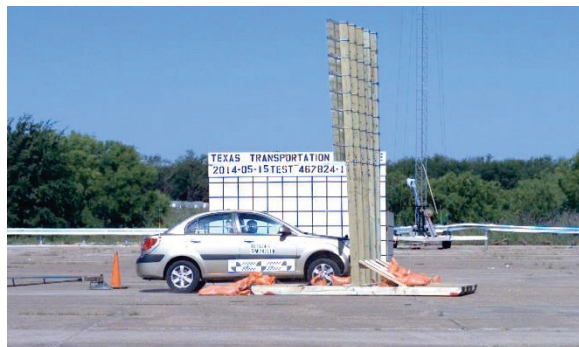
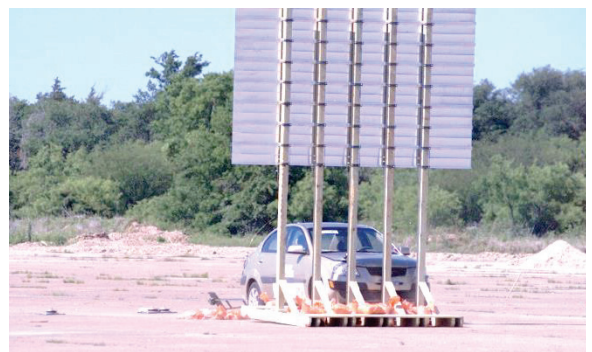
**Figure C1. Sequential Photographs for Test No. 467824-1 (Perpendicular and Oblique Views).**

**Figure C1. Sequential Photographs for Test No. 467824-1 (Perpendicular and Oblique Views) (Continued).**

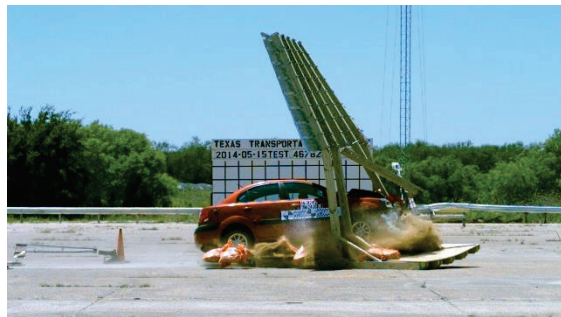
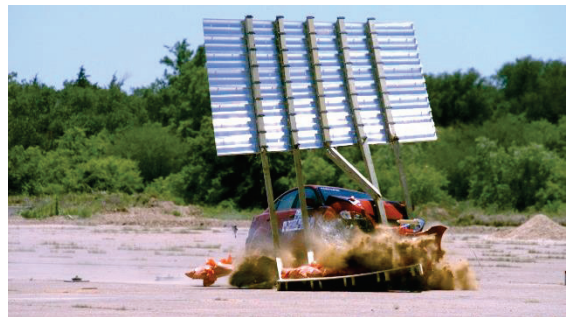
**Figure D1. Sequential Photographs for Test No. 467824-2 (Perpendicular and Oblique Views).**

0.000 s

0.065 s

0.130 s

0.195 s

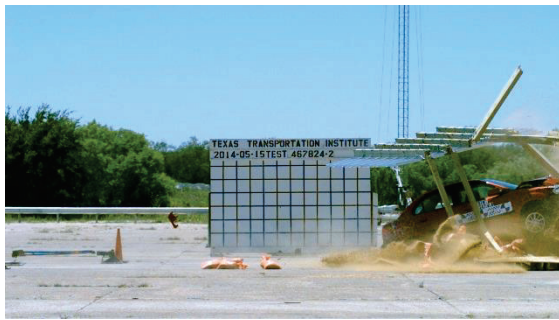
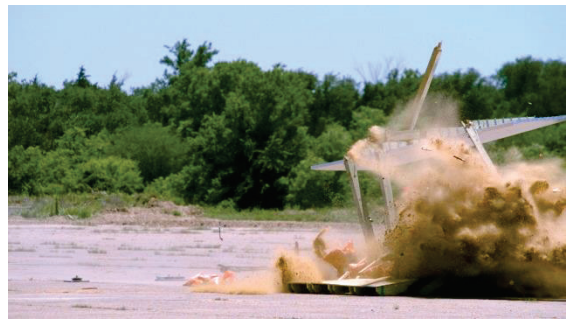
**Figure D1. Sequential Photographs for Test No. 467824-2 (Perpendicular and Oblique Views) (Continued).**

0.259s

0.324 s

0.389 s

0.454 s

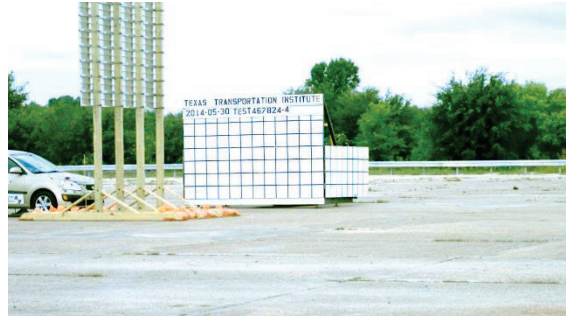
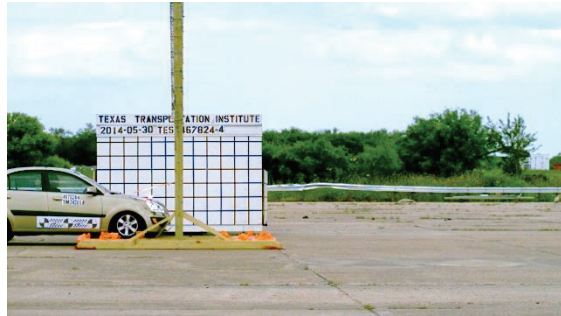
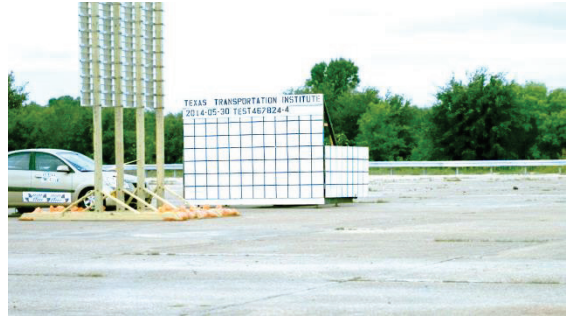
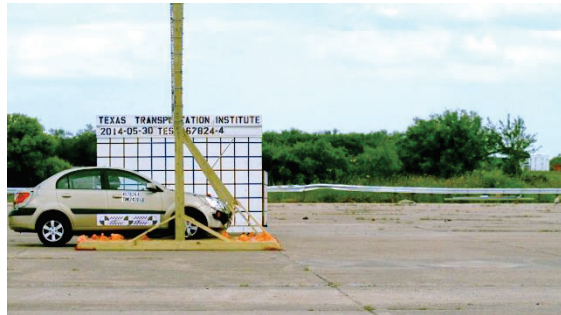
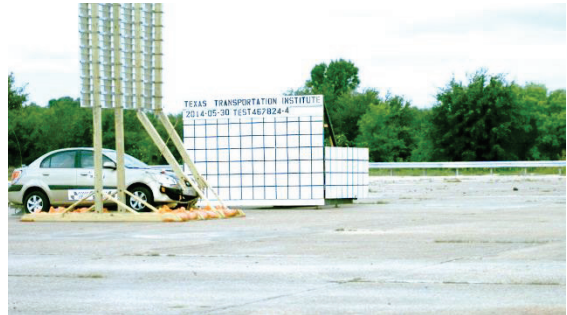
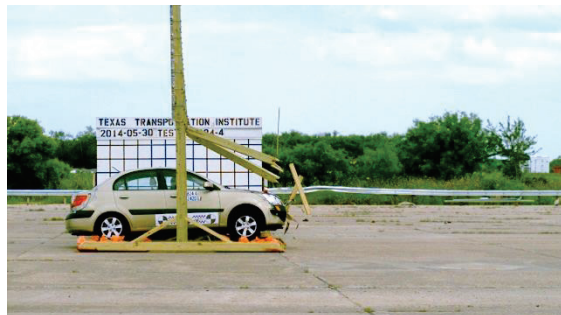
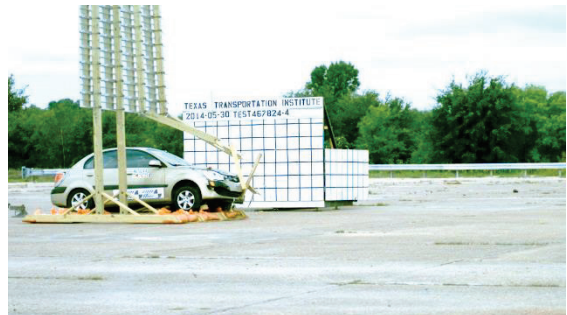
**Figure G1. Sequential Photographs for Test No. 467824-4 (Perpendicular and Oblique Views).**

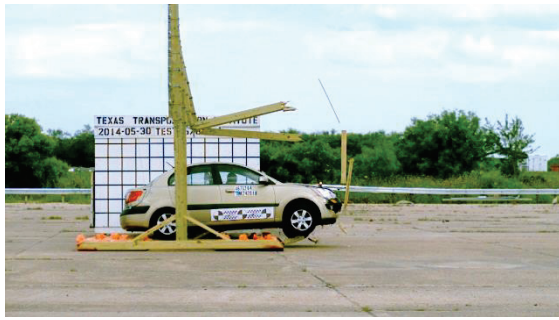
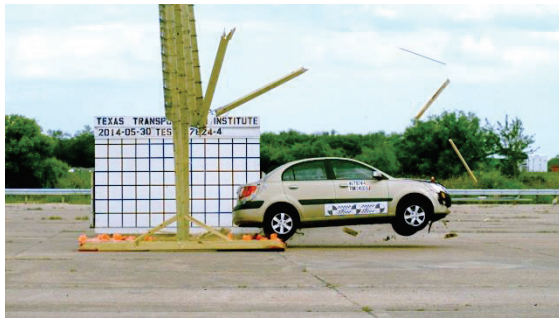
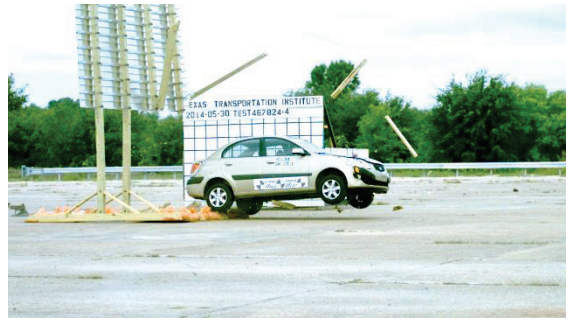
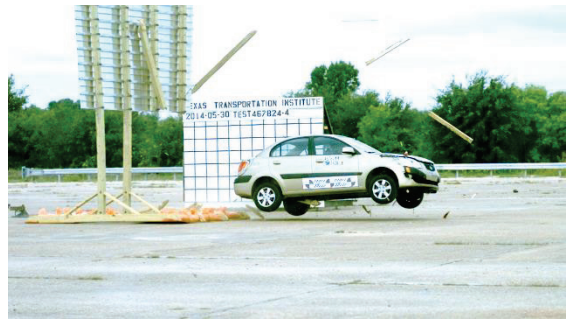
**Figure G1. Sequential Photographs for Test No. 467824-4 (Perpendicular and Oblique Views) (Continued).**

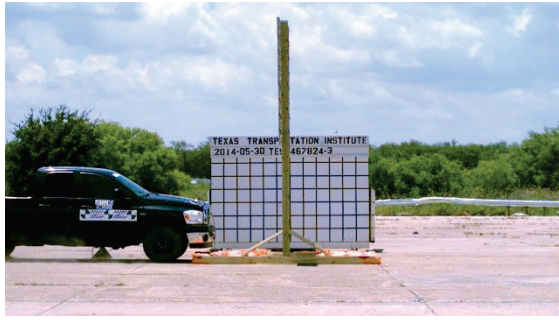
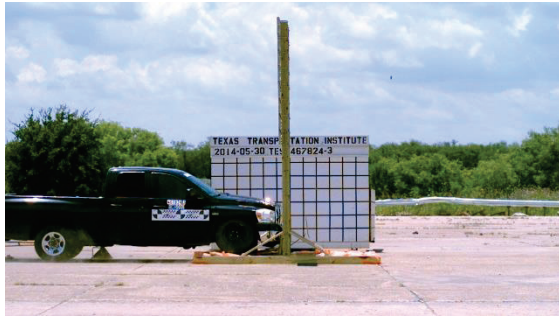
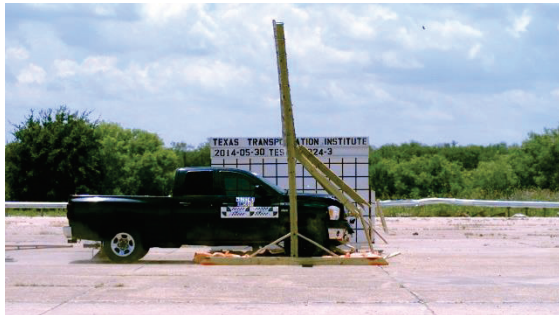
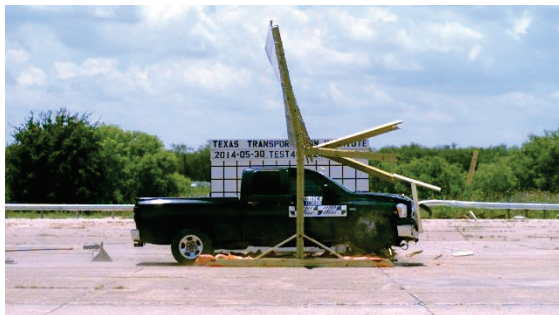
**Figure H1. Sequential Photographs for Test No. 467824-3 (Perpendicular and Oblique Views).**
