*Midwest States' Regional Pooled Fund Research Program  
Fiscal Year 2002-2003 (Year 13)  
Research Project Number SPR-3(017)  
NDOR Sponsoring Agency Code RFPF-03-03*

## **EVALUATION OF RIGID HAZARDS PLACED IN THE ZONE OF INTRUSION**

### **MIDWEST ROADSIDE SAFETY FACILITY**

MwRSF Research Report No. TRP-03-151-08

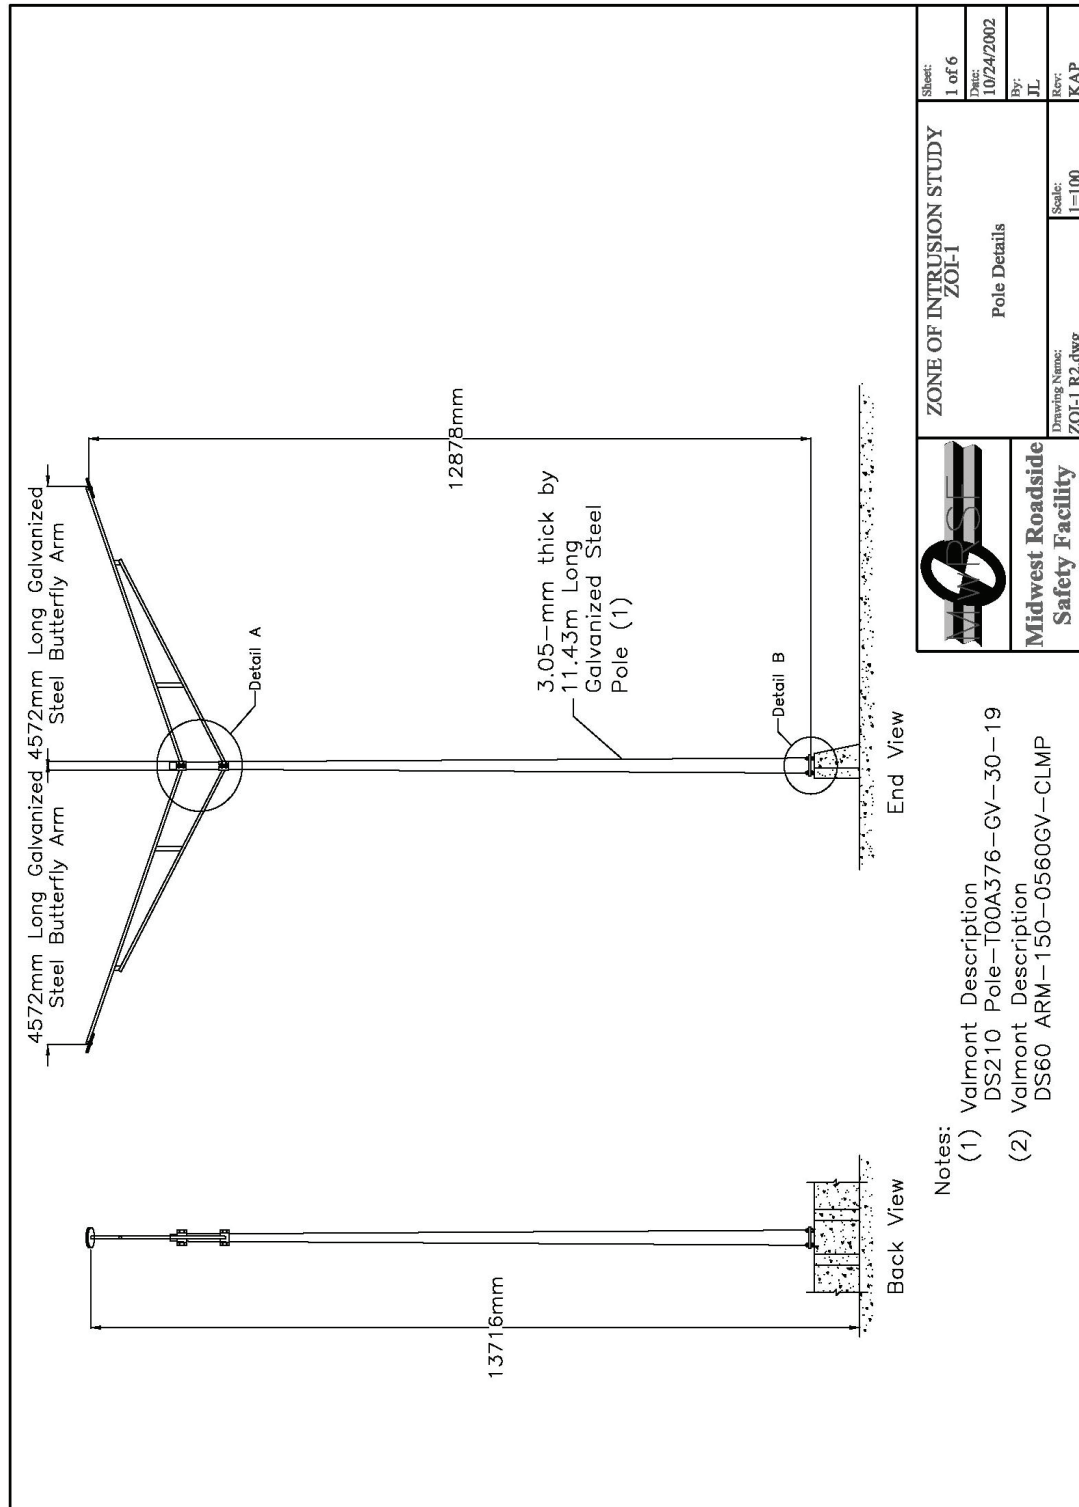
Figure 1. Pole Details, Test Nos. ZOI-1 and ZOI-2

The test installation consisted of a luminaire pole attached to the top of a 36.58-m (120-ft) long, standard single-slope concrete barrier. Design details are shown in Figures 1 through 6. The corresponding English-unit drawings are shown in Appendix C. Photographs of the barrier and luminaire pole installation are shown in Figures 7 through 10.

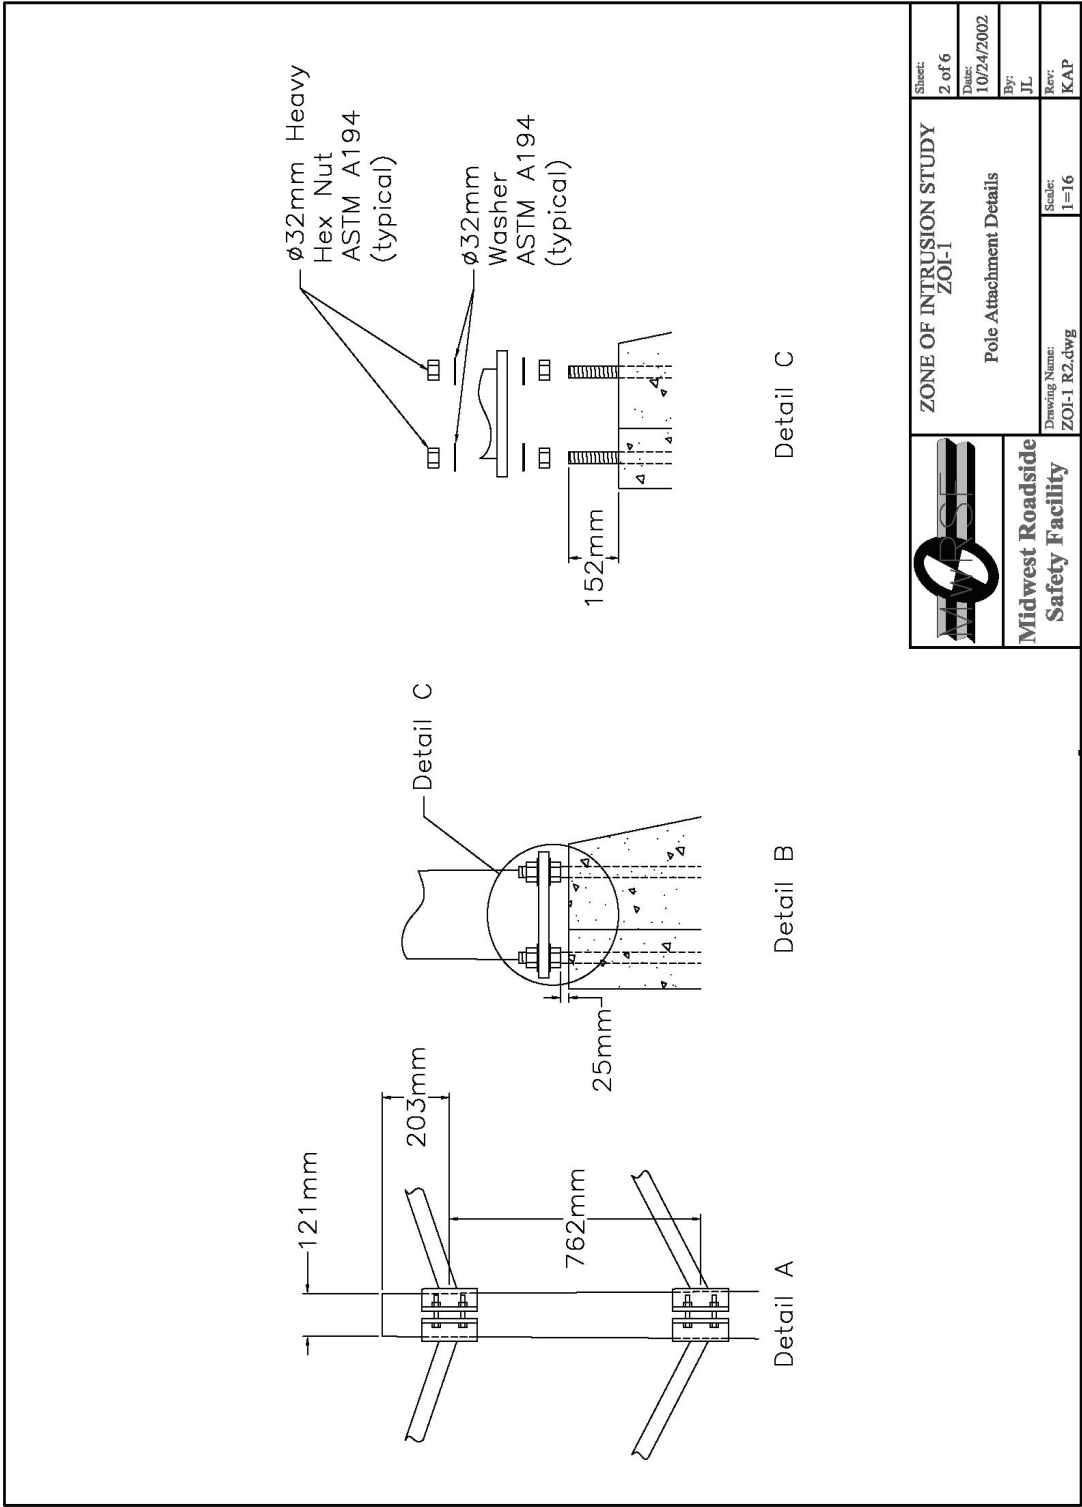
Figure 2. Pole Attachment Details, Test Nos. ZOI-1 and ZOI-2

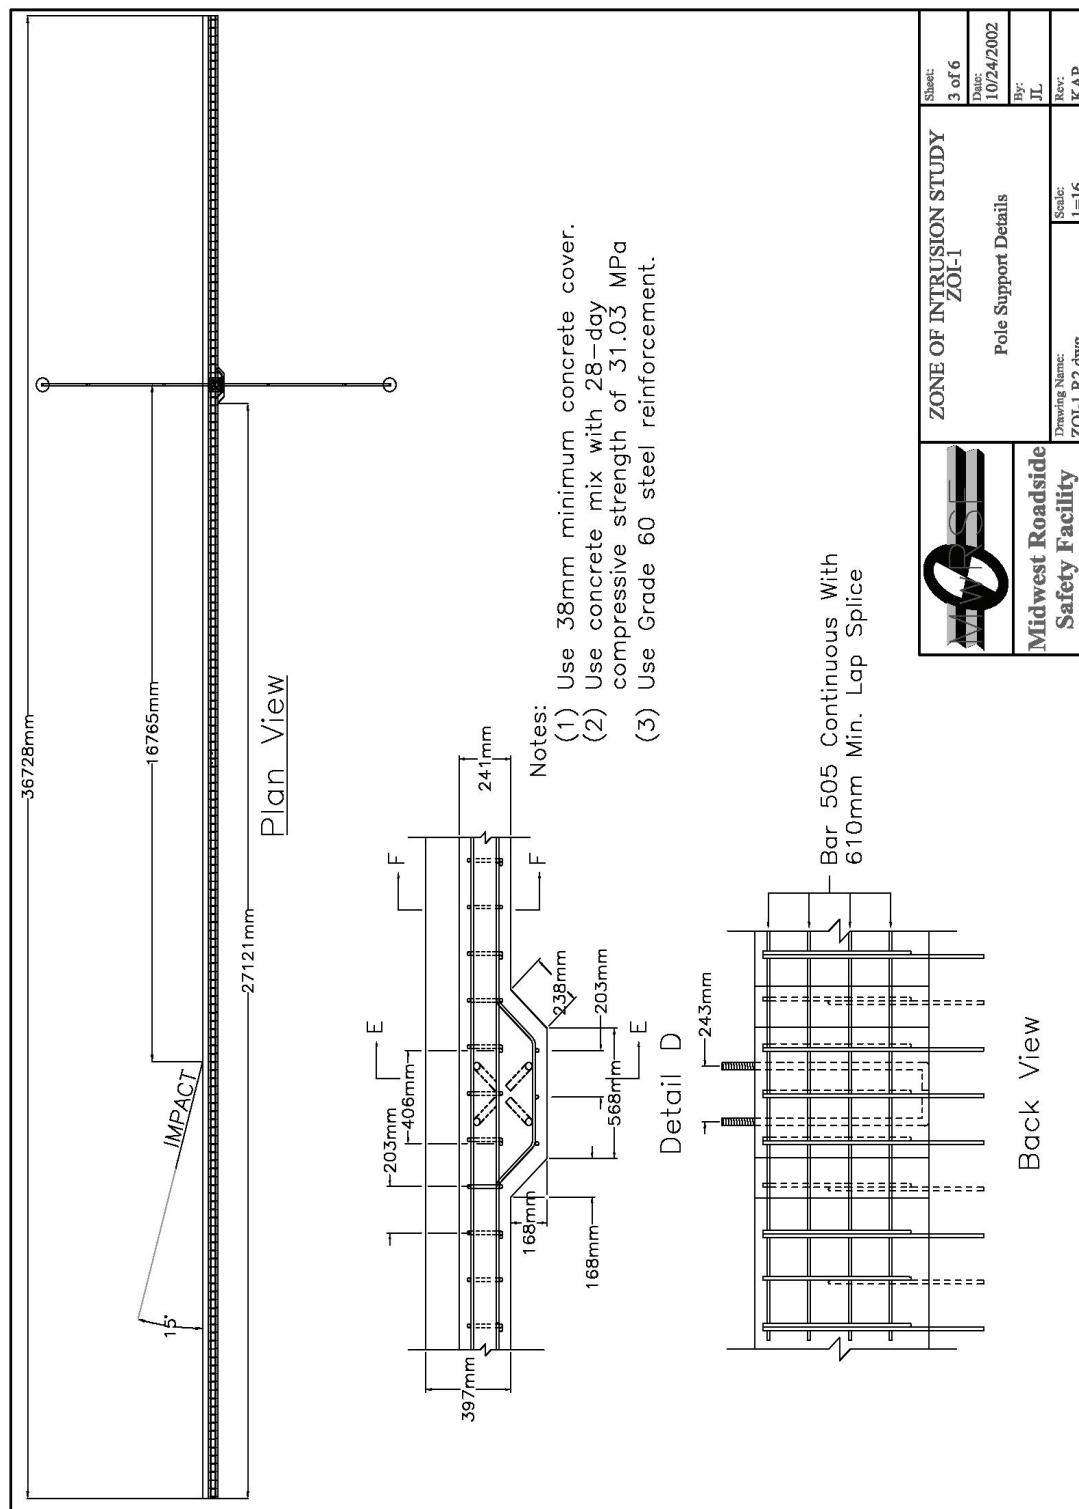
Figure 3. Pole Support Details, Test Nos. ZOI-1 and ZOI-2

The concrete used for the barrier consisted of Nebraska 47-BD Mix Type 3, with a minimum 28-day concrete compressive strength of 31.03 MPa (4,500 psi). The 46-day concrete compressive strength for the barrier, as determined from concrete cylinder testing, was found to be approximately 46.93 MPa. (6,807 psi). A minimum concrete cover of 38 mm (1.5 in.) was used along the entire barrier. All the steel reinforcement in the barrier was ASTM Grade 60 rebar. The barrier reinforcement details are shown in Figures 3 through 5.

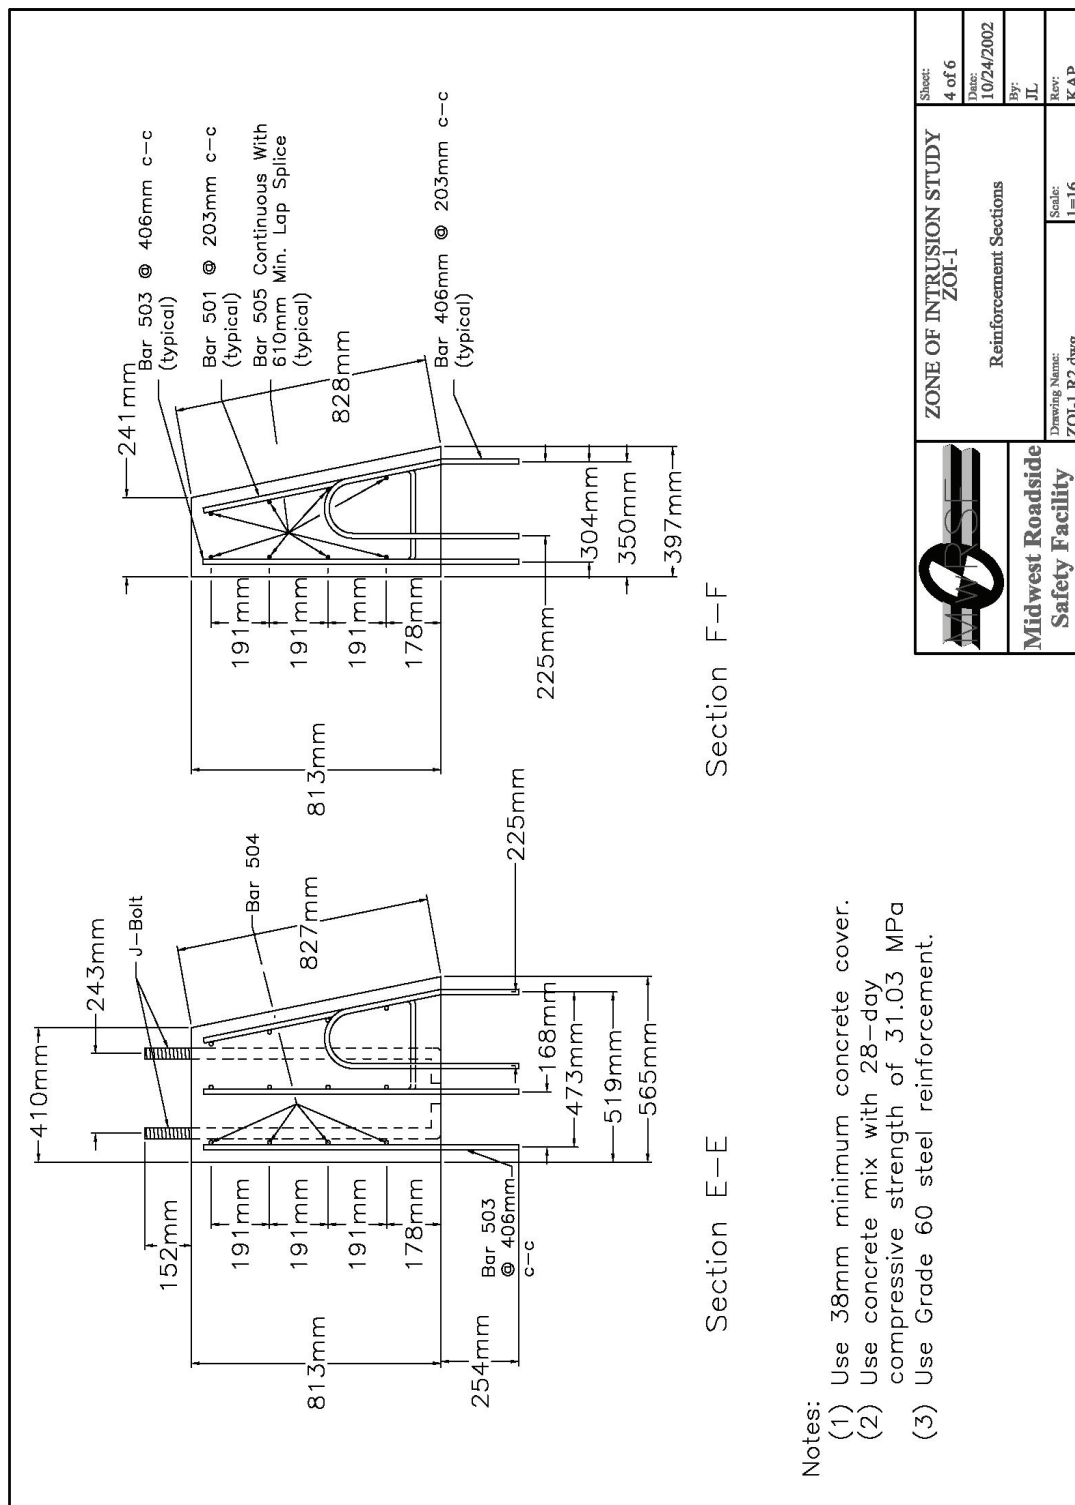
Figure 4. Reinforcement Sections, Test Nos. ZOI-1 and ZOI-2

Barrier reinforcement consisted of No. 5 bars. Each of the eight longitudinal rebar measured 36.50 m (119 ft - 9 in.) long with minimum 610-mm (24-in.) long laps along each bar. The vertical spacings of the lower, lower middle, upper middle, and upper longitudinal bars were 178 mm (7 in.), 368 mm (14.5 in.), 559 mm (22 in.), and 749 mm (29.5 in.) from the ground to their centers, respectively. The vertical stirrups measured 1,676 mm (66 in.) and were bent into a U-shape. Their longitudinal spacings were 203 mm (8 in.) on center, as shown in Figure 3. The barrier-to-tarmac attachment utilized straight bars and angled bars, which were bent into the shape of the front face of the barrier, as shown in Figures 3 through 5. The straight bars utilized on the back face were 1,029 mm (40.5 in.) long, while the angled bars utilized on the front face were 1,346 mm (53 in.) long. The longitudinal spacings of the straight and angled bars were 406 mm (18 in.) and 203 mm (8 in.) on center, respectively, as shown in Figures 3 and 4. The barrier-to-tarmac attachment bars were epoxied into the concrete to an embedment depth of 254 mm (10 in.), as shown in Figure 4. The epoxy consisted of FastSet's Formula Power-Fast's high strength epoxy anchorage system.

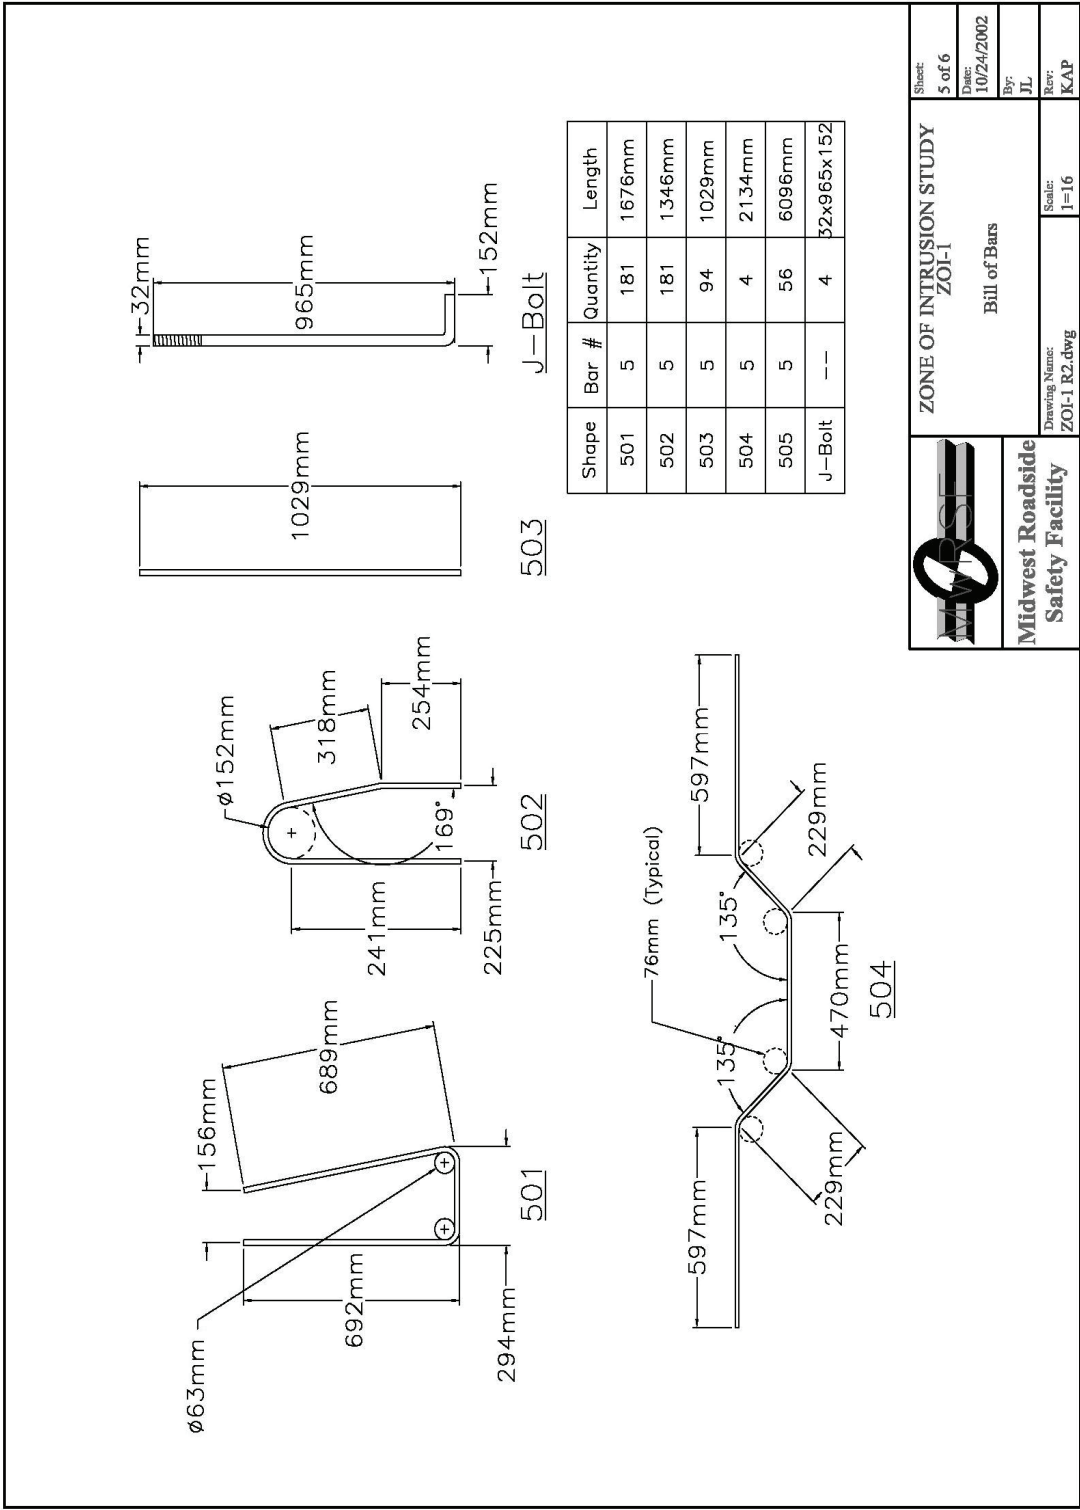
Figure 5. Bill of Bars, Test Nos. ZOI-1 and ZOI-2

For the concrete pedestal, the barrier reinforcement consisted of No. 5 bars. The four longitudinal bars, bent into the shape of the pedestal, were 2,134 mm (84 in.) long, as shown in Figure 5. The vertical spacings of these bars were 178 mm (7 in.), 368 mm (14.5 in.), 559 mm (22

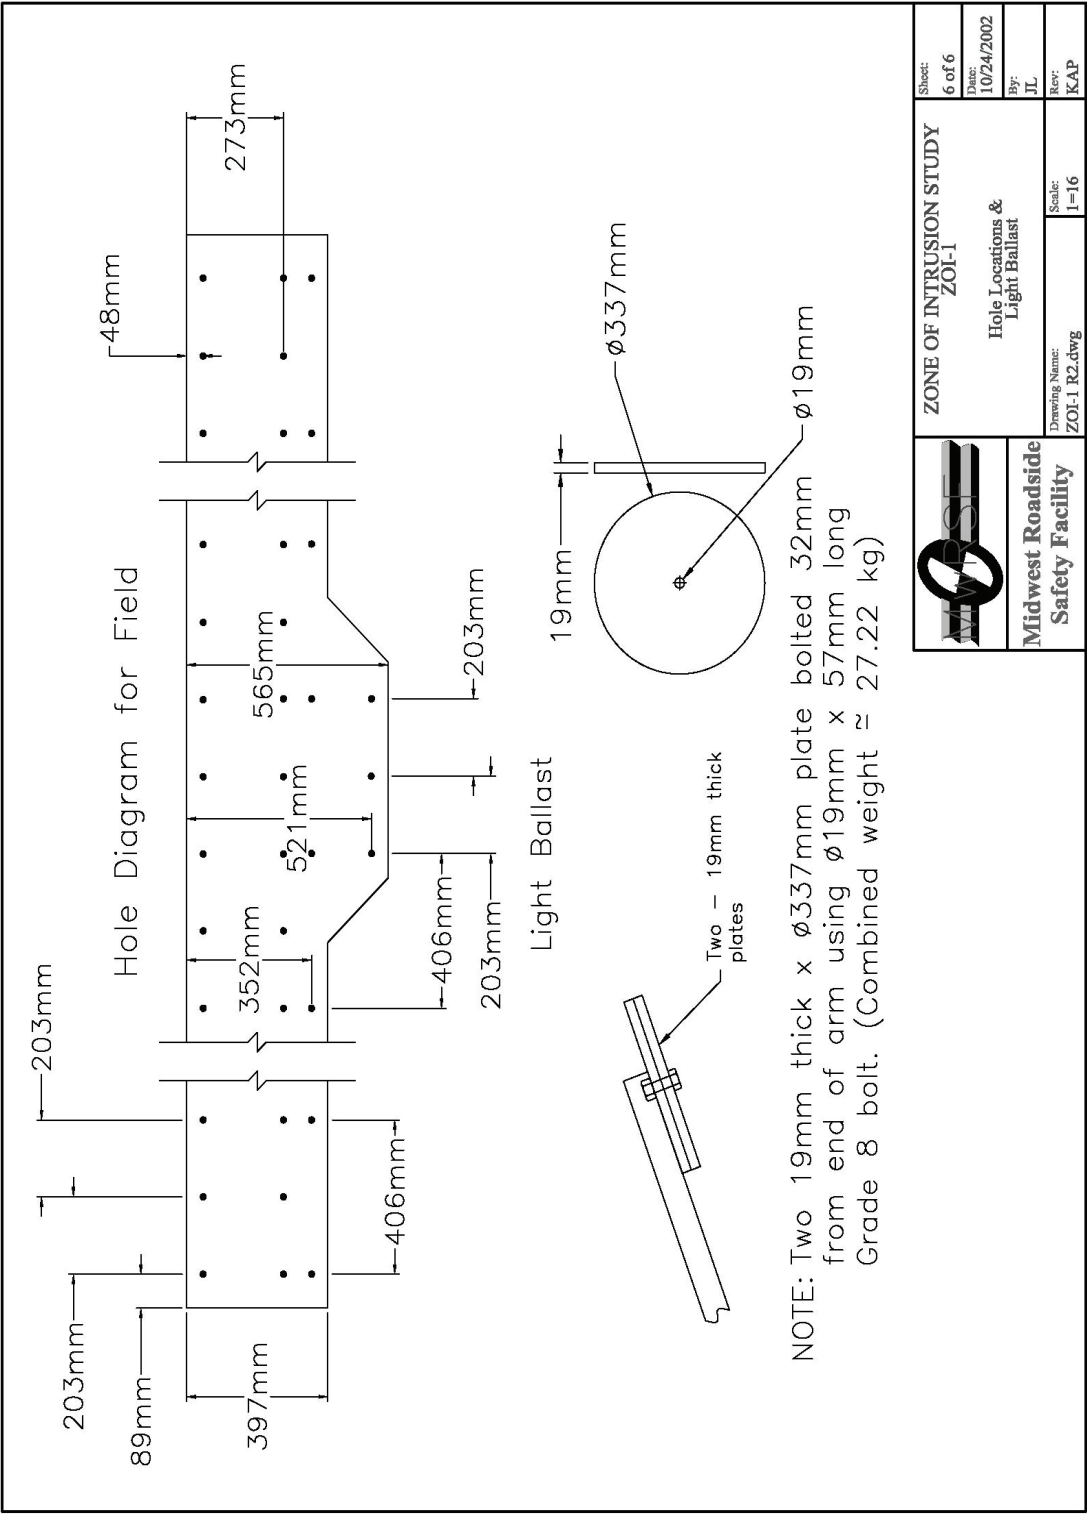
Figure 6. Hole Locations and Light Ballast, Test No. ZOI-1 and ZOI-2

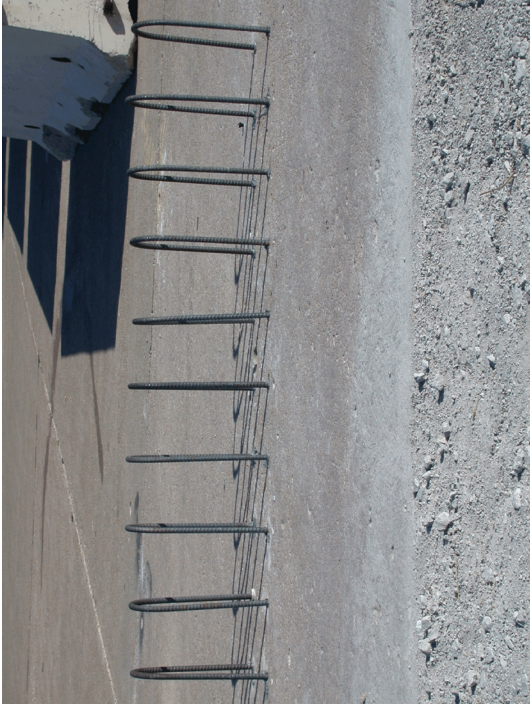
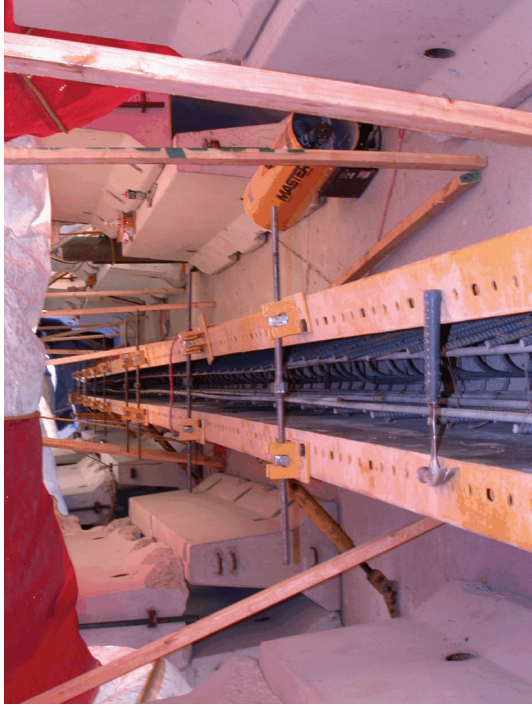
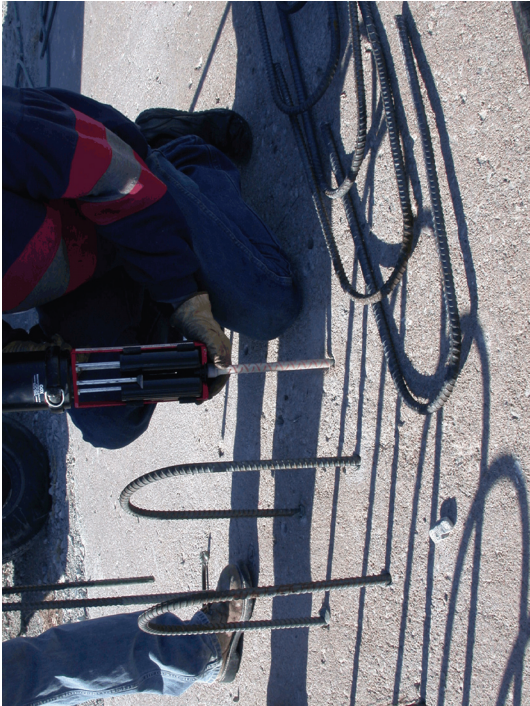
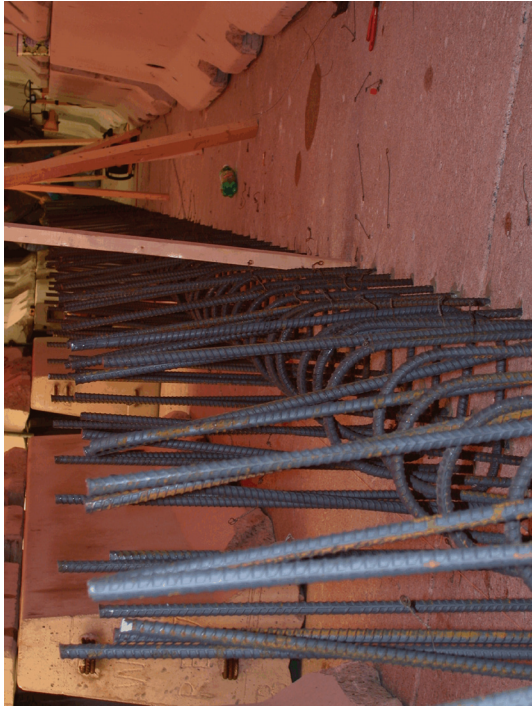
Figure 7. Single-Slope Concrete Barrier Construction

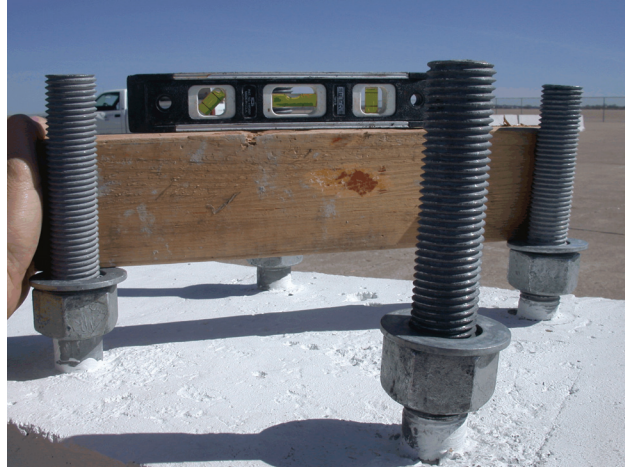
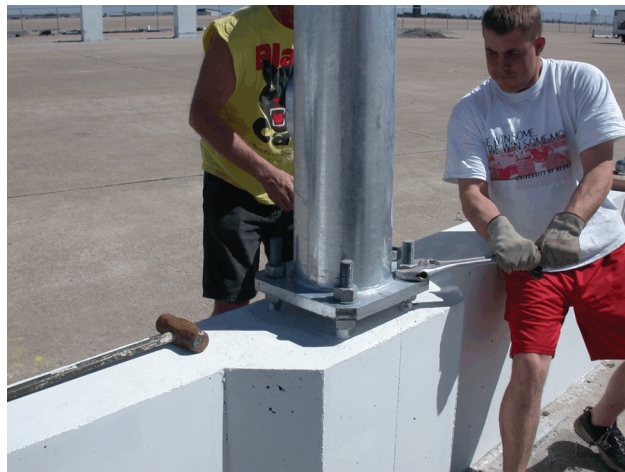
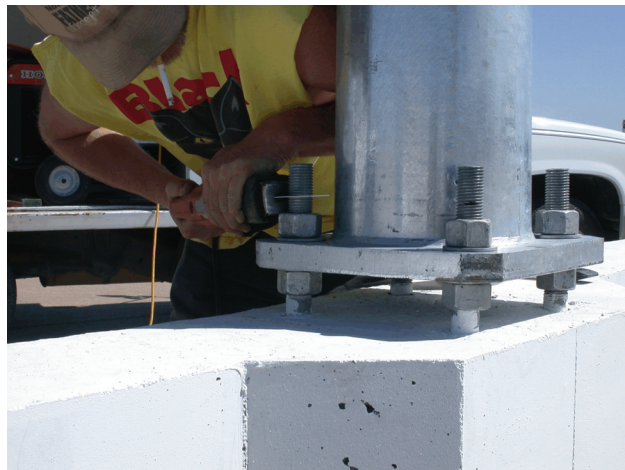
Figure 8. Luminaire Pole Attached to Single-Slope Concrete Barrier, Test No. ZOI-1

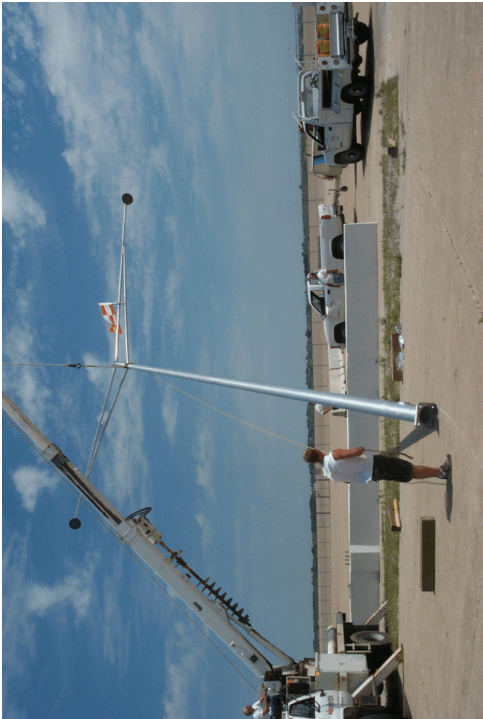
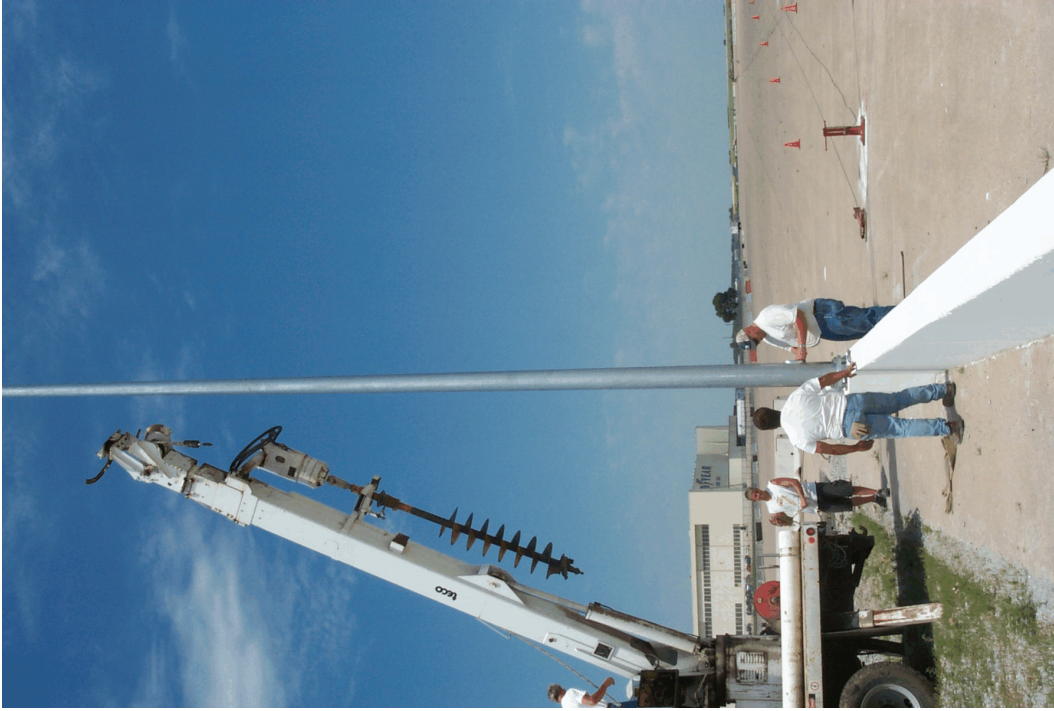
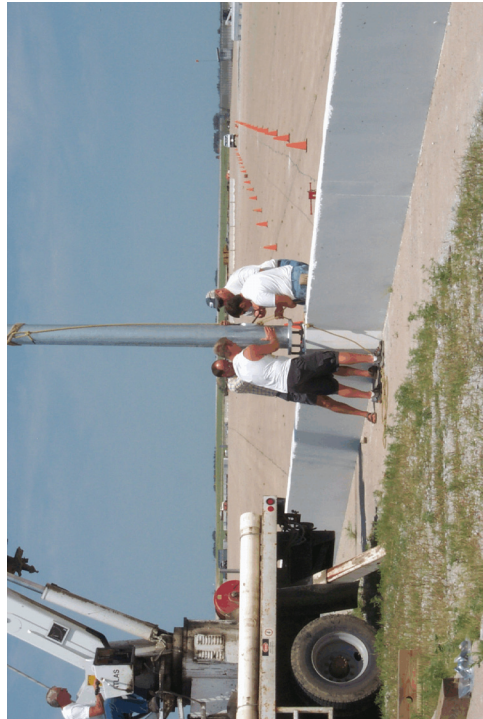
Figure 9. Luminaire Pole Attached to Single-Slope Concrete Barrier, Test No. ZOI-2

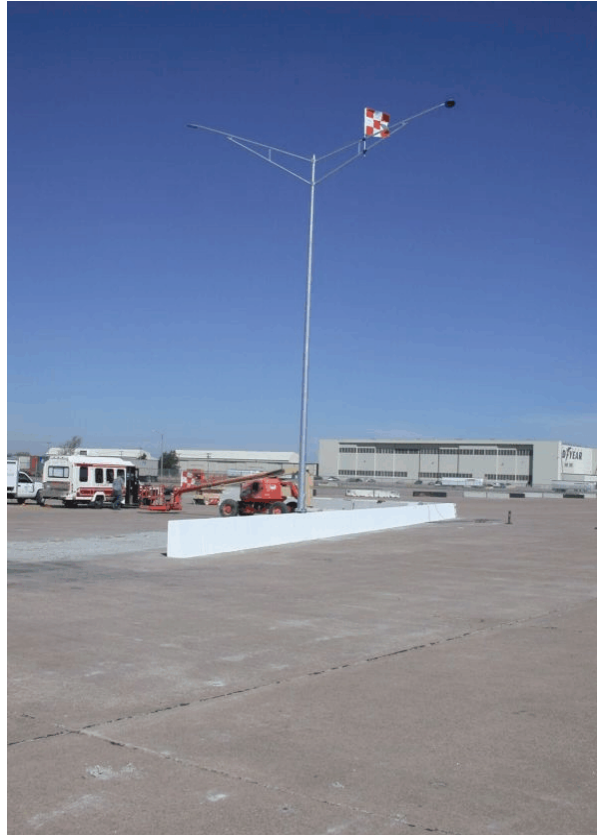
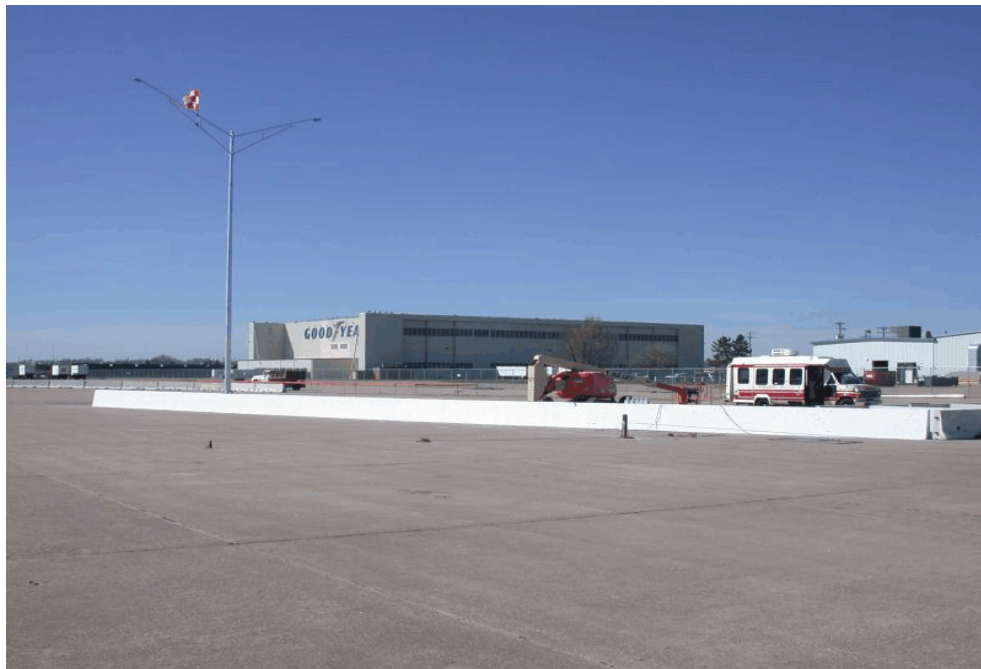
Figure 10. Luminaire Pole Attach to Single-Slope Concrete Barrier, Test Nos. ZOI-1 and ZOI-2

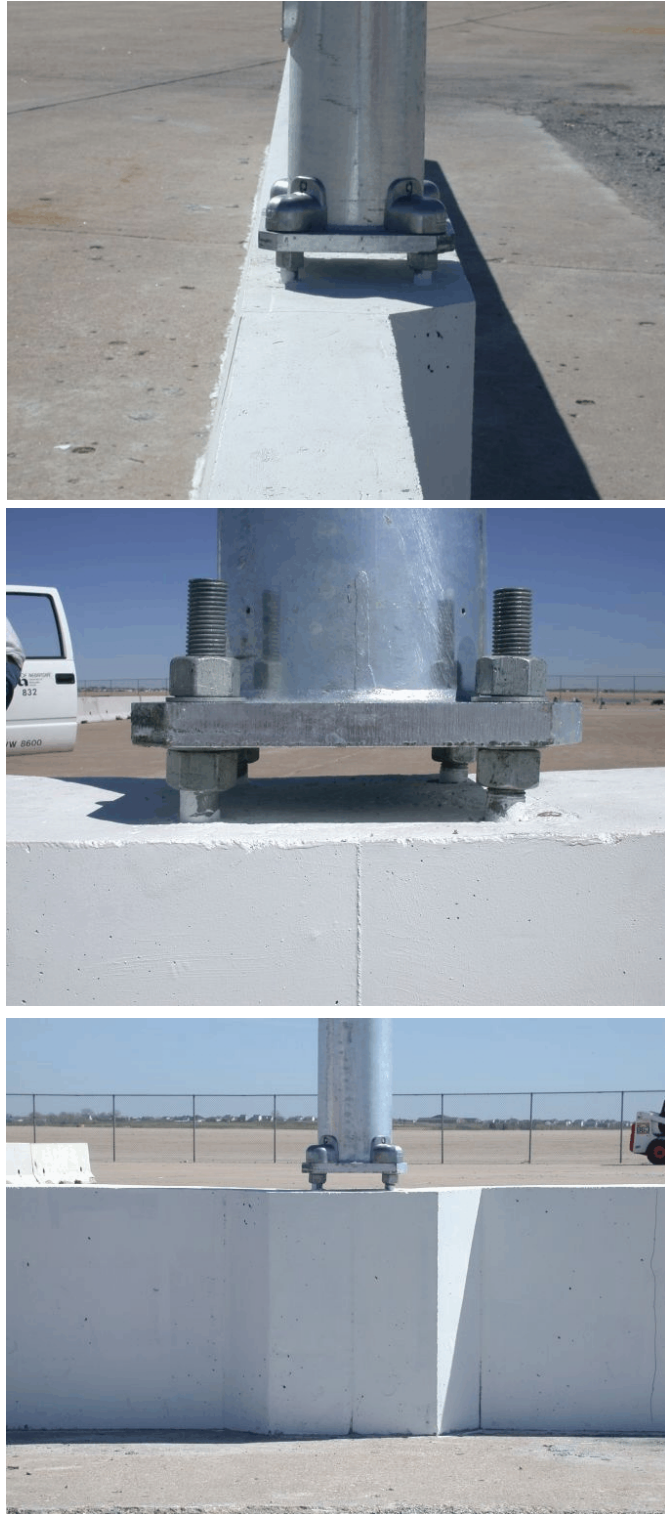
Figure 11. Luminaire Pole Attached to Single-Slope Concrete Barrier, Connection Details for Test Nos. ZOI-1 and ZOI-2

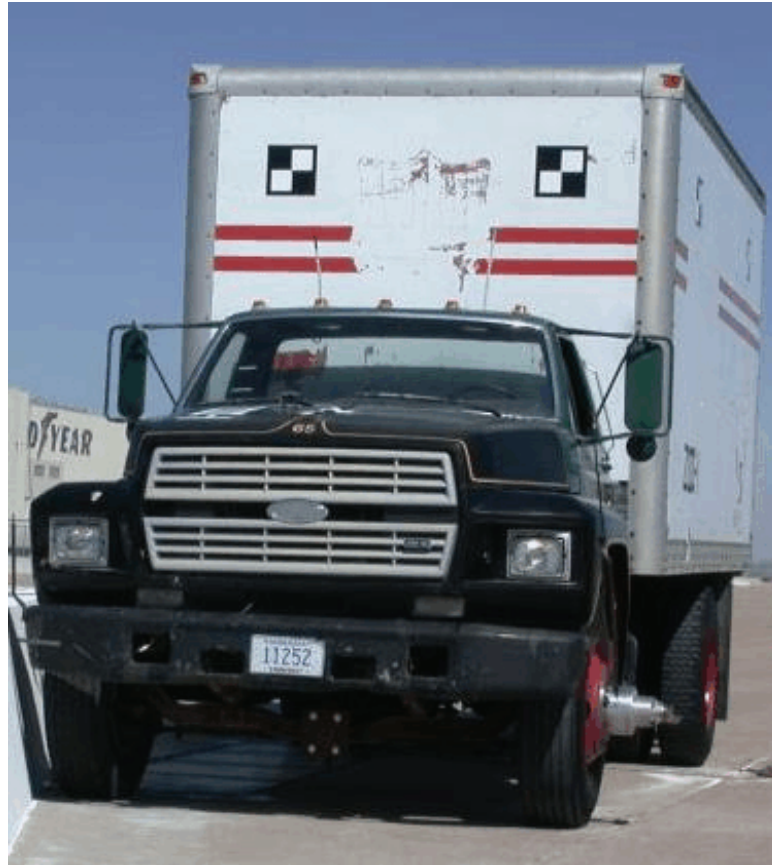
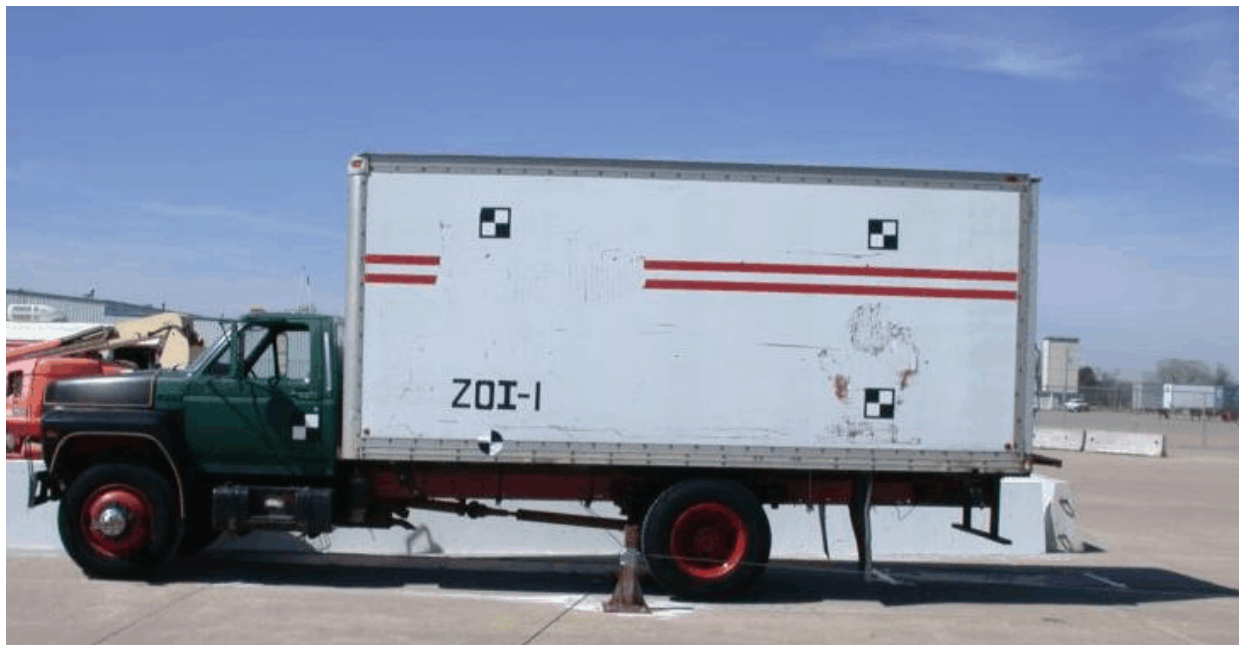
Figure 12. Test Vehicle, Test No. ZOI-1

For test no. ZOI-1, a 1989 Ford F-800 single-unit truck was used as the test vehicle. The test inertial and gross static weights were 7,985 kg (17,605 lbs). The test vehicle is shown in Figure 12,

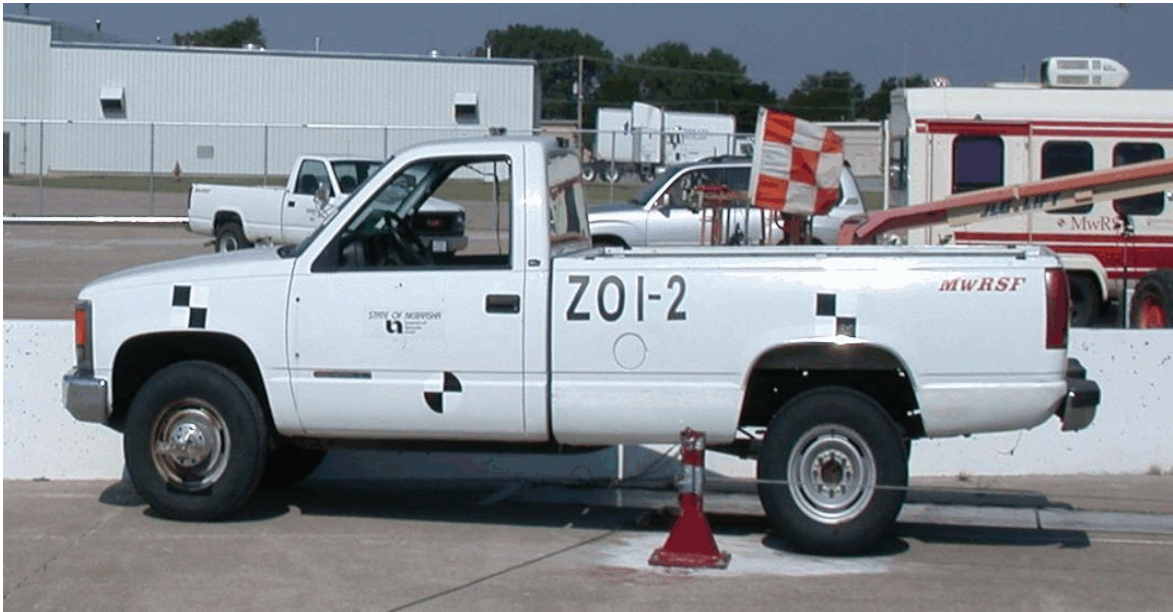
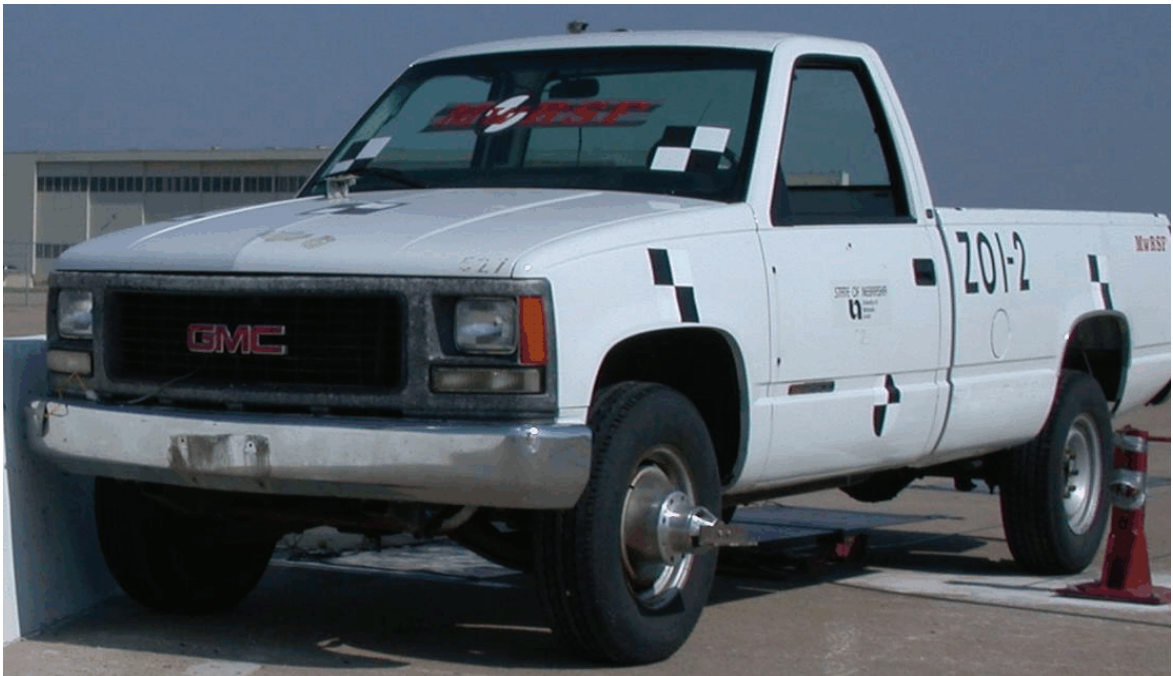
Figure 14. Test Vehicle, Test No. ZOI-2

vehicle dimensions are shown in Figure 13. For test no. ZOI-2, a 1997 GMC 2000P 3/4-ton pickup truck was used as the test vehicle. The test inertial gross static weights were 2,009 kg (4,430 lbs). The test vehicle is shown in Figure 14, and vehicle dimensions are shown in Figure 15.

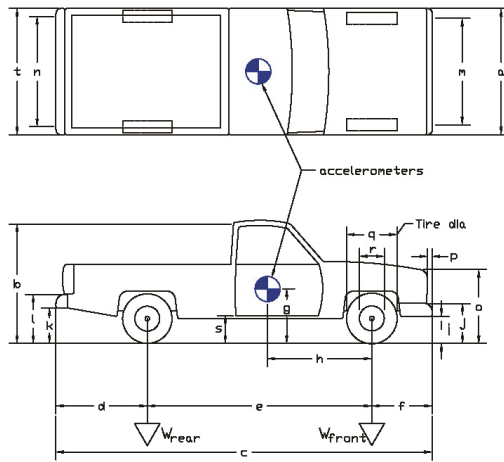
Vehicle Geometry - mm (in.)

a 1930 (76.0) b 1975 (77.75)  
 c 5563 (219) d 1321 (52.0)  
 e 3327 (131.0) f 889 (35.0)  
 g 641 (20.25) h 1372 (54.0)  
 i 445 (17.5) j 664 (26.125)  
 k 673 (26.5) l 787 (31.0)  
 m 1581 (62.25) n 1613 (63.5)  
 o 1025 (40.365) p 83 (3.25)  
 q 743 (29.25) r 445 (17.5)  
 s 413 (16.25) t 1867 (73.5)

Figure 15. Vehicle Dimensions, Test No. ZOI-2

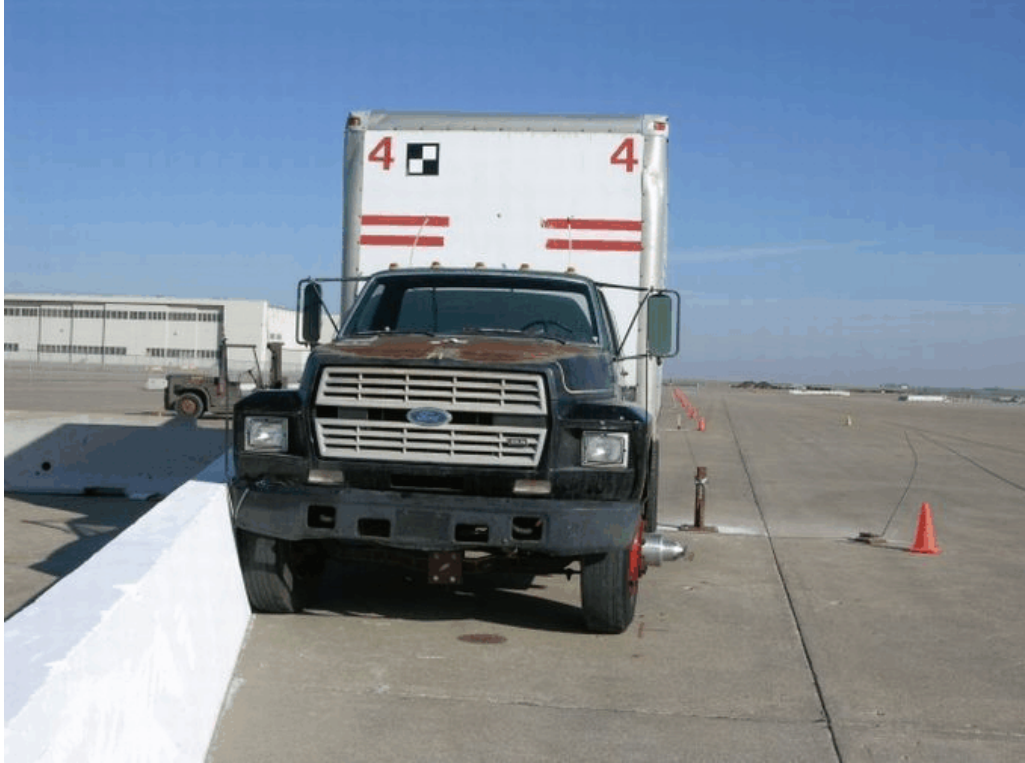
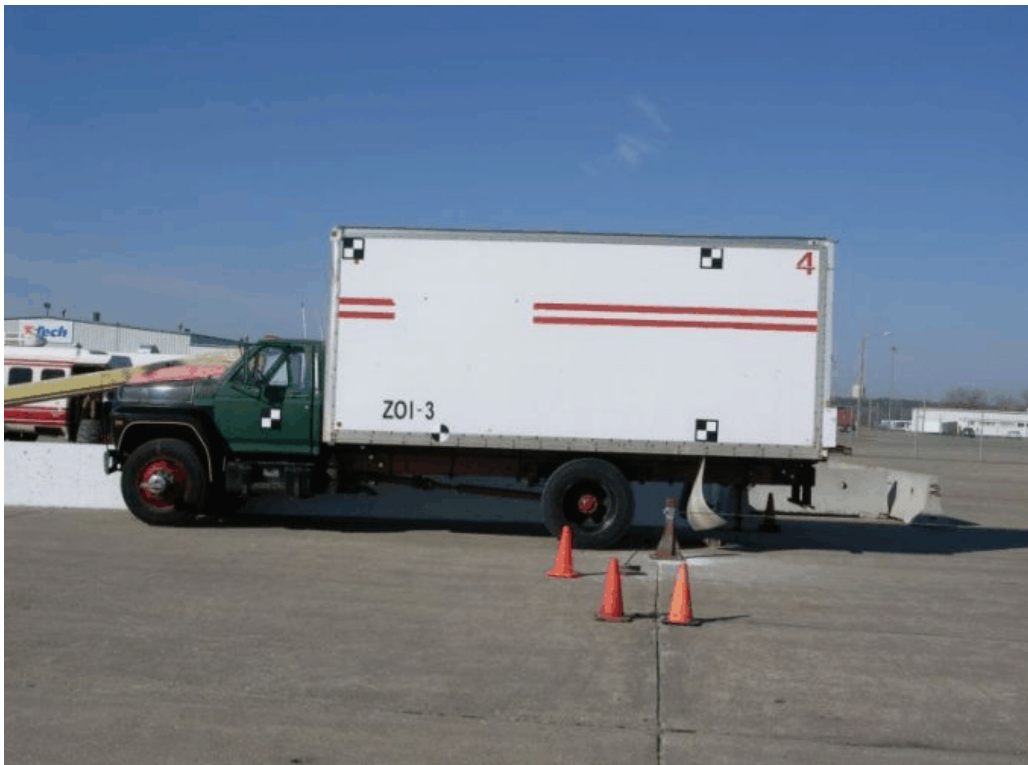
Figure 16. Test Vehicle, Test No. ZOI-3

For test no. ZOI-3, a 1989 Ford 8000S single-unit truck was used as the test vehicle. The test inertial and gross static weight were 8,000 kg (17,637 lbs). The test vehicle is shown in Figure 16, and vehicle dimensions are shown in Figure 17.

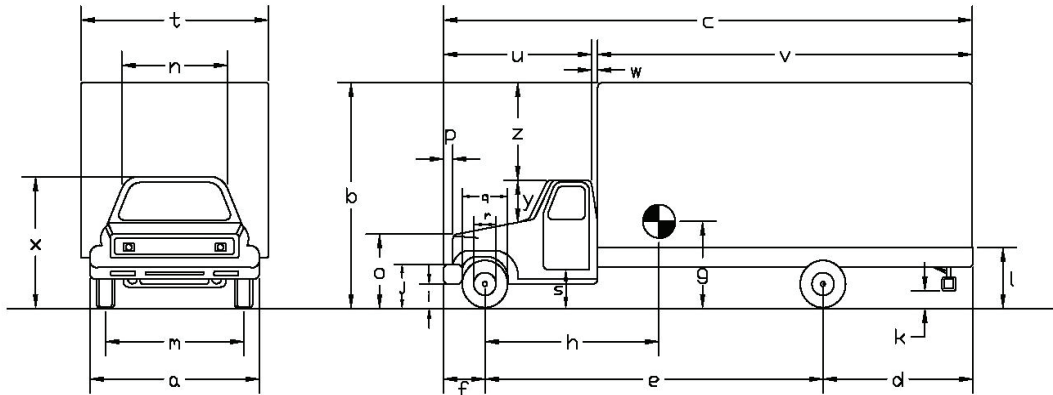
Vehicle Geometry – mm (inches)

a> fr. bump. width 2350 (92.5) j> fr. bump. top 864 (34.0) s> bot. door height 940 (37.0)  
b> overall height 3613 (142.25) k> rr. bump. bot. 565 (22.25) t> overall width 2423 (95.375)  
c> overall length 8553 (336.75) l> rr. frame top 1048 (41.25) u> cab length 2597 (102.25)  
d> rear overhang 2883 (113.5) m> fr. track width 2010 (79.125) v> trlr/box length 5886 (231.75)  
e> wheel base 4807 (189.25) n> roof width 1537 (60.5) w> gap width 57 (2.25)  
f> front overhang 845 (33.25) o> hood height 1556 (61.25) x> overall fr. height 2299 (90.5)  
g> C.G. height 1259 (49.58) p> bump. extension 70 (2.75) y> roof-hood dist. 514 (20.25)  
h> C.G. hor. dist. 3137 (123.5) q> fr. tire width 1029 (40.5) z> roof height dif. 1270 (50.0)  
i> fr. bump. bot. 565 (22.25) r> fr. wheel width 597 (23.5)

Figure 17. Vehicle Dimensions, Test No. ZOI-3
