*Midwest States' Regional Pooled Fund Research Program  
Fiscal Year 2002-2003 (Year 13)  
Research Project Number SPR-3(017)  
NDOR Sponsoring Agency Code RFPF-03-03*

## **EVALUATION OF RIGID HAZARDS PLACED IN THE ZONE OF INTRUSION**

### **MIDWEST ROADSIDE SAFETY FACILITY**

MwRSF Research Report No. TRP-03-151-08

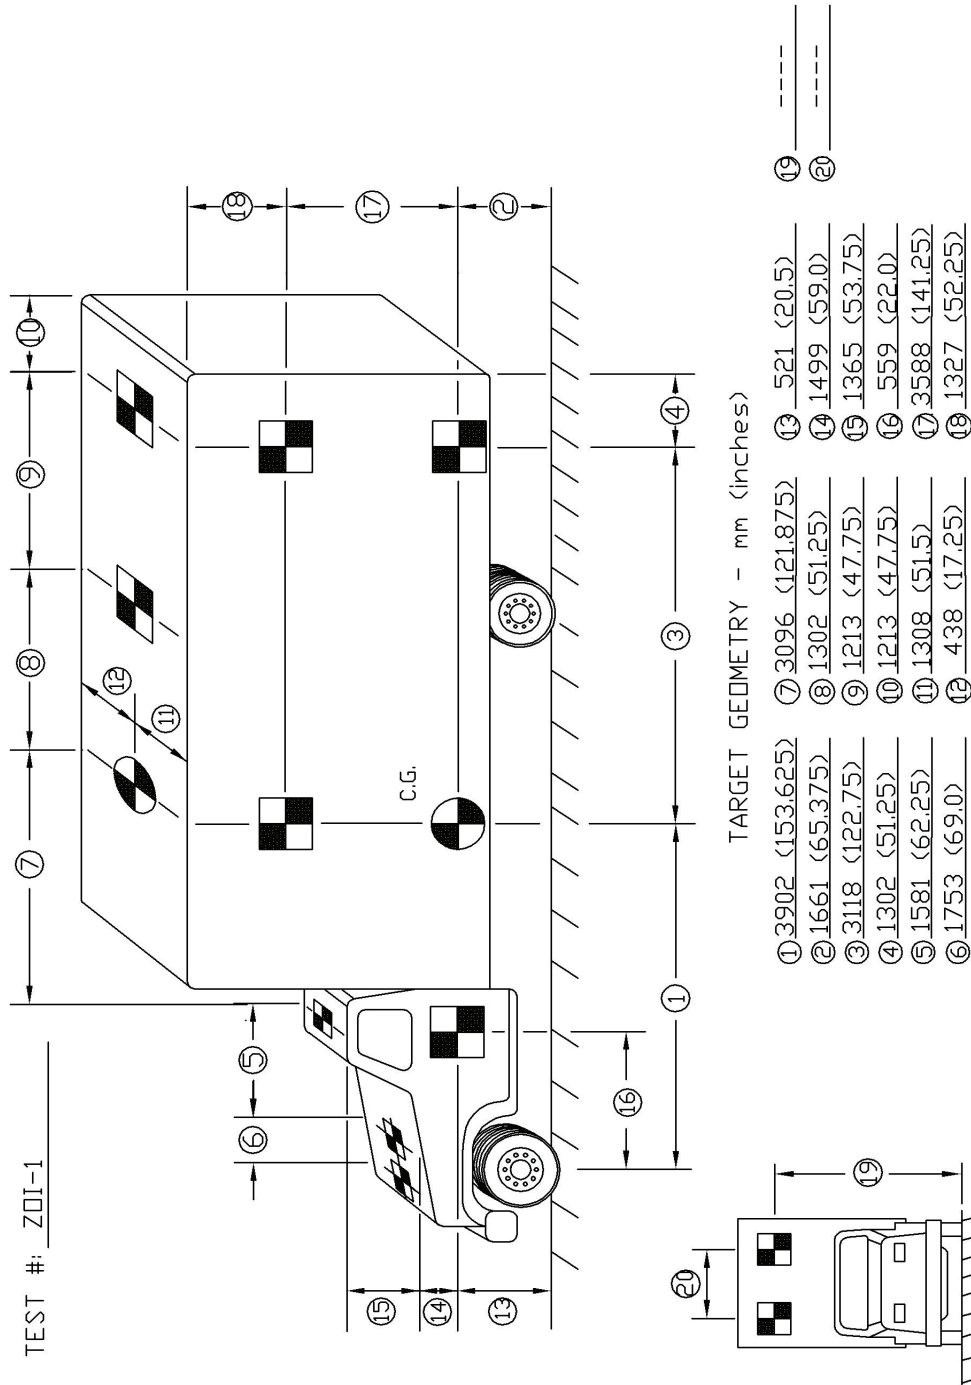
Figure 18. Vehicle Target Locations, Test No. ZOI-1

The Suspension Method (6) was used to determine the vertical component of the center of gravity (c.g.) for the 2000P test vehicle. This method is based on the principle that the c.g. of any freely suspended body is in the vertical plane through the point of suspension. The vehicle was suspended successively in three positions, and the respective planes containing the c.g. were established. The intersection of these planes pinpointed the location of the center of gravity. The Elevated Axle Method (7) was used to determine the vertical component of the center of gravity for the 8000S test vehicles. This method converts measured wheel weights at different elevations to the location of the vertical component of the center of gravity. The longitudinal component of the c.g. for all three test vehicles, and the vertical component of the two 8000S test vehicles, were determined using measured axle weights. The location of the final centers of gravity is shown in Figures 18 through 20.

Black and white, checkered targets were placed on the vehicles to aid in the analysis of the high-speed film and high-speed digital video, as shown in Figures 18 through 20. Round checkered targets were placed on the center of gravity, on the driver's side door, on the passenger's side door, and on the roof of the vehicle. The remaining targets were located for reference so that they could be viewed from the high-speed cameras for film analysis.

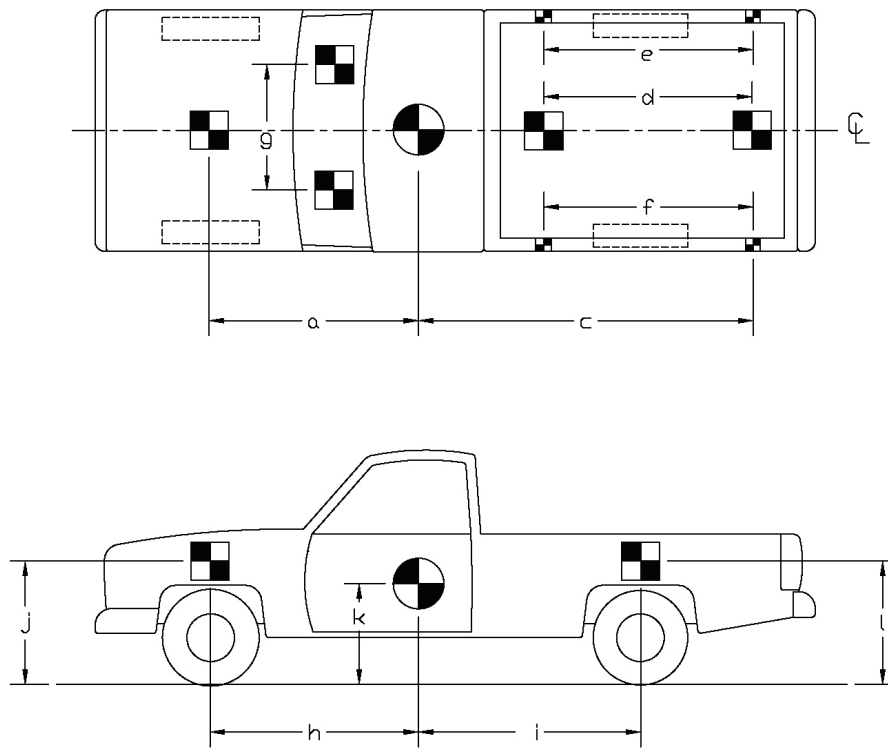
TARGET GEOMETRY -- mm (in.)

Figure 19. Vehicle Target Locations, Test No. ZOI-2

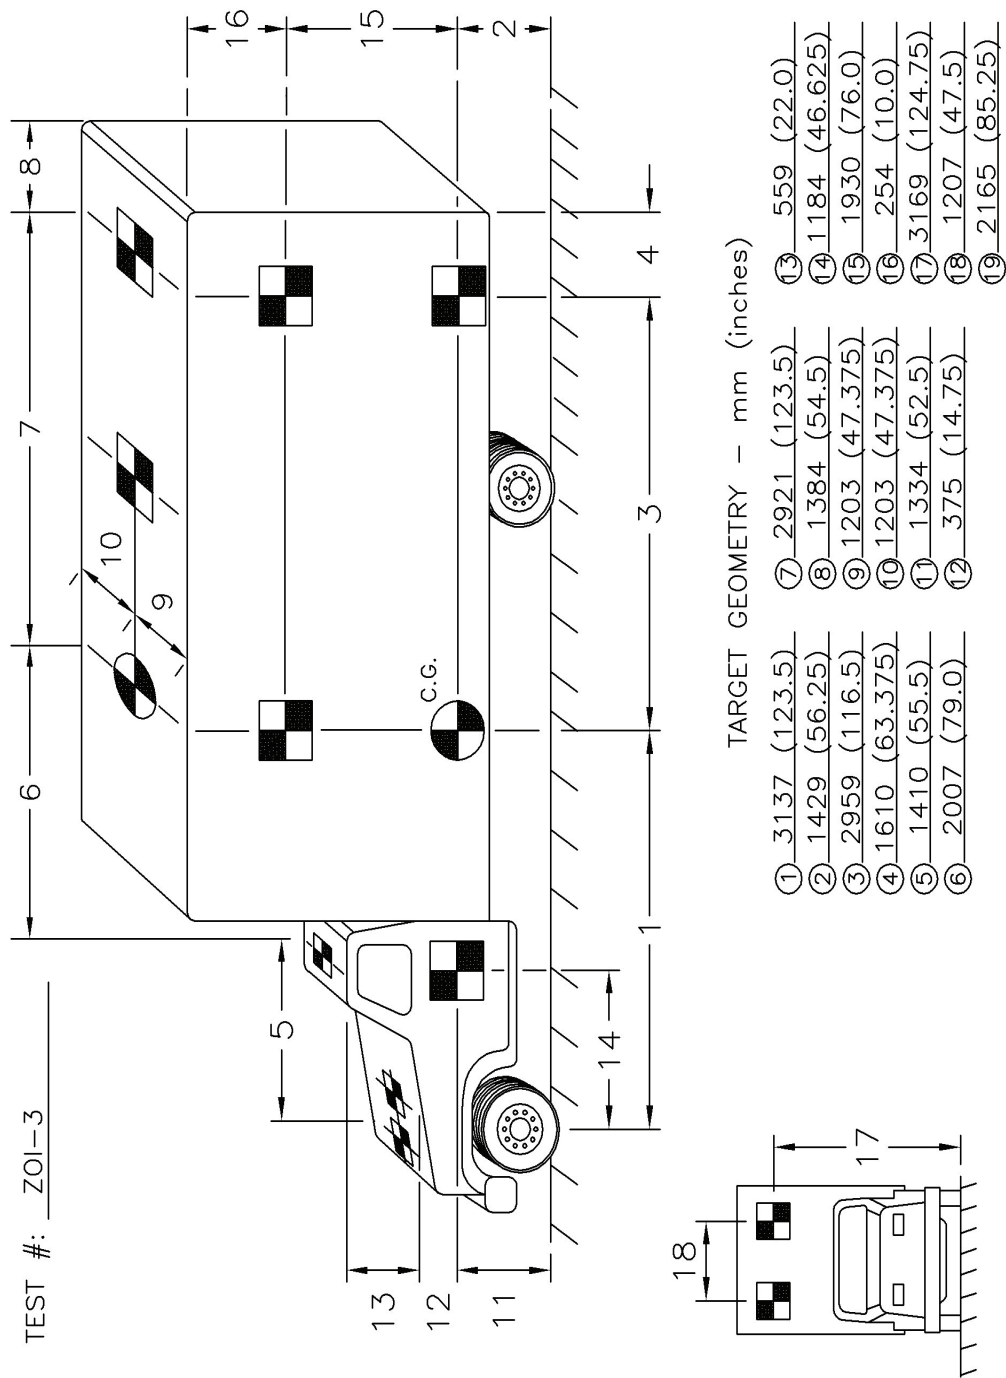
Figure 20. Vehicle Target Locations, Test No. ZOI-3

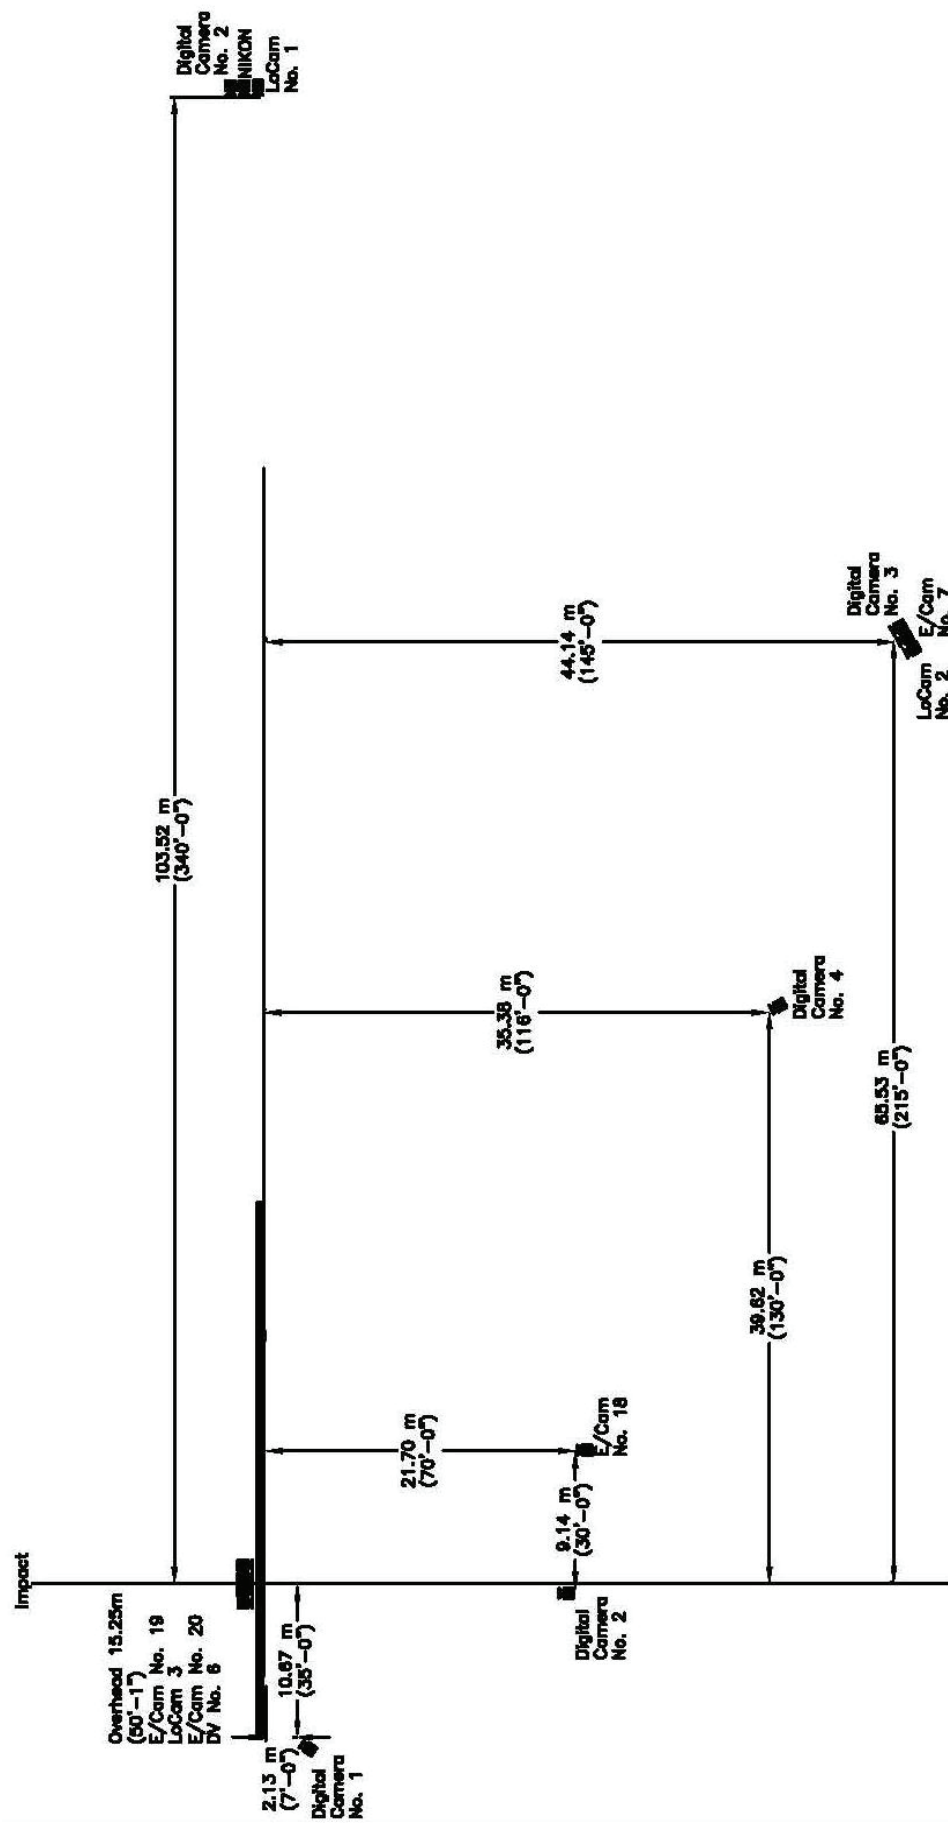
Figure 21. Location of Cameras, Test No. ZOI-1

For test ZOI-1, three high-speed 16-mm Redlake Locam cameras, with operating speeds of approximately 500 frames/sec, were used to film the crash test. Four high-speed Red Lake E/cam video cameras, with operating speeds of 500 frames/sec, were also used to film the crash test. Six Canon digital video cameras, with a standard operating speed of 29.97 frames/sec, were also used to film the crash test. Camera details and a schematic of all thirteen camera locations for test ZOI-1 are shown in Figure 21.

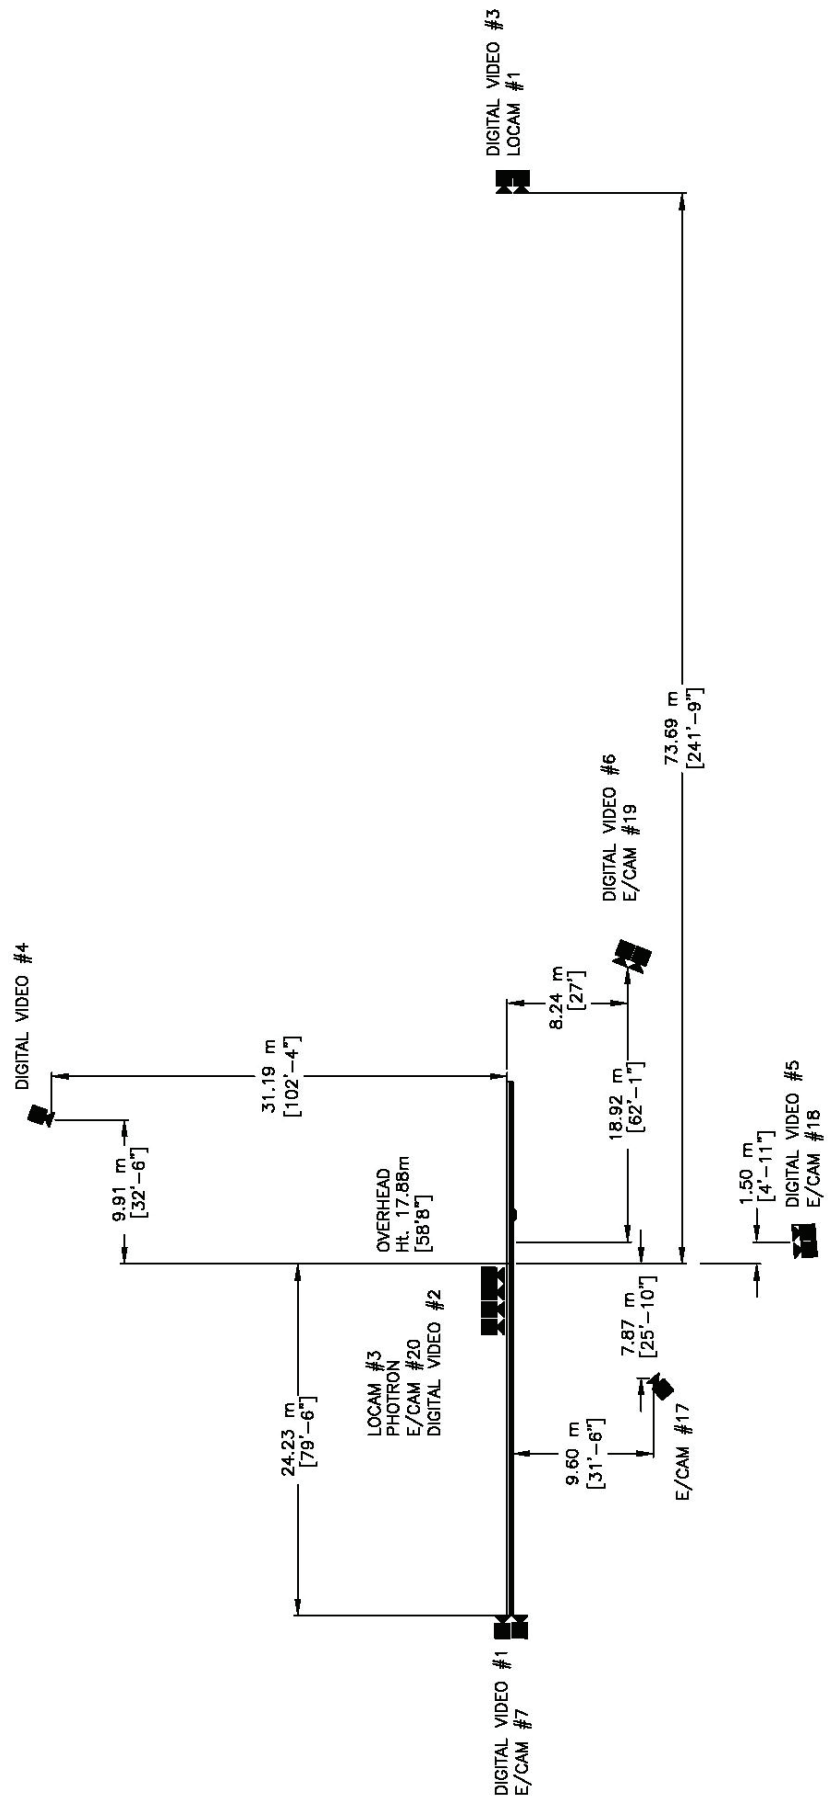
Figure 22. Location of Cameras, Test No. ZOI-2

For test ZOI-2, two high-speed 16-mm Red Lake Locam cameras, with operating speed of approximately 500 frames/sec, were used to film the crash test. A high-speed Photron video camera and five high-speed Redlake E/cam video cameras, all with operating speeds of 500 frames/sec, were also used to film the crash test. Six Canon digital video cameras, with a standard operating speed of 29.97 frames/sec, were also used to film the crash test. Camera details and a schematic of all fourteen camera locations for test ZOI-2 are shown in Figure 22.

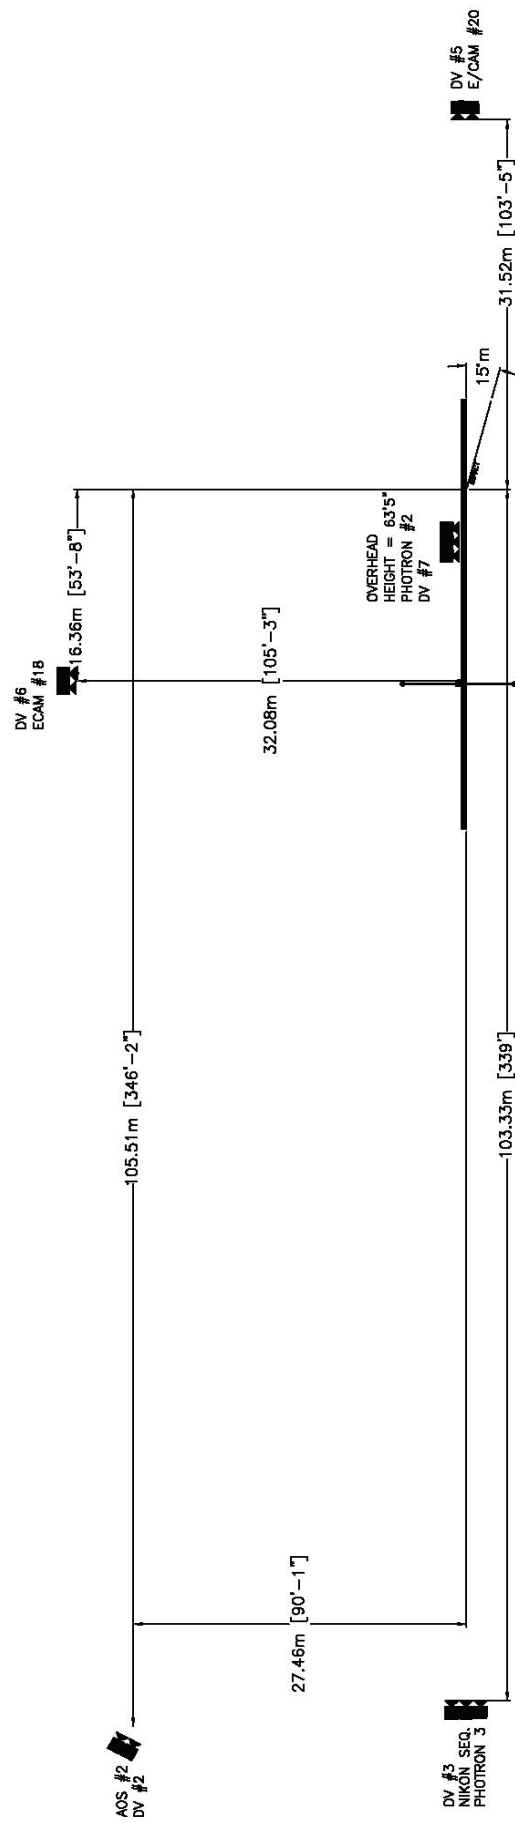
Figure 23. Location of Cameras, Test No. ZOI-3

frames/sec, were used to film the crash test. Five Canon digital video cameras, with a standard operating speed of 29.97 frames/sec, were also used to film the crash test. Camera details and a schematic of all ten camera locations for test ZOI-3 are shown in Figure 23.

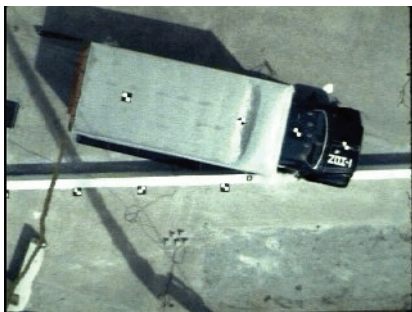
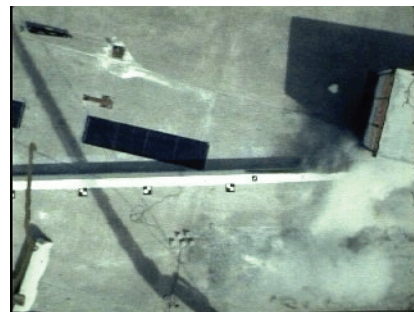
Figure 25. Additional Sequential Photographs, Test No. ZOI-1

0.311 sec

0.159 sec

0.697 sec

A 7,985-kg (17,605-lbs) single-unit truck impacted the single-slope concrete barrier with a luminaire pole attached to the top of the barrier at a speed of 80.8 km/h (50.4 mph) and at an angle of 15.6 degrees. A summary of the test results and sequential photographs are shown in Figure 24. The summary of the test results and sequential photographs in English units are shown in Appendix D. Additional sequential photographs are shown in Figures 25 and 26. Documentary photographs of the crash test are shown in Figures 27 through 32.

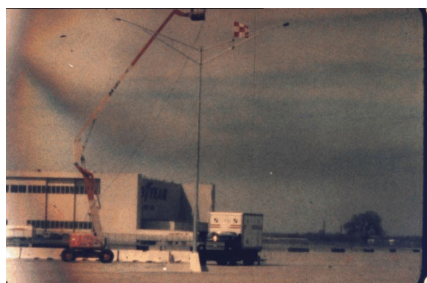
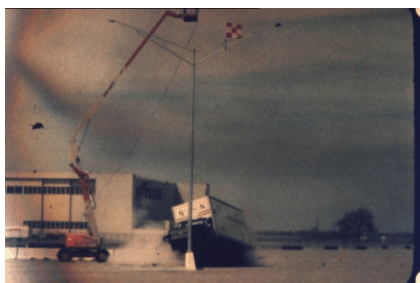
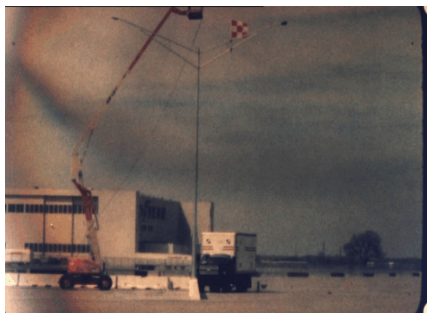
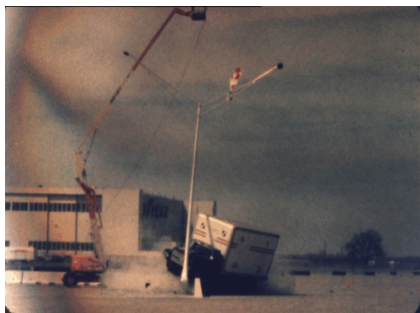
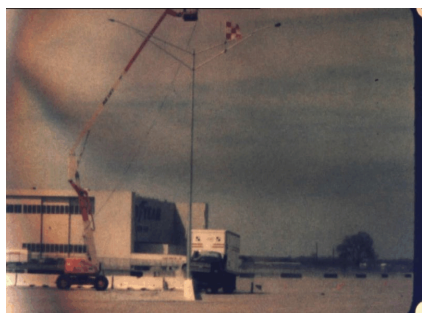
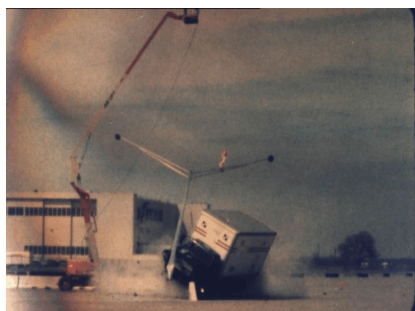
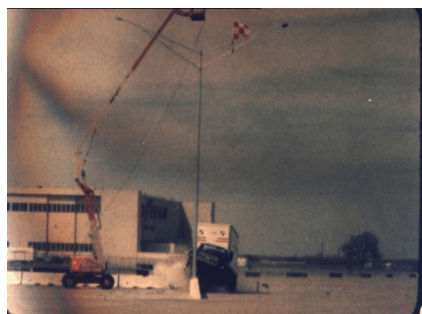
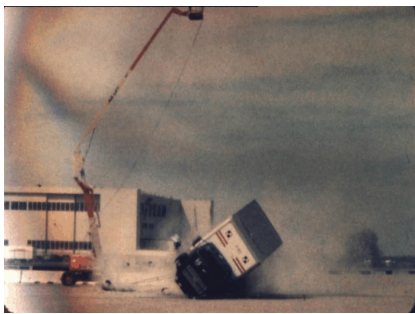
Figure 26. Additional Sequential Photographs, Test No. ZOI-1

0.000 sec

0.830 sec

0.078 sec

1.411 sec

0.320 sec

1.984 sec

0.394 sec

2.050 sec

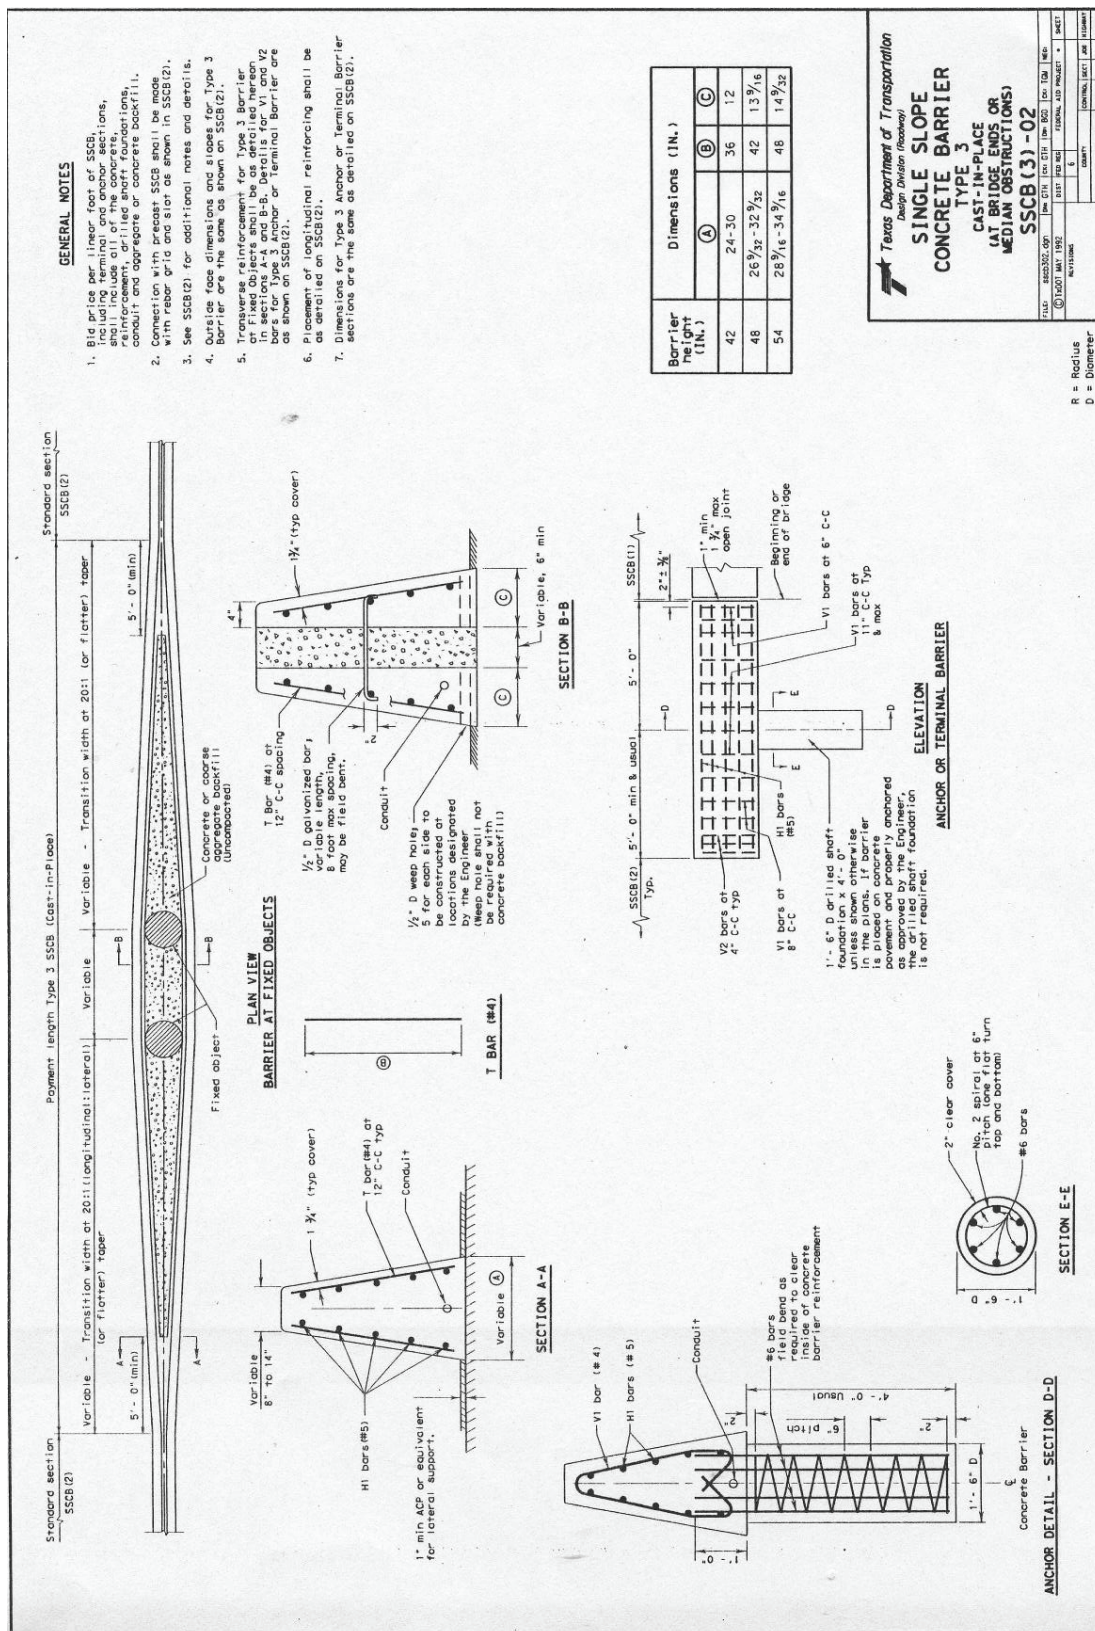
Figure A-6. TxDOT Single-Slope Concrete Barrier

TREATMENT AT END OF BRIDGE

## ILLUMINATION POLE BRACKET AND CONDUIT LOCATION

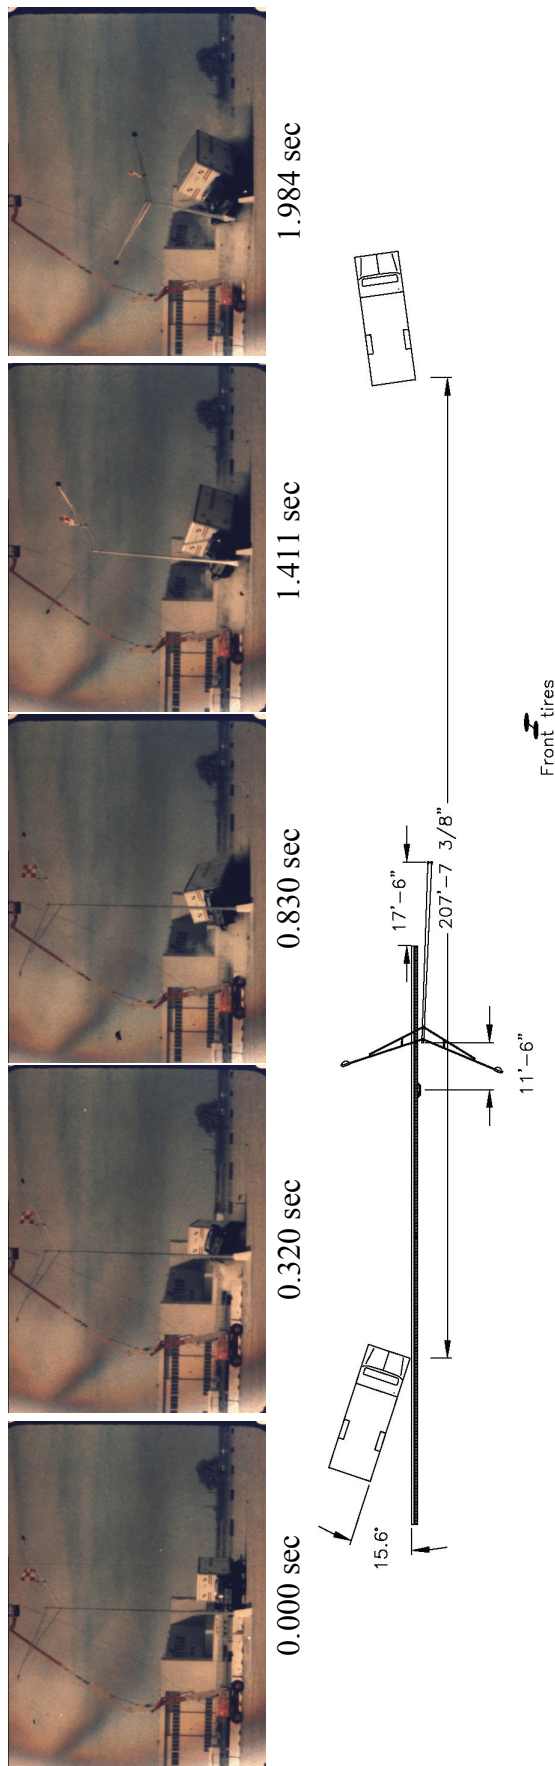
Figure D-1. Summary of Test Results and Sequential Photographs, Test No. ZO1-1 (English)

| ● Test Agency | MwRSF | ● Impact Conditions | |
| ● Test Number | ZO1-1 | Speed | 50.4 mph |
| ● Appurtenance | Single-Slope Concrete Barrier with an Attached Luminaire Pole | ● Exit Conditions | |
| Size | 11 Gauge thick by 37 ft - 6 in. long | ● Test Article Damage | Pole disengaged |

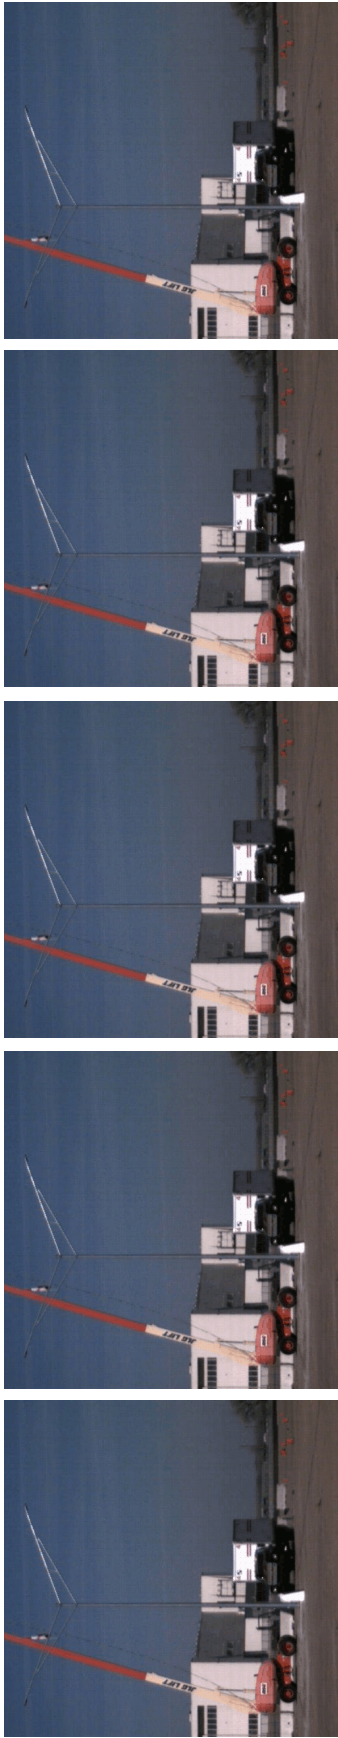
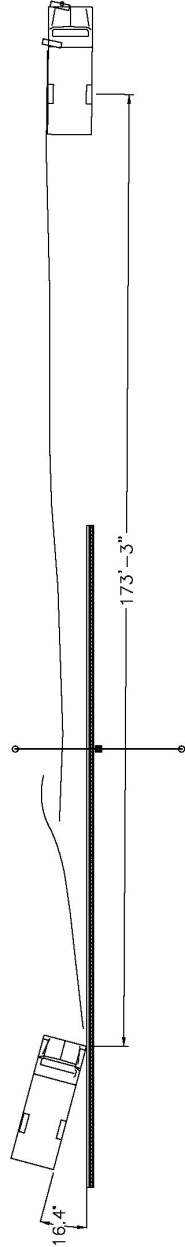
Figure D-3. Summary of Test Results and Sequential Photographs, Test No. ZOI-3 (English)

| <ul style="list-style-type: none"> <li>● Test Agency . . . . . MwRSF</li> <li>● Test Number . . . . . ZOI-3</li> <li>● Date . . . . . 3/2/05</li> <li>● NCHRP 350 Test Designation . . . . . 4-12</li> <li>● Appurtenance . . . . . Single-Slope Barrier with Luminaire Pole Behind Barrier</li> </ul> | <ul style="list-style-type: none"> <li>● Impact Conditions</li> <li>Speed . . . . . 50.2 mph</li> <li>Angle . . . . . 16.4 degrees</li> <li>Impact Location . . . . . 54 ft - 6 in. upstream of pole centerline</li> </ul> |
| <ul style="list-style-type: none"> <li>● Total Length . . . . . 120 ft</li> <li>● Overall Height . . . . . 42 ft - 6 in.</li> <li>● Key Elements - Barrier</li> <li>Description . . . . . Single-Slope Concrete Barrier</li> <li>Base Width . . . . . 15.625 in.</li> <li>Top Width . . . . . 9.5 in.</li> <li>Height . . . . . 32 in.</li> <li>Concrete Material . . . . . Nebraska 47-BD Mix</li> <li>Reinforcing Steel Material . . . . . Grade 60 Rebar</li> </ul> | <ul style="list-style-type: none"> <li>● Exit Conditions</li> <li>Speed . . . . . NA</li> <li>Angle . . . . . NA</li> <li>Exit Box Criterion . . . . . Pass</li> </ul> |

An 8,000-kg (17,637-lbs) single-unit truck impacted the single-slope concrete barrier with a luminaire pole placed behind the barrier and mounted to the lower concrete surface at a speed of 80.8 km/h (50.2 mph) and at an angle of 16.4 degrees. A summary of the test results and sequential photographs are shown in Figure 63. The summary of the test results and sequential photographs in English units are shown in Appendix D. Additional sequential photographs are shown in Figure 64 through 67. Documentary photographs of the crash test are shown in Figures 68 and 69.

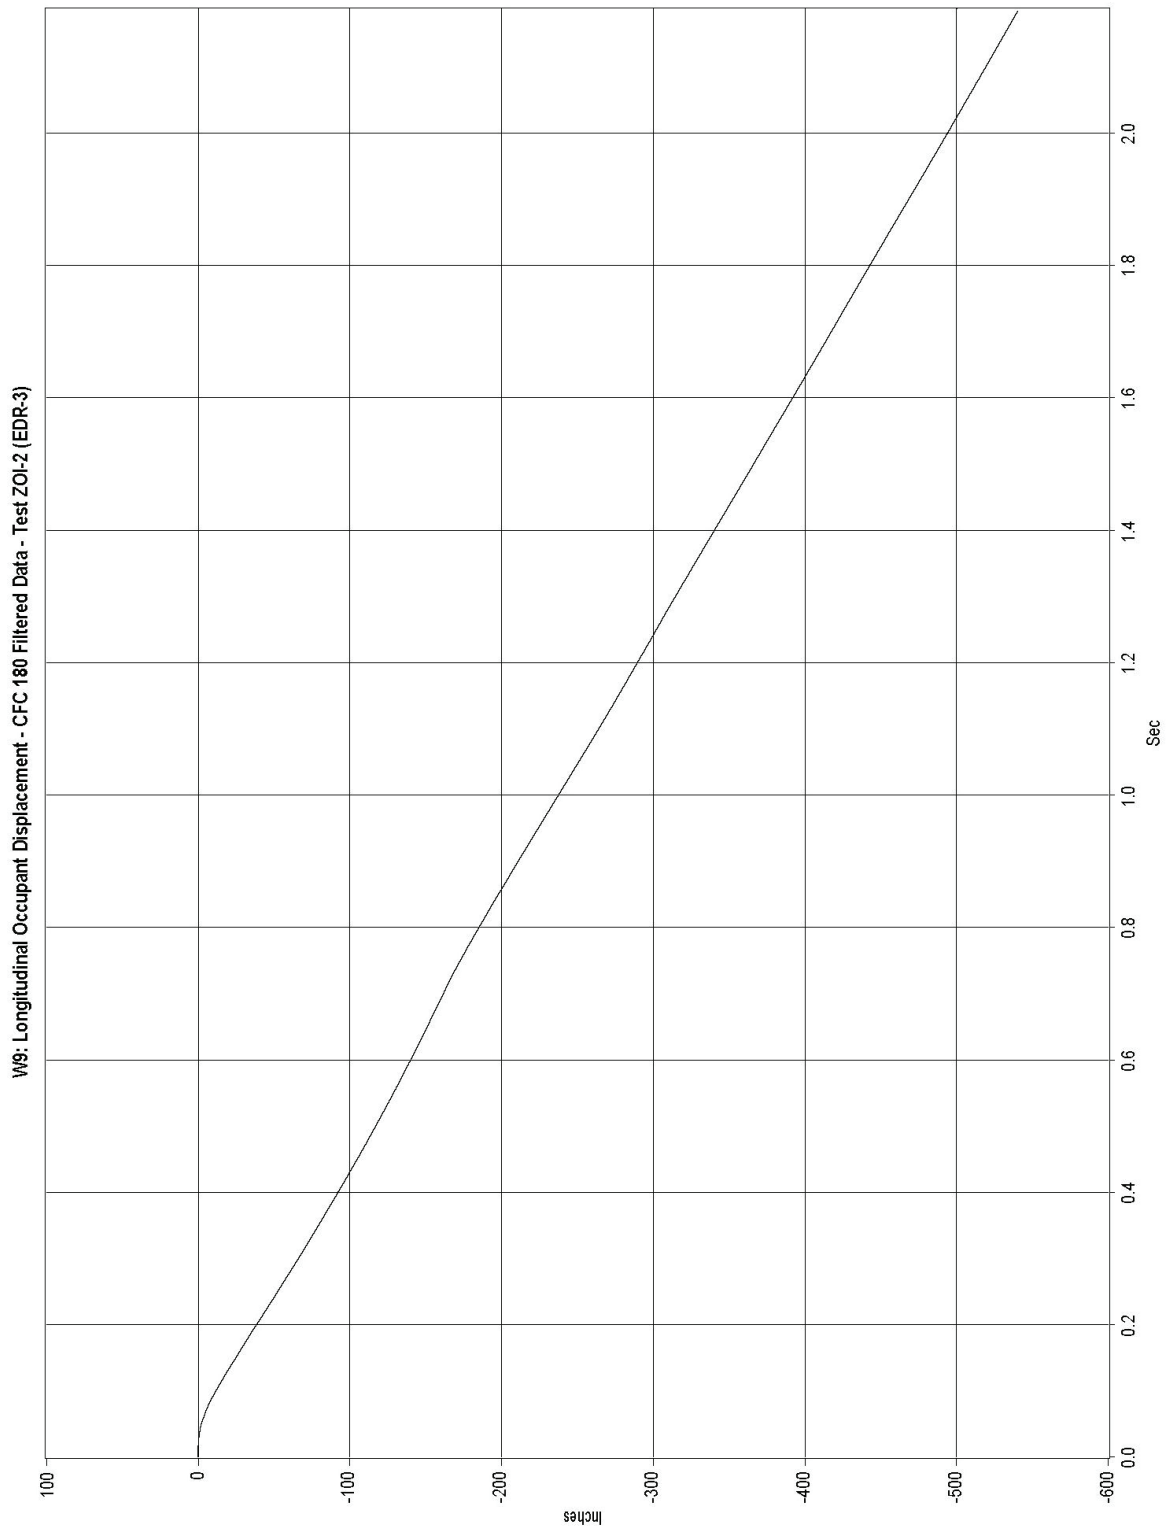
Figure G-3. Graph of Longitudinal Occupant Displacement, Test ZOI-2

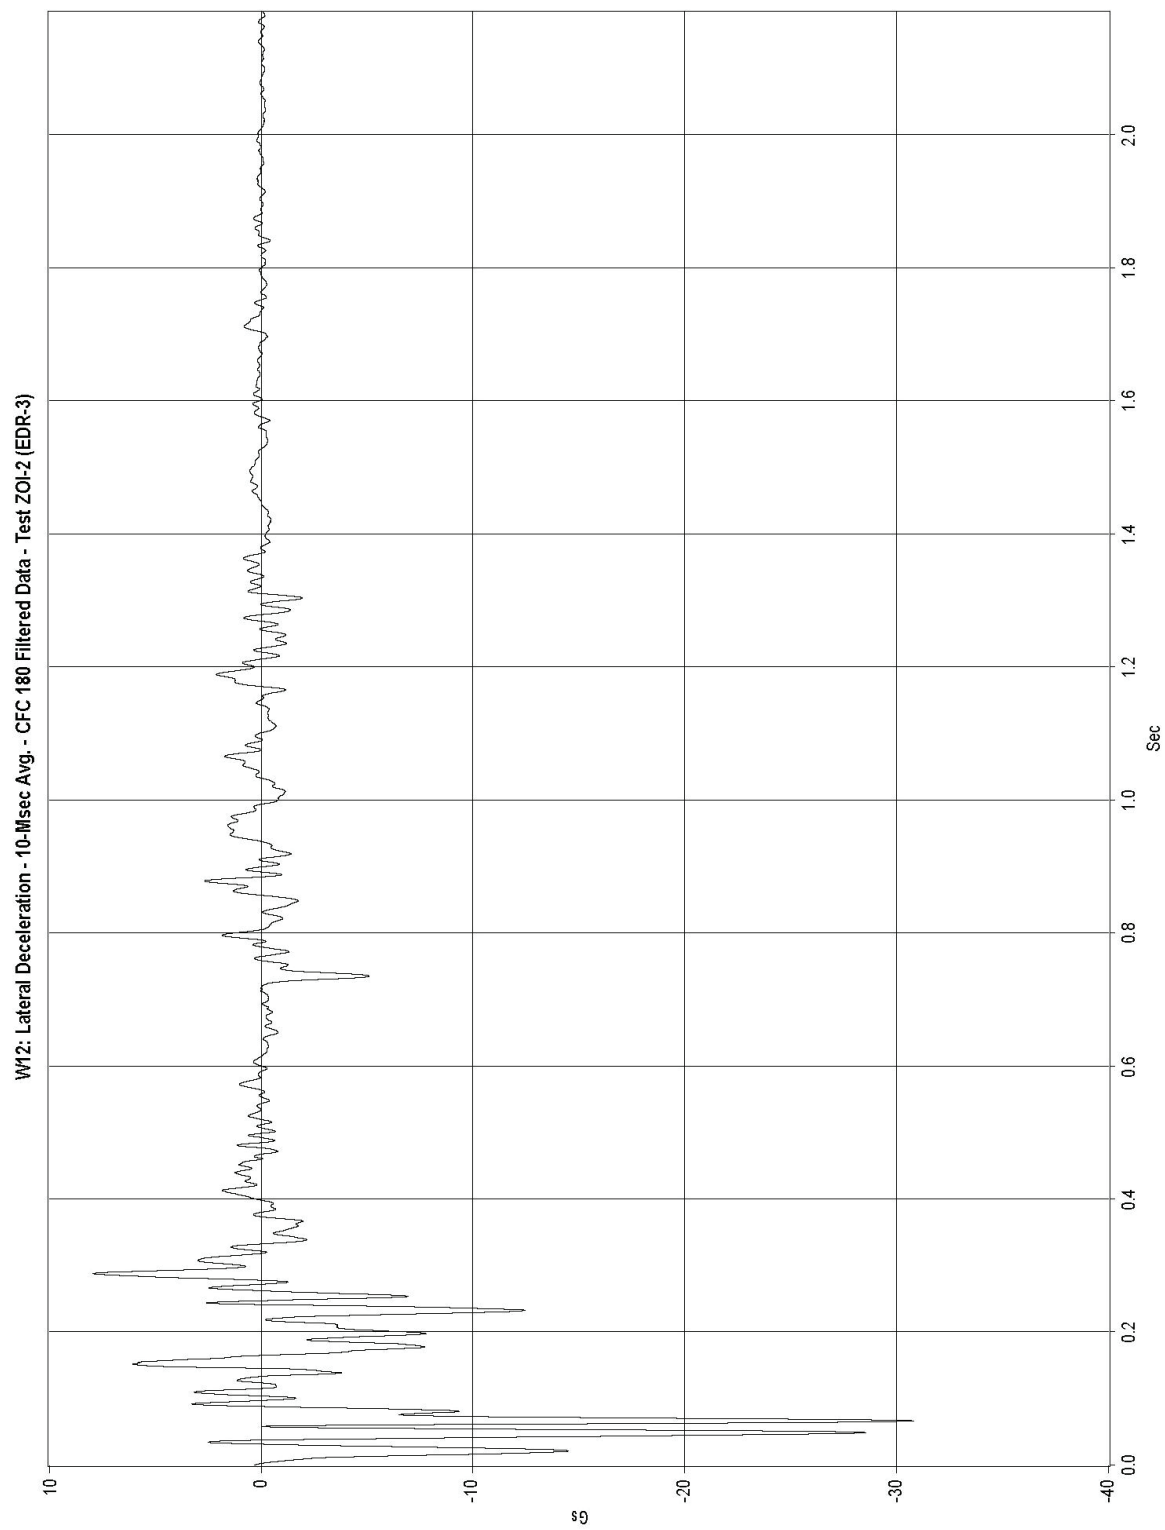
Figure G-4. Graph of Lateral Deceleration, Test ZOI-2

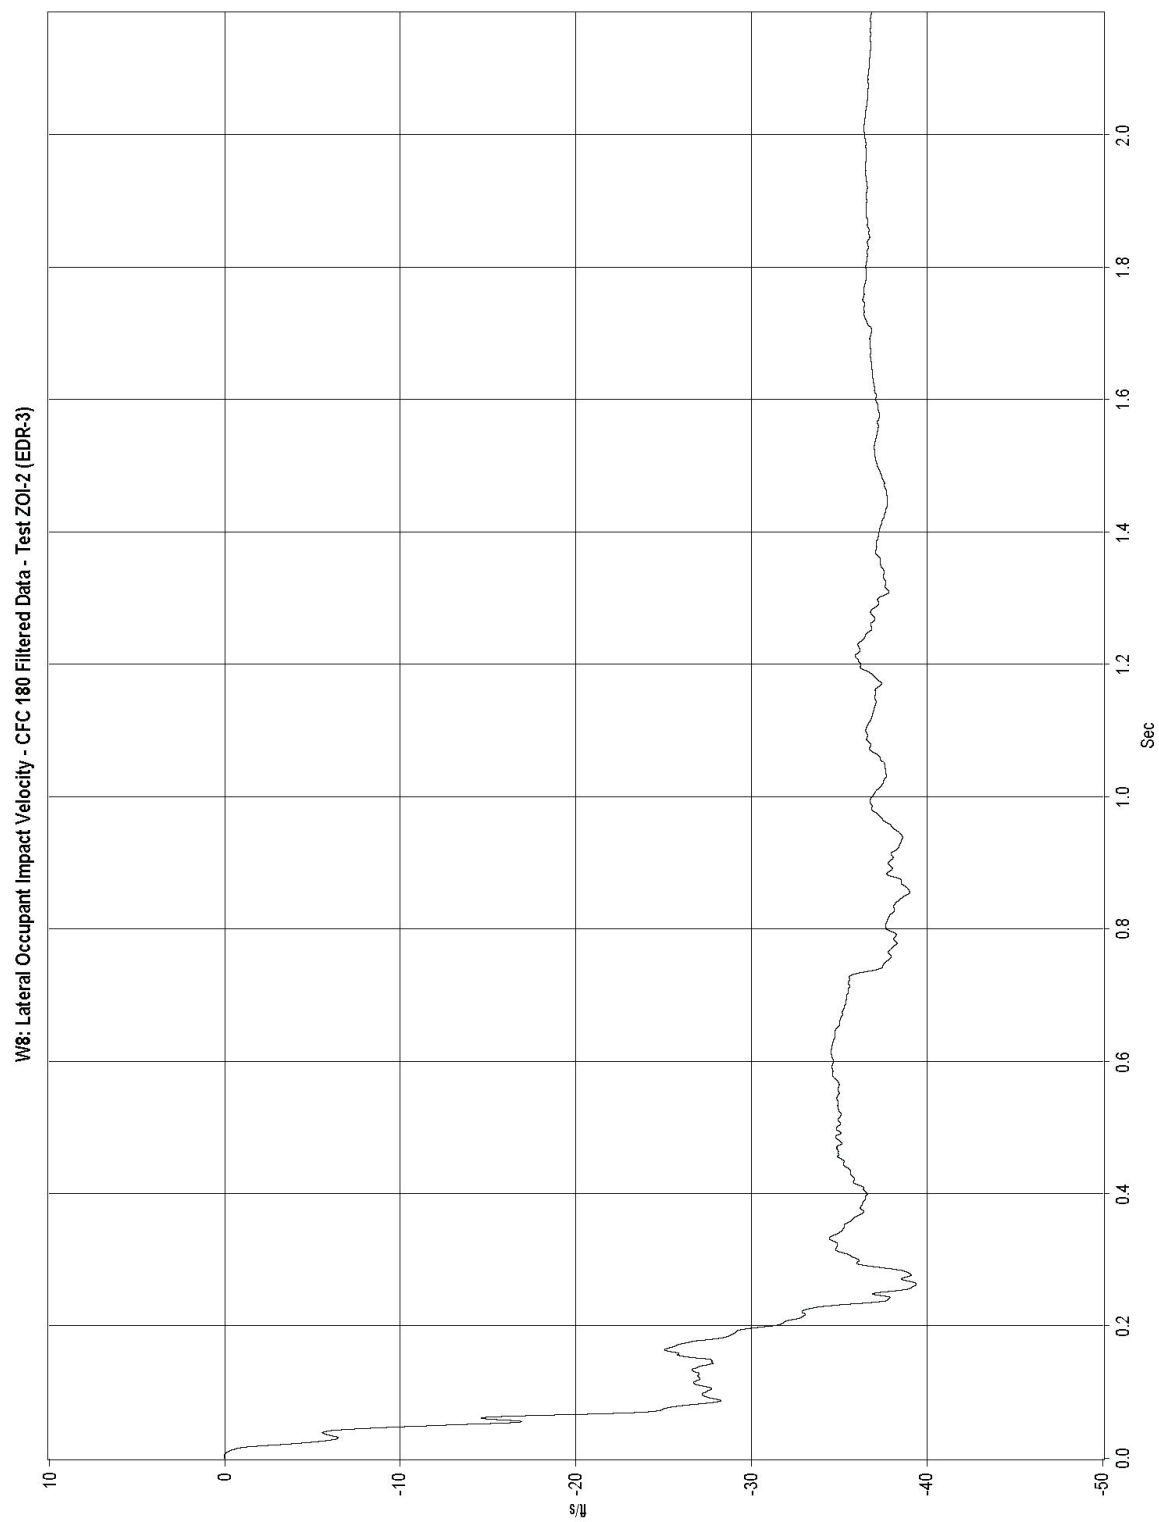
Figure G-5. Graph of Lateral Occupant Impact Velocity, Test ZOI-2

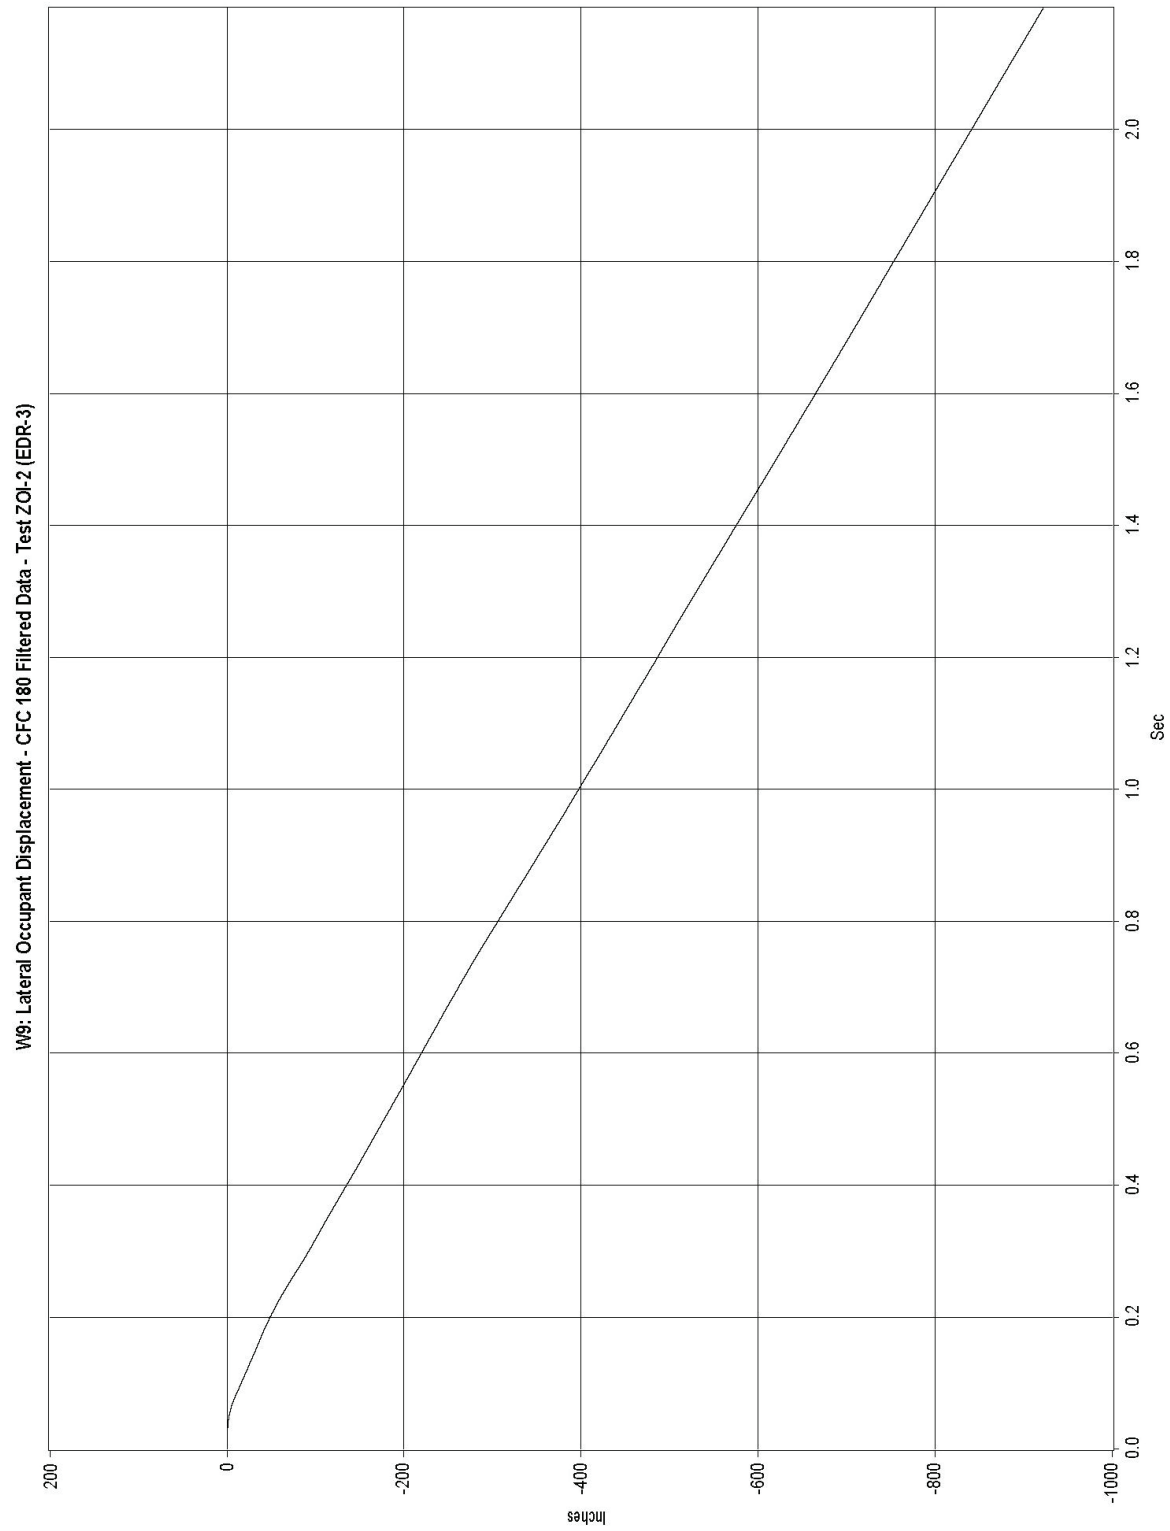
Figure G-6. Graph of Lateral Occupant Displacement, Test ZOI-2

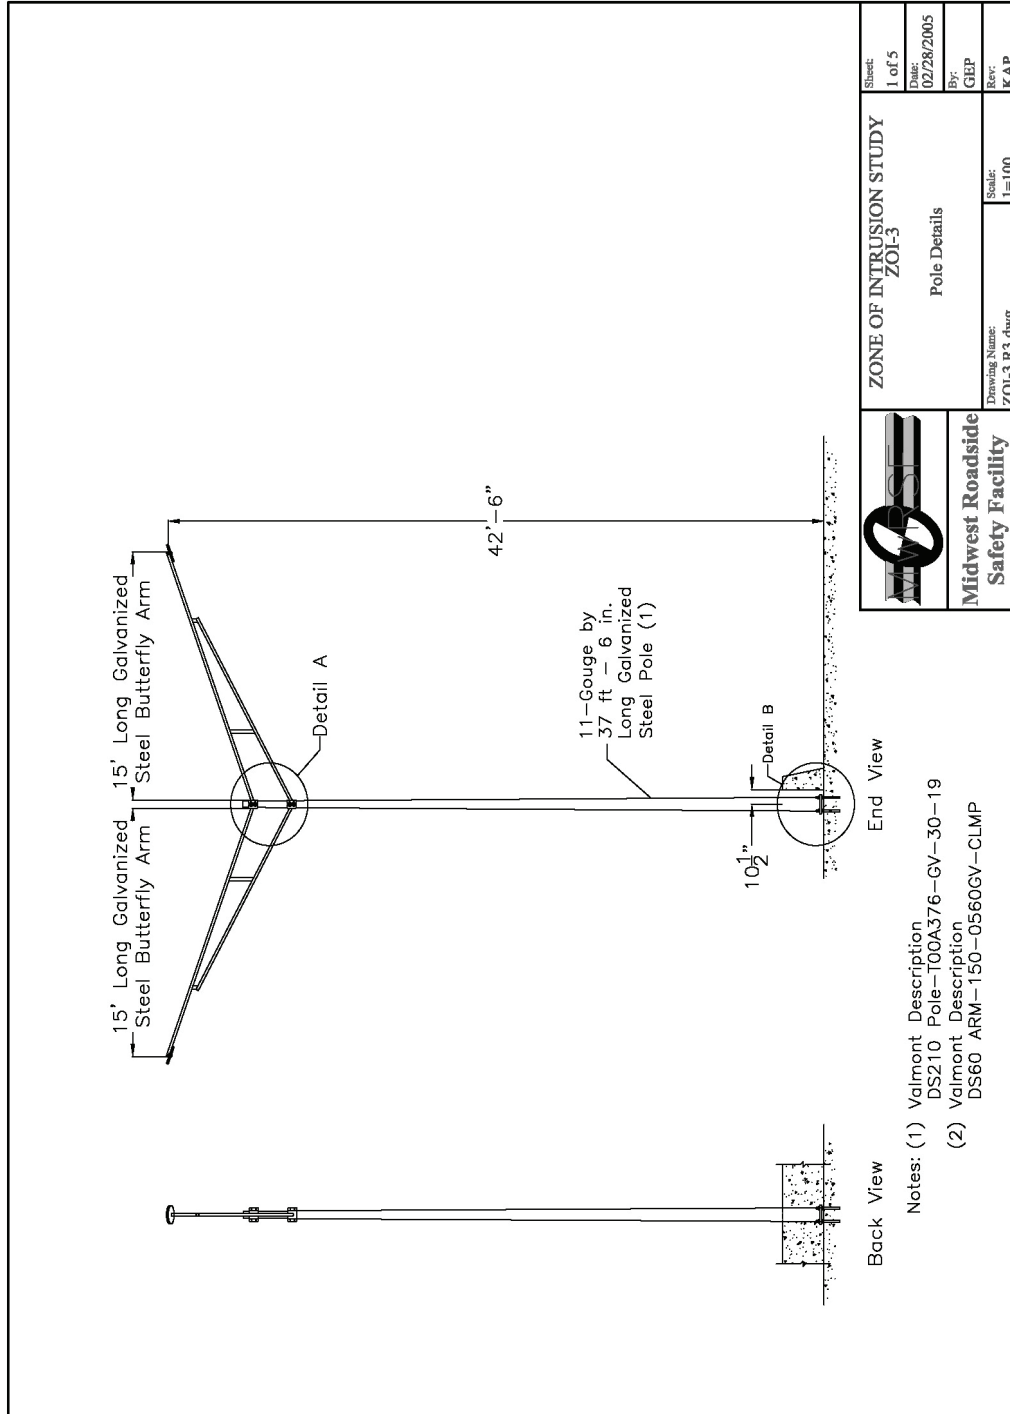
Figure H-1. Pole Details, Test No. ZOI-3 (English)
