*Midwest States' Regional Pooled Fund Research Program  
Fiscal Year 2002-2003 (Year 13)  
Research Project Number SPR-3(017)  
NDOR Sponsoring Agency Code RFPF-03-03*

## **EVALUATION OF RIGID HAZARDS PLACED IN THE ZONE OF INTRUSION**

### **MIDWEST ROADSIDE SAFETY FACILITY**

MwRSF Research Report No. TRP-03-151-08

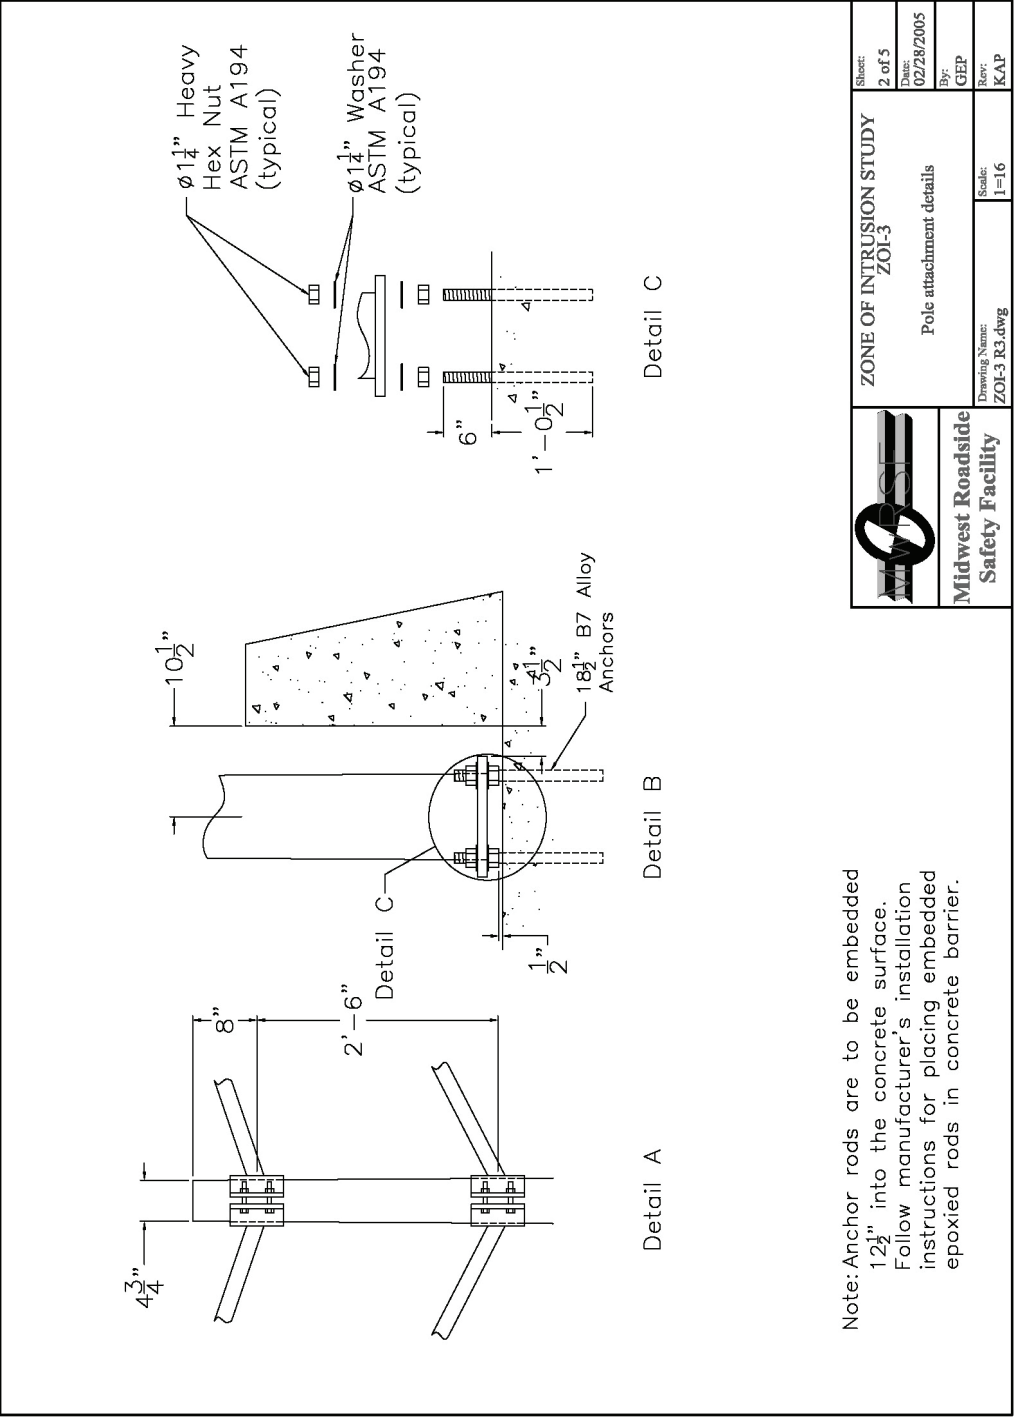
Figure H-2. Pole Attachment Details, Test No. ZOI-3 (English)

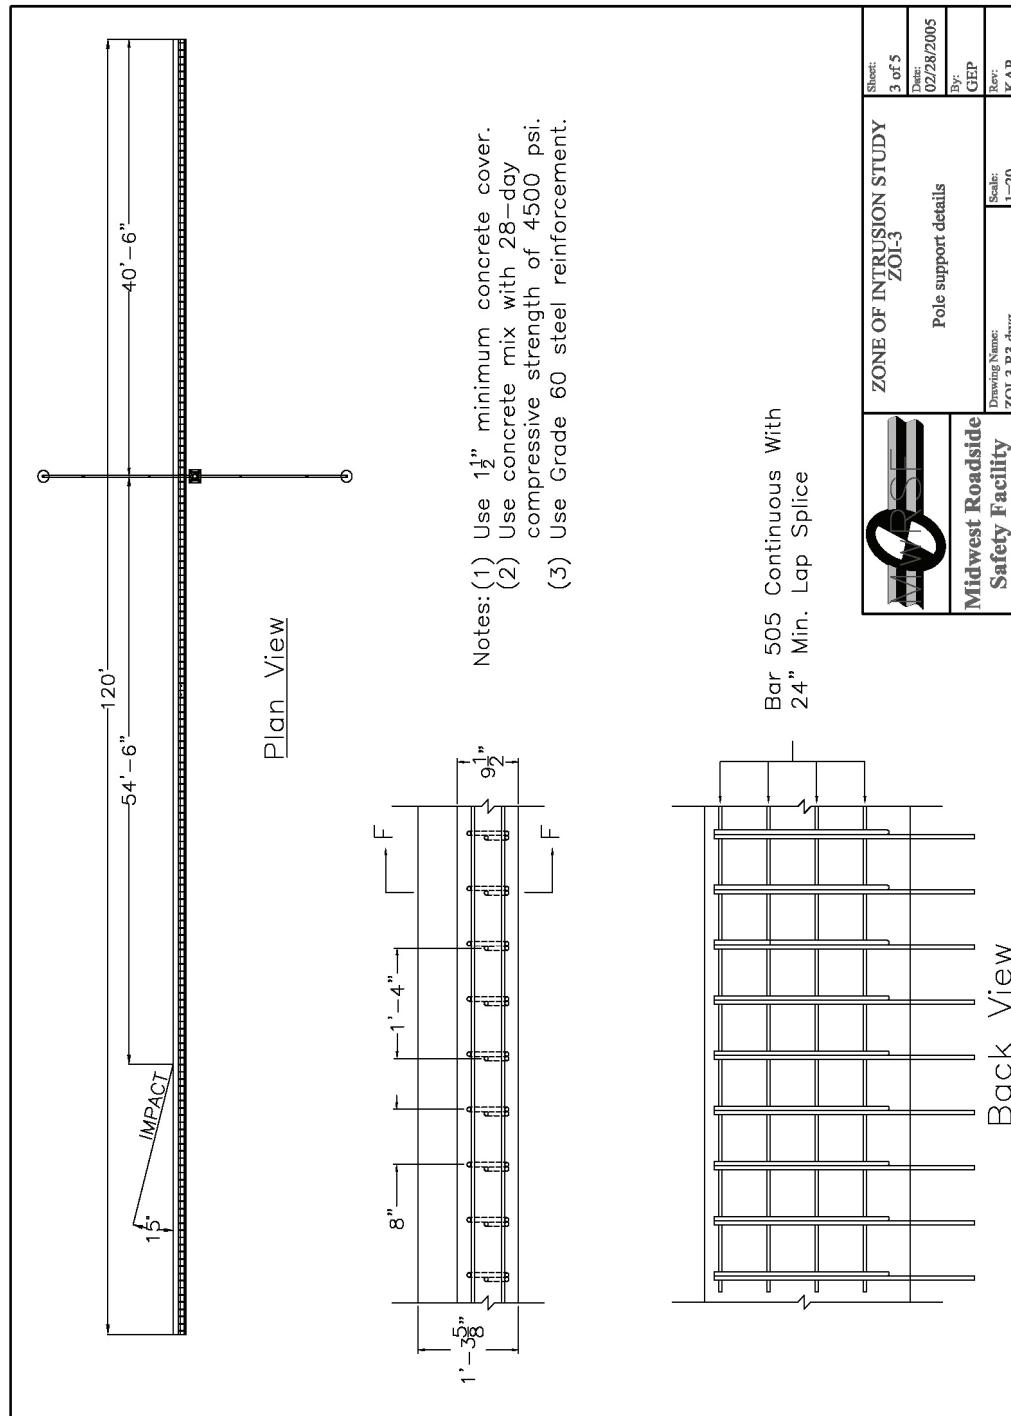
Figure H-3. Pole Support Details, Test No. ZOI-3 (English)

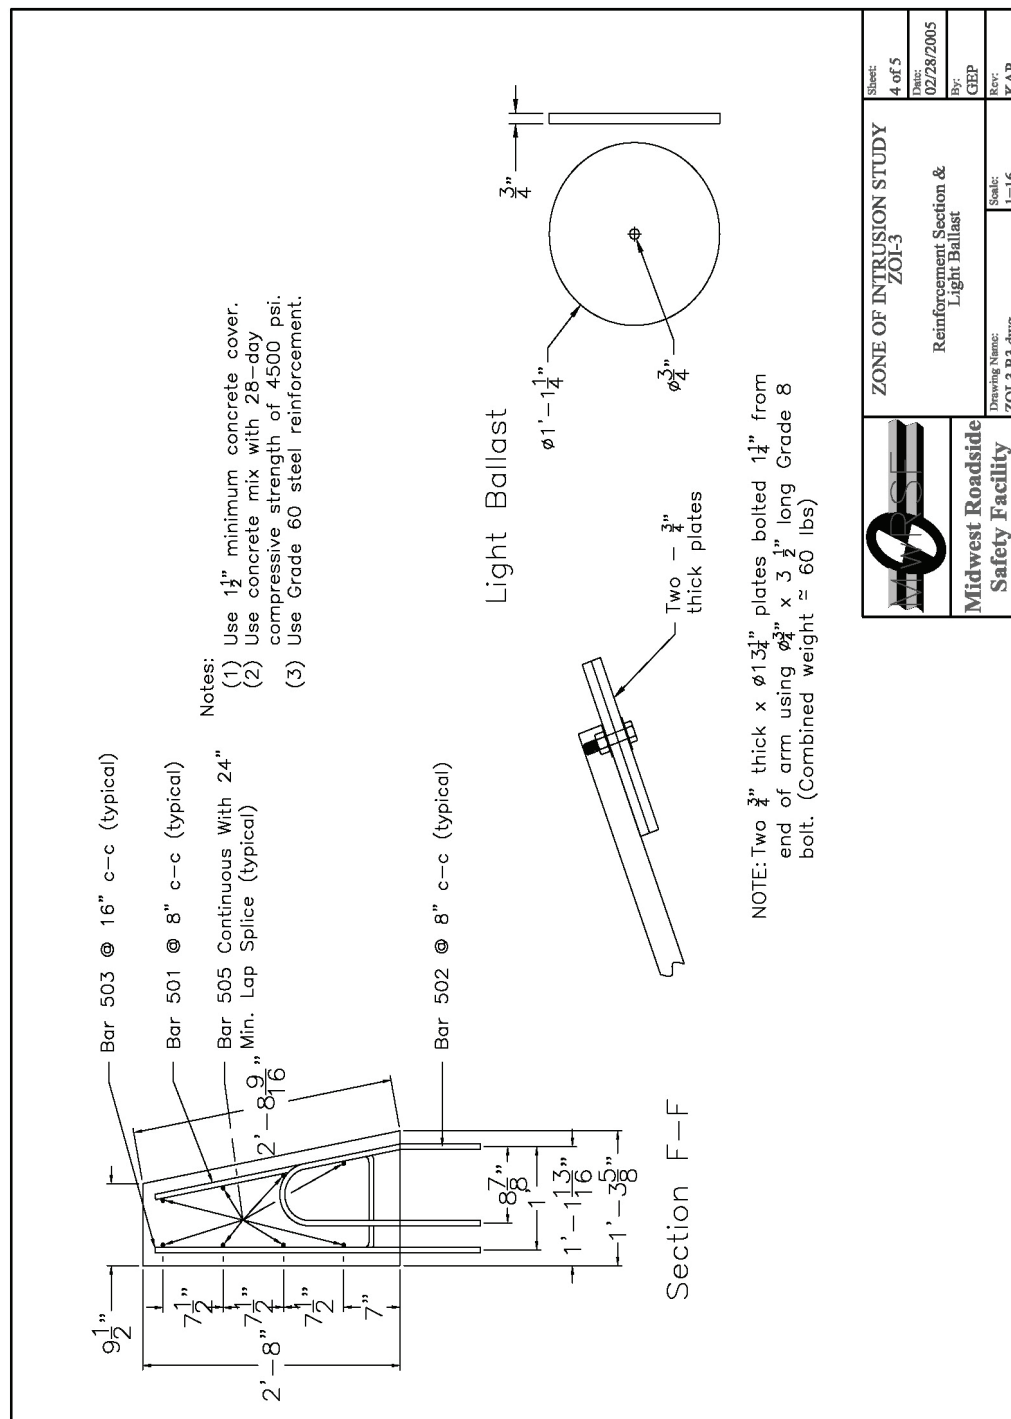
Figure H-4. Reinforcement Section and Light Ballast, Test No. ZOI-3 (English)

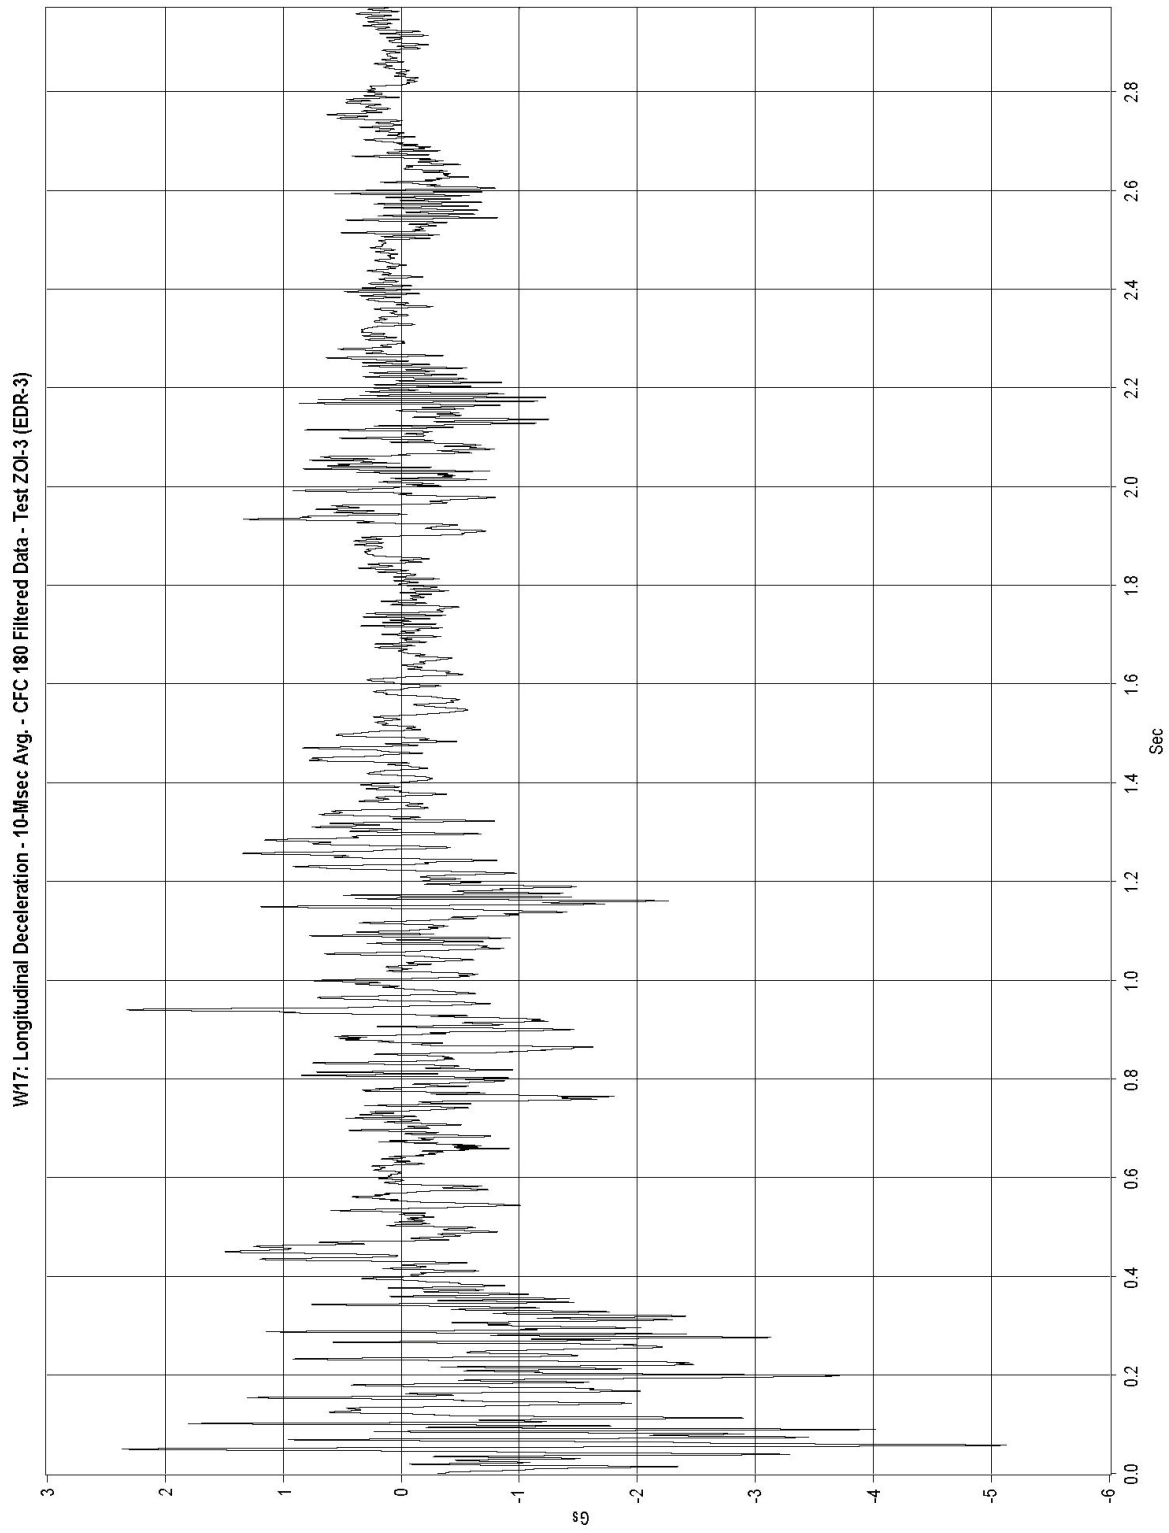
Figure J-1. Graph of Longitudinal Deceleration, Test ZOI-3

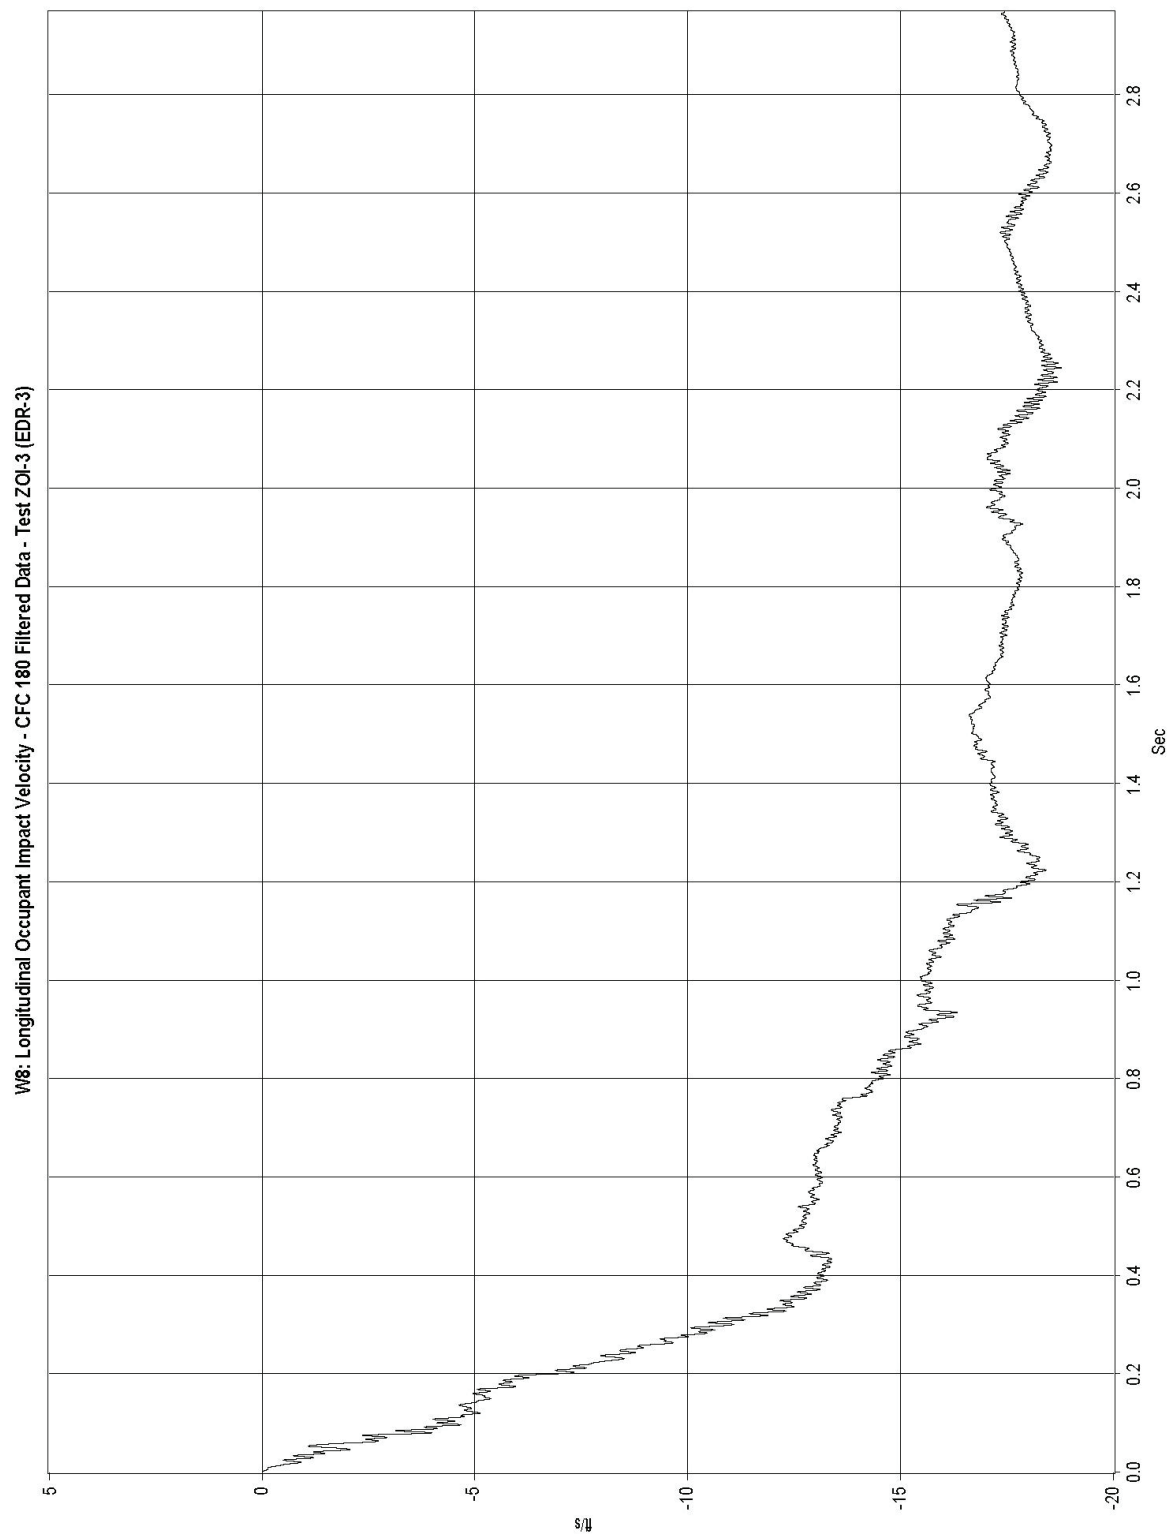
Figure J-2. Graph of Longitudinal Occupant Impact Velocity, Test ZOI-3

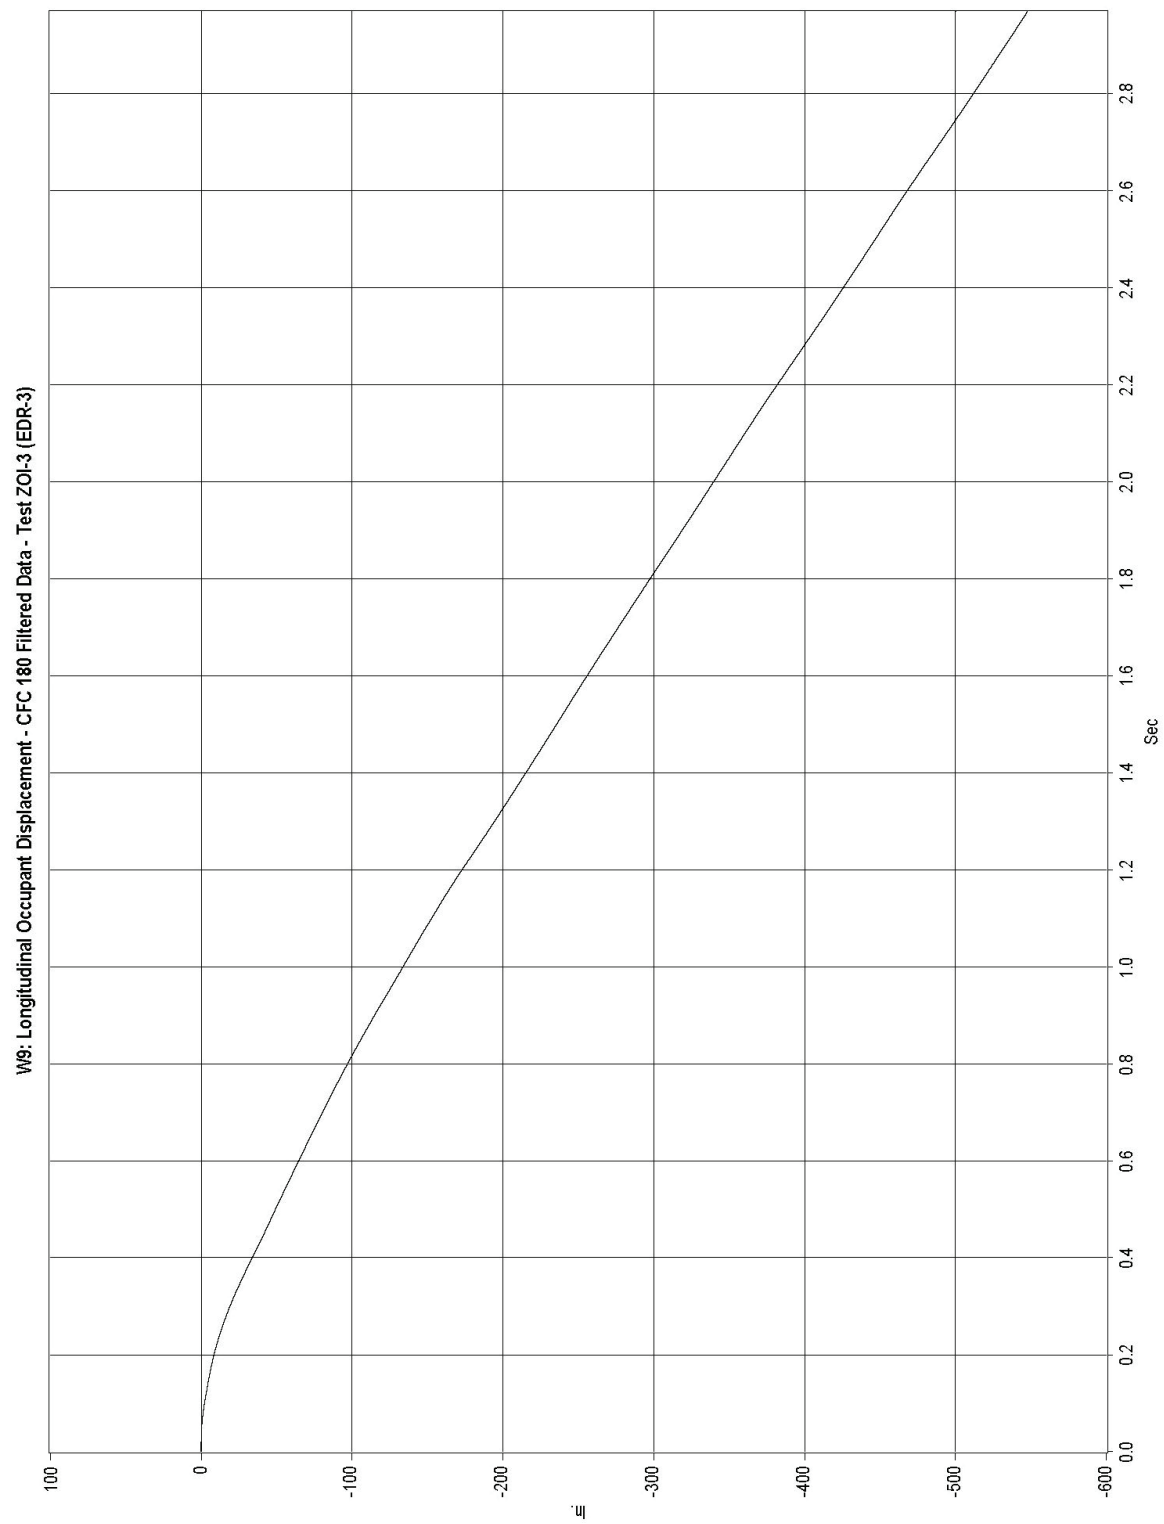
Figure J-3. Graph of Longitudinal Occupant Displacement, Test ZOI-3

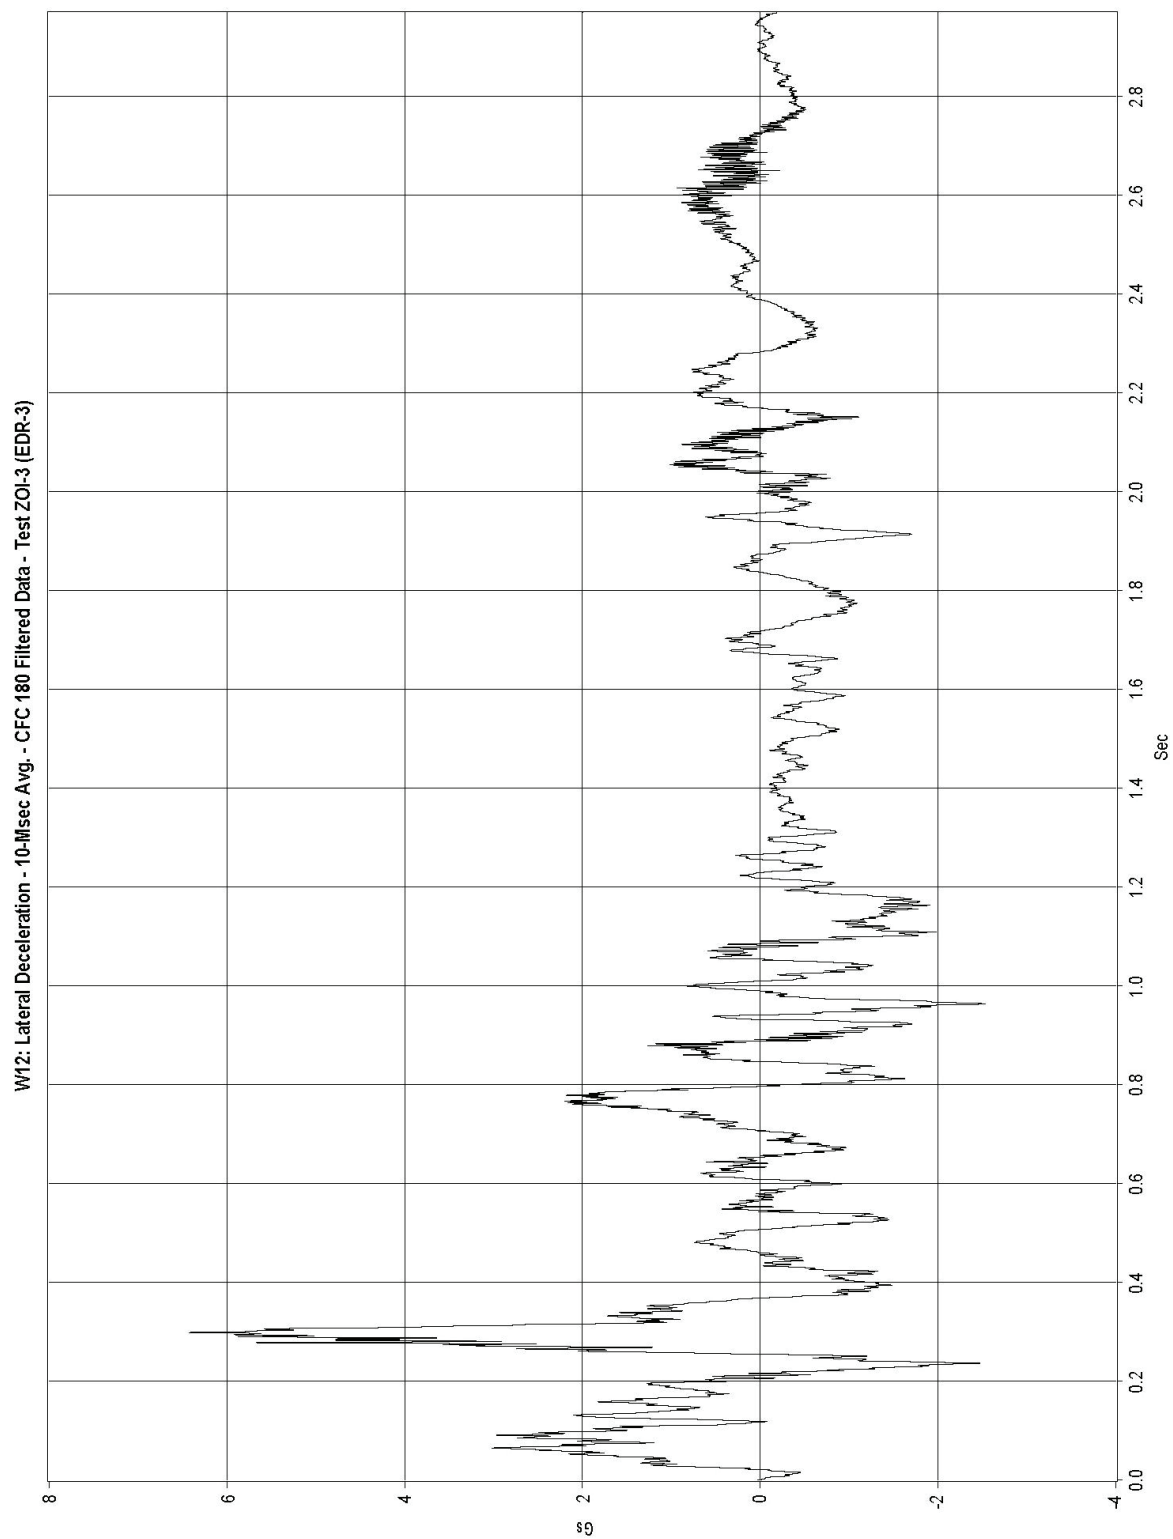
Figure J-4. Graph of Lateral Deceleration, Test ZOI-3

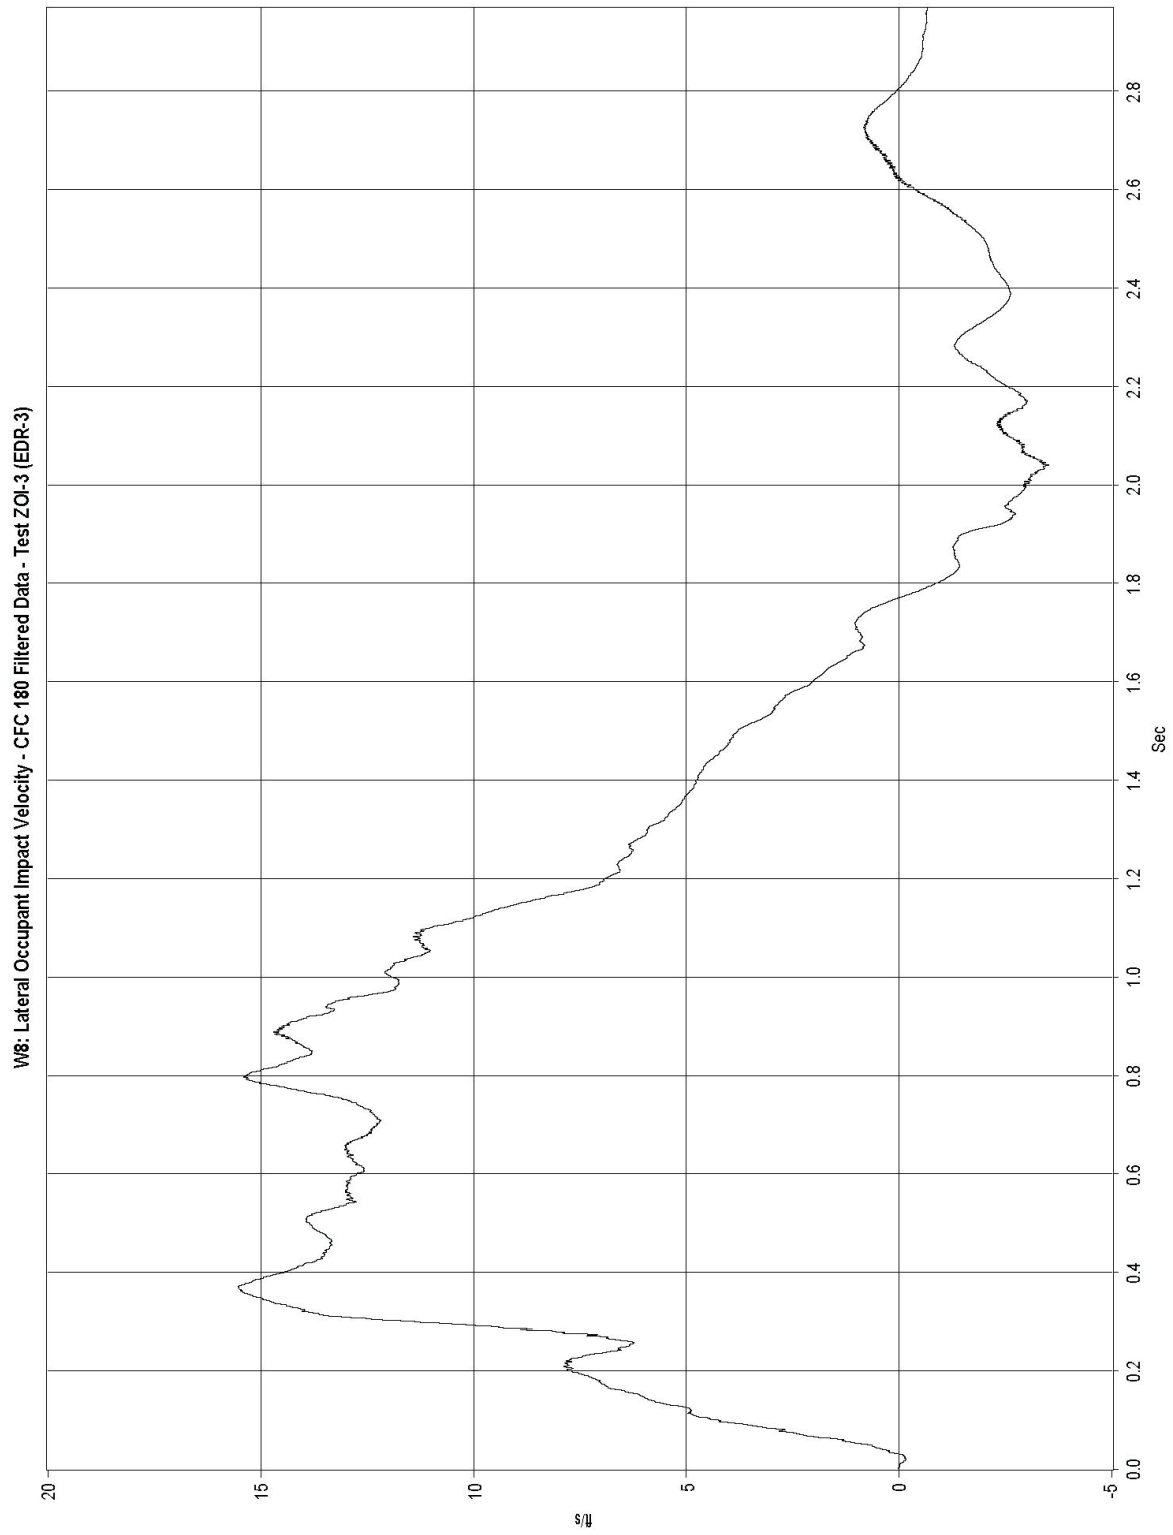
Figure J-5. Graph of Lateral Occupant Impact Velocity, Test ZOI-3

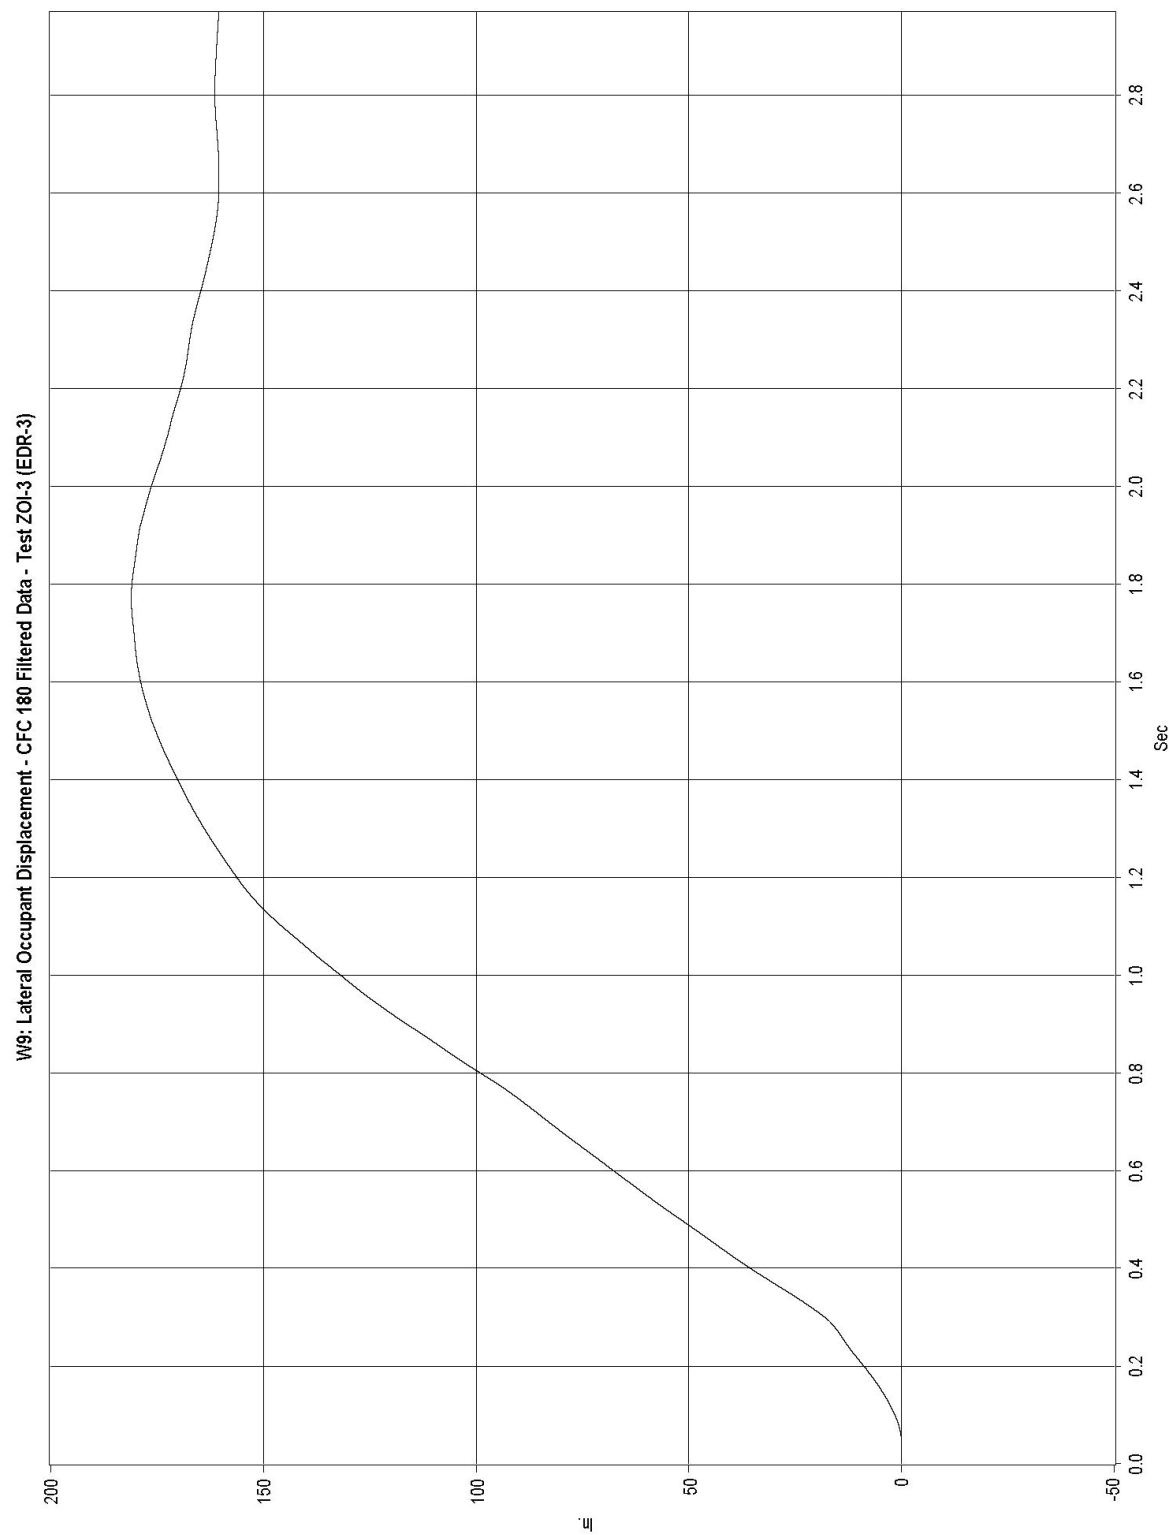
Figure J-6. Graph of Lateral Occupant Displacement, Test ZOI-3

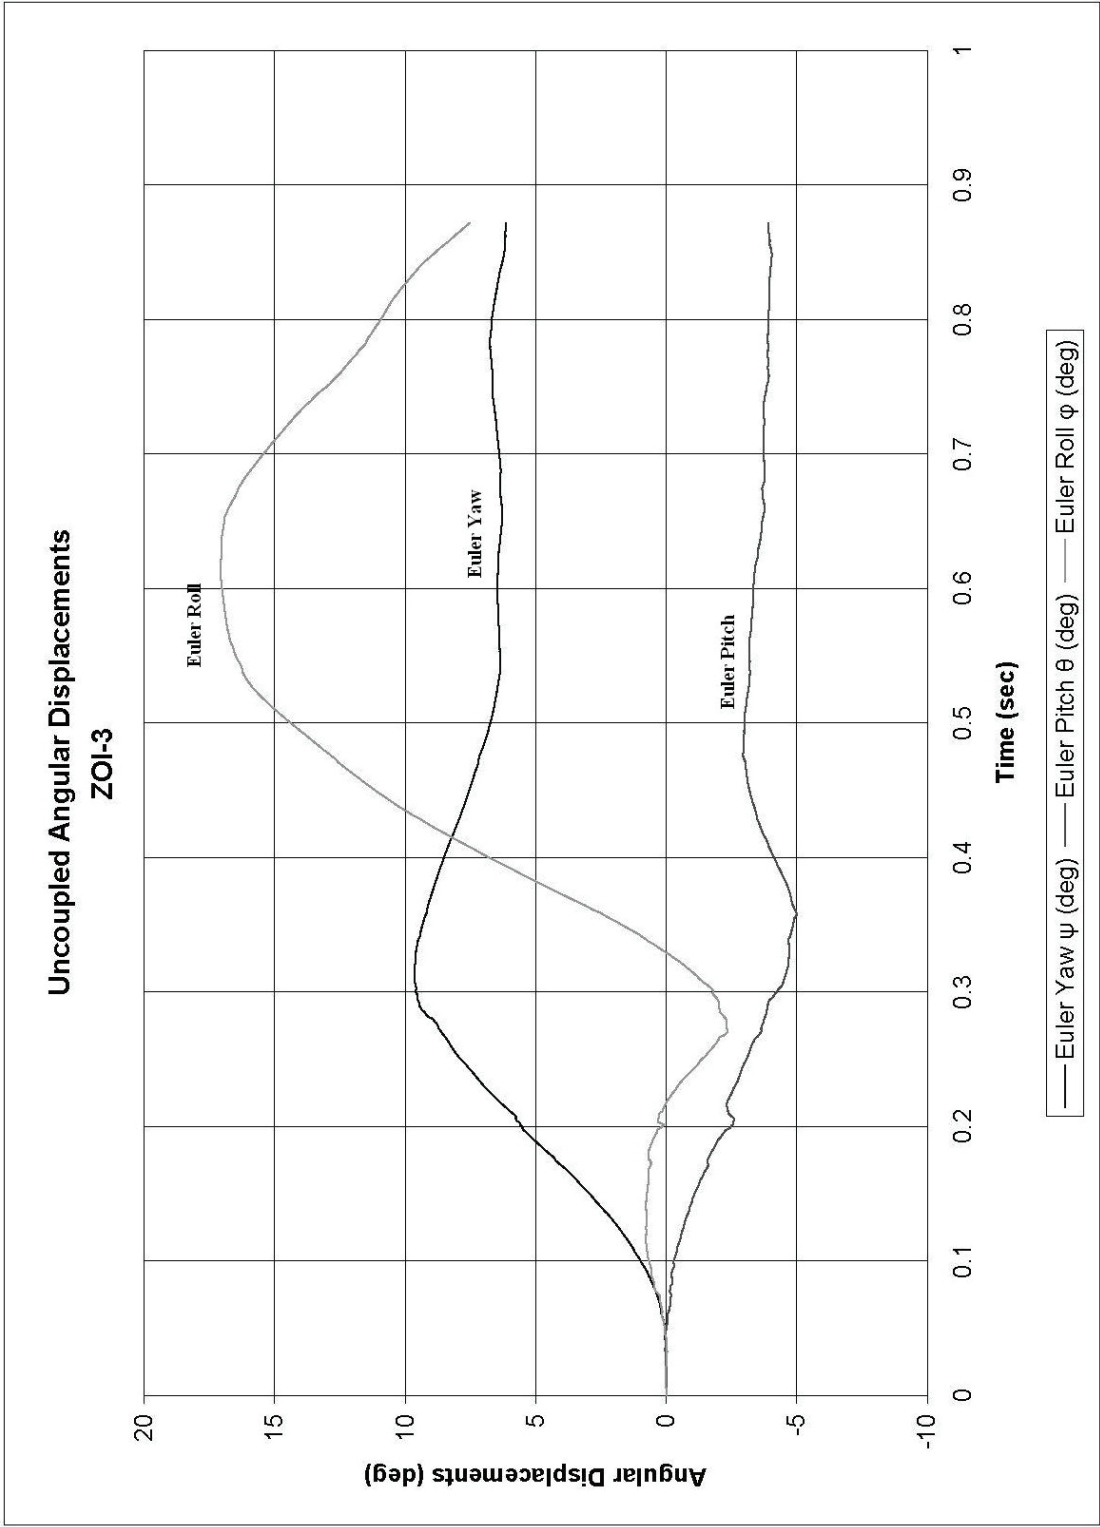
Figure J-7. Graph of Roll, Pitch and Yaw Angular Displacements, Test ZOI-3
