Design and Testing of a Dual Support Breakaway Sign

4. Title and Subtitle Design and Testing of a Dual Support Breakaway Sign		
5. Author(s) Paulsen, G.W., Pfeifer, B.G., Holloway, J.C., and Reid, J.D.		
6. Performing Organization Name and Address Midwest Roadside Safety Facility (MwRSF) Civil Engineering Department University of Nebraska - Lincoln 1901 Y St., Bldg C Lincoln, Nebraska 68588-0601 (402) 472-6864

9. Abstract <p>The Missouri Highway Transportation Department (MHTD) has been using a dual leg breakaway roadside sign supports with a perforated tension fuse plate. A very important feature of this system is the ability of its support to release upon impact and swing up and out of the way when impacted by an errant vehicle. Another critical feature of the sign system is its ability to withstand wind loads without causing structural damage to the system. A modified dual support breakaway sign system is proposed which improves both of these criteria.</p> <p>Recently, MHTD added a multi-directional slip base to the breakaway sign design details. MHTD wished to evaluate the performance of the multi-directional slip base and the dual support breakaway system when impacted by a

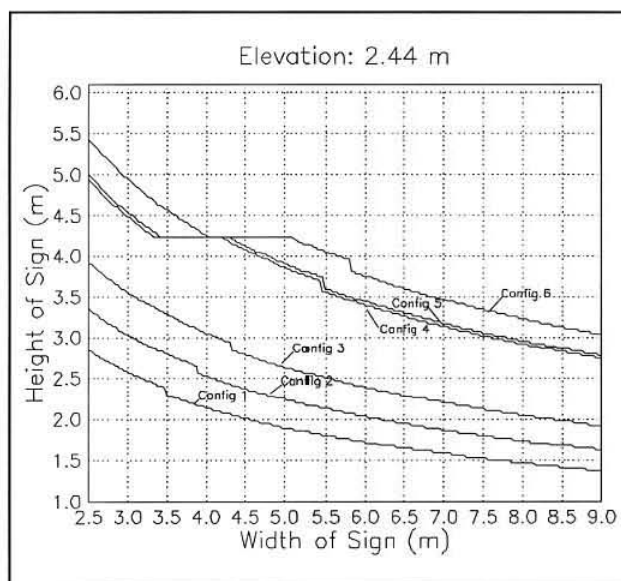
The Wind Load Charts show the maximum sign size each post configuration can withstand based on the fuse plate material and the elevation height (also known as clearance height). Equations 1-4 and Tables 1-3 can be used to construct wind load charts for any variety of fuse plate material and clearance height. One such example, for an A36 steel fuse plate with a sign elevation of 2.44 m (8 ft) is shown in Figure 3. The different lines on the figure represent the different post size configurations listed in Table 3. Note that the sign systems in this study are all dual post configurations.

Figure 3. Wind Load Chart.

The Wind Load Charts are used by finding the point on the chart corresponding to the height and width of the sign which is of interest. The curve directly above this point represents a post configuration with an accompanying fuse plate that will support the wind loads incurred with a sign of such a size. For example, if you plan to install a sign that has a clear height of 2.44 m (8 ft) and is 4.88 m (16 ft) wide and 2.44 m (8 ft) high, then the Wind Load Chart specifies the use of 2-No. 3 posts.

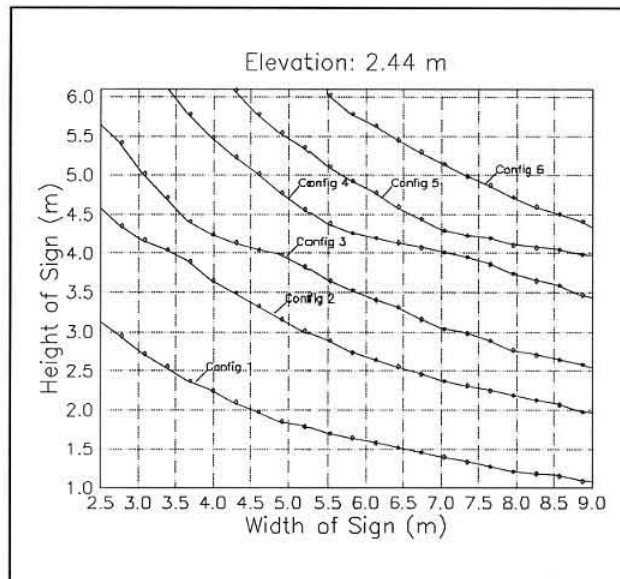
The Missouri Post Design Charts (7) are currently used by MHTD to determine the proper post configuration for a certain sign size. There are several charts to use depending on the elevation, or *clear height* of the sign. Figure 4 shows one such chart for a clearance height of 2.44 m (8 ft). Once again, the chart shown depicts only dual leg sign systems. This chart is used in the same manner as the Wind Load Charts.

Figure 4. Missouri Post Design Charts.

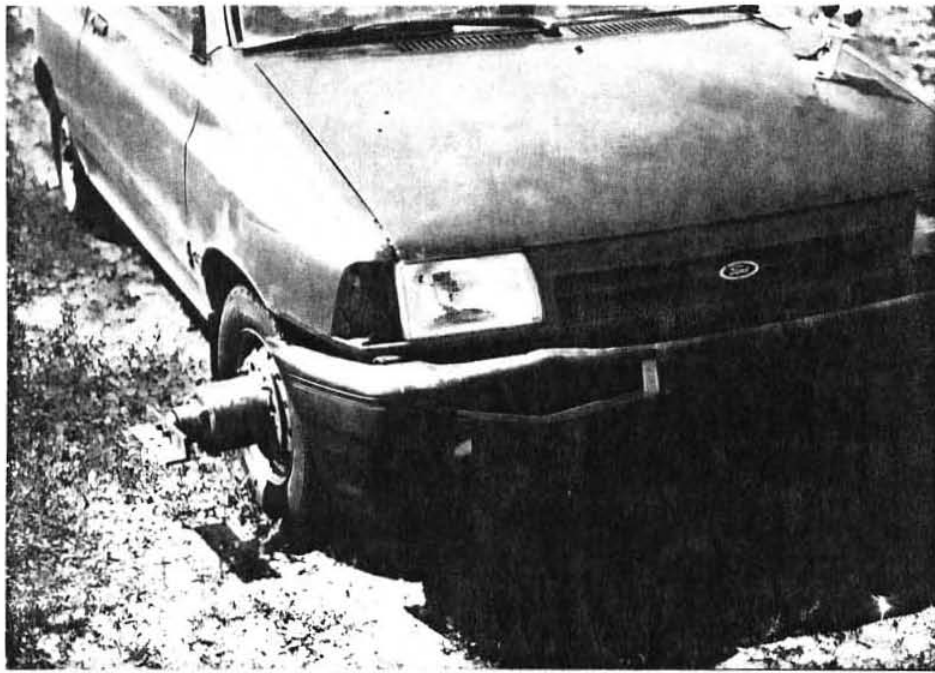
Figure 12. Test Vehicle Damage, MO3-1.

Figure 12 shows the damage to the vehicle, which consisted of a maximum crush depth of 13 mm (0.5 in.) in the bumper. No other damage occurred to the vehicle and the bumper was replaced for test MO3-2. Damage to the sign is shown in Figure 13. The impacted support and corresponding fuse plate were destroyed when the hinge mechanism activated. The other support deformed during impact as the rest of the sign system rotated about it during impact. Both sign supports and fuse plates had to be replaced for the second test. The sign panel was replaced as well, even though it was undamaged.

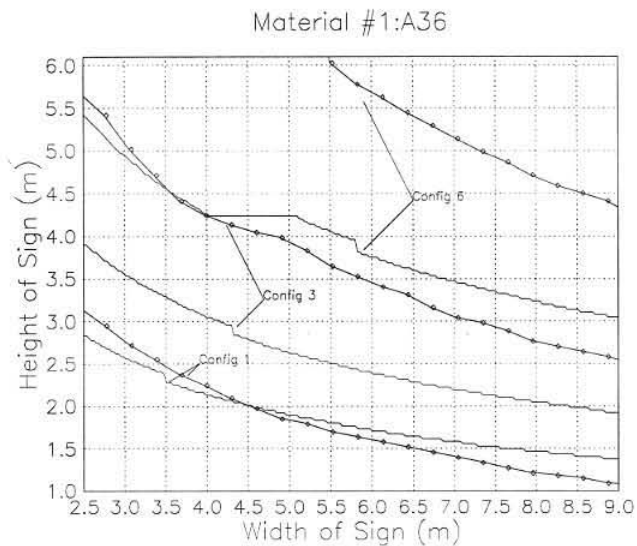
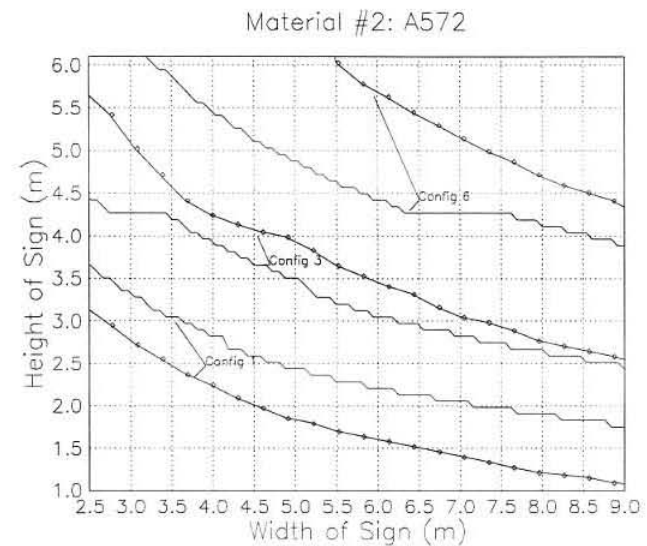
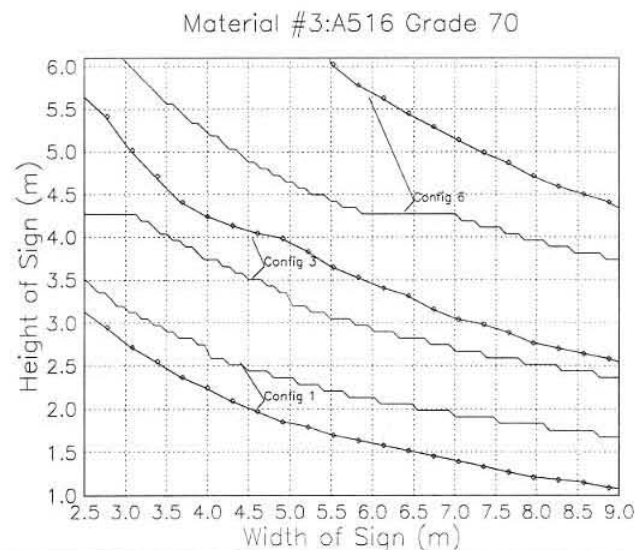
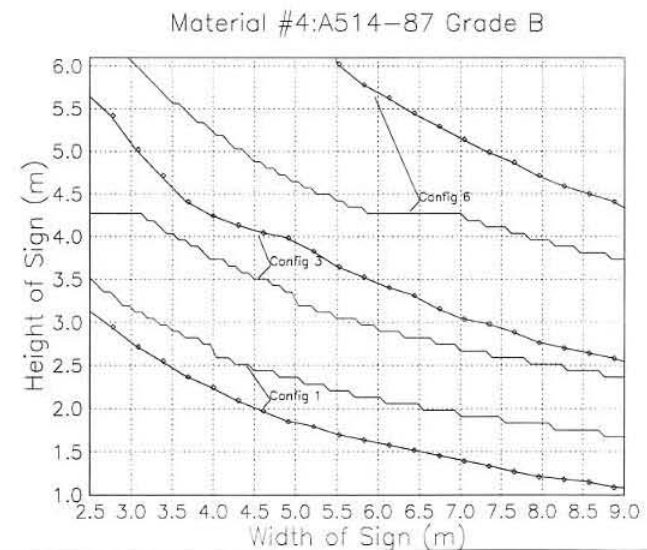
Figure A-1. Wind Load Charts, Elevation Height 2.44 m
Missouri chart lines have markers.

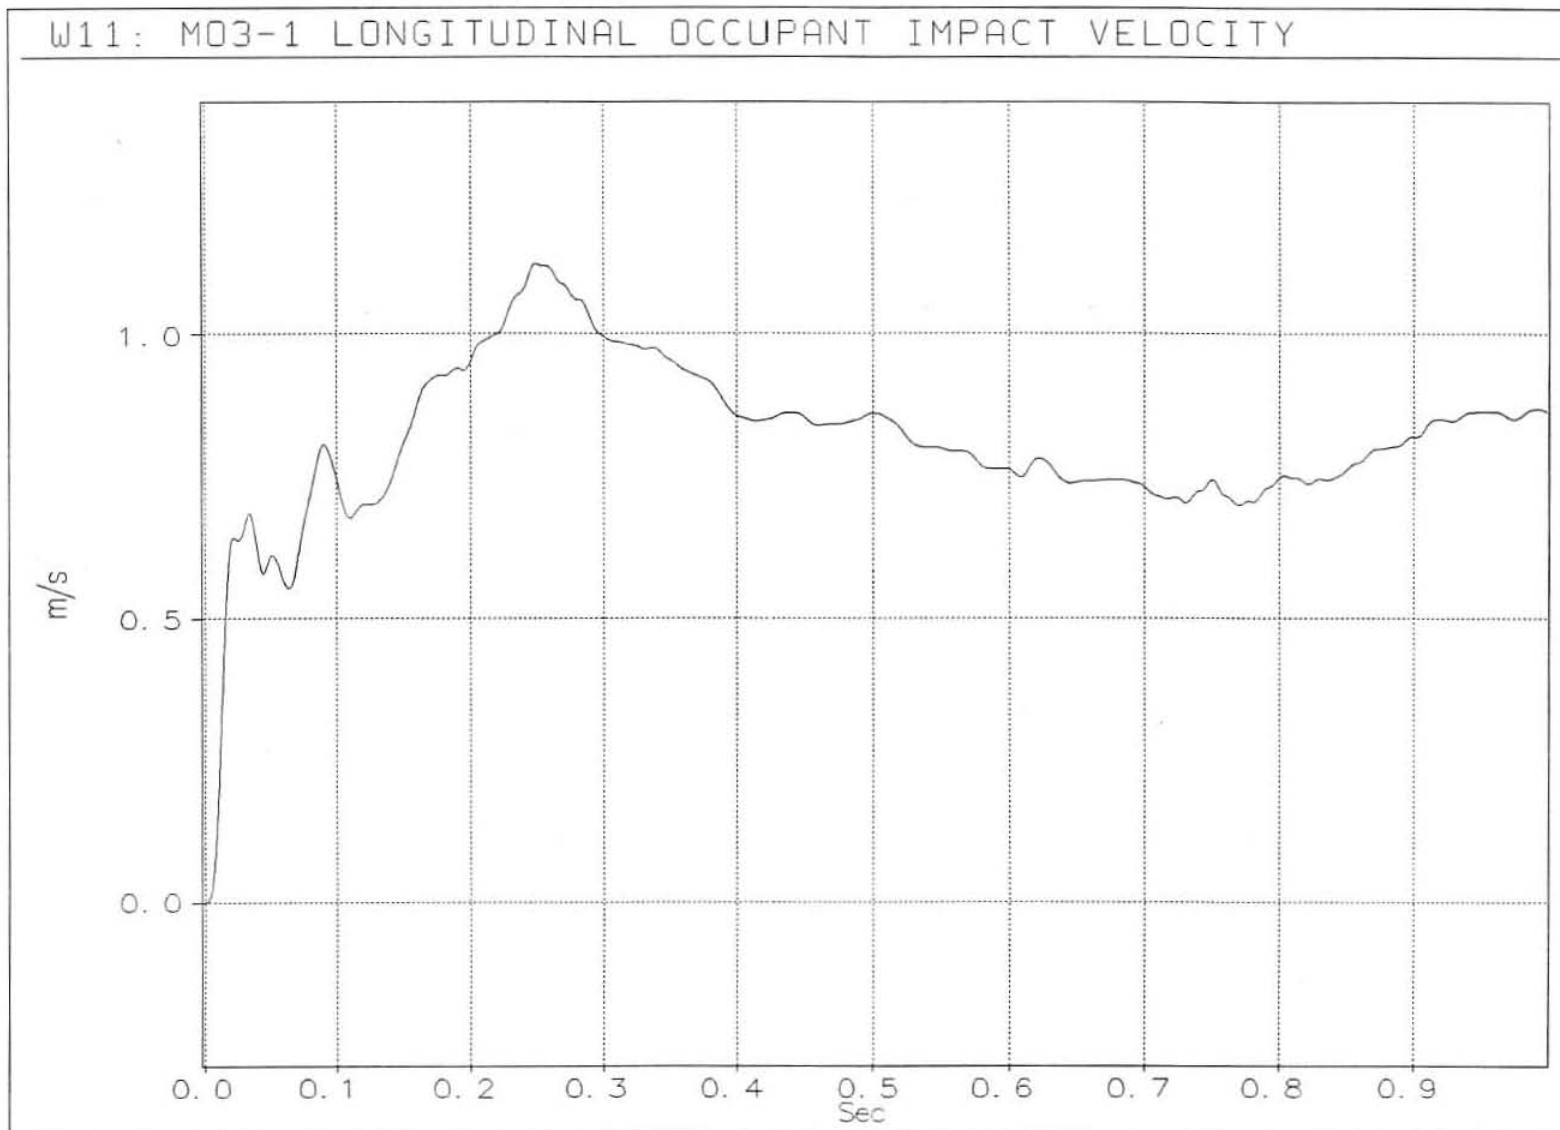
Figure C-2. Longitudinal Occupant Impact Velocity - Test MO3-1

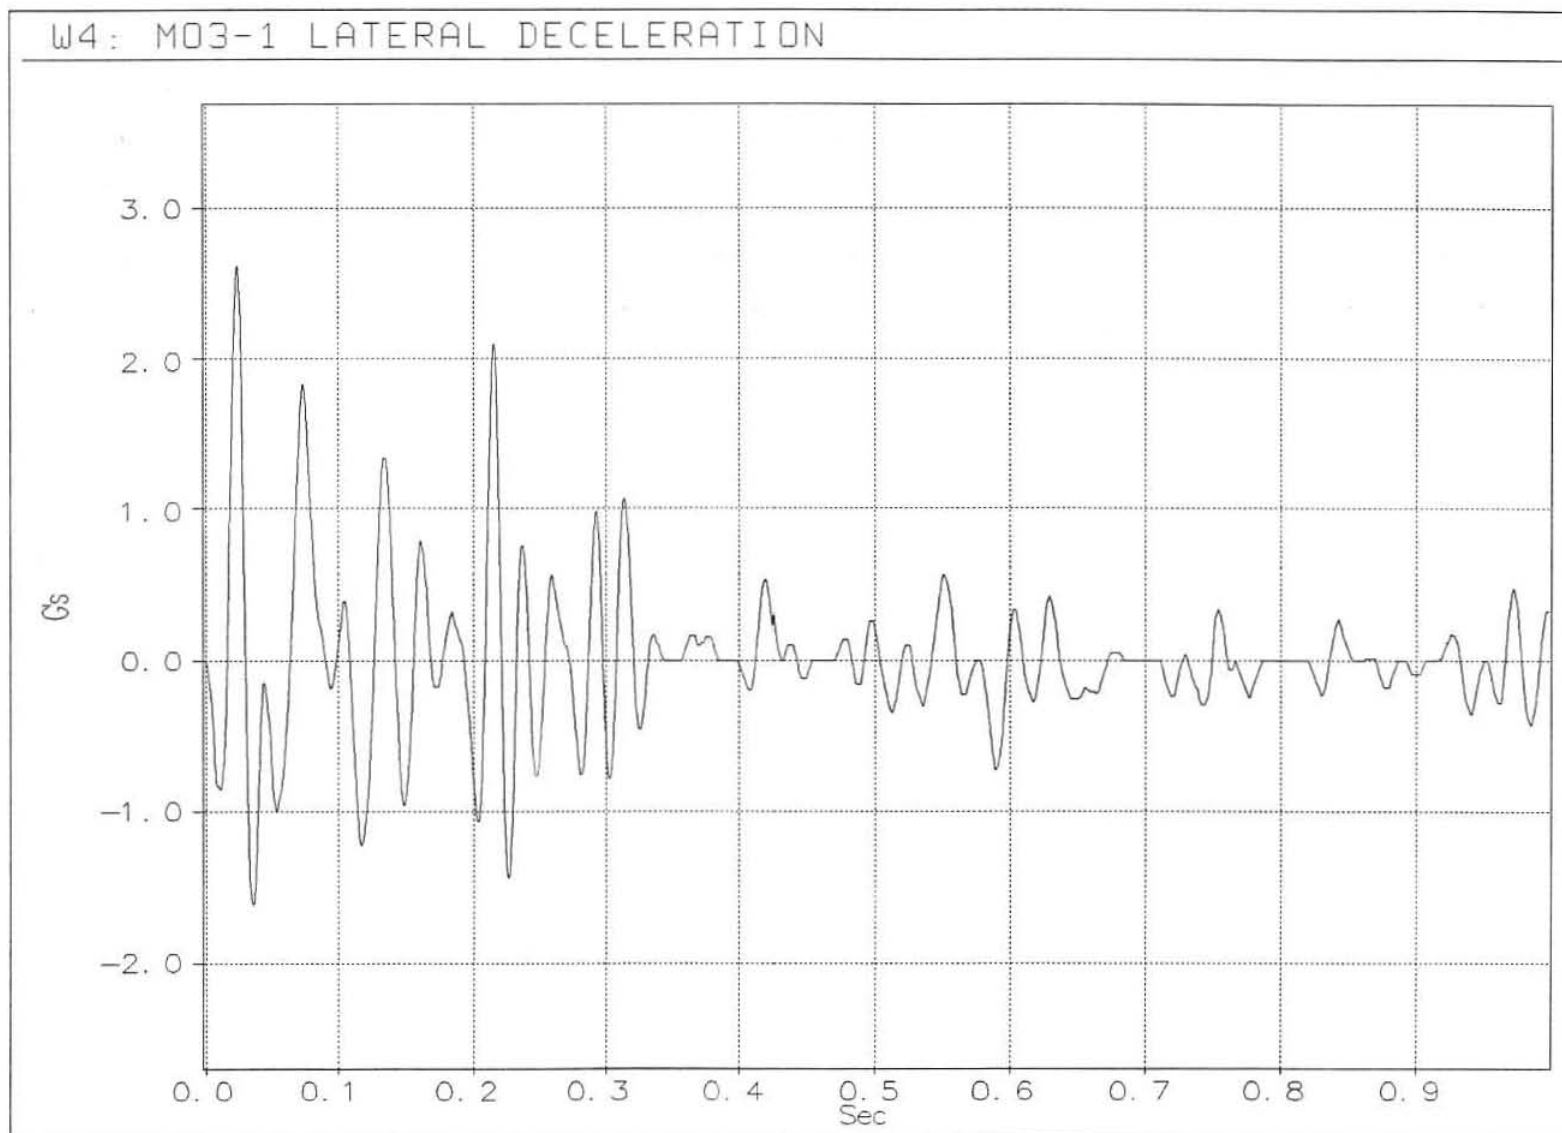
Figure C-3. Lateral Deceleration - Test M03-1

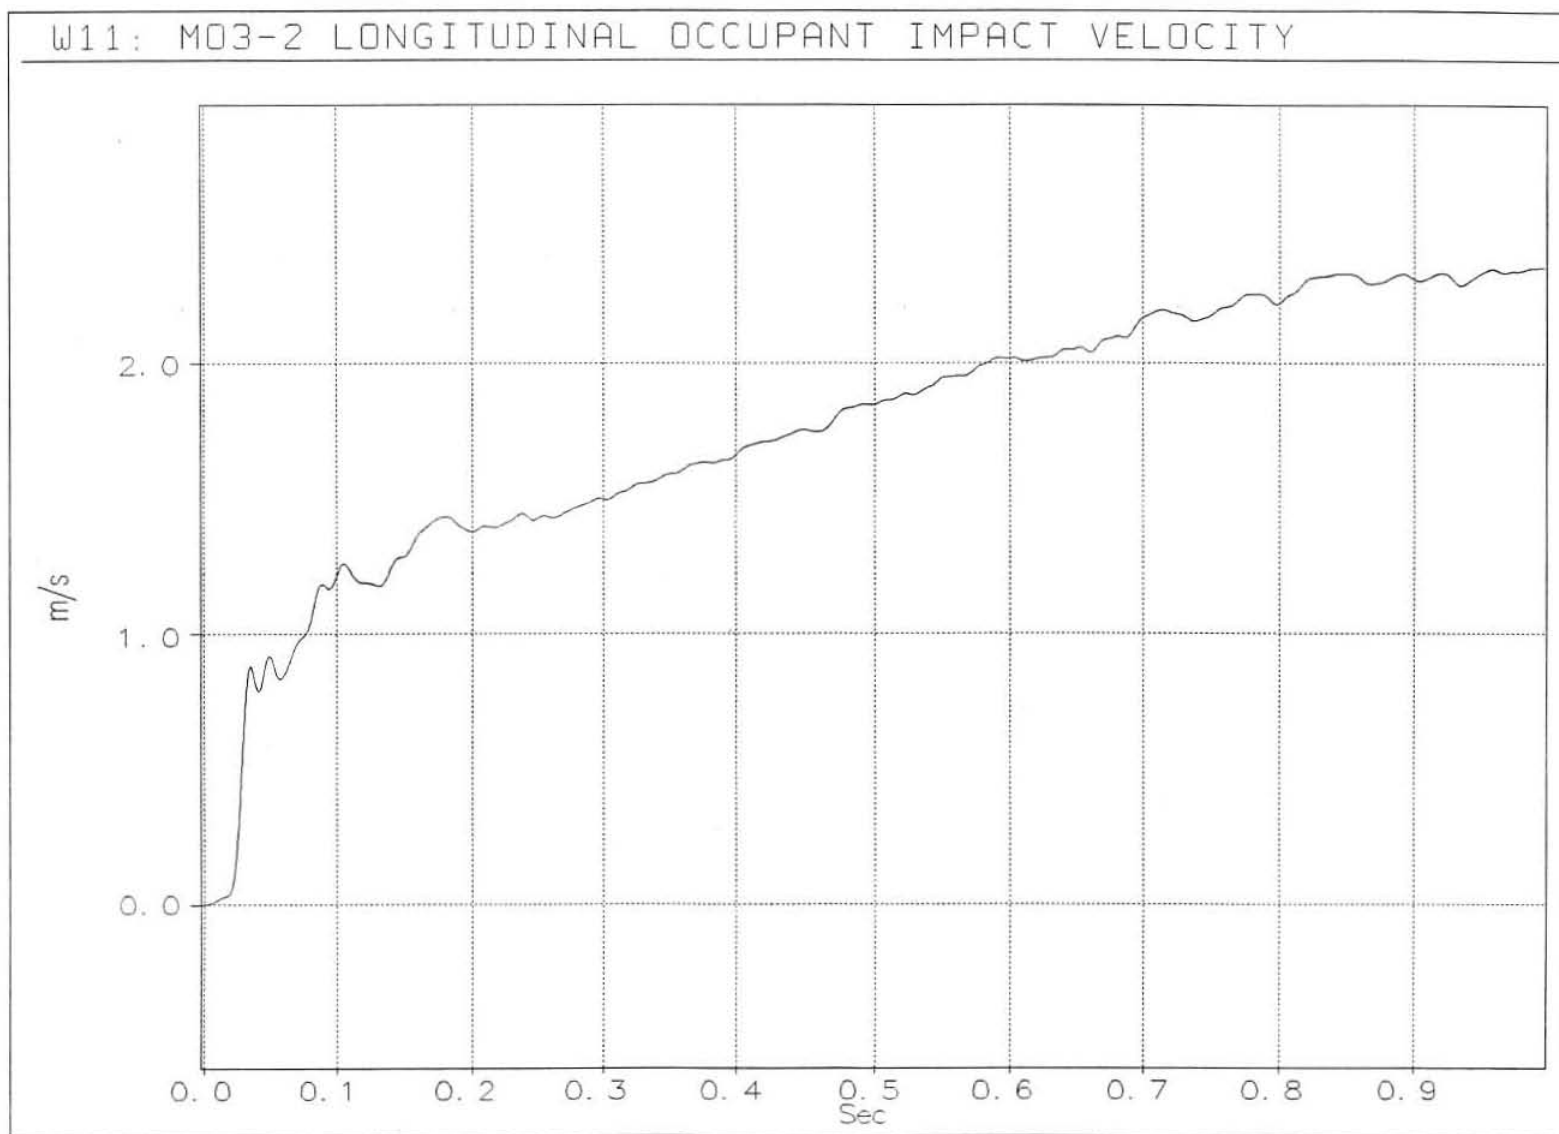
Figure C-6. Longitudinal Occupant Impact Velocity - Test MO3-2
