# DEVELOPMENT OF AN ECONOMICAL GUARDRAIL SYSTEM FOR USE ON WIRE- FACED, MSE WALLS

Publication No. FHWA-CFL/TD-12-009

FEBRUARY 2012

**CENTRAL FEDERAL LANDS HIGHWAY DIVISION  
12300 WEST DAKOTA AVENUE  
Lakewood, CO 80228**

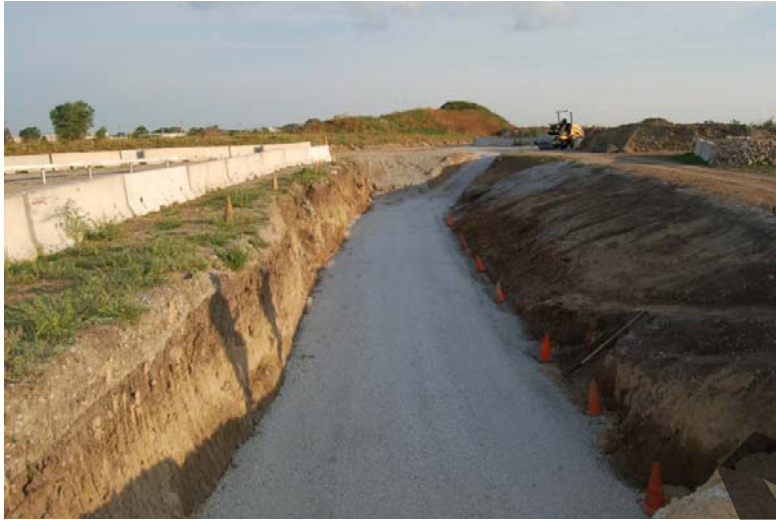
a. MSE Wall, Pit Base Layer

**Figure 31. Photo. Construction of Wire-Faced, MSE Wall.**

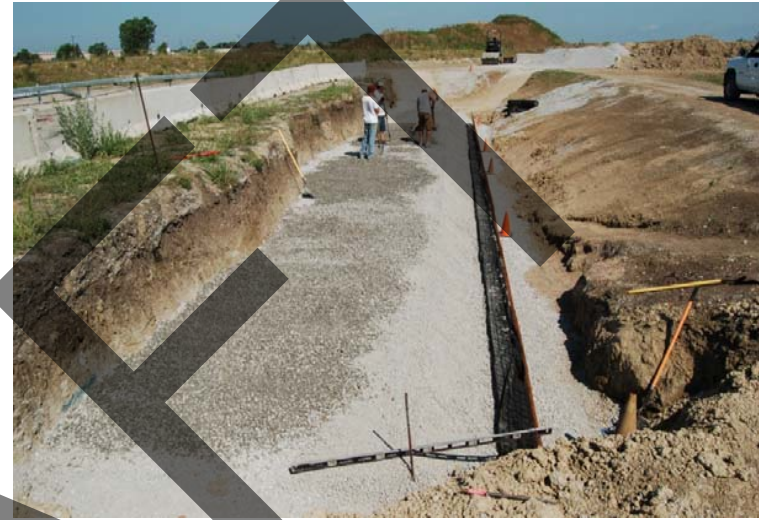
c. MSE Wall, First Fill Layer, Upstream View

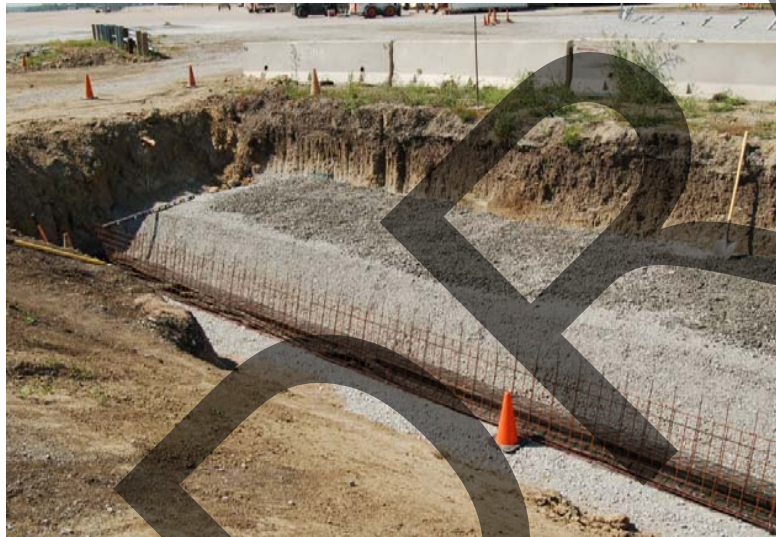
b. MSE Wall, First Fill Layer, Rear View

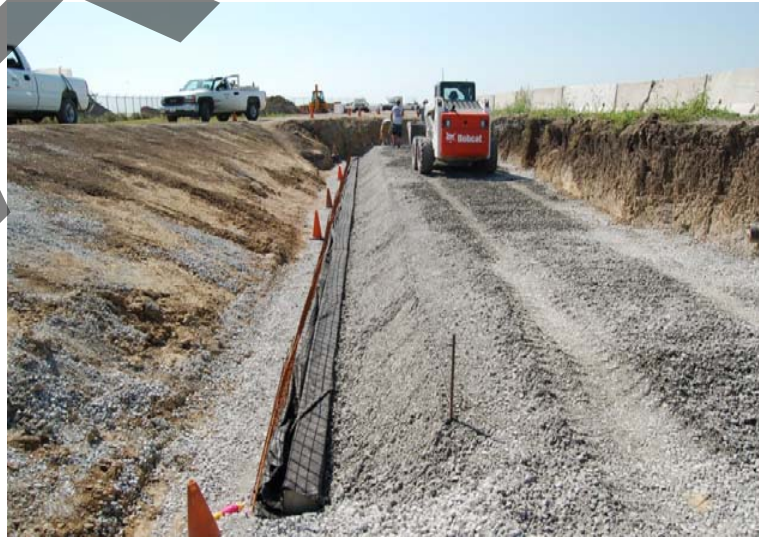
d. MSE Wall, First Fill Layer, Downstream View

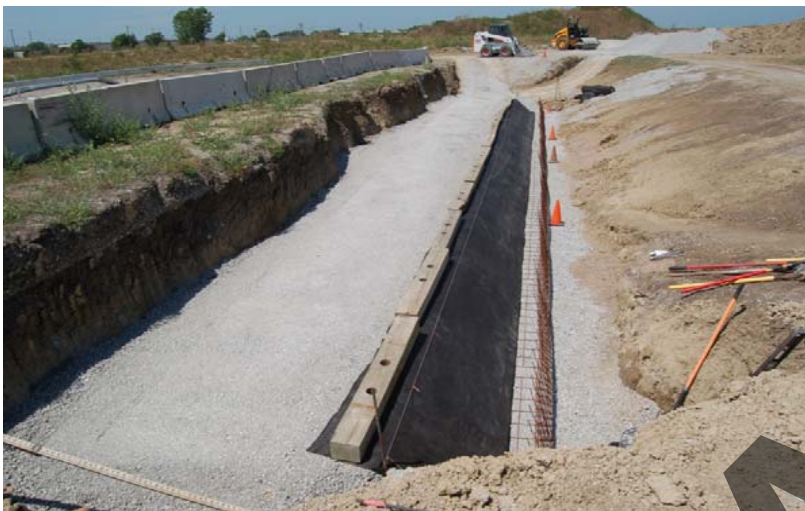
a. Filter Fabric Held by Posts

**Figure 32. Photo. Construction of Wire-Faced, MSE Wall. (continued.)**

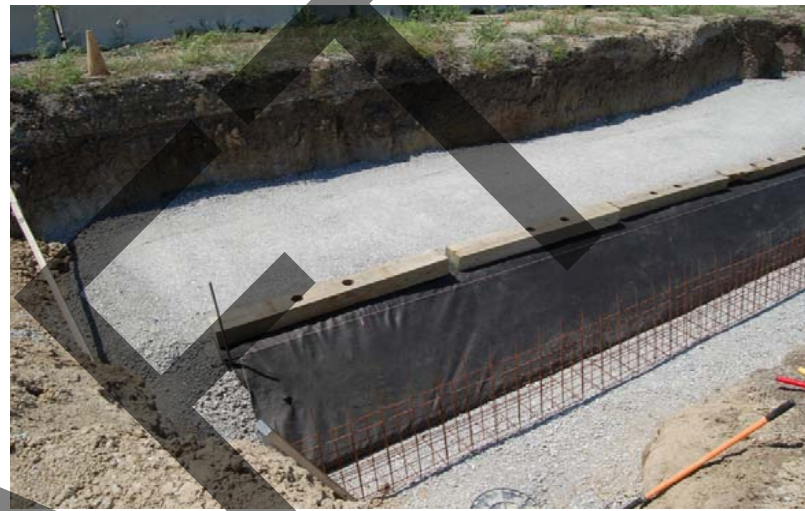
c. Filter Fabric Positioned

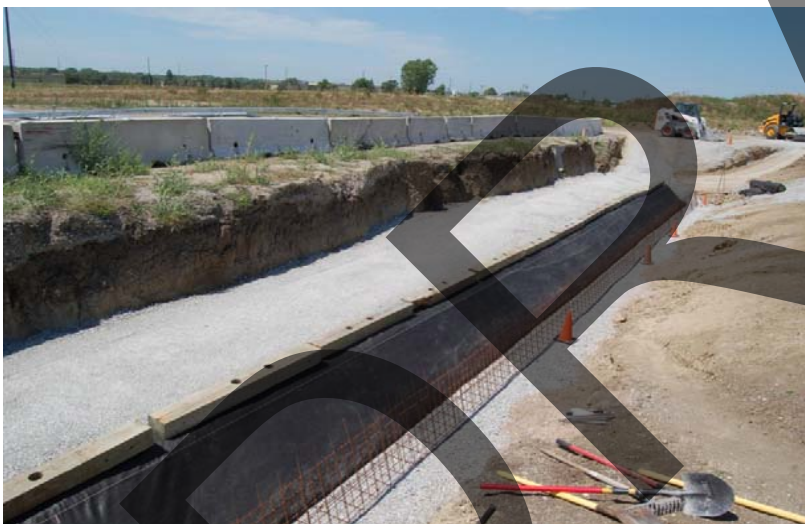
b. Fiber Filter Positioned, Ready for Course Aggregate

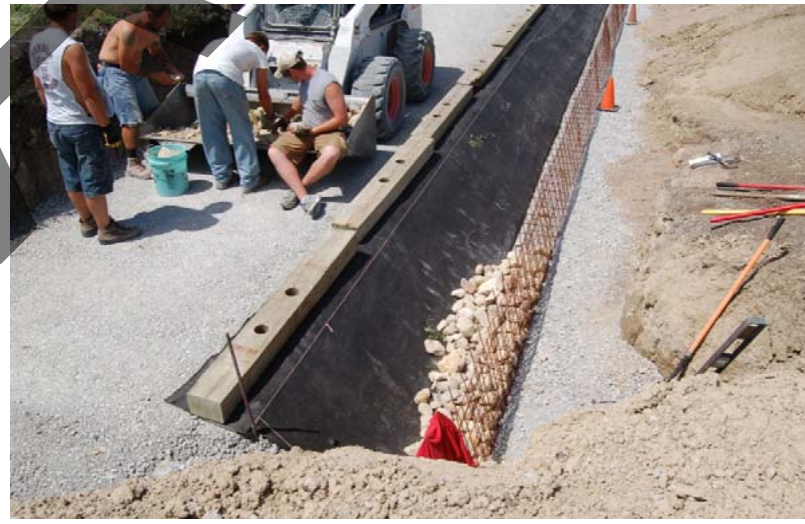
d. Wall Face Aggregate Filled by Hand

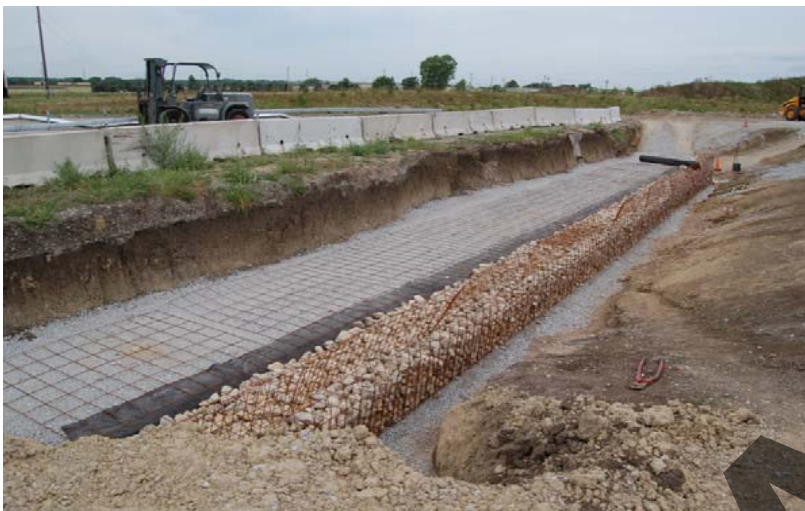
a. Second Layer Wire Mat Installed

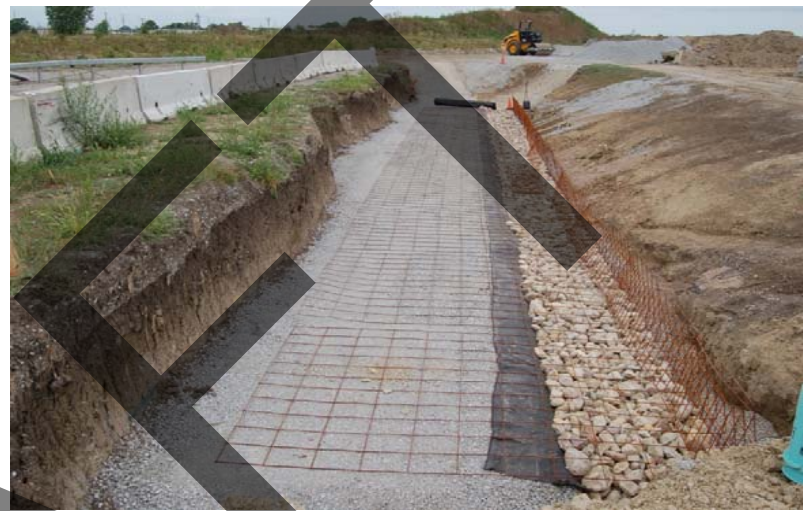
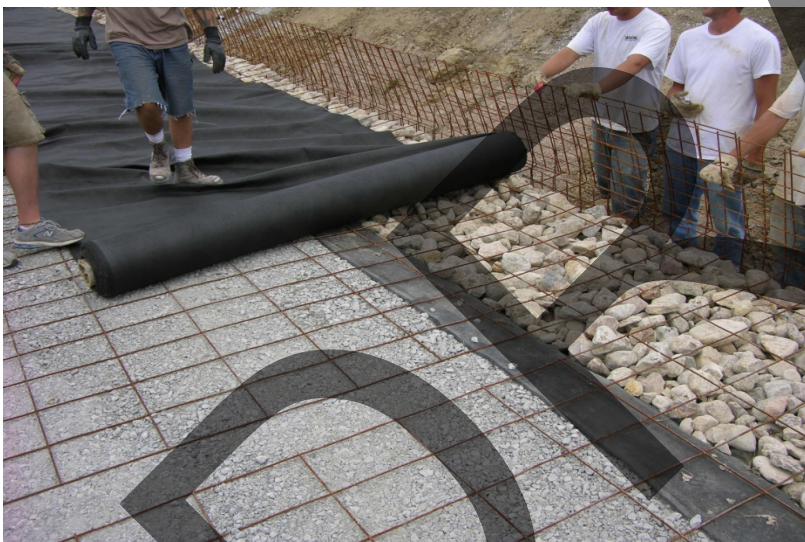
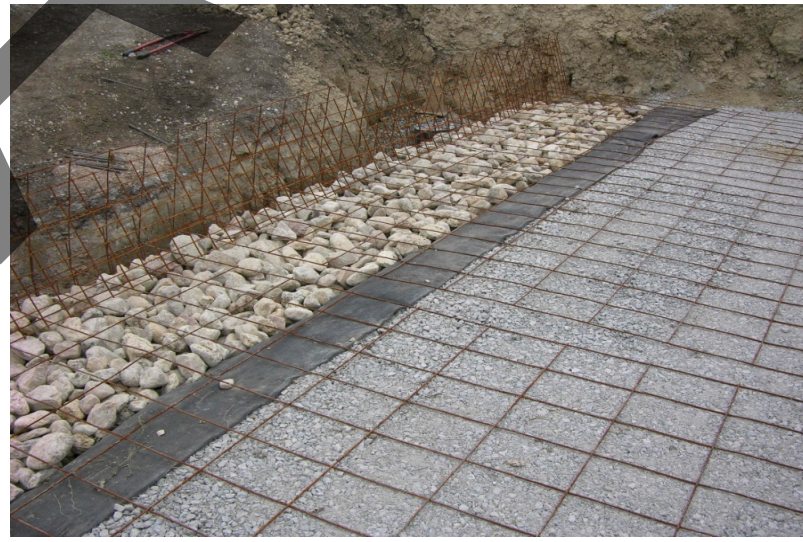
c. Wire Mat Final Allignment Before Filter Fabric

b. Rolling Out Fiber Filter

d. Second Layer Wire Mat Installed, Upstream End

**Figure 33. Photo. Construction of Wire-Faced, MSE Wall. (continued.)**

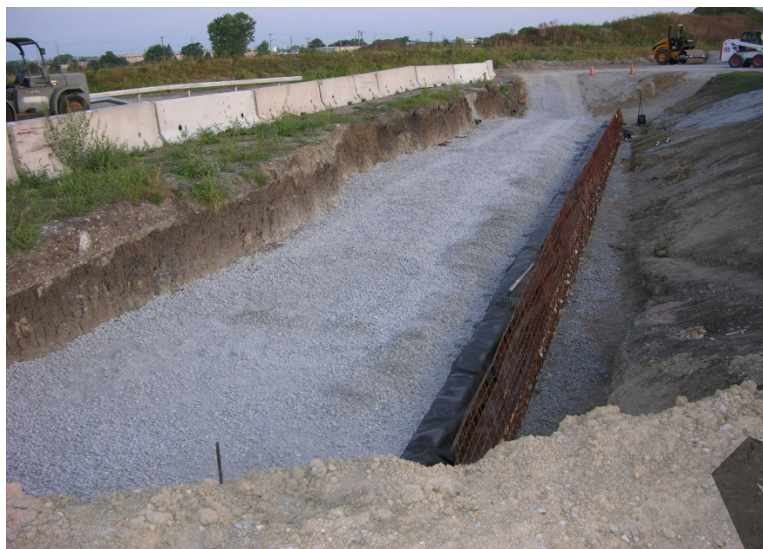
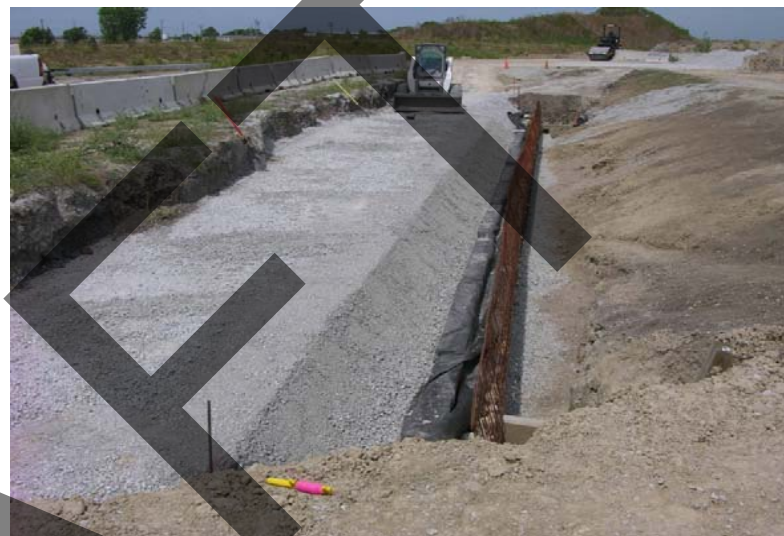
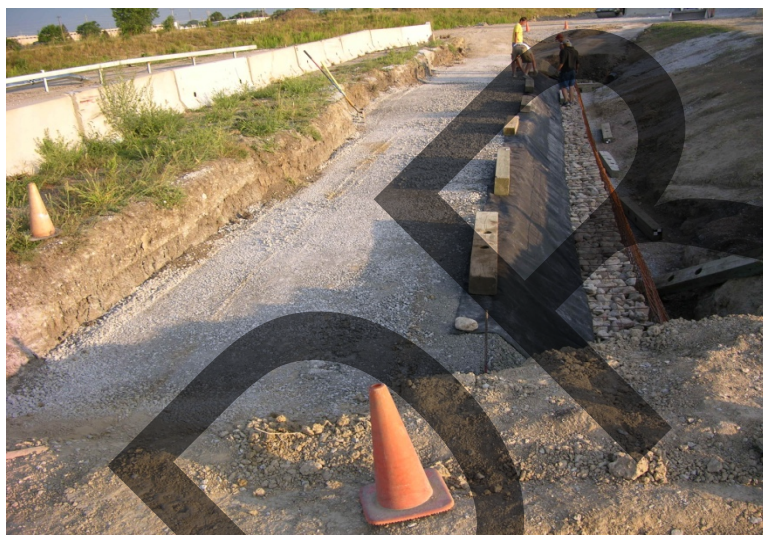
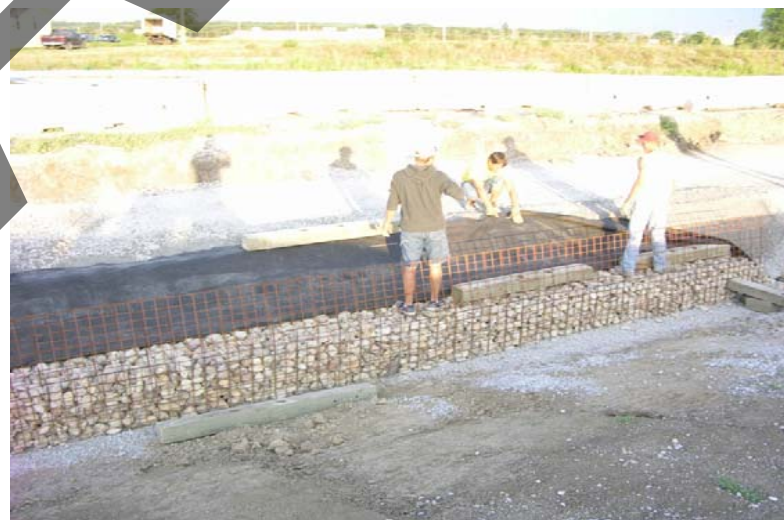
a. MSE Wall, Second Layer, Uncompacted

c. MSE Wall, Second Layer, Leveling

b. MSE Wall, Second Layer With Fiber Filter

d. Second Layer Fiber Filter Positioning

**Figure 34. Photo. Construction of Wire-Faced, MSE Wall. (continued.)**

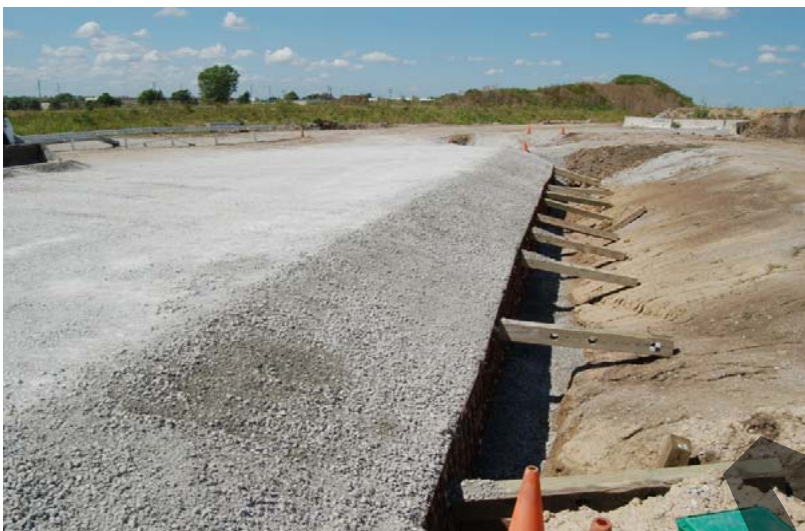
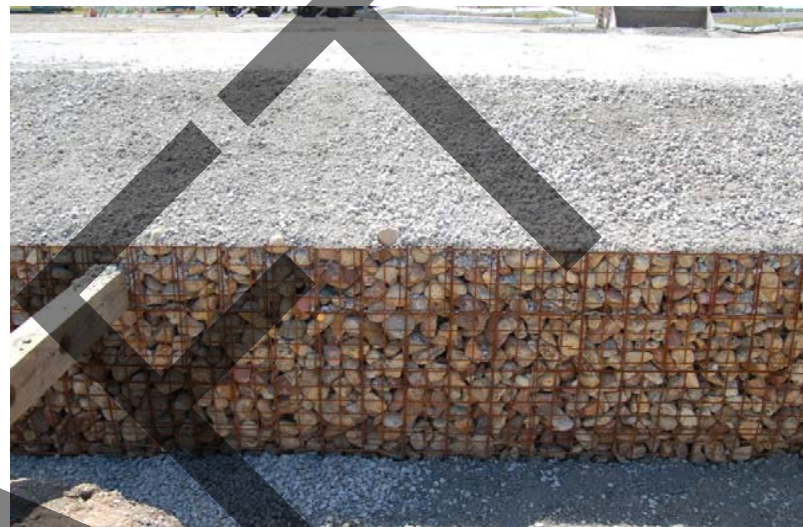
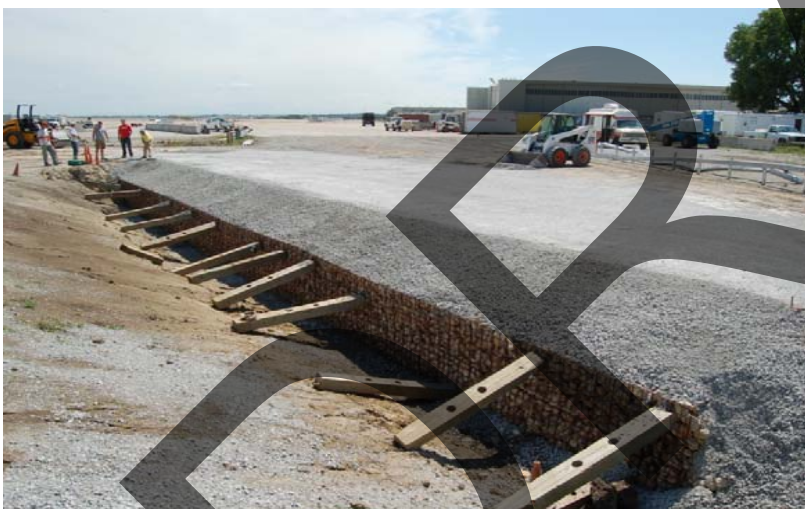
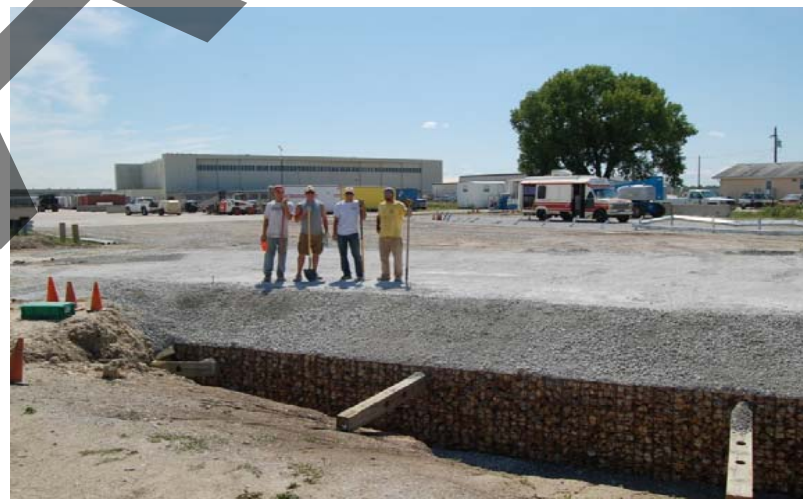
a. MSE Wall, Upstream View

c. MSE Wall Stone Face

b. MSE Wall, Downstream View

d. MSE Wall. Back View

**Figure 35. Photo. Construction of Wire-Faced, MSE Wall. (continued.)**

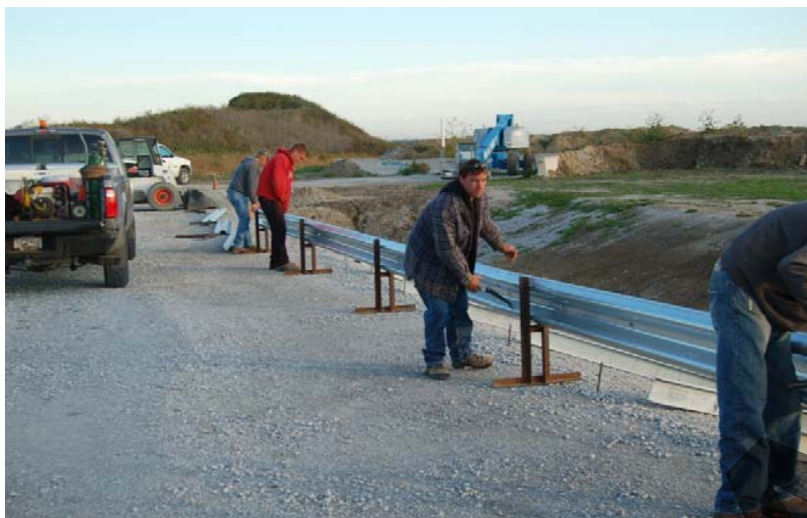
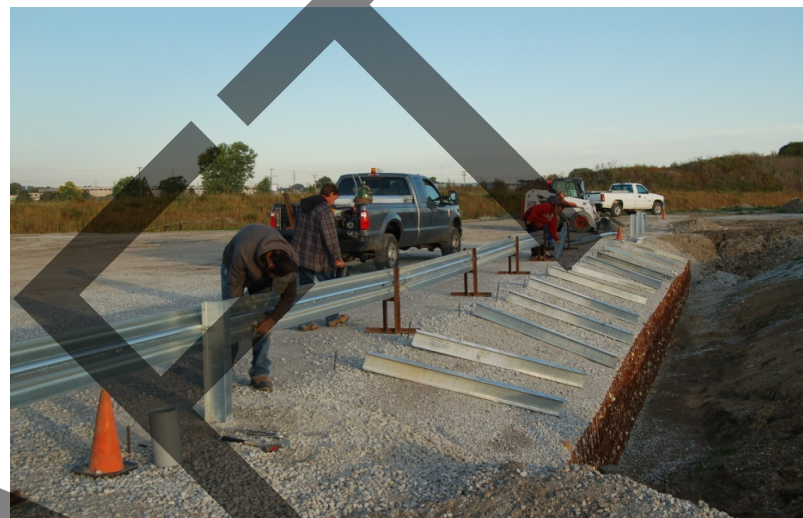
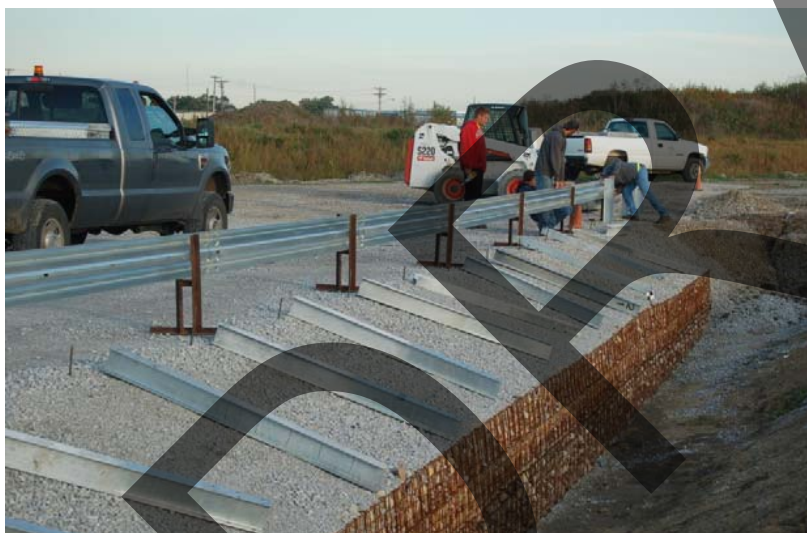
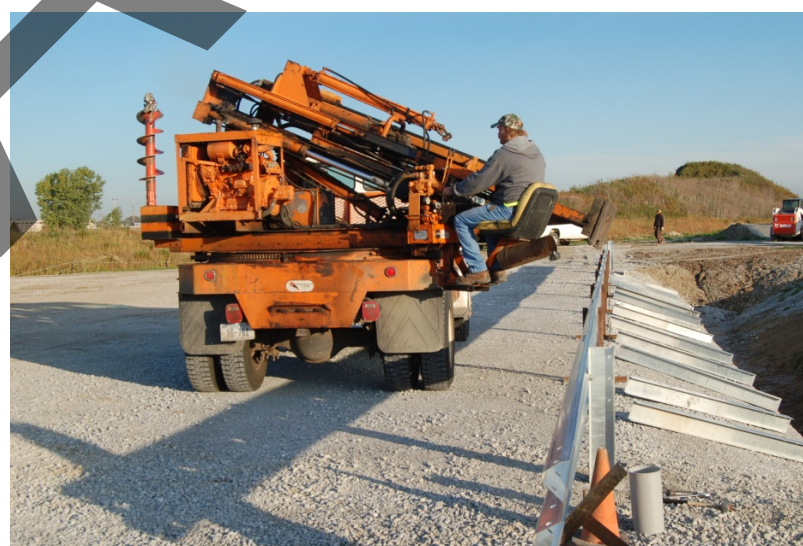
a. Non-Blocked MGS System Installation

c. Non-Blocked MGS System, Initial Rail Attachment

b. Non-Blocked MGS Installation, Leveling Rail

d. Non-Blocked MGS Installation, Driving Posts-1

**Figure 36. Photo. Construction of Midwest Guardrail System (MGS) on MSE Wall.**

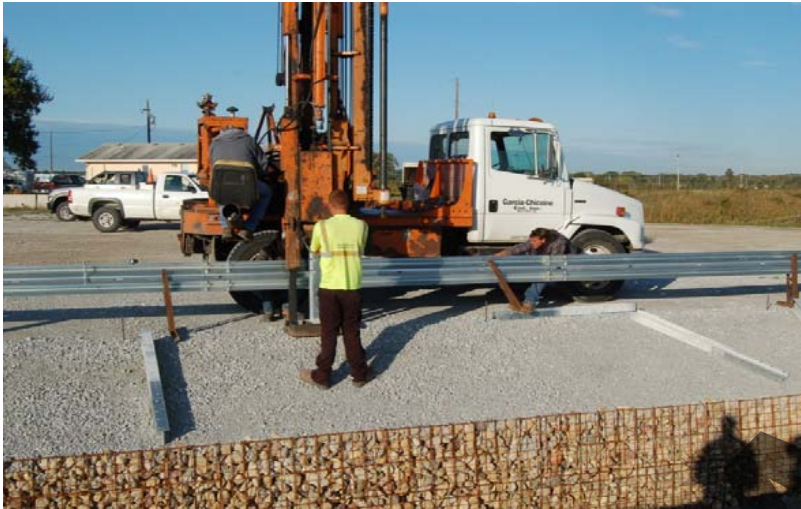
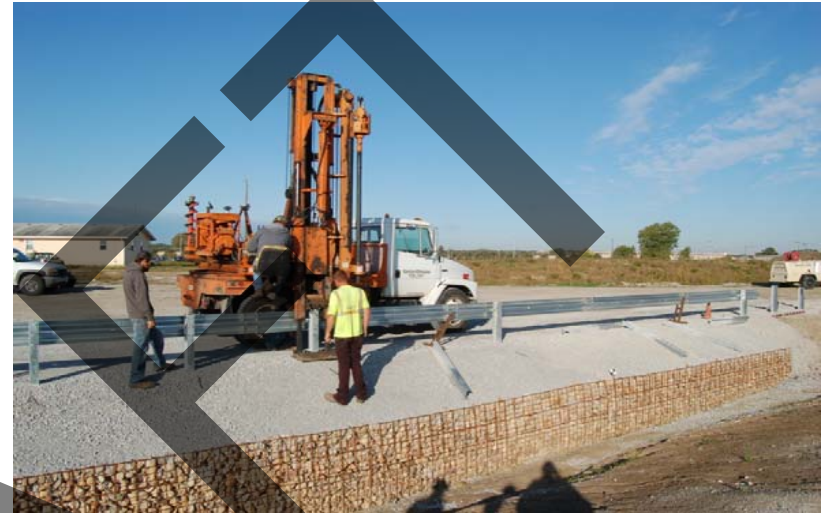
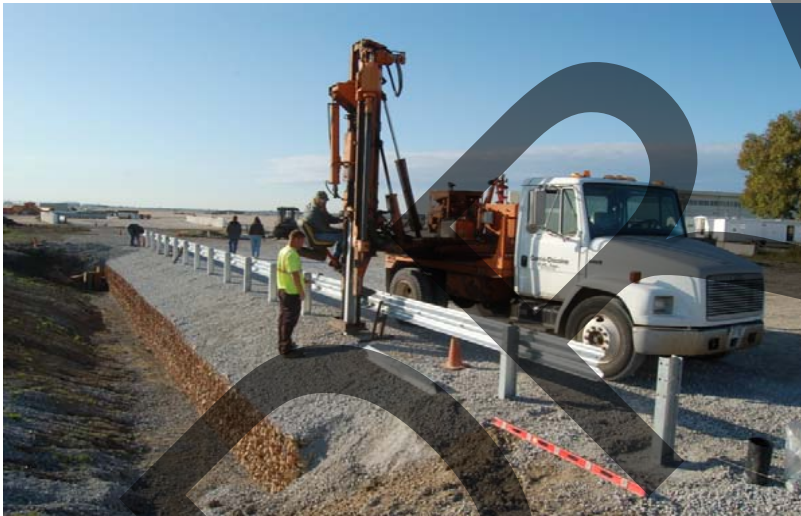
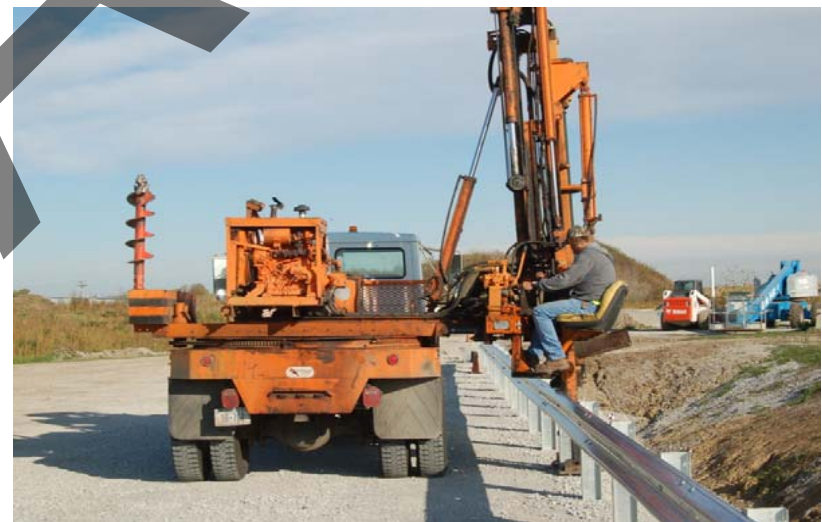
a. Non-Blocked MGS Installation, Driving Post No. 2

c. Non-Blocked MGS Installation, Driving Post No. 4

b. Non-Blocked MGS Installation, Driving Post No. 3

d. Non-Blocked MGS Installation, Driving Post No. 5

**Figure 37. Photo. Construction of Midwest Guardrail System (MGS) on MSE Wall. (continued.)**

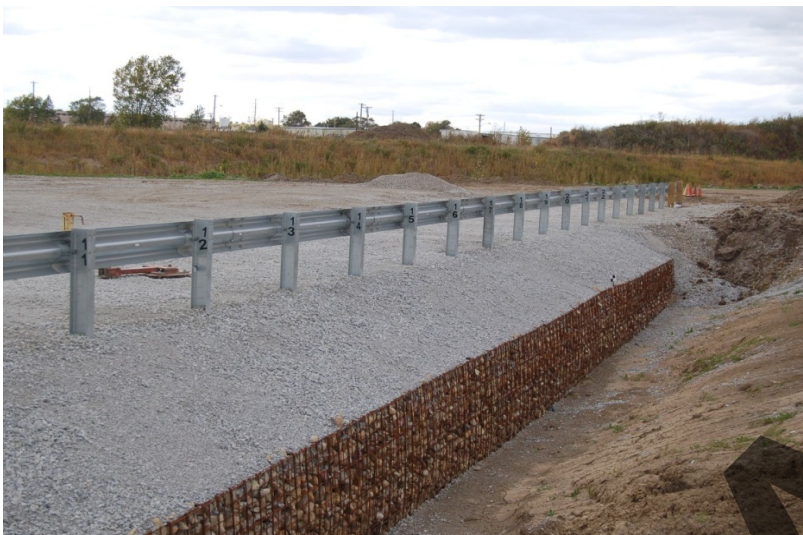
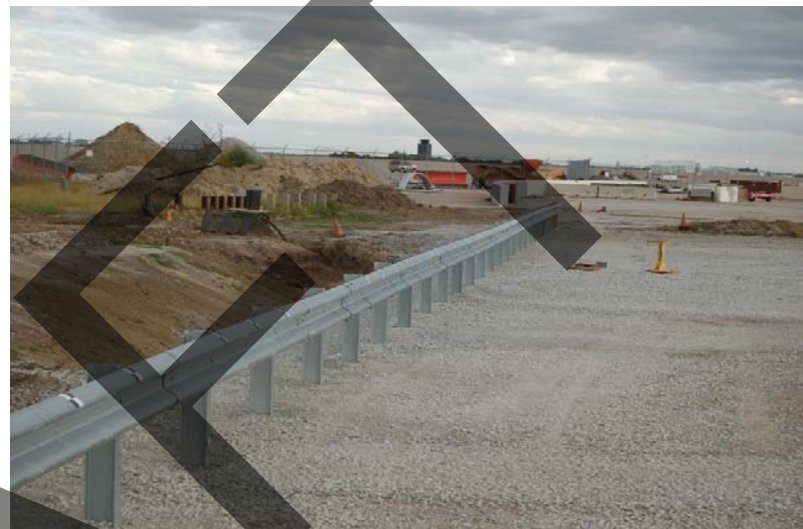
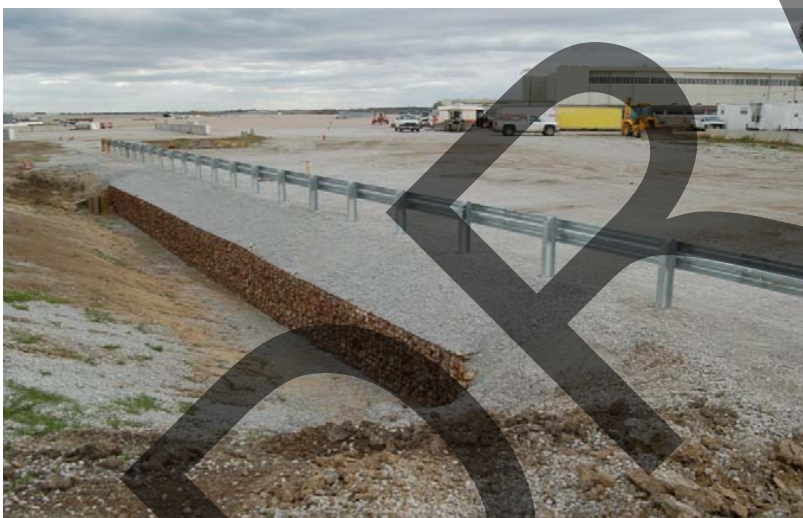
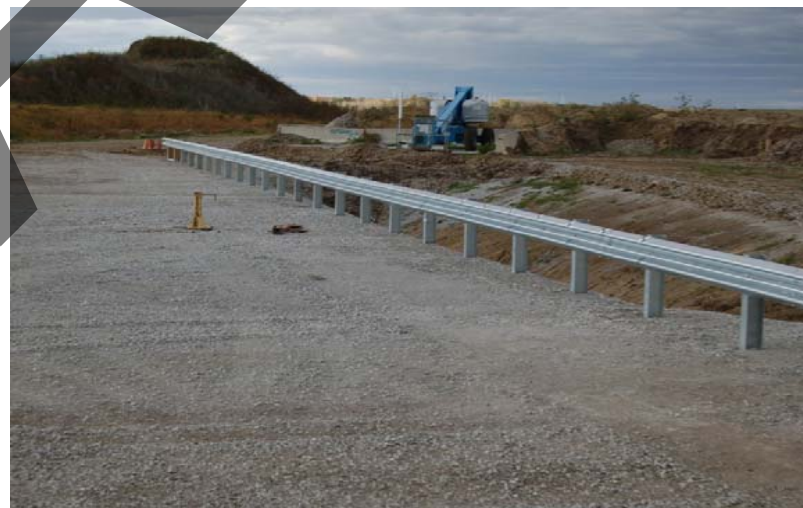
a. MGS on MSE Wall, Upstream Quarter View

c. MGS on MSE Wall, Downstream Quarter View

b. MGS on MSE Wall, Rear Quarter View

d. MGS on MSE Wall, Upstream Quarter View

**Figure 38. Photo. Test Installation – MGS on MSE Wall.**

The entire system was constructed with twenty-nine guardrail posts. Post nos. 3 through 27 were galvanized ASTM A36 W6x8.5 (W152x12.6) steel sections measuring 72 in. (1,829 mm) long. Post no. 1, 2, 28, and 29 utilized timber Breakaway Cable Terminal (BCT) posts measuring 5½ in. wide x 7½ in. deep x 46 in. long (140 mm x 190 mm x 1,168 mm) and were placed in 72-in. (1,829-mm) long steel foundation tubes, as shown in Figures 14, 26, and 28. A tangent anchorage system was utilized on the upstream and downstream ends of the guardrail system in order to develop the barrier's tensile capacity. The anchorage system consisted of timber posts, foundation tubes, anchor cables, bearing plates, rail brackets, and channel struts, which closely resembled the hardware used in the Modified BCT system.

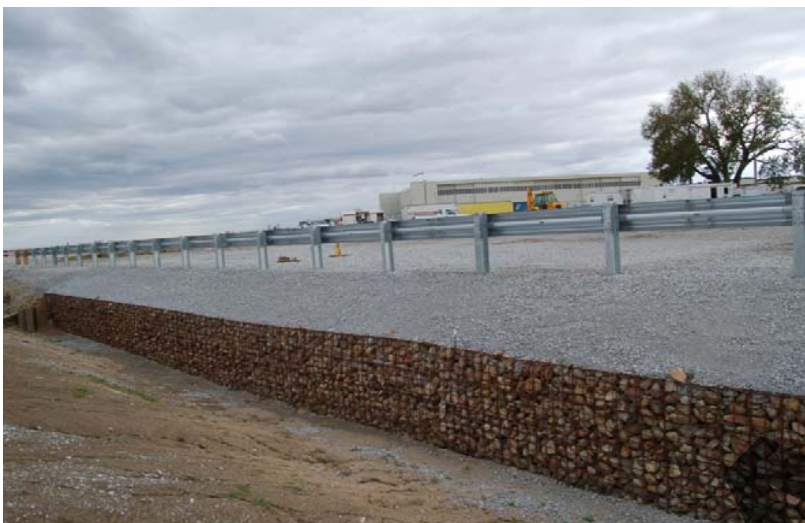
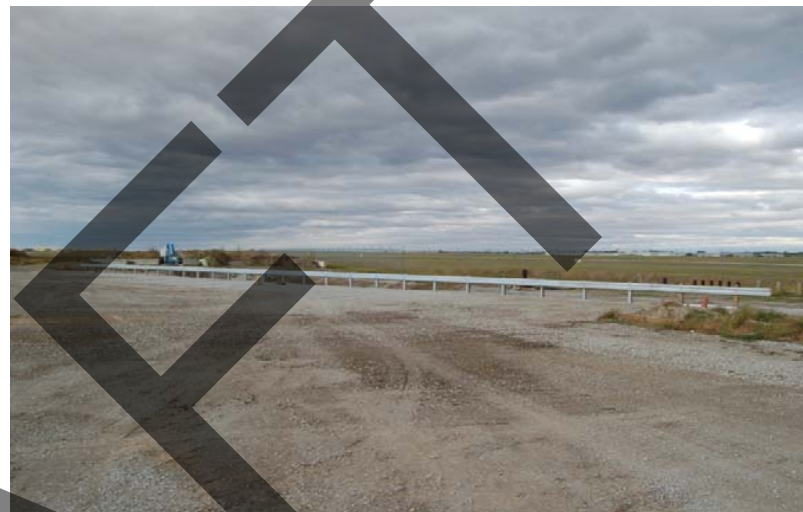
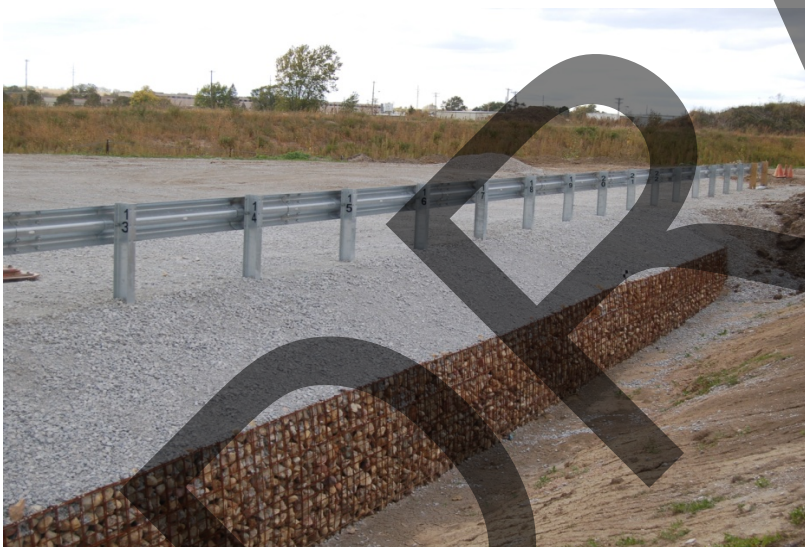
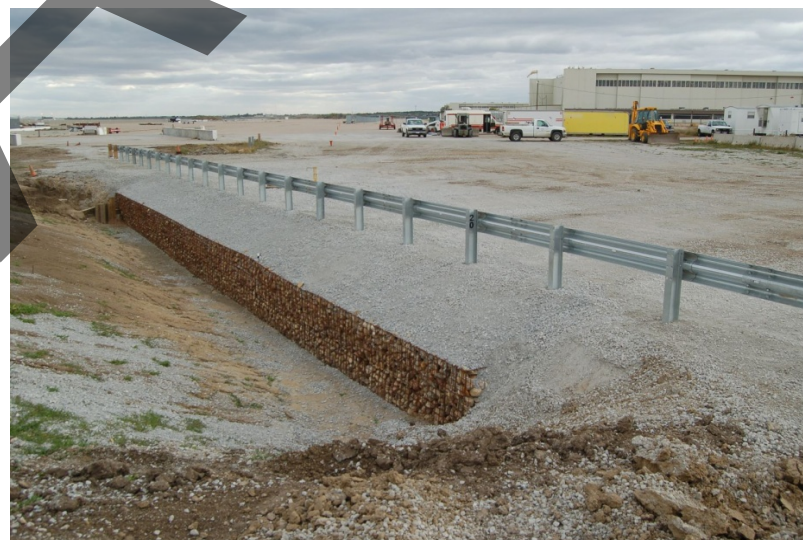
a. MGS on MSE Wall, Rear Quarter View

c. MGS on MSE Wall, Front View

b. MGS on MSE Wall, Upstream Rear Quarter View

d. MGS on MSE Wall, Downstream Rear View

**Figure 39. Photo. Test Installation – MGS on MSE Wall. (continued.)**

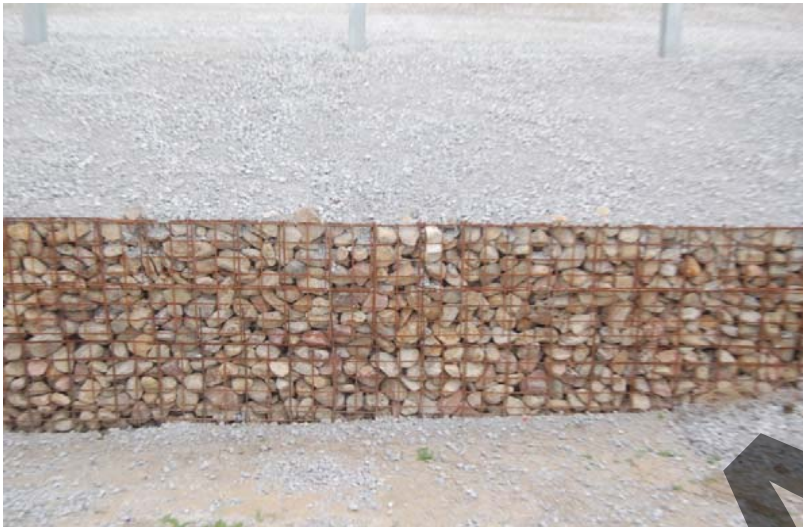
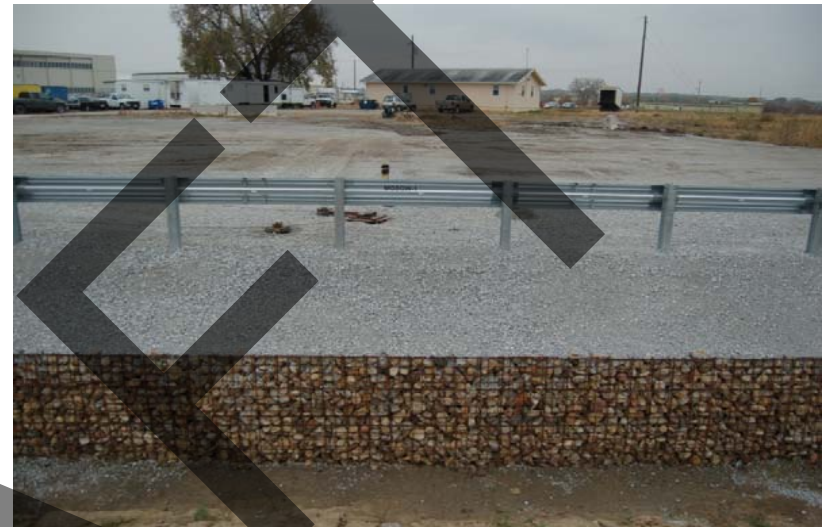
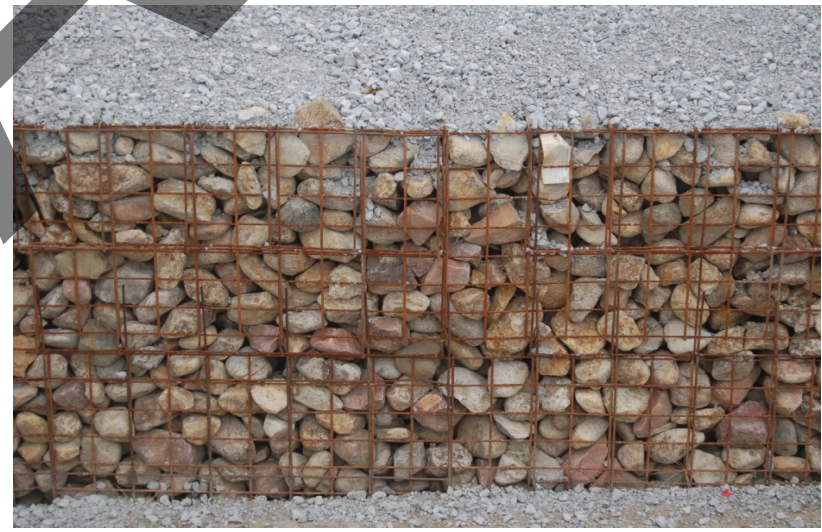
a. MSE Wall

c. MSE Wall, Near Impact

b. MSE Wall, Downstream End

d. MSE Wall, Course Aggregate Close-up

**Figure 40. Photo. Test Installation – Wire-Mesh and Wall Facing Rock.**

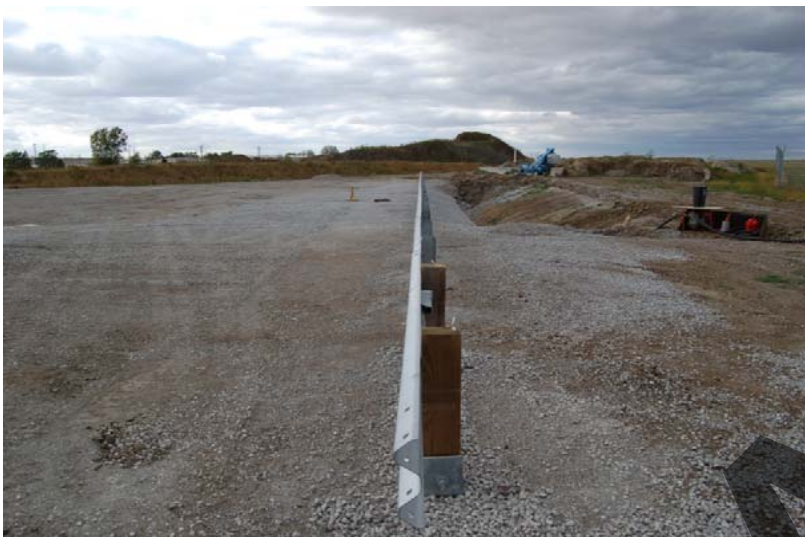
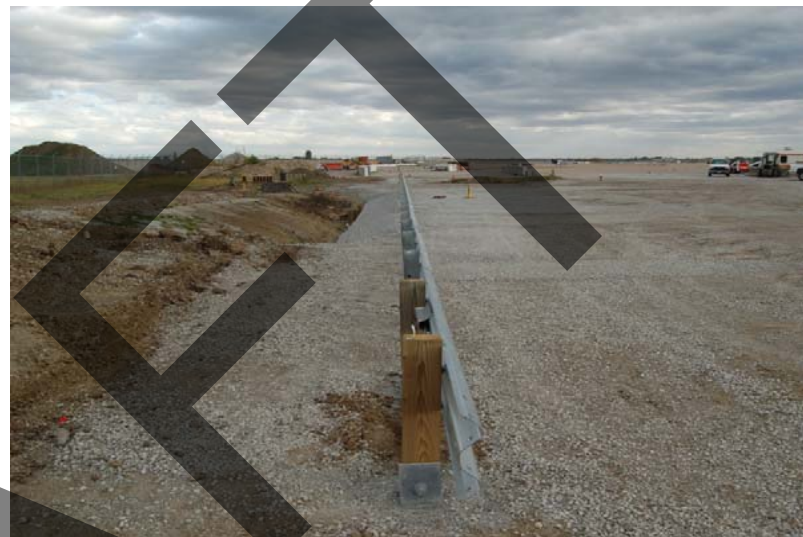
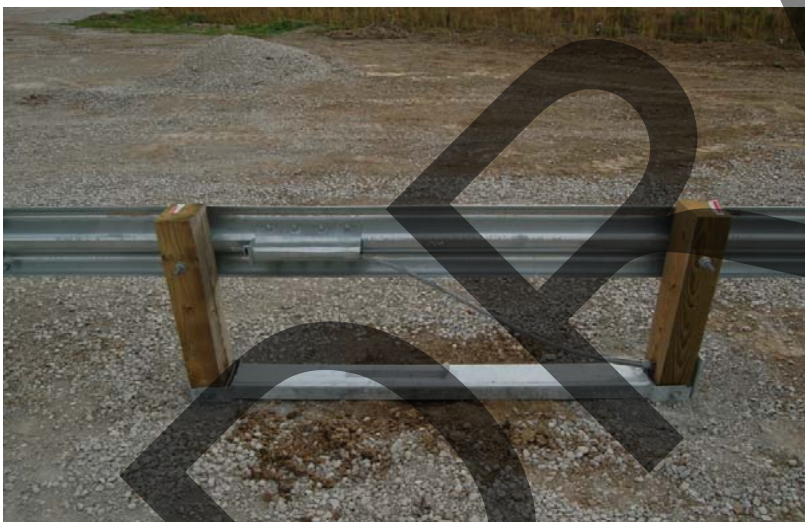
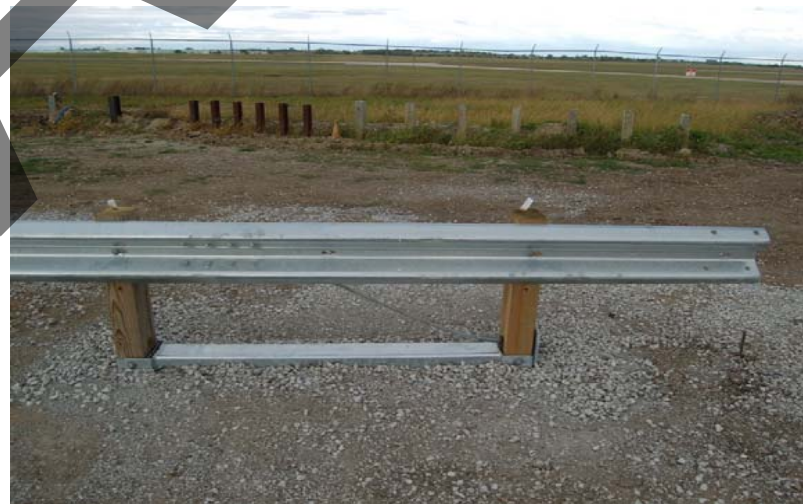
a. Upstream Inline View

c. Downstream Inline View

b. Rear View of Downstream Anchor

d. Front View of Upstream Anchor

**Figure 41. Photo. Test Installation – End Anchorage System.**

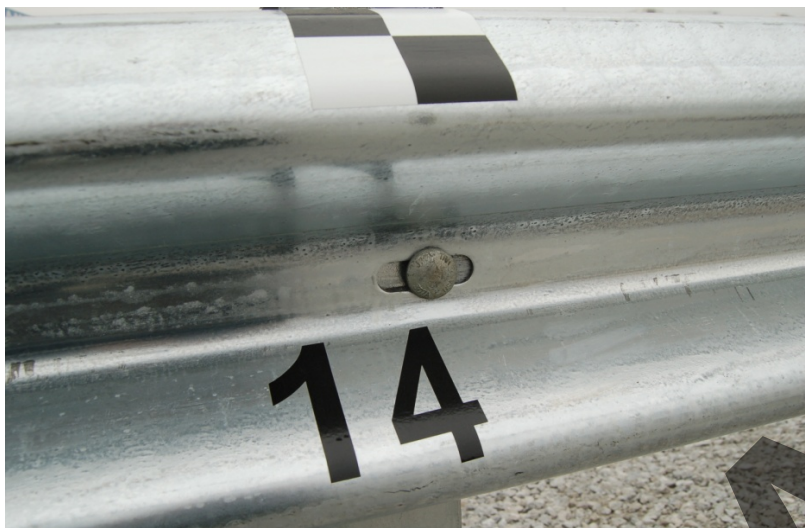
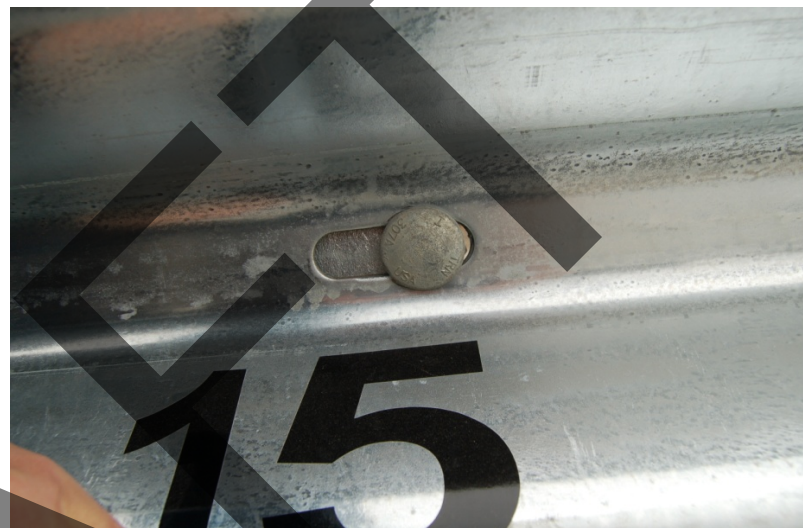
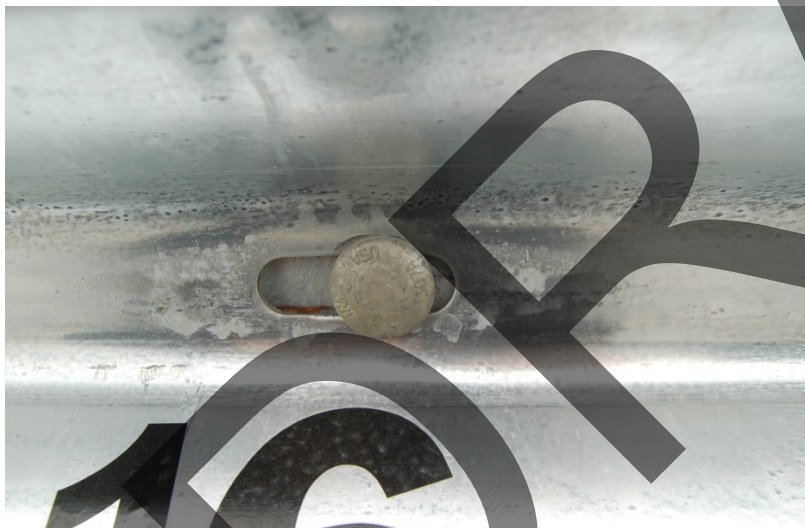
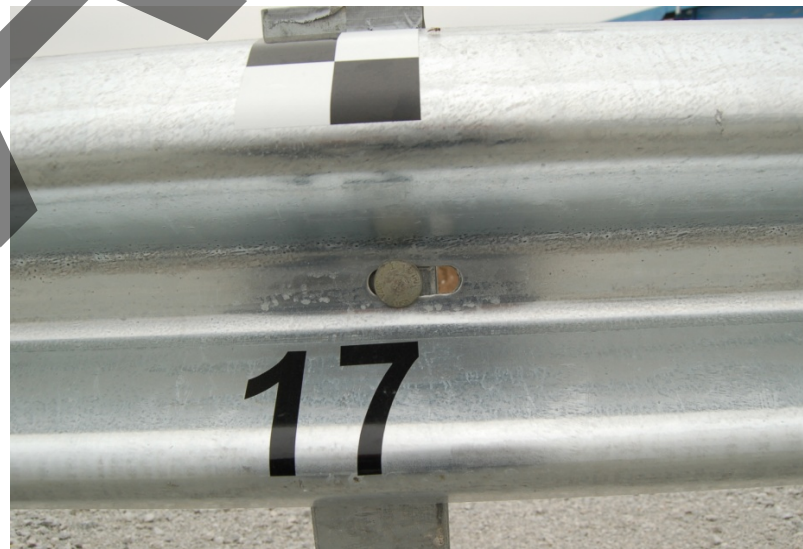
a. Bolt Location at Post 14

c. Bolt Location at Post 15

b. Bolt Location at Post 16

d. Bolt Location at Post 17

**Figure 42. Photo. W-Beam Backup Plate and Post Bolt Locations, Test No. MGSGW-1.**

For test no. MGSGW-1 (1100C small car test), the W-beam backup plates at post nos. 14 through 17 were longitudinally shifted to different positions in order to determine whether rail slot alignment, or mis-alignment, affects post bolt release away from the rail. The bolt heads were also positioned at different locations within the guardrail slots. For post nos. 14 and 16, the guardrail slots and W-beam backup plate slots were mis-aligned. For post nos. 15 and 17, the guardrail slots and W-beam backup plate slots were aligned with one another. The four post bolts and rail slots are depicted in Figure 42.

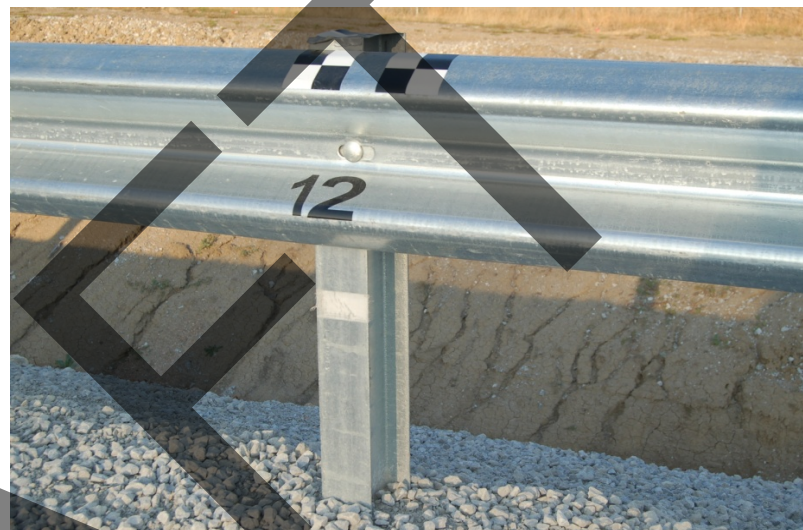
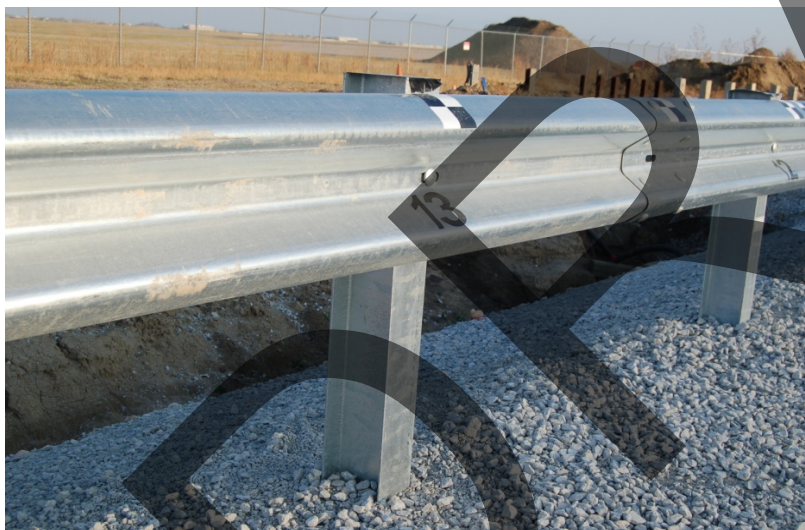
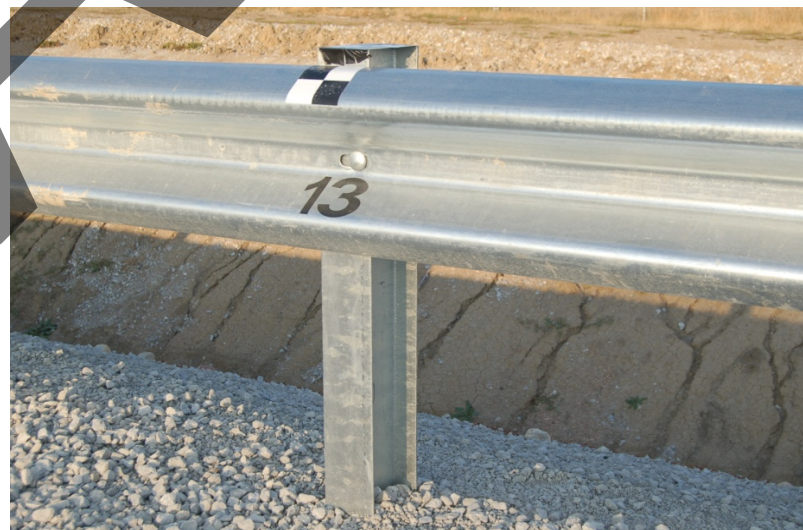
**Figure 43. Photo. Post Bolt Locations at Post Nos. 12 and 13, Test No. MSGW-2.**

a. Downstream View of Post 12

c. Upstream View of Post 12

b. Downstream View of Post 13

d. Upstream View of Post 13

For test no. MGSGW-2 (2270P pickup truck test), the head of the post bolts were positioned at different locations within the guardrail slots. For post nos. 12 through 17, three different locations were considered - the upstream end of the slot, the downstream end of the slot, and centered in slot. These configurations are shown in Figures 43 through 45.
