# DEVELOPMENT OF AN ECONOMICAL GUARDRAIL SYSTEM FOR USE ON WIRE- FACED, MSE WALLS

Publication No. FHWA-CFL/TD-12-009

FEBRUARY 2012

**CENTRAL FEDERAL LANDS HIGHWAY DIVISION  
12300 WEST DAKOTA AVENUE  
Lakewood, CO 80228**

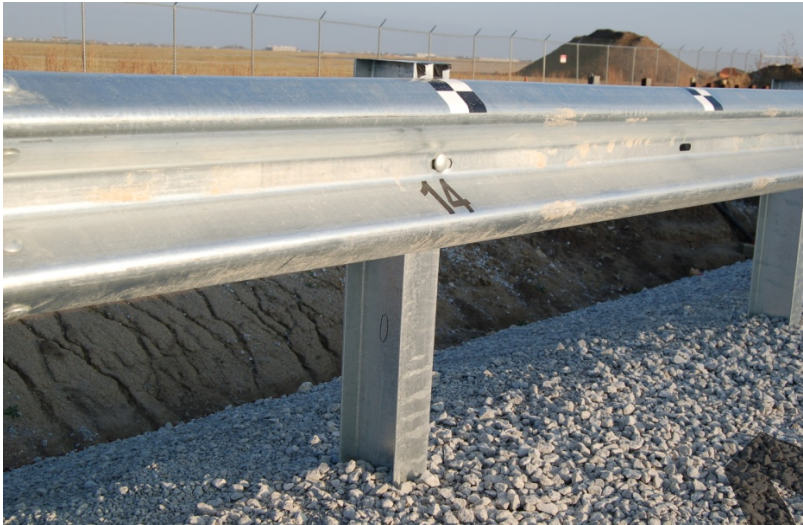
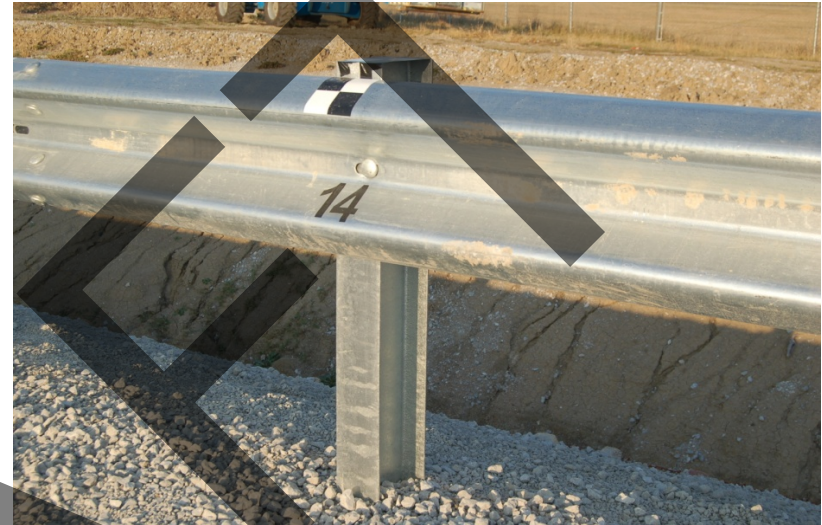
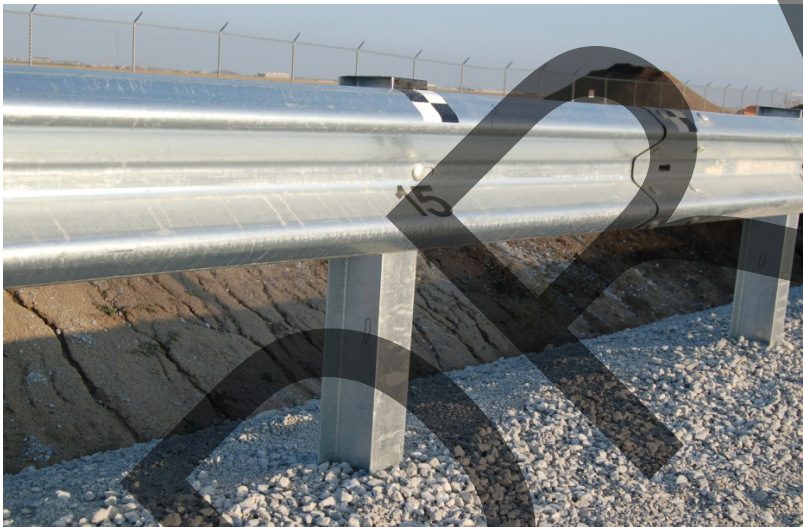
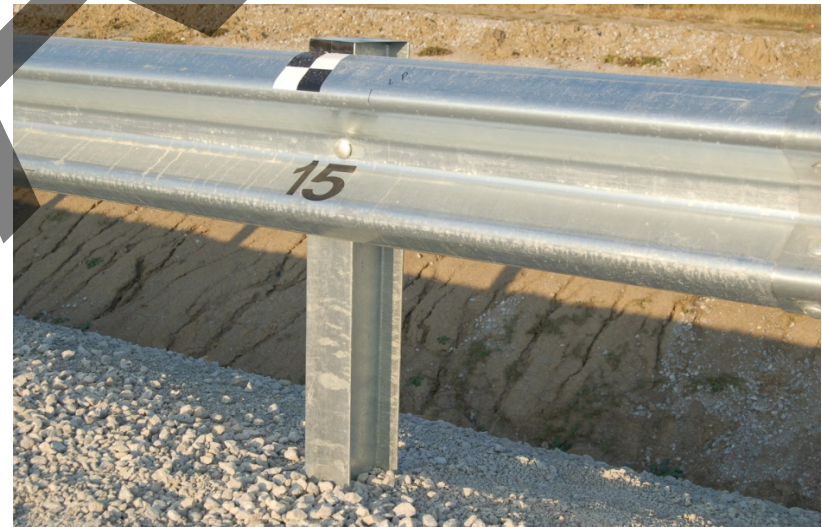
**Figure 44. Photo. Post Bolt Locations at Post Nos. 14 and 15, Test No. MGS GW-2.**

a. Downstream View of Post 14

c. Upstream View of Post 14

b. Downstream View of Post 15

d. Upstream View of Post 15

For test no. MGSGW-2 (2270P pickup truck test), the head of the post bolts were positioned at different locations within the guardrail slots. For post nos. 12 through 17, three different locations were considered - the upstream end of the slot, the downstream end of the slot, and centered in slot. These configurations are shown in Figures 43 through 45.

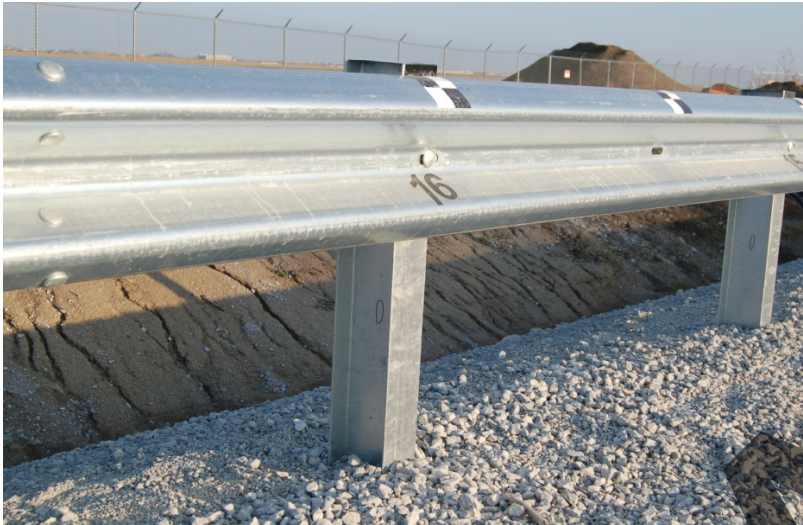
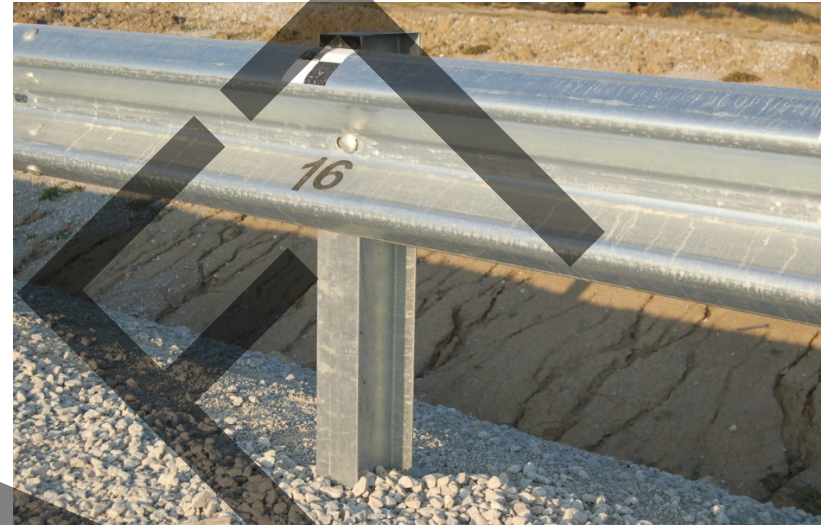
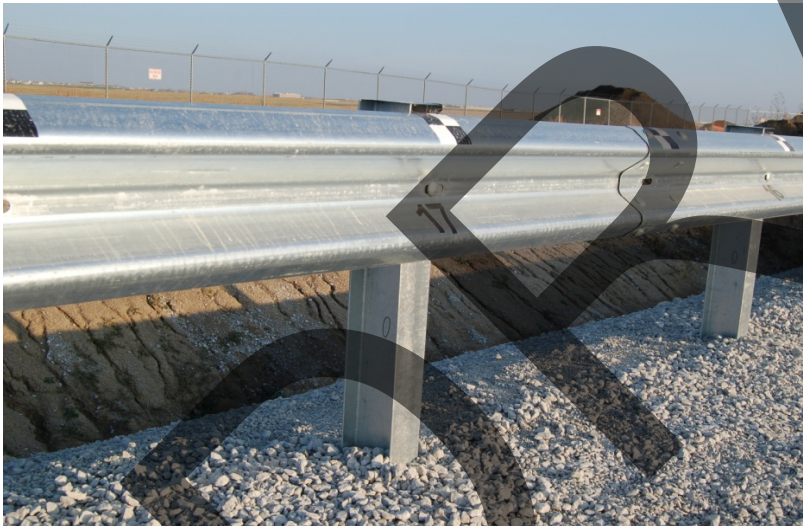
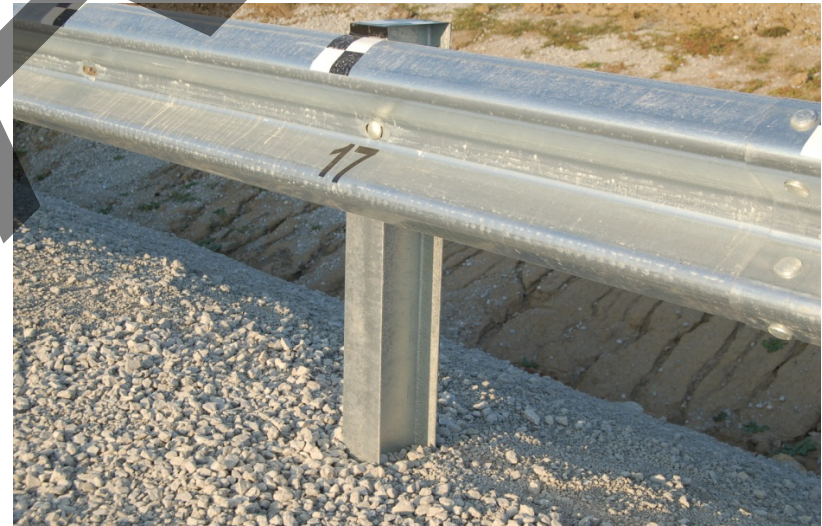
**Figure 45. Photo. Post Bolt Locations at Post Nos. 16 and 17, Test No. MGS GW-2.**

a. Downstream View of Post 16

c. Upstream View of Post 16

b. Downstream View of Post 17

d. Upstream View of Post 17

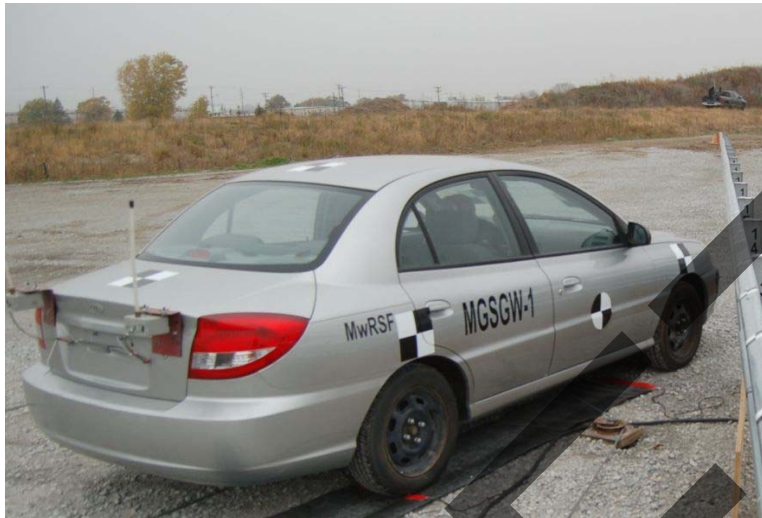
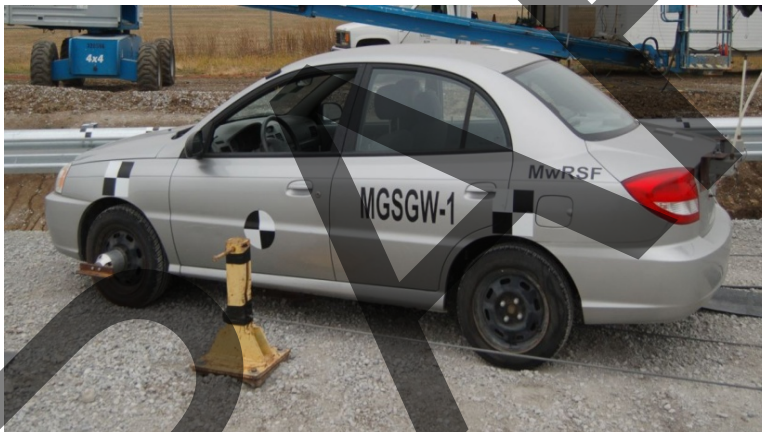
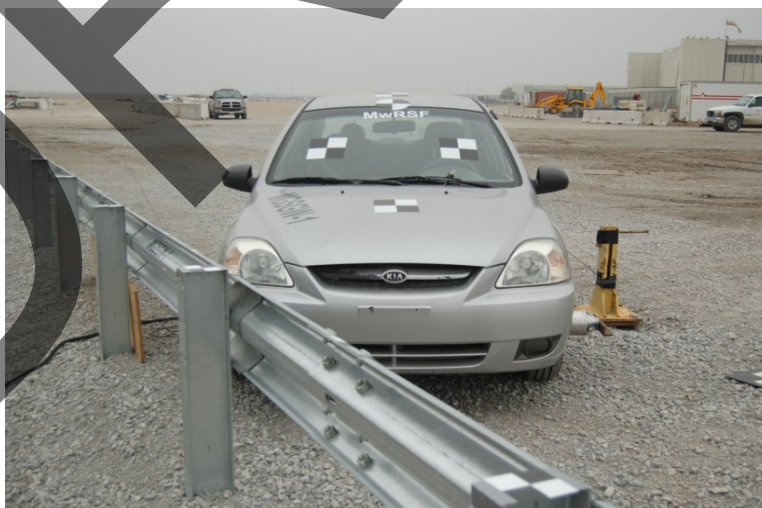
**Figure 46. Photo. Test Vehicle, Test No. MGSW-1.**

a. Rear Quarter View

b. Non-Impact Side

c. Front View

For test no. MSGGW-1, a 2003 Kia Rio Sedan was used as the test vehicle. The curb, test inertial, and gross static vehicle weights were 2,302 lb (1,044 kg), 2,427 lb (1,101 kg), and 2,596 lb (1,178 kg), respectively. The test vehicle is shown in Figure 46, and vehicle dimensions are shown in Figure 47.

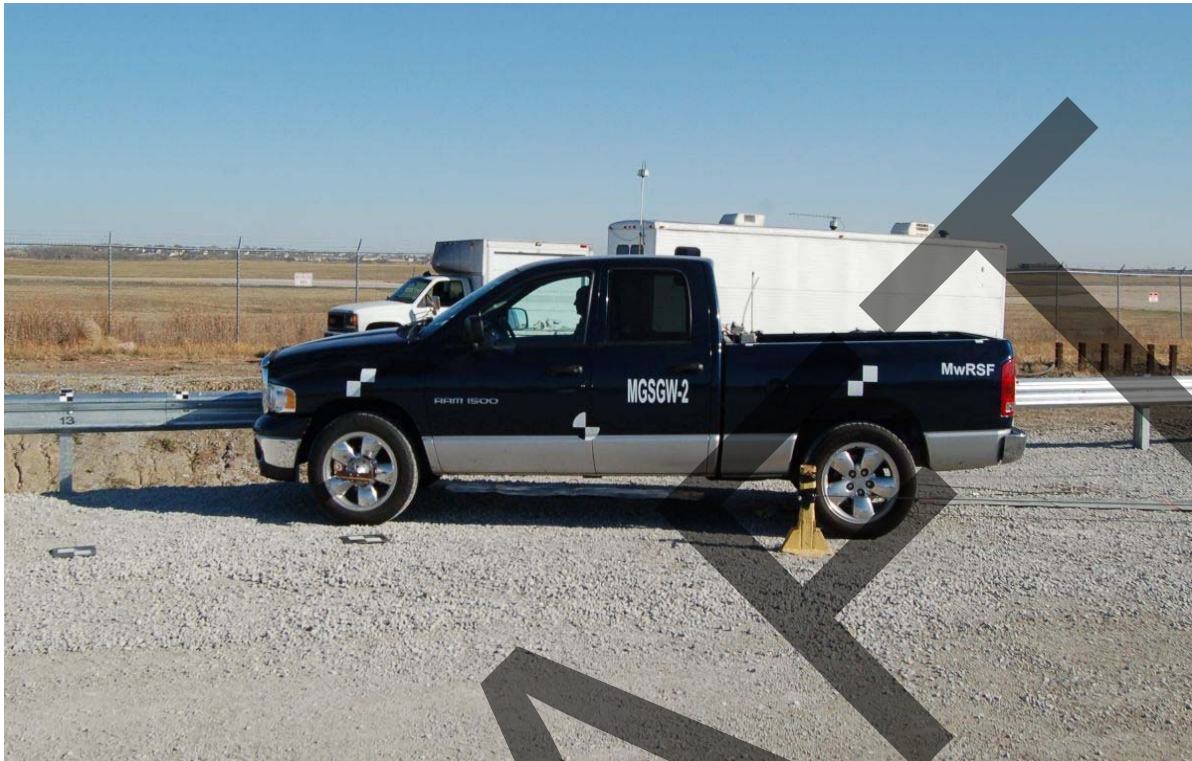
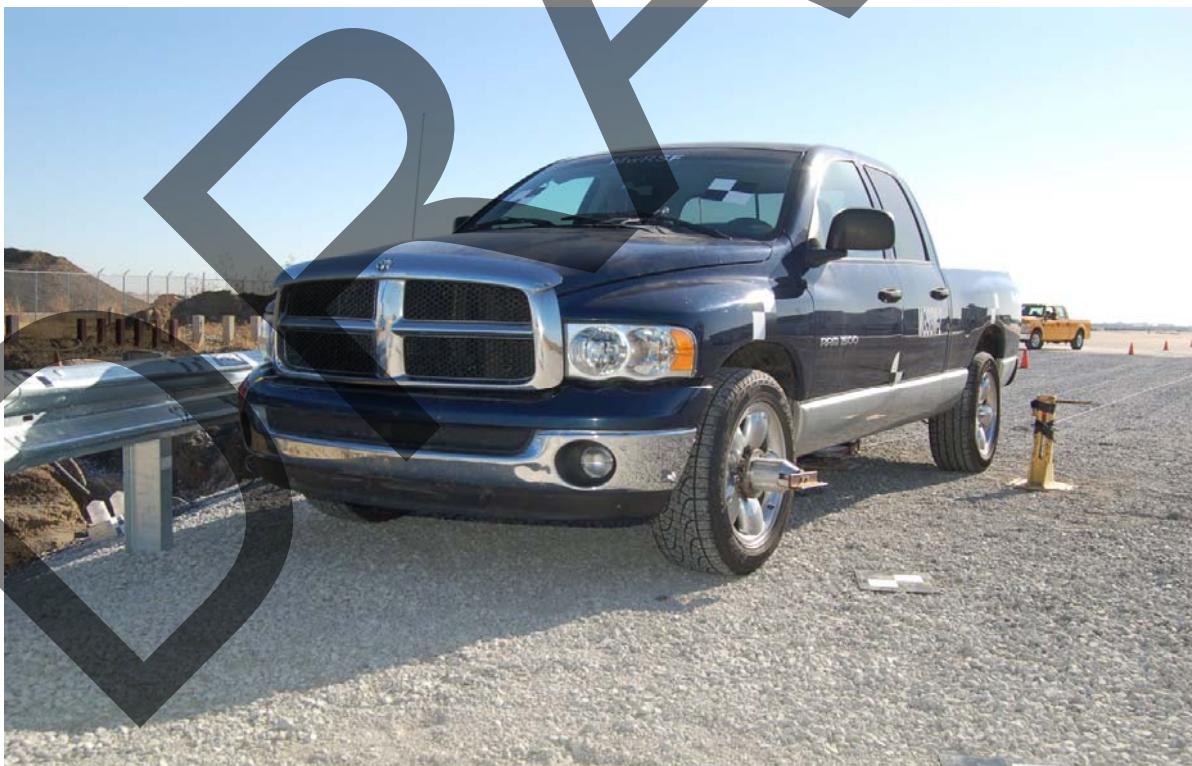
**Figure 48. Photo. Test Vehicle, Test No. MSGW-2**

a. Non-Impact Side

b. Front Quarter View

For test no. MSGGW-2, a 2003 Dodge Ram Quad Cab pickup truck was used as the test vehicle. The curb, test inertial, and gross static vehicle weights were 5,081 lb (2,305 kg), 4,999 lb (2,268 kg), and 5,169 lb (2,345 kg), respectively. The test vehicle is shown in Figure 48, and vehicle dimensions are shown in Figure 49.

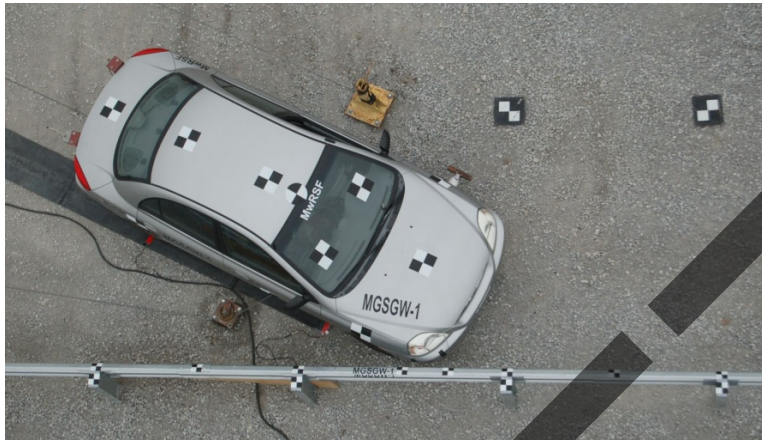
a. Impact Location, Overhead

Initial vehicle impact was to occur 4 ft - 9½ in. (1.5 m) upstream of the splice between post nos. 14 and 15, as shown in Figure 59. The actual point of impact was 4½ in. (114 mm) downstream from the target impact location, or 4 ft - 5 in. (1.3 m) upstream from the centerline of the splice between post nos. 14 and 15. A sequential description of the impact events is shown in Table 11. The vehicle came to rest 31 ft - 1 in. (9.5 m) downstream from impact and 11 ft - 3 in. (3.4 m) laterally in front of the traffic-side face of the barrier and oriented with its front end facing upstream. The vehicle trajectory and final position are shown in Figures 54 and 60.

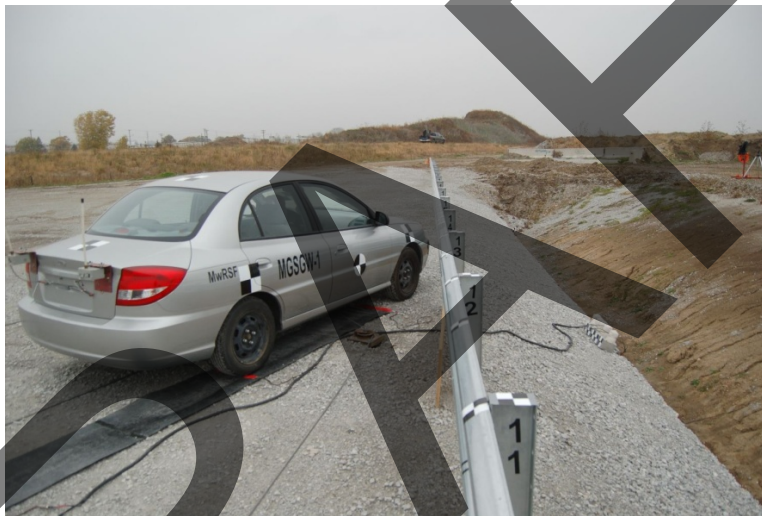
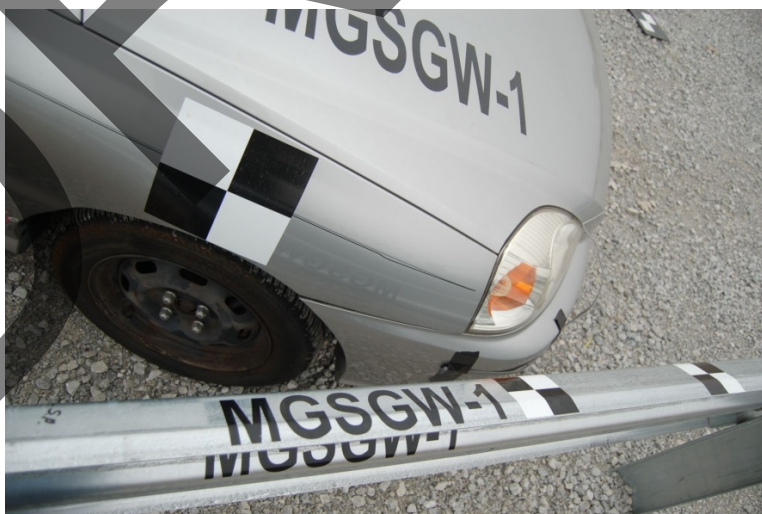
**Figure 59. Photo. Impact Location, Test No. MGSGW-1.**

b. Impact Location Upstream

c. Impact Location, Close-up

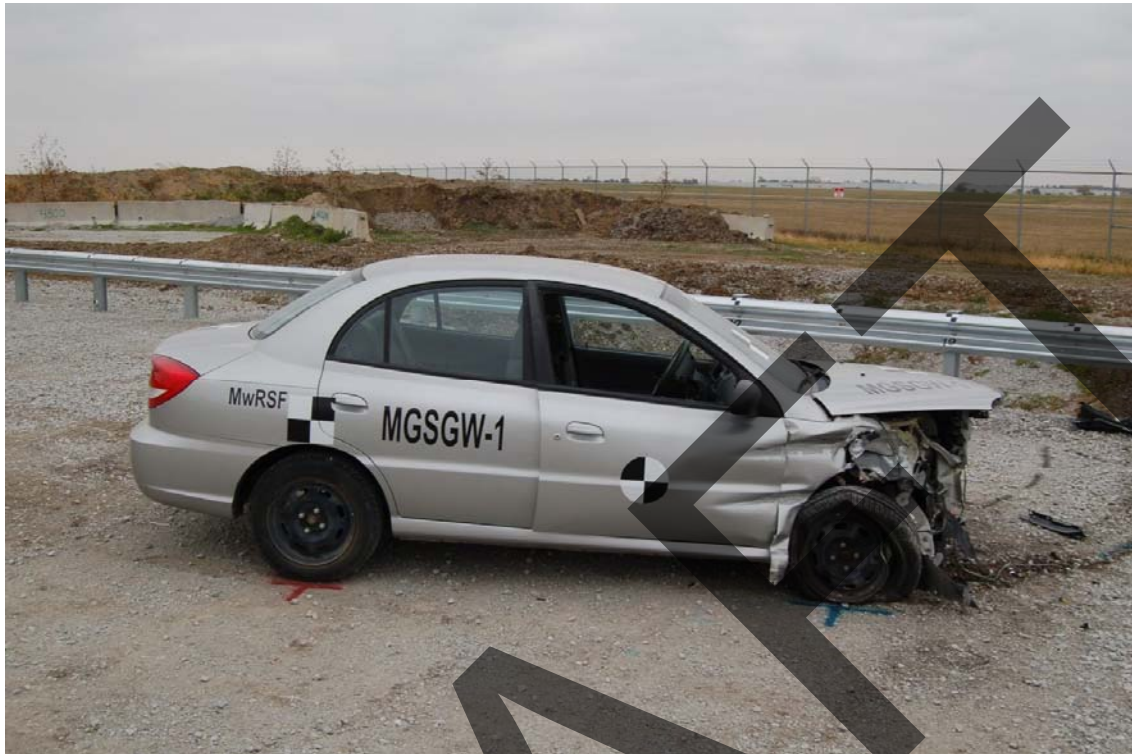
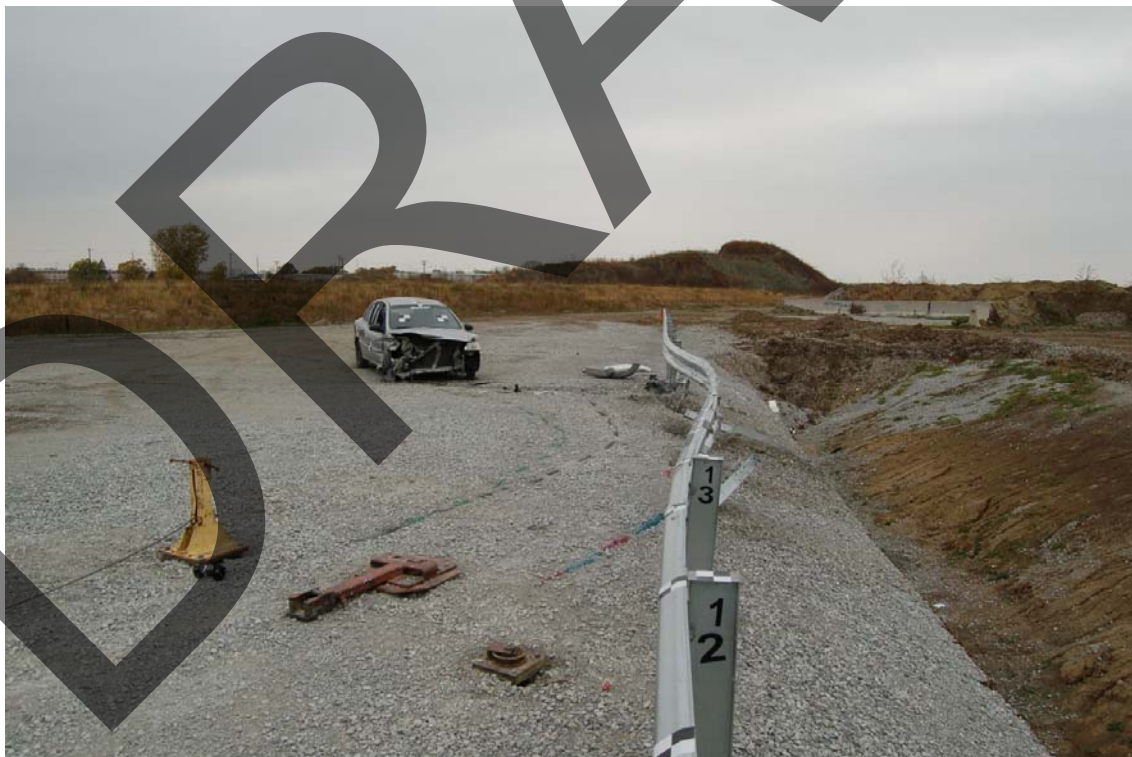
**Figure 60. Photo. Vehicle Final Position and Trajectory Marks, Test No. MGSGW-1.**

a. Vehicle Final Position, Profile View

b. Vehicle Trajectory Marks

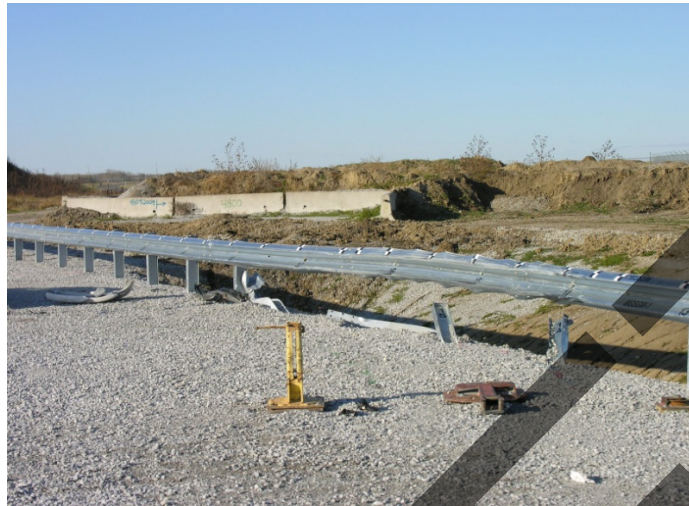
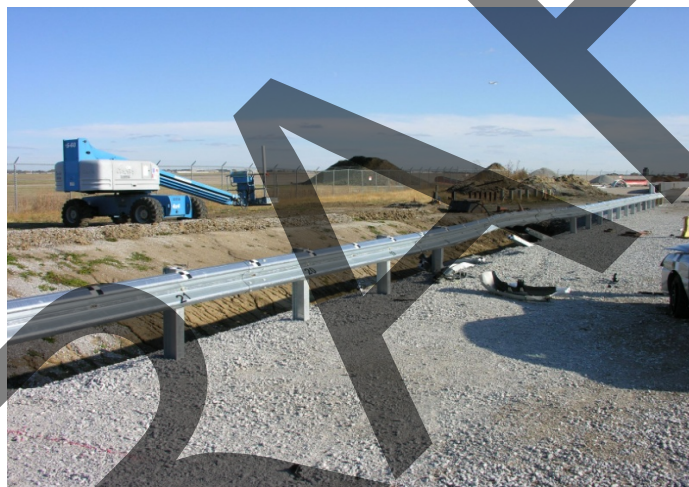
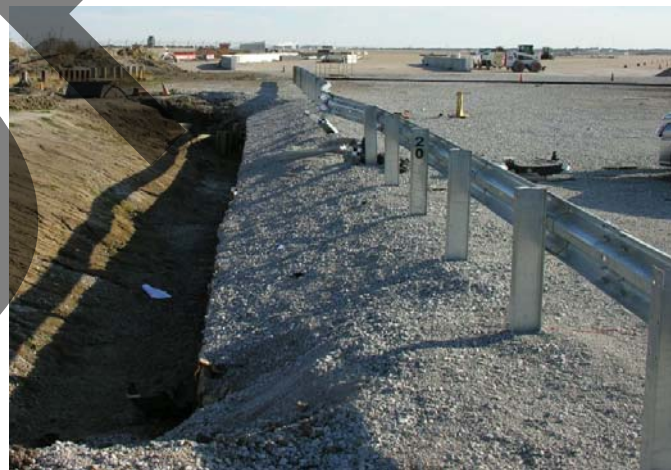
**Figure 61. Photo. System Damage, Test No. MGSGW-1.**

a. Vehicle Path View

b. Exit Trajectory View

c. Downstream View

Damage to the barrier was moderate, as shown in Figures 61 through 66. Barrier damage consisted of contact marks on and deformation to the guardrail posts and W-beam rail. The length of vehicle contact along the barrier was approximately 24 ft – 2 in. (7.4 m) extending from 53 in. (1,346 mm) upstream of the centerline of the splice between post nos. 14 and 15 to 26 in. (660 mm) upstream of post no. 18.

The permanent set of the barrier system is shown in Figure 61. The maximum lateral permanent set rail and post deflections were 17⅞ in. (441 mm) at the midspan between post nos. 15 and 16 and 20⅞ in. (511 mm) at post no. 14, respectively, as measured in the field. The maximum lateral dynamic rail and post deflections were 27.4 in (696 mm) at the midspan between post nos. 15 and 16 and 26.2 in. (665 mm) at post no. 14, respectively, as determined from high-speed digital video analysis. The working width of the system was found to be 35.7 in. (907 mm).

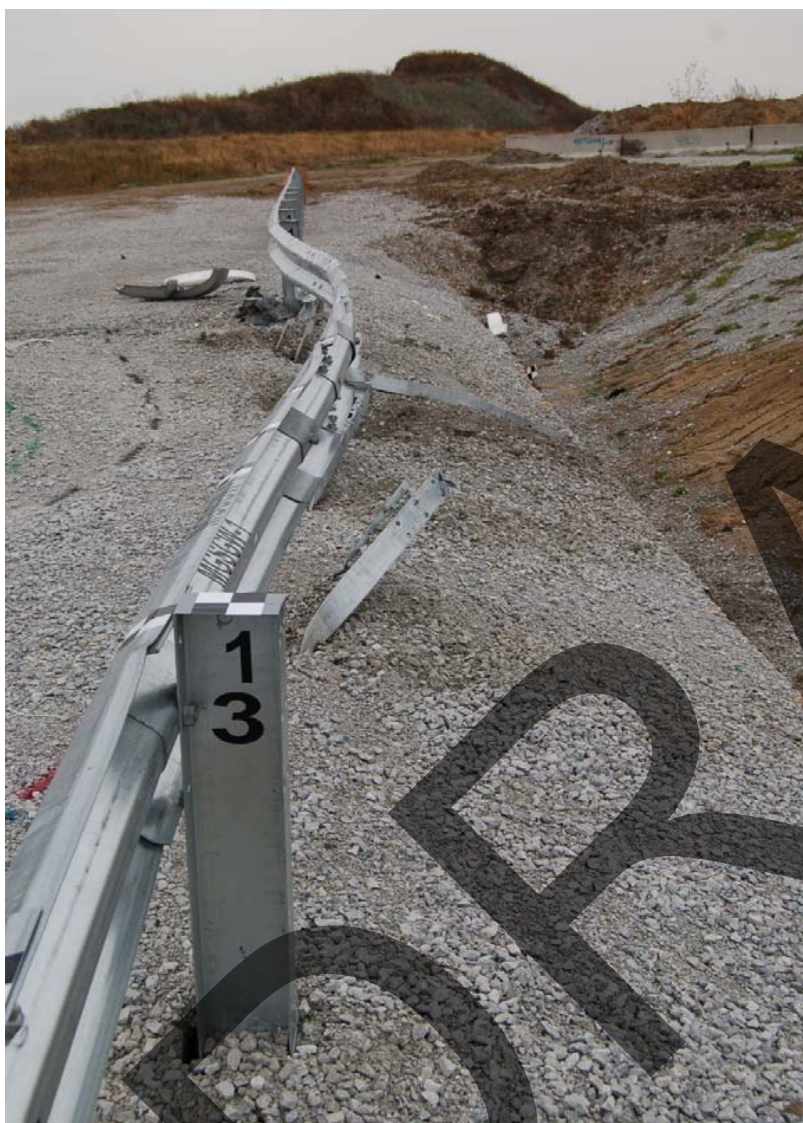
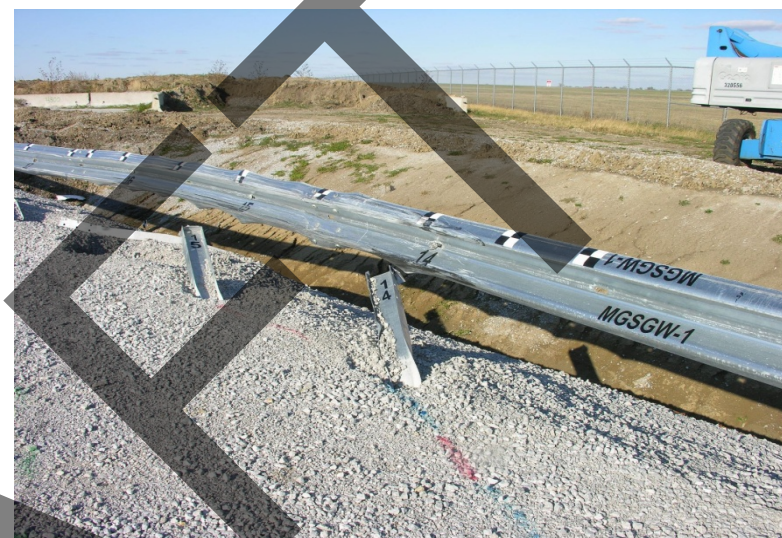
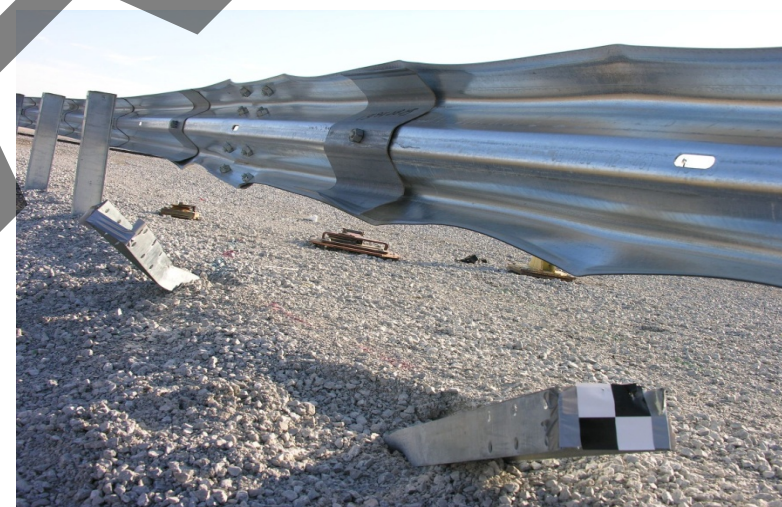
**Figure 62. Photo. System Damage, Test No. MGS GW-1.**

a. Permanent Set Deflection

b. Front Side

c. Back Side

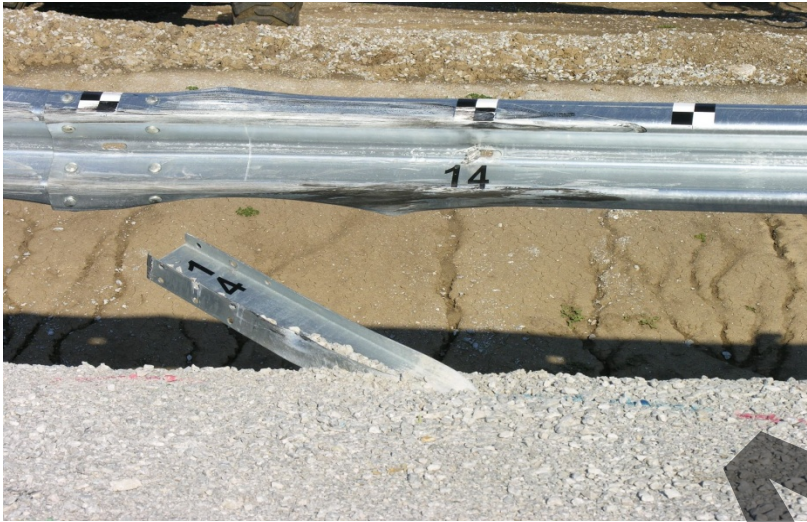
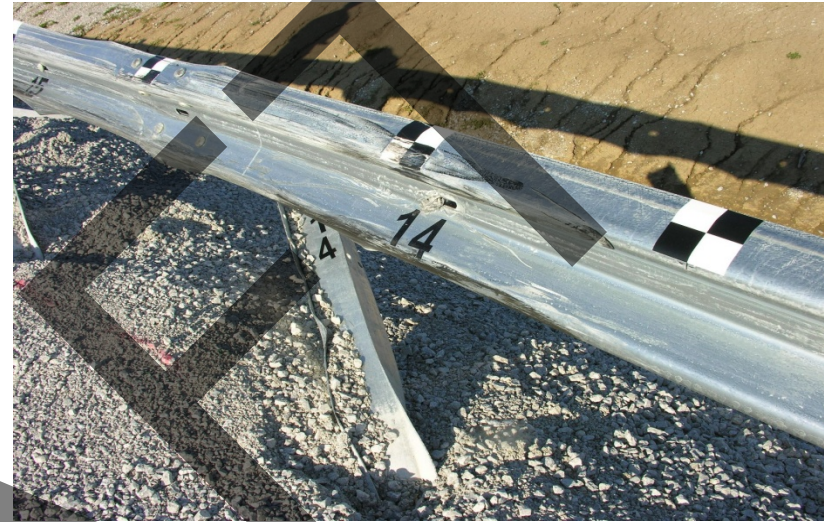
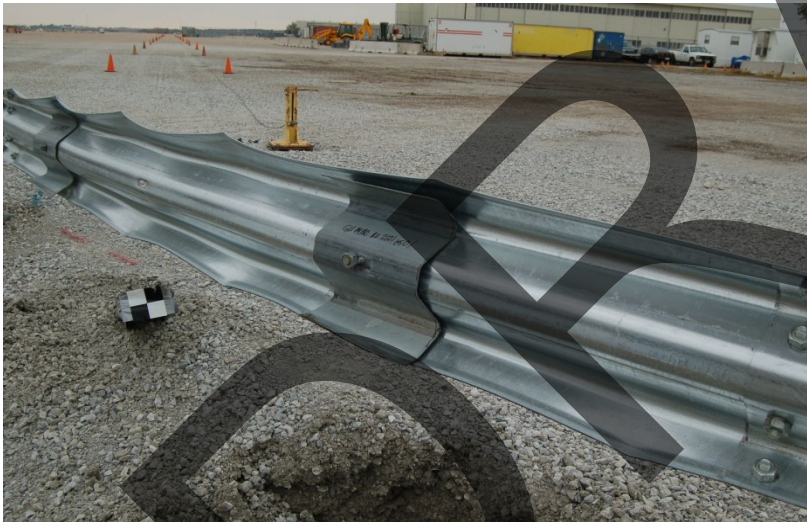
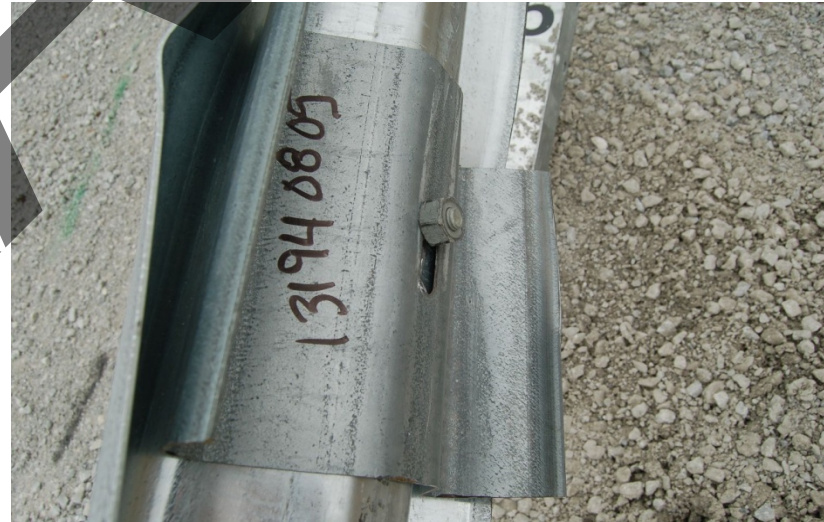
**Figure 63. Photo. System Damage, Test No. MGSGW-1.**

a. Rail at Post No. 14, Front View

c. Rail at Post No. 14 Upstream Quarter View

b. Rail at Post No. Back View

d. Backing Plate at Post No. 14

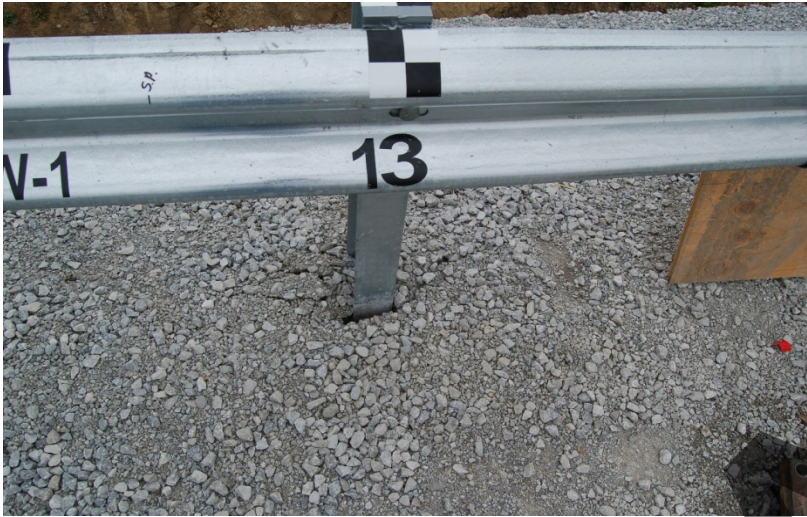
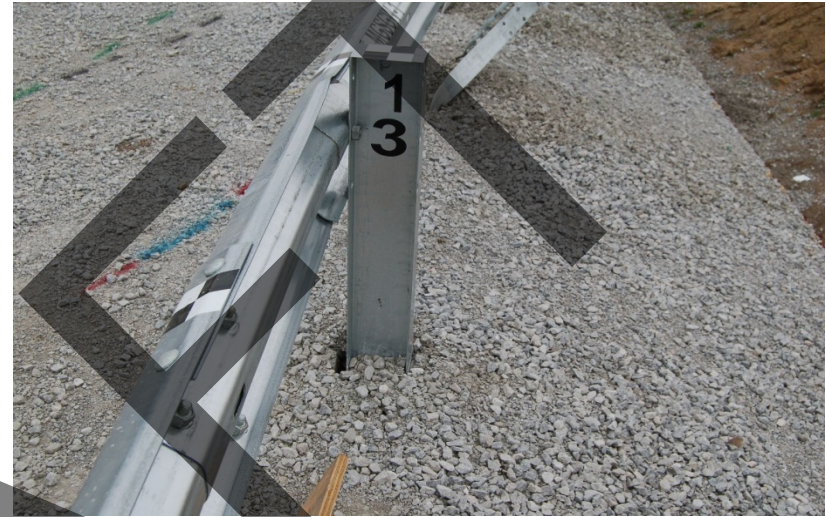
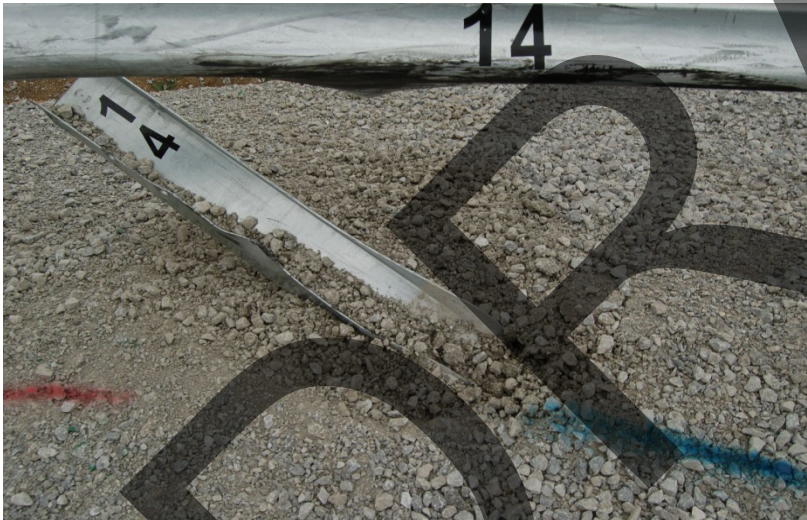
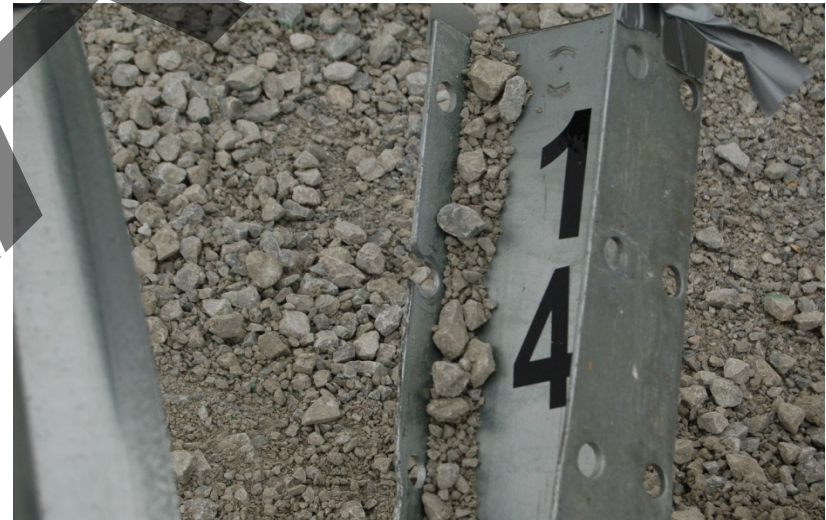
**Figure 64. Photo. Post Nos. 13 and 14 Damage, Test No. MGSGW-1.**

a. Post No. 13, Front Side

c. Post No. 13, Upstream View

b. Post No. 14, Front Side

d. Post No. 14, Post Bolt Hole Tear

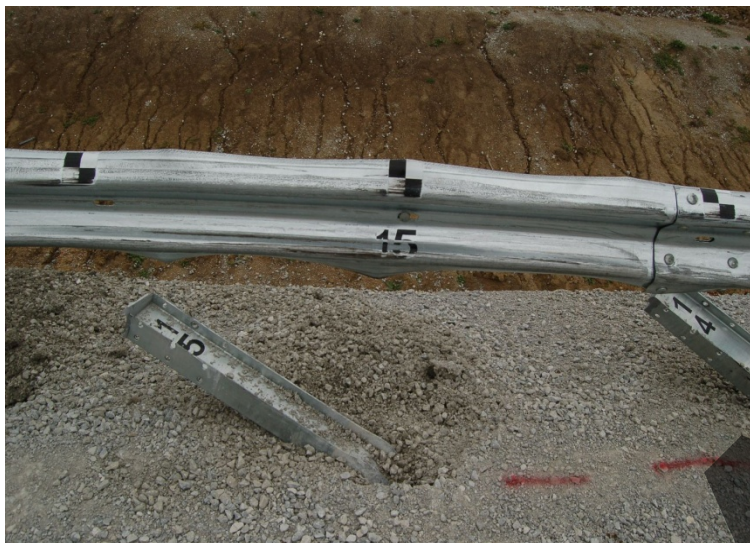
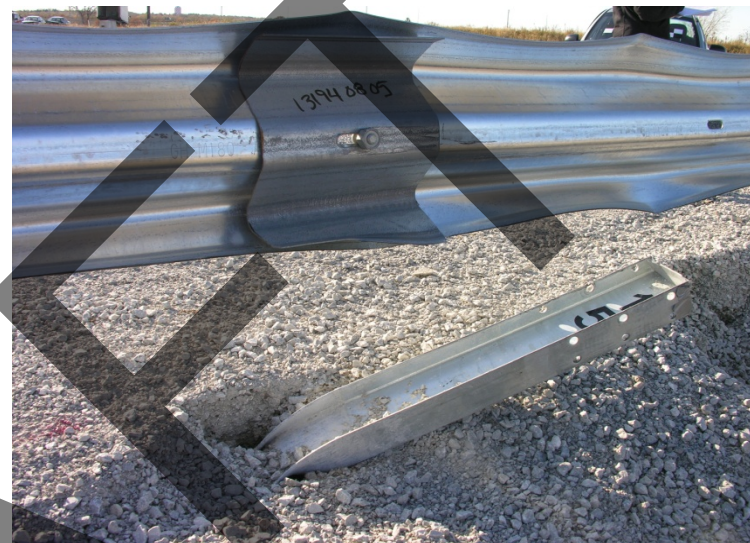
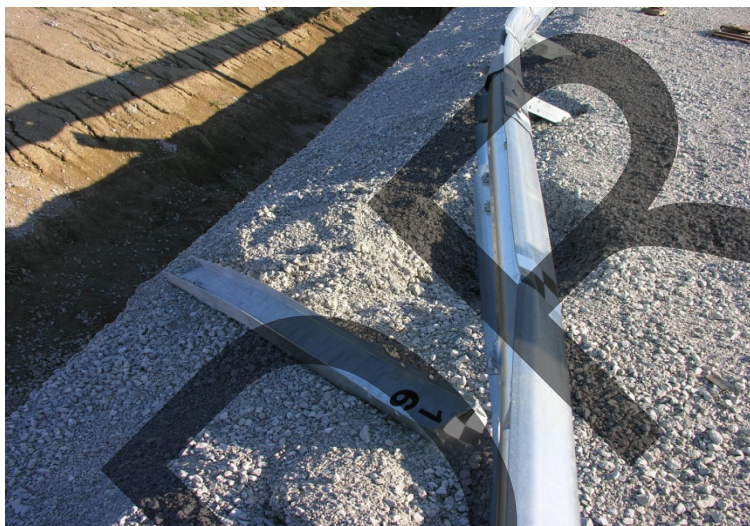
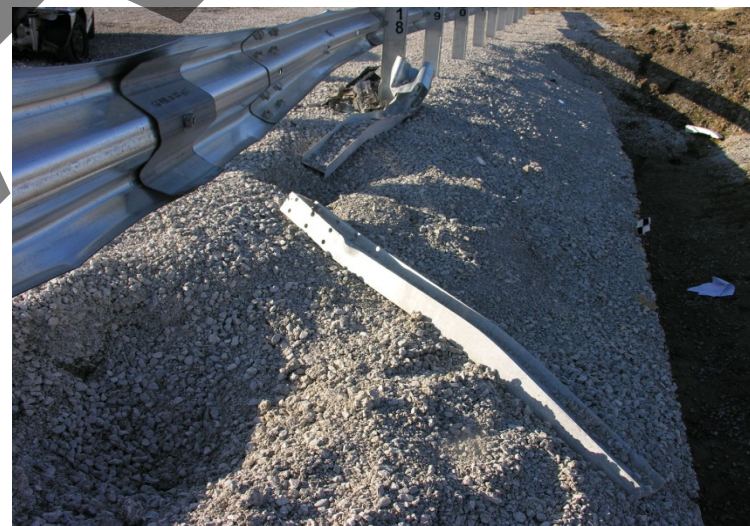
**Figure 65. Photo. Post Nos. 15 and 16 Damage, Test No. MGSGW-1.**

a. Post No. 15, Front View

c. Post No. 15, Rear View

b. Post No. 16, Downstream View

d. Post Nos. 15 and 16, Upstream View

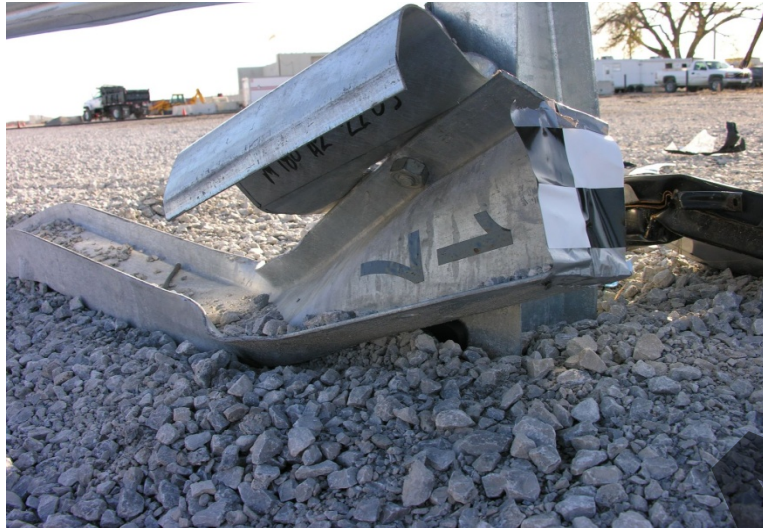
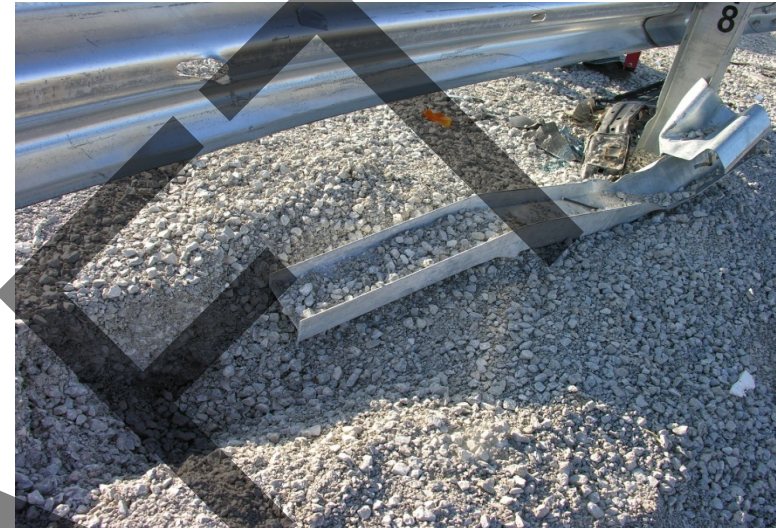
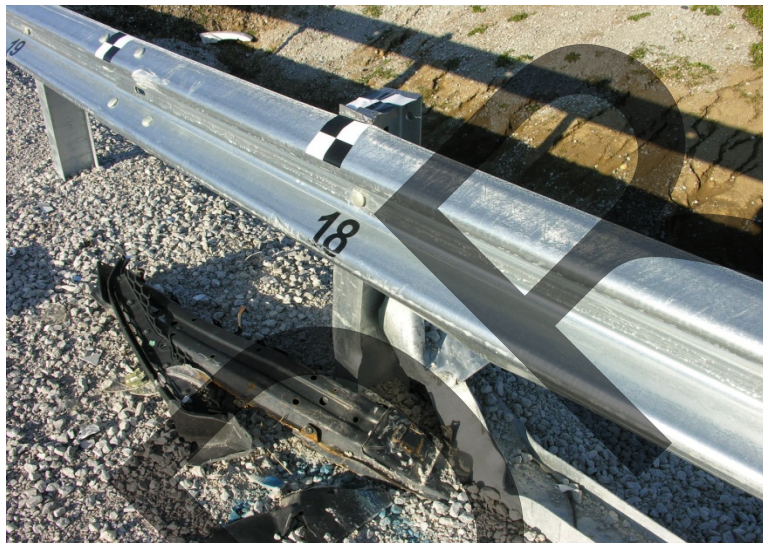
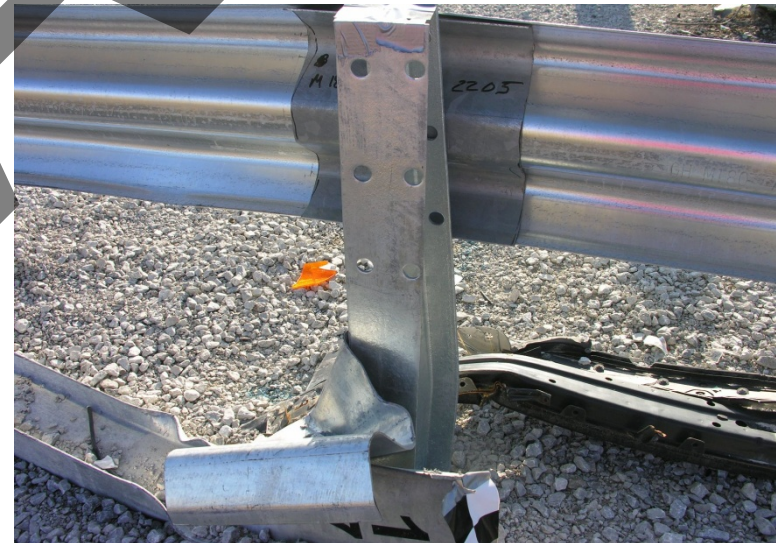
**Figure 66. Photo. Post Nos. 17 and 18 Damage, Test No. MGSGW-1.**

a. Post Nos 17, Top Portion

c. Post No. 17, Entire Length

b. Post No. 18, Front View

d. Post No. 18, Rear View

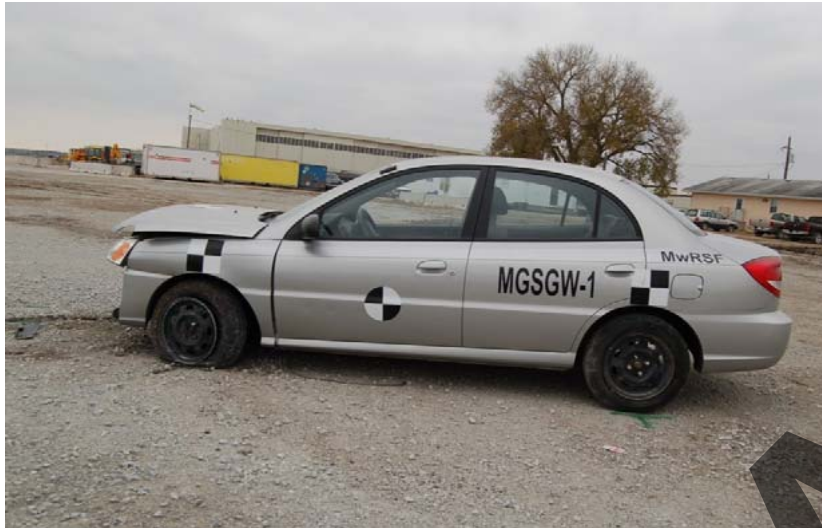
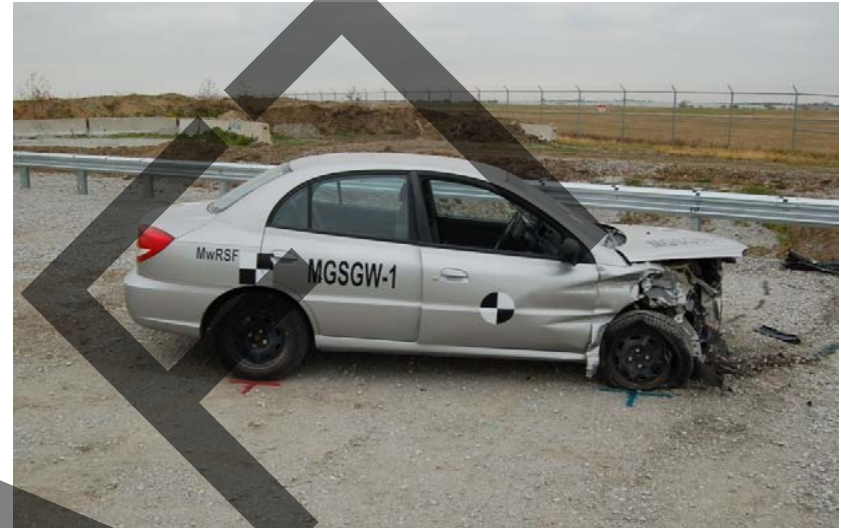
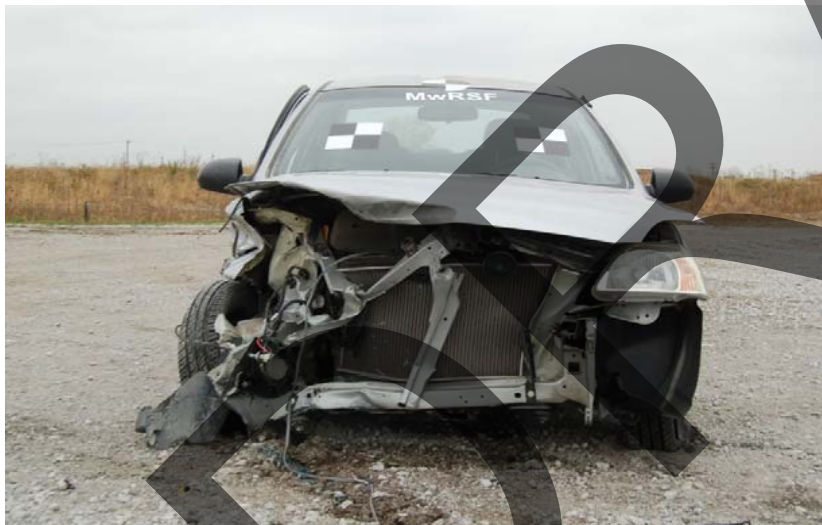
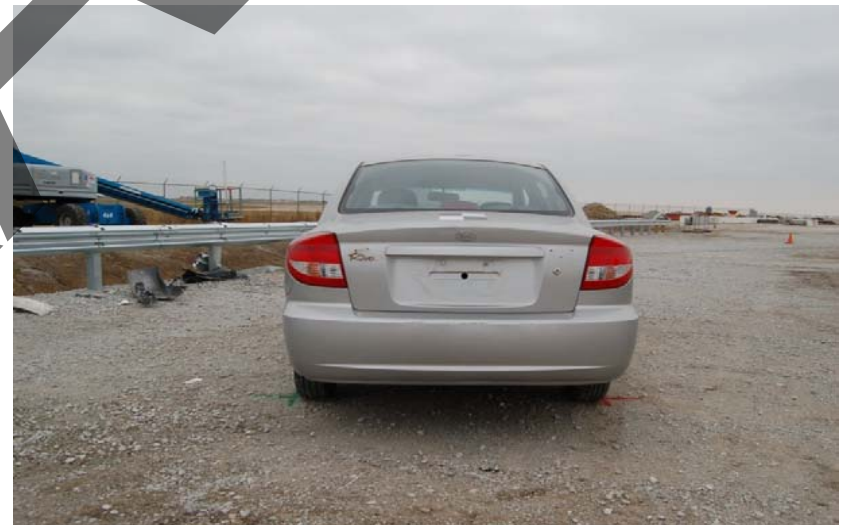
**Figure 67. Photo. Vehicle Damage, Test No. MGSGW-1.**

a. Left Side

c. Right Side

b. Front

d. RearMGSGW-1

The damage to the vehicle was moderate, as shown in Figures 67 through 70. The maximum occupant compartment deformations are shown in Table 12 with the deformation limits established in MASH for various regions of the occupant compartment. It should be noted that the MASH-established deformation limits were not violated. Complete interior occupant compartment deformations as well as other vehicle deformations, along with the corresponding locations, are provided in Appendix D.

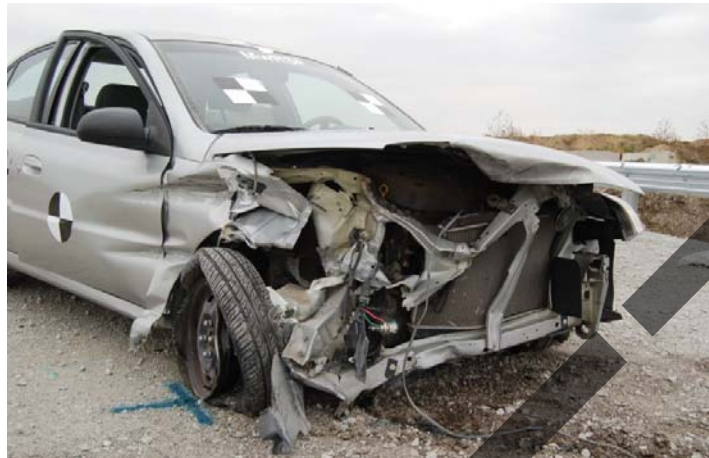
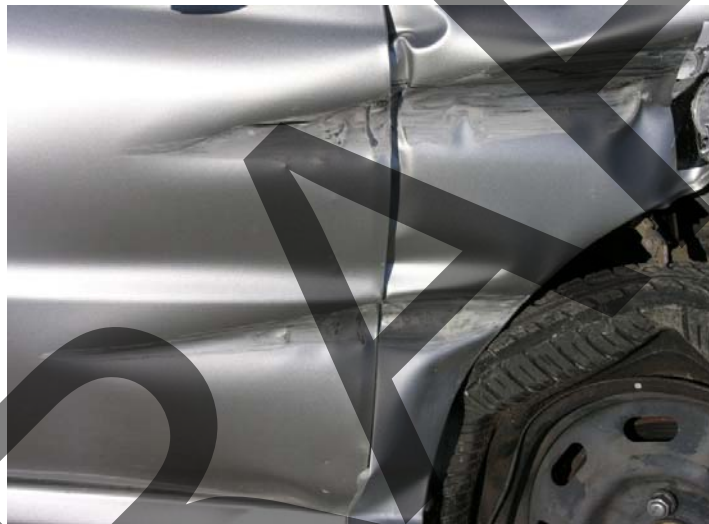
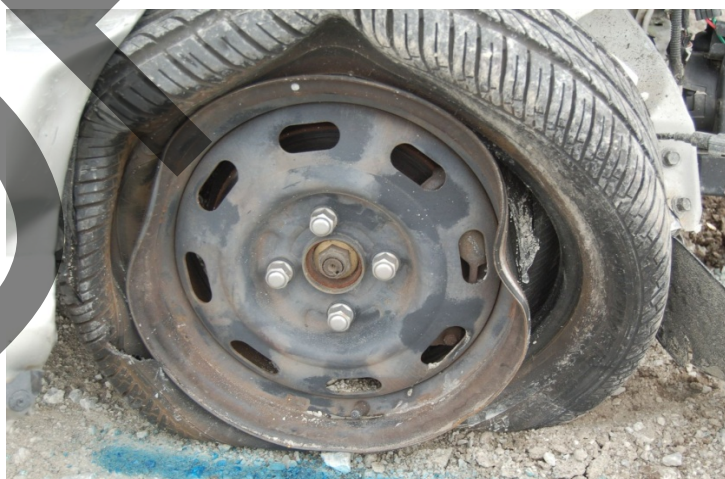
**Figure 68. Photo. Vehicle Damage, Test No. MSGGW-1.**

a. Impact Side Quarter View

b. Rail Interlock

c. Impact Side Wheel
