# DEVELOPMENT OF AN ECONOMICAL GUARDRAIL SYSTEM FOR USE ON WIRE- FACED, MSE WALLS

Publication No. FHWA-CFL/TD-12-009

FEBRUARY 2012

**CENTRAL FEDERAL LANDS HIGHWAY DIVISION  
12300 WEST DAKOTA AVENUE  
Lakewood, CO 80228**

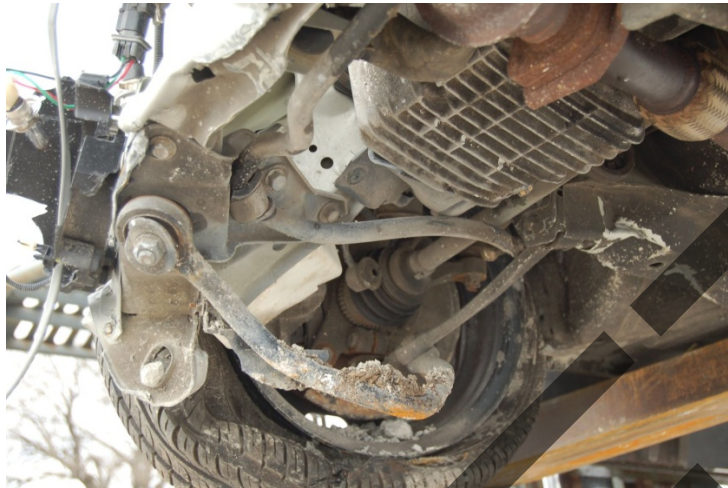
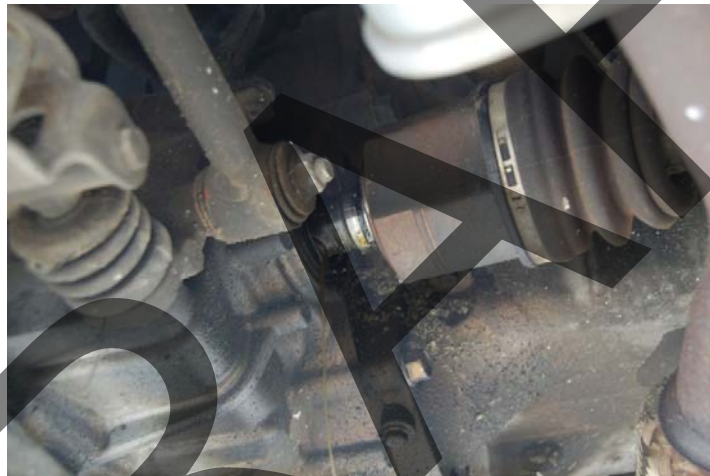
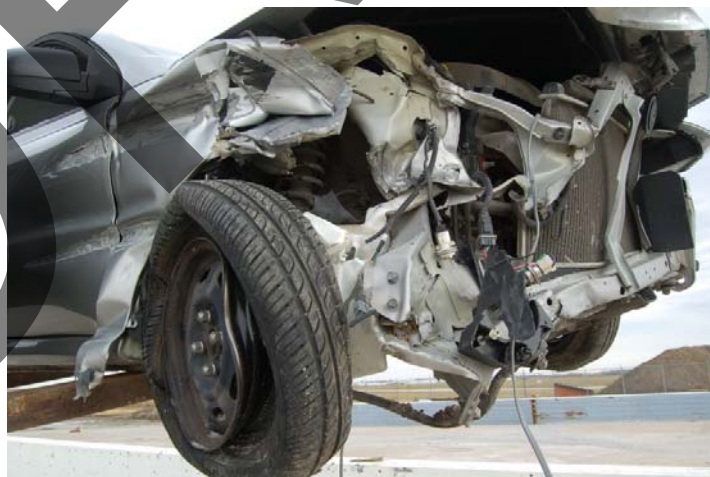
**Figure 69. Photo. Vehicle Undercarriage Damage, Test No. MGSGW-1.**

a. Impact Side Suspension

b. Axel/Transmission Connection

c. Impact Side

The damage to the vehicle was moderate, as shown in Figures 67 through 70. The maximum occupant compartment deformations are shown in Table 12 with the deformation limits established in MASH for various regions of the occupant compartment. It should be noted that the MASH-established deformation limits were not violated. Complete interior occupant compartment deformations as well as other vehicle deformations, along with the corresponding locations, are provided in Appendix D.

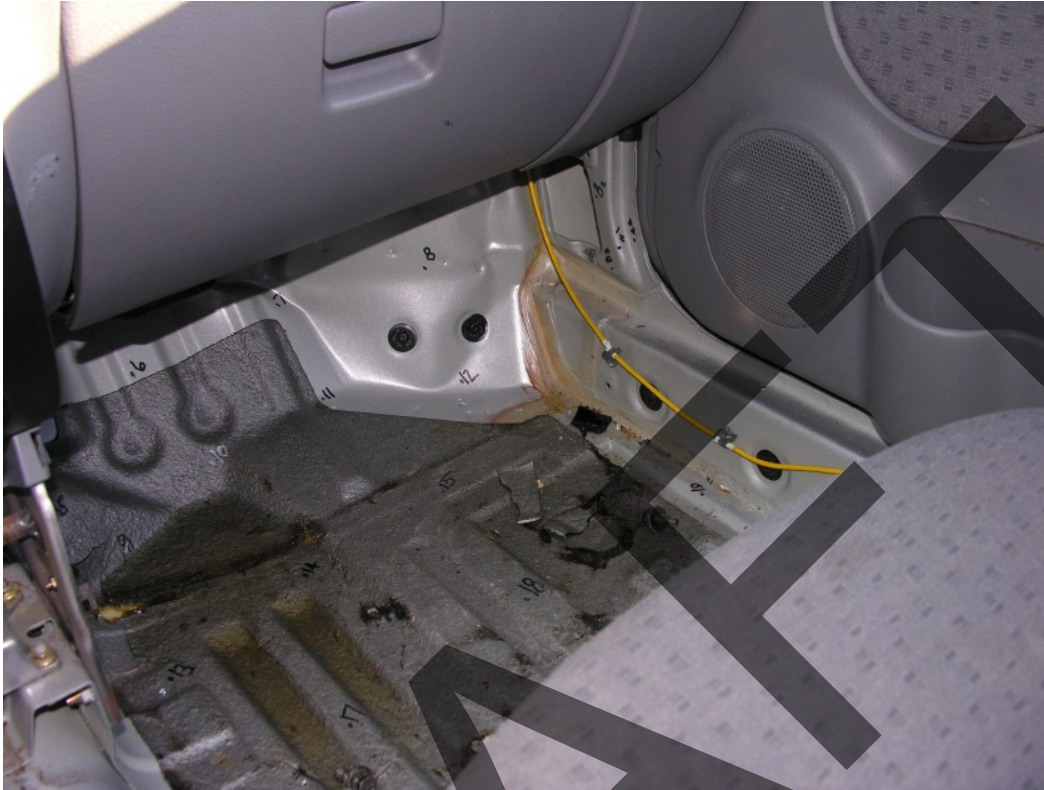
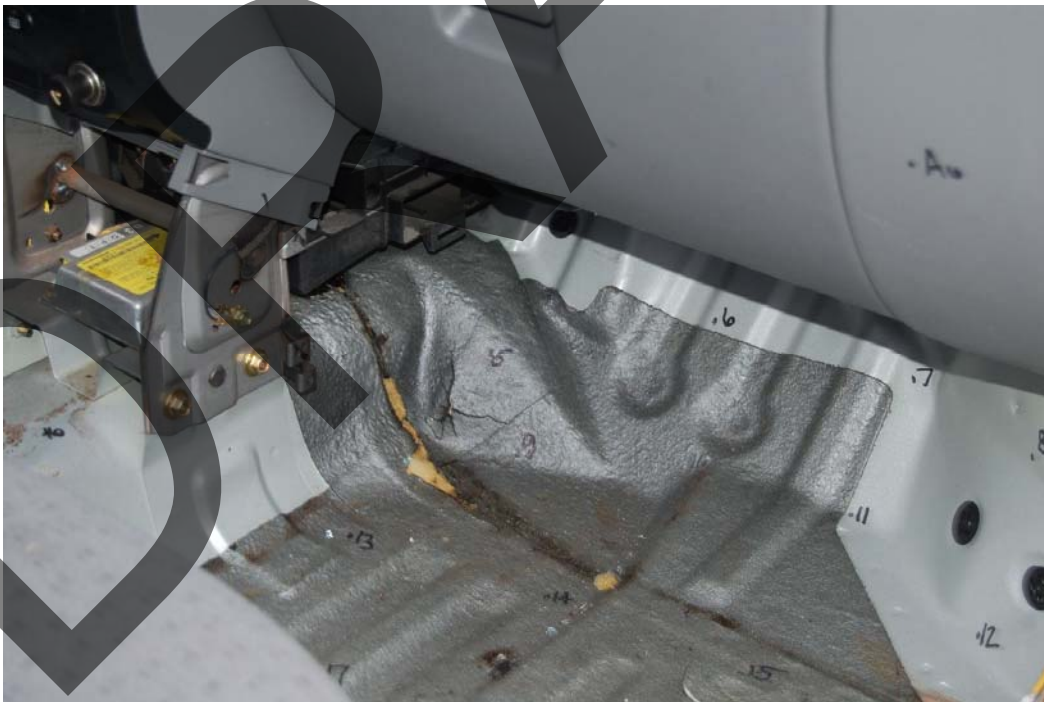
**Figure 70. Photo. Vehicle Occupant Compartment Damage, Test No. MSGGW-1.**

a. Impact Side Firewall

b. Impact Side Tunnel

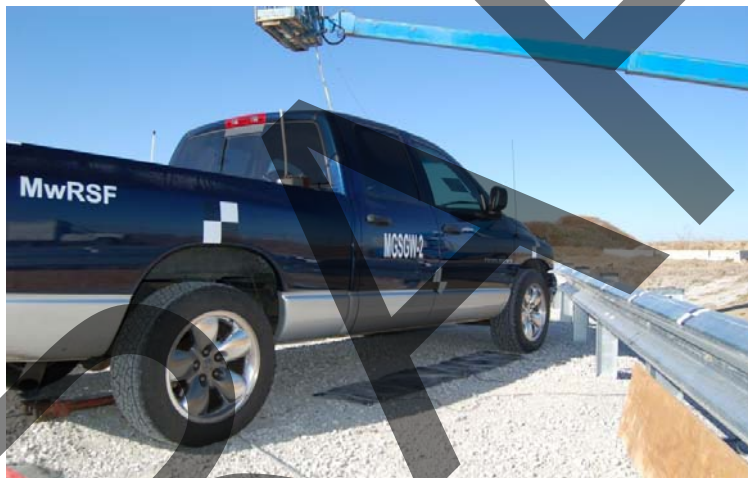
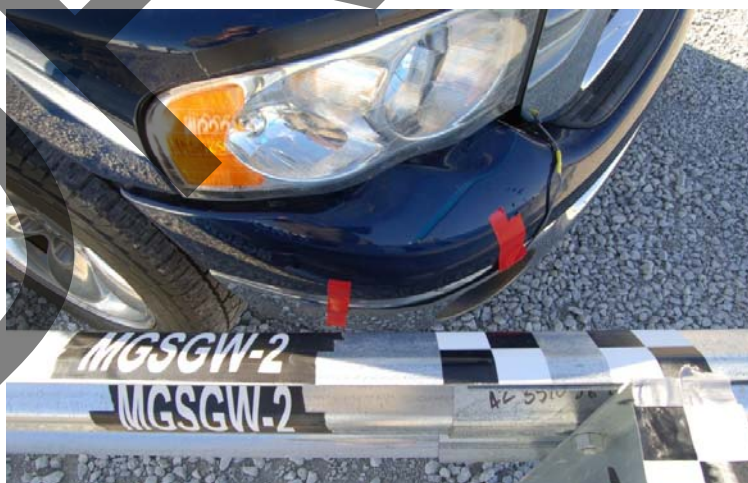
a. Overhead

b. Upstream View

c. Closeup View

**Figure 77. Photo. Impact Location, Test No. MGSGW-2.**

Initial vehicle impact was to occur 16 ft (4.9 m) upstream of the splice between post nos. 14 and 15, as shown in Figure 77. The actual point of impact occurred at the target impact point. A sequential description of the impact events is shown in Table 15. The vehicle came to rest 103 ft - 4½ in. (31.5 m) downstream from impact and 16 ft - 3 in. (4.9 m) laterally in front of the barrier. The vehicle trajectory and final position are shown in Figures 71 and 78.

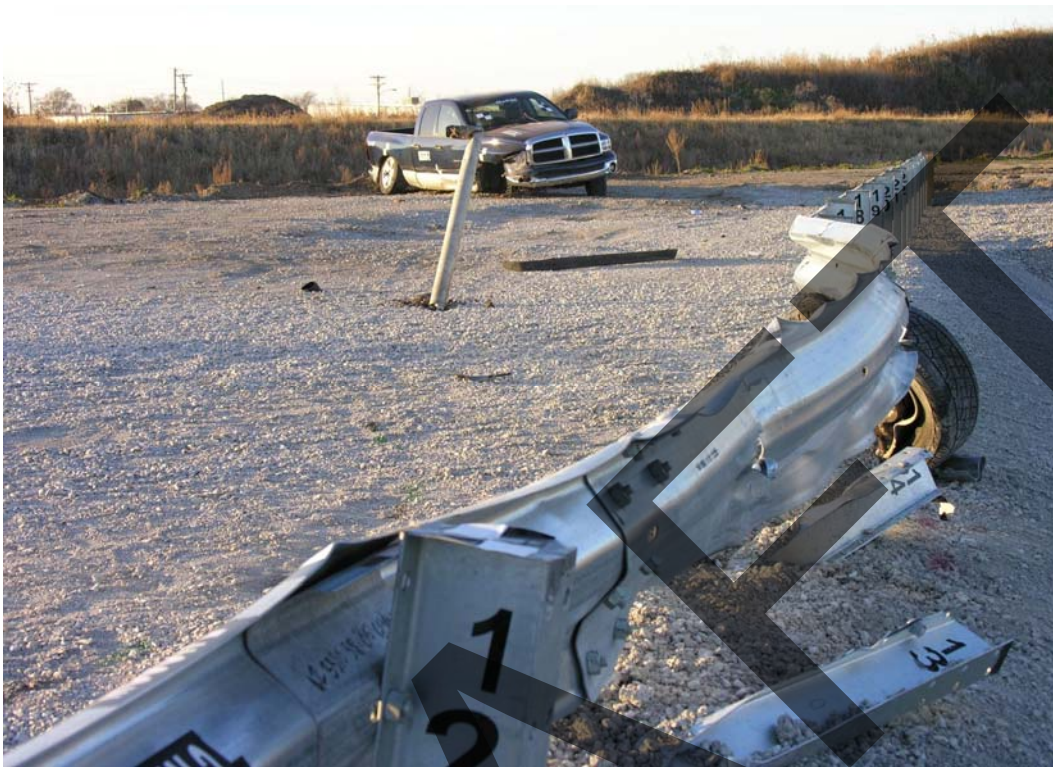
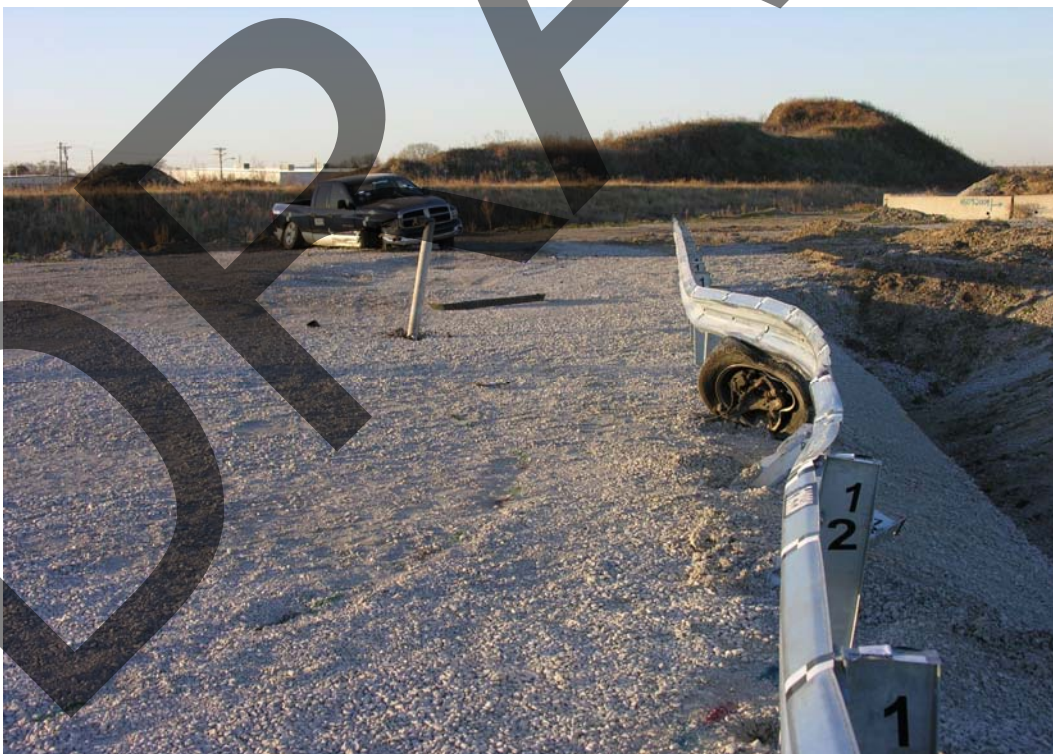
a. Vehicle Final Position

b. Broad View

**Figure 78. Photo. Vehicle Final Position and Trajectory Marks, Test No. MGSGW-2.**

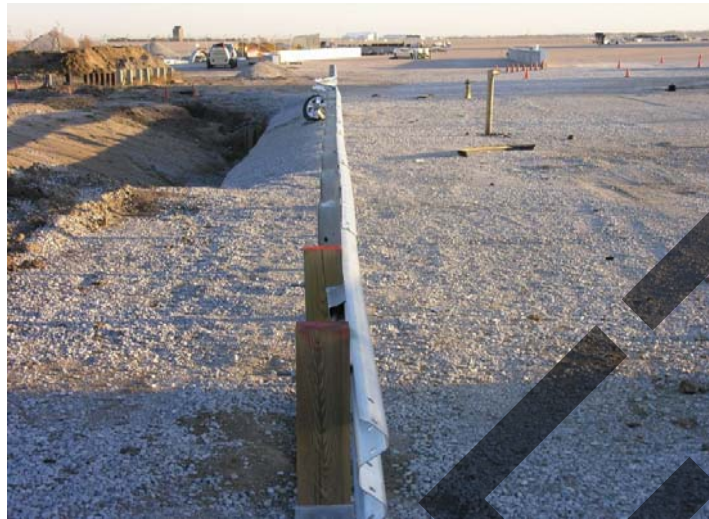
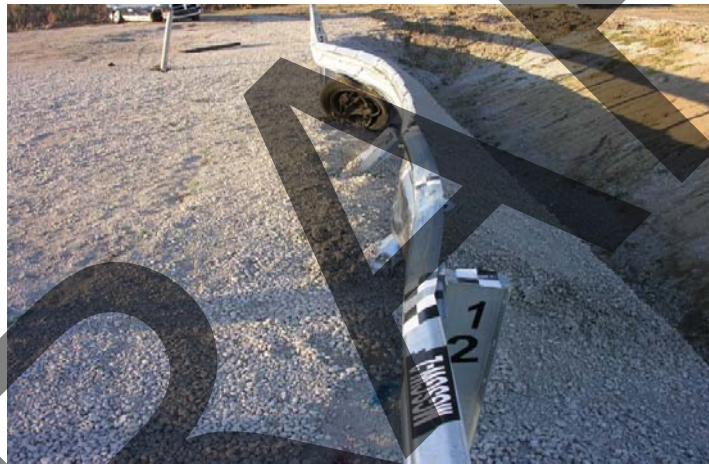
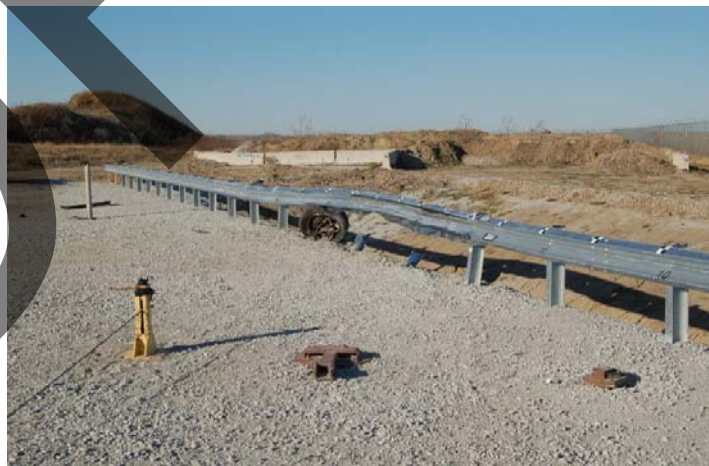
a. Downstream Inline View

b. Upstream Inline View

c. Front View

**Figure 79. Photo. System Damage, Test No. MSGGW-2.**

Damage to the barrier was moderate, as shown in Figures 79 through 84. Barrier damage consisted of deformed guardrail posts, contact marks on the W-beam rail and guardrail posts, and deformed W-beam rail. The length of vehicle contact along the barrier was approximately 25 ft – 9½ in. (7.9 m), extending from 5 in. (127 mm) upstream of post no. 12 to 4½ in. (114 mm) downstream of post no. 16.

The permanent set of the barrier system is shown in Figure 79. The maximum lateral permanent set rail and post deflections were 22¼ in. (565 mm) at post no. 14 and 26¼ in. (667 mm) at post no. 13, respectively, as measured in the field. The maximum lateral dynamic rail and post deflections were 35.7 in (907 mm) at the midpoint of post nos. 13 and 14 and 35.7 in. (907 mm) at post no. 14, respectively, as determined from high-speed digital video analysis. The working width of the system was found to be 45.2 in. (1,148 mm).

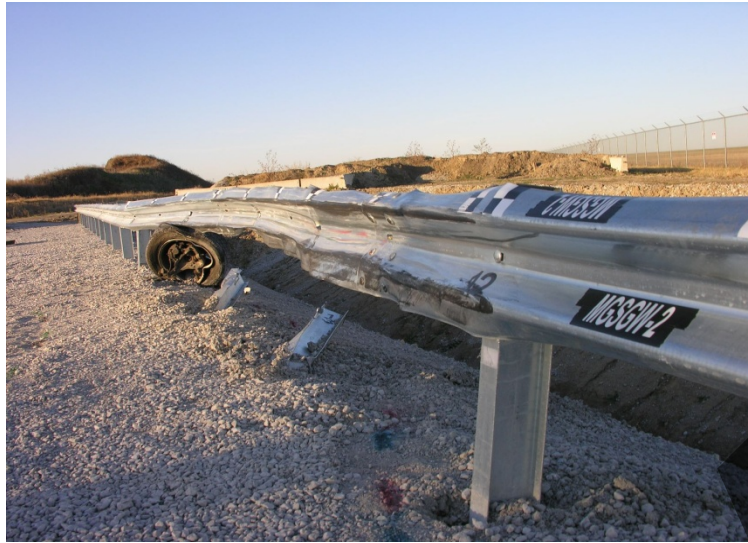
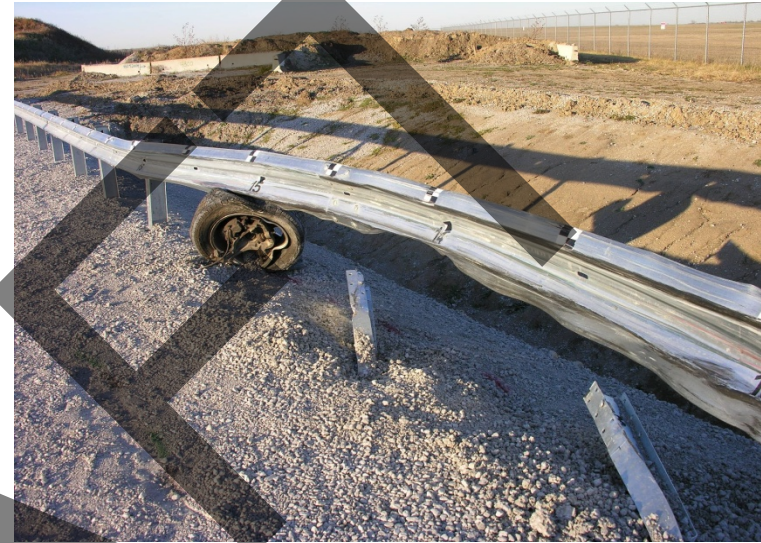
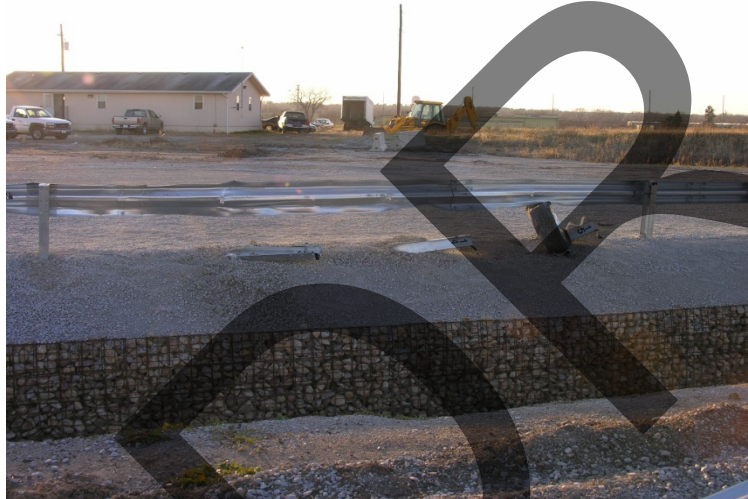
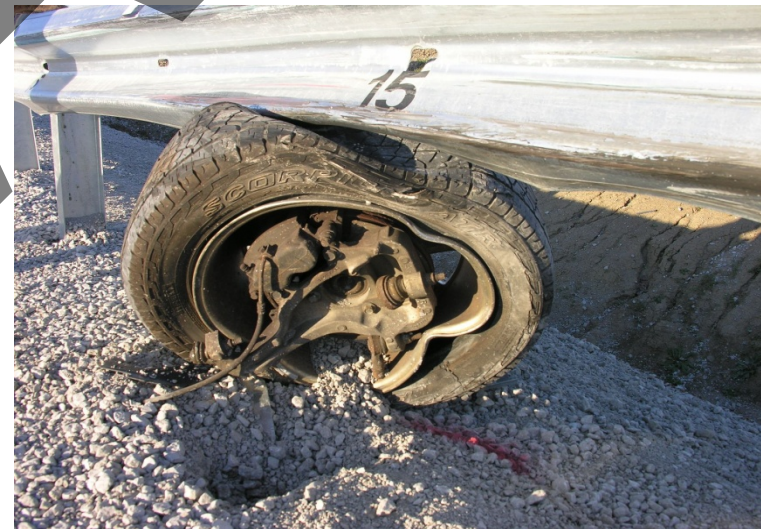
a. Impacted Rail

c. Impacted Rail, Front Quarter View

b. Impacted Rail Rear View

d. Wheel Lodged Under Rail

**Figure 80. Photo. System Damage, Test No. MGSGW-2.**

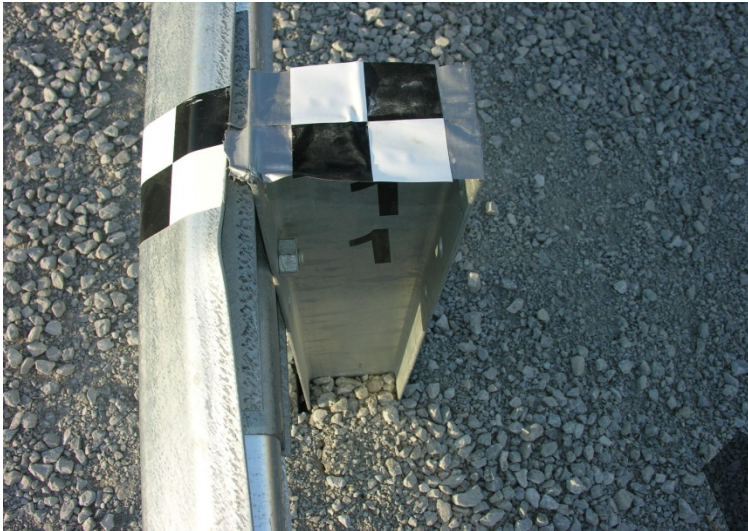
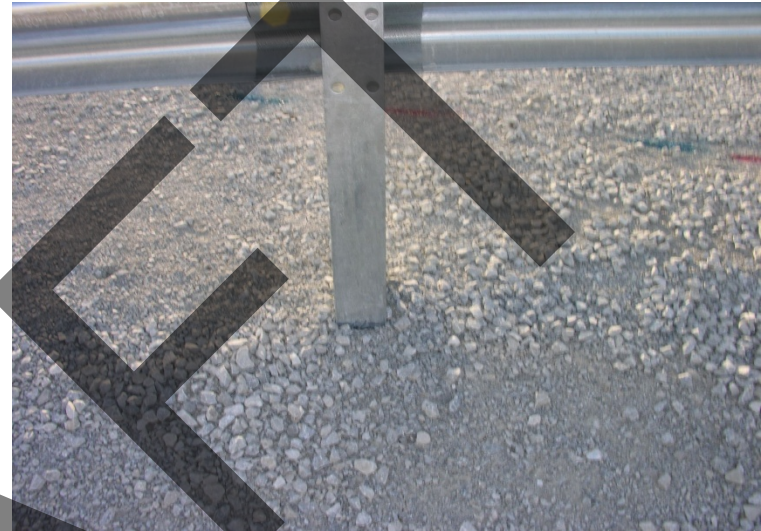
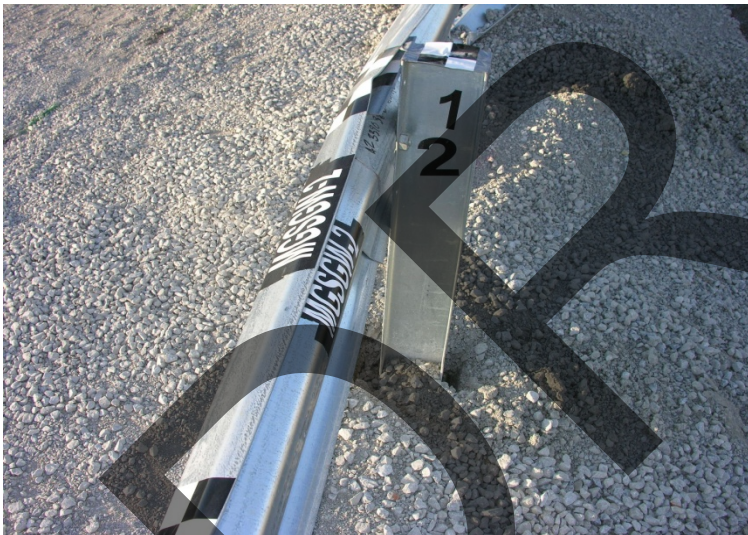
a. Post No. 11 Top View

c. Post No. 11 Rear View

b. Post No. 12 Upstream View

**Figure 81. Photo. Post Nos. 11 and 12 Damage, Test No. MGSGW-2.**

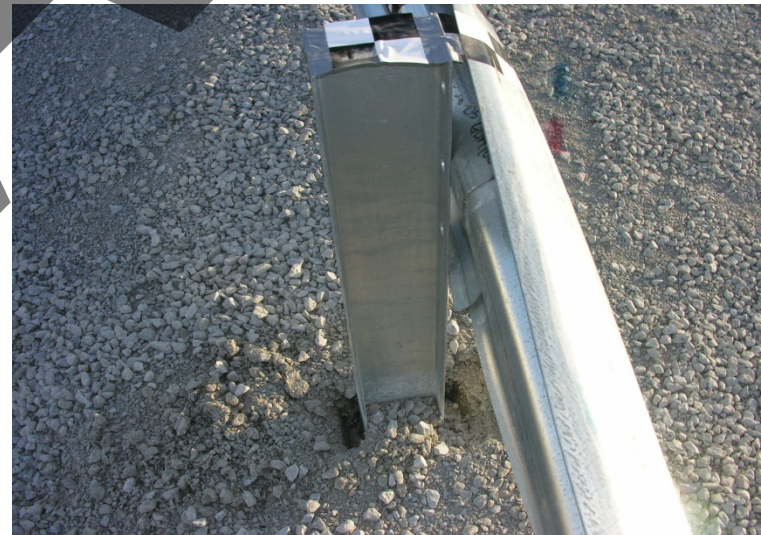
d. Post No. 12 Downstream View

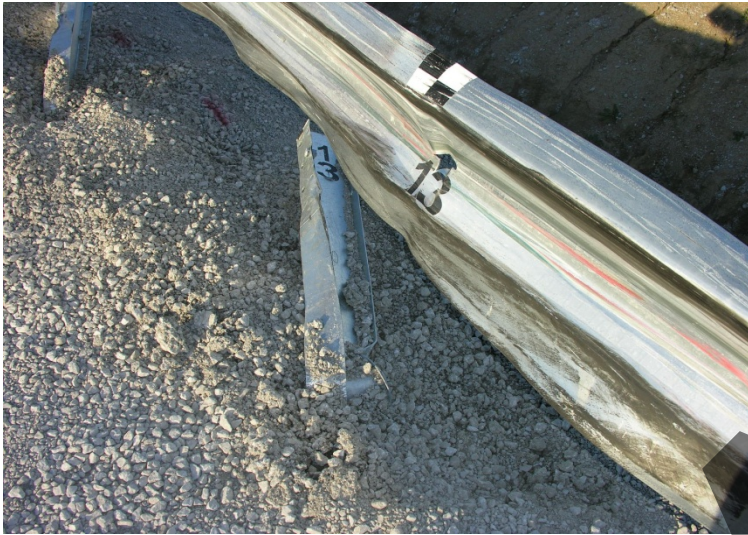
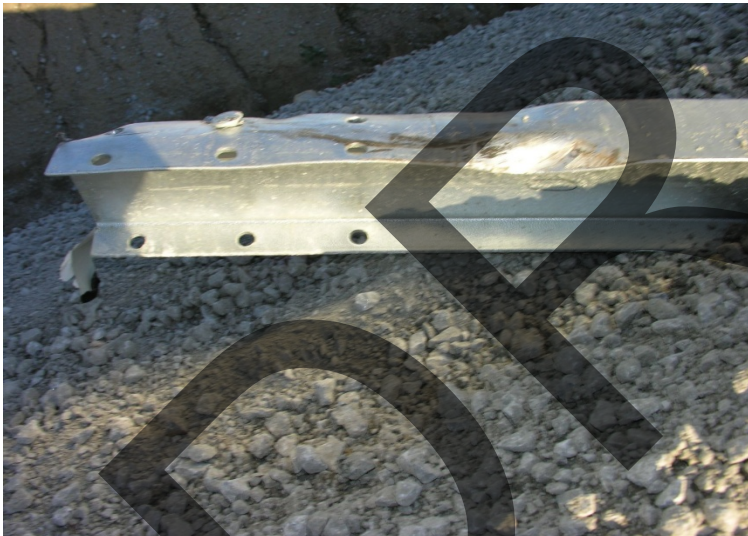
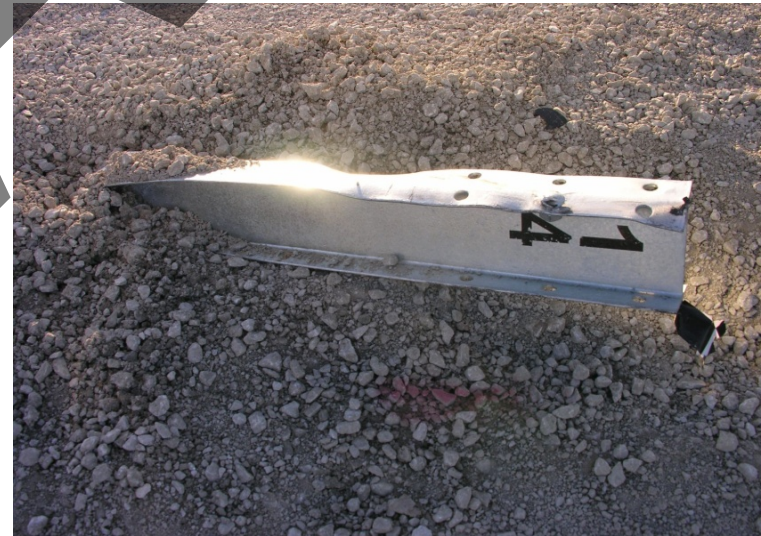
**Figure 82. Photo. Post Nos. 13 and 14 Damage, Test No. MGSGW-2.**

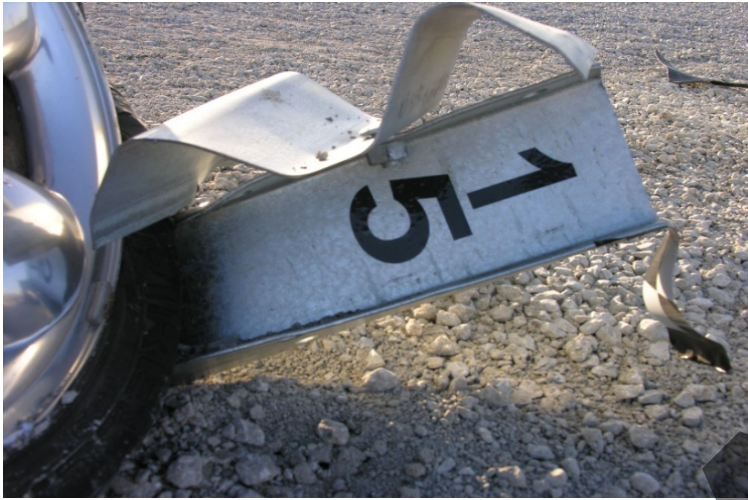
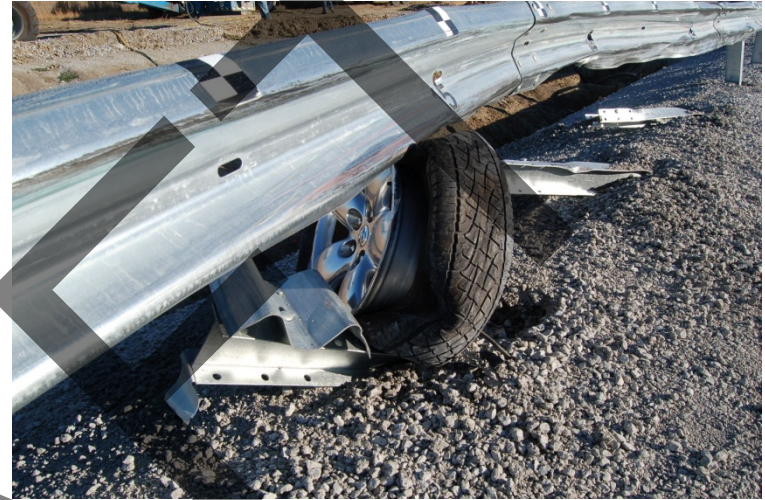
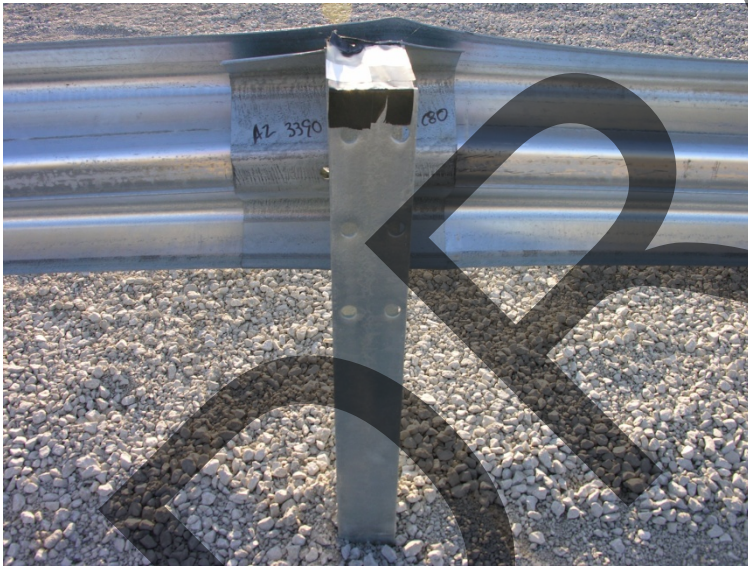
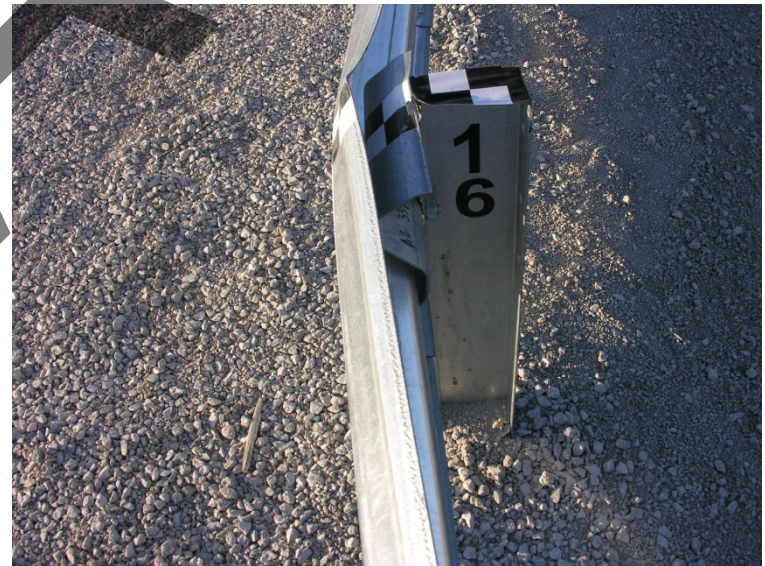
**Figure 83. Photo. Post Nos. 15 and 16 Damage, Test No. MGSGW-2.**

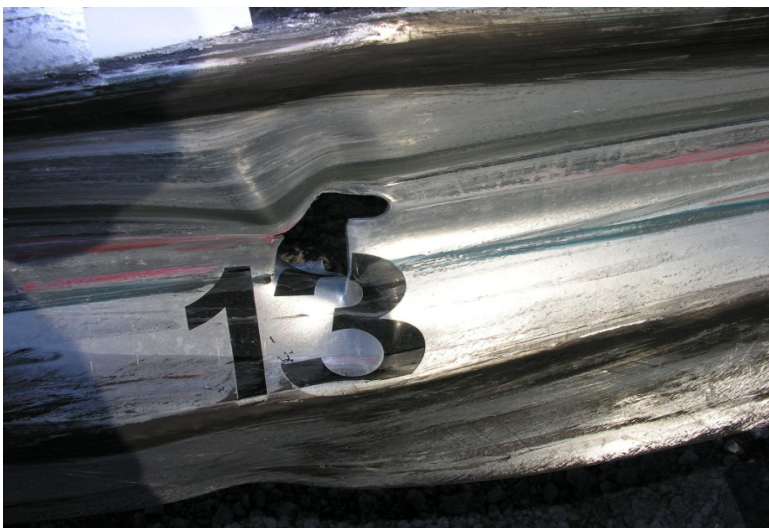
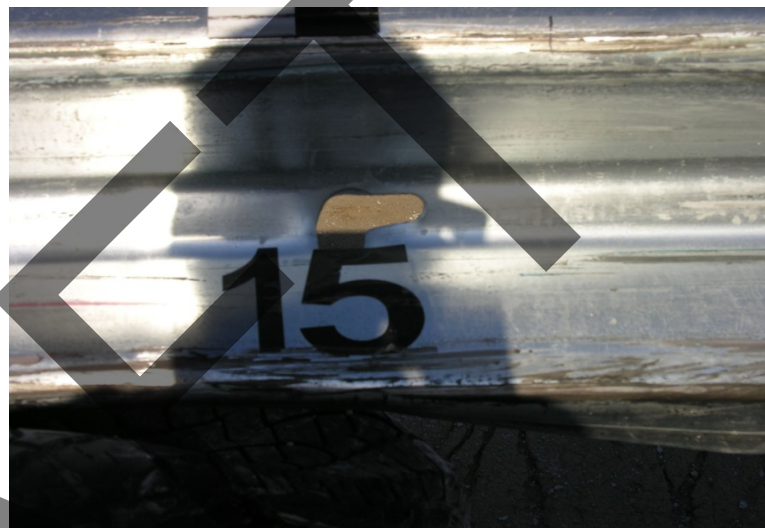
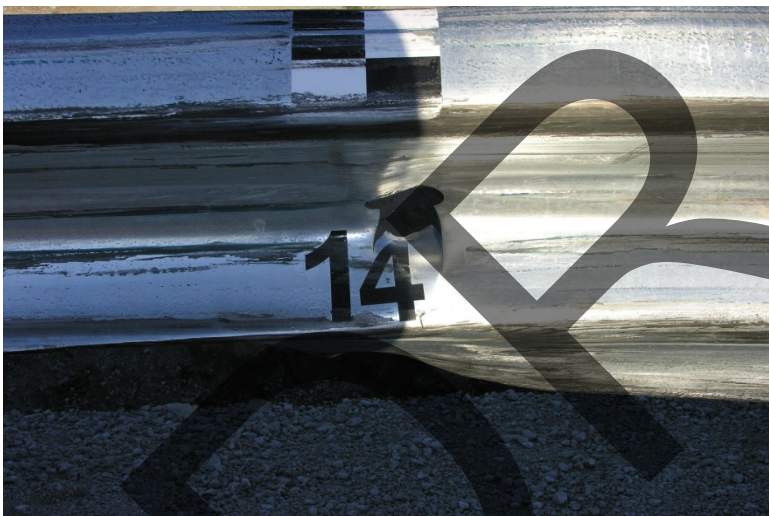
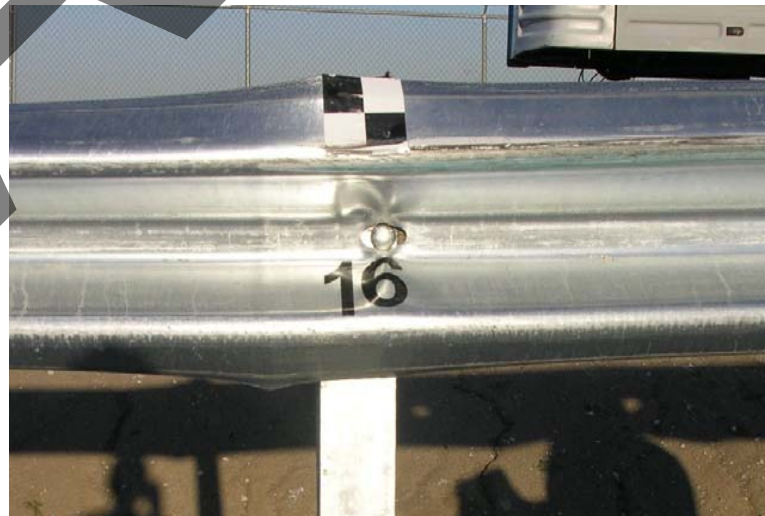
**Figure 84. Photo. Post Bolt Location Rail Damage Photographs, Test Nos. MGSGW-2.**

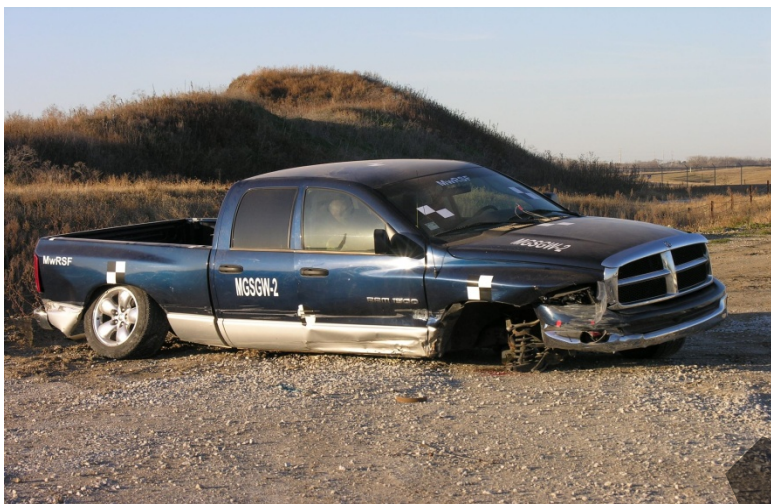
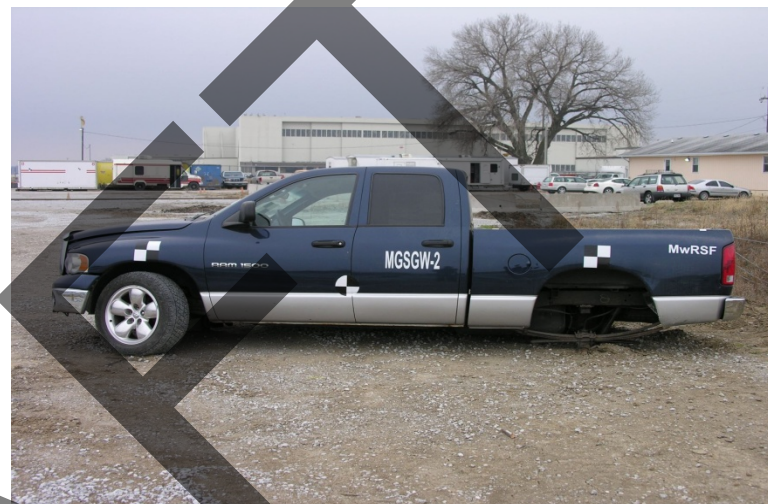
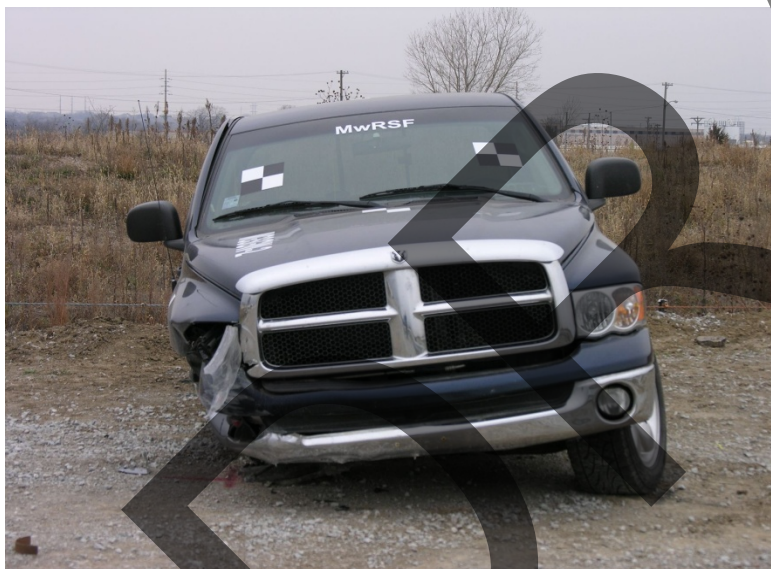
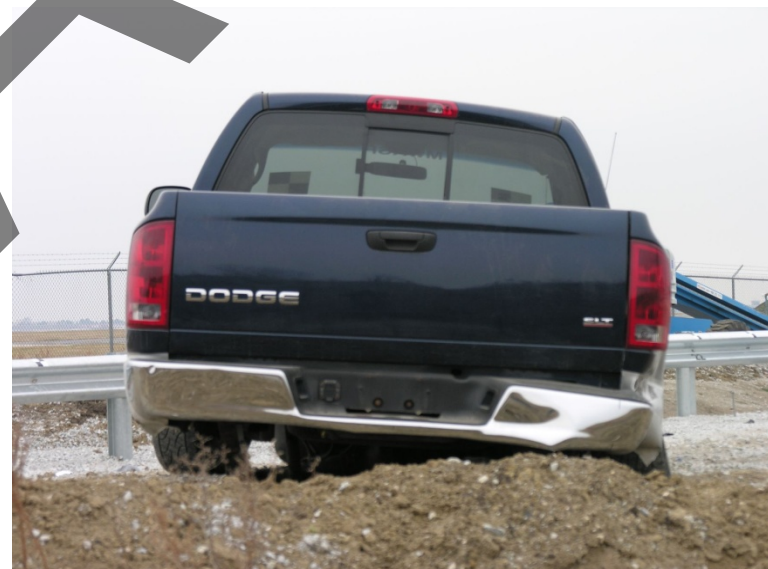
**Figure 85. Photo. Vehicle Damage, Test No. MGSGW-2.**

The damage to the vehicle was moderate, as shown in Figures 85 through 88. The maximum occupant compartment deformations as well as the deformation limits established in MASH for various regions of the occupant compartment are shown in Table 16. It should be noted that the MASH-established deformation limits were not violated. Complete interior occupant compartment deformations as well as other vehicle deformations, along with the corresponding locations, are provided in Appendix D.

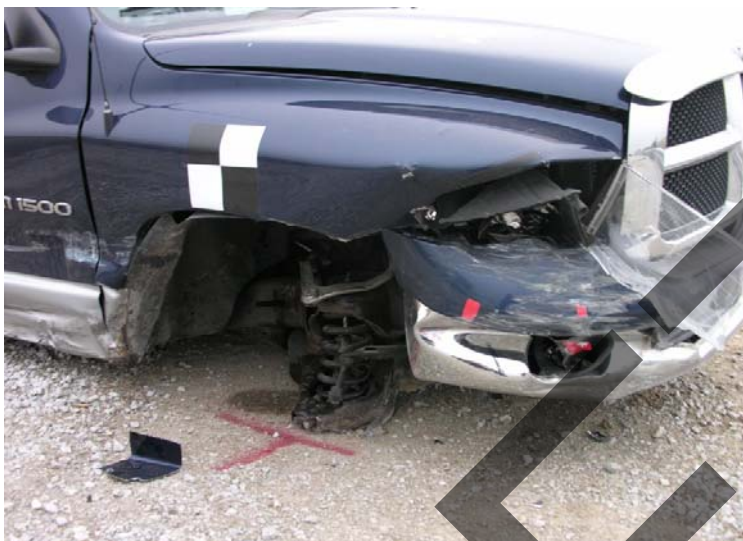
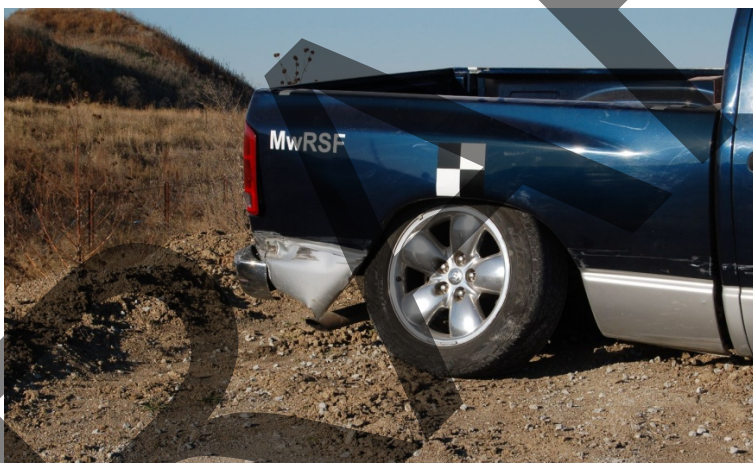
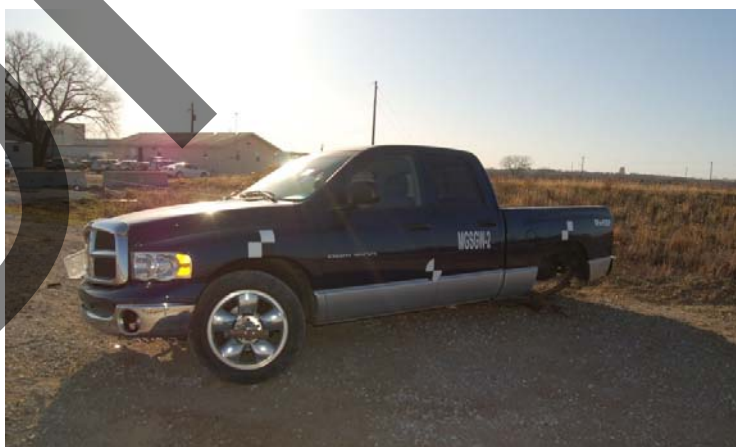
**Figure 86. Photo. Vehicle Damage, Test No. MGSGW-2.**

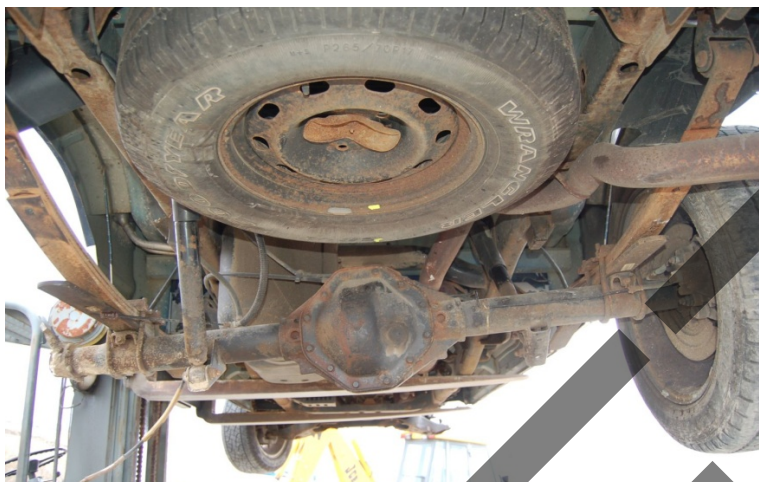
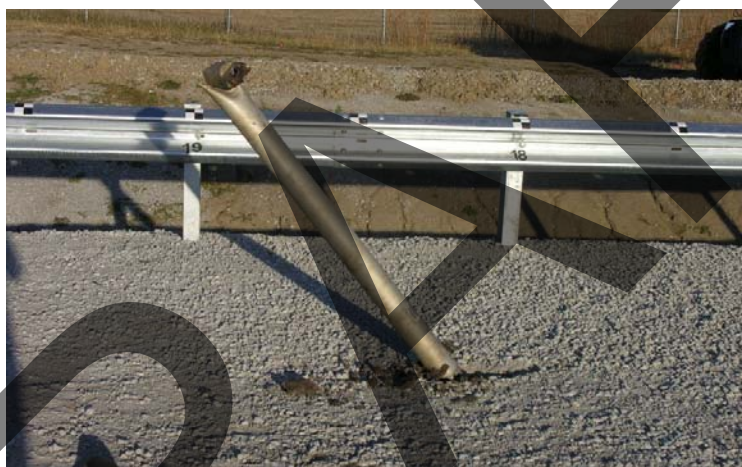
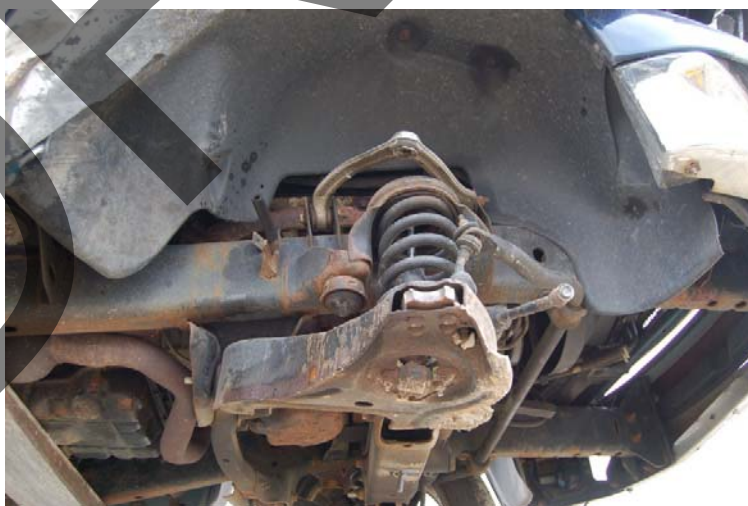
**Figure 87. Photo. Vehicle Undercarriage Damage, Test No. MSGGW-2.**

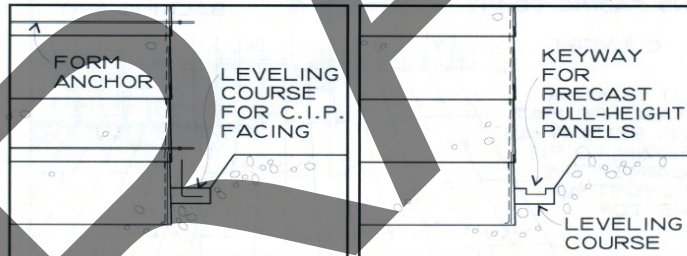
A LEVELING COURSE IS CAST AGAINST THE TOE OF THE WELDED WIRE WALL. THIS WILL SERVE TO SUPPORT AND ALIGN THE FORMS FOR THE C.I.P. FACING, OR WILL HAVE A KEYWAY FOR ALIGNMENT AND CONTROL OF THE TOE OF THE PRECAST FULL-HEIGHT PANELS.

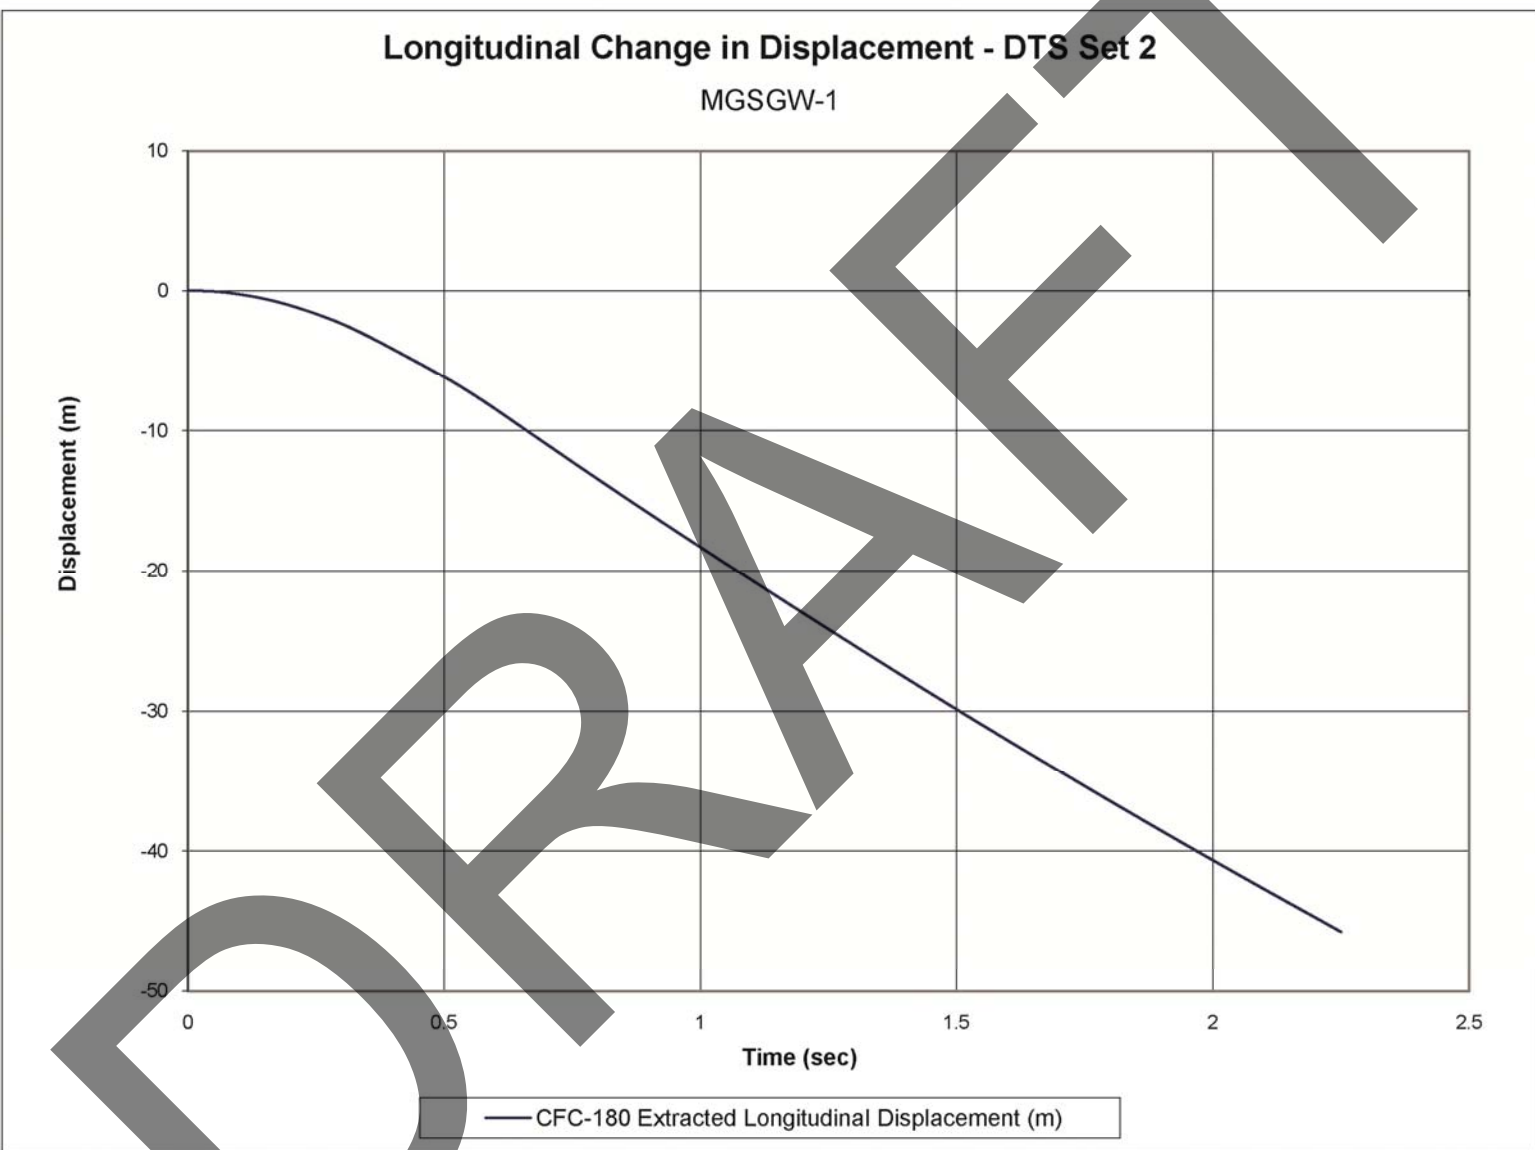
**Figure 157. Graph. Longitudinal Occupant Displacement (DTS Set 2), Test No. MSGGW-1.**

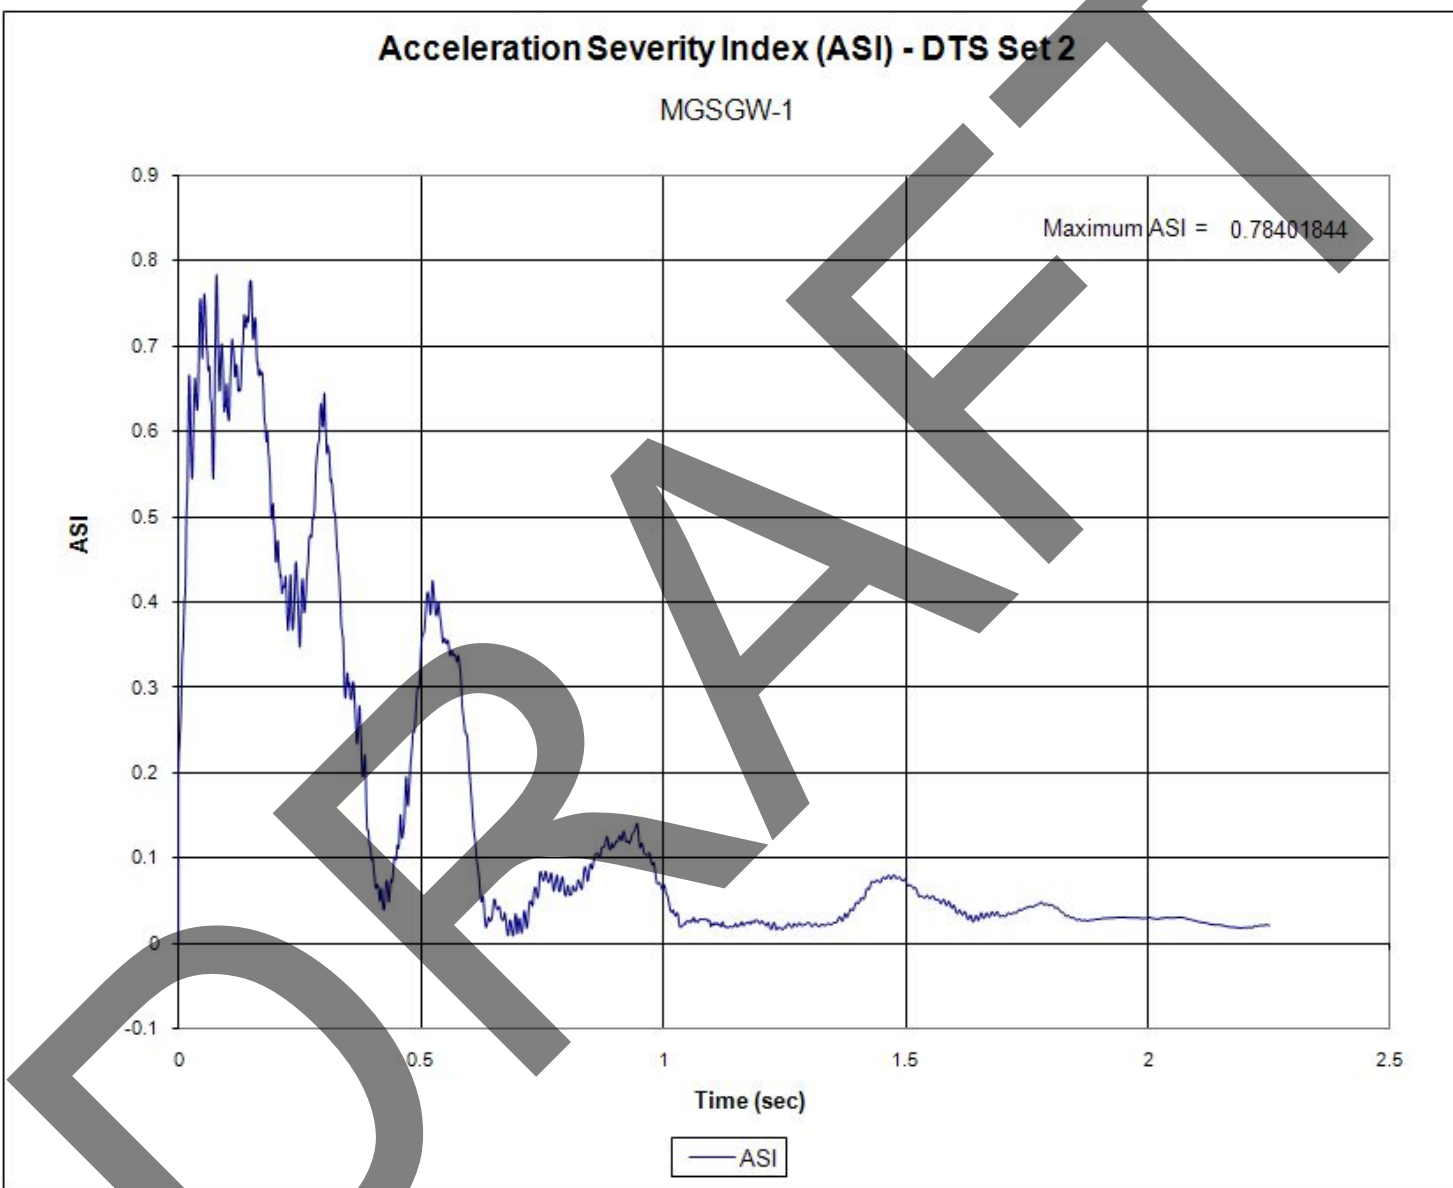
Figure 161. Graph. Acceleration Severity Index (DTS Set 2), Test No. MSGGW-1.
