# DEVELOPMENT OF AN ECONOMICAL GUARDRAIL SYSTEM FOR USE ON WIRE- FACED, MSE WALLS

Publication No. FHWA-CFL/TD-12-009

FEBRUARY 2012

**CENTRAL FEDERAL LANDS HIGHWAY DIVISION  
12300 WEST DAKOTA AVENUE  
Lakewood, CO 80228**

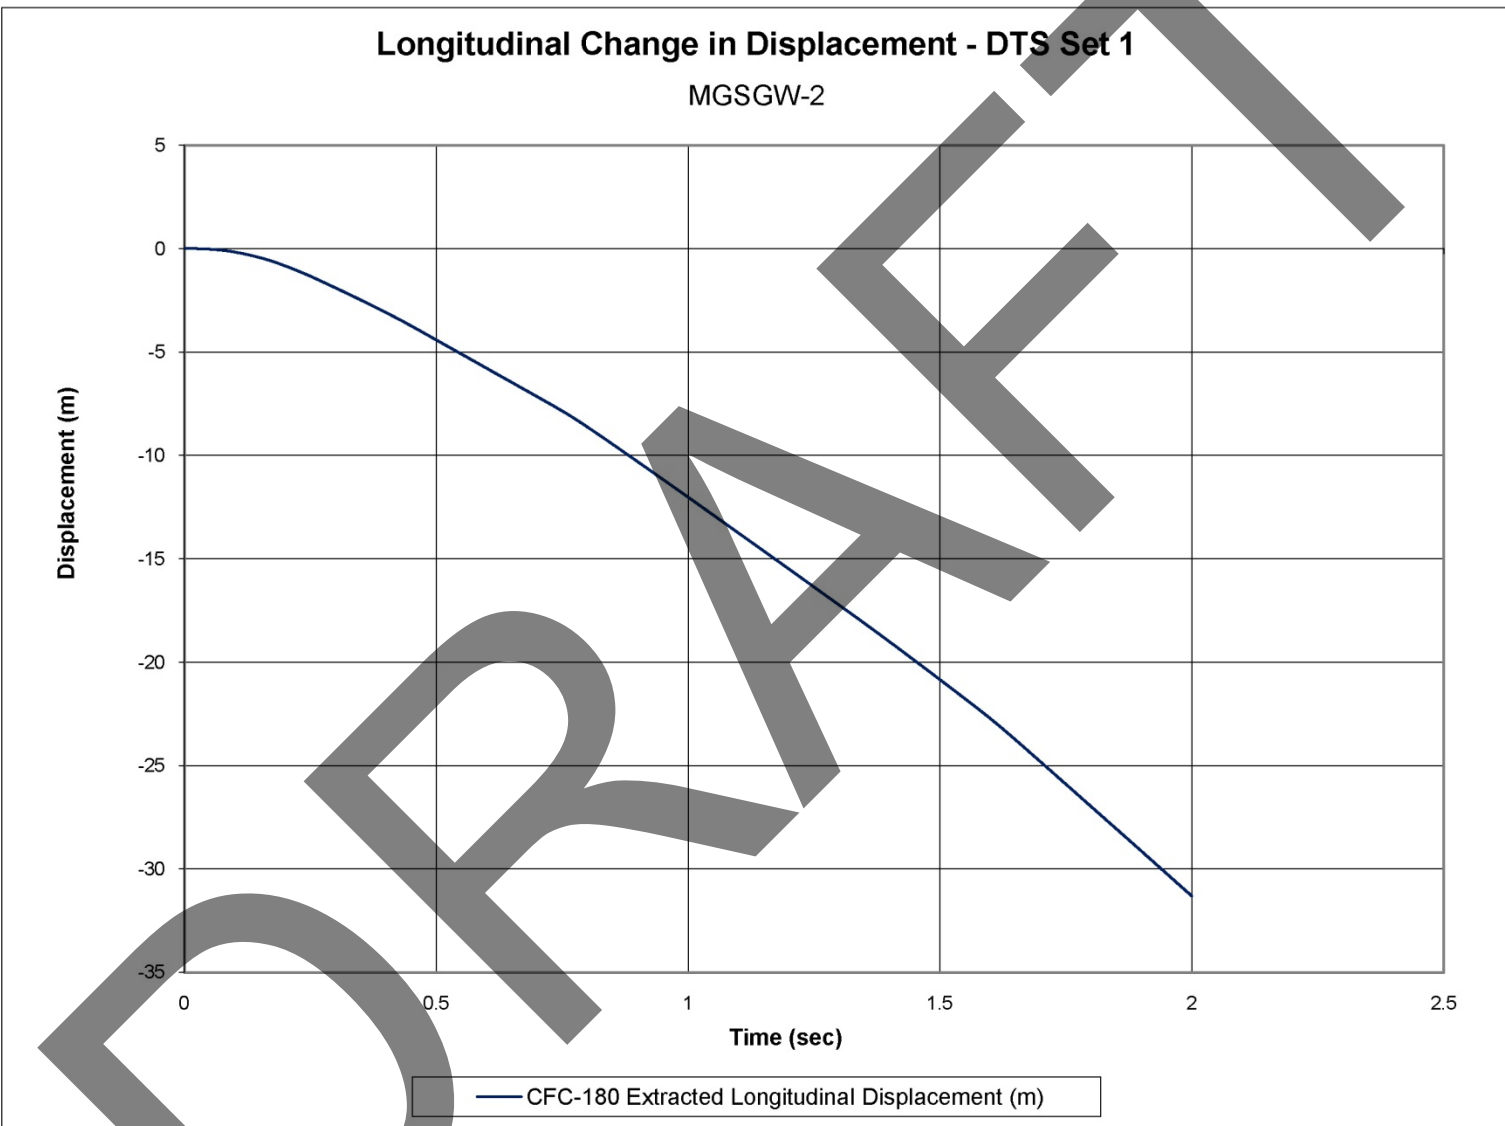
**Figure 171. Graph. Longitudinal Occupant Displacement (DTS Set 1), Test No. MGSGW-2.**

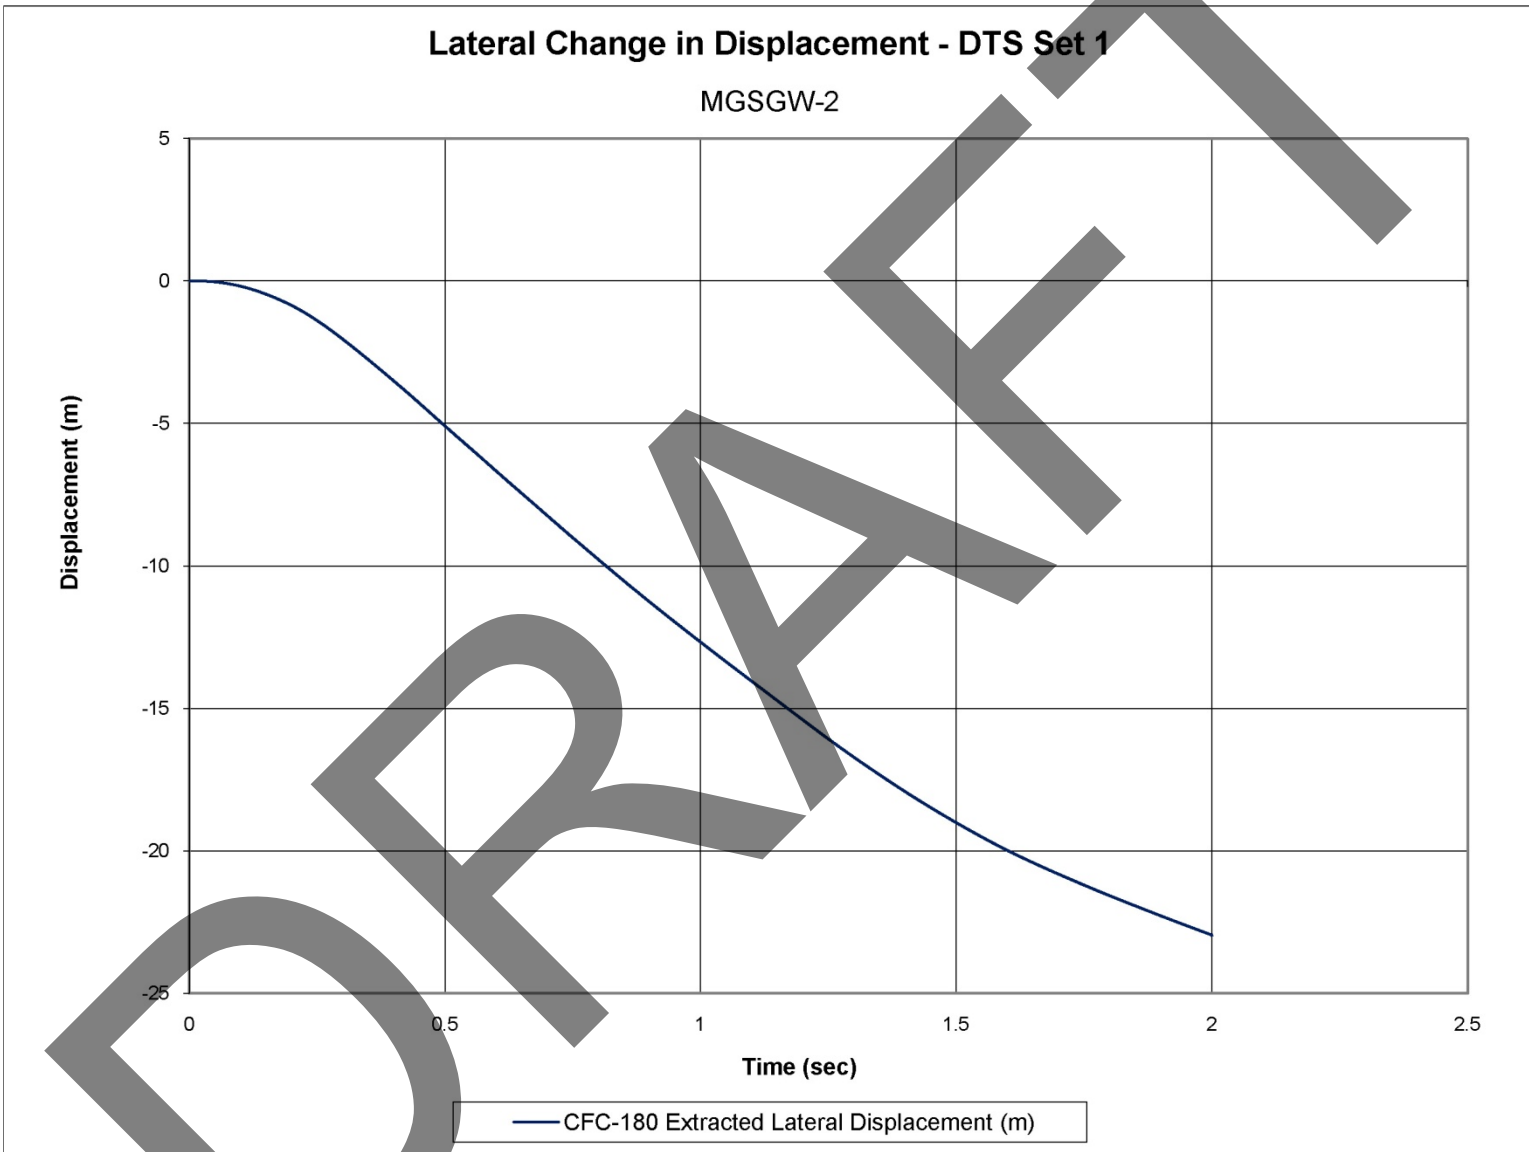
**Figure 174. Graph. Lateral Occupant Displacement (DTS Set 1), Test No. MGSGW-2.**

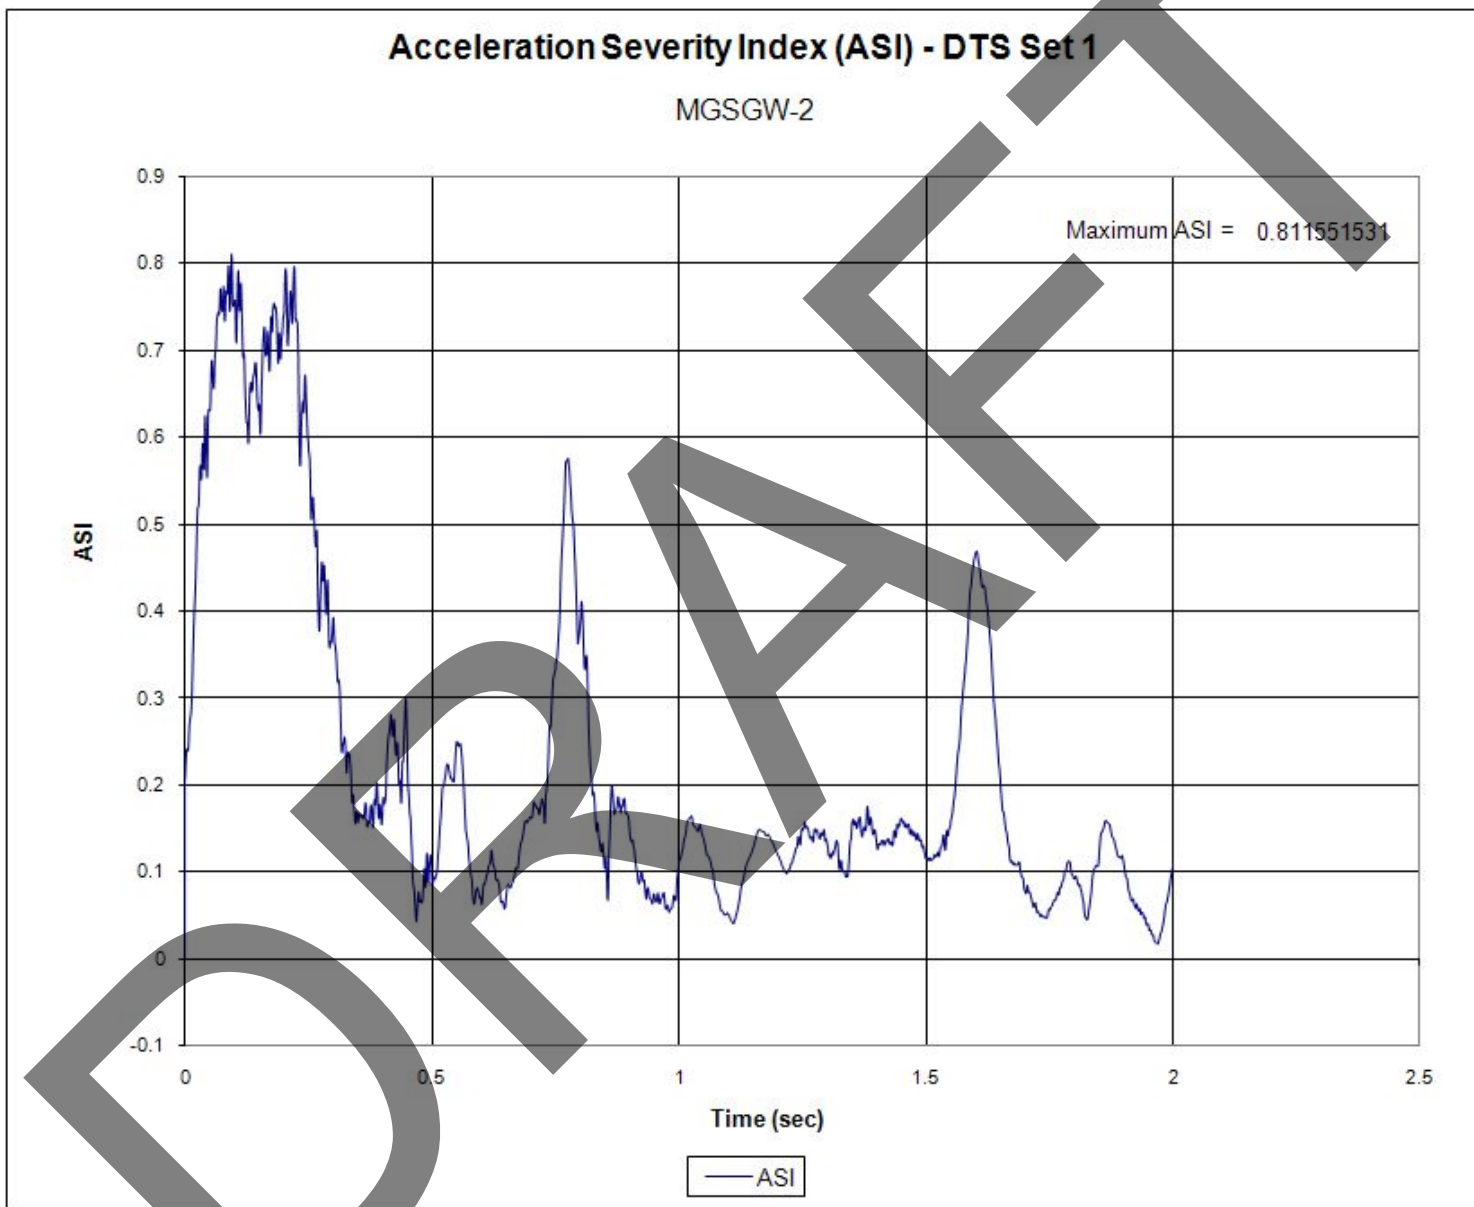
Figure 176. Graph. Acceleration Severity Index (DTS Set 1), Test No. MSGGW-2.

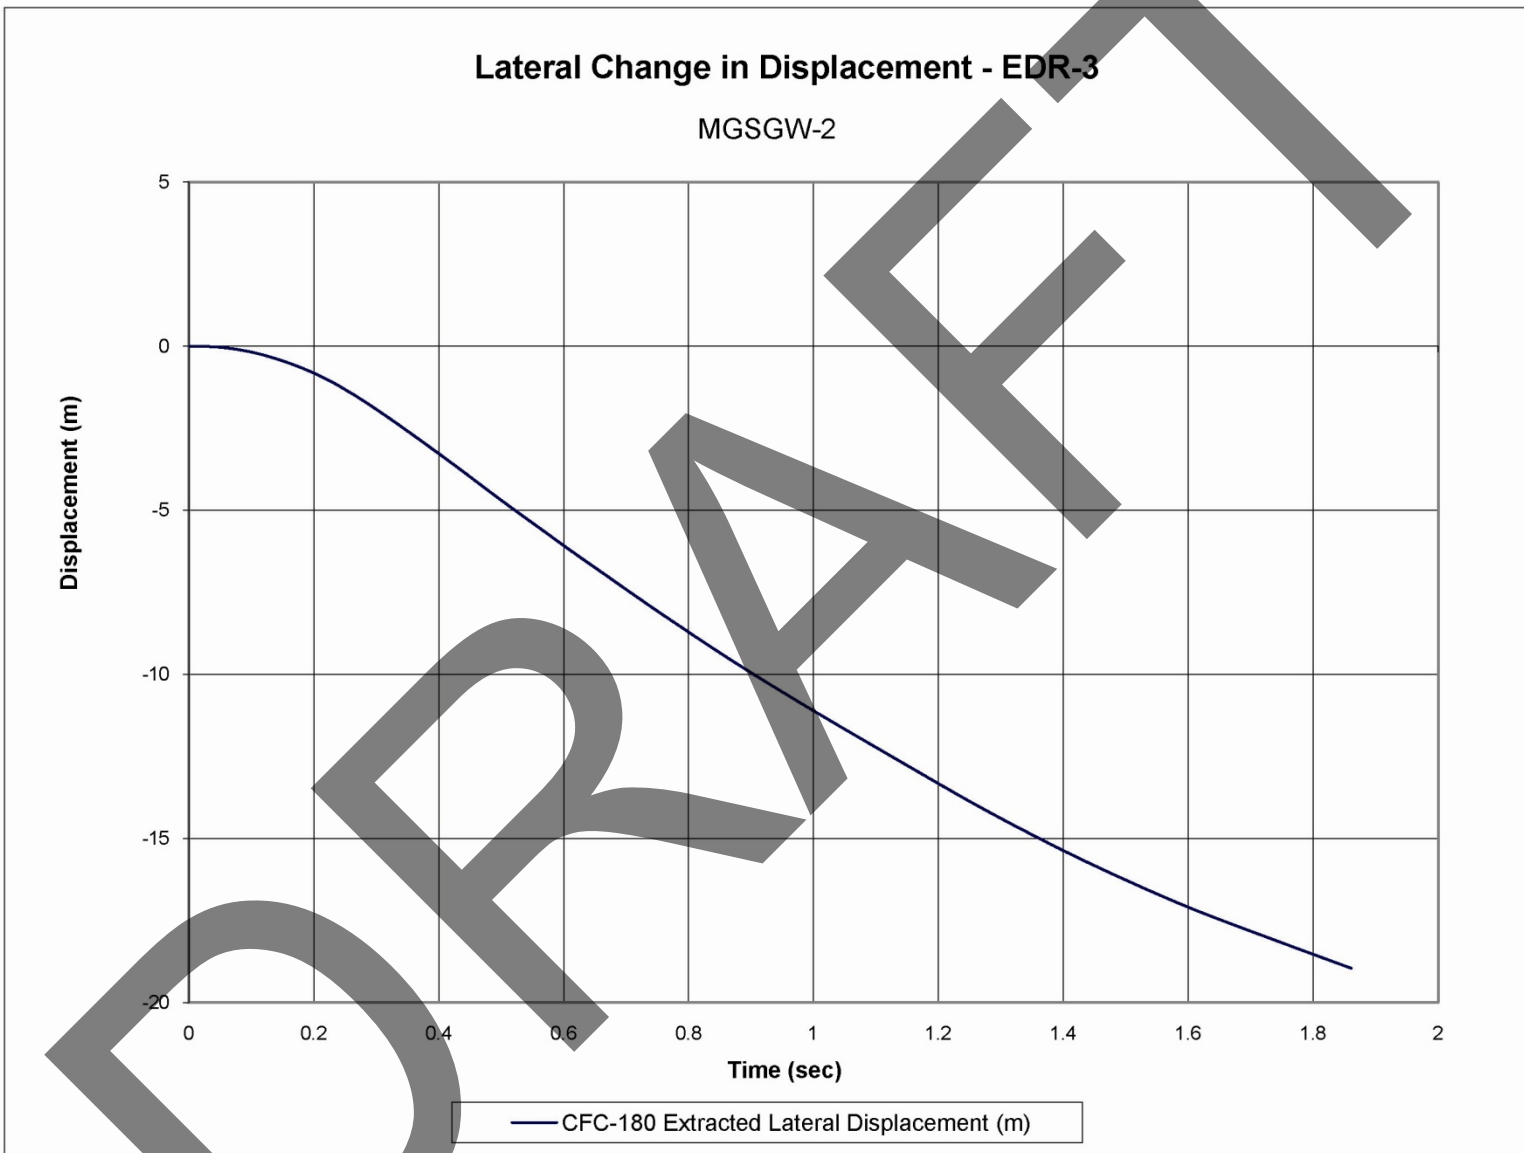
Figure 189. Graph. Lateral Occupant Displacement (EDR-3), Test No. MSGGW-2.
