DEVELOPMENT OF A TL-1 TIMBER, CURB- TYPE, BRIDGE RAILING FOR USE ON TRANSVERSE, NAIL-LAMINATED, TIMBER BRIDGES

MIDWEST ROADSIDE SAFETY FACILITY

WEST VIRGINIA DEPARTMENT OF TRANSPORTATION

MwRSF Research Report No. TRP-03-211-09

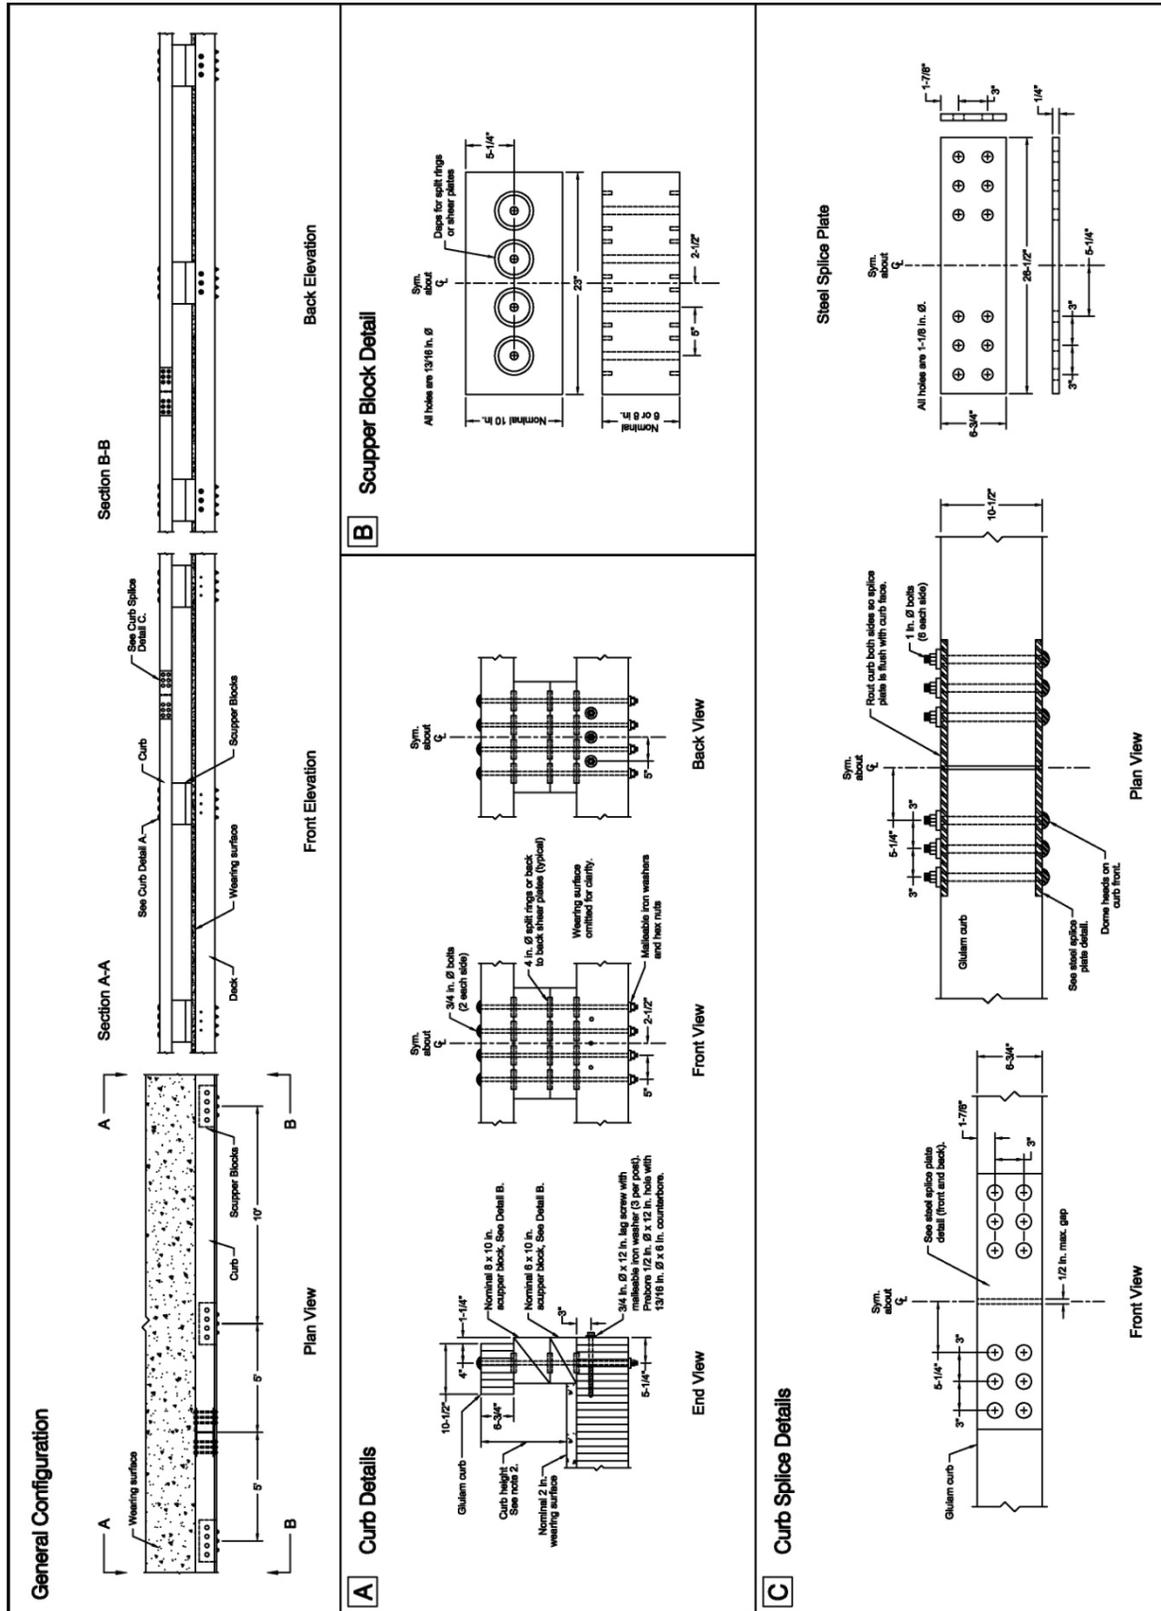
Figure 1. TL-1 Bridge Railing for Longitudinal Glue-Laminated Timber Decks [3-4]

In 1995, MwRSF researchers developed a fourth low-height, timber, curb-type railing system [3-4]. This bridge rail system was also designed for longitudinal, glulam, timber deck bridges. For this design, a 6 ¾-in. by 10 ½-in. (171 x 267 mm) rectangular, glulam beam was supported by scupper blocks using a top rail mounting height of 17 ¾ in. (451 mm). Steel splice plates were used to connect adjacent rail elements end-to-end, while steel split rings and vertical bolts were utilized to transfer the impact loads from the rail, through the wooden support blocks, and into the deck. During the testing program, the bridge railing system safely redirected a ¾-ton pickup truck impacting at 31.6 mph (50.9 km/h) and 24.3 degrees. This crash testing and evaluation program was conducted according to the TL-1 impact conditions found in NCHRP Report No. 350 [5]. This TL-1 railing system formed the basis for design work completed in this project. Design drawings for this TL-1 curb-type railing system are shown in Figure 1.

MwRSF's curb-type, timber bridge rail system, as shown previously in Figure 1, was successfully crash tested to the TL-1 safety performance criteria found in NCHRP Report No. 350. This timber bridge rail system served as the basis for the new timber bridge rail design. However, the railing for this project was required to meet the TL-1 safety performance criteria provided in MASH-08. Therefore, modifications were made to the previous system in order to accommodate the increased impact severity and increased vehicle height, resulting from the 2270P vehicle provided in the MASH-08 guidelines. These changes are described throughout the remainder of this chapter.

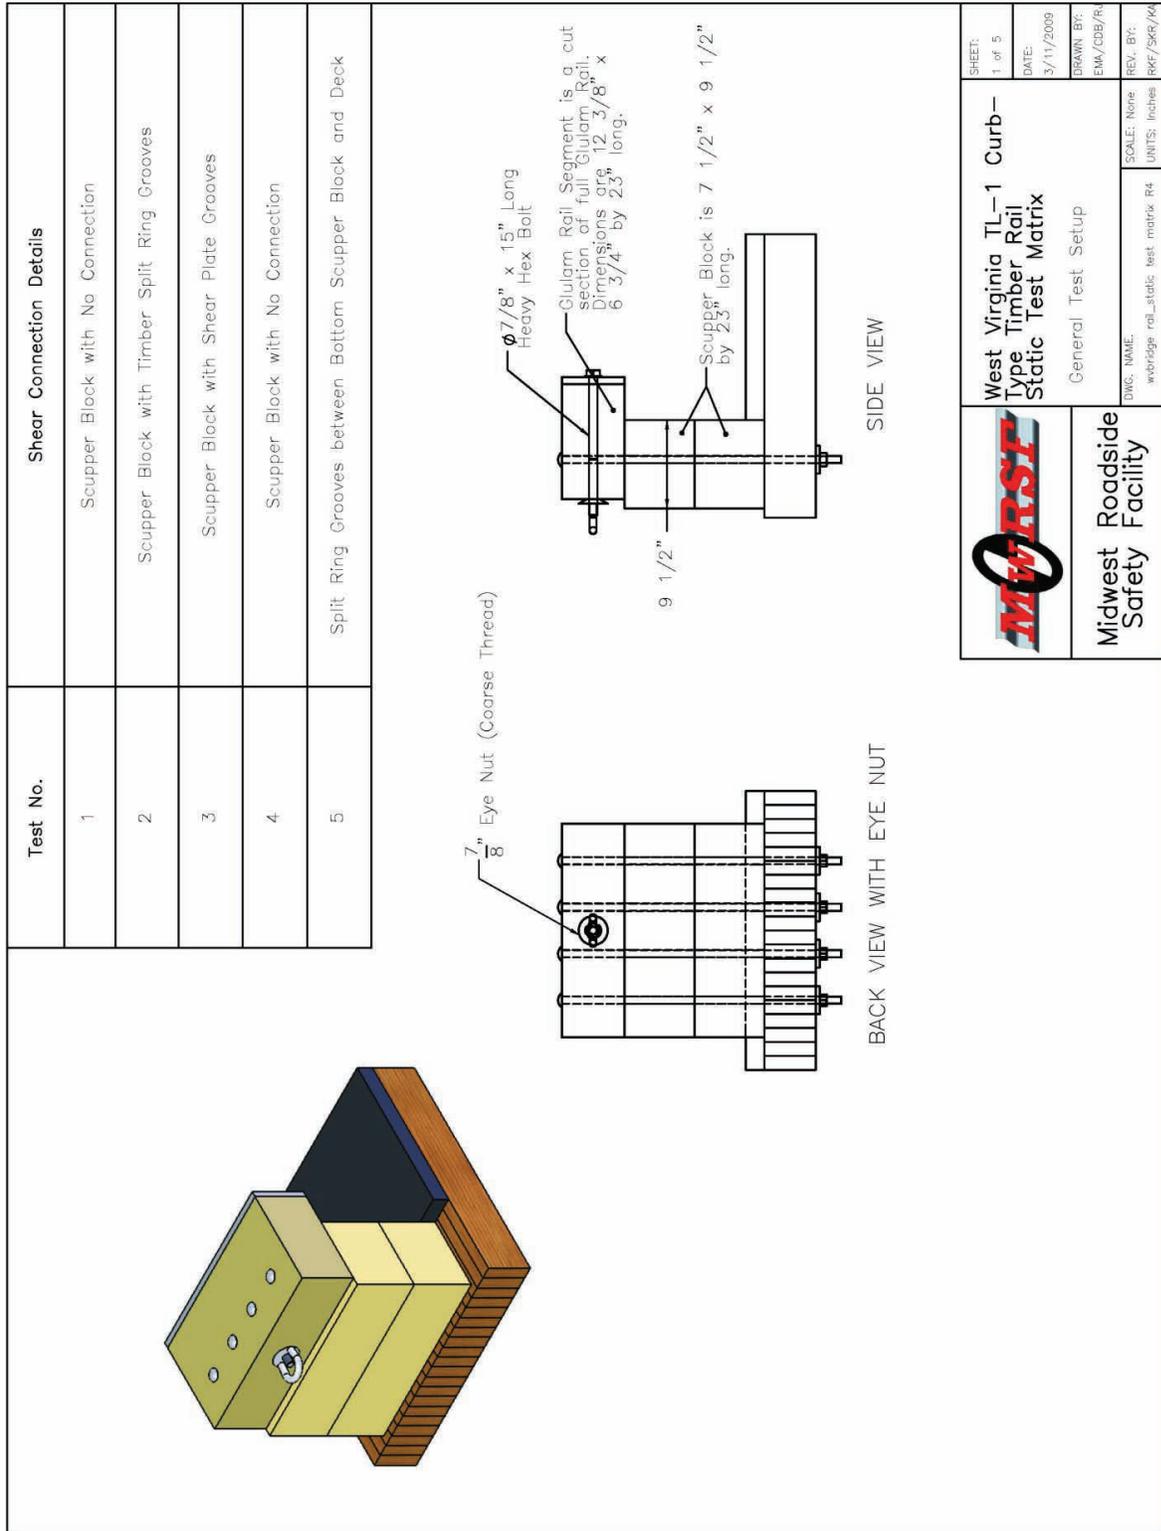
Figure 2. Static Testing Matrix and Setup

<p>Midwest Roadside Safety Facility</p>	<p style="text-align: center;">West Virginia TL-1 Curb— Type Timber Rail Static Test Matrix</p> <p style="text-align: center;">General Test Setup</p> <p style="font-size: small;"> Dwg. Name: wvbridge_rail_static_test_matrix_R4 SCALE: None UNITS: inches SHEET: 1 of 5 DATE: 3/11/2009 DRAWN BY: EMA/CDB/RK REV. BY: RKZ/SKR/KJ </p>
--	---

The static testing matrix and components are provided in Figures 2 through 6. For this testing, a 23-in. (584-mm) long, timber glulam rail segment was supported by two timber scupper blocks and bolted to the nail-laminated, timber bridge deck using four $\frac{3}{4}$ -in. (19-mm) diameter bolts. A lateral load was applied to each built-up post through a $\frac{7}{8}$ -in. (22-mm) diameter, steel rod placed through the center of the glulam rail segment. An eye nut was attached to the bolt on the back side of the rail, while a $\frac{1}{2}$ -in. (13-mm) thick plate washer was used to distribute the load to the front face of the rail segment.

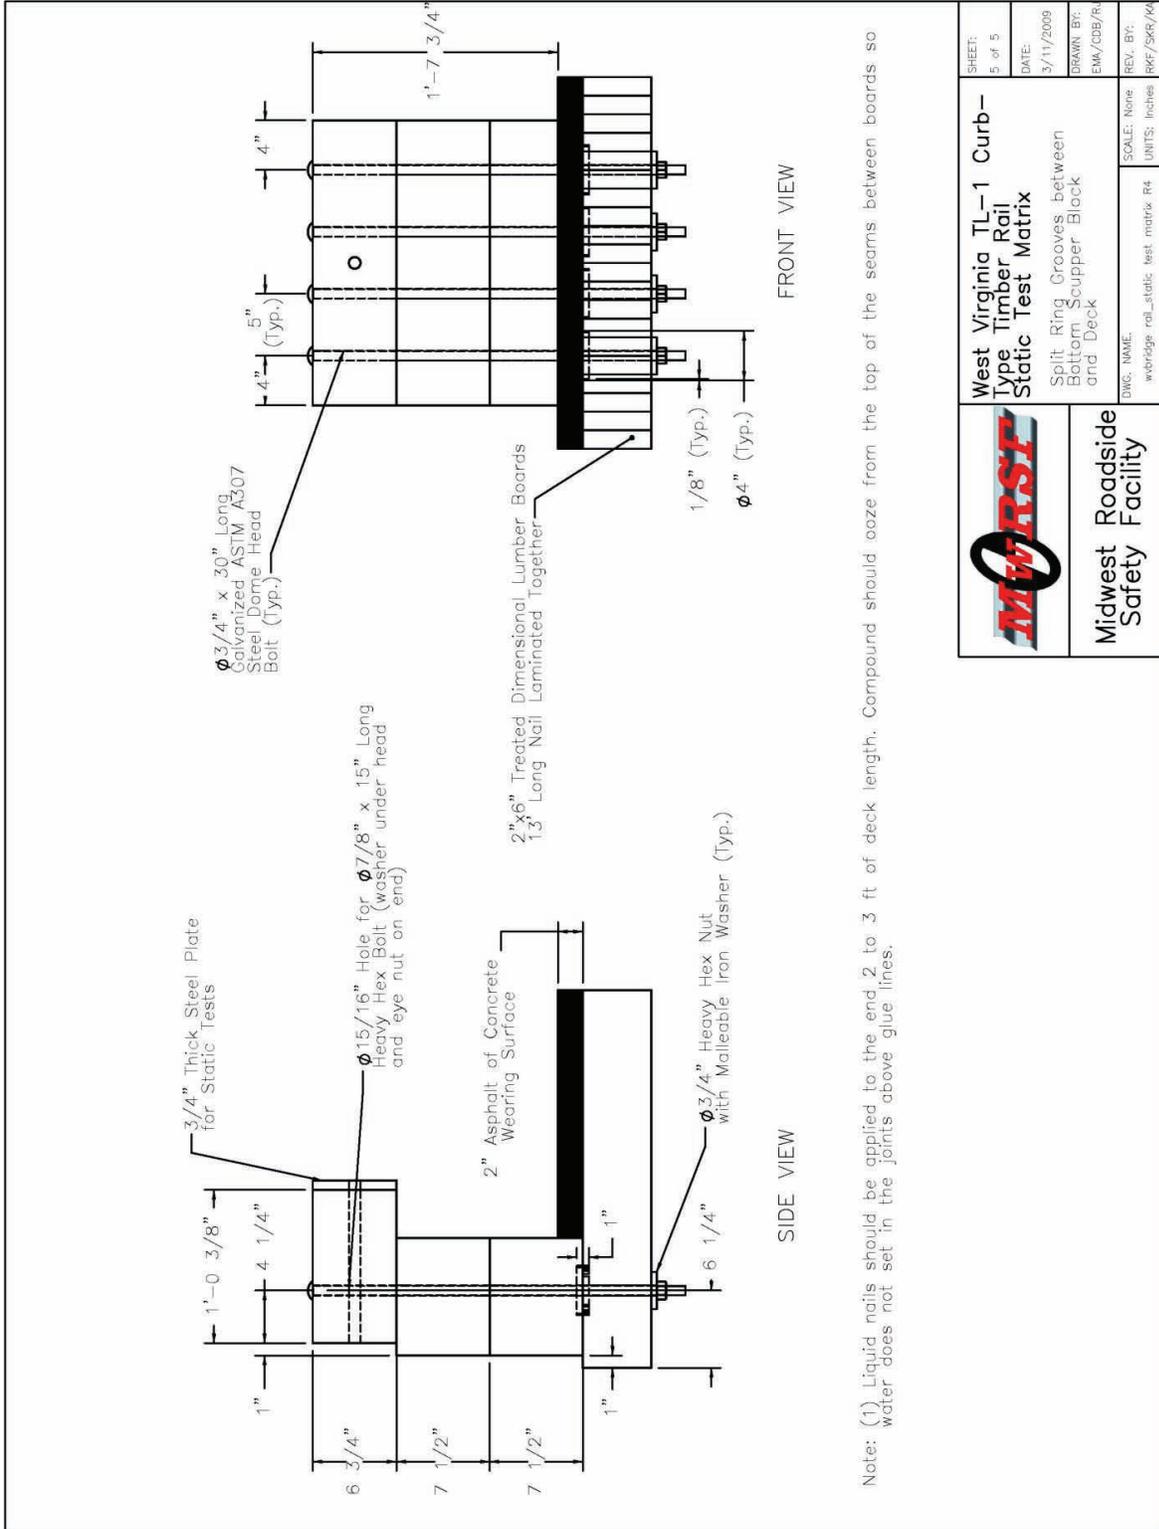
Figure 6. Static Test Component Details, Test No. WVS-5

West Virginia TL-1 Curb-Type Timber Rail Static Test Matrix	SHEET: 5 of 5
	Split Ring Grooves between Bottom Scupper Block and Deck Dwg. Name: wvrdggr_rail_static_test_matrix_R4 SCALE: None UNITS: inches	DATE: 3/11/2009 DRAWN BY: EMA/CDB/RK REV. BY: RKZ/SKR/KK
Midwest Roadside Safety Facility

in Figure 4, split rings were used at each timber interface: (1) deck to scupper; (2) scupper to scupper; and (3) scupper to rail. Test no. WVS-3 utilized shear plates at every timber interface, as shown in Figure 5. Finally, test no. WVS-5 was configured with split rings located only between the top deck surface and the bottom of the lower scupper block, as shown in Figure 6.

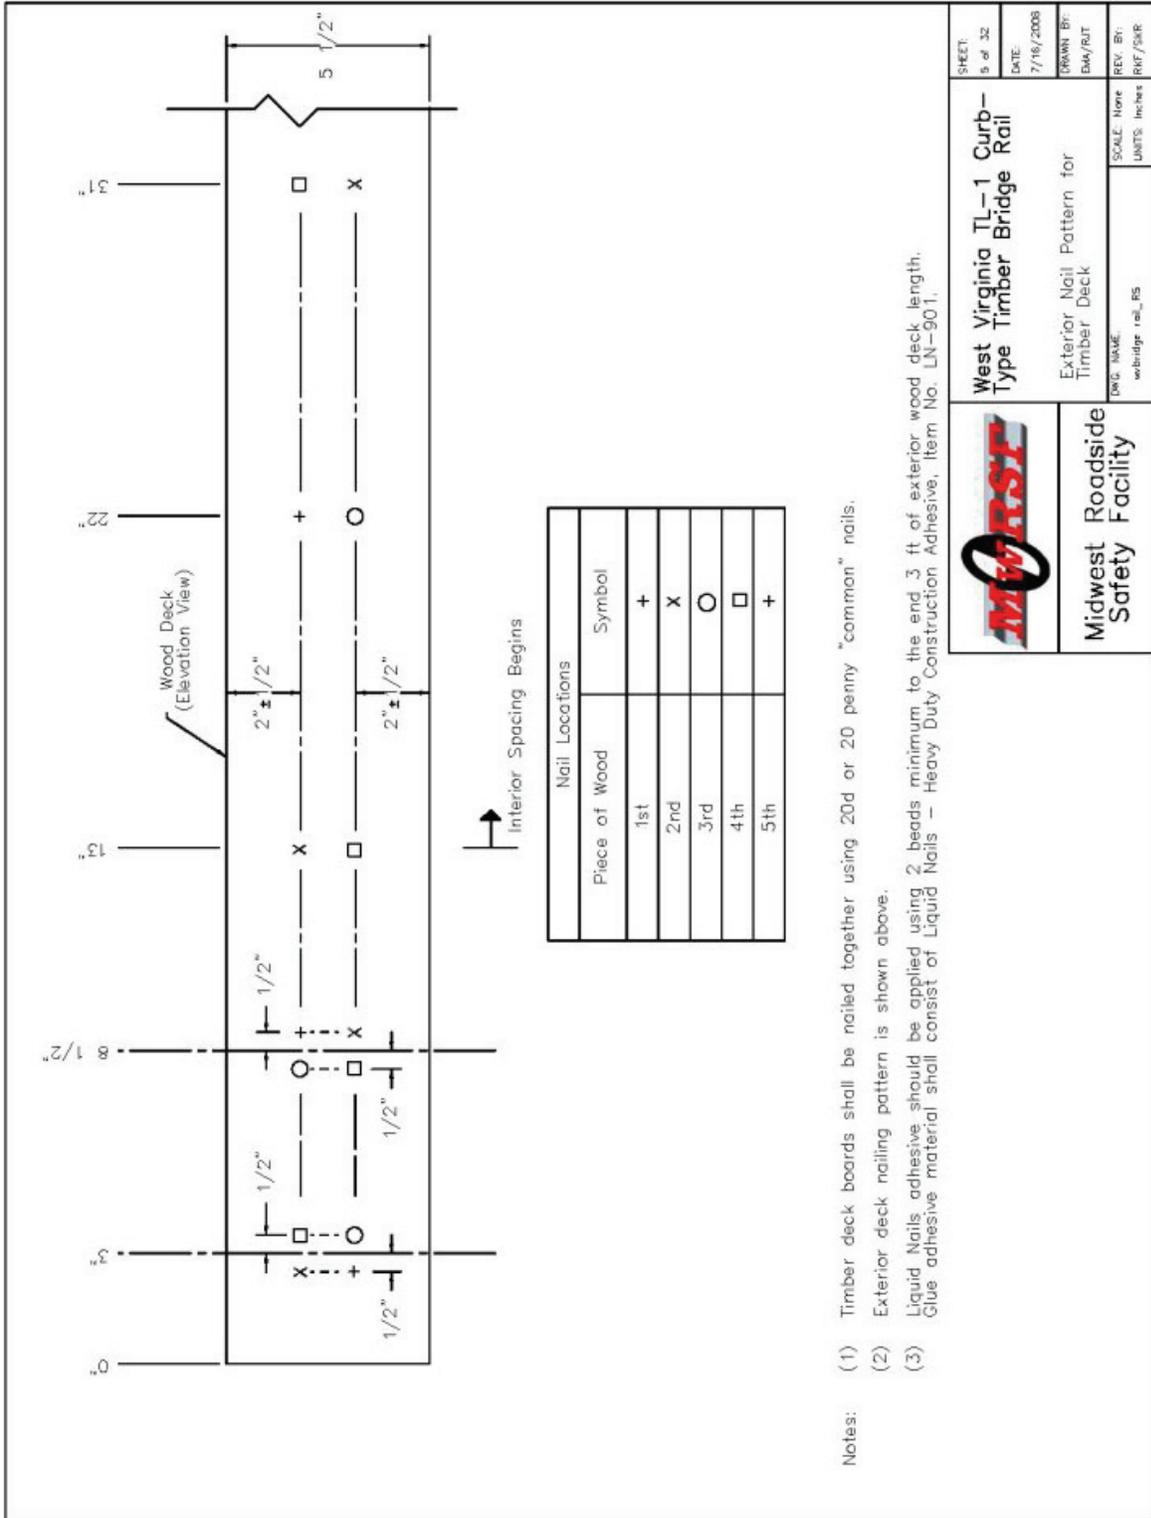
Figure 29. Exterior Nail Pattern for Transverse, Nail-Laminated, Timber Bridge Deck

- Notes:
- (1) Timber deck boards shall be nailed together using 20d or 20 penny "common" nails.
 - (2) Exterior deck nailing pattern is shown above.
 - (3) Liquid Nails adhesive should be applied using 2 beads minimum to the end 3 ft of exterior wood deck length. Glue adhesive material shall consist of Liquid Nails - Heavy Duty Construction Adhesive, Item No. LN-901.

For the test bridge, the timber deck measured approximately 14 ft (4.3 m) wide and 120 ft (36.6 m) long. The bridge deck was fabricated with 2-in. x 6-in. (51-mm x 152-mm) by 14-ft (4.3-m) long, dimensional lumber boards covered with a 2-in. (51-mm) thick, concrete wearing surface. The timber boards were manufactured from Grade No. 1 Southern Yellow Pine and treated with ACQ-D to a minimum net retention of 0.40 lbs/ft³ (6.41 kg/m³) satisfying AWWA U1, UC4A. For actual bridge installations, it is recommended that the dimensional lumber boards be treated to a net retention of 0.60 lbs/ft³ (9.61 kg/m³) satisfying AWWA U1, UC4B, as shown in Figure 40. The boards were placed on end and nailed together through and perpendicular to the wide face of the board using 20d or 20 penny “common” nails. A specific nail pattern, which repeated every four boards, was used to ensure that a nail did not contact a previously driven nail. Special care was given to the nail pattern near the deck edge to ensure the nails did not occupy space where the vertical bolt holes for the bridge rail would later be drilled. During deck assembly, two beads of Liquid Nails Heavy Duty Construction Adhesive (Item No. LN-901) were applied to the sides of the boards and over the outer 3 ft (0.9 m) of deck. The adhesive was used to provide additional punching shear resistance in the deck as well as improved load transfer between boards. The nailing patterns are shown in Figures 29 and 30.

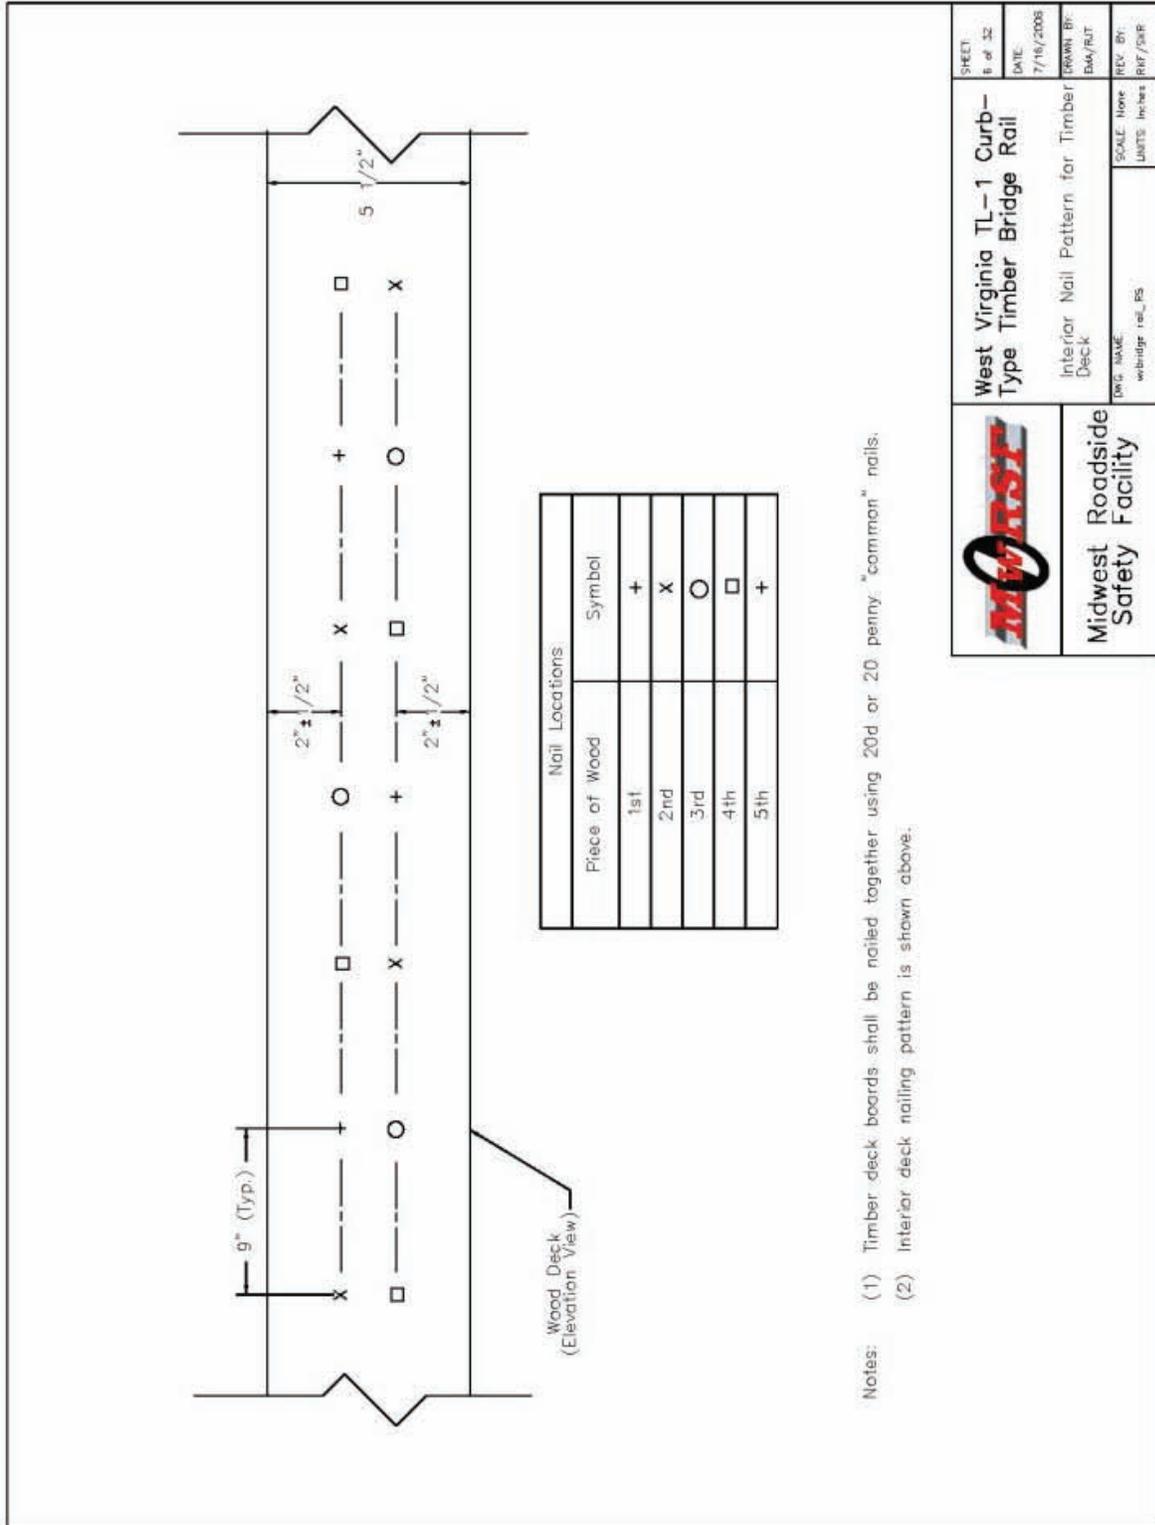
Figure 30. Nail Pattern for Transverse, Nail-Laminated, Timber Bridge Deck

- Notes: (1) Timber deck boards shall be nailed together using 20d or 20 penny "common" nails.
(2) Interior deck nailing pattern is shown above.

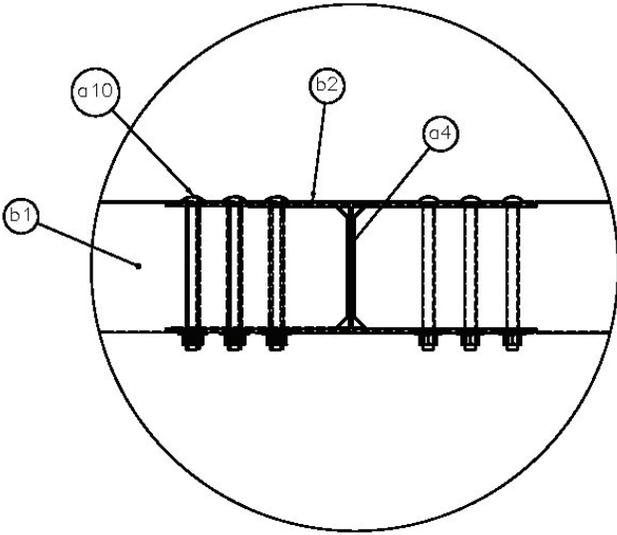
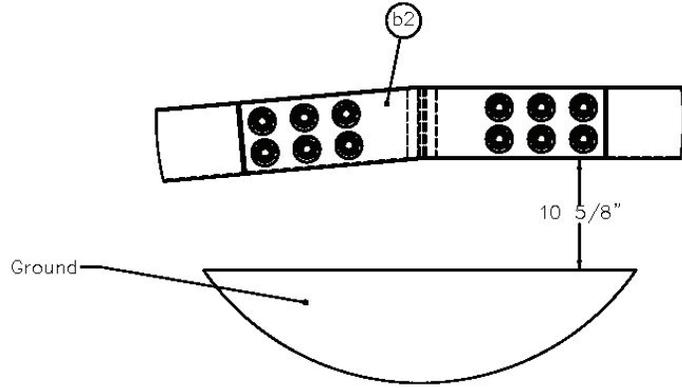
Figure 33. Rail End Treatment Connection Details, Test No. WVBR-1

DETAIL K
PLAN VIEW

DETAIL L
PROFILE VIEW

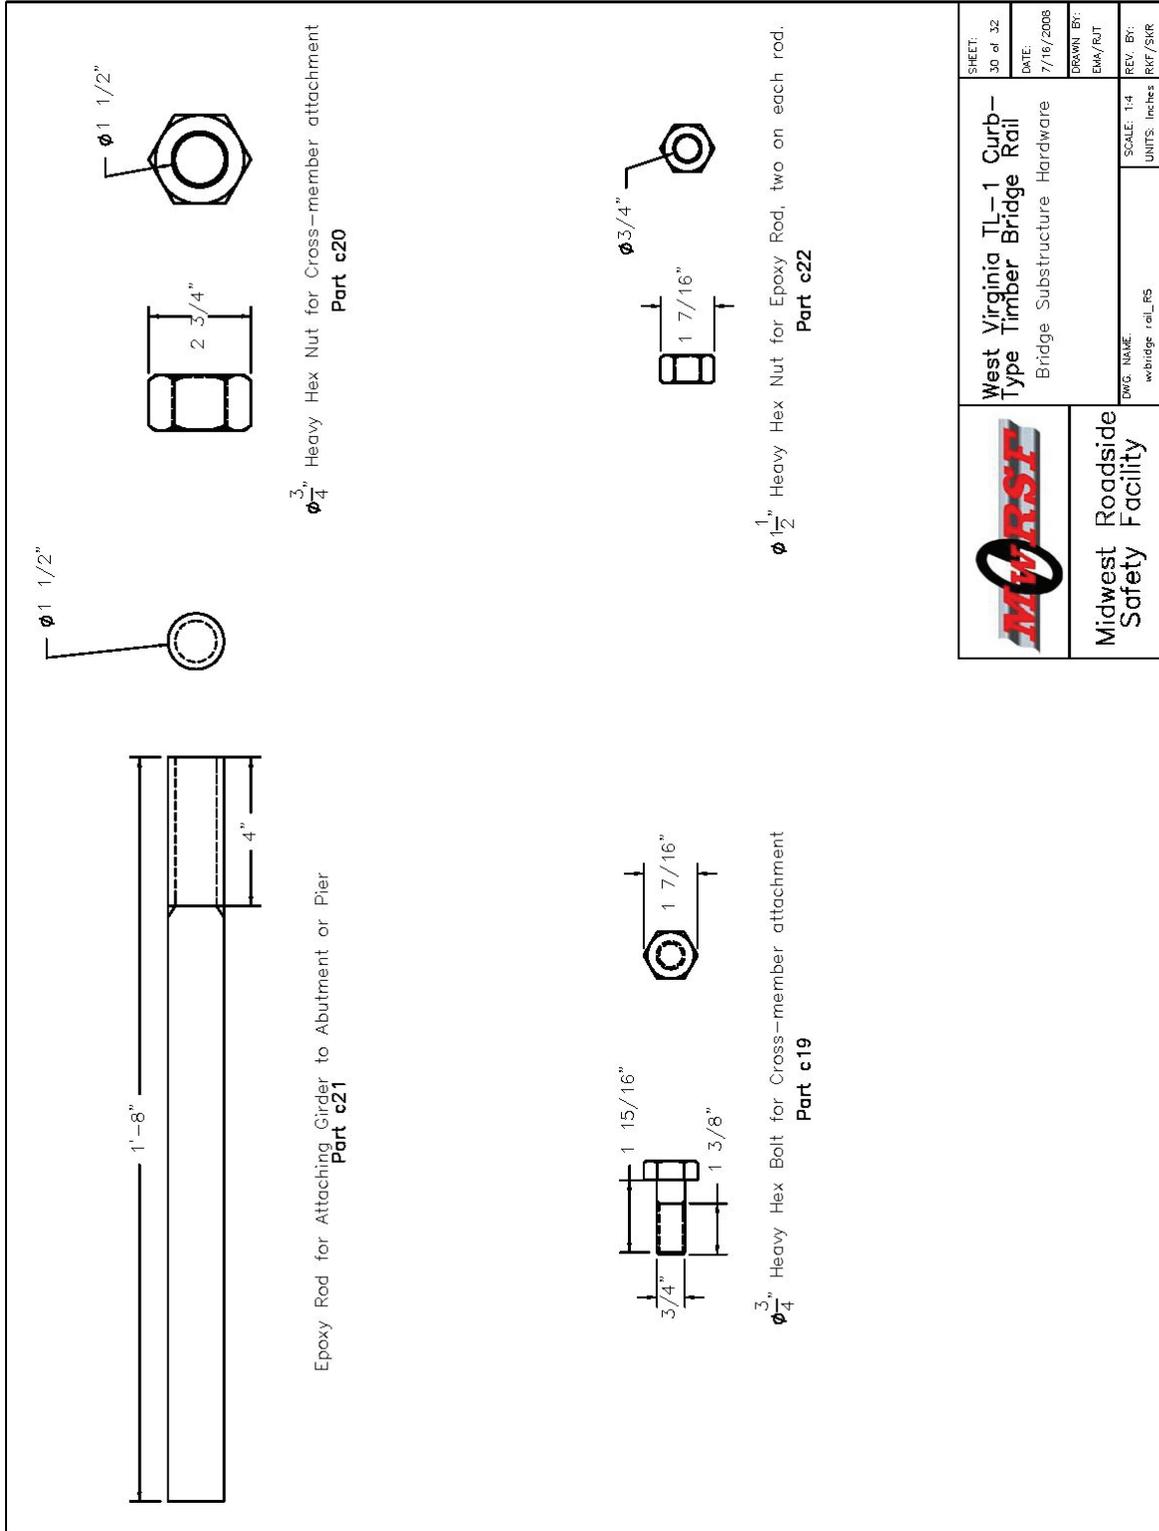
Figure 54. Bridge Substructure Hardware, Test No. WBBR-1

West Virginia TL-1 Curb-Type Timber Bridge Rail Bridge Substructure Hardware	SHEET: 29 of 32 DATE: 7/16/2008 DRAWN BY: EMA/PJT DWG. NAME: wbridge_cel_RS SCALE: None UNITS: Inches	REV. BY: RKF/SKR
	Midwest Roadside Safety Facility

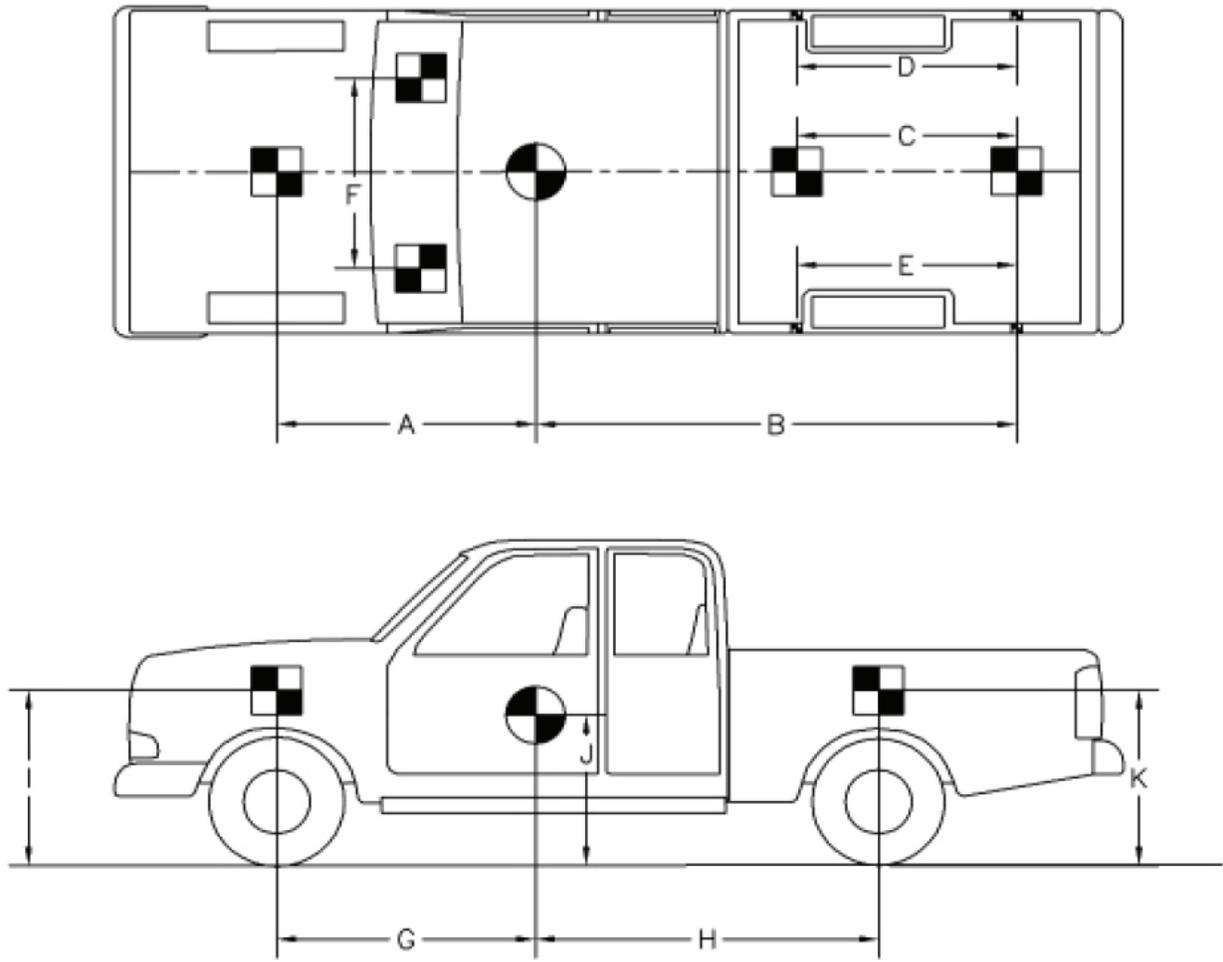
Figure 63. Target Geometry, Test No. WVBR-1

TEST #: WVBR-1					
TARGET GEOMETRY-- mm (in.)					
A	<u>1746</u>	(68.75)	E	<u>965</u>	(38.0)
B	<u>2511</u>	(98.875)	F	<u>660</u>	(26.0)
C	<u>965</u>	(38.0)	G	<u>1568</u>	(61.75)
D	<u>965</u>	(38.0)	H	<u>1994</u>	(78.5)
			I	<u>1003</u>	(39.5)
			J	<u>714</u>	(28.125)
			K	<u>1080</u>	(42.5)

The Suspension Method [10] was used to determine the vertical component of the center of gravity (c.g.) for the pickup truck. This method is based on the principle that the c.g. of any freely suspended body is in the vertical plane through the point of suspension. The vehicle was suspended successively in three positions, and the respective planes containing the c.g. were established. The intersection of these planes pinpointed the location of the c.g. The longitudinal component of the c.g. was determined using the measured axle weights. The locations of the final centers of gravity are shown in Figures 62 and 63.

Square, black and white, checkered targets were placed on the vehicle to aid in the analysis of the high-speed VITcam videos, as shown in Figure 63. Round, checkered targets were placed on the center of gravity, on the left-side door, on the right-side door, and on the roof of the vehicle. The remaining targets were located for reference purposes so that they could be viewed from the high-speed cameras for video analysis.

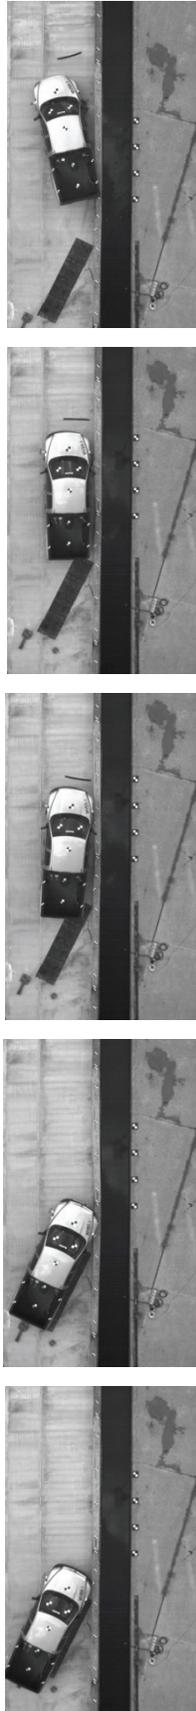
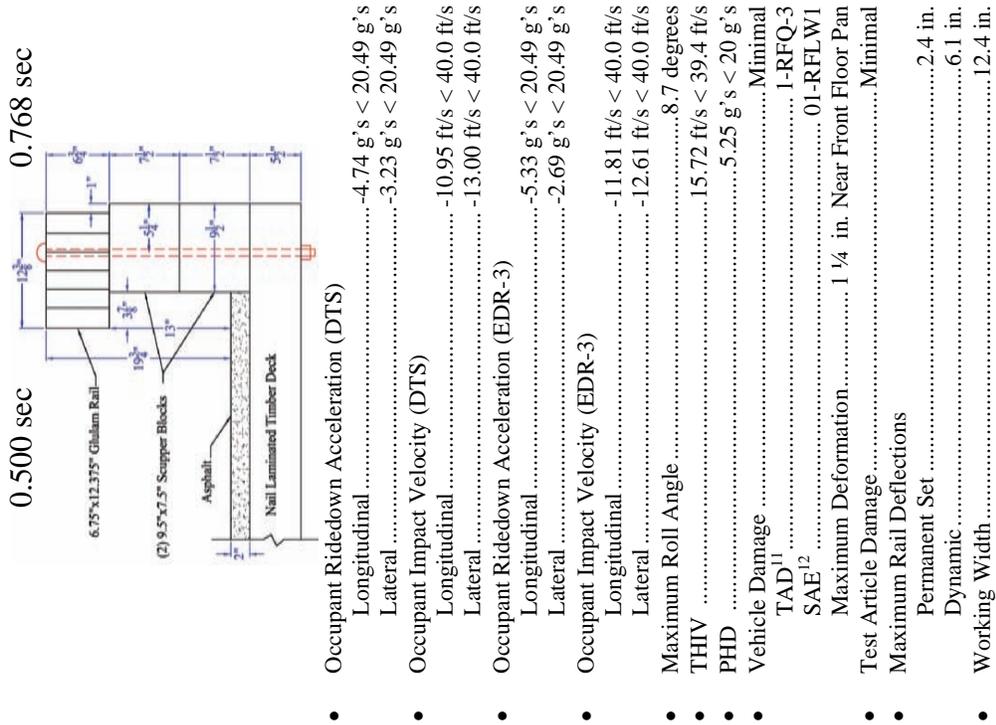
Figure 65. Summary of Test Results and Sequential Photographs, Test No. WVBR-1

0.000 sec	0.152 sec	0.350 sec	0.500 sec	0.768 sec
-----------	-----------	-----------	-----------	-----------

•	Test Agency MwRSF
•	Test Number WVBR-1
•	Date 7/18/08
•	MASH-08 Test Designation 1-11
•	Test Article Low-Profile, Curb-Type, Timber Bridge Rail
•	Total Length 155 ft
•	Scupper Block or Post Spacing 10 ft
•	Key Component - Glulam Bridge Rail Segment	
	Length 20 ft
	Width 6 3/4 in.
	Depth 12 3/8 in.
•	Key Component - Scupper Block	
	Length 23 in.
	Width 7 1/2 in.
	Depth 9 1/2 in.
•	Vehicle Model 2002 Dodge Ram 1500 Quad Cab
	Curb 5,119 lbs
	Test Inertial 5,007 lbs
	Gross Static 5,179 lbs
•	Impact Conditions	
	Speed 30.8 mph
	Angle 26.1 deg
	Impact Location 30 1/2 in. Upstream from Post No. 4
•	Exit Conditions	
	Speed 19.1 mph
	Angle 12.6 deg
•	Vehicle Stability Satisfactory
•	Vehicle Stopping Distance 120 ft Downstream from Impact

•	Occupant Ridedown Acceleration (DTS)	
	Longitudinal -4.74 g's < 20.49 g's
	Lateral -3.23 g's < 20.49 g's
•	Occupant Impact Velocity (DTS)	
	Longitudinal -10.95 ft/s < 40.0 ft/s
	Lateral -13.00 ft/s < 40.0 ft/s
•	Occupant Ridedown Acceleration (EDR-3)	
	Longitudinal -5.33 g's < 20.49 g's
	Lateral -2.69 g's < 20.49 g's
•	Occupant Impact Velocity (EDR-3)	
	Longitudinal -11.81 ft/s < 40.0 ft/s
	Lateral -12.61 ft/s < 40.0 ft/s
•	Maximum Roll Angle 8.7 degrees
•	THIV 15.72 ft/s < 39.4 ft/s
•	PHD 5.25 g's < 20 g's
•	Vehicle Damage Minimal
	TAD ¹¹ 1-RFQ-3
	SAE ¹² 01-RFLW1
	Maximum Deformation 1 1/4 in. Near Front Floor Pan
•	Test Article Damage Minimal
•	Maximum Rail Deflections	
	Permanent Set 2.4 in.
	Dynamic 6.1 in.
•	Working Width 12.4 in.

The 5,179-lb (2349-kg) pickup truck impacted the timber bridge rail at a speed of 30.8 mph (49.6 km/h) and at an angle of 26.1 degrees. A summary of the test results and sequential photographs are shown in Figure 65. The summary of the test results in SI units are shown in APPENDIX B. Additional sequential photographs are shown in Figures 66 through 68. Documentary photographs of the crash test are shown in Figure 69.

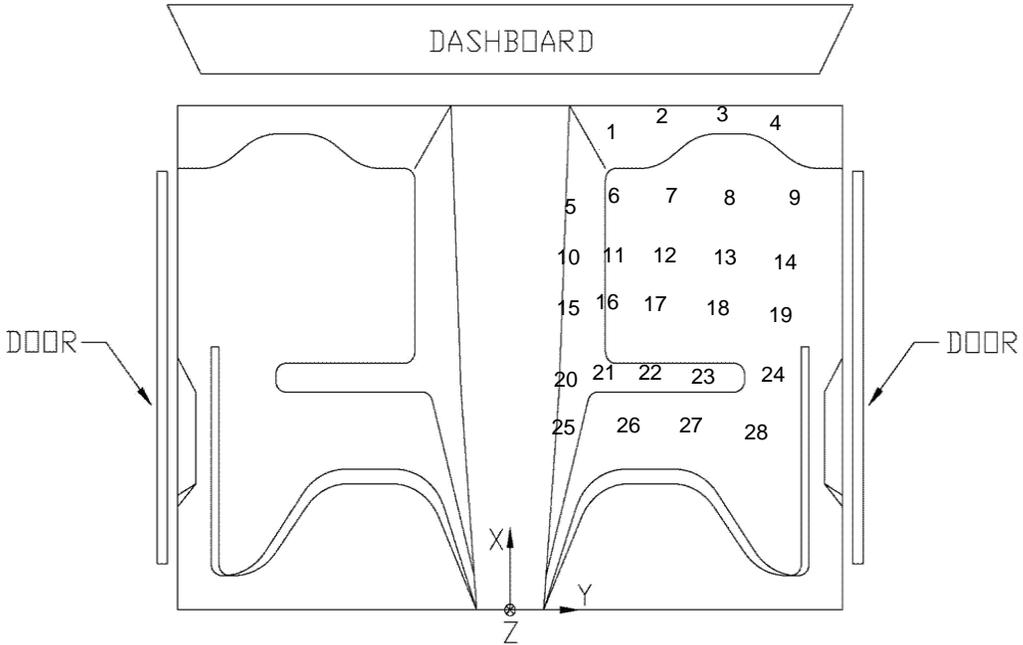
Figure C-1. Occupant Compartment Deformation Data – Set 1, Test No. WVBR-1

POINT	X	Y	Z	X'	Y'	Z'	DEL X	DEL Y	DEL Z
1	27	12	0	27	12	0	0	0	0
2	30	17.75	-1.25	30	17.25	-1.25	0	-0.5	0
3	31.75	23.75	-1.5	30.5	23.5	-0.5	-1.25	-0.25	1
4	29.5	29.75	-0.25	29.25	29.5	0	-0.25	-0.25	0.25
5	23.5	9.5	0.25	23.75	9.5	0	0.25	0	-0.25
6	25.25	17	-3	25.5	16.75	-3	0.25	-0.25	0
7	26.5	22.5	-6	26.25	22.25	-5.75	-0.25	-0.25	0.25
8	26	30.25	-5.5	26.25	30.5	-5.5	0.25	0.25	0
9	14.25	0.5	-2.5	14.25	0.5	-2.5	0	0	0
10	16.75	7.5	-2.25	16.75	7.5	-2.25	0	0	0
11	18.5	13	-5.5	18.5	13	-5.5	0	0	0
12	20.5	21.5	-9	20.25	22	-9.25	-0.25	0.5	-0.25
13	20.75	30	-9	20.75	30.25	-8.75	0	0.25	0.25
14	10.25	0	-3	10.25	0	-3	0	0	0
15	12	7.75	-3	12	7.5	-2.75	0	-0.25	0.25
16	16.5	16	-9.5	16.25	16	-9.25	-0.25	0	0.25
17	16.5	23.25	-9	16.5	23.25	-8.75	0	0	0.25
18	17	31	-9.5	17	31	-9.25	0	0	0.25
19	5.5	0.75	-3	5.5	0.75	-3	0	0	0
20	6	8	-3.5	6	7.75	-3.25	0	-0.25	0.25
21	10.75	16	-9	10.75	16.25	-8.75	0	0.25	0.25
22	11	23.75	-8.75	11	23.5	-8.25	0	-0.25	0.5

23	10.5	30.25	-8.5	10.5	30.25	-8	0	0	0.5
24	1.25	0.5	-2.75	1.25	0.5	-2.5	0	0	0.25
25	1.25	6.75	-2.5	1.5	6.75	-2.5	0.25	0	0
26	0.75	13	-5	0.75	13.25	-4.75	0	0.25	0.25
27	1	21.5	-4.5	1	21.75	-4.5	0	0.25	0
28	1	28.5	-4.25	1	28.5	-4	0	0	0.25
29							0	0	0

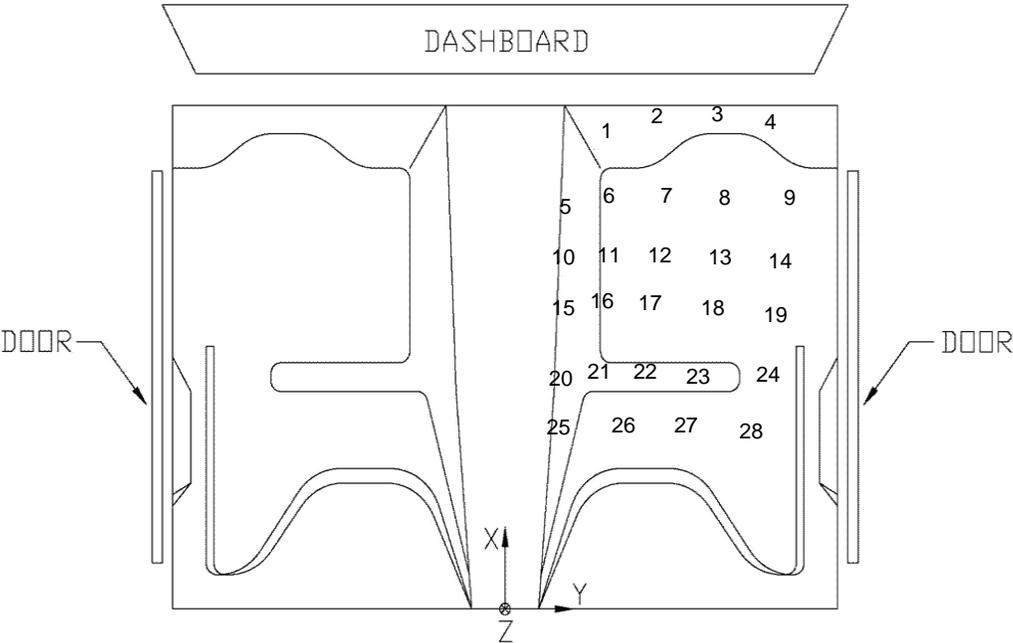
Figure C-2. Occupant Compartment Deformation Data – Set 2, Test No. WVBR-1

POINT	X	Y	Z	X'	Y'	Z'	DEL X	DEL Y	DEL Z
1	50	14.75	0	50	14.75	0	0	0	0
2	53	20.5	-1.25	53	20	-1.25	0	-0.5	0
3	54.75	26.5	-1.5	53.5	26.25	-0.5	-1.25	-0.25	1
4	52.5	32.5	0	52.25	32.25	0	-0.25	-0.25	0
5	46.5	12.25	0	46.75	12.25	0	0.25	0	0
6	48.25	19.75	-3	48.5	19.5	-3	0.25	-0.25	0
7	49.5	25.25	-5.75	49.25	25	-5.75	-0.25	-0.25	0
8	49	33	-5.25	49.25	33.25	-5.5	0.25	0.25	-0.25
9	37.25	3.25	-3	37.25	3.25	-3	0	0	0
10	39.75	10.25	-2.5	39.75	10.25	-2.5	0	0	0
11	41.5	15.75	-5.75	41.5	15.75	-5.75	0	0	0
12	43.5	24.25	-9.25	43.25	24.75	-9.25	-0.25	0.5	0
13	43.75	32.75	-8.75	43.75	33	-9	0	0.25	-0.25
14	33.25	2.75	-3.5	33.25	2.75	-3.5	0	0	0
15	35	10.5	-3.5	35	10.25	-3.25	0	-0.25	0.25
16	39.5	18.75	-9.5	39.25	18.75	-9.75	-0.25	0	-0.25
17	39.5	26	-9.25	39.5	26	-9.25	0	0	0
18	40	33.75	-9.5	40	33.75	-9.75	0	0	-0.25
19	28.5	3.5	-3.5	28.5	3.5	-3.5	0	0	0
20	29	10.75	-4	29	10.5	-4	0	-0.25	0
21	33.75	18.75	-9.5	33.75	19	-9.5	0	0.25	0
22	34	26.5	-9	34	26.25	-9.25	0	-0.25	-0.25

23	33.5	33	-8.75	33.5	33	-8.75	0	0	0
24	24.25	3.25	-3.25	24.25	3.25	-3.25	0	0	0
25	24.25	9.5	-3.25	24.5	9.5	-3.25	0.25	0	0
26	23.75	15.75	-5.5	23.75	16	-5.75	0	0.25	-0.25
27	24	24.25	-5.25	24	24.5	-5.25	0	0.25	0
28	24	31.25	-5	24	31.25	-5	0	0	0
29							0	0	0

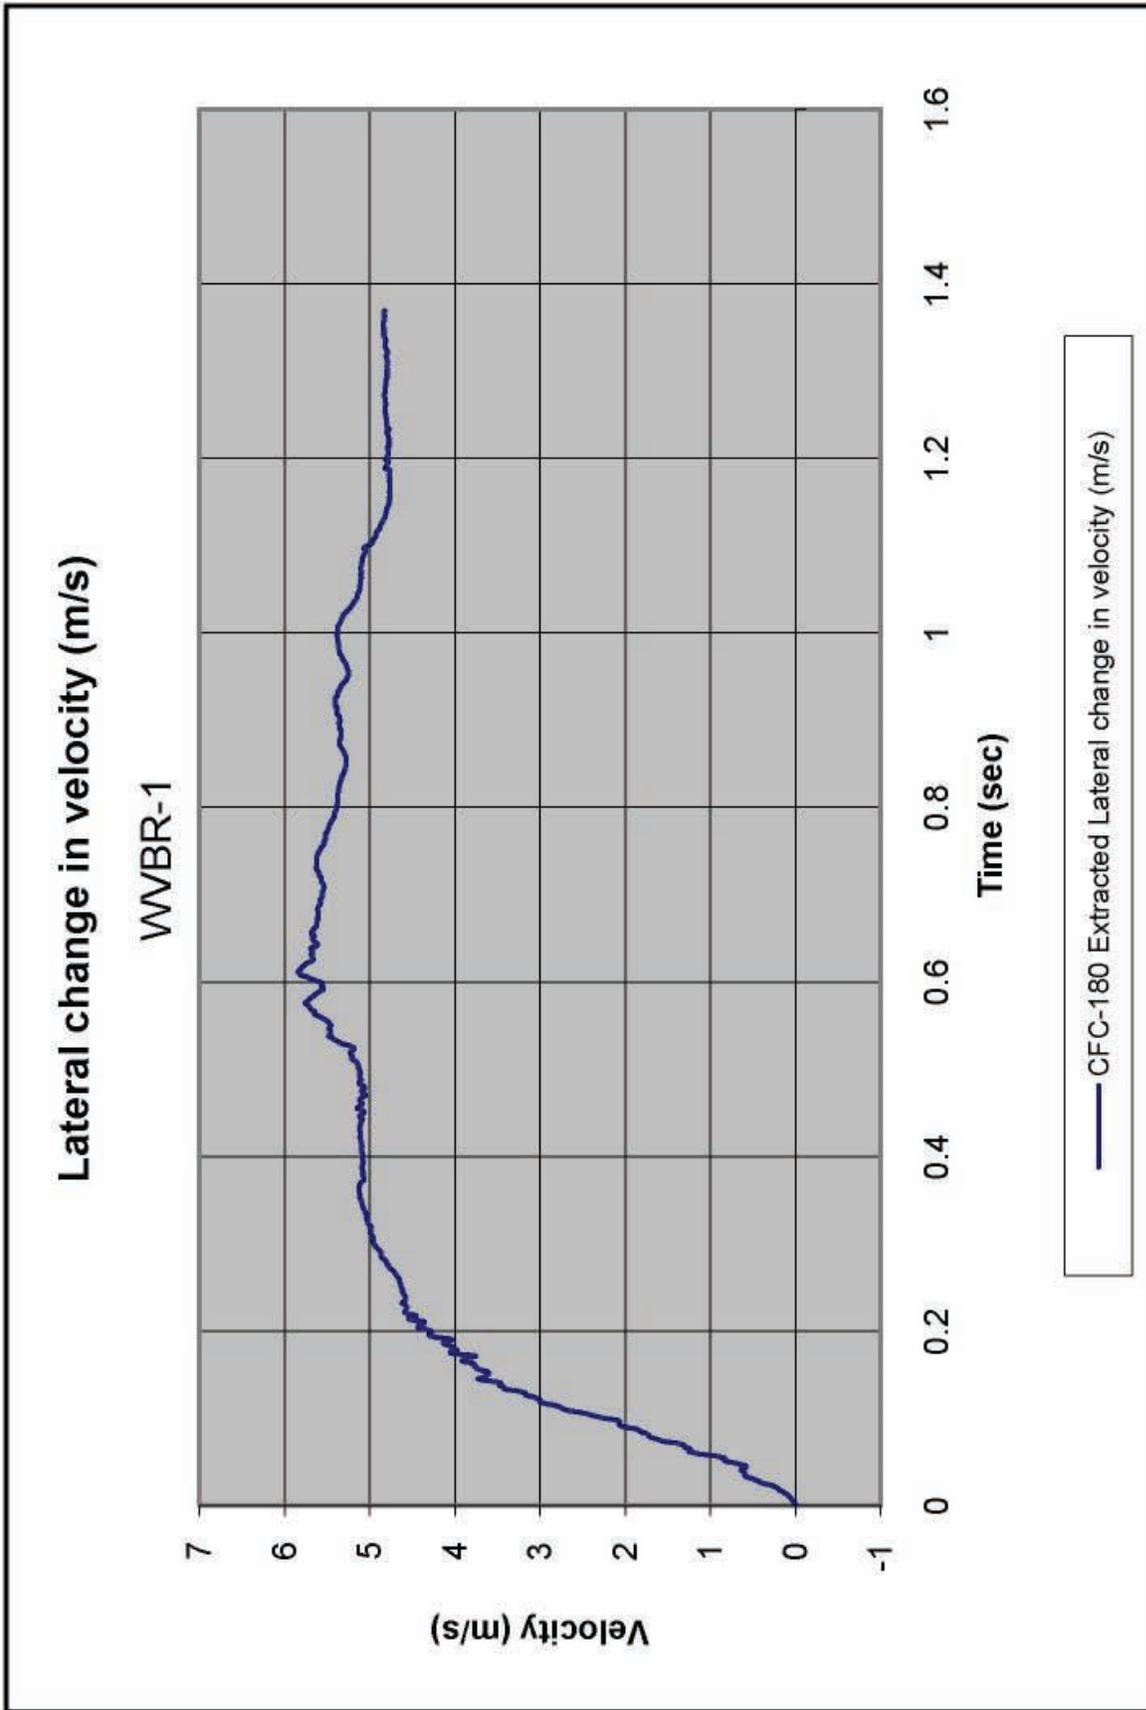
Figure D-5. Lateral Occupant Impact Velocity, Test No. WVBR-1 (EDR-3)

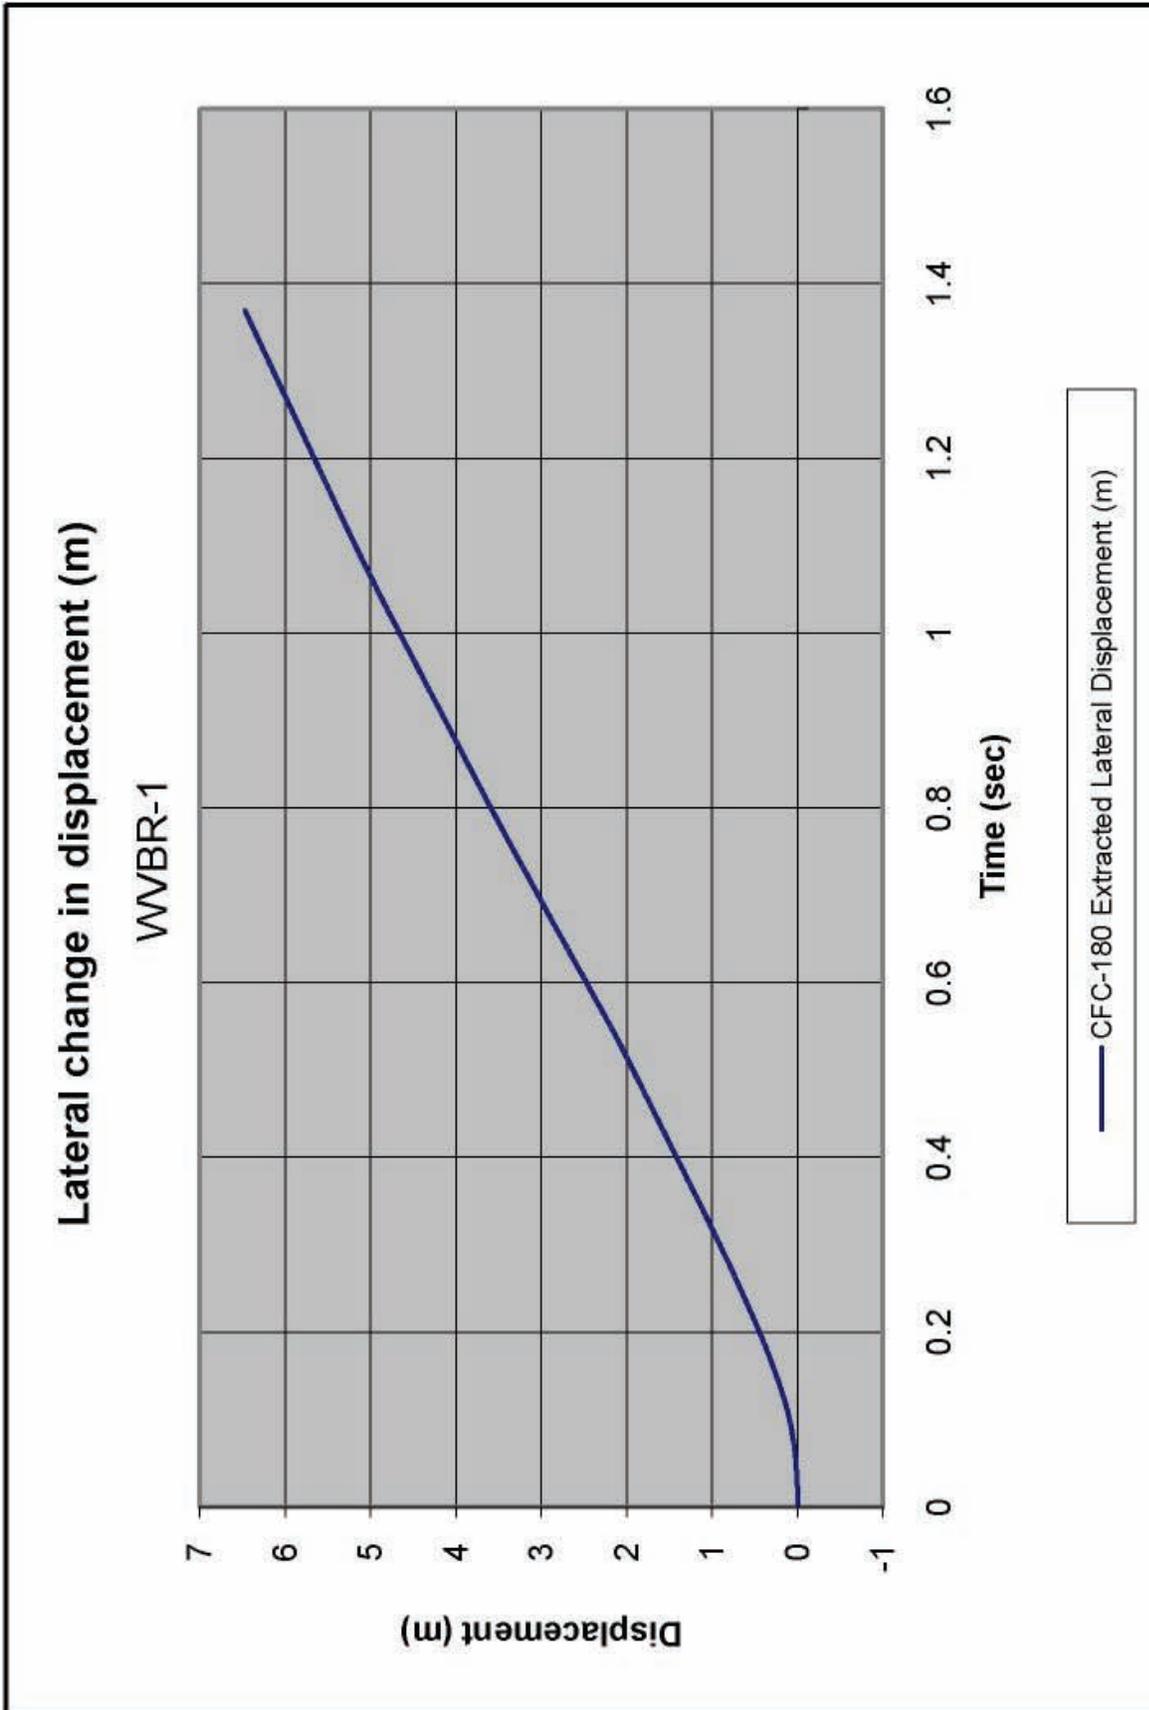
Figure D-6. Lateral Occupant Displacement, Test No. WVBR-1 (EDR-3)
