DEVELOPMENT OF A TL-1 TIMBER, CURB- TYPE, BRIDGE RAILING FOR USE ON TRANSVERSE, NAIL-LAMINATED, TIMBER BRIDGES

MIDWEST ROADSIDE SAFETY FACILITY

WEST VIRGINIA DEPARTMENT OF TRANSPORTATION

MwRSF Research Report No. TRP-03-211-09

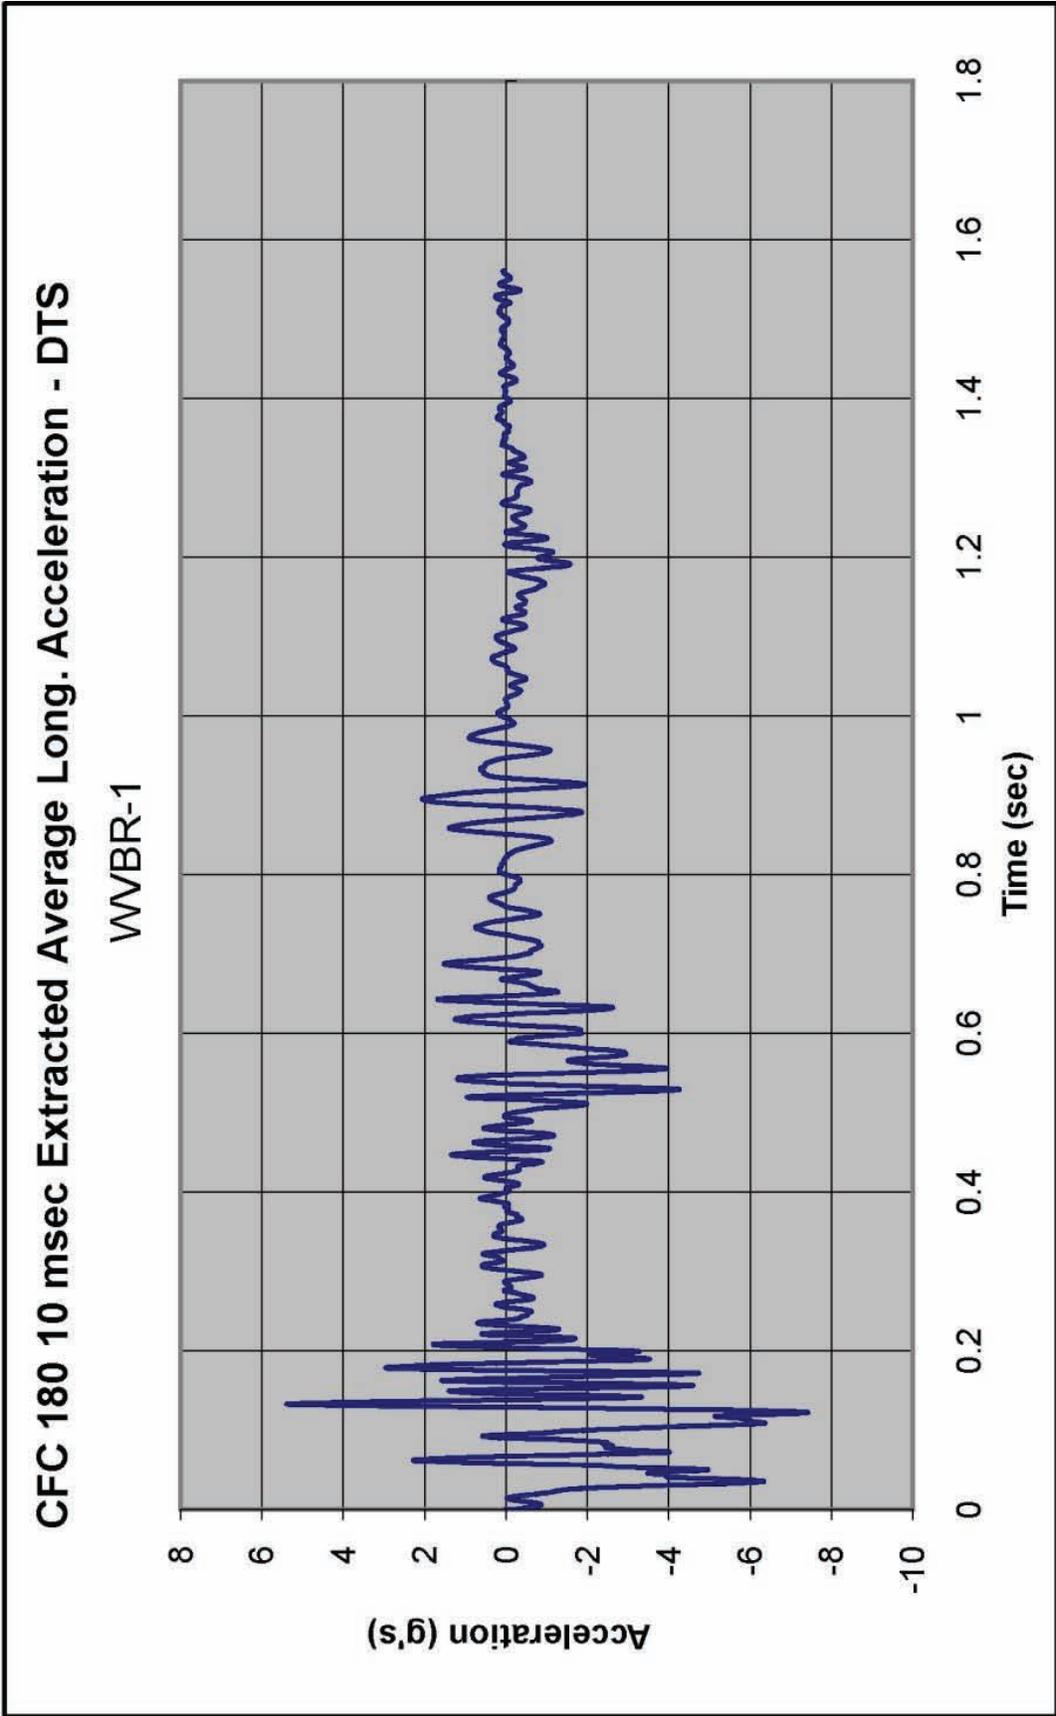
Figure D-7. 10-ms Average Longitudinal Acceleration, Test No. WVBR-1 (DTS)

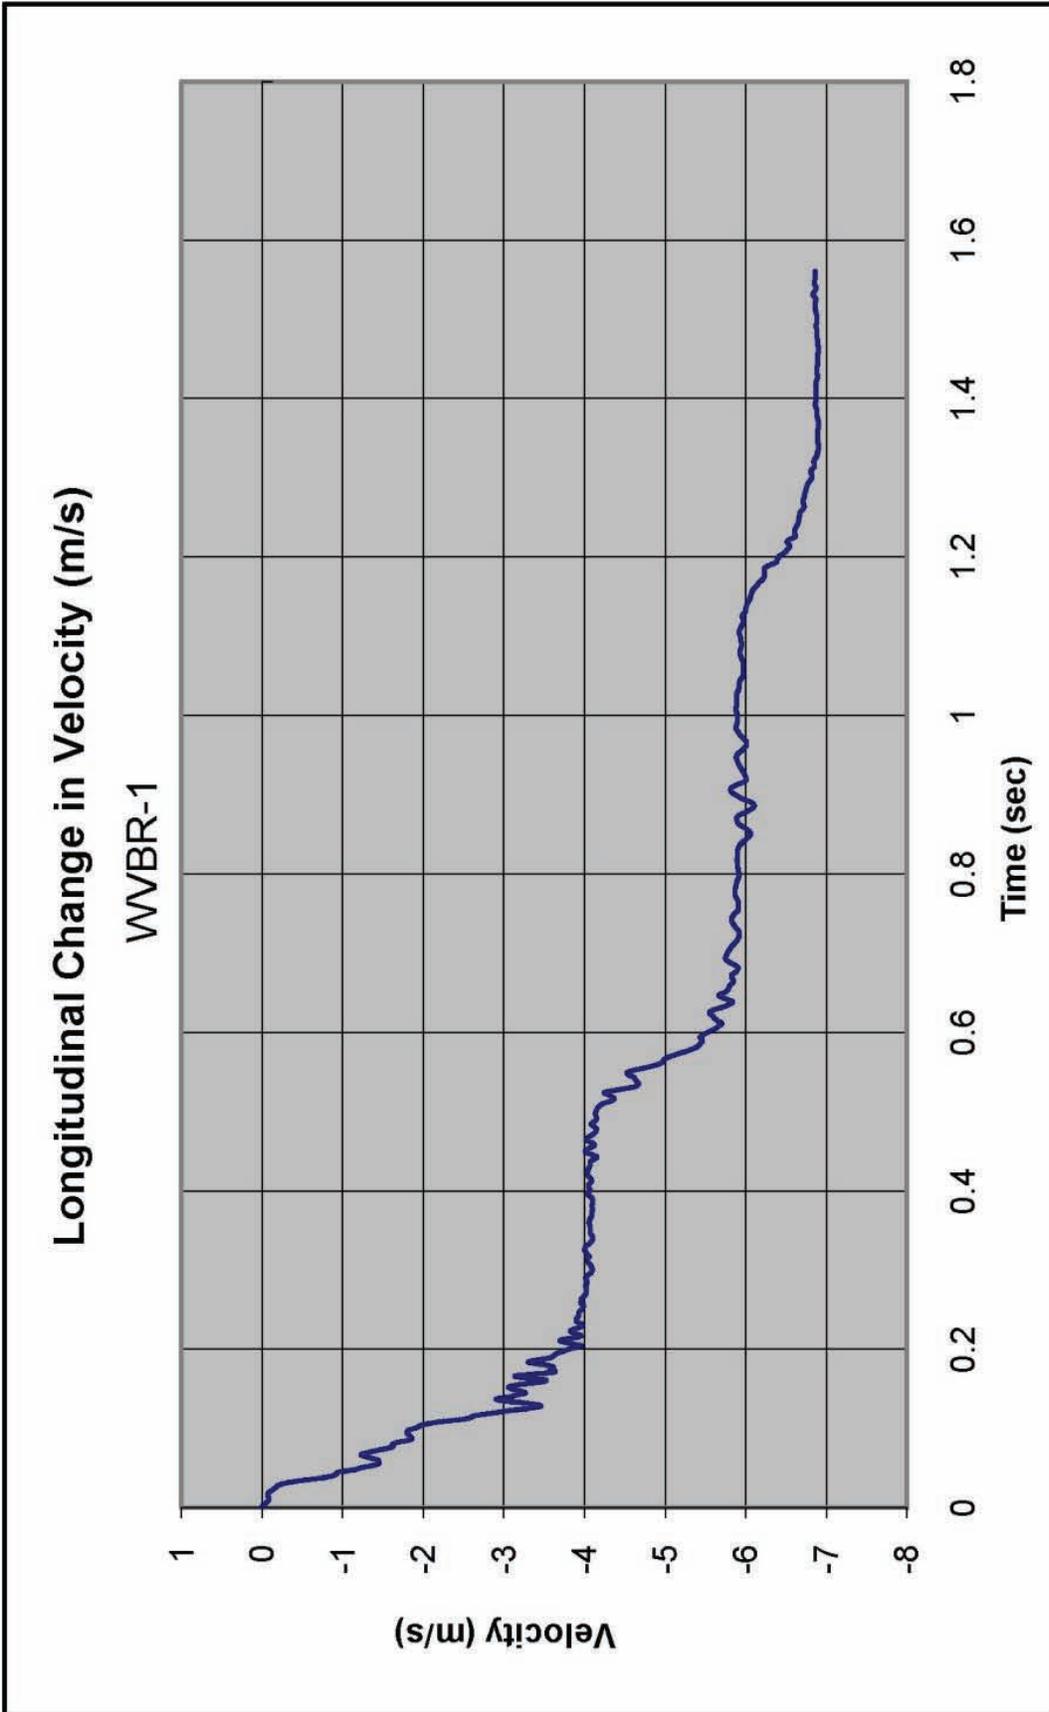
Figure D-8. Longitudinal Occupant Impact Velocity, Test No. WVBR-1 (DTS)

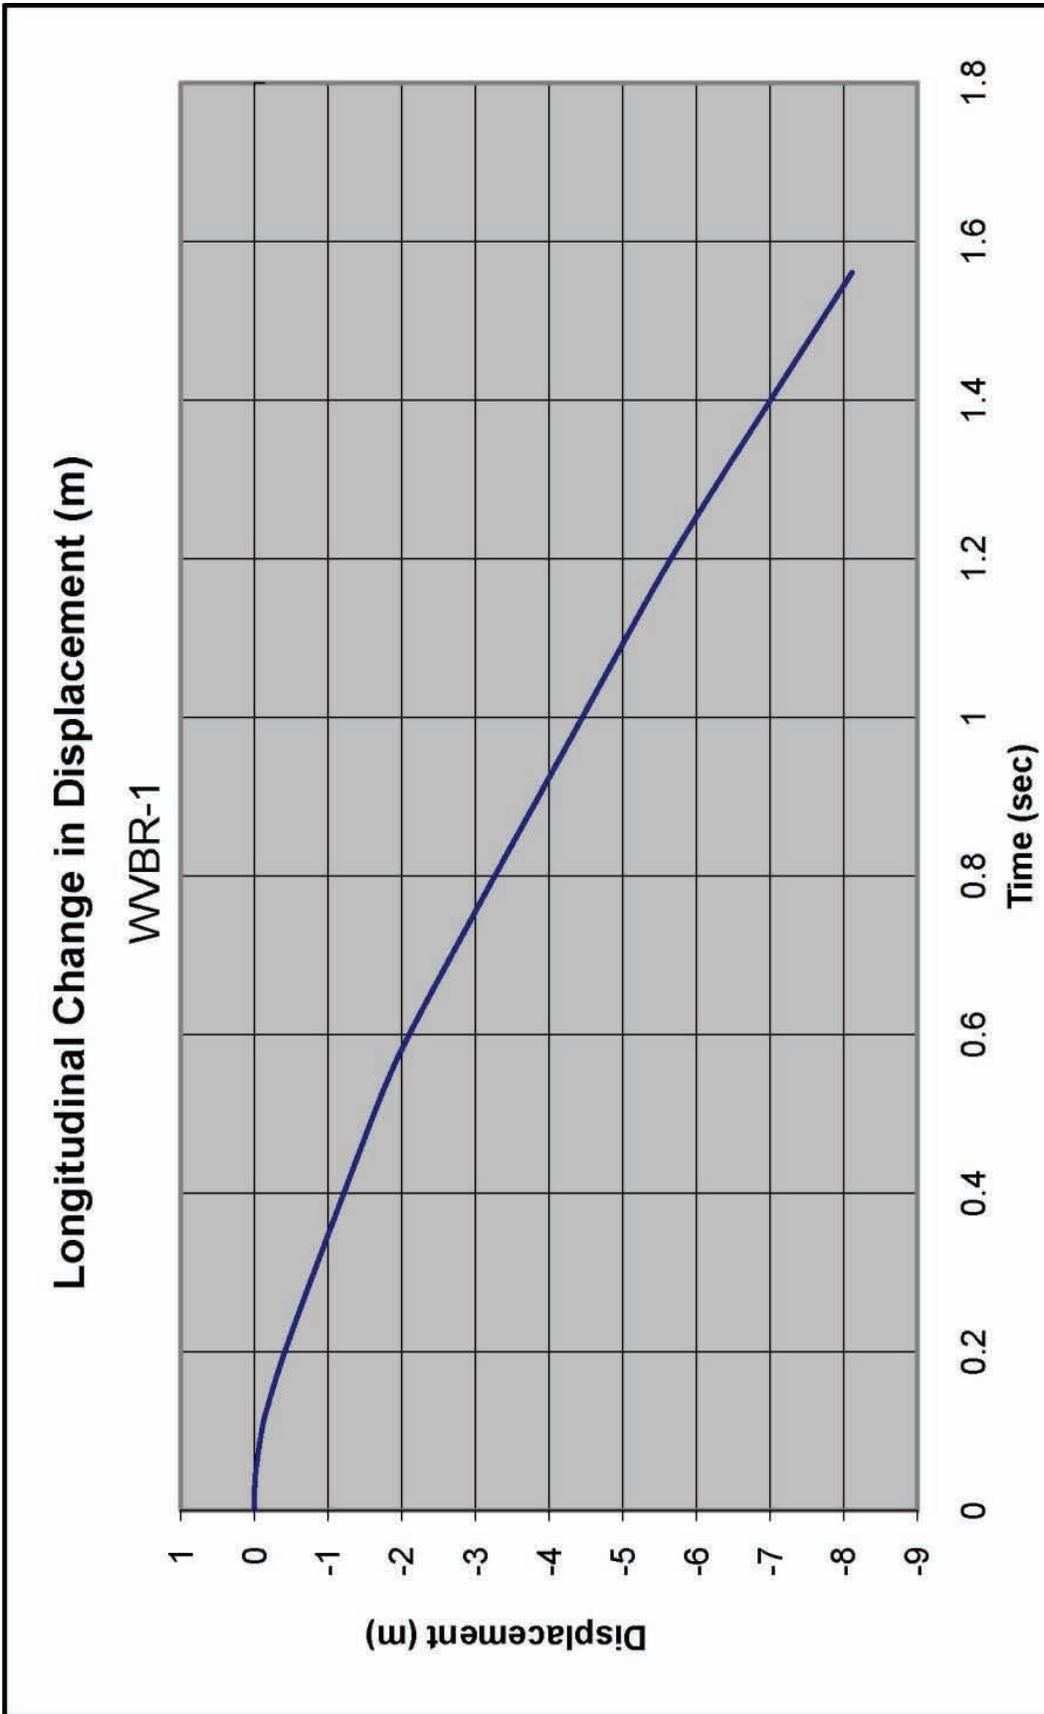
Figure D-9. Longitudinal Occupant Displacement, Test No. WVBR-1 (DTS)

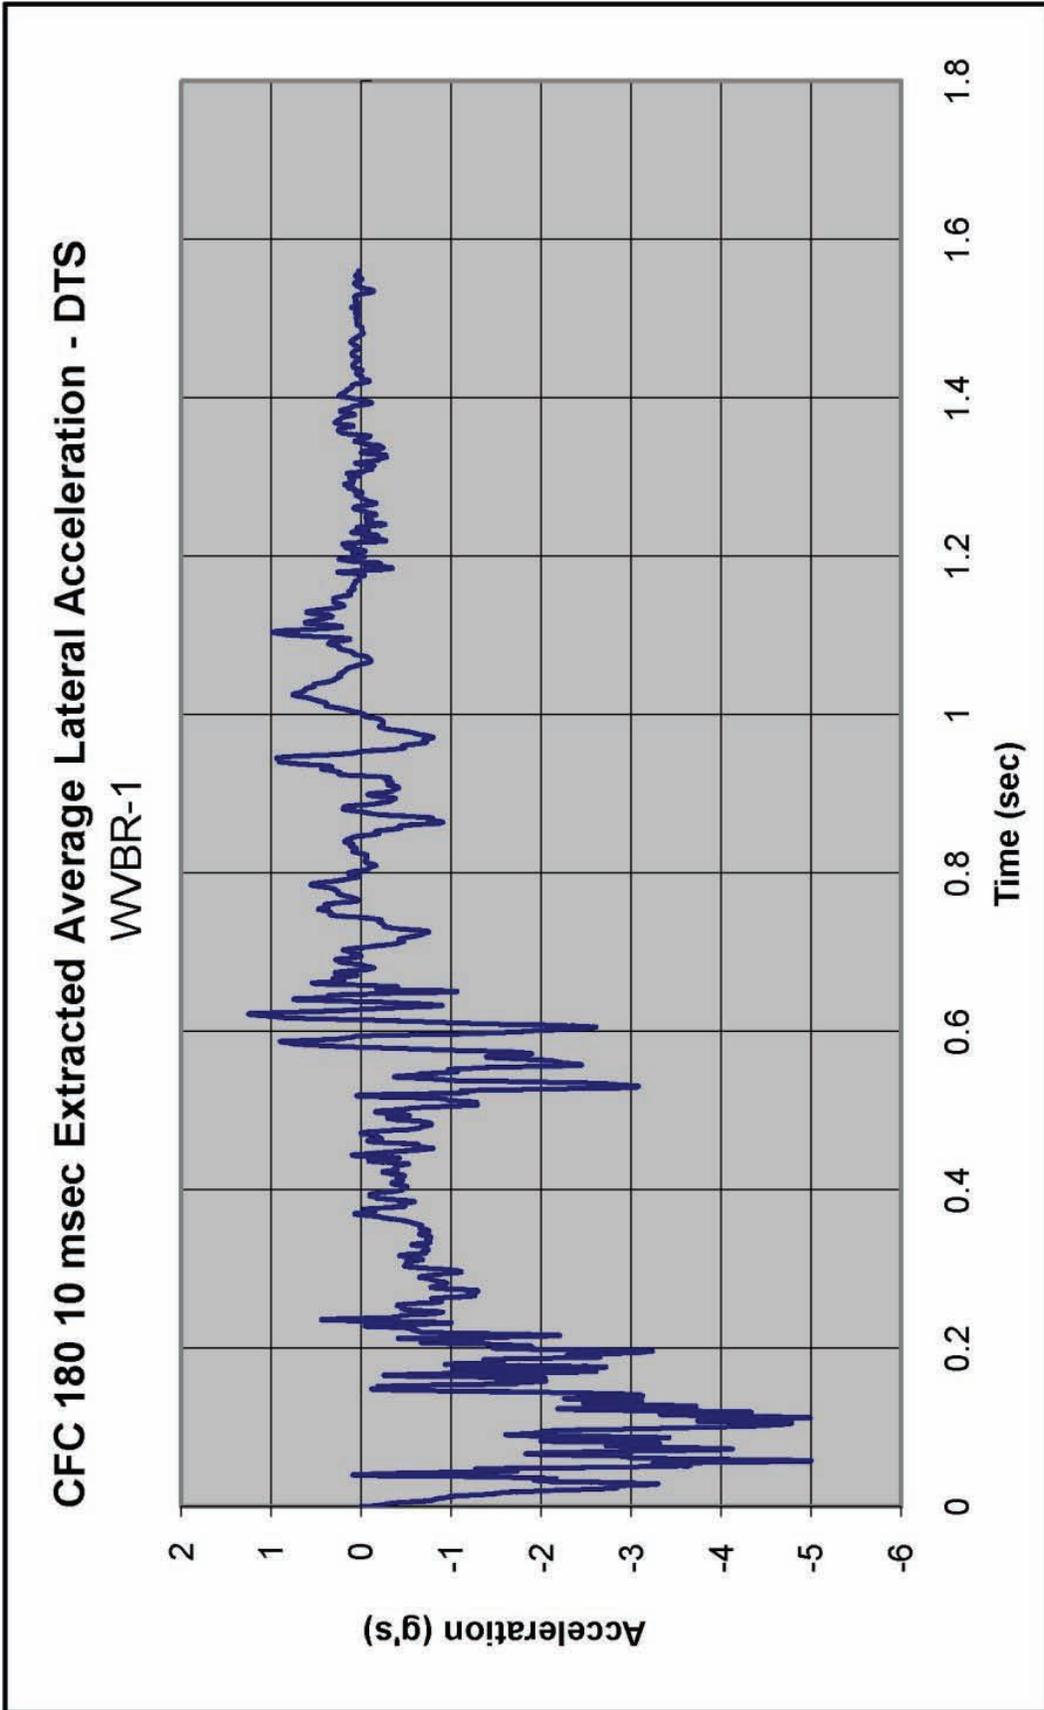
Figure D-10. 10-ms Average Lateral Acceleration, Test No. WVBR-1 (DTS)

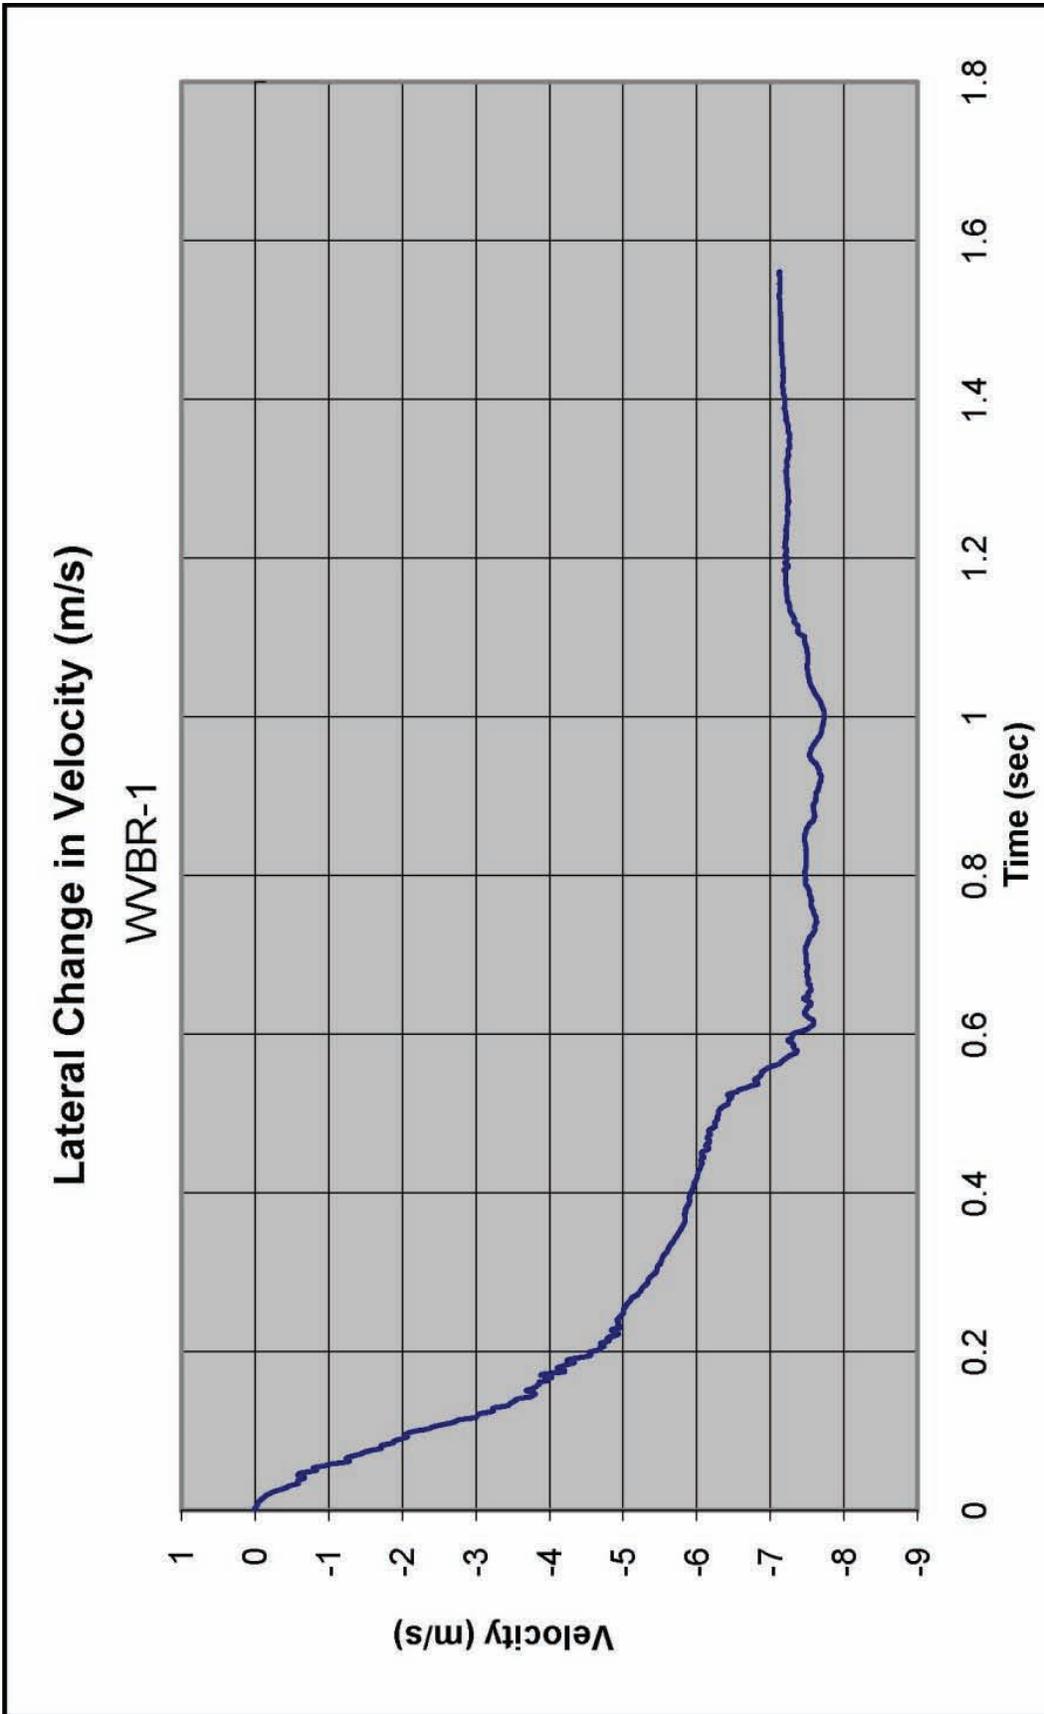
Figure D-11. Lateral Occupant Impact Velocity, Test No. WVBR-1 (DTS)

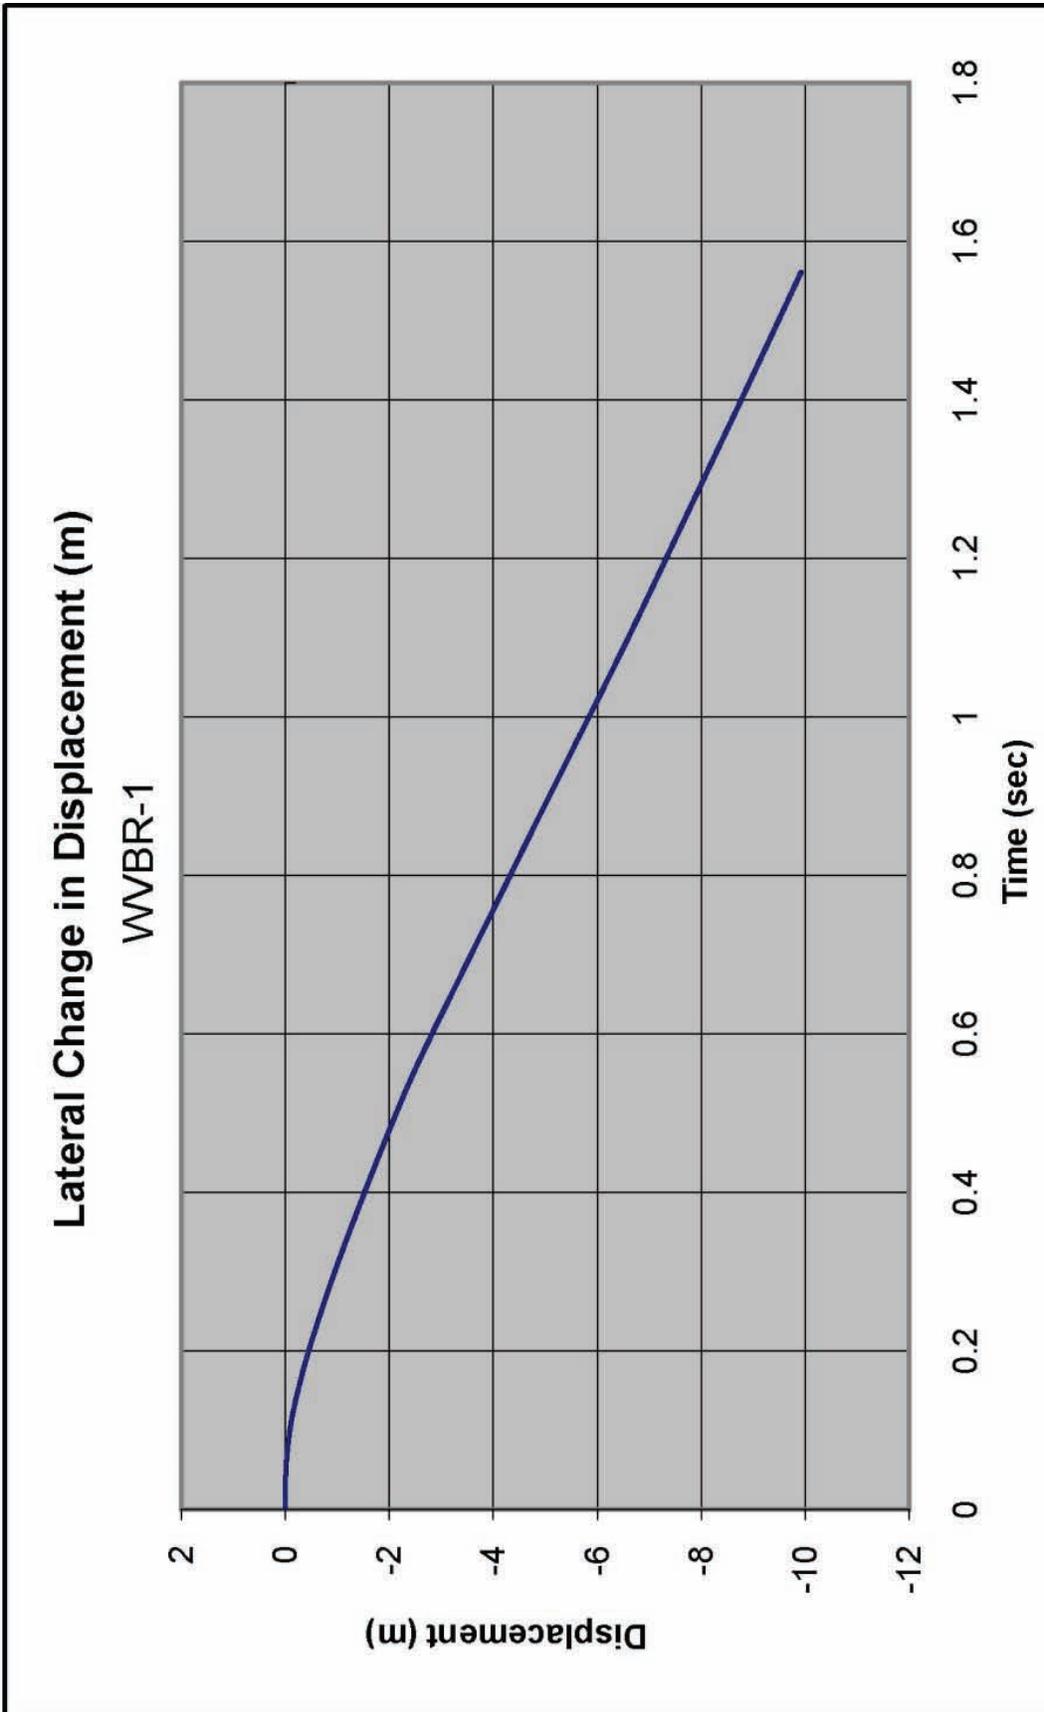
Figure D-12. Lateral Occupant Displacement, Test No. WVBR-1 (DTS)

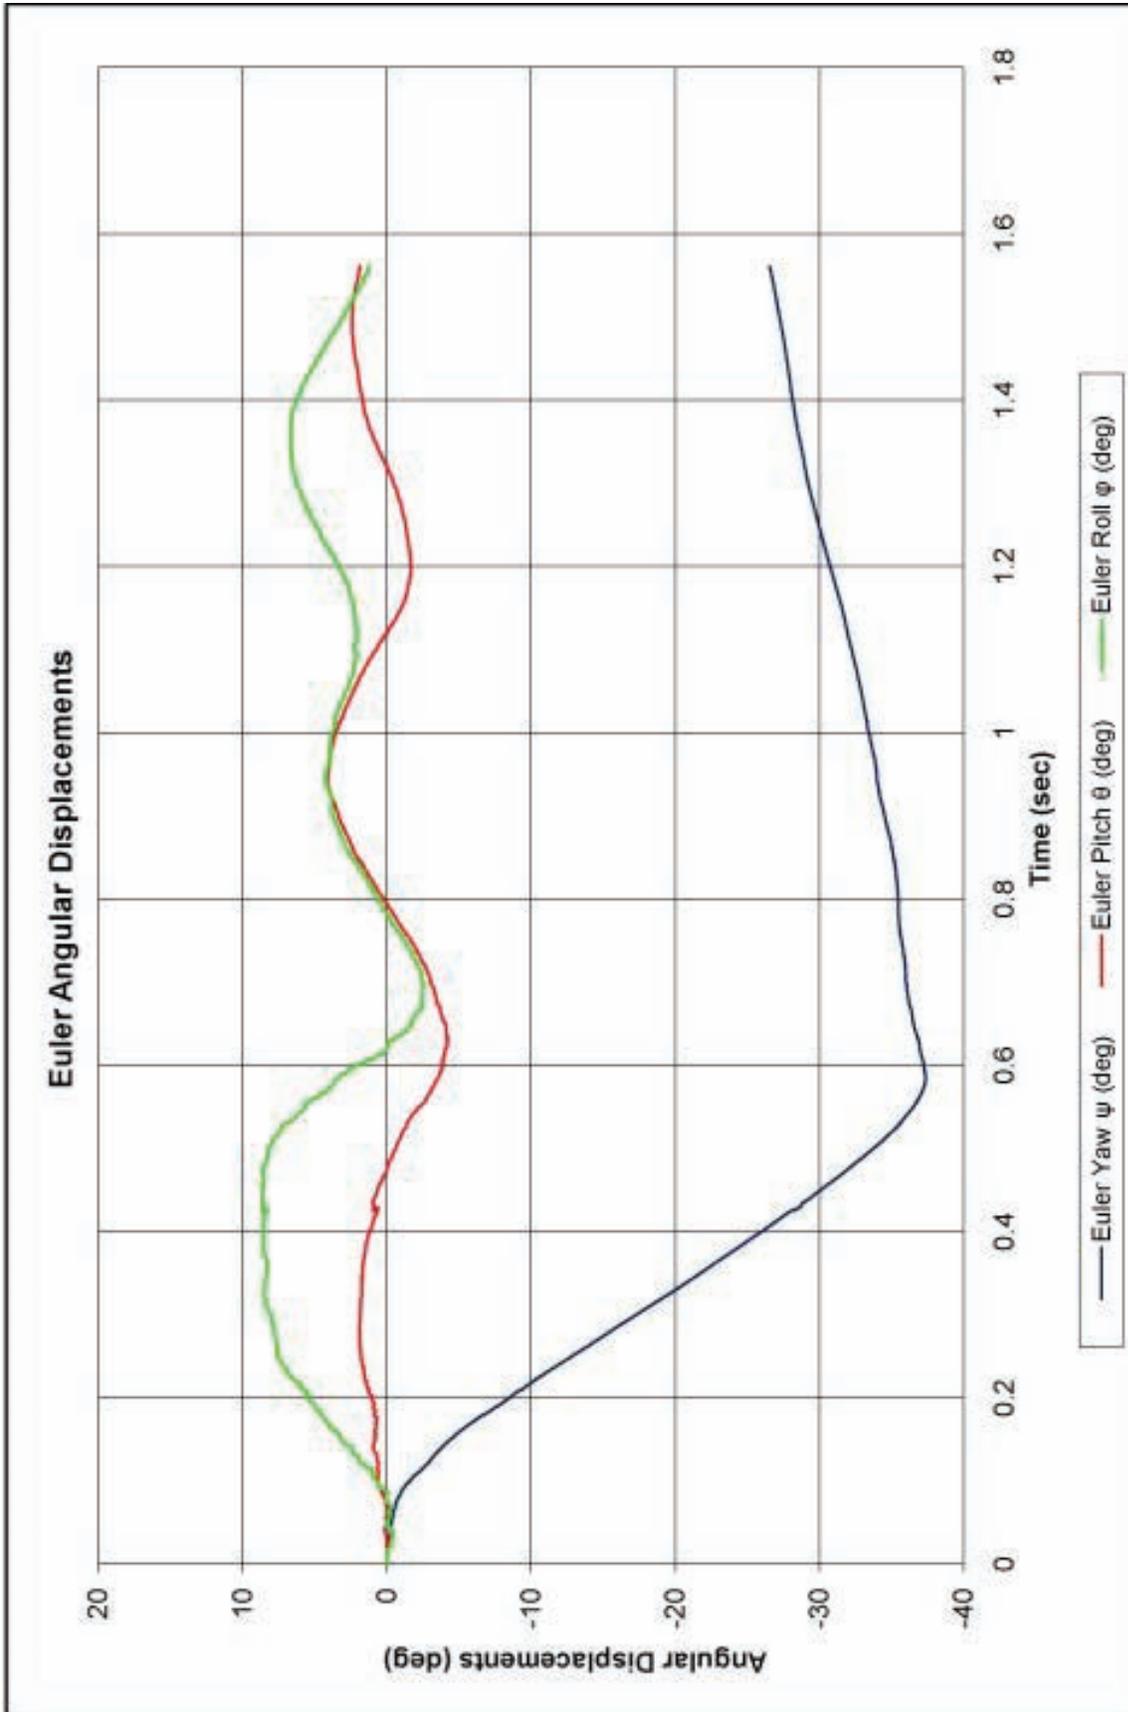
Figure D-13. Vehicle Roll, Pitch, and Yaw Angular Displacements, Test No. WVBR-1
