LENGTH OF NEED AND MINIMUM SYSTEM LENGTH FOR F-SHAPE PORTABLE CONCRETE BARRIER

MIDWEST ROADSIDE SAFETY FACILITY

NEBRASKA DEPARTMENT OF ROADS

MwRSF Research Report No. TRP-03-337-17

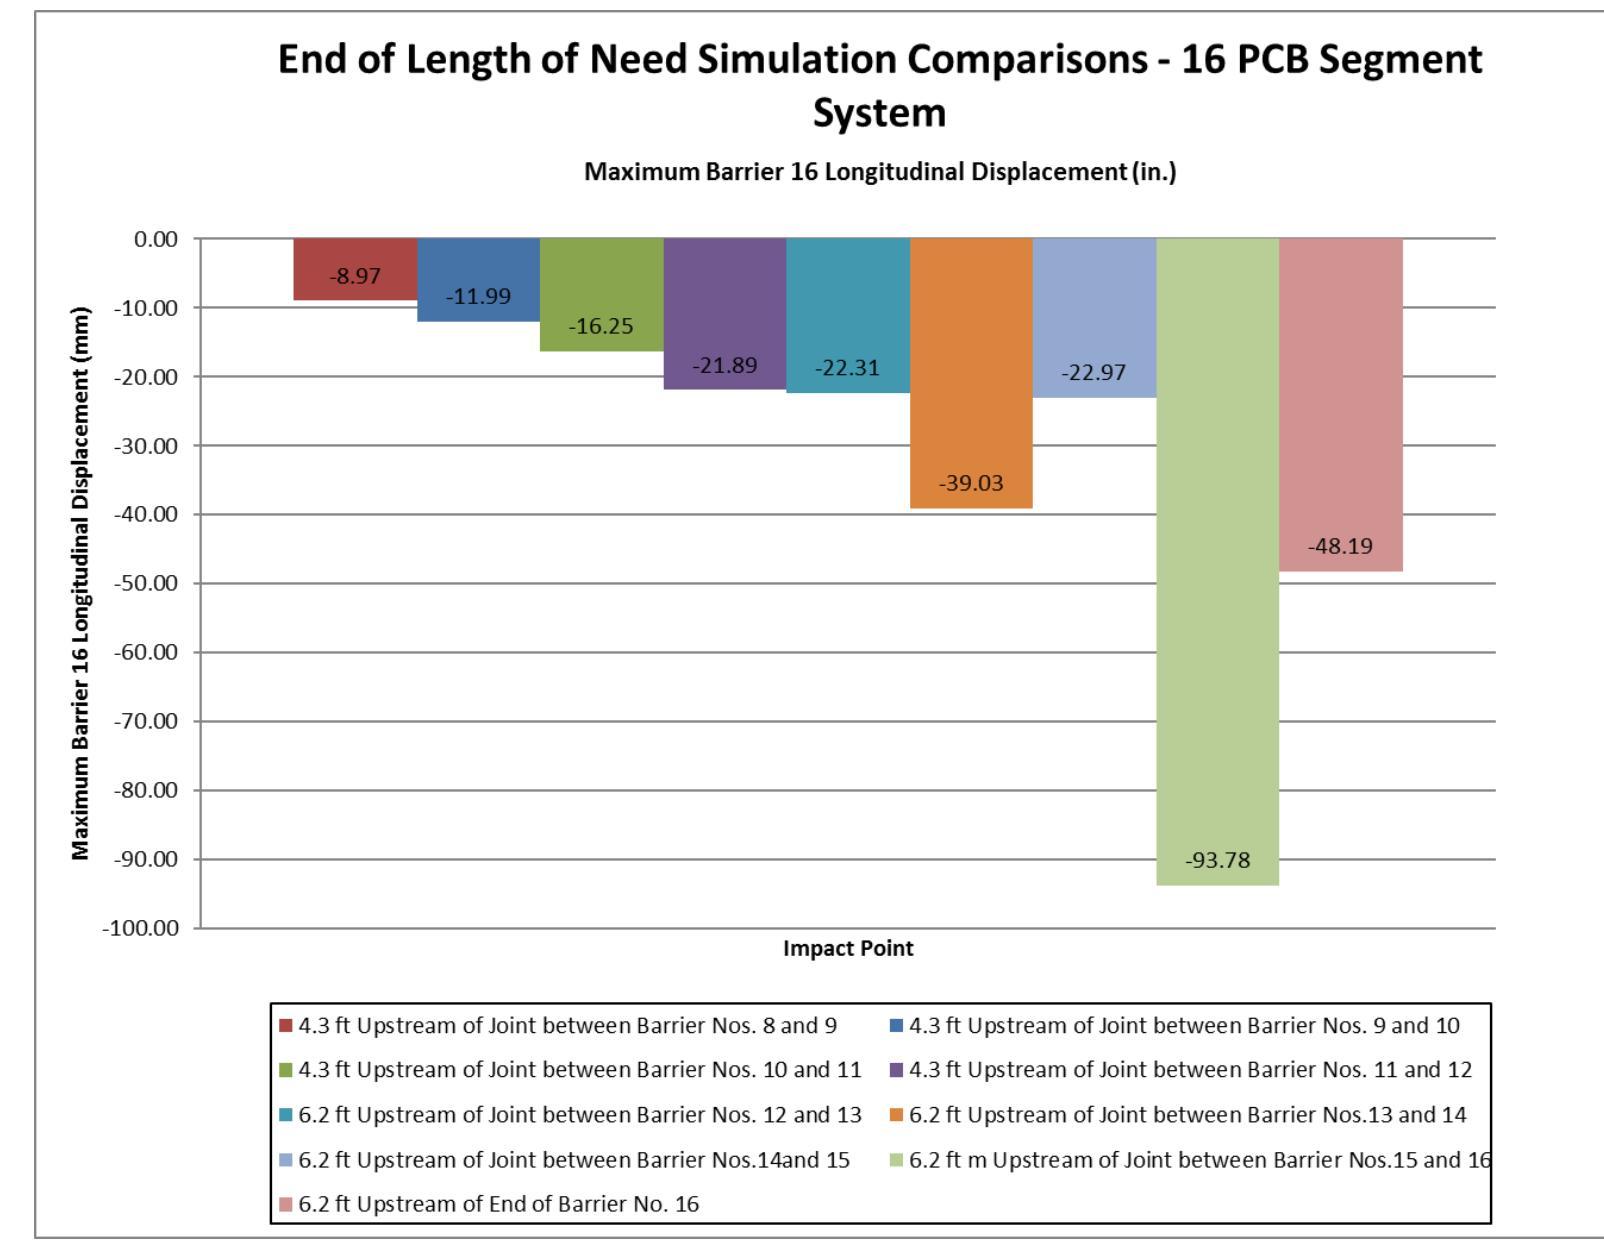
Figure 35. End of LON Simulations, Maximum Longitudinal Displacement of Barrier No. 16

The maximum longitudinal displacement of the end barriers of the PCB system was also collected during the simulations, as shown in Figures 34 and 35. Large displacements of the end barriers indicated that the barrier system was not potentially providing sufficient tension upstream and downstream of the impact point and that barrier performance may be degraded. Longitudinal displacement of barrier no. 16 on the downstream end was most affected as the vehicle impacts approached the downstream end. Displacement of this barrier tended to increase as the impact point moved downstream. These increases were less severe when impacting barrier nos. 9 through 12, but became larger when impacting the last four barriers of the system. Impact on barrier nos. 14 through 16 resulted in gating of the end of the barrier, which generated large lateral deflections of the end barrier but not large longitudinal displacement. Longitudinal displacement of barrier no. 1 was not as drastically affected, but the displacement of this barrier decreased as the impact point of the vehicle moved upstream.

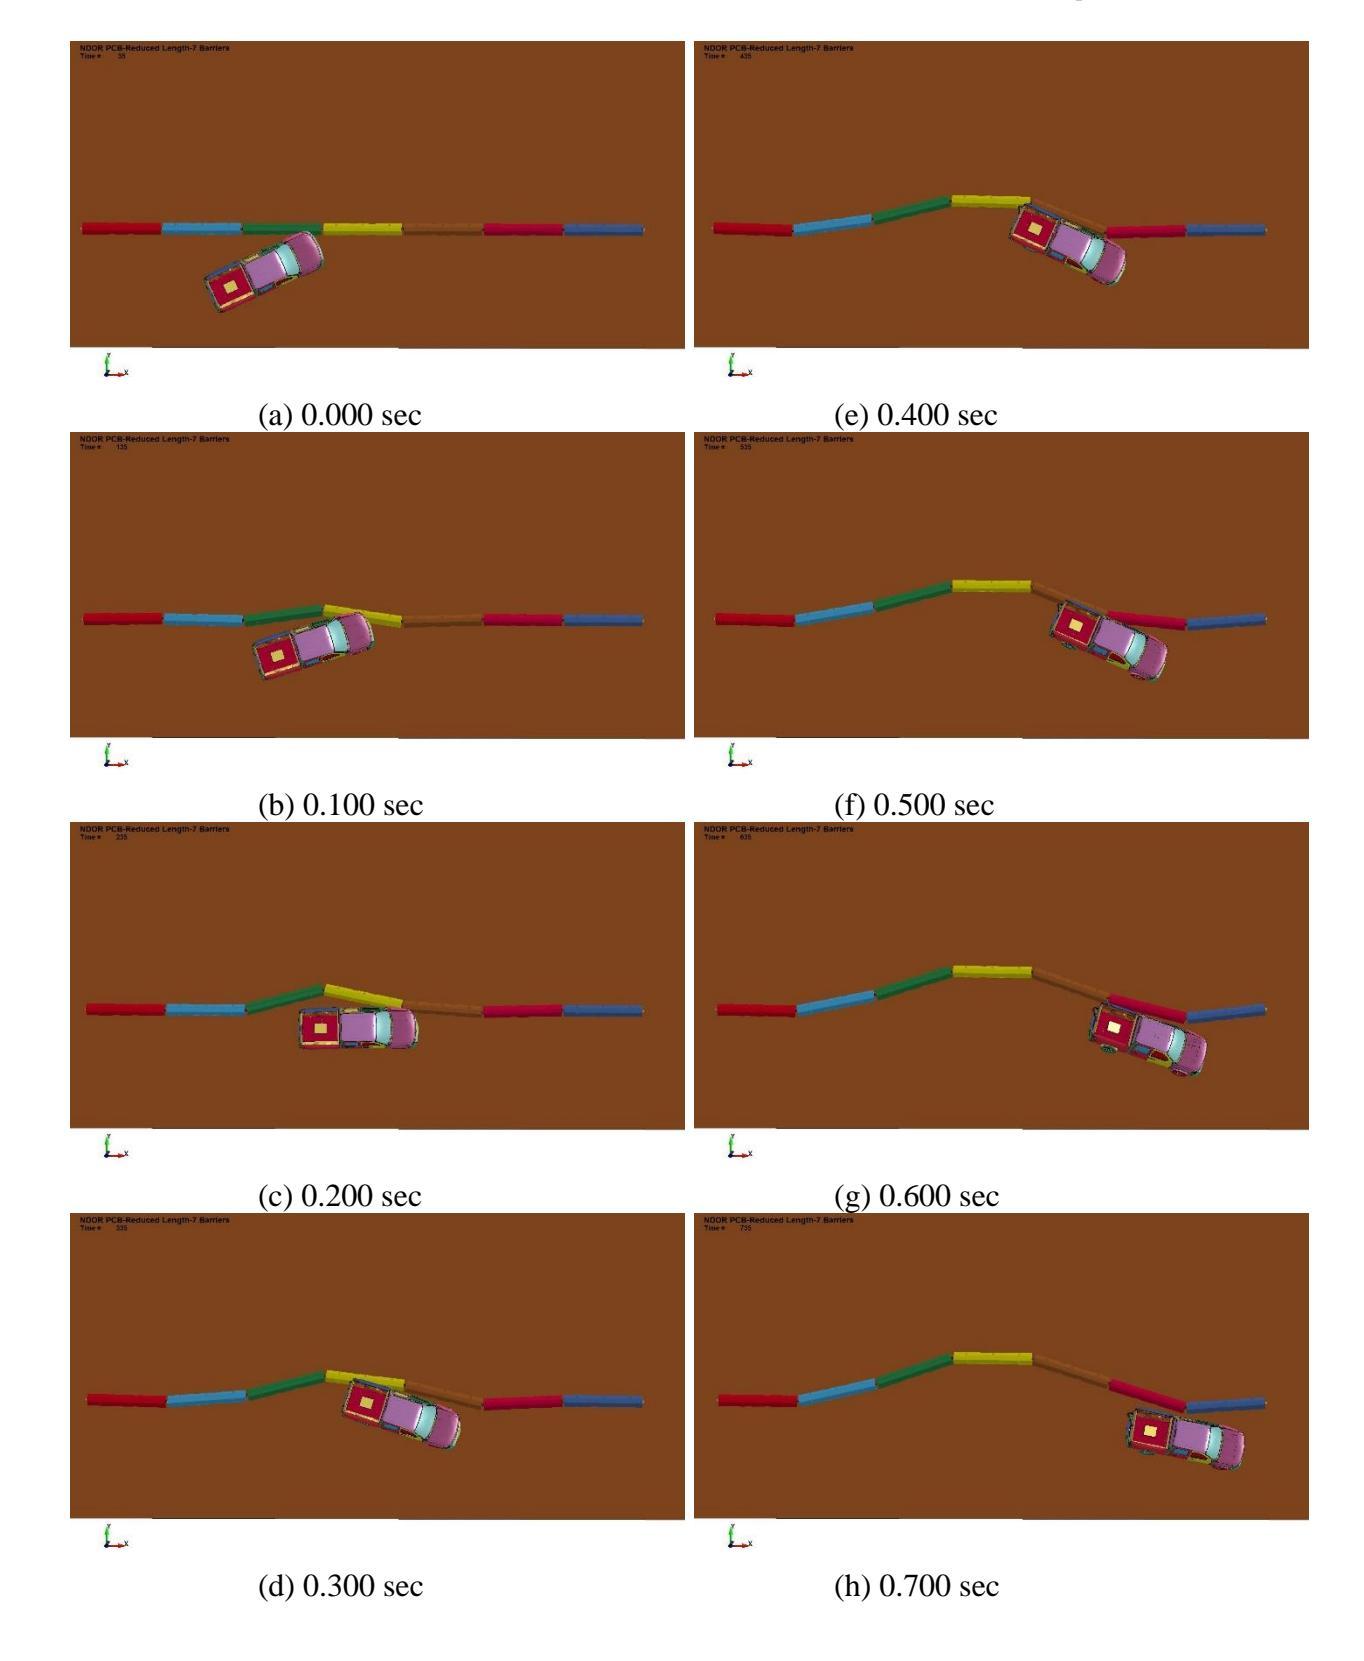
Figure 38. Simulation of Beginning of LON for 7-Barrier F-Shape PCB System, Downstream View

Simulation of the impact on the beginning of LON for the seven-barrier long system displayed acceptable results in terms of the barrier performance, as shown in Figures 37 and 38. The 2270P vehicle was safely and smoothly redirected with vehicle stability that compared well with the baseline model of the original sixteen-barrier long PCB system. Occupant risk values for the simulation were well below the MASH limits. As would be expected, lateral and longitudinal barrier displacements increased significantly as compared to an impact near the midspan of the standard 200-ft (61-m) system length used for full-scale crash testing. Peak lateral barrier deflections were found to be 95.3 in. (2,420 mm) at the downstream end of barrier no. 4, while the longitudinal displacement of the barriers on the upstream and downstream ends of the system were found to be 27.3 in. (693 mm) and 7.0 in. (178 mm), respectively. However, the peak lateral deflection was within 3 percent of the deflection of the standard length PCB system when impacted at the beginning of the LON.

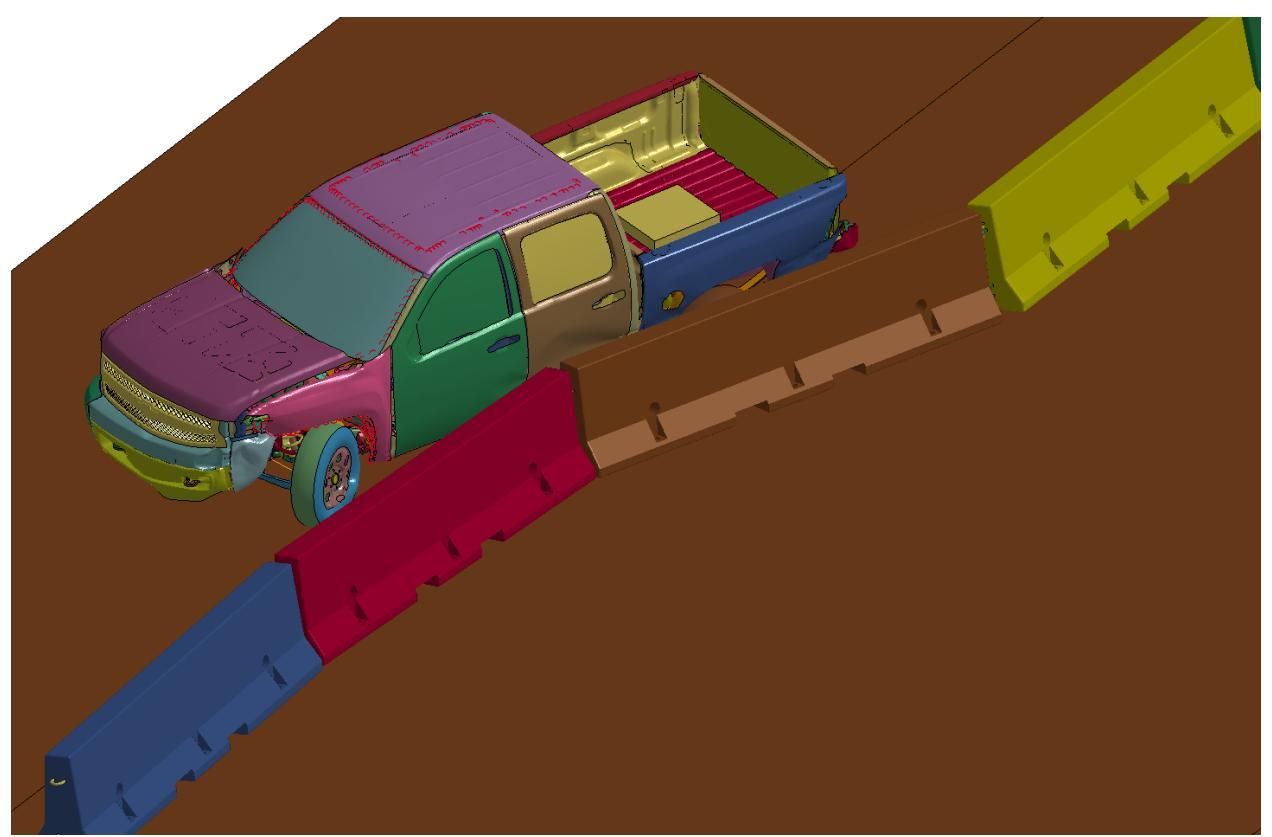
Figure 39. Simulation of Beginning of LON for 7-Barrier F-Shape PCB System, Barrier Knee Impact at Barrier Nos. 5 and 6 Joint

It was noted that the reduced length and corresponding reduction in upstream and downstream tensile loads in the system altered the deflection of the PCB segments. Specifically, it was noted that a knee formed at the joint between barrier nos. 5 and 6 and impacted the rear, left-side door on the 2270P vehicle as the vehicle traversed the joint, as shown in Figure 39. The formation of a knee between the barrier segments that impacted the side of the vehicle was not observed in simulations of the full-length systems nor had it been noted in full-scale testing. The impact of the knee on the rear, left-side door caused only moderate damage and did not affect vehicle stability or occupant risk values. As such, this was not believed to pose a serious degradation of the barrier performance. However, it did indicate that the reduced length of the system affected barrier behavior.

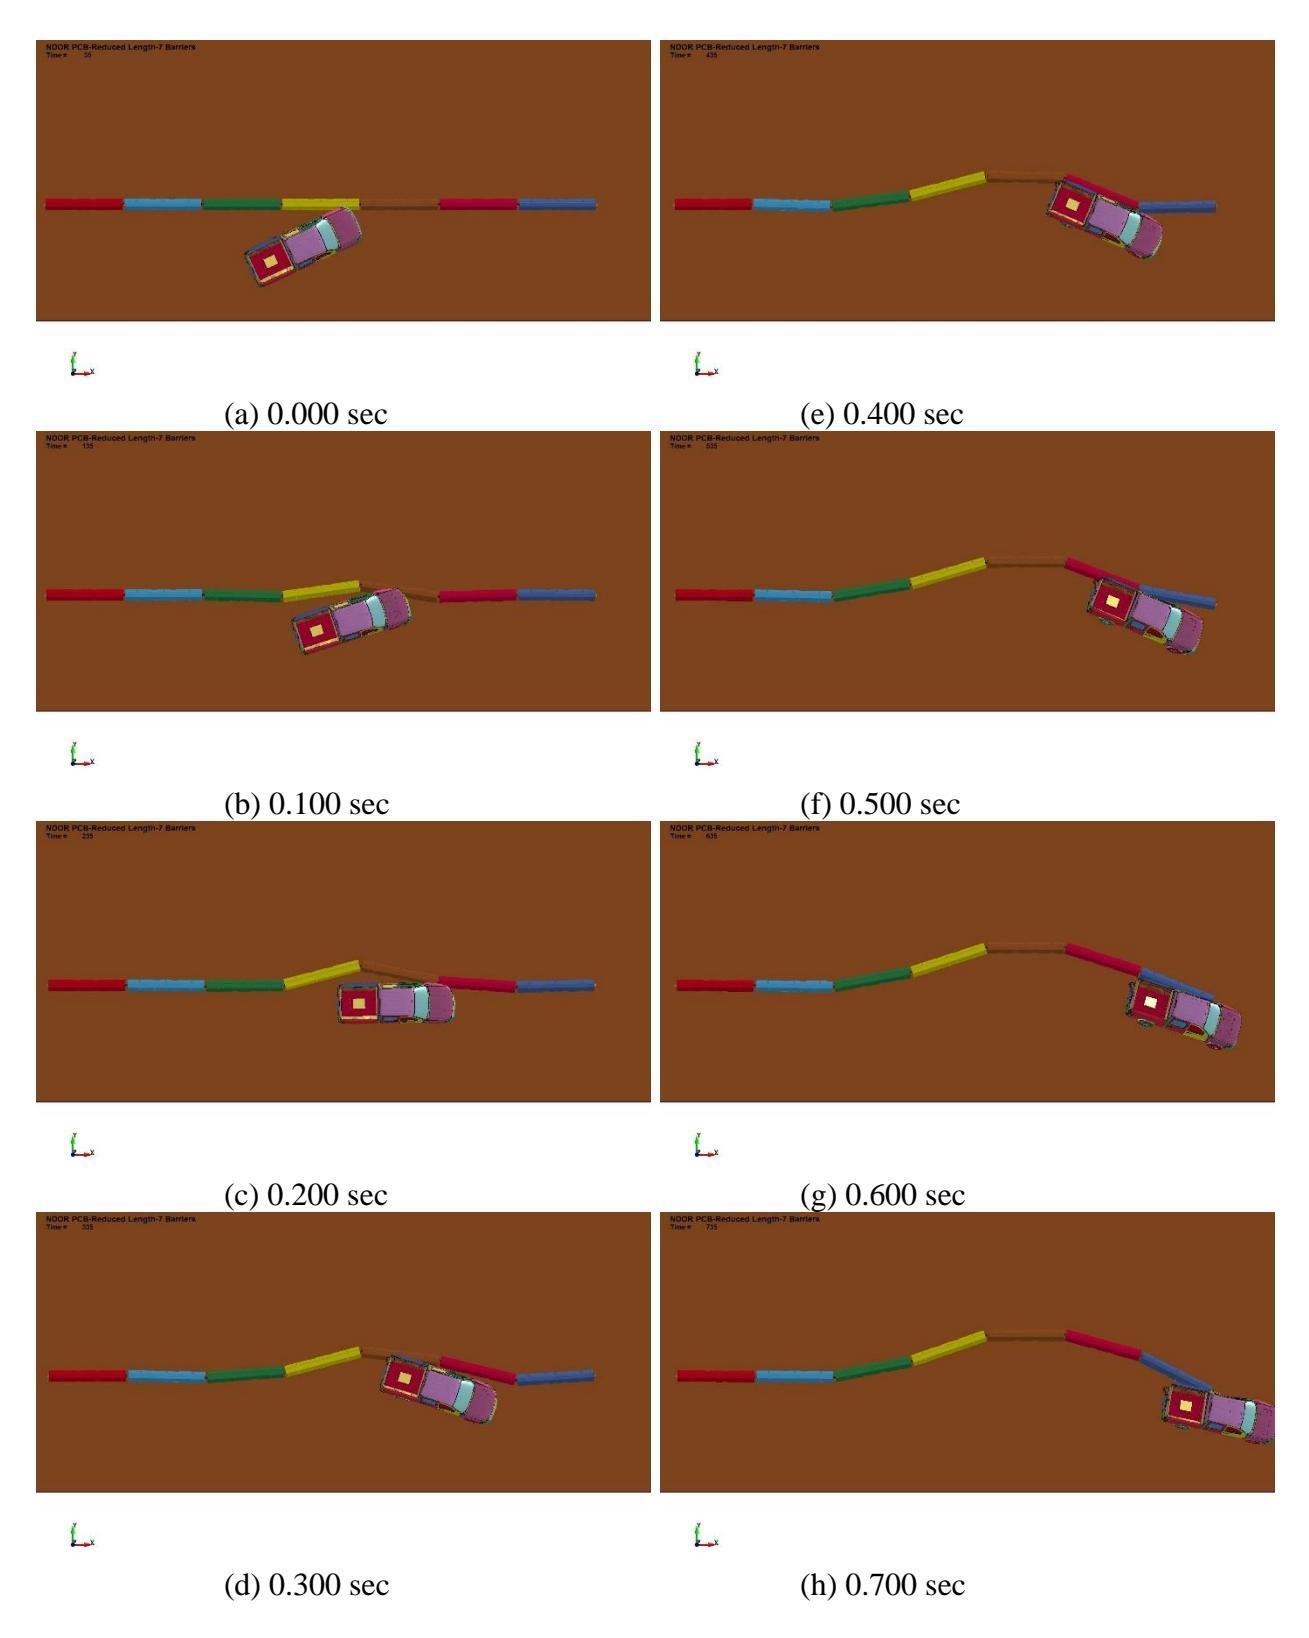
Figure 40. Simulation of End of LON for 7-Barrier F-Shape PCB System, Overhead View

Simulation of the impact on the end of LON for the seven-barrier long system raised potential concerns regarding the use of the shorter system length. Sequential images of the sevenbarrier F-shape PCB system impacted at the proposed end of LON are shown in Figures 40 and 41. The 2270P vehicle was redirected, and occupant risk values for the simulation were below the MASH limits. Peak lateral barrier deflections were 96.5 in. (2,451 mm) at the upstream end of barrier no. 6, while the longitudinal displacement of the barriers on the upstream and downstream ends of the system were found to be 17.2 in. (437 mm) and 23.2 in. (589 mm), respectively. Of more concern was the vehicle interaction with the barrier as it reached the end of the system. At .630 s after impact, the vehicle was proceeding past the final barrier in the PCB system when the final barrier in the system rotated into the left-side door, as shown in Figure 42. The motion of the PCB segments downstream of impact in the reduced-length system changed as compared to the full length system simulated previously due to the difference in longitudinal resistance provided on the upstream end of the system. This resulted in more pronounced rotation of the end barrier that caused the end of the barrier segment to impact the left-side door. Impact of the end of the barrier with the door in the simulation caused significant damage to the door and raised concerns with respect to occupant compartment safety, occupant risk concerns, and potential degradation of vehicle stability. Review of these results with the project sponsor verified these concerns, and it was desired to mitigate the potential for impact of the end barrier segment on the vehicle.

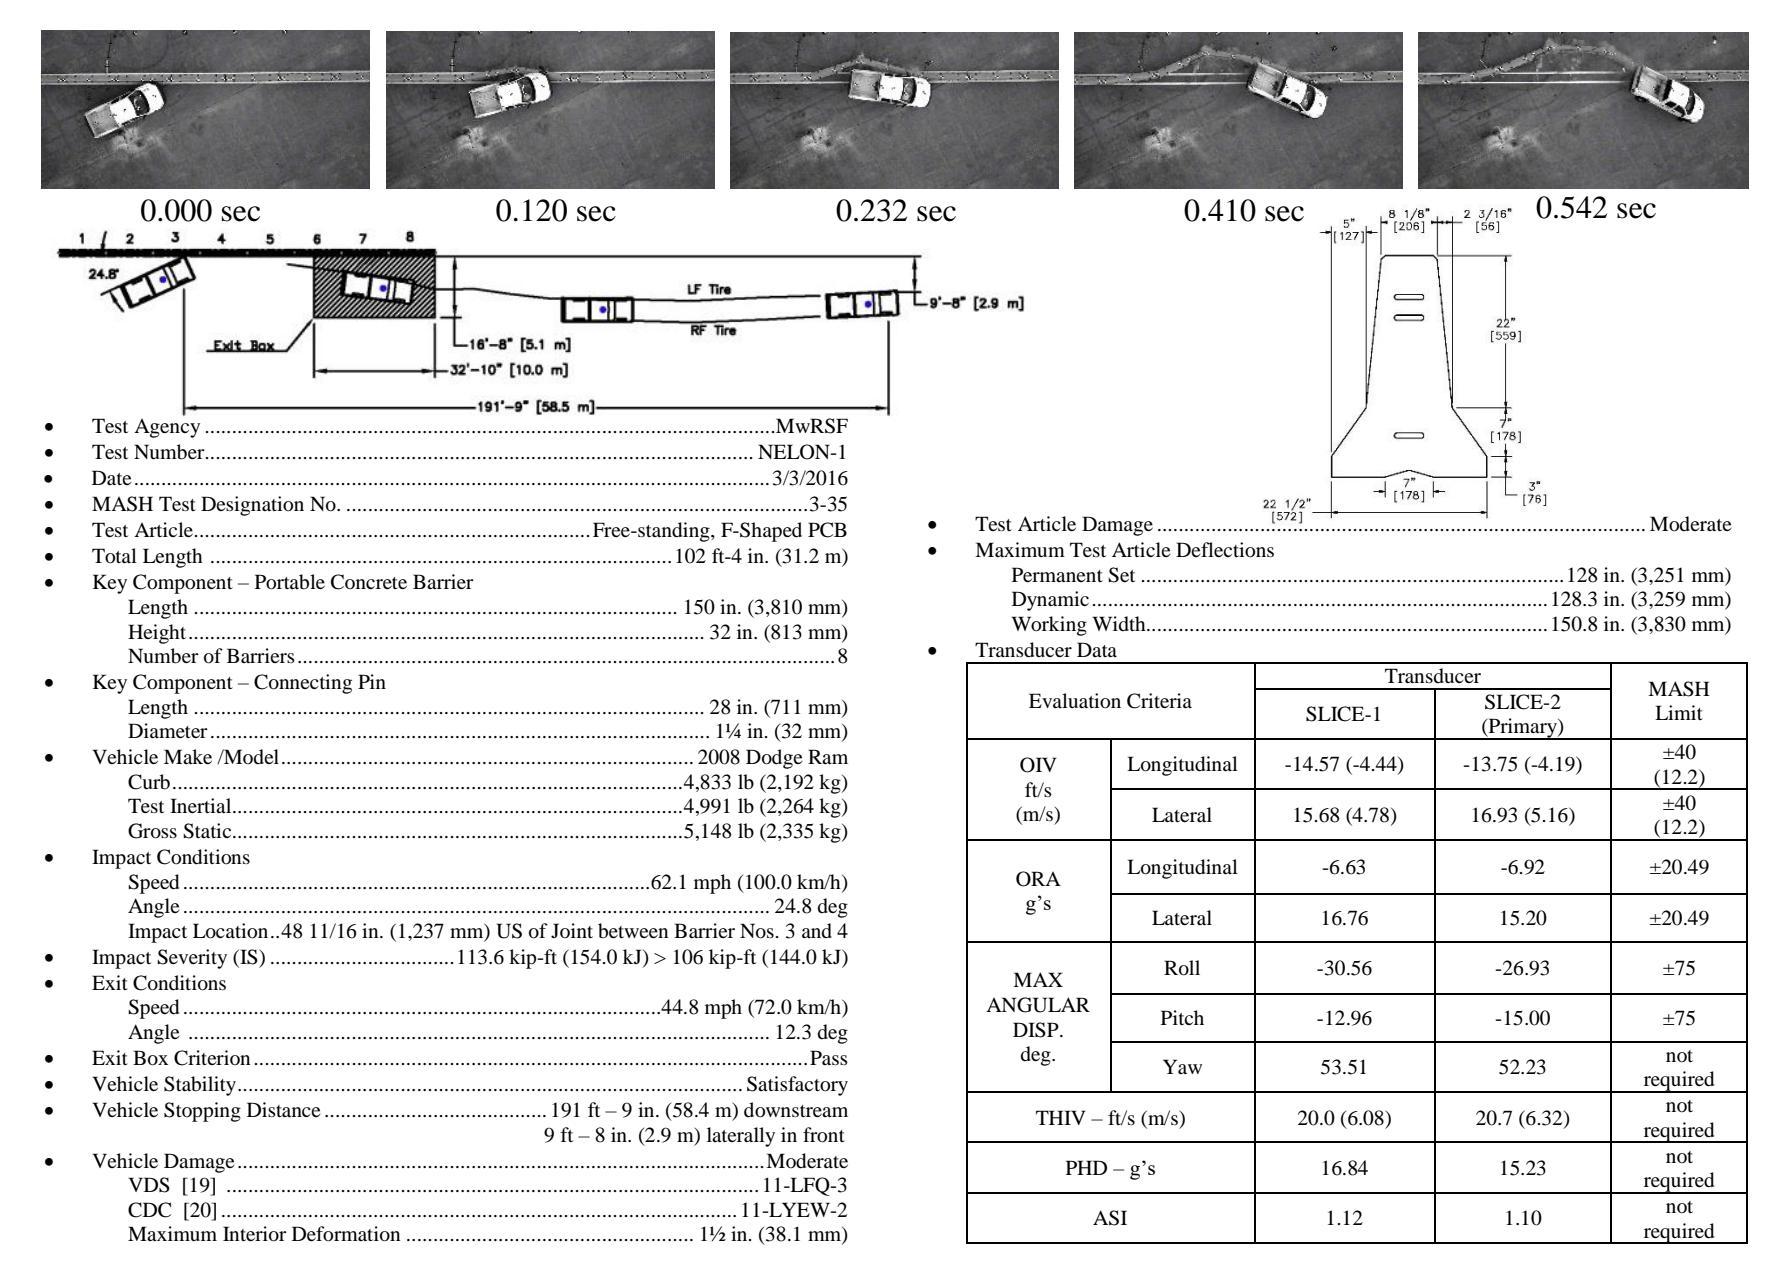
Figure 66. Summary of Test Results and Sequential Photographs, Test No. NELON-1

The analysis of the test results for test no. NELON-1 showed that the beginning of the LON for the free-standing, F-shape PCB system adequately contained and redirected the 2270P vehicle with controlled lateral displacements of the barrier. There were no detached elements nor fragments which showed potential for penetrating the occupant compartment nor presented undue hazard to other traffic. Deformations of, or intrusions into, the occupant compartment that could have caused serious injury did not occur. The test vehicle did not penetrate nor ride over the barrier and remained upright during and after the collision. Vehicle roll, pitch, and yaw angular displacements, as shown in Appendix D, were deemed acceptable, because they did not adversely influence occupant risk nor cause rollover. After impact, the vehicle exited the barrier at an angle of 12.3 degrees and its trajectory did not violate the bounds of the exit box. Therefore, test no. NELON-1 was determined to be acceptable according to the MASH safety performance criteria for test designation no. 3-35.

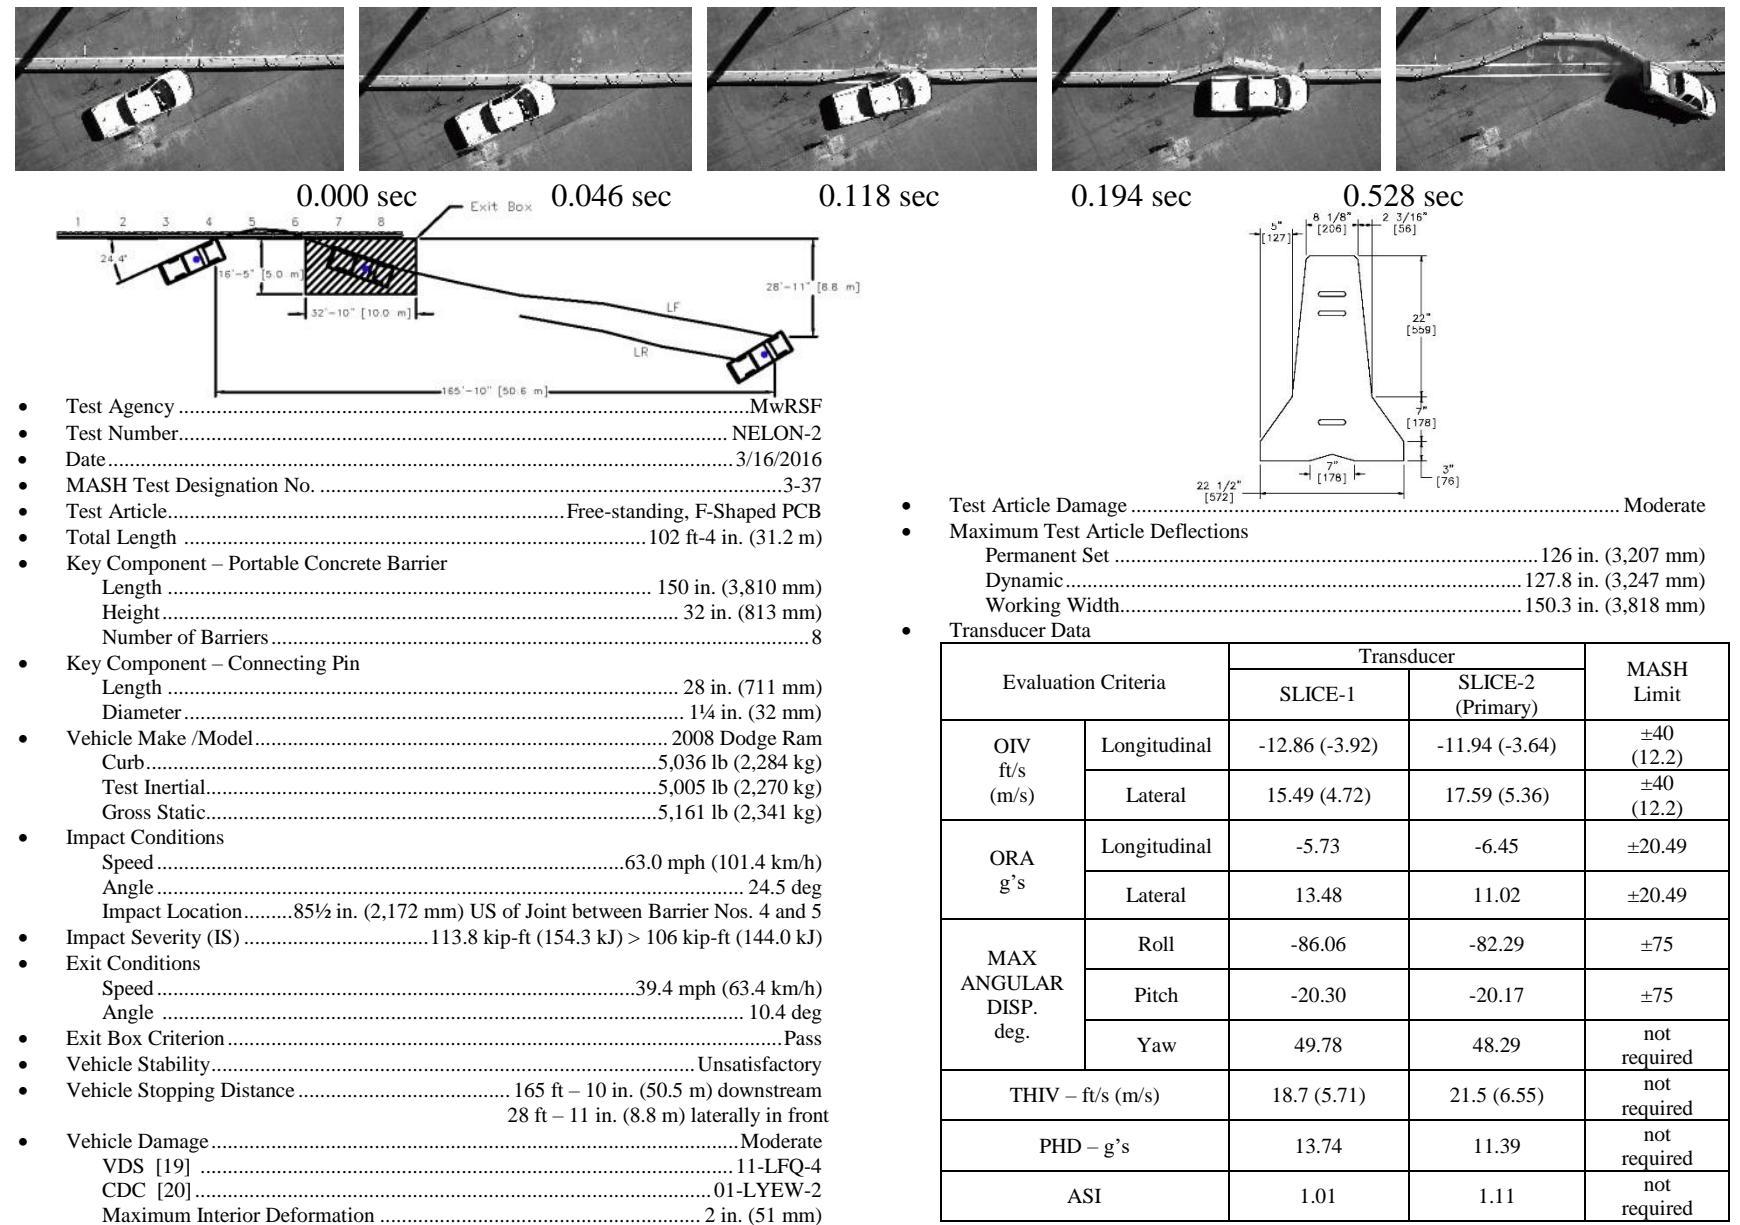
Figure 84. Summary of Test Results and Sequential Photographs, Test No. NELON-2

The analysis of the test results for test no. NELON-2 showed that the end of LON for the reduced length, free-standing, F-shape PCB system adequately contained and redirected the 2270P vehicle with controlled lateral displacements of the barrier. There were no detached elements nor fragments which showed potential for penetrating the occupant compartment nor presented undue hazard to other traffic. Deformations of, or intrusions into, the occupant compartment that could have caused serious injury did not occur. However, the left-front door of the vehicle became unlatched and opened during the impact. The cause for the door latch release was not determined. Examination of the door latch did not reveal damage or fracture that would have caused the latch to disengage, but motion of the dummy limbs or the impact of the door into the barrier may have potentially activated the latch mechanism. While this behavior is not specifically outlined as violating the safety requirements in MASH, there was potential concern that the opening of the door exposed the vehicle occupant. The test vehicle did not penetrate nor ride over the barrier and remained upright during and after the collision. Vehicle pitch and yaw angular displacements, shown in Appendix E, were deemed acceptable because they did not adversely influence occupant risk, however, vehicle roll did exceed the occupant risk safety criteria of 75 degrees established in MASH. After impact, the vehicle exited the barrier at an angle of 10.4 degrees, and its trajectory did not violate the bounds of the exit box. Therefore, due to the excessive roll of the vehicle, test no. NELON-2 was determined to be unacceptable according to the MASH safety performance criteria for test designation no. 3-37.

Test no. NELON-2 initially performed similarly to test no. NELON-1 as the vehicle was captured and redirected. Peak lateral barrier deflections were similar to NELON-1 and were again larger than those predicted by the LS-DYNA simulation. However, test no. NELON-2 was deemed unacceptable according to the MASH safety requirements due to vehicle roll that exceeded 75 degrees after it exited the barrier system. Review of the test suggested potential factors that may have contributed to the vehicle rollover. First, the increased barrier deflections observed in test no. NELON-2 due to reduced system length and impact at the downstream LON point may have adversely affected the vehicle trajectory. Comparison of the barrier deflections and vehicle trajectories from test nos. NELON-1, NELON-2, and 2214TB-2 are shown in Figures 100 through 103. Review of these three tests showed that the reduced length system tests displayed higher deflections of barrier segments near the impact of the vehicle and less gradual deflection of adjacent barrier segments as compared to the full-length PCB system. These differences were likely due to both the reduced upstream and downstream tensile forces developed by shorter systems, as evidenced by the increased longitudinal displacement of the ends of the system, and increased barrier damage, as noted previously. The increased deflection of the reduced length systems clearly affected vehicle trajectory. Test nos. NELON-1 and NELON-2 exhibited higher exit angles of 12.3 degrees and 10.4 degrees, respectively, as compared to 7.9 degrees for test no. 2214TB-2. Similarly, comparison of vehicle roll angles during the first 0.500 sec of the vehicle redirection exhibited significantly higher roll for the reduced length systems, as shown in Figure 104. Thus, it was believed that the effect of reduced system length on the PCB deflections contributed to vehicle instability.

A second factor that potentially contributed to the vehicle instability observed in test no. NELON-2 was the impact from a knee formed at the joint between barrier segment nos. 6 and 7. The knee extended forward laterally from the original barrier line and impacted the left-front door of the 2270P vehicle at approximately 0.390 sec after initial impact. The impact of the knee into the door may have further increased vehicle instability.

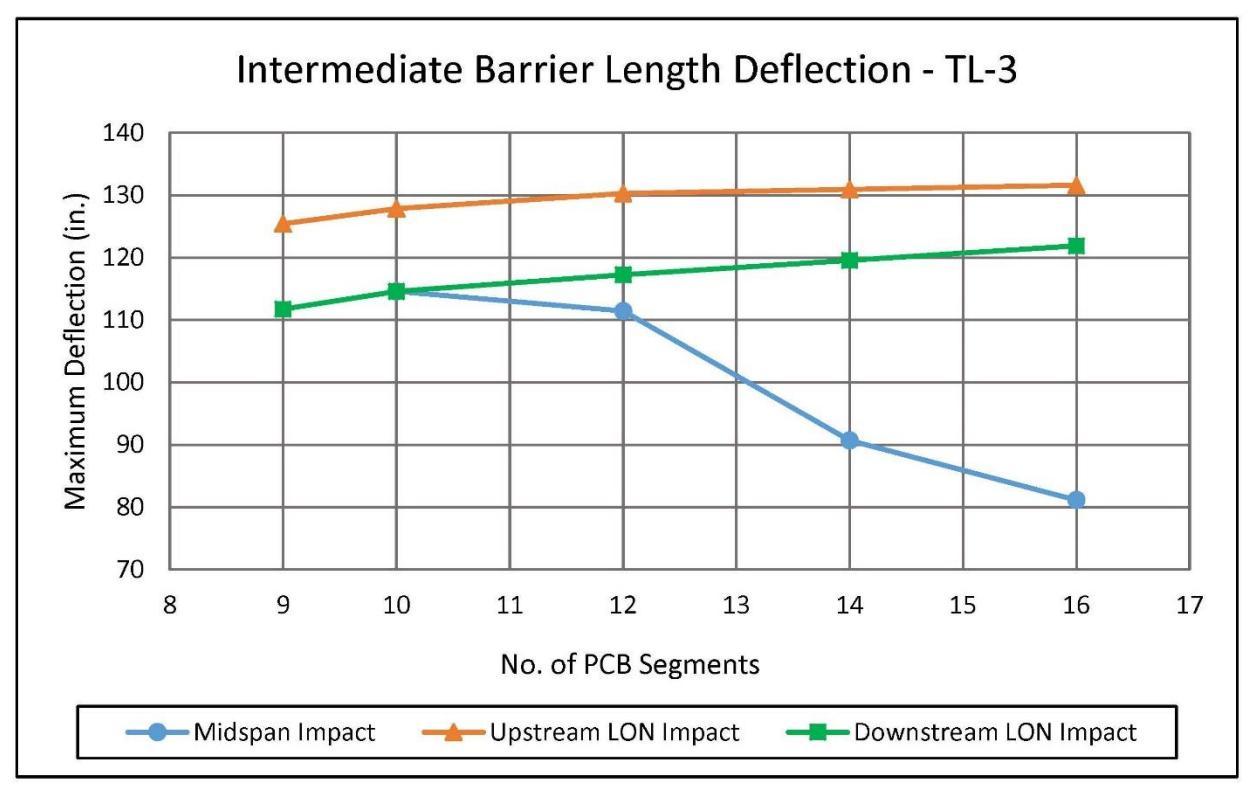
Figure 110. Lateral Barrier Deflections for Intermediate PCB System Lengths, MASH TL-3

Lateral barrier deflections for impacts at the end of LON displayed similar behavior. The lateral barrier deflection values for the end of LON impacts ranged from 111.7 in. (2,837 mm) to 121.9 in. (3,096 mm) and tended to increase slightly as the number of barriers in the system increased. Deflection magnitude decreased as compared to the beginning of LON impacts due to the impact being two barrier segments farther from the free end of the system. However, a similar trend toward an increase in barrier deflections with increased barrier system length was noted.

Finally, midspan impacts on intermediate length F-shape PCB systems demonstrated the lowest lateral barrier deflections. The lateral barrier deflection values for the midspan impacts ranged from 114.6 in. (2,911 mm) for a 10-barrier long system to 81.1 in. (2,060 mm) for a 16-barrier long system. For the midspan impacts, lateral barrier deflection tended to decrease as system length increased.

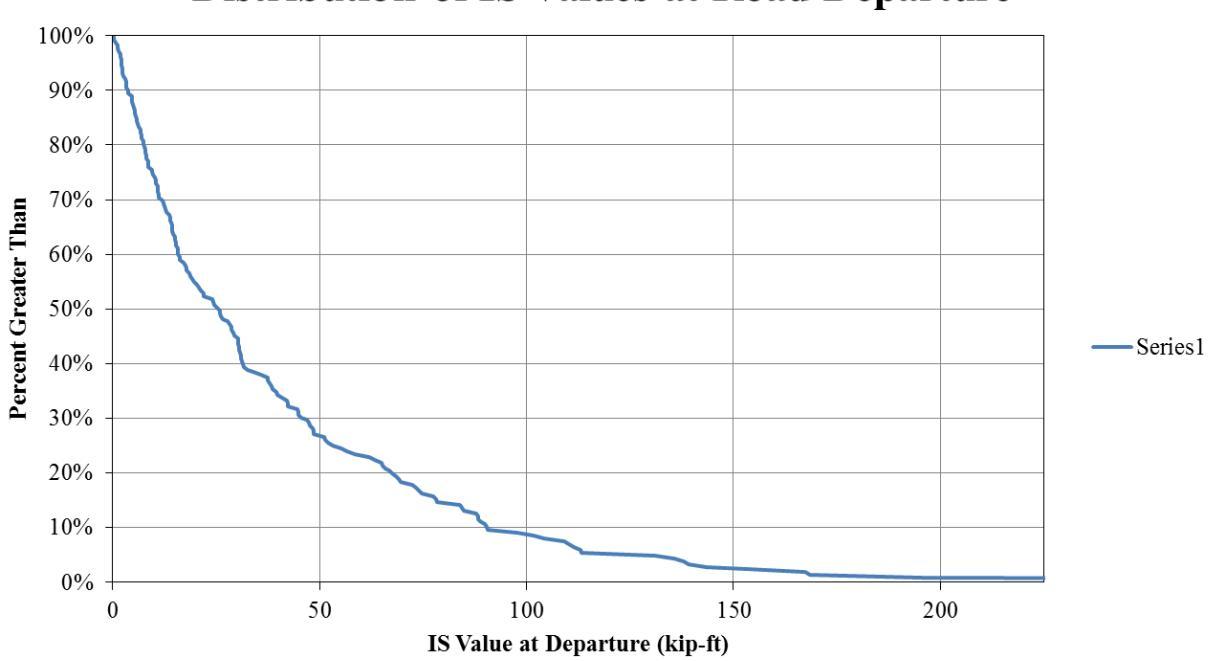
Figure 111. NCHRP 22-17 IS Distribution for Freeways

Distribution of IS Values at Road Departure

Thus, a second series of computer simulations were conducted on the F-shape PCB system to estimate lateral dynamic barrier deflections for the 85th percentile IS value. Simulations were conducted on the F-shape PCB system with 9, 10, 12, 14, and 16 barriers and at the beginning of LON, the midspan of the system, and the end of LON. Note that no midspan simulation was conducted for the nine-barrier long system as this location would have been outside of the LON of the barrier. As noted previously, a reduced barrier-to-ground friction coefficient of 0.27 was used for the simulation model of the midspan impact on the sixteen barrier F-shape PCB system used the original barrier-to-ground friction coefficient of 0.40, as this model had previously been validated against test no. 2214TB-2. All simulations where conducted using the 85th percentile IS impact conditions of 51.2 mph (82.4 km/h) and an angle of 25 degrees with the 2270P vehicle model.

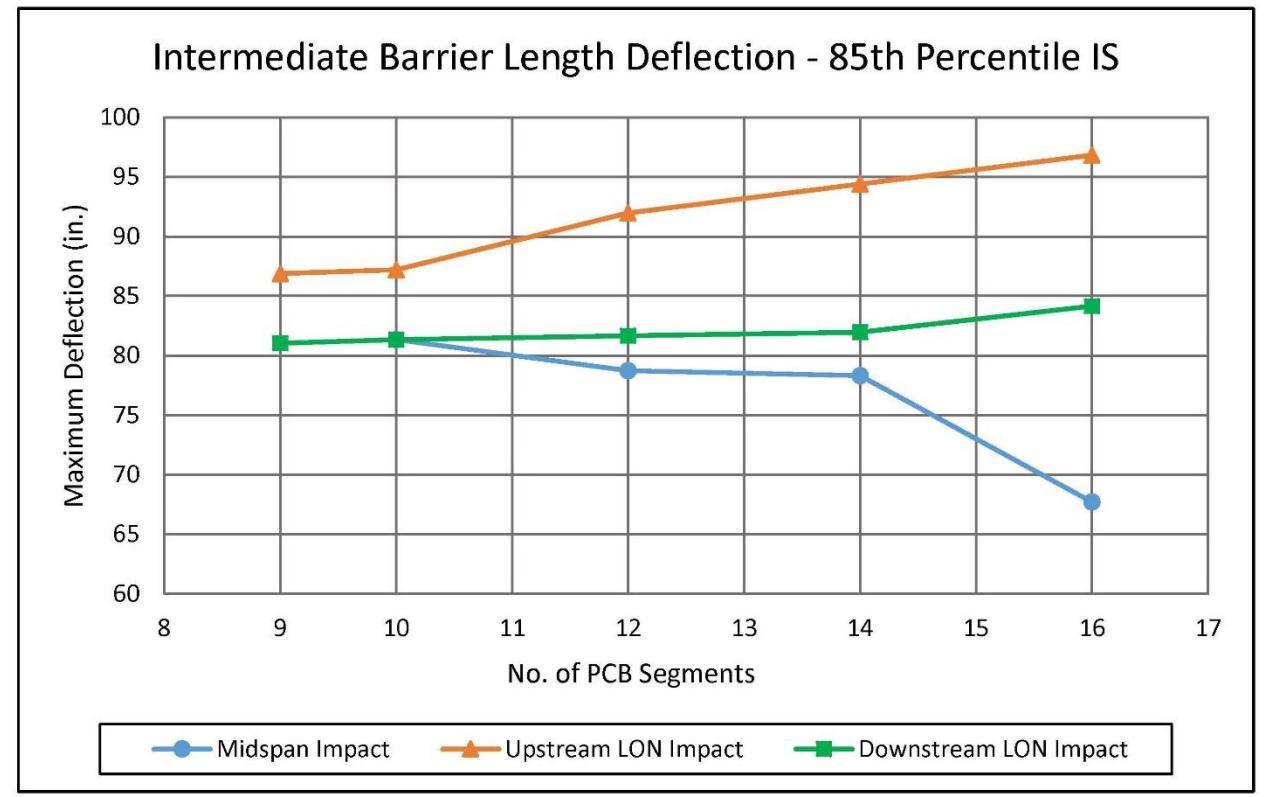
Figure 112. Lateral Barrier Deflections for Intermediate PCB System Lengths, 85th Percentile IS

The lateral barrier deflections from the simulations of intermediate systems lengths using 85th percentile IS impact conditions are shown in Figure 112. Lateral barrier deflections were plotted versus the number of barriers in the system for the beginning of LON, end of LON, and midspan impacts. The beginning of LON impacts demonstrated the highest lateral deflections as the impact was closer to the end of the system than the other conditions. The lateral barrier deflection values for the beginning of LON impacts ranged from 86.9 in. (2,207 mm) to 96.8 in. (2,459 mm) and tended to increase slightly as the number of barriers in the system increased. The lateral deflections did not vary significantly due to the proximity of the impact to the free end of the system having a greater effect than the system length. Similarly, barrier deflections did not decrease as system length increased, as would typically be expected, because the increased loading and deflection of the upstream end of the barriers.

Lateral barrier deflections for impacts at the end of LON displayed similar behavior. The lateral barrier deflection values for the end of LON impacts ranged from 81.0 in. (2,057 mm) to 84.2 in. (2,139 mm) and tended to increase slightly as the number of barriers in the system increased. The deflection magnitude decreased as compared to the beginning of LON impacts due to the impact being two barrier segments farther from the free end of the system. However, a similar trend toward an increase in barrier deflections with increased barrier system length was noted.

It is recommended that installations in non-critical locations use the estimated lateral deflection values for the 85th percentile IS impact provided in Figure 114 until further full-scale crash testing at reduced IS values or in-service evaluation of system damage for lower severity impacts indicate that lower deflection estimates are more appropriate. For critical installations adjacent to drop-offs or bridge deck edges, the MASH TL-3 system deflections provided in Figure 113 should be applied.

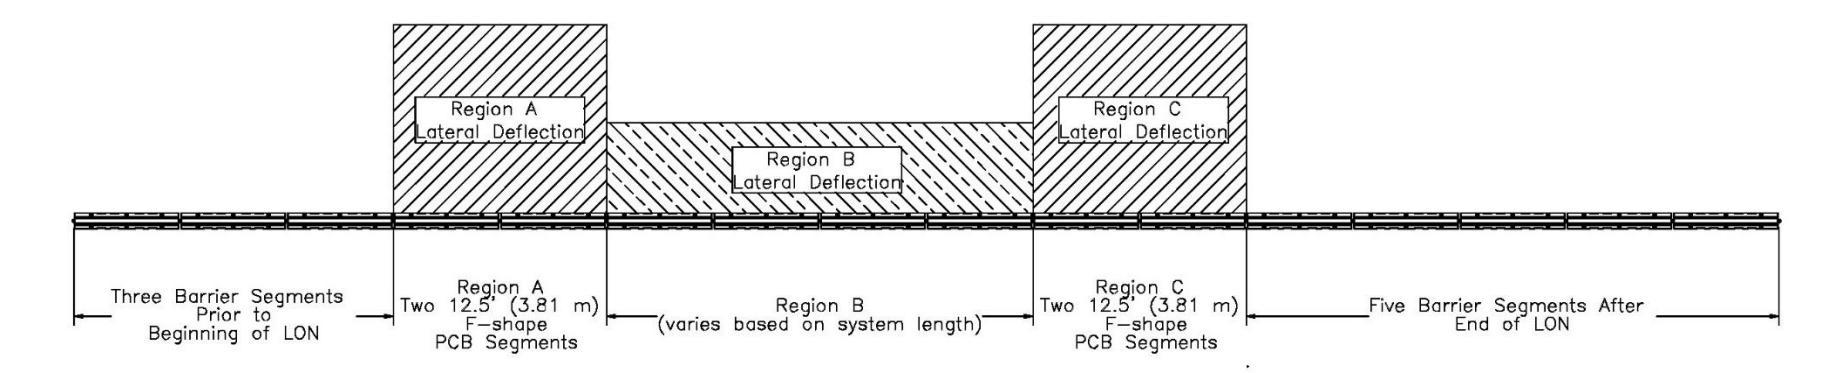
Figure 113. F-Shape PCB Lateral Deflection Guidance, MASH TL-3

PCB System Length	MASH TL-3 Estimated Lateral Barrier Deflection in. (mm)			
(No. of Barrier Segments)	Region A	Region B	Region C	
9	132 (3,353)	-	132 (3,353)	
10	132 (3,353)	-	132 (3,353)	
12	132 (3,353)	-	132 (3,353)	
14	132 (3,353)	91 (2,311)	132 (3,353)	
≥ 16	132 (3,353)	80 (2,032)	132 (3,353)

Deflection guidance for each region based on PCB system length is provided in Figures 113 and 114. Figure 113 displays the barrier deflection guidance for MASH TL-3 impact conditions and Figure 114 displays the barrier deflection guidance for the 85th percentile IS impact condition. For simplicity and ease of implementation, the lateral barrier deflections in regions A and C were assumed to be the same. The magnitude of the lateral deflection was selected in a conservative manner due to the use of computer simulation to determine the values. Thus, the deflection for regions A and C were selected as the maximum lateral deflection predicted by the simulations over the range of system lengths for both the beginning or end of the LON point. The deflection of region B was based on the simulated lateral deflections for a midspan impact on the various system lengths. Note that for system lengths of 12 barriers or less, region B does not exist and the deflection values for regions A and C are used throughout the LON. System lengths greater than or equal to 16 barrier segments are assumed to have similar lateral deflections in all regions. Also, deflection guidance was not provided for the areas outside of the beginning and end of the LON point as the performance of the PCB system in these areas is unknown.
