## DEVELOPMENT AND RECOMMENDATIONS FOR A

## NON-PROPRIETARY, HIGH-TENSION, CABLE END

## TERMINAL SYSTEM

MwRSF Research Report No. TRP-03-268-12

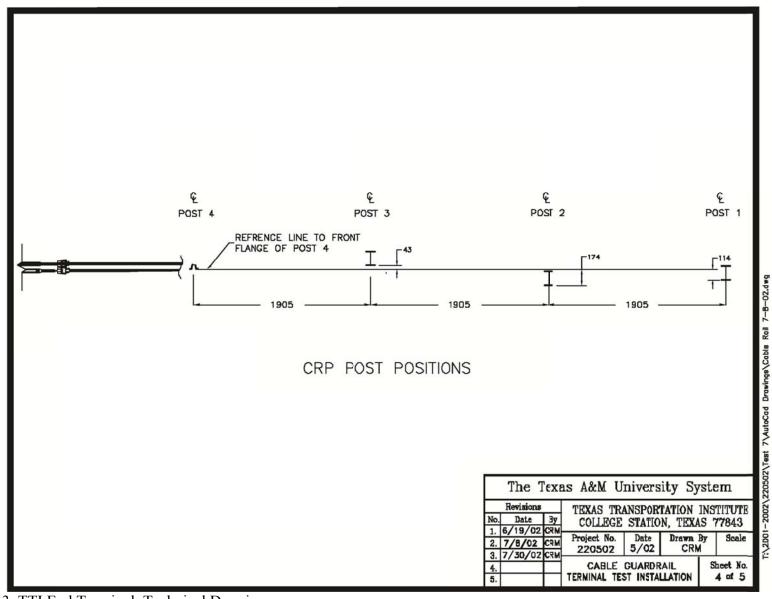
Figure 3. TTI End Terminal, Technical Drawing

photographs it appears that the vehicle was aligned with respect to CRP post no. 3 in the end terminal. CRP post no. 3 was offset from the tangent of the system and resulted in the vehicle's centerline being closely aligned with the centerline of the U-Channel line posts. This alignment resulted in a favorable vehicle trajectory after the vehicle had passed through the three breakaway terminal posts. The centerline vehicle impact with the line posts eliminated much of the yawing and instability concerns observed in other systems.

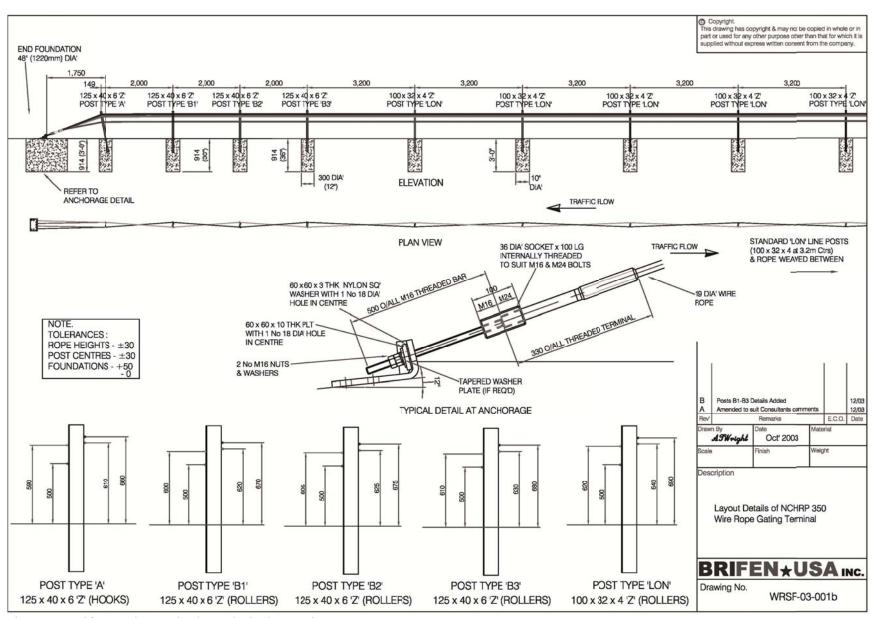
Figure 4. Brifen End Terminal, Technical Drawing

At the present, there is no mechanism to release the cables during end-on impacts with the terminal. In the case of a centerline vehicular impact on the end terminal system, it is possible that the vehicle could ramp up the cables and land on top of one or more line posts, possibly puncturing the undercarriage of the occupant compartment. Such an occurrence would be hazardous to occupants for several reasons. First, a penetrating post could directly cause harm to an occupant. Second, the airborne vehicle could become entangled within or snagged on system components, thus resulting in rapid decelerations and/or vehicle instabilities, such as rollover.

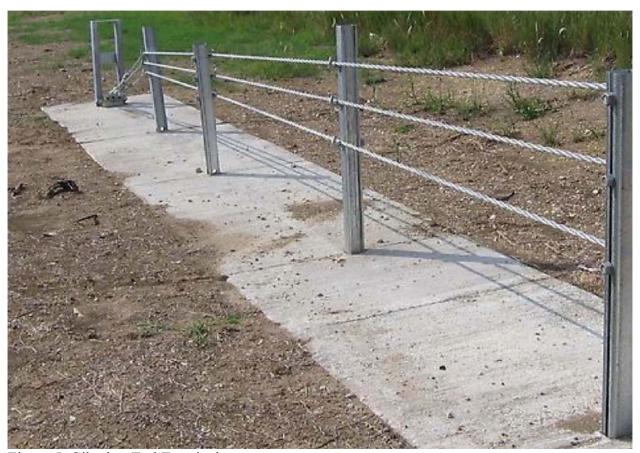
Figure 5. Gibraltar End Terminal

A Gibraltar cable barrier end terminal installed in a median application is shown in Figure 5. Technical drawings of the system layout and photographs of the constructed end terminal are shown in Figure 6.

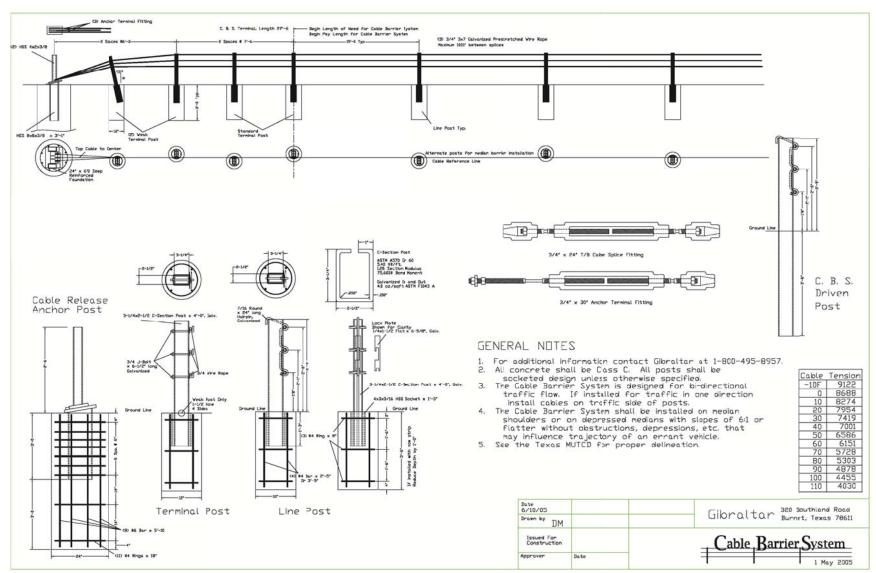
Figure 6. Gibraltar End Terminal, Technical Drawing

Gibraltar's end terminal system exhibited good control of the vehicle and performed well in all end terminal testing. In test 3-30, the cable release anchor post functioned as designed and allowed the vehicle to travel through the system without ramping up the cables. However, the vehicle did rollover during this test, which was subsequently attributed to the vehicle's tires tripping on loose soil. Following a review of the test details, it was observed that the end terminal used in test 3-30 was a shortened version of the system. As such, there is concern that small car testing on a longer, more realistic system length may result in increased roll motion and vehicle instabilities. However, it is unknown as to how these changes would affect the stability of the vehicle and the overall success of the crash test.

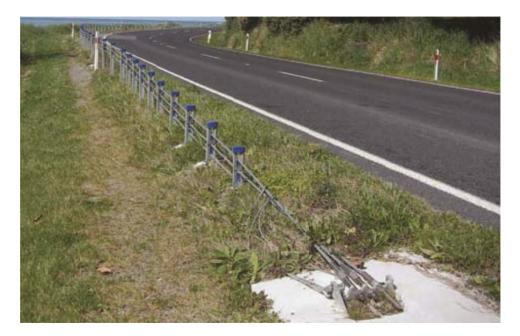
Figure 7. Safence End Terminal

A Safence end terminal installed in a roadside application is shown in Figure 7. A technical drawing of the system layout is shown in Figure 8.

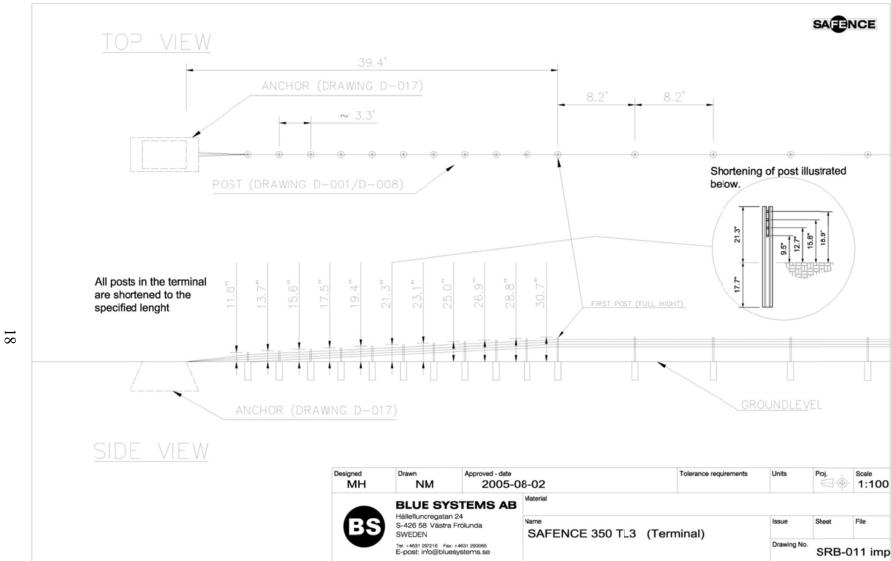
Figure 8. Safence End Terminal, Technical Drawing

Safence's end terminal testing resulted in higher values of vehicle roll and pitch than were typically seen in other testing. However, considering the gradual slope of the cables, the vehicle exhibited more roll prior to losing contact with the system. Like Brifen's system, the vehicle was safely redirected, or allowed to pass through the system in all tests. The same potential for vehicle damage was evident. While test 3-30 successfully directed the vehicle out of the end terminal, it was determined that the successful redirection was in large part due to the ½-point offset impact with the end terminal. A centerline vehicular impact with the terminal end could pose significant risk for the vehicle to land on top of posts, thus increasing the potential for penetration of the undercarriage and putting the occupants in considerable danger.

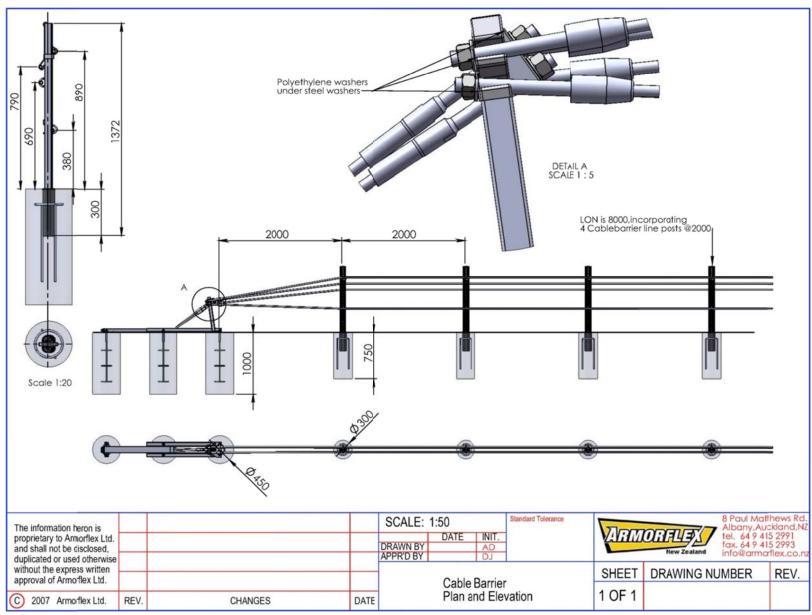
Figure 10. Armorwire End Terminal, Technical Drawing

The Armorflex end terminal design prevented significant vehicle rolling or other instabilities that could have resulted in test failure. However, tests 3-30 and 3-32 did result in considerable yawing. Due to the lack of available test data, the exact causes for the increased yaw are unknown. However, upon examination of the system characteristics and comparing with other systems, the yawing is possibly due to the relatively high strength of the terminal and line posts. Off-center impacts with these posts would likely result in high forces imparted on the vehicle and induce substantial yawing in the vehicle.

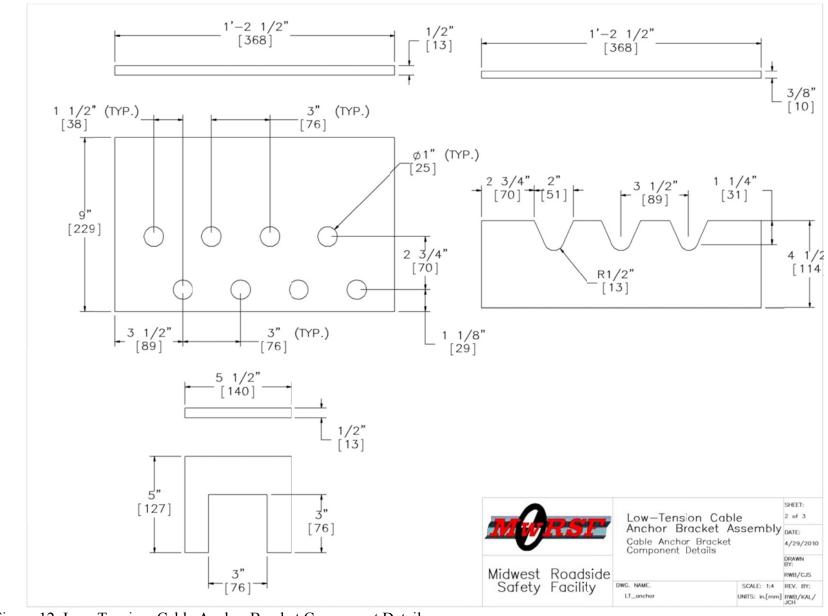
Figure 12. Low-Tension, Cable Anchor Bracket Component Details

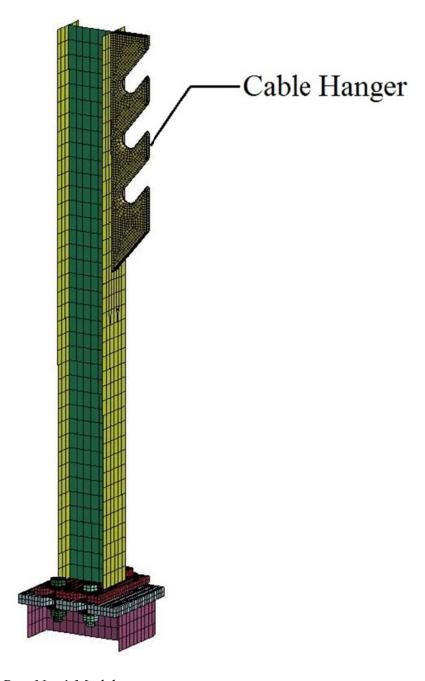
Figure 15. Slip Base Post No. 1 Model

The slip base post was the result of previously validated work. The primary purpose of the post was to support the cables as they transitioned from the horizontal, guardrail section, down to the anchor bracket. The difference between slip base post no.1 and the standard, slip base terminal posts is the cable hangar that is welded to one of the flanges of the upper slip base post section. The cable hangar is necessary to withstand the vertical forces resulting from the redirection of the system cables. Post component details and a description of the development of the model can be found in Nick Hiser's Master's Thesis [15]. The post model is shown in Figure 15.

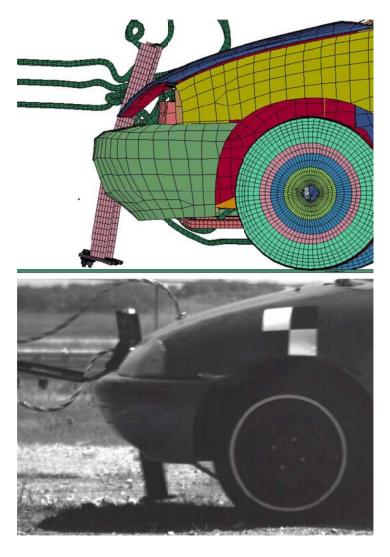
Figure 24. Cable Interaction with Slip Base Post No. 1

Another sensitive part of the end terminal system was the interaction between the cable compensators and slip base post no. 1. In the "best" simulation model, it was discovered that the cables immediately downstream from slip base post no. 1 coiled on the downstream face of the web. This action forced the detached slip base post section up onto the hood of the vehicle, which prevented the simulated vehicle from overriding the post section. In test CT-4, the cable compensators located between slip base post nos. 1 and 2 similarly impacted the downstream face of the web on slip base post no. 1 and forced the post section onto the hood of the vehicle. The vehicle-to-post interactions for both the simulation and test CT-4 are shown in Figure 24.

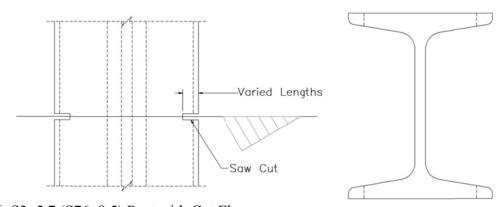
Figure 26. S3x5.7 (S76x8.5) Post with Cut Flanges

In 2004, a testing program was accomplished at MwRSF to evaluate the directional strength properties of modified S3x5.7 (S76x8.5) posts [18]. Posts with varying length cuts into the ends of the flanges were impacted in both strong-axis and weak-axis orientations. These results were compared with impact data obtained from unmodified S3x5.7 (S76x8.5) posts [19]. A technical drawing of a sample post modification is shown in Figure 26.

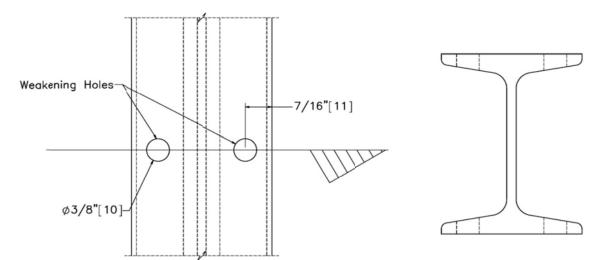
Figure 27. S3x5.7 (S76x8.5) Post with Weakening Holes

Weakening holes measuring 3/8-in. (9.5-mm) in diameter would result in a weak-axis bending strength reduction of 40 percent, and a 25 percent reduction in the strong-axis bending strength. The decreased weak-axis bending strength would aid in the reduction of vehicle roll motion. Unlike the cut flanges option, no bogie tests have been performed on S3x5.7 (S76x8.5) posts with weakening holes. Thus, physical testing and evaluation will be required prior to moving forward with this option. The weakening hole option is shown in Figure 27.

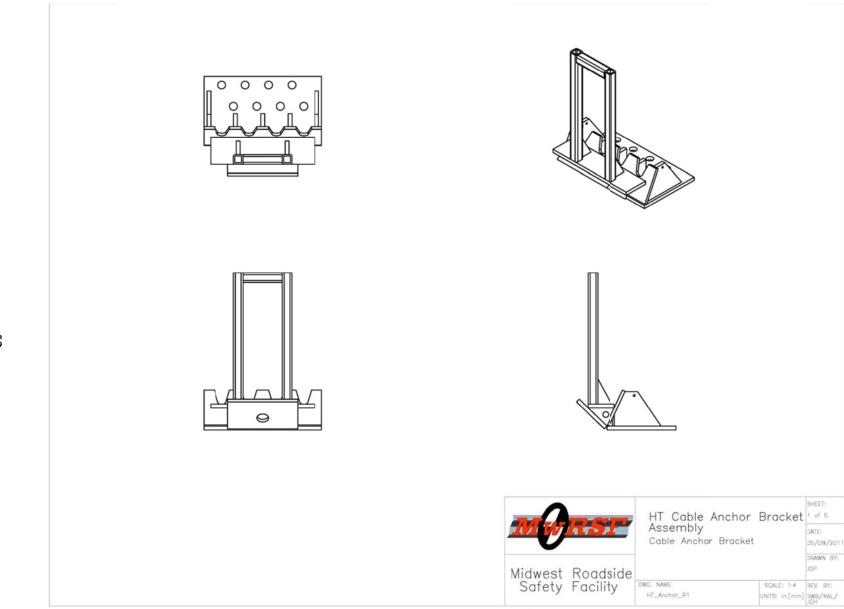
Figure 28. Cable Anchor Bracket Assembly Drawings

Detailed drawings of the high-tension, cable anchor bracket assembly are shown in Figures 28 through 32.

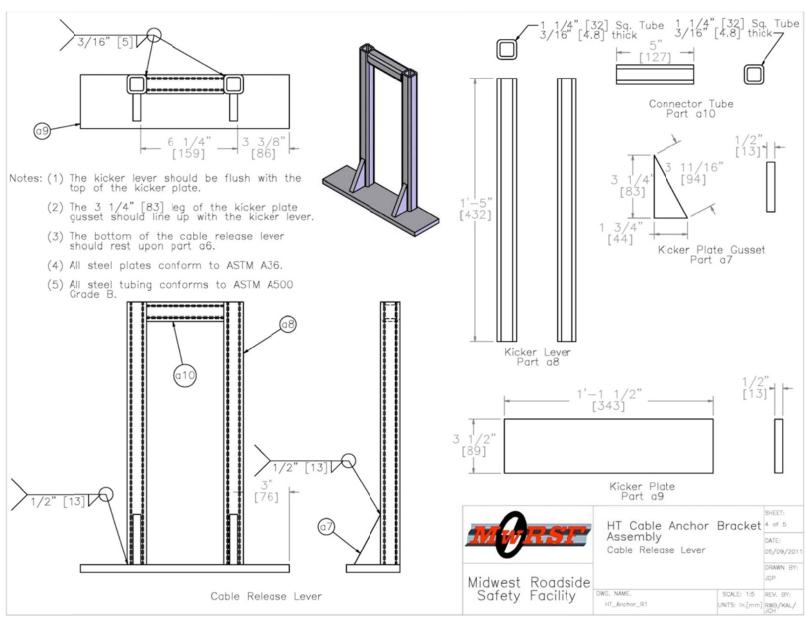
Figure 31. Cable Release Lever Assembly Details

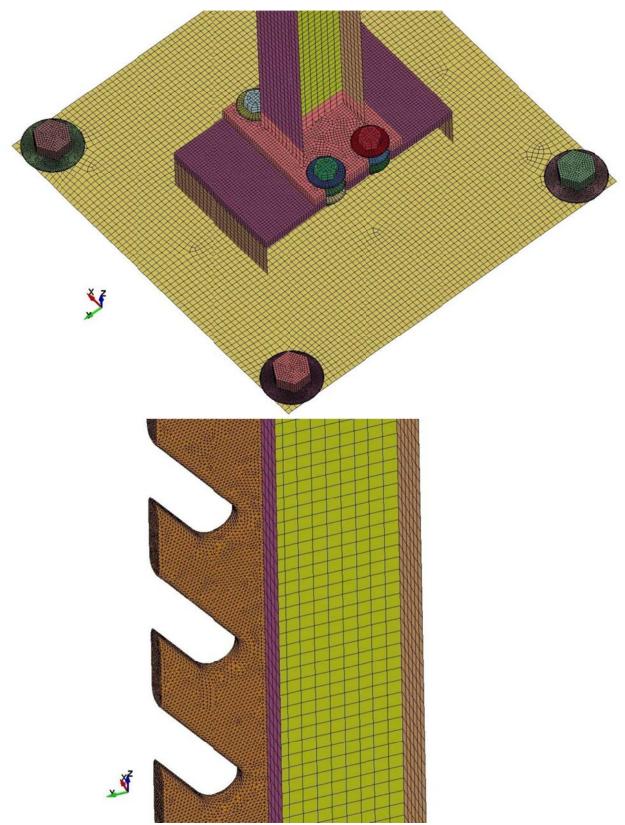
Figure 35. Slip Base Post Assembly Component Mesh

The cable model used in the high-tension simulation differed from the model used for the low-tension end terminal validation. The cable model used in the current component test simulation model was the result of a previous study [20]. However, at the time of the low-tension end terminal validation there were some issues with the cable model that prevented its use. Since then, the issues were corrected and the model was available for use. The new cable model has several advantages over the older model, including accuracy and usability. The cables main purpose in the simulation is to provide a load on the cable anchor bracket. Thus, it is reasonable to assume that changing cable models would have a negligible effect on the performance of the anchor or the simulation in general.

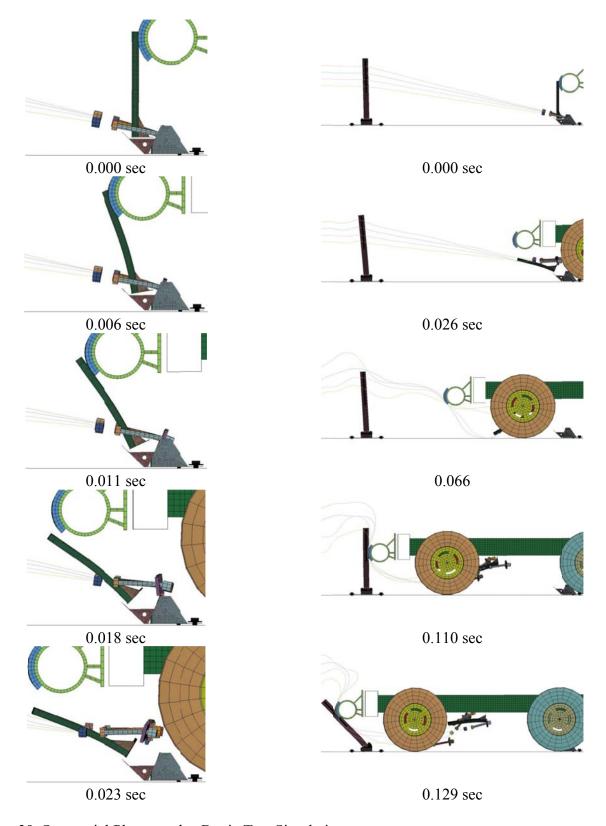
0.110	The bogie head impacted the upstream edge of the slip base post.
0.129	The bottom slip base plate seperated from the slip base supports due to element failure along the component boundary. The element failure occurred due to the slip base mechanism failing to activate. The failure of the plate-support boundary marked the end of the simulation.

Figure 39. Sequential Photographs, Bogie Test Simulation

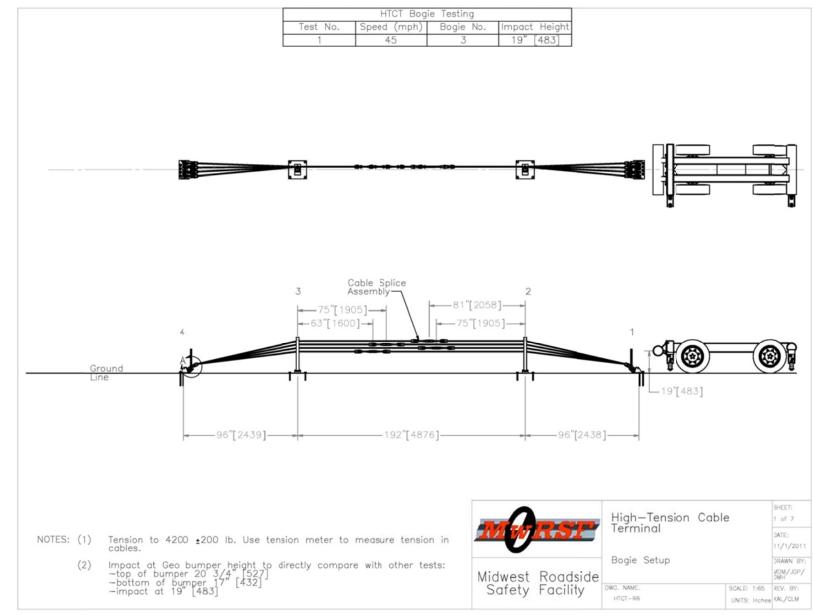
Figure 42. Bogie Test Layout, Test No. HTCT-1

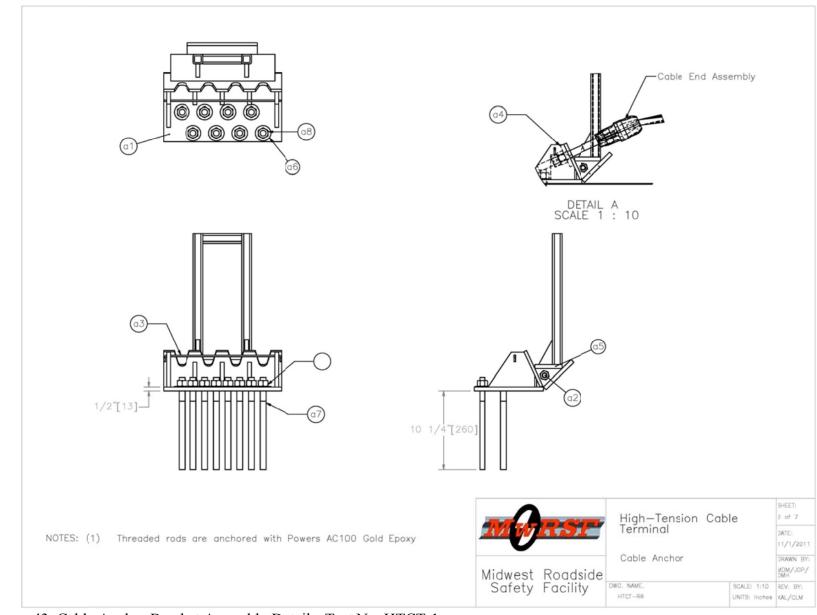
Figure 43. Cable Anchor Bracket Assembly Details, Test No. HTCT-1

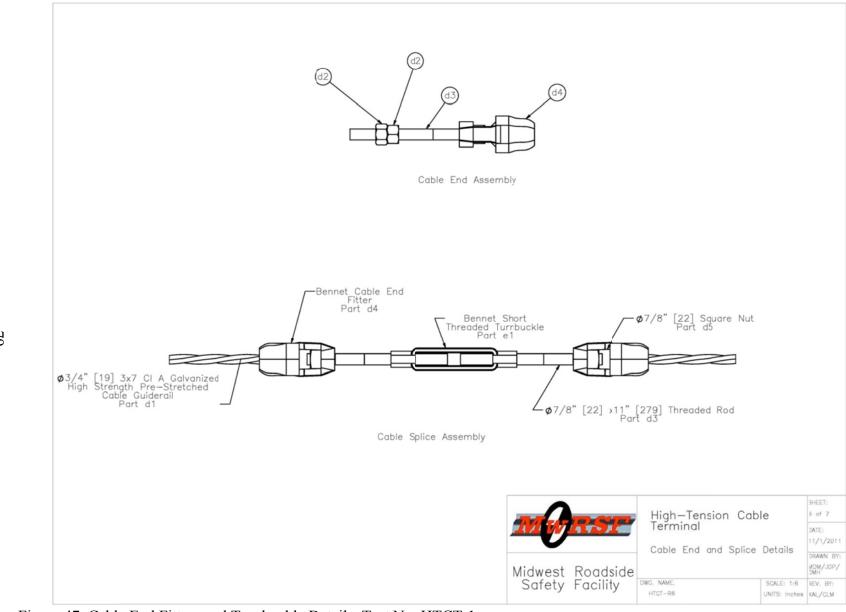
Figure 47. Cable End Fitters and Turnbuckle Details, Test No. HTCT-1

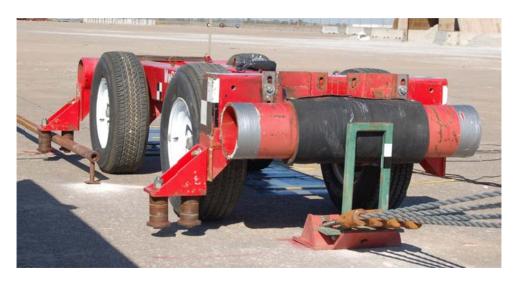
A rigid frame bogie was used to impact the system. The bogie impact head was constructed of 8-in. (203-mm) diameter, 1/2-in. (12.7-mm) thick, standard steel pipe, with 3/4-in. (19.1-mm) thick neoprene belting wrapped around the pipe to prevent local damage to the post from the impact. The bogie with the impact head is shown on the guidance track in Figure 49. The weight of the bogie with the addition of the mountable impact head was 1,794 lb (814 kg). The impact head contacted the release lever at 19-in. (483-mm) above the ground. The target speed for the test was 45 mph (72.4 km/h).

Figure 49. Rigid Frame Bogie on Guidance Track

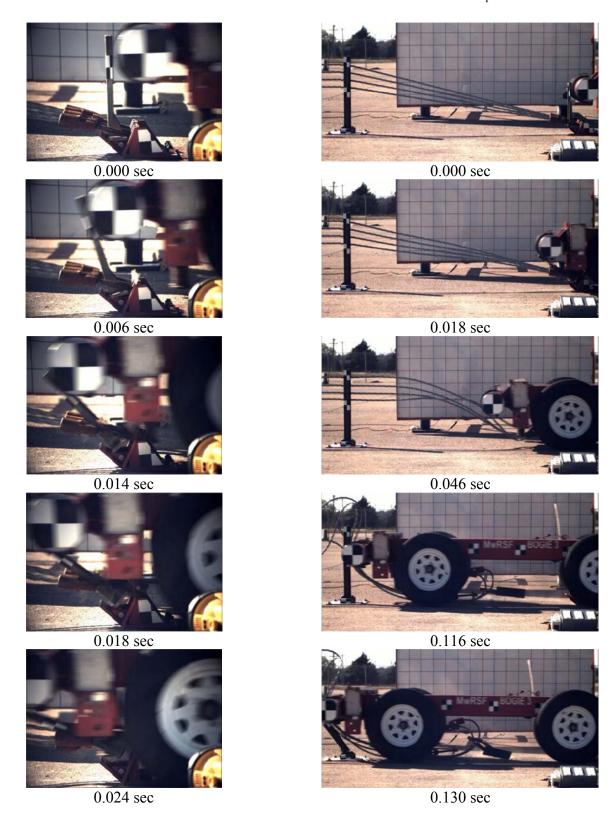
Figure 50. Sequential Photographs, Test No. HTCT-1

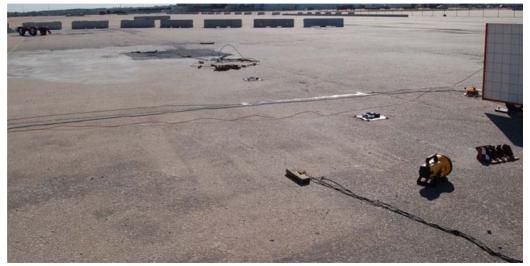
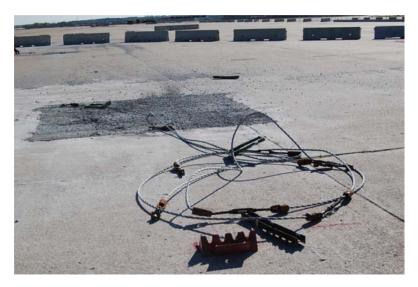
Figure 52. System Damage, Test No. HTCT-1

The damage to system components in test no. HTCT-1 was moderate. Both of the slip base post assembly bases buckled under impact loading, and the top S3x5.7 (S76x8.5) post sections fractured off of the lower assembly due to weld failure in both cases. The detached S3x5.7 (S76x8.5) post sections exhibited some plastic bending in the impact region.

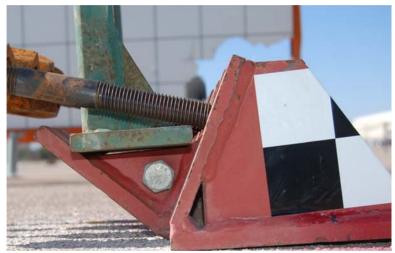
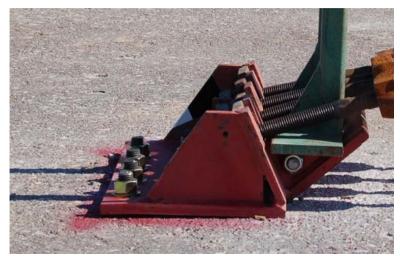
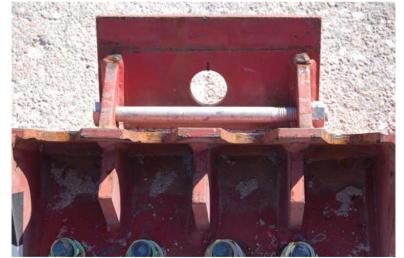
Upstream Cable Anchor Bracket Assembly – Pre-Test

Upstream Cable Anchor Bracket Assembly – Post-Test

Figure 53. System Damage, Test No. HTCT-1

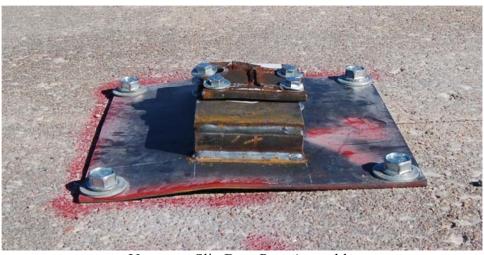
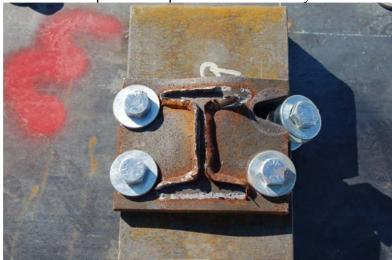
Upstream Slip Base Post Assembly

Figure 54. System Damage, Test No. HTCT-1

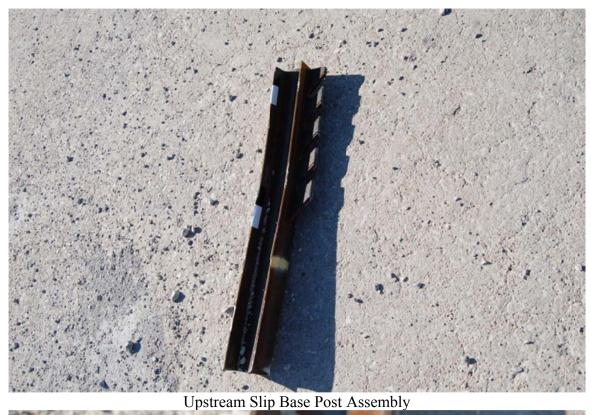
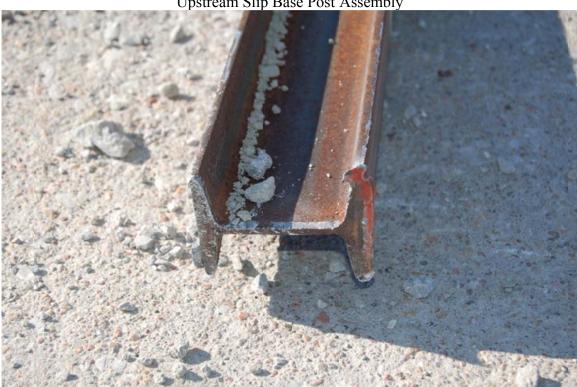
Upstream Slip Base Post Assembly

Figure 55. System Damage, Test No. HTCT-1

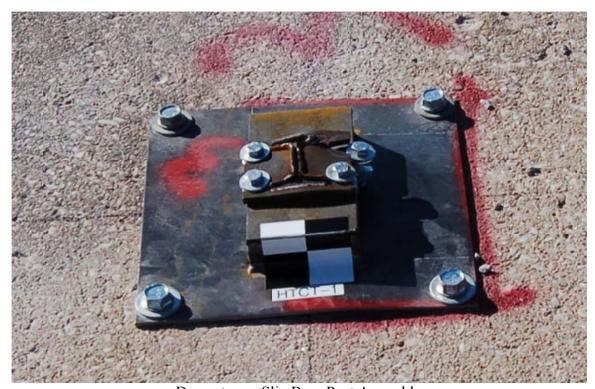
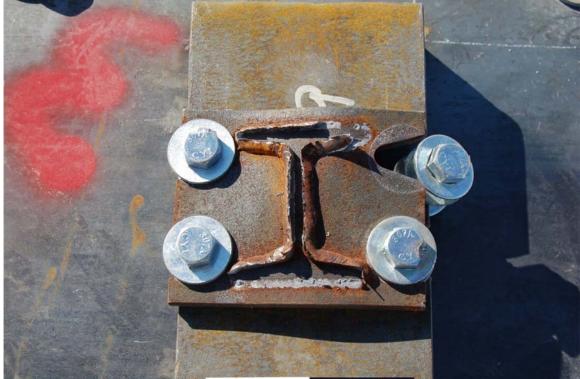
Downstream Slip Base Post Assembly

Figure 56. System Damage, Test No. HTCT-1

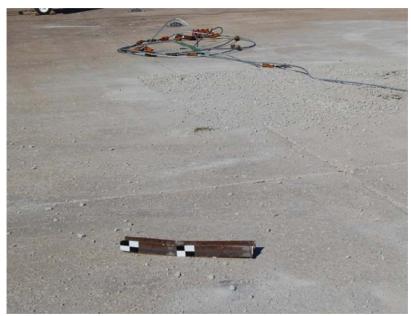
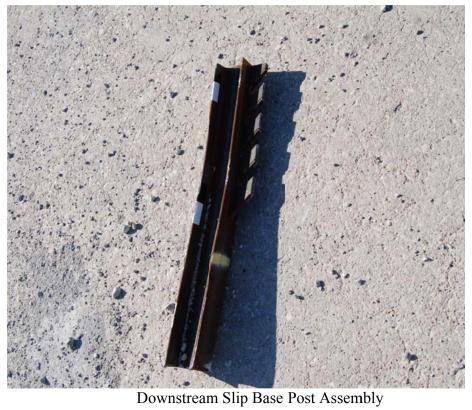
Downstream Slip Base Post Assembly

Figure 57. System Damage, Test No. HTCT-1

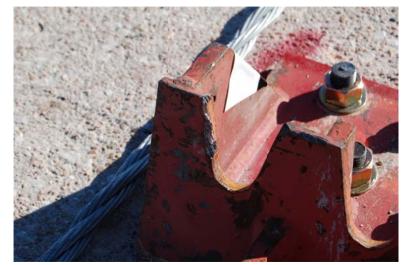
Downstream Cable Anchor Bracket Assembly – Post-Test

Figure 58. System Damage, Test No. HTCT-1

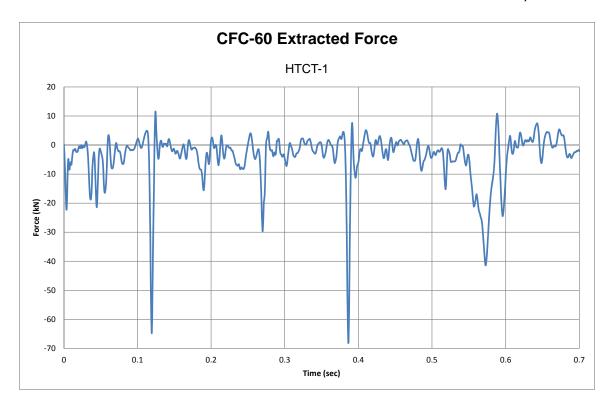
Figure 59. Force vs. Time, Test No. HTCT-1

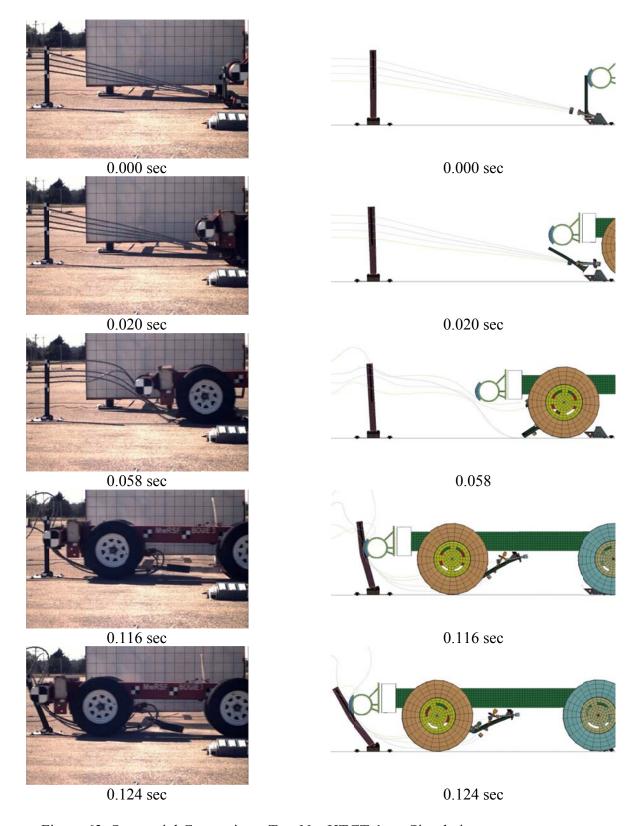
Figure 63. Sequential Comparison, Test No. HTCT-1 vs. Simulation

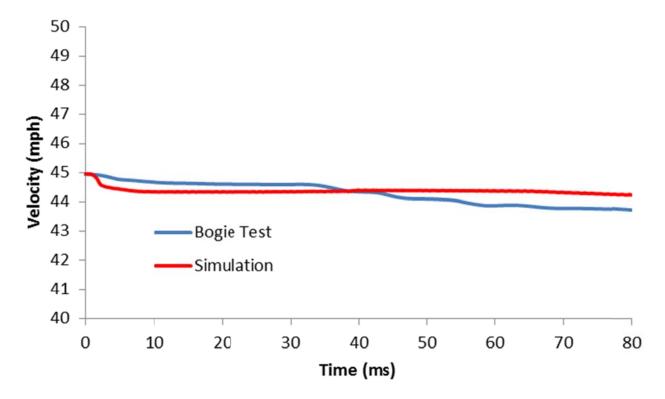
The velocity data agreed well between the physical bogie test and the simulation. The average error in velocity between the physical test and numerical simulation was 0.79 percent. After the anchor bracket impact, the bogie velocity in both the simulation and physical test stabilized for a short time before small impacts with the system cables and other detached anchor bracket components. These secondary impacts caused small velocity reductions at roughly 35 ms after initial impact. The stabilized velocity in test no. HTCT-1 after impact with the cable anchor

bracket was 44.6 mph (71.8 km/h), compared with 44.3 mph (71.3 km/h) observed in the simulation. The resulting error in the  $\Delta v$  from the impact was 0.7 percent.

Figure 64. Bogie Velocity Comparison, Test No. HTCT-1 vs. Simulation

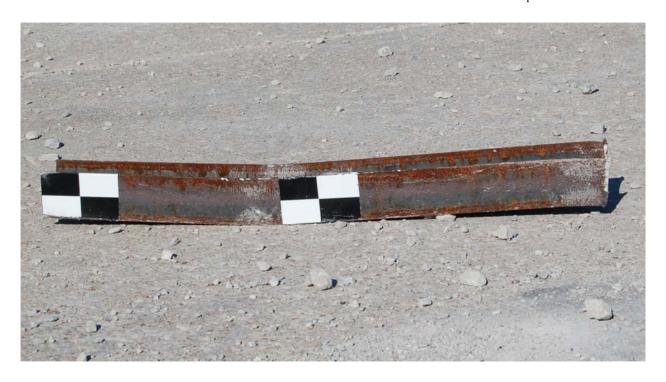
Figure 66. S3x5.7 (S76x8.5) Post Damage Comparison, Test No. HTCT-1 vs. Simulation

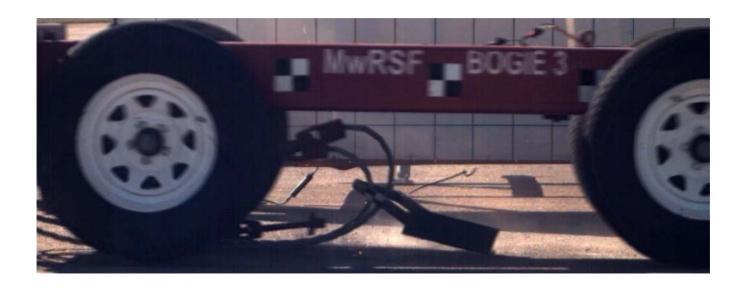
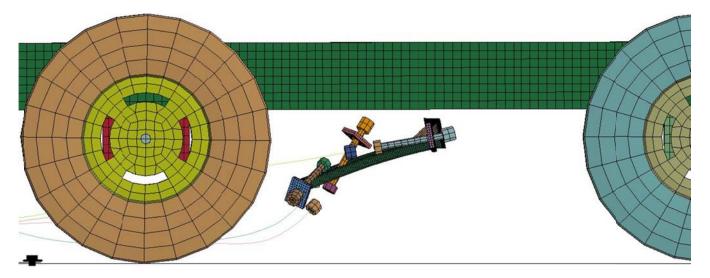
Figure 67. Release Lever Interaction with System Cables, Test No. HTCT-1 vs. Simulation

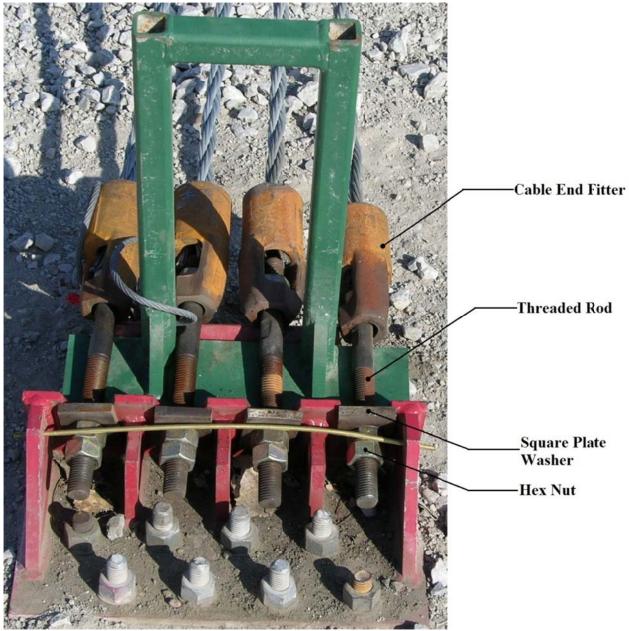
The smaller the spacing between the end fitters, the more difficult it is to assemble the anchor bracket. There is also a limit to how much slack can be taken up in the end fitters since the end fitters will eventually contact each other and cause flexural deformations in the threaded rods.

Figure 70. Cable End Fitter Interference

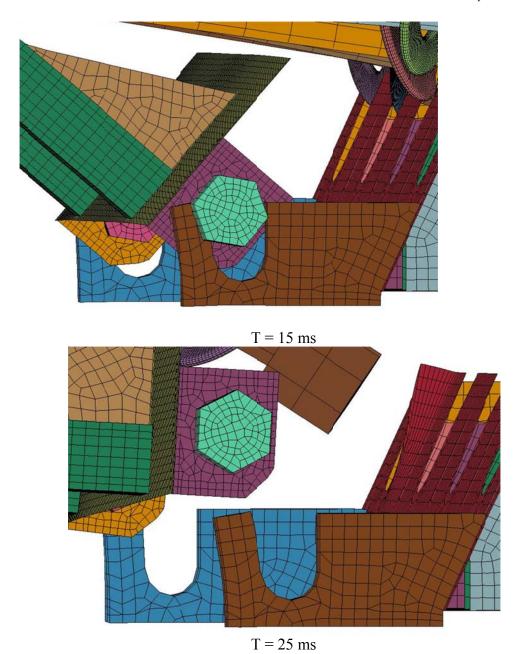
It was determined that the cable anchor bracket rotation support bracket's geometry and performance was the primary cause for the cable release lever not being retained. Deformation in the bracket slot as well as the bracket height allowed for the cable release lever rotation bolts to slide upwards out of the slot. It was concluded that the bracket's geometry was the primary reason the cable release lever was able to disengage from the rest of the assembly.

Figure 75. Release Lever Disengaging from Assembly, Simulation No. 1

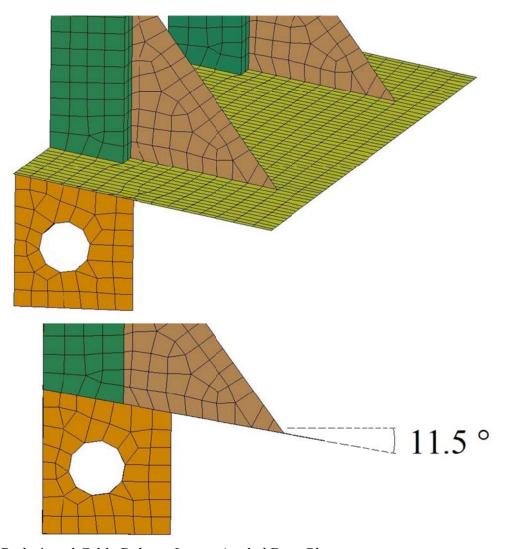
Figure 77. Redesigned Cable Release Lever, Angled Base Plate

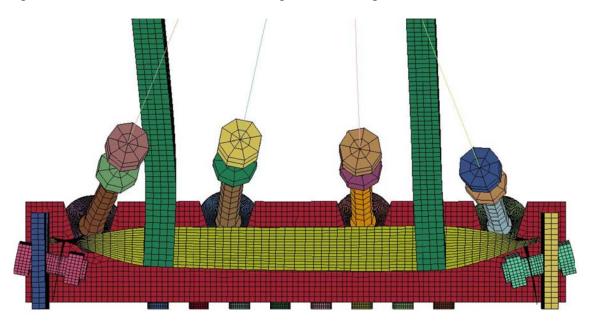
rotational joint on the front of the cable anchor bracket. The distorted joint resulted in deformation in the release lever base plate. The base plate deformation delayed the cable release and led to high impact forces being imparted to the rest of the assembly. This behavior resulted in the damage to the cable release lever assembly as well as the support brackets. Hardware damage and rotation behavior are shown in Figures 78 through 80.

Figure 78. Distorted Joint on Cable Anchor Bracket Assembly, Simulation No. 2

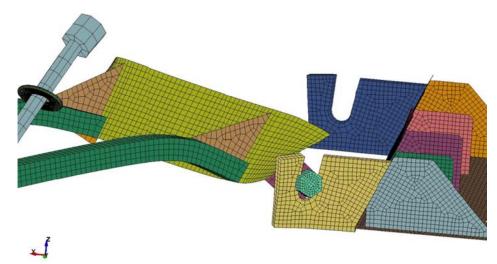
Figure 79. Anchor Bracket Assembly Damage, Simulation No. 2

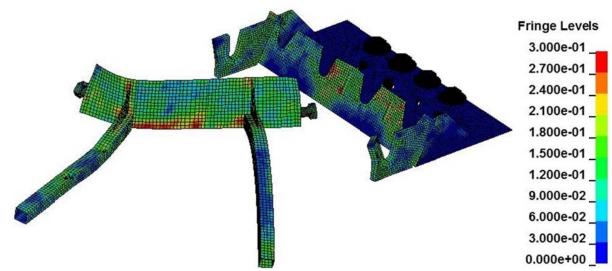
Figure 80. Anchor Bracket Assembly von Mises' Stress, Simulation No. 2

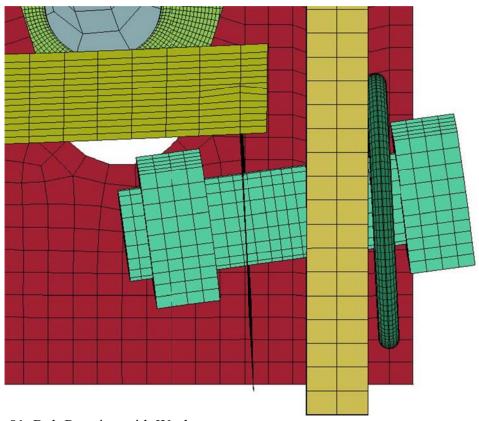
Figure 81. Bolt Rotation with Washer

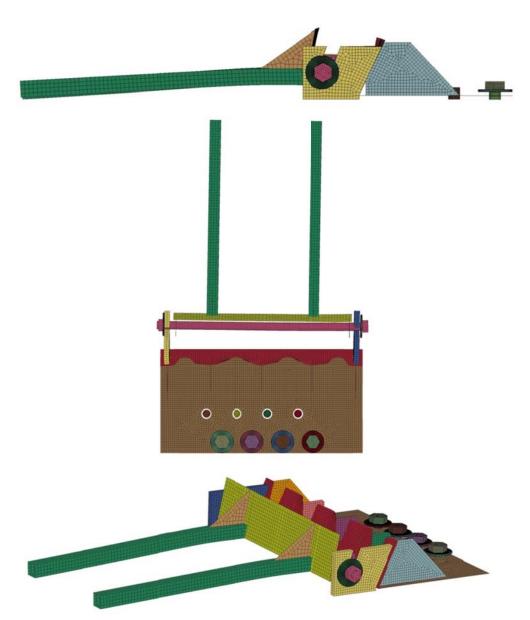
During simulation no. 3, the cable release lever rotated smoothly during impact. The cables were released evenly and without incident. At the conclusion of the simulation, the cable release lever was successfully retained. There was some slight deformation to the vertical release lever tubes, and extensive deformation to the angled cable plate. The support brackets and remainder of the anchor bracket assembly were undamaged during the simulation. The cable anchor bracket assembly at the conclusion of simulation no. 3 is shown in Figure 83.

Figure 83. Cable Anchor Bracket Assembly Deformation, Simulation No. 3

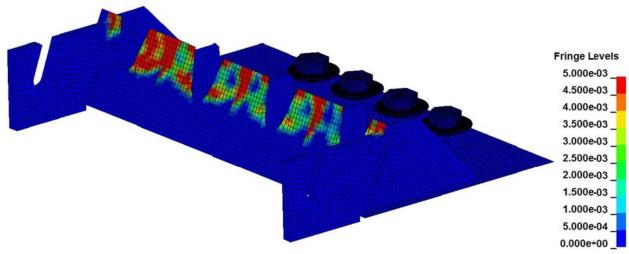
The cable plate sustained severe plastic deformation in such a manner that the entire anchor bracket assembly would require replacement before the terminal could safely function. The robustness of the high-tension, cable end terminal design as a whole would be greatly aided by an anchor that was reusable or required minimal repair following an impact event. The plastic strain distribution in the anchor assembly after the release of the cables is shown in Figure 84.

Figure 84. Anchor Bracket Assembly Plastic Strain, Simulation No. 3

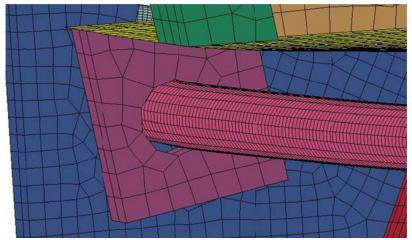
Another simulation was conducted with the updated cable anchor bracket assembly model. The solid element rotation brackets improved the contact between the brackets and the steel rod. The updated contact is shown in Figure 87.

Figure 87. Rotation Bracket Contact Using Solid Elements

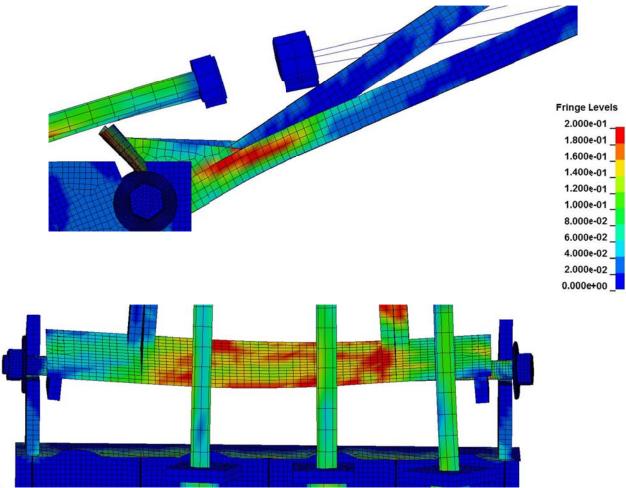
In order to successfully release the cables, the torsion and deformation to the release lever assembly needed to be alleviated. Therefore, the vertical tubes were strengthened by replacing the 1 1/4-in. x 1 1/4-in. x 3/16-in. (32-mm x 32-mm x 4.8-mm) section tubes with 1 1/2-in. x 1 1/2-in. x 1/4-in. (38-mm x 38-mm x 6.4-mm) section tubes. The steel base plate size was also increased from 1/2-in. to 5/8-in. (12.7-mm to 15.9-mm) thick.

Figure 88. Deformation of Release Lever Assembly Components, von Mises' Stress

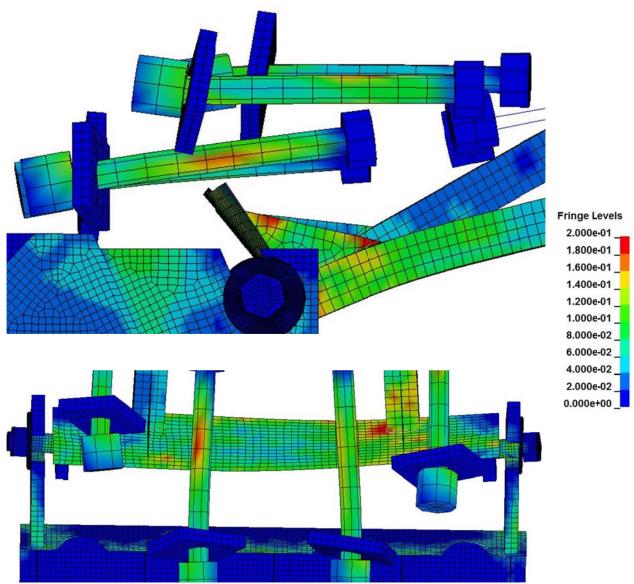
of the anchor bracket that would require replacement post impact. The damage in the cable anchor bracket assembly at the instant the cables fully released is shown in Figure 89.

Figure 89. Cable Anchor Bracket Assembly von Mises' Stress, Simulation No. 4

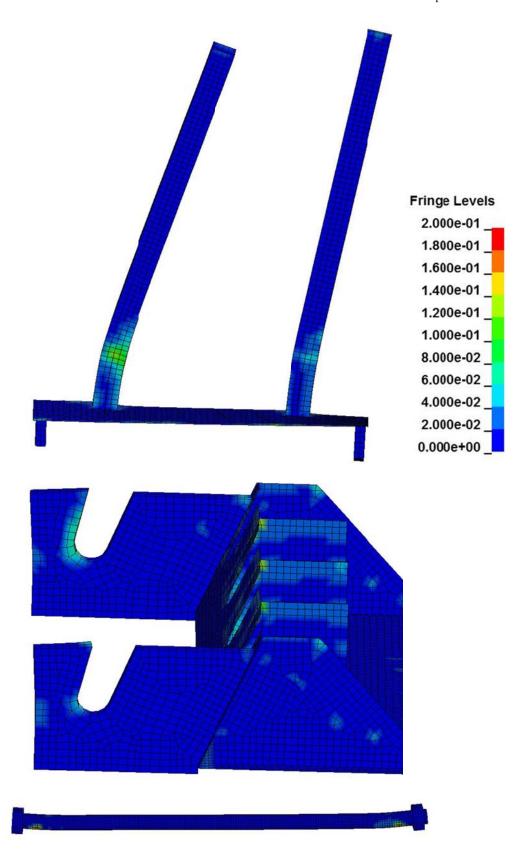
Figure 96. Component Plastic Strain, Simulation No. 7

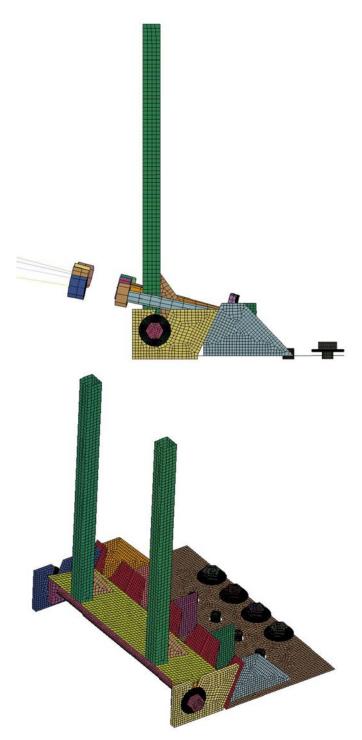
Figure 97. Redesigned, High-Tension, Cable Anchor Bracket Assembly Model

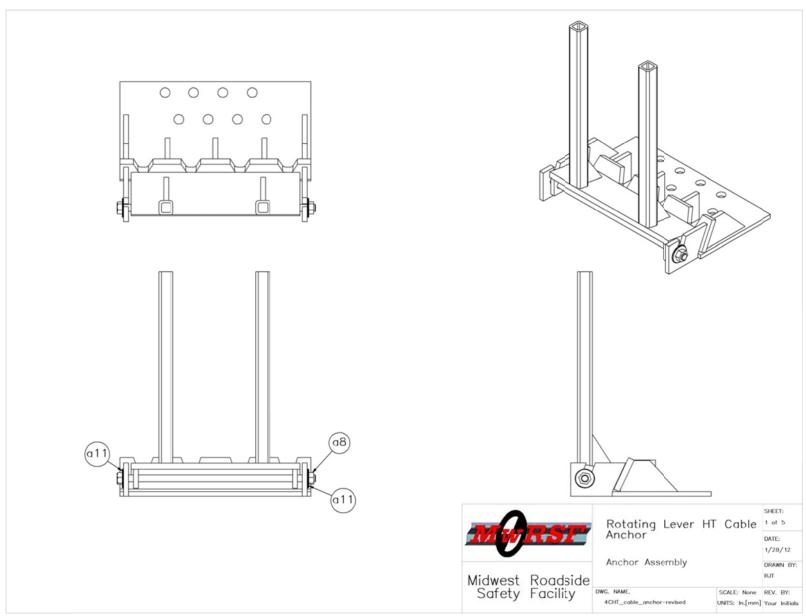
Figure 98. Redesigned, High-Tension, Cable Anchor Bracket Assembly

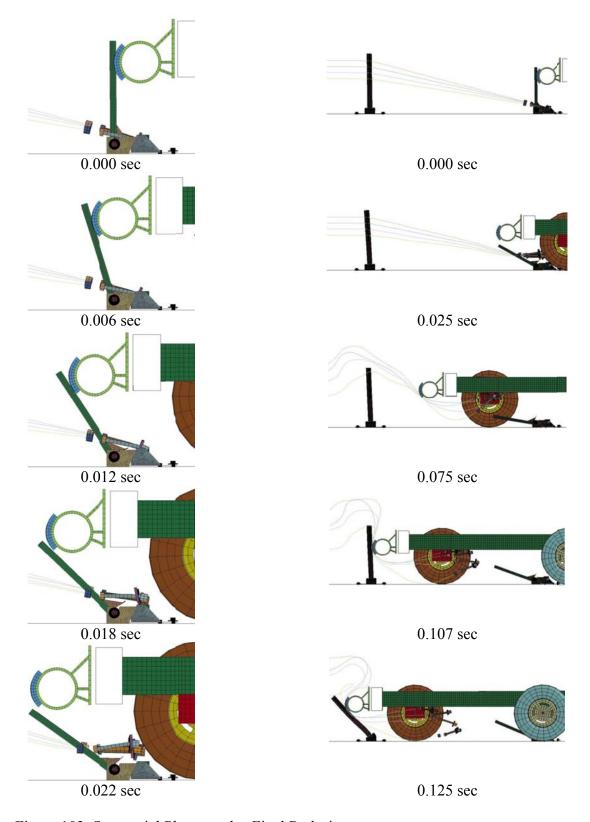
0.107	The bogie head imapcted the upstream side of the slip base post.			
0.125	The bottom slip base post base plate seperated from the slip base post support plates. The failure of the slip base post was due to element erosion along the boundary between the bottom slip base post plate and the slip base post support plates.

Figure 103. Sequential Photographs, Final Redesign

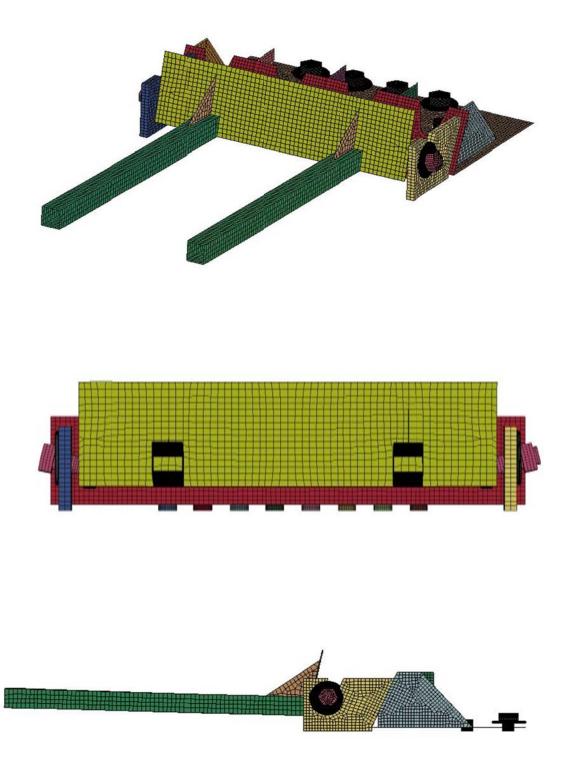
Figure 104. Cable Anchor Bracket Assembly Damage, Final Redesign

the rotational bolt. Other structural components of the anchor assembly had no deformation. Post-test images of the anchor bracket assembly at the conclusion of simulation are shown in Figures 104 through 106.

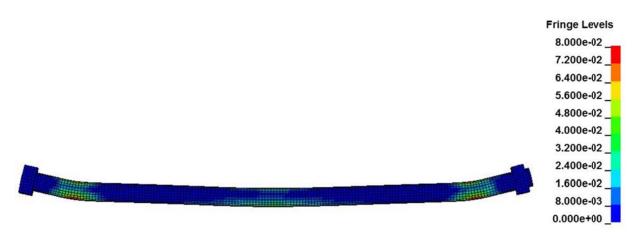
Figure 105. Plastic Strain in Rotational Bolt, Final Redesign

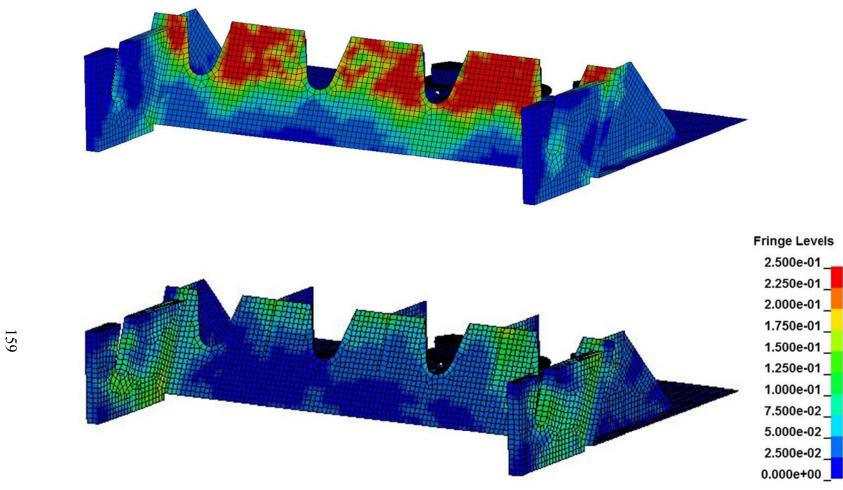
Figure 108. Comparison of Anchor Assembly von Mises' Stress Distribution
