## DEVELOPMENT AND RECOMMENDATIONS FOR A

## NON-PROPRIETARY, HIGH-TENSION, CABLE END

## TERMINAL SYSTEM

MwRSF Research Report No. TRP-03-268-12

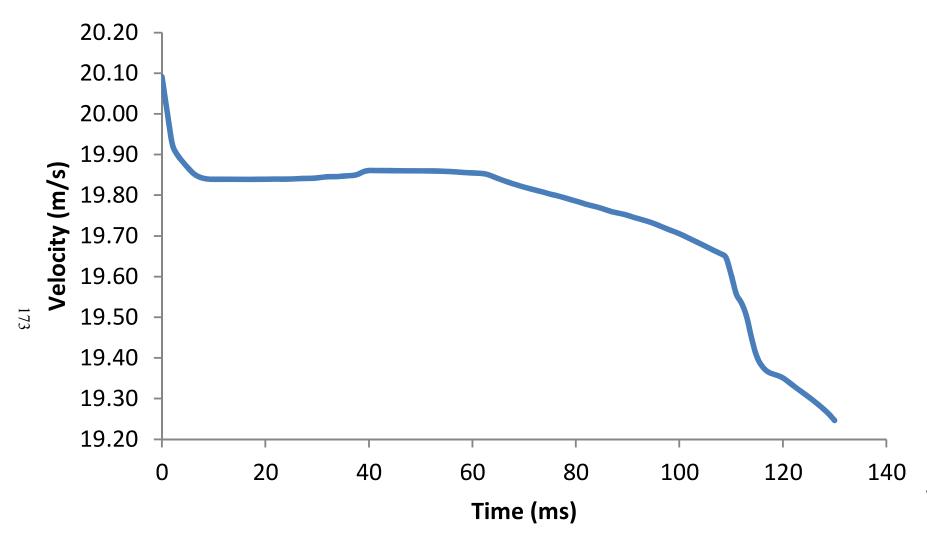
Figure A-1. Bogie Velocity, Initial Simulation

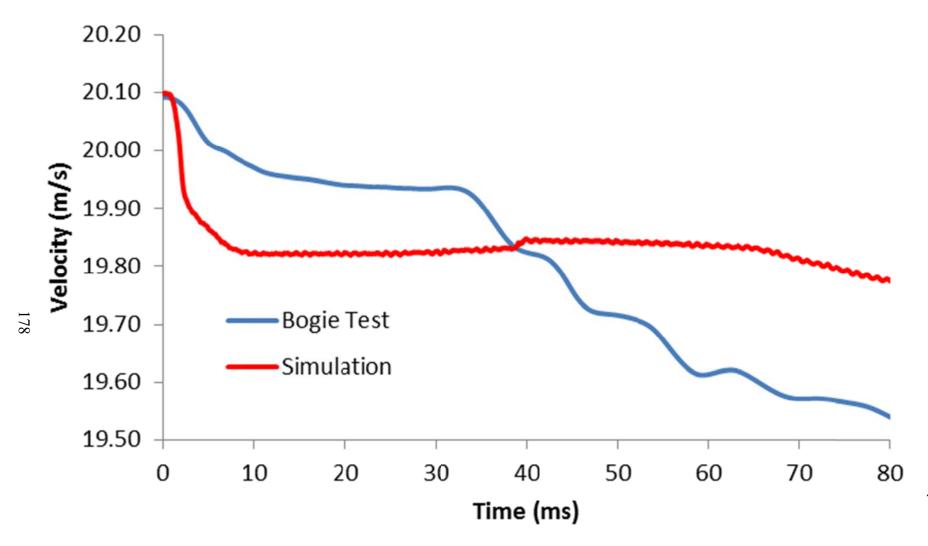
Figure B-4. Bogie Velocity Comparison, Test No. HTCT-1 vs. Simulation

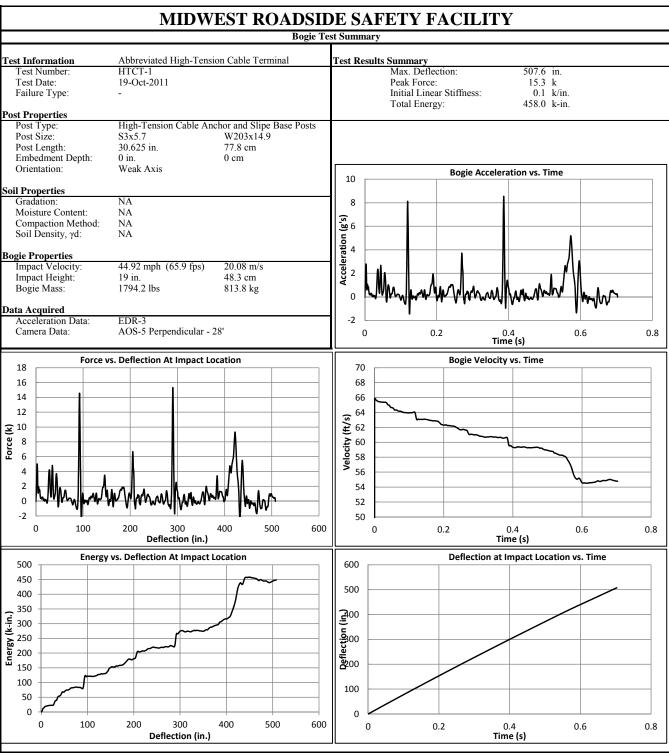
Figure C-1. Results of Test No. HTCT-1 – English

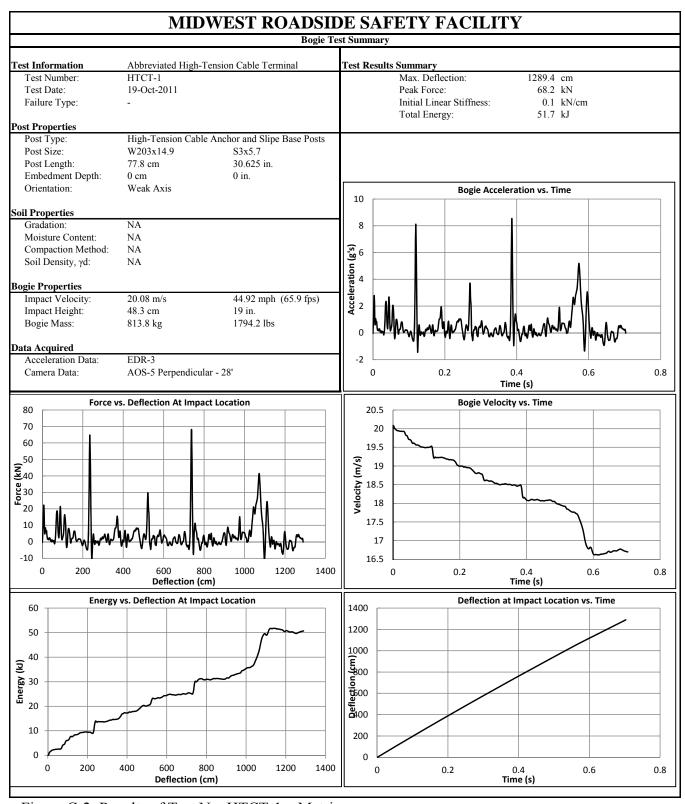
Figure C-2. Results of Test No. HTCT-1 – Metric

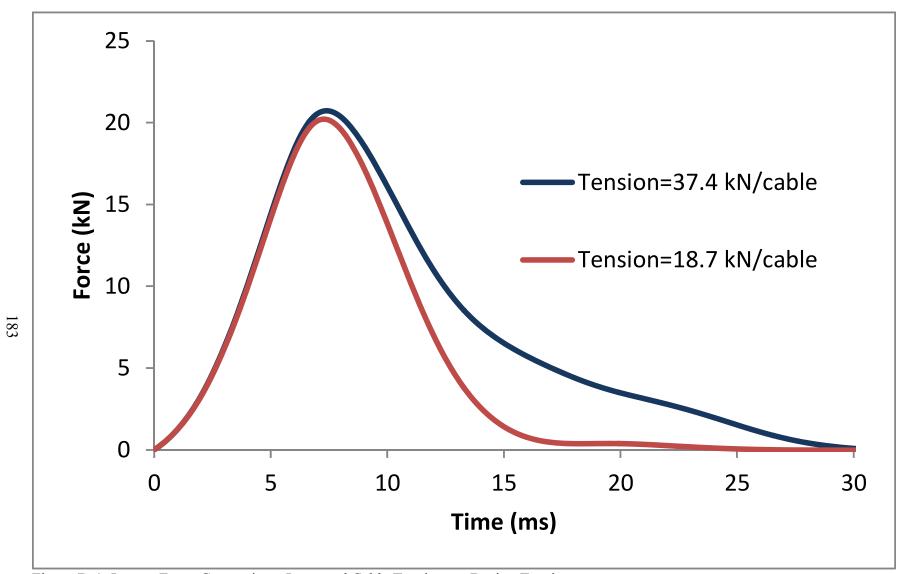
Figure D-1. Impact Force Comparison, Increased Cable Tension vs. Design Tension

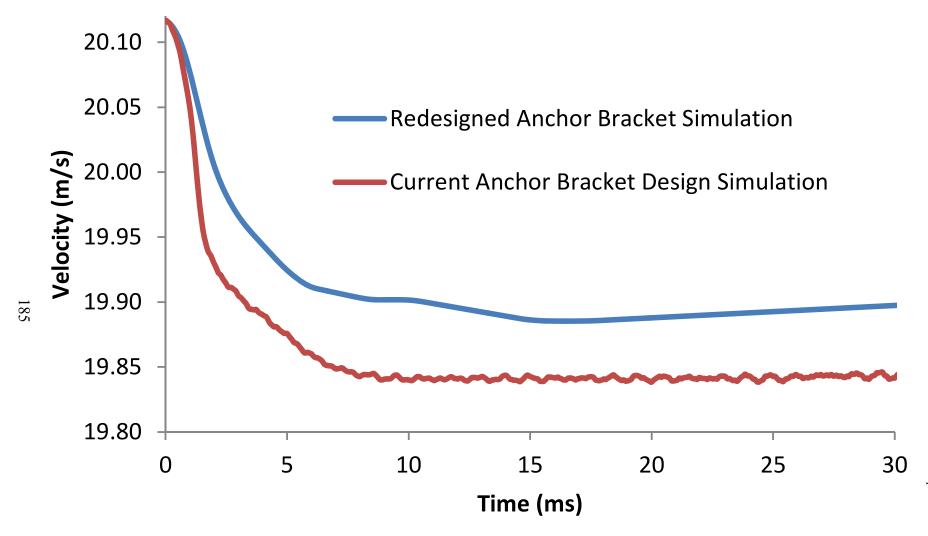
Figure D-3. Anchor Bracket Assembly Simulations Velocity Comparison
