POST WELD AND EPOXY ANCHORAGE VARIATIONS FOR W-BEAM GUARDRAIL ATTACHED TO LOW-FILL CULVERTS

MIDWEST ROADSIDE SAFETY FACILITY

MwRSF Research Report No. TRP-03-278-13

August 12, 2013

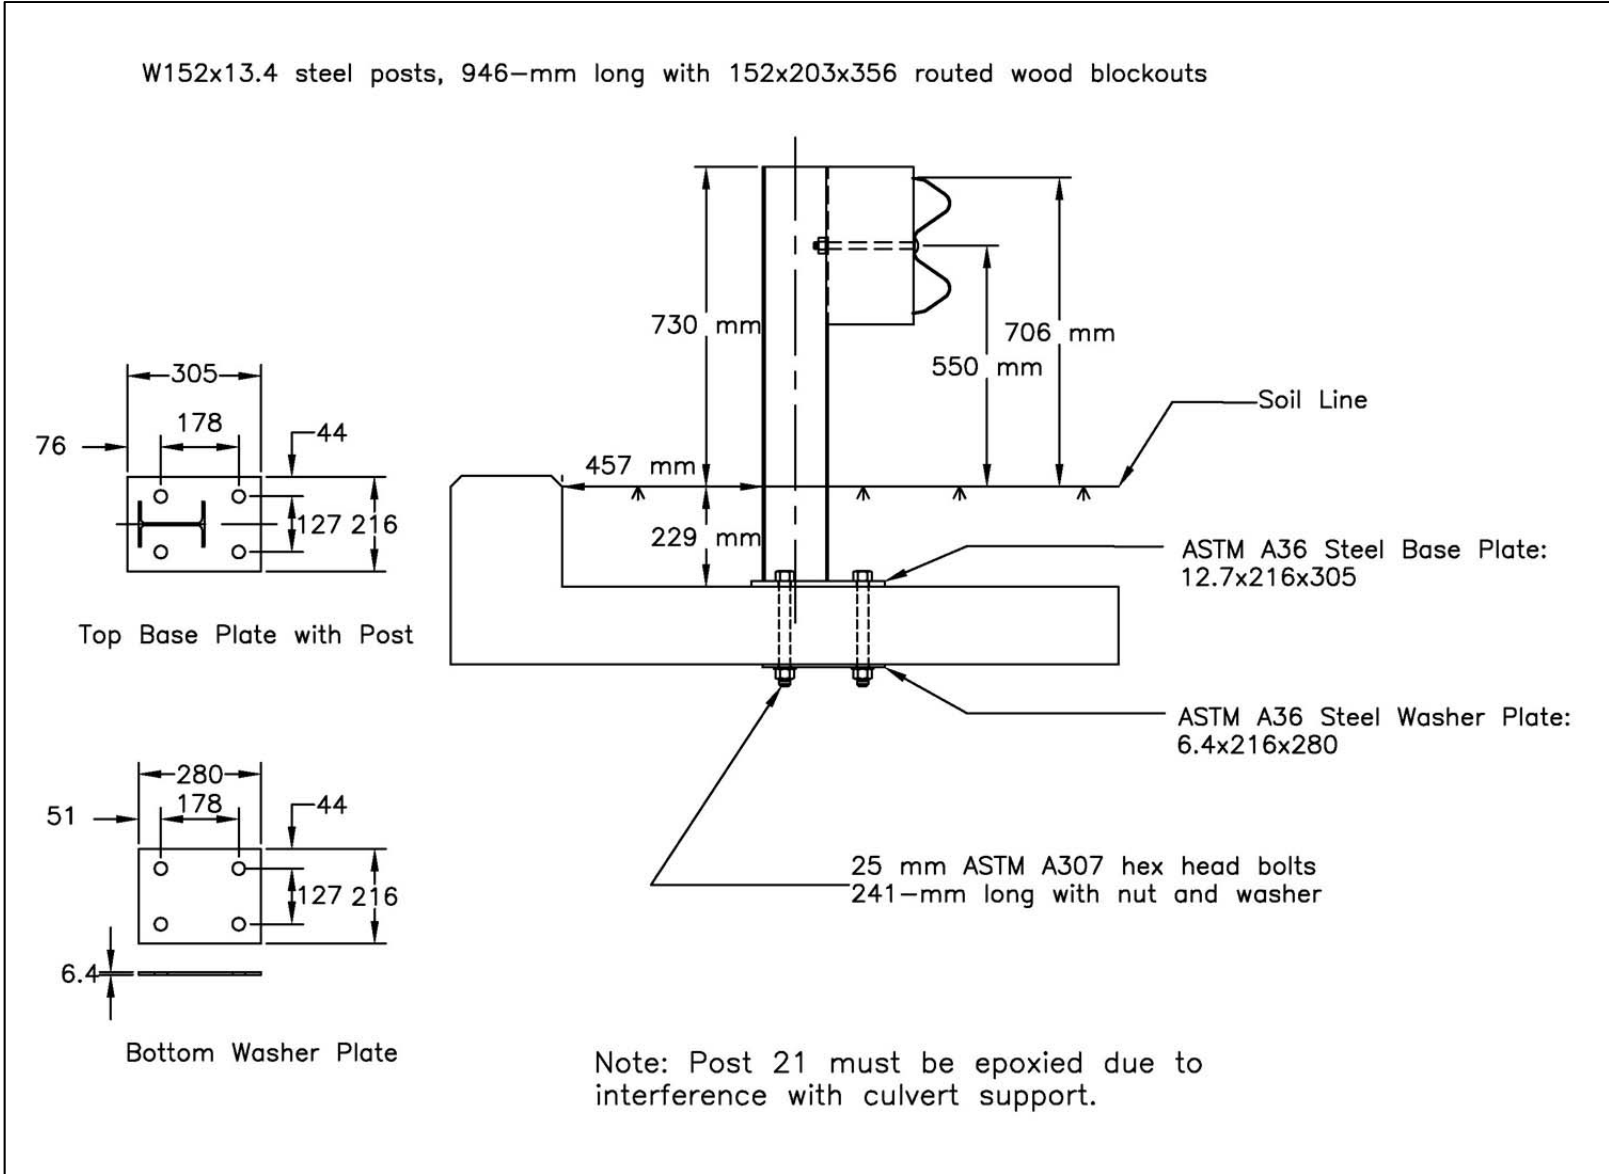
Figure 1. Original System Details for Guardrail Attachment to Culverts [1]

W-beam guardrail systems often span across reinforced concrete box culverts in order to prevent motorists from encountering hazardous conditions near the openings. For low-fill culverts of widths exceeding the maximum unsupported length of long-span systems, a few W-beam guardrail designs are available for direct attachment to the top culvert slab. One such guardrail system was developed in 2002 by the Midwest Roadside Safety Facility (MwRSF) [1]. This system utilized a ½-in. (13-mm) thick steel plate welded to the bottom of each guardrail post with a 5/16-in. (8-mm) three-pass fillet weld on the front (tension) flange and a ¼-in. (6-mm) fillet weld on the web and back (compression) flange. The post assembly was anchored to the culvert slab using four 1-in. (25-mm) diameter through bolts. Finally, the back-side of the post was offset 18 in. (457 mm) from the inside of the culvert headwall to prevent interaction between the posts and the rigid headwall as the system deflects during an impact event. This system was successfully developed and full-scale crash tested according to the Test Level 3 (TL-3) safety performance guidelines found in National Cooperative Highway Research Program (NCHRP) Report No. 350 [2]. Drawings for this system are shown in Figures 1 and 2.

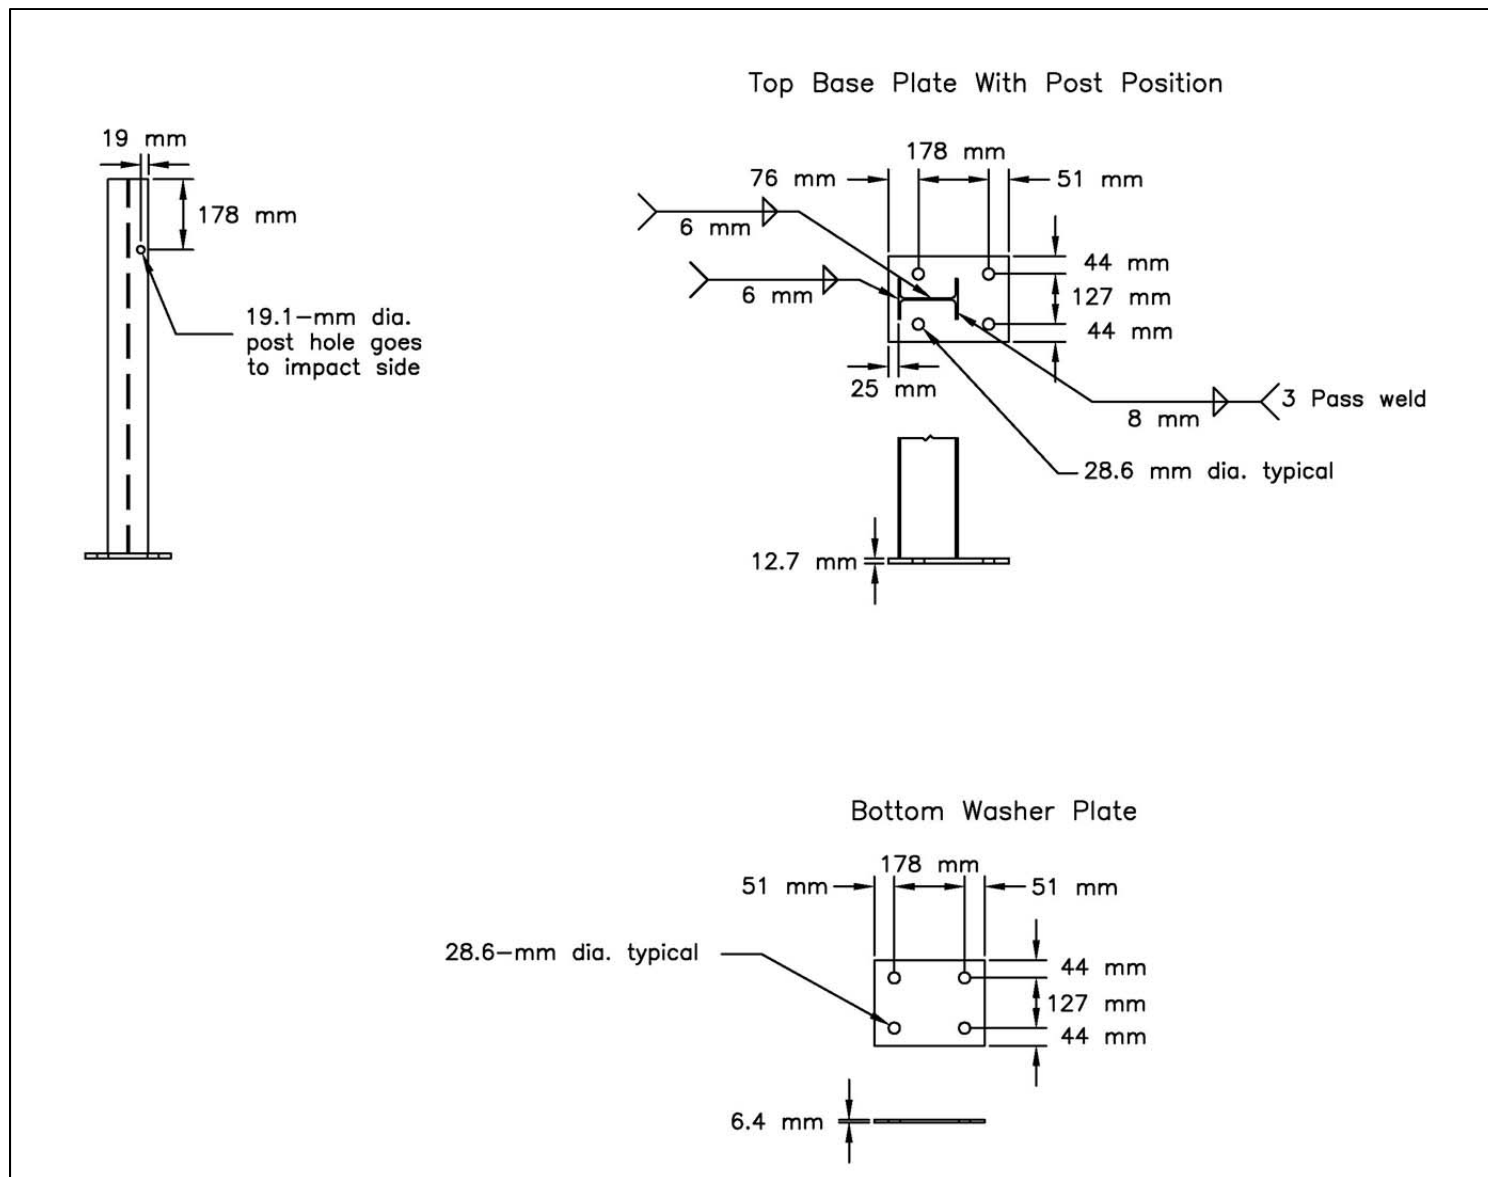
Figure 2. Original System Post and Weld Details [1]

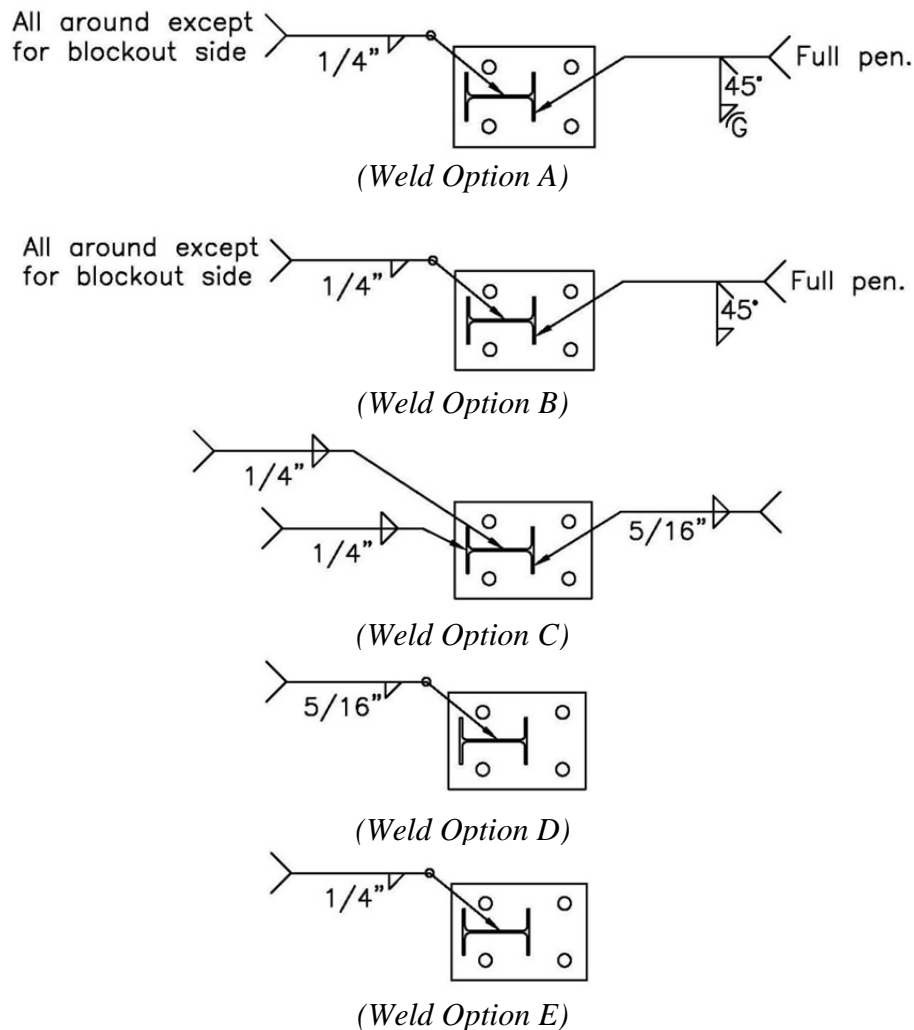
Figure 3. Proposed Standardized Weld Options

Through a review of State DOT drawings and recommendations for the simplification of the post-to-plate attachment, five different weld options were identified as possible replacements to the 3-pass, 5/16-in (8-mm) fillet weld. These five weld options are shown in Figure 3. Weld Option A included a ¼-in. (6-mm) fillet weld on the web and back flange and a full penetration weld on the front flange with minor grinding to reduce residual stresses. Weld Option B was the same as Weld Option A, but without the grinding. Weld Option C utilized a single-pass 5/16-in.

(8-mm) weld on the front flange while maintaining the 1/4-in. (6-mm) fillet welds on the web and back flange. Finally, Weld Options D and E utilized only single fillet welds around the entire base of the post measuring 5/16 in. (8 mm) and 1/4 in. (6 mm), respectively.

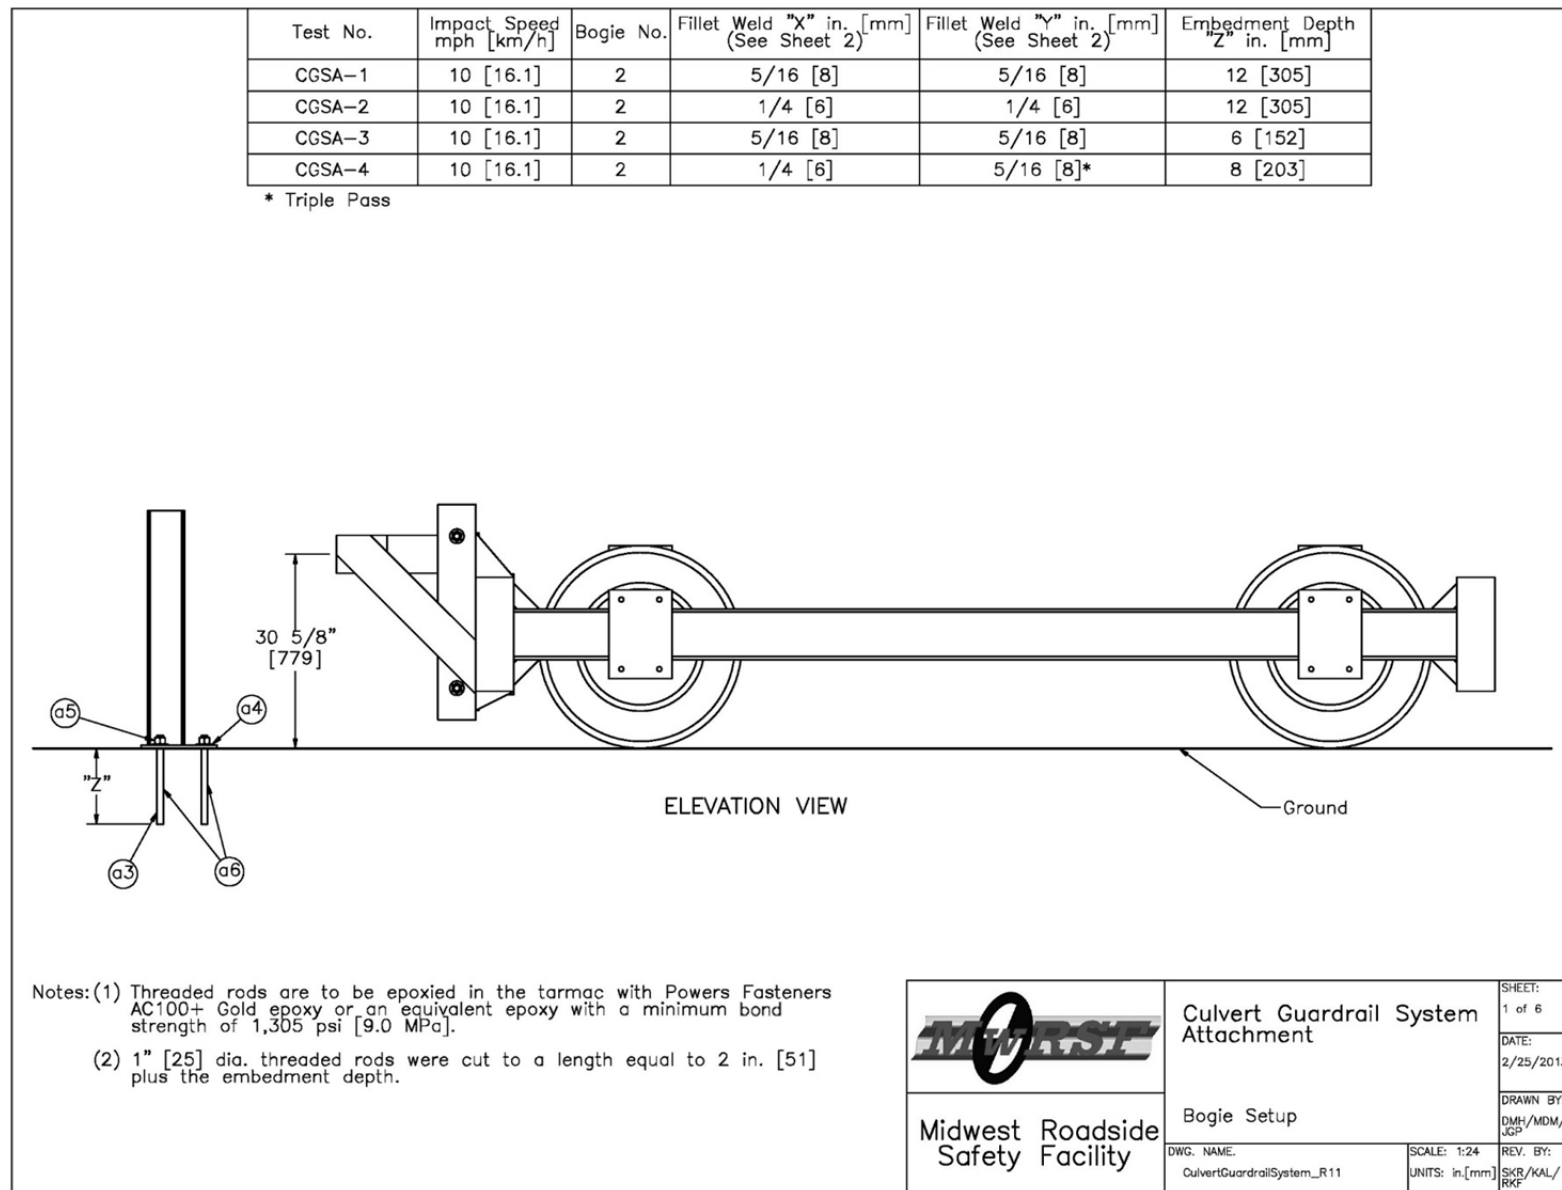
Figure 4. Bogie Testing Setup, Test Nos. CGSA-1 through CGSA-4

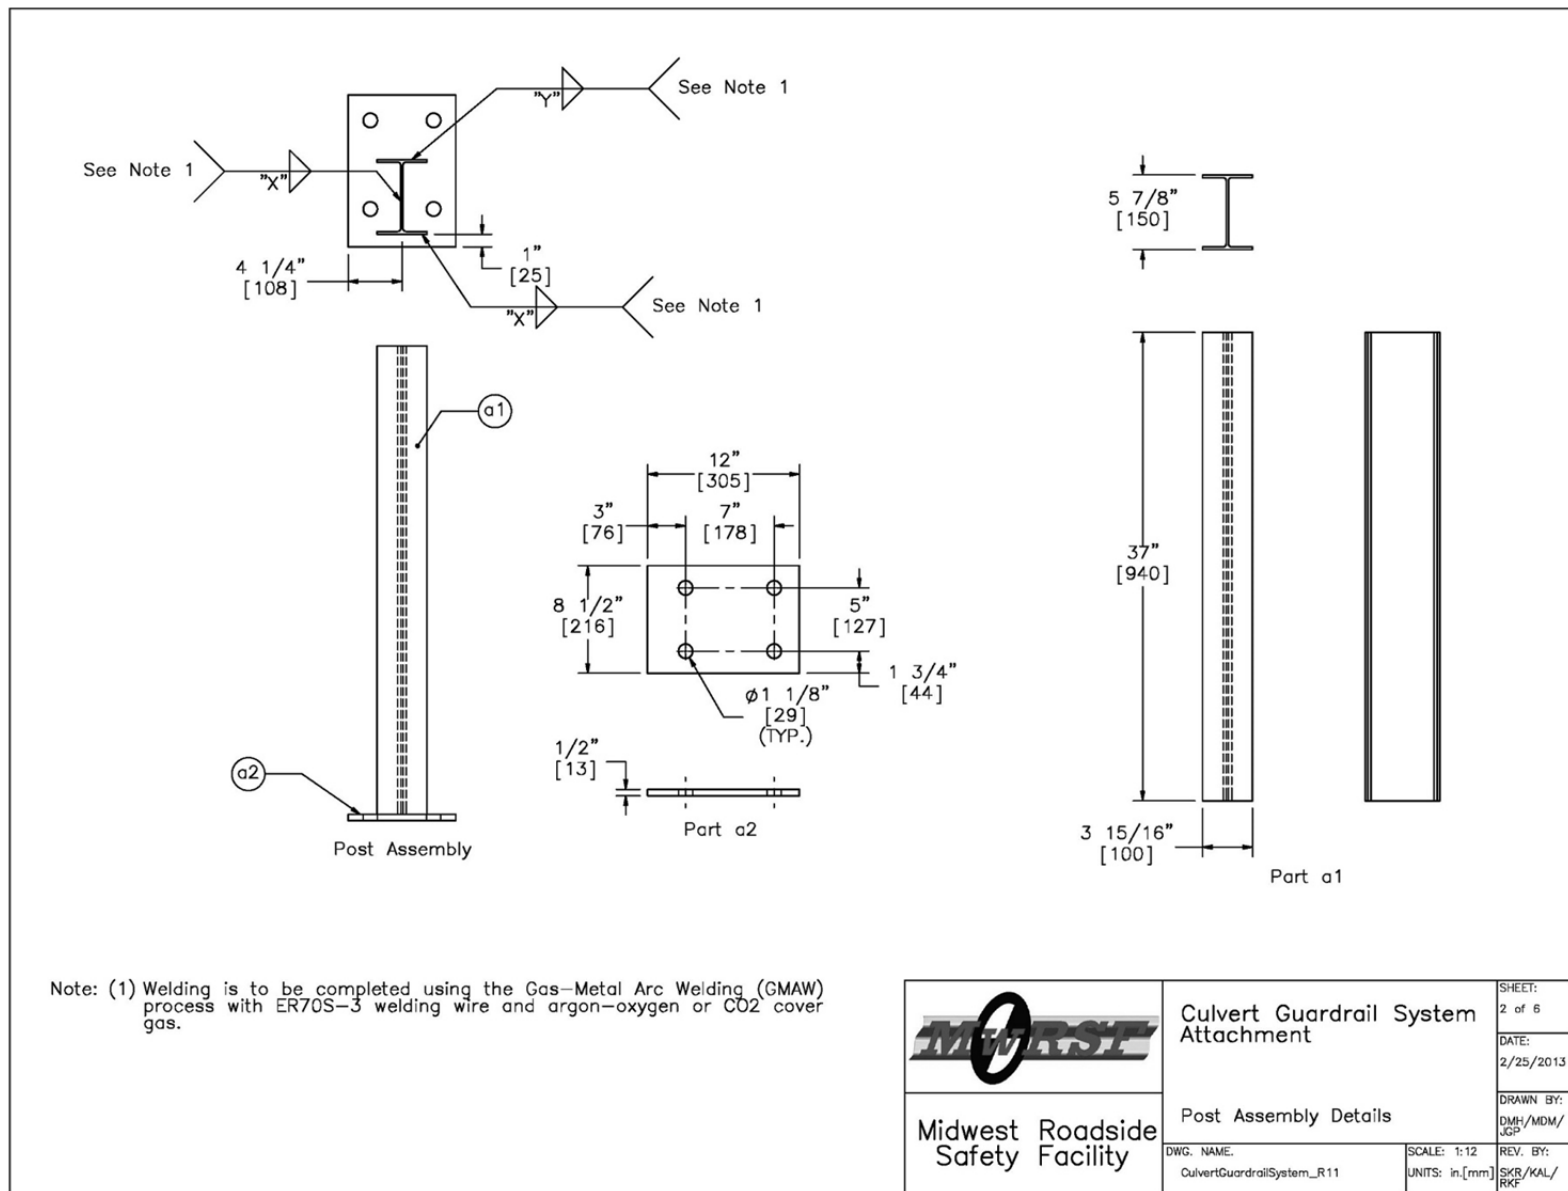
Figure 5. Post Assembly and Weld Details, Test Nos. CGSA-1 through CGSA-4

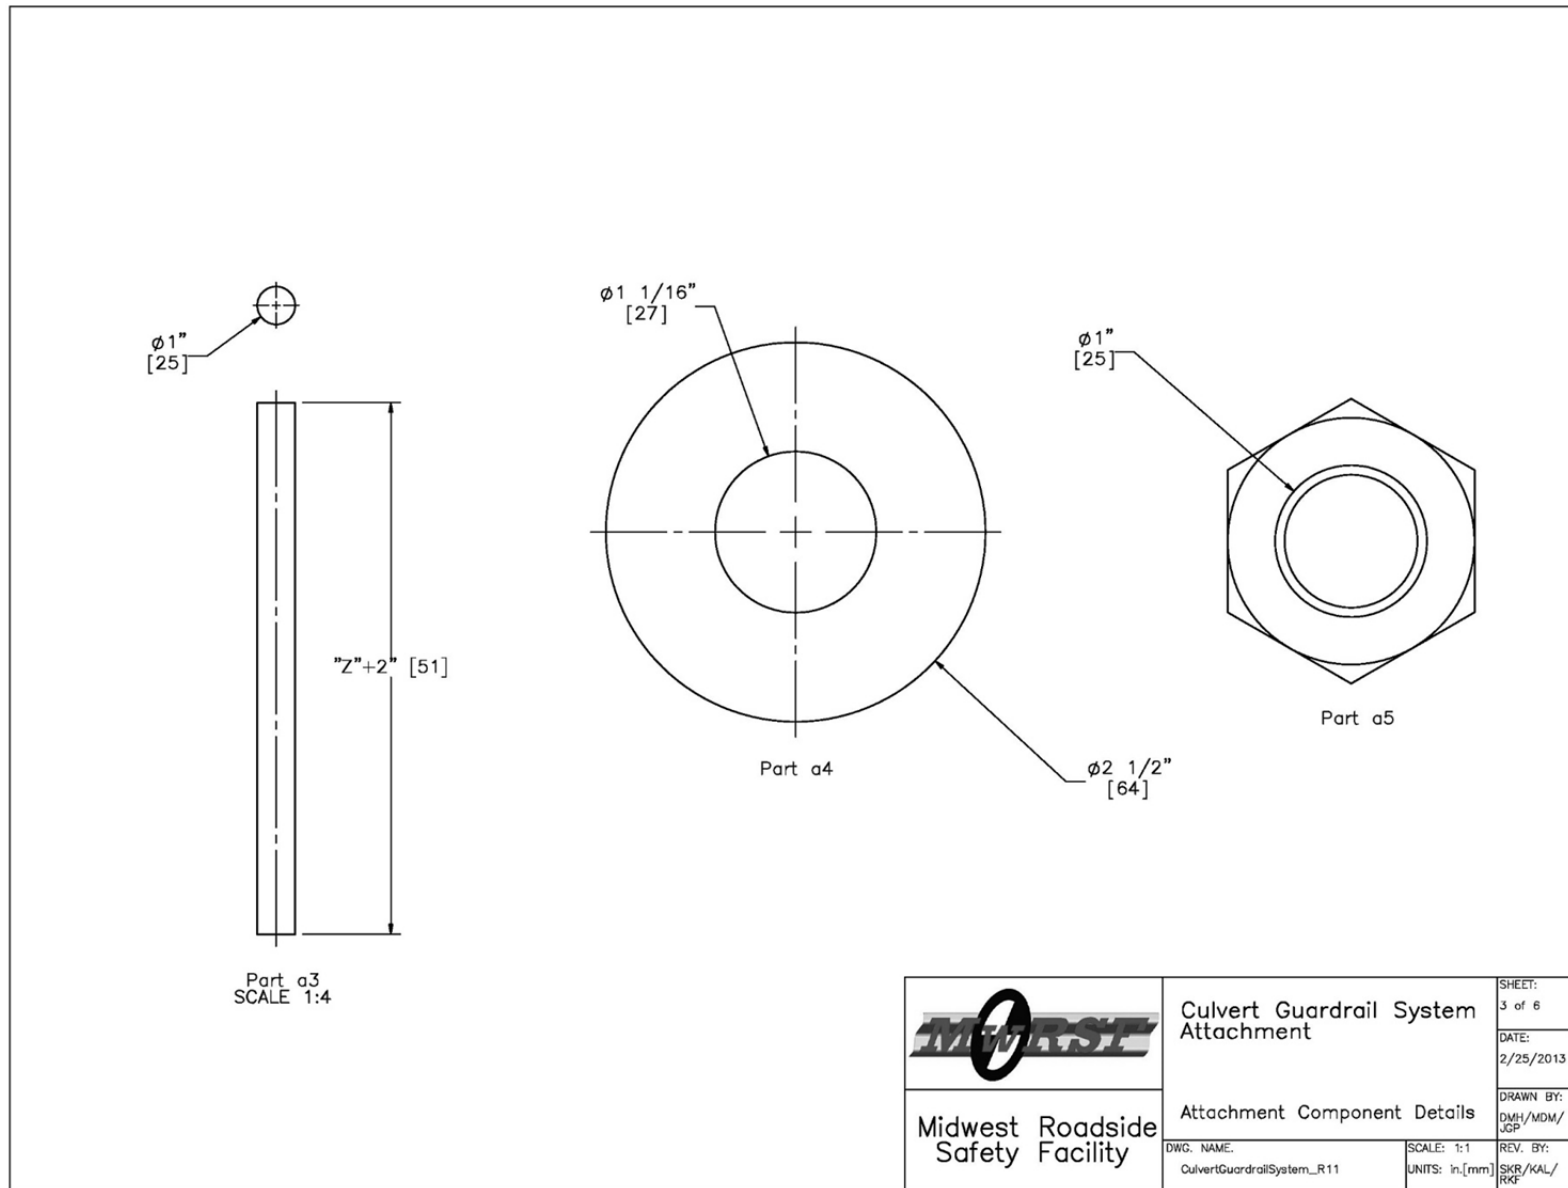
Figure 6. Attachment Component Details, Test Nos. CGSA-1 through CGSA-4

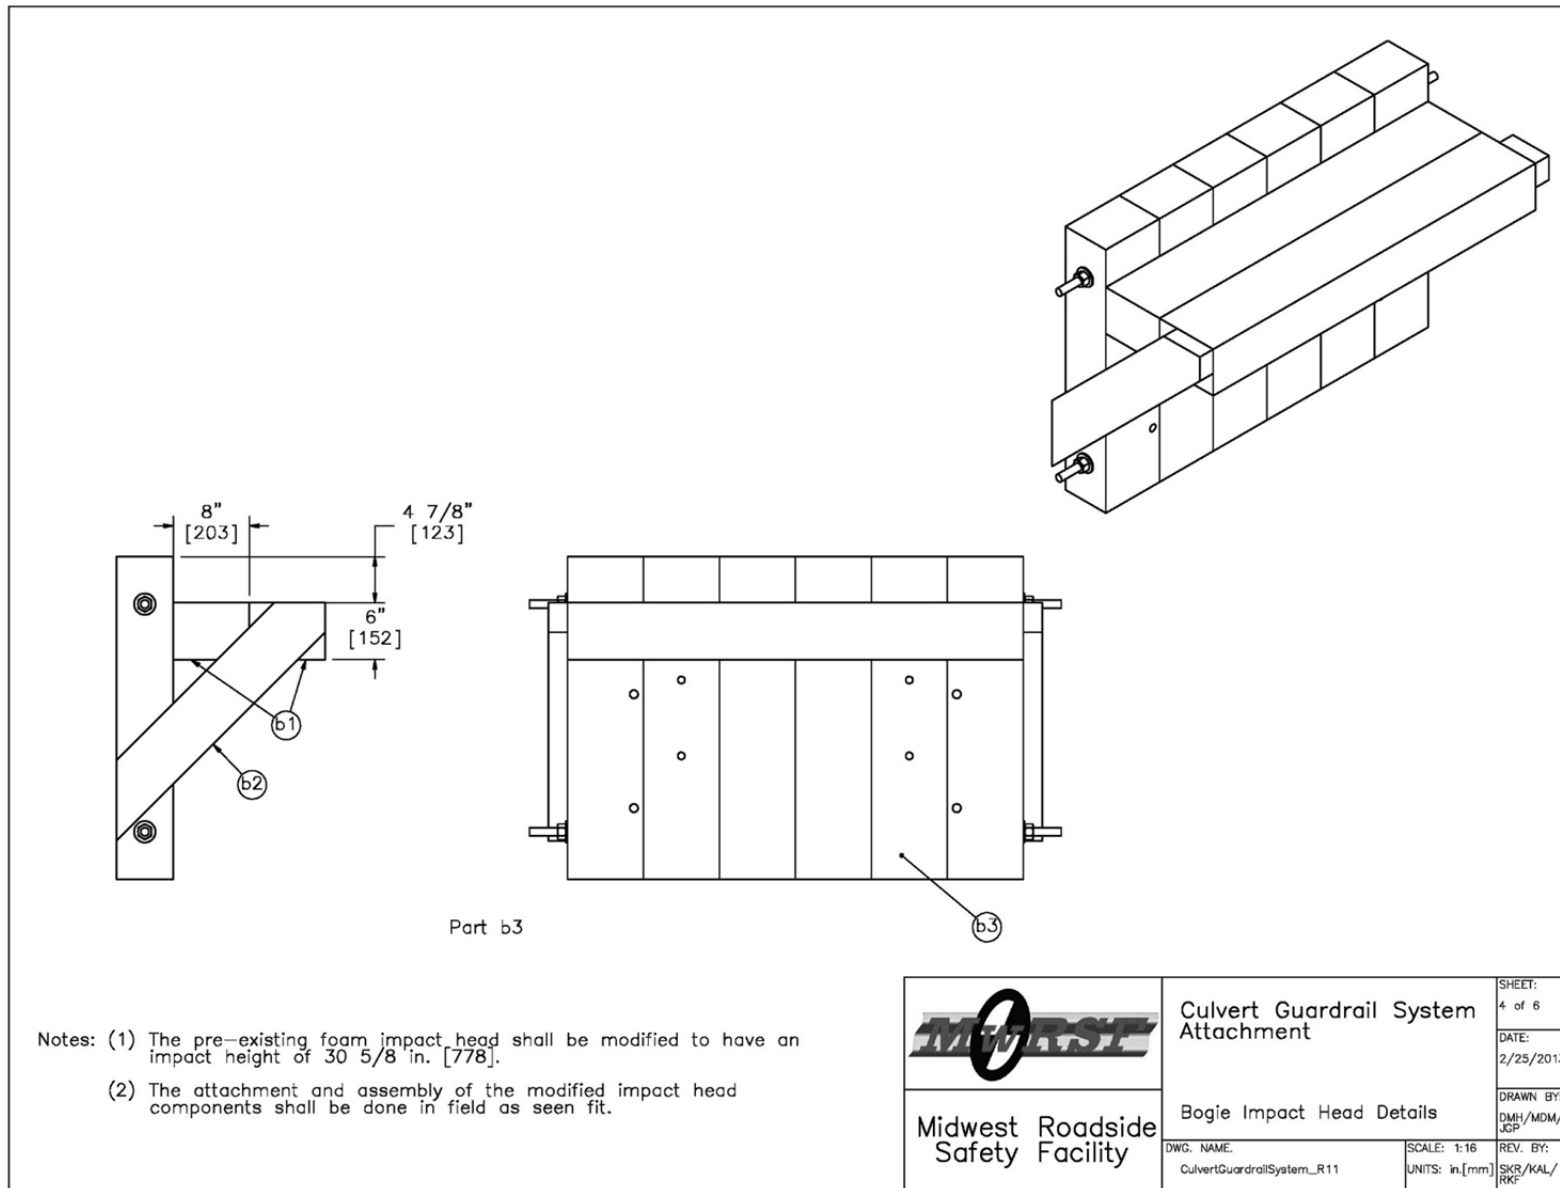
Figure 7. Bogie Impact Head Details, Test Nos. CGSA-1 through CGSA-4

A rigid-frame bogie was used to impact the posts. A customized, detachable wooden impact head, shown previously in Figures 7 and 8, was used in the testing. The bogie head consisted of six vertical and two horizontal 6 in. x 8 in. (152 mm x 203 mm) wood posts. This impact head matched the one used previously during the original component testing of the post-to-culvert attachment. The impact head was bolted to the bogie vehicle, thus creating a rigid frame with an impact height of 30⁵/₈ in. (778 mm), as shown in Figure 11. The weight of the bogie with the addition of the mountable impact head was 4,996 lb (2,266 kg), 4,999 lb (2,268 kg), 5,010 lb (2,273 kg), and 4,995 lb (2,266 kg) for test nos. CGSA-1, CGSA-2, CGSA-3, and CGSA-4, respectively.

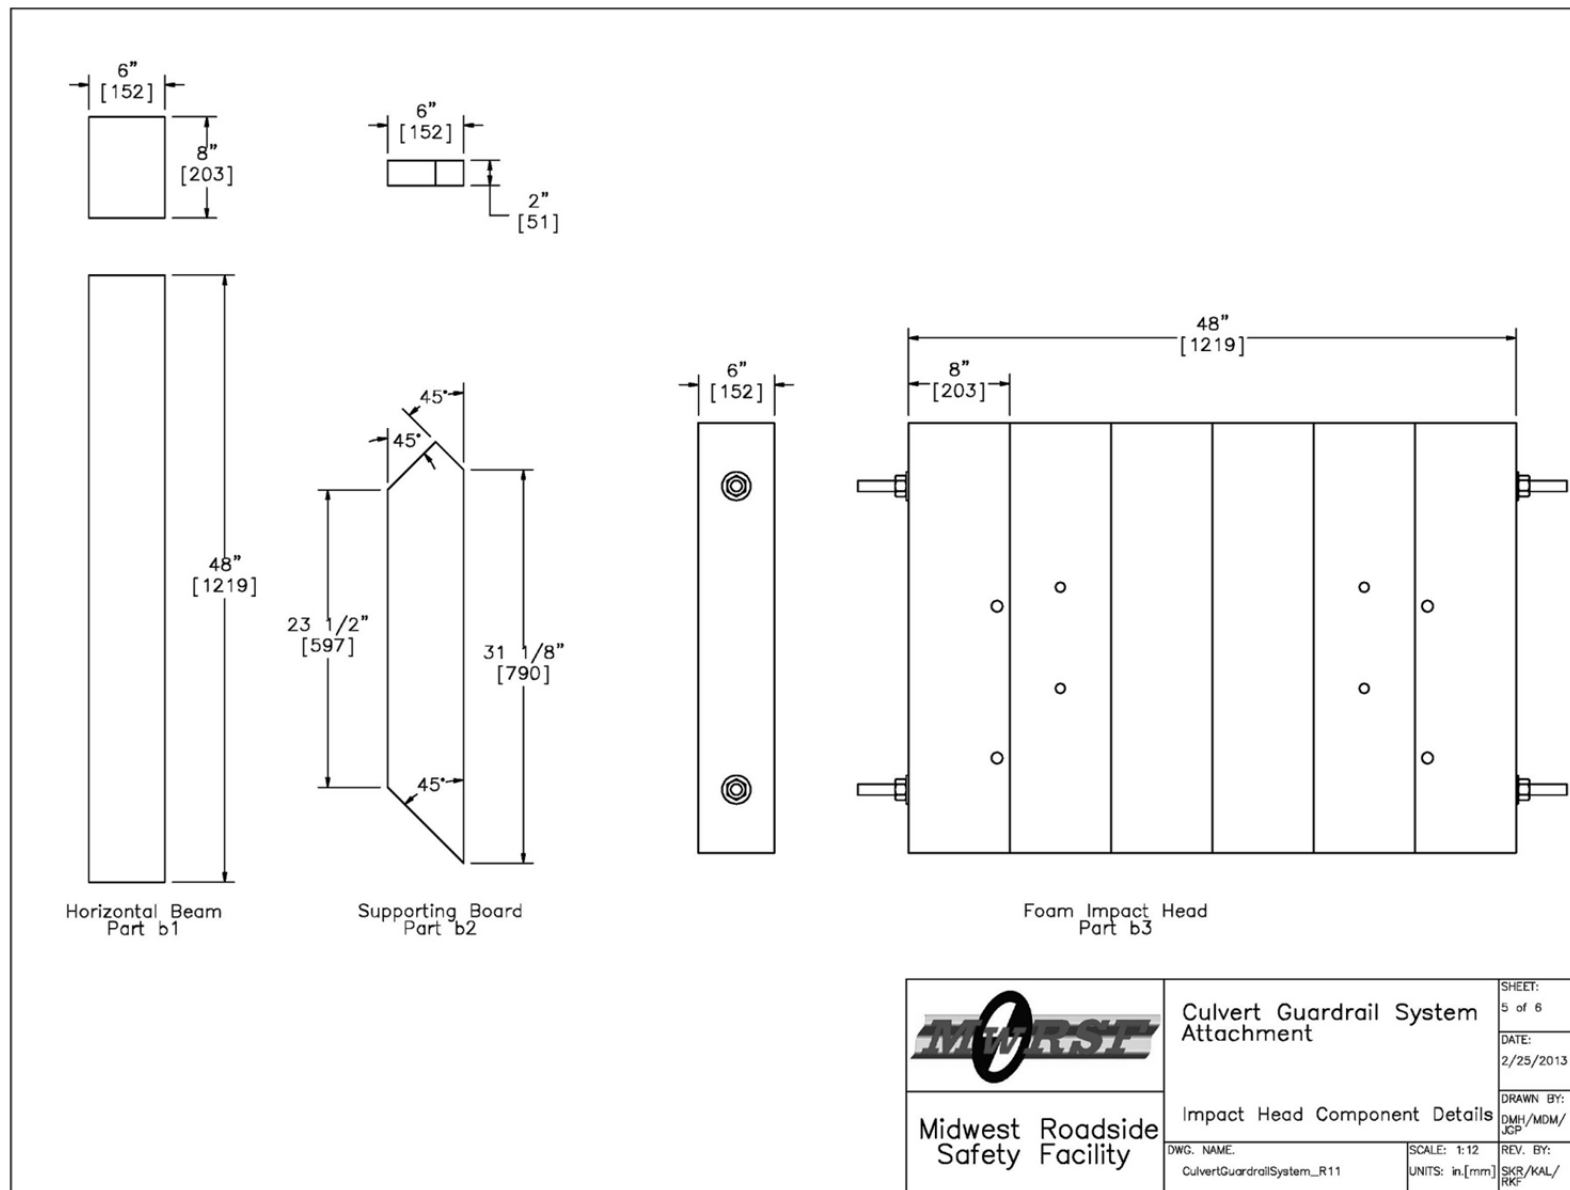
Figure 8. Impact Head Component Details, Test Nos. CGSA-1 through CGSA-4

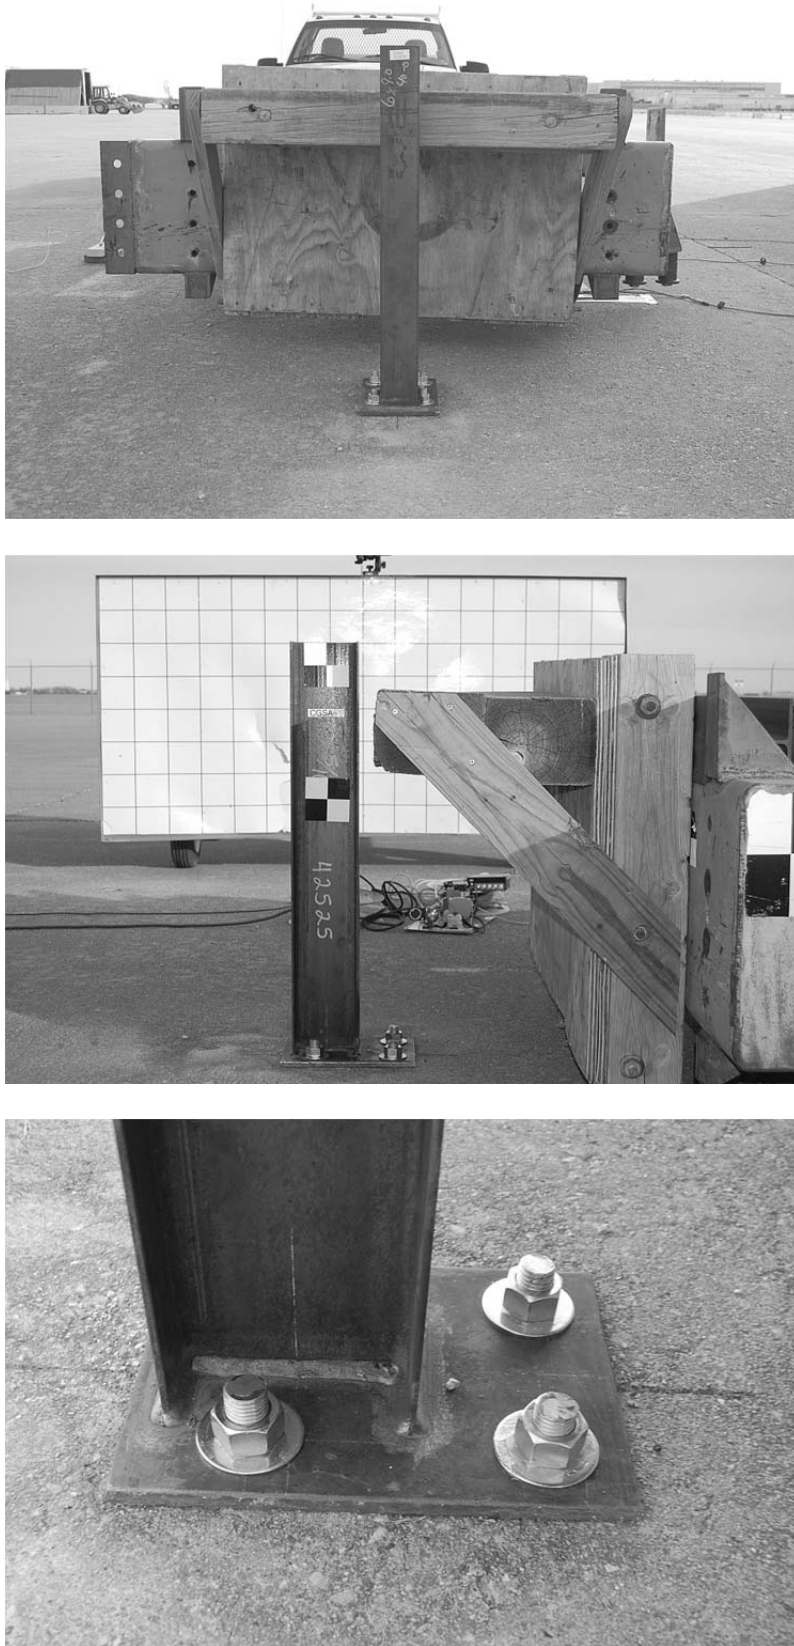
Figure 10. Pre-test Installation Photographs

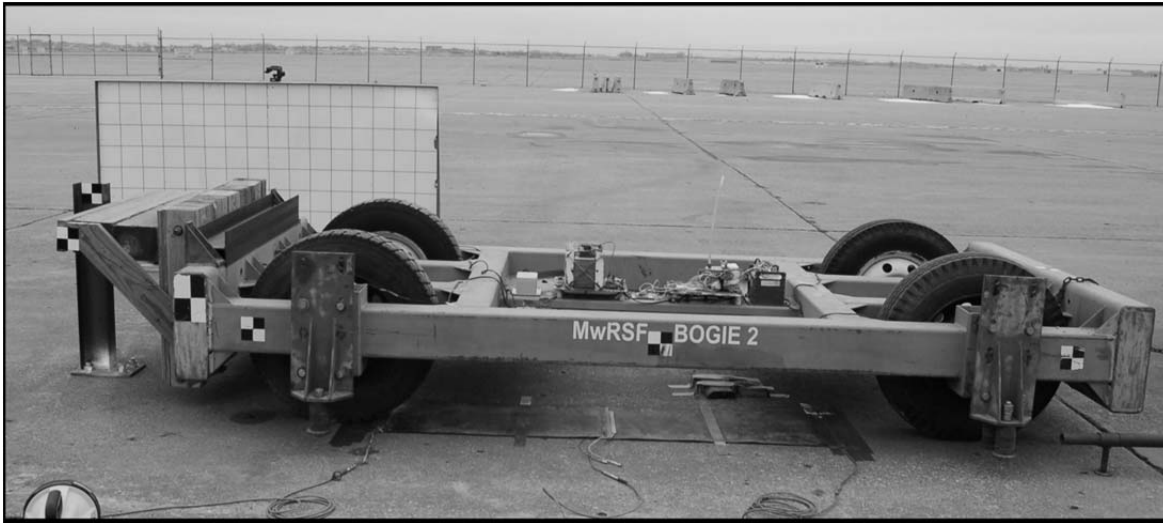
Figure 11. Rigid-Frame Bogie

The tests were conducted using a steel pipe guidance track to steer the bogie vehicle into a centered, head-on impact with the test article. A pickup truck was used to propel the bogie vehicle to the targeted impact velocity of 10 mph (16 km/h), at which point the pickup truck braked, allowing the bogie to become a free projectile as it came off the track.

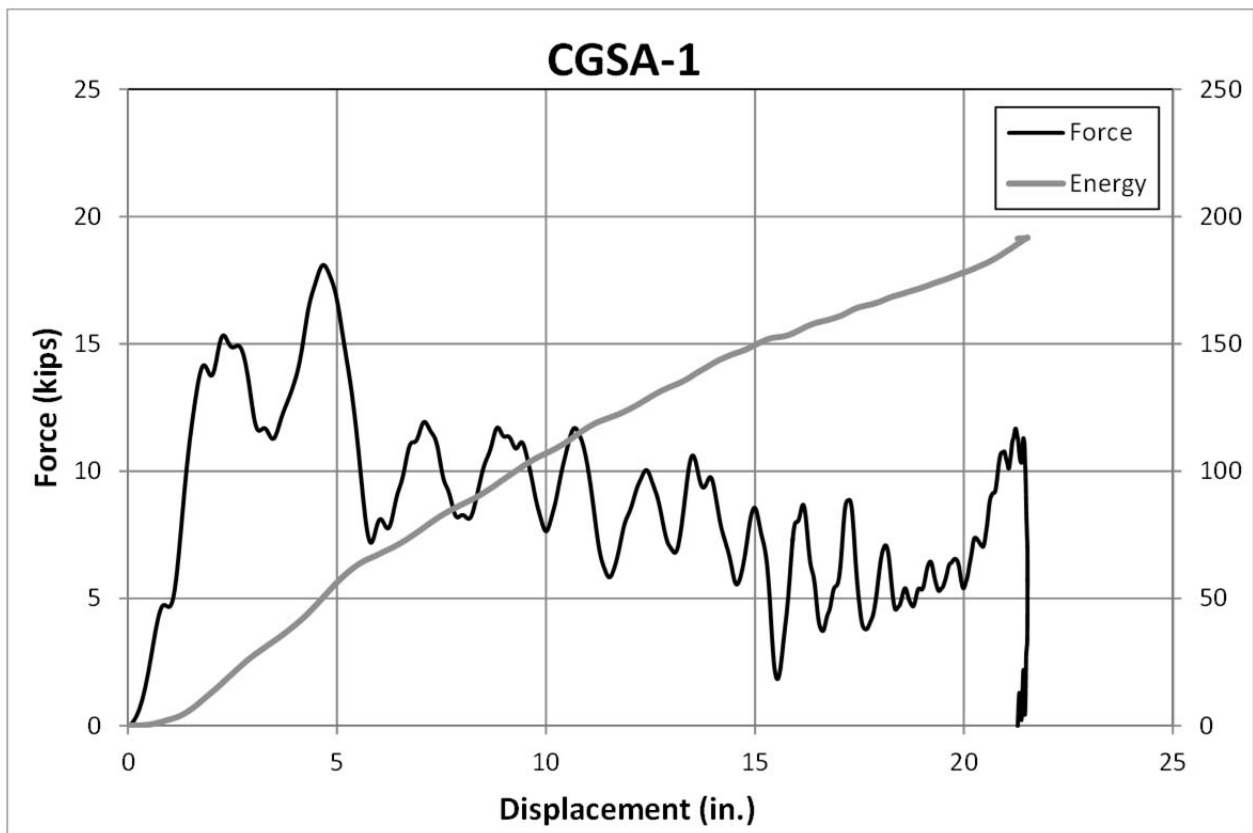
Force vs. deflection and energy vs. deflection curves were created from the DTS accelerometer data, as shown in Figure 12. Early in the impact event, a maximum resistance of 18.1 kips (80.5 kN) was recorded at 4.7 in. (119 mm) of deflection. Video analysis confirmed this peak force corresponded to the time just prior to the plate beginning to tear, or 0.034 seconds after impact. After the onset of tearing, the resistance force decreased and remained relatively constant. At the maximum deflection of 21.7 in. (551 mm), the post assembly had absorbed 191.7 k-in. (21.7 kJ) of energy. Time-sequential and post-impact photographs are shown in Figures 13 through 15.

Figure 12. Force vs. Deflection and Energy vs. Deflection, Test No. CGSA-1

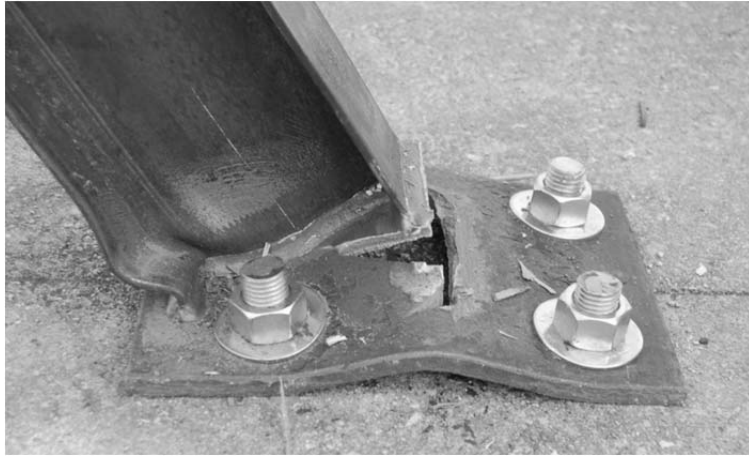
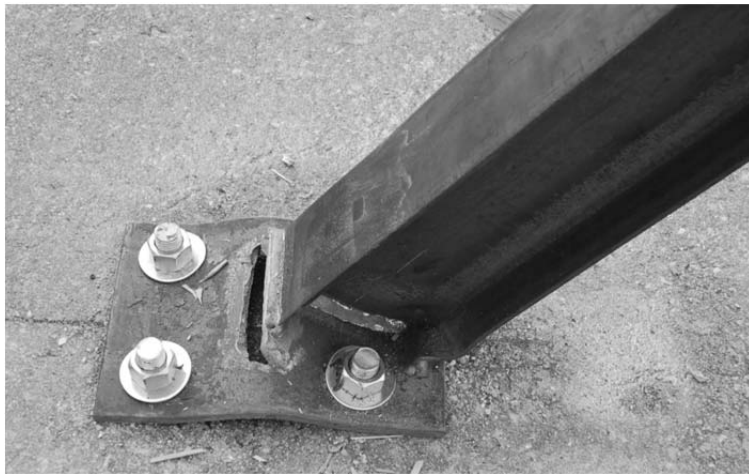
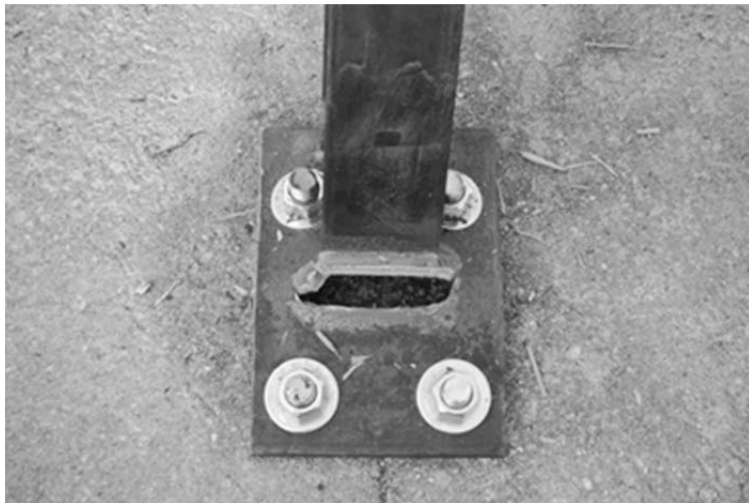
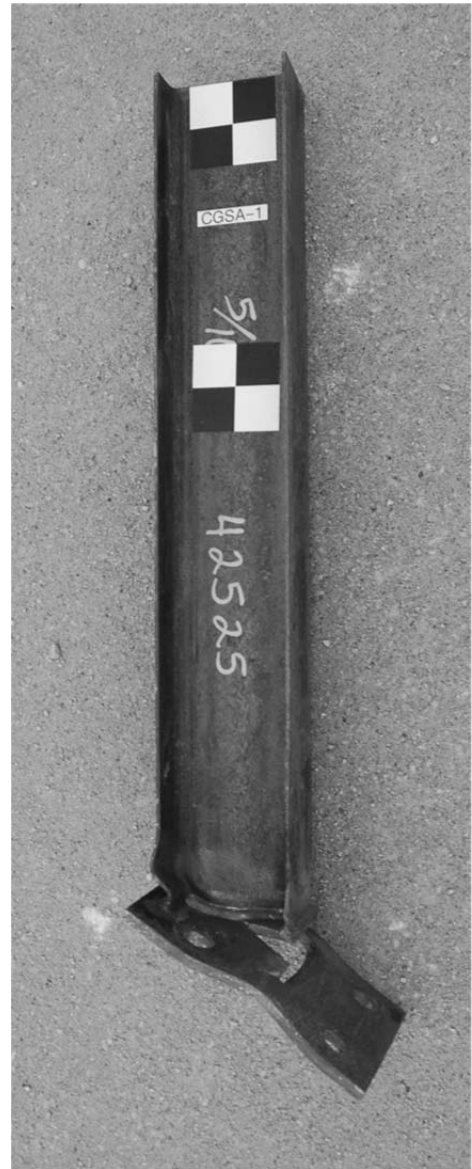
For test no. CGSA-1, the post was connected to the base plate using a $\frac{5}{16}$ -in. (8-mm) fillet weld all around the base of the post. To anchor the post assembly, four 1-in. (25-mm) diameter threaded rods were epoxied into the tarmac with an embedment depth of 12 in. (305 mm). During test no. CGSA-1, the bogie impacted the post at a speed of 9.8 mph (15.8 km/h). As a result, the post rotated backward, and the bogie was eventually brought to a stop at a displacement of 21.7 in. (546 mm) as determined from the DTS data. Post-test inspection revealed that both the back flange and the web of the post had buckled and the base plate was bent upward. Although the weld held, the plate was torn adjacent to the weld on the front flange, and the tearing extended around the flange and 1 in. (25 mm) toward the back of the plate on both sides.

Figure 15. Post-Impact Photographs, Test No. CGSA-1

Both $\frac{1}{4}$ -in. and $\frac{5}{16}$ -in. (6-mm and 8-mm) fillet weld options were explored. However, both of these weld details resulted in large tears in the base plate adjacent to front flange of the post in test nos. CGSA-1 and CGSA-2. An attempt was made to utilize a 50-ksi (345-MPa) steel base plate with the $\frac{5}{16}$ -in. (8-mm) weld to prevent tearing, but the epoxy anchors failed during test no. CGSA-3 prior to the development of the full lateral resistance of the post assembly. Only test no. CGSA-4, which utilized the original weld details from the as-tested system, resisted the full impact load without component failure. Therefore, the recommended weld details for the post-to-base plate remain the same with a 3-pass, $\frac{5}{16}$ -in. (8-mm) fillet weld on the front flange and a $\frac{1}{4}$ -in. (6-mm) fillet weld on the web and back flange.

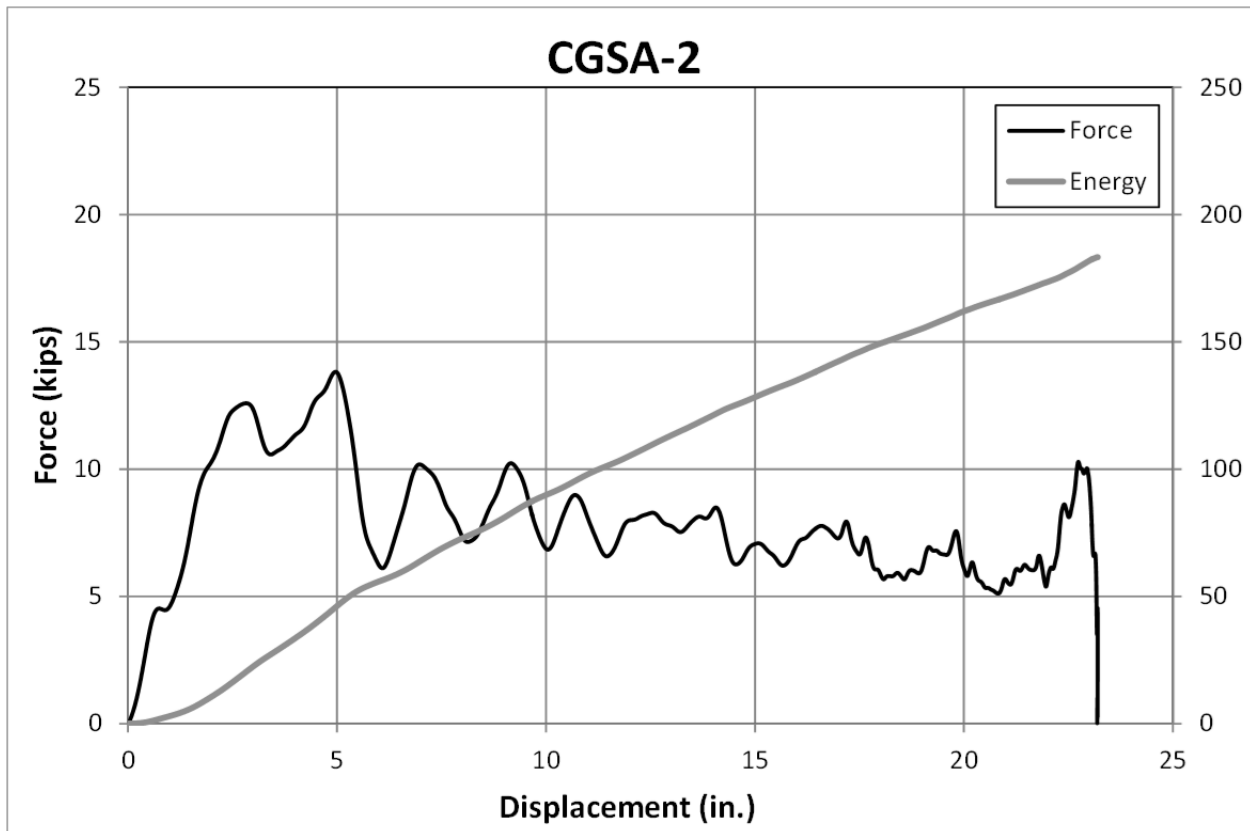
Force vs. deflection and energy vs. deflection curves were created from the DTS accelerometer data, as shown in Figure 16. Early in the impact event, a maximum force of 13.8 kips (61.4 kN) was recorded at a deflection of 5.0 in. (127 mm). Video analysis confirmed this peak force occurred just prior to the onset of plate tearing, or 0.030 seconds after impact. Once tearing began, the resistance force decreased and remained relatively constant. At a maximum deflection of 23.2 in. (589 mm), the post assembly had absorbed 183.2 k-in. (20.7 kJ) of energy. Time-sequential and post-impact photographs are shown in Figures 17 through 19.

Figure 16. Force vs. Deflection and Energy vs. Deflection, Test No. CGSA-2
