POST WELD AND EPOXY ANCHORAGE VARIATIONS FOR W-BEAM GUARDRAIL ATTACHED TO LOW-FILL CULVERTS

MIDWEST ROADSIDE SAFETY FACILITY

MwRSF Research Report No. TRP-03-278-13

August 12, 2013

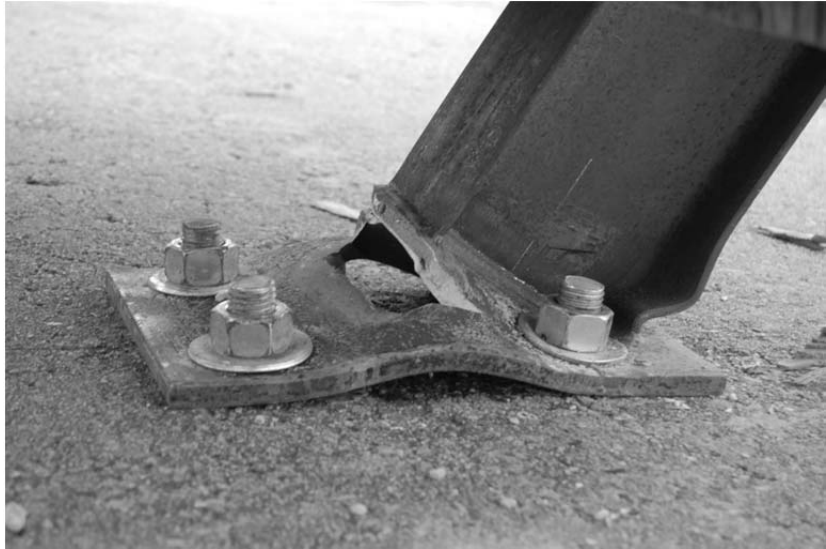
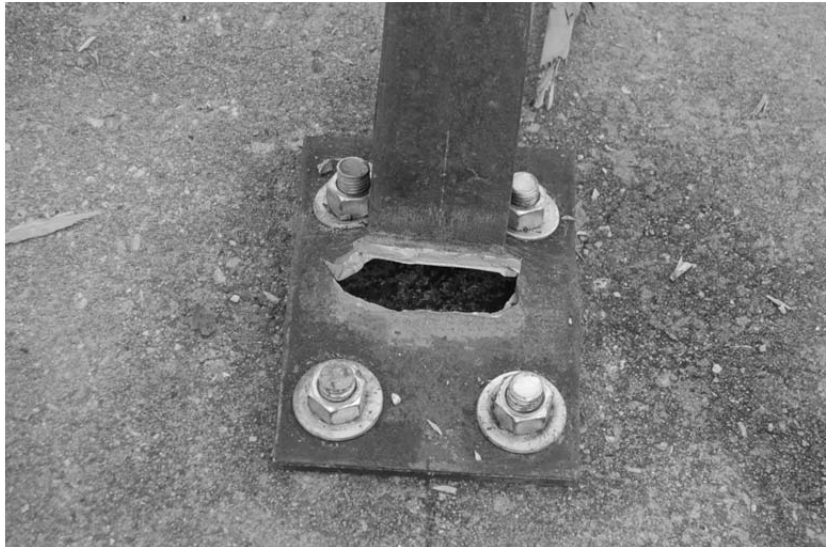
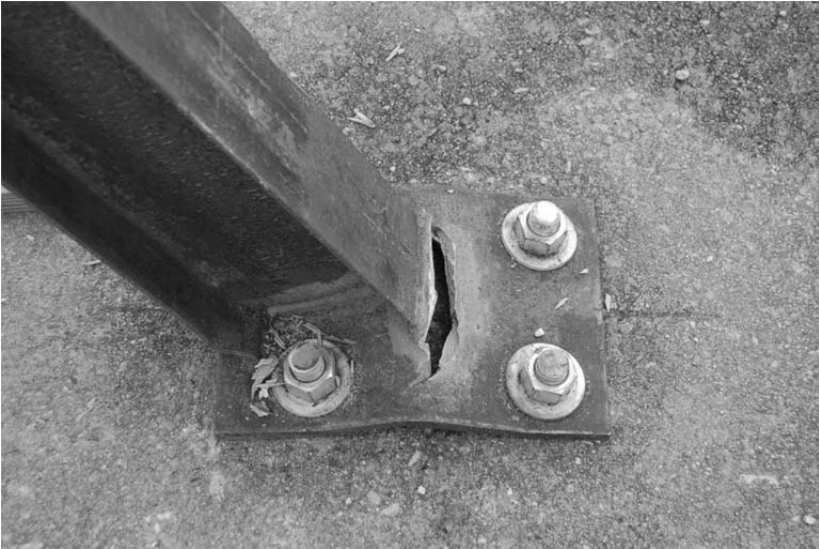
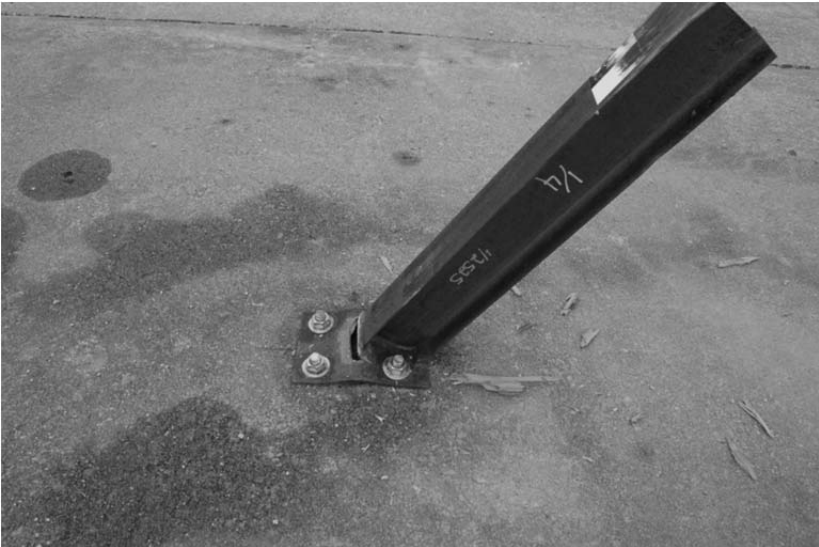
For test no. CGSA-2, the post was connected to the base plate using a ¼-in. (6-mm) fillet weld all around the base of the post. To anchor the post assembly, four 1-in. (25-mm) diameter threaded rods were epoxied into the tarmac with an embedment depth of 12 in. (305 mm). During test no. CGSA-2, the bogie impacted the post at a speed of 9.6 mph (15.4 km/h). As a result, the post rotated backward, and the bogie eventually overrode the top of the post at a displacement of 23.2 in. (589 mm) as determined from the DTS data. Post-test examination revealed failure modes similar to test no. CGSA-1. The back flange of the post had buckled, and the plate was torn adjacent to the front flange weld and continued approximately ¾ in. (19 mm) backward on each side.

Figure 19. Post-Impact Photographs, Test No. CGSA-2

Both $\frac{1}{4}$ -in. and $\frac{5}{16}$ -in. (6-mm and 8-mm) fillet weld options were explored. However, both of these weld details resulted in large tears in the base plate adjacent to front flange of the post in test nos. CGSA-1 and CGSA-2. An attempt was made to utilize a 50-ksi (345-MPa) steel base plate with the $\frac{5}{16}$ -in. (8-mm) weld to prevent tearing, but the epoxy anchors failed during test no. CGSA-3 prior to the development of the full lateral resistance of the post assembly. Only test no. CGSA-4, which utilized the original weld details from the as-tested system, resisted the full impact load without component failure. Therefore, the recommended weld details for the post-to-base plate remain the same with a 3-pass, $\frac{5}{16}$ -in. (8-mm) fillet weld on the front flange and a $\frac{1}{4}$ -in. (6-mm) fillet weld on the web and back flange.

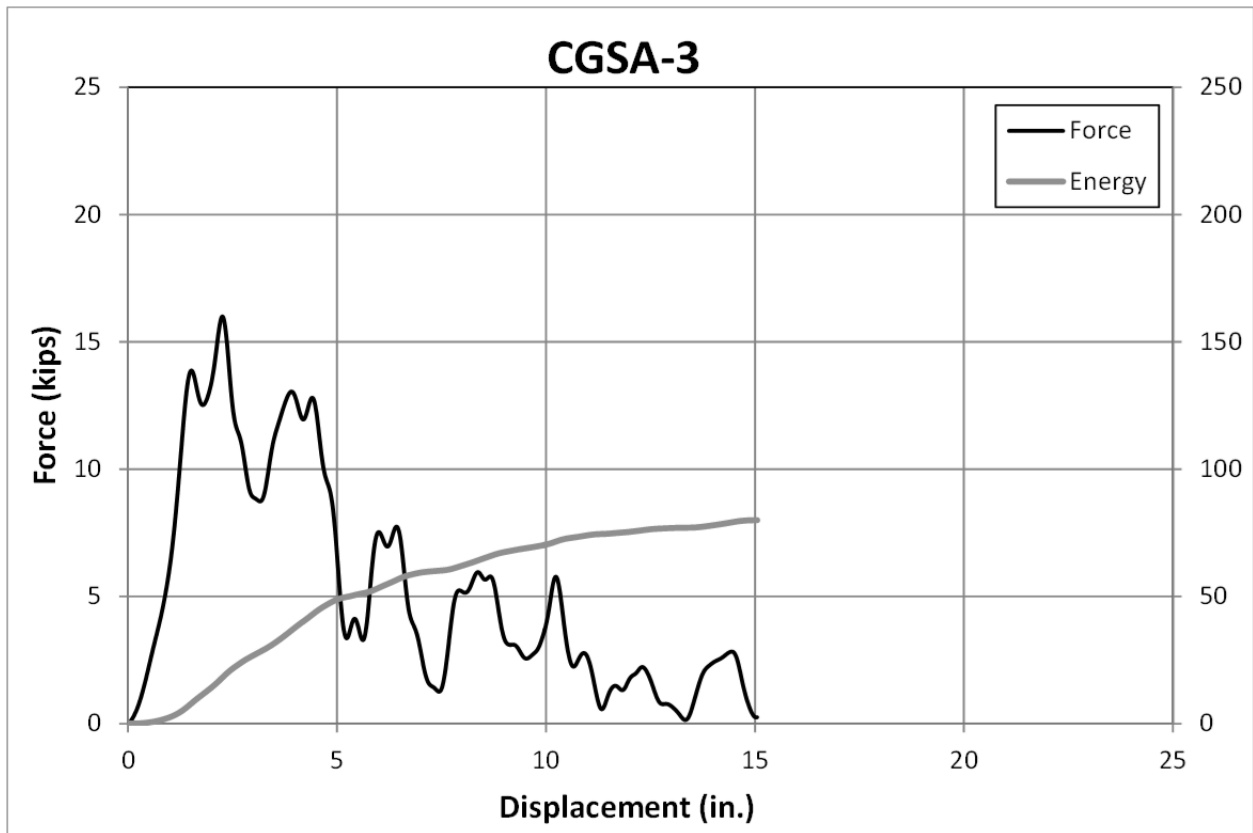
Force vs. deflection and energy vs. deflection curves were created from the DTS accelerometer data, as shown in Figure 20. Note, the curves only show the interaction forces and energies related to the primary impact. The plotted data was extracted prior to the secondary impact between the bottom of the bogie head and the base of the post. Early in the test, peak forces of 16.0 kips and 13.0 kips (71.2 kN and 57.8 kN) were recorded. Once the anchorage failed at approximately 5 in. (127 mm) of deflection, the resistance force decreased quickly and was nearly zero when the base of bogie impacted the post at 15.1 in. (384 mm) of deflection. Prior to this secondary impact, the assembly had absorbed 80.4 k-in. (9.1 kJ) of energy. Time-sequential and post-impact photographs are shown in Figures 21 through 23.

Figure 20. Force vs. Deflection and Energy vs. Deflection, Test No. CGSA-3

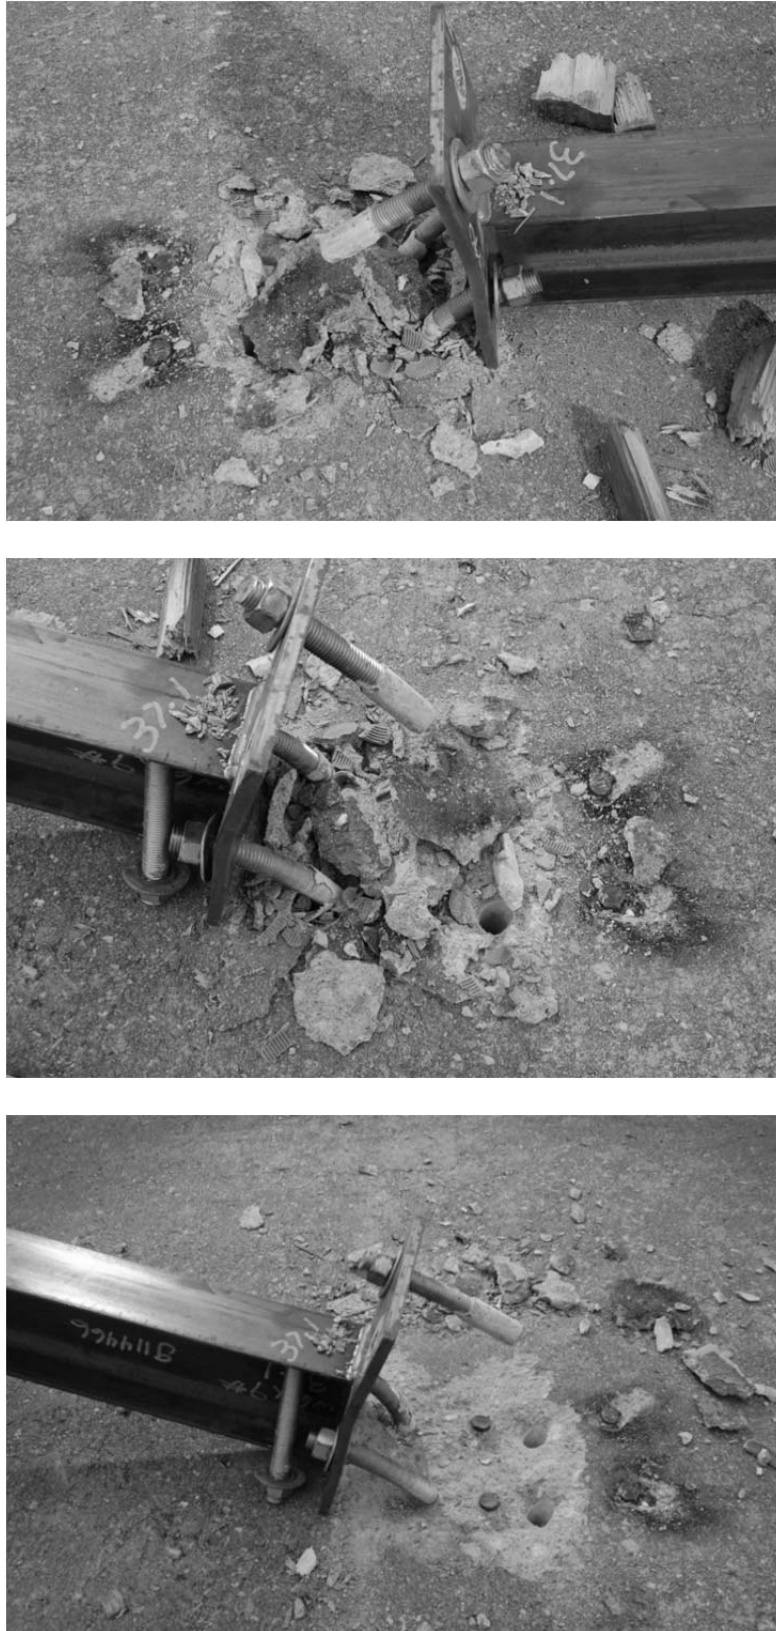
For test no. CGSA-3, the post was connected to the base plate using a $\frac{5}{16}$ -in. (8-mm) fillet weld all around the base of the post. To anchor the post assembly, four 1-in. (25-mm) diameter threaded rods were epoxied into the tarmac with an embedment depth of 6 in. (152 mm). During test no. CGSA-3, the bogie impacted the post at a speed of 9.7 mph (15.6 km/h). As a result, the post rotated backward, and the bogie eventually overrode the top of the post. At 0.020 sec after impact, concrete cracks began to form around the front anchor rods, and by 0.026 seconds, the anchor rods were pulled out of the concrete. The post assembly then rotated about the back of the plate causing the back anchors to bend. At approximately 0.150 seconds, the base of the bogie head impacted the post and caused the back anchor rods to pull out.

Figure 23. Post-Impact Photographs, Test No. CGSA-3

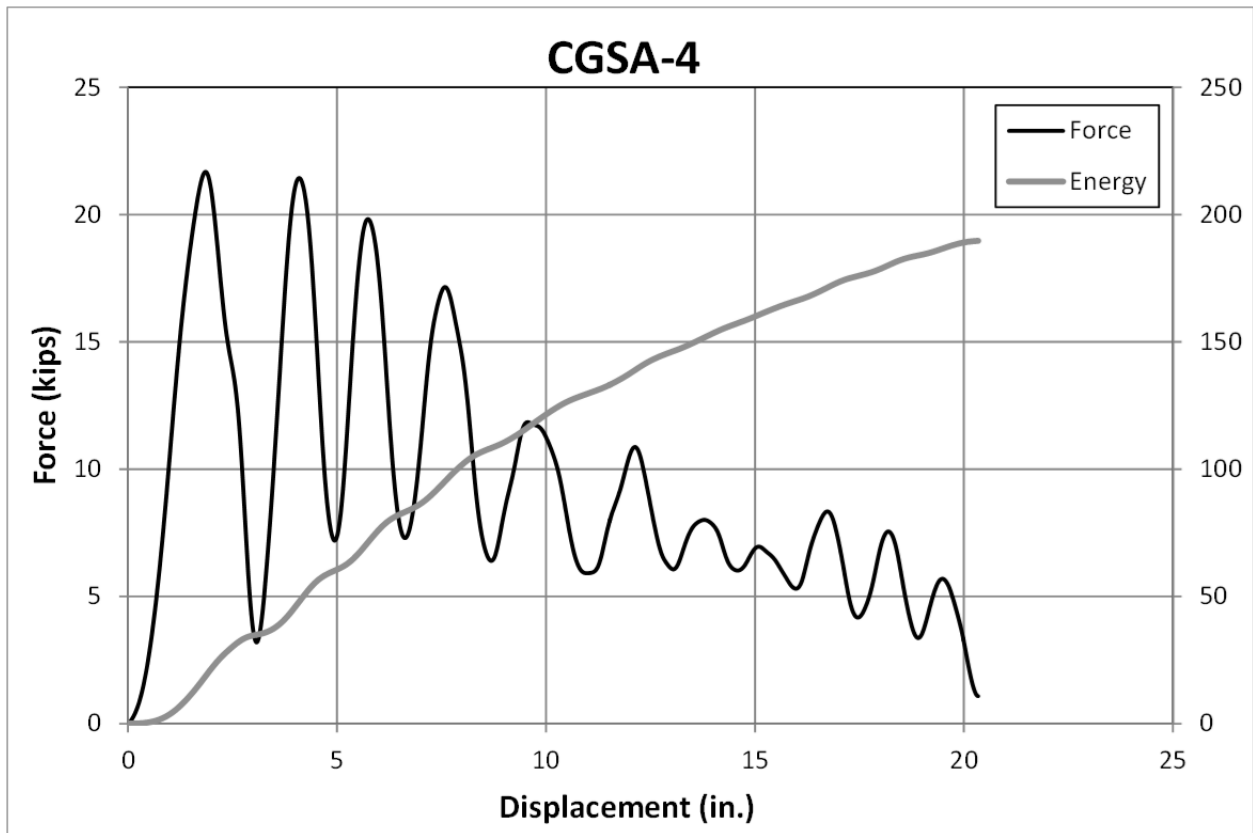
Force vs. deflection and energy vs. deflection curves were created from the DTS-SLICE accelerometer data, as shown in Figure 24. Early in the test, multiple force spikes of around 20 kips (89 kN) were recorded within the first 6 in. (152 mm) of deflection. The resistance force then steadily declined until the bogie overrode the post at a deflection of 20.3 in. (516 mm). The post assembly absorbed a total of 189.7 k-in. (21.4 kJ) of energy. Time-sequential and post-impact photographs are shown in Figures 25 through 27.

Figure 24. Force vs. Deflection and Energy vs. Deflection, Test No. CGSA-4

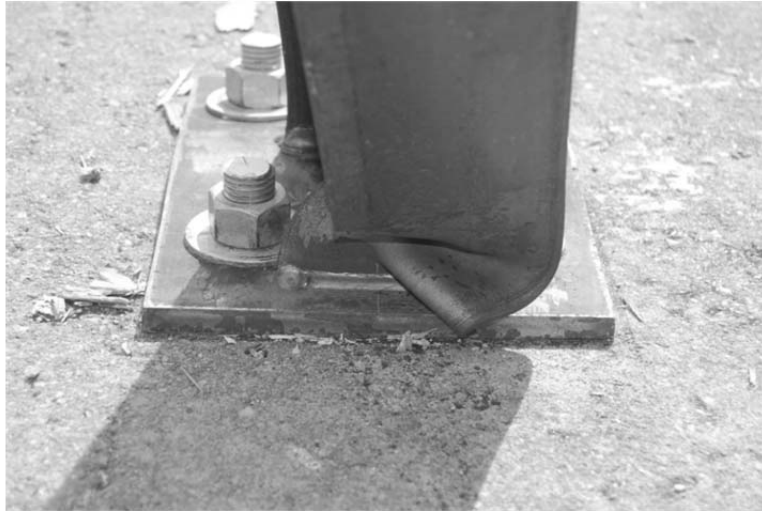
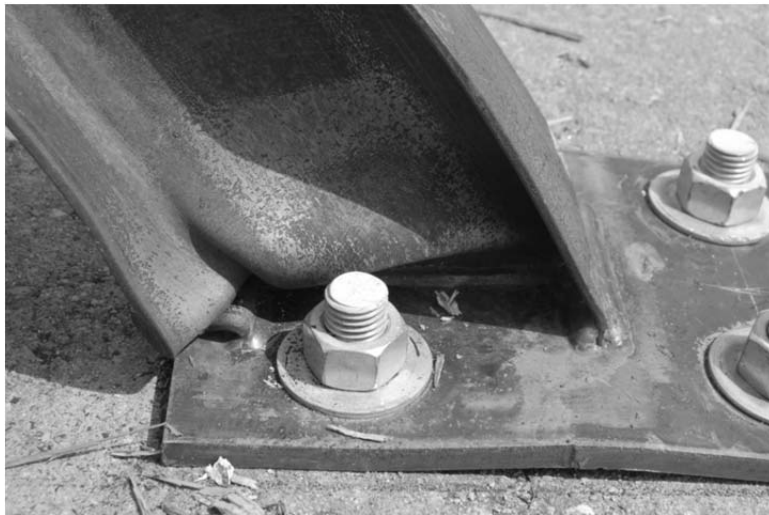
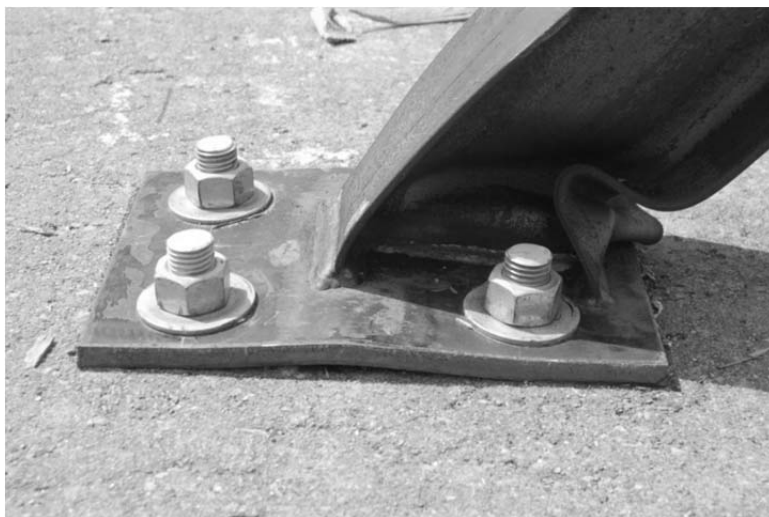
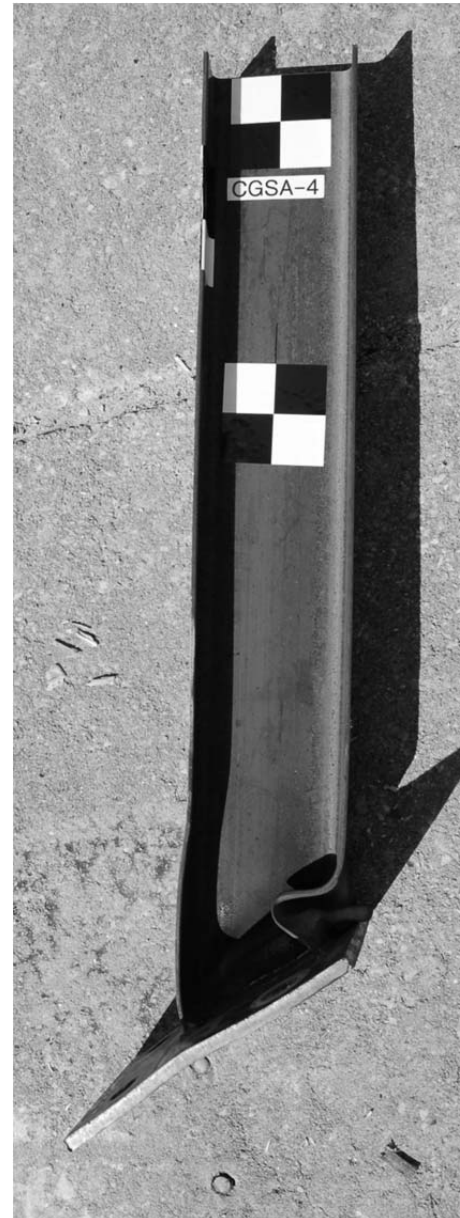
For test no. CGSA-4, the post was connected to the base plate using a 3-pass, $\frac{5}{16}$ -in. (8-mm) fillet weld on the front flange and a single-pass $\frac{1}{4}$ -in. (6-mm) fillet weld on the web and back flange. To anchor the post assembly, four 1-in. (25-mm) diameter threaded rods were epoxied into the tarmac with an embedment depth of 8 in. (203 mm). During test no. CGSA-4, the bogie impacted the post at a speed of 11.6 mph (18.7 km/h). As a result, the post bent backward, and the bogie eventually overrode the top of the post at a displacement of 20.3 in. (516 mm) as determined from the DTS-SLICE data. Post-test examination revealed buckling of the back flange and web of the post along with bending of the base plate. No evidence of plate tearing or weld failure was present.

Figure 27. Post-Impact Photographs, Test No. CGSA-4

(203-mm) embedment depth utilized in test no. CGSA-4 provided the necessary anchorage strength throughout the duration of the test and showed no signs of premature failure. Therefore, the recommended minimum embedment depth for epoxied anchor rods was set as 8 in. (203 mm).

Test no. CGSA-4 provided the desired anchorage results by preventing weld fracture, plate tearing, and anchor pullout. However, both the post and base plate utilized in test no. CGSA-4 were fabricated from steel materials with a minimum yield stress of 50 ksi (345 MPa), while the original system was fabricated and tested utilizing A36 steel components. Therefore, it was important to quantify any differences in resistance that results from the change in material grade.

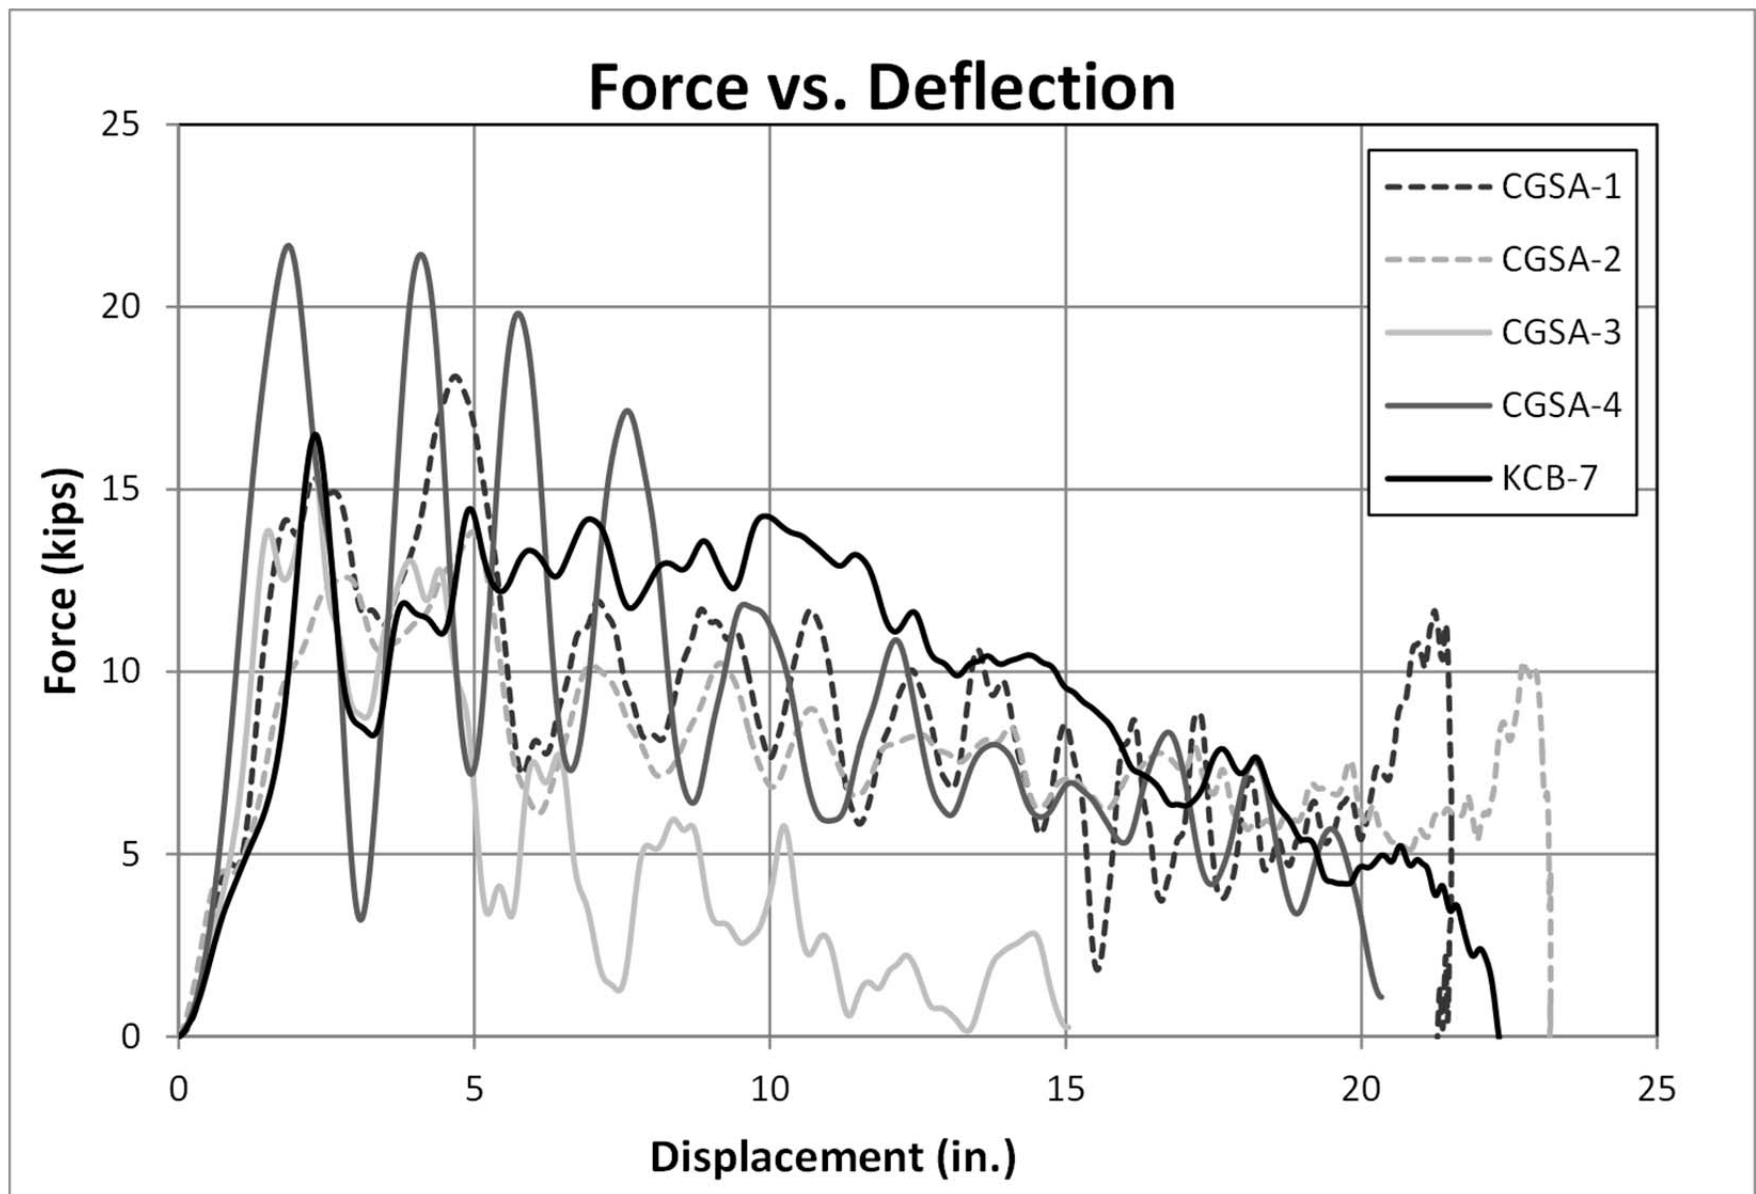
The force vs. displacement and energy vs. displacement curves from the four bogie tests conducted for this study and the curves from the bogie test conducted in the original study, test no. KCB-7 [1], are shown in Figures 28 and 29, respectively. The 50-ksi (345-MPa) steel of test no. CGSA-4 resulted in higher peak forces of the first 8 in. (203 mm) of deflection. However, after 20 in. (508 mm) of deflection, there was only a 6 percent difference in the total energy absorbed between test nos. CGSA-4 and KCB-7. Thus, both post assemblies would be expected to perform similarly when used in a full-system installation. The use of either steel grade should be acceptable for use in the W-beam guardrail system attached to low-fill culverts.

Figure 28. Comparison of Force vs. Deflection Curves

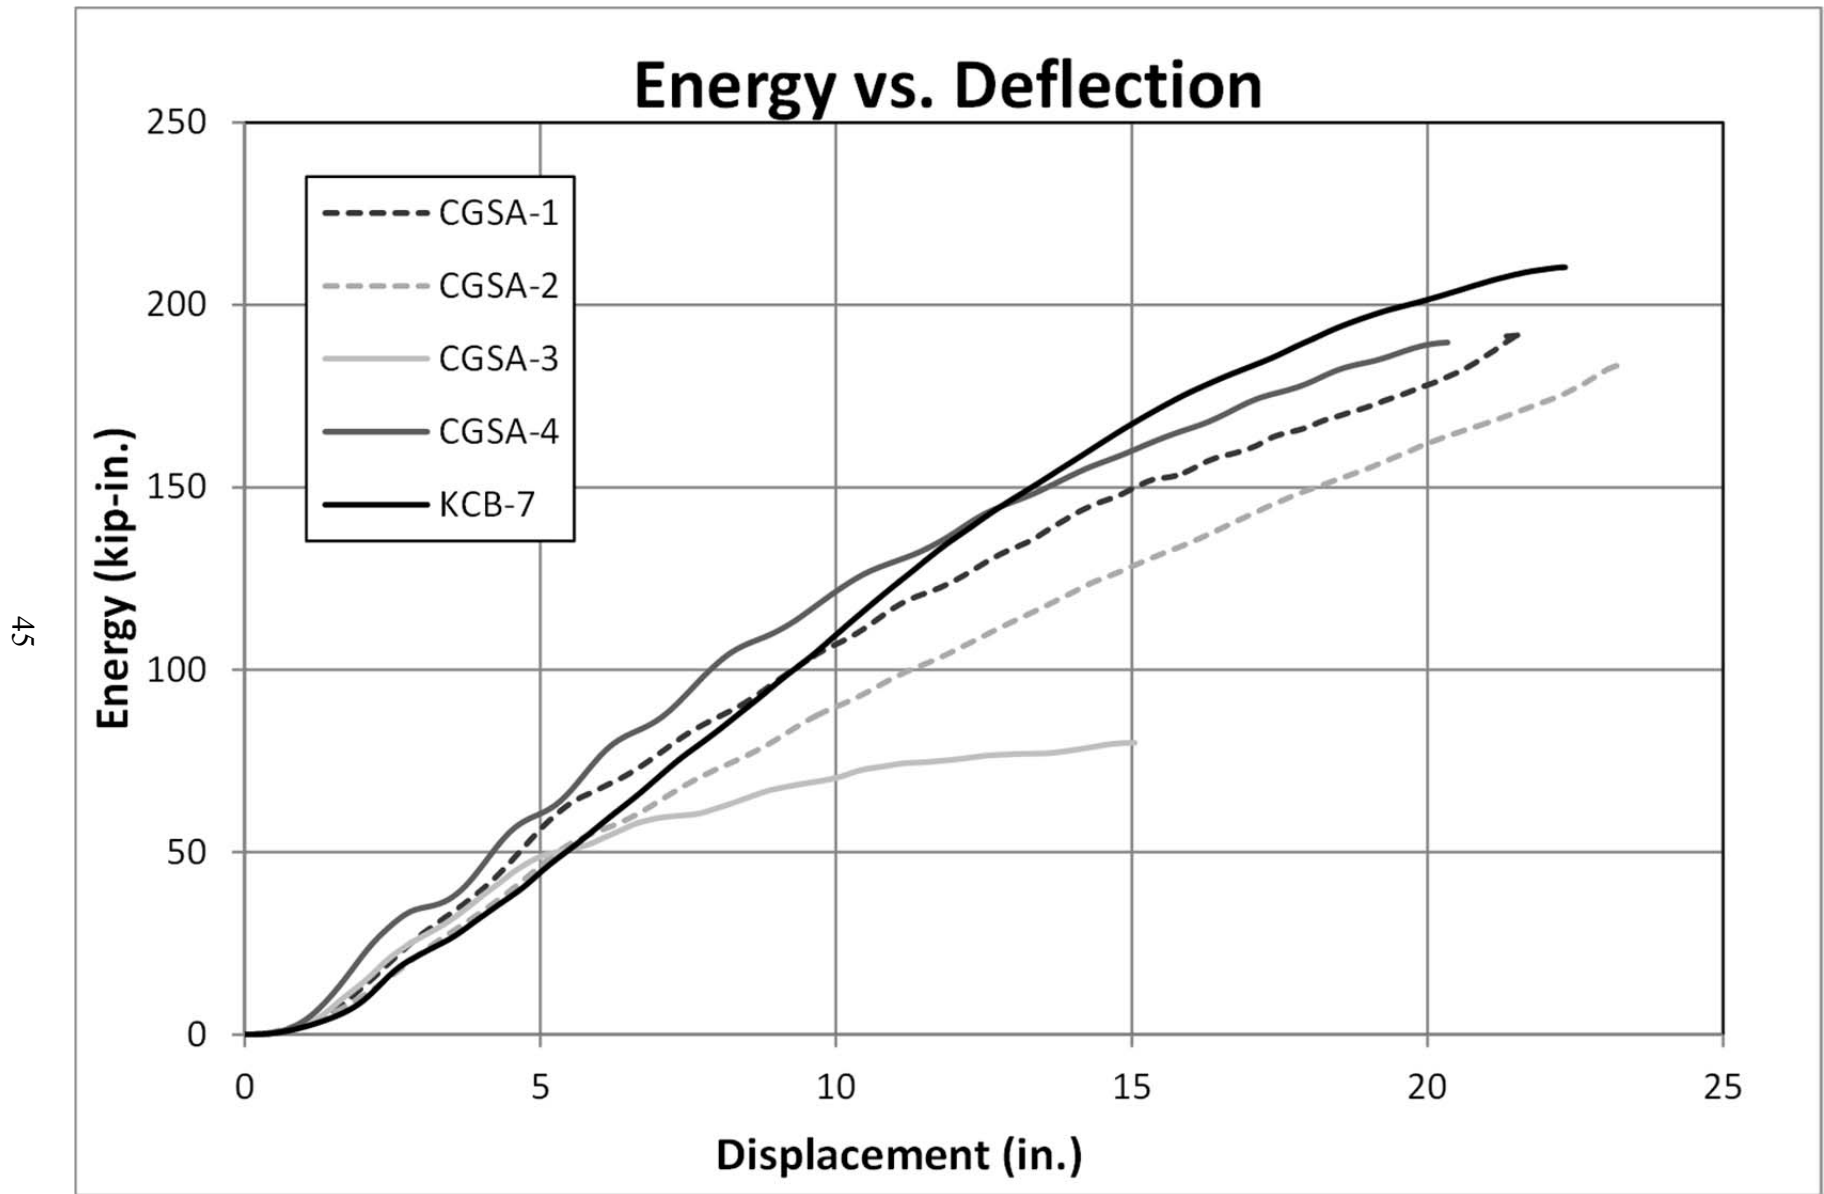
Figure 29. Comparison of Energy vs. Deflection Curves
