KDOT Guidelines for Temporary Pre-Cast Concrete Safety Barrier Condition Inspection

This is a guide developed for educational purposes to aid in evaluating the condition of Temporary Pre-Cast Concrete Safety Barrier (TCSB) used in work zones and is based, in part, on information published by the American Traffic Safety Services Association (ATSSA). This guide illustrates examples of TCSB categorized into acceptable, marginal, and unacceptable conditions. It should not be considered comprehensive and should be used in conjunction with good engineering judgement.

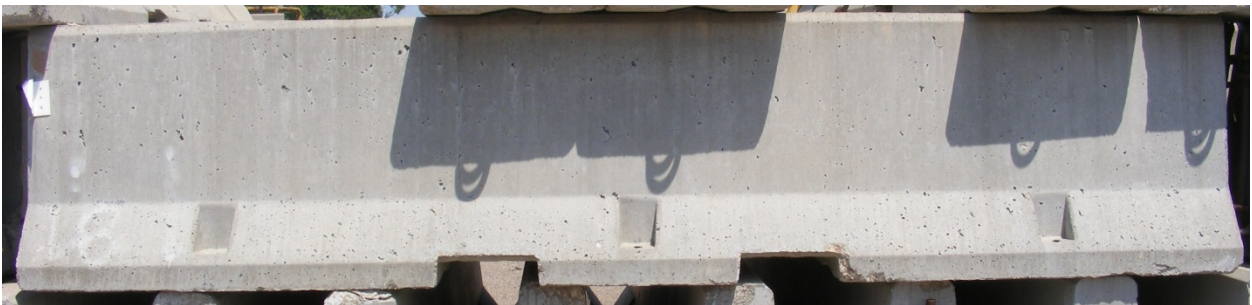
Figure 1: Acceptable TCSB

1. The barrier is typically completely intact and there may be only a few minor blemishes that can be seen, which may include superficial gouges or minor cracks.

2. The face of the barrier is intact and there is low probability of vehicles being snagged or otherwise damaged on spalls, chipped concrete, or exposed rebar.

3. The connecting loop and pin assemblies are not damaged, are all intact, and fixed in their positions.
4. Each barrier section is permanently marked with the following information:

5. Examples of acceptable TCSB may be seen in Figures 1 and 2.

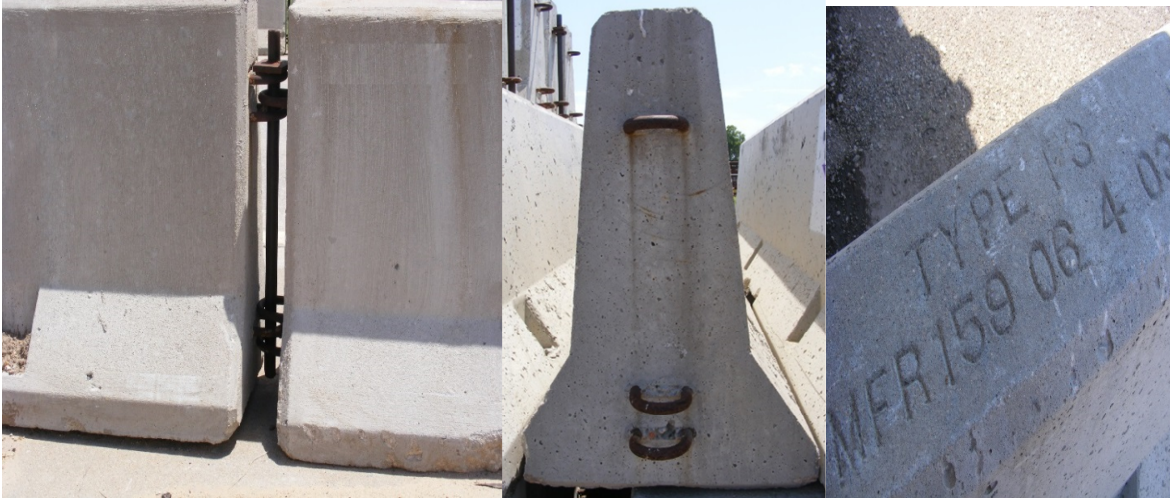
Figure 2: Acceptable TCSB

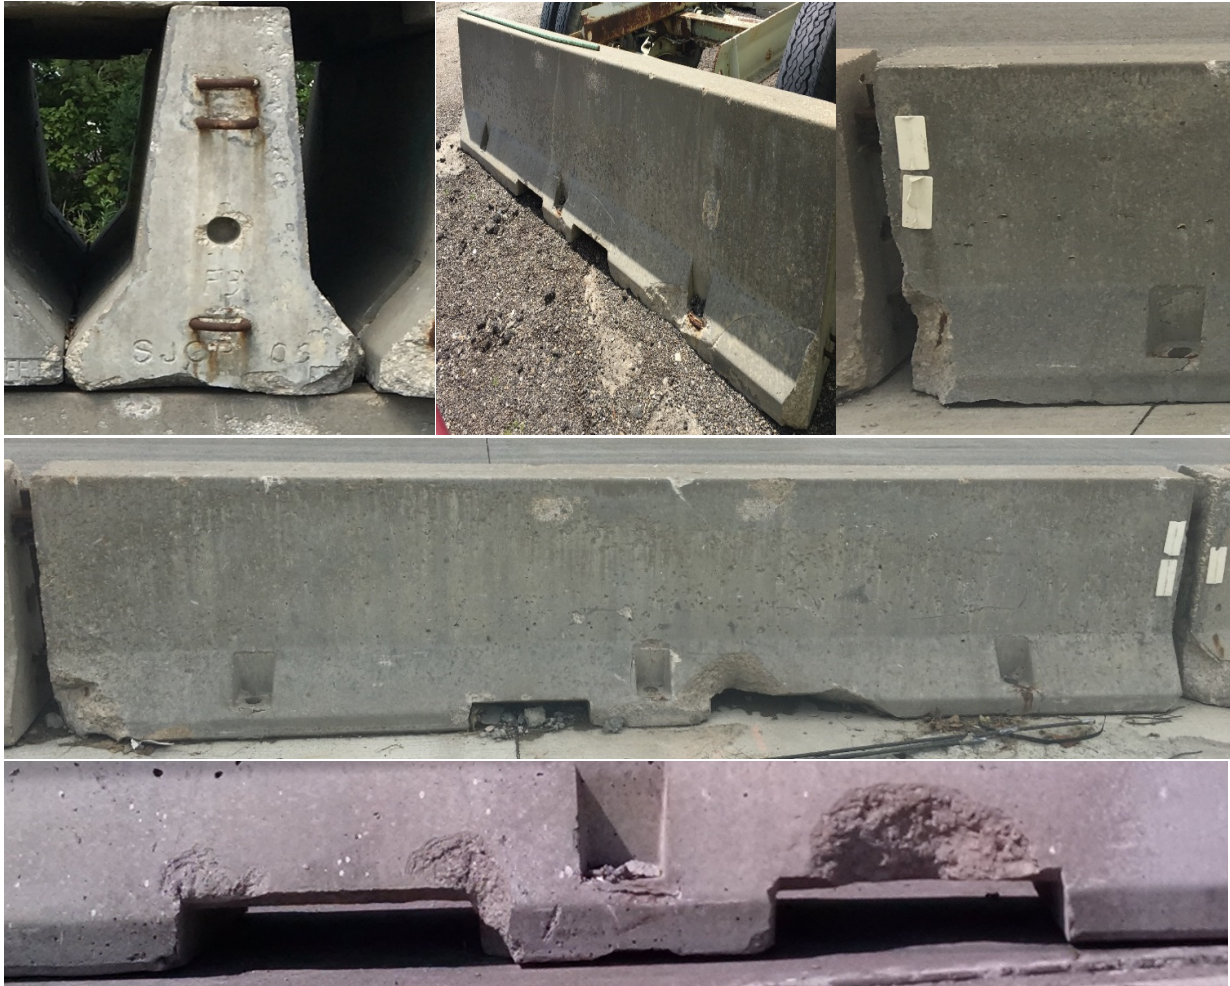
Figure 3: Marginal TCSB

1. The barrier may have some cracks, minor spalls, and imperfections. If cracks are present, they should not propagate through both sides of the barrier section. In general, spall dimensions less than or equal to approximately 12" L x 3" D x 3" H may be considered minor.
2. The connecting loop and pin assemblies are not damaged, are all intact, and fixed in their positions.
3. There may be limited sections of concrete that have fallen off or become disengaged from the barrier.
4. Some rebar may be exposed.
5. Significant structural cracking is not present.
6. Examples of marginal TCSB may be seen in Figure 3.

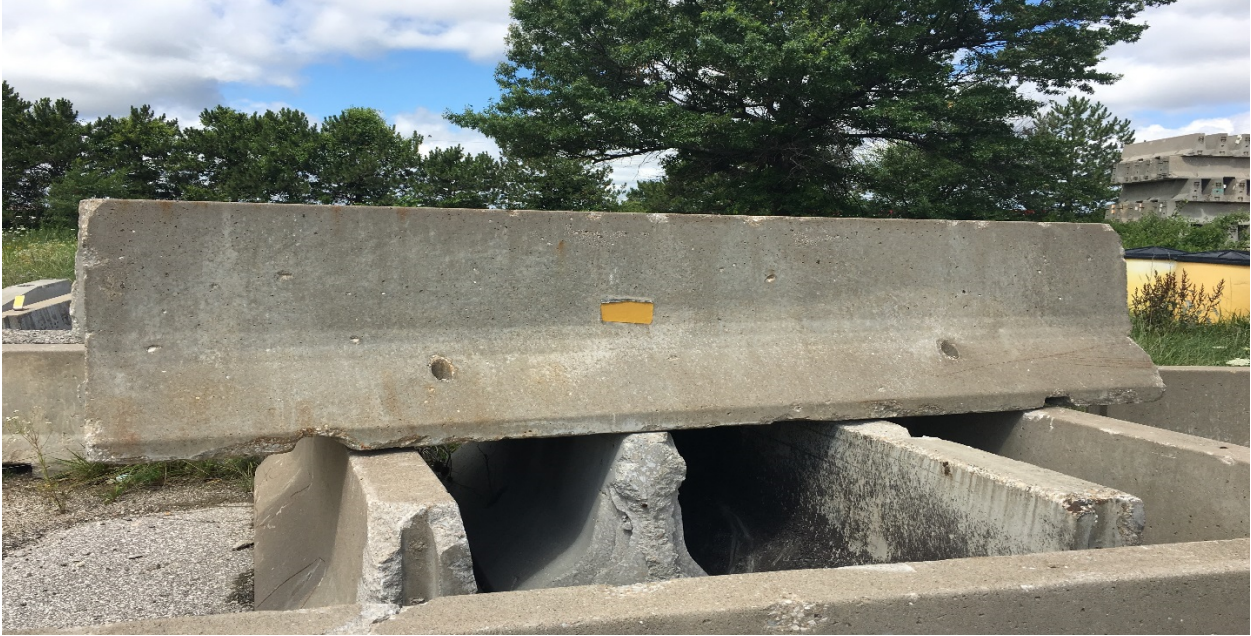
Figure 4: Non F-Shape TCSB

6. Barrier is not an F-Shape Barrier and therefore does not meet the contract documents. An example of a Non F-Shape Temporary Pre-Cast Concrete Safety Barrier may be seen in Figure 4.
7. Examples of unacceptable TCSB may be seen in Figure 5.

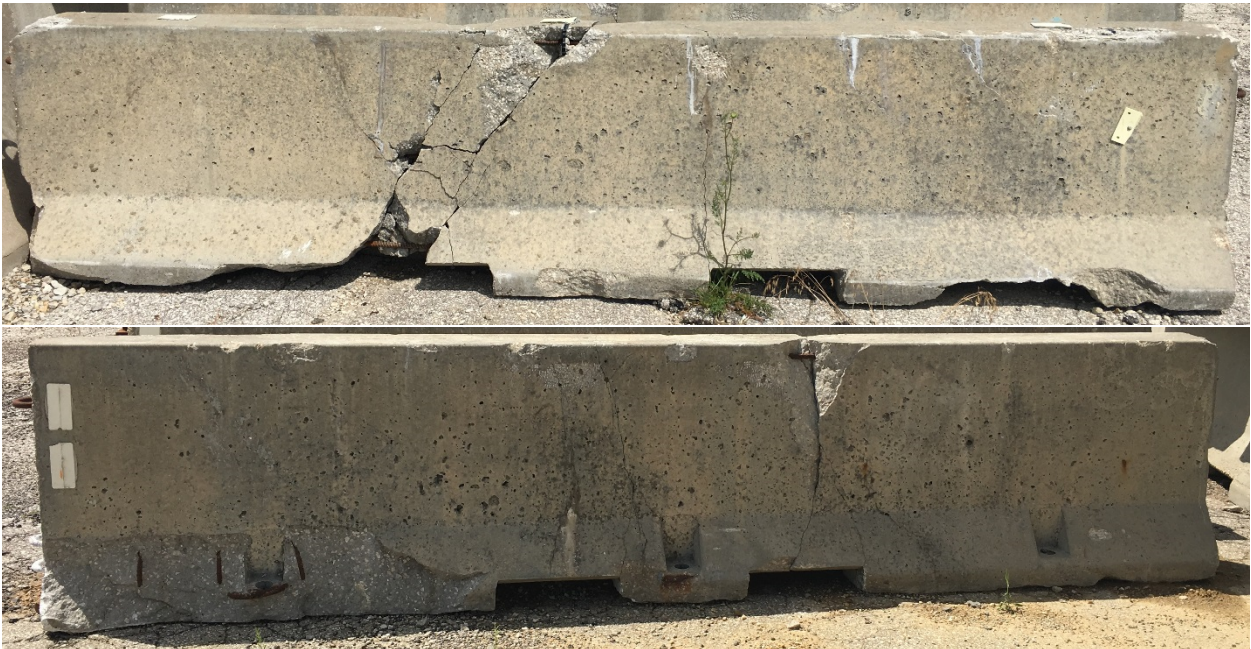
Figure 5: Unacceptable TCSB

1. The barrier exhibits signs of significant structural cracking where large spalls and cracks may be seen throughout the barrier. Some cracks may propagate through both sides of the barrier section. In general, spall dimensions greater than approximately 12" L x 3" D x 3" H are unacceptable.
2. Concrete has become disengaged from the barrier section and could easily be knocked loose if hit.
3. The shape of the barrier face is no longer intact presenting the potential for the barrier not to perform as intended during a crash due to vehicles to becoming snagged or damaged.
4. The connecting loop and pin assemblies are deformed, bent, broken, or no longer fixed in their position.
5. Significant amounts of rebar may be exposed or protruding from the barrier.
