Historic Bridge Railing Details

NCHRP Report 554, Figure 83

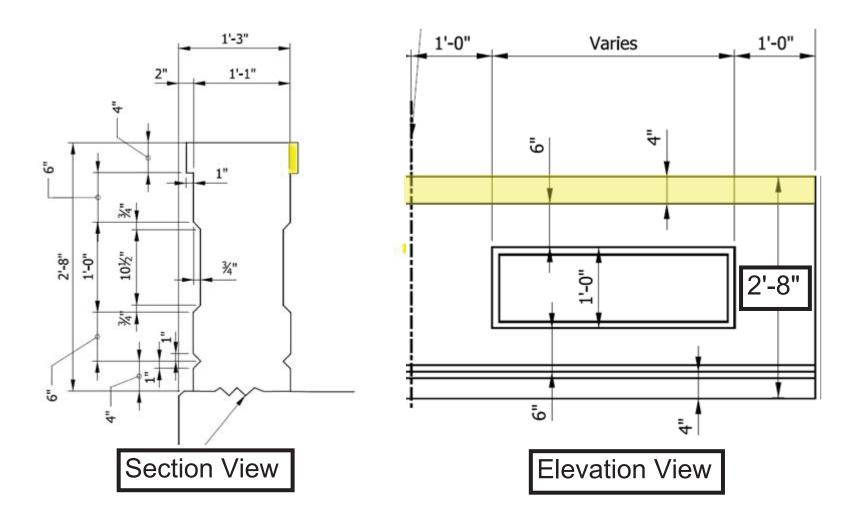
Not to Scale

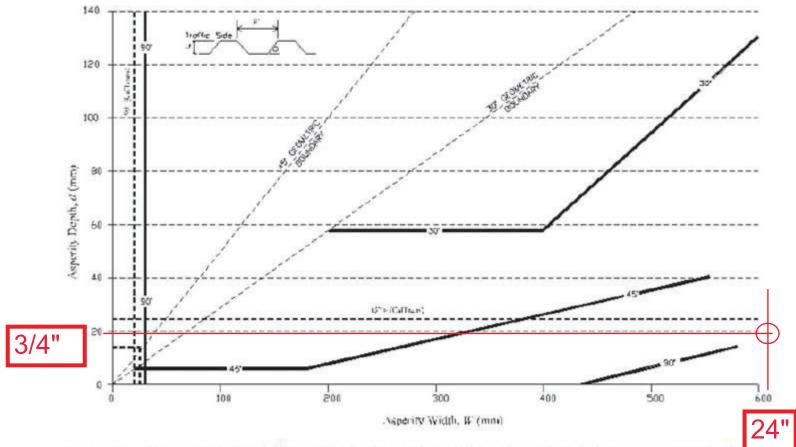
Figure 83. Comparison of guidelines for single-slope and vertical-face barriers and stone masonry guardwalls.
