SAFETY PERFORMANCE EVALUATION OF MINNESOTA'S TEMPORARY RIGID PANEL SIGN STAND SYSTEMS

MIDWEST ROADSIDE SAFETY FACILITY

MwRSF Research Report No. TRP-03-166-07

February 8, 2007

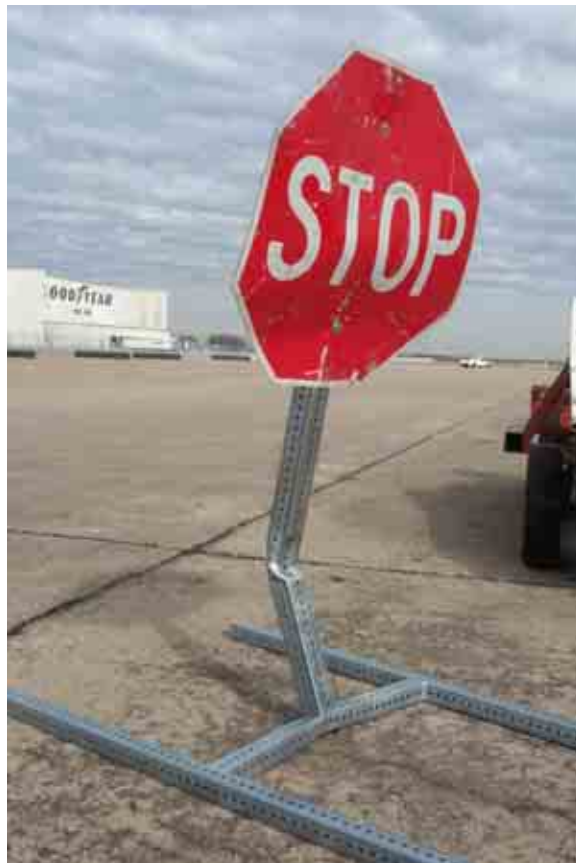
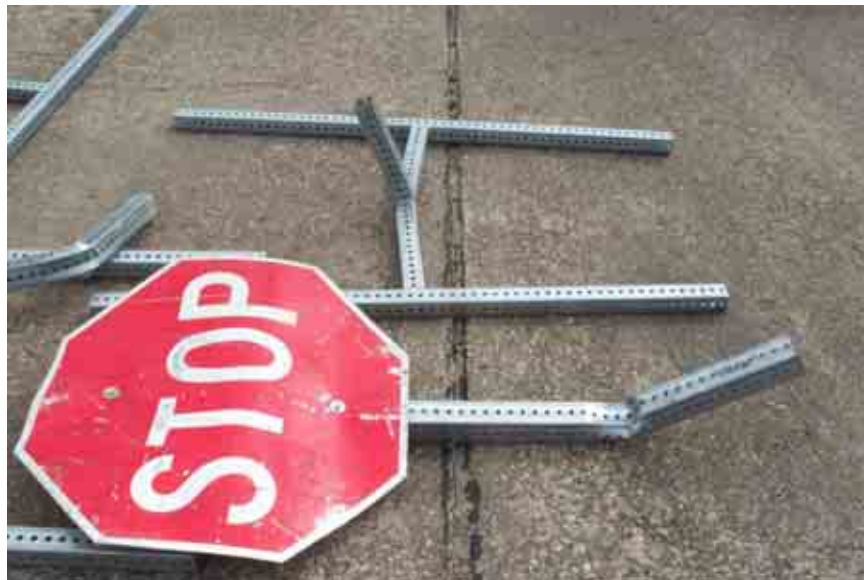
Figure 6. Stop Sign System Damage, Bogie Test MN1C-0 (0 degrees)

- Ballast (sandbags): 20.4 kg (45 lbs) – 1 sandbag at end of each leg
3. Bogie Vehicle Weight: 1,119 kg (2,467 lbs)
 4. Test Date: 3/17/04
 5. Impact Speed: 98.7 km/h (61.3 mph)
Impact Orientation: 0 degrees
 6. Velocity Change: 9.5 km/h (5.9 mph)
 7. System Performance – Minor mast deformation was observed. The sign panel, mast, and legs remained intact. The top of the sign panel and mast rotated toward the vehicle, but no contact nor damage to the simulated windshield was observed. Throughout the entire test, the system remained in front of the vehicle and never became a potential hazard to the bogie nor the occupant compartment.

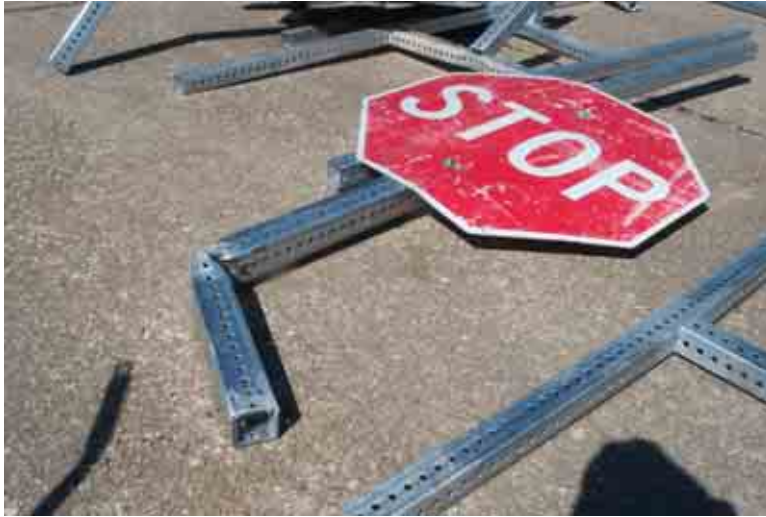
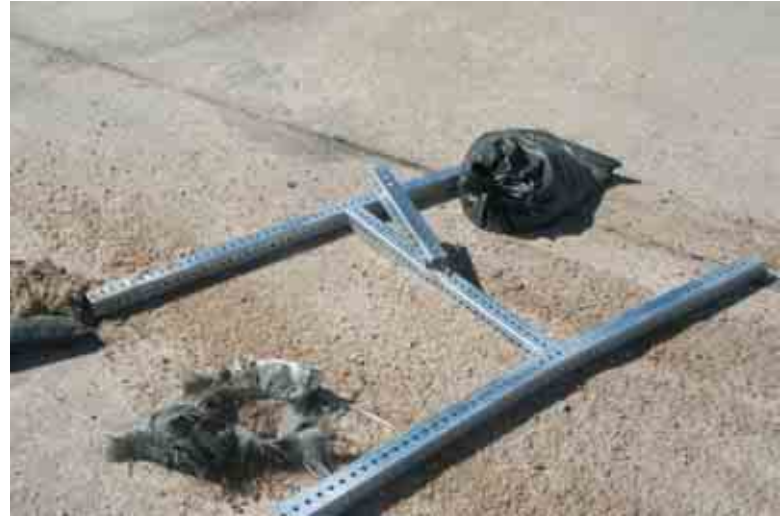
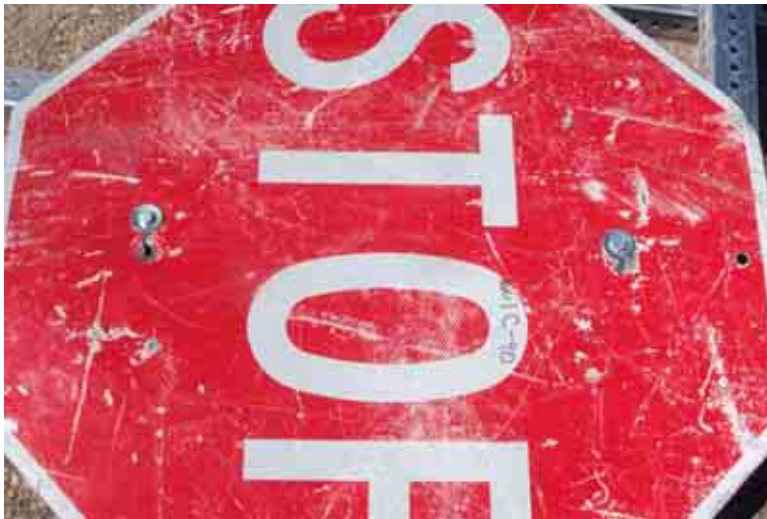
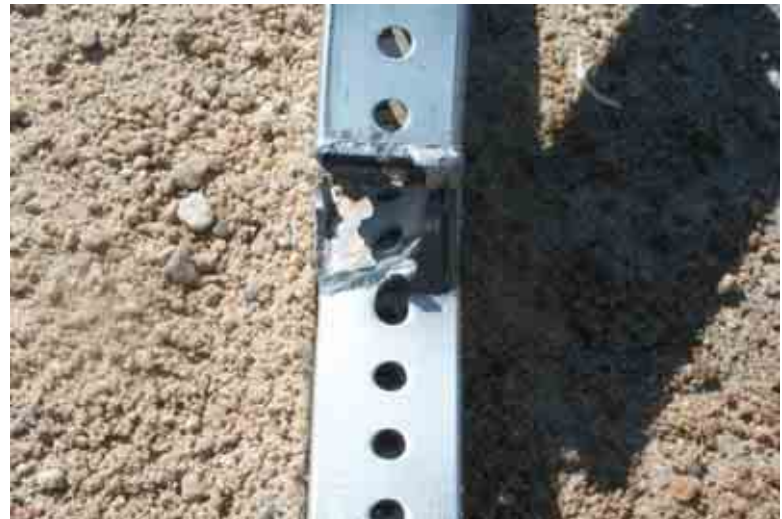
Figure 7. Stop Sign System Damage, Bogie Test MN1C-90 (90 degrees)

7. System Performance – Minor mast and panel deformations were observed. The mast disengaged completely from the base. The top of the sign panel and mast rotated toward the vehicle and contacted the hood, but no contact nor damage to the simulated windshield was observed. After contact with the hood, the system rebounded off the bogie and traveled up and away from the bogie and was never considered to be a potential hazard to the bogie nor the occupant compartment.

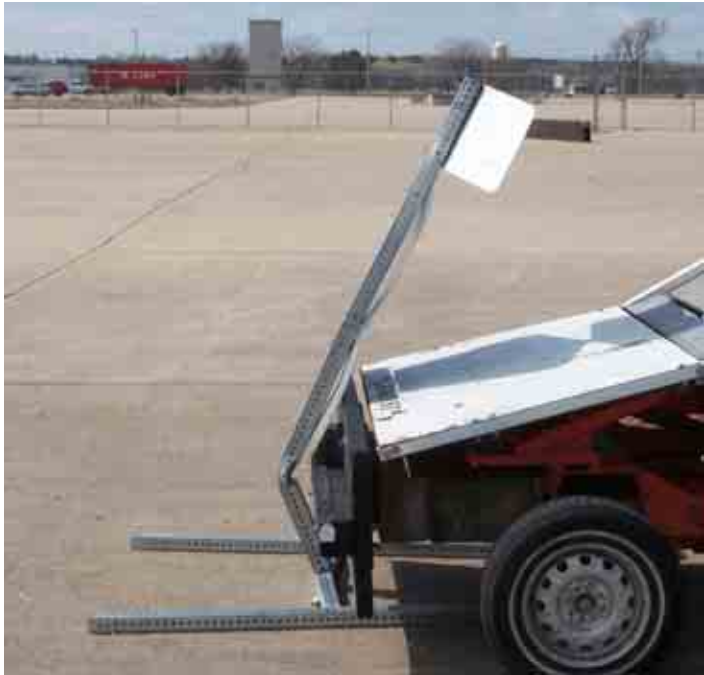
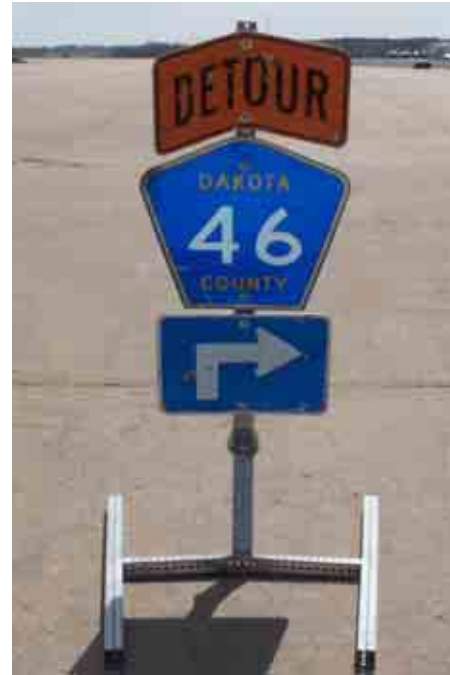
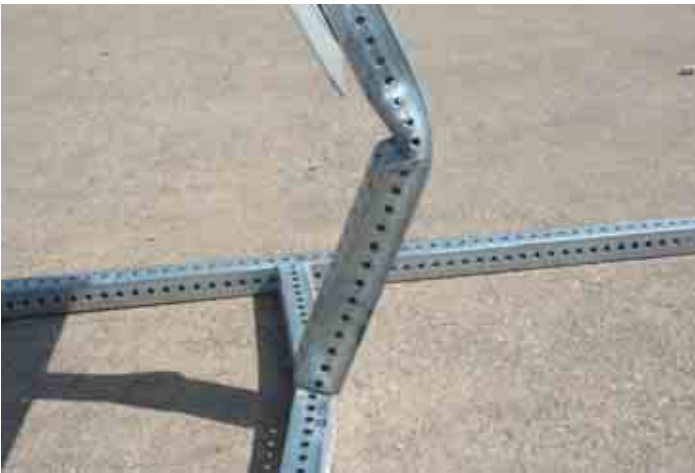
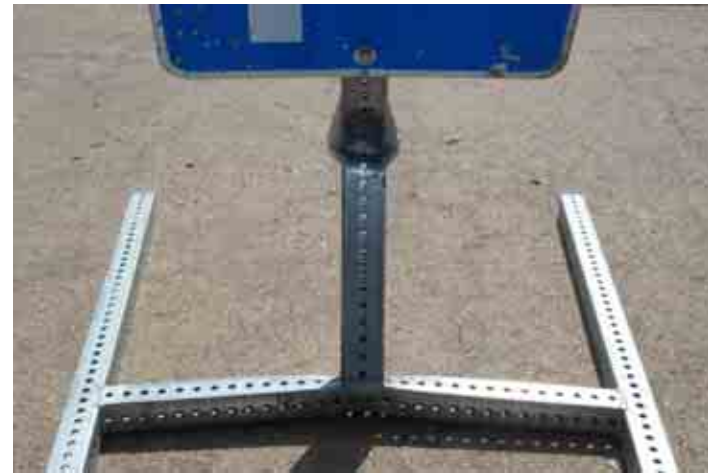
Figure 13. Route Marker Assembly System Damage, Bogie Test MN2C-0 (0 degrees)

Legs:	13.154 kg (29 lbs)
Panel, Mast, and Outside Tubes:	15.876 kg (35 lbs)
Total System Weight:	29.030 kg (64 lbs)
Ballast (sandbags):	20.4 kg (45 lbs) – 1 sandbag at end of each leg
3. Bogie Vehicle Weight: 1,119 kg (2,467 lbs)
4. Test Date: 3/17/04
5. Impact Speed: 101.5 km/h (63.0 mph)
Impact Orientation: 0 degrees
6. Velocity Change: 7.0 km/h (4.4 mph)
7. System Performance – Minor mast deformation was observed. The sign panels, mast, and legs remained intact. The top of the sign panels and mast rotated toward the vehicle, but no contact nor damage to the windshield was observed. Throughout the entire test, the system remained in front of the vehicle and never became a potential hazard to the bogie nor the occupant compartment.

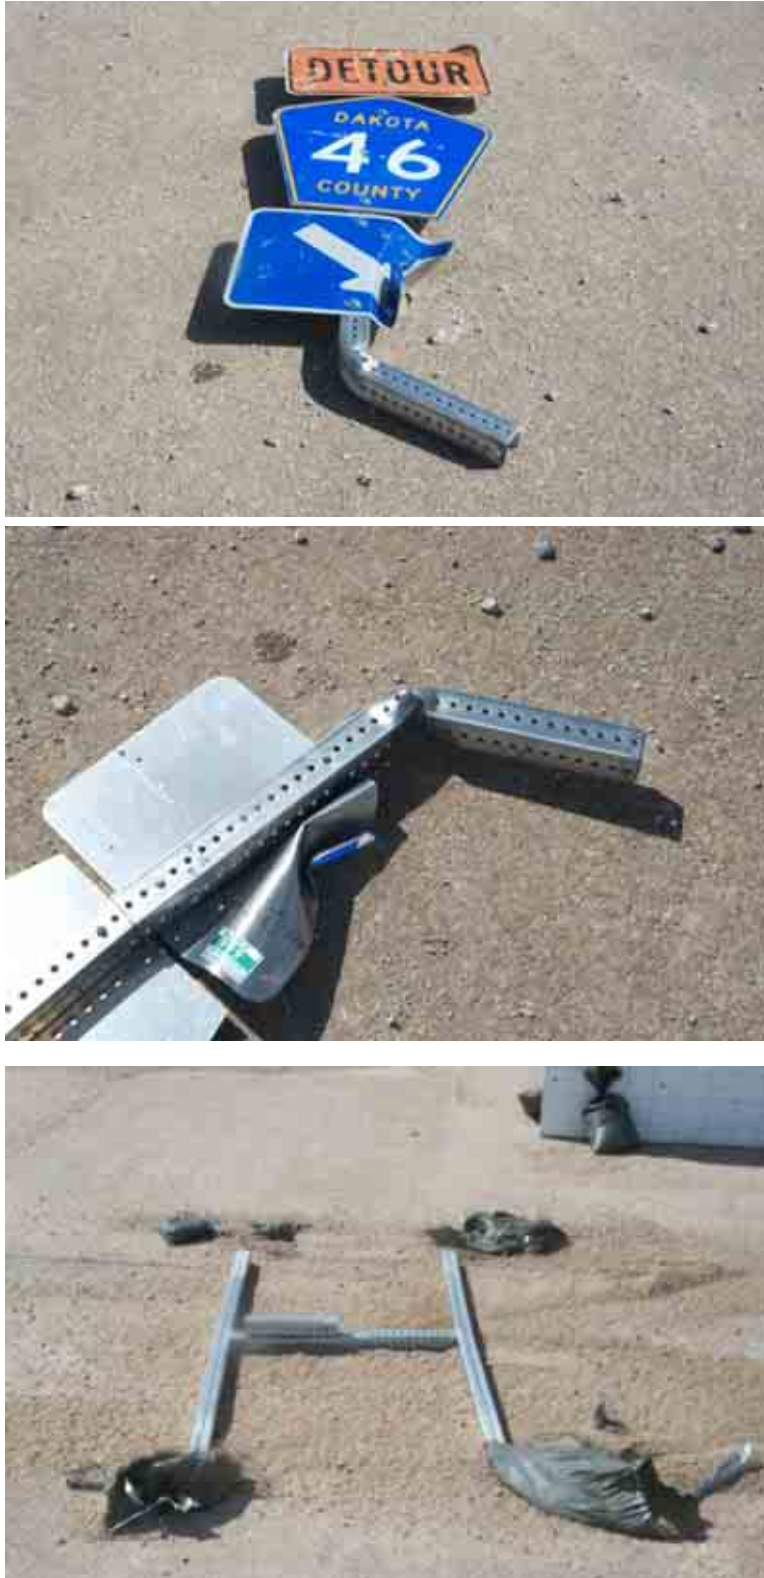
Figure 14. Route Marker Assembly System Damage, Bogie Test MN2C-90 (90 degrees)

7. System Performance – Minor mast and panel deformations were observed. The mast disengaged completely from the base. The top of the sign panels and mast rotated toward the vehicle and contacted the hood, but no contact nor damage to the simulated windshield was observed. After contact with the hood, the system rebounded off the bogie and traveled up and away from the bogie and was never considered to be a potential hazard to the bogie nor the occupant compartment.

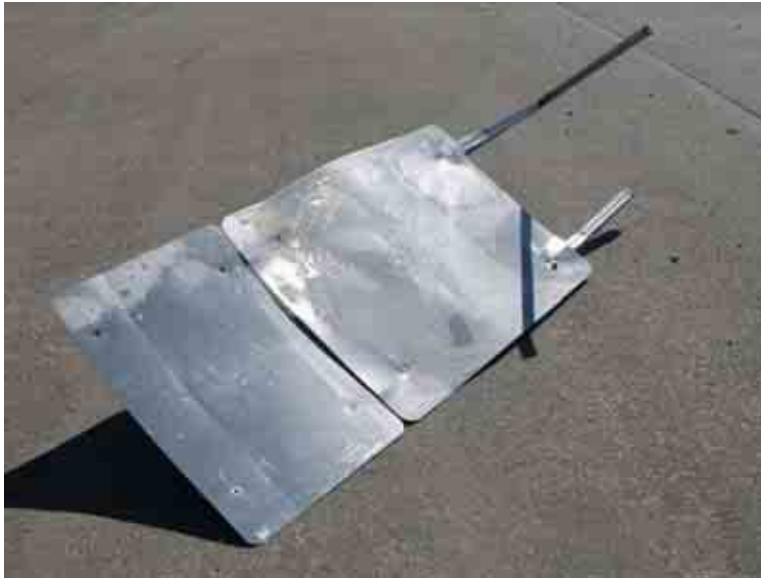
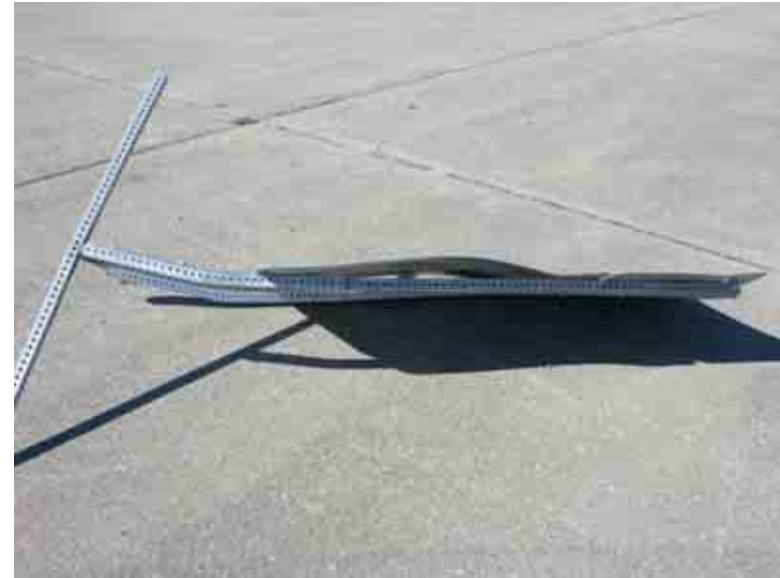
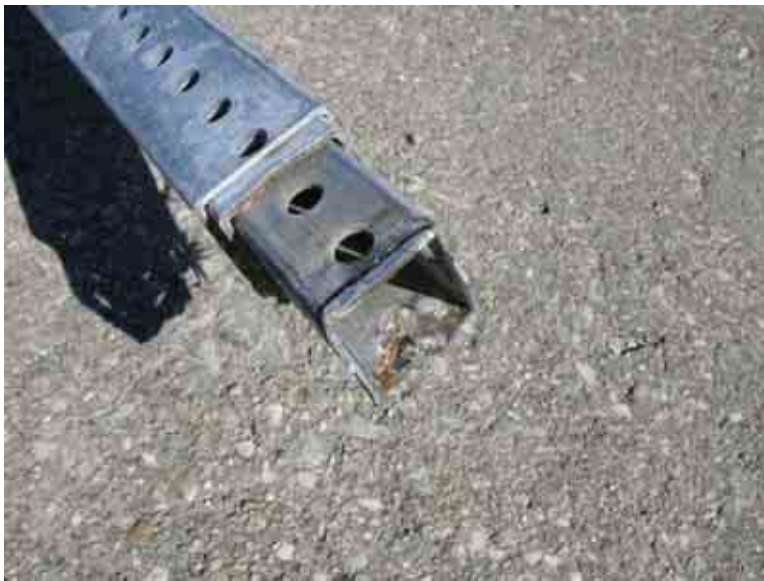
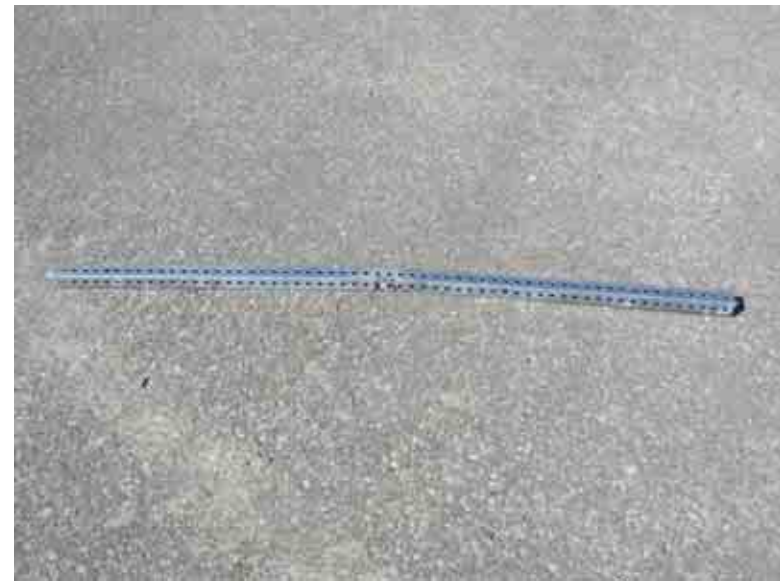
Figure 21. Work Zone Speed Limit Sign System Damage, Bogie Test MN3B-0-2 (0 degrees)

3. Bogie Vehicle Weight: 1,119 kg (2,467 lbs)
4. Test Date: 9/24/04
5. Impact Speed: 98.6 km/h (61.3 mph)
Impact Orientation: 0 degrees
6. Velocity Change: 5.2 km/h (3.2 mph)
7. System Performance – Minor mast deformation was observed. The sign panels, masts, and legs remained intact. The top of the sign panels and masts rotated toward the vehicle and contacted the roof, but no contact nor damage to the simulated windshield was observed. After contact with the roof, the system rebounded off the bogie and traveled up and away from the bogie and was never considered to be a potential hazard to the bogie nor the occupant compartment.

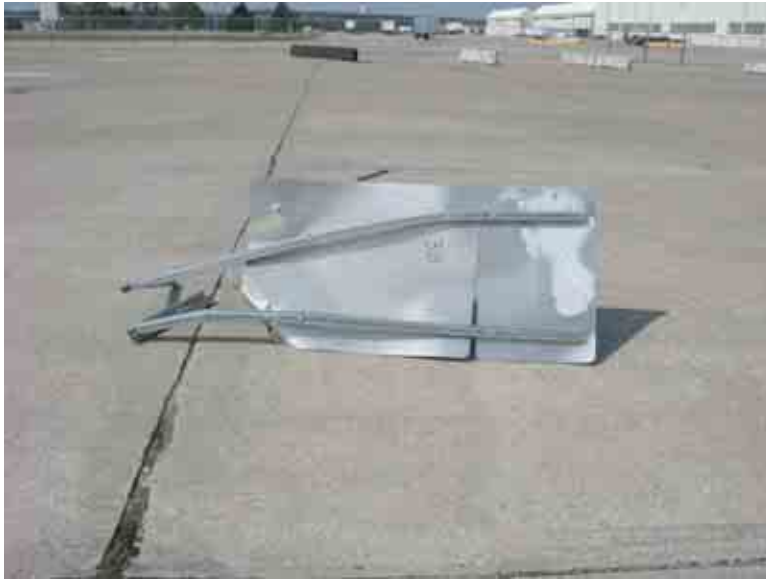
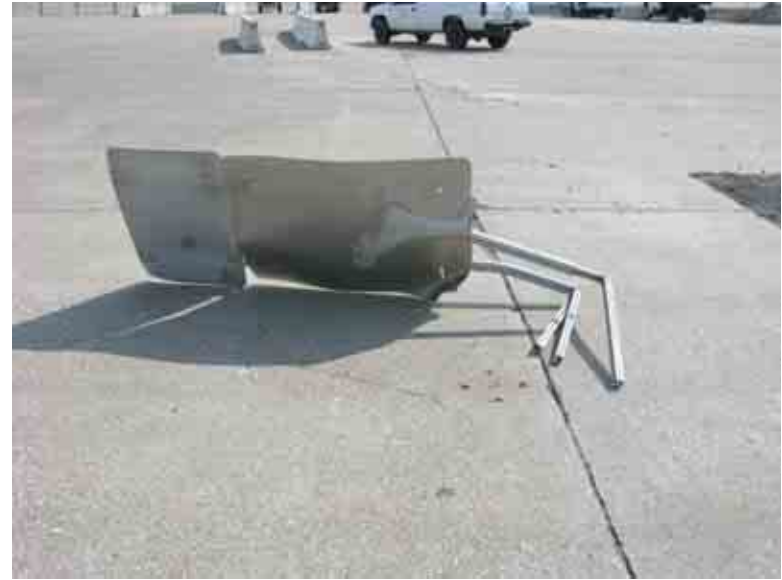
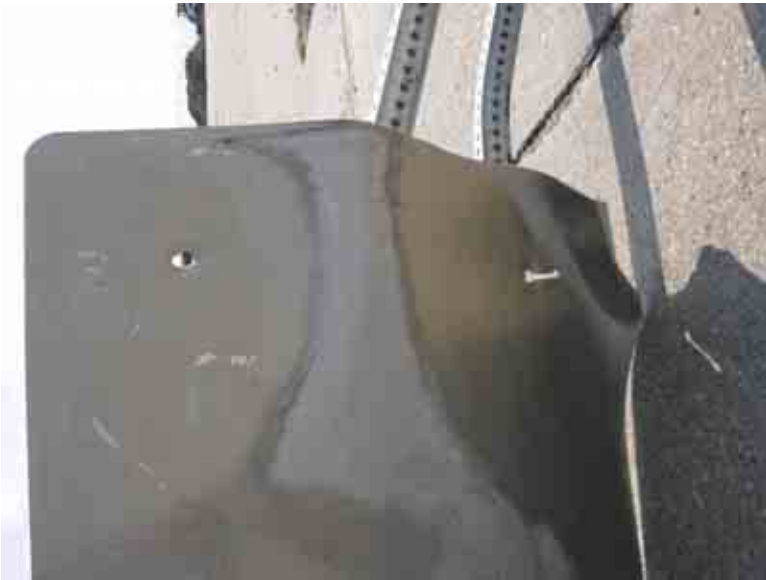
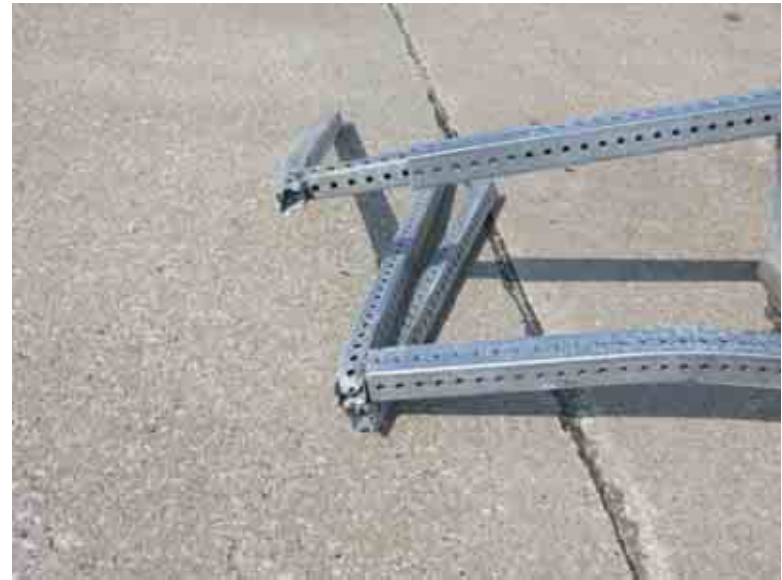
Figure 22. Work Zone Speed Limit Sign System Damage, Bogie Test MN3B-90 (90 degrees)

7. System Performance – Mast and panel deformations were observed. One side of the legs fractured. The impacted side of the sign panels and masts rotated toward the vehicle and contacted the roof, but no contact nor damage to the simulated windshield was observed. After contact with the roof, the system rebounded off the bogie and traveled up and away from the bogie and was never considered to be a potential hazard to the bogie nor the occupant compartment.

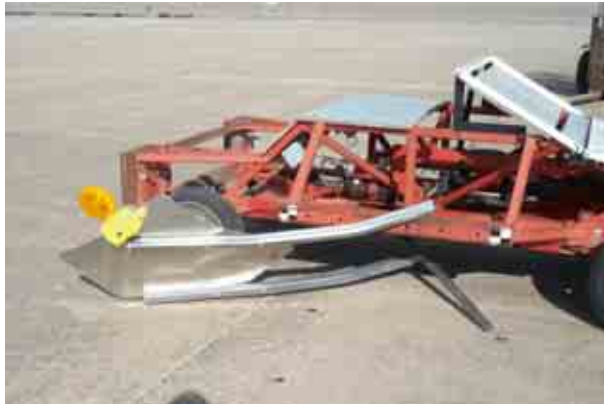
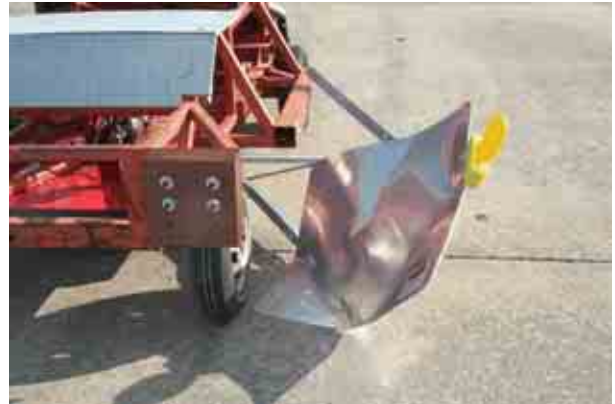
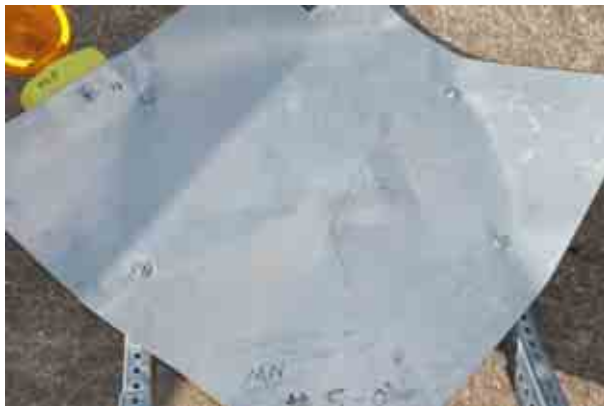
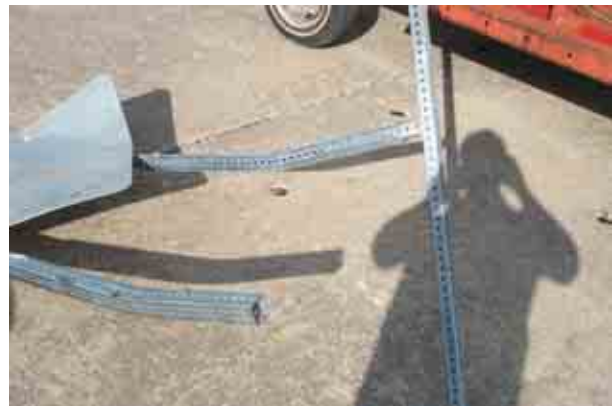
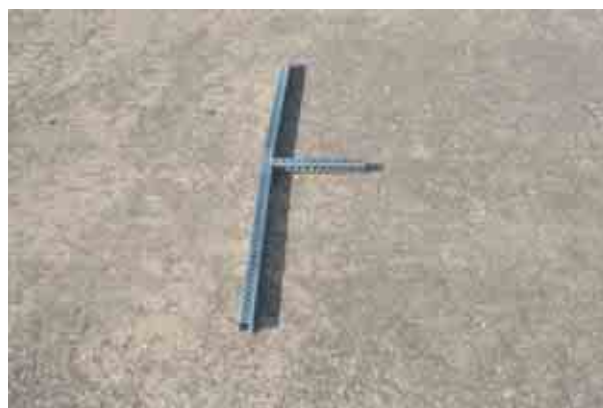
Figure 30. 36" x 36" Diamond Work Zone Sign System Damage, Bogie Tests MN5A-0

7. System Performance – Minor mast deformation was observed. The sign panel, masts, and legs remained intact. The top of the sign panel and masts rotated toward the vehicle, but no contact nor damage to the simulated windshield was observed. Throughout the entire test, the system remained in front of the vehicle and never became a potential hazard to the bogie nor the occupant compartment.

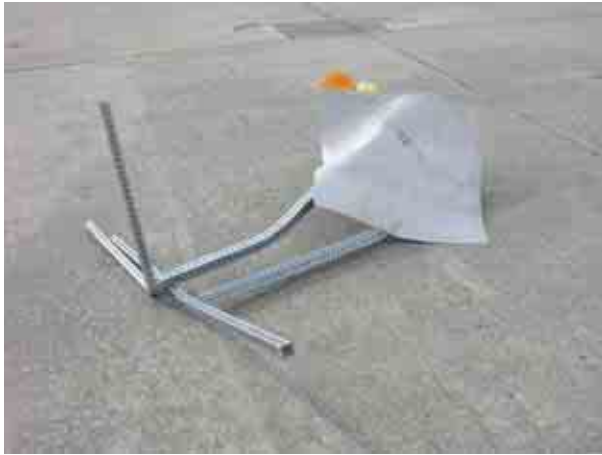
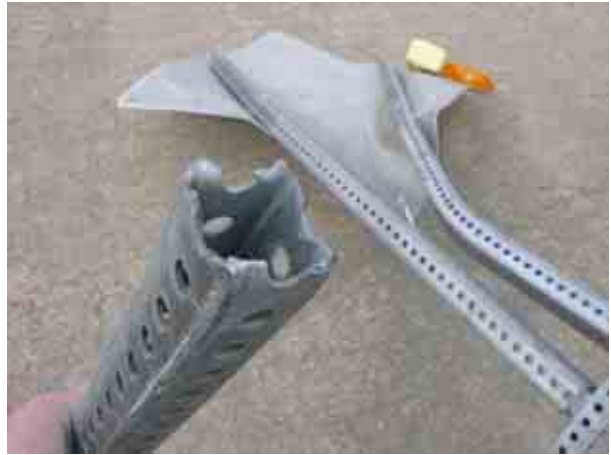
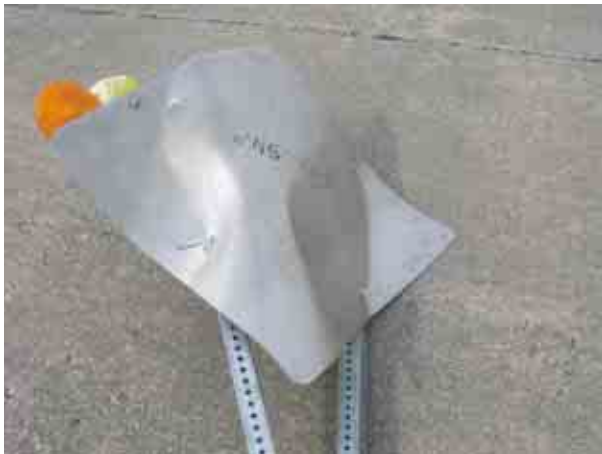
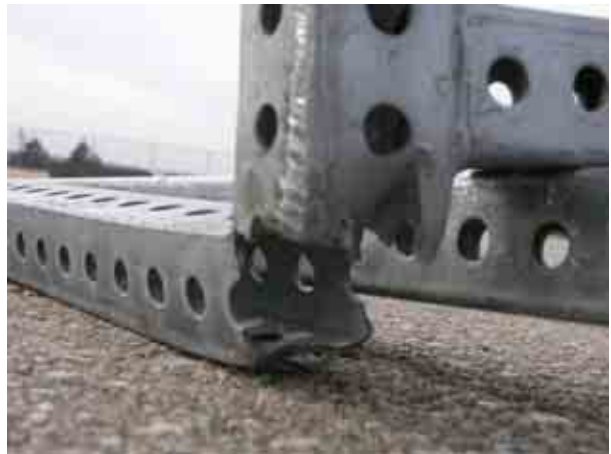
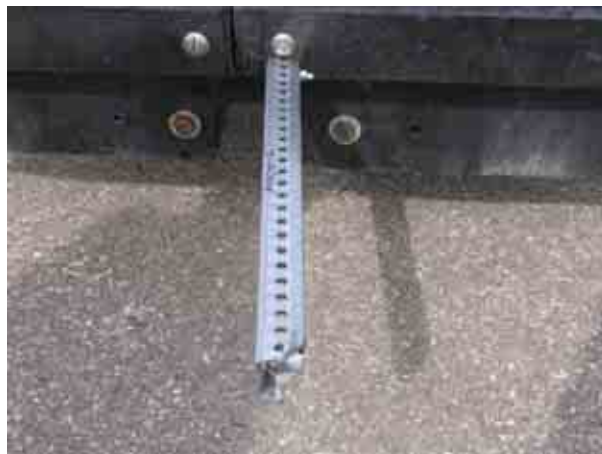
Figure 31. 36" x 36" Diamond Work Zone Sign System Damage, Bogie Tests MN5C-90-2

7. System Performance – Minor mast and panel deformations were observed. The leg on the impact side fractured. The bumper strut disengaged from the rest of the system and remained embedded in the bumper of the bogie. The impacted side of the sign panel and masts rotated toward the vehicle, but no contact nor damage to the simulated windshield was observed. Throughout the entire test, the system remained in front of the vehicle and never became a potential hazard to the bogie nor the occupant compartment.

It should be noted that the 90-degree orientation of the original system did not perform satisfactorily. Thus, the system design was modified and performed satisfactorily as shown in bogie

test MN5C-90-2. However, the 0-degree orientation of the modified system tested in bogie test MN5C-90-2 was not tested. It was believed that adding the bumper strut to the system would not affect the performance of the 0-degree orientation test of this system. Therefore, it is believed that the system would perform similarly to that behavior observed in the bogie test results of the original system, bogie test MN5A-0. The final design is shown in Figures 27 and 29.

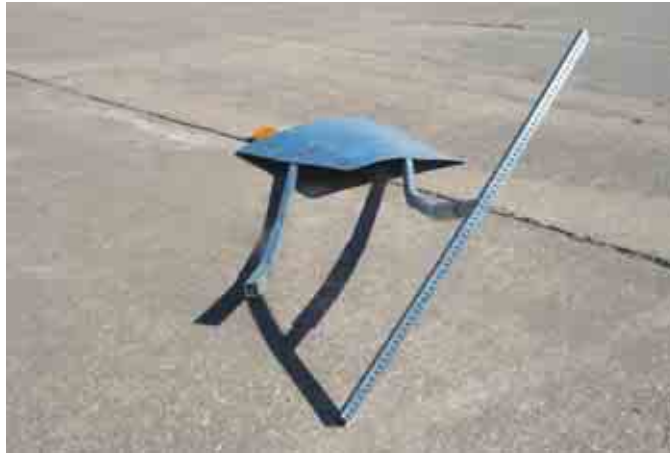
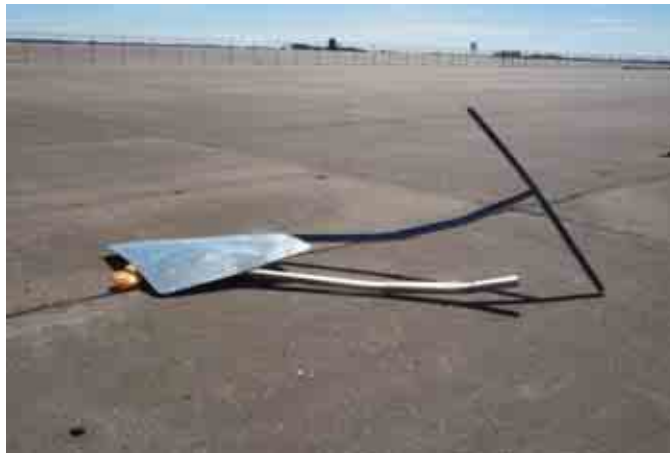
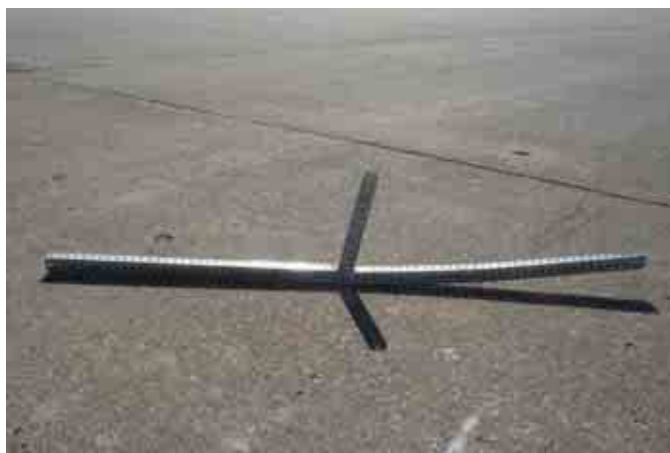
Figure 38. 48" x 48" Diamond Panel Work Zone Sign System with 5' Mounting Height Damage, Bogie Test MN6A-0 (0 degrees)

3. Bogie Vehicle Weight: 1,119 kg (2,467 lbs)
4. Test Date: 3/18/04
5. Impact Speed: 107.5 km/h (66.8 mph)
Impact Orientation: 0 degrees
6. Velocity Change: 18.4 km/h (7.9 mph)
7. System Performance – Minor mast and panel deformations were observed. The sign panel, masts, and one leg remained intact. One leg disengaged from the rest of the system. The top of the sign panel and mast rotated toward the vehicle and lightly contacted the front of the roof, but no contact nor damage to the simulated windshield was observed. Throughout the entire test, the system remained in front of the vehicle and never became a potential hazard to the bogie nor the occupant compartment.

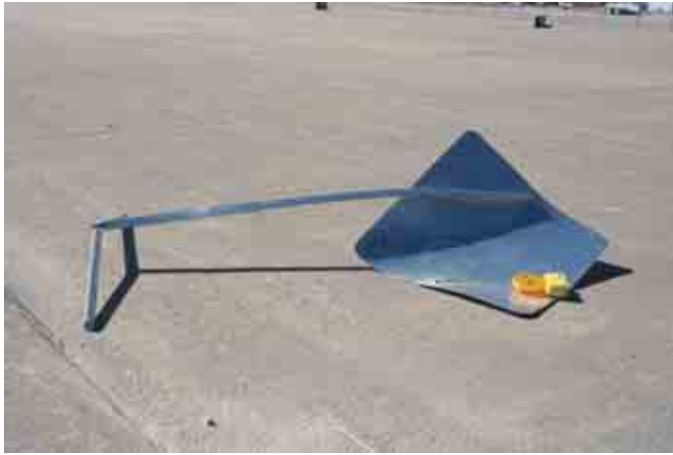
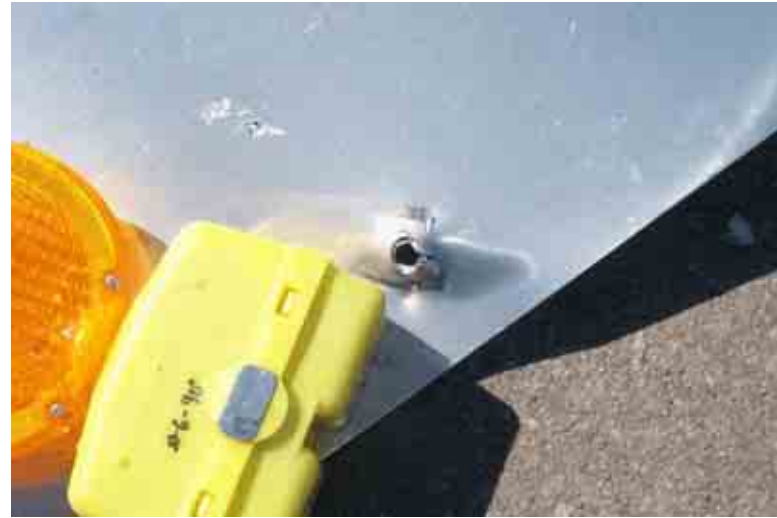
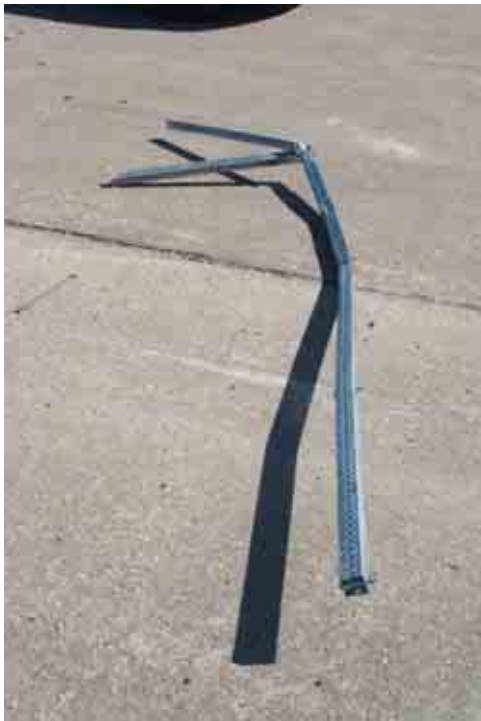
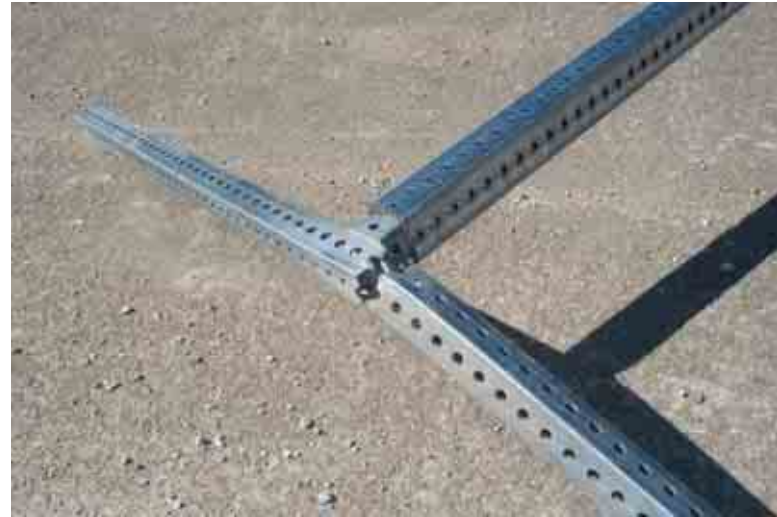
Figure 39. 48" x 48" Diamond Panel Work Zone Sign System with 5' Mounting Height Damage, Bogie Test MN6A-90 (90 degrees)

7. System Performance – Minor mast and panel deformations were observed. The impacted mast and leg disengaged completely from the system. The non-impacted leg fractured. The top of the sign panel and mast rotated toward the vehicle and contacted the roof, but no contact nor damage to the simulated windshield was observed. After contact with the roof, the system rebounded off the bogie and traveled up and away from the bogie and was never considered to be a potential hazard to the bogie nor the occupant compartment.

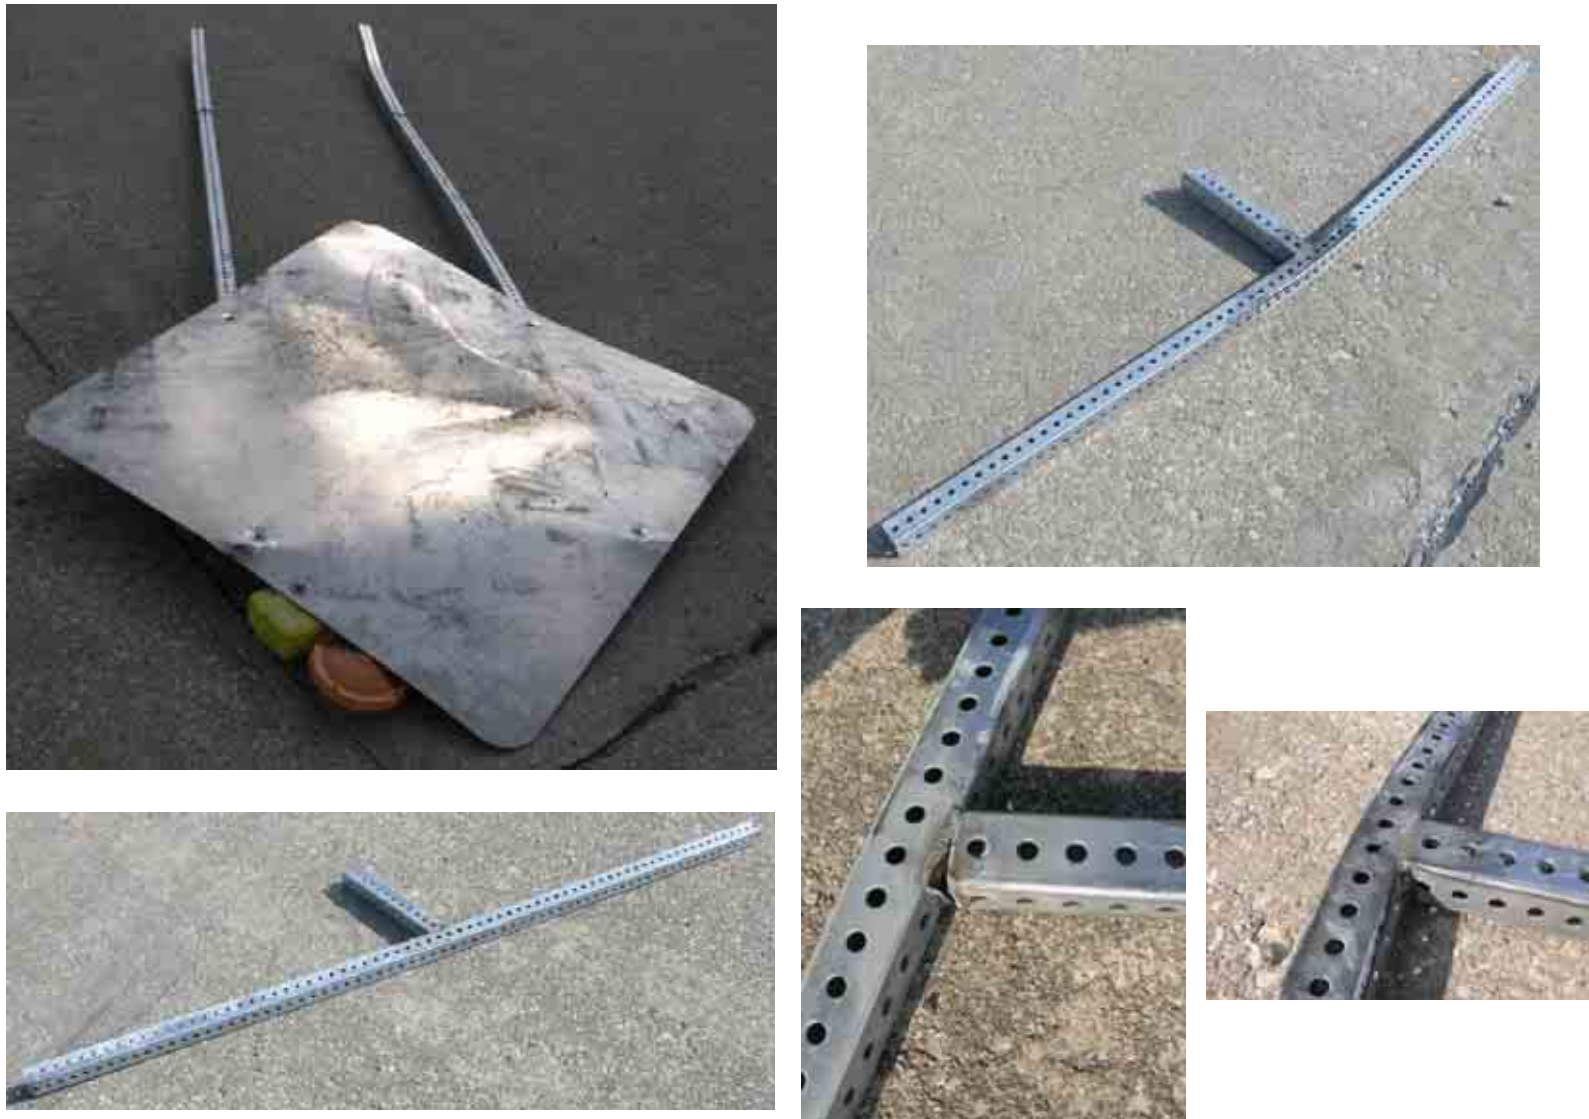
Figure 47. 48" x 48" Diamond Panel Work Zone Sign System with 7' Mounting Height Damage, Bogie Test MN7A-0 (0 degrees)

3. Bogie Vehicle Weight: 1,119 kg (2,467 lbs)
4. Test Date: 9/22/04
5. Impact Speed: 102.2 km/h (63.5 mph)
Impact Orientation: 0 degrees
6. Velocity Change: 5.7 km/h (3.5 mph)
7. System Performance – Minor mast deformations were observed. The sign panel and masts remained intact, while the legs disengaged from the rest of the system. Both legs encountered weld failure at the vertical upright stub. The top of the sign panel and masts rotated toward the vehicle, but no contact nor damage to the simulated windshield was observed. As the system rotated over the top of the bogie, no contact with the bogie was observed, and the system was never considered to be a potential hazard to the bogie nor the occupant compartment.

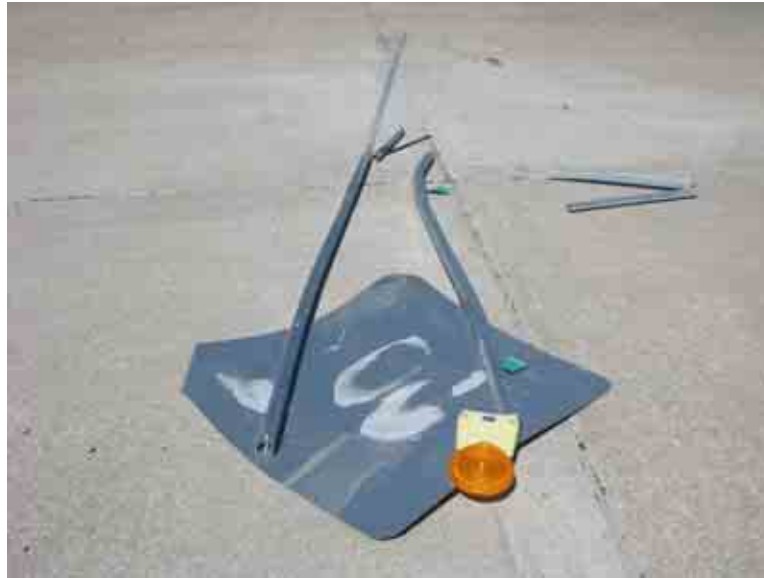
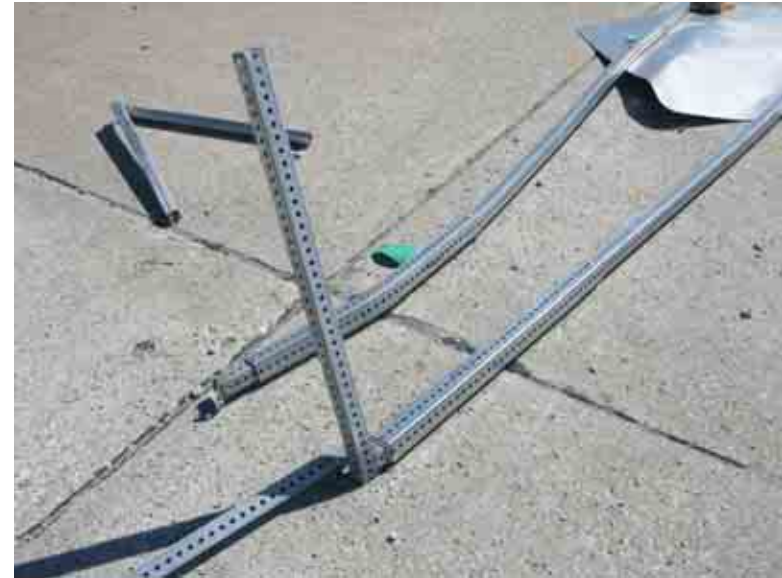
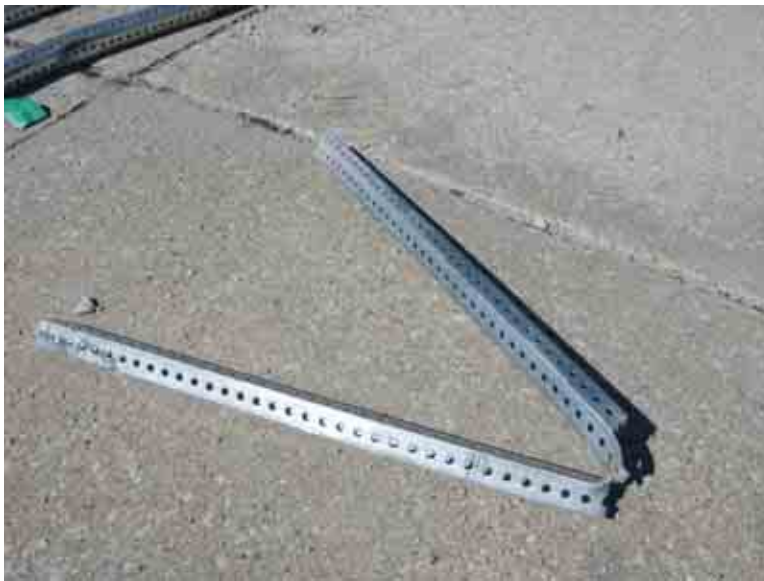
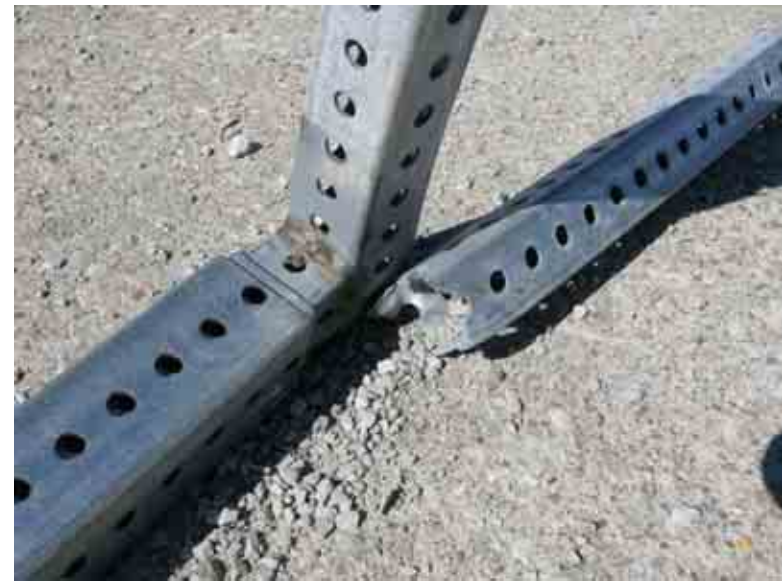
Figure 48. 48" x 48" Diamond Panel Work Zone Sign System with 7' Mounting Height Damage, Bogie Test MN7A-90 (90 degrees)

7. System Performance – Minor mast and panel deformations were observed. The welds on the legs for the vertical upright stubs fractured. The impacted side of the sign panel and masts rotated toward the vehicle and contacted the front of the roof, but no contact nor damage to the simulated windshield was observed. After contact with the front of the roof, the system continued to rotate over the top of the bogie, the system was never considered to be a potential hazard to the bogie nor the occupant compartment.

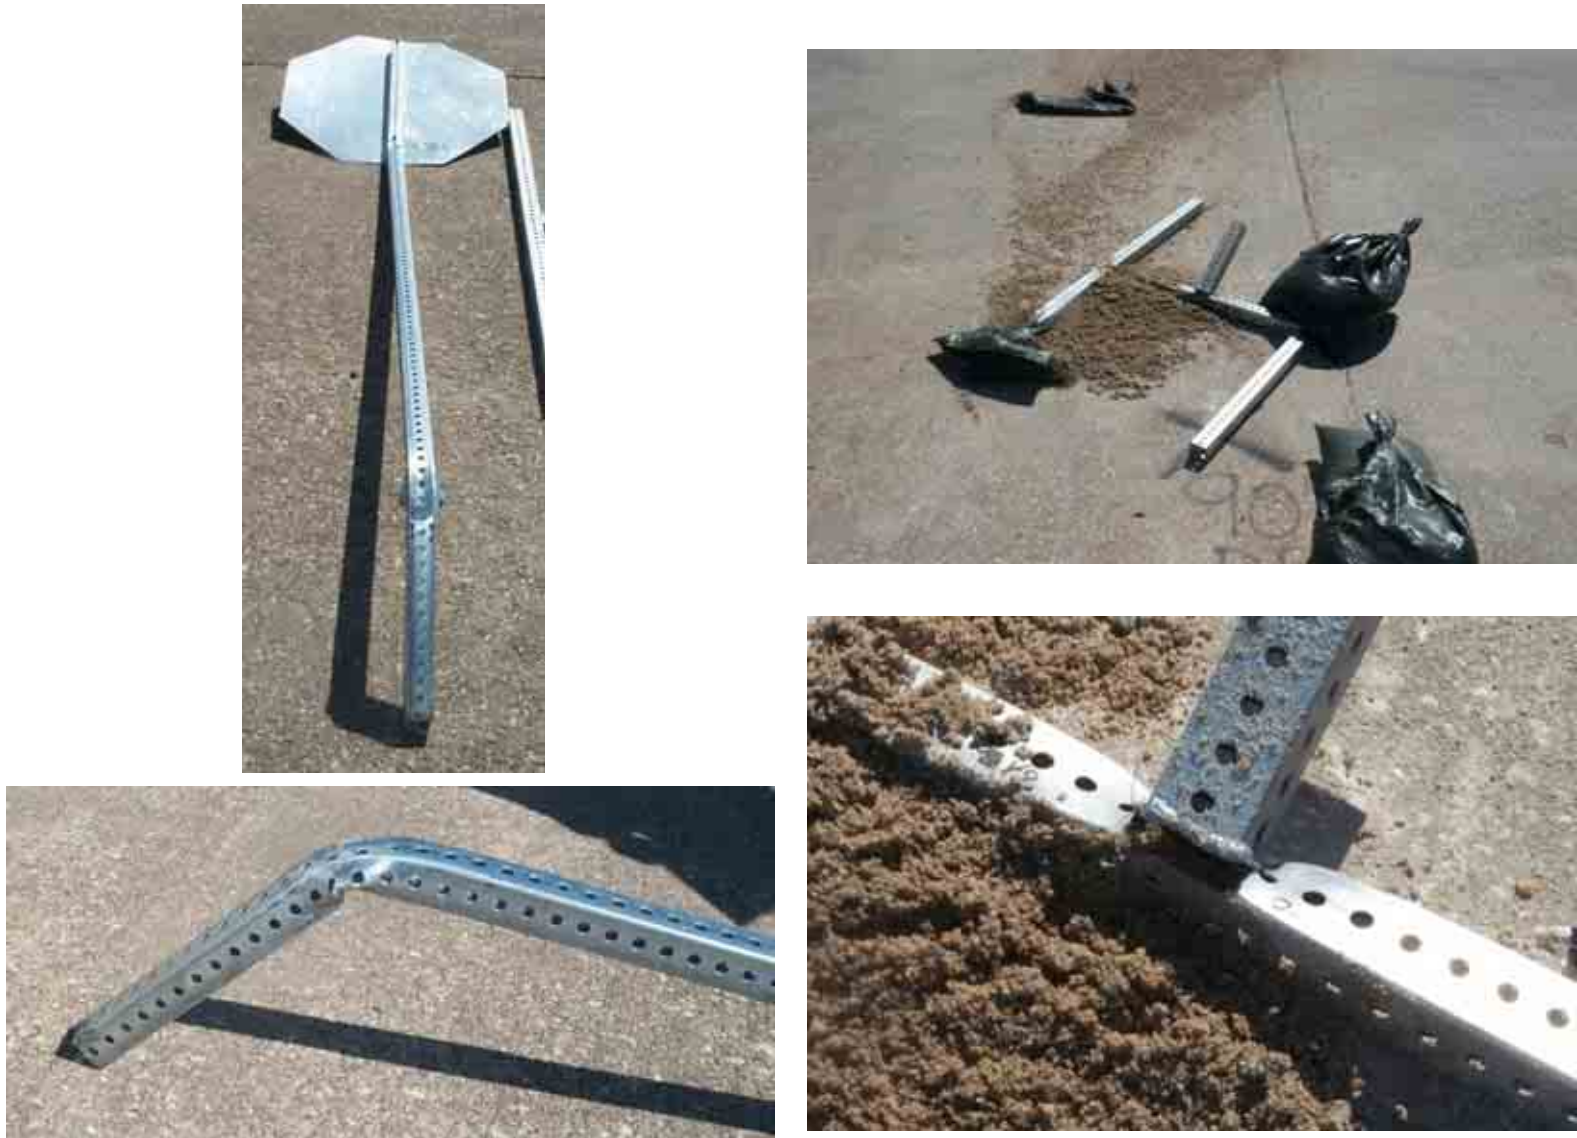
Figure 54. Stop Sign System with 7' Mounting Height Damage, Bogie Test MN8A-0 (0 degrees)

5. Impact Speed: 101.4 km/h (63.0 mph)
Impact Orientation: 0 degrees
6. Velocity Change: 6.5 km/h (4.0 mph)
7. System Performance – Mast deformation was observed. The sign panel and mast remained intact. The welds around the vertical upright stub failed. The top of the sign panel and mast rotated toward the vehicle, but no contact nor damage to the simulated windshield was observed. Throughout the entire test, the system never became a potential hazard to the bogie nor the occupant compartment.
