SAFETY PERFORMANCE EVALUATION OF MINNESOTA'S TEMPORARY RIGID PANEL SIGN STAND SYSTEMS

MIDWEST ROADSIDE SAFETY FACILITY

MwRSF Research Report No. TRP-03-166-07

February 8, 2007

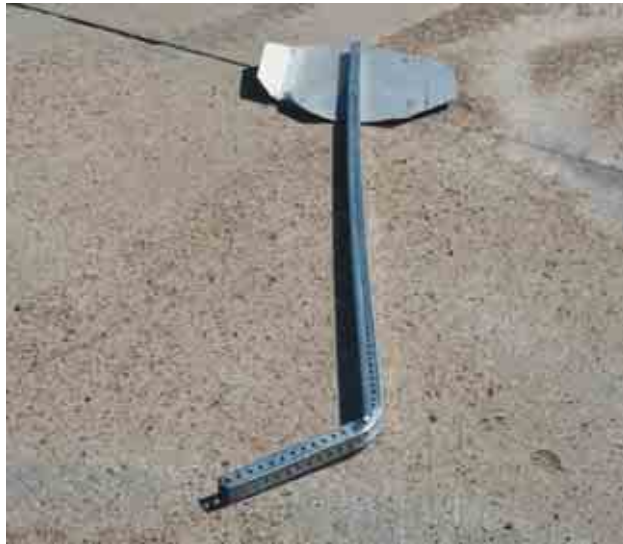
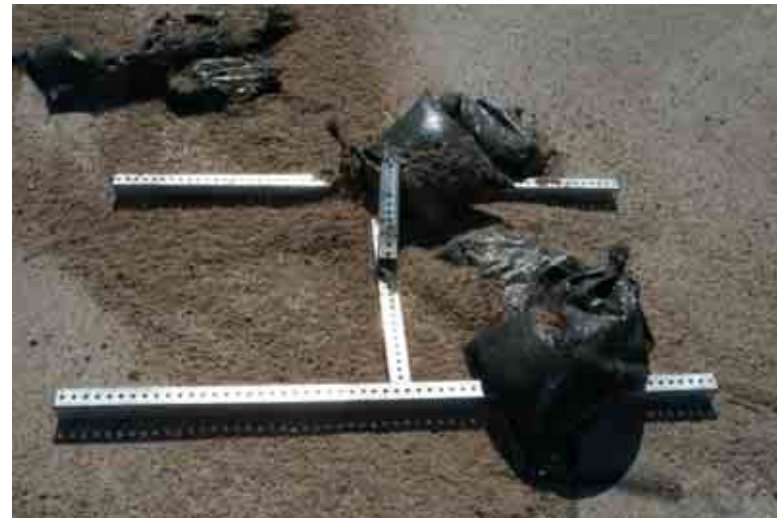
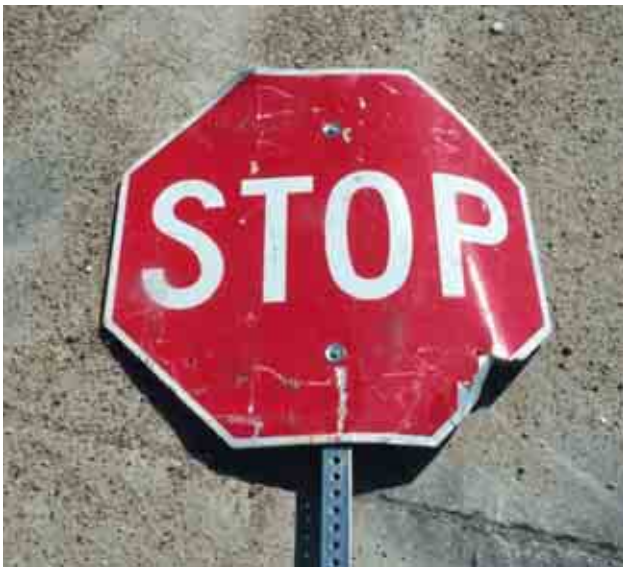
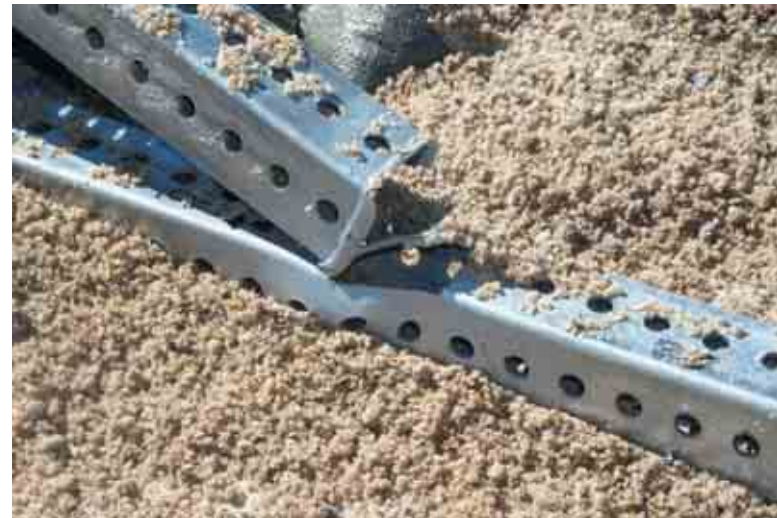
Figure 55. Stop Sign System with 7' Mounting Height Damage, Bogie Test MN8A-90 (90 degrees)

7. System performance – Mast and panel deformations were observed. The sign panel and mast remained intact. The welds around the vertical upright stub failed. The top of the sign panel and mast rotated toward the vehicle and contacted the front of the roof, but no contact nor damage to the simulated windshield was observed. After contact with the roof, the system rebounded off the bogie and traveled up and away from the bogie and was never considered to be a potential hazard to the bogie nor the occupant compartment.
