| | PCB Gap Cover<br>12'-6" [3.8m] Gap<br>Test No. GSH-1 | | SHEET:<br>1 of 3 |
| | System Layout | | DATE:<br>6/12/2018 |

PCB Gap Cover  
12'-6" [3.8m] Gap  
Test No. GSH-1

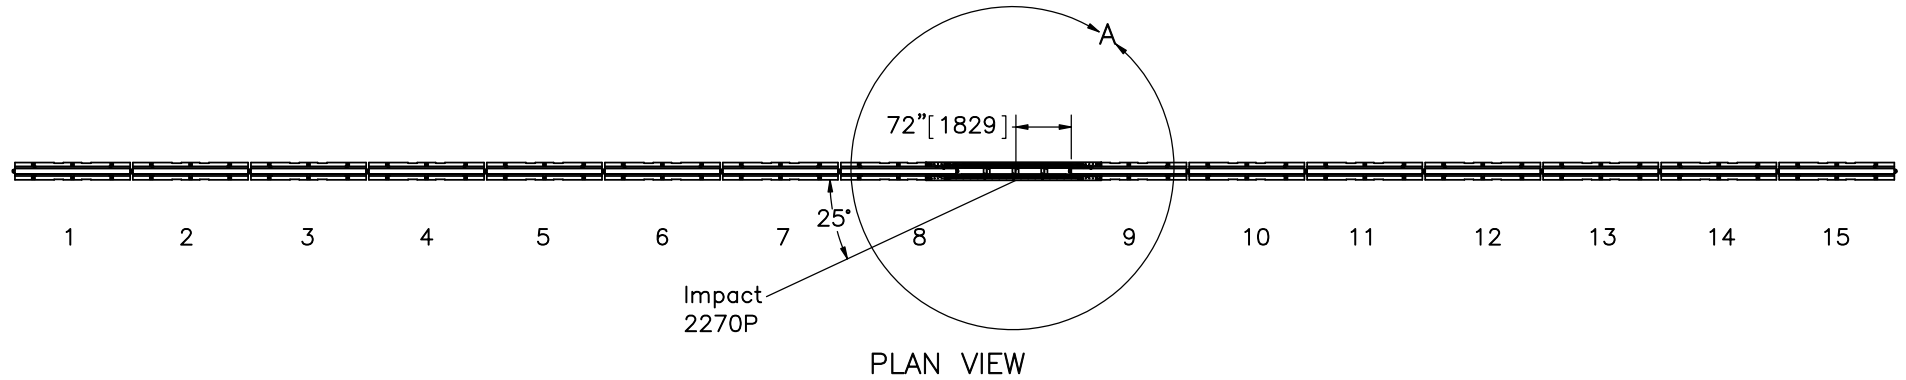
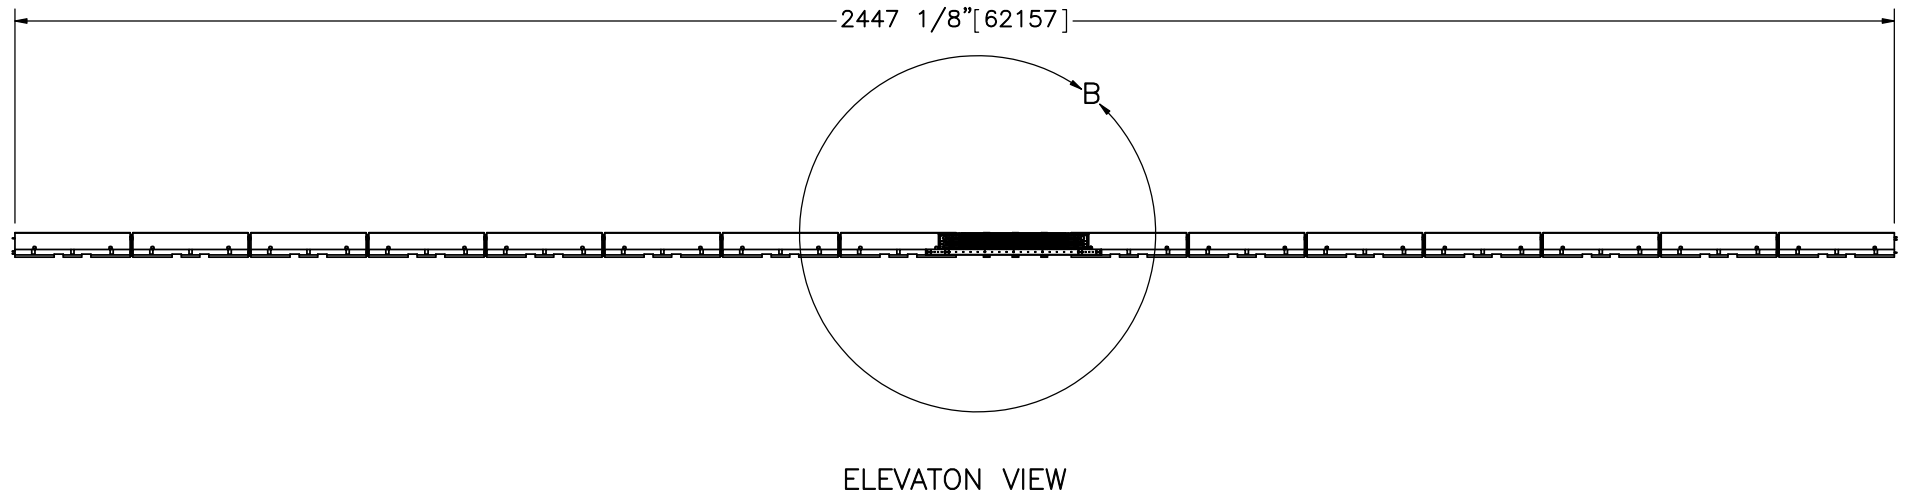
- Notes: (1) Test shall be performed according to test designation no. 3-11 using MASH 2016 criteria.  
 (2) The impact location is 72" [1,829] upstream from barrier no. 9.
