EVALUATION OF A NEW JERSEY SAFETY SHAPE, SEGMENTED CONCRETE BARRIER FOR USE ON COMPOSITE PANEL BRIDGE DECKS

MwRSF Research Report No. TRP-03-181-07

June 5, 2007

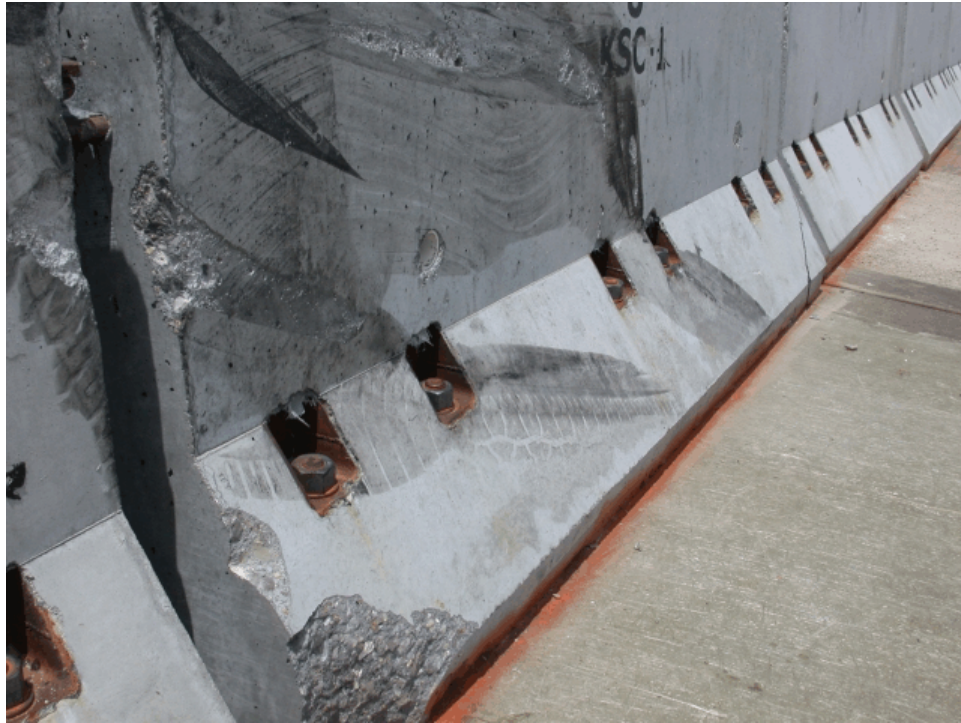
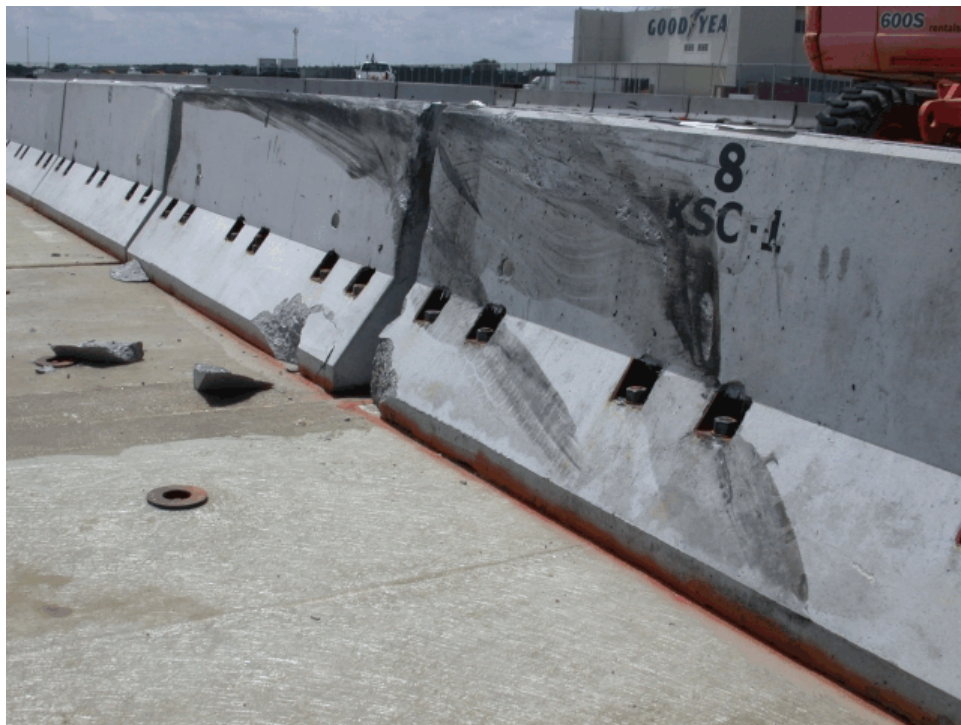
Figure 32. System Damage, Test KSC-1

Damage to the barrier was moderate, as shown in Figures 31 through 41. Barrier damage consisted of contact marks on the front face of the concrete barriers, spalling of the concrete, and concrete cracking and failure. The length of vehicle contact along the barrier was approximately 5.1 m (16.7 ft) which spanned from 1,619 mm (63.75 in.) upstream from the center of the joint between barrier nos. 7 and 8 to the center of barrier no. 6.

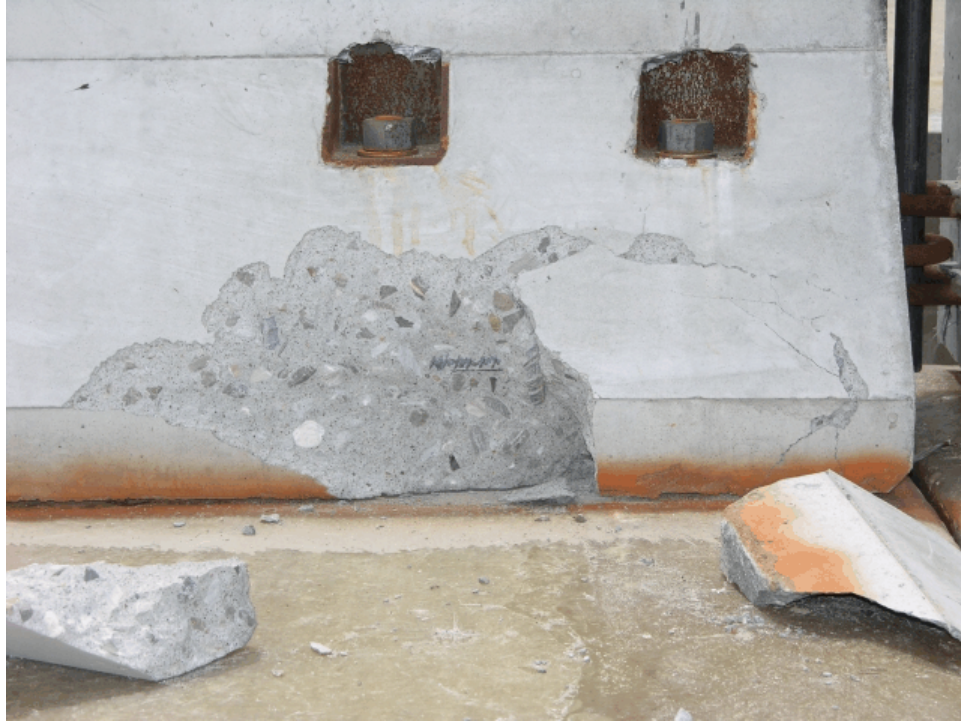
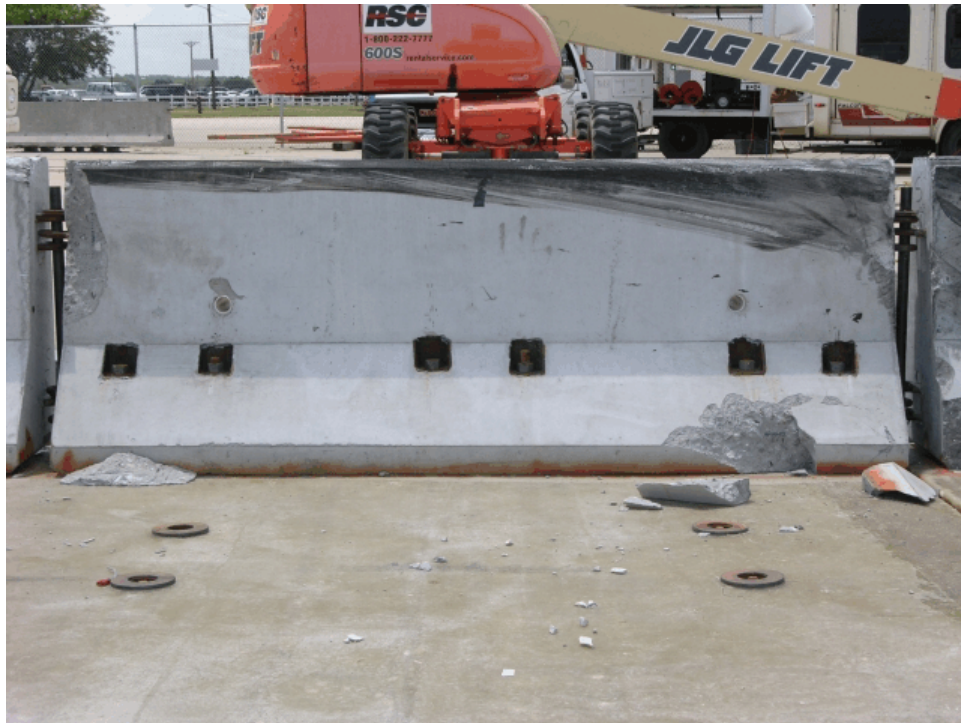
Figure 35. Barrier No. 7 Damage, Test KSC-1

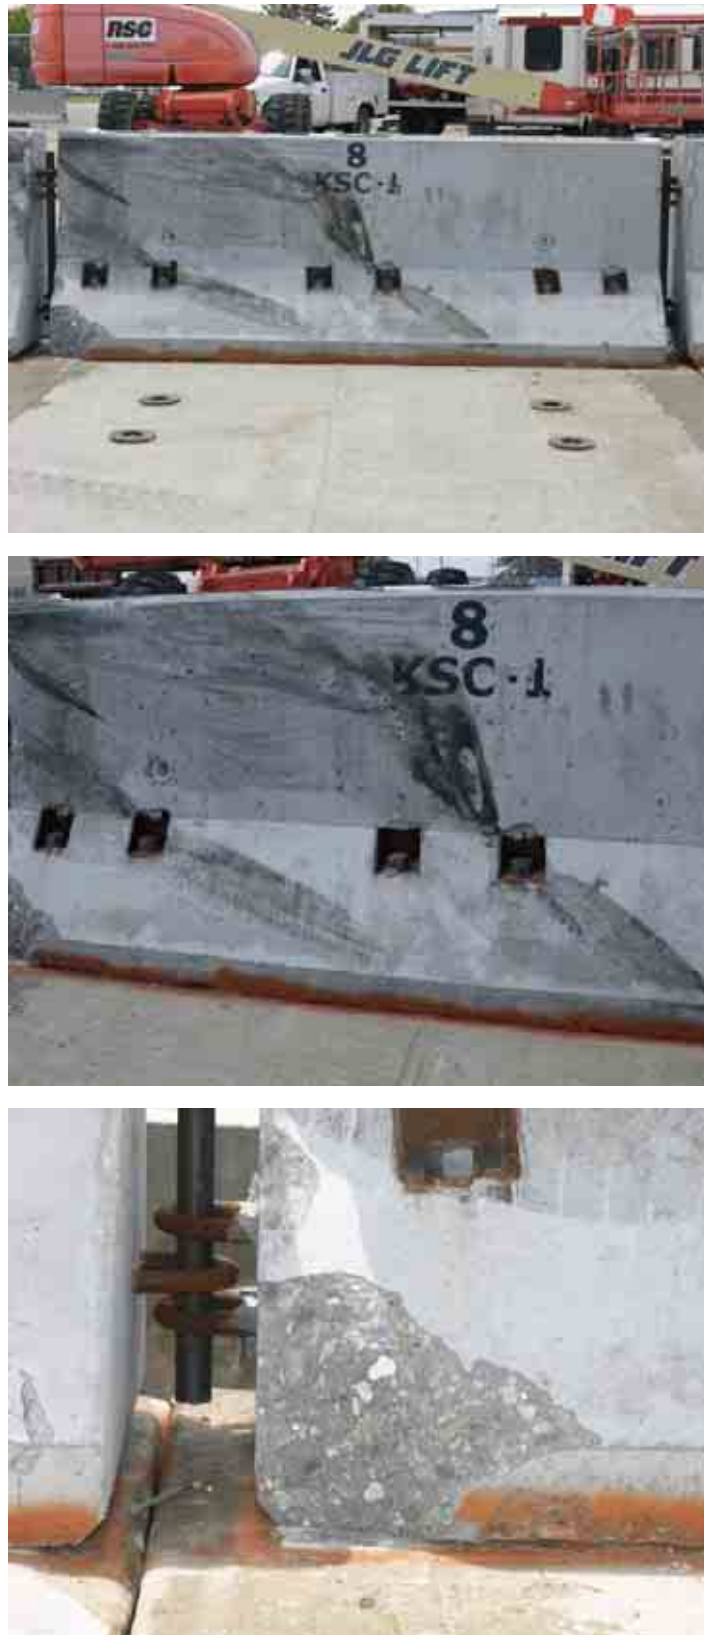
Figure 36. Barrier No. 8 Damage, Test KSC-1

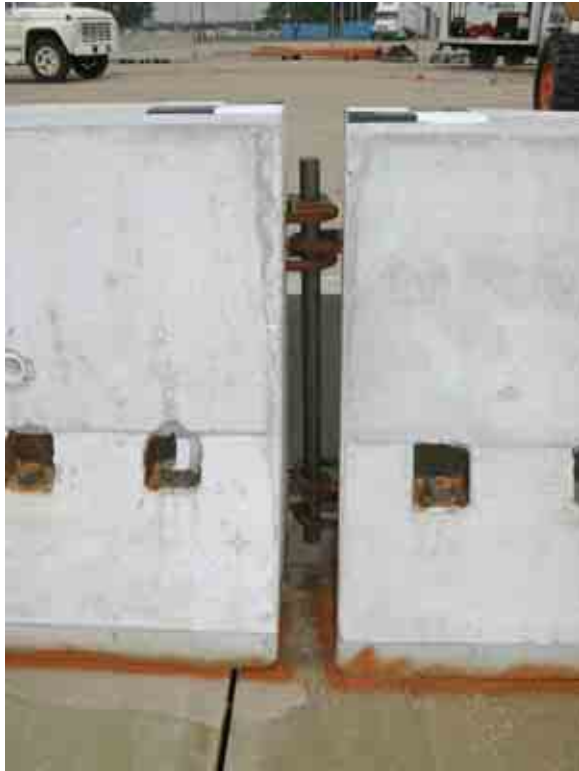
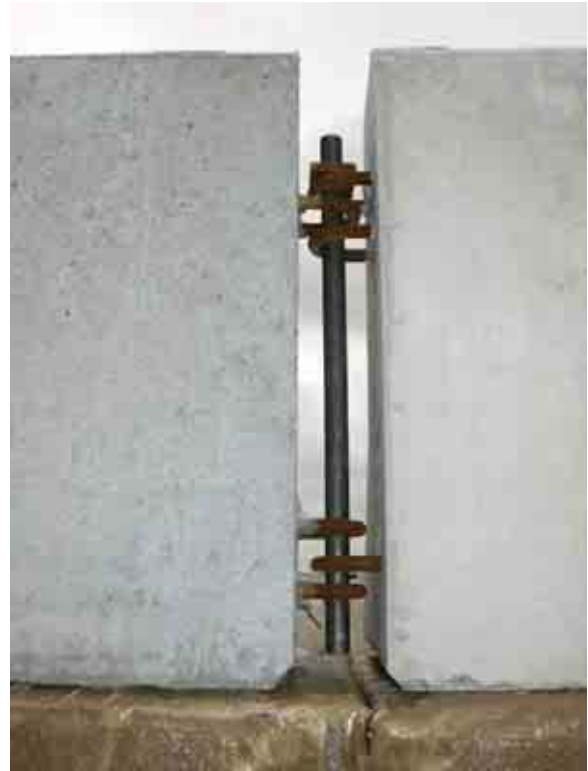
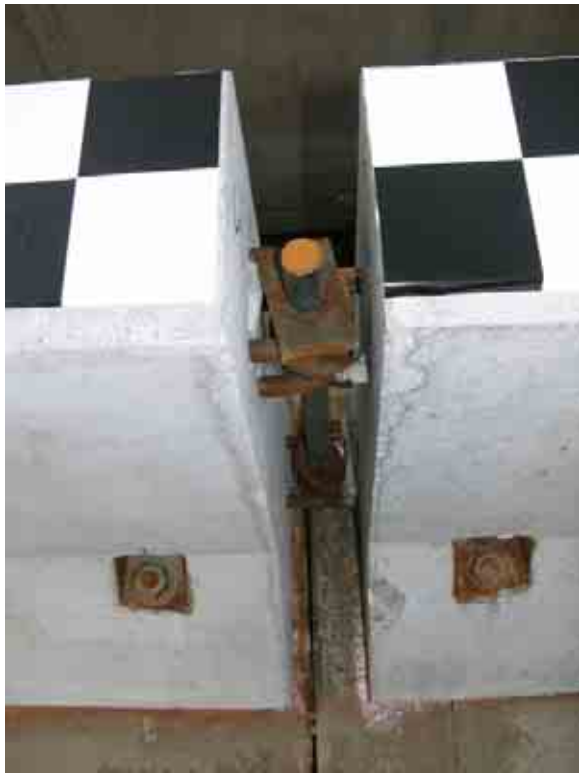
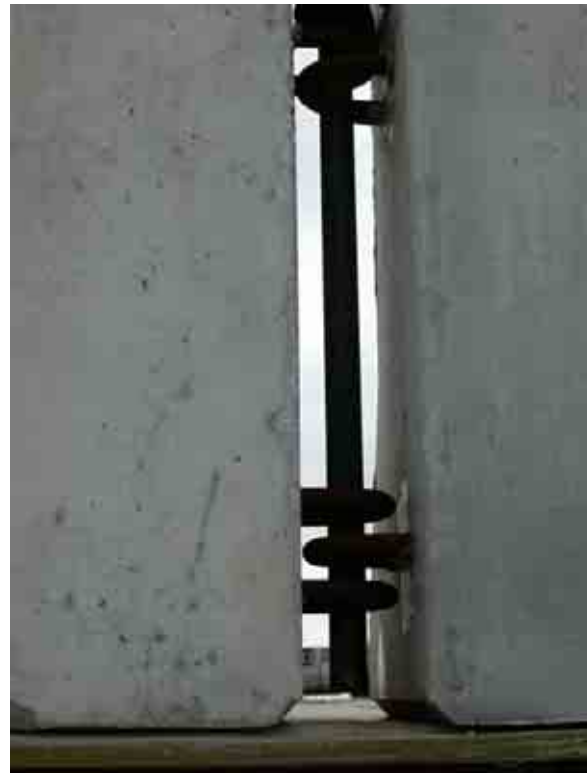
Figure 37. Barrier Connection Deformations Between Barrier Nos. 8 and 9, Test KSC-1

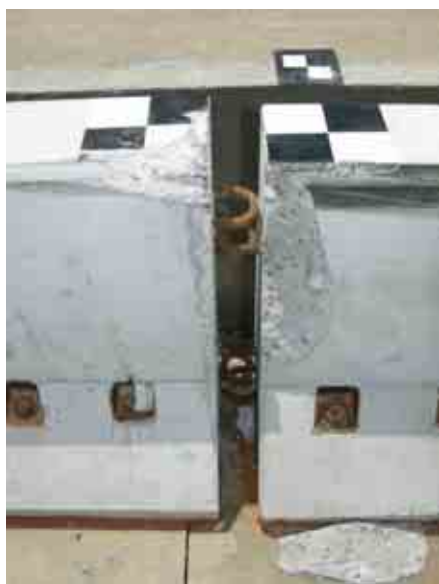
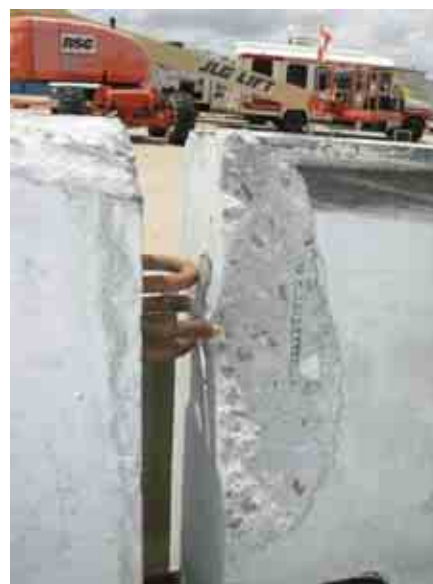
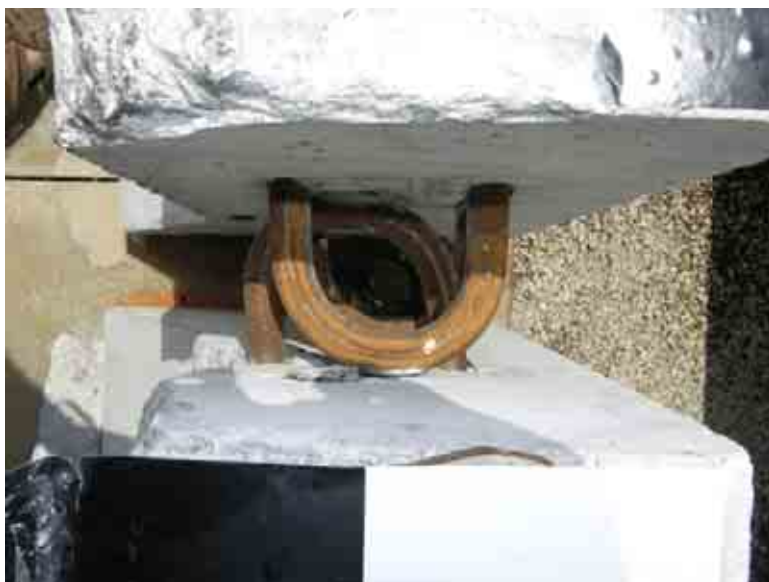
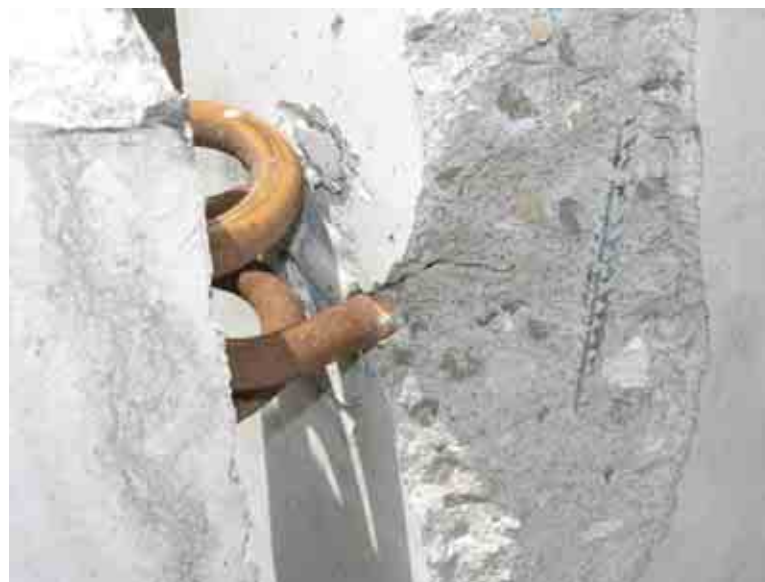
Figure 38. Barrier Connection Damage Between Barrier Nos. 6 and 7, Test KSC-1 (pin removed)

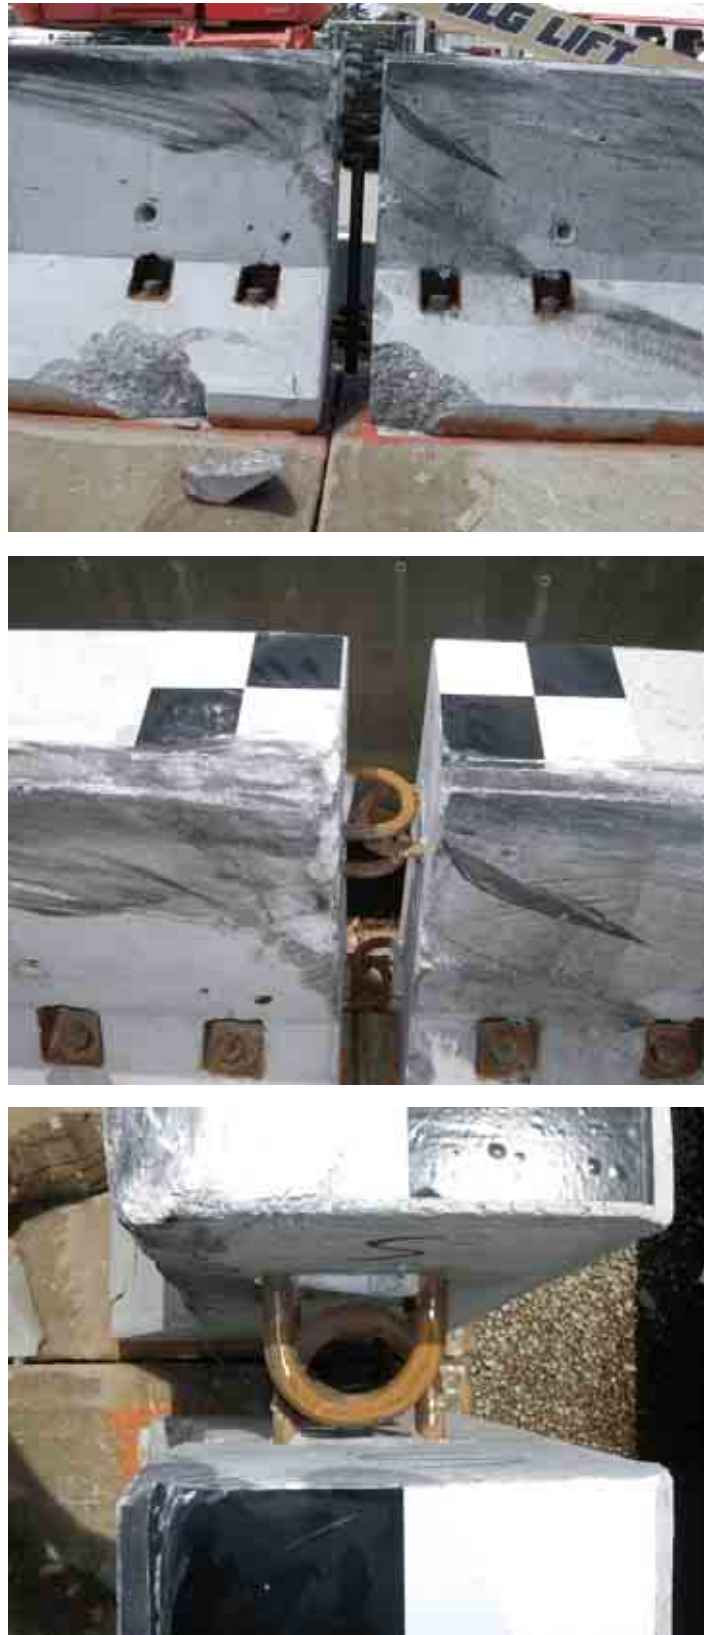
Figure 39. Barrier Connection Damage Between Barrier Nos. 7 and 8, Test KSC-1 (pin removed)

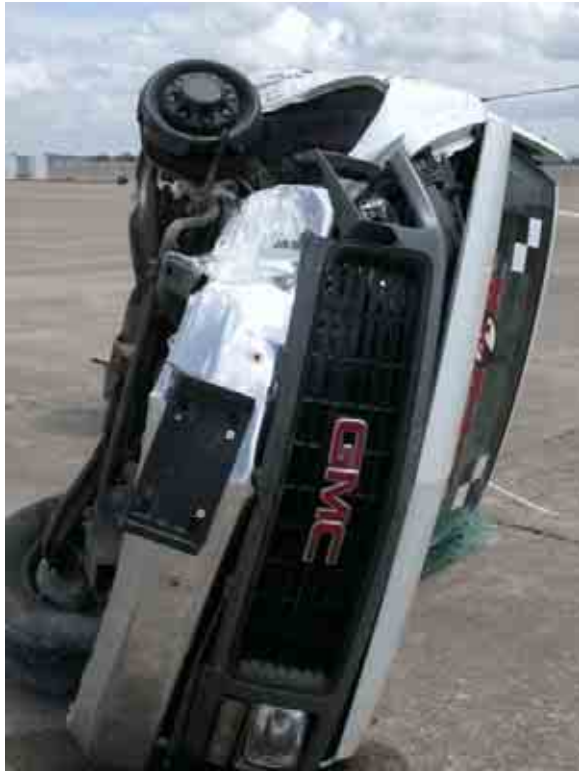
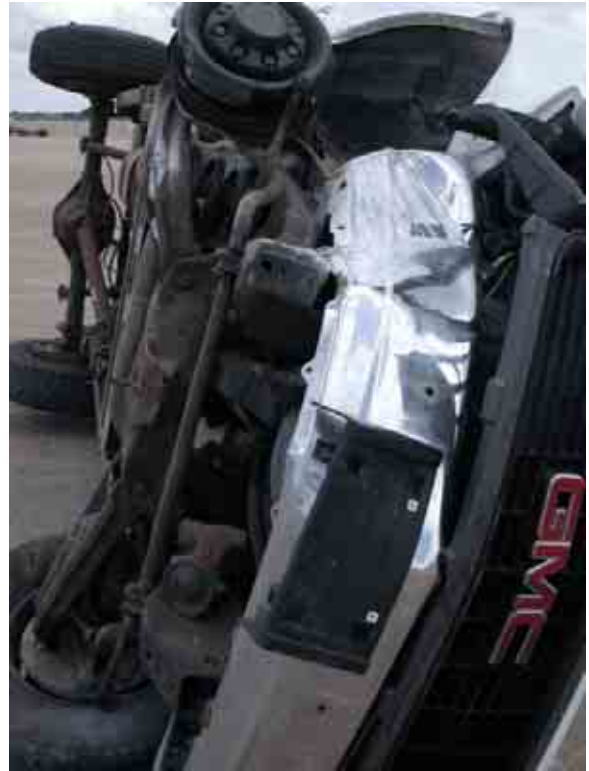
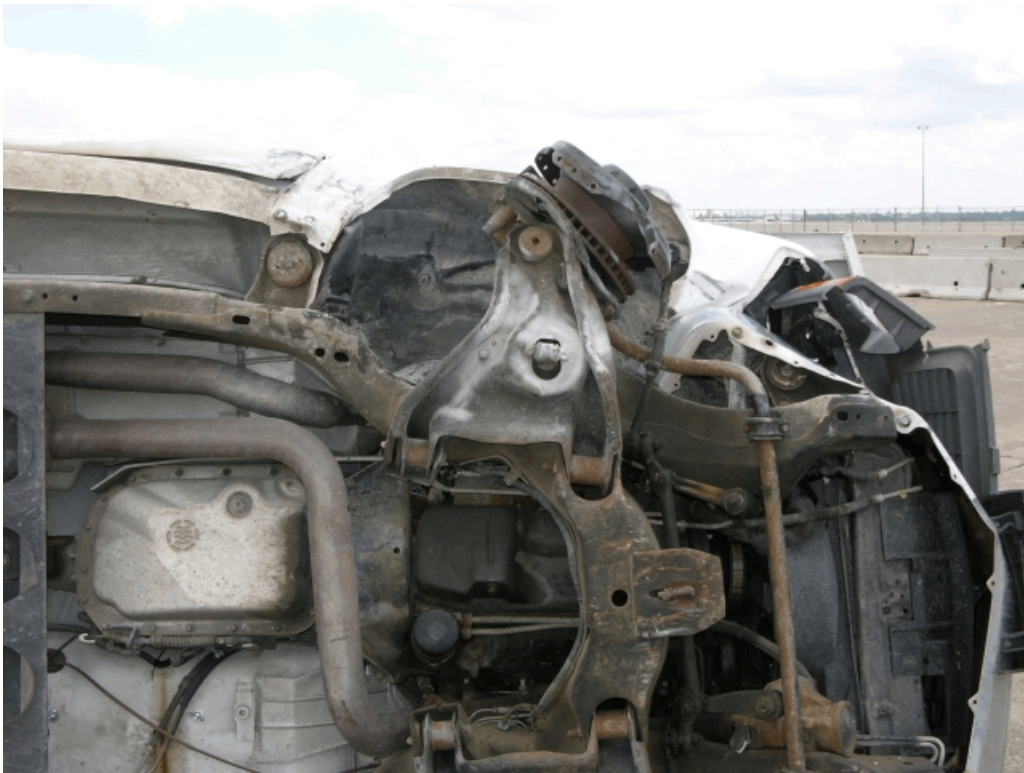
Figure 43. Vehicle Damage, Test KSC-1

Exterior vehicle damage was extensive, as shown in Figures 42 through 46. The majority of the damage was concentrated on the right-front corner and right side of the vehicle where the impact occurred, as well as the left side where the vehicle rolled over. The right-front corner of the vehicle was crushed inward and back, including the fender, bumper, and frame rail. Buckling points were found at the center and the right-front edge of the front bumper. Major frame damage was observed, including fracture of the flange at the right-front box attachment. The lower-right control arm was bent upwards. The right-rear leaf spring bracket was deformed, and the right-rear leaf spring was fractured. The exhaust pipe was bent. The starter housing, starter, and rear axle housing were fractured. The drive shaft disengaged at the yoke. Both right-side and left-side tie rod connections failed with bent and fractured tie rods. The right-front and right-rear steel rims were severely deformed. All four tires encountered scuff and scrape marks. Denting and scraping were observed between the right-front quarter panel and the door. The top of the right-side door was ajar with a 133-mm (5.25-in.) gap. Minor scrapes and dents were also observed on both the right and left sides

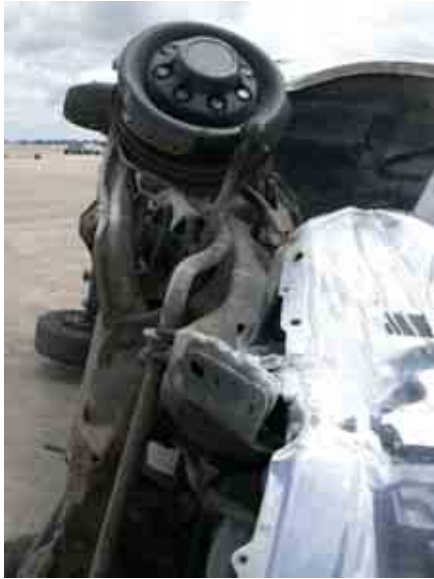
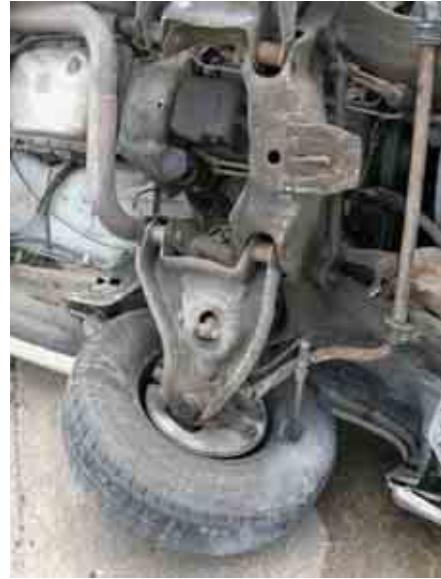
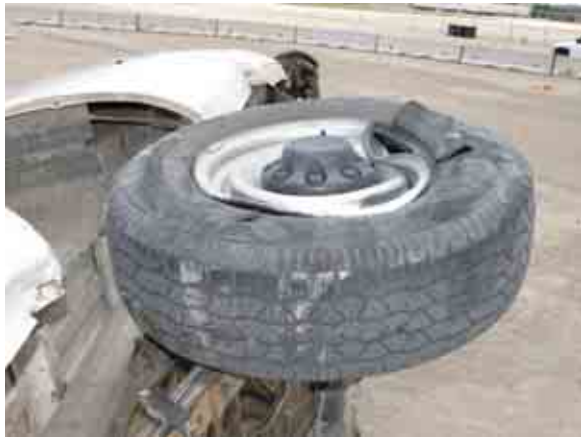
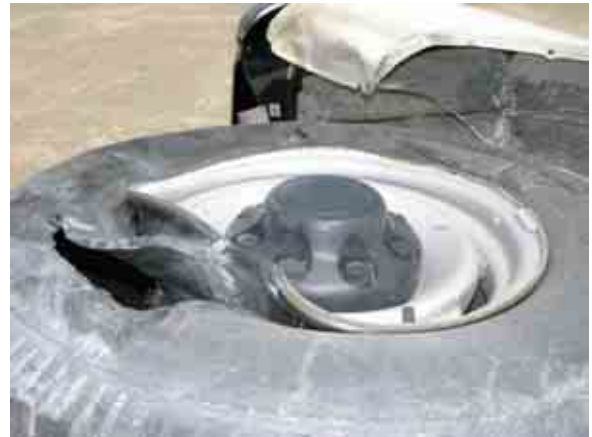
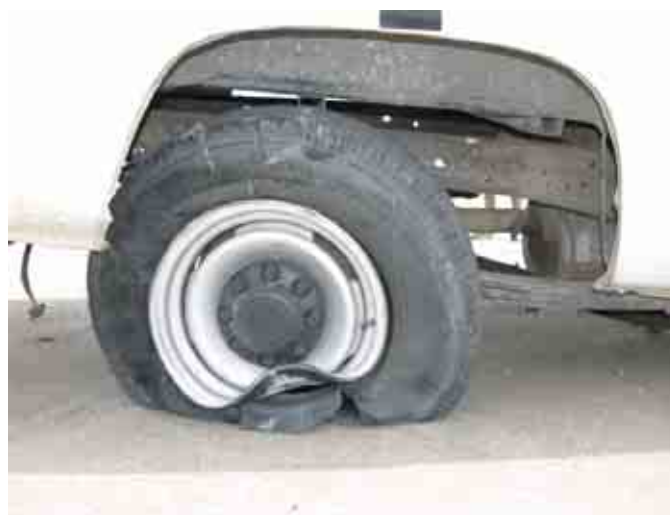
Figure 44. Tire Damage, Test KSC-1

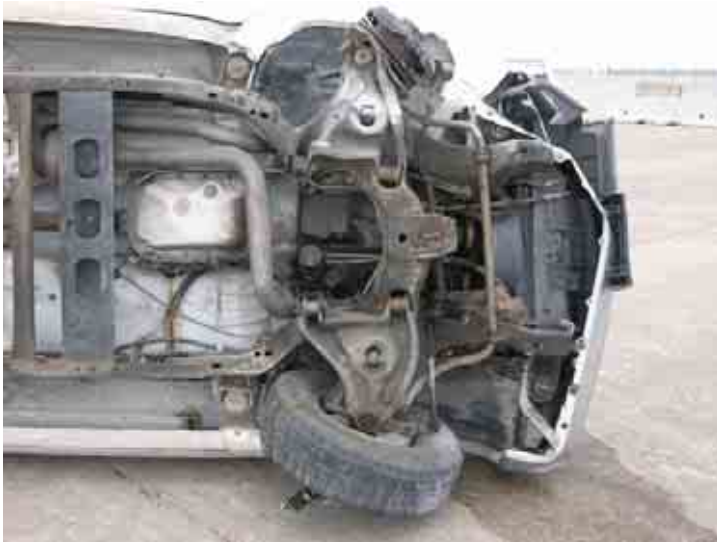
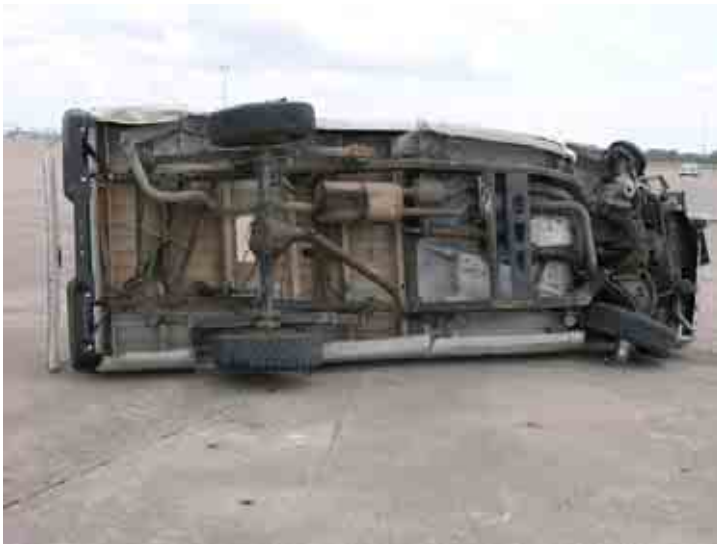
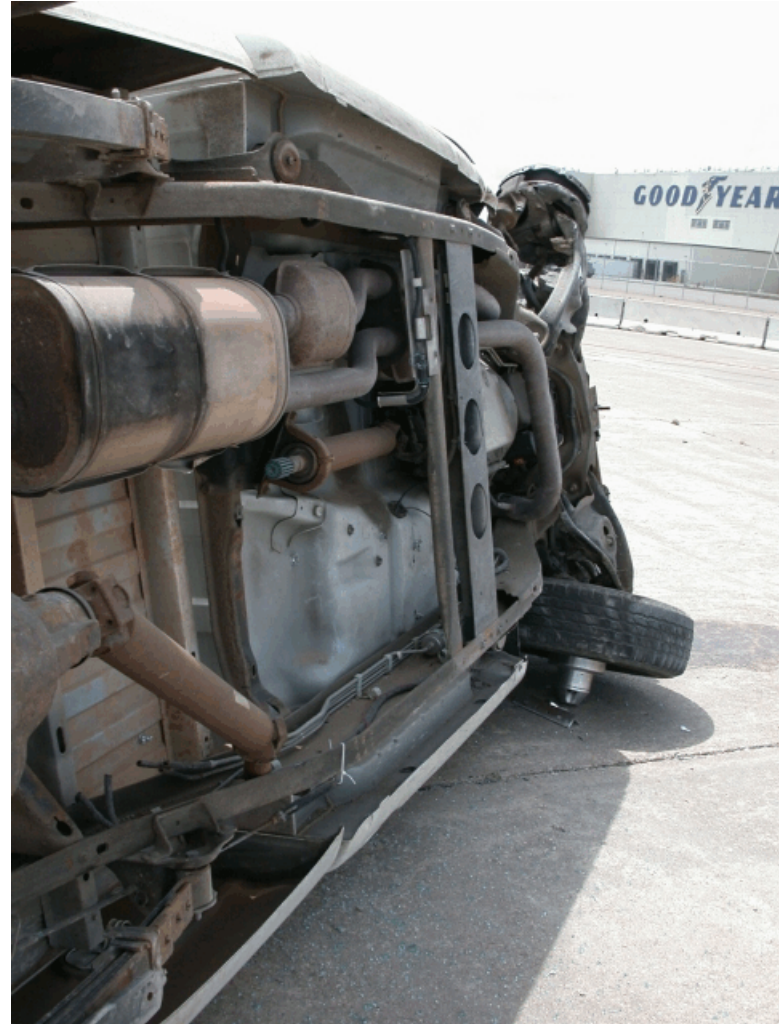
Figure 45. Vehicle Undercarriage Damage, Test KSC-1
