DESIGN AND EVALUATION OF MINNESOTA'S TIMBER RUB-RAIL FOR NOISE BARRIERS

MIDWEST ROADSIDE SAFETY FACILITY

MwRSF Research Report No. TRP-03-156-05

March 8, 2005

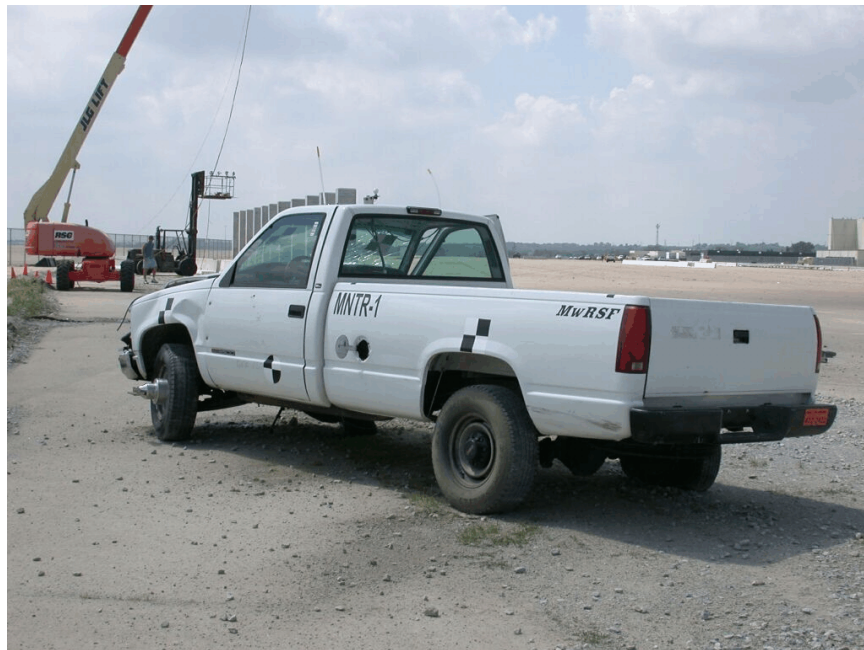
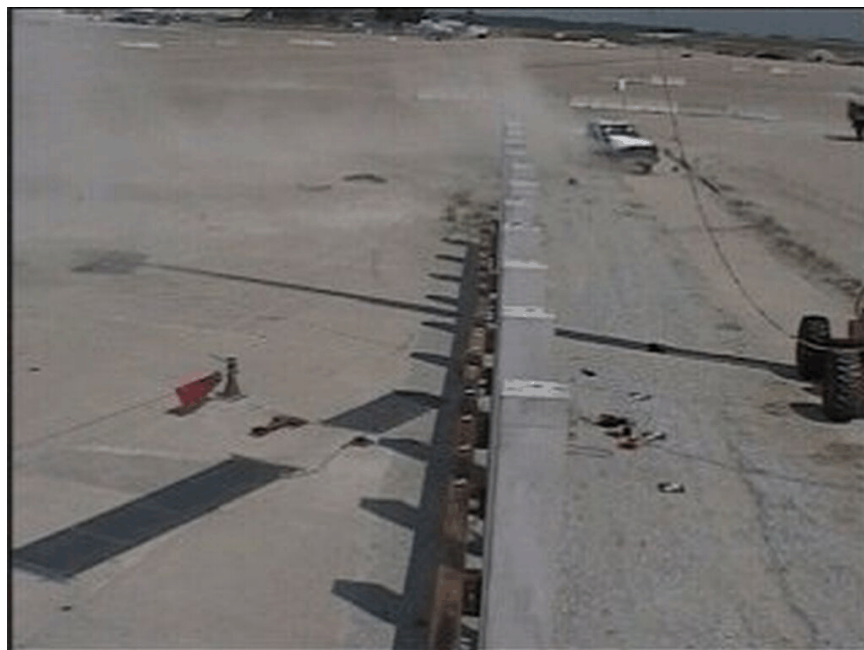
Figure 30. Impact Location, Test MNTR-1

Initial vehicle impact was to occur 305-mm (12-in.) upstream from the centerline of post no. 6 in order to generate a critical impact for the splice in the next span (i.e., $\frac{3}{4}$ -point) and also a potential for engine hood snag on the upstream side of post no. 7, as shown in Figure 30. Actual vehicle impact occurred 254-mm (10-in.) upstream from the centerline of post no. 6. At 0.014 sec after initial impact, the right-front corner of the vehicle crushed inward as the right-front tire contacted the rail. At 0.034 sec, the right-front corner of the hood protruded over the timber rail. At 0.054 sec, post no. 6 deflected backward and soil movement occurred. At this same time, the right-front quarter panel of the vehicle was in contact with the timber rail, and the hood continued to protrude over the rail. At 0.062 sec, sheet metal rippling was visible on the right-side door. At 0.074 sec, the right-side door was ajar, and visible gaps formed between the hood and the front quarter panels. At this same time, post no. 6 continued to deflect, and post no. 7 began to deflect backward. It appears that the vehicle began to redirect about this same time. Also around this time, the rail splice deflected toward the back side of the system. At 0.098 sec, the right-front corner of the

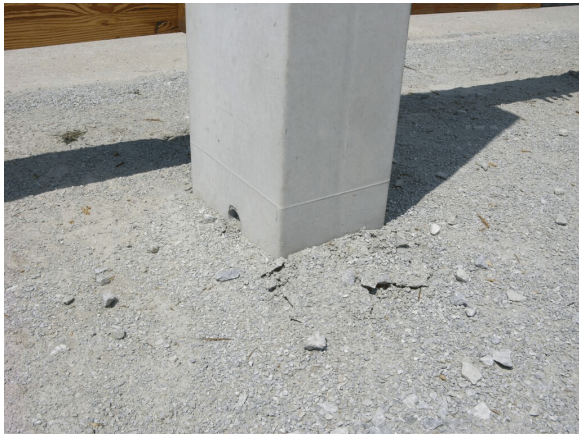
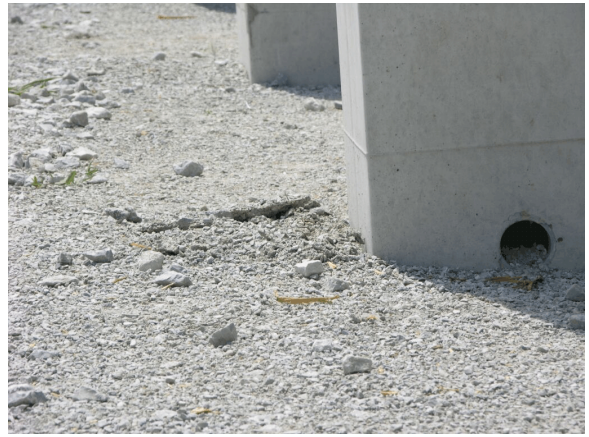
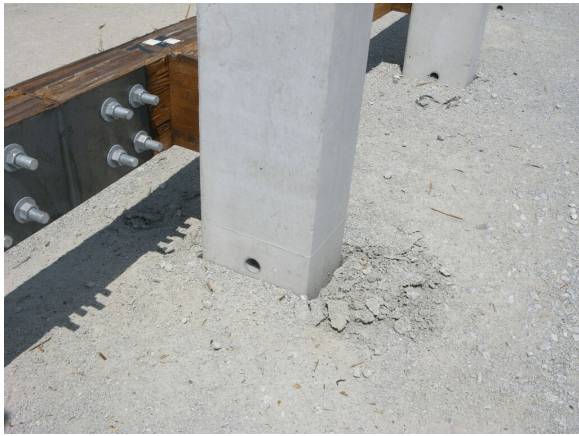
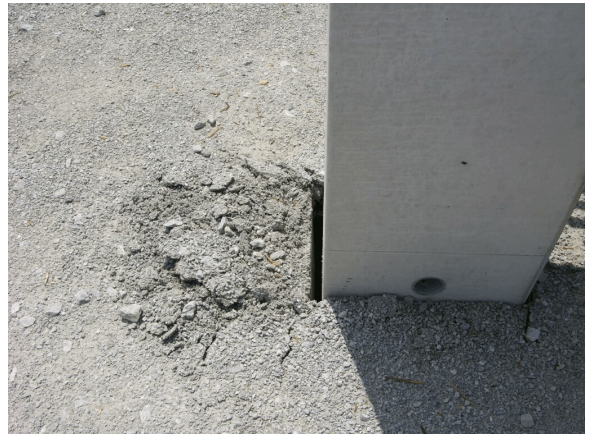
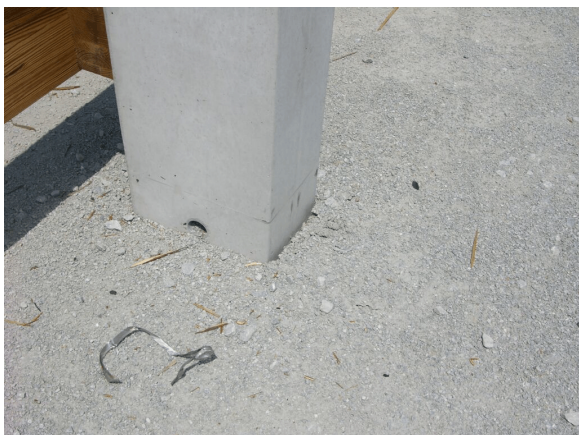
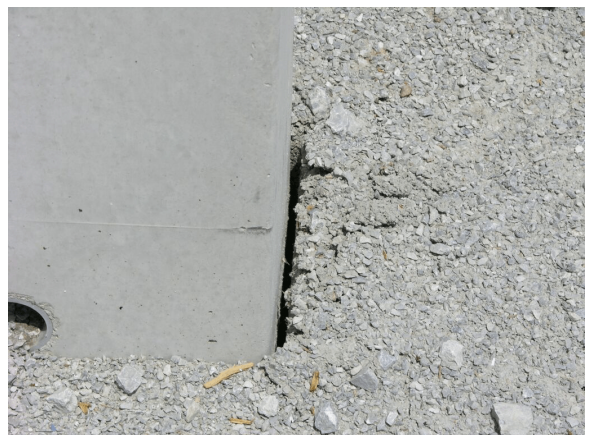
Figure 38. Post Damage and Movement at Post Nos. 6 through 8, Test MNTR-1

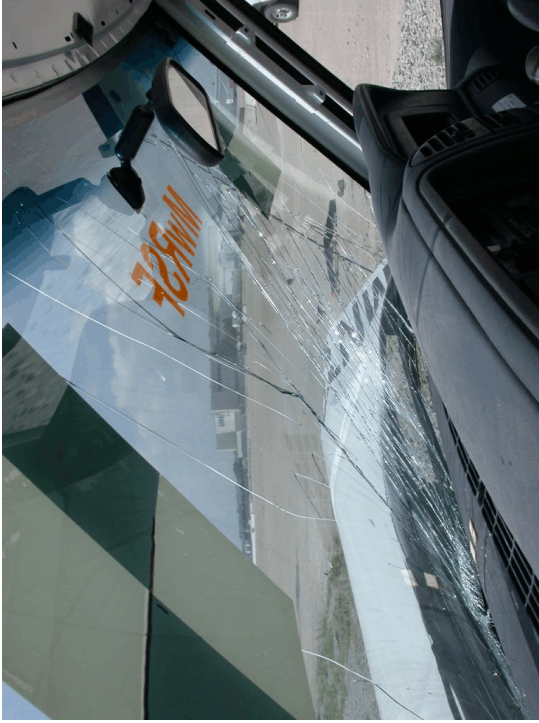
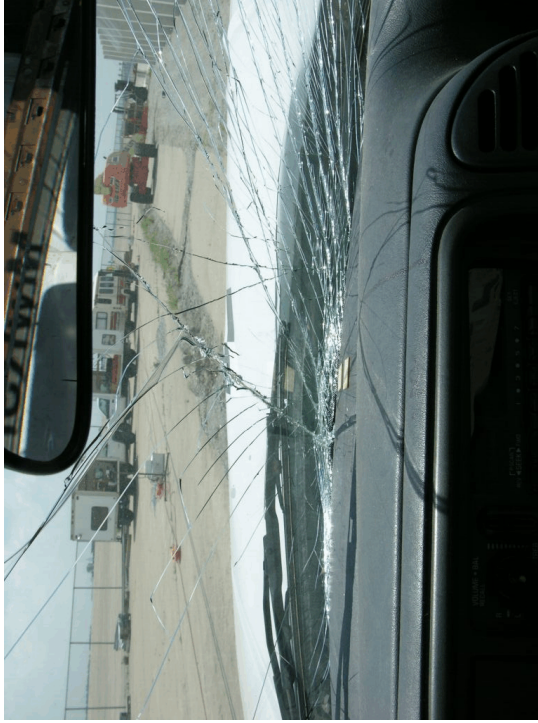
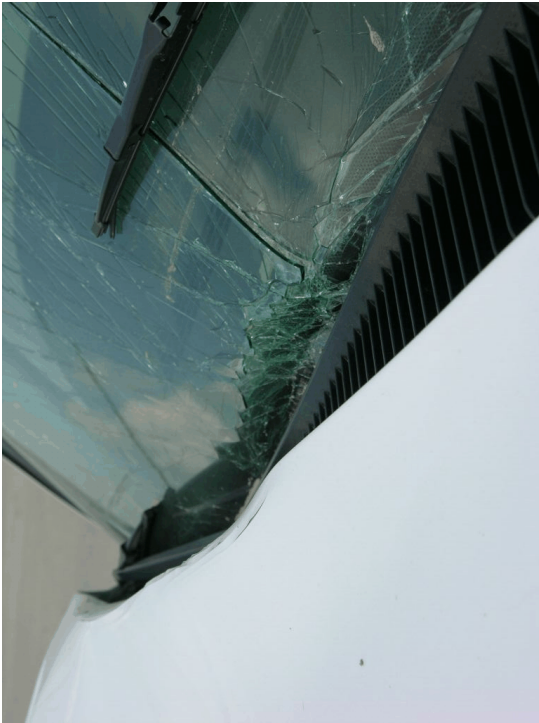
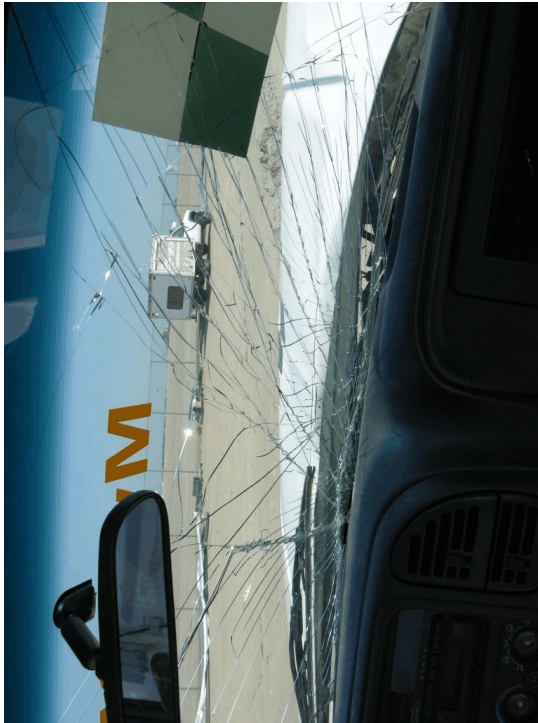
Figure 42. Vehicle Damage, Test MNTR-1
