# DEVELOPMENT OF AN ECONOMICAL GUARDRAIL SYSTEM FOR USE ON WIRE- FACED, MSE WALLS

Publication No. FHWA-CFL/TD-12-009

FEBRUARY 2012

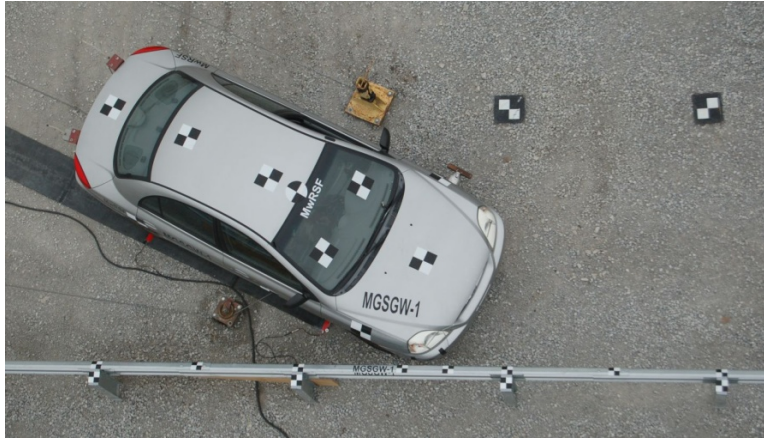
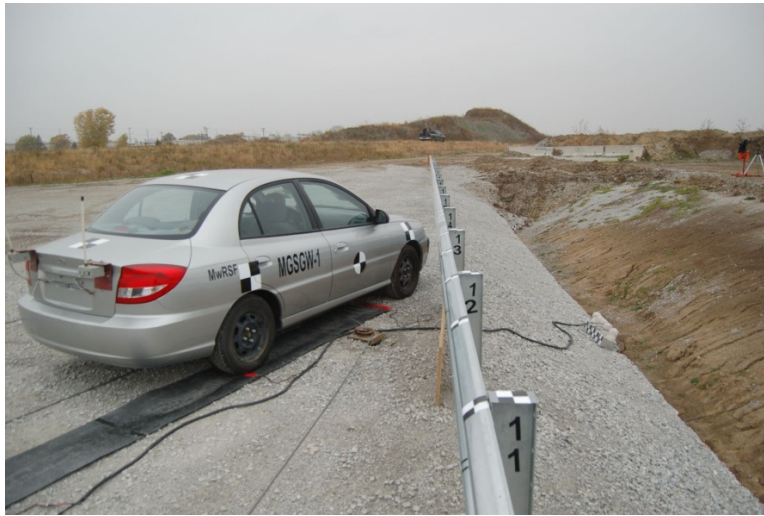
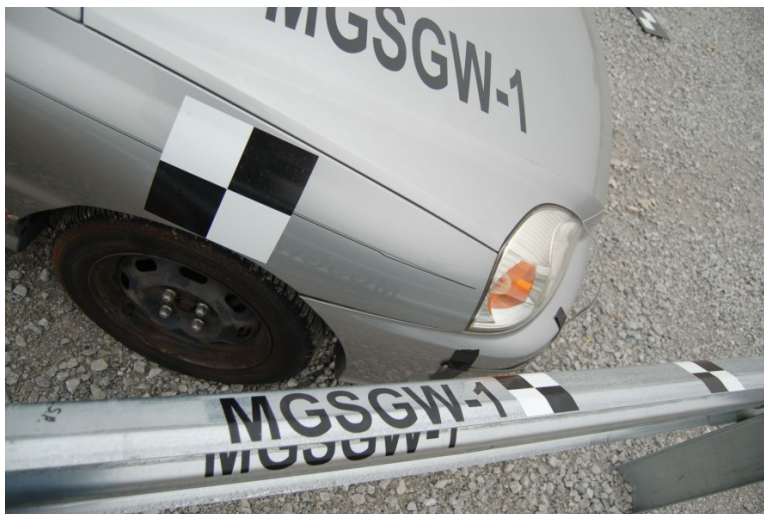
**Figure 59. Photo. Impact Location, Test No. MGSGW-1.**

Initial vehicle impact was to occur 4 ft - 9½ in. (1.5 m) upstream of the splice between post nos. 14 and 15, as shown in Figure 59. The actual point of impact was 4½ in. (114 mm) downstream from the target impact location, or 4 ft - 5 in. (1.3 m) upstream from the centerline of the splice between post nos. 14 and 15. A sequential description of the impact events is shown in Table 11. The vehicle came to rest 31 ft - 1 in. (9.5 m) downstream from impact and 11 ft - 3 in. (3.4 m) laterally in front of the traffic-side face of the barrier and oriented with its front end facing upstream. The vehicle trajectory and final position are shown in Figures 54 and 60.

a. Impact Location, Overhead

b. Impact Location Upstream

c. Impact Location, Close-up

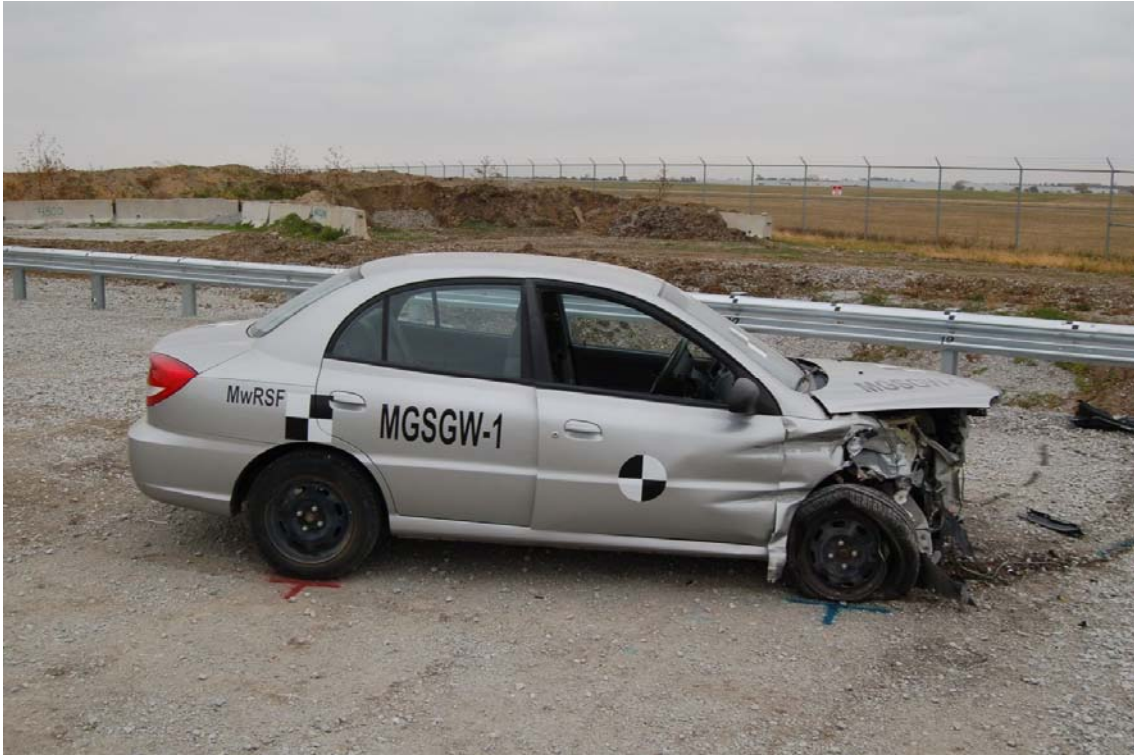
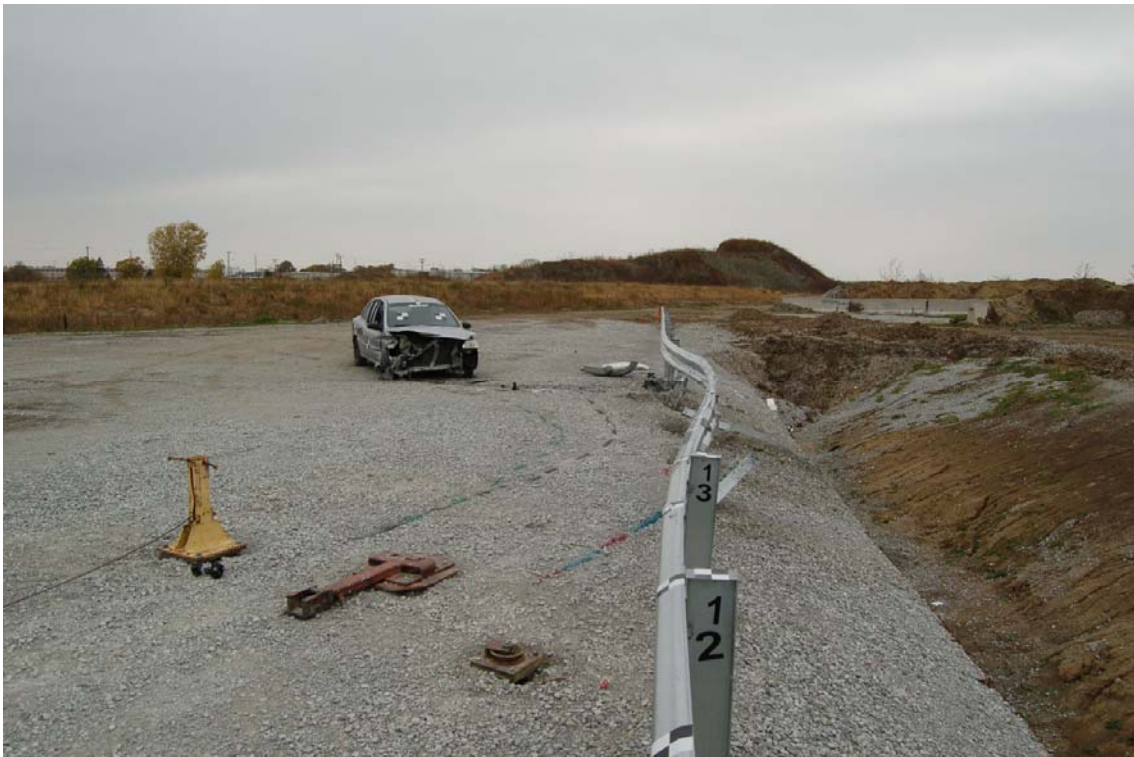
**Figure 60. Photo. Vehicle Final Position and Trajectory Marks, Test No. MGSGW-1.**

a. Vehicle Final Position, Profile View

b. Vehicle Trajectory Marks

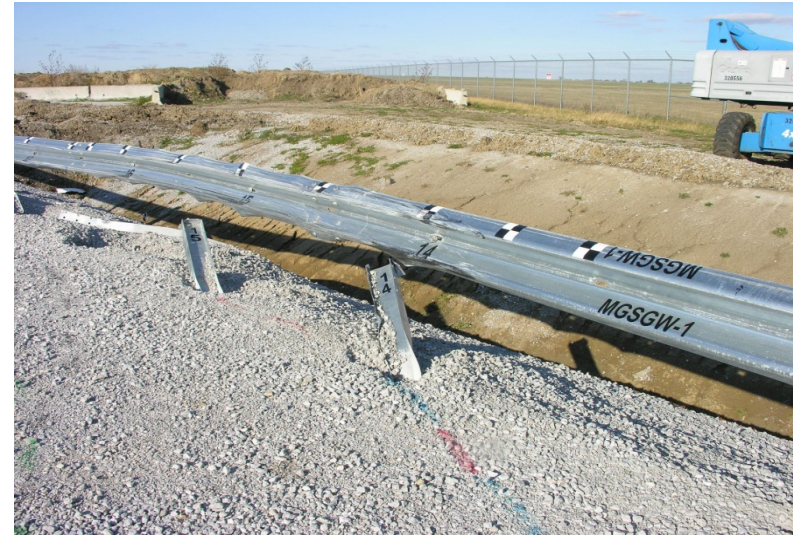
**Figure 62. Photo. System Damage, Test No. MGSGW-1.**

b. Front Side

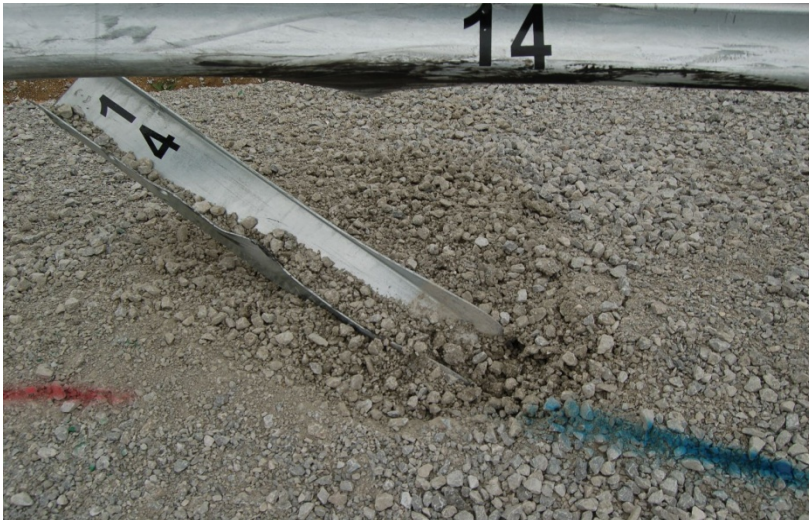
**Figure 64. Photo. Post Nos. 13 and 14 Damage, Test No. MGSGW-1.**

c. Post No. 13, Upstream View

b. Post No. 14, Front Side

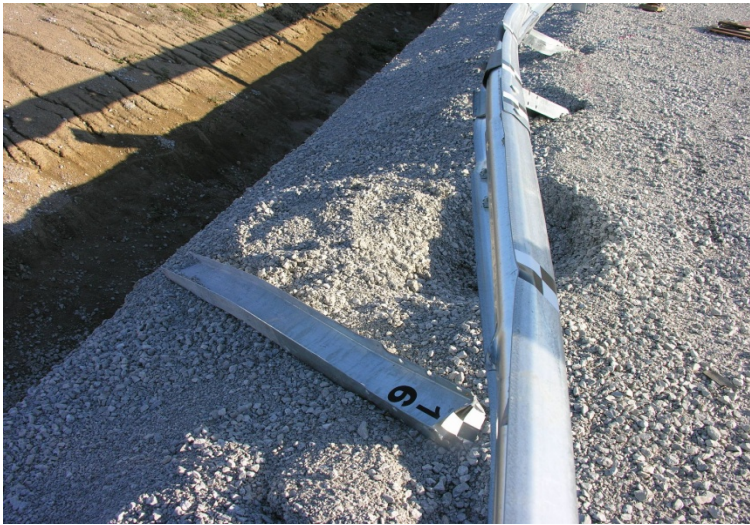
**Figure 65. Photo. Post Nos. 15 and 16 Damage, Test No. MGSGW-1.**

c. Post No. 15, Rear View

b. Post No. 16, Downstream View

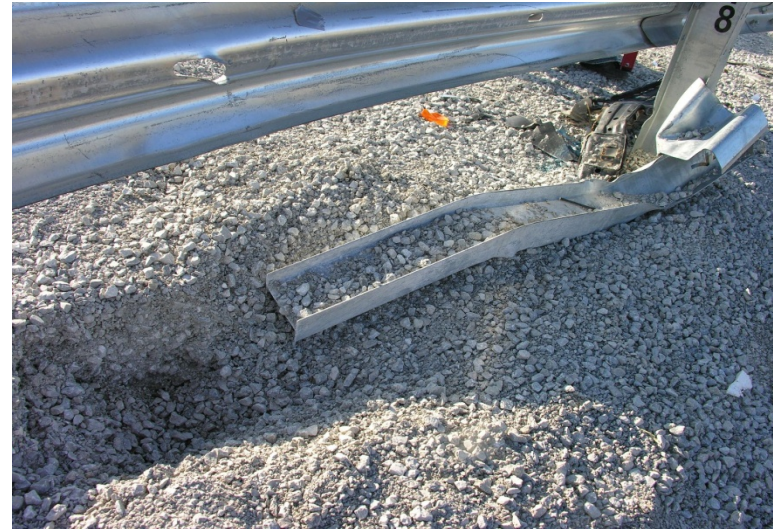
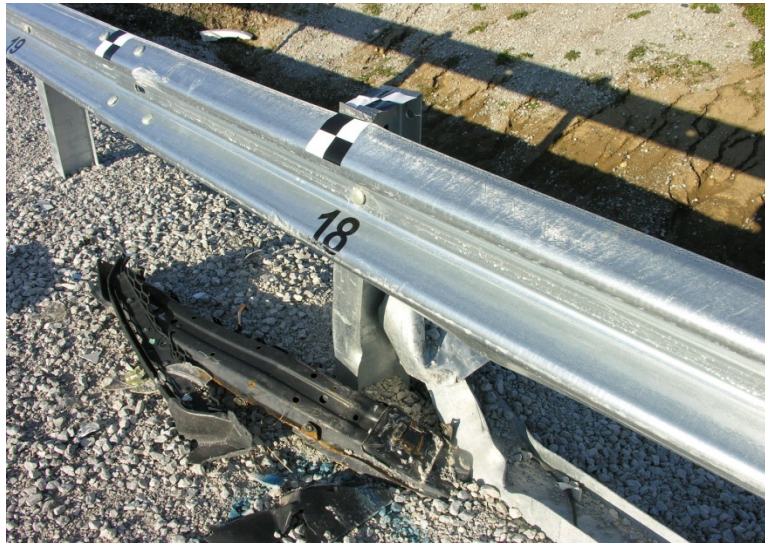
**Figure 66. Photo. Post Nos. 17 and 18 Damage, Test No. MGSGW-1.**

c. Post No. 17, Entire Length

b. Post No. 18, Front View

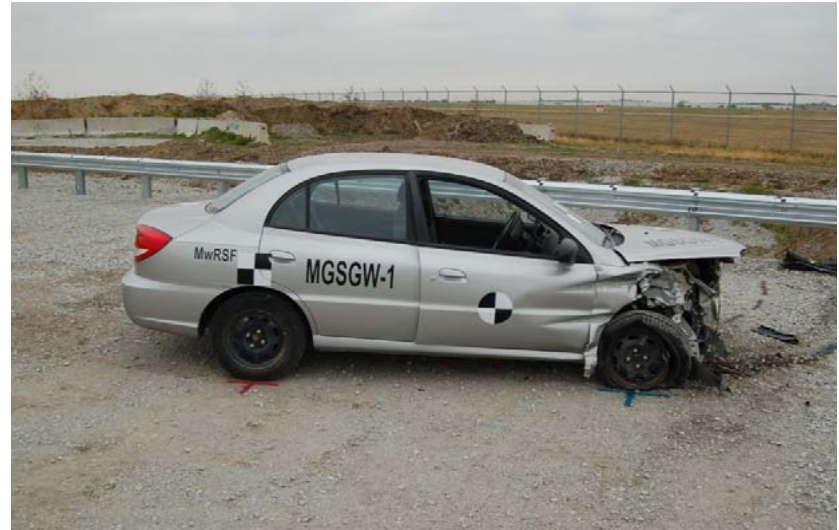
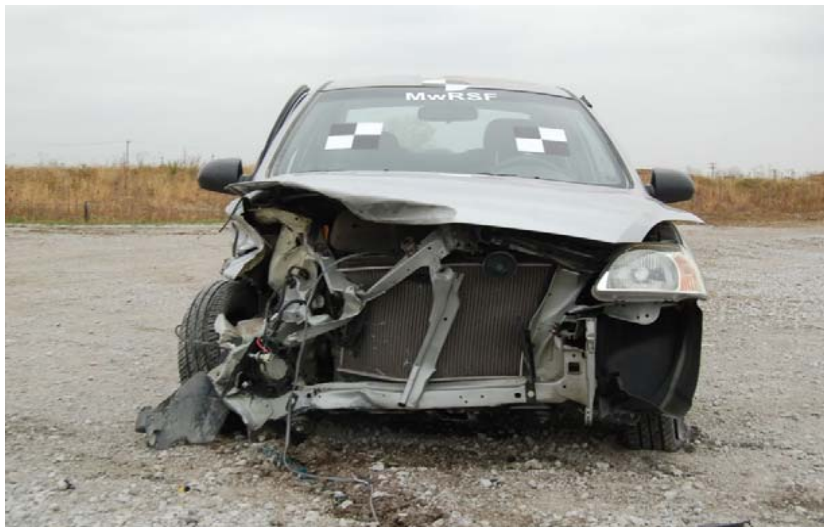
Figure 67. Photo. Vehicle Damage, Test No. MGSGW-1.

c. Right Side

b. Front

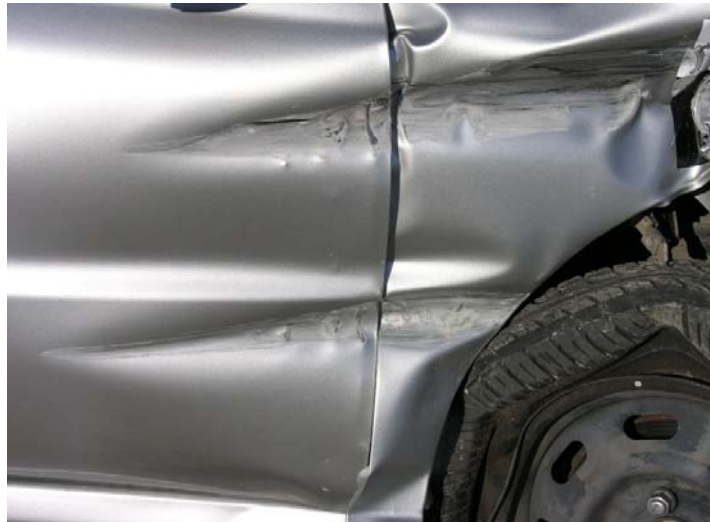
**Figure 68. Photo. Vehicle Damage, Test No. MGSGW-1.**

b. Rail Interlock

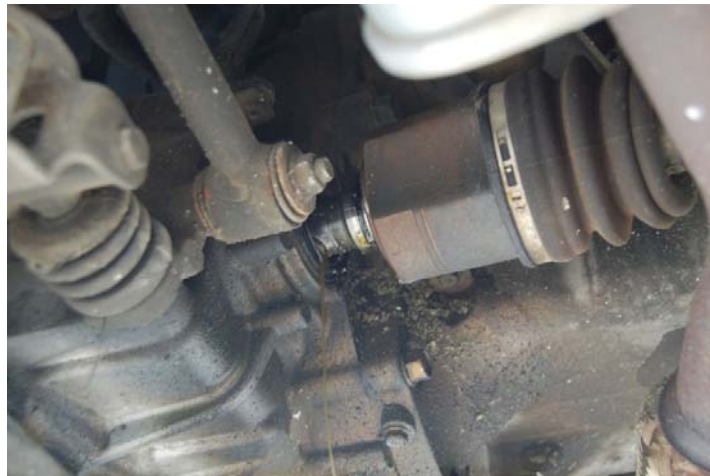
**Figure 69. Photo. Vehicle Undercarriage Damage, Test No. MGSGW-1.**

b. Axle/Transmission Connection

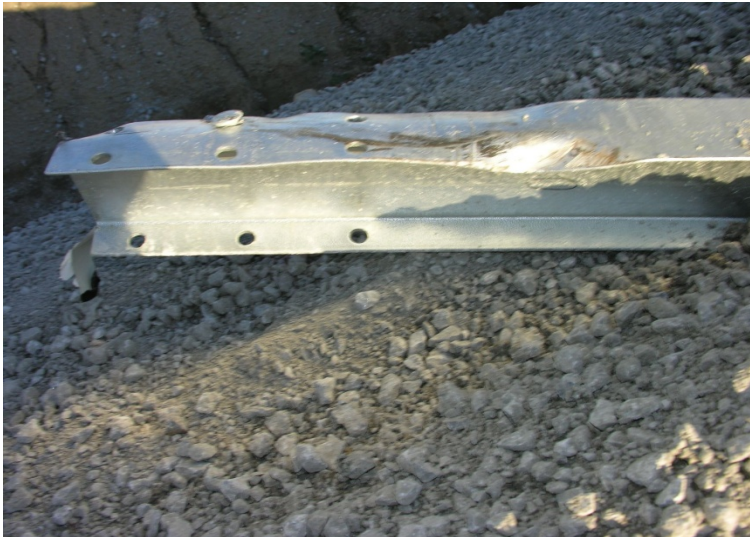
**Figure 82. Photo. Post Nos. 13 and 14 Damage, Test No. MGSGW-2.**

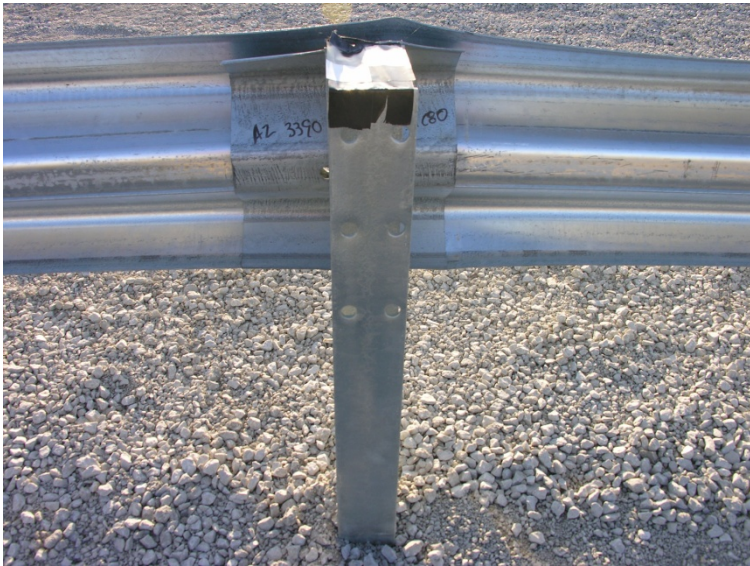
**Figure 83. Photo. Post Nos. 15 and 16 Damage, Test No. MGSGW-2.**

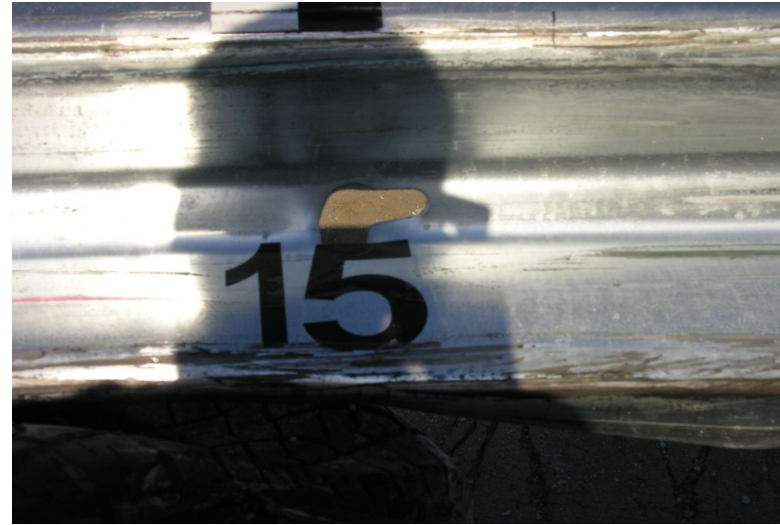
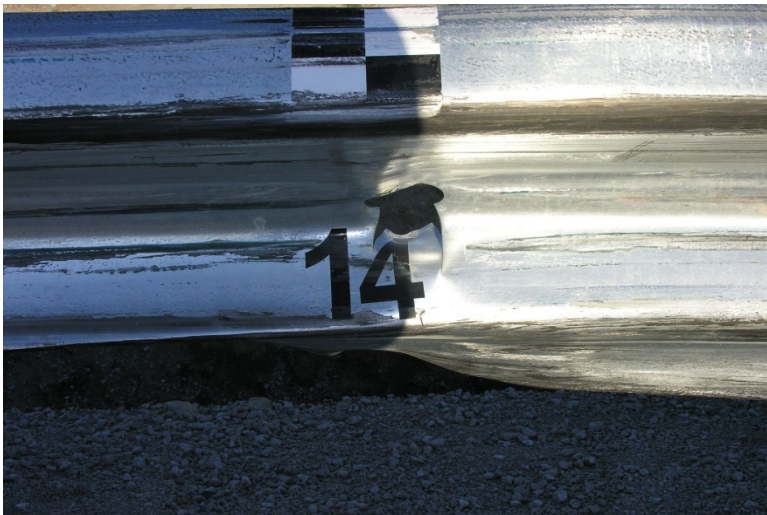
**Figure 84. Photo. Post Bolt Location Rail Damage Photographs, Test Nos. MGSGW-2.**

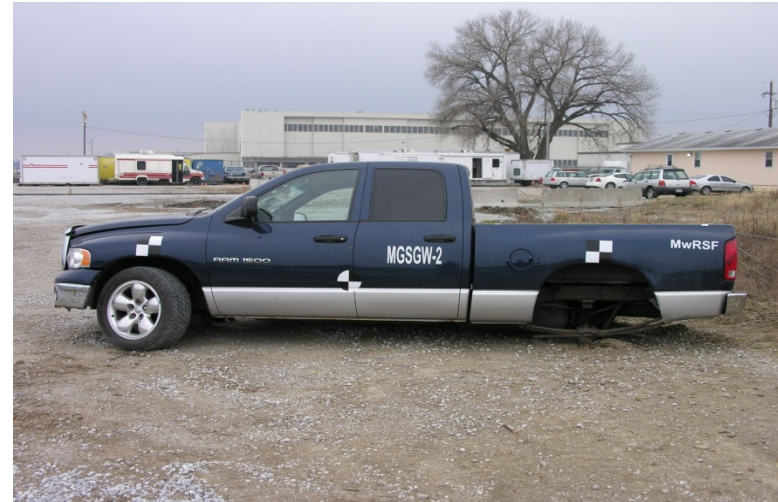
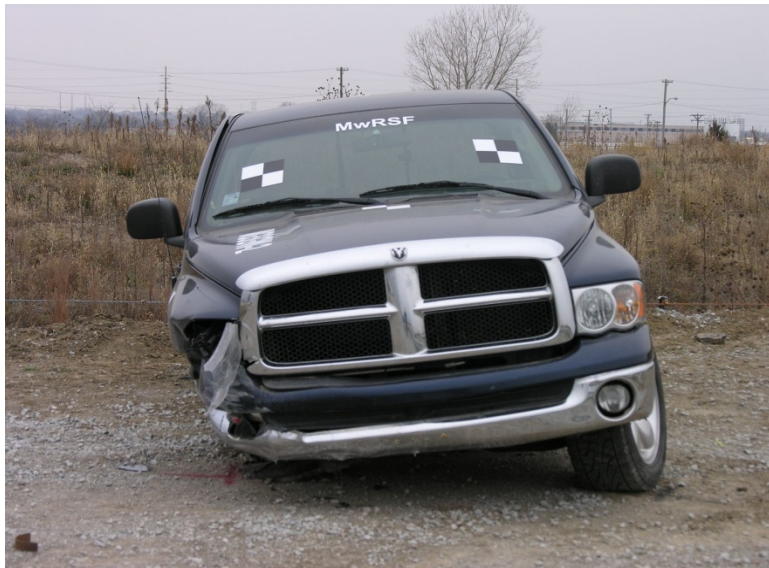
Figure 85. Photo. Vehicle Damage, Test No. MGSGW-2.

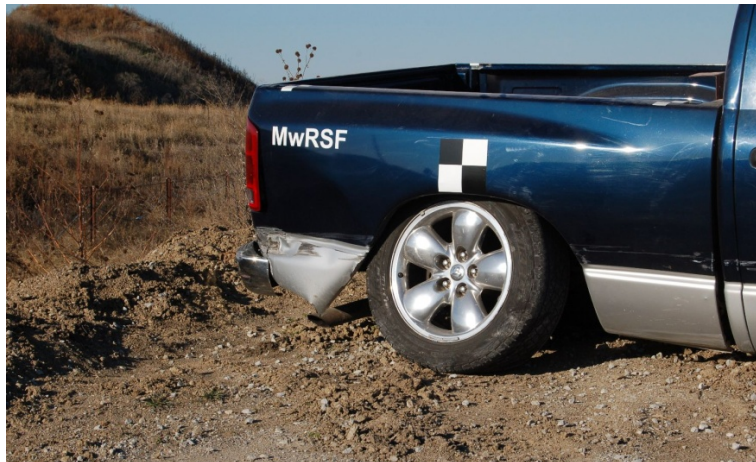
b. Right Side Rear Quarter

**Figure 86. Photo. Vehicle Damage, Test No. MGSGW-2.**

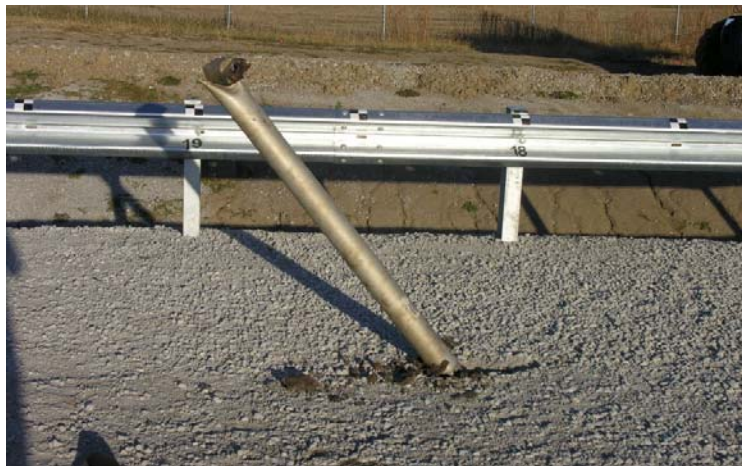
b. Drive Shaft

**Figure 87. Photo. Vehicle Undercarriage Damage, Test No. MGSGW-2.**
