*Midwest Pooled Fund Research Program
Fiscal Year 2019 (Year 29)
TPF-5(193) Supplement #138
NDOT Sponsoring Agency Code RPFP-19-CABLE-1*

**MASH TEST DESIGNATION NOS. 3-11 & 3-17 OF A NON-
PROPRIETARY, HIGH-TENSION CABLE MEDIAN BARRIER
WITH CLOSED-SECTION POSTS**

MwRSF Research Report No. TRP-03-431-22

December 1, 2022

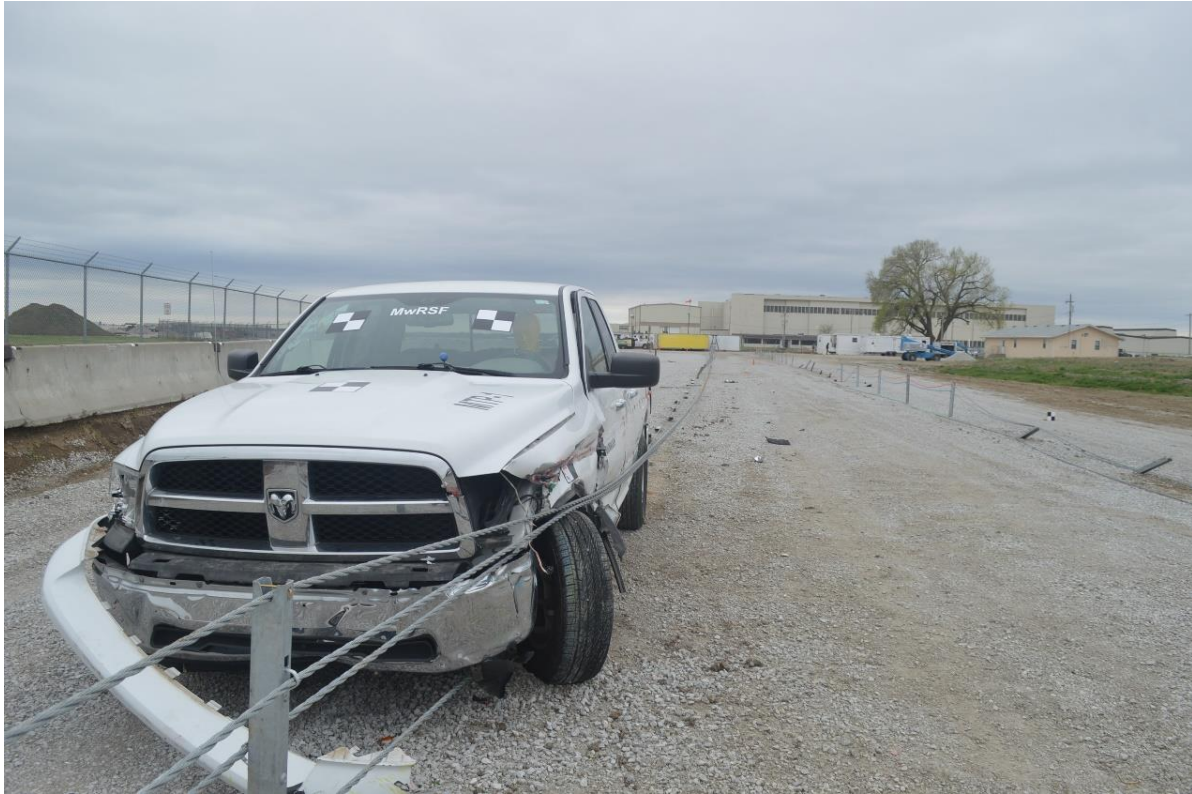
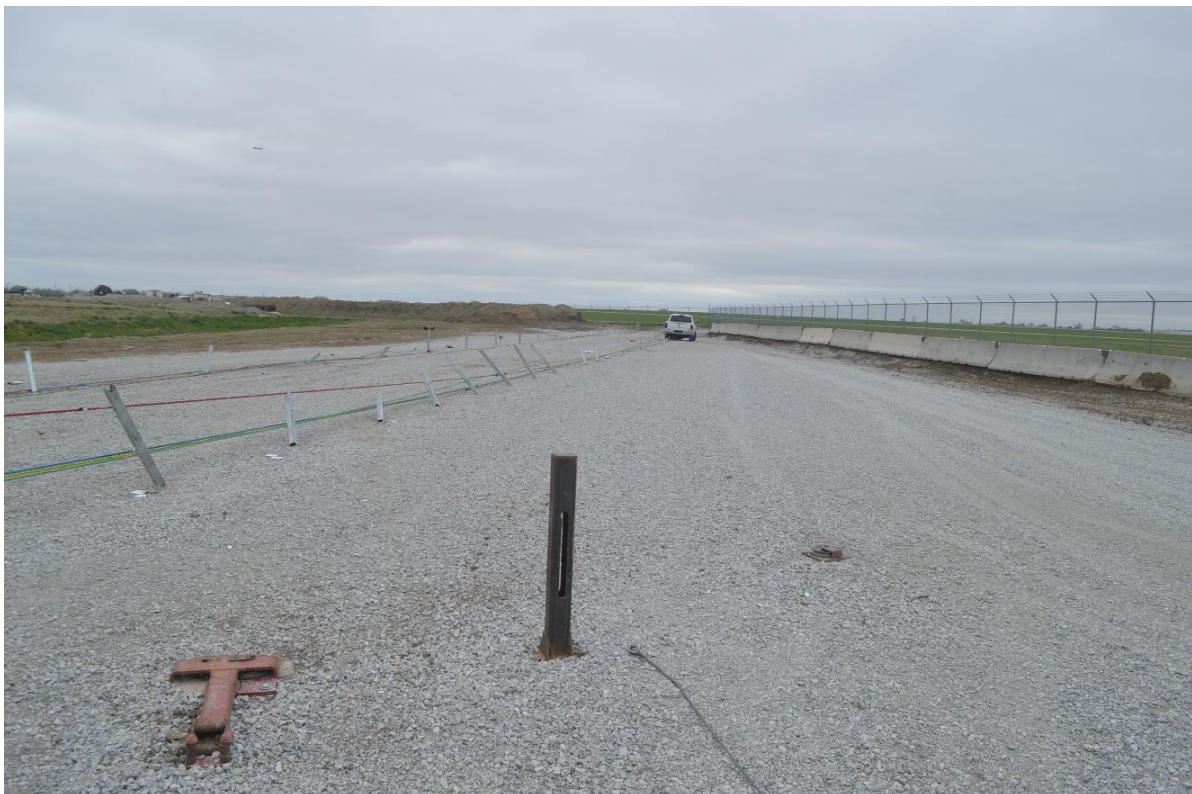
Figure 49. Vehicle Final Position and Trajectory Marks, Test No. MTP-1

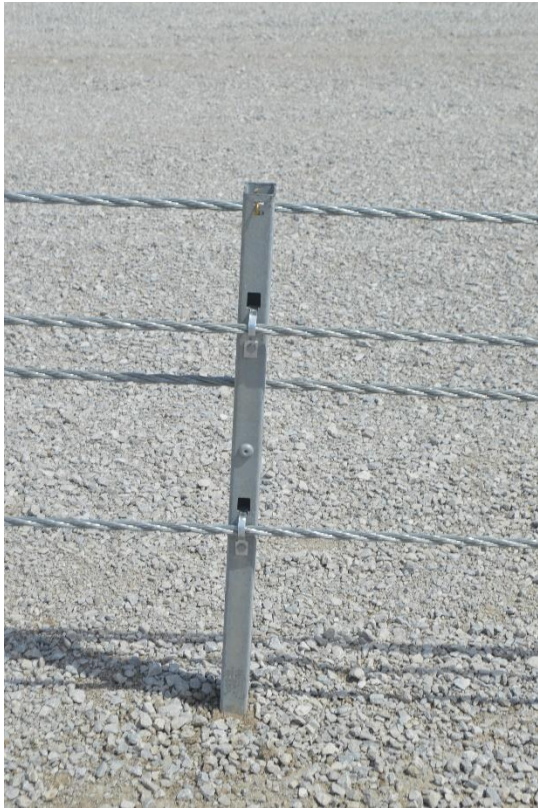
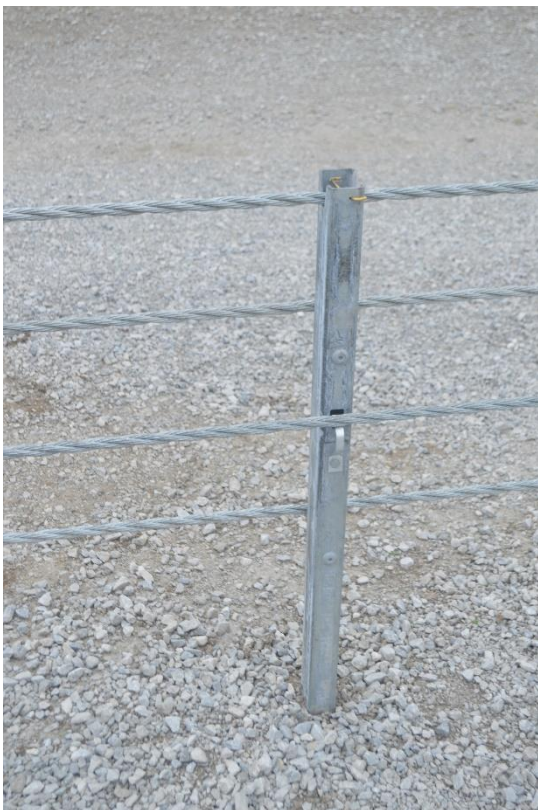
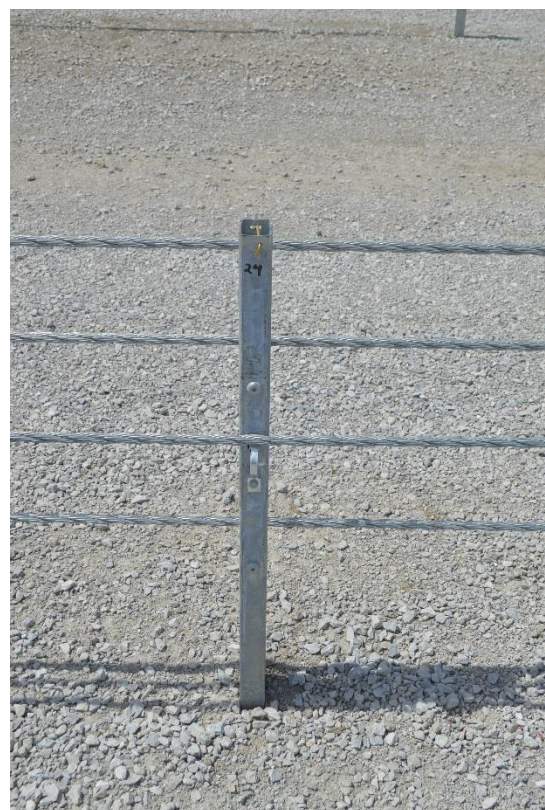
Figure 51. Post Nos. 23 (Left) and 24 (Right) Damage, Test No. MTP-1

Damage consisted primarily of bracket and brass rod deformation, cable release, soil gap formation, and minor post rotation between post nos. 18 and 25. Significant ground line post bending began at post no. 26, which bent backward. Combined backward bending and non-impact side wall buckling behavior occurred at post nos. 27 and 29 through 31. Partial section fracture occurred at post no. 28, with the upstream, downstream, and impact side walls of the post separating entirely from the post base along a plane through the two ground line holes. The non-impact side wall of post no. 28 remained intact. Post no. 32 twisted significantly but a small section of material remained between the two ground line holes on the downstream side wall. Post nos. 33 through 37 and 39 bent backward and downstream and experienced partial section fracture. Post no. 38 did not fracture, but bent backward and downstream. Complete section fracture through the ground line holes occurred at post no. 40. Post nos. 41 through 45 and 48 through 58 sustained a combination of partial section fracture and downstream bending. Post nos. 46 and 47 fractured completely. Only minor damage including bracket deformation, minor soil gap formation, and brass rod damage occurred between post no. 59 and 76. A summary of disengaged cables, bracket damage, and brass rod damage is shown in Table 7.

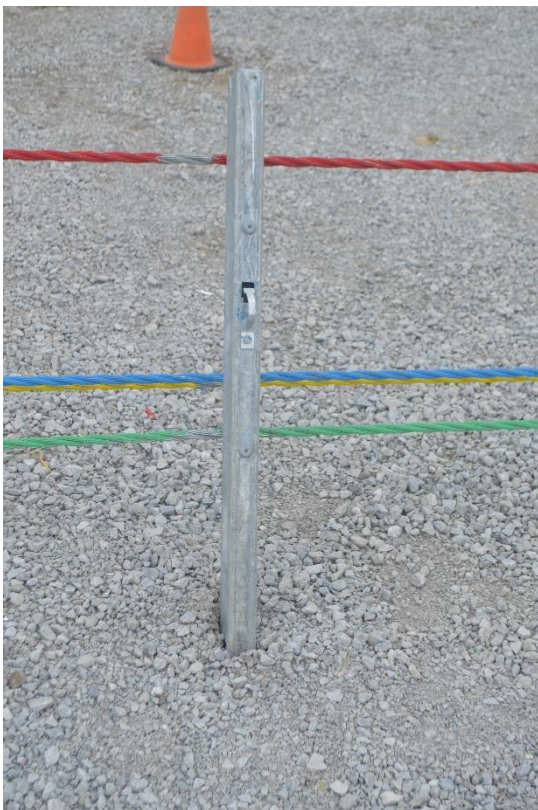
Figure 55. Post Nos. 31 (Left) and 32 (Right) Damage, Test No. MTP-1

0.032	Post no. 31 deflected backward and post no. 32 fractured.
0.038	Cable nos. 1, 2, and 3 disengaged from post no. 32.
0.050	Post no. 34 deflected backward. Vehicle's front bumper contacted cable no. 3.

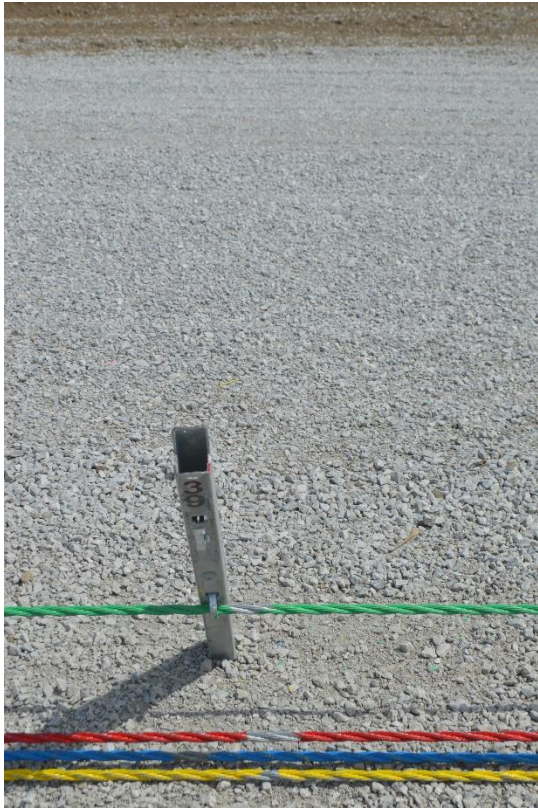
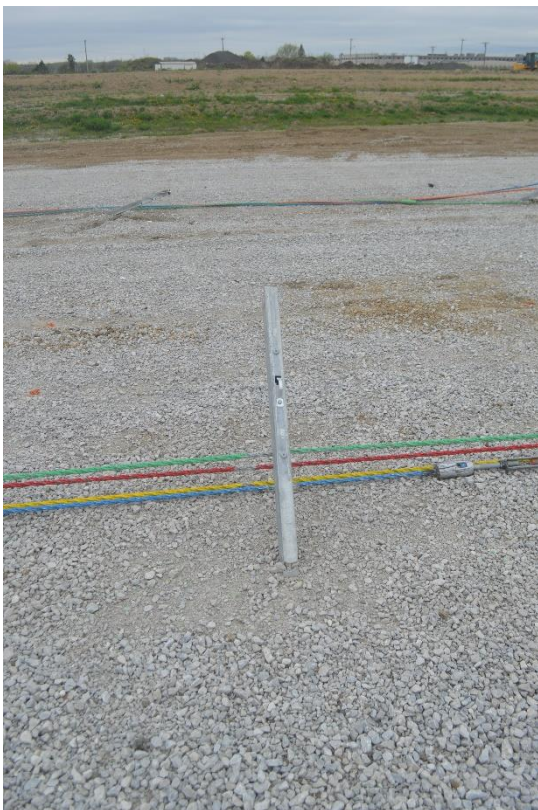
Figure 59. Post Nos. 39 (Left) and 40 (Right) Damage, Test No. MTP-1

The maximum lateral permanent set of the posts in the system was 28.1 in. (714 mm), which occurred at post no. 39, as measured via GPS in the field. The maximum lateral dynamic barrier deflection was 101.8 in. (2,586 mm), as determined from high-speed digital video analysis. The working width of the system was found to be 102.1 in. (2,593 mm), which was also determined from high-speed digital video analysis. The working width and dynamic deflection were determined to be the point reached by the test vehicle's left-rear bumper between post nos. 35 and 36 and the cable in contact with the bumper at that same location, respectively. A schematic of the permanent set deflection, dynamic deflection, and working width is shown in Figure 76.

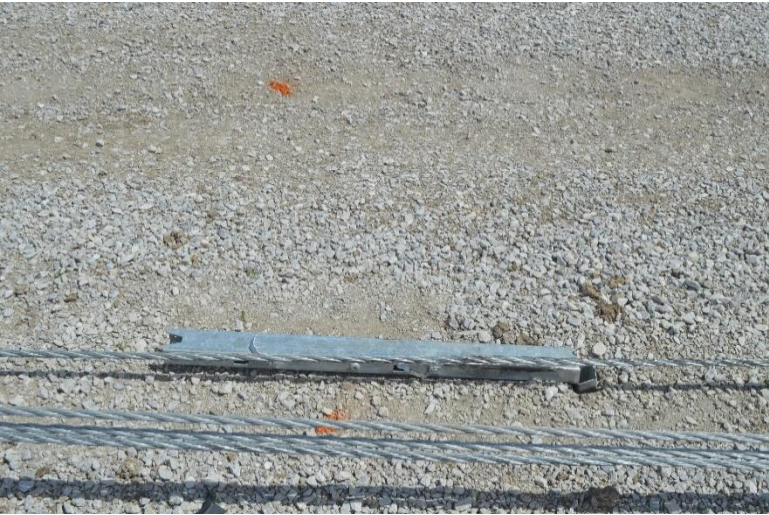
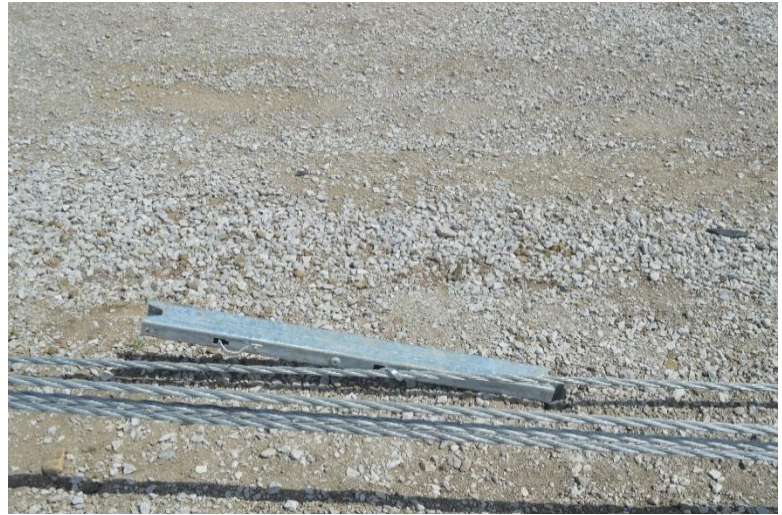
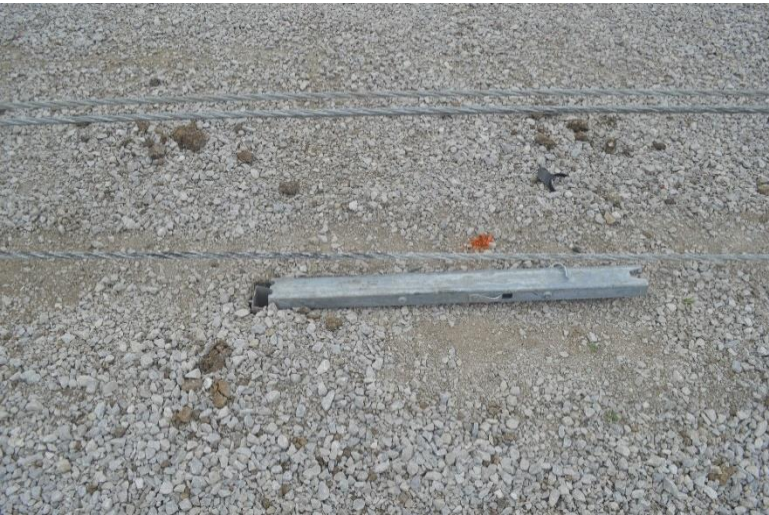
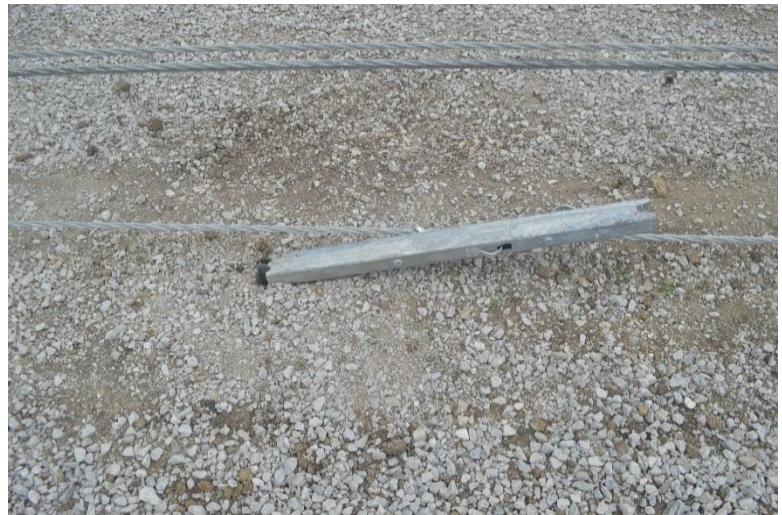
Figure 66. Post Nos. 53 (Left) and 54 (Right) Damage, Test No. MTP-1

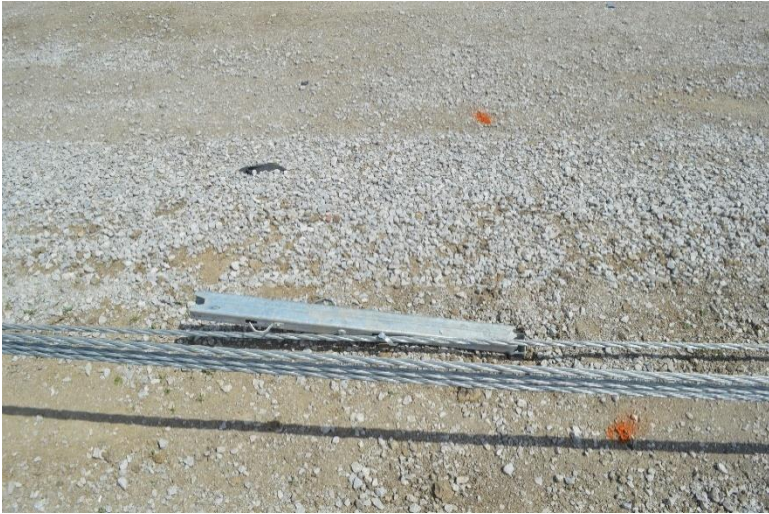
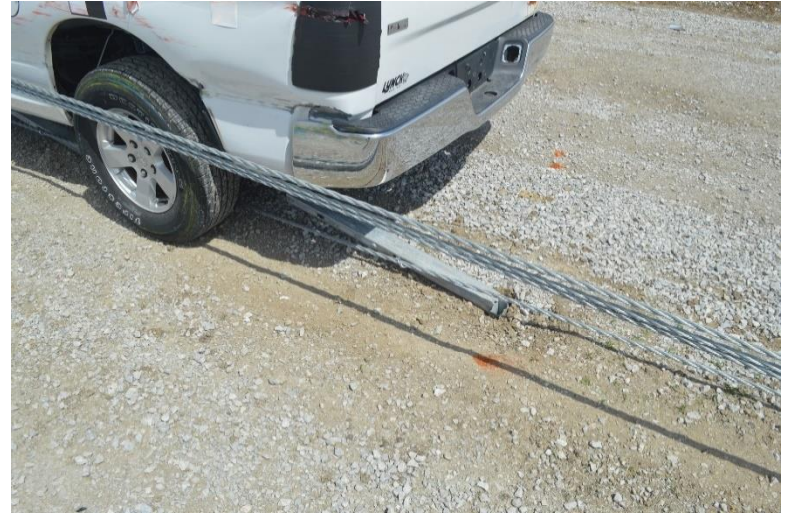
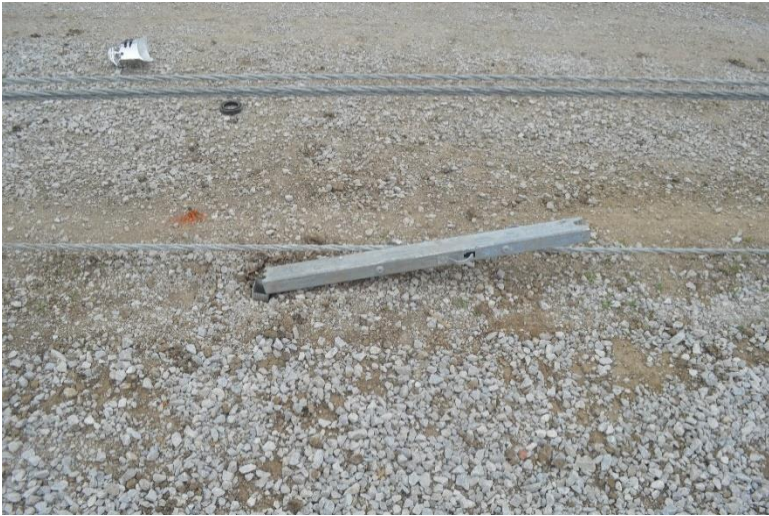
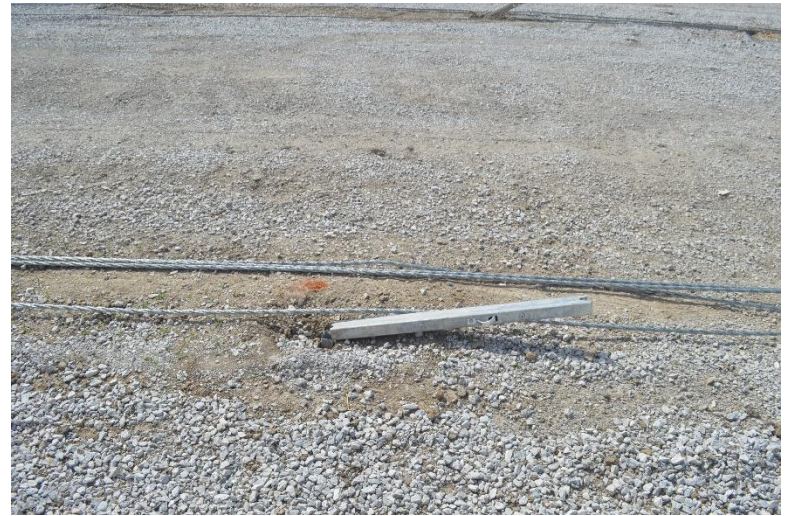
Figure 67. Post Nos. 55 (Left) and 56 (Right) Damage, Test No. MTP-1

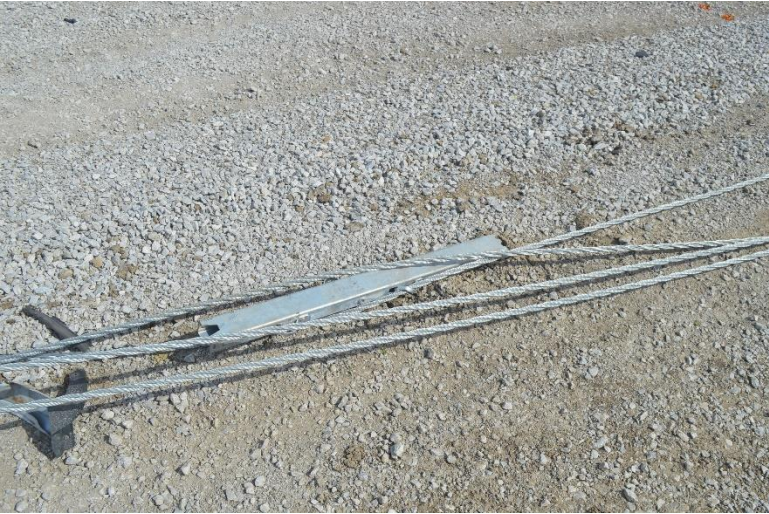
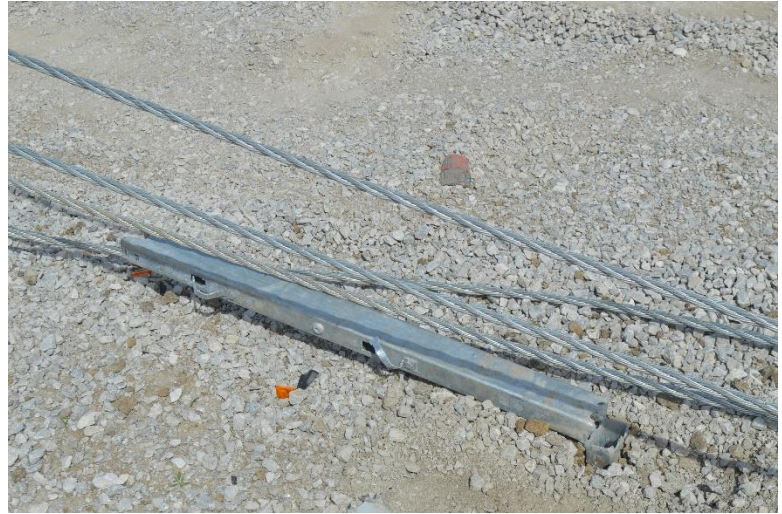
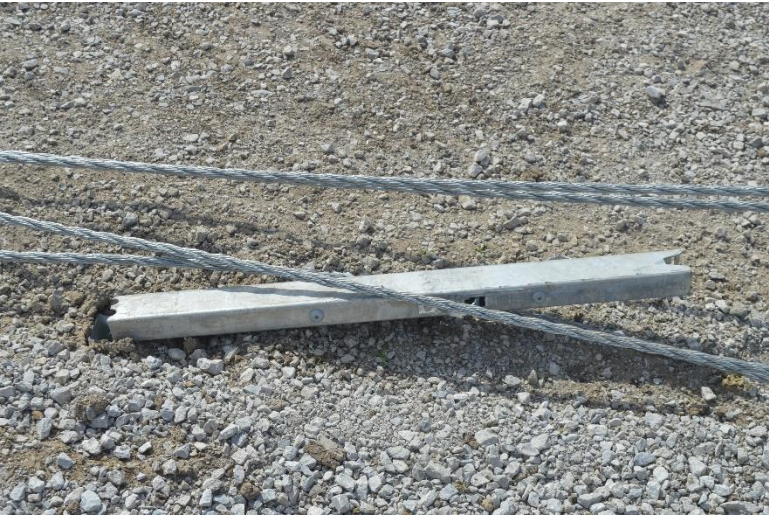
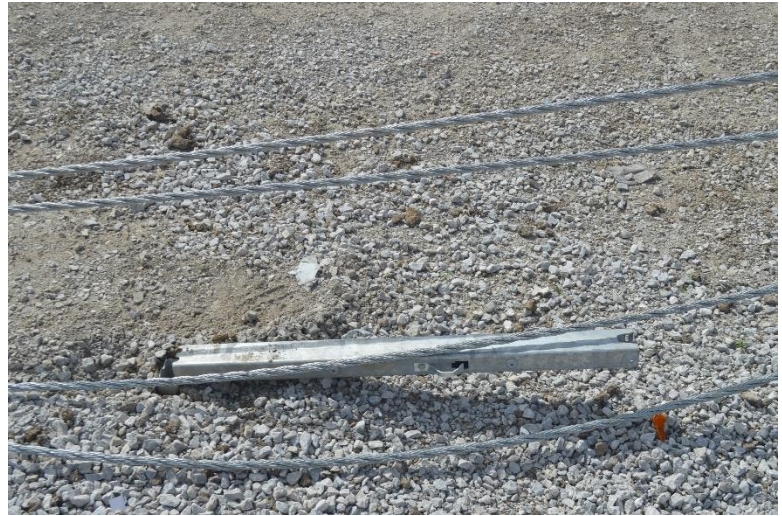
Figure 68. Post Nos. 57 (Left) and 58 (Right) Damage, Test No. MTP-1

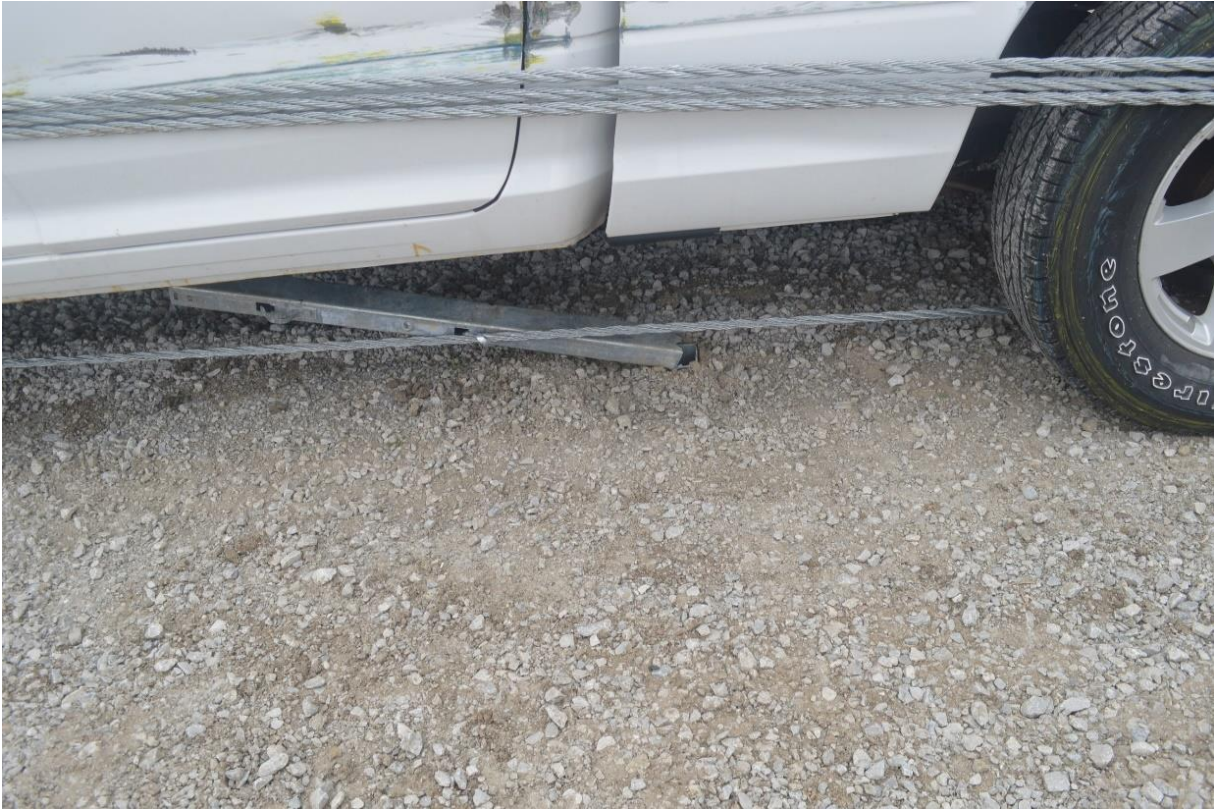
Figure 69. Post Nos. 57 and 58 with Vehicle, Test No. MTP-1

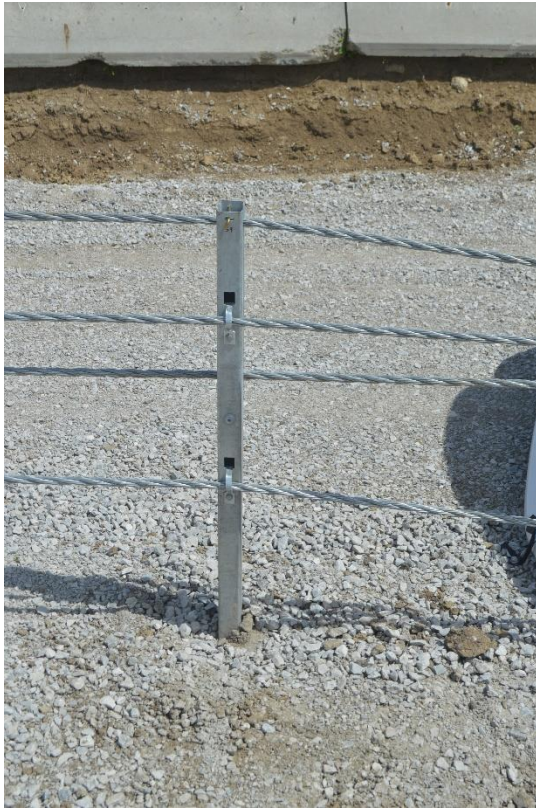
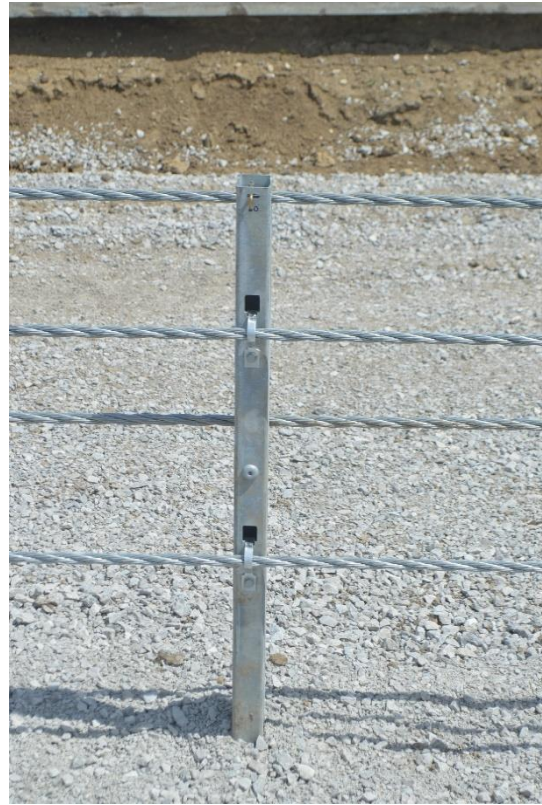
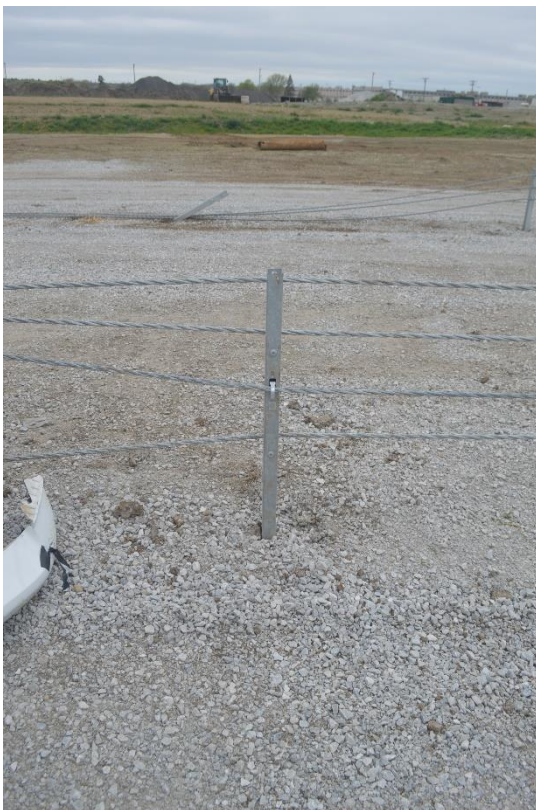
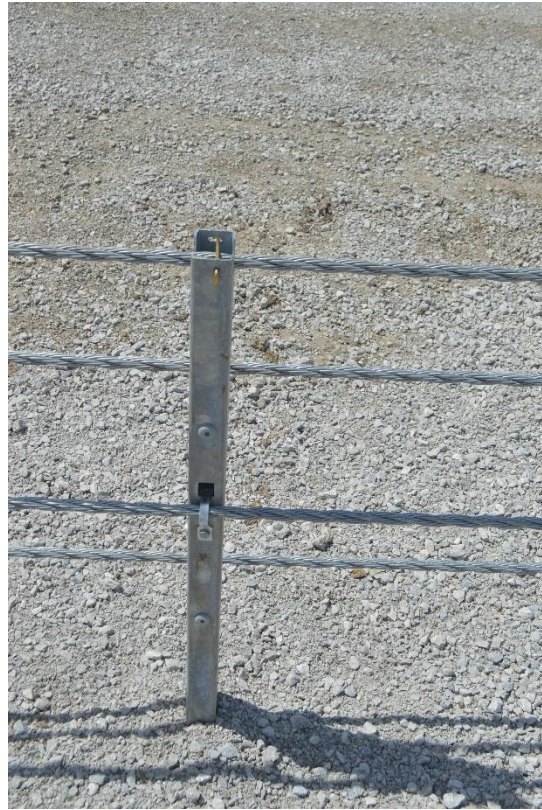
Figure 70. Post Nos. 59 (Left) and 60 (Right) Damage, Test No. MTP-1

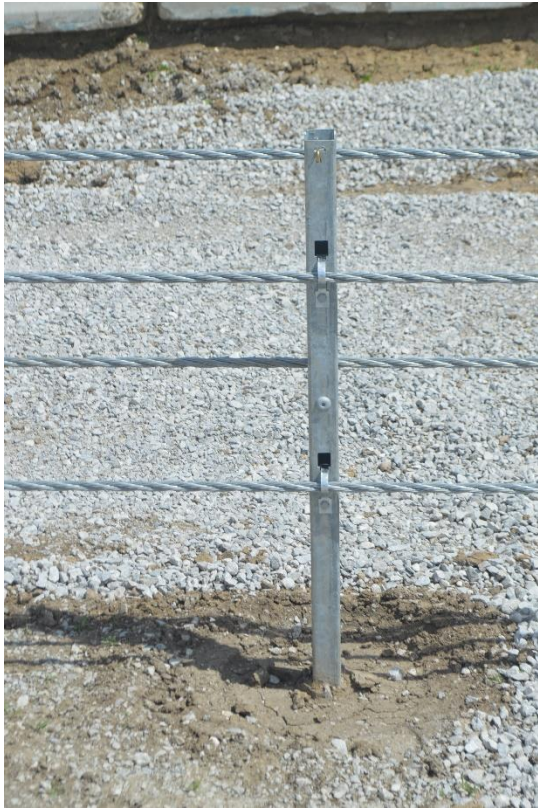
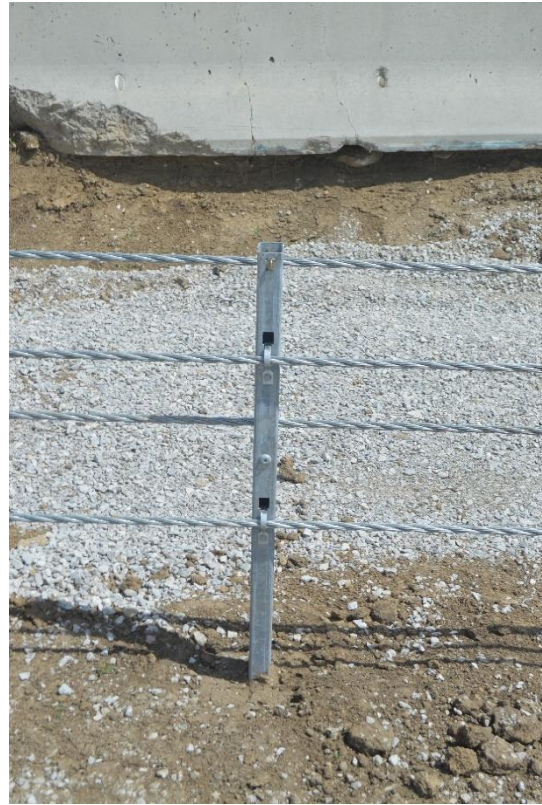
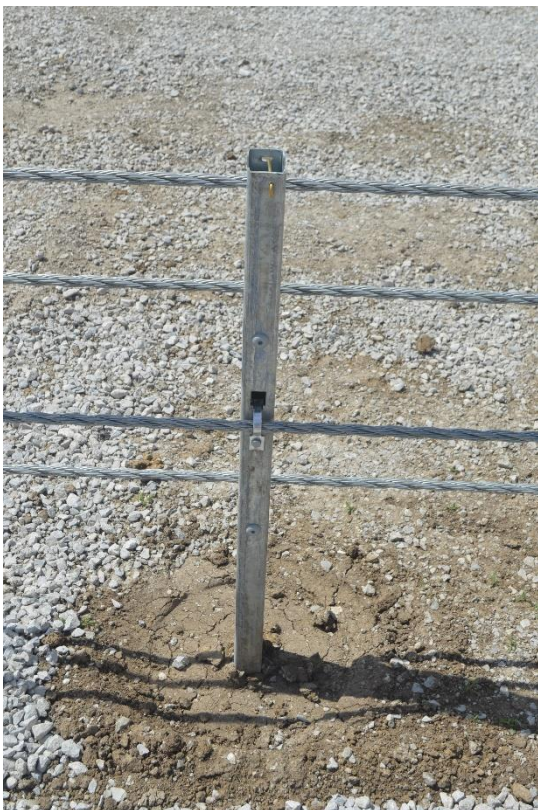
Figure 71. Post Nos. 61 (Left) and 62 (Right) Damage, Test No. MTP-1

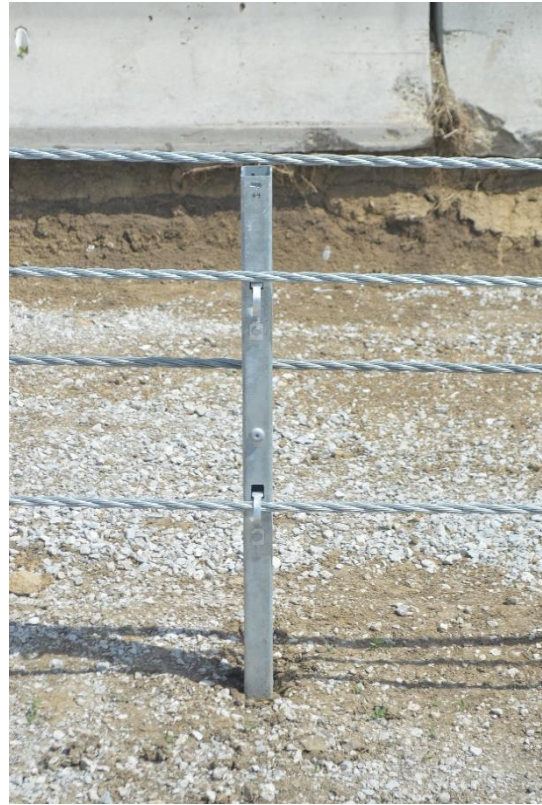
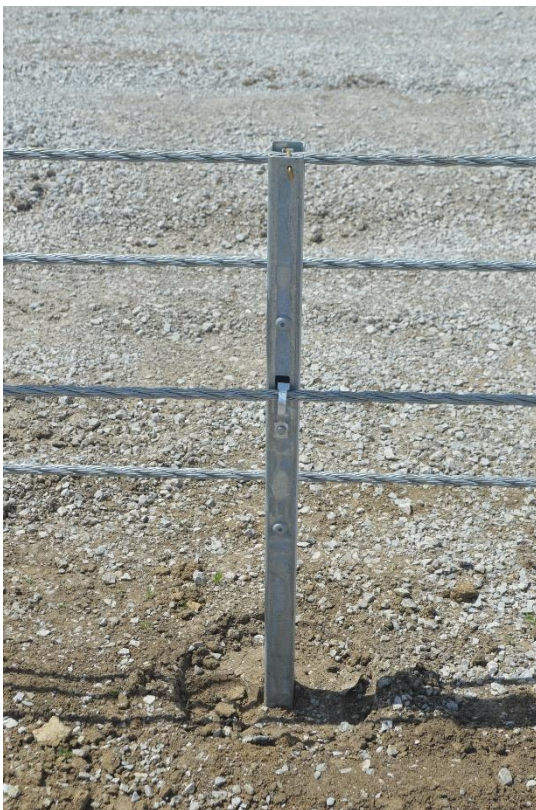
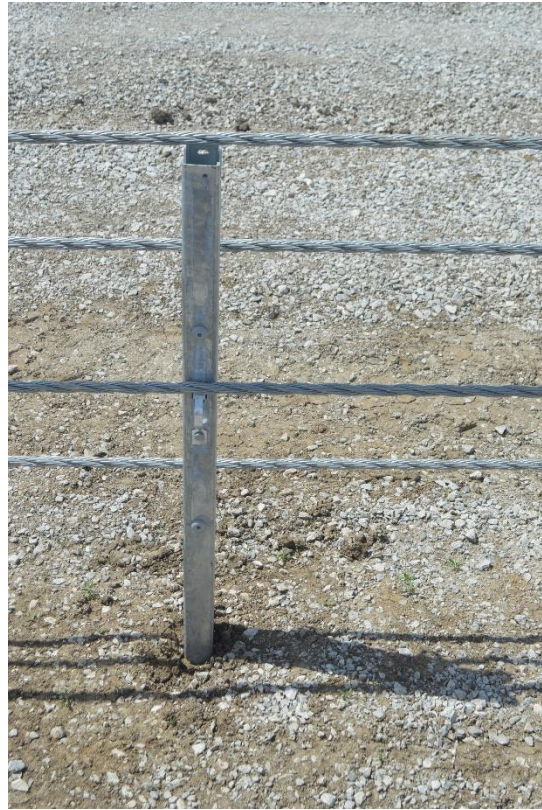
Figure 72. Post Nos. 63 (Left) and 64 (Right) Damage, Test No. MTP-1

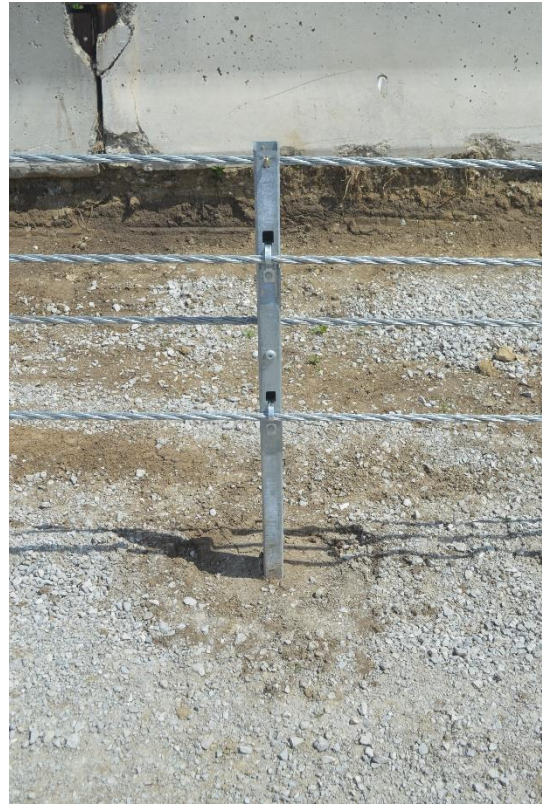
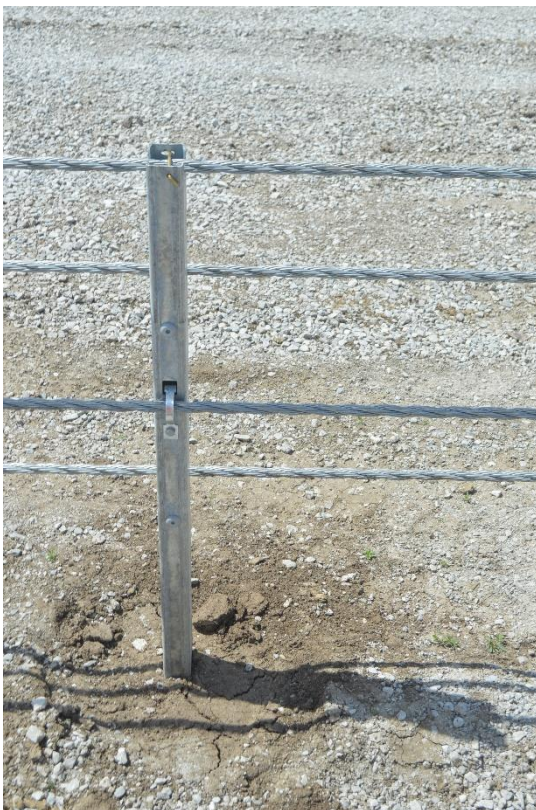
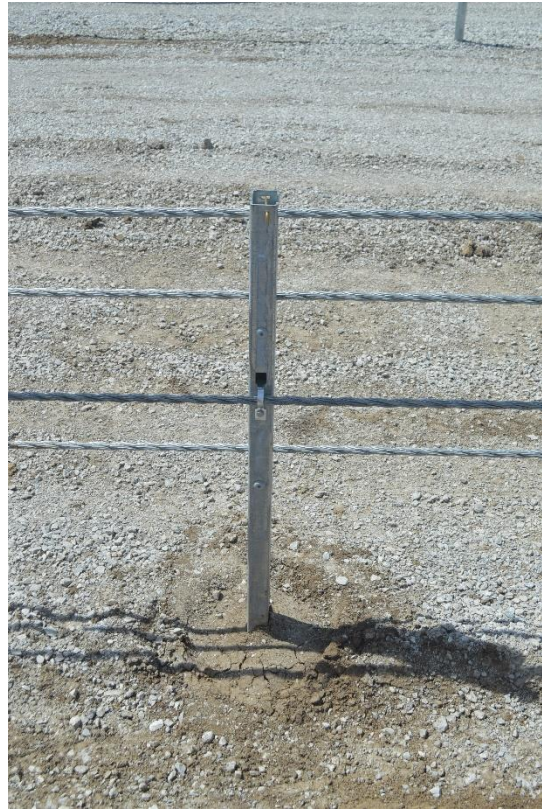
Figure 73. Post Nos. 65 (Left) and 66 (Right) Damage, Test No. MTP-1

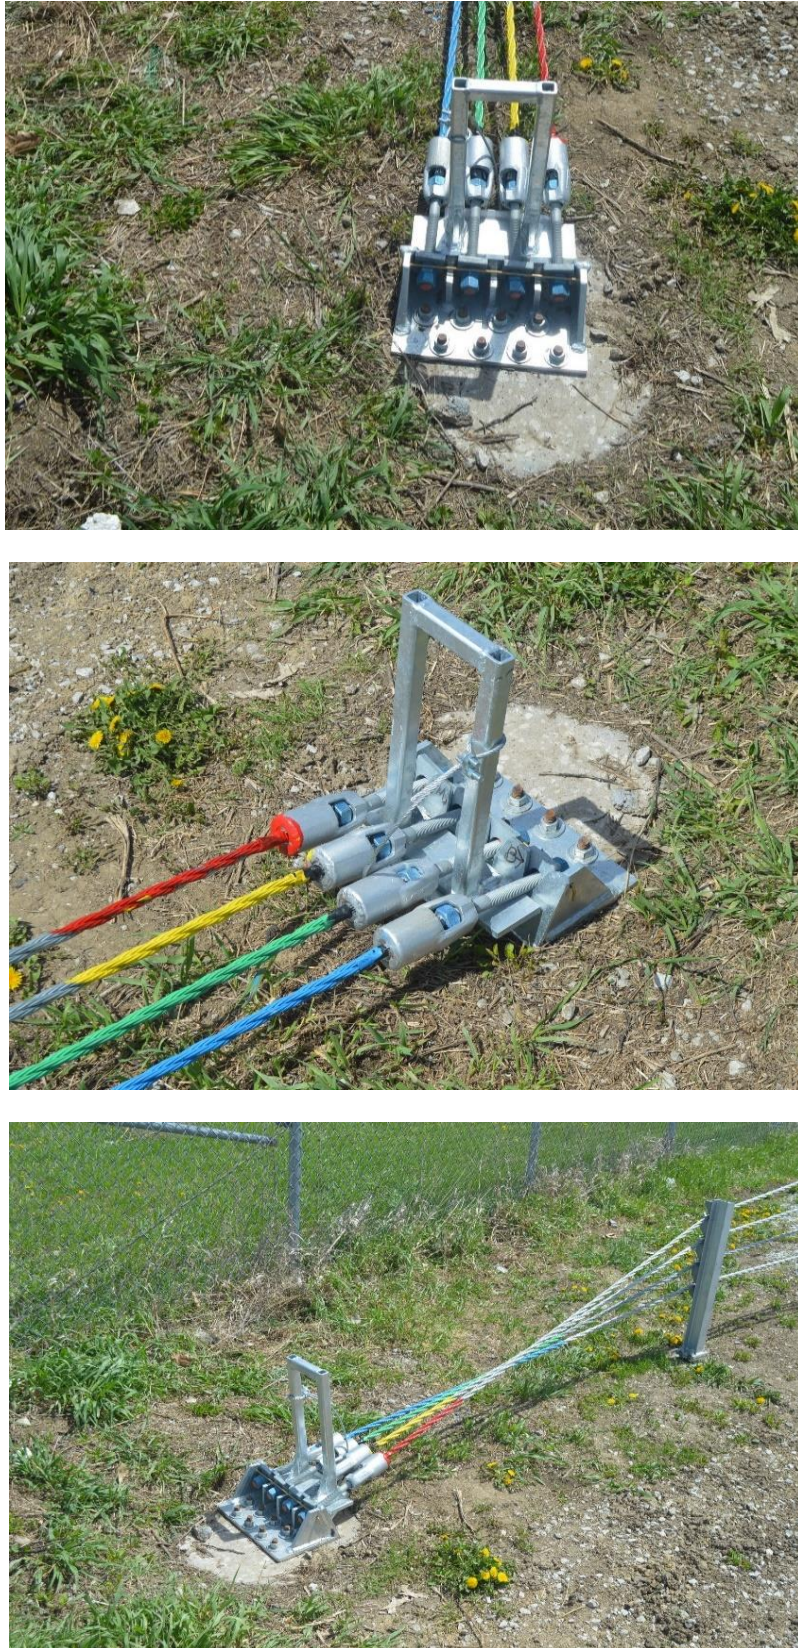
Figure 74. Post-Test Downstream Anchorage, Test No. MTP-1

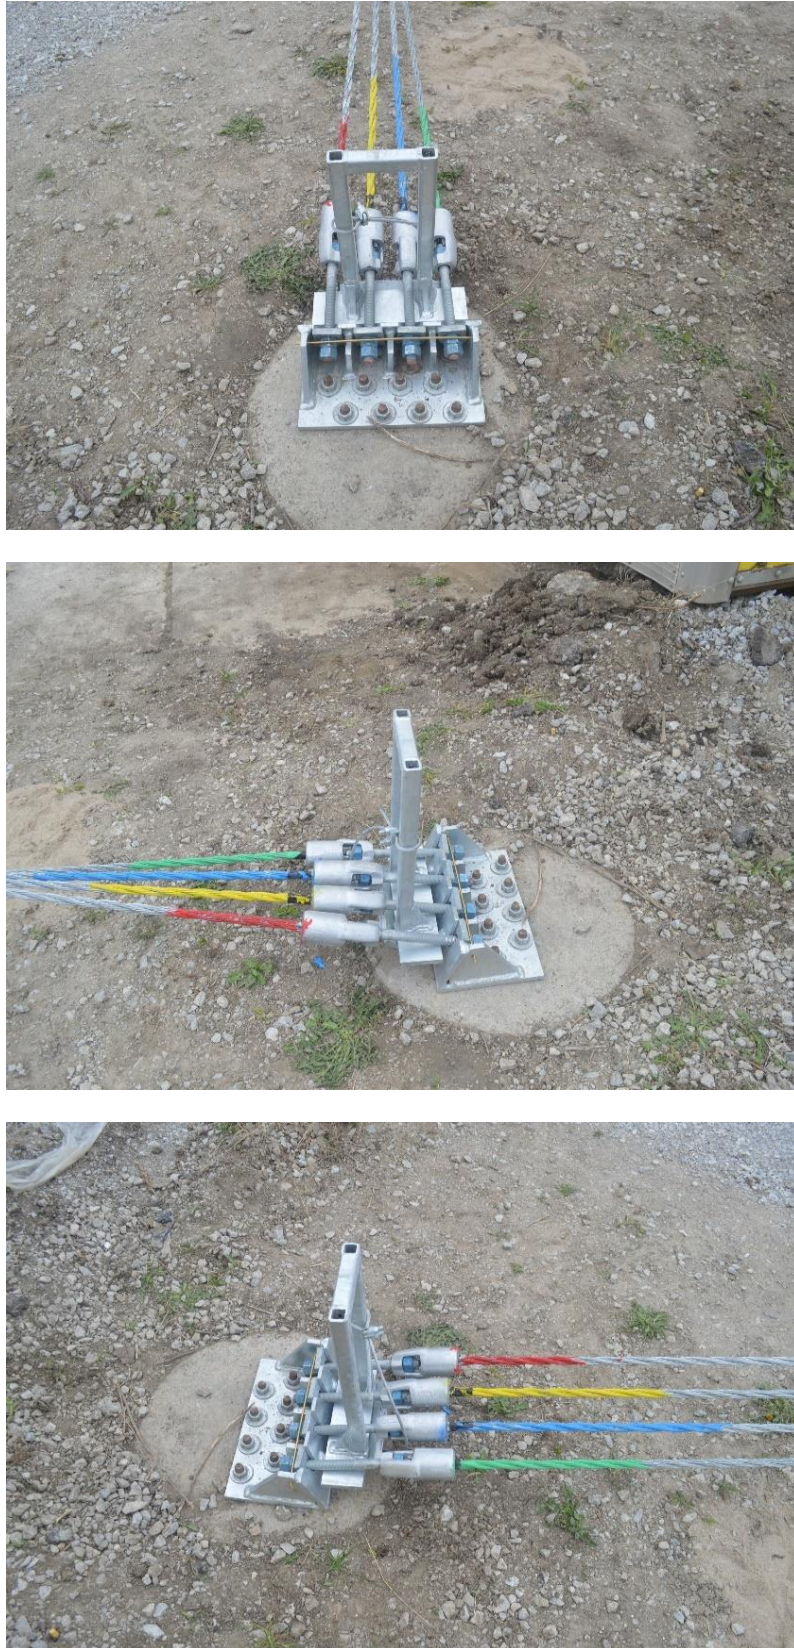
Figure 75. Post-Test Upstream Anchorage, Test No. MTP-1

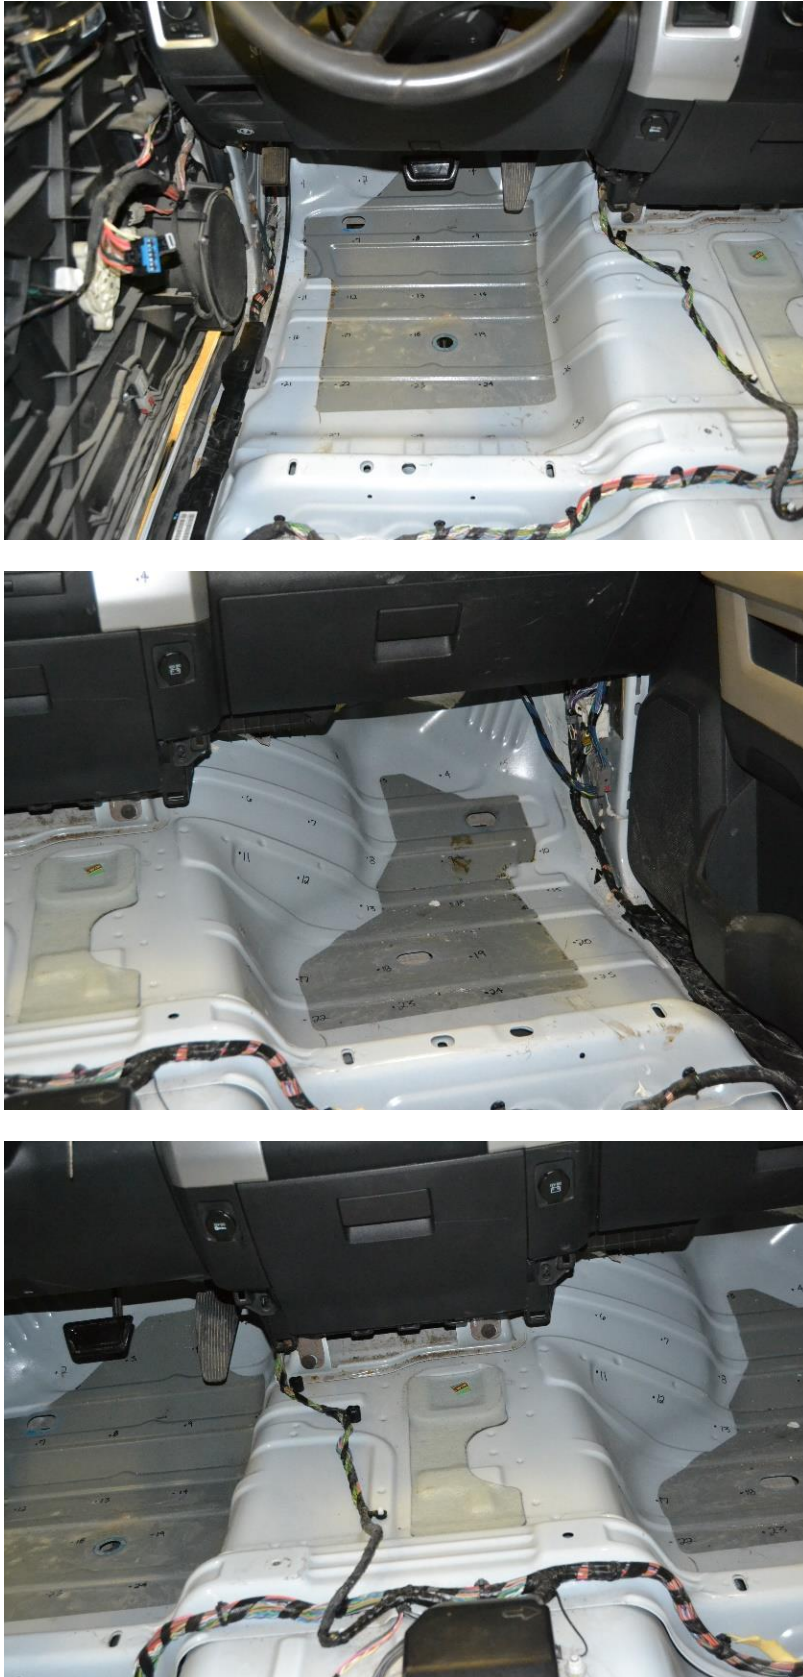
reduced in size with no observed penetration. There were no penetrations into the occupant compartment, and none of the established MASH 2016 deformation limits were violated. Outward deformations, which are denoted as negative numbers in Appendix D, are not considered crush toward the occupant, and are not evaluated by MASH 2016 criteria.

Figure 79. Occupant Compartment Damage, Test No. MTP-1

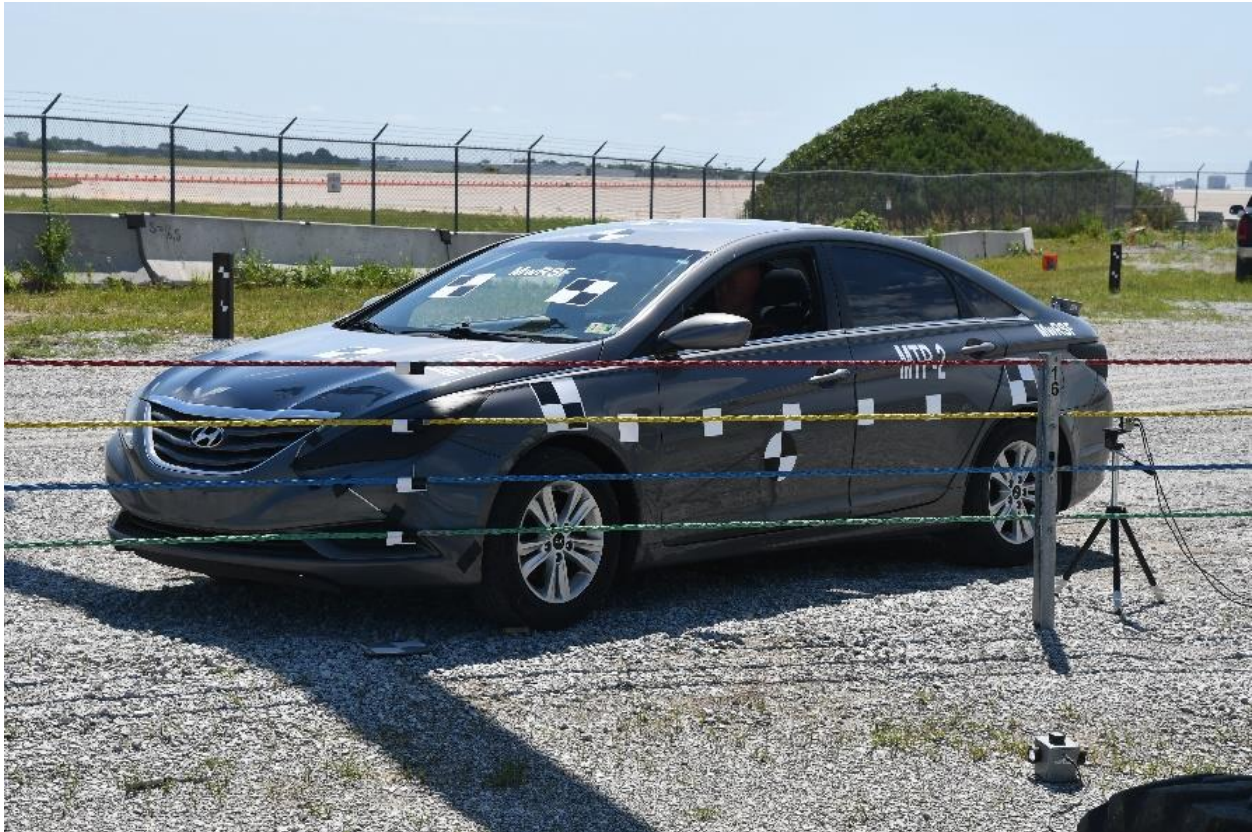
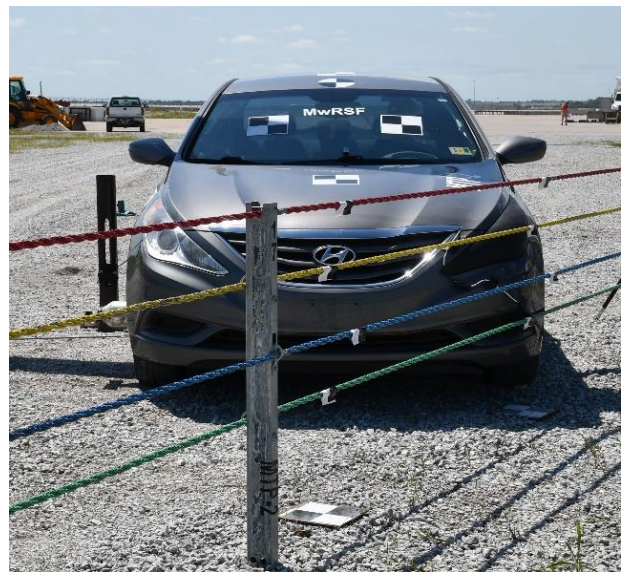
Figure 114. Impact Location, Test No. MTP-2

Initial vehicle impact was to occur 96 in. (2,438 mm) upstream from the centerline of post no. 17, as shown in Figure 114, which was selected using Table 2-2D of MASH 2016. The 3,301-lb (1,497-kg) sedan impacted the cable barrier system at a speed of 61.6 mph (99.1 km/h) and at an angle of 25.0 degrees for an impact severity of 74.8 kip-ft (101.4 kJ). The actual point of impact was at the target impact location. The vehicle came to rest 266 ft – 10 in. (81.3 m) downstream and 8.3 ft (2.5 m) behind the system and in contact with the system after brakes were applied.
