*Midwest Pooled Fund Research Program
Fiscal Year 2019 (Year 29)
TPF-5(193) Supplement #138
NDOT Sponsoring Agency Code RPFP-19-CABLE-1*

**MASH TEST DESIGNATION NOS. 3-11 & 3-17 OF A NON-
PROPRIETARY, HIGH-TENSION CABLE MEDIAN BARRIER
WITH CLOSED-SECTION POSTS**

MwRSF Research Report No. TRP-03-431-22

December 1, 2022

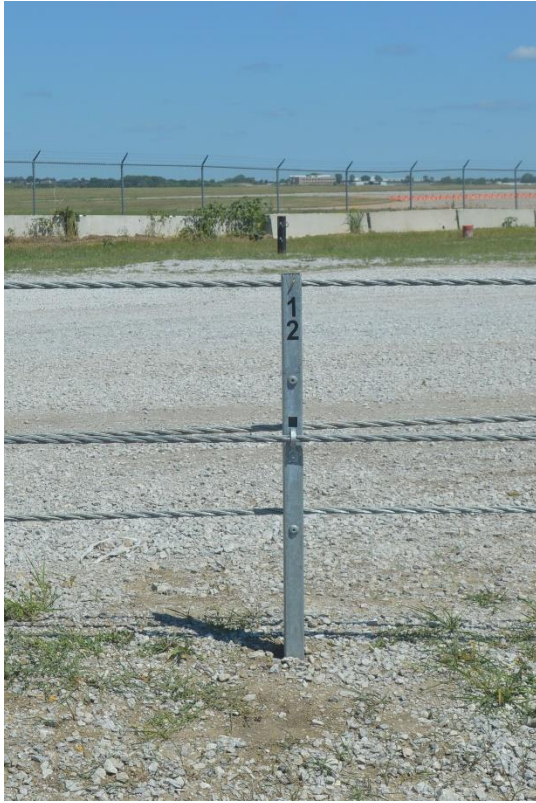
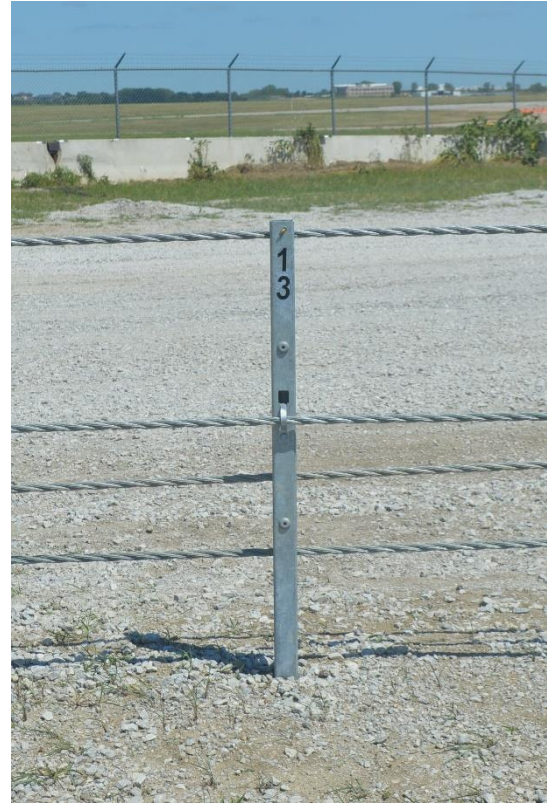
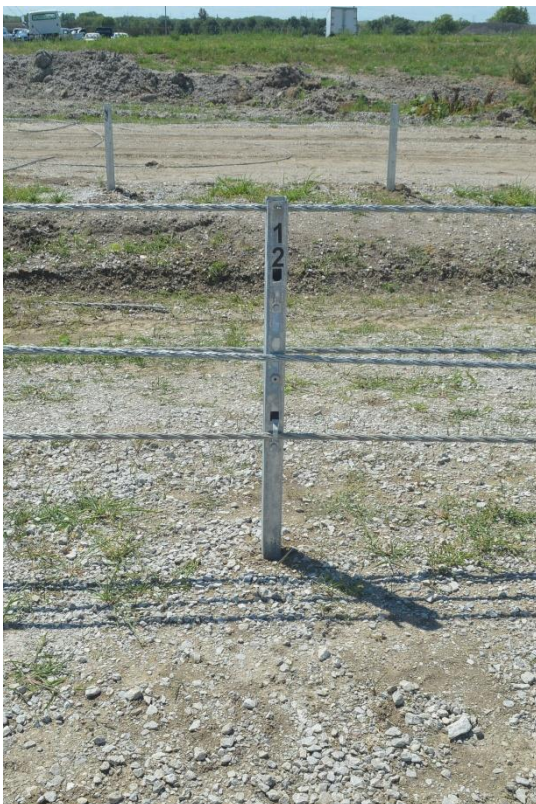
Figure 123. Post Nos. 12 (Left) and 13 (Right) Damage, Test No. MTP-2

Post no. 13 rotated backward, while post no. 14 bent and rotated backward. Post no. 15 rotated backward and bent backward and upstream in addition to fracturing on the front face, upstream, and downstream sides through the weakening holes. Post no. 16 rotated backward and upstream and bent backward. Post no. 17 was twisted counterclockwise and bent backward and downstream. The bend in post no. 17 was located 46 in. (1,168 mm) from the top of the post. Post no. 18 bent and rotated backward and clockwise. Post no. 19 bent backward and rotated backward and upstream. Post no. 20 rotated clockwise and downstream. Post nos. 21 and 26 rotated backward and downstream. Post nos. 22, 24, 27, and 35 rotated backward. Post nos. 16, 23, 36, and 37 rotated backward and upstream. Cable bracket deformation, bracket fracture through the bolt hole, and brass rod deformation and fracture are specified for each cable and post in Table 14.

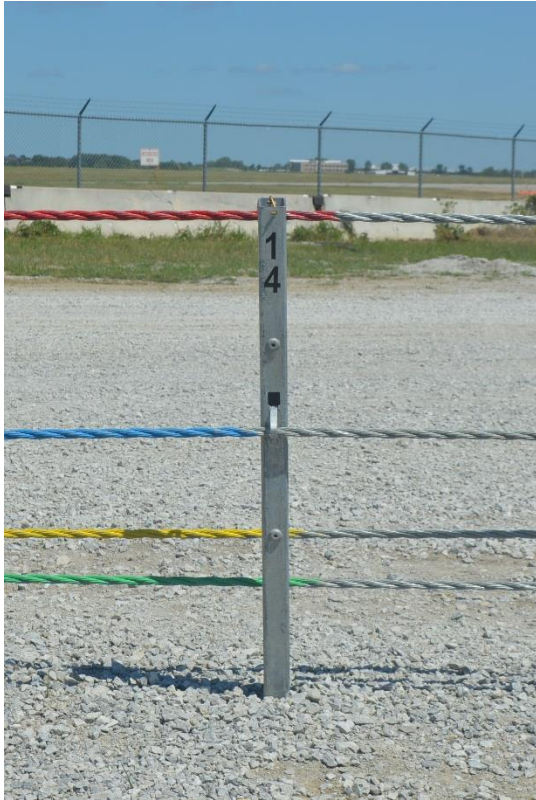
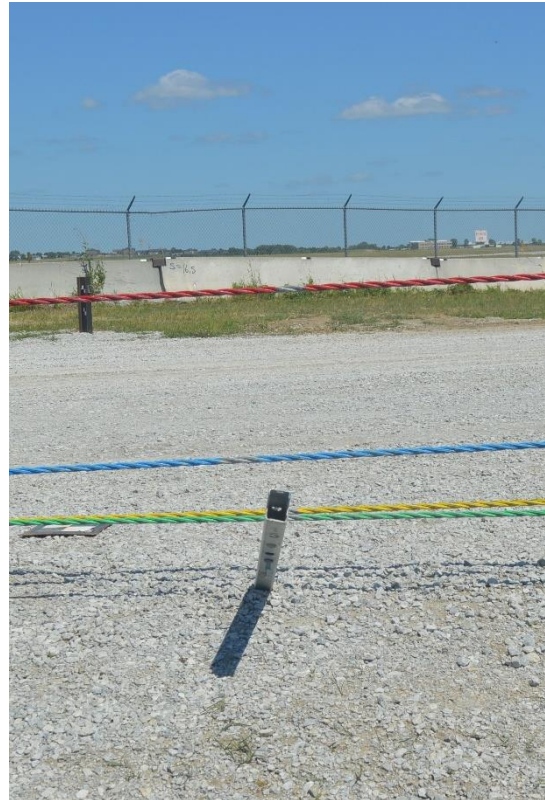
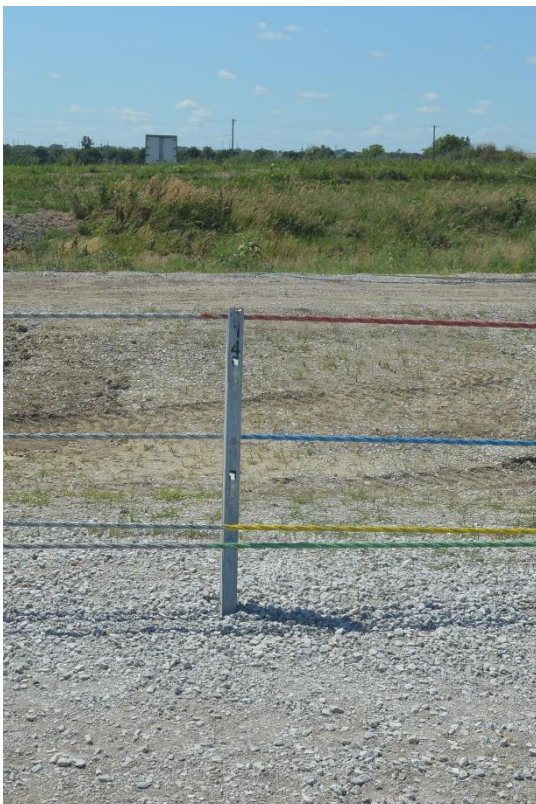
Figure 124. Post Nos. 14 (Left) and 15 (Right) Damage, Test No. MTP-2

The maximum lateral permanent set of the posts in the system was 36.8 in. (935 mm), which occurred at post no. 15, as measured via GPS in the field. The maximum lateral dynamic barrier deflection was 199.9 in. (5,077 mm), as determined from high-speed digital video analysis and the GPS trajectory data in the field. The working width of the system was found to be 200.6 in. (5,095 mm) determined from the GPS trajectory data in the field. The working width and dynamic deflection were determined to be the point reached by the test vehicle's left-front corner between post nos. 24 and 25 and the cable's position on the vehicle at that time, respectively. A schematic of the permanent set deflection, dynamic deflection, and working width is shown in Figure 138.
